**Periodic Inspection Report No. 5
Hancock Brook
Plymouth, Connecticut**

Hancock Brook Lake

November 1995

**US Army Corps
of Engineers**

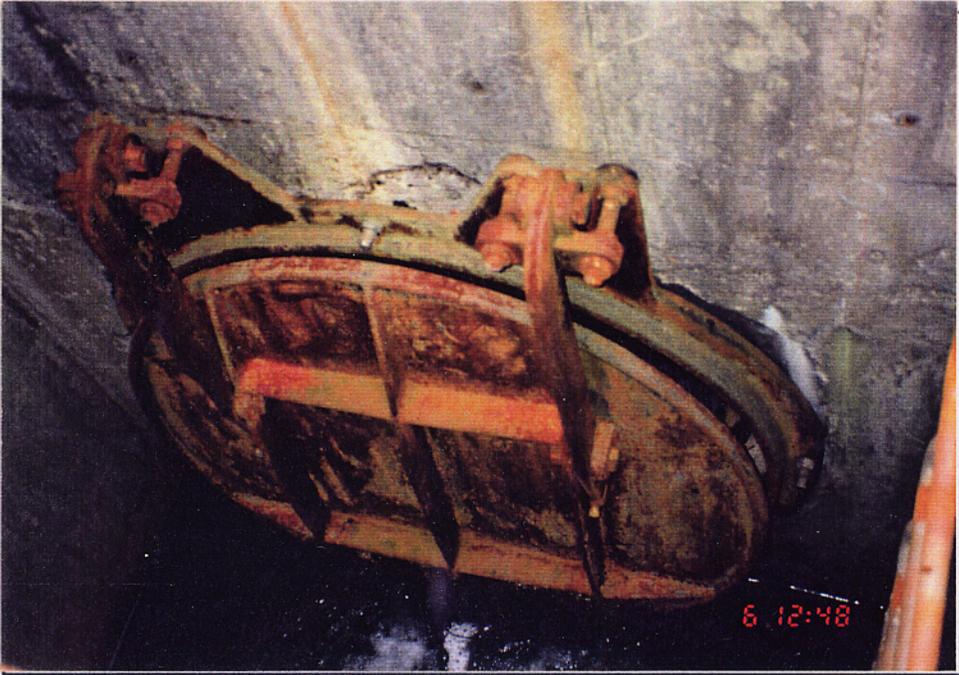
Photo A-1. Rusty flap gate at Diversion Dike No. 1.

(1) 60" RCP from Diversion Dike No. 1. The overall condition of the storm drain system is fair, and the flap gate (see photo A-1) has several deficiencies.

The steel flap gate frame was originally set too high. There is a 6"+ difference in elevation between the pipe invert and the steel frame. As noted in the previous report, the water flowing under the frame has further deteriorated the concrete below the flap gate. There are also concrete spalls around the flap gate. The deterioration of the concrete will eventually cause the anchor bolts around the steel gate frame to loosen or dislodge.

b. Reset flap gate in correct position for diversion dike no. 1, manhole no. 1, and seal the joint between the steel flap gate frame and the end of the pipe. Repair cracks and deteriorated concrete in 60-inch RCP for diversion dikes no. 1 and 2. Operations directorate to budget within next two years. Estimated construction cost is \$55,000; estimated E&D costs is \$10,000.

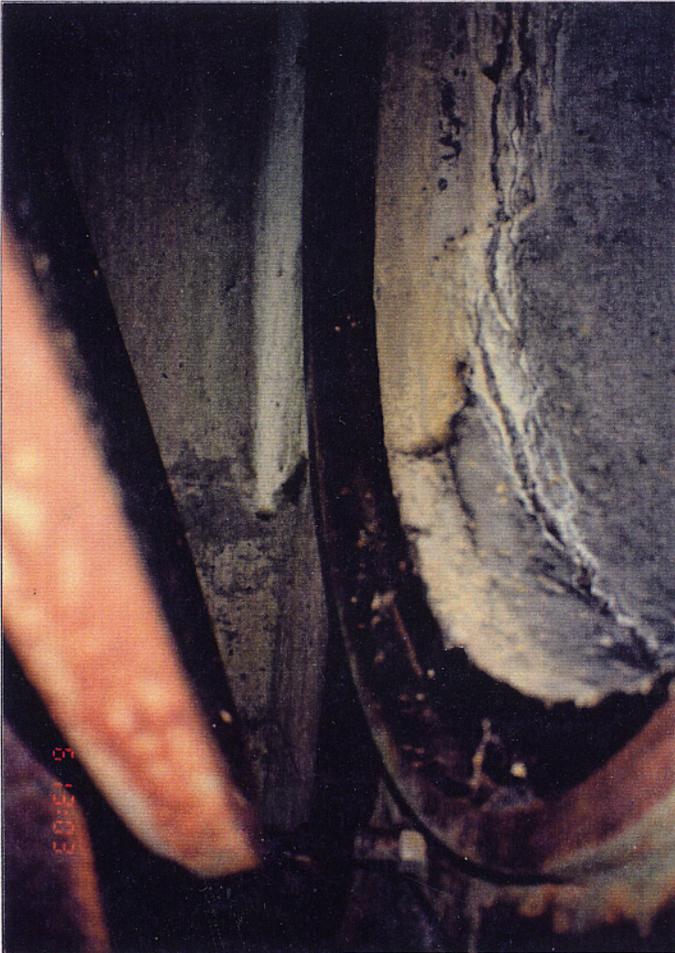
Photo A-2. 1-1/2" wide circumferential cracks at the steel flap gate frame in Diversion Dike No. 1.

The 1-1/2" wide circumferential cracks, as noted in the previous inspection, have not worsened, but a few more spots of exposed rebar inside the RCP have been located (see photo A-2 and A-3).

- a. 60" RCP Outlet. Circumferential crack 1 1/2" wide at outlet just inside steel frame (see App. II, photo A-2).

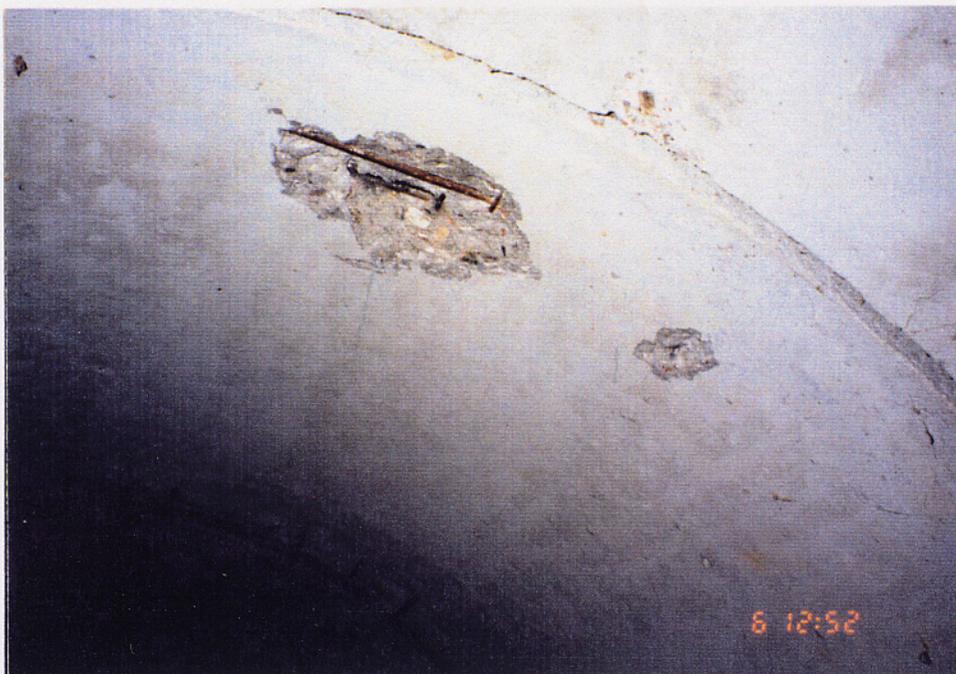
Photo A-3. Exposed rebar inside the RCP from Diversion Dike No. 1.

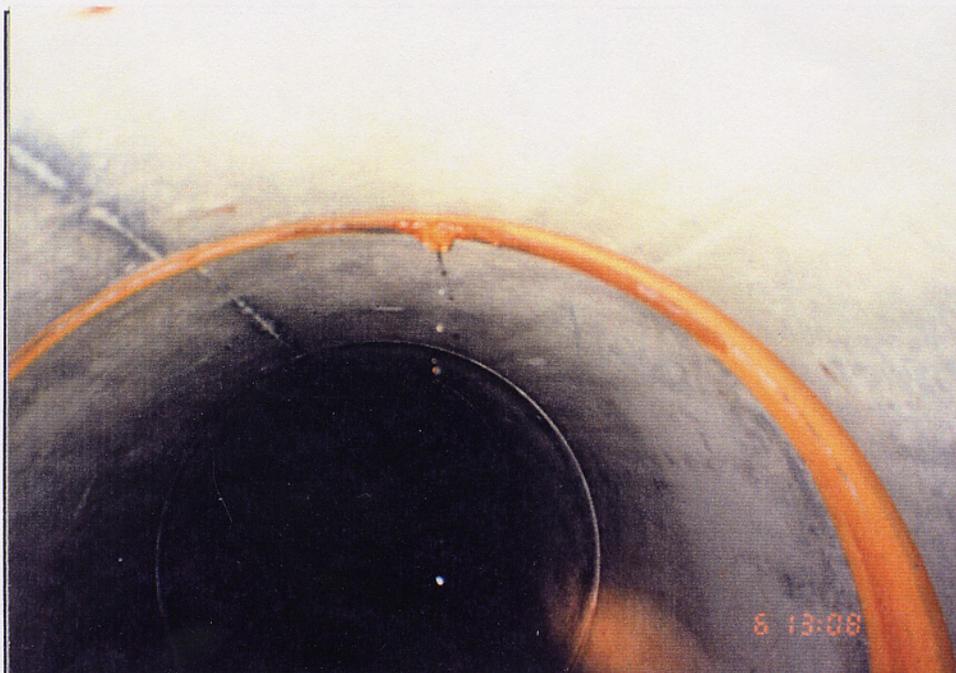
Photo A-4. Water leakage with buildup of orange, rust colored material inside Diversion Dike No. 1 RCP.

Water is leaking from various circumferential construction joints. An orange/rust colored material has developed at these locations (see photo A-4).

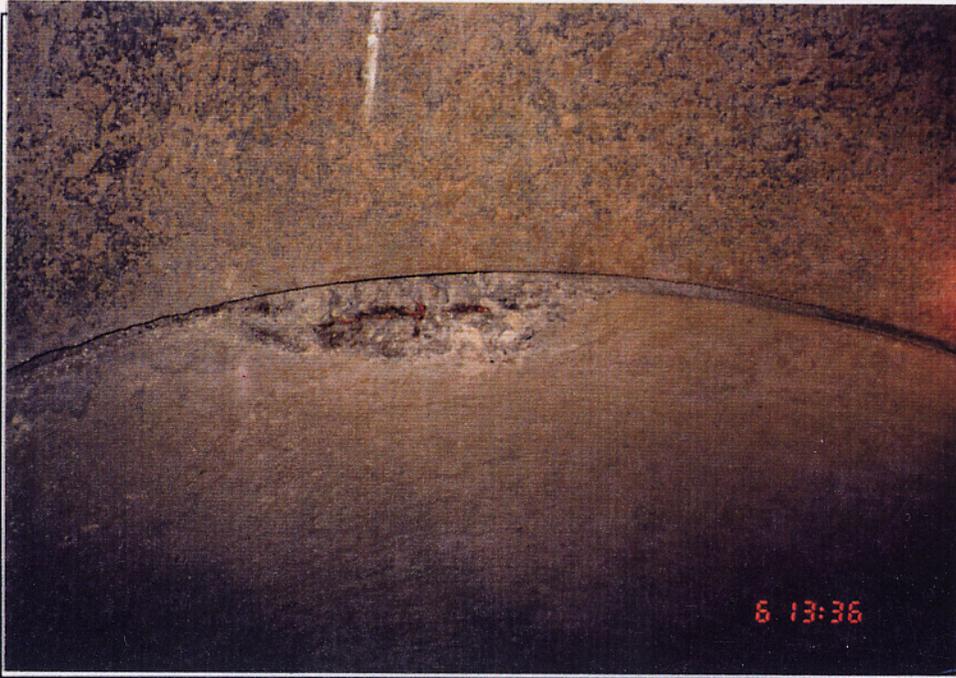
Photo A-5. Concrete spall and exposed rebar around the external end of the RCP pipe opening in Diversion Dike No. 1.

The three eight foot sections of the pipe downstream of Manhole No.1 are in fair to good condition. There are concrete spalls and exposed steel rebar around the downstream end of the pipe opening (see photo A-5).

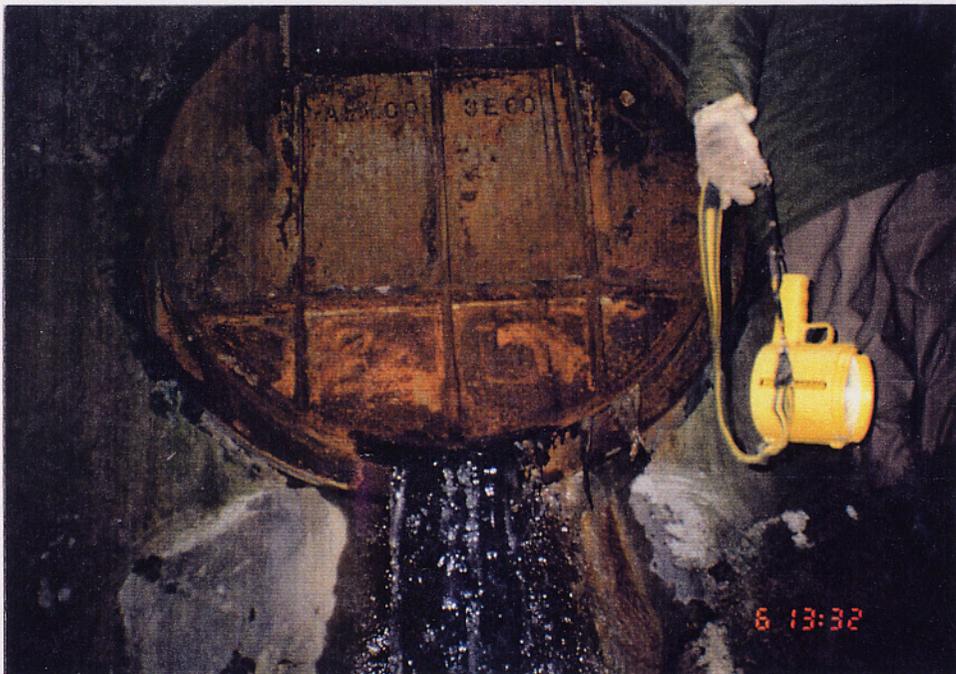
Photo A-6. Rusty steel flap gate for the 60" RCP in Diversion Dike No. 2

(2) 60" RCP from Diversion Dike No. 2. The overall condition of the storm drain system is fair to good. The deterioration of concrete around the steel frame has not worsened from the previous inspection. The flap gate has a thin coat of surface rust but no other major steel section loss (see photo A-6). There are minor areas of exposed steel rebar. Leakage from the flap gate is present with an excess amount of orange/rust colored material (see photo A-7).

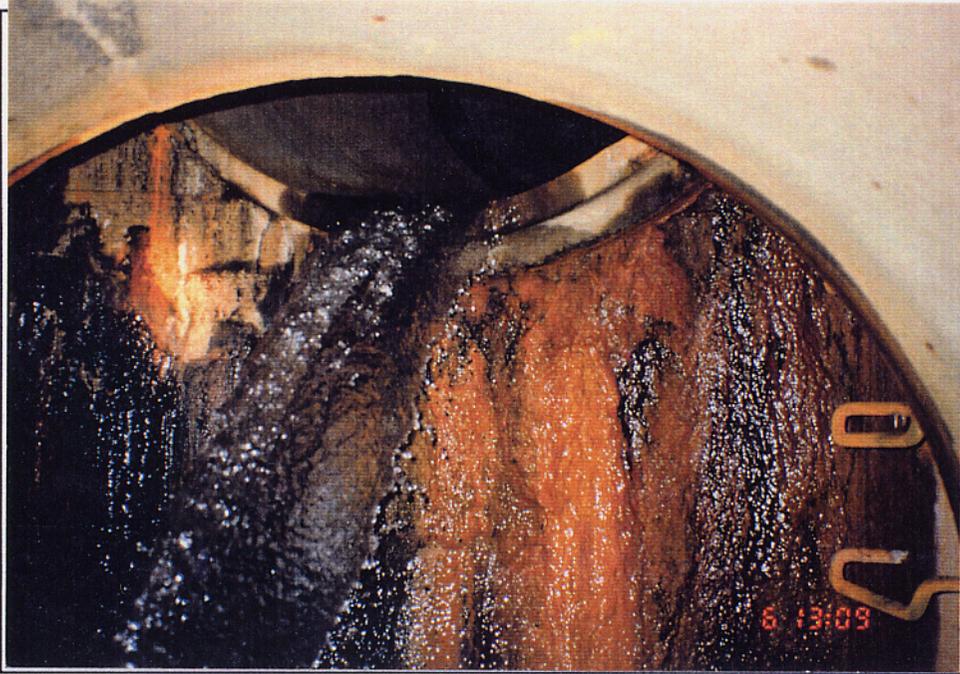
Photo A-7. Excess amount of orange, rust colored material buildup at the flap gate of Diversion Dike No. 2.

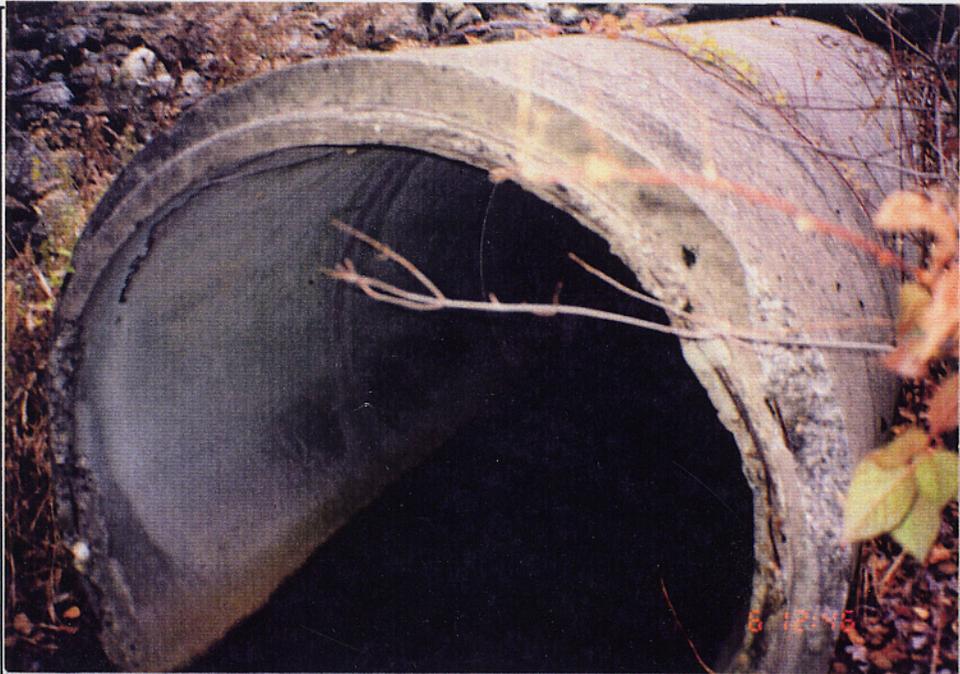
Photo A-8. Exposed rebar and concrete spall at the top of pipe in Diversion Dike No. 2.

The downstream side of Manhole No. 2 is in good condition. There are only minor exposures of steel rebar and hairline cracks in the top of the pipe (see photo A-8). The pipe exits into the reservoir below normal water level, so the entire pipe length on the downstream side could not be inspected.

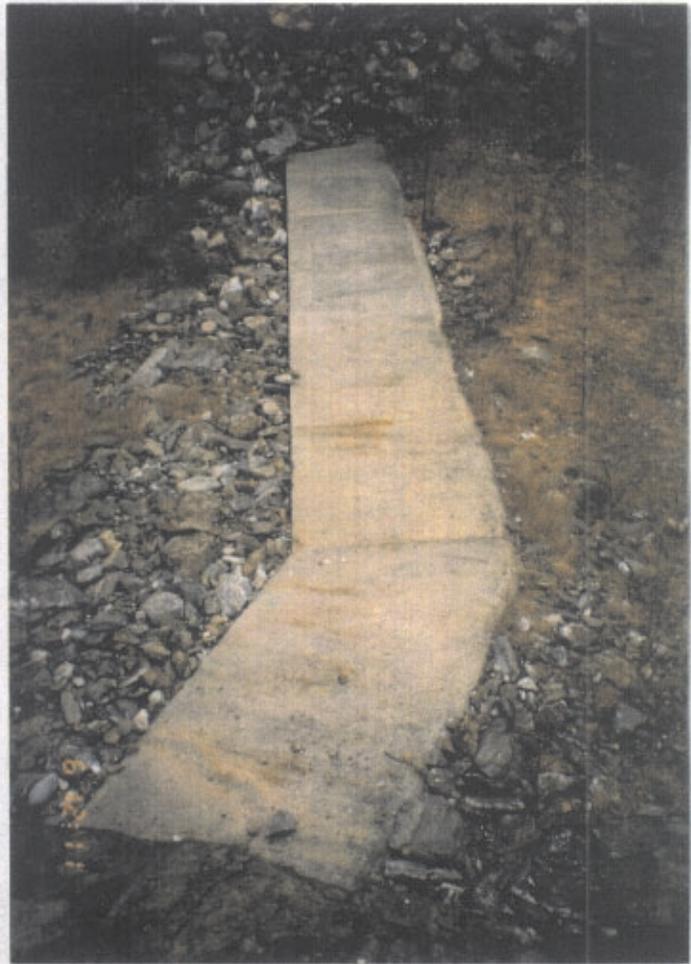
(2) Weir. The overall condition of the concrete in the spillway weir is good. There are minor spalls along the upstream and downstream edges of the weir, but they will not affect hydraulic capacity of the channel. The transverse crack that was reported in the last report has slightly increased, but will not affect the integrity of the spillway weir (see photo A-9).

Photo A-9. Minor spalls at the spillway weir.

a. Weir. The overall condition of the concrete in the spillway weir is good. There are minor spalls along the upstream and downstream edges of the weir. The transverse

crack that was reported in the last report has slightly increased, but will not affect the integrity of the spillway weir (see photo A-9).

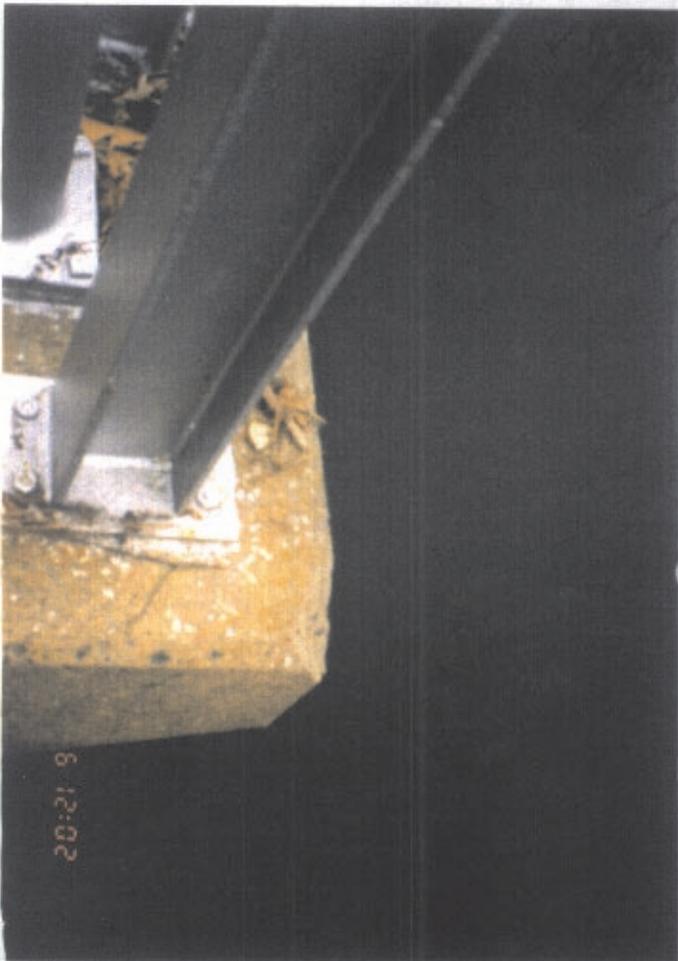
(b) Intake Structure. The spall on the top inside edge of the headwall was patched but there are various small spalls along the top edge of the headwalls. A concrete spall is located at the corner near the protective beams of the gate operator (photo A-10). The tubular steel supports for the lower platform, which also serve as trash racks, are rustier than they were last inspection (photo A-11).

Photo A-10. Concrete spall at the corner near the gate operator protective beam

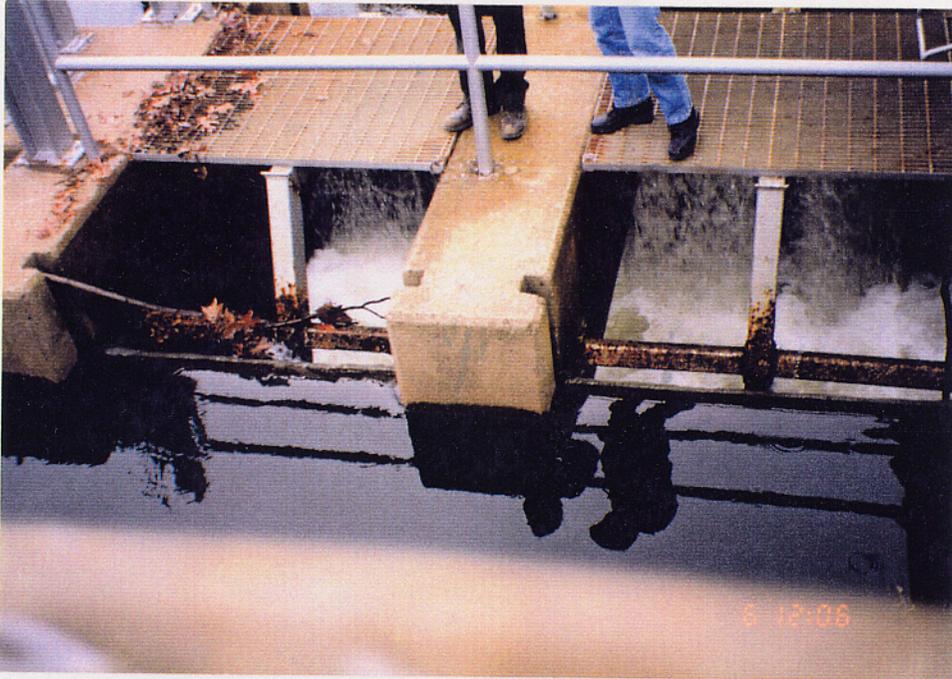
Photo A-11. Rusty trash rack at the inlet structure.

a. Intake Structure. The spall on the top inside edge of the headwall was patched but there are various small spalls along the top edge of the headwalls. A concrete spall is located at the corner near the protective beams of the gate operator (see photo A-10). The tubular steel supports for the lower platform, which also serve as trash racks, are rustier than they were last inspection (see photo A-11). The trash racks should be repainted to prevent further deterioration.

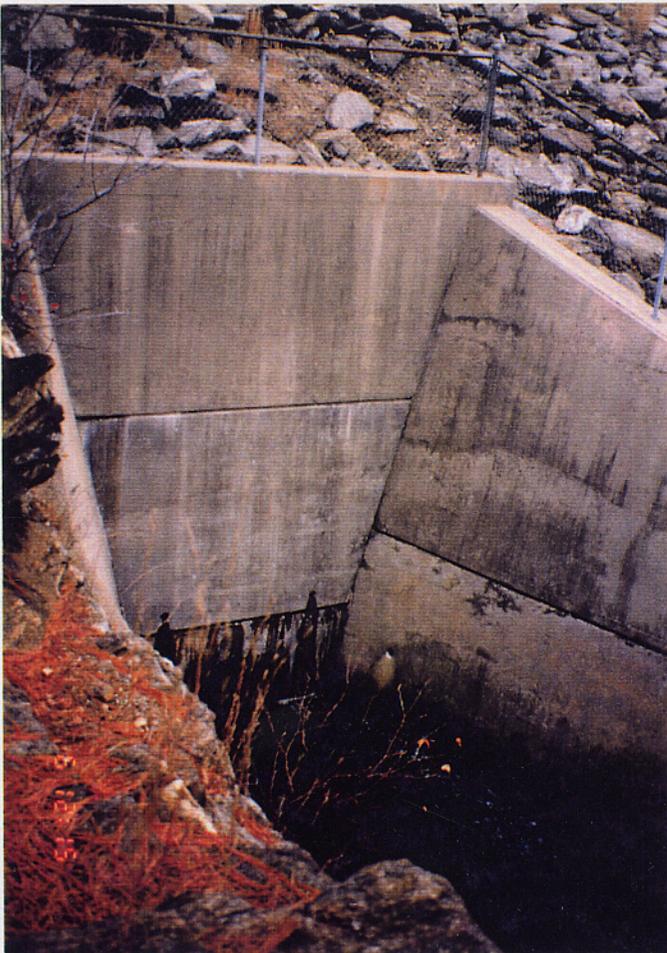
(e) Outlet Structure. The overall condition of the concrete in the outlet structure is good. The condition of three vertical cracks and one horizontal crack in the west wall has not worsened since the previous inspection. The amount of the efflorescence along the horizontal construction joint above the conduit and along the vertical crack extending the full height and width of the east wall has increased moderately since the last inspection (photos A-12 and A-13). All weepholes are functioning properly, and

Photo A-12. Efflorescence along the horizontal construction joint above the inlet structure.

b. Outlet Structure. The overall condition of the concrete in the outlet structure is good. The condition of three vertical cracks and one horizontal crack in the west wall has not worsened since the previous inspection. The amount of the efflorescence along the horizontal construction joint above the conduit and along the vertical crack extending the full height and width of the east wall has increased moderately since the last inspection (see photo A-12 and A-13). All weepholes are functioning properly, and the chain link fences on top of the outlet walls have only minor rust. The conduit was not inspected due to high water level. The next inspection of the conduit should be a physical inspection performed when the water level and temperature are acceptable.

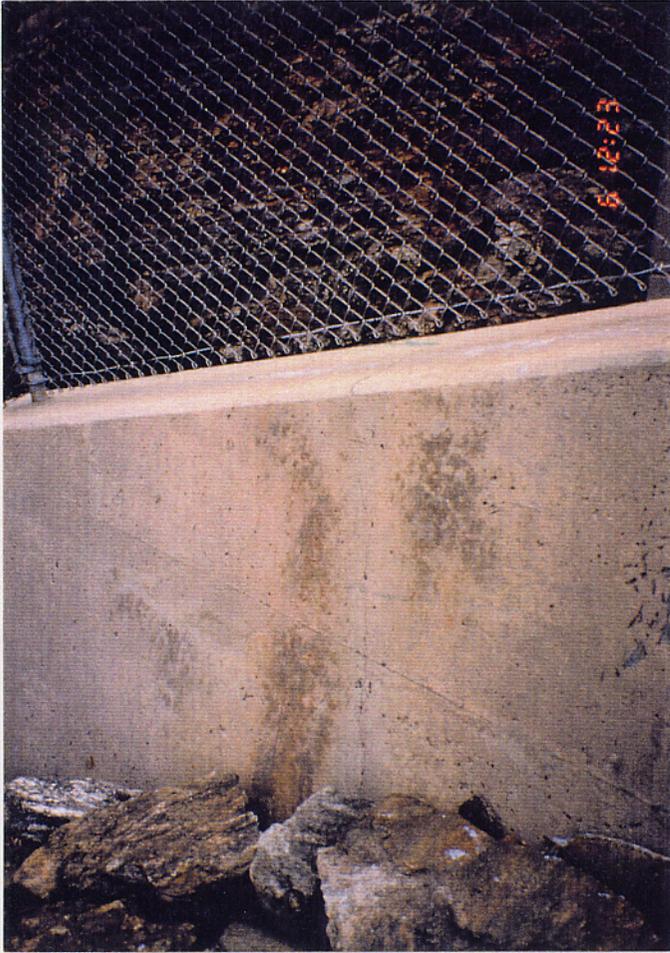
Photo A-13. Vertical crack along the east wall of the outlet structure.

1/8" wide vertical crack through wall (see App. II, photo A-13)

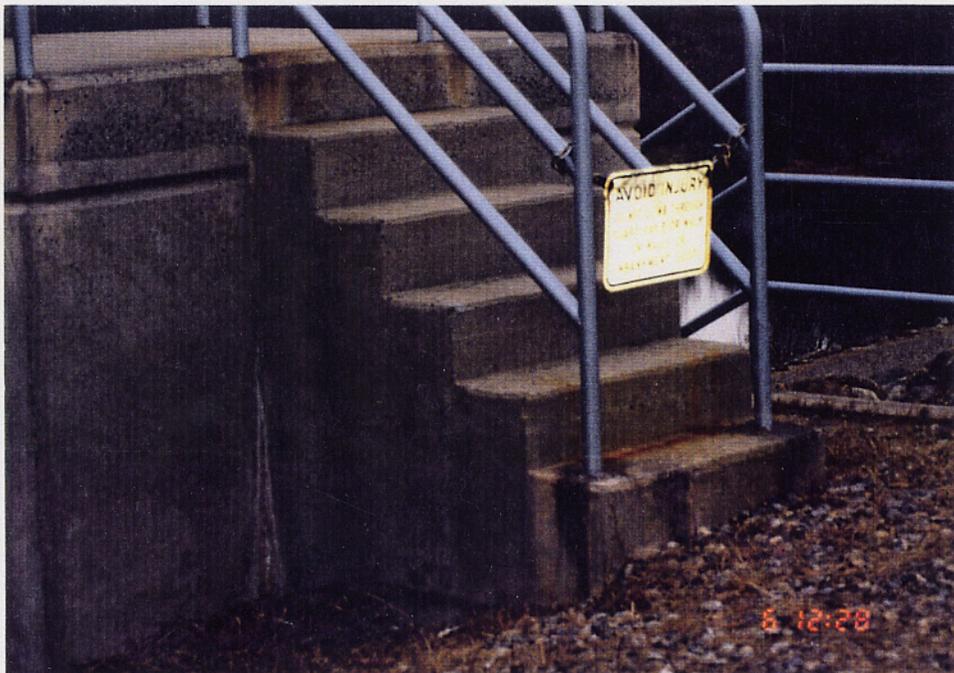
Photo A-14. Settlement of stairs to the bubble

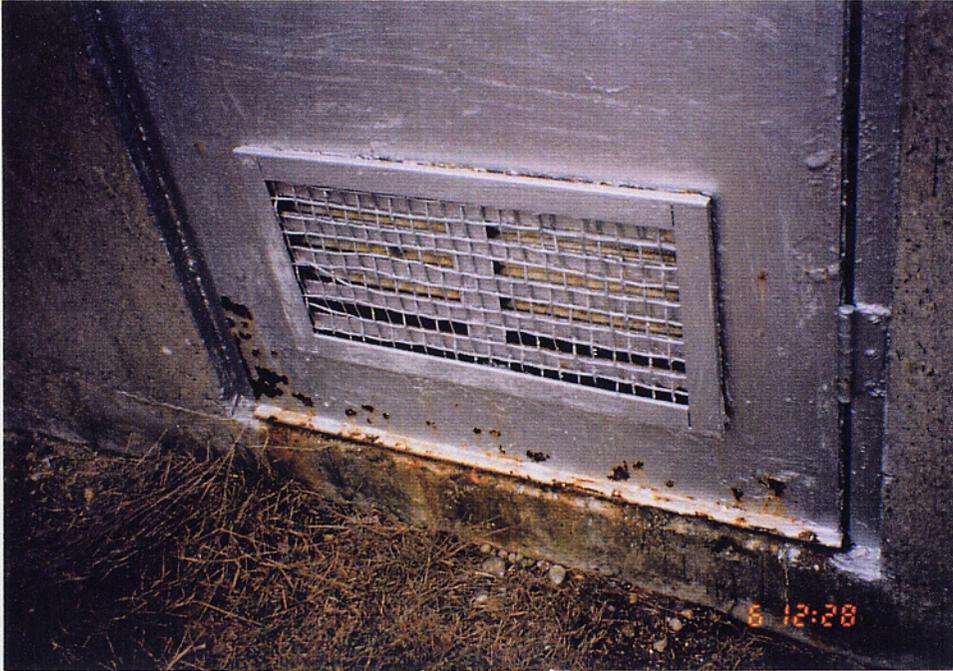
(3) Bubble Gage Shelter. The overall condition of the concrete and structure is good. The hairline cracks in the northwest corner of the west face of the roof slab and the cold joint that extends around the entire perimeter of the roof slab have remained unchanged since the last inspection. The shelter stairs have settled approximately 1/2 inch, as indicated in the last inspection report (photo A-14). The bottom edge of the metal door has rusted and it should be repainted (photo A-15).

Photo A-15. Rusty bottom edge of metal door of bubble gage shelter.

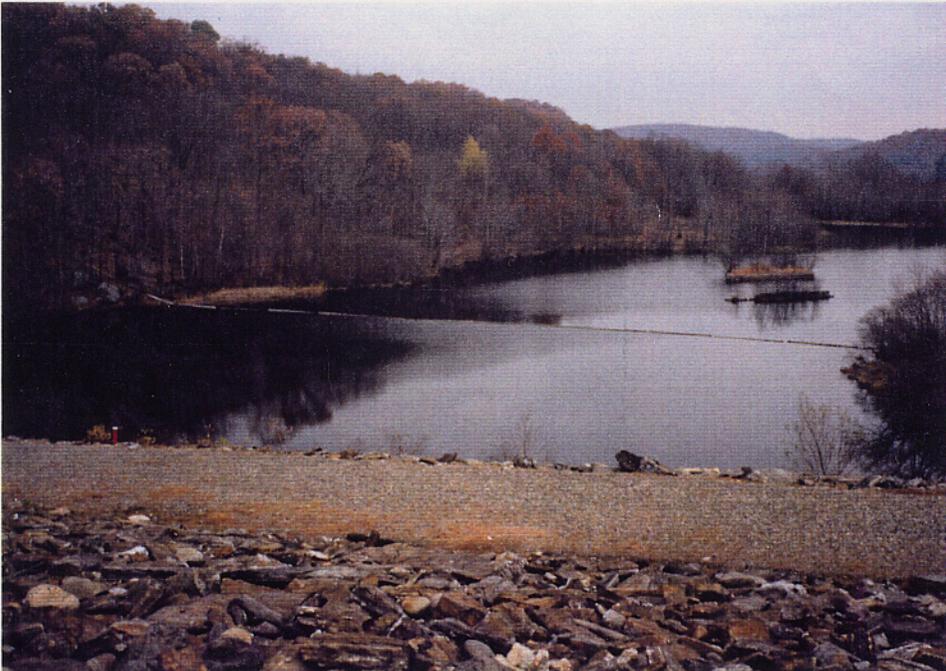
(a) Inlet Channel. The inlet channel is in good condition with no major obstructions. The partially submerged log boom appears to be in good working condition. Some small trees and brush have grown up around the safety fences (photo D-4). The inlet channel bottom was not inspected.

Photo D-4. Inlet channel and log boom.

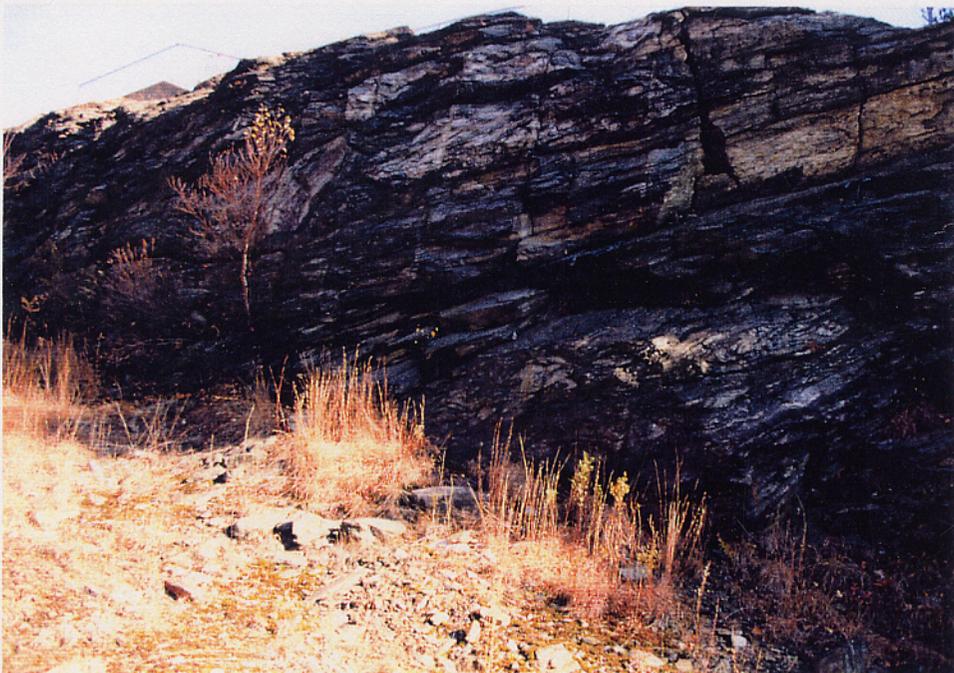
(3) Retaining Walls. The overall condition of the spillway retaining walls appears to be good and shows no significant change from the previous inspection. There are large cracks in the left rock wall just past the weir (as noted in previous inspections). One small block of rock (approximately 2 ft by 2 ft) has slipped off the face since the last periodic inspection. Most bonding and alignment of joints show no sign of unusual movement. The chain link fence on top of the wall is in good condition.

▲PHOTO E-4: Spillway Channel left rock wall

(2) Perform mapping of the fractures in the rock around the left spillway wall and monitor the progressive movement. This item was not funded. Geotechnical team members reevaluated and changed this recommendation. Project personnel should visit the site yearly to observe current conditions of the rock. The project manager should contact GED in the event movement of the rock is observed.

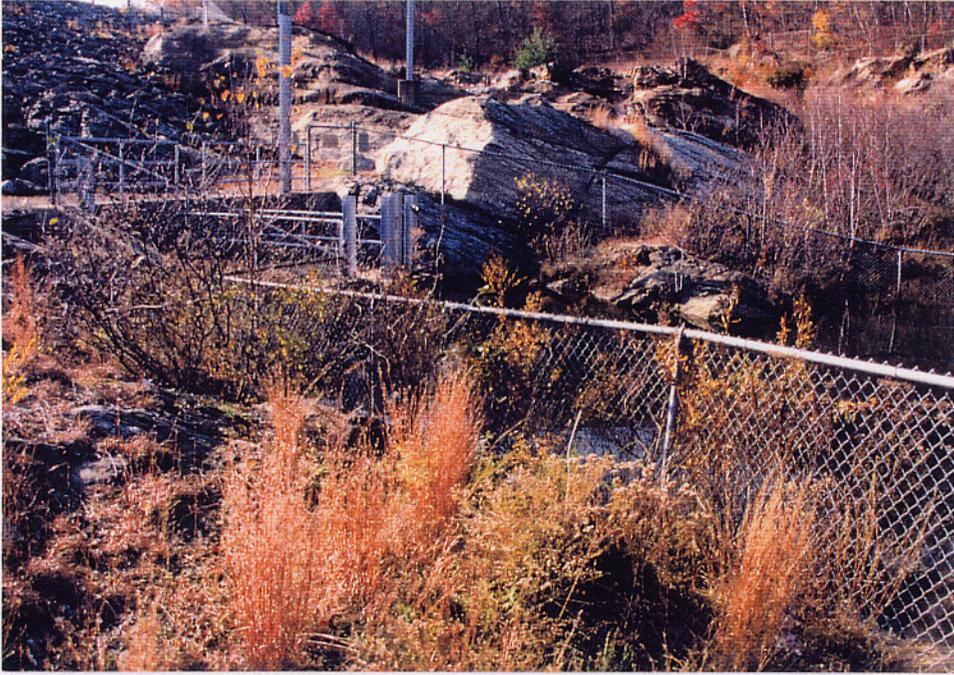
▲PHOTO E-5: Intake structure. Note brush grown up around the safety fence.

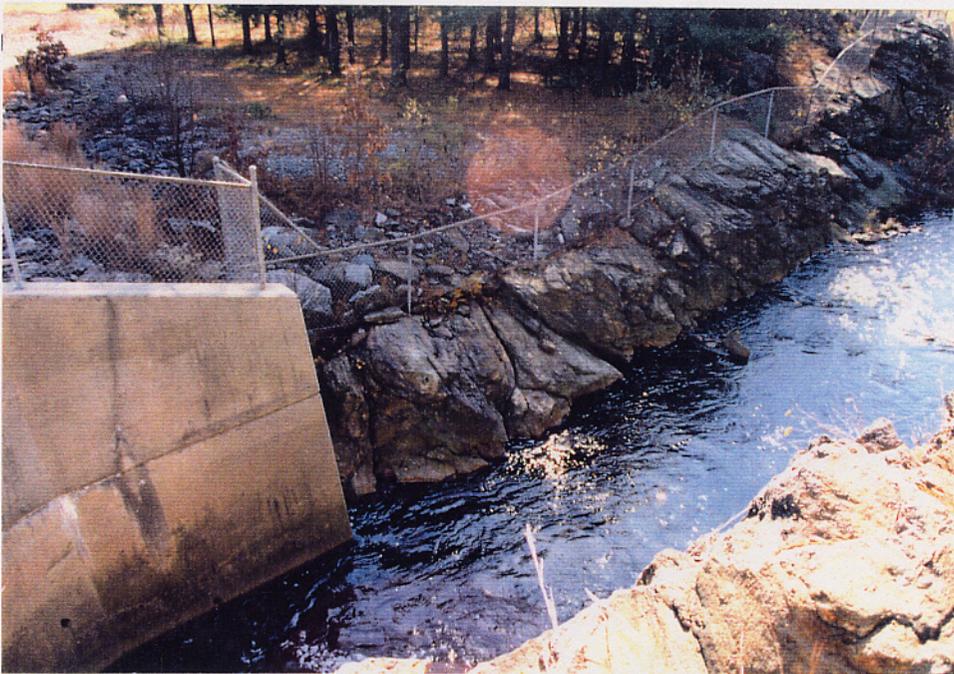
(f) Exit Channel. The exit channel was in good condition. There are several small stones across the channel about 40-feet downstream from the outlet, as noted in the previous inspection. These stones will have very minor impact to the channel flow capacity.

▲PHOTO E-6: Outlet channel. Stone pile across channel is under water on right side of photo.
