Report on the Dam of the Holyoke Water Power Company  
Holyoke, Massachusetts

1945

War Department  
United States Engineer Office  
Providence, Rhode Island

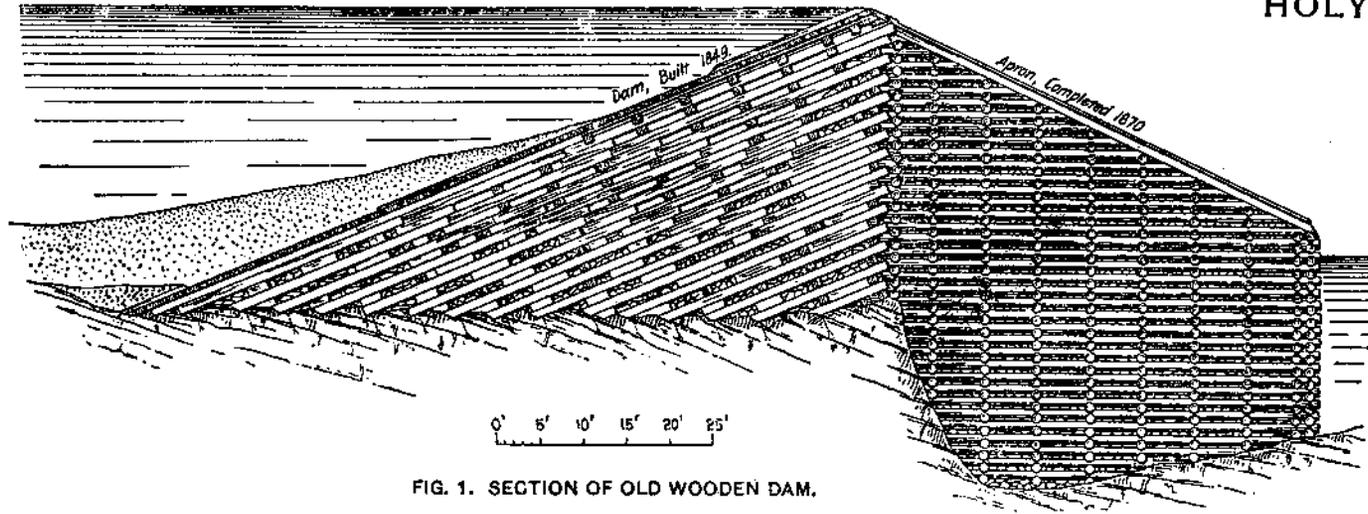
FIG. 1. SECTION OF OLD WOODEN DAM.

"The permanent dam shown in Fig. 1, Plate No. 1, was begun the following year and finished in the summer. This dam is still standing, but will soon be replaced by a masonry dam below it. It is 1017 feet long and has a maximum height of about 30 feet. The down-stream face of the dam was originally made vertical, but in 1870 a sloping apron was built in front of the dam, as shown in Plate No. 1.

"The dam was founded on a ledge of red slate and sandstone, which dips down-stream about 30° from a horizontal plane. The whole dam was built of heavy timbers, nothing less than 12 by 12 inches being used. The bottom timbers (15 by 15 inches in section) were placed parallel with the current and were bolted to the bed-rock with iron bolts 1-1/4 inches in

"The water, ice, logs, etc., passing over it rapidly wore away the rock in front of it. By 1868 the ledge had been eroded to a depth of 20 to 25 feet, and the dam had become undermined in some places. Besides the wearing out of the rock, the front timbers had become injured by logs and ice which, after passing over the dam, were forced against the front face by the eddies caused by the falling water. In some cases logs having become wedged among the front timbers and being struck by the falling water forced the timbers apart, acting like large levers. In order to protect the dam against such injuries and to reduce the fall of the water, a large inclined apron of cribwork was built in front of the dam during the years 1868, 1869, and 1870 (Plate No. 1.). This crib, which exceeds the original dam in volume, was built of round logs laid so as to form pockets 6 by 6 feet, which were filled with stone to the top before the covering, consisting of 6-inch planks of hard wood, was put on. The cost of the apron is given variously as \$263,000 to \$350,000--about double the cost of the original dam.

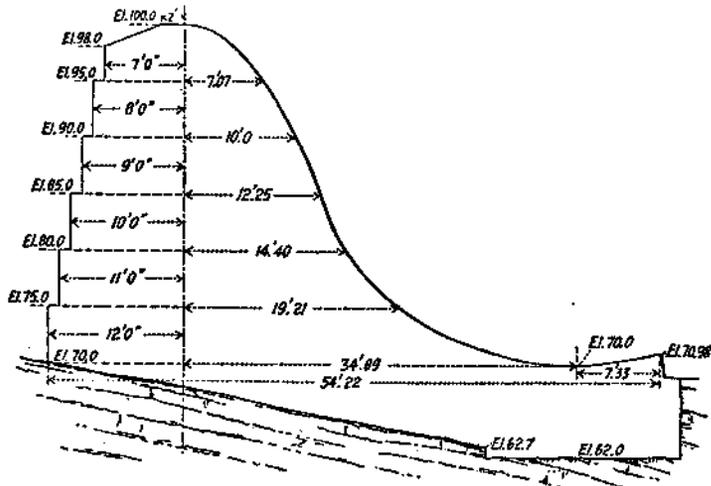
FIG. 2. OUTLINE SECTION OF DAM.

"Figs 2 and 3, Plate No. 1, show the profile adopted for the masonry dam. The upper part of the down-stream face is the parabola, which a sheet of water 4 feet in depth over the crest would describe in falling freely. The parabola continues to the point of reversing below which a cycloid (the curve of "quickest descent") is adopted for the face. At the extreme toe the face is turned somewhat upwards to break the force of the water and to prevent it from cutting the ledge beyond. The back slope forms a series of steps, 5 feet high, equivalent to a batter of 1 foot in 5 feet. The length of the rollway of the new dam will be 1020 feet. The plans for the masonry dam were prepared by Mr. E. S. Waters, Chief Engineer of the Holyoke Water Power Company."

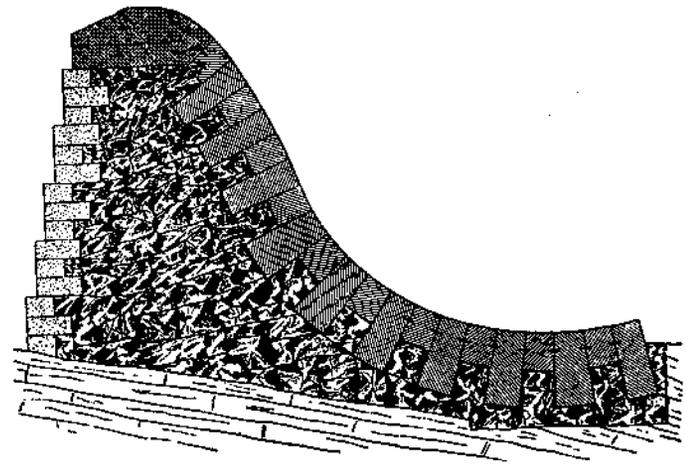
FIG. 3. CROSS SECTION OF DAM.

"An outline section of the main dam is shown on Plate No. 2. The upper part of the curve on the downstream face of the dam is that of a parabola. The parabola selected being the curve of freely falling water flowing  $\frac{1}{4}$  foot in depth over the crest of a dam. The parabola extends down the slope as far as the point of reversing, and below this the curve is a cycloid. Selected as the "curve of quickest descent," the up-curve at the extreme toe is designed to break the force of the water and prevent its cutting into the ledge beyond. The slope of the back or upstream face is equivalent to a batter of 1-foot in 5-foot. It is stepped off every 5 feet in height in order to afford a footing for the coffer as will be described further on.

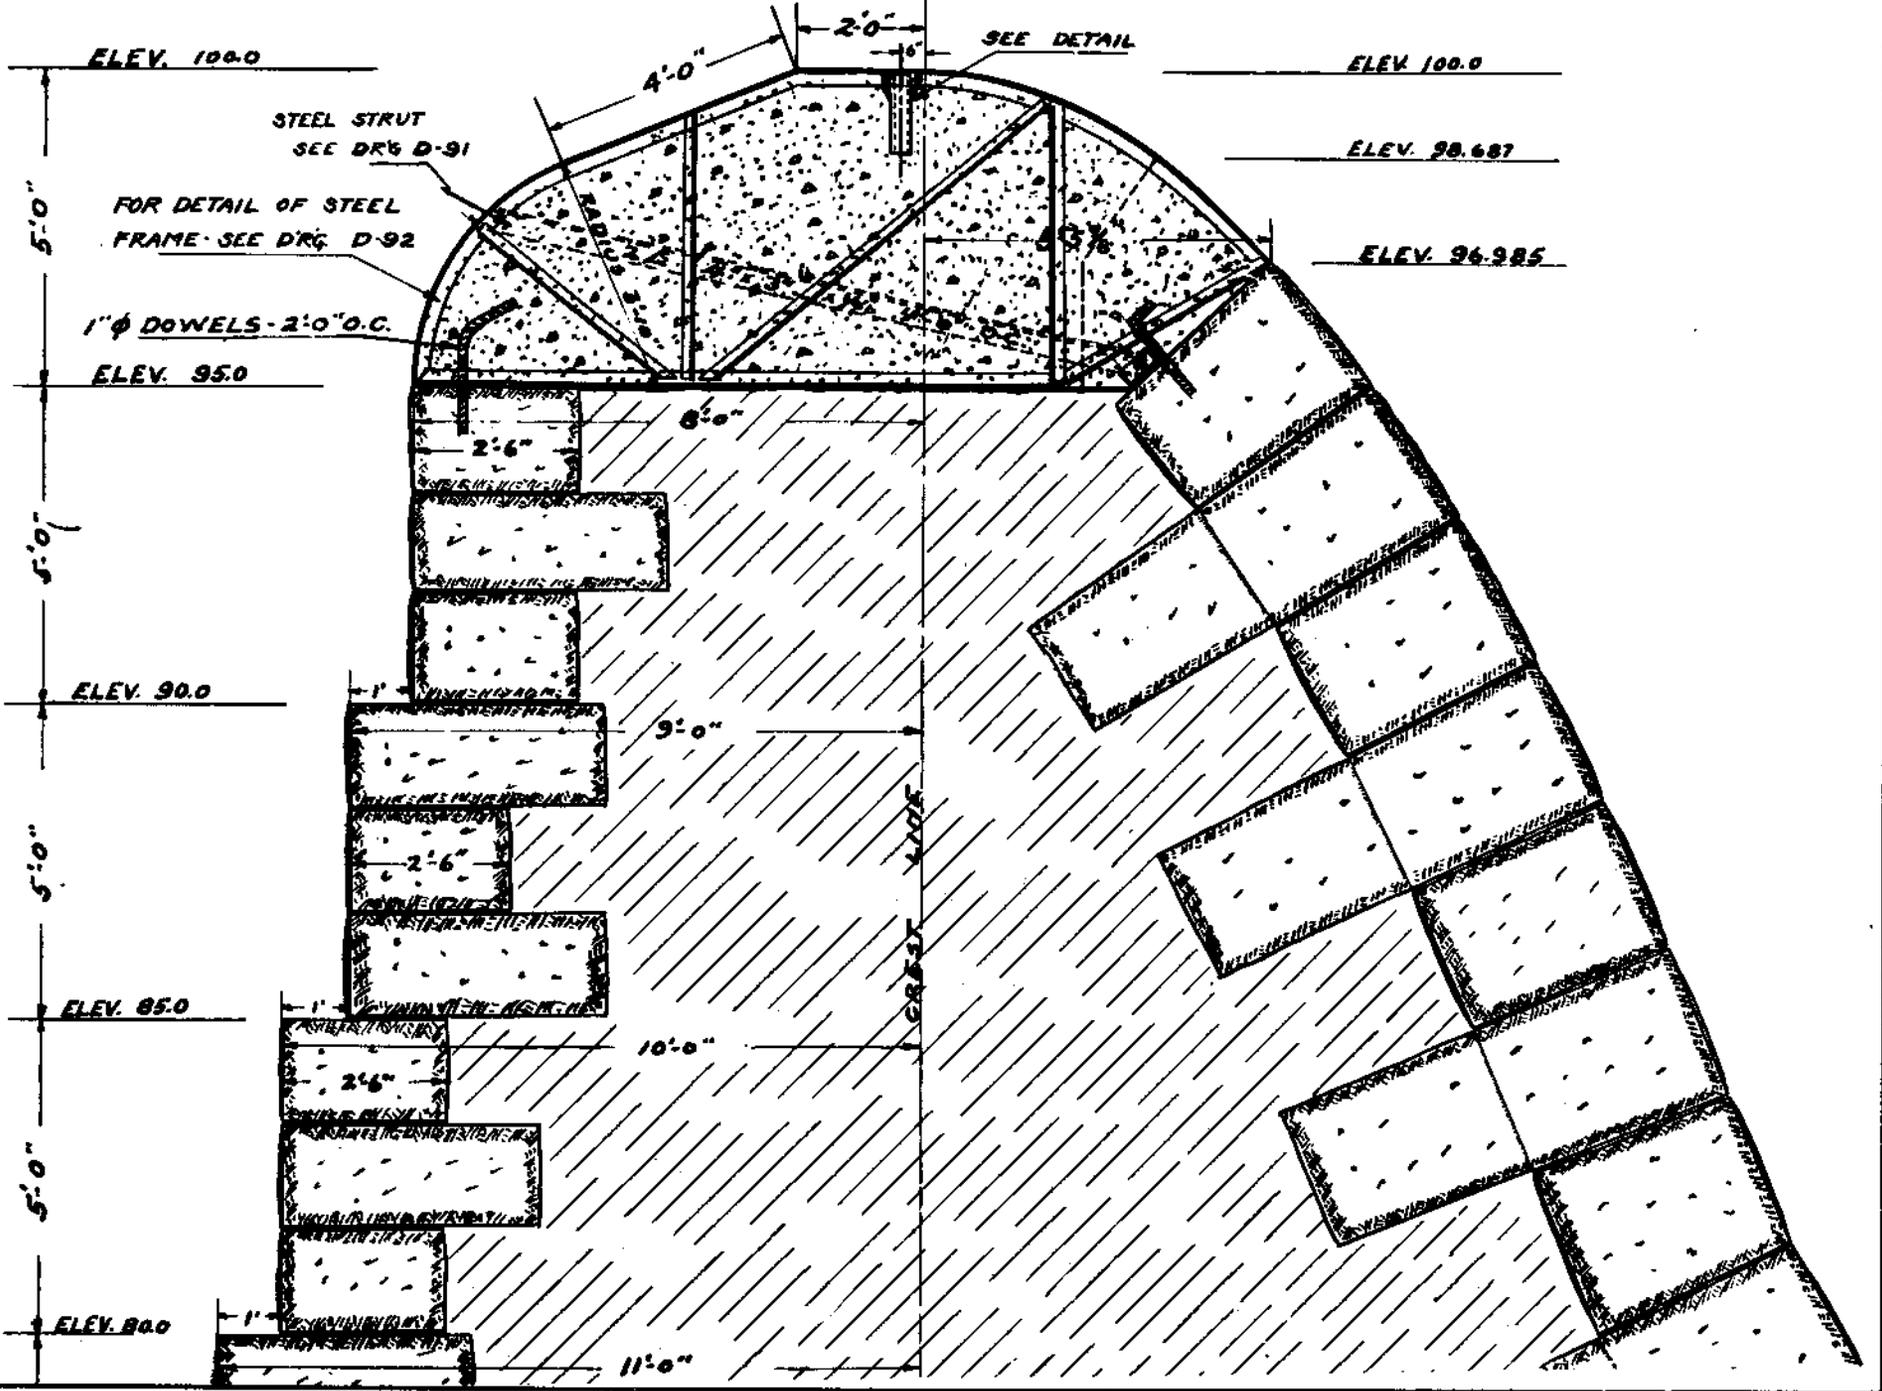
c. Damage to the Masonry Dam in 1936 - The 1936 floods resulted in the displacement of the capstones at the crest of the dam to a depth of 5 feet. The exact time of the accident is not known but is believed to have occurred during a minor crest, accompanied by ice passage, which occurred about one week in advance of the record-breaking March 21, 1936 flood. It has been reported that the amount of material which it was necessary to replace is as shown on Plate No. 3. Concrete was used to replace the lost capstones. The section shown is typical for the full length of the dam with the exception of 28 feet at the left abutment and 6 feet at the right abutment, where no damage occurred, and also with the exception of 213 feet where the stone indicated in dotted lines on Plate No. 3 withstood the water pressure. Those capstones which did not carry away were permitted to remain in place. The structural members indicated on Plate No. 3 were for the purpose of supporting the concrete forms and the coffer dam, and were left in place in the concrete.

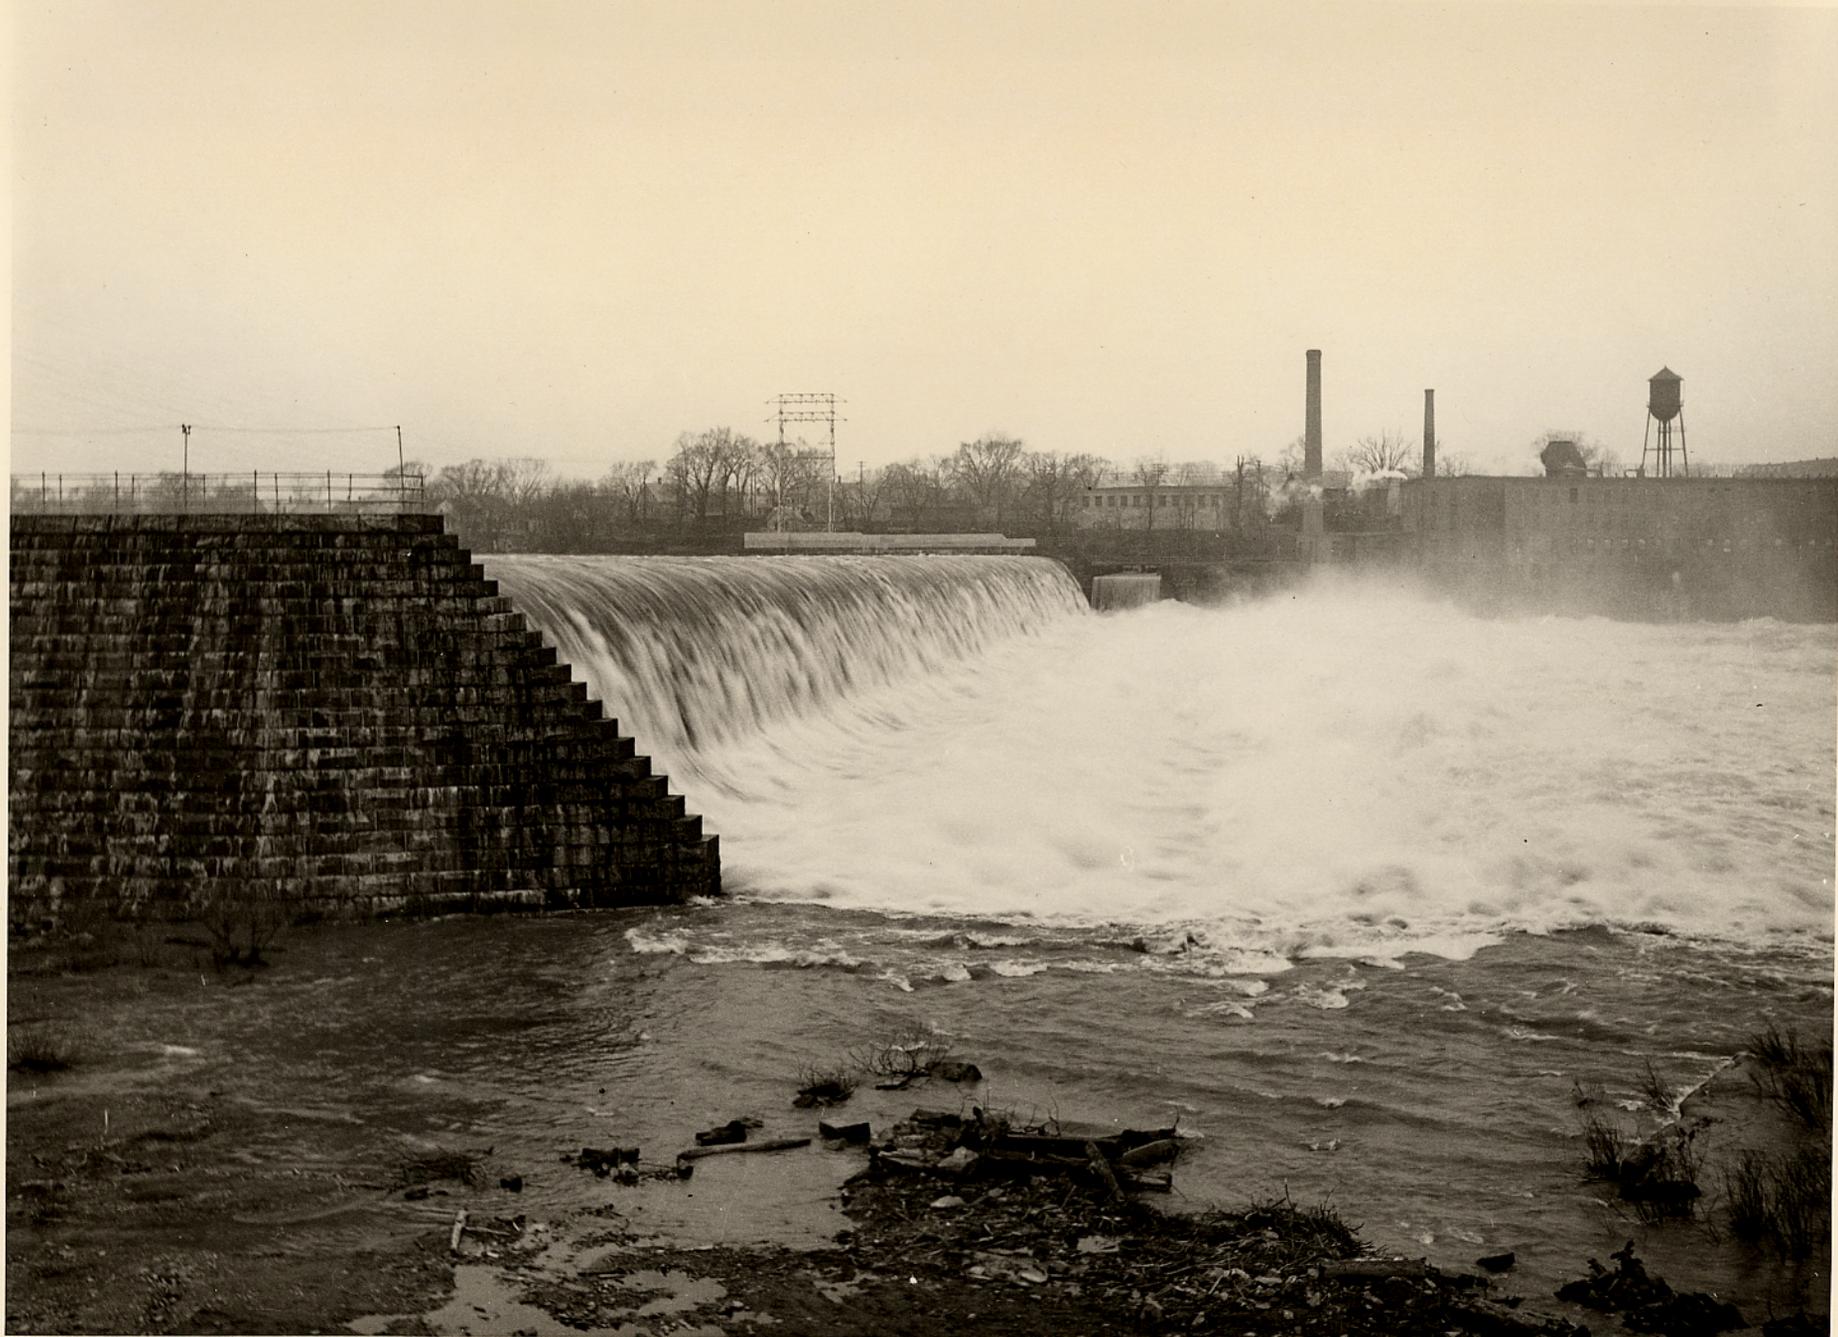
Plate No. 5

8.8 Ft. Over Spillway
