Access Study to all Pertinent Parts of  
Dam Projects During High Reservoir  
Conditions

# **Upper Connecticut Basin New Hampshire and Vermont**

JULY 1992

**US Army Corps  
of Engineers**  
New England Division

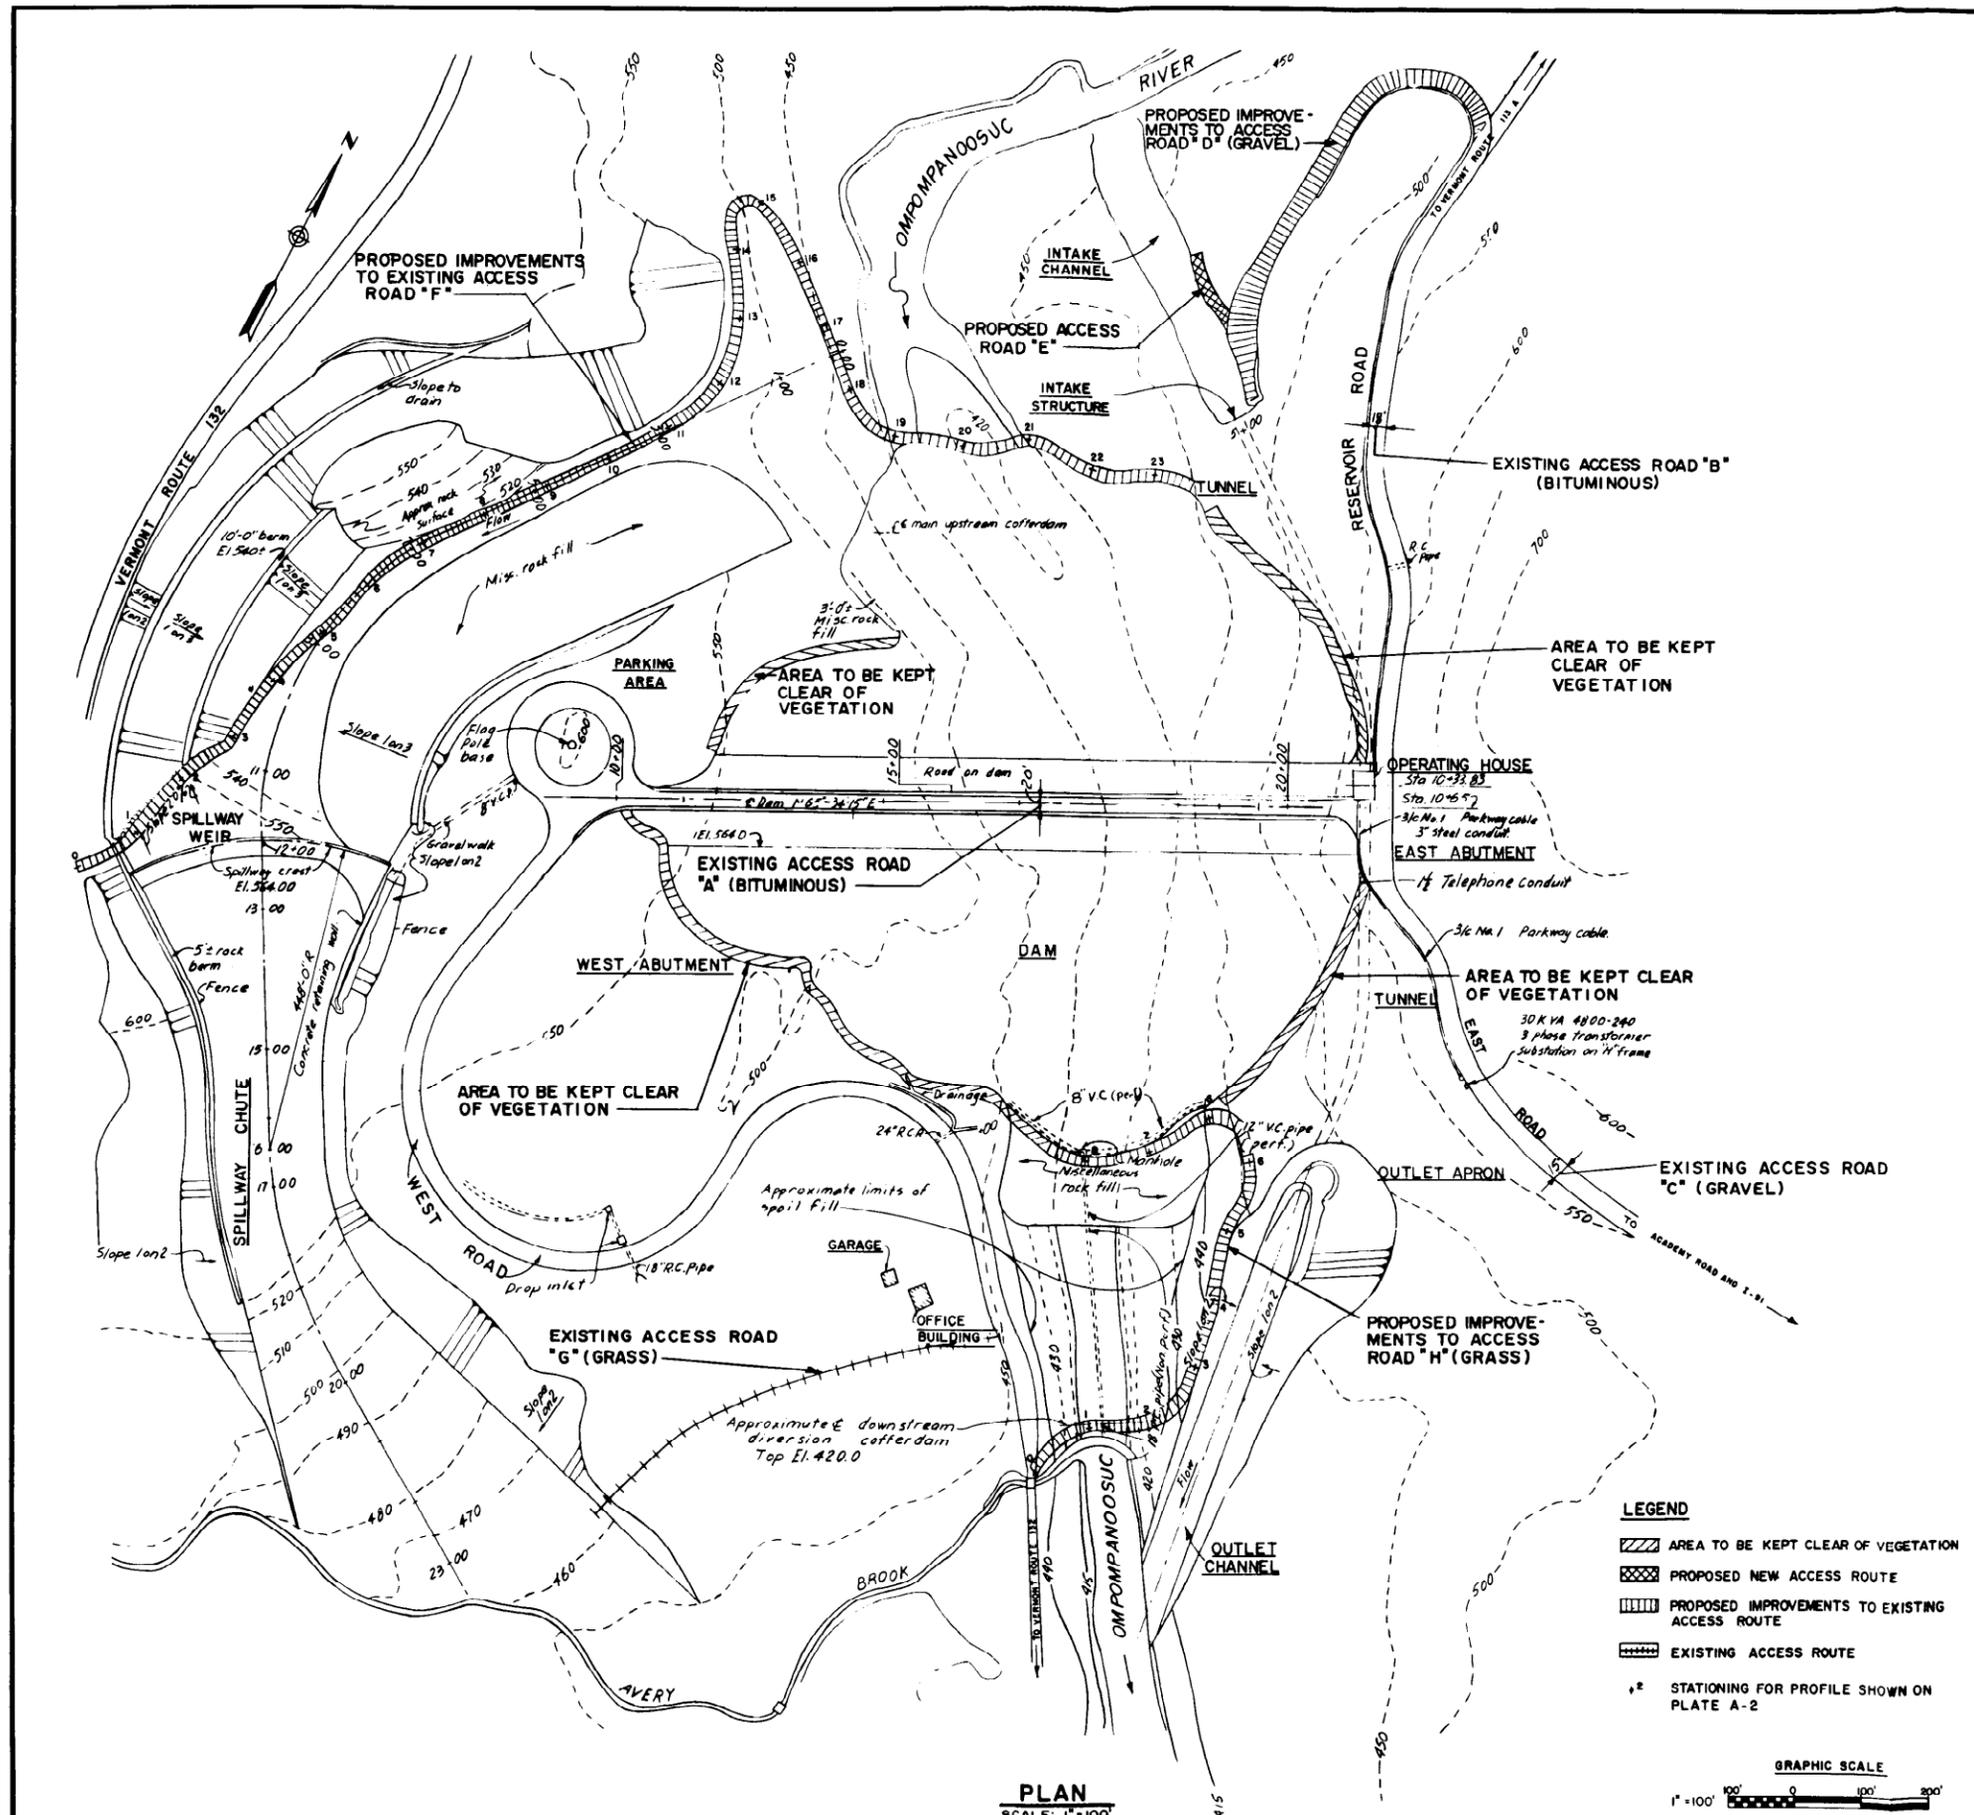
3. Adequacy of Access. The grassy area in the immediate vicinity of the downstream toe does not meet design criteria. Heavy equipment would probably have difficulty operating in the downstream toe area during spillway discharge. Only equipment under eight tons in weight could reach the toe area once spillway discharge conditions occurred because of the load limitations on the Academy Road covered bridge.

6. Adequacy of Access. Access to the crest of Union Village Dam is adequate. Presently, access to the lower portion of the upstream toe of the dam is inadequate during normal pool conditions.

4. Recommended Improvements. Access Road "H" as shown on Plates A-1 and A-2 should be improved in the downstream toe area. Flattening of the gravel ramp at West Road and a steep slope on the east side of the old Ompompanoosuc River channel would be required to improve Access Road "H". The improvement would also provide better access to the outlet channel and structure. Upgrading the covered bridge on Academy Road to allow a higher load limit is beyond the scope of this study.

7. Recommended Improvements. Access Road "F" should be improved, as shown in Plates A-1 and A-2, so that the upstream toe and slope of Union Village Dam can be reached during normal pool conditions. Flattening two steep slopes and placement of a significant amount of rock fill will be required to improve Access Road "F".

10. Recommended Improvements. Access Road "D" should be cleared, grubbed, widened and surfaced with six additional inches of gravel to make it easier to use the road. Access "E" should be constructed as shown in Plates A-1 and A-2 to provide access to the north 100 feet of the inlet channel. Access Road "H" should be improved as discussed in paragraph 4 to provide better access to the outlet channel and structure.

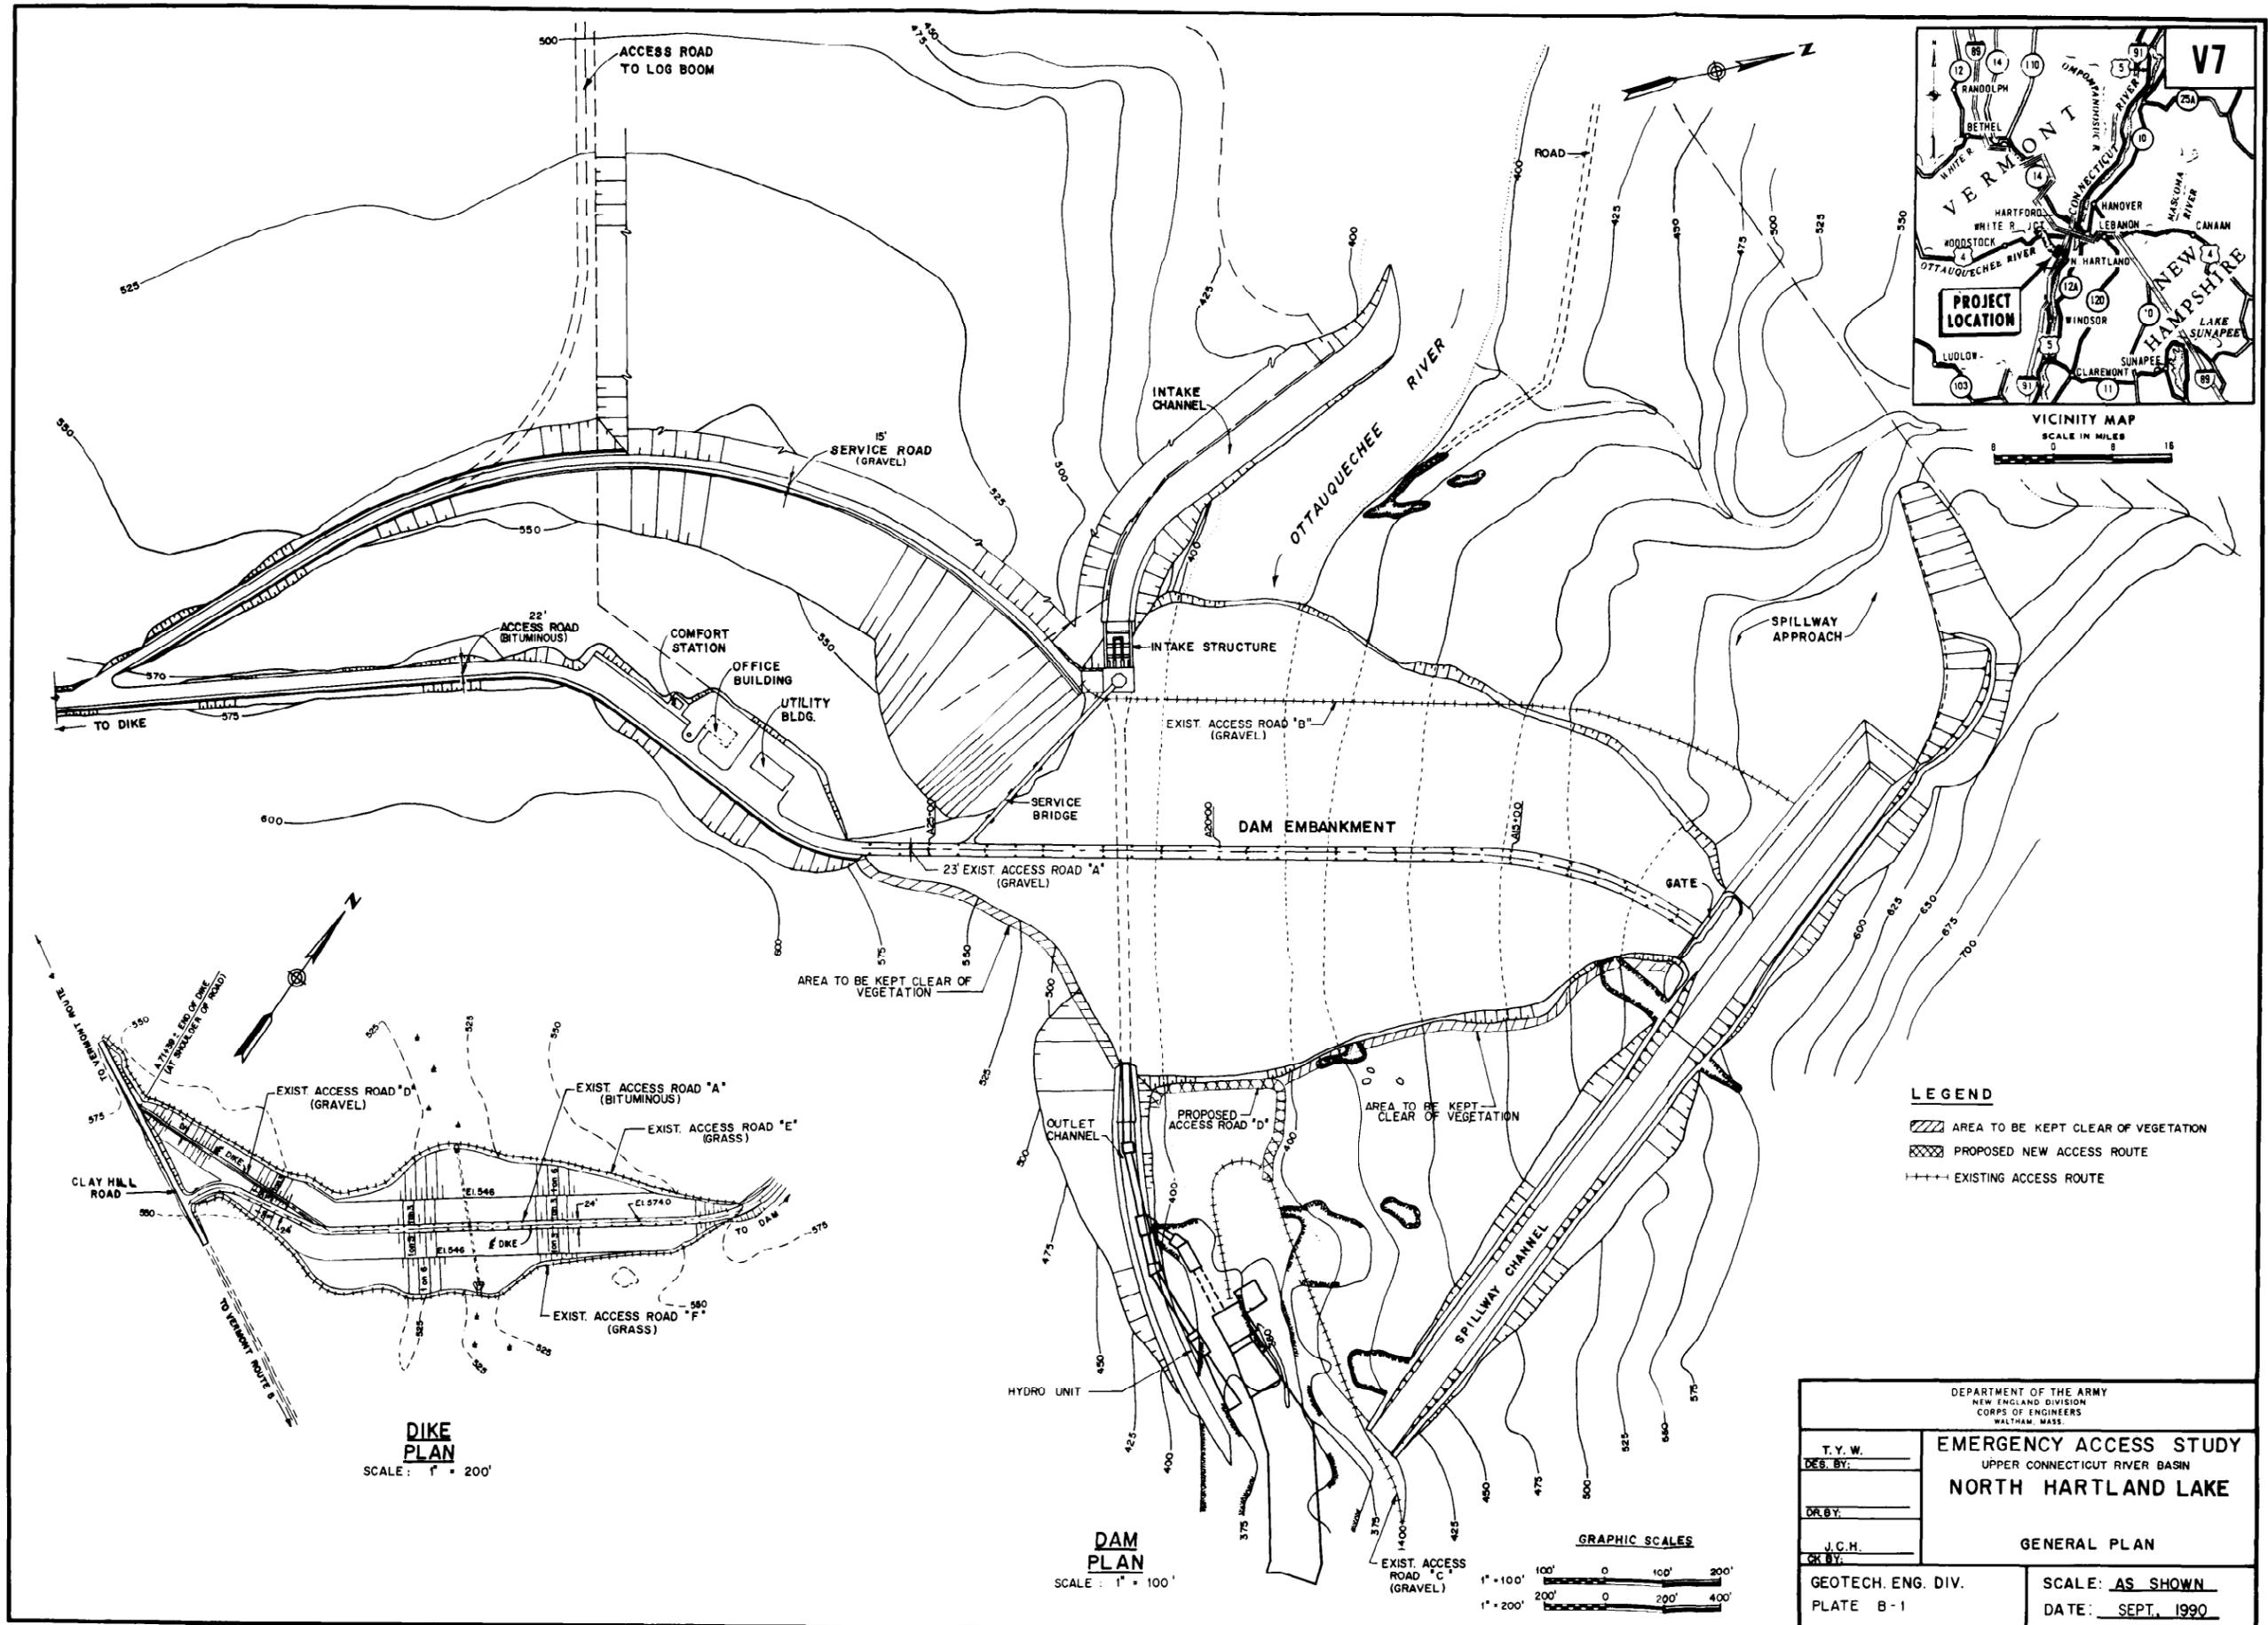
3. Adequacy of Access. Access to the downstream toe of North Hartland Dam is inadequate. Heavy equipment may bog down in the grassy downstream toe area and cannot traverse the steep adjacent abutment slopes. Spillway discharges would prevent access to the area by blocking Access Road "C". Providing access to the downstream toe during spillway discharge is beyond the scope of this study.

4. Recommended Improvements. Access Road "D" should be constructed to allow heavy equipment to reach the downstream toe of North Hartland Dam without bogging down. Access Road "D" construction would require removal of existing vegetation and soft material along the proposed road alignment and then placement of 12 inches of gravel. Vegetation should be periodically removed from the dam abutment interfaces to allow for inspection of the interfaces and light weight equipment to traverse the interfaces.

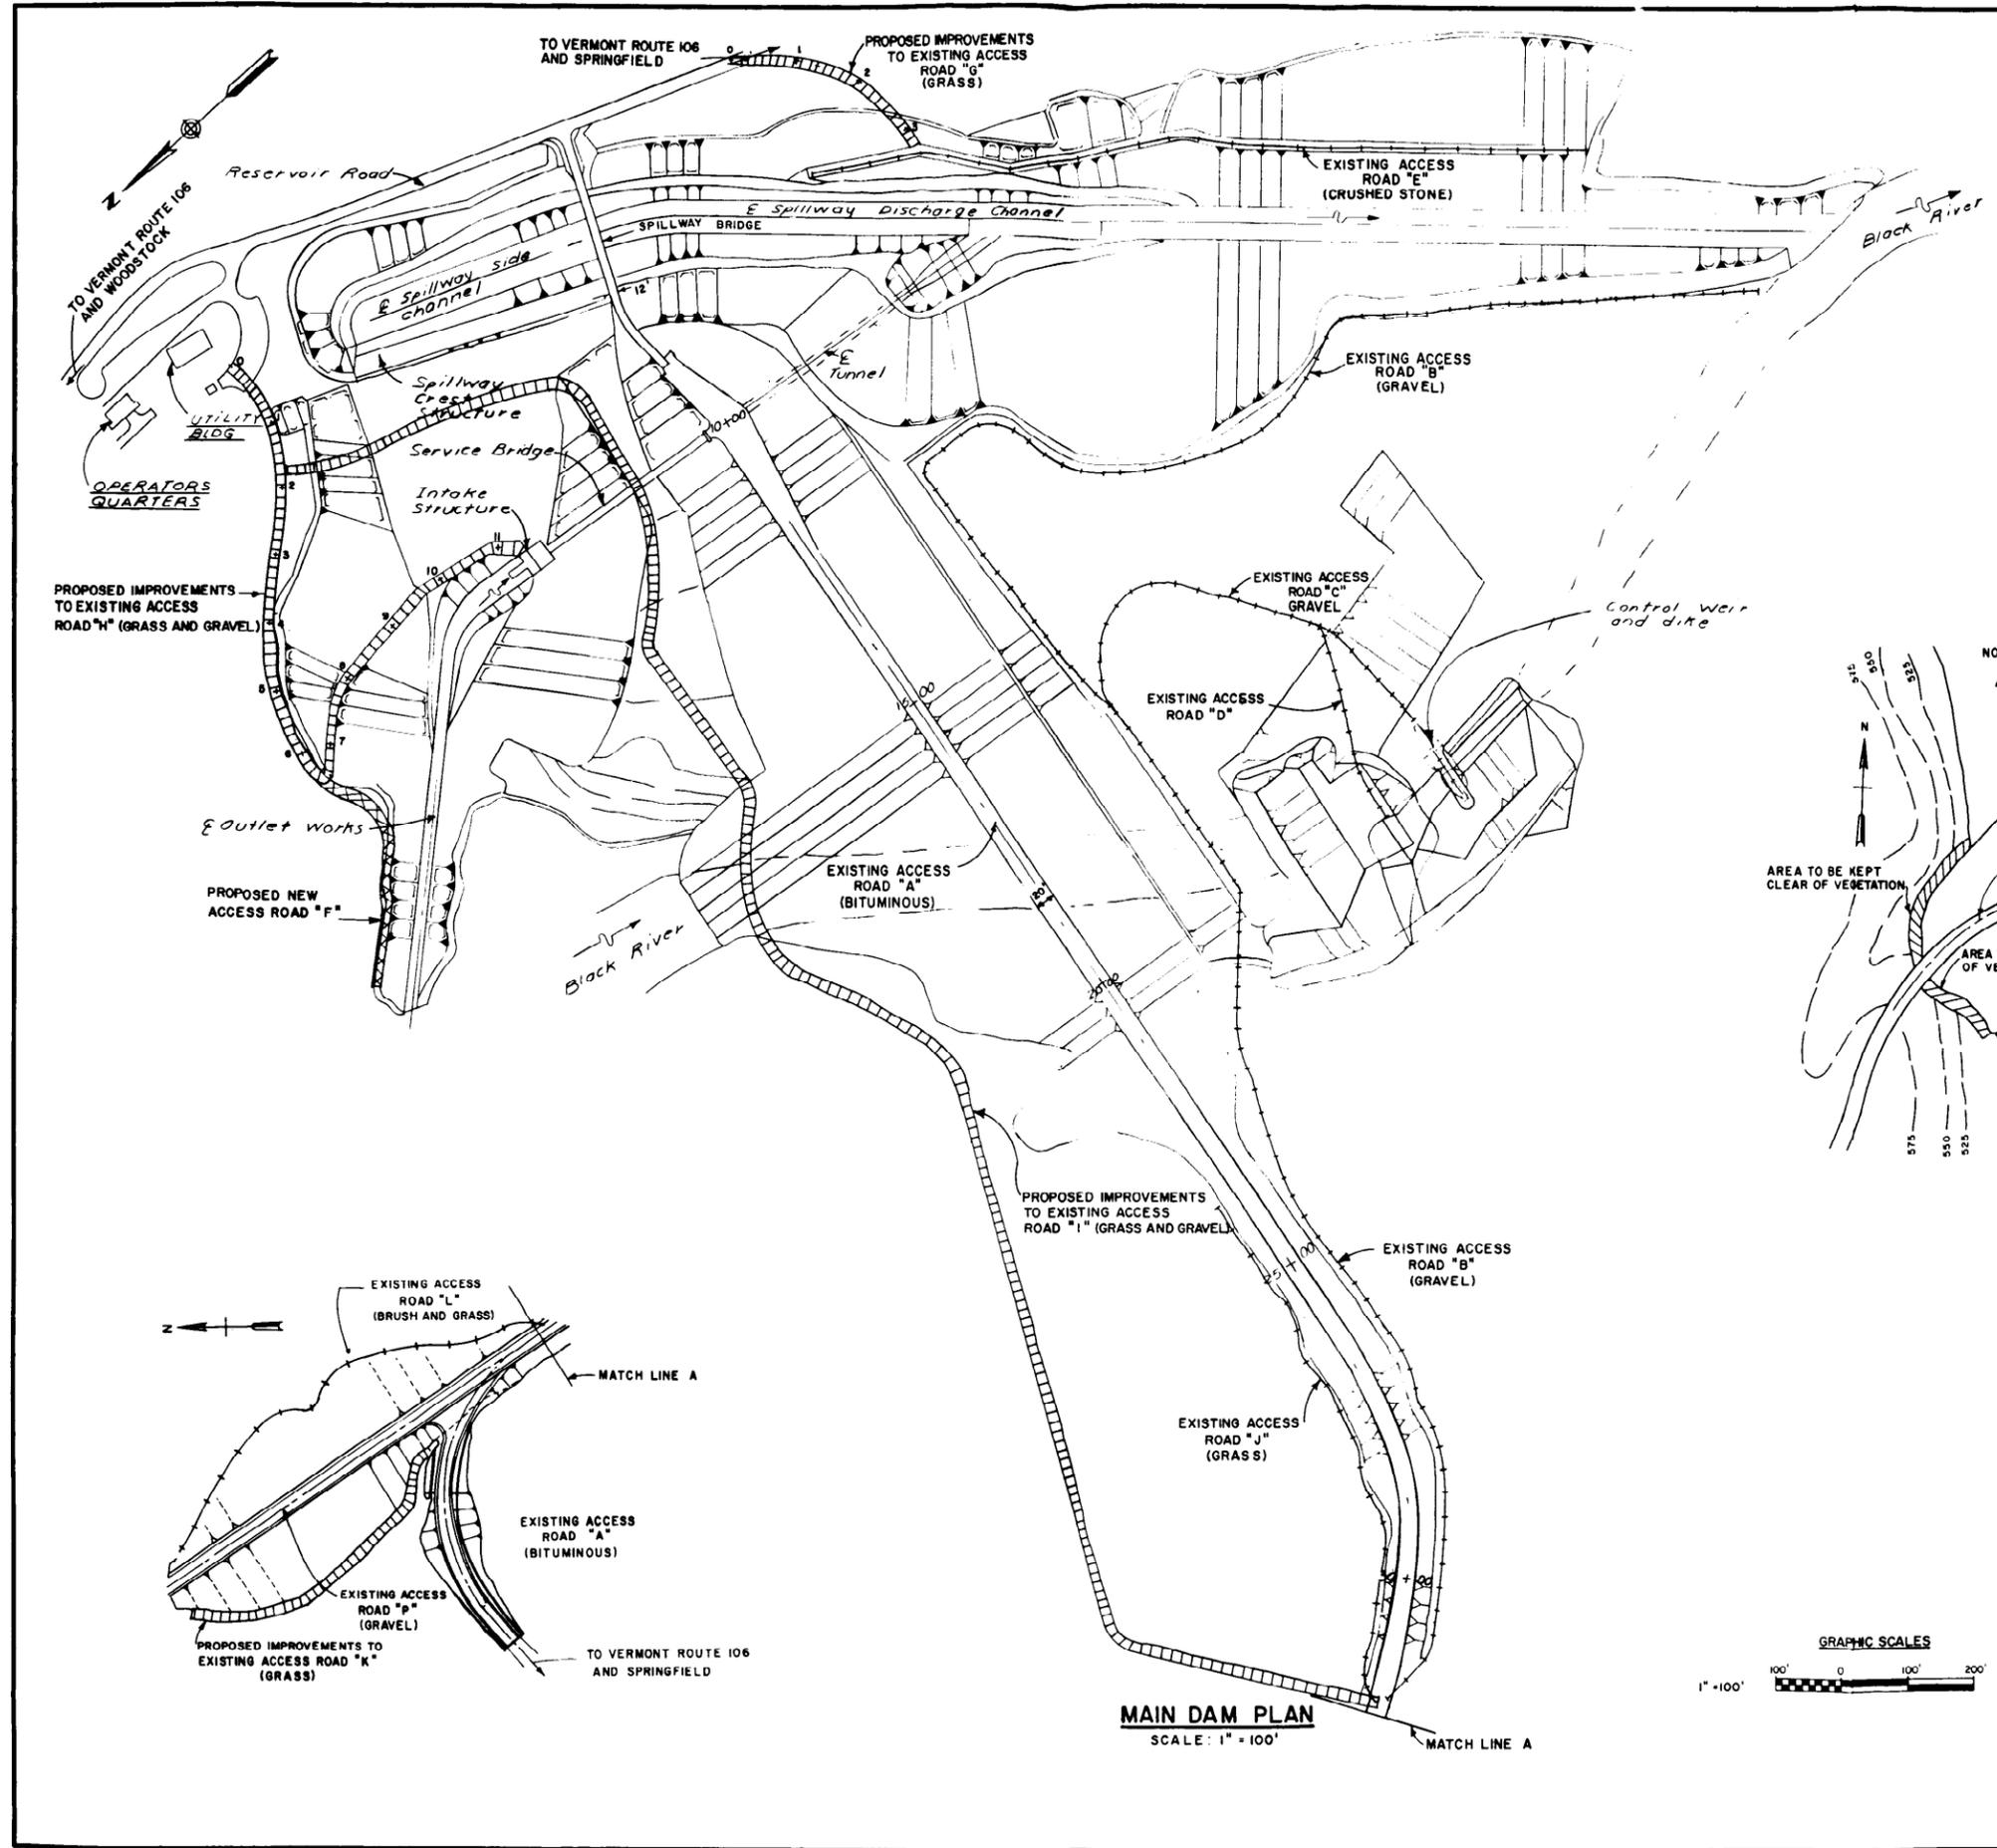
DEPARTMENT OF THE ARMY NEW ENGLAND DIVISION CORPS OF ENGINEERS WALTHAM, MASS.	
<b>EMERGENCY ACCESS STUDY</b>	
UPPER CONNECTICUT RIVER BASIN	
<b>NORTH SPRINGFIELD LAKE</b>	
GENERAL PLAN	
DES. BY: _____	SCALE: AS SHOWN
DR. BY: _____	DATE: SEPT. 1990
CK. BY: _____	
GEOTECH. ENG. DIV. PLATE C-1

9. Adequacy of Access. Access to the outlet works at North Springfield Dam is inadequate. The grass surface and steep slopes of Access Road "H" to the inlet channel and structure do not meet the design criteria. Only lightweight equipment can reach the outlet structure and channel under very difficult conditions.

15. Adequacy of Access. Access to the crest of the North Branch Dam is adequate. Access to the toes of the dam is inadequate.

13. Recommended Improvements. Access Roads "G", "H", and "I" should be upgraded as shown on Plates C-1 and C-2, and discussed in paragraph 7. It should be noted that the road surface on the spillway bridge is only 12.5 feet wide and that some grading and gravel will be required for heavy equipment to work between the spillway channel and Reservoir Road.

16. Recommended Improvements. Access Road "N" should be constructed as shown on Plates C-1 and C-2 to improve access to the downstream toe of the North Branch Dam. Access Road "O" should be constructed to improve access to the upstream toe of the dam. It would be a 12-inch gravel road at existing grade. Clearing, grubbing and stripping would be required before placement and compaction would be performed. The east abutment should be kept clear of vegetation to allow light weight vehicle and inspection along the abutment and North Branch interface.
