WILSONVILLE, CONNECTICUT
FRENCH RIVER

LANGERS POND DAM
CT-00186

**NATIONAL DAM INSPECTION PROGRAM
CORPS OF ENGINEERS**

INSPECTION REPORT
LANGERS POND DAM
CT 00186

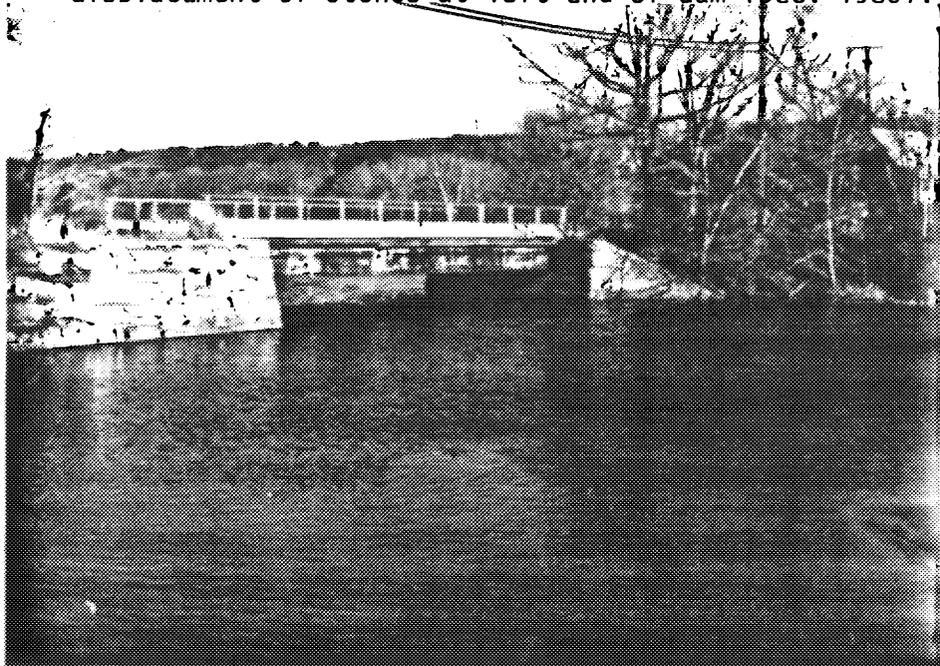
Photo 2 - Embankment and opening at road just upstream from dam (Dec. 1980).

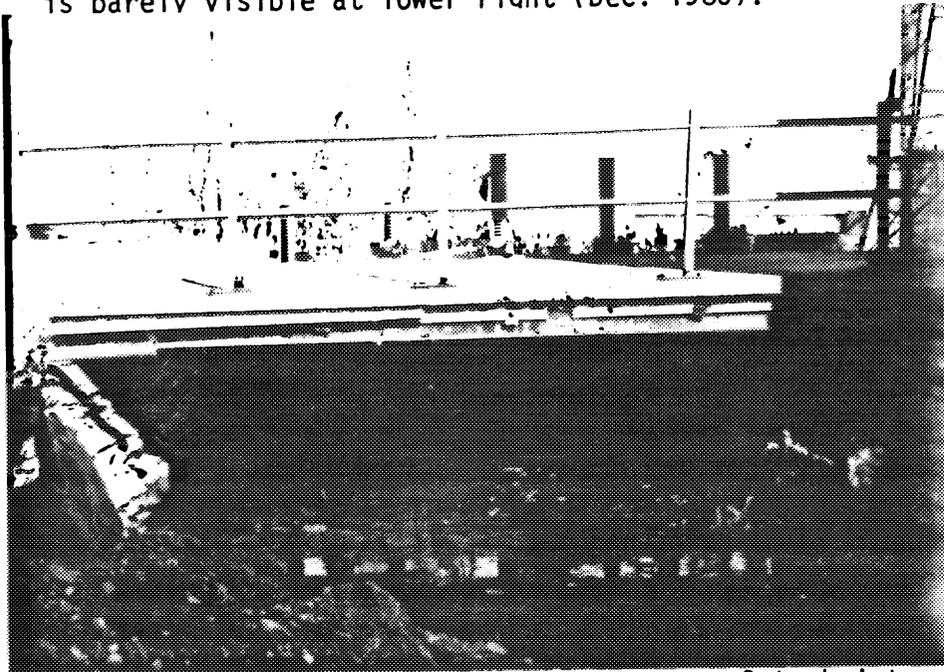
Photo 6 - Outlet channel from downstream. Gate hoists are visible in background, fill just above building housing the turbine is visible at lower left (Dec. 1980).
