HOUSATONIC RIVER BASIN
ANSONIA, CONNECTICUT
QUILLINAN RESERVOIR DAM
CT 00024

PHASE I INSPECTION REPORT
NATIONAL DAM INSPECTION PROGRAM

February 1980

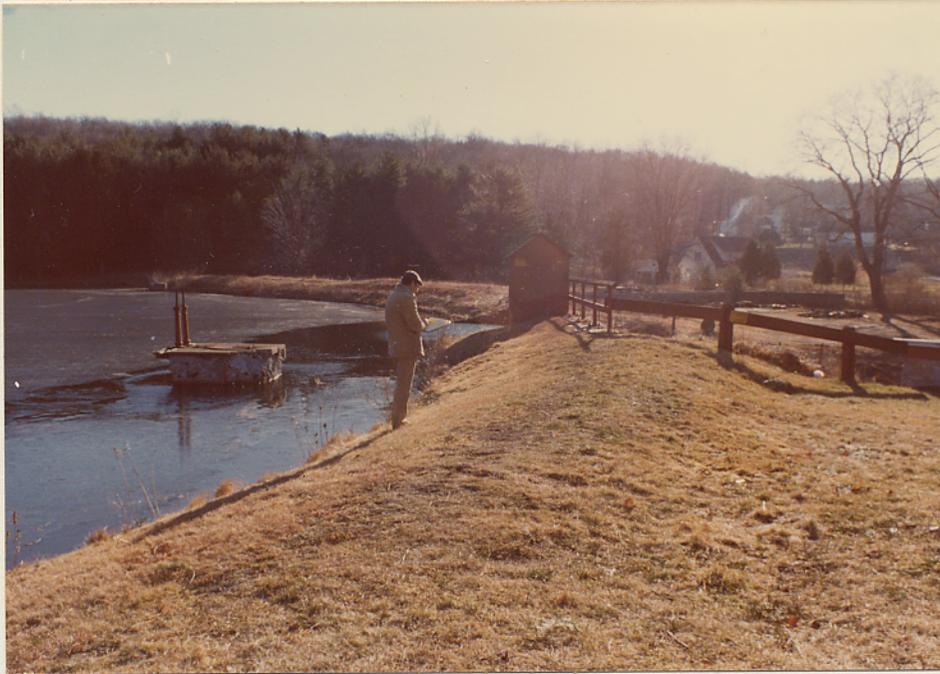
Crest - The crest of the earth embankment is very irregular and ranges from 0.5+ feet below to 1.5+ feet above the top of the masonry section of the dam (Photos 1, 2 and 4). Several paths (or ruts) from pedestrian traffic were noted on the left embankment.

Upstream Slope - Erosion was noted along the water line of the upstream slope of the left section of embankment (Photo 1 and 2). This erosion extends from the riprap protection (just below the water line) to 3+ feet up the slope. A small area of erosion was also noted at the embankment to the right of the spillway. This area is 4+ feet long and is located at the water line just opposite the supply intake and gate tower. Small brush was also observed on several portions of the upstream slope.

Photo 1 - Upstream slope and top of dam from right abutment. Gate structure for supply intake at left (Jan. 1980)

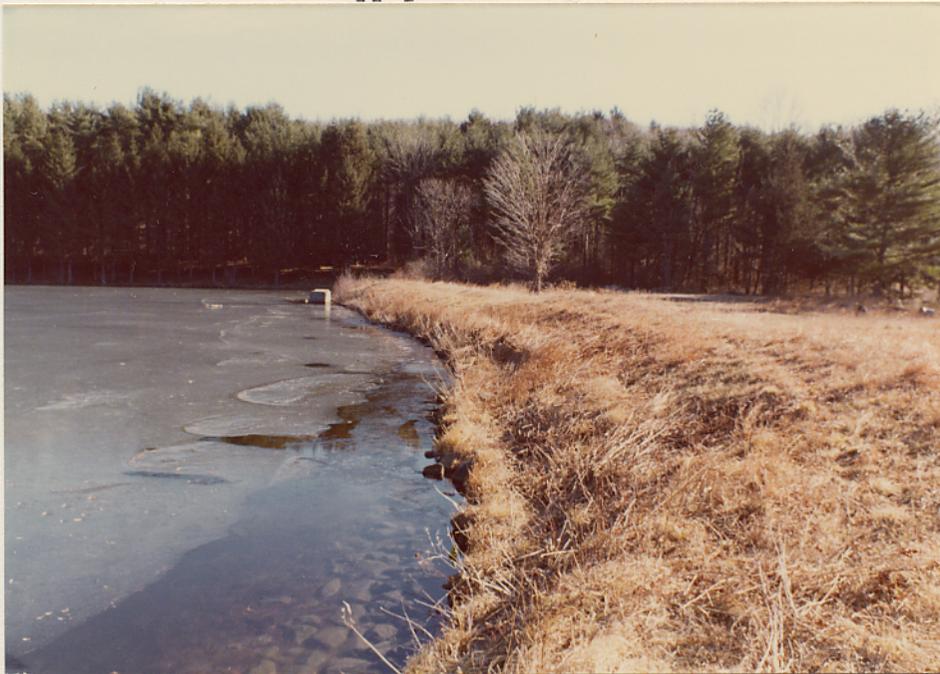
Photo 2 - Upstream slope and top of embankment left of spillway (Jan. 1980).

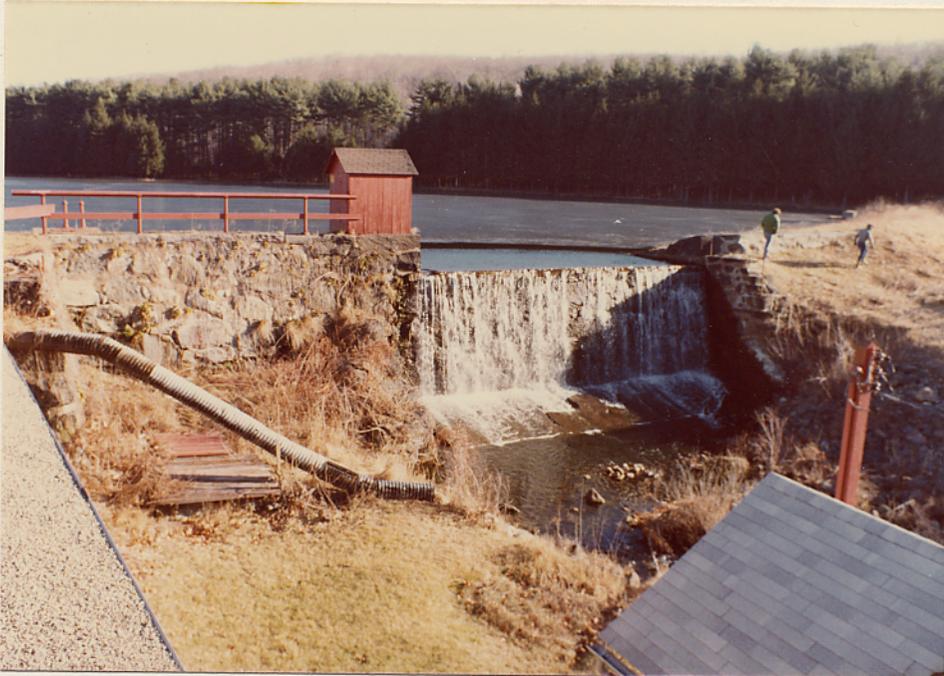
Downstream Slope - The downstream slope of the masonry section is covered with grass, weeds and brush, which is growing out between the masonry joints of the stone masonry (Photos 3 and 5). Seepage through the joints was noted at the lower portion of the masonry section and in several joints approximately 7 feet below the top of the masonry. The total seepage flow is approximately 0.5 to 1 gallon per minute (gpm). Many of the joints in the masonry are cracked and leaching at the areas of seepage, leaving the mortar soft and non-cohesive (Photo 6). The toe of the masonry section is also wet and covered with brush (Photo 3). The downstream slope of the left earth embankment has a grass cover with some brush. No cracks or seepage was observed.

Spillway - The downstream face of the masonry spillway is slightly deteriorated near the top. The spillway crest is in good condition. The spillway apron is severely damaged with spalling at the central and left portions (Photo 3). A scour area in the discharge channel approximately 2 feet wide and 2 feet deep was noted along the toe of the spillway apron.

Photo 3 - Downstream face of masonry section with spillway (Jan 1980)

5. Cracked masonry joints of the spillway training walls should be sealed to prevent further deterioration.
6. The concrete damage at the spillway apron should be repaired or the apron replaced. Erosion at the toe of the apron should be filled and riprapped.

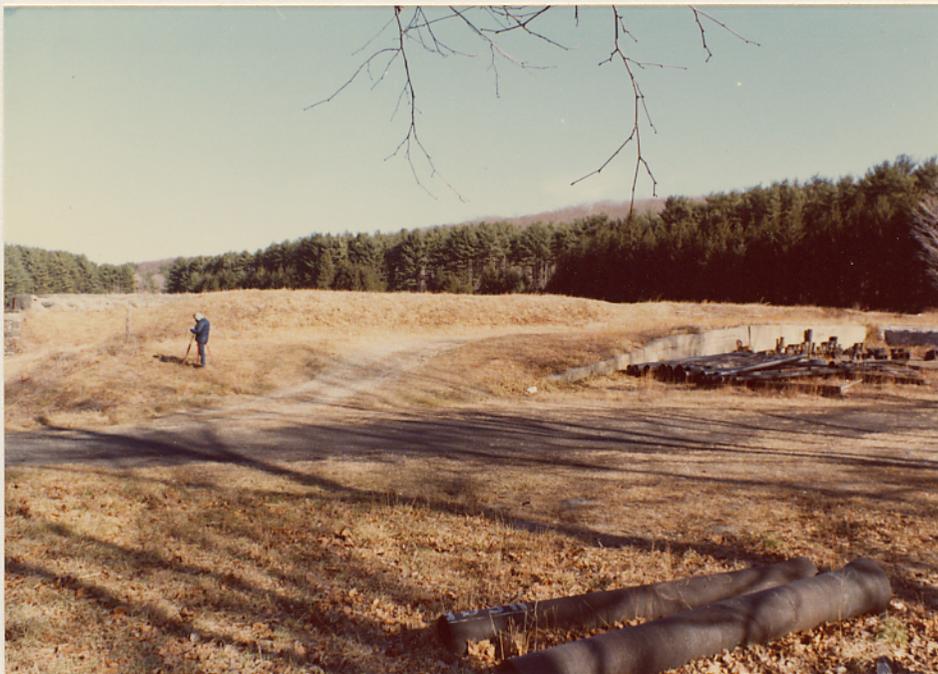
The fill at the toe of the left embankment has a weed cover on the top and terminates to the right at a concrete foundation (Photos 4 and 5, Sheet B-1). For 65+ feet at the left end of the dam, there is no fill dumped as yet. In this area the embankment is 8 to 10 feet in height with the downstream slope and toe covered with brush and trees.

Photo 4 - Downstream slope of embankment left of spillway. Note irregularity of crest. (Jan. 1980)

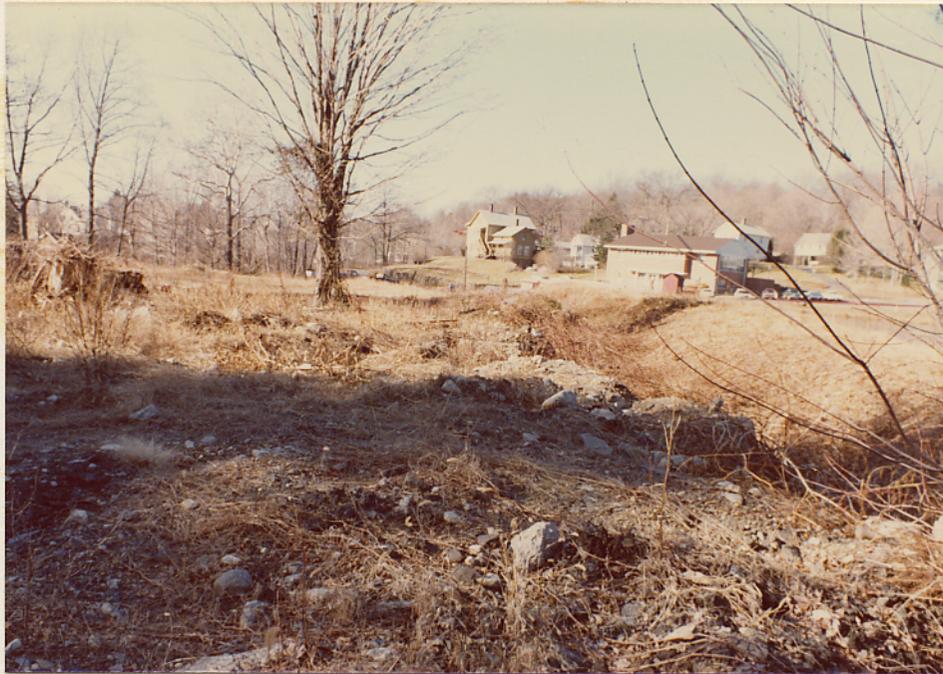
Photo 5 - Fill dumped at toe of dam left of Spillway (Jan. 1980)

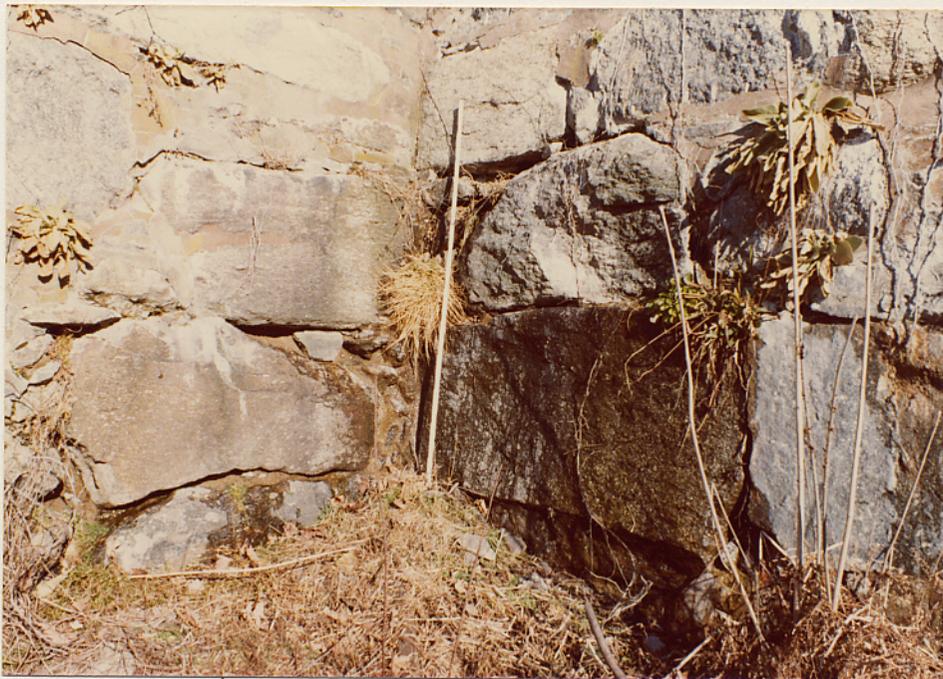
1. Seepage through the masonry section of the dam, accompanied by leaching of the cement mortar joints, could weaken the masonry and create stability problems.
2. Seepage at the chlorinator chamber could be caused by permeable zones in the base of the masonry section and in the foundation, or leaks from a damaged water supply line. The origin of the seepage should be investigated.

Photo 6 - Seepage in corner of downstream face of masonry section. (Jan. 1980)

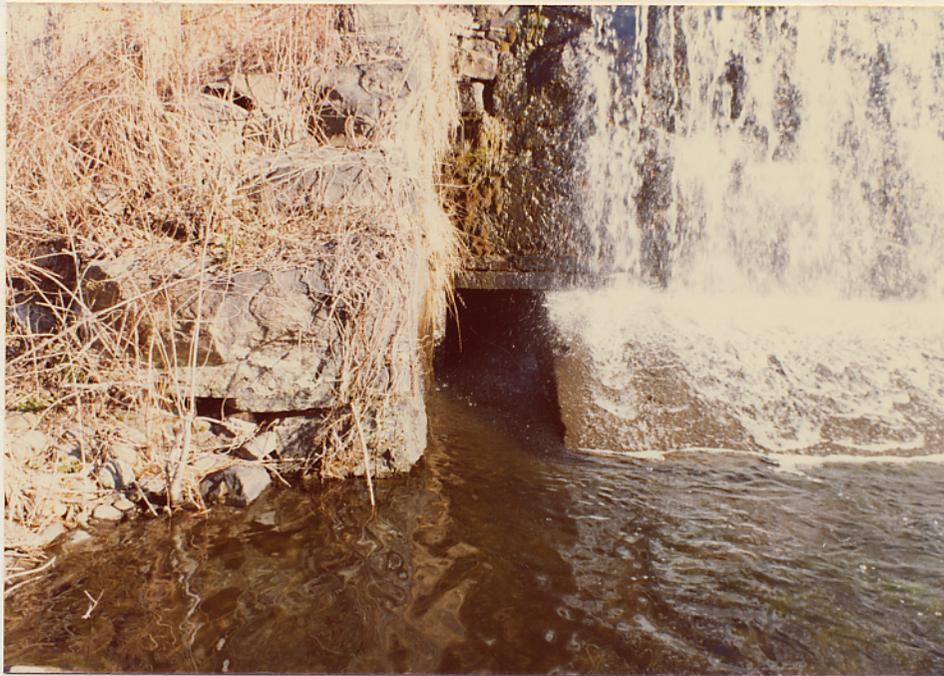
c. Appurtenant Structures - The gate house at the right end of the spillway and low-level conduit, including the butterfly valve and valve stand, are in good condition (Photos 3 and 7).

Photo 7 - Rectangular conduit at right side of spillway (Jan 1980)

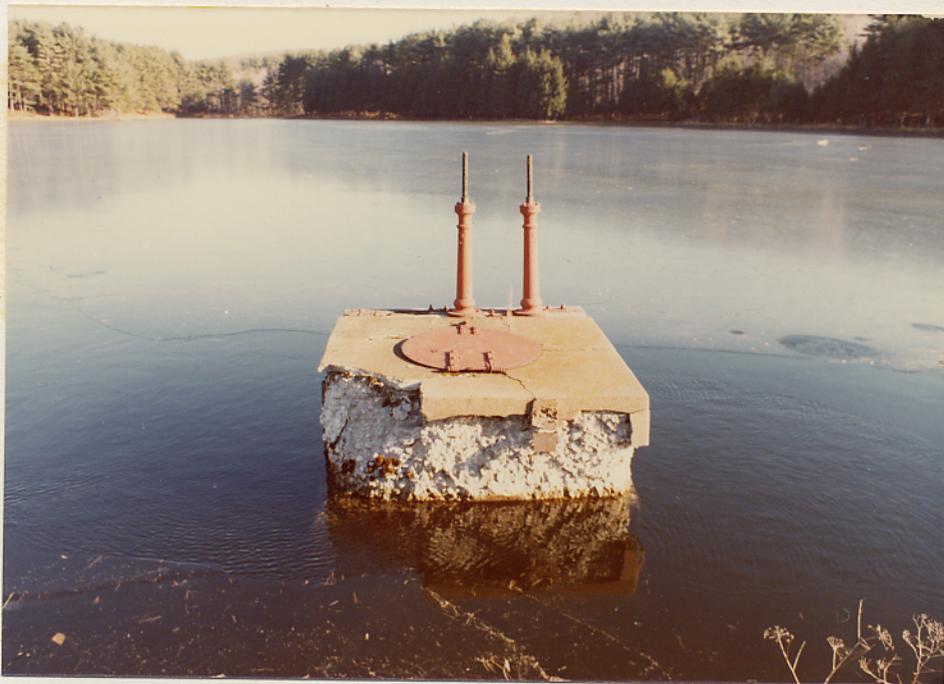
The concrete gate tower for the supply intake is deteriorated; including exposed aggregate, severe spalling, and cracking (Photo 8).

Photo 8 - Gate structure for supply intake (Jan 1980)

5. Repair of the concrete intake and gate tower for the supply line.
6. Origin and significance of seepage at the abandoned chlorinator chamber and location of the 4 inch drain pipe.
7. A comprehensive program for further investigation of the dam. Of particular importance are:
 - a. Condition of the masonry spillway and the concrete apron when no water is flowing over the spillway. This should include investigation into the extent of the scouring at the toe of the apron and the affect of this erosion on the stability of the concrete apron.
 - b. Effect of the fill at the toe of the left embankment on possible seepage through the dam and monitoring of this seepage.
 - c. Development of a program to reduce or stop seepage through the masonry section of the dam.

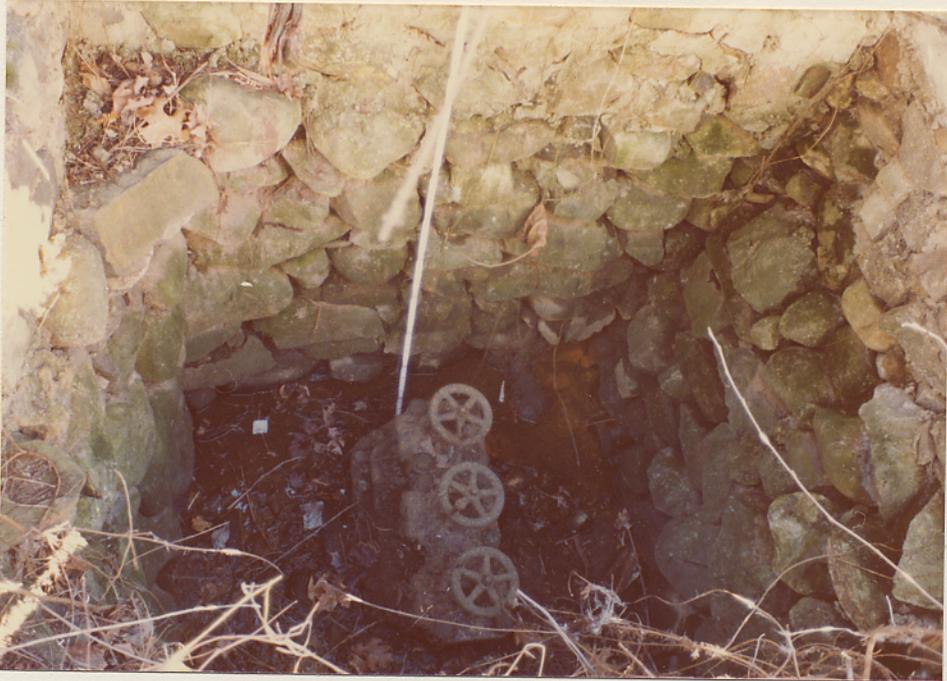
The valve chamber and the (apparently abandoned) chlorinator chamber for water supply, located at the toe of the masonry section of the dam, are dry-laid stone structures. The floor in both chambers were not visible because of debris and siltation, but seepage was observed at the base of the chlorinator chamber. One seep, with a flow of 0.5 gpm, was in the right upstream corner, with the direction of flow nearly parallel to the dam. Another seep, with a flow of approximately 0.6 gpm, was located in the left downstream corner (Photo 9). There was an indication of hydraulic pressure in this seep with water flowing up out of the ground. Some deposits of brown silt sediments were also noted in this area. There is a 4 inch tile drain pipe at the base of the downstream wall of the chlorinator chamber. The drain was silted sufficiently to reduce by 1/2 the diameter of the pipe. Seepage water was flowing out of the chamber through this pipe but the actual direction of this drain could not be determined.

Photo 9 - Chamber for chlorinator. Seepage at base of chamber in left downstream corner, right corner in photo (Jan 1980)

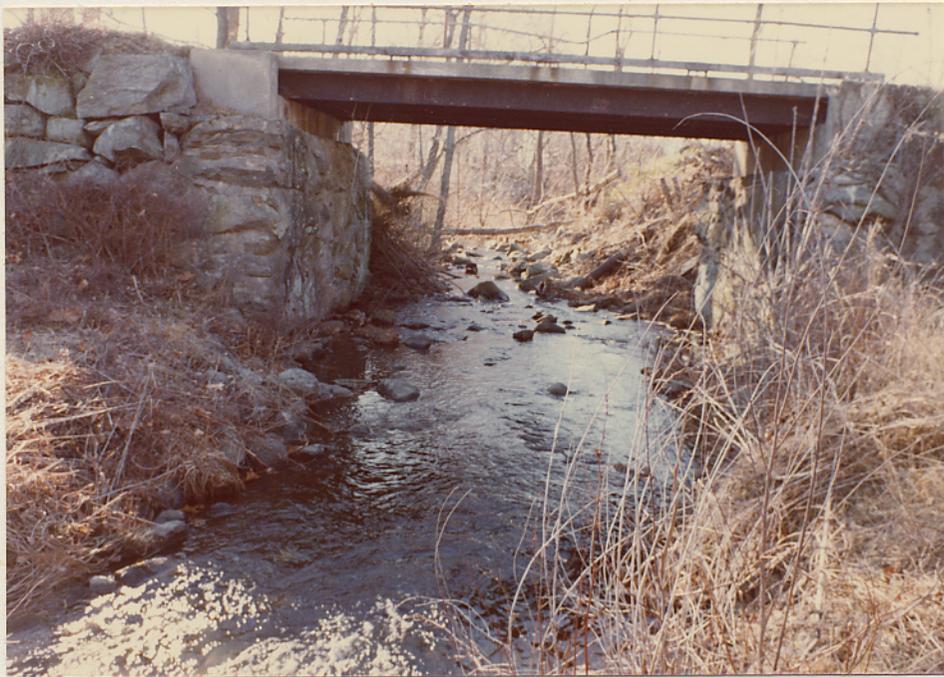
Photo 10 - Downstream channel from spillway (Jan 1980)

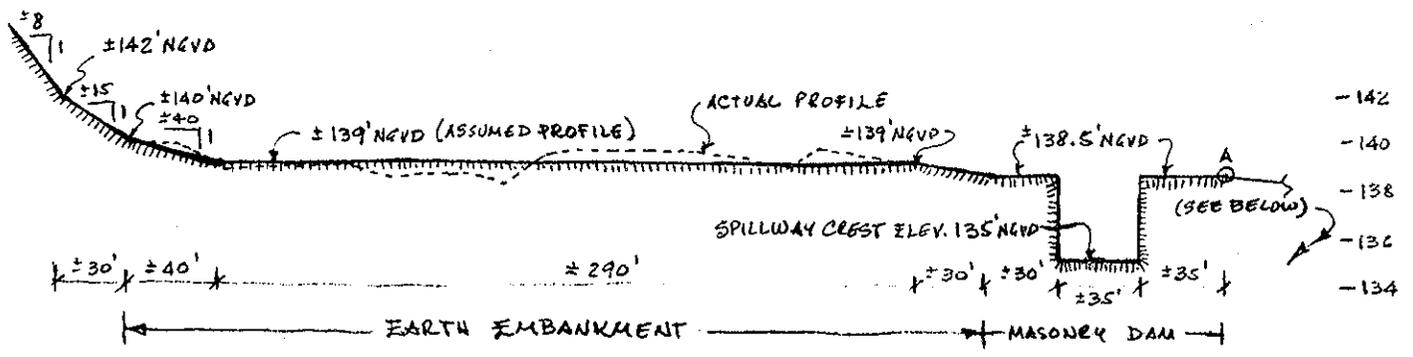
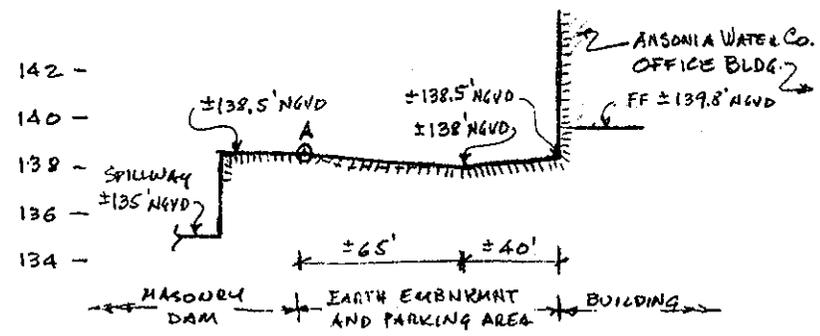
- OVERFLOW PROFILE -

THE TOP ELEVATION OF THE LEFT EMBANKMENT VARIES FROM (+) 138' NGVD TO (+) 140' NGVD AND PRESENTS WITHIN THESE LIMITS A VERY IRREGULAR OVERFLOW PROFILE (SEE SKETCH BELOW). THE RIGHT EMBANKMENT FALLS TO (+) ELEV. 138' NGVD (± 0.5' LOWER THAN THE TOP OF THE MASONRY DAM), AND TIES WITH THE PARKING AREA OF THE ANSONIA-DERBY WATER CO. BUILDING TO FORM THE OVERFLOW SECTION. IT WILL BE ASSUMED THAT THIS BUILDING (FF. ELEV. (+) 139.8' NGVD) CLOSES VERTICALLY, ABOVE GROUND ELEV. (+) 138.5' NGVD AT THE RIGHT SIDE OF THE OVERFLOW SECTION. TO THE LEFT, THE DAM AND ADJACENT TERRAIN RAISE GRADUALLY AS SHOWN BELOW ON THE OVERFLOW PROFILE ASSUMED FOR THIS COMPUTATION.
