NEW CANAAN, CONNECTICUT

**GRUPES RESERVOIR DAM  
CT 00057**

PHASE I INSPECTION REPORT  
NATIONAL DAM INSPECTION PROGRAM

DECEMBER, 1979

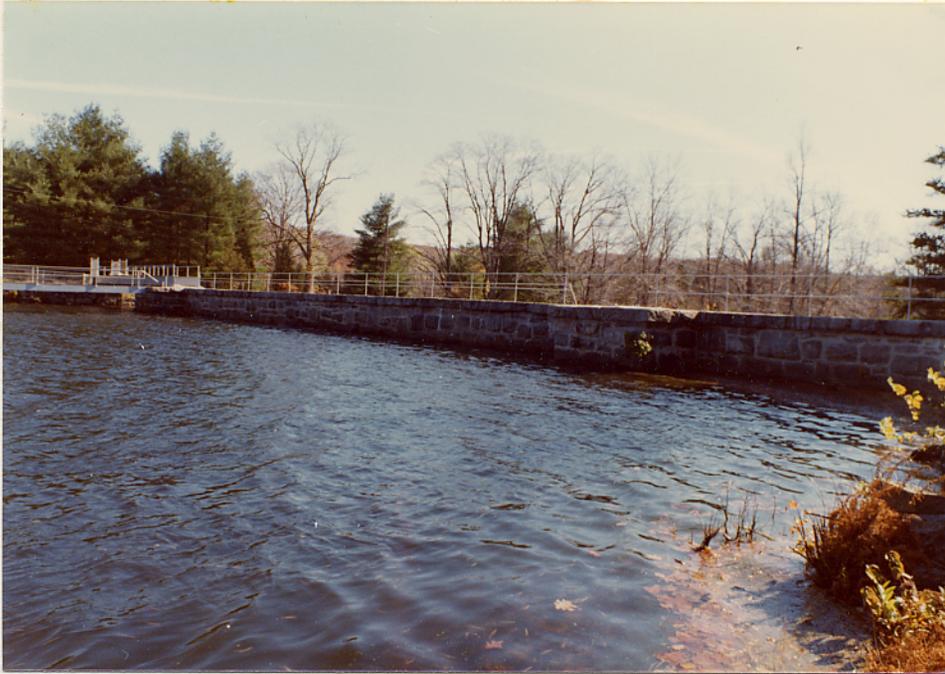
Upstream Slope - There are cracks in the mortar joints of the masonry, with considerable cracking noted at the right side of the slope in the area of the emergency inlet valve chamber (Photo 1). The top of the concrete lining appears to be in sound condition.

Photo 1 - Upstream slope and emergency intake valve chamber.  
(Nov. 1979)

- 3. A comprehensive program of inspection by a registered professional engineer qualified in dam inspection should be instituted on an annual basis.
- 4. Cracked masonry joints on the upstream slope of the dam and the upper 24 inch and emergency intake valve chambers should be sealed to prevent masonry deterioration and water penetration to the dam.

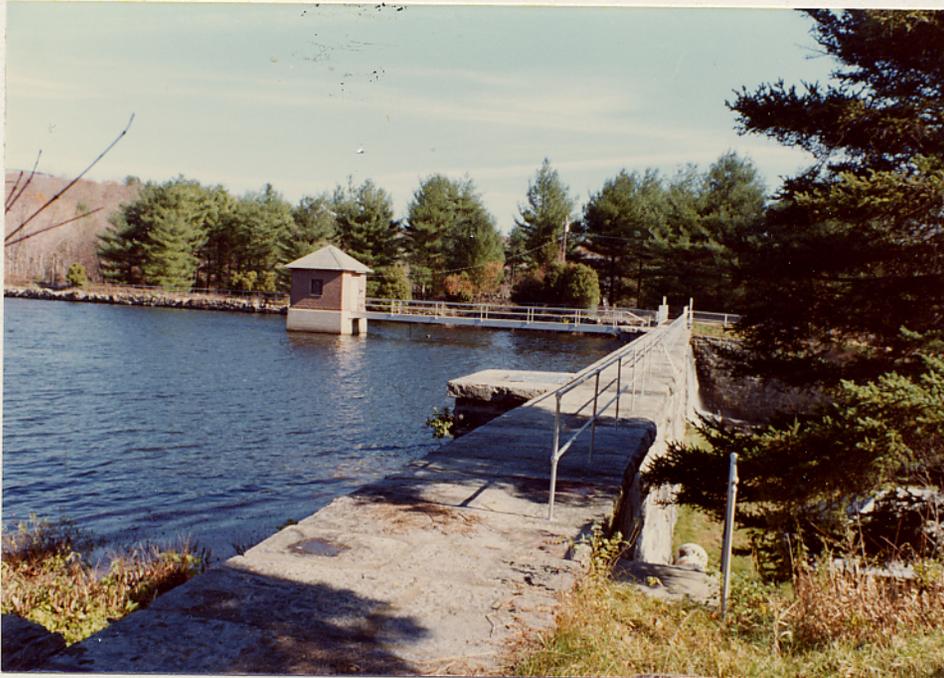
Crest - The crest of the dam is in good condition. No signs of misalignment, spalling or visible cracks were observed (Photo 2).

c. Appurtenant Structures - The intake gatehouse is in good condition (Photo 2). No cracks or spalling was observed on the external or internal surfaces of the concrete chamber.

Photo 2 - Crest of dam and gatehouse (Nov. 1979)

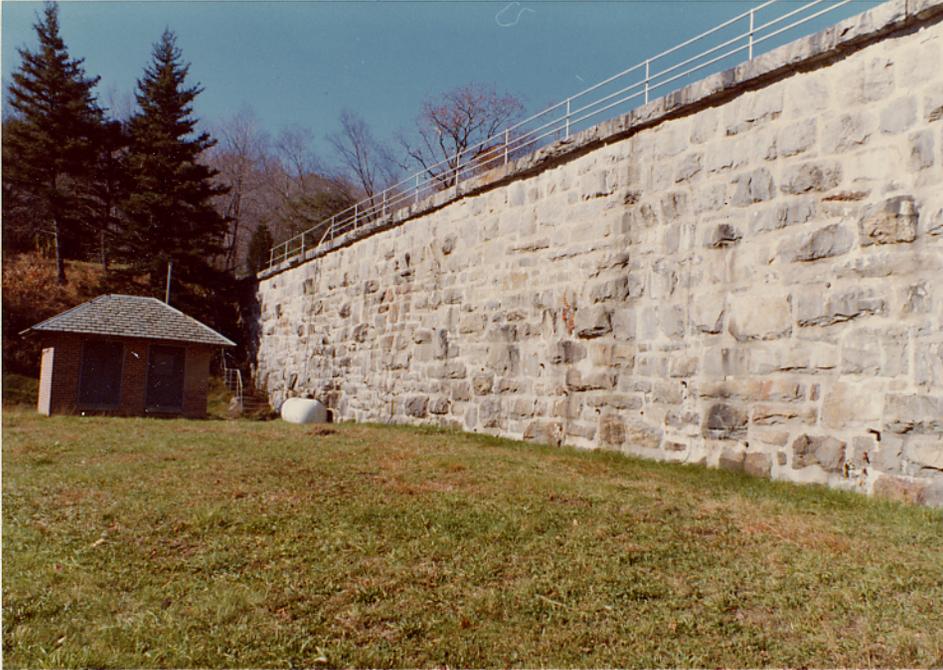
Downstream Slope - No misalignment or signs of movement were observed on this slope. Efflorescence was noted along the mortar joints of this slope (Photo 3). There are several seepage areas on the right side and central portion of the downstream slope (Photos 11 and 12). In this area of the slope, seepage emanated through the numerous cracks in the joints of the stone masonry. In some places, the mortar is completely washed out from between the stones. There are several metal pipes protruding from the downstream slope and are reported to have been used for pressure grouting of the masonry in the 1960's (Photo 12).

Photo 3 - Downstream slope of dam (Nov. 1979)

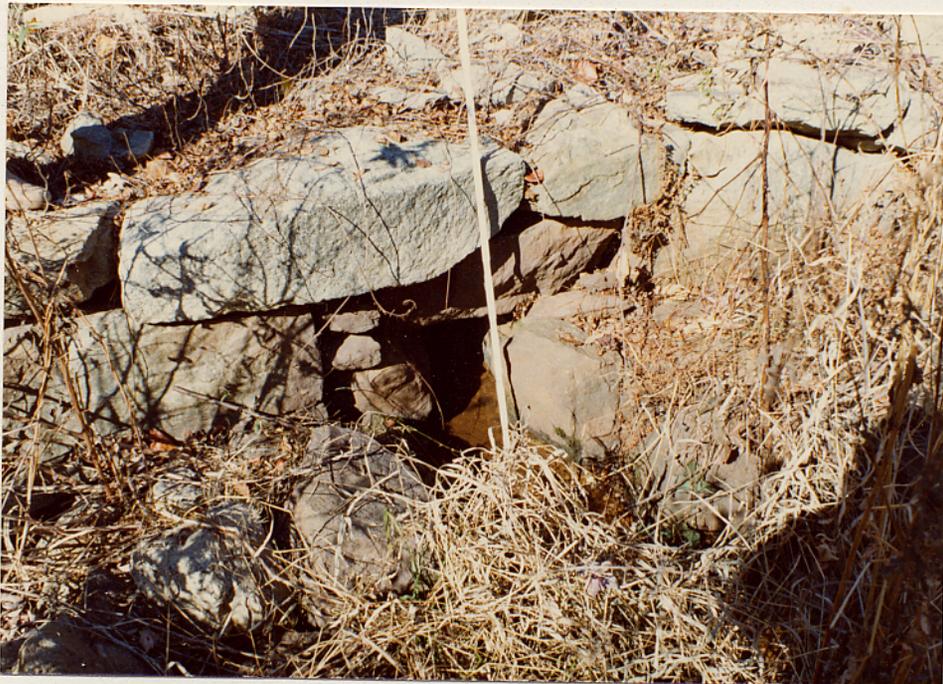
There is a 12 inch tile drain pipe which runs from a dry well, which is reported to be located to the right of the chlorine house, to the downstream river channel. (See Sheet B-1). Discharge from this pipe was approximately 10 gpm (Photo 4). A two inch thick deposit of siltation was observed on the bottom of the pipe outlet. The ground in the vicinity of the dry well is wet and according to the dam operator there is water in this area all year long (Photo 10).

Photo 4 - Outlet for 12 inch pipe to drywell (Nov. 1979)

1. A detailed hydraulic/hydrologic analysis to assess the overflow section at the service road as an auxiliary spillway. Recommendations should be made by the engineer and implemented by the owner.
2. A Further investigation and inspection of the project and make any necessary recommendations. Items of particular importance are as follows:
  - a. Evaluation of the need for a dam stability analysis at test flood conditions. This analysis could require implementation of a boring program, piezometer installation and material testing.
  - b. The condition of the dry well on the right side of the dam toe and the development of measures to control drainage at the wet area surrounding this well. Also the origin and significance of seepage flow from the 12 inch tile drain pipe.

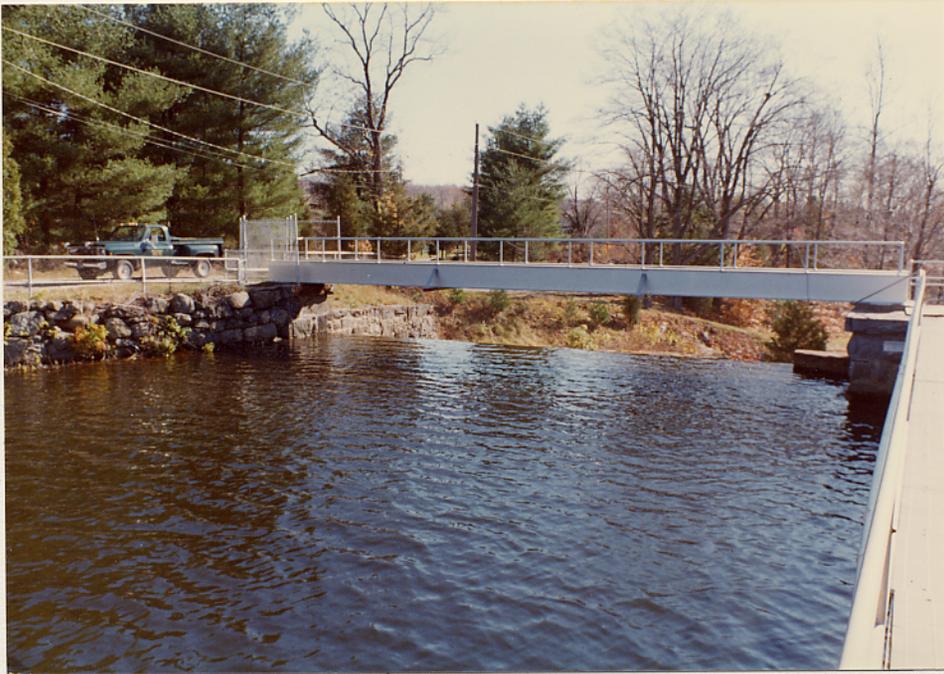
Main Spillway - The spillway section of the dam was overflowing with about 2 inches of water and portions of the downstream wall were not visible (Photo 5 through 7). There is a dry-laid stone wall along the left side of the reservoir for several hundred feet upstream from the left spillway wall. This stone wall is showing signs of deterioration near the spillway with some of the stone falling into the spillway approach channel (Photo 5). The downstream spillway walls are stone and mortar masonry. There is considerable deterioration of the left wall immediately downstream of the spillway with cracking of the mortar joints (Photo 6). According to the operator, there are wet areas on the middle and lower sections of the downstream face of the spillway, which are visible when the spillway is dry. The floor of the spillway channel is an outcrop of natural rock with several loose boulders and some brush (Photos 6 and 7). There is a 200 foot long dry-laid stone wall along the right side of the spillway discharge channel.

Photo 5 - Spillway from upstream (Nov. 1979)

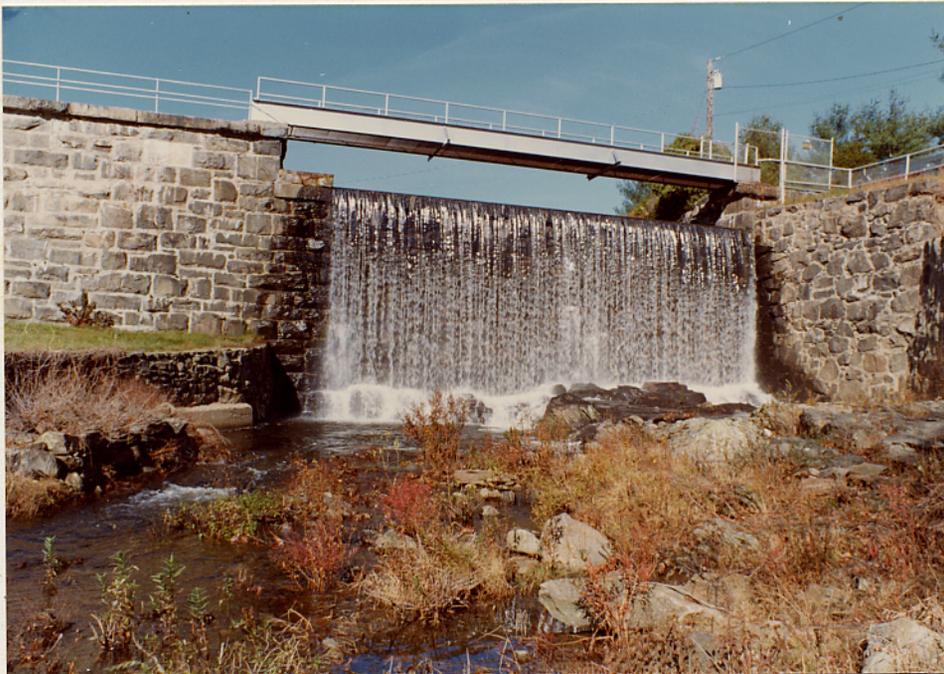
Photo 6 - Spillway from downstream. (Nov. 1979)

- 5. Deteriorated areas of the masonry and stone spillway training walls and the stone wall along the left shore of the reservoir should be repaired to prevent erosion of the banks and to increase the stability of these walls.

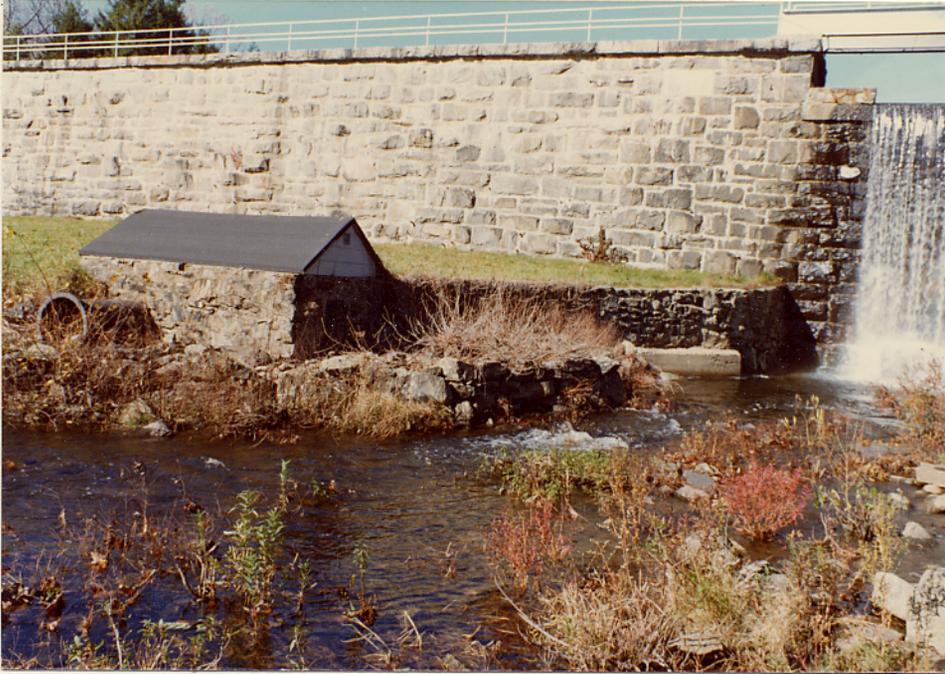
The 24 inch low-level outlet chamber is a masonry structure with some signs of cracking and weathering (Photo 7). The other structures at the right downstream toe of the dam, such as the chlorine house, diffuser, venturi and 24 inch valve house are in good condition.

Photo 7 - Valve chamber and outlet for 24 inch low-level outlet  
(Nov. 1979)

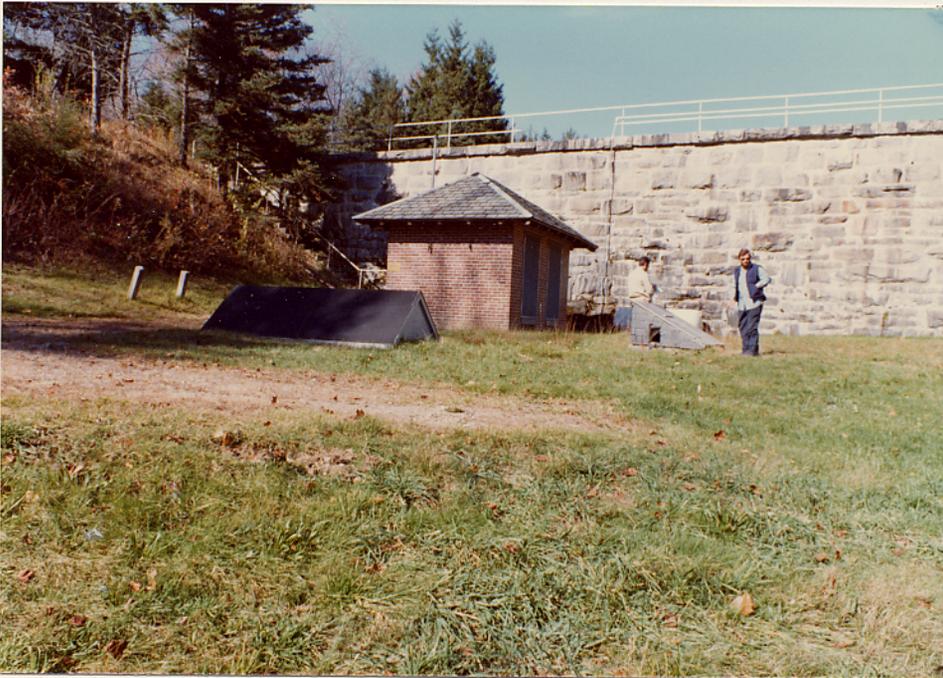
Photo 8 - Brick Chlorine house, valve chamber for 20 inch  
supply line, and diffuser house on right. (Nov. 1979)

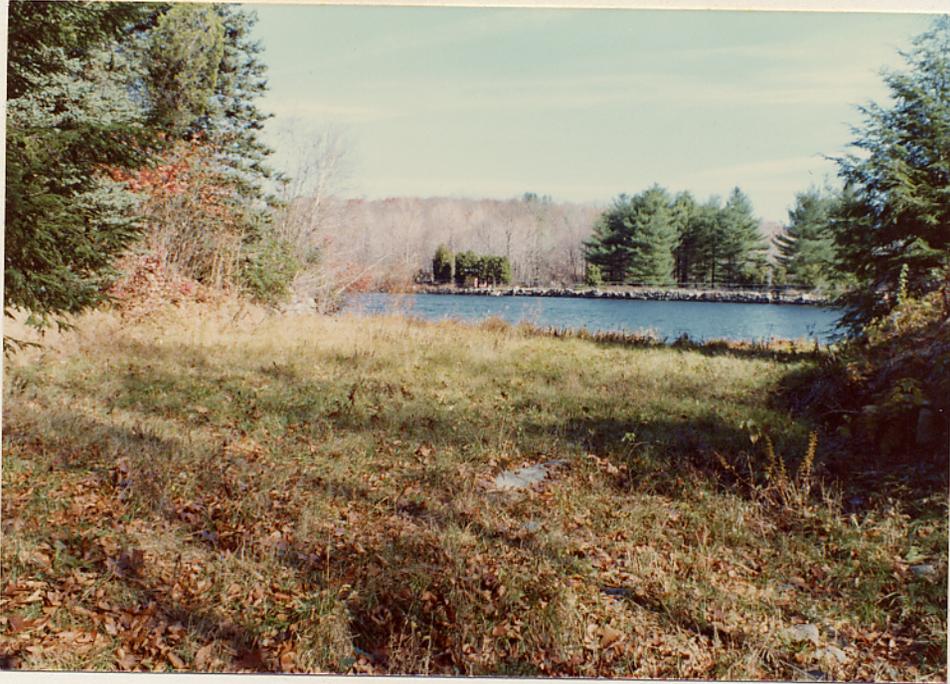
Photo 9 - Auxiliary spillway from downstream (Nov. 1979)

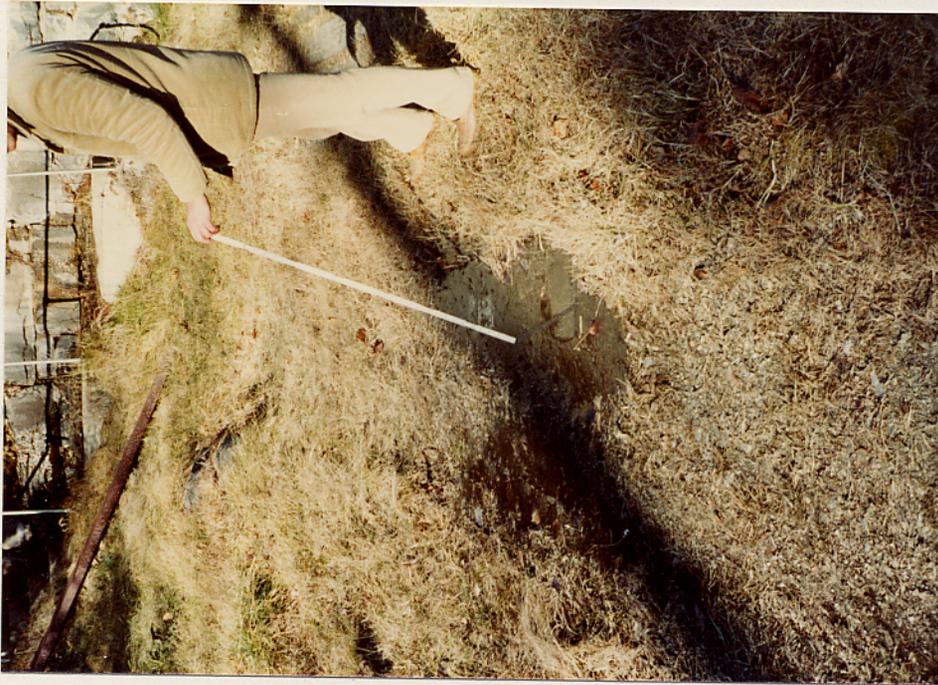
Photo 10 - Wet area near chlorine house and drywell.(Nov. 1979)

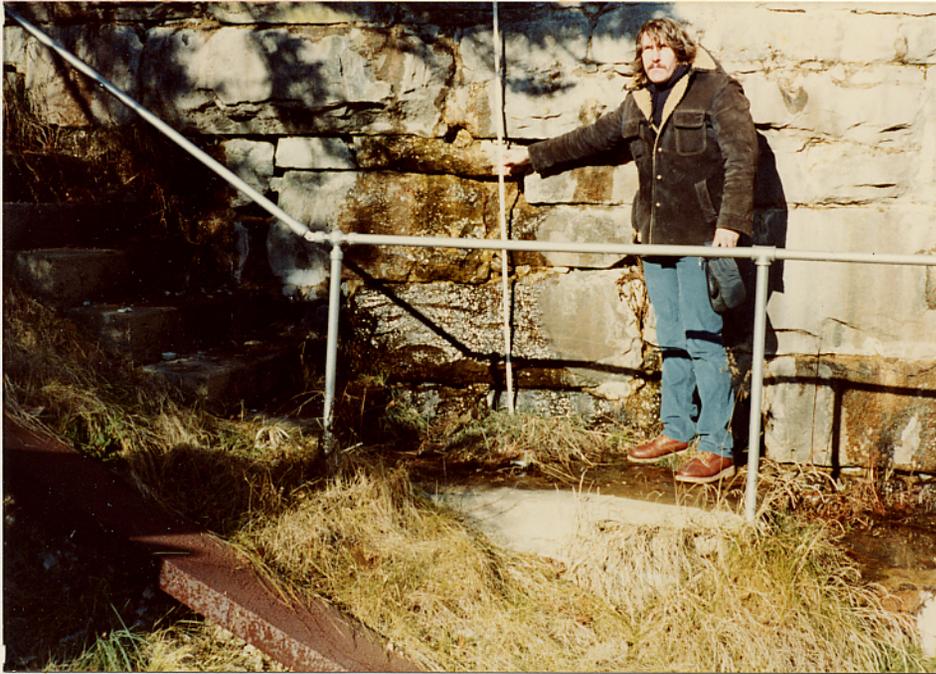
Photo 11- seepage near stairway at right downstream side of dam. (Dec. 1979).

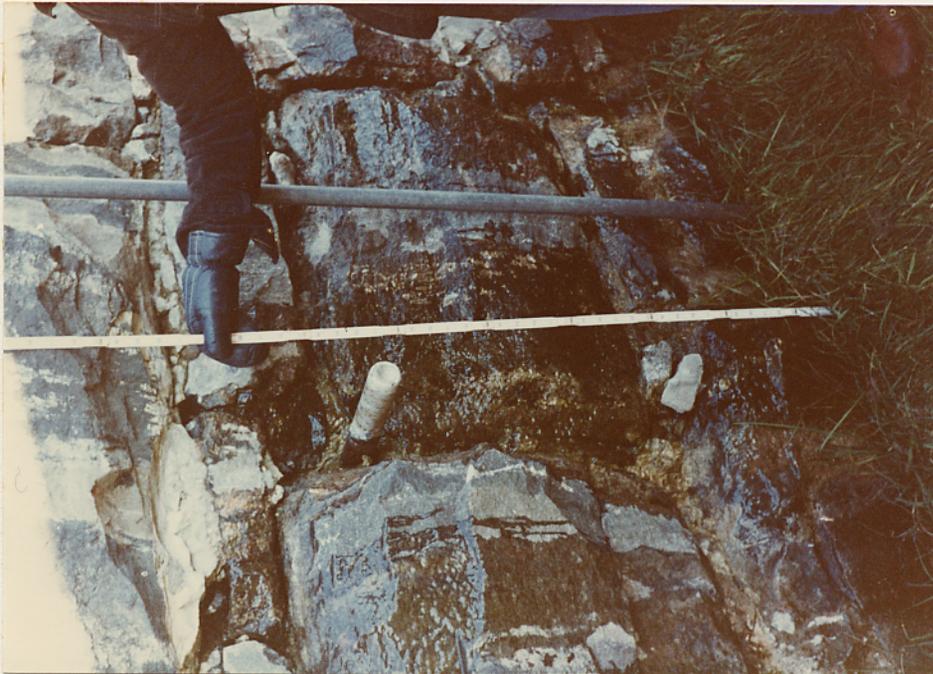
Photo 12 - Seepage at central downstream side of dam. Note grouting pipe. (Dec.79)
