CONNECTICUT WESTERN COASTAL AREA
WESTON , CONNECTICUT

SAMUEL P. SENIOR RESERVOIR DAM
CT 00108
and
POPPS MOUNTAIN DIKE
CT 00022

PHASE I INSPECTION REPORT
NATIONAL DAM INSPECTION PROGRAM

SEPTEMBER 1978

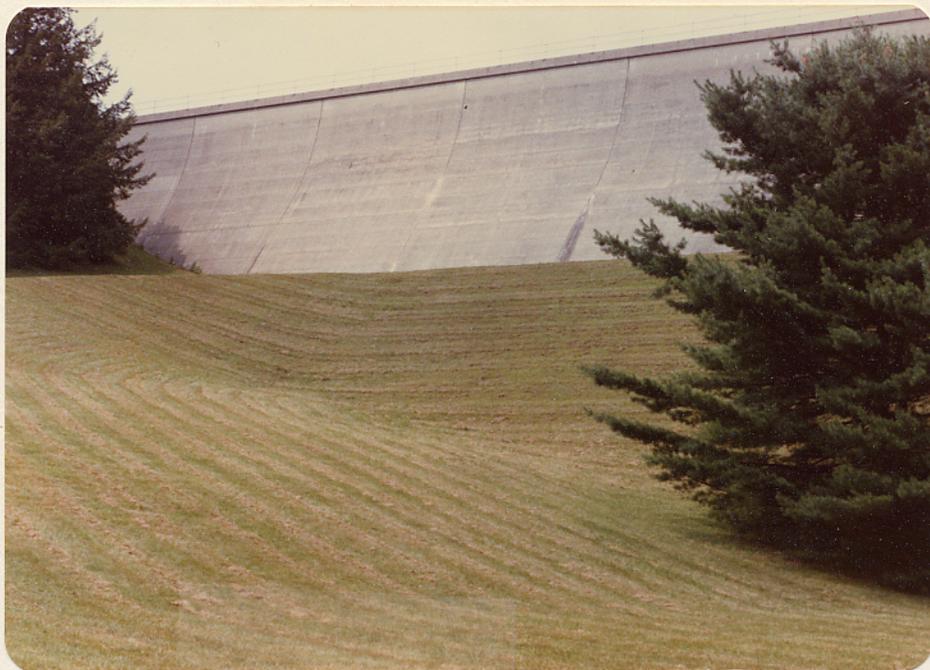
PHOTO #1: View of the western, downstream face of the dam.

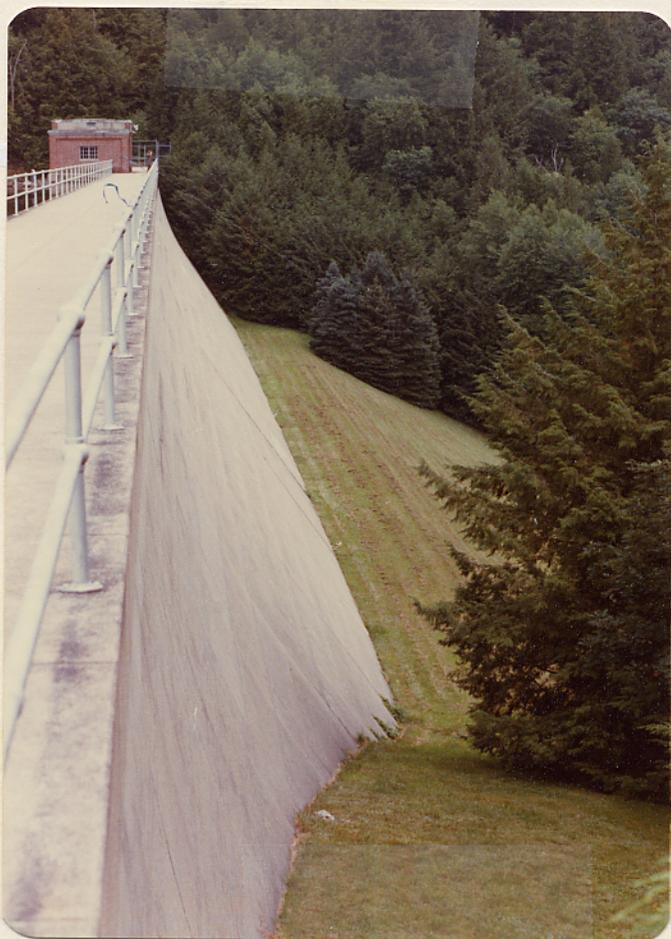
PHOTO #2: View along the face of the dam, looking east.

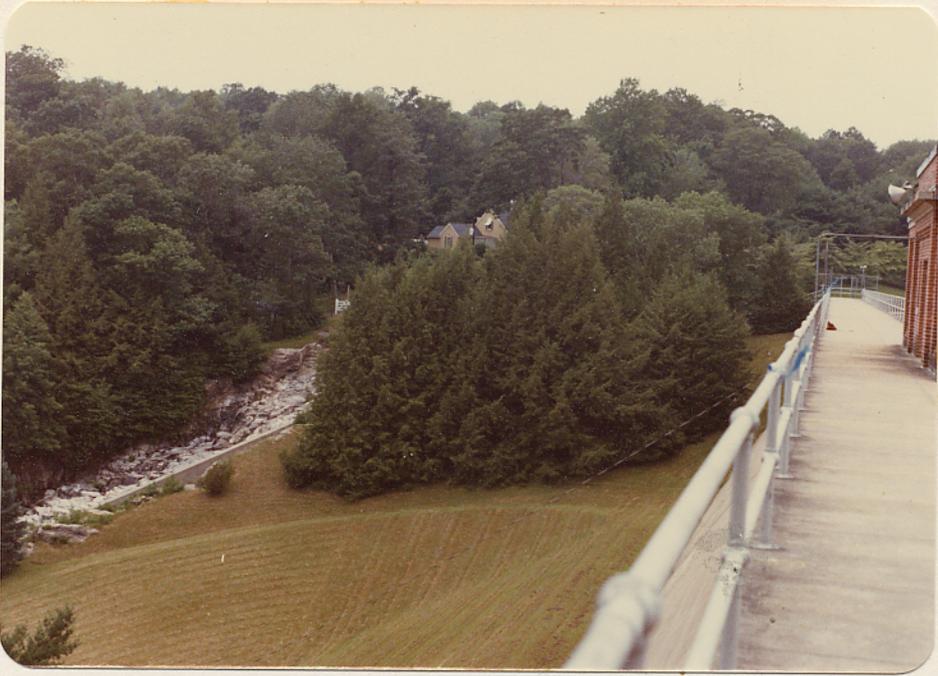
PHOTO #3: Looking west along the crest of the dam.

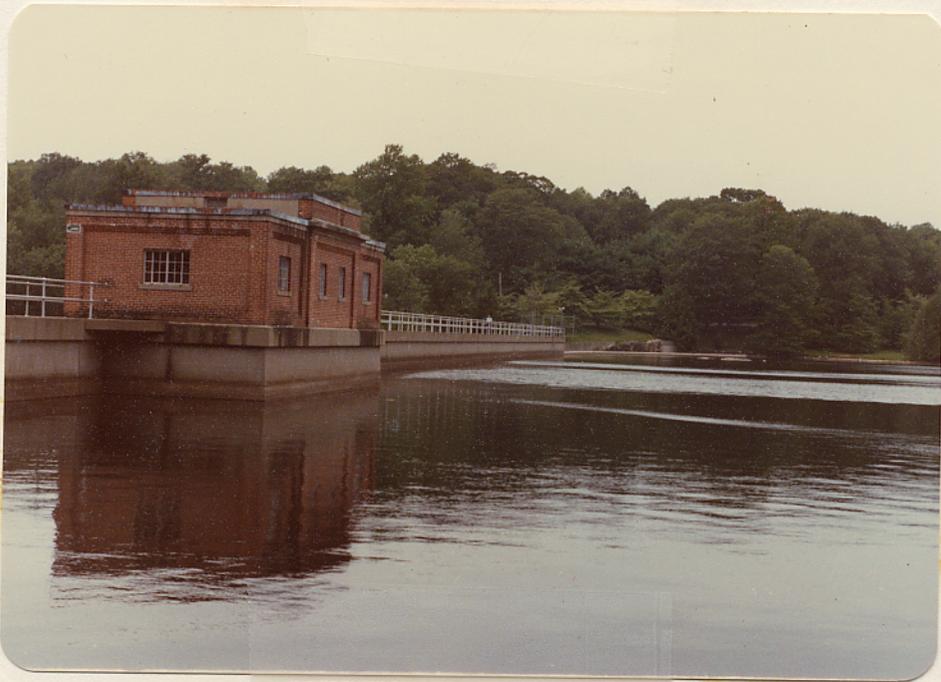
1) Upstream Face - At or above the water line, slight spalling was evident. Generally the concrete was in good condition.

2) Upper Gate House - This structure, located on upstream face of dam, was clean and neat. Gates are reportedly operated once a year, and were inspected by divers in 1977 with minor repair work required at stem guides. There are cracks in the brickwork in the northwest, west, and southwest walls. The cracks are wide enough to allow daylight through in some places. The building has 100 amp, 240 volt electrical service for lights and a deicer which is located adjacent to the spillway.

PHOTO #4: Upstream face of the dam and upper gate house.

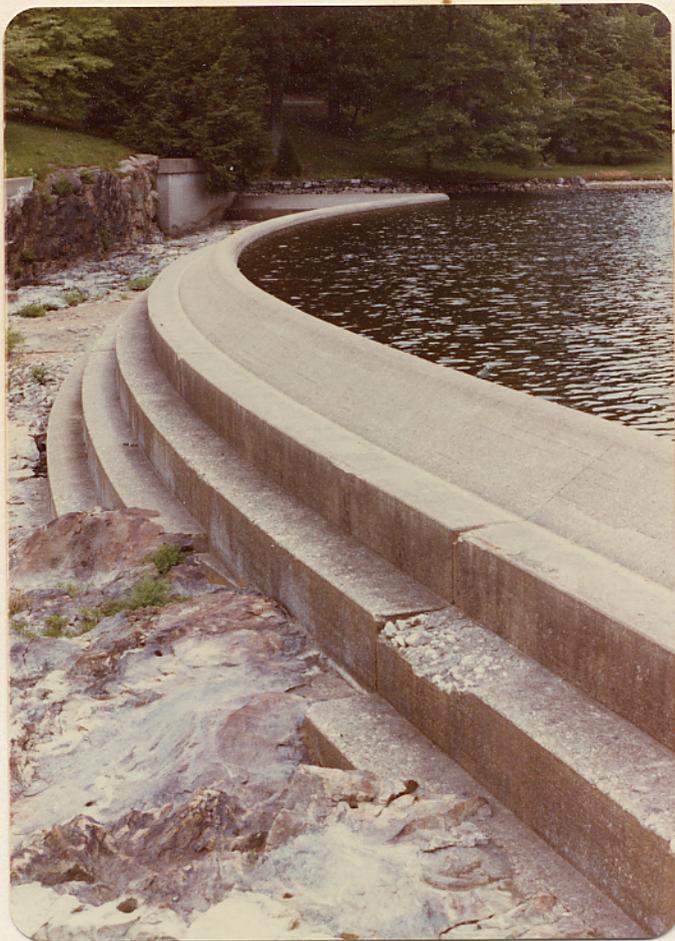
3) Spillway - The concrete in the spillway and steps was found to be in generally good condition. A crack was noted at the crest of the spillway, where it meets the training wall. Some surface spalling of the concrete steps was observed.

PHOTO #5: View of the spillway, looking west.

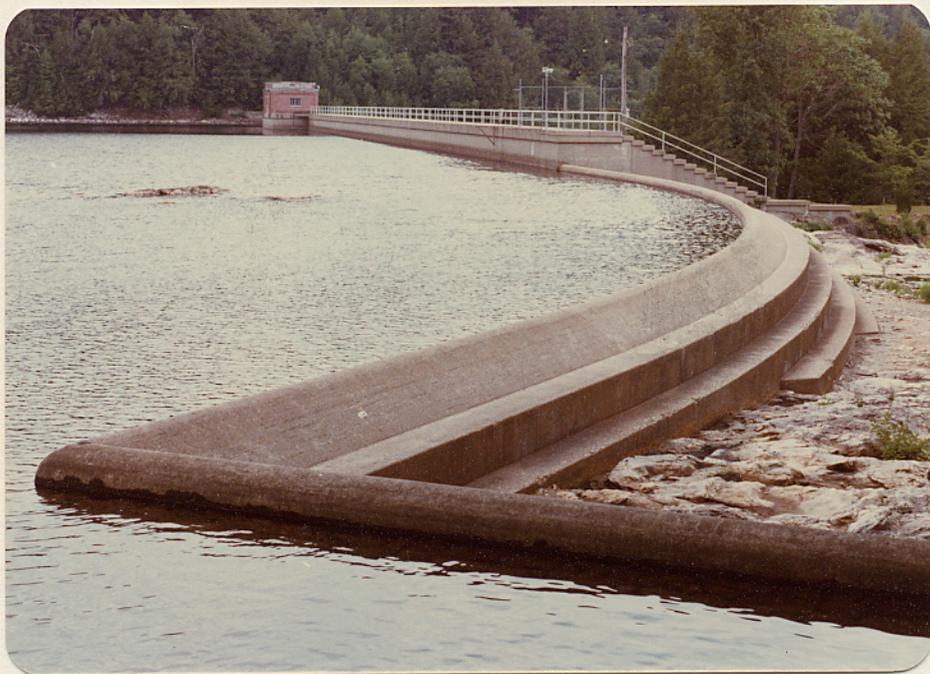
PHOTO #6: View of the spillway and dam, looking east from west abutment.

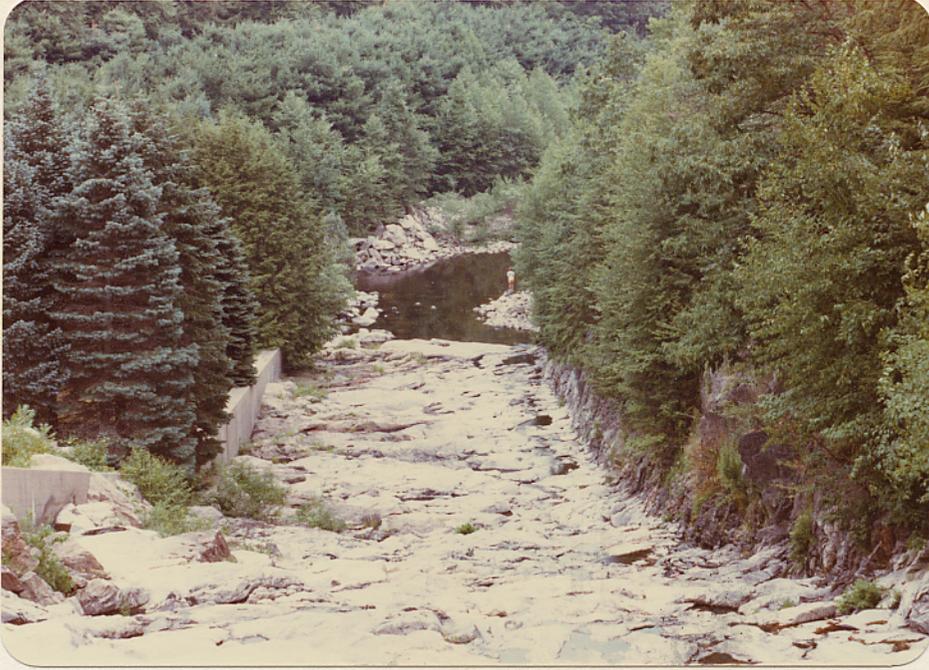
PHOTO #7: The spillway discharge channel, looking down at the natural river in the background.

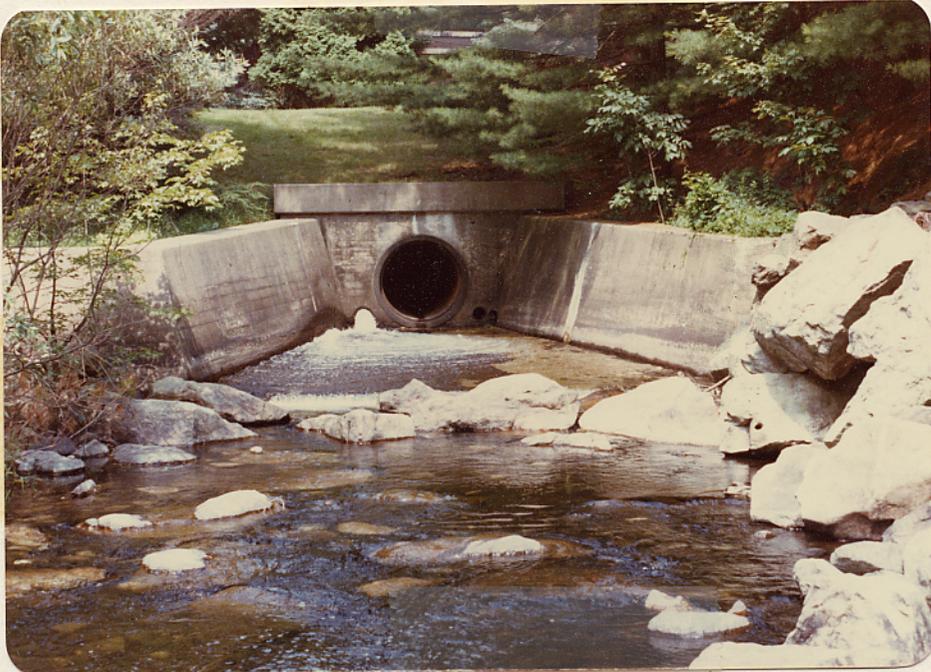
1) Spillway Channel - The spillway channel is in good condition. Low concrete walls on the right and left side of the channel are also in good condition. Layered mica gneiss bedrock is exposed in the bottom of the spillway channel from the spillway weir to the large pool at the end of the left concrete training wall. A small amount of seepage was noted in the channel floor. A rock fall has occurred in the upper part of the channel from its east bank, however, it does not restrict flow. The blow-off discharge structure is in excellent condition.

PHOTO #8: Blow-off discharge point, showing the wingwalls and riprap.

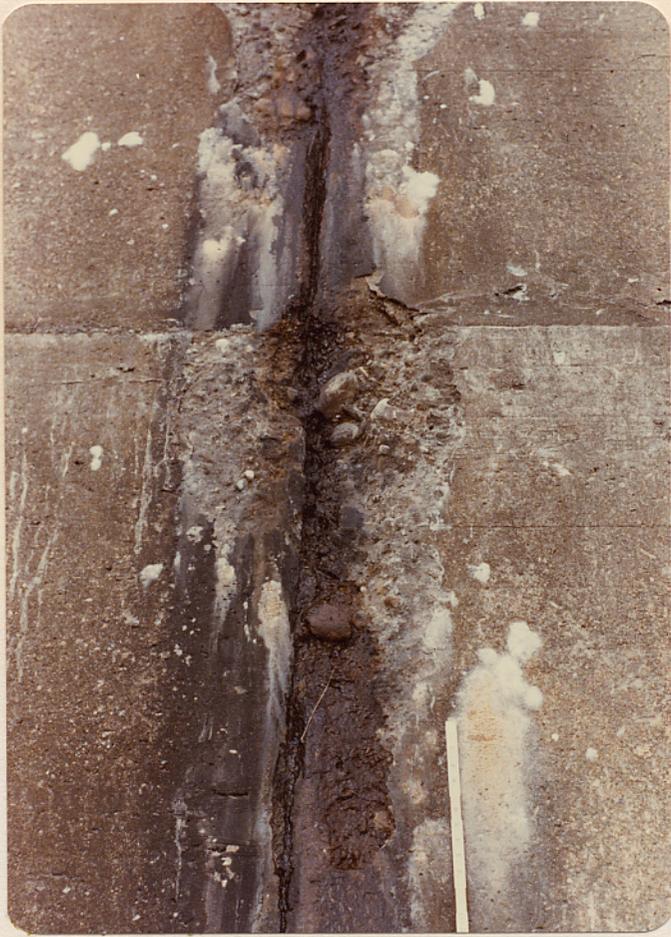
2) Downstream Face - There was evidence of wet spots, staining, efflorescence and joint spalling at nearly every construction joint. From Station 1+90 to Station 2+30 about 30 feet above the berm there was a horizontal line of efflorescence at a horizontal pour joint. In the panel between Station 3+45 to 3+85, about 10 feet up from the top of the berm, there are four drilled holes about 2 inches in diameter, depth undetermined, spaced 3 to 4 feet apart horizontally, which were dry but showed evidence of efflorescence (the purpose of these holes is unknown). There was quite a bit of spalling below the holes and some slight spalling above them. The joint at Station 3+85 was wet and stained from about the berm to a height of 35 feet. For about 20 feet from the top of berm, the joint was badly spalled and quite deteriorated.

PHOTO #9: Typical spalling at a construction joint.

1) Spalling at joints along the downstream face should be repaired.

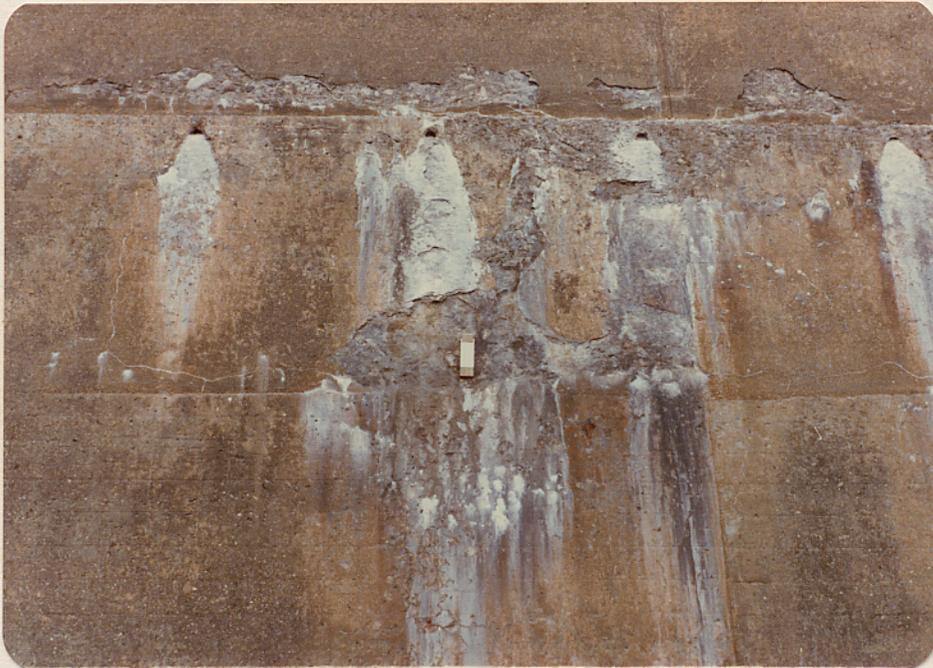
PHOTO #10: Holes cored in concrete dam—purpose unknown.

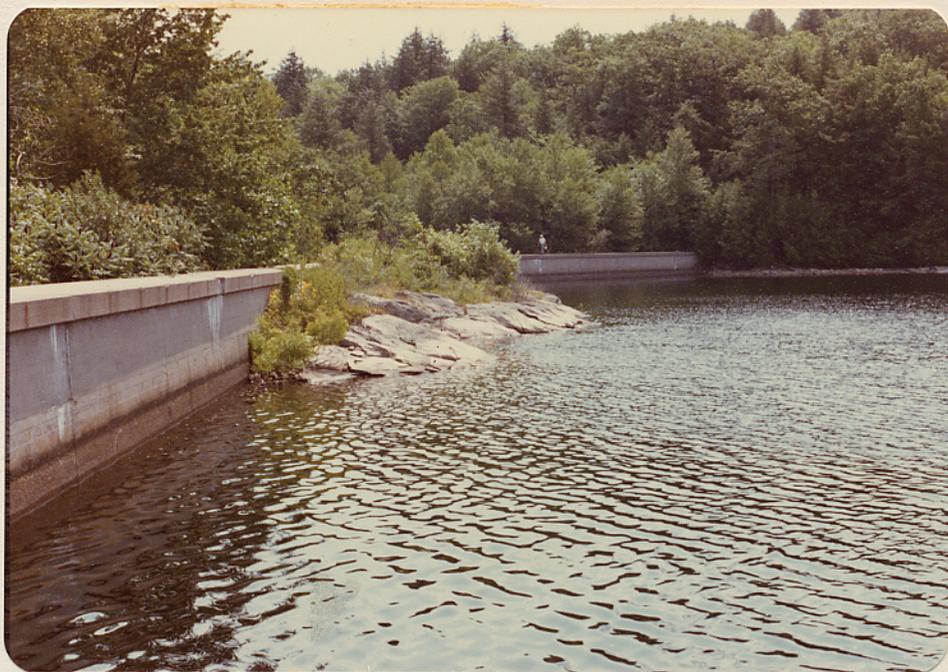
PHOTO #11: View looking south along the concrete dike.

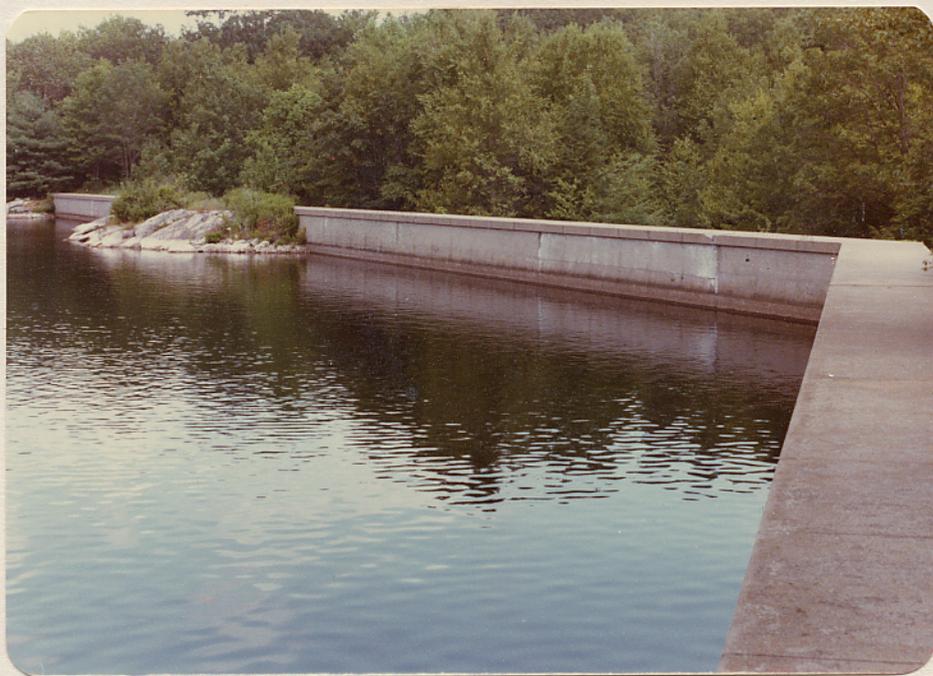
PHOTO #12: View looking north along the concrete dike.

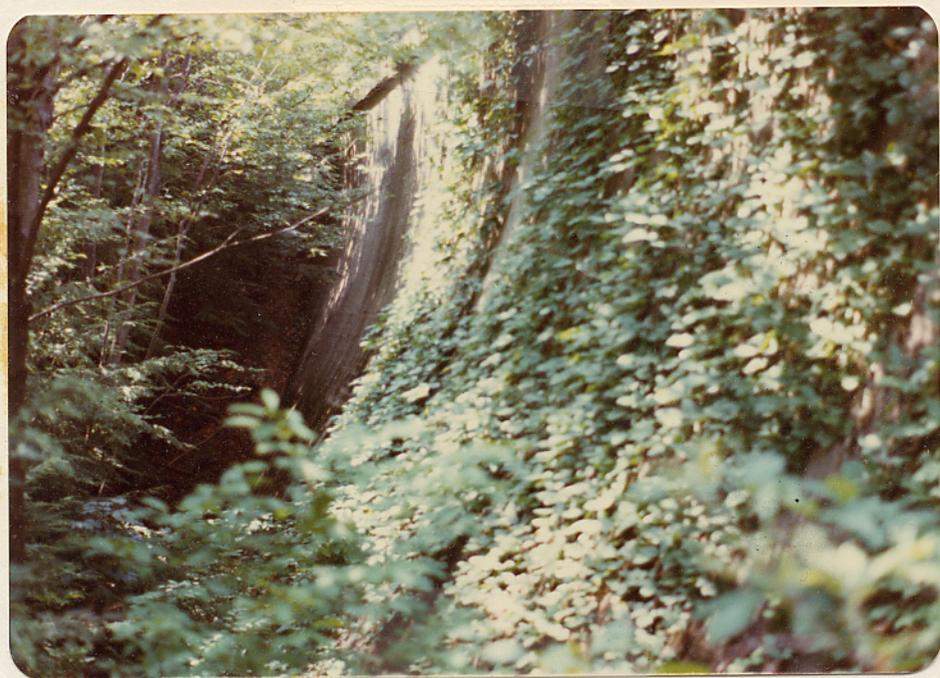
b. Dike. Visual observations indicated that the dike was in good condition. Although spalling has occurred at several joints, this does not affect the stability of the dike.

PHOTO #13: Downstream face of the concrete dike.
