QUINNIPIAC RIVER BASIN
HAMDEN, CONNECTICUT

**LAKE WINTERGREEN DAM
CT 00118**

**PHASE I INSPECTION REPORT
NATIONAL DAM INSPECTION PROGRAM**

AUGUST 1978

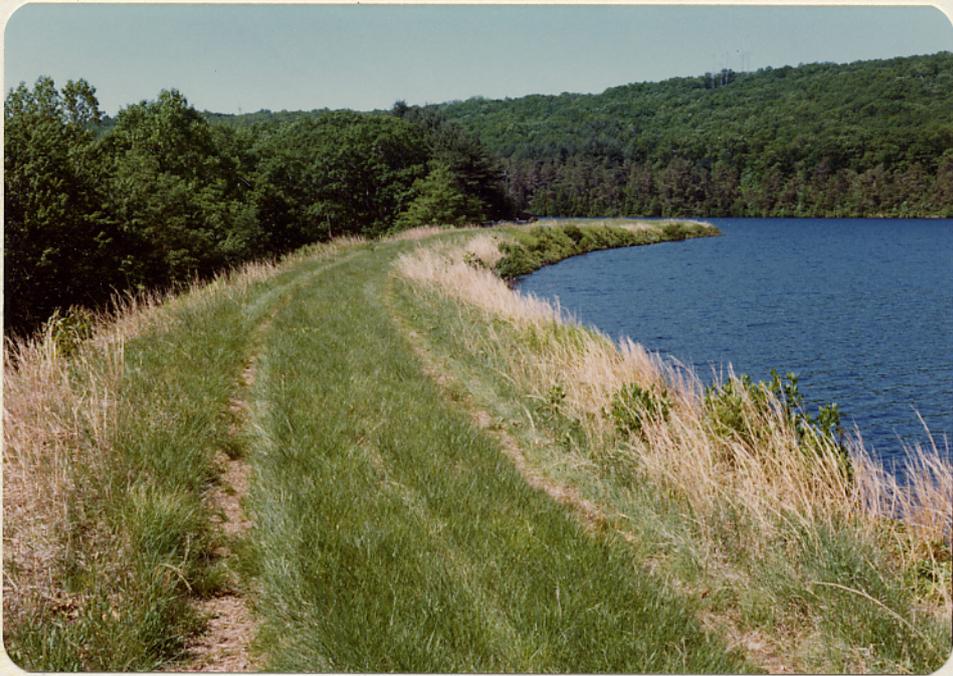
PHOTO NO.1 - General view of crest of dam taken from left end.

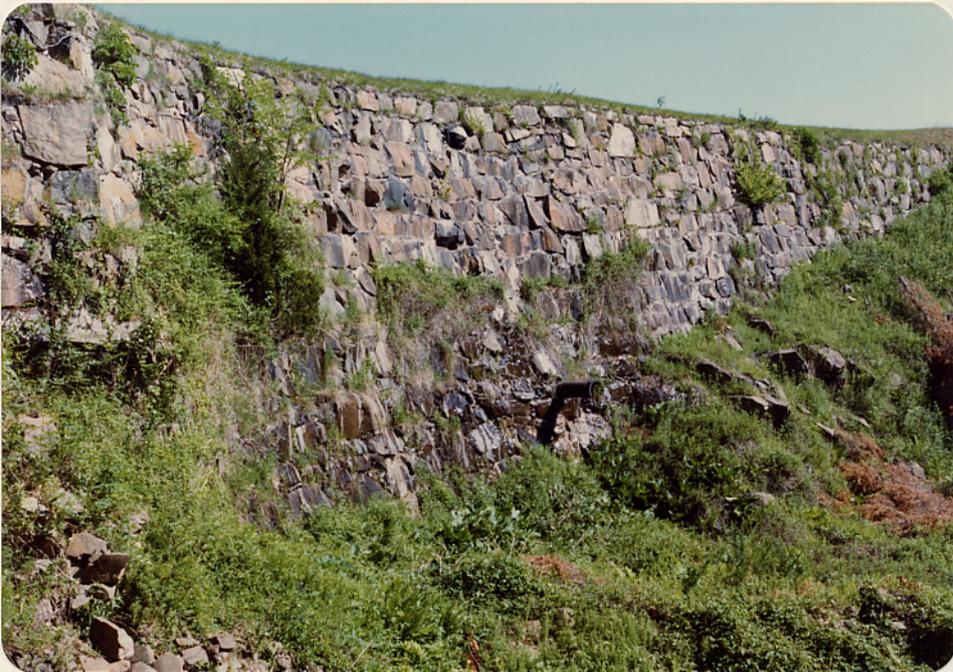
Masonry Wall Section - The wall is very irregular and thus visual inspection would not detect any misalignment or movements of the wall. There are some bushes growing on the wall which can accelerate deterioration of the wall. There are several seeps through the wall, one of which comes from under the inoperative 12" low level outlet. The water is clear and does not produce significant staining of the wall.

PHOTO NO.2 - General view of masonry retaining wall. Note brush growing from face of wall and 12 inch outlet exiting from lower face.

1. The bushes growing in the downstream face of the stone wall should be removed and measures taken to discourage future growth, thus reducing further deterioration of the masonry.

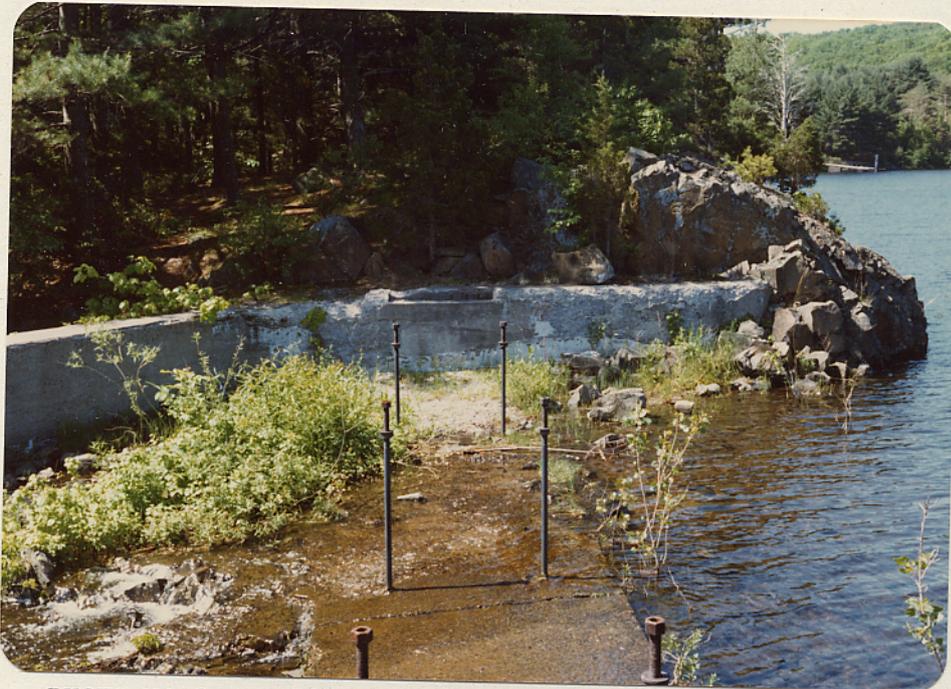
c. Appurtenant Structures - The spillway and its downstream channel are excavated in bedrock. The concrete weir and wingwalls have deteriorated and in general appear to be only in fair condition. Six metal rods protrude approximately 4 feet up from the center of the concrete spillway crest. The channel is very steep (maximum 1.5H to 1V inclination), and has a very irregular bottom. There are no obstructions to the flow of water in the channel. The high level intake approximately 900+ feet to the right of the dam is a 16 inch water supply line to the downstream chlorination station. The low level intake is a 12 inch cast iron pipe exiting from the masonry retaining wall at an elevation of approximately 221.6.

PHOTO NO.3 - Spillway crest and right abutment.

5. Required remedial measures should be carried out for the repair of the concrete spillway and abutment walls which have deteriorated due to concrete spalling.

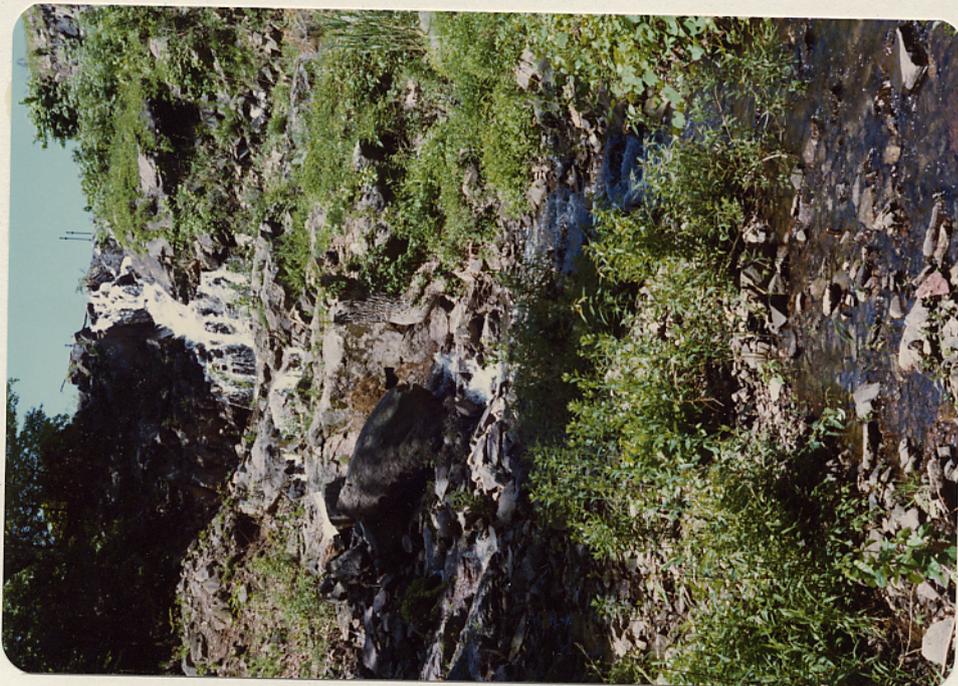
PHOTO NO.4 - Natural rock spillway channel.
Note metal rods indicating spillway location.

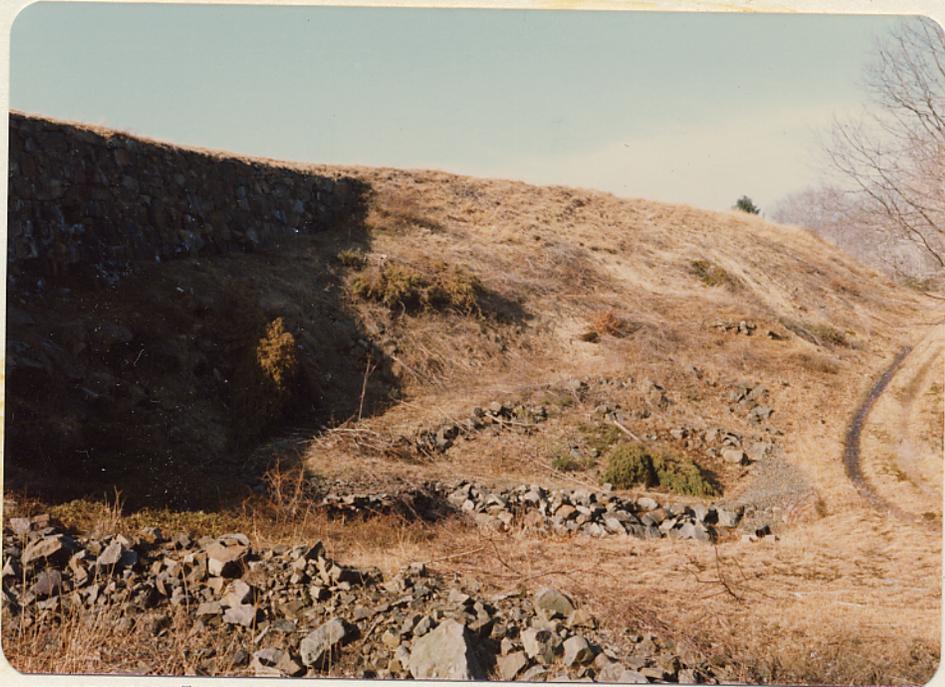
PHOTO NO.5 - General view of earthen embankment to left of masonry wall. Note toe drain outlet and stone in lower right corner of picture. (Below)

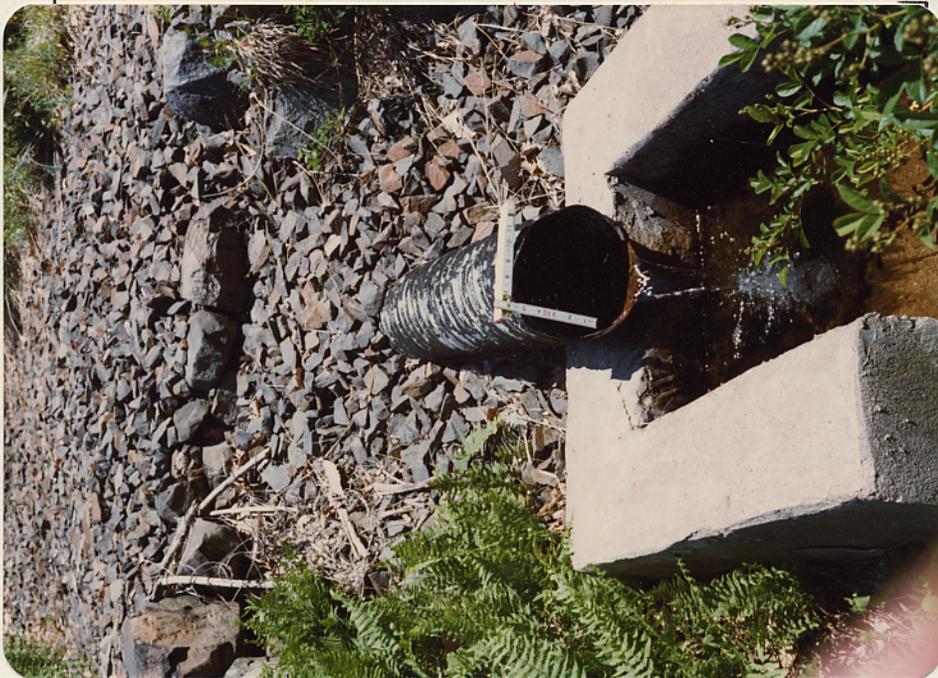
PHOTO NO.6 - Close up view of toe drain outlet pipe and structure.

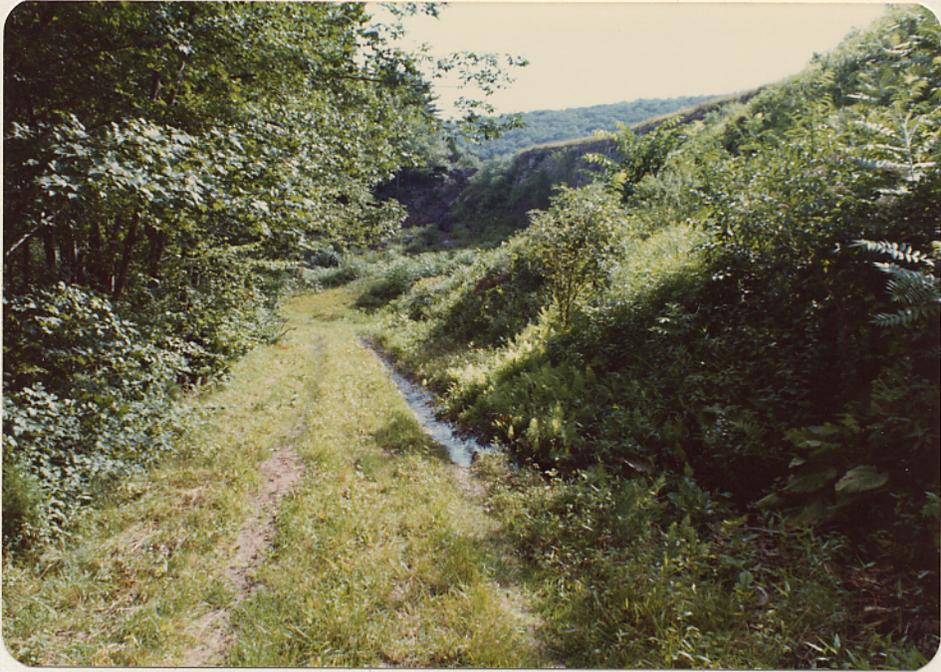
PHOTO NO.7 - General view of seepage flowing in dirt road at left end of dam.

Studies should also be performed to determine whether seepage through the earthen embankment is of a high enough volume and serious enough nature to warrant the installation of drains at the toe of the downstream face of the embankment. To facilitate this determination, vegetation should be removed from the downstream face of the dam. Monitoring of the various seeps should be instituted to determine the quantity and turbidity of the seeps, and to guard against any substantial increases in the quantity and turbidity of the seeps going unnoticed.

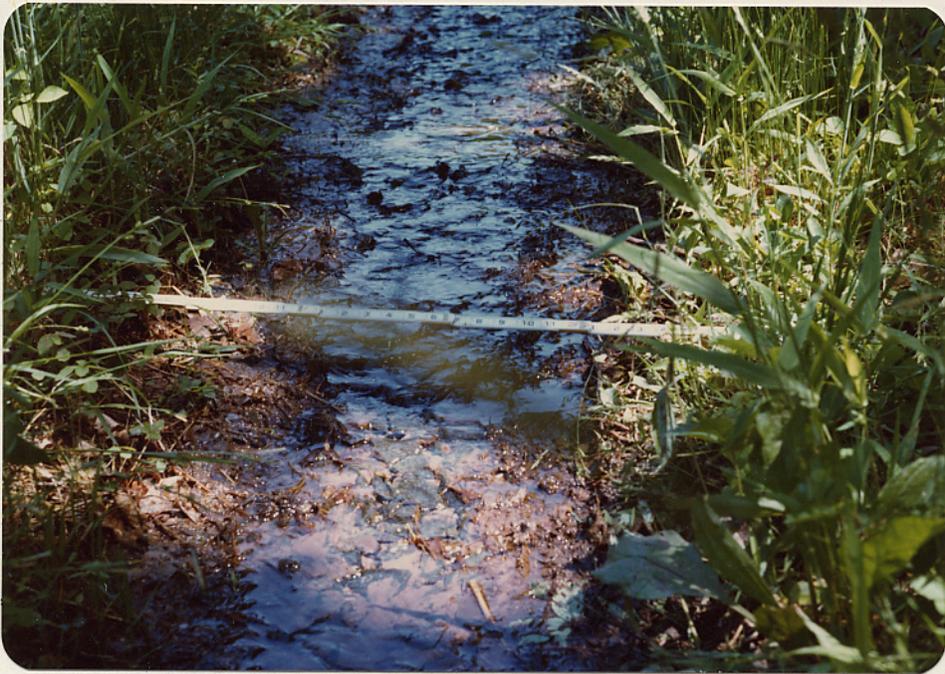
PHOTO NO.8 - Closeup of seepage flowing in dirt road.
