**SHELTON RES. NO. 2 DAM
CT 00093**

**PHASE I INSPECTION REPORT
NATIONAL DAM INSPECTION PROGRAM**

SEPTEMBER 1980

Identification Number:	CT 00093
Name:	Shelton Reservoir No. 2 Dam
Town:	Shelton
County and State:	Fairfield County, Connecticut
Stream:	Curtiss Brook
Date of Inspection:	June 10, 1980

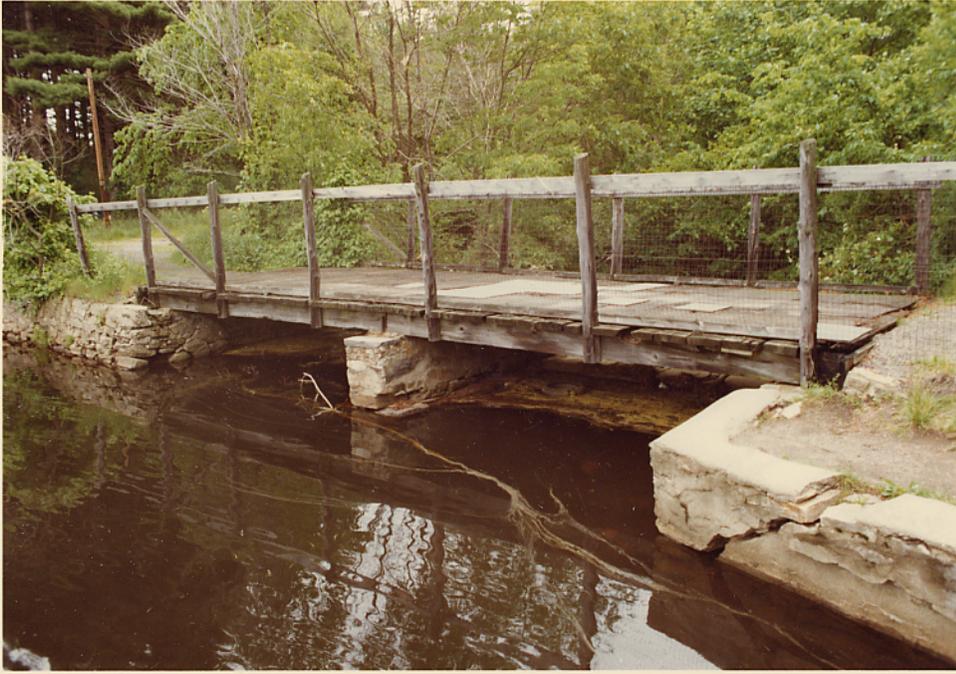
The upstream face of the dam has a stone masonry retaining wall that is in poor condition (Photos 1 and 2). The wall is cracked in many places and in some locations, it is overturning and falling into the water (Photo 1).

PHOTO 1
UPSTREAM FACE OF DAM

- a. Seepage through the dam and the spillway training walls should be investigated further to determine its origin and monitored to determine any changes.
- b. Cracking and movement of the upstream retaining wall should be investigated and means of repair established.
- c. Trees, including stumps and root systems, should be removed from the toe and embankment slopes and backfilled with proper material.

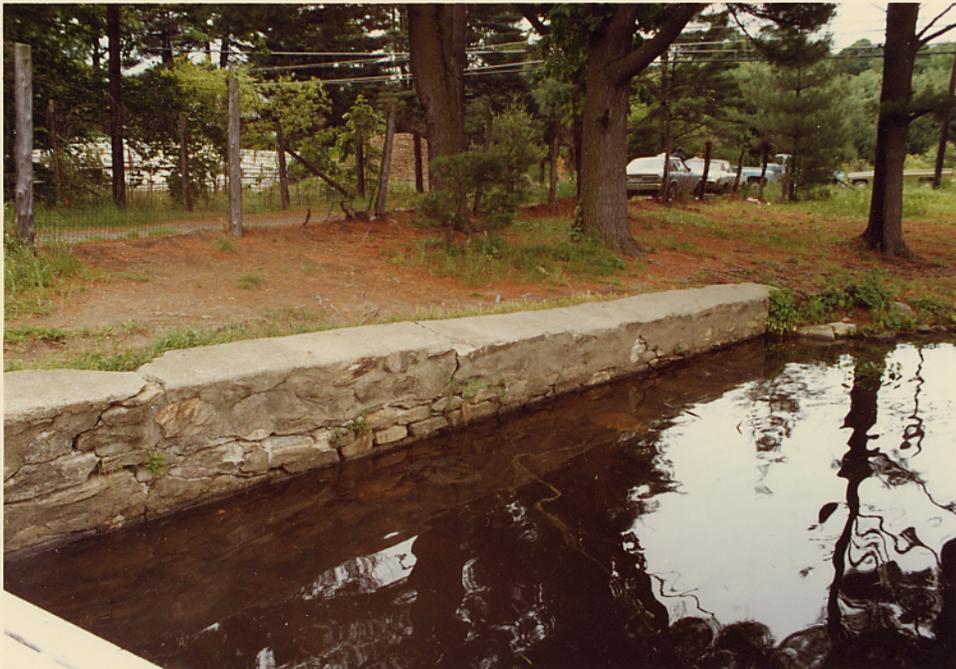
PHOTO 2
UPSTREAM FACE OF DAM

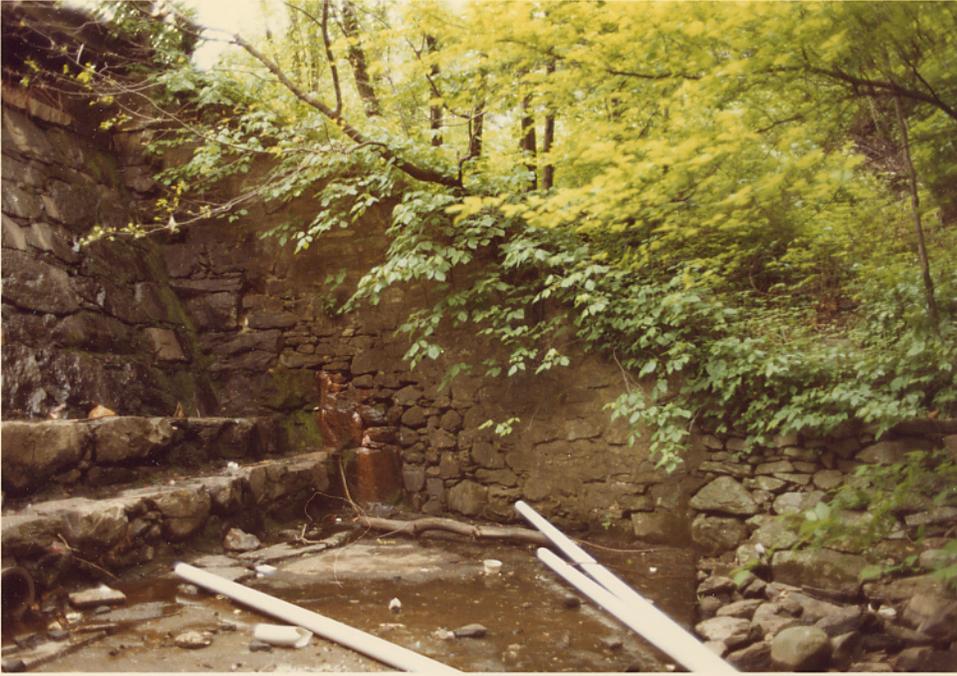
b. Dam - The dam is a stone masonry and earth embankment structure. A majority of the downstream face is stone masonry as shown in the overview photo. The earth embankments are heavily overgrown with trees and brush (Photos 1, 2, 3 and 4). There are several areas of seepage through the face of the dam (Photos 4, 6 and 7). The amount of water, however, was not measurable. The masonry of the downstream face of the dam just below the spillway was in poor condition with the joints in need of repair. Water was seeping out in some locations (Photos 3 and 4).

PHOTO 3
DOWNSTREAM FACE AND WEST ABUTMENT

- a. Operation and Maintenance Procedures -
 - (1) Remove all brush from the earth embankment, downstream face of the dam and within 20 feet of the toe of the dam.
 - (2) Clear the downstream channel and the spillway of debris.
 - (3) Repair the bridge over the spillway.
 - (4) Repair all joints and cracked and spalled concrete.
 - (5) Institute a program of annual technical inspection by a qualified Engineer.
 - (6) Develop plans for around-the-clock surveillance for periods of unusually heavy rains and institute a formal downstream warning system for use in the event of an emergency.

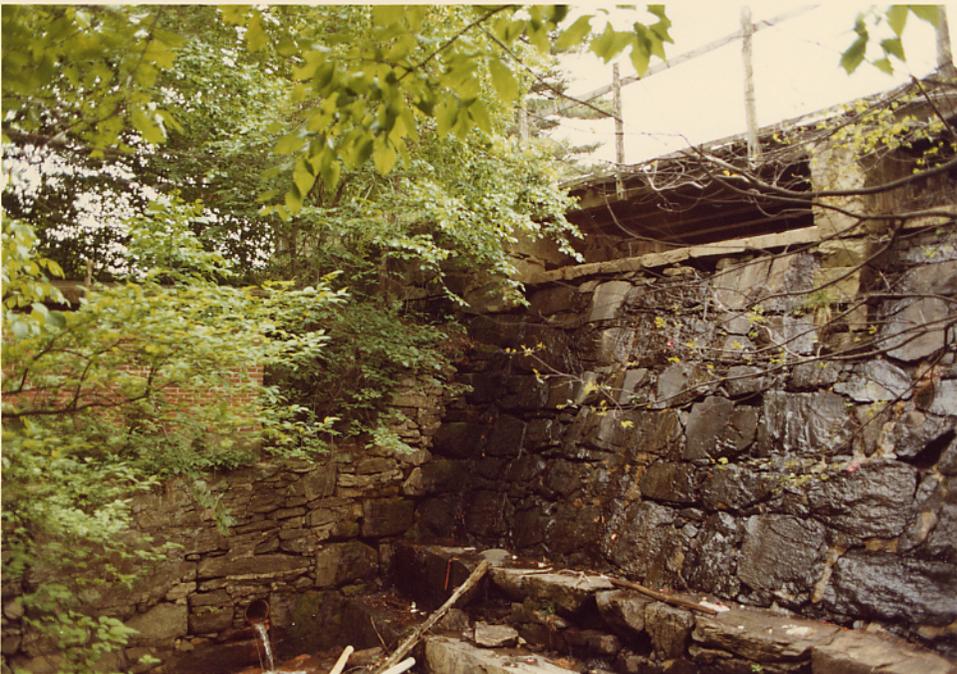
PHOTO 4
DOWNSTREAM FACE AND EAST ABUTMENT

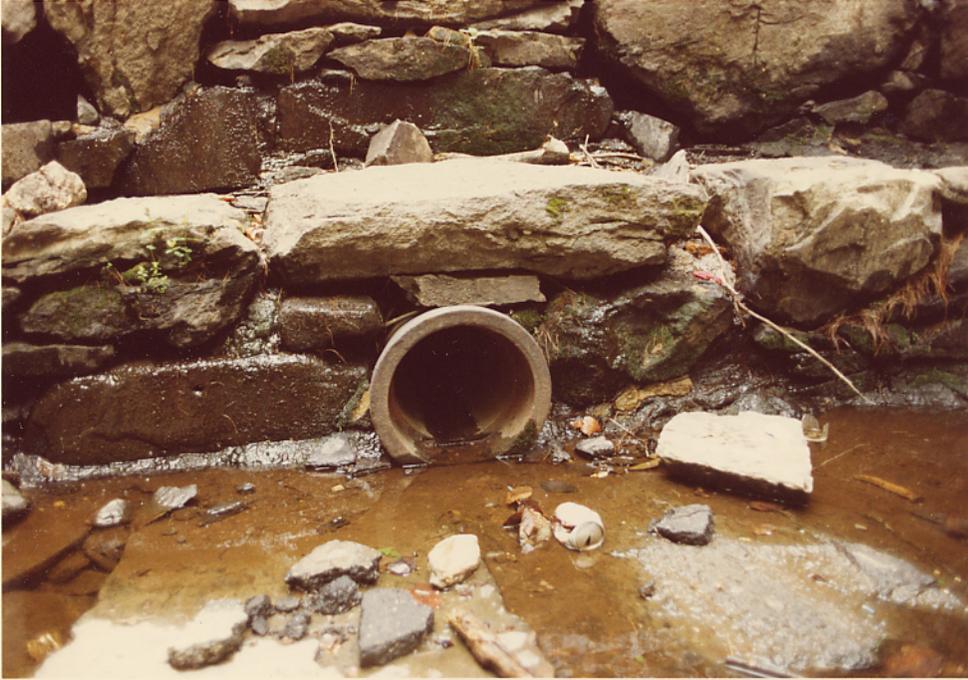
PHOTO 5

BLOWOFF

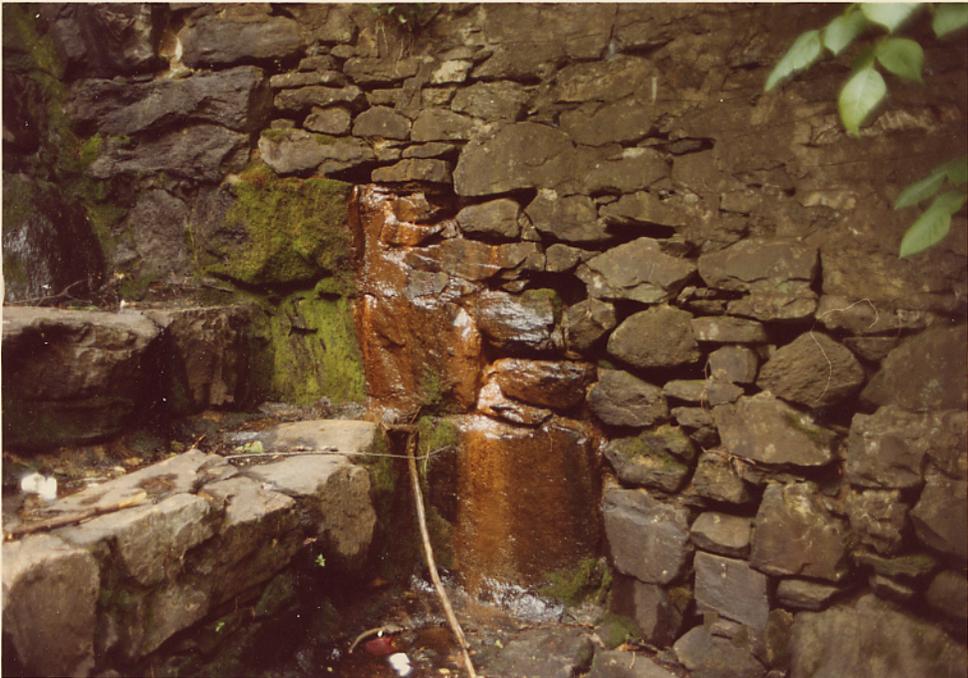
PHOTO 6

Both spillway training walls, like the rest of the stone masonry, were in need of repair. The north wall showed signs of seepage with some staining (Photo 6). The amount of water seeping, however, was negligible.

SEEPAGE - WEST ABUTMENT

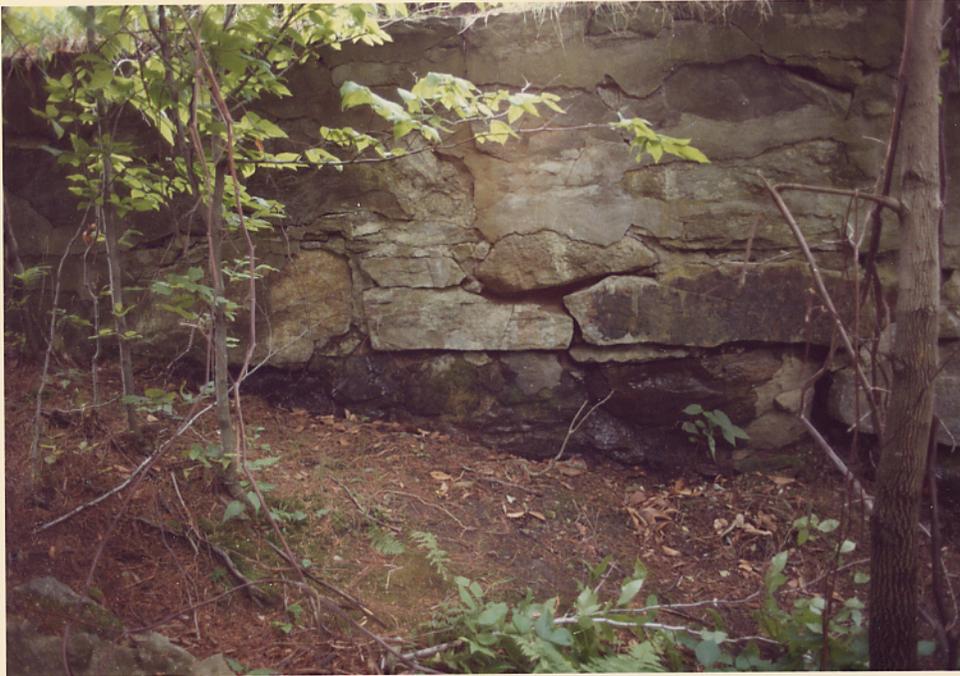
PHOTO 7
SEEPAGE - DOWNSTREAM FACE

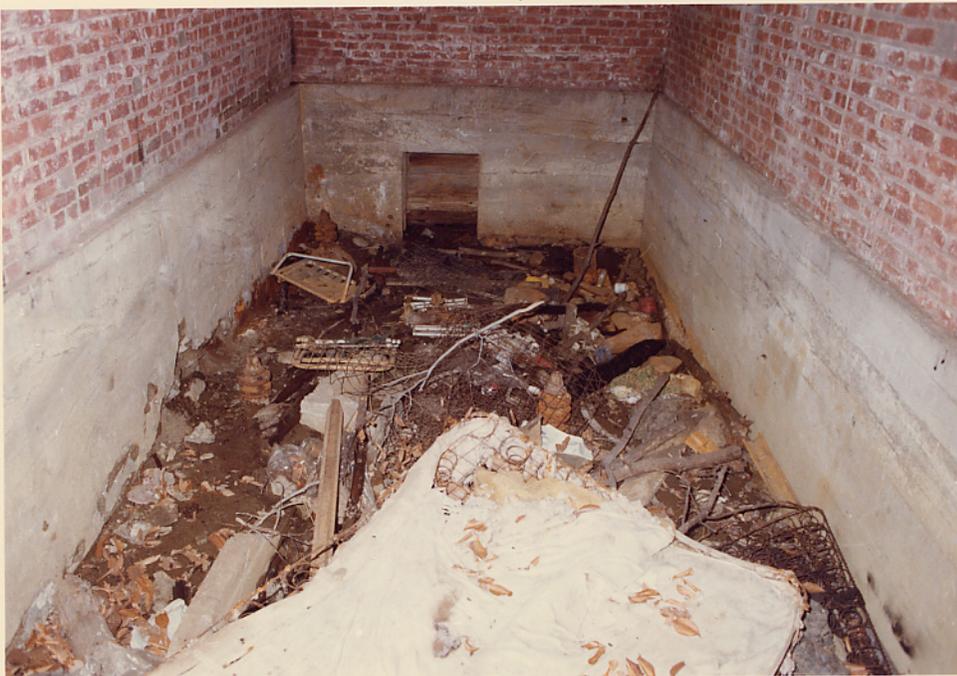
Both the upper and lower gate houses are in poor condition (Photos 8 and 9). The deck of the service bridge to the upper gate house is missing and the support beams are rusting away. The lower gate house is in better condition, however, trespassing is a problem. The water main that was controlled by the gates in the gate houses is not operable and is plugged.

PHOTO 8
INSIDE LOWER GATE HOUSE

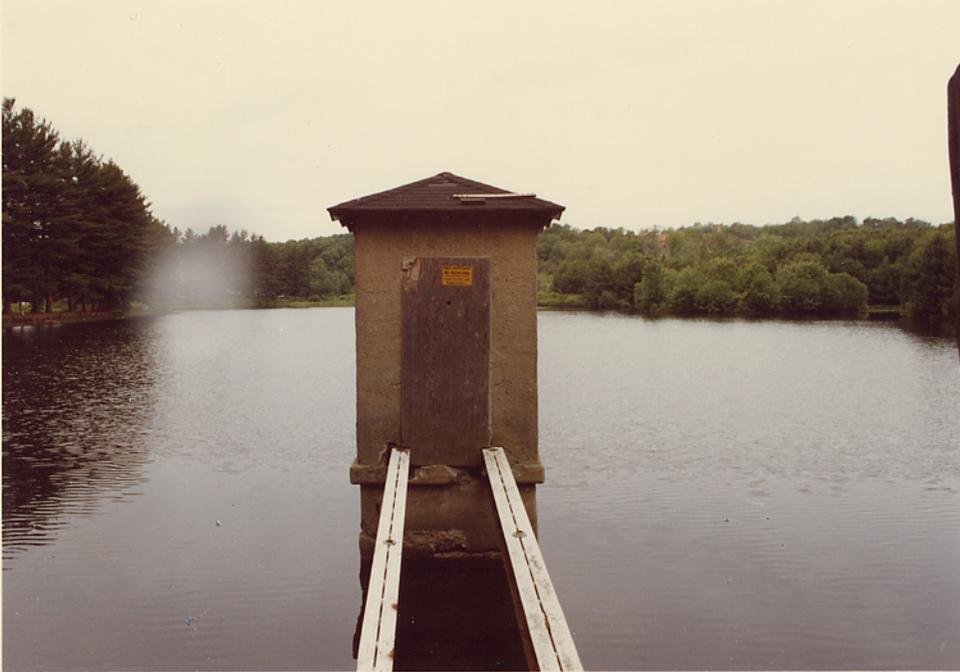
PHOTO 9
UPSTREAM GATE HOUSE

- d. The condition of the low level discharge pipe and valve should be evaluated and both pipe and valve be made operable.
- e. The bridge to the upper gate house should be repaired.
- f. Prepare a detailed hydraulic/hydrologic study to determine spillway adequacy and an increase of the total project discharge if necessary.

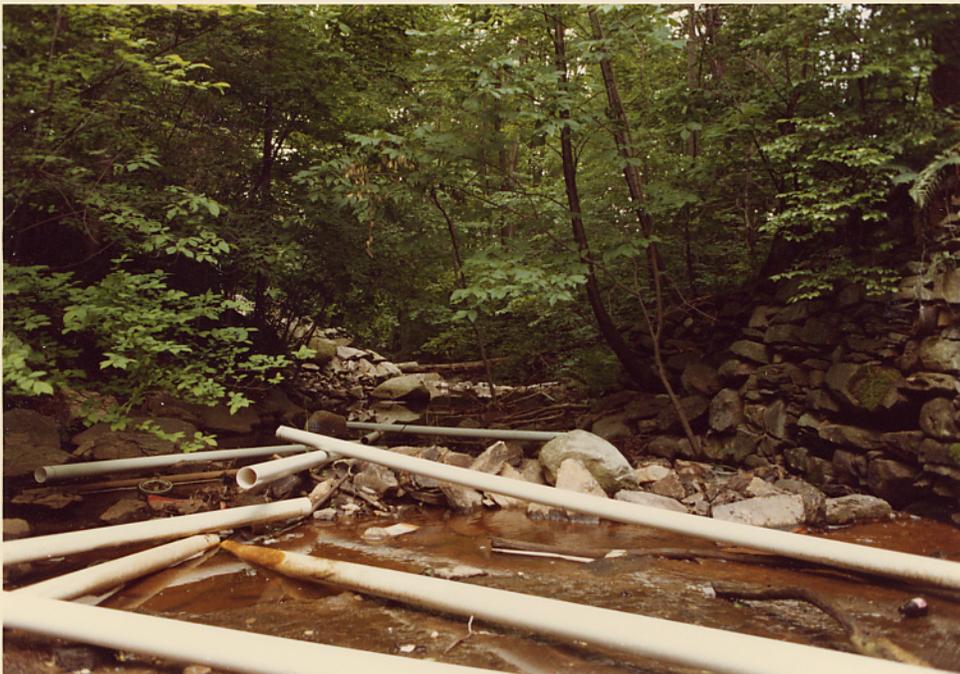
The channel approaching the spillway and the area under the bridge was cluttered with debris. The banks of the downstream channel were heavily overgrown. The channel was in a natural condition except for the debris thrown in from a local construction project.

PHOTO 10
DOWNSTREAM CHANNEL LOOKING DOWNSTREAM
