**NAUGATUCK RIVER BASIN
TORRINGTON - GOSHEN, CONNECTICUT**

**WHIST POND DAM
CT 00102**

**PHASE I INSPECTION REPORT
NATIONAL DAM INSPECTION PROGRAM**

DECEMBER 1980

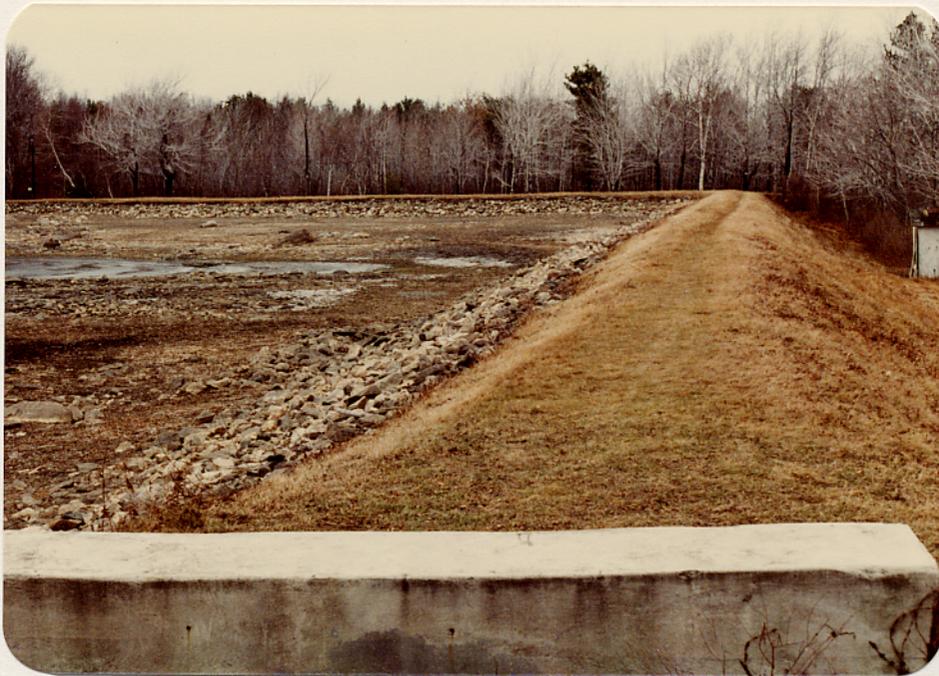
PHOTO NO. 1

The crest of the dam is generally level and covered with grass, Photos 1 and 4. There is a foot path at approximately the center line of the crest along the entire length of the dam. Tree roots were observed at several locations along the crest of the dam, Photo 5, and appear to originate from trees located downstream of the embankment, Photo 4.

The downstream slope of the dam is grass-covered, Photos 1 and 4. Several ruts due to mowing equipment were observed on the downstream slope.

VIEW OF DAM FROM
RIGHT END OF SPILLWAY

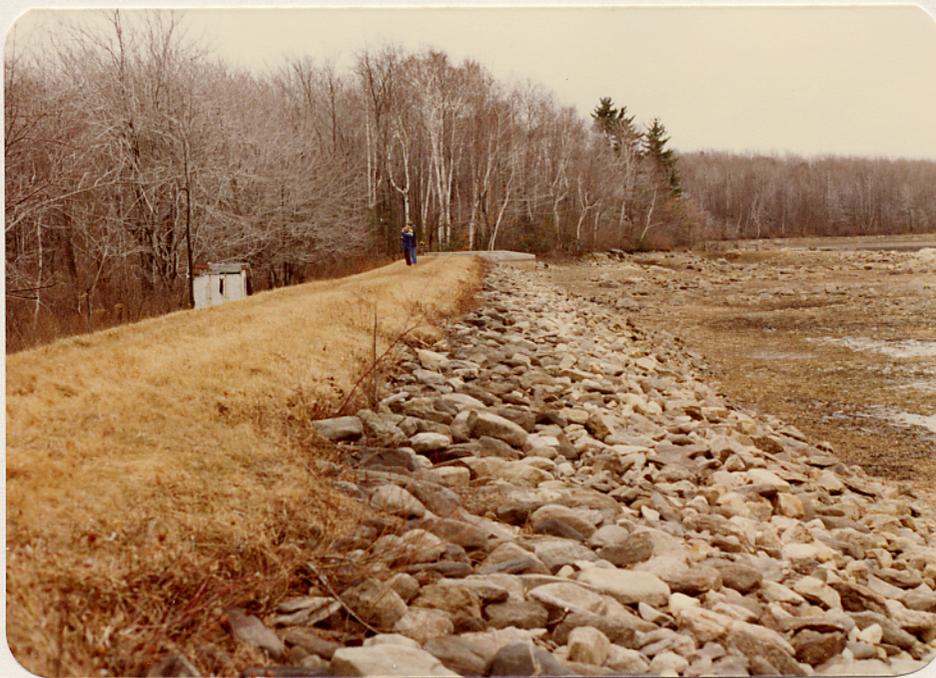
PHOTO NO. 2

RIPRAP ON UPSTREAM SLOPE

1. Investigate the slumping of the riprap slope protection, and design remedial measures as required.
2. Investigate the condition of the spillway weir and training walls, and design required repairs.
3. Clear trees from the area downstream of the dam to within 20 feet of the toe.
4. Design an upstream gate for the low level diversion outlet in order to relieve full reservoir water pressure in the pipe under the dam.
5. Inspect the dam for seepage when the impoundment is full.
6. Investigate freeboard requirements for the dam.

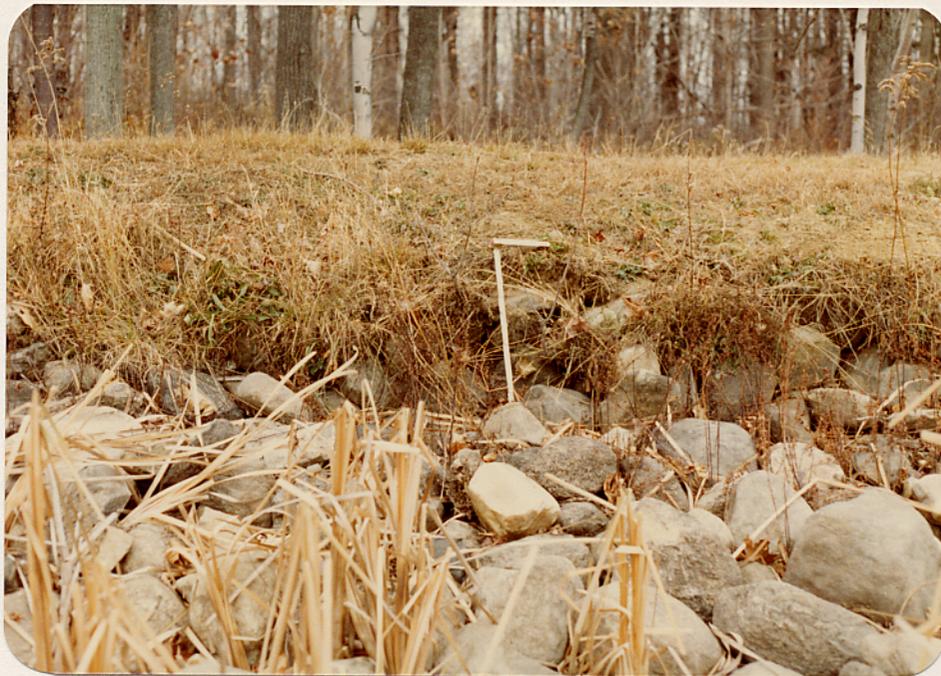
PHOTO NO. 3

1. Slumping of the riprap could cause further erosion of the crest resulting in a breach of the dam.
2. Roots through the embankment could provide seepage paths for internal erosion.
3. Continued deterioration of the spillway weir and training walls could lead to failure of the spillway.
4. The lack of a defined spillway discharge channel could cause flooding and erosion of the downstream toe of the embankment.
5. The location of the low level diversion outlet valve at the downstream toe permits full water pressure to exist in the outlet pipe through the dam. In the event of a leak in the outlet pipe, seepage and high pore pressure near the downstream toe or base of the dam could cause sliding failure or piping failure of the embankment.

SLUMPING RIPRAP. RULE EXTENDED 18 INCHES.
NOTE TREES DOWNSTREAM.

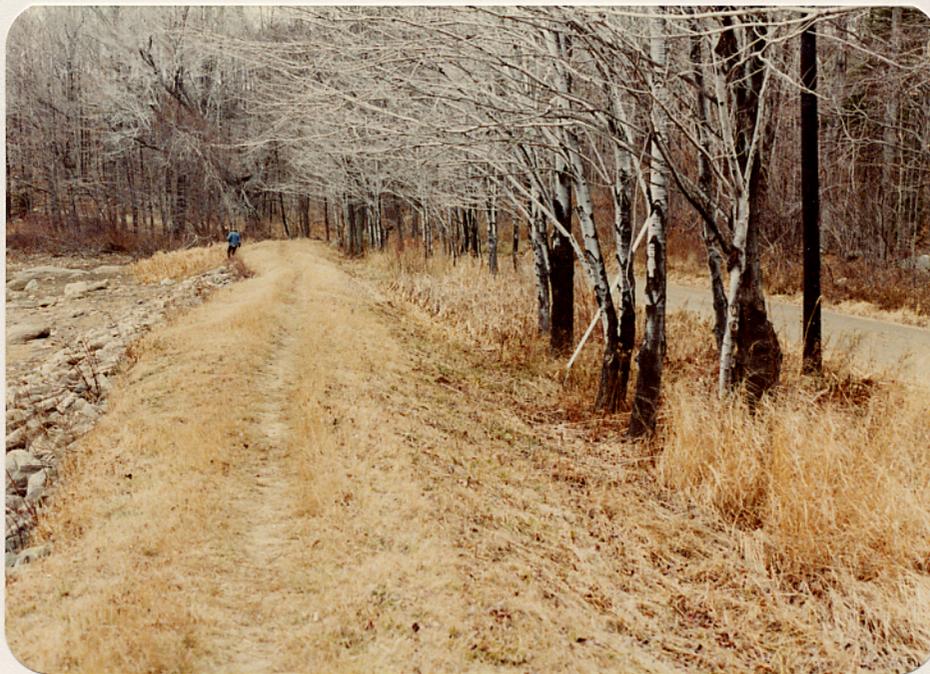
PHOTO NO. 4

LEFT SECTION OF DAM. NOTE SLUMPING
RIPRAP CUTTING INTO CREST.

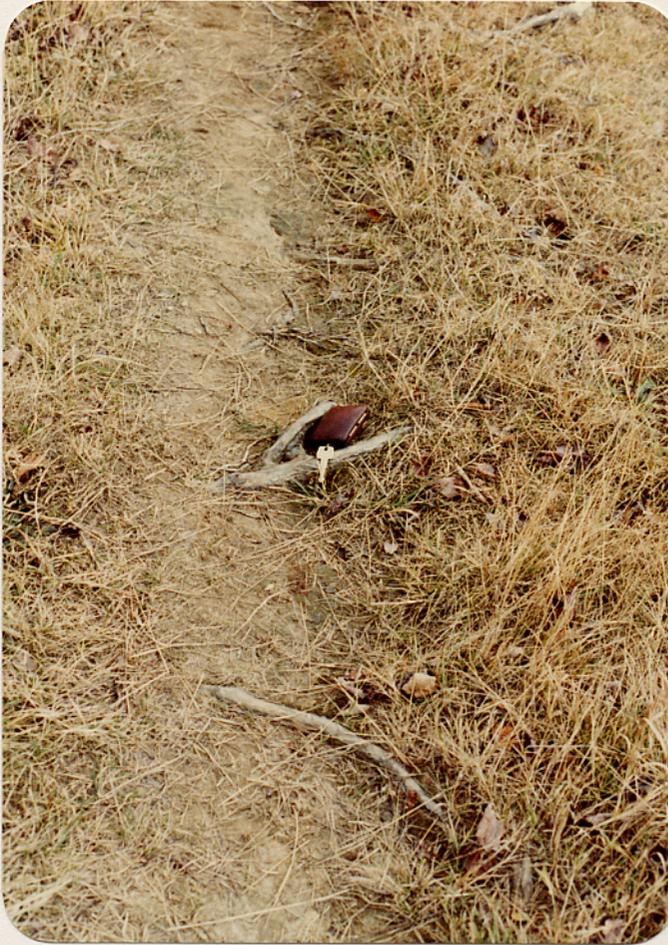
PHOTO NO. 5

ROOTS AT CREST
OF EMBANKMENT.

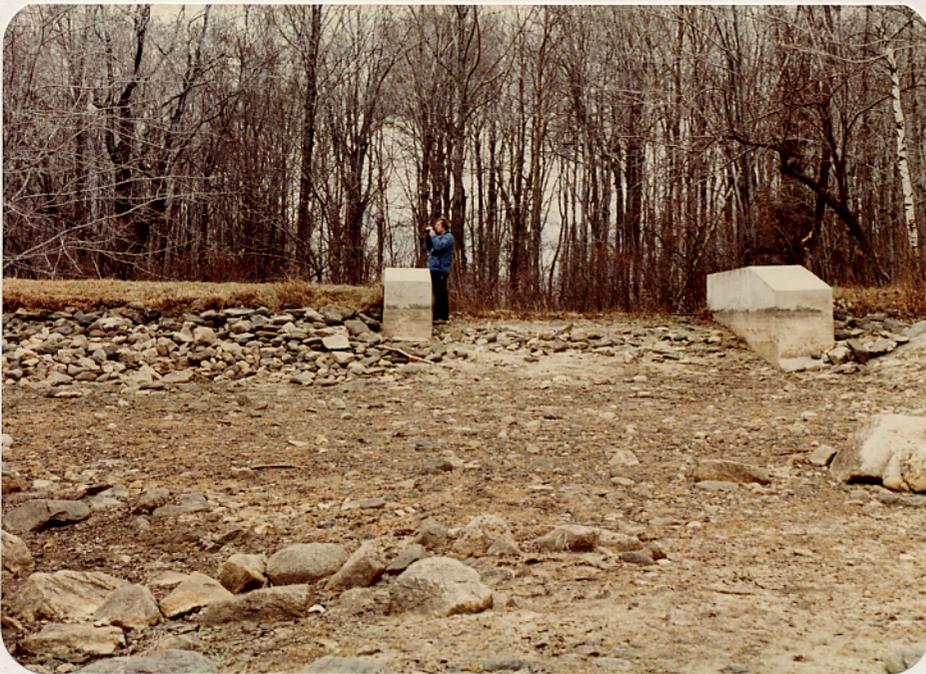
PHOTO NO. 6

The overflow spillway consists of a stone masonry weir with concrete training walls upstream and stone masonry training walls downstream, Photos 6 and 7. The right training wall is cracked and displaced approximately 5/8 inch at the top of the wall, Photo 8. The left concrete training wall appeared to be in good condition. The concrete training walls appeared to have been poured over existing stone masonry training walls. The downstream stone masonry training walls show some signs of deterioration, Photo 7.

SPILLWAY FROM
UPSTREAM.

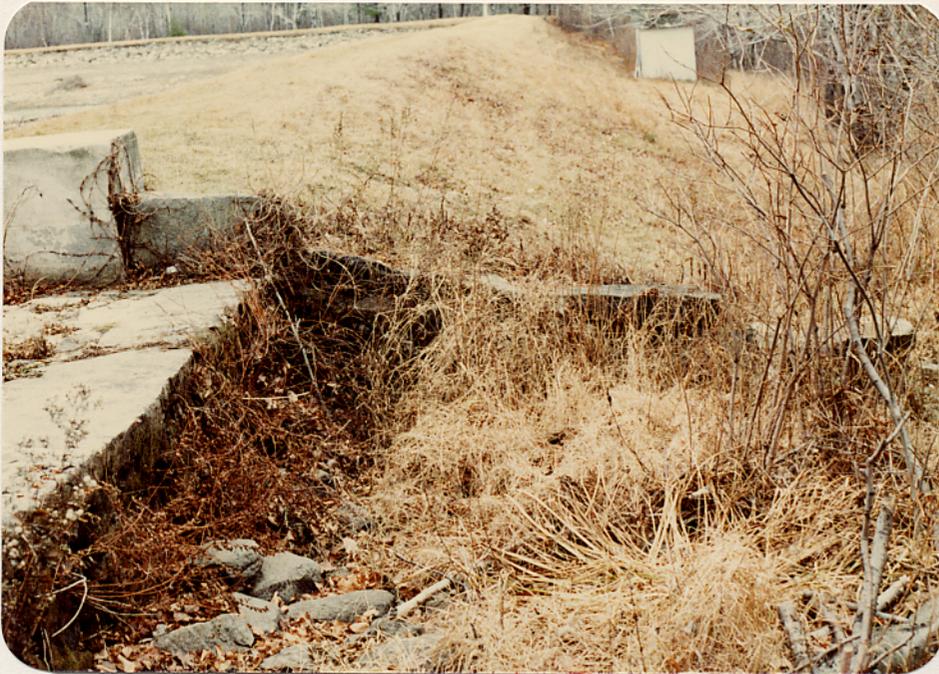
PHOTO NO. 7

C. <u>DISCHARGE CHANNEL:</u>	
<u>GENERAL CONDITION</u>	Overgrown, not very well-defined.
<u>LOOSE ROCK OVERHANGING CHANNEL:</u>	None observed
<u>TREES OVERHANGING CHANNEL:</u>	Brush and small trees in channel
<u>FLOOR OF CHANNEL:</u>	Cobbles and Gravel
<u>OTHER OBSTRUCTIONS</u>

SPILLWAY WEIR AND
DOWNSTREAM TRAINING
WALL. NOTE BRUSH
IN SPILLWAY
DISCHARGE CHANNEL.

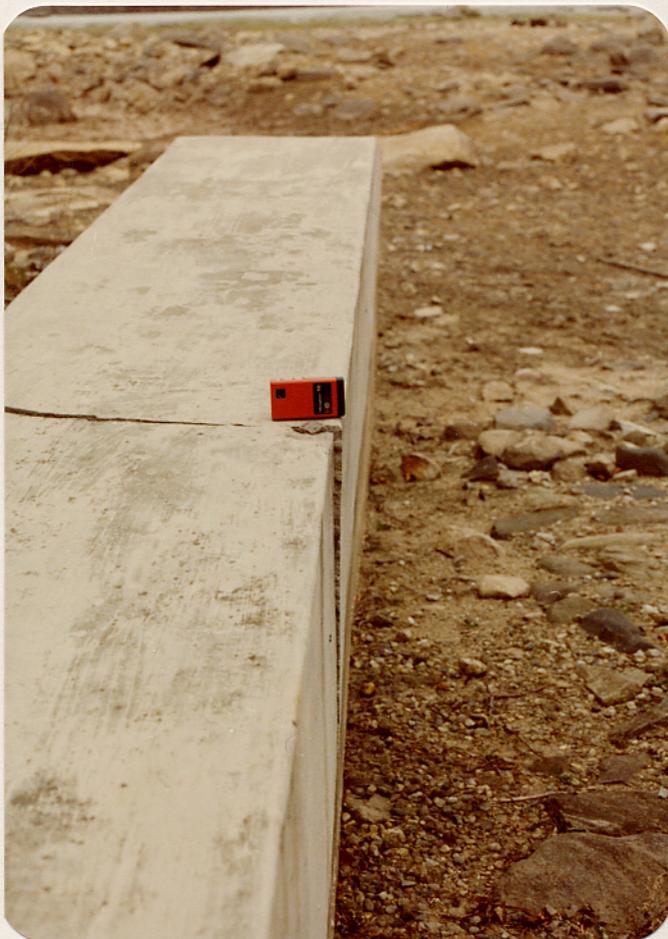
PHOTO NO. 8

B. <u>WEIR AND TRAINING WALLS:</u>	Weir stone masonry; training walls concrete upstream, stone masonry downstream.
<u>GENERAL CONDITION OF CONCRETE</u>	Right training wall cracked and displaced 5/8" at top. Downstream walls and weir need work - deteriorated.
<u>RUST OR STAINING</u>	N/A
<u>SPALLING</u>	None observed
<u>ANY VISIBLE REINFORCING</u>	None observed
<u>ANY SEEPAGE OR EFFLORESCENCE</u>	No seepage. Water level below spillway.
<u>DRAIN HOLES</u>	None

CONCRETE TRAINING WALL.
NOTE CRACK AND 5/8 INCH
DISPLACEMENT AT TOP
OF WALL.

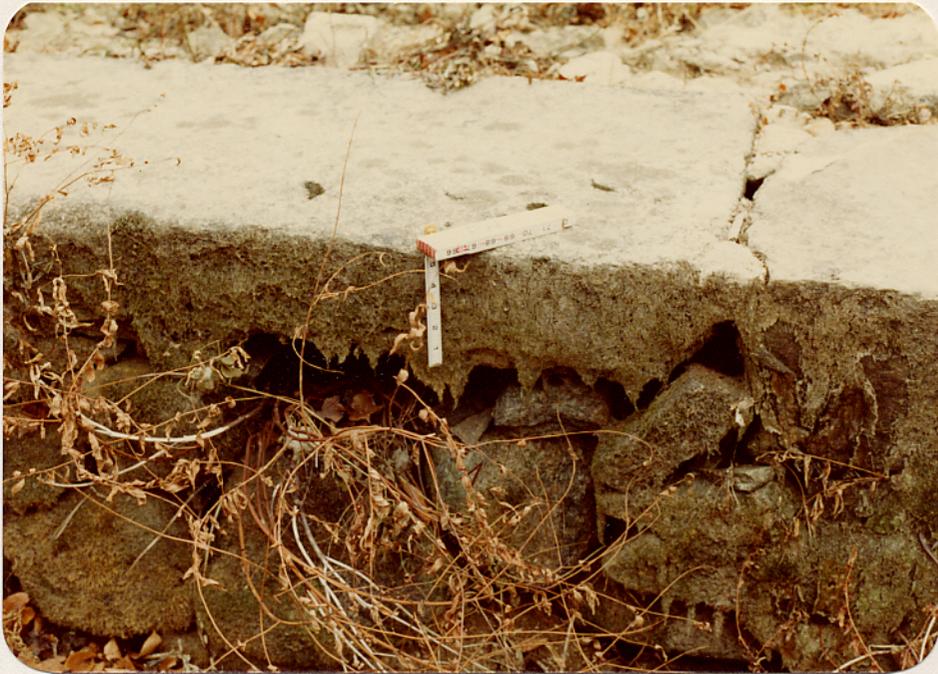
PHOTO NO. 9

STONE MASONRY
WEIR. NOTE VOIDS
UNDER CAPSTONES.

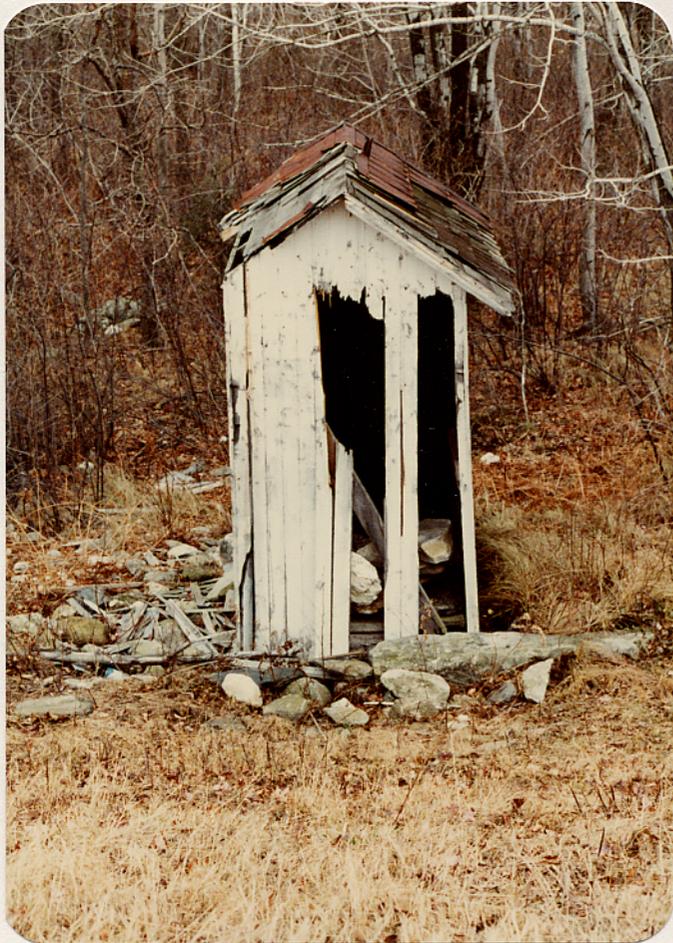
PHOTO NO. 10

AREA EVALUATED	CONDITIONS
<u>OUTLET WORKS - CONTROL TOWER</u>	No control tower - gate housed in shed at toe of downstream slope
A. <u>CONCRETE AND STRUCTURAL:</u>	
<u>GENERAL CONDITION</u>	Poor
<u>CONDITION OF JOINTS</u>	N/A
<u>SPALLING</u>	N/A
<u>VISIBLE REINFORCING</u>	N/A
<u>RUSTING OR STAINING OF CONCRETE</u>	N/A
<u>ANY SEEPAGE OR EFFLORESCENCE</u>	N/A
<u>JOINT ALIGNMENT</u>	N/A
<u>UNUSUAL SEEPAGE OR LEAKS IN GATE CHAMBER</u>	N/A
<u>CRACKS</u>	N/A
<u>RUSTING OR CORROSION OF STEEL</u>	N/A
B. <u>MECHANICAL AND ELECTRICAL:</u>	N/A
<u>AIR VENTS</u>	N/A
<u>FLOAT WELLS</u>	N/A
<u>CRANE HOIST</u>	N/A
<u>ELEVATOR</u>	N/A
<u>HYDRAULIC SYSTEM</u>	N/A
<u>SERVICE GATES</u>	Manually operated downstream gate reported to be operable.
<u>EMERGENCY GATES</u>	N/A
<u>LIGHTNING PROTECTION SYSTEM</u>	N/A
<u>EMERGENCY POWER SYSTEM</u>	N/A
<u>WIRING AND LIGHTING SYSTEM IN GATE CHAMBER</u>	N/A

VALVE SHED AT
DOWNSTREAM TOE.

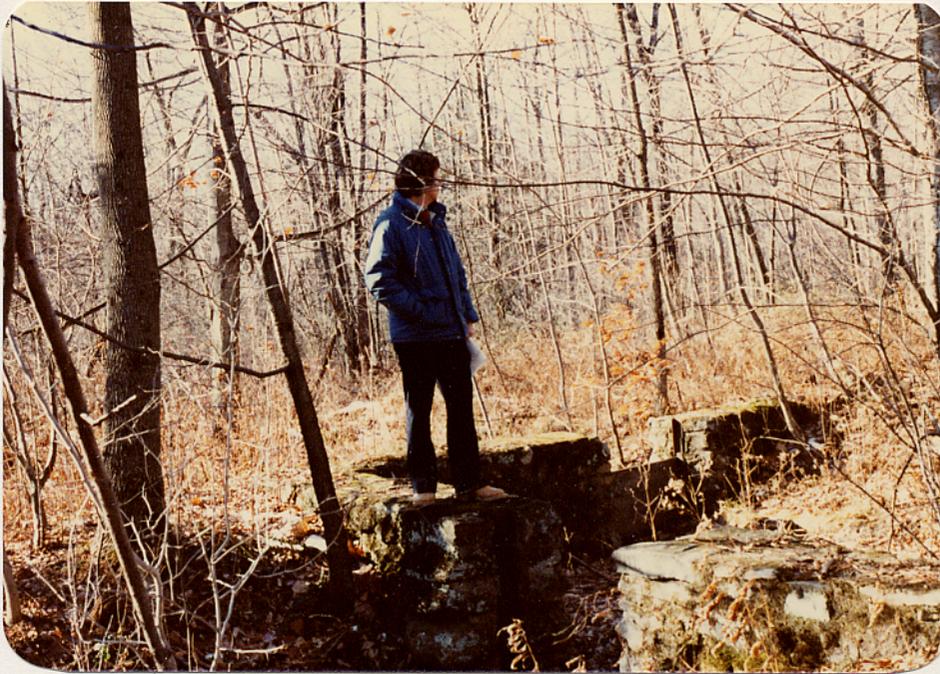
PHOTO NO. 11

DIVERSION STRUCTURE. FLASHBOARDS IN BACKGROUND
 DIVERT WATER FROM NATURAL STREAM TO WHIST POND.

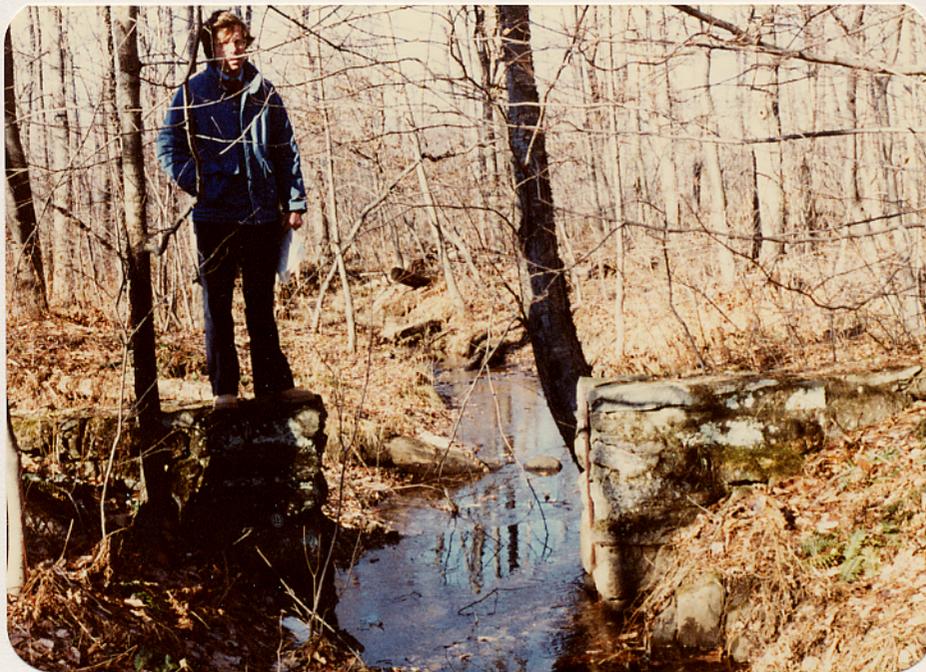
PHOTO NO. 12

DIVERSION STRUCTURE. LOOKING
 DOWN CHANNEL TOWARD WHIST POND.
