LAKE KONOMOC DAM

CT. 00152

PHASE I INSPECTION REPORT  
NATIONAL DAM INSPECTION PROGRAM

JUNE 1979

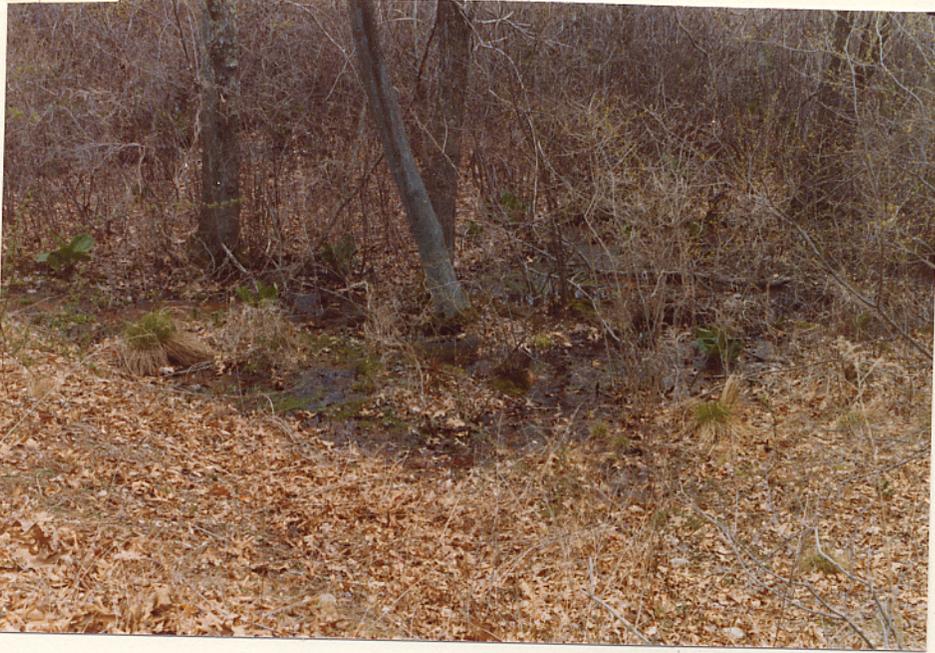
3. Seepage at downstream toe of left abutment dike.

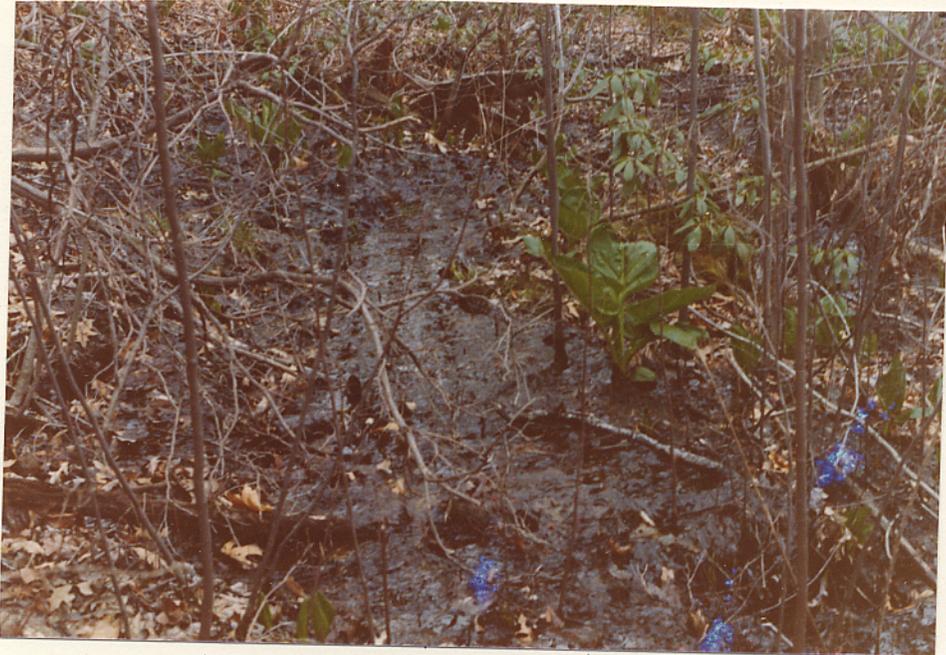
4. Seepage at downstream toe of road opposite the "Frog Pond".

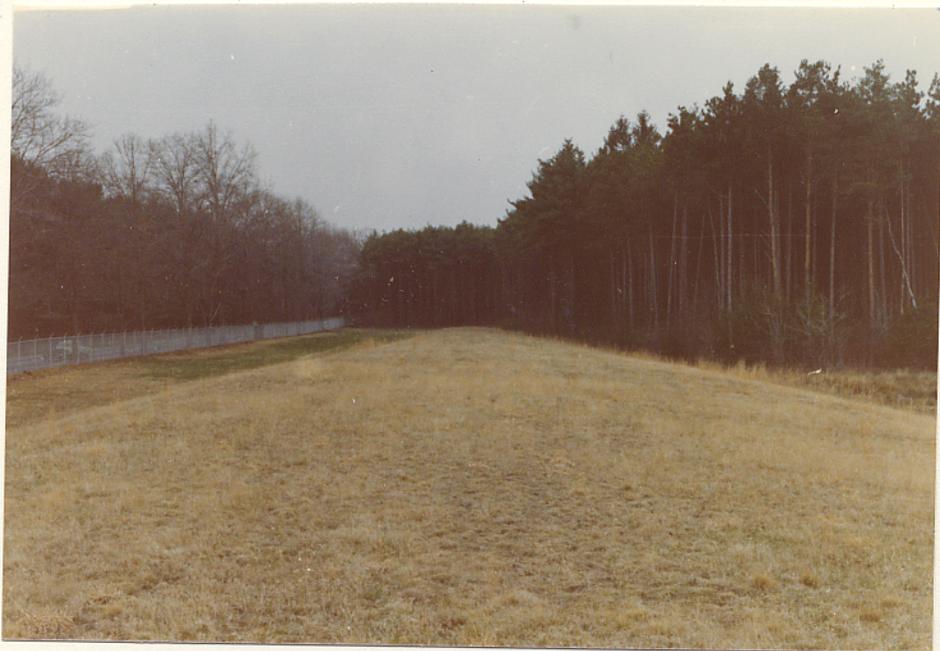
3. Right Abutment Dike. No seepage was observed along the toe of the right abutment dike, which is in a similar condition to the main dam (see Photo No. 5, Appendix C).

5. View along crest of right abutment dike.

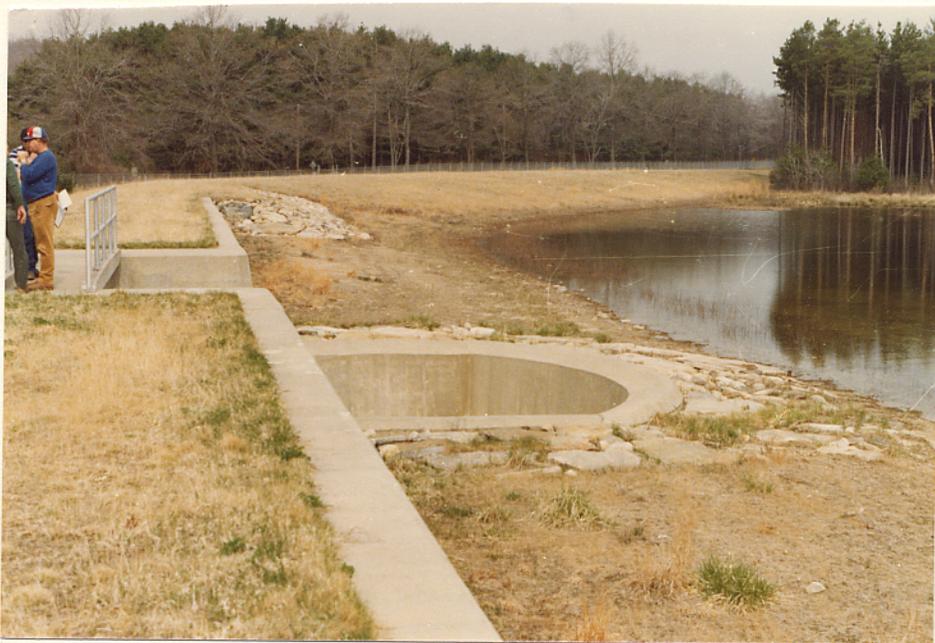
transported a slight but steady flow across its width, indicating either ground water intrusion through defective concrete slabs, or slow release of rain water or spillway flow retained in the 3.5 ft. thick boulders in the stilling basin. However, the "as-builts" indicate the joints of the slab to have been equipped with rubber waterstops; there are no weep holes and little or no precipitation is said to have occurred for some period before the inspection. Site personnel stated that this moisture has been evident almost from the completion of construction (see Photo Nos. 11, 12, 13 and 14, Appendix C).

11. Overview of spillway crest.

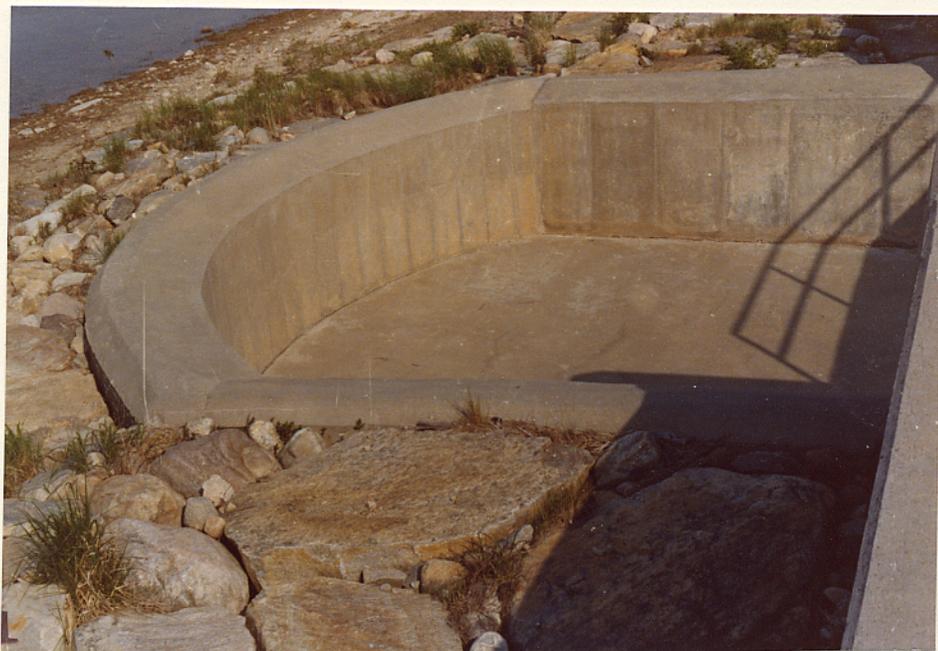
12. View of spillway.

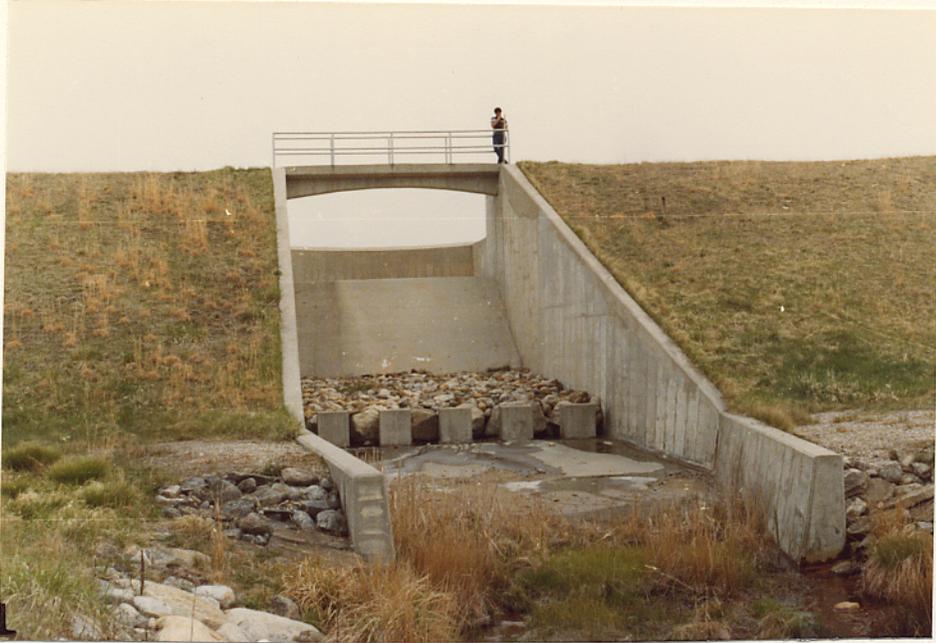
13. View of spillway chute from downstream channel.

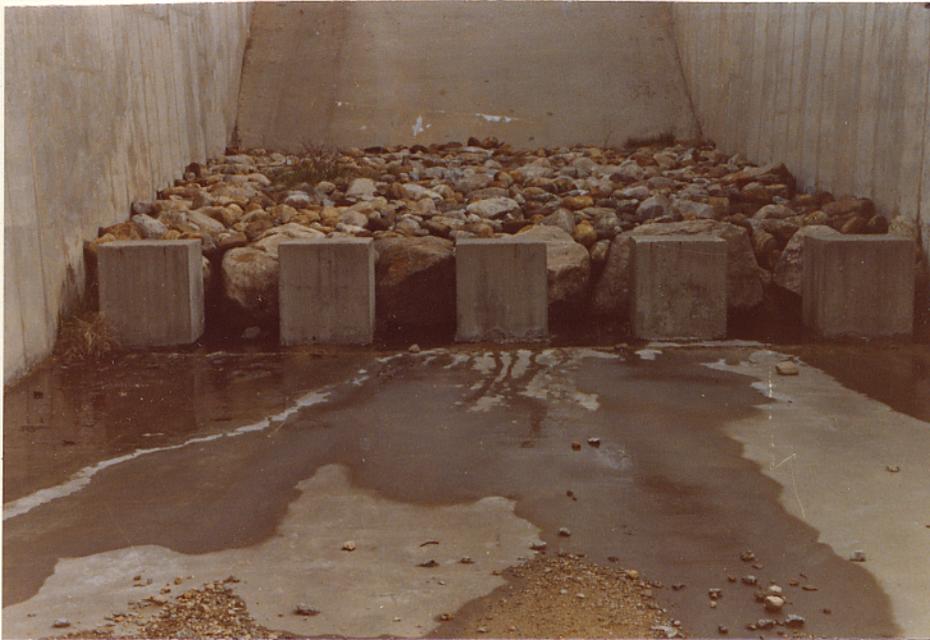
14. Stilling basin apron with rock riprap.

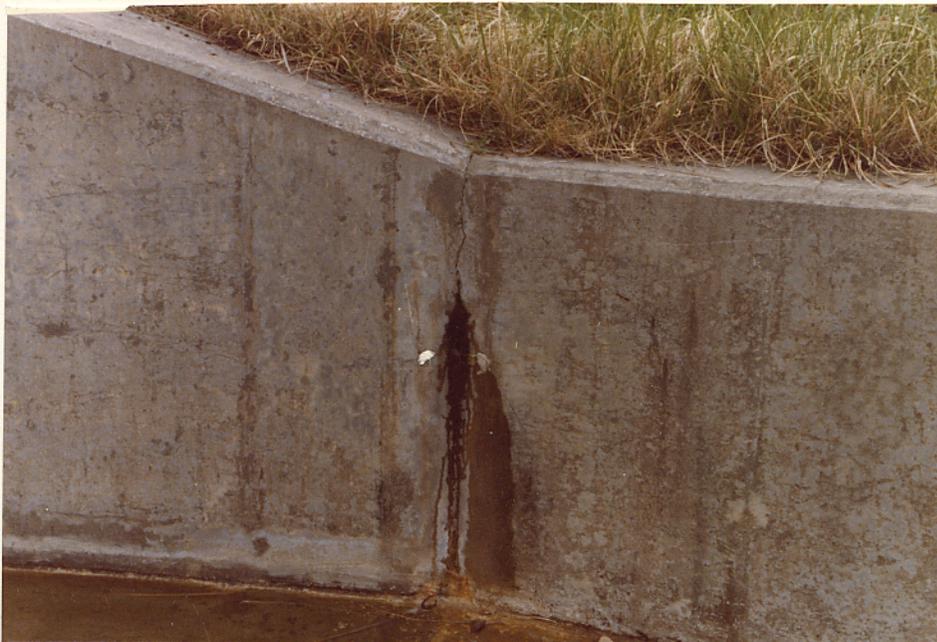
Concrete cracks were noted in the spillway at a construction joint on the inner walls of the chute section, where the chute starts making a transition from a 20 ft. width to a width of 12 ft (Appendix C, Photo No. 15).

15. Deteriorated spillway concrete training wall.

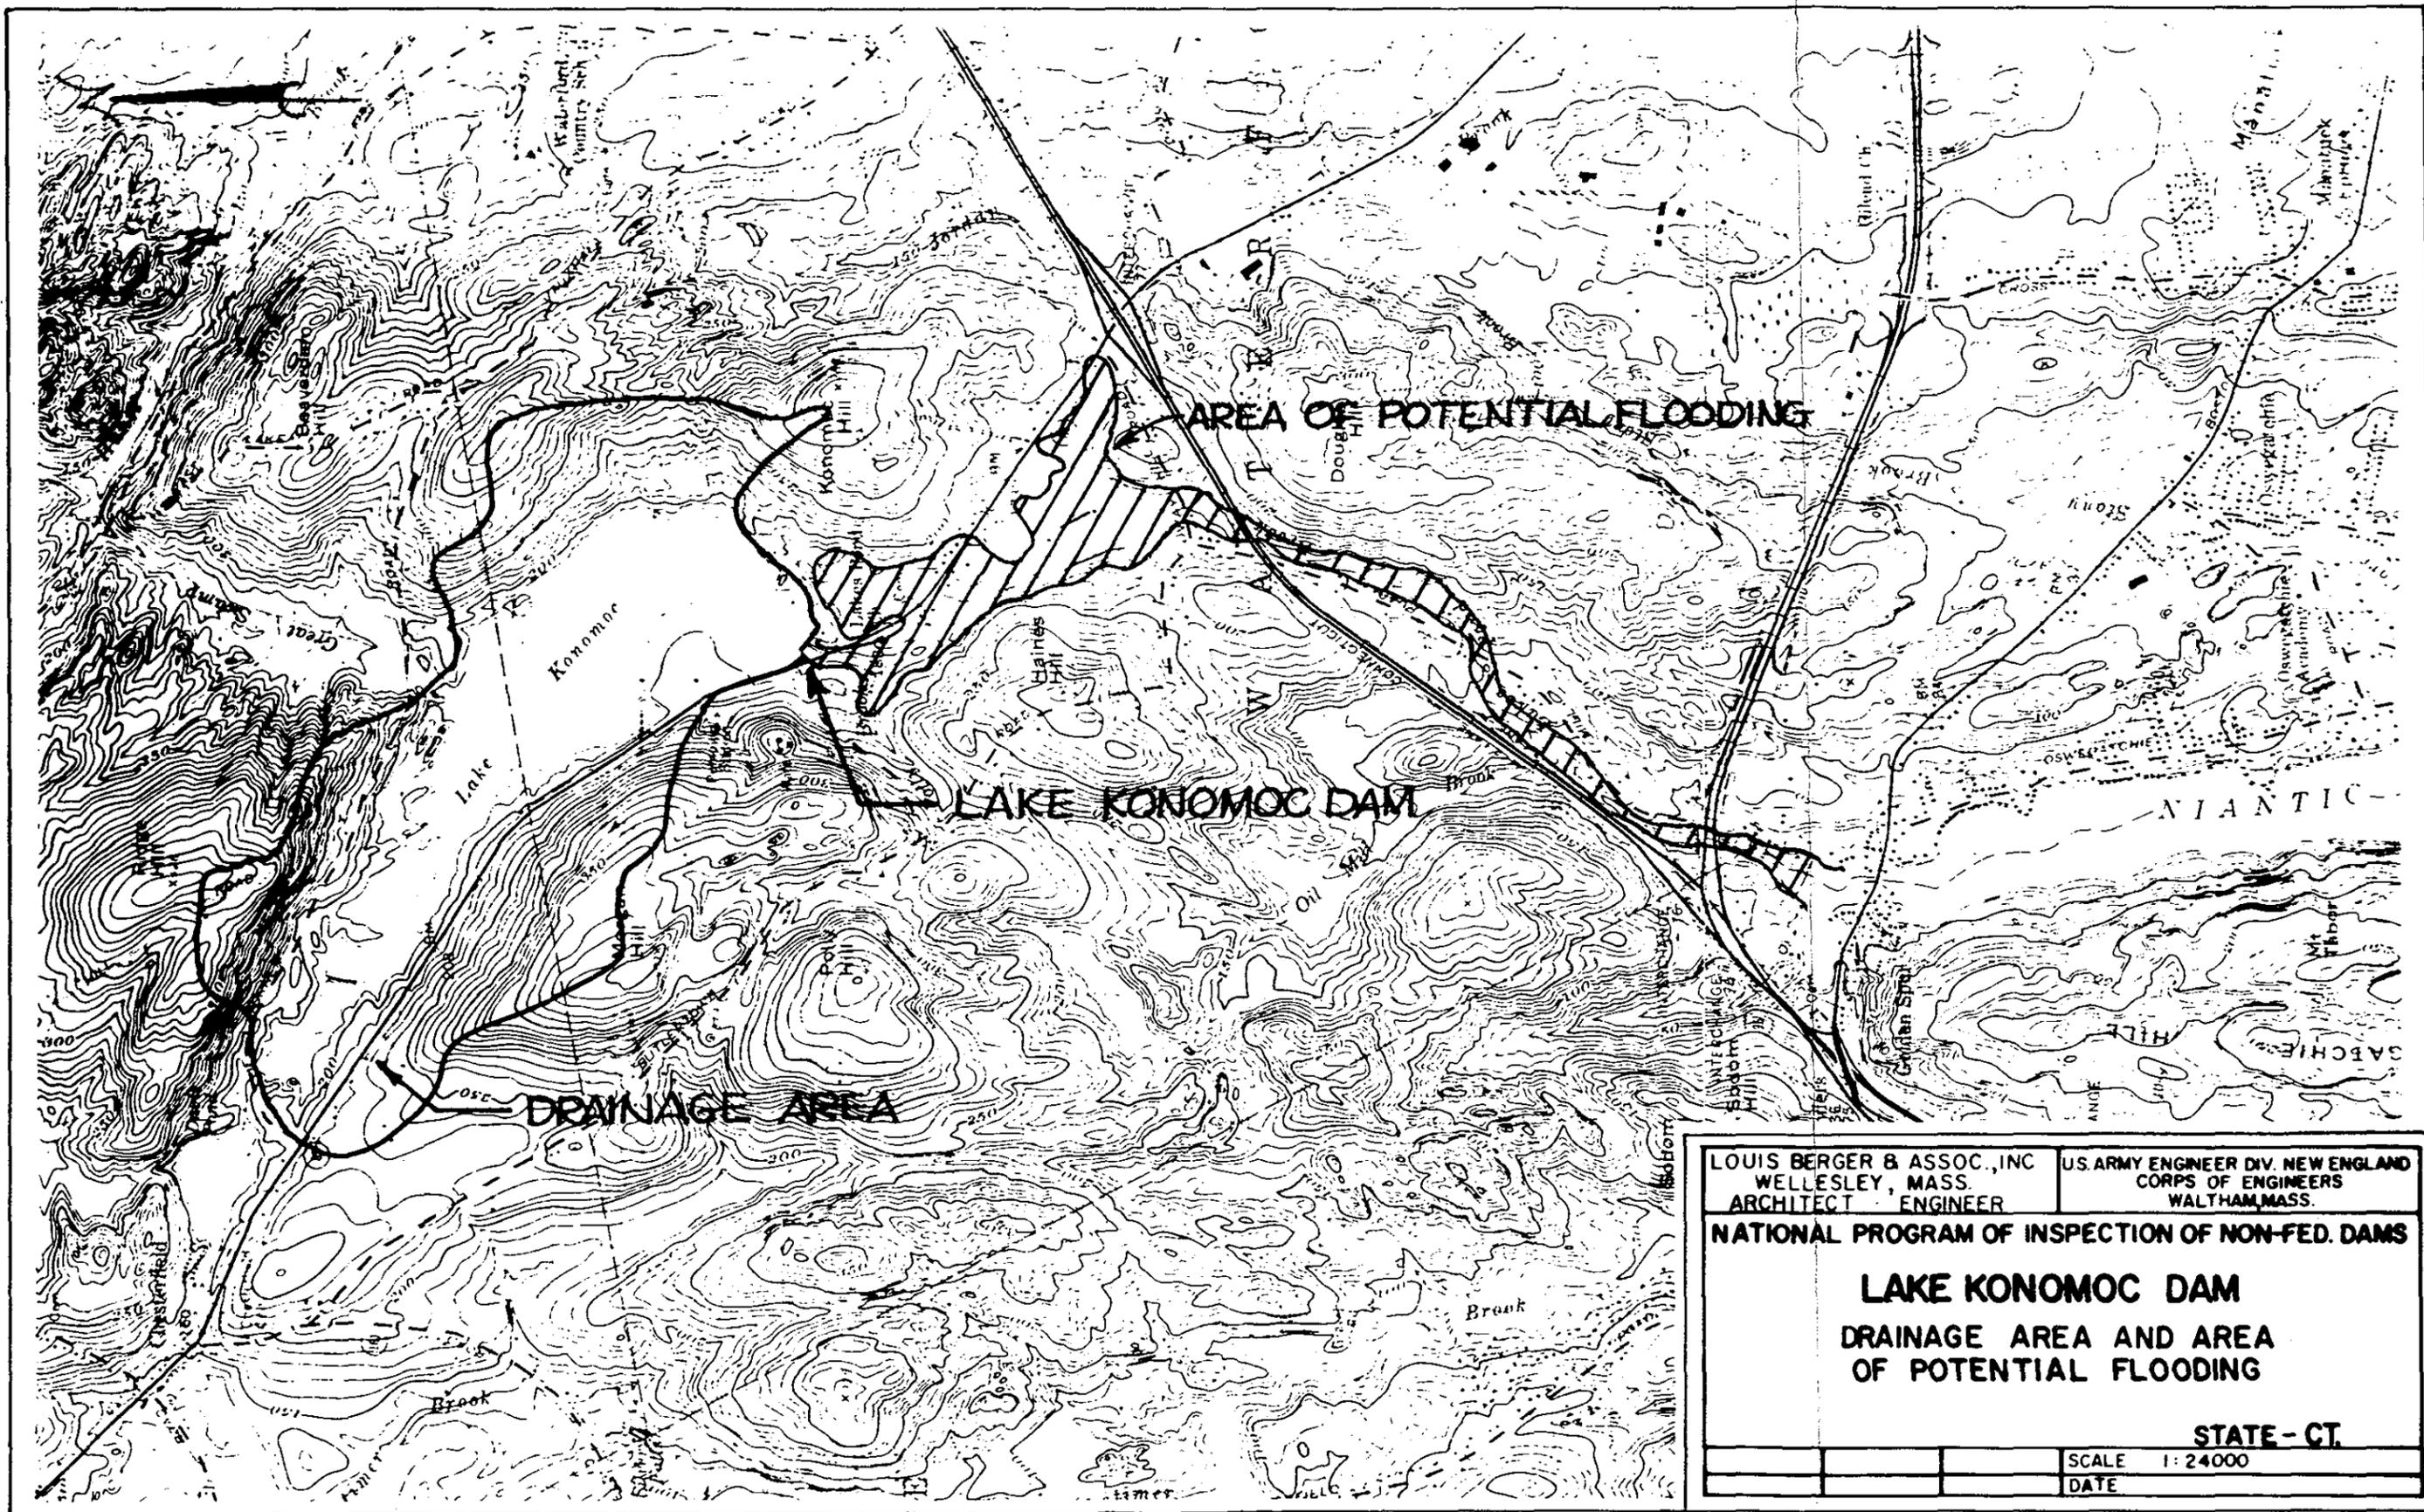
FIGURE 5 - SHEET D-18

An outflow of 21,500 cfs from Konomoc Lake would produce a flood depth of about 20 ft. in the valley below the dam. In this reach the dam failure would cause about a 14 ft. rise in water stage above the spillway discharge stage. It would cause major flooding of State Route 85 and damage about seven homes. In the next reach which extends to the Connecticut Turnpike it is estimated that the stage would rise by about 7.5 ft. to a stage of 11.5 ft. In this reach Way Hill Road, an automobile race track and two homes would sustain major damage. In the reach extending from the Connecticut Turnpike to the Niantic River it is estimated that the brook would rise about 7.0 ft. to a stage of about 11.0 ft. and that five homes would sustain damage.

In summary, about 14 homes, a racetrack, two local roads, and a two lane state highway (Route 85) are within the area of potential flooding. The Connecticut Turnpike and Interstate Route 95 also might sustain damage. Figure 5, Sheet D-18, Appendix D, shows the area of potential flooding.
