LOWER CONNECTICUT RIVER BASIN
MIDDLETOWN , CONNECTICUT

**CRYSTAL LAKE DAM
CT 00138**

**PHASE I INSPECTION REPORT
NATIONAL DAM INSPECTION PROGRAM**

JANUARY 1980

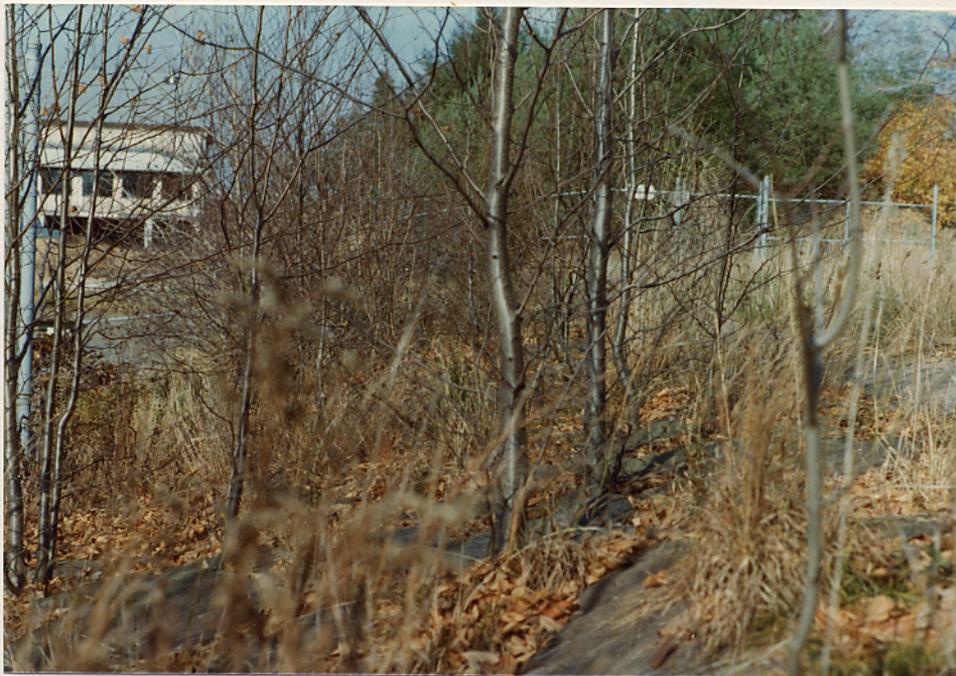
The dam is judged to be in generally fair condition. The crest is level, and no lateral movement was observed. The vertical and horizontal alignment of the dam is good. Some minor erosion along the dam adjacent to the left abutment was noted. The riprap paving on the upstream face is in good condition. The rockfill downstream face is also in good condition. Small trees and scrub brush are growing on the upstream and downstream slopes and could cause problems if not removed.

PHOTO #2: Upstream face of dam. Note sappling trees growing through riprap.

toe, and the outlet channel for a distance of 100 feet downstream of the dam; 2) engage a qualified registered engineer to make a comprehensive technical inspection once every year; 3) establish a surveillance program for use during and immediately after heavy rainfall and also a warning program to follow in case of emergency conditions and 4) remove grate or establish provisions for quick release at downstream end of 36 in. diameter outlet pipe.

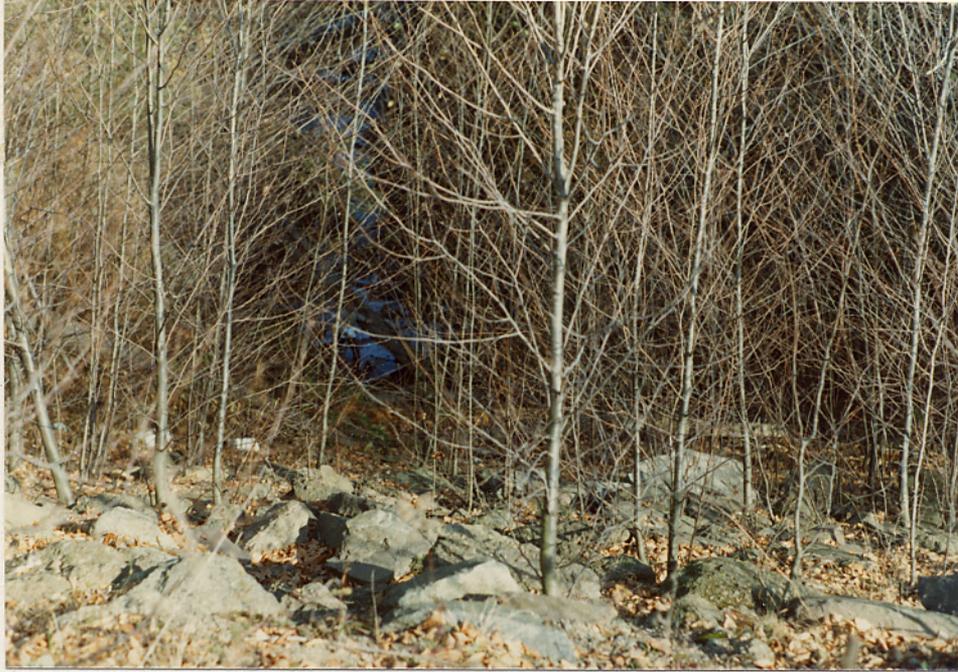
PHOTO #7: Looking downstream from crest. Trees growing out of rockfill up to 4 inches in diameter.

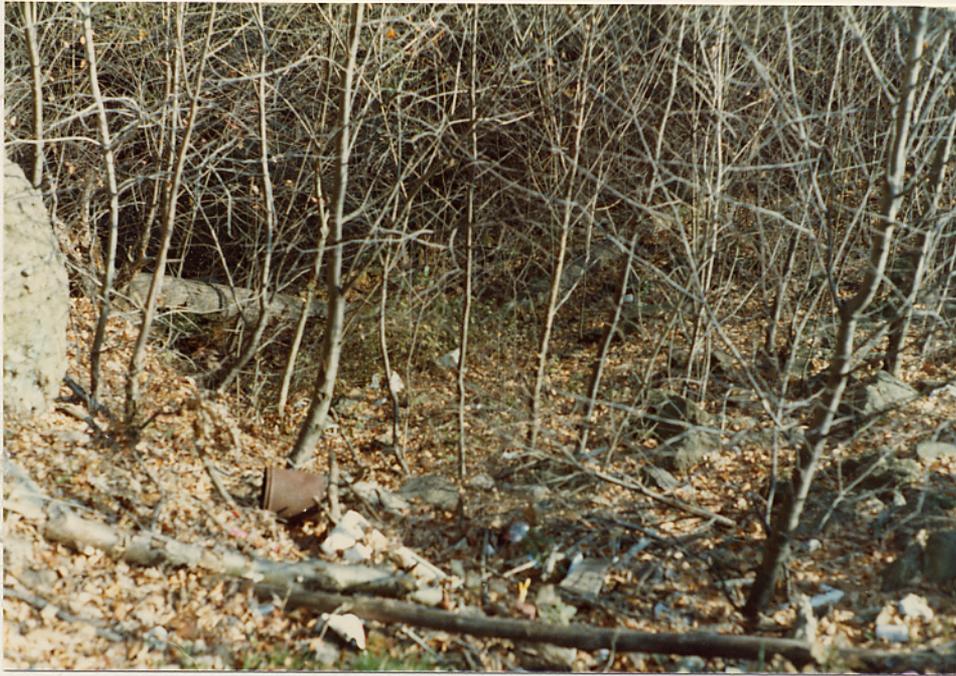
PHOTO #9: Looking toward outlet structure near toe of dam. Note tree uprooted on the slope.

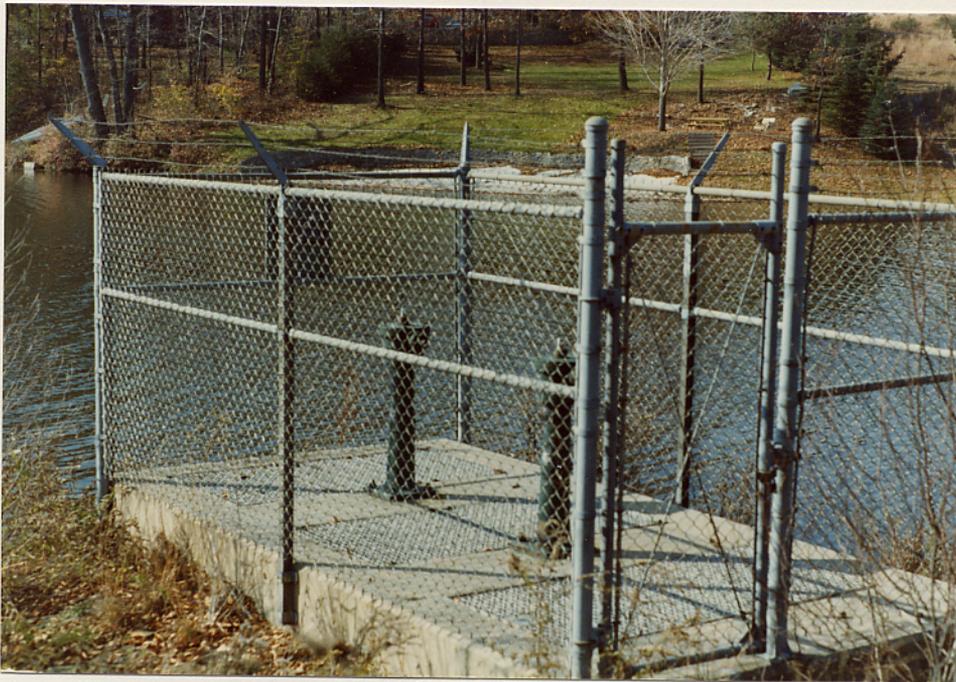
c. Appurtenant Structures. The visible portions of the concrete water control structure above the water level surface is in good condition. The top of the structure is enclosed with a perimeter chain link fence. There are aluminum grate covers over each of the three interior chambers. Two valve stems without operator handles were observed on the top of this structure (see Photo No. 10).

PHOTO #10: Water control structure.

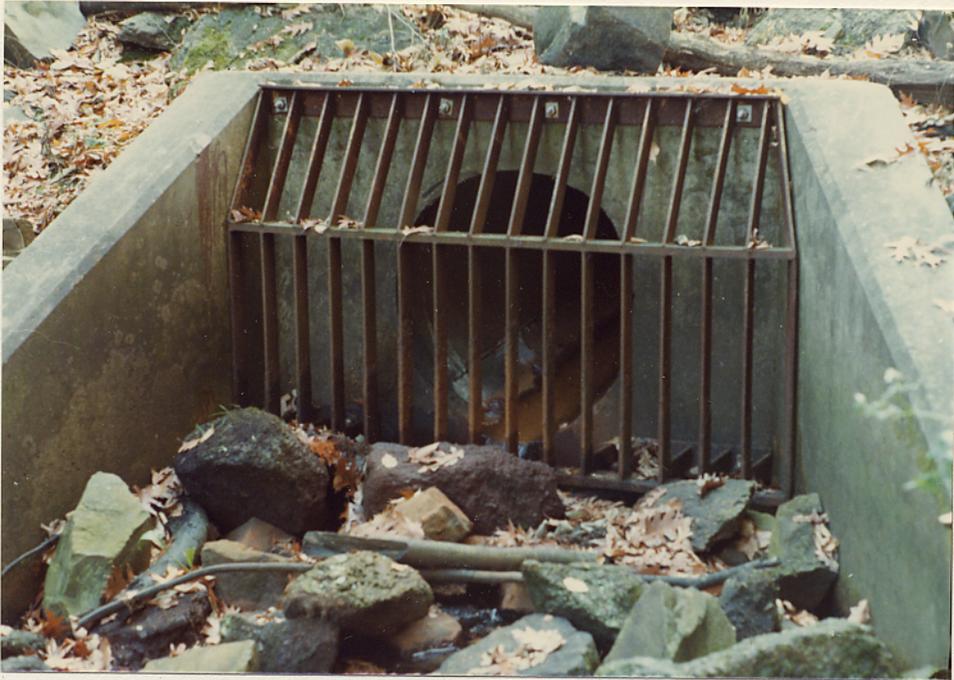
All water which passes through the water control structure is conveyed through the dam in a 36-inch diameter concrete conduit. This conduit extends from the water control structure and outlets at the toe of the dam. The conduit was visually inspected at its outlet located at the base of the downstream face of the dam embankment, and found to be in good condition. The 36" diameter pipe outlets at a concrete endwall with concrete wingwalls. All concrete was in good condition, with no evidence of spalling, erosion or efflorescence. A metal bar rack bolted to the endwall prevents access to the outlet conduit (see Photo No. 11).

PHOTO #11: 36"-diameter outlet pipe and grated endwall.

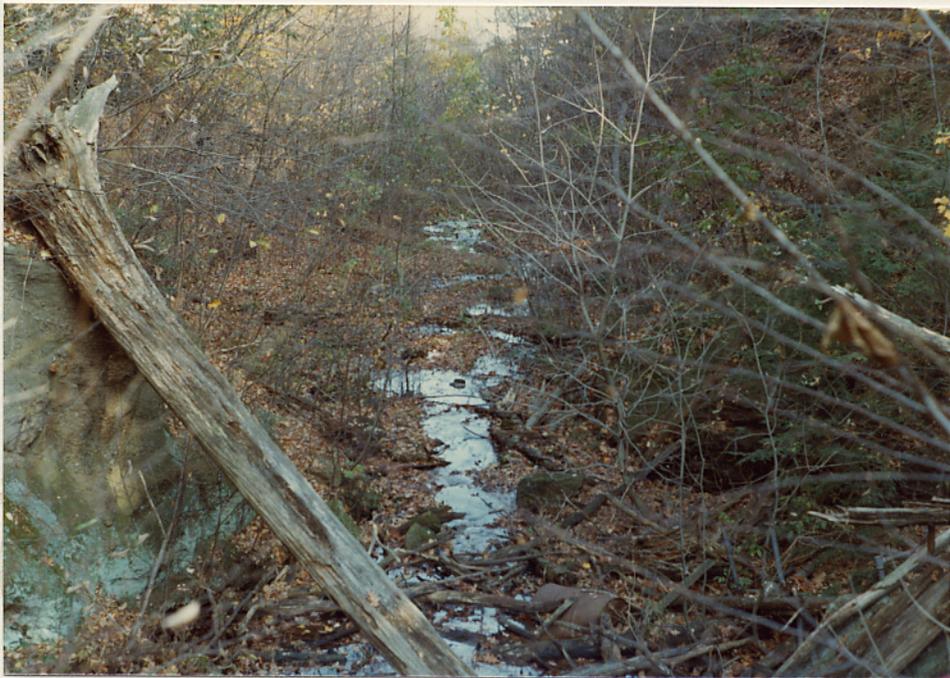
e. Downstream Channel. The outlet flows into a natural stream which begins at the base of the dam. The channel width varies from 5 to 10 feet with bed materials consisting of sand and gravel, with scattered cobbles and boulders. The bed appears stable but the banks experienced severe erosion when the original dam failed in 1961. These banks have since stabilized due to natural soil sloughing and revegetation. Approximately 100 feet downstream of the endwall outlet, there is a low valley without a well defined channel. The floodplain area and stream are heavily vegetated with brush and young saplings and is covered with forest litter and debris. The channel downstream of the outlet endwall is filled with fallen trees, brush, vegetation and trash as indicated in Photo No. 12.

AREA EVALUATED	CONDITIONS
<u>OUTLET WORKS - OUTLET STRUCTURE AND OUTLET CHANNEL</u>	
General Condition of Concrete	Excellent condition, no evidence of deterioration.
Rust or Staining	None.
Spalling	None.
Erosion or Cavitation	None.
Visible Reinforcing	None.
Any Seepage or Efflorescence	None.
Condition at Joints	
Drain Holes	None observed.
Channel	Natural soil and gravel bottom.
Loose Rock or Trees Overhanging Channel	Trees and rocks overhanging channel on both banks.
Condition of Discharge Channel	Considerable trees, brush and trash located in channel downstream of outlet works.

PHOTO #12: Looking downstream along outlet channel. Note large trees and brush.
