**CONNECTICUT COASTAL BASIN  
EAST LYME, CONNECTICUT**

**GORTON POND DAM  
CT. 00157**

**PHASE I INSPECTION REPORT  
NATIONAL DAM INSPECTION PROGRAM**

**JANUARY, 1981**

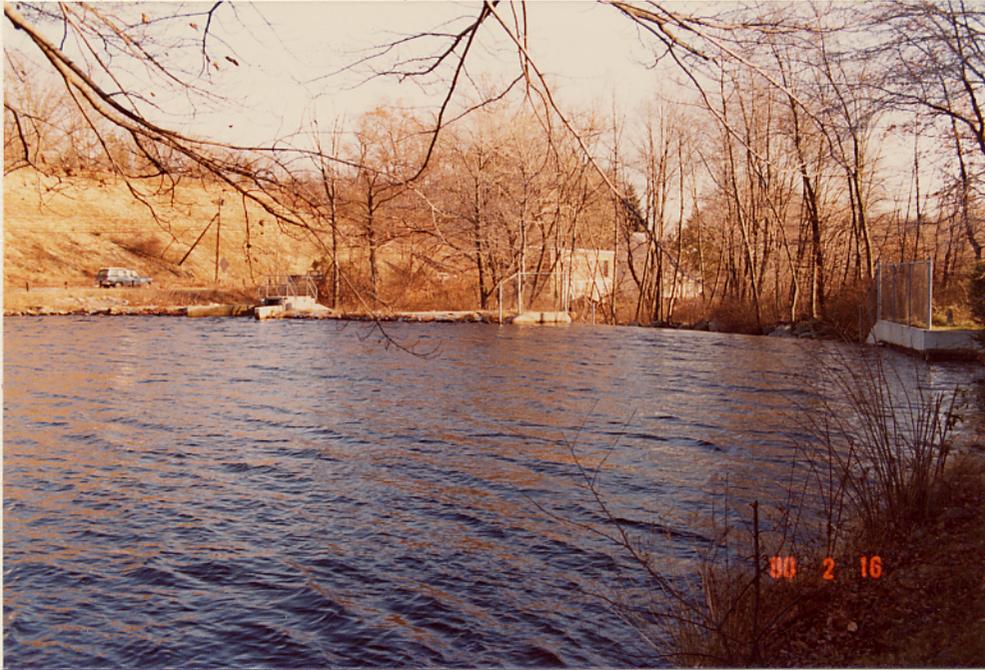
1. Upstream Face. The upstream face of the dam (Photo C-1) is riprap covered with a slope of 2:1. The riprap protection has brush growing through the rock. Some minor erosion has occurred. The right abutment area at the end of the spillway training wall has no riprap protection. The left abutment has incomplete riprap protection. However, there was no significant erosion observed at these locations.

PHOTO C-1: Upstream face of dam from right side.

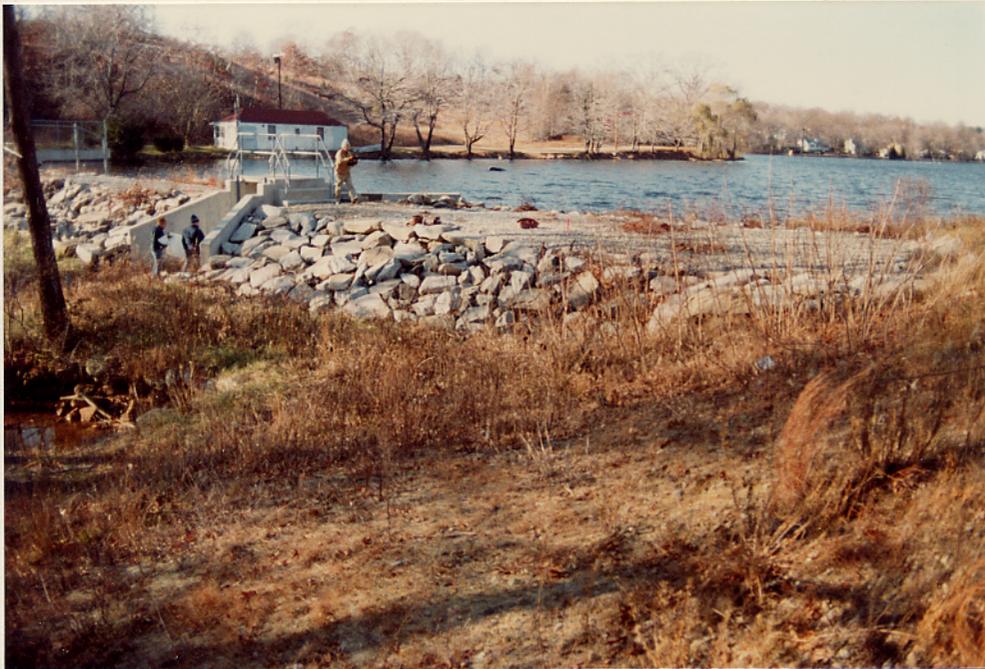
- b. Dam. The original dam was an earth embankment with a vertical stone wall on the downstream side. In 1974 a dumped riprap shell was added on the downstream side against the vertical stone wall (See Appendix B-3, Section A-A, and Photo C-2). As a part of the repairs in 1974, the crest and upstream slope were riprapped and crushed stone was used to fill the voids on the crest (Photo C-4).

PHOTO C-2: Downstream face of dam from left side.

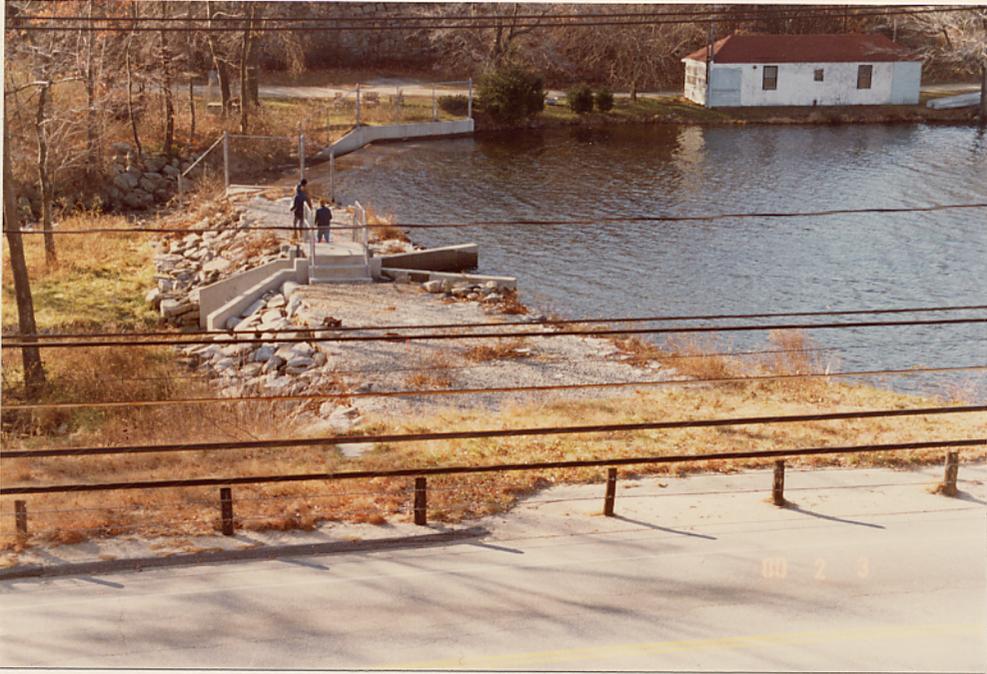
2. Crest. The crest of the dam (Photos C-3 and C-4) varies from 12 to 18 feet wide and is covered with a layer of riprap and then crushed stone filling the voids presenting a smooth crushed stone surface. There is some brush growing through this stone surface. At the contact between the crest and the left abutment (Photo C-4), riprap protection appears inadequate to prevent erosion during overtopping of the embankment.

PHOTO C-3: Embankment, outlet structure and spillway from left side.

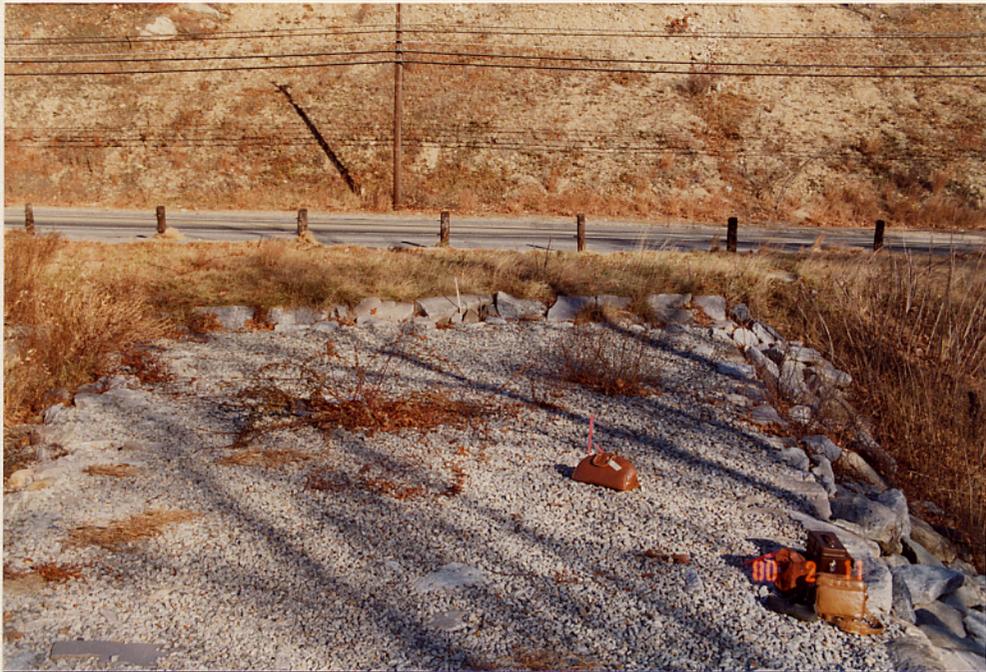
PHOTO C-4: Embankment crest and left abutment.

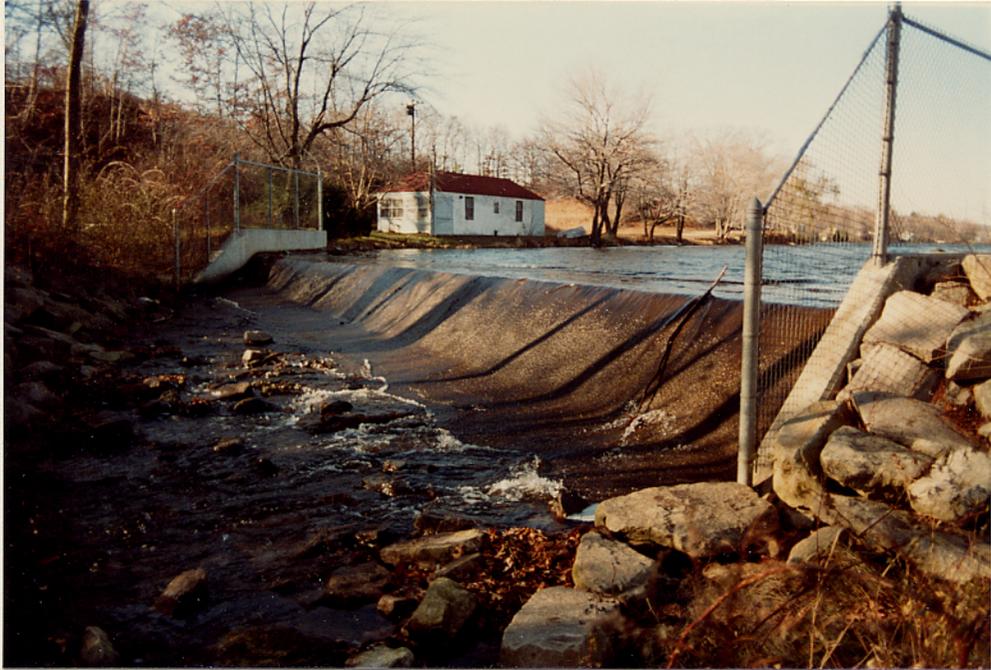
1. Spillway. A concrete spillway 62 feet wide extends across the right side of the dam (Photo C-5). The approach channel was submerged and could not be inspected, and water was overflowing the spillway preventing full inspection of it. The concrete spillway weir is in fair condition. A 1/2 inch wide open crack at the contact of the downstream spillway face with the base of the left training wall was observed (Photo C-9). Water overflowing the spillway was observed to flow into the crack and thus enter the downstream rock shell. Seepage observed to exit at the base of the downstream slope adjacent to the left training wall was believed to result from flow into the crack (Photo C-9). Seepage was also observed to emerge through a construction joint at the top of the weir at the center of the spillway at an estimated rate of 4 gpm.

PHOTO C-5: Spillway from left side.

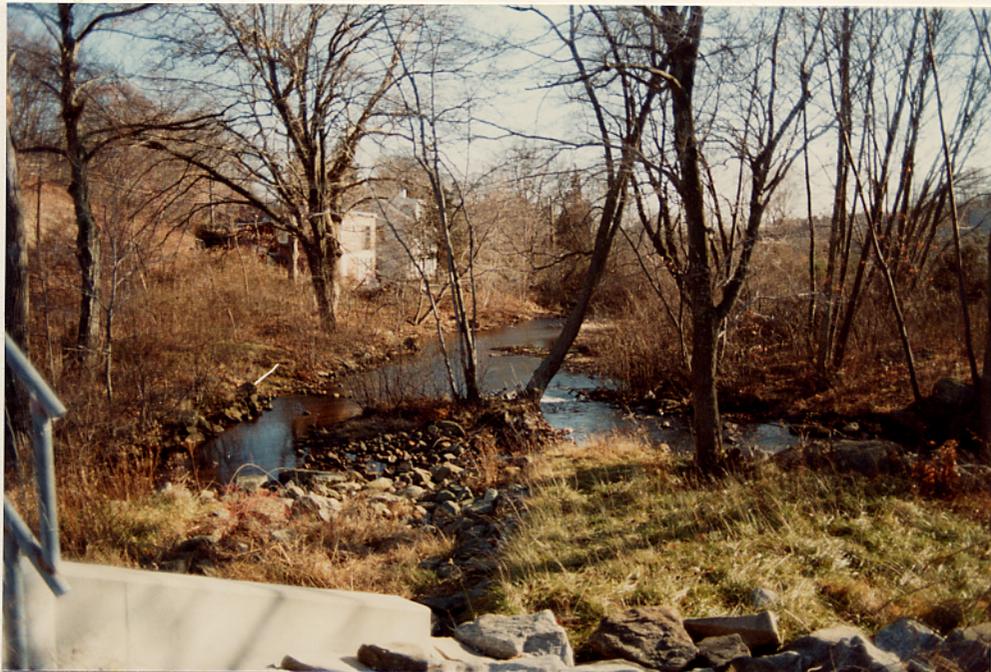
- d. Reservoir Area. No specific detrimental features in the reservoir area were observed during the visual inspection.
- e. Downstream Channel. The downstream channel (Photo C-6) is riprap lined for approximately 100 feet to where it joins the natural streambed of the Pataguanset River. There is a small island with several trees growing on it right at this junction. The channel banks below this point are unprotected earth and heavily overgrown with trees and brush obstructing the flow capacity. The downstream channel passes under a roadway bridge 350 feet from the dam.

PHOTO C-6: Downstream channel from embankment.

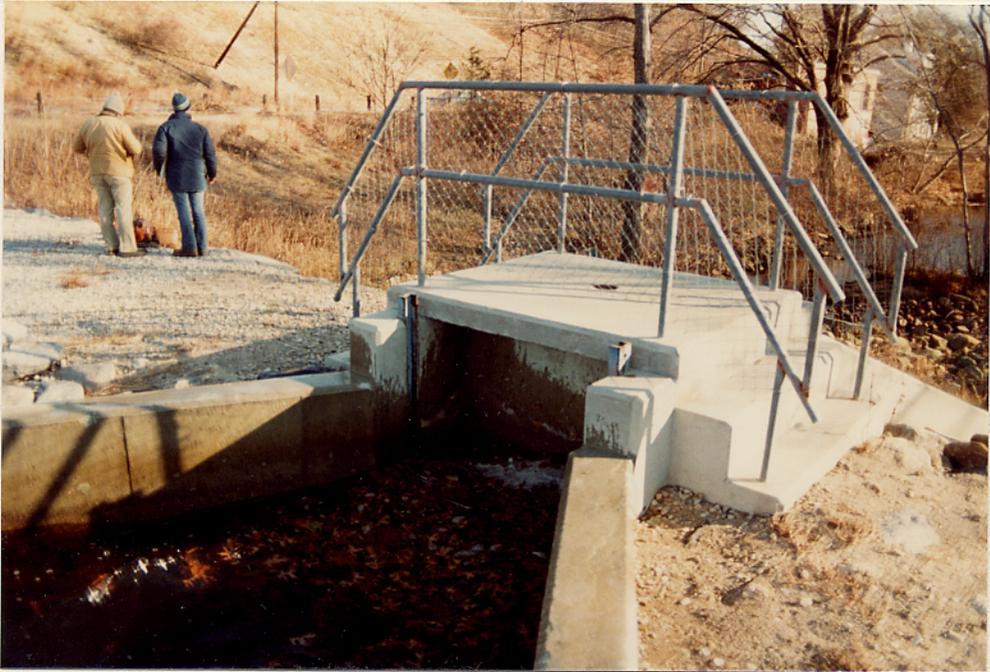
2. Outlet Works. A concrete drawdown structure is located near the center of the embankment (Photos C-7 and C-8). The outlet is controlled with a 36 inch square sluice gate, operated from above. At the time of inspection the gate was closed and minor seepage at less than 1 gpm was observed to emerge from the bottom of the gate. Concrete on the upstream and downstream sides of the structure appeared to be in good condition. Both sides of the structure have stop log slots but no boards. The upstream and downstream training walls contained small hairline cracks in the construction joints.

PHOTO C-7: Outlet structure from upstream.

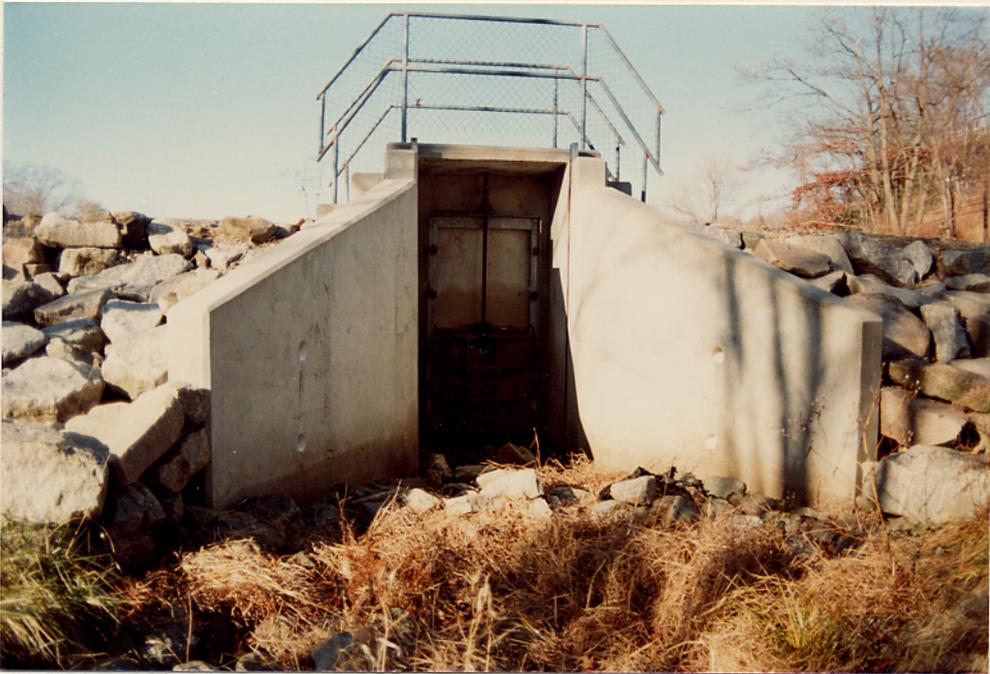
PHOTO C-8: Outlet structure from downstream.

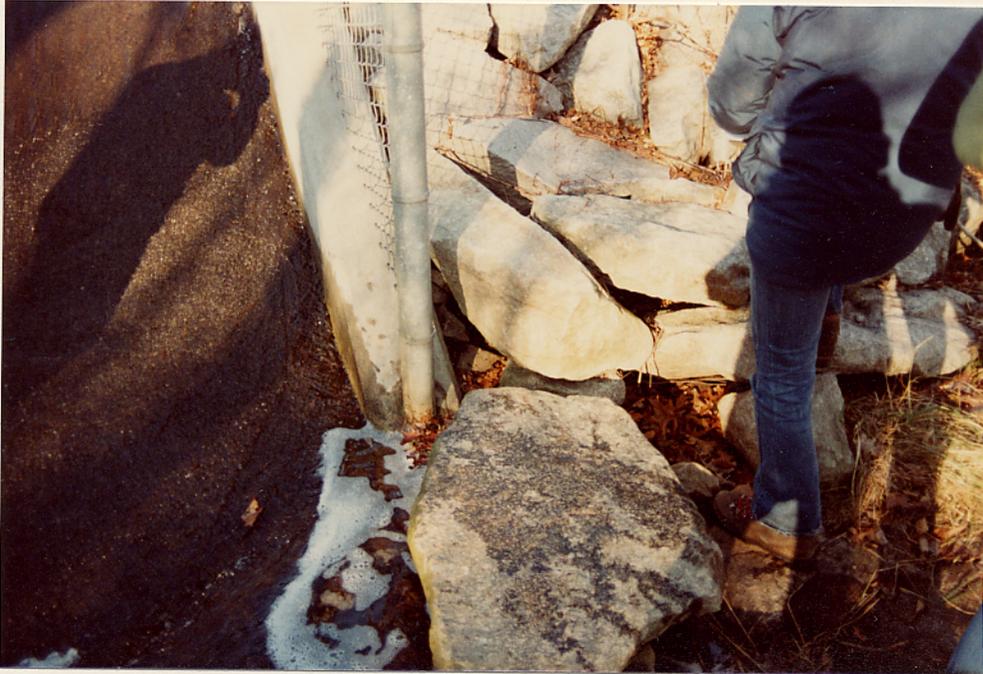
Minor seepage flowing clear (approximately 1 gpm) was observed to emerge from the riprap at the toe of the downstream slope adjacent to the left training wall of the spillway. The source of this seepage may be from leakage of overflow water through a crack in the downstream face of the spillway at the base of the left training wall.

2. Lack of a filter layer between the downstream shell and the original riprap to prevent erosion of material from within the embankment.
  3. A 1/2" wide crack in the downstream concrete face of the spillway at the base of the left training wall which permits seepage of water overflowing the spillway into the embankment.

PHOTO C-9: Joint separation and seepage at left spillway training wall.

- d. Investigate the lack of a filter on the upstream side of the downstream riprap shell and design an effective filter and supervise its construction where such a filter is required.
- e. Determine the source and potential effects of seepage emerging from the plugged outlet on the left abutment.
- f. Design and inspect the repair of cracks in the downstream face of the concrete spillway.

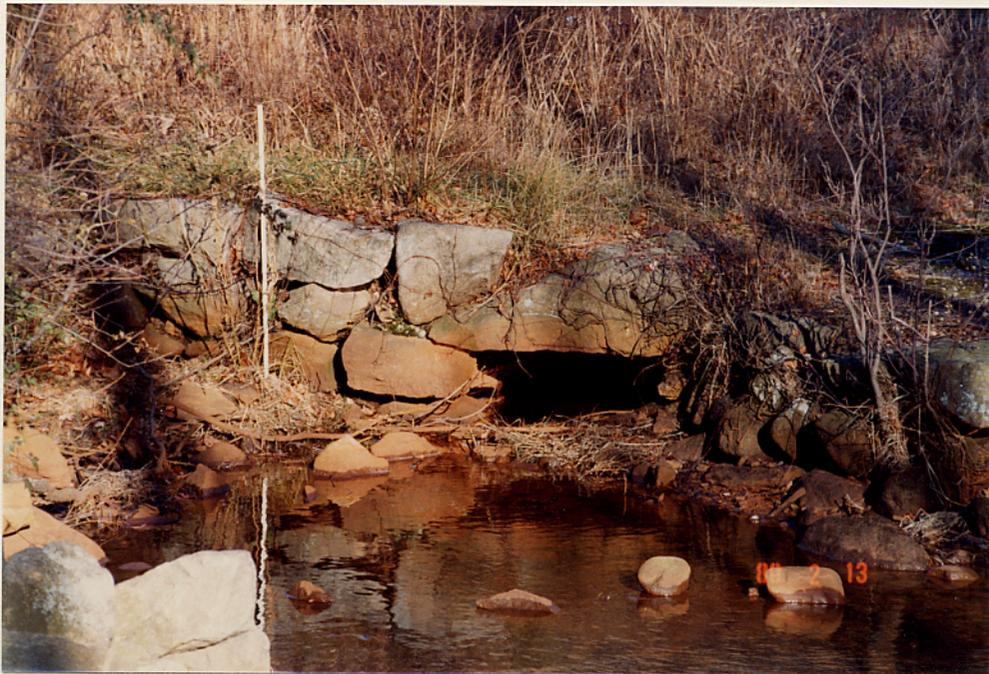
Standing water was observed in the channel of an abandoned drawdown outlet about 15 feet downstream from the toe near the left abutment. This water was observed to be clear seepage emerging at an estimated rate of 10 gpm from the outlet in the left abutment (Photo C-10). Rusty stains were observed at the bottom of this ponded area.

4. Unknown source of seepage from plugged outlet on the left abutment.
- b. Adequacy of Information. The Phase 1 inspection was based on the visual inspection on site and the available repair design plans. The construction inspection reports are not available.

PHOTO C-10: Abandoned outlet and apparent seepage.
