**QUINEBAUG RIVER BASIN  
KILLINGLY, CONNECTICUT**

**ACME POND DAM  
CT 00172**

**PHASE 1 INSPECTION REPORT  
NATIONAL DAM INSPECTION PROGRAM**

**MARCH 1981**

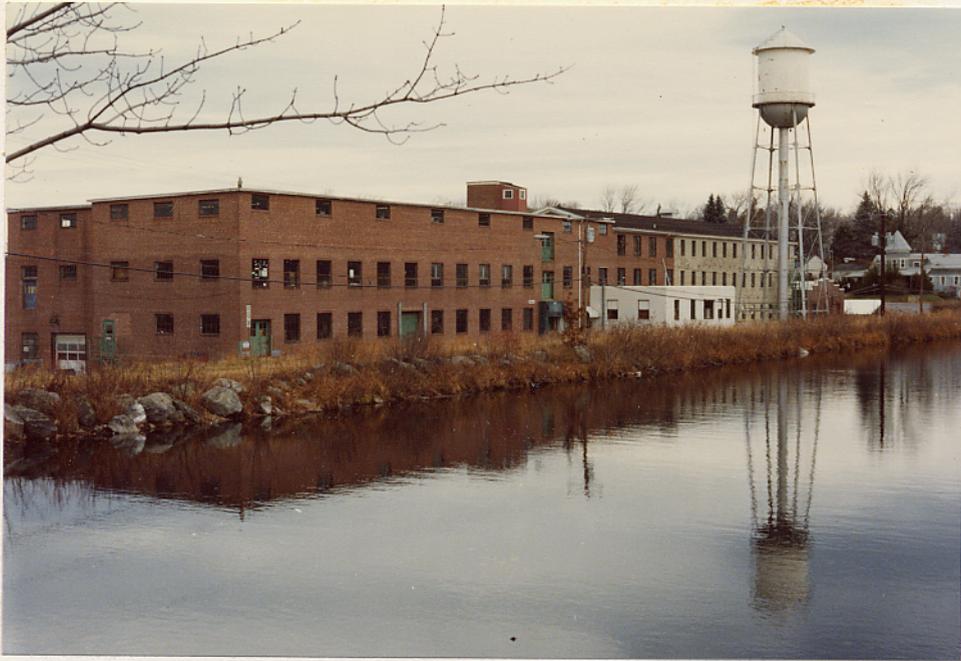
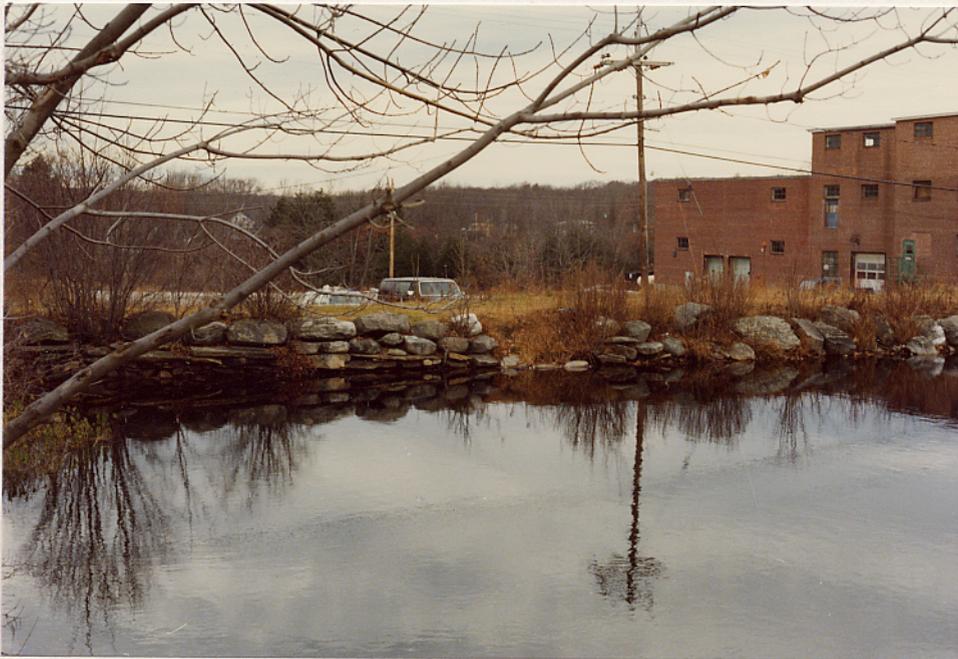
Photos 1 & 2. View of upstream side of dam as seen from left abutment. Note stone wall near left abutment and large riprap to the right of the dam. Spillway is at far right.

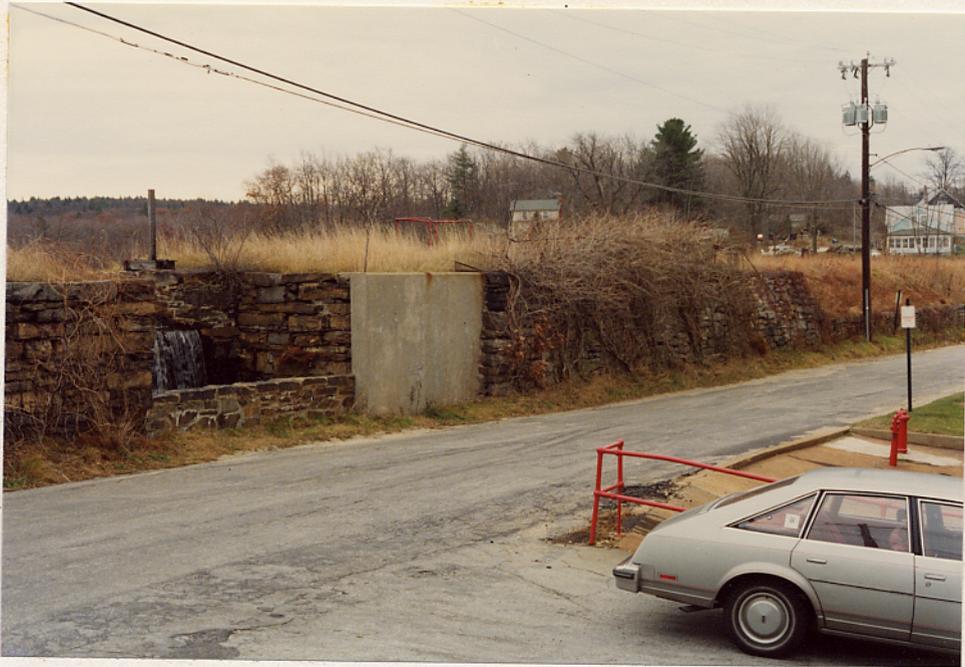
3. Downstream slope: The downstream stone masonry wall is the full height of the dam in the vicinity of the spillway and outlet structure and is about 7 feet lower than the dam elsewhere (Photos 3 and 4). The downstream stone wall has tilted in several areas, particularly near the right abutment (Photos 5 and 6). Because of the excessive tilting, the joints opened up as shown in Photo 6. It should be noted that the bulging of the downstream walls was first observed some time ago, as noted in the inspection report of William W. Pike in 1954. Apparently because of this report, a section of the downstream wall was repaired with a concrete wall left of the spillway (Photo 3). The concrete wall has no drainage holes. The remaining downstream slope above the wall is irregular and its inclination ranges from 1.5H:1.0V to 2.0H:1.0V. The slope has some growth of bushes and saplings. No seepage was observed on the downstream slope nor at the toe. A masonry stairway is built into the stone wall just south of the intake structure (See Site Plan and Photo 10). Immediately south of the stairway, the stone wall bulges as shown in Photo 10. Towards the left abutment several bedrock outcroppings were observed at the toe of the stone masonry wall. Indications are that this section of the dam is resting on bedrock. No seepage was noted on the left side of the dam.

Photo 3. Downstream wall of dam and spillway. Note reinforced concrete wall installed to the left of the spillway.

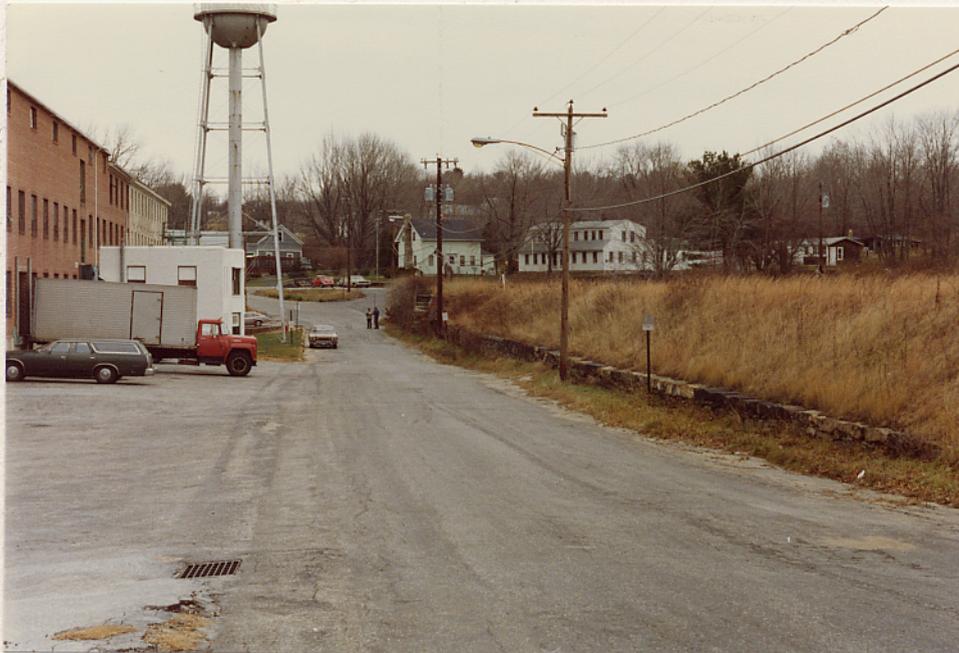
Photo 4. Overall view of downstream wall and slope.

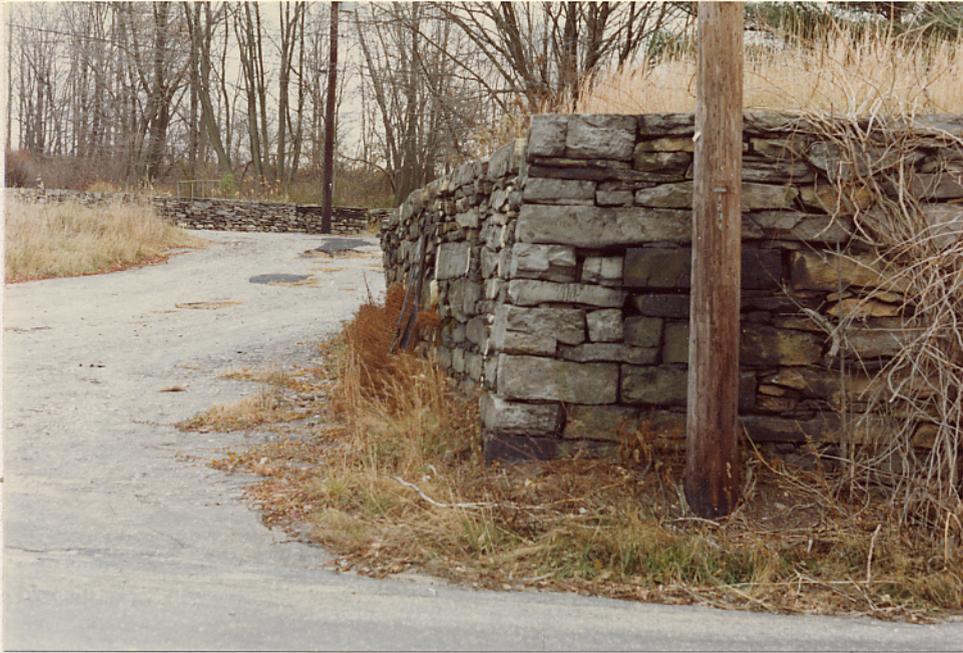
- 6.1 Visual Observations: The visual inspection showed evidence of instability in several areas of the dam. The downstream wall has tilted locally at several points, particularly near the right abutment. Stones dislodged from these tilted walls could lead to an unstable situation in this area of the dam. At the upstream end of the culvert passing the spillway discharge beneath the mill building, there is evidence of a depression. Because it could lead to a collapse and blockage of the discharge channel, the cause and extent of this depression should be further investigated. The 4 foot diameter steel plate pipe passing beneath the dam and road is corroded. Because it houses the only discharge pipe from the dam (the 16" diameter pipe), its condition should be further assessed and evaluated. Failure of this pipe casing would mean the loss of the only means of drawing down the water from the pond behind the dam, and it could also lead to a partial collapse of the dam over the section of pipe passing beneath it. The longitudinal distortion of the spillway walls could lead to the collapse of the spillway channel or a blockage of the opening. Along with the cavities between the stones of these walls, which may indicate a wash out of soil particles, this distortion should be assessed and repairs instituted. It is recommended that an in-depth stability analysis of the dam be conducted, particularly with respect to the above mentioned items of concern.

Photo 5. Tilted downstream wall near right abutment.

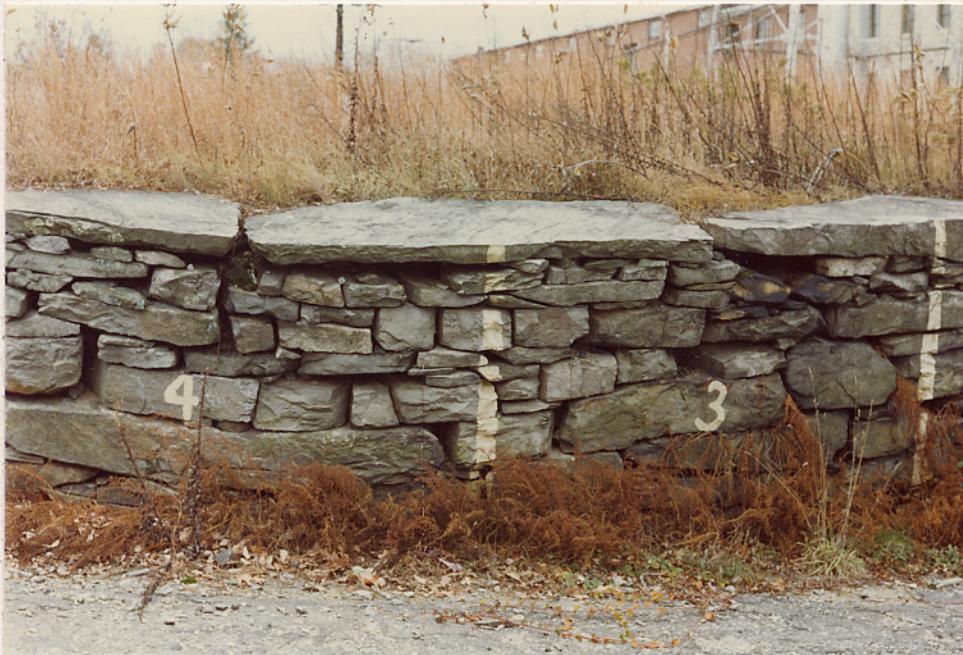
Photo 6. Closeup of tilted downstream wall at right abutment. Note voids between stones as a result of tilting of wall. Markings on wall are for parking purposes.

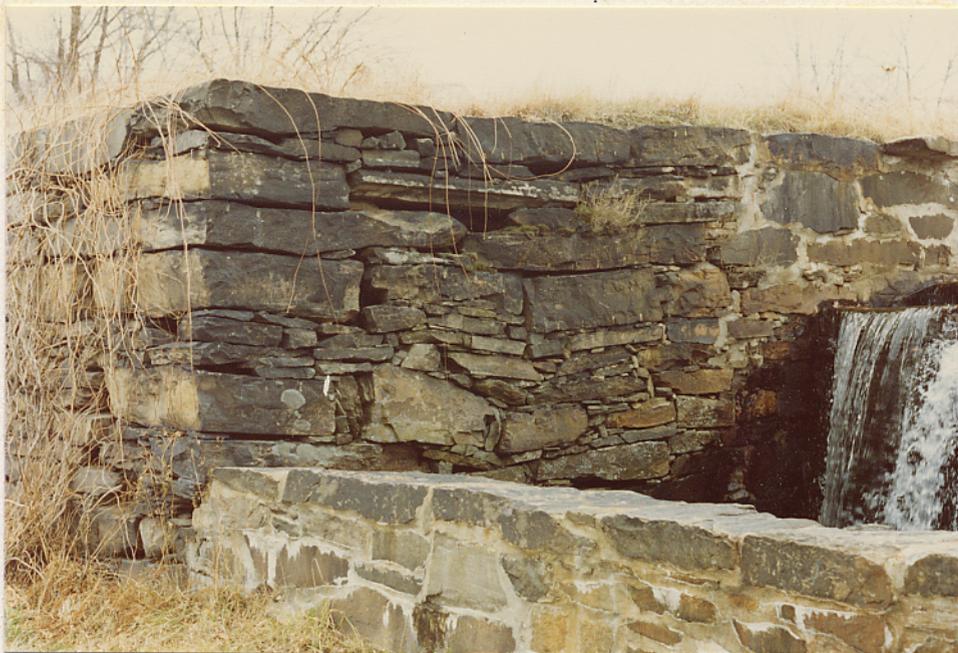
vertical masonry wall. The training walls are in fair condition with some indication of longitudinal distortion (Photo 7). There are signs, however, that soil may be washing into the culvert, as shown by the cavities between stones of the training walls. The spillway flow passes beneath Bailey Hill Road and the mill building through a rectangular stone culvert with an arch at the entrance (Photo 3). There is a depression at the ground surface near the edge of the road at the upstream end of the culvert. The cause and extent of this depression could not be ascertained, but its implications should be studied along with the stability analysis. The culvert extends through the basement of the mill building and exits about 150 feet downstream of the dam. The spillway is in generally fair condition. Clear seepage exiting out of the downstream face of the spillway could be observed at the left end (Photo 11 and closeup, Photo 12). The quantity of seepage here and elsewhere on the downstream face could not be ascertained because of water flowing over the spillway. The spillway is a broad-crested weir and is 16 feet long at an elevation of 555 feet. The training walls extend 3 feet above the spillway crest on both sides. The approach channel was clear of obstructions, but showed signs of minor siltation.

Photo 7. Right wall of spillway. Note apparent deformation of wall.

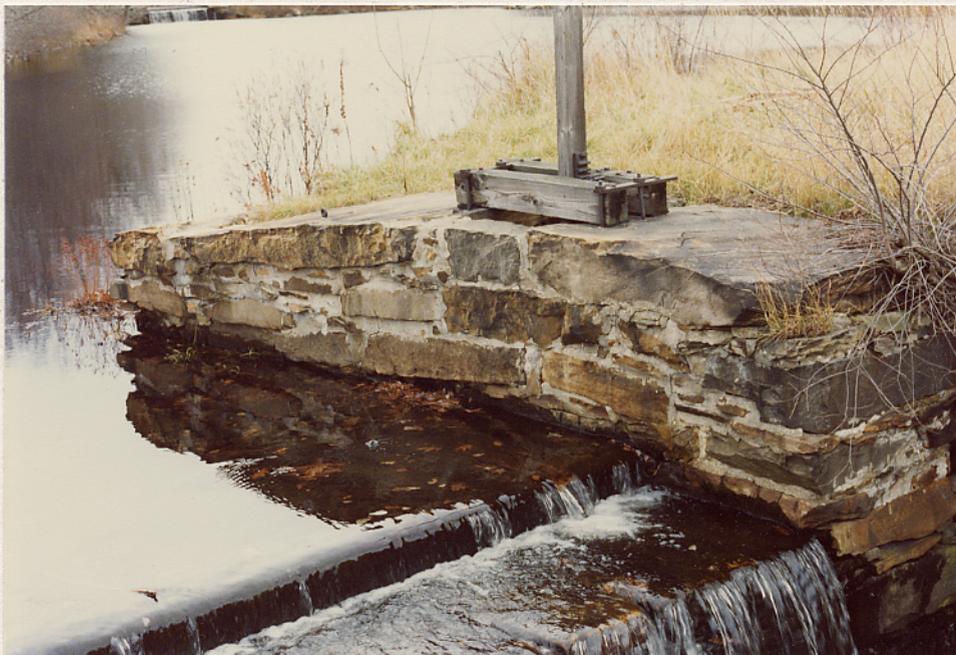
There is another outlet, as shown on Photo 8, with a wooden sluice gate on the left training wall. This outlet discharges immediately downstream of the spillway, but is not presently operable. The intake end of this outlet could not be observed because it was under water.

Photo 8. Left training wall of spillway. Note remains of gate mechanism. Discharge from gate mechanism is apparently downstream of spillway wall.

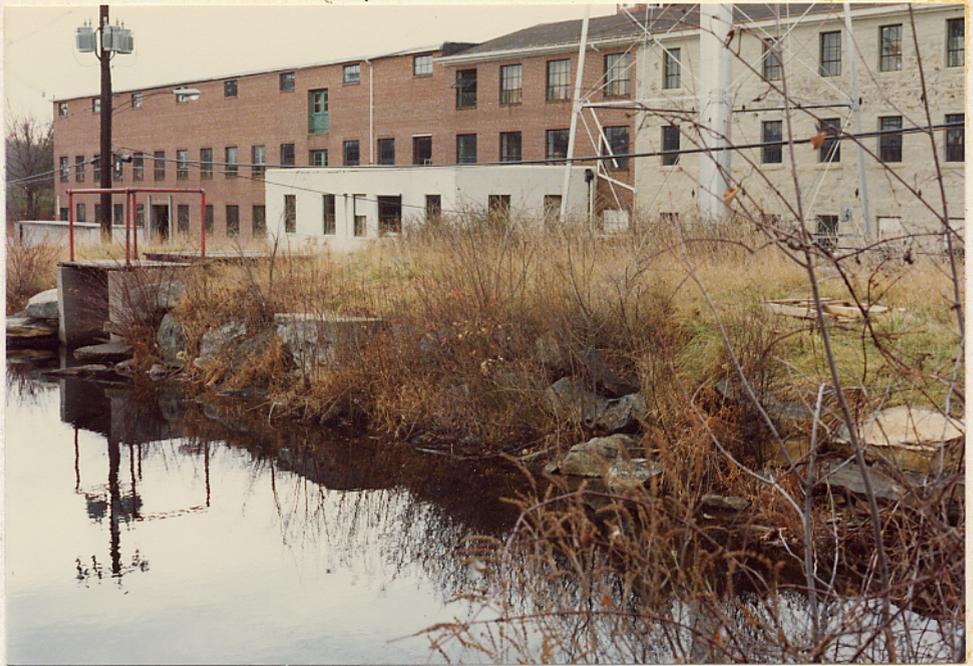
Photo 9

2. Outlet works: The outlet works include a concrete intake structure which is in good condition (Photo 9) and two upstream stone wingwalls which could be observed under water. There is a 16 inch pipe which passes beneath the road, installed inside an existing 4 foot diameter steel plate pipe which shows signs of corrosion and whose condition should be assessed along with a stability analysis. A brick arch could be observed over the downstream end of this pipe where it entered the basement of the mill building. The outlet continues through the building as a culvert. The bottom of the culvert was cut into bedrock with masonry of different types above. The outlet joins the spillway culvert immediately upstream of the point where the flow exits out of the building into an open channel (See Site Plan).

Upstream wall between inlet structure and spillway.

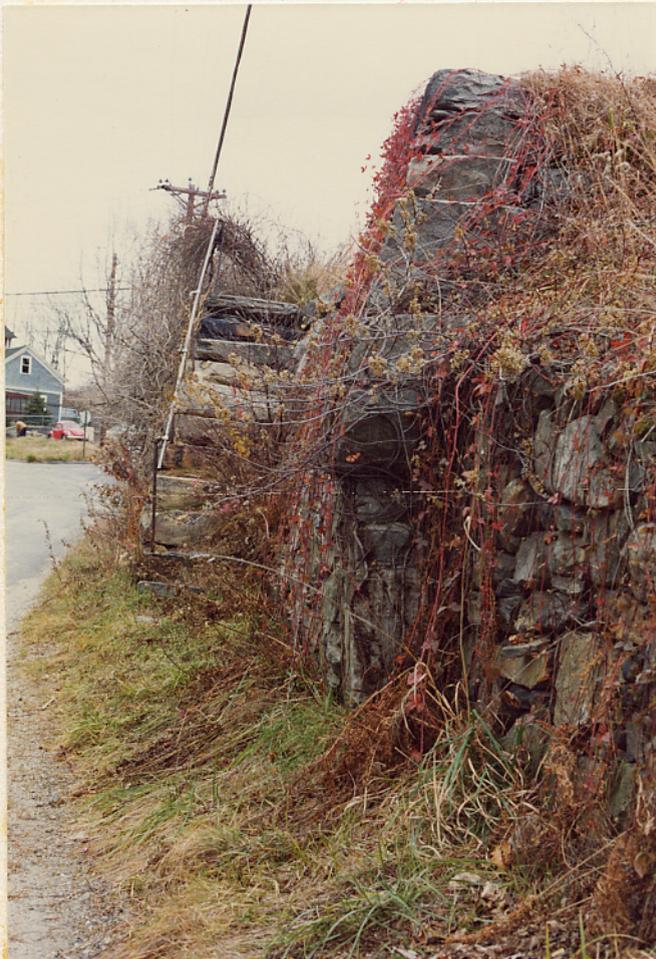
Photo 10

Downstream wall of dam at stairs left of spillway. Note bulging of wall at about third point from bottom.

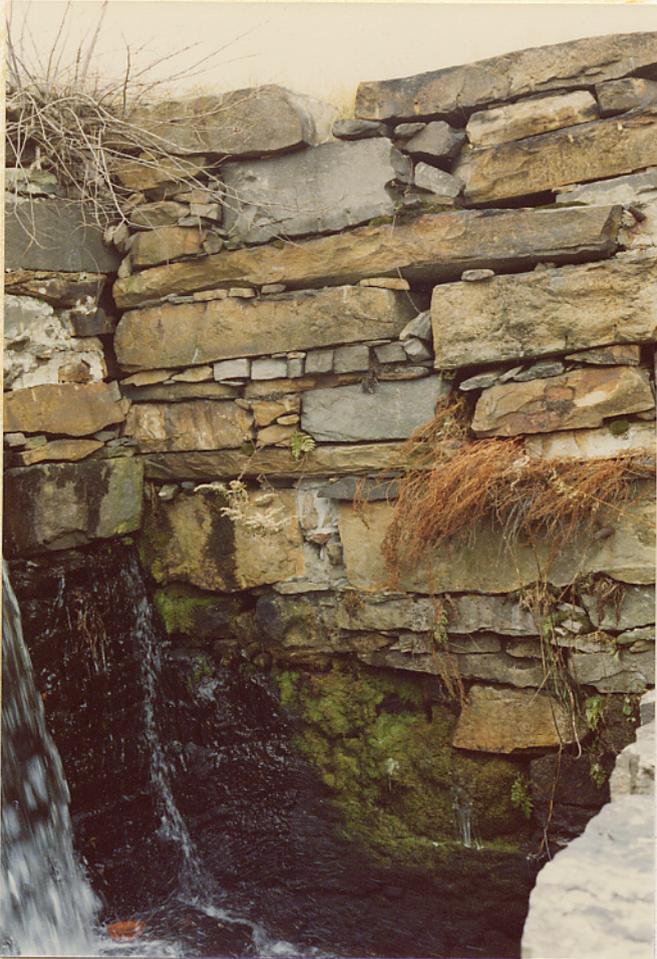
Photo 11

Left wall of spillway. Note leakage at corner of wall and downstream face of spillway.

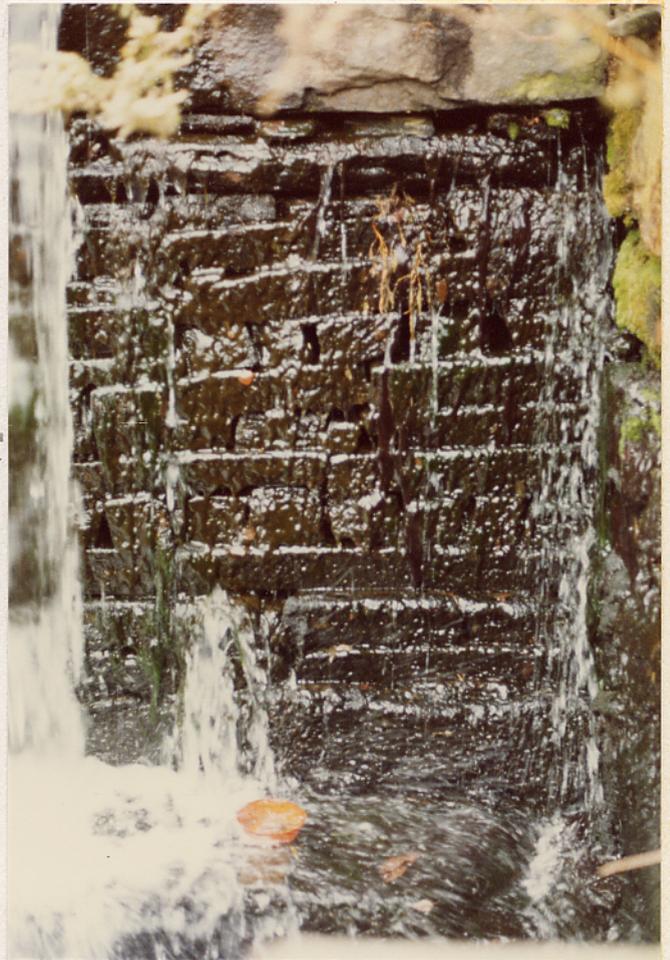
Photo 12

Closeup of leakage of left wall.

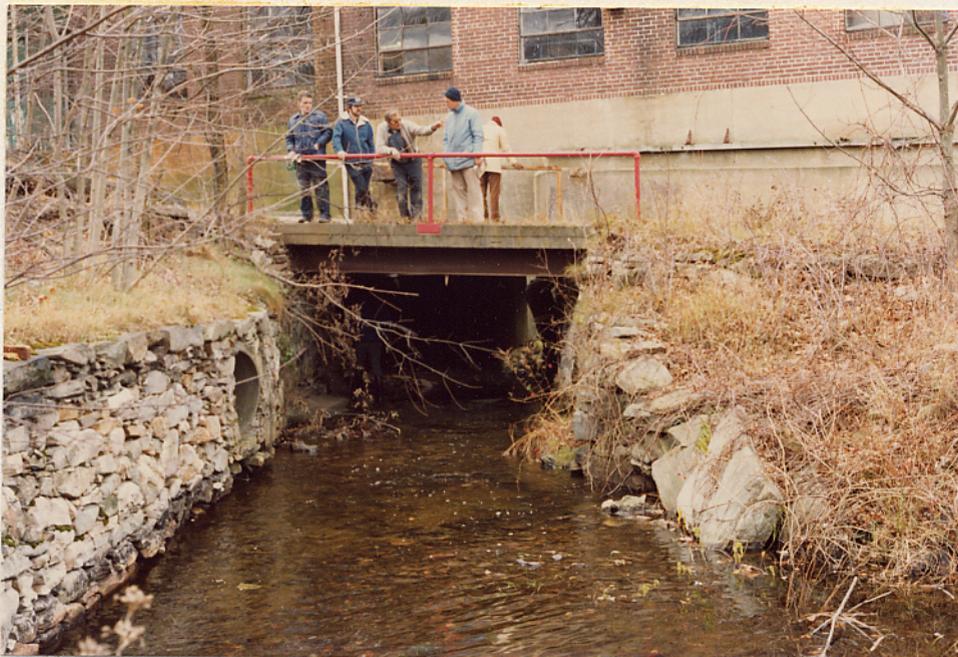
Photo 13. Outlet side of spillway discharge channel below mill building.
