**KENMERE RESERVOIR DAM**  
**CT - 00251**

**PHASE I INSPECTION REPORT**  
**NATIONAL DAM INSPECTION PROGRAM**

FEBRUARY 1980

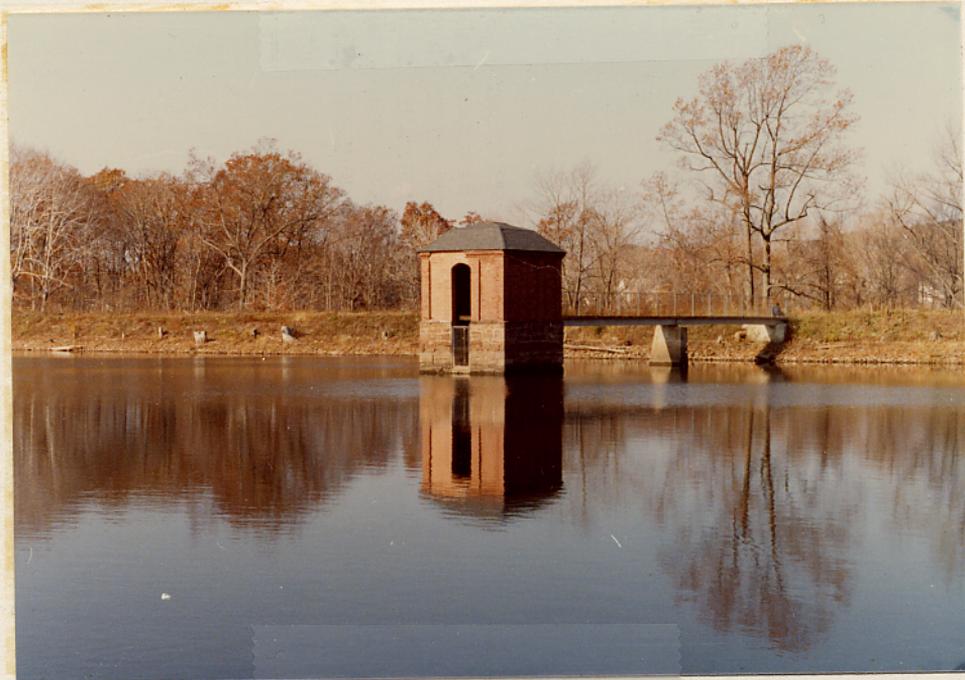
1) Upstream slope - The exposed part of the upstream slope of the main dam is partially covered with riprap. (Photo No. 1 and Photo No. 2) The riprap only extends approximately halfway up the slope from the reservoir surface and is missing or has been eroded away at many locations. Numerous tree stumps up to 3 ft. diameter were observed on the upstream slope. (as shown on Photo No. 3 and Photo No. 4)

PHOTO #1: Upstream face of dam from dike.

4) Design and oversee the repair of erosion on the upstream slope of the dam and the installation of required erosion protection measures.

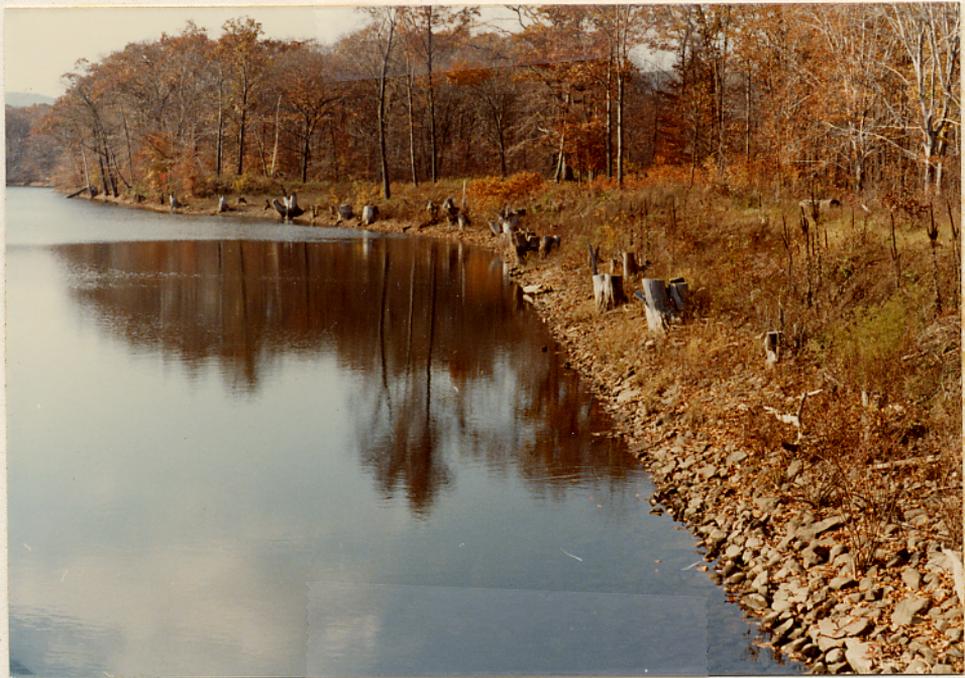
PHOTO #2: Upstream face of dam from gatehouse looking toward spillway.

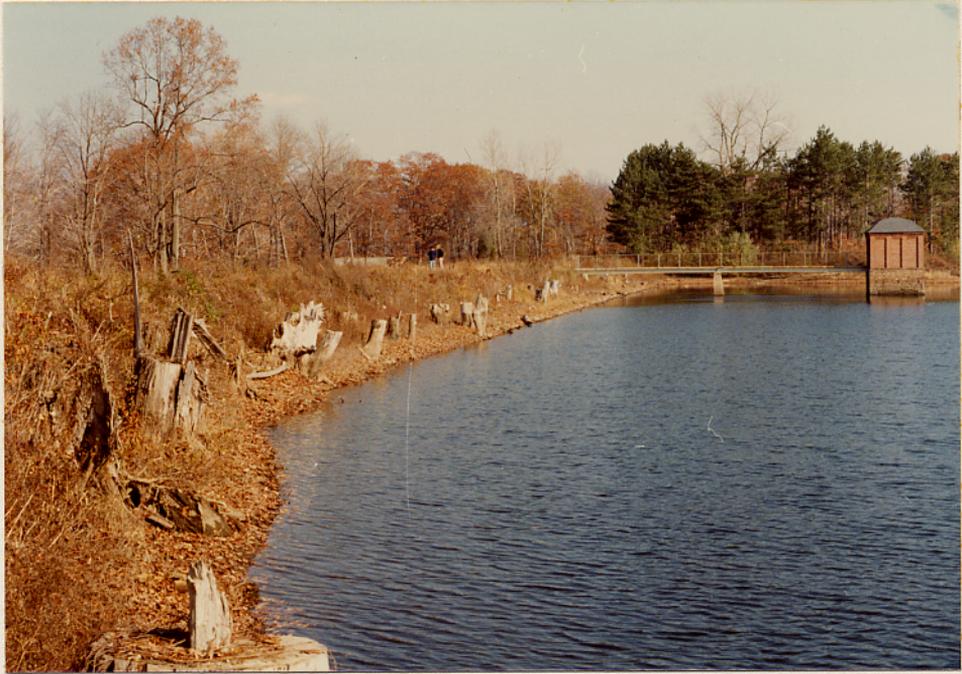
PHOTO #3: Upstream face of dam from vicinity of spillway.

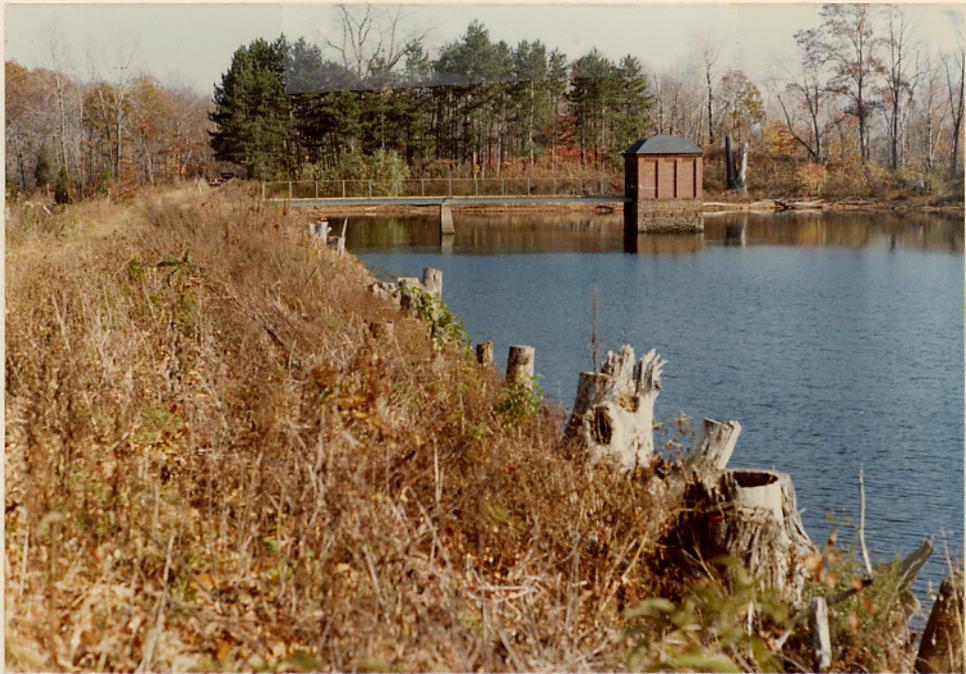
PHOTO #4: Upstream face and crest of dam from vicinity of spillway.

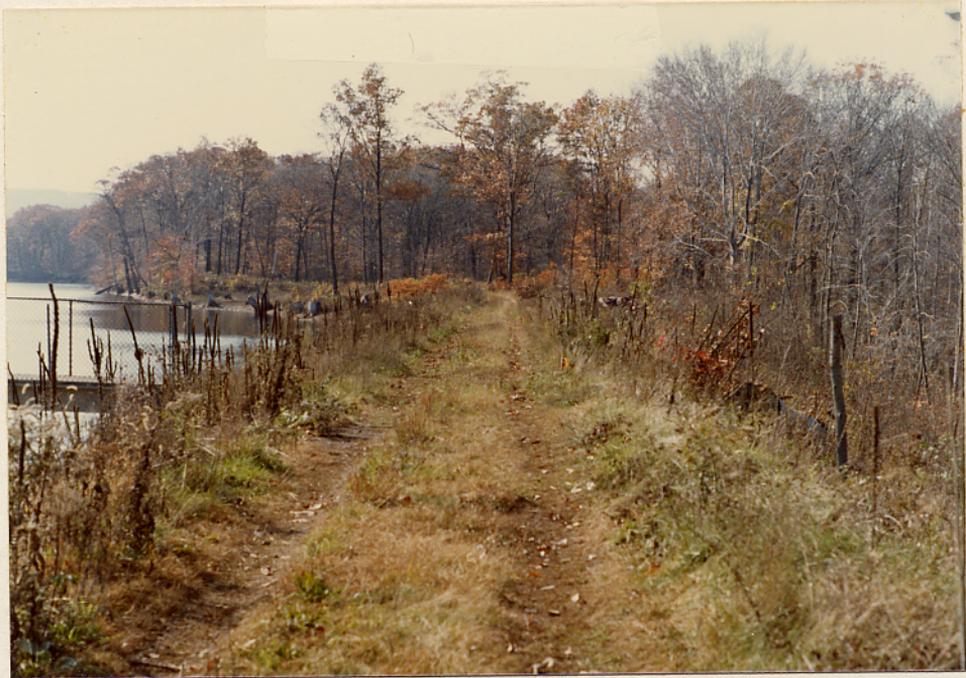
2) Crest - The crest of the dam appears fairly constant in elevation. Two paths which are partially bare of vegetation as a result of vehicular and pedestrian traffic can be seen in Photo No. 5. A hole approximately 12 inches square by 8 in. deep was observed on the crest near the service bridge foundation.

PHOTO #5: Crest of dam from right (north) abutment.

7) Specify and oversee procedures for establishing additional grassy vegetation and repair the erosion on the crest of the dam.

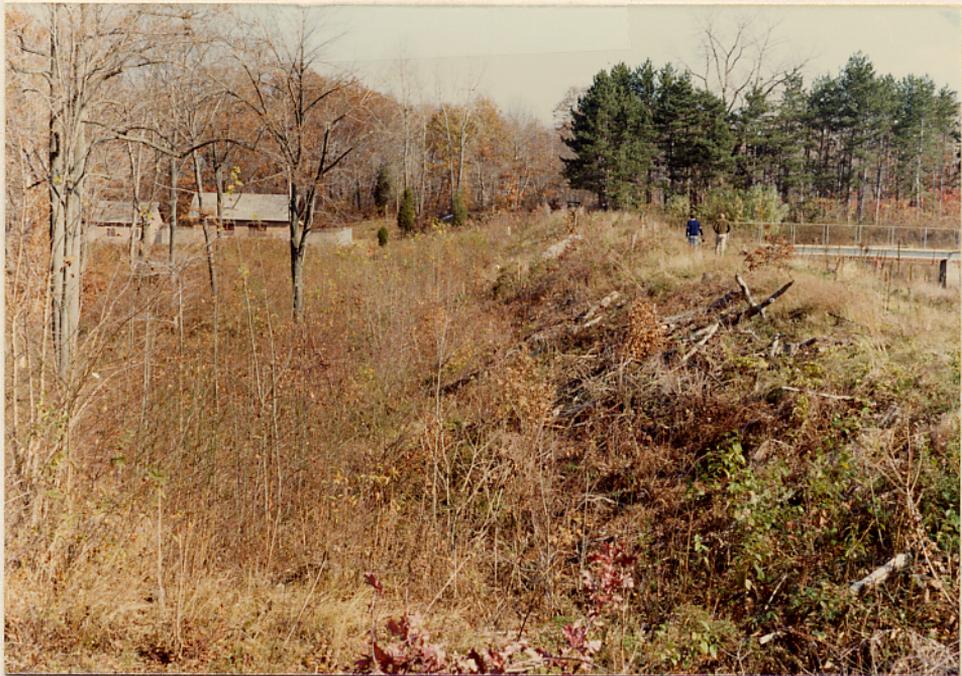
3) Downstream slope - The downstream slope is overgrown with brush, grass and tree stumps as indicated in Photo No. 6. The surface appears dry and firm. Some undulations of the surface may indicate previous sloughing. Occasional animal burrow holes were observed. The ground is wet and marshy downstream of the dam and along the toe, extending from the area adjacent to the pumping station at the right toe to the intersection of the dam with the left abutment. Ponded water at the downstream toe is shown in Photo No. 10. It appears that the source of the water may be a combination of seepage from the dam and surface water runoff that accumulates in the low area downstream of the dam. Water has ponded in several large pools downstream of the dam toward the spillway channel. The bed is carrying a sediment load of fine white sand in sufficient quantities to create small bed forms (dunes) as indicated in Photo No. 11. The sediment was recent enough to be burying fallen leaves. Despite considerable search in the field, no external source could be found.

PHOTO #6: Downstream slope looking toward right (north) abutment.

- 1) Inspect the downstream slope of the dam and dike after the grass, brush, weeds and brambles have been cleared.
- 2) The source of the discharge observed near the downstream

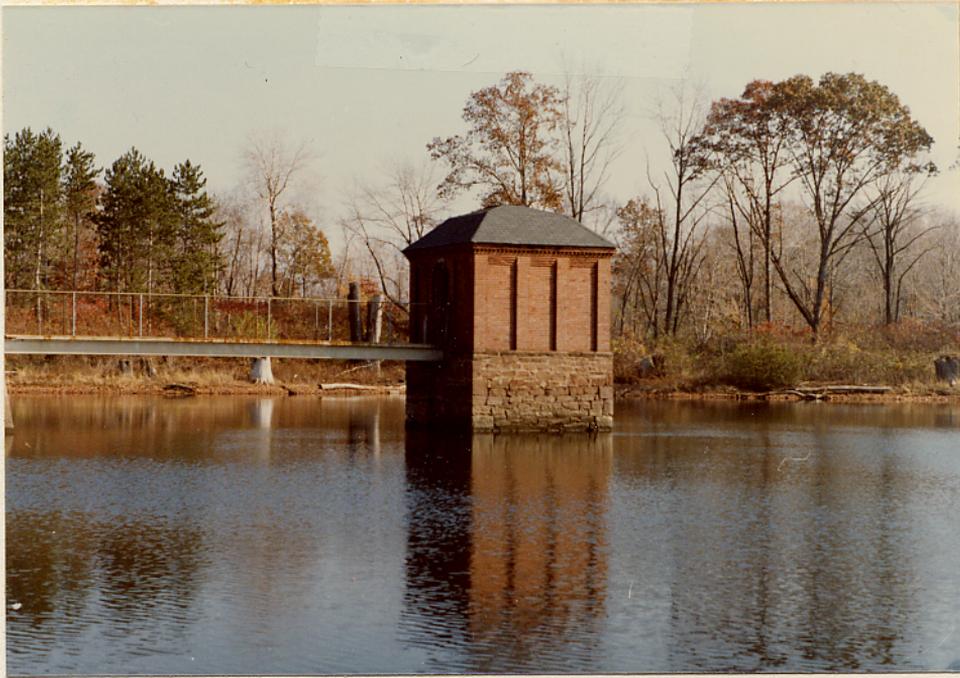
c. Appurtenant Structures. The freestanding control tower is in disrepair. The plywood floor is unsafe. Two valve stems without operator handles were observed extending to the floor.

f. Footbridge. The prestressed concrete T-beam that serves as the access bridge to the control tower is deteriorating and steel reinforcing bars are exposed. The bridge is in generally poor condition.

PHOTO #7: Gatehouse and service bridge.

5) Repair gatehouse and service bridge.

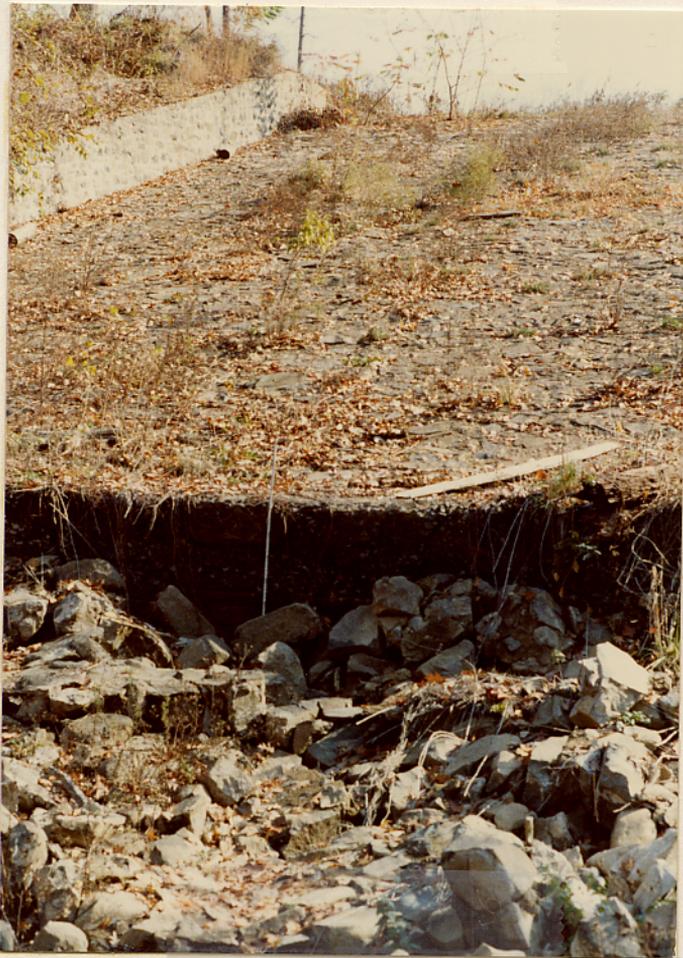
Four 6-foot-deep concrete cut-off walls were found crossing the channel downstream of the spillway. All have failed, and the degradation of the channel bed has continued below the bottom elevation of the cut-off walls.

PHOTO #8: Cutoff wall at end of downstream face of spillway. Rule extended 4 ft. to spillway channel surface.

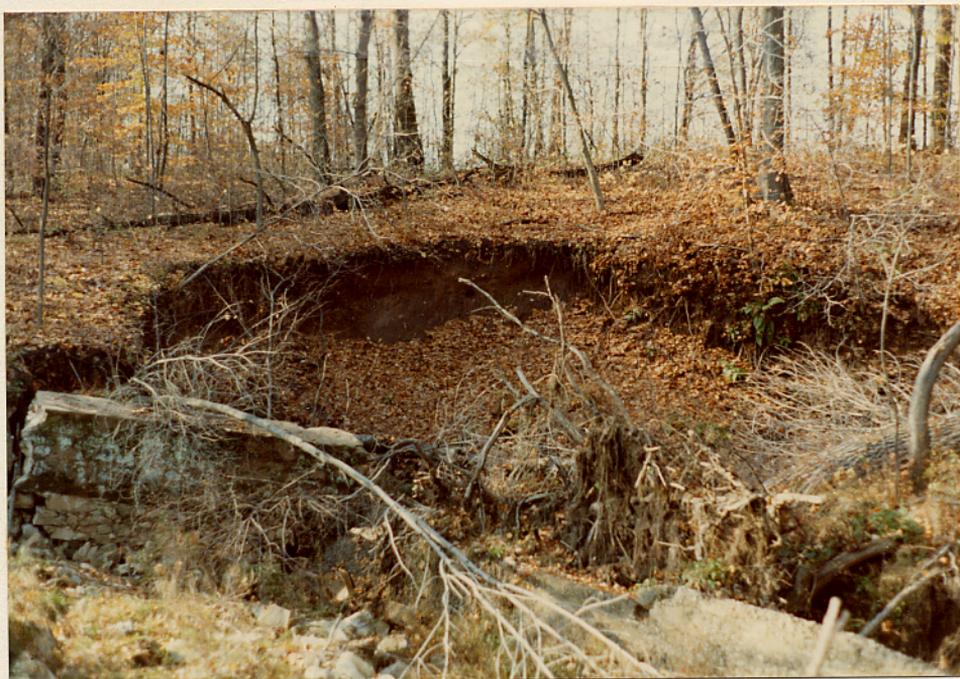
The visual observations did not disclose any evidence of present structural instability other than the slope failure adjacent to the left spillway training wall approximately 80 ft. downstream from the spillway crest.

PHOTO #9: Large bank failure. Lower spillway cutoff wall in the foreground.

3) Design and oversee the repair of the slope failure adjacent to the left spillway wing wall approximately 80 ft. downstream from the spillway crest. In addition, the failure of the stone paving located on the spillway channel bottom should be investigated and repaired. Repairs should be made to the spillway's left training wall and the erosion of the downstream channel must be controlled.

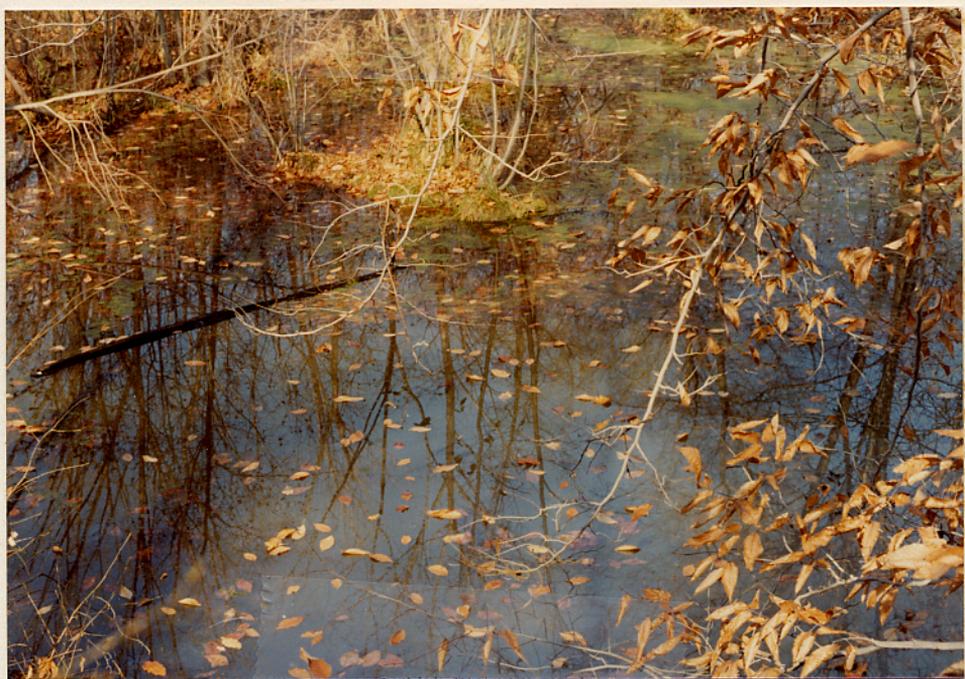
PHOTO #10: Large wet area at toe of downstream slope.

toe of the main dam and dike should be investigated and appropriate recommendations for remedial measures developed and implemented. The investigation should also determine the quality of seepage and turbidity associated with the discharge.

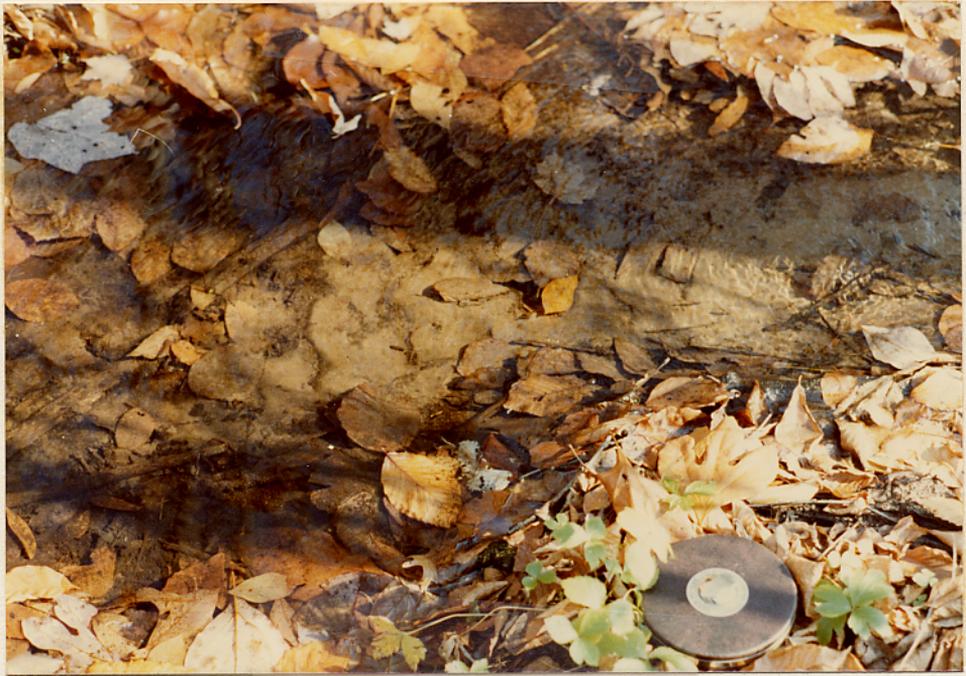
The discharges observed near the downstream toe of the main dam and dike showed some evidence of sediment transport and warrant further investigation.

PHOTO #11: Seepage at toe of slope. Note fine sand deposited.

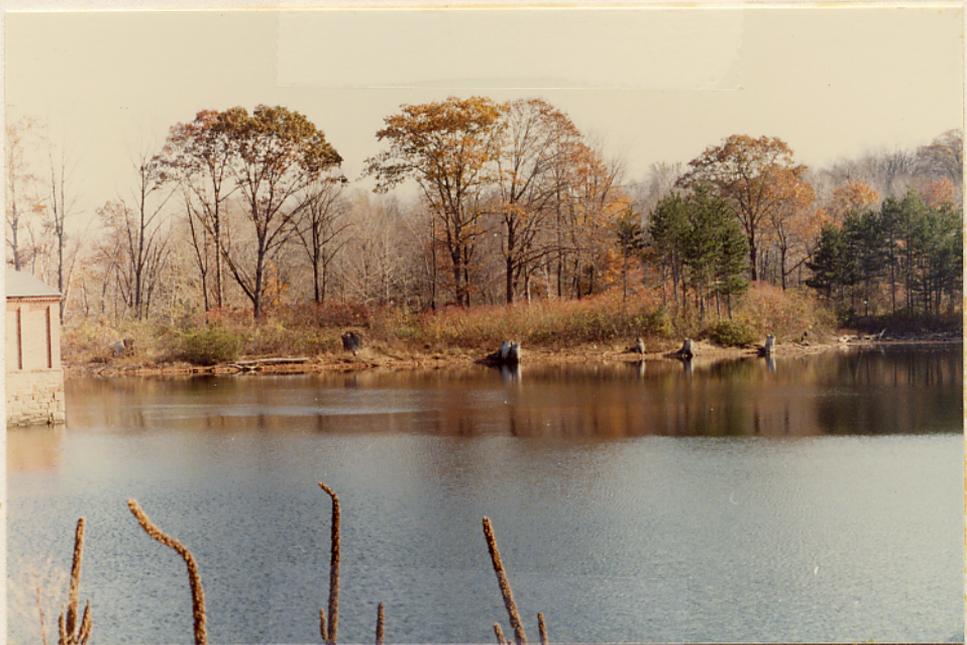
trees and stumps as shown in Photo No. 12. No riprap was observed on the upstream face. Photo No. 13 shows the unprotected earth face and a typical large tree stump that was noted. An access road traverses the crest of the dike as seen in Photo No. 14.

PHOTO #12: Upstream face of dike.

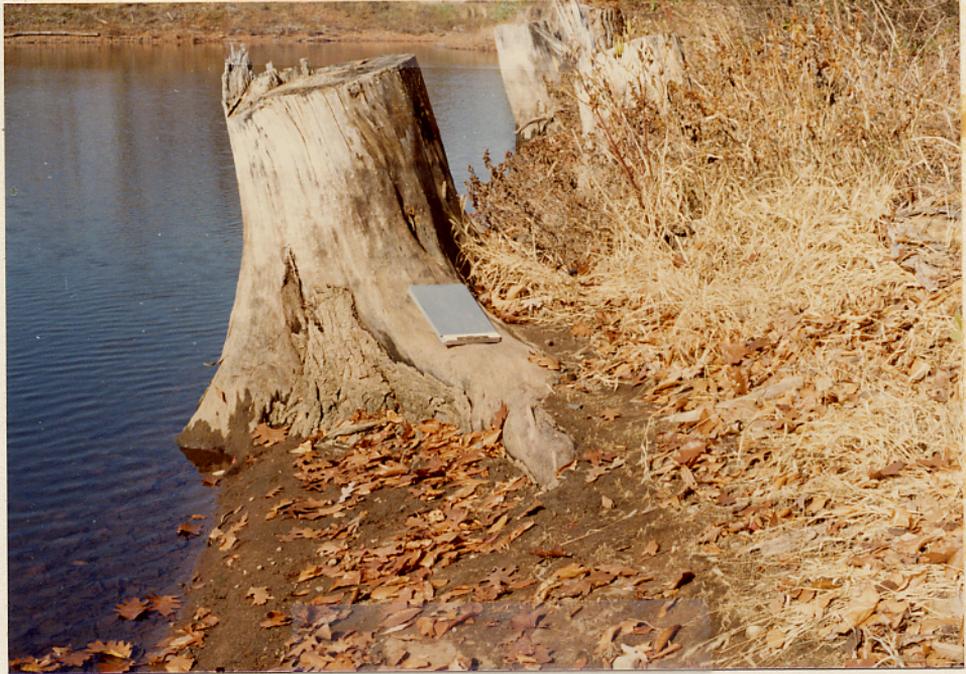
PHOTO #13: Upstream face of dike. No riprap protection.

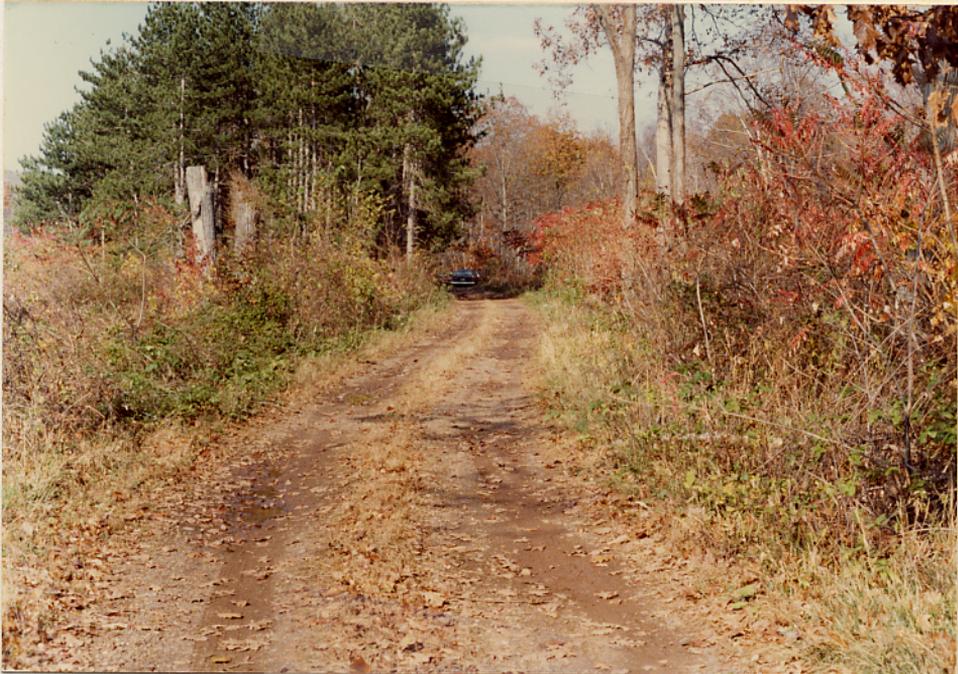
PHOTO #14: Crest of dike from right (east) side.

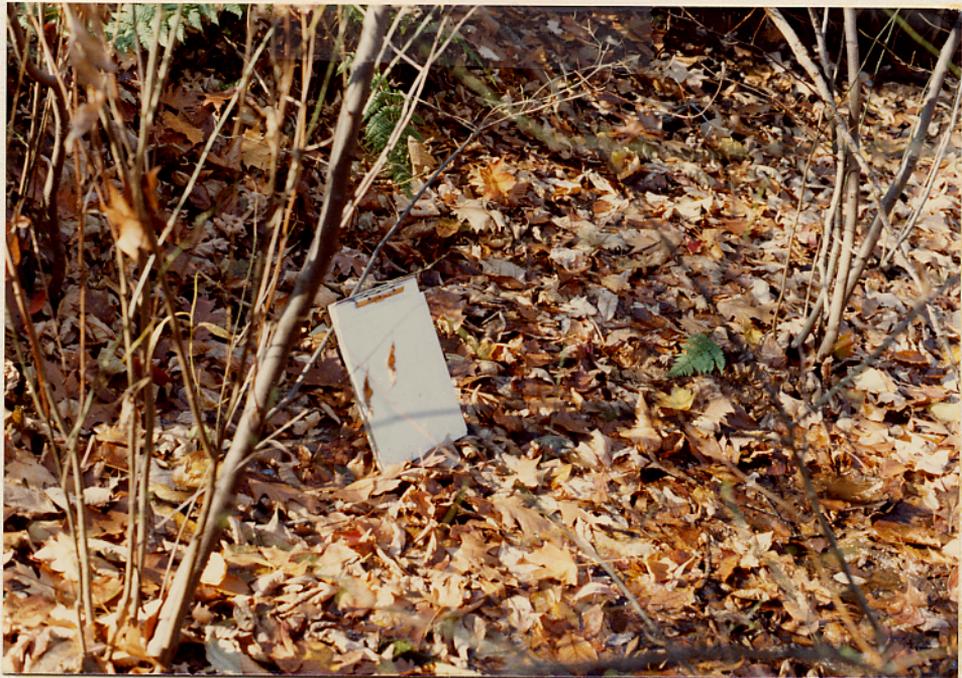
PHOTO #16: Toe of slope at Sta. D5+0. Standing and flowing water.

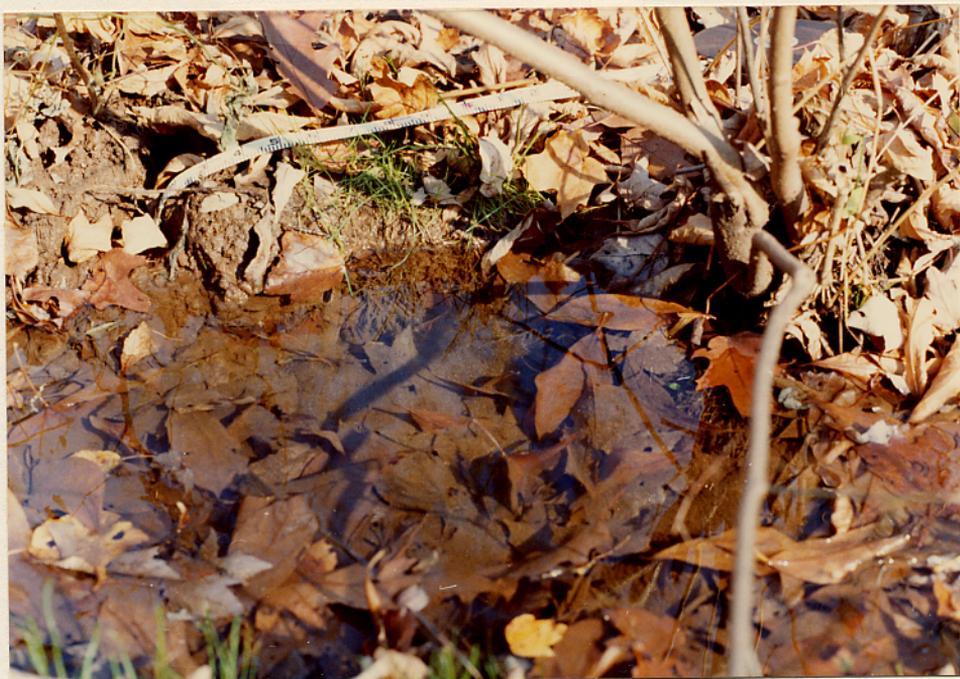
f. If the seepage velocities at the "boil" noted near the downstream toe of the dike are sufficient, soil particles may erode, forming a hole or "pipe".

PHOTO #17: Small spring approximately 20 ft. from toe.

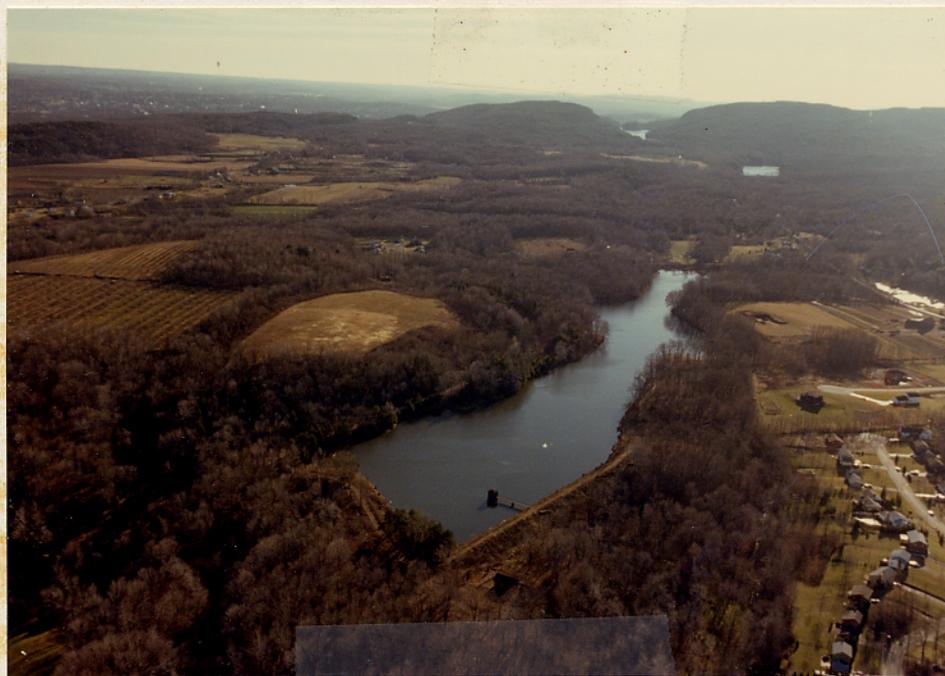
d. Reservoir Area. The land around the perimeter of the reservoir has a mild well vegetated slopes. No visible slides or unstable slopes were observed. (see Photo No. 18.) The reservoir did not have any visible deposits of sediment.

PHOTO #18: Reservoir Area.
