**CONNECTICUT RIVER BASIN
PLYMOUTH , CONNECTICUT**

OLD MARSH POND DAM

CT 00285

**PHASE I INSPECTION REPORT
NATIONAL DAM INSPECTION PROGRAM**

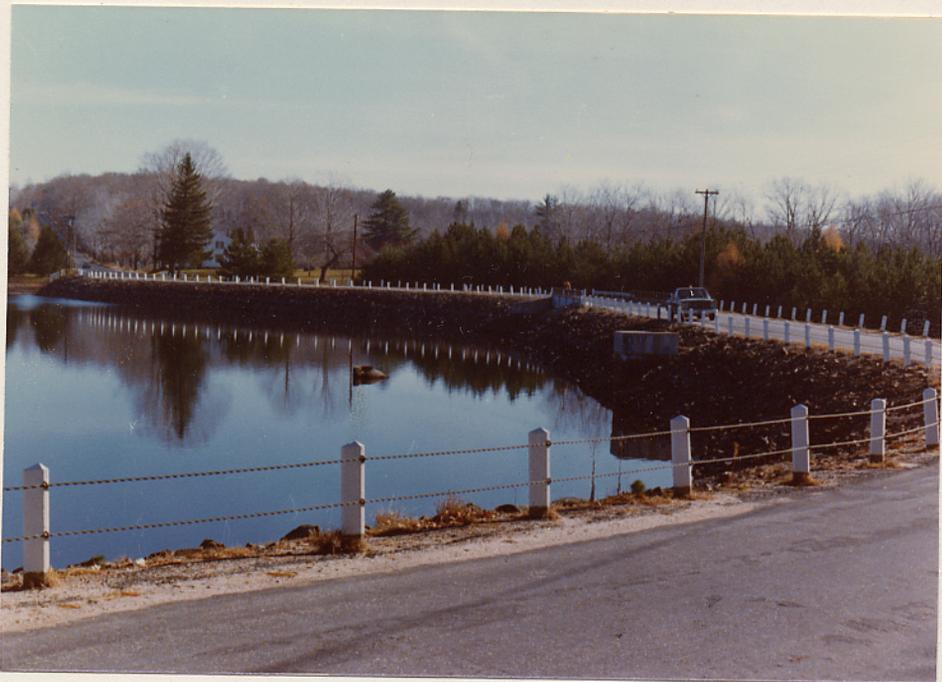
Overview of dam from right abutment of dam.

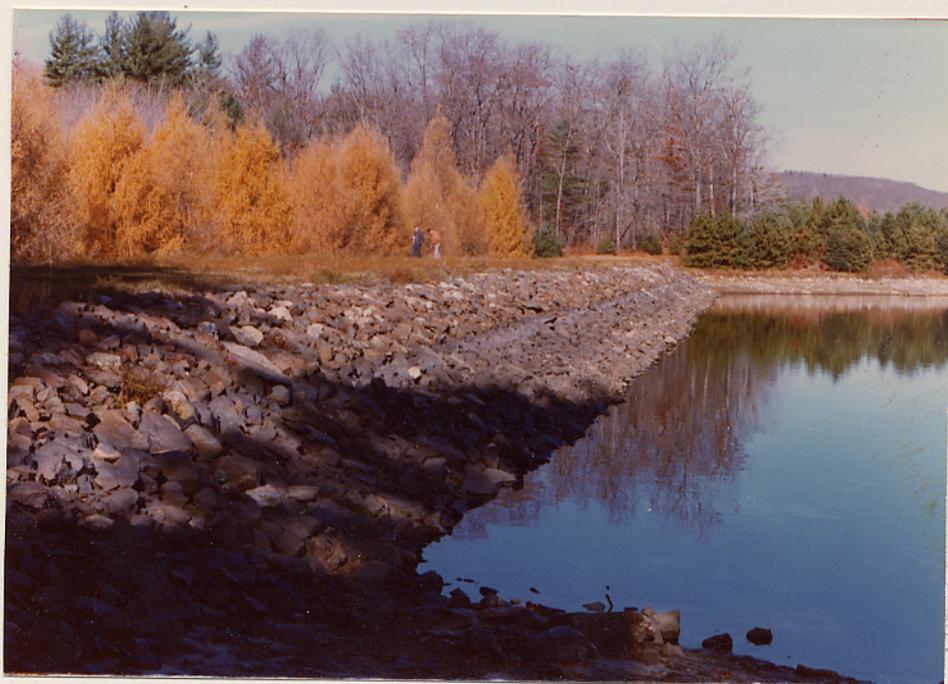
Overview of closure dike from left abutment of dike.

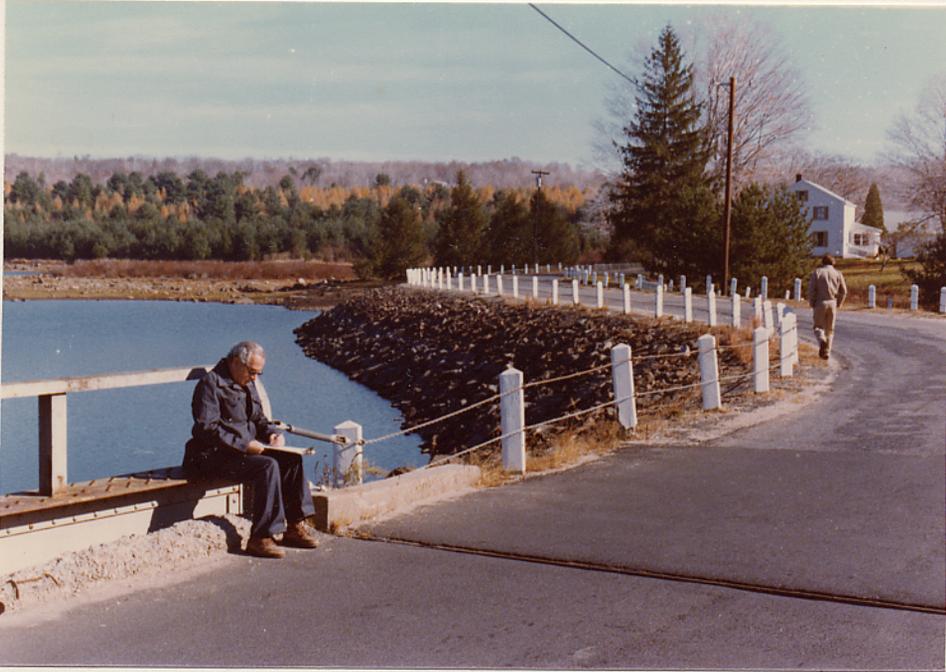
The crest of the dam is a well travelled paved roadway which is in good condition (Appendix C, Photo No. 1).

1. Upstream slope left of spillway bridge.

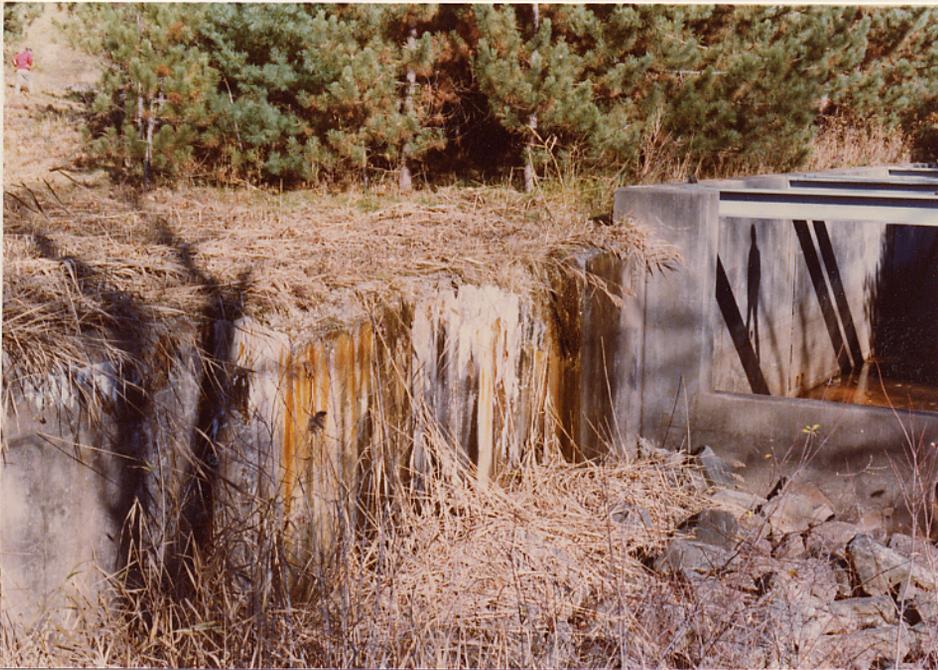
stilling basin. When it reaches the end of the spillway channel, the flow issues from a boggy plateau and cascades over a concrete retaining wall adjacent to the spillway stilling basin wall. Additional seepage comes from the side of the wall, and the combined flow was estimated to be about 5 gpm. The top of this wall is badly deteriorated, probably due to freezing and thawing action from the seepage overtopping the wall. The line of seepage from the dam coincides with the alignment of the water supply line, and a swath some 20 ft. wide has been cut in the growth for the full length of the pipe. (Appendix C, Photo Nos. 2, 3 & 4) According to the Water Department's representative, this marshy area and its seepage was present, in about the same condition, as long ago as 1968.

2. Seepage over wall below stilling basin.

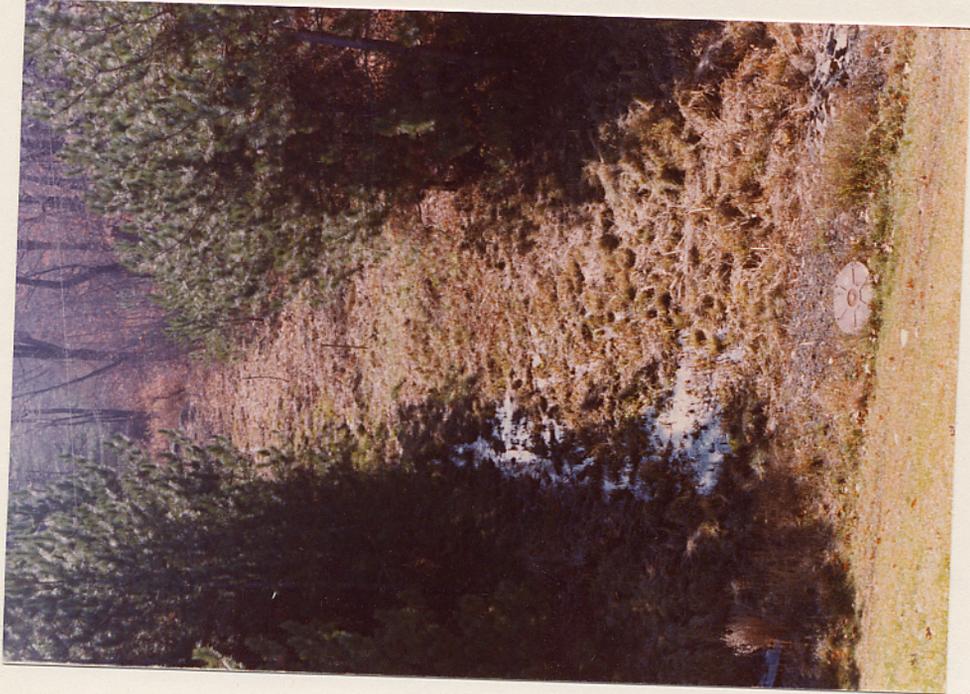
Both the main dam and closure dike were judged to be in good condition. There was no evidence of any major maintenance problems. Fairly heavy seepage was noted in the vicinity of the original stream channel below the dam, but its source was not determined.

4. Valve chamber at downstream toe and seepage in old stream bed.

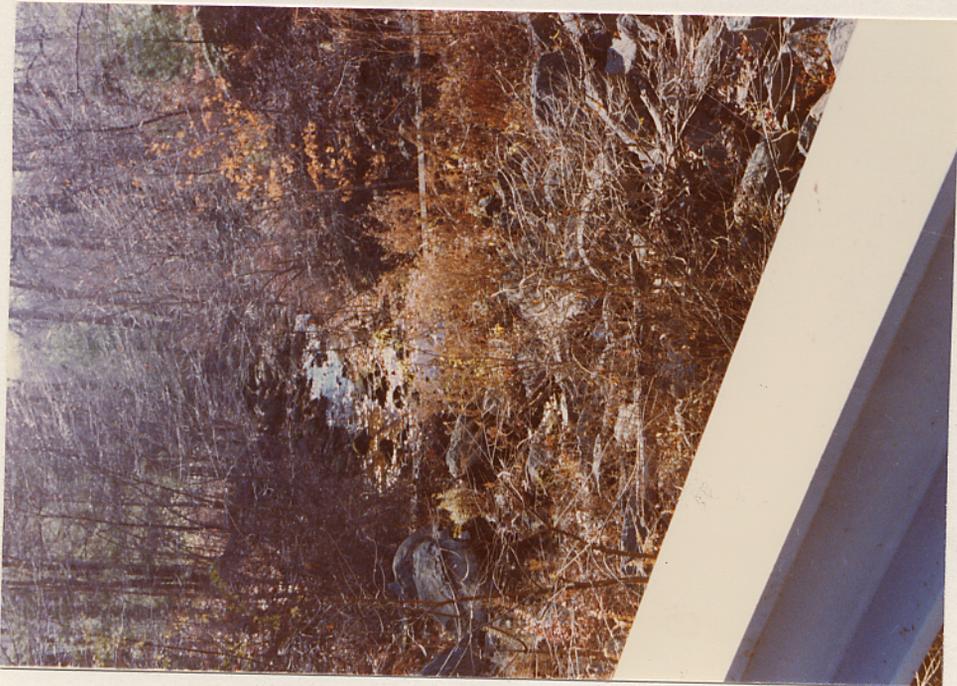
3. Downstream channel from spillway stilling basin.

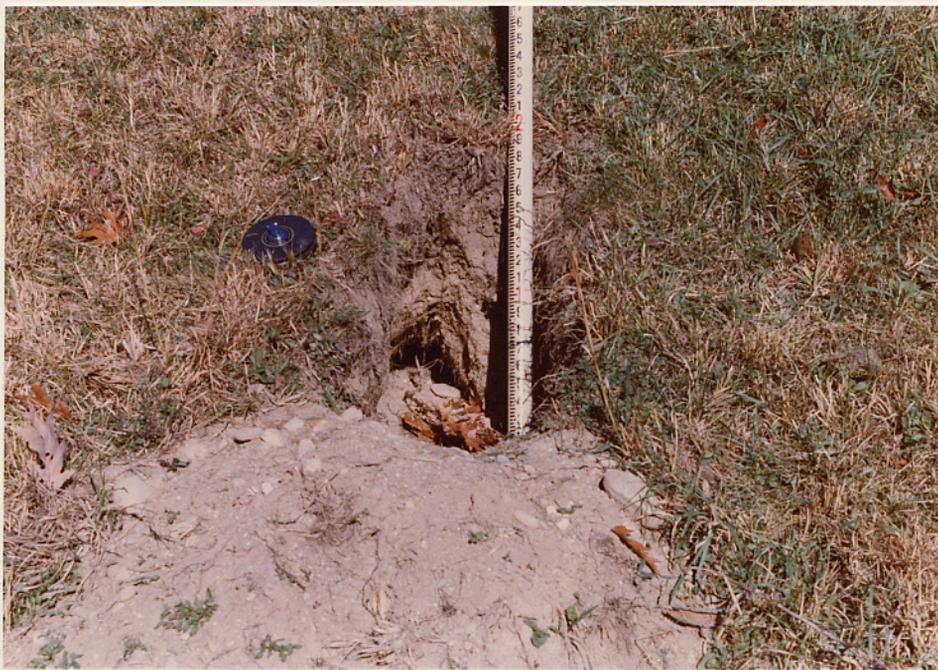
5. Animal burrow on downstream face.

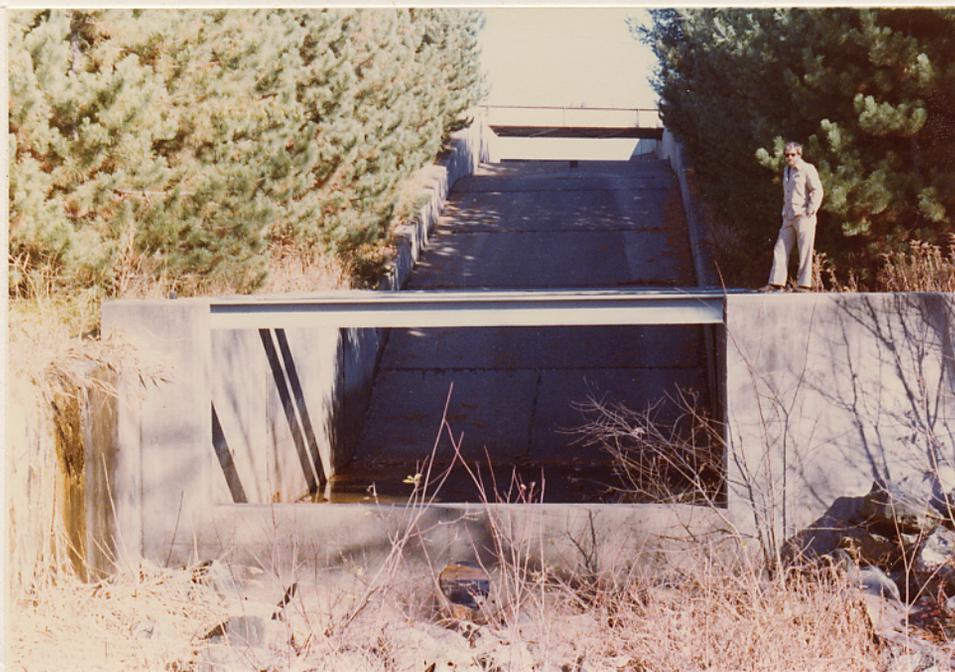
Except as noted below, the spillway alignment appears to be good and concrete surfaces appear to be in good condition. No cracks or spallings of consequence were detected (Appendix C, Photo No. 6).

6. Spillway channel and stilling basin.

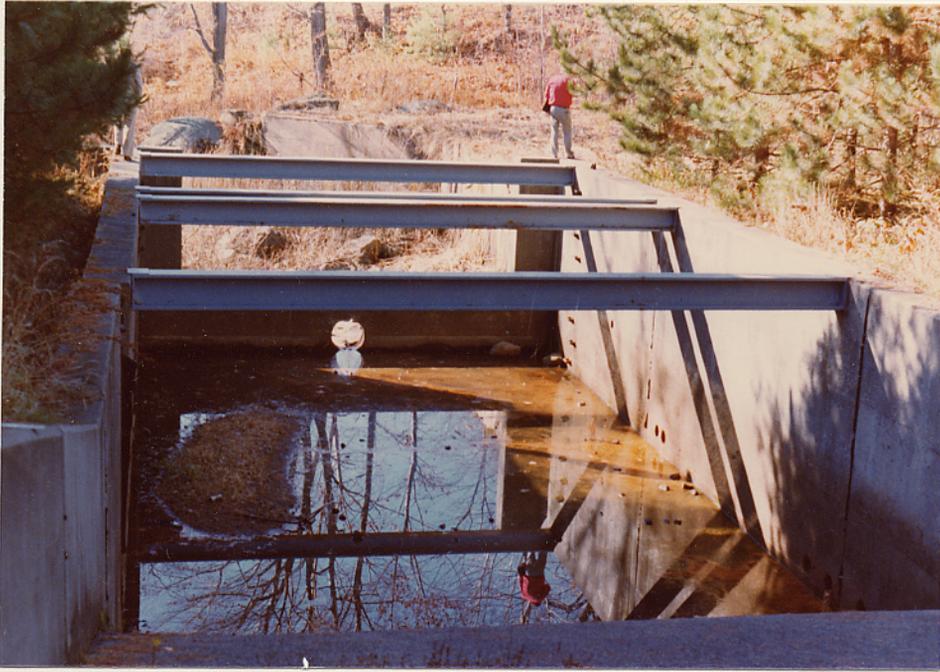
7. Spillway stilling basin.

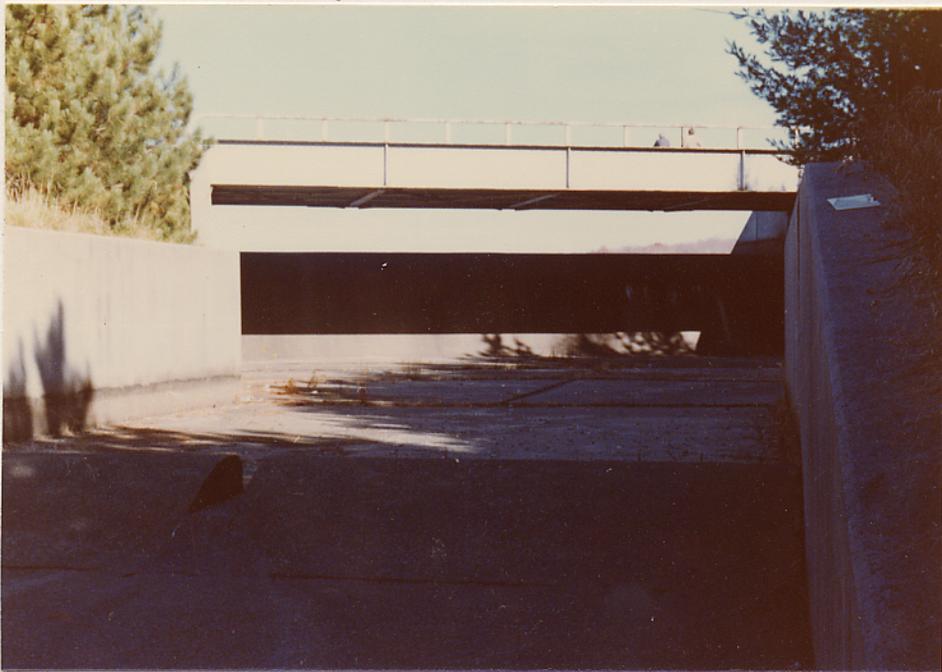
8. Spillway channel with retarding sill.
