HOUSATONIC RIVER BASIN
NEWTOWN, CONNECTICUT

ROCKY GLEN DAM
CT 00310

PHASE I INSPECTION REPORT
NATIONAL DAM INSPECTION PROGRAM

JANUARY 1980

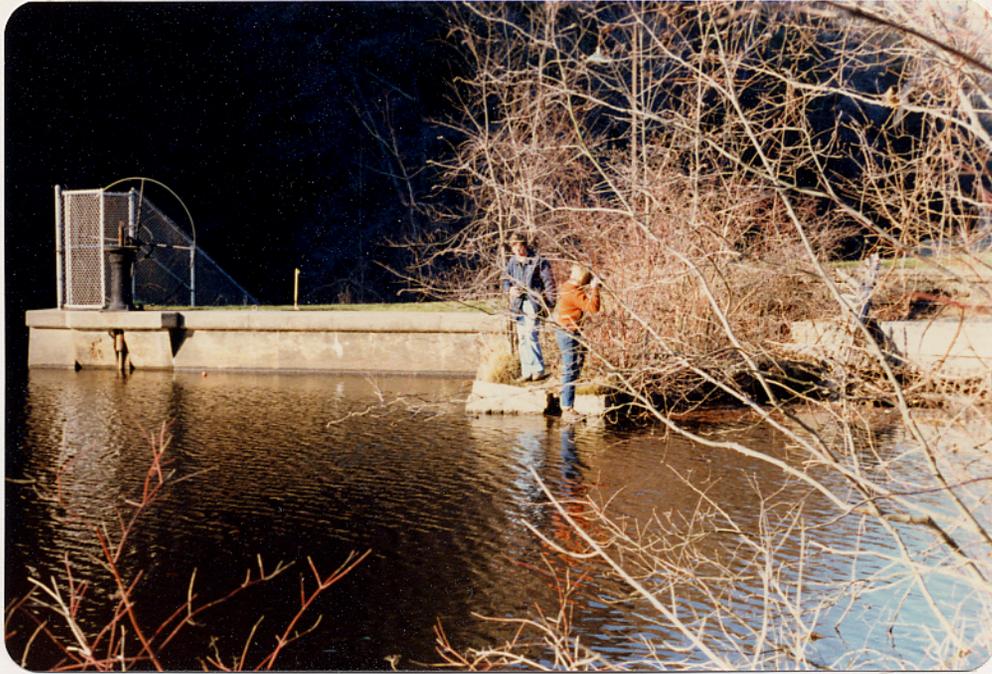
PHOTO NO. 1

The exposed portion of the upstream concrete wall is in good condition with minor cracking and efflorescence as shown in Photo 1. The crest and downstream slope are grass covered and show no signs of erosion. There are some bushes and small trees growing on the downstream-slope against the right spillway training wall. The downstream slope appears dry with no evidence of seepage. Some bushes are growing on the crest.

BLOWOFF INLET ON THE LEFT, CANAL INLET ON THE RIGHT
UPSTREAM CONCRETE FACE OF DAM

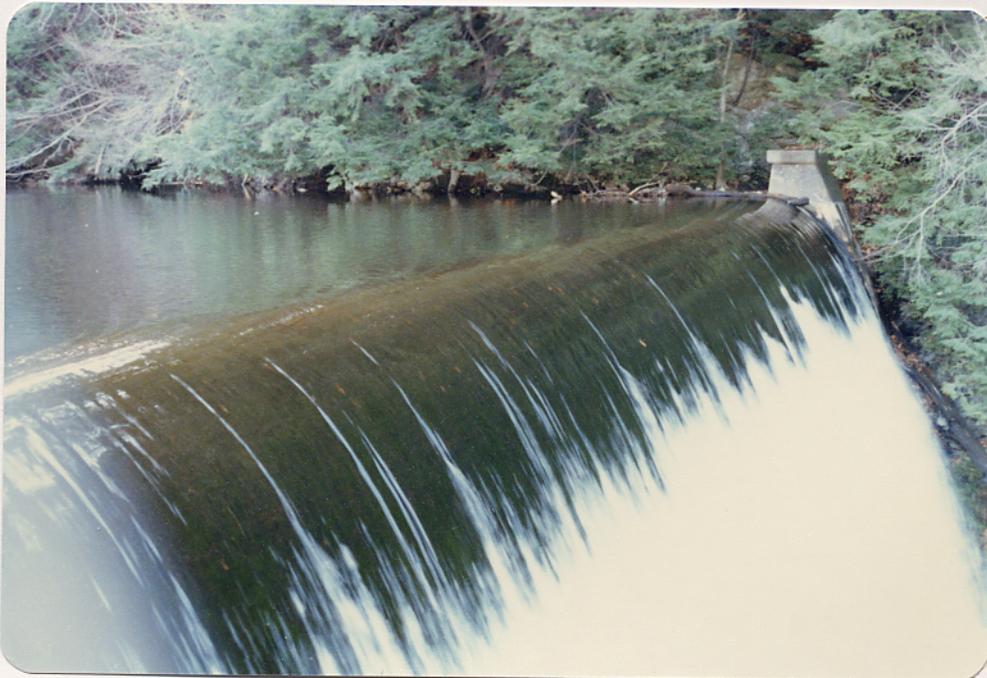
PHOTO NO. 2

SPILLWAY FROM RIGHT
TRAINING WALL

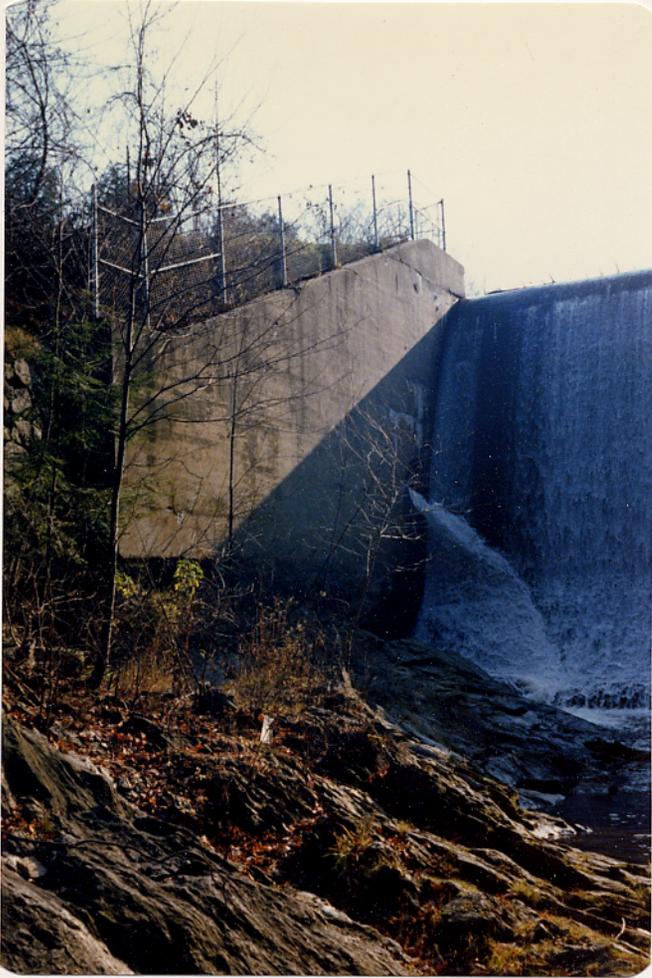
PHOTO NO. 3
 RIGHT TRAINING WALL

indicating the concrete at the crest to be in good condition. The right training wall consists of a concrete section and a dry stone masonry section, Photo 3. The concrete shows some deterioration in the lower part of the wall, Photo 4. Some minor cracking and efflorescence is present near the outlet to the blowoff. Erosion has occurred at the base of both the concrete and dry stone masonry walls, as shown in Photo 5. Some seepage was observed from the cavity at the base of stone wall but no soil transport was apparent. Minor cracking and efflorescence is also present at the concrete wall which connects the spillway section to the left abutment.

The right training wall of the spillway has been undermined and could in the future collapse under further erosion. Trees growing on the downstream slope of the dam at the top of the training wall increase the pressure against the wall and could cause damage to it.

- 1) Trees growing on the downstream slope next to the right spillway training wall should be removed. The bar screen for the intake structure to the power canal should be cleaned and the wood deck repaired.
- 2) A program of technical inspections by qualified registered engineers once every two years should be instituted. Records of findings and recommendations should be maintained.
- 3) A formal operations and maintenance manual for the dam and operating facilities should be prepared.
- 4) A formal warning system should be put into effect, and should include monitoring of the dam during extremely heavy rains; and procedures for notifying downstream authorities in the event of an emergency.

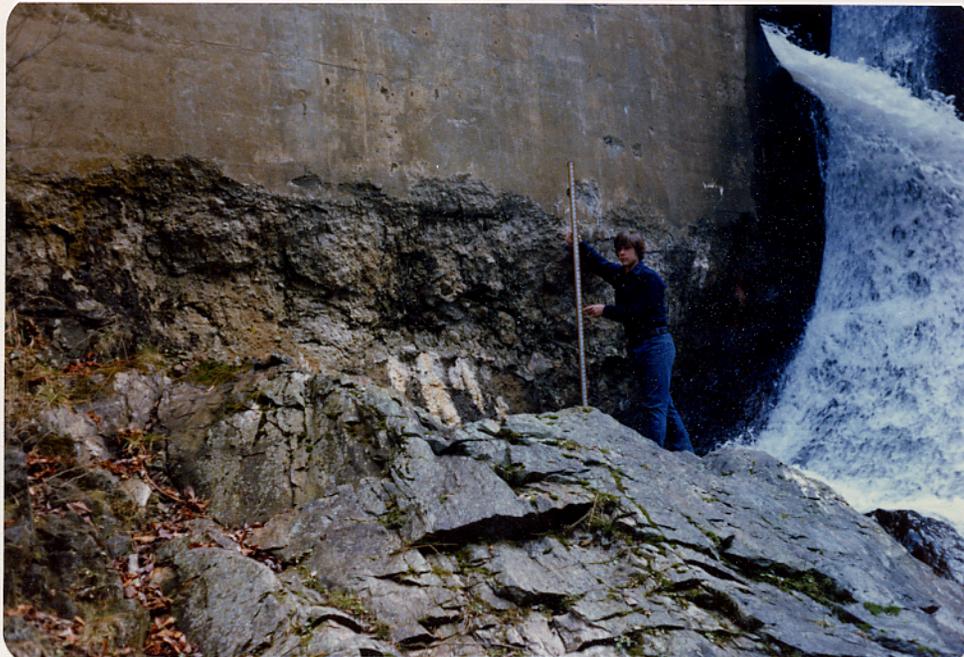
The present operational and maintenance procedures are inadequate as is evident from the erosion at the base of the right spillway training wall and the condition of the canal intake structure.

PHOTO NO. 4
 CONCRETE EROSION
 AT BASE OF RIGHT
 TRAINING WALL

- a) Perform further studies to determine the adequacy of the spillway discharge capacity.
- b) Investigate the ability of the non-overflow section of the dam to withstand overtopping and evaluate the stability of the overflow section of the dam under increased loads; or to provide for additional spillway capacity if the studies performed under a) indicate that the spillway capacity is insufficient.
- c) Investigate the cause of the concrete erosion at the base of the right training wall and oversee repairs.
- d) Inspect the spillway and downstream toe during a no flow condition.

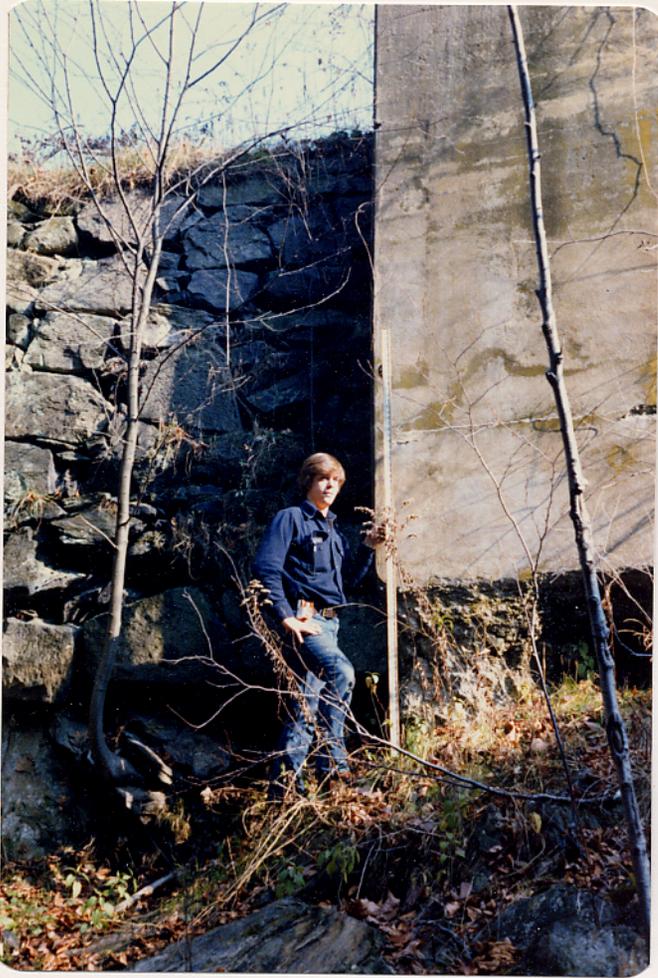
PHOTO NO. 5

UNDERMINING AT BASE
OF RIGHT TRAINING
WALL

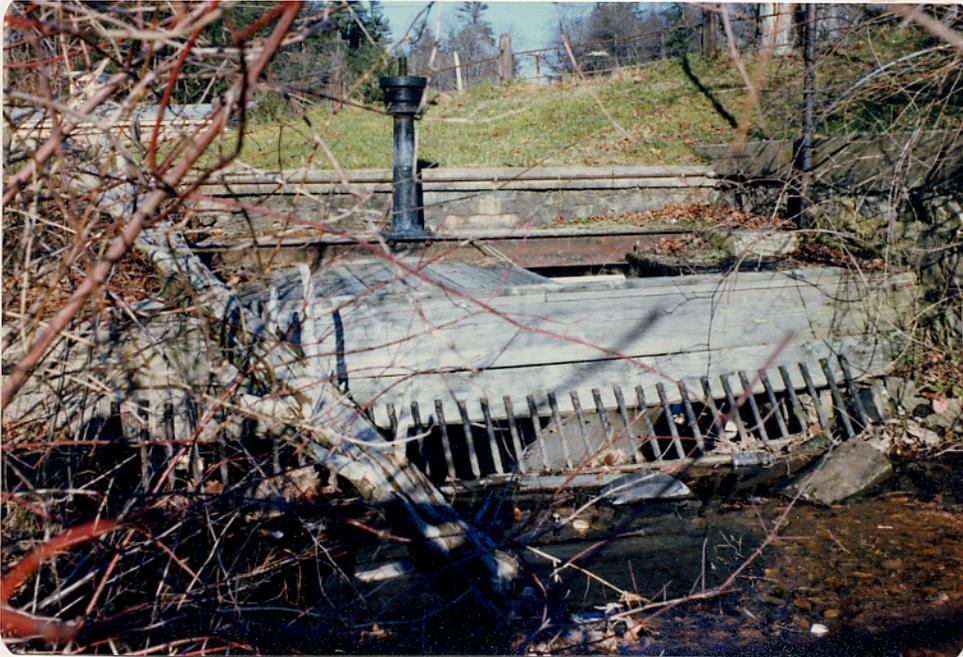
PHOTO NO. 6

The deteriorated wood deck and clogged bar screen of the power canal intake structure could hamper its use.

Water has not been drawn from the impoundment for the past two years.. No maintenance has been performed on the canal intake structure during this period (Photo No. 6). The blowoff gate and operating stem were repaired approximately eight years ago after a log had jammed in the gate.

COMMENTS: Wood deck of intake structure deteriorated.

INTAKE STRUCTURE
TO POWER CANAL

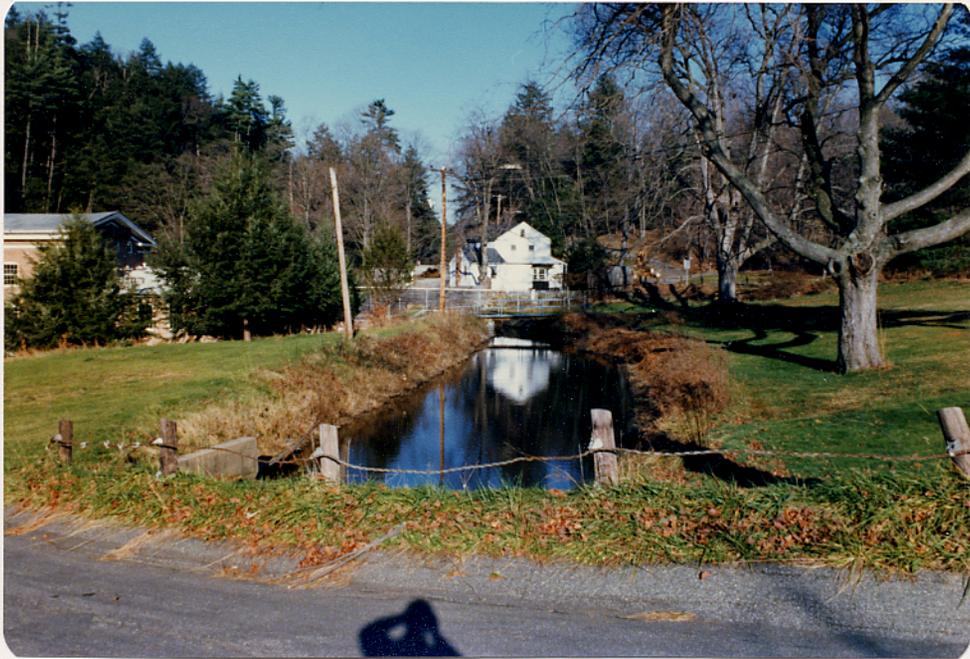
The intake structure for the canal is located to the right of the dam. Water flows from the intake structure through a conduit under the access road and into the canal. The concrete and stone masonry intake structure appears to be in good condition but the wood deck is deteriorated and the bar screen clogged with debris, Photo 6. The manual operator that controls the 6'-6" x 5'-0" sluice gate is reported to be in working condition. The canal is formed by an earth dike at the left side and the abutment along the right side. The dike shows no apparent seepage. The downstream slope is covered with grass, bushes, and a few trees, Photo 7.

PHOTO NO. 7
CANAL FROM ACCESS ROAD

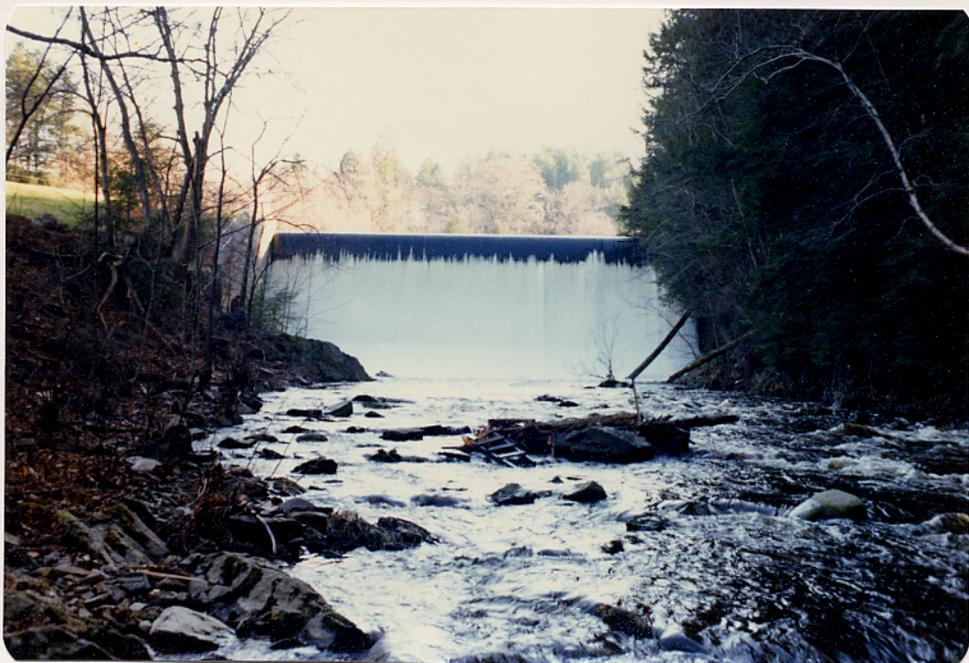
PHOTO NO. 8
SPILLWAY AND CHANNEL
FROM DOWNSTREAM
