CORNELIS DAM

CT 00293

**PHASE 1 INSPECTION REPORT
NATIONAL DAM INSPECTION PROGRAM**

**DEPARTMENT OF THE ARMY
NEW ENGLAND DIVISION, CORPS OF ENGINEERS
WALTHAM, MASS.**

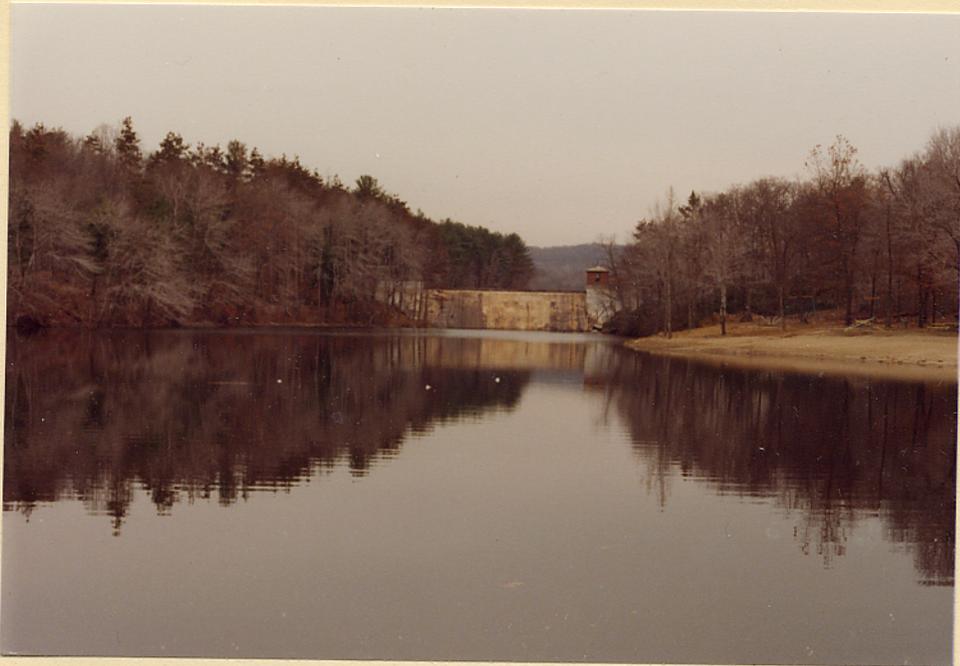
The Woodtick Reservoir Dam is located approximately 800 feet upstream of the dam and failure of this upstream dam would create a potential hazard at the Cornelis Dam (Photo C-2).

C-2 WOODTICK RESERVOIR DAM (CT 294) -
LOOKING NORTH

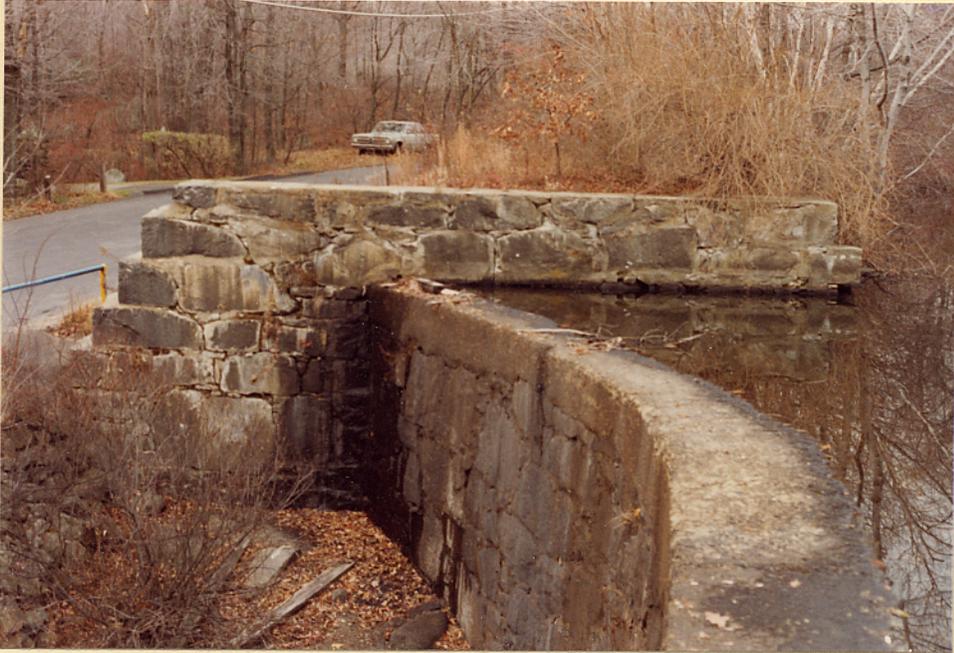
1. **Western Spillway:** This spillway is constructed of stone masonry and is a 57 foot long by 6 foot wide broad crested weir. (Photos C-3 and C-4.) Mortar is missing from many of the joints and there is clear seepage (approximately 1 to 2 gallons per minute) through the stone joints near the west abutment (Photo C-7). There is also clear seepage at the bottom of the spillway and west abutment. The quantity of this seepage was approximately 1 gallon per minute. Grass and moss is growing from many joints on the spillway and abutment. The west abutment is also stone masonry with many open joints and missing stones (Photo C-3). The weir is capped with concrete which is cracked and spalled. There are two small trees and brush growing between the spillway and the road.

C-3 WEST END OF WEST SPILLWAY - LOOKING FROM CENTER ABUTMENT

- a. A detailed hydrologic/hydraulic investigation to determine the need for and means of increasing the discharge capacity of the project.
- b. The removal of the trees and their respective root systems on the embankments, below the spillways to the road, and at the upstream end of the east abutment; and the backfilling with suitable compact material.
- c. The upstream face be visually inspected.
- d. The vegetation should be removed from the joints and the joints repointed on the downstream face of the west spillway.
- e. The missing stones replaced and the joints repointed at the west abutment.

- f. The seepage on the downstream face of the west spillway and abutment should be investigated to determine its potential impact on the integrity of the dam and repairs designed as necessary.

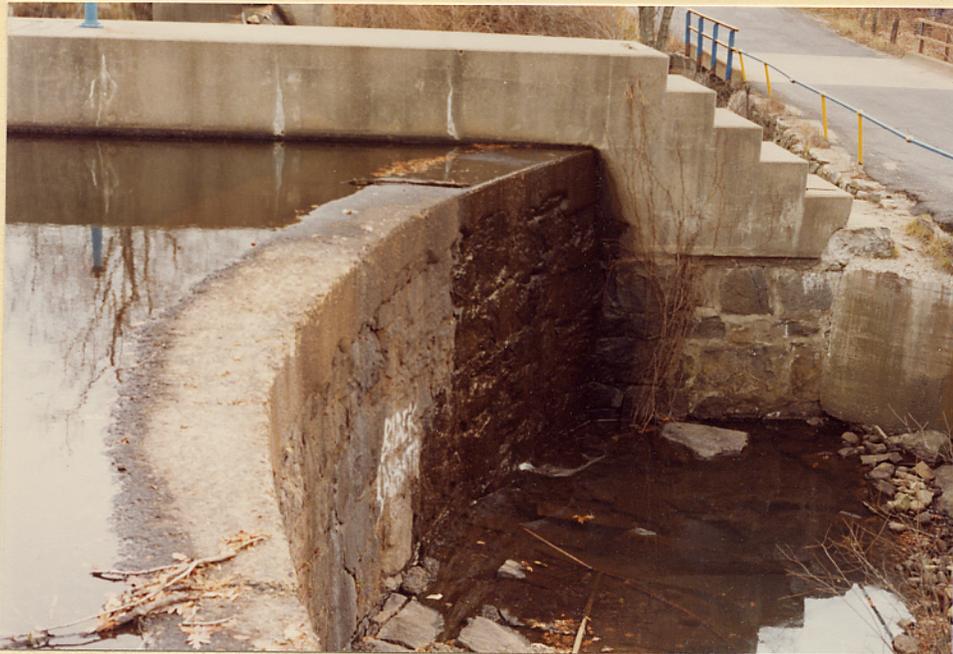
3. **Central Abutment:** The concrete central abutment contains three minor cracks (1/16 inch) which extend from one side, across the top, and down the other side. These cracks correspond to the efflorescence noted on both sides (Photos C-4 and C-5). Other than these cracks, the structure is in good condition.

C-4 EAST END OF WEST SPILLWAY - LOOKING EAST

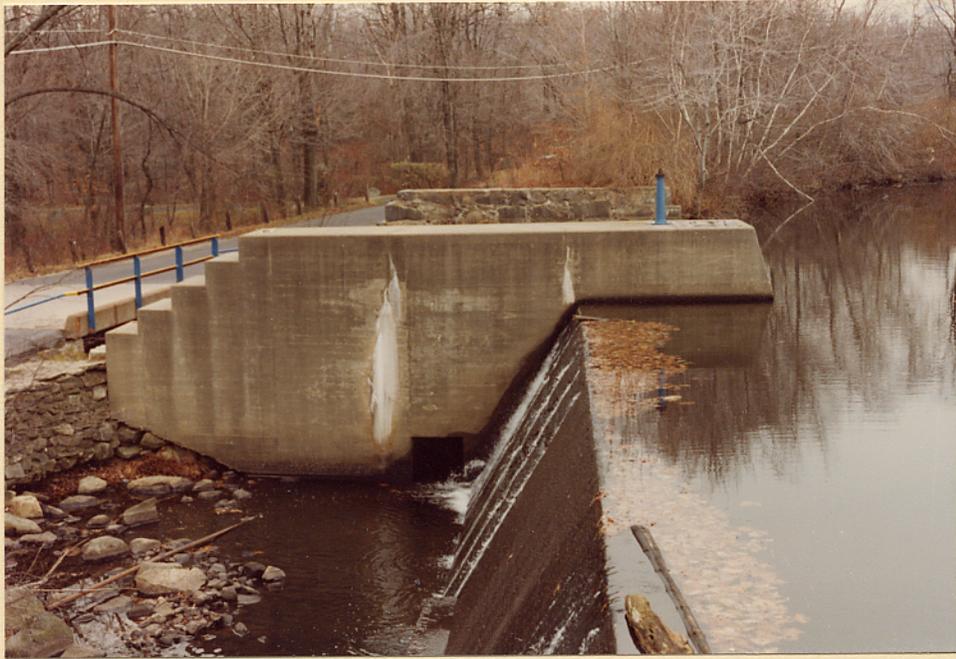
2. **Eastern Spillway:** This spillway is a 75 foot long concrete weir (Photo C-5 and C-6). The face is cracked and spalled near the central abutment (Photo C-8). The entire spillway was flowing on the day of the inspection. The east abutment is concrete and is generally in good condition. There are two weepholes in the abutment below the spillway which were seeping. The concrete around the weepholes and further downstream to the road is spalled and chipped (Photos C-6 and C-11). There is a tree growing between the spillway and road (Photo C-11).

C-5 WEST END OF EAST SPILLWAY - LOOKING WEST

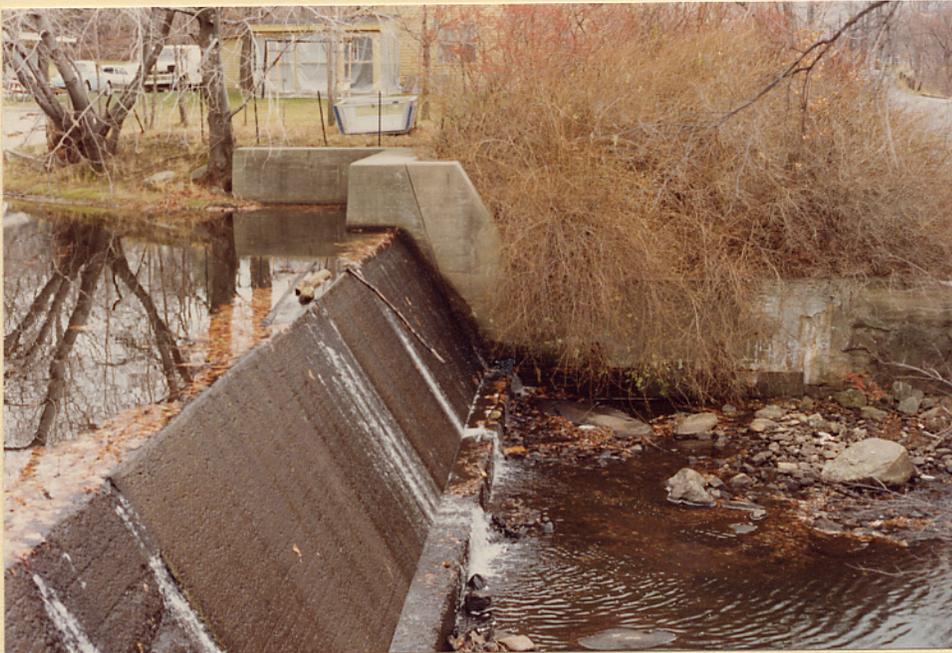
C-6 EAST END OF EAST SPILLWAY - LOOKING FROM CENTER ABUTMENT

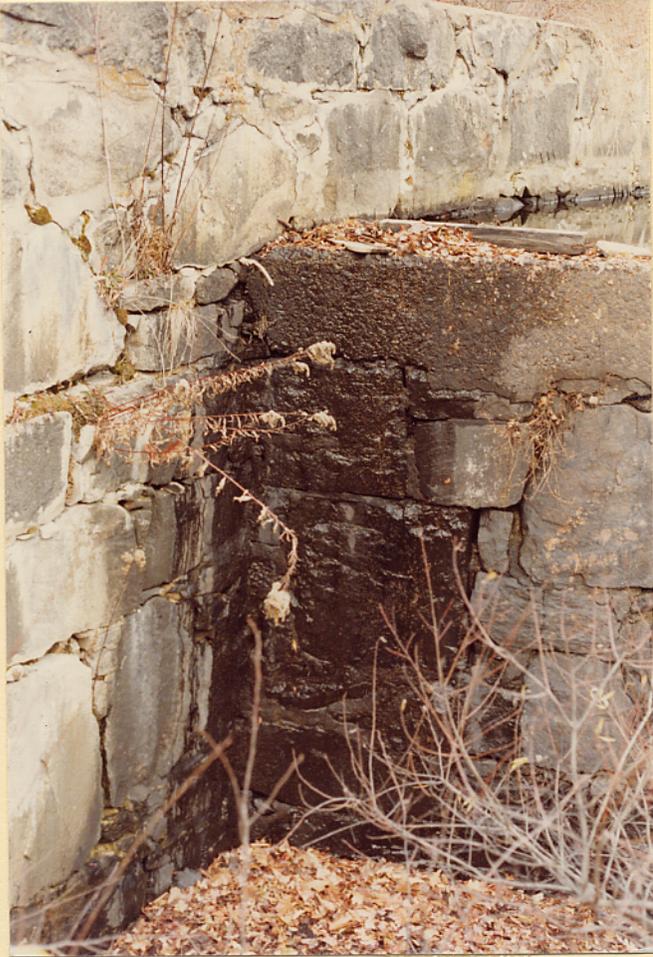
The visual inspection revealed no signs of major physical distress in the structure. However, seepage was noted through the joints on the downstream face of the west spillway and abutment. The upstream face of the spillway could not be inspected due to the pond level. The seepage may be occurring or enhanced due to defects in the upstream face of the spillway.

C-7 SEEPAGE AT WEST END
OF WEST SPILLWAY

1. Brush should be cleared from the embankments and between the spillways and road.
2. Fill and repair the depressions and eroded areas on the embankments.
3. Monitor the seepage through the weepholes to note any change from the existing conditions.
4. Develop a surveillance and downstream warning plan, including round-the-clock monitoring during heavy precipitation.
5. Institute a program of annual periodic technical inspection including insuring the operability of the outlet works.

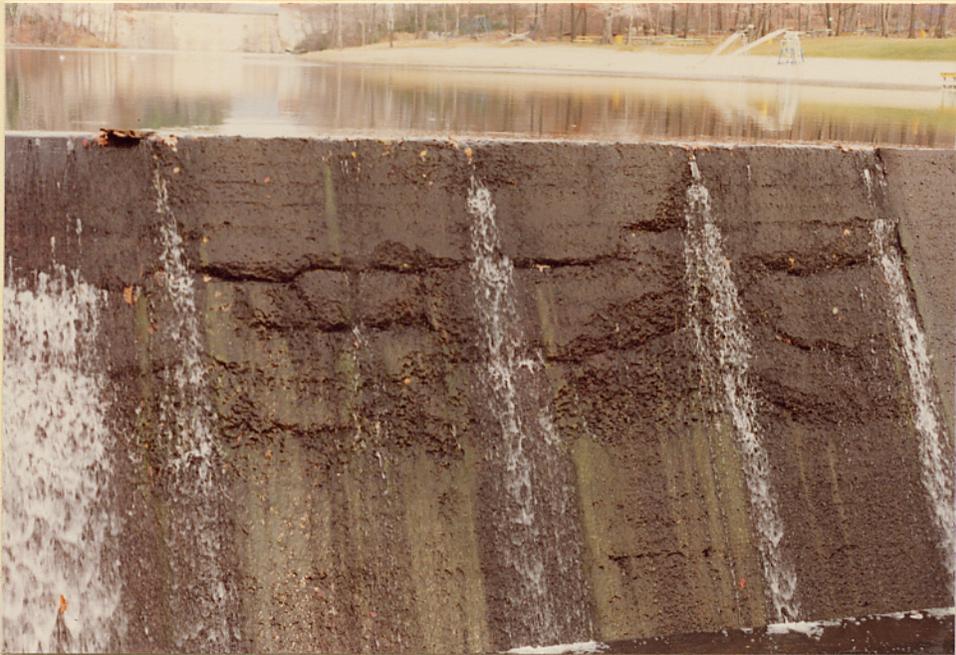
C-8 SPALLING ON DOWNSTREAM FACE OF EAST SPILLWAY

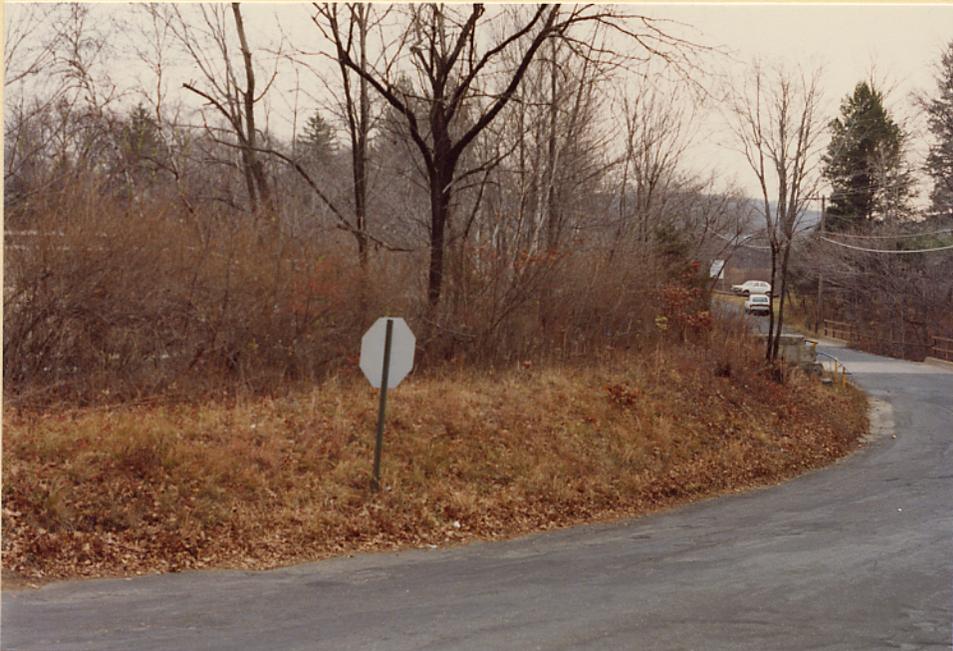
3. **Downstream Face:** The downstream face to the west of the spillways is clear of trees and brush. There are signs of minor erosion at the corner and a hole (2 feet diameter by 18 inches deep) exists at this point near the crest. The eastern embankment is vegetated with brush and there are two small depressions (1 foot diameter by 6 inches deep) near the east abutment. There were no signs of seepage observed on the embankments.

C-10 DOWNSTREAM FACE OF EARTH EMBANKMENT
TO WEST OF SPILLWAYS - LOOKING EAST
