MIXVILLE POND DAM CT 00302

PHASE I INSPECTION REPORT NATIONAL DAM INSPECTION PROGRAM

Identification Number:	CT 00302
Name:	Mixville Pond Dam
Town:	Cheshire
County and State:	New Haven County, Connecticut
Stream:	Tenmile River
Date of Inspection:	October 23, 1980

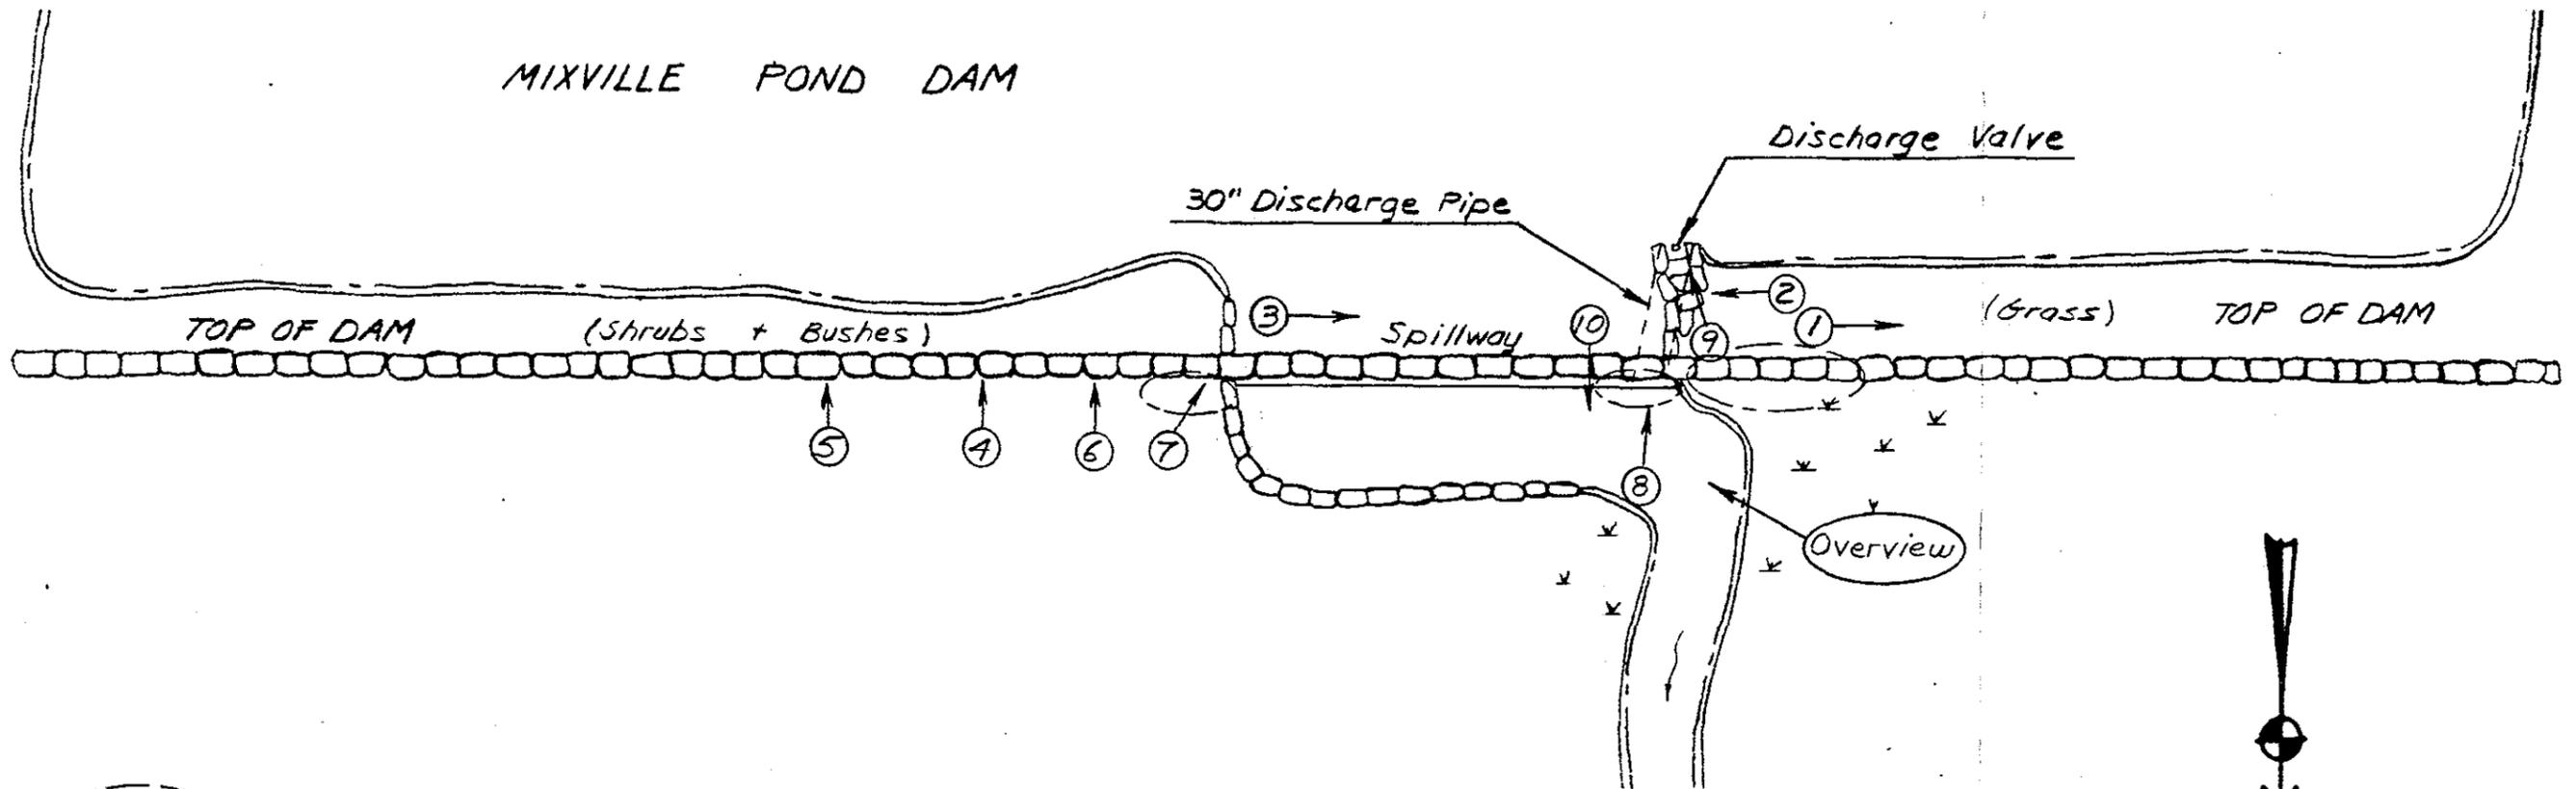
There are a number of seepage locations in the vicinity of the spillway (See Photo Location Plan - Plate 3 for location). There is seepage in two locations to the east of the spillway and along a large boulder just to the west of the spillway (Photos 6 and 7). The seepage in these locations is small and could not be measured. There is also seepage occurring under the capstones on the west side of the spillway as well as through several other joints in the downstream face below the spillway

○
Denotes Seepage

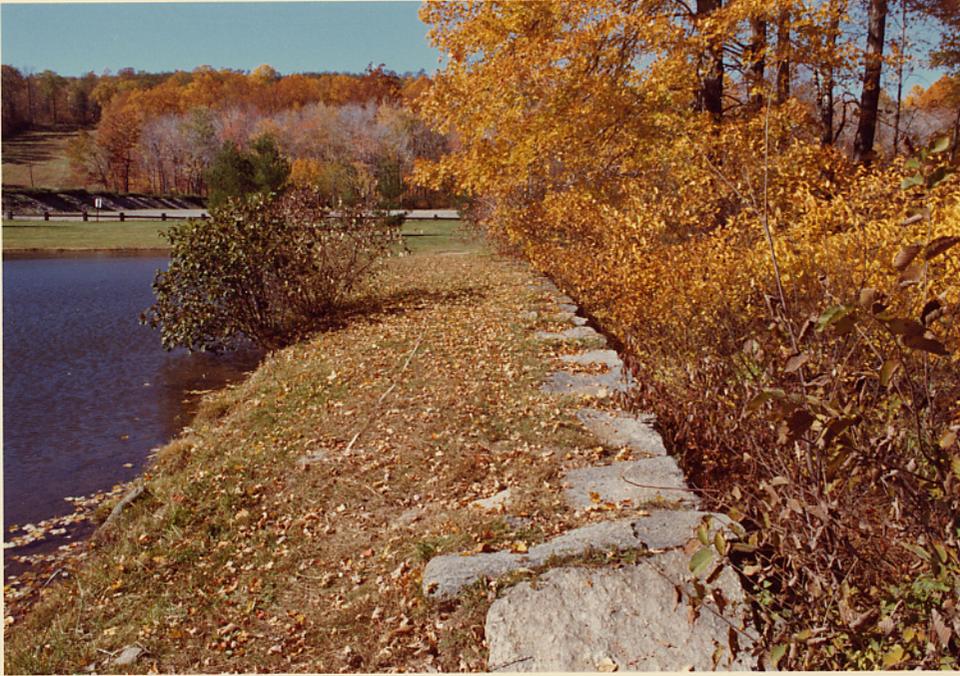
PHOTO 1

TOP OF DAM. LOOKING WEST

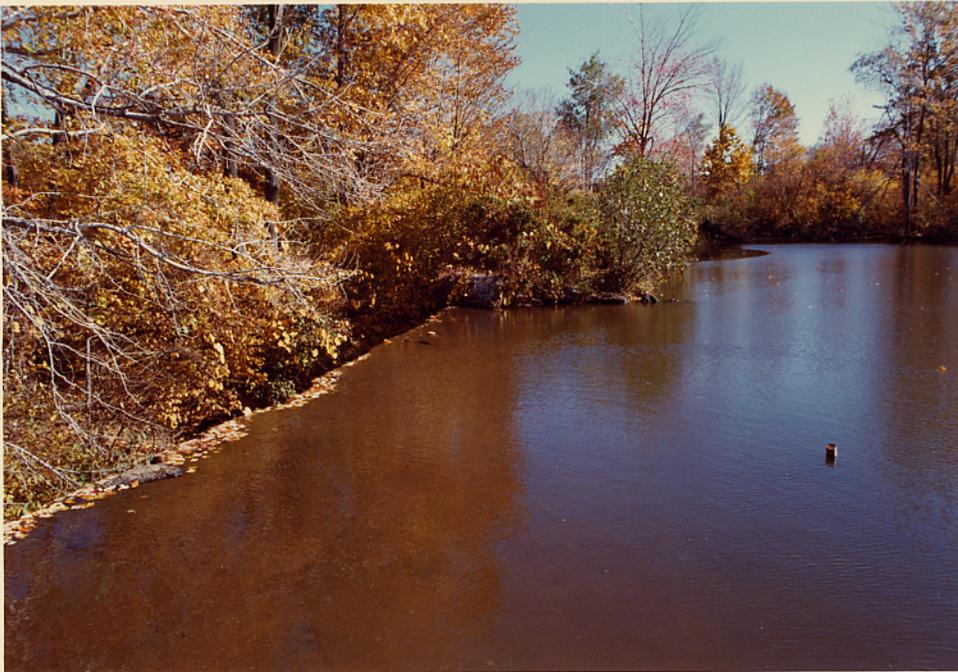
PHOTO 2

SPILLWAY - TOP OF DAM. LOOKING EAST

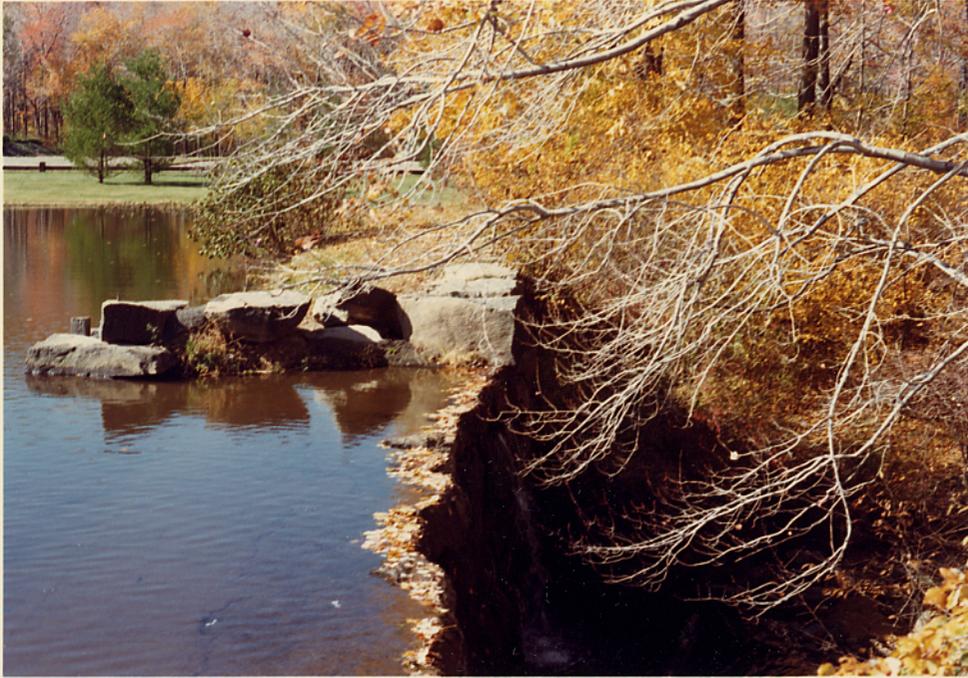
PHOTO 3
WEST SPILLWAY ABUTMENT

c. Appurtenant Structures - There is a masonry gate inlet structure at the west end of the spillway (Photos 3 and 9) that controls a 30-inch low-level discharge pipe passing through the base of the dam (Photo 8). The gate is operable although it is difficult to reset. The masonry for the gate inlet structure is out of alignment.

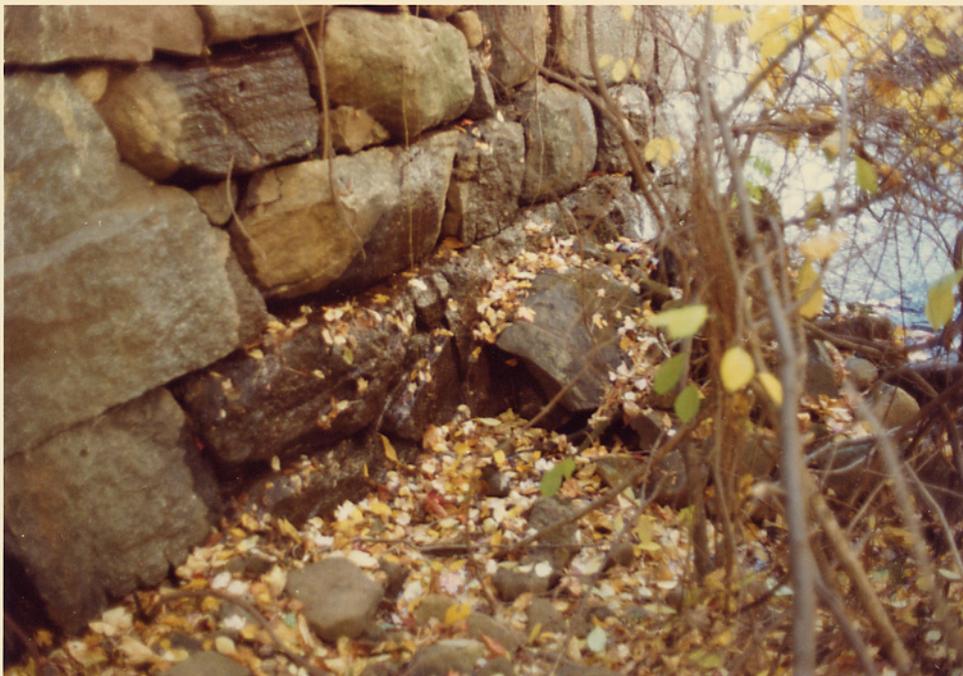
PHOTO 7

SEEPAGE - DOWNSTREAM FACE OF DAM

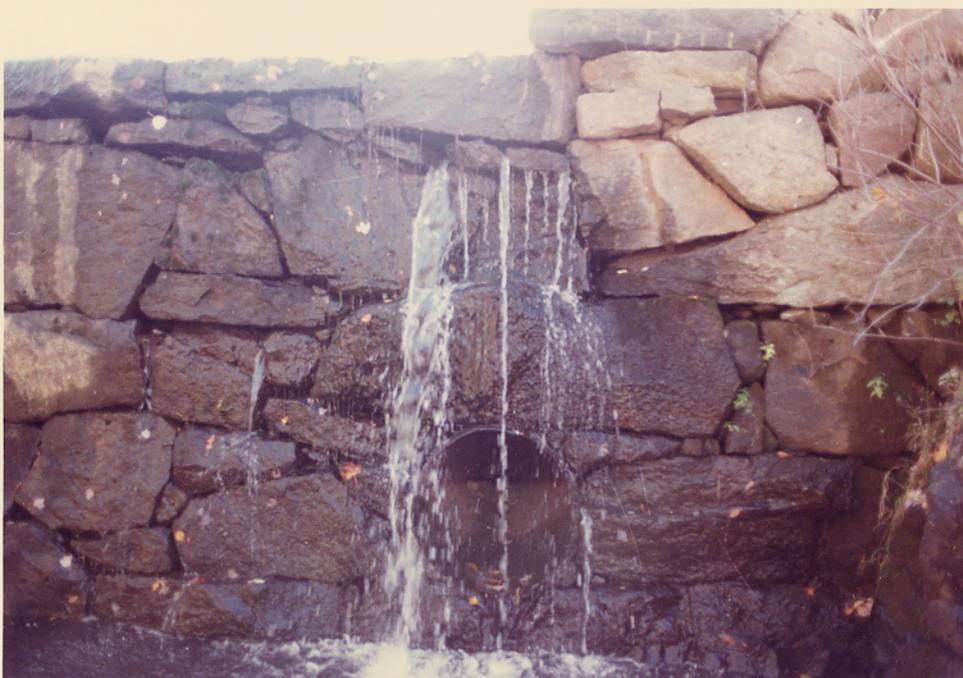
PHOTO 8

(Photo 8). The flow in these locations is approximately 10 to 20 gpm. At all locations the water is clear and shows no sign of particle movement.

SEEPAGE - LOW LEVEL DISCHARGE OUTLET

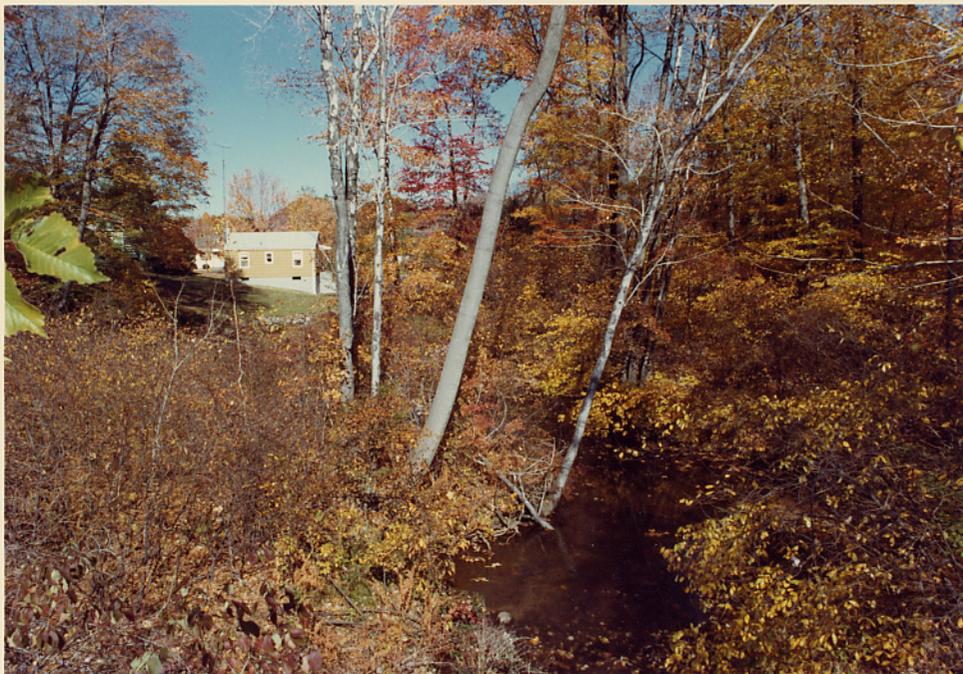
PHOTO 10
DOWNSTREAM CHANNEL

e. Downstream Channel - The downstream channel is a natural channel with heavily wooded gently sloping banks (Photo 10). Approximately 180 feet downstream, the channel is bounded by stone walls and about 340 feet downstream there is a bridge.
