**THAMES RIVER BASIN
STAFFORD, CONNECTICUT**

**RIVERSIDE POND DAM
CT. 00336**

**PHASE 1 INSPECTION REPORT
NATIONAL DAM INSPECTION PROGRAM**

OCTOBER, 1980

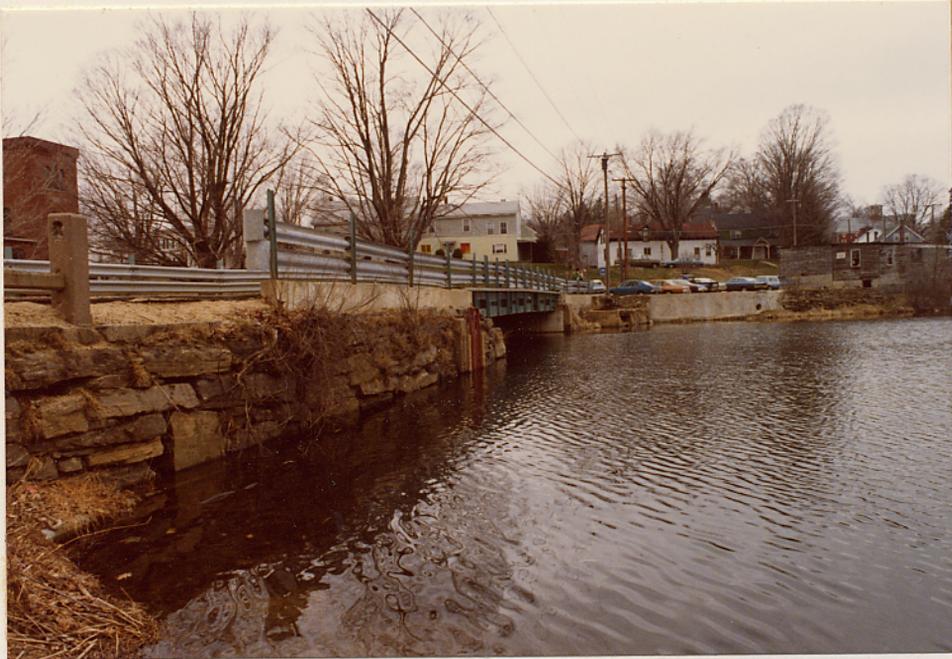
2. Left Outlet - The intake structure for the left outlet is located on the upstream face of the dam left of the spillway (See Photo C-1). Most of the intake structure was submerged. The steel and wood portion of the gates above the water level appeared to be in good condition. The outlet left of the spillway consists of a 42-in.-diameter steel pipe passing through the dam and emerging through the downstream face of the dam. The pipe is rusted and has many holes at the invert that allow water that leaks through the upstream gate to emerge from the pipe and flow through the dam beneath the pipe invert (See Photo C-11). Large riprap was observed on the left abutment beneath the outlet pipe (see Photo C-6). The outlet works are not presently in operable condition.

PHOTO C-1 Upstream face of dam from left abutment.

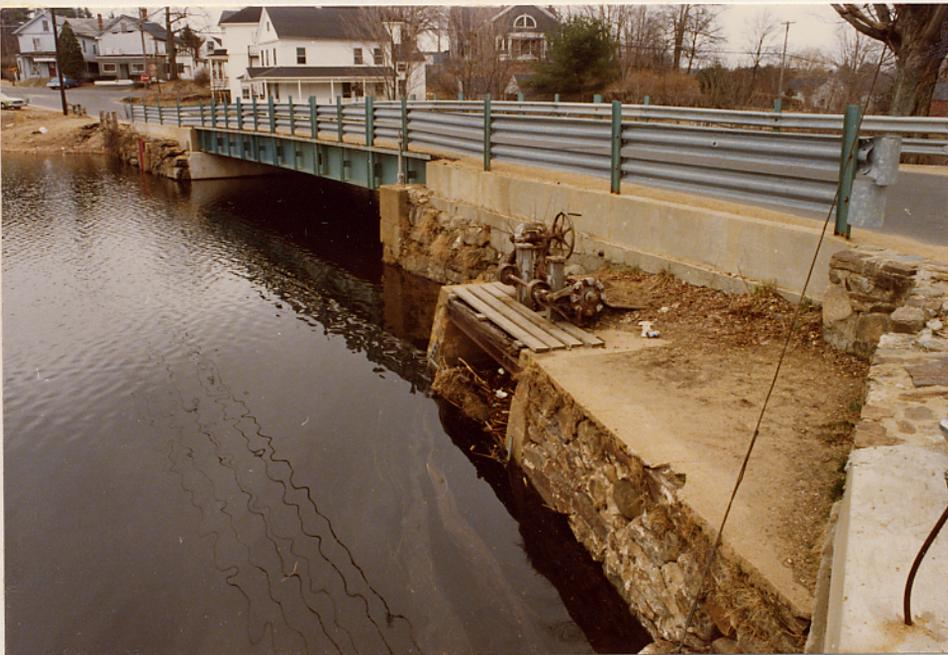
2. Upstream Face - The lower portion of the upstream face is stone masonry construction and the upper portion consists of a recently constructed concrete wall which forms the base for the roadway (See Photo C-2). The stone masonry face of the wall is very uneven with many bulges and voids resulting from displaced stones in the wall. Some voids and erosion between the stones in the wall extend as far as 4 feet into the face of the dam with the area on the left upstream face being the most severely effected. Grass and small brush were observed to grow from between the stones in the upstream face.

3. Right Outlet - The gated intake structure for the right outlet is located to the right of the spillway (See photo C-2). At the time of the inspection, considerable debris had accumulated at the intake gates. Additional information pertaining to the type and operational characteristics of the gate could not be verified or obtained at the site. Spalling of concrete was observed on the training walls of the intake structure, and the left training wall appeared to be tilted slightly inward.

PHOTO C-2 Upstream face of dam from right abutment.

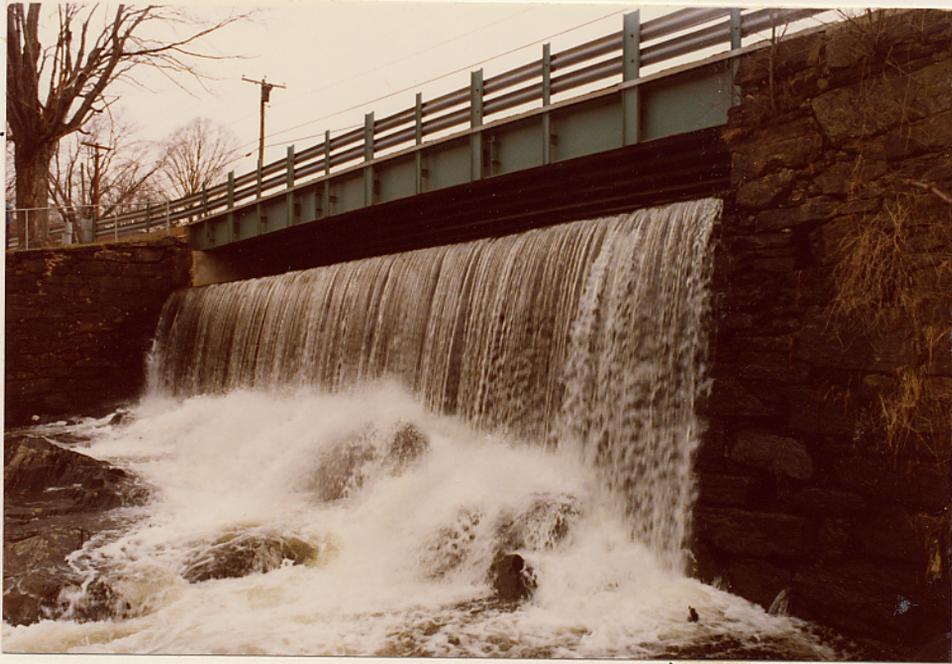
PHOTO C-3 Crest and downstream face of dam from left abutment.

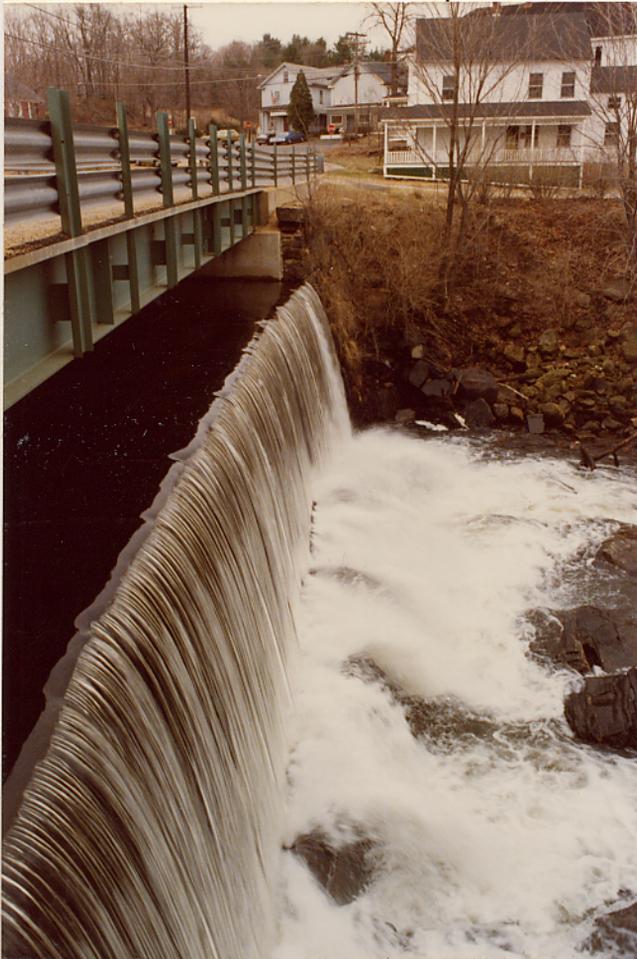
PHOTO C-4 Crest and downstream face from right abutment.

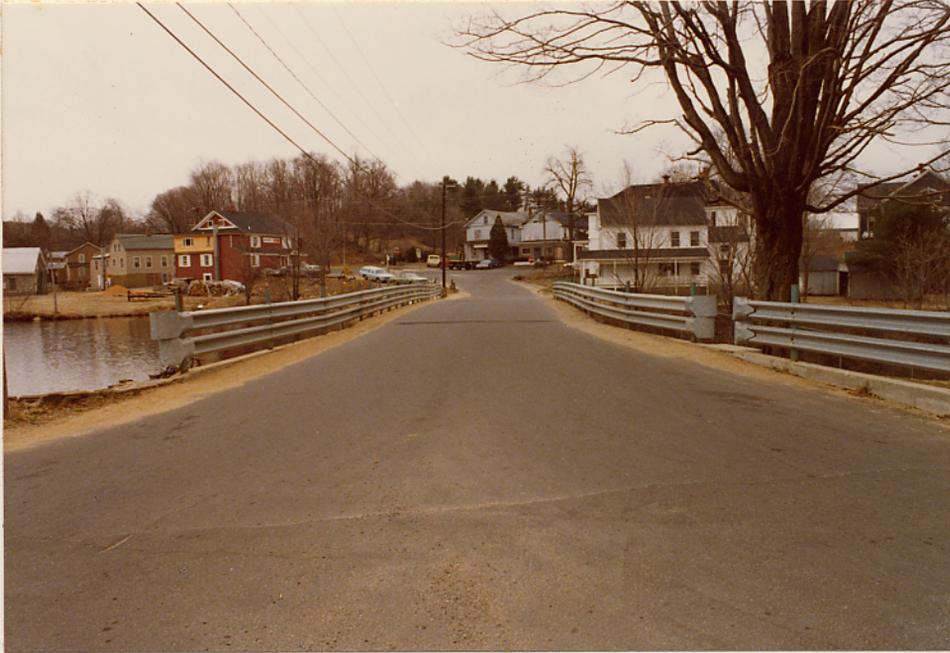
PHOTO C-5 Bridge over crest of dam from right dam abutment.

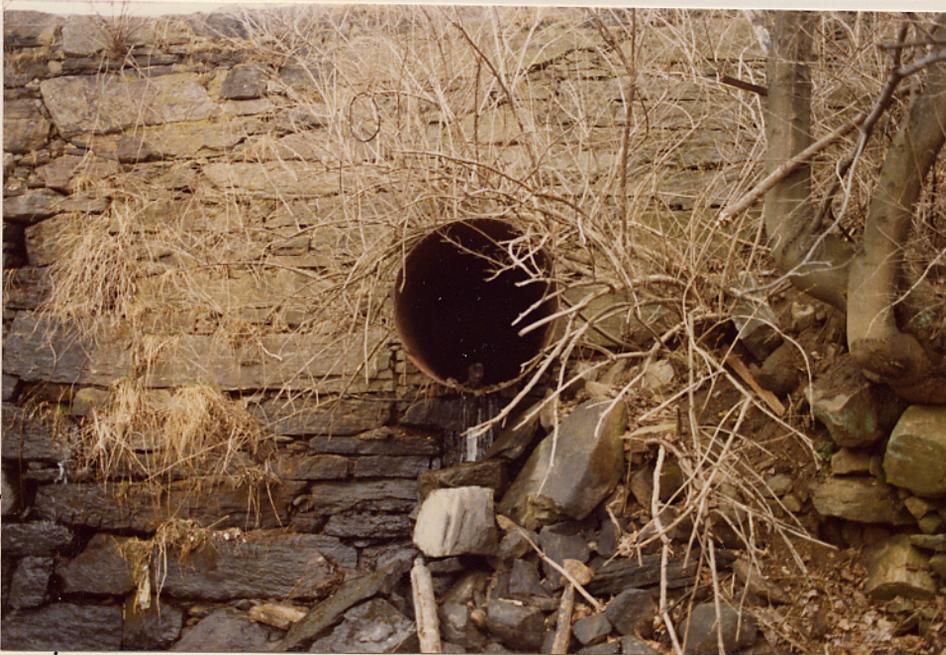
AREA EVALUATED	CONDITION
<p><u>OUTLET WORKS - CONDUIT</u></p>	<p>Left outlet works conduit is 42 inch diameter riveted steel pipe, rusted with many holes. Unable to inspect or measure right outlet works due to high water level. Left outlet works conduit is severely rusted.</p>

PHOTO C-6 Left outlet works conduit at downstream face of dam.

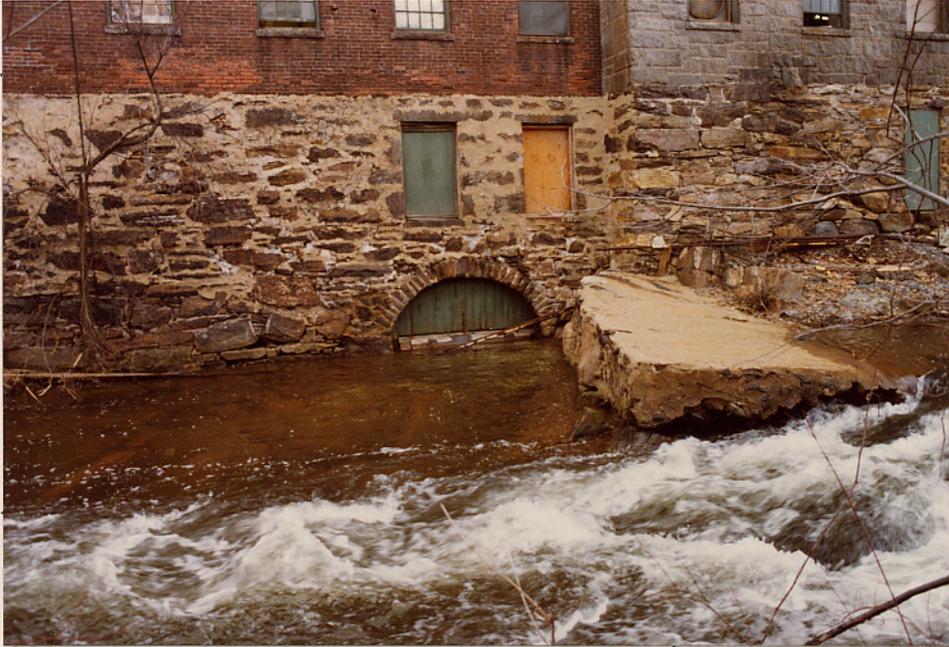
PHOTO C-7 Left outlet works sluiceway, located

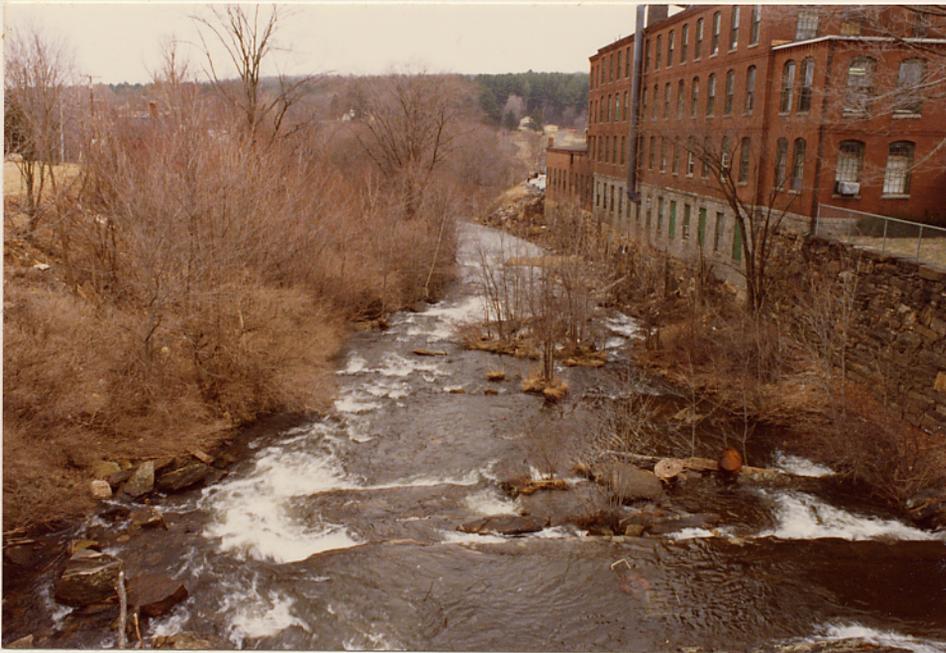
PHOTO C-9 Spillway discharge channel from crest of dam.

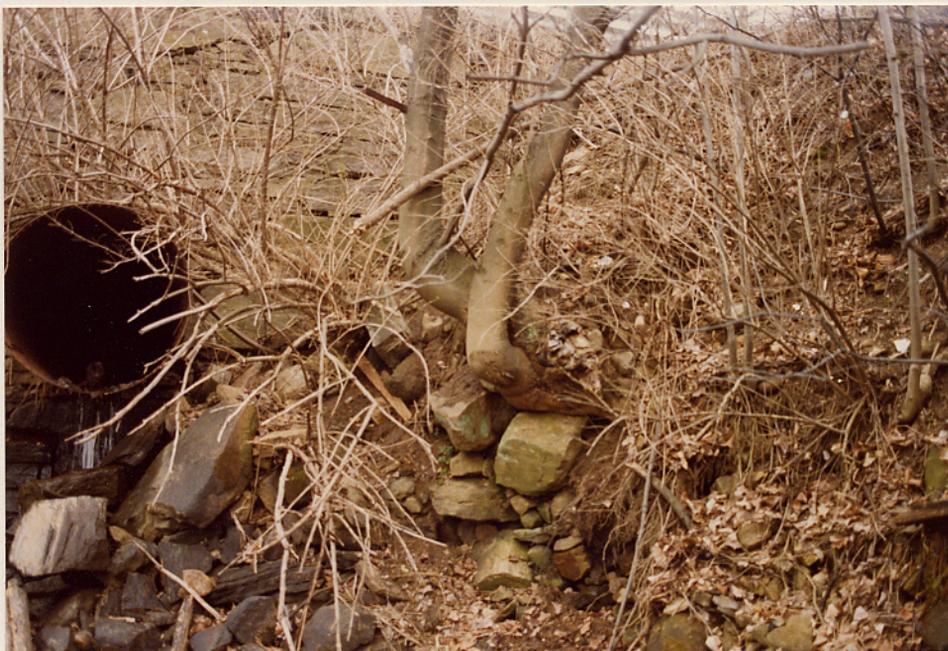
The downstream face of the wall located at the left of the spillway is uneven and bulged outward in the area surrounding the outlet conduit. A series of horizontal and vertical cracks surround this portion of the wall and it appears to have moved outward in the downstream direction. A vertical crack extending from the foot of the wall to the crest was observed 6 to 8 feet left of the spillway. Grass, brush and small trees were observed growing from between the stones in the downstream face at many locations (See Photos C-10, C-11 and C-12).

PHOTO C-10 Trees growing on downstream slope of left dam embankment near left outlet works discharge pipe.

1. Remove vegetation growing in the upstream and downstream face of the dam.
2. Repair all cracks and voids in the upstream face of the dam.
3. Institute a program of annual technical inspection by a qualified registered engineer.
4. Develop and implement a regular maintenance program.
5. Develop an "Emergency Action Plan" that will include an effective preplanned downstream warning system, locations of emergency equipment, materials and manpower, authorities to contact and potential areas that require evacuation.

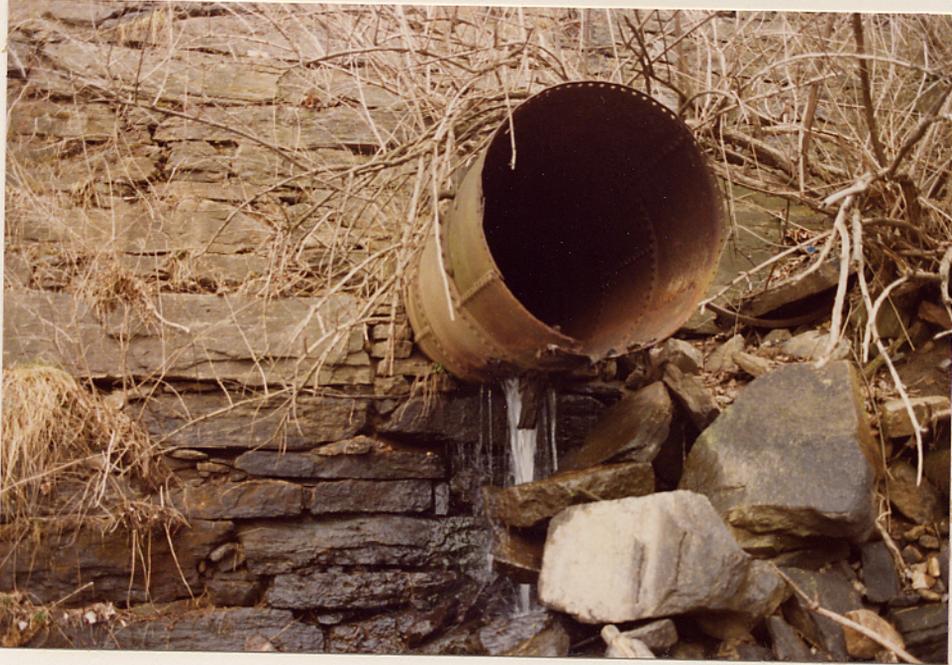
Seepage was observed flowing from several cracks and voids in the downstream face in the area between the spillway and outlet conduit and extends vertically from the toe of the dam to within 11 feet of the crest. Larger amounts of water were flowing from beneath the invert of the outlet pipe (see Photos C-11 and C-12). All seepage observed was clear and free of sediment. The elevation of the bed of the reservoir at the upstream side of the dam is 2 feet above the elevation of the uppermost seepage observed at the downstream face.

PHOTO C-11 Seepage emerging from beneath invert of left outlet works discharge pipe.

4. Periodically inspect the downstream face of the dam to monitor the extent of seepage and examine the downstream wall for additional movement or cracking.
5. Inspect the downstream face of the spillway when there is no flow over the spillway.
6. Perform detailed hydrologic and hydraulic studies to further assess the need for and means to increase the project discharge capacity.
7. Repair the upstream face of the dam by sealing cracks in the stone wall and preventing the growth of vegetation on the wall. Also prevent erosion on the upstream slope of the left and right abutments.
8. Seepage at 9" tree should be investigated.

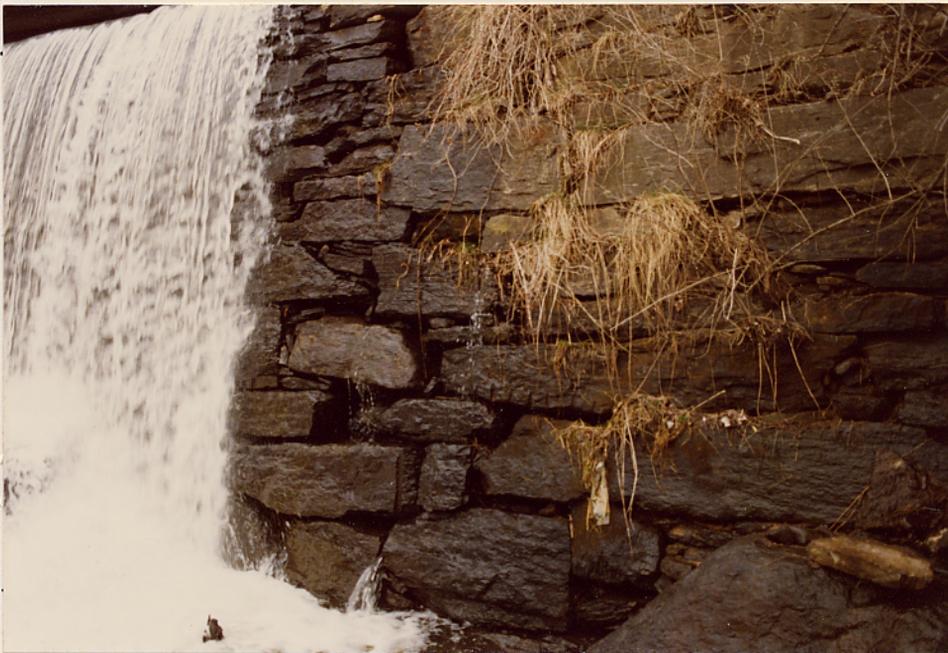
PHOTO C-12 Seepage at downstream face of dam at left spillway abutment.

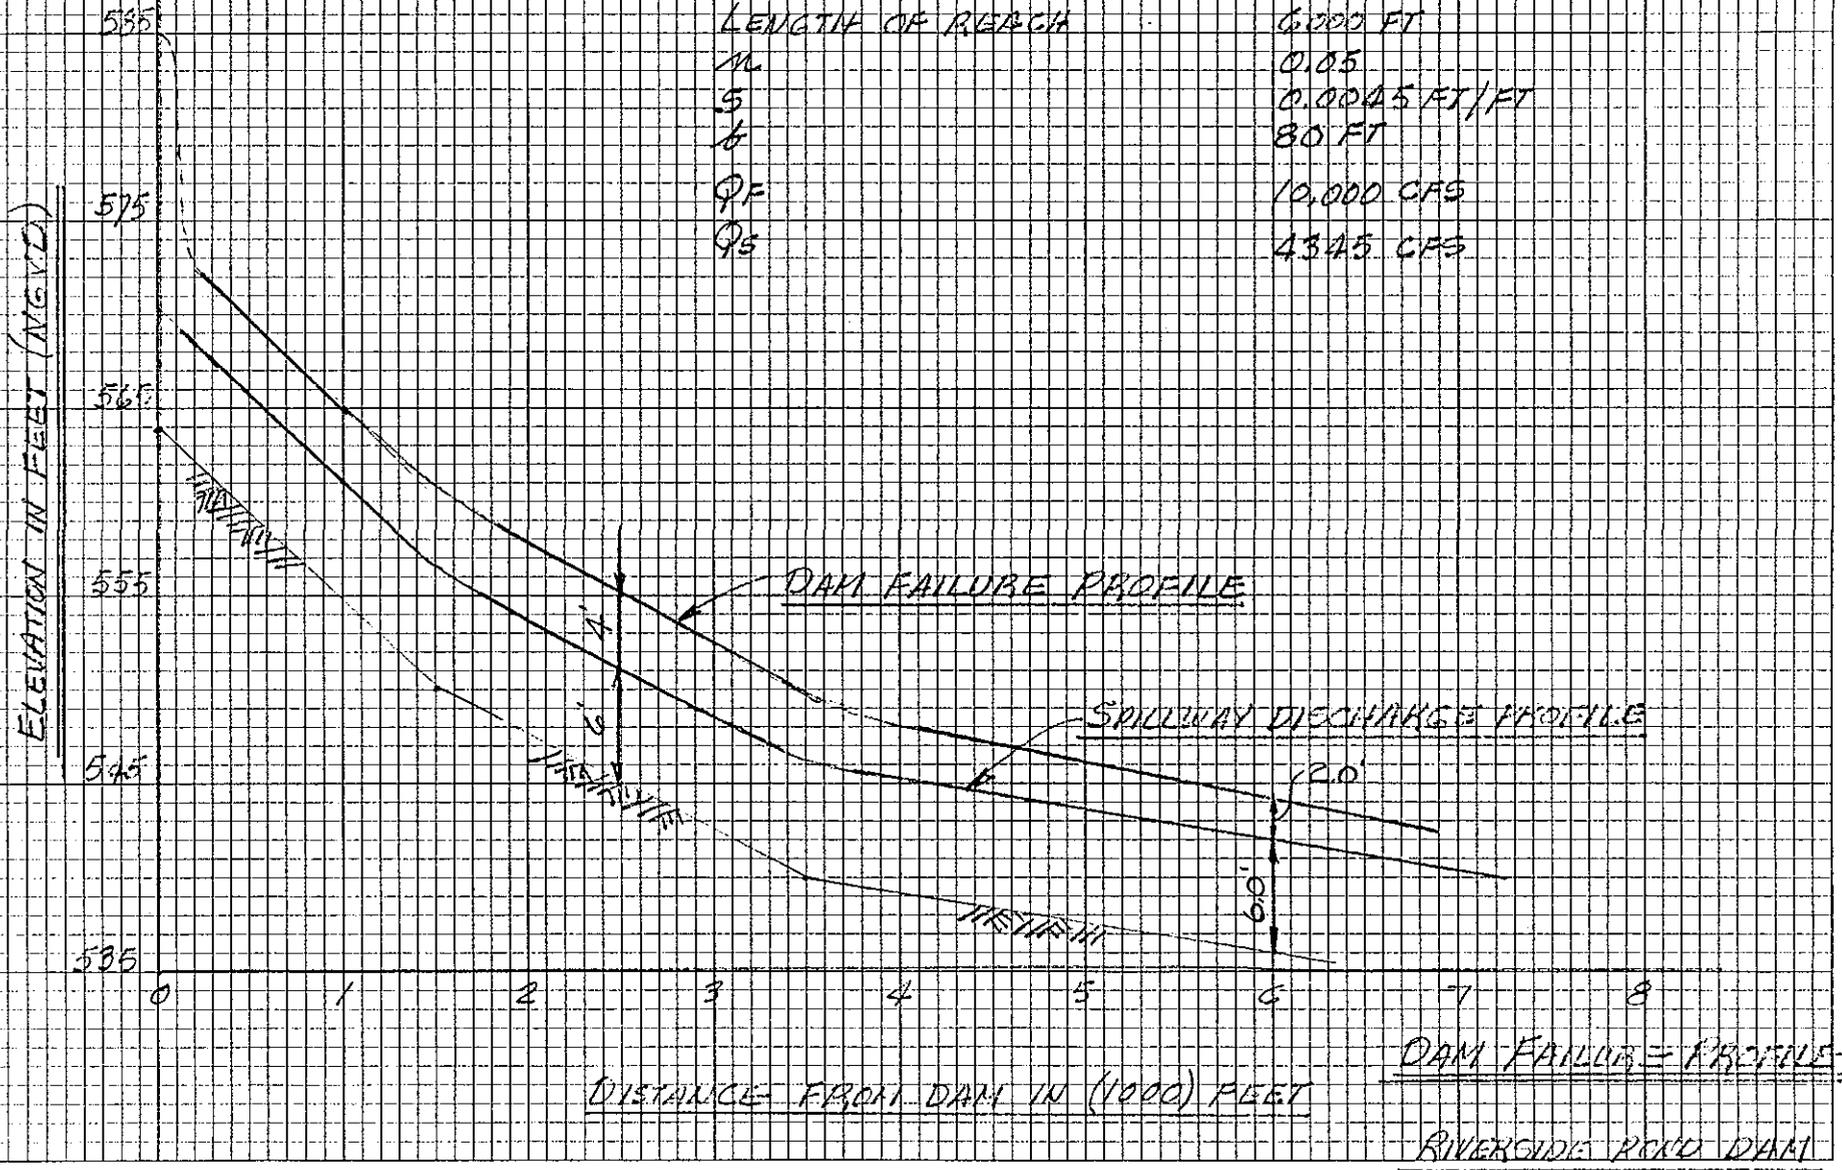
PLATE D-11

Water surface profiles resulting from maximum spillway discharge and also from dam failure discharge are shown on Plate D-11 for comparison purposes. This figure also shows the rise in water depth due to failure of dam.
