HATTERTOWN POND DAM

CT 00313

**PHASE I INSPECTION REPORT
NATIONAL DAM INSPECTION PROGRAM**

MAY 1981

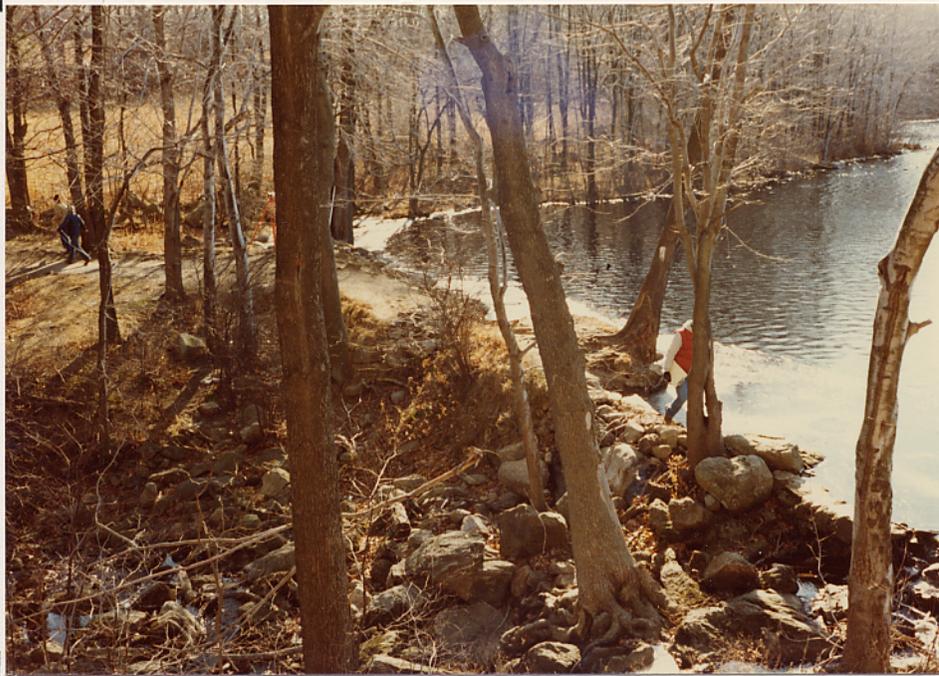
Photo 1 Spillway (foreground), top and downstream slope of embankment.

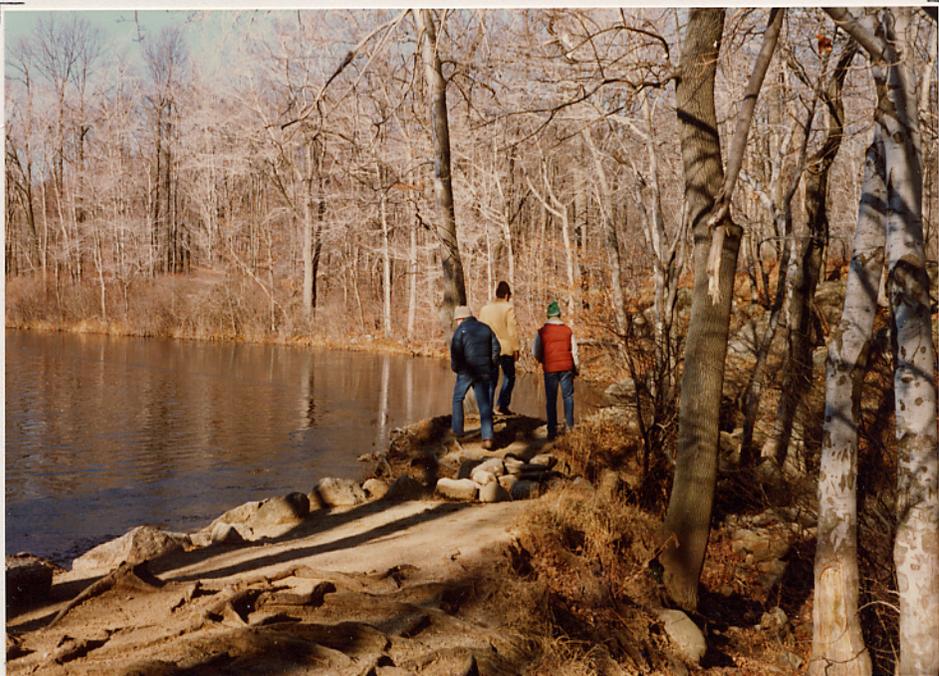
Photo 2 Top of embankment with repaired breached area and downstream slope.

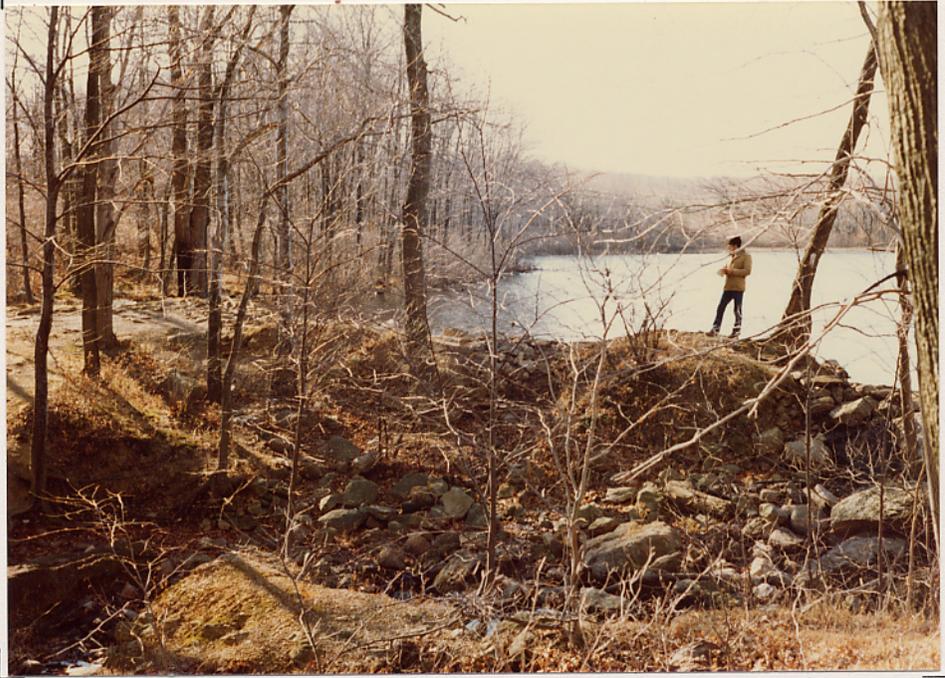
Photo 3 Top and downstream slope of embankment and breached earth dam in foreground.

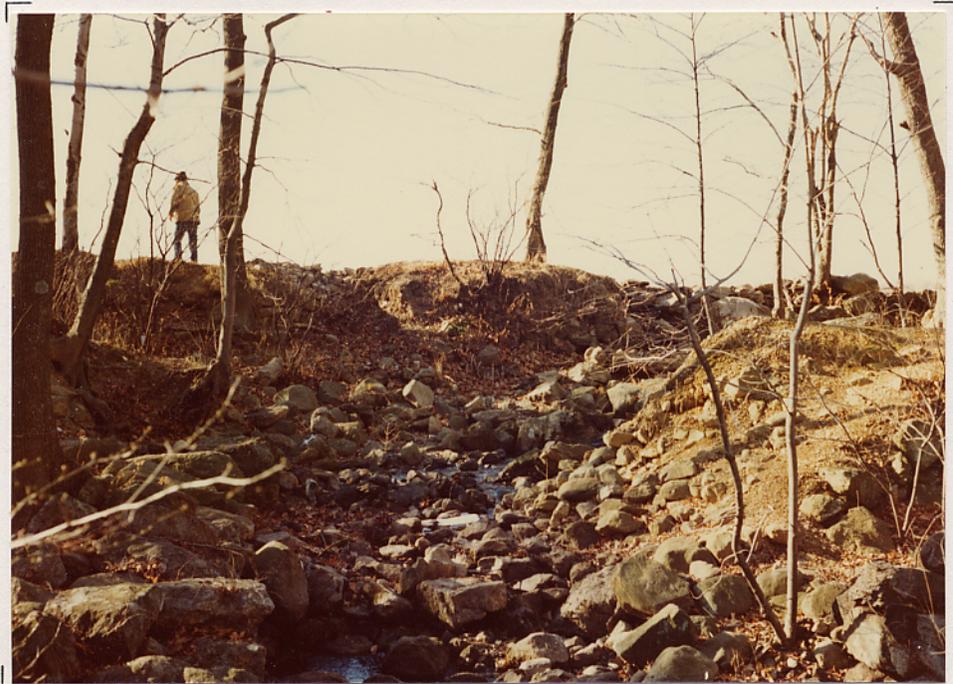
Photo 4 Downstream slope of existing dam, outlet channel, and remains of breached earth dam.

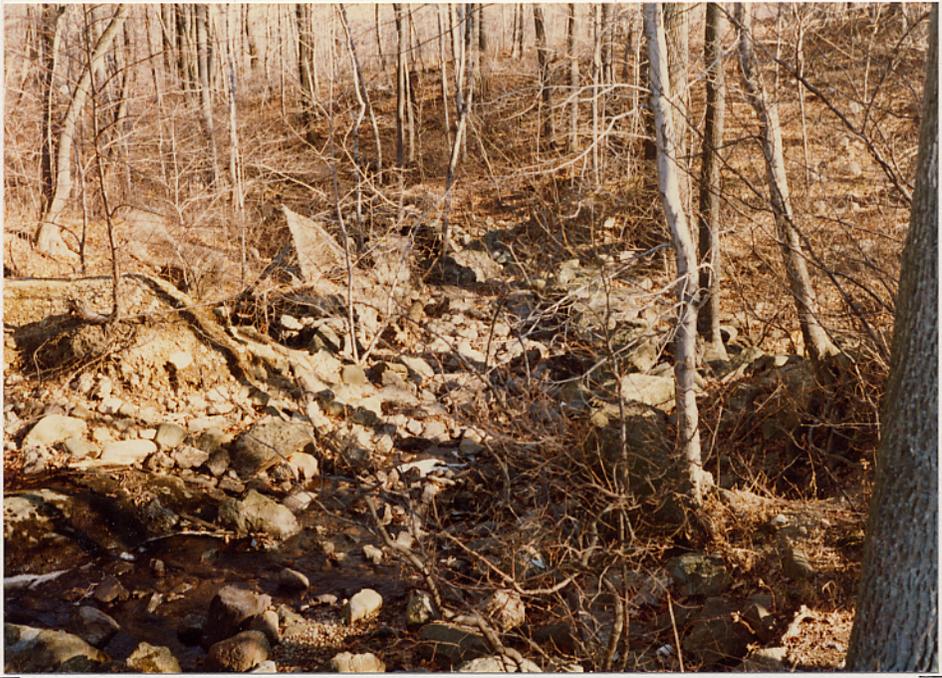
Photo 5 Existing spillway discharge channel and left abutment of remains of breached dam.

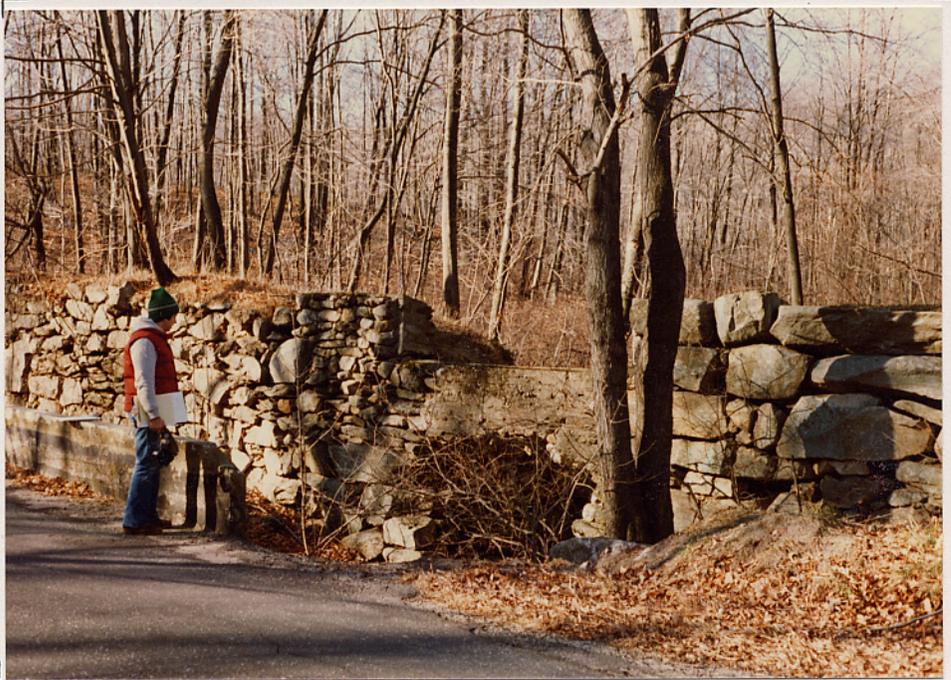
Photo 6 Breached dam near Castle Meadow Road bridge culvert.

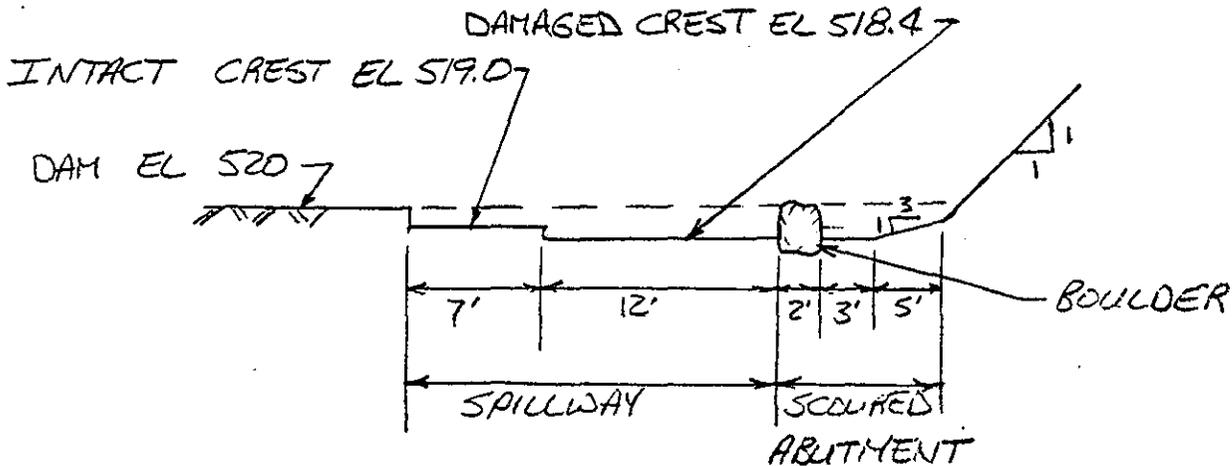
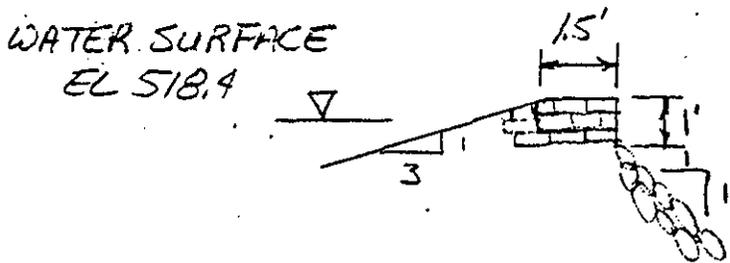
THE LEFT ABUTMENT, THAT HAS BEEN DAMAGED.
 THE INTACT PORTION OF THE SPILLWAY IS 1 FOOT
 BELOW THE TOP OF THE DAM (EL 520) AND THE
 CREST OF THE DAMAGED SPILLWAY SECTION IS
 1.6 FEET BELOW THE TOP OF THE DAM. THE LEFT
 SPILLWAY ABUTMENT IS DEFINED BY A LARGE BOULDER
 WHICH SEPERATES THE SPILLWAY FROM A SCOURED
 AREA AT THE DAM ABUTMENT. AN ELEVATION AND
 SECTION OF THE SPILLWAY ARE SHOWN BELOW.
