LAKE GAILLARD DAM
CT. 00387

PHASE I INSPECTION REPORT
NATIONAL DAM INSPECTION PROGRAM

SEPTEMBER 1978

Identification Number: CT 00387
Name: Lake Gaillard Dam
State Location: Connecticut
County Location: New Haven
Stream: Branford River
Date of Inspection: August 1, 1978

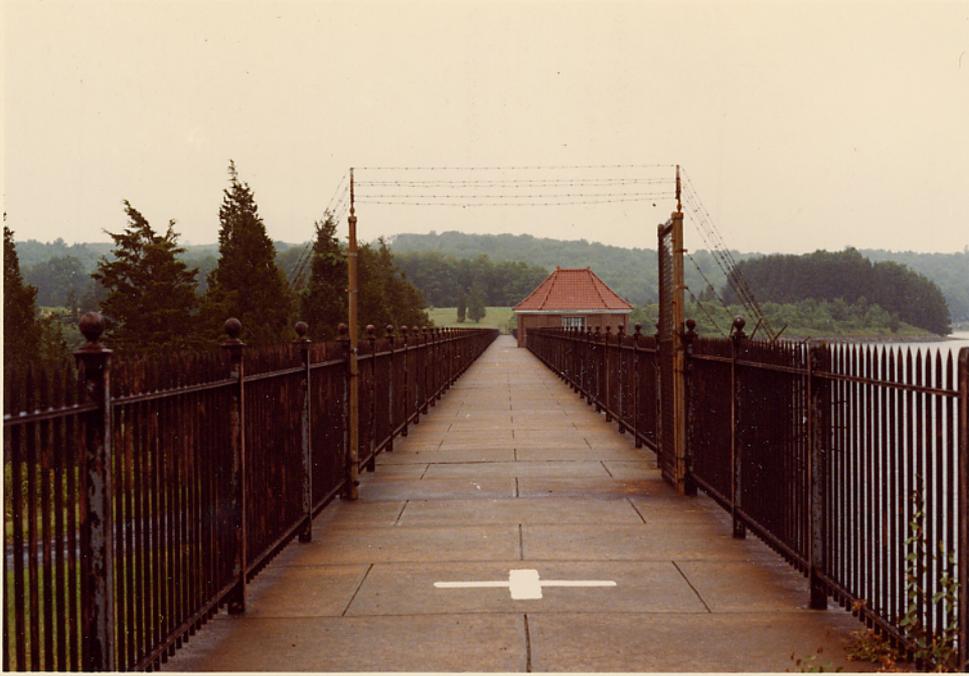
PHOTO 1
CREST OF DAM AND UPPER GATE HOUSE

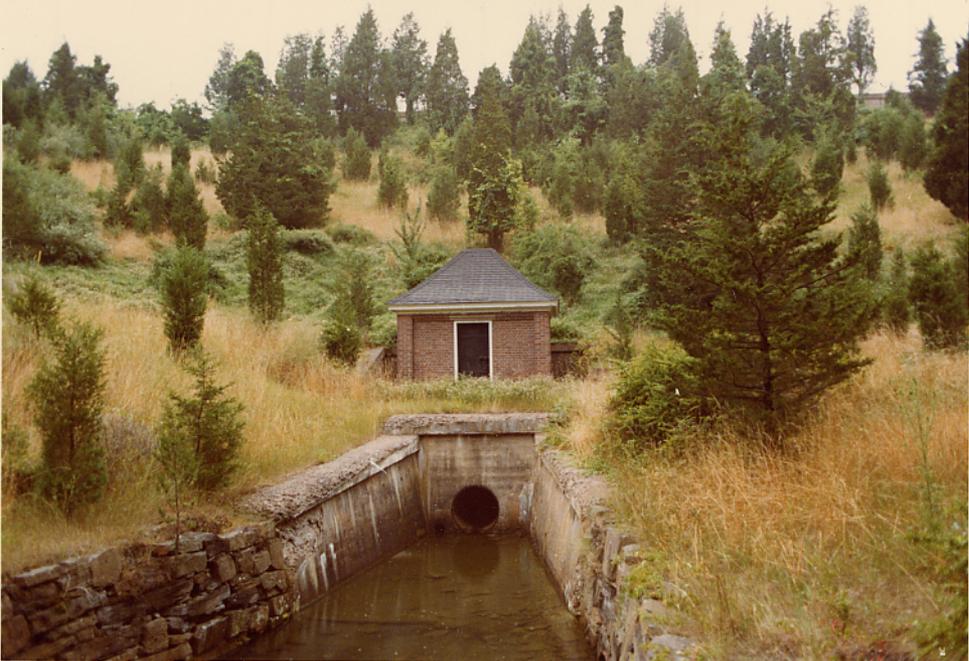
2. Considerable distress in the concrete and stone masonry walls of the lower valve chamber (Appendix C, Photos 2, 4 and 5, Pages II-1A through II-3A).
3. Seepage discharges of approximately 5 gallons per second measured at the metering weir from the zone of the lower valve chamber and the drainage system of the main dam (Appendix C, Photo 5, Page II-3A).
4. Wet areas on the downstream slopes of the east dike (Appendix C, Photo 4, Page II-2B).
5. Repair to the face of the main dam by gunite in 1947.

PHOTO 2
FACE OF DAM AND LOWER GATE HOUSE

- a. Alternatives - Not applicable.
- b. O & M Maintenance and Procedures -
 1. Grass, brush and trees on the downstream slopes of the main dam should be removed to facilitate visual observations.
 2. Repairs should be made to the concrete and stone masonry walls of the channel from the lower valve chamber and the bottom of the channel should be cleaned of loose materials, stones, brush and trees.

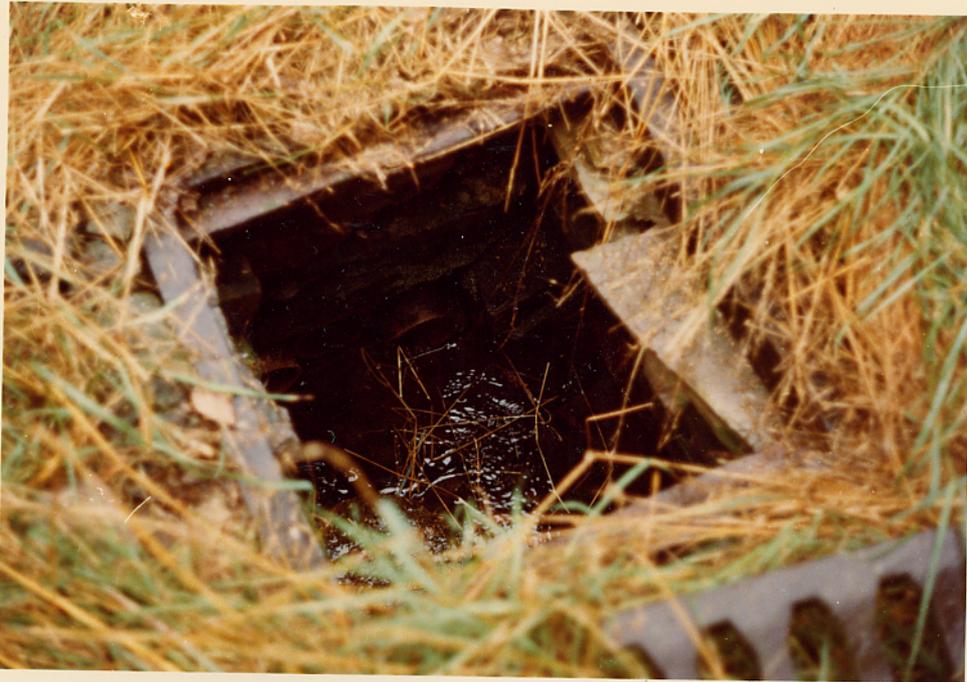
PHOTO 3
SEEPAGE FLOW IN CATCH BASIN DOWNSTREAM

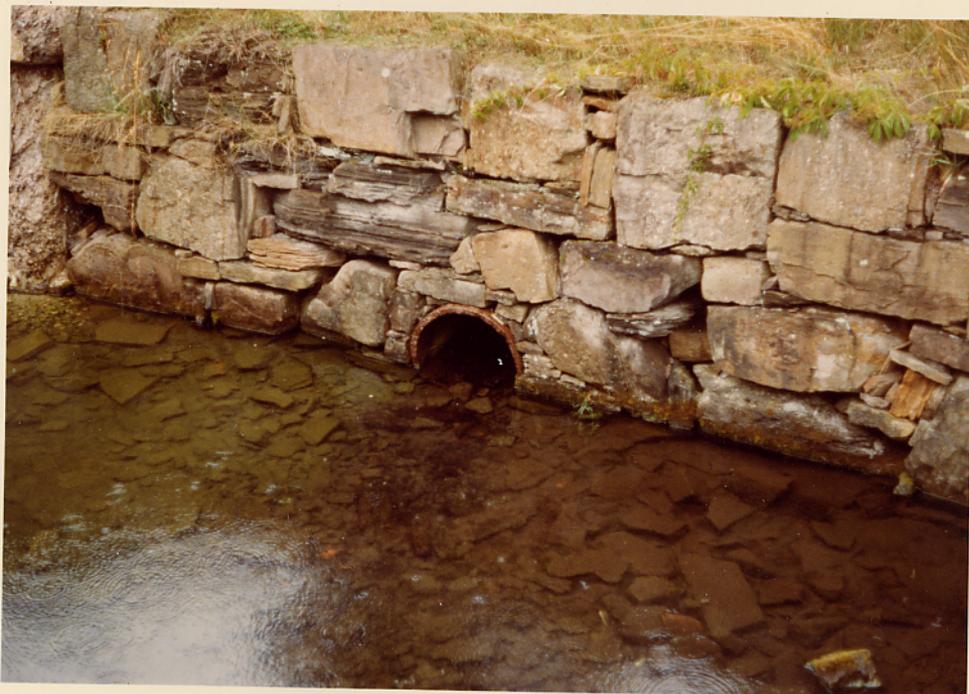
b. Dam - The downstream face of the main dam has many trees and brush which obscured the view of the embankment. At the lower level, there is a 20 inch diameter pipe (Appendix C, Photo 4, Page II-2A) for the purpose of carrying the surface runoff from the roadway, which is just below the crest into the downstream channel. Beneath the rubble stone masonry walls lining the channel, a steady seepage flow (Appendix C, Photo 5, Page II-3A) was observed of approximately 5 to 10 gallons/min.

PHOTO 4
DRAINAGE OUTLET INTO DOWNSTREAM CHANNEL

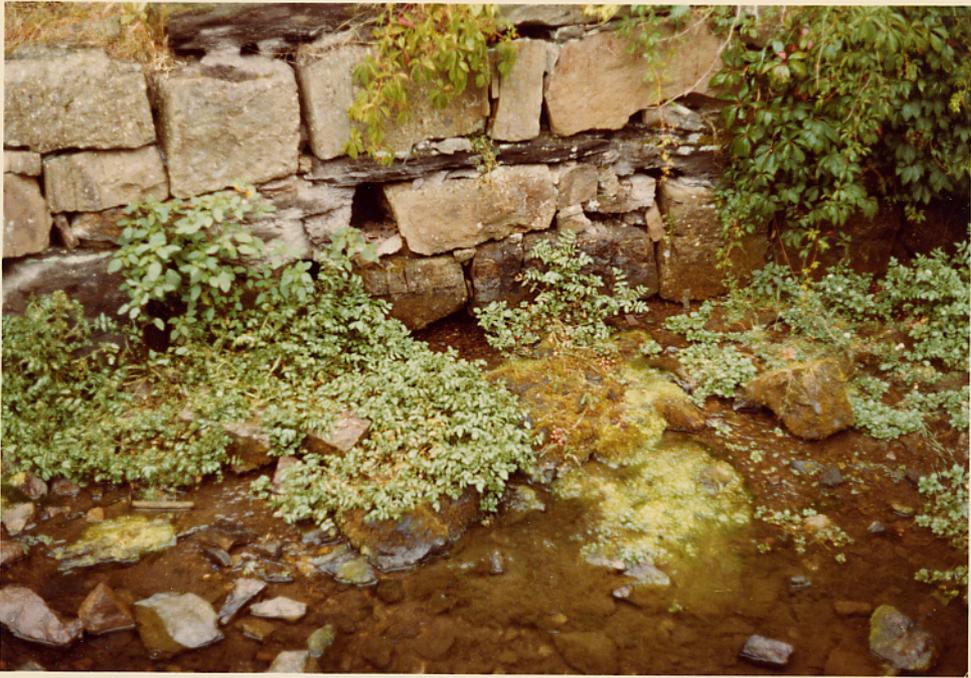
PHOTO 5
SEEPAGE UNDER DOWNSTREAM CHANNEL WALL

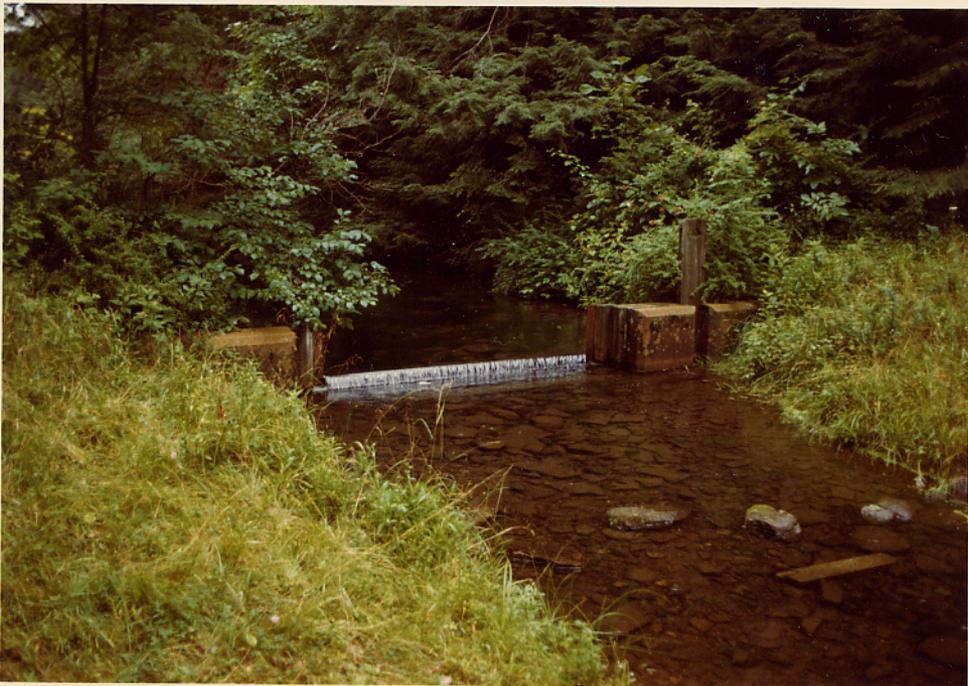
PHOTO 6
METERING WEIR ON DOWNSTREAM CHANNEL

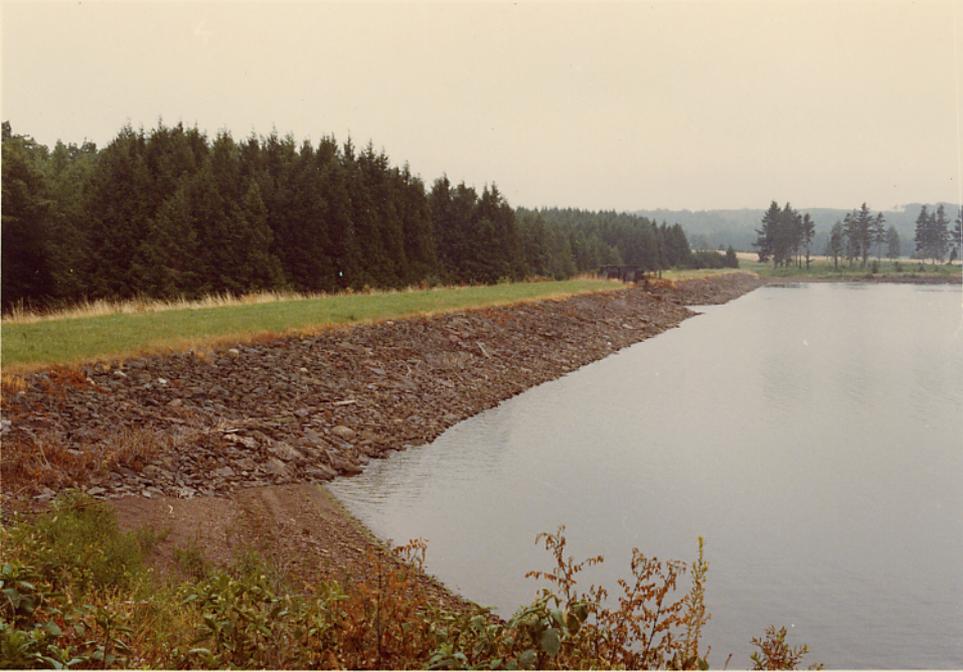
PHOTO 1
CREST AND UPSTREAM FACE OF EAST DIKE

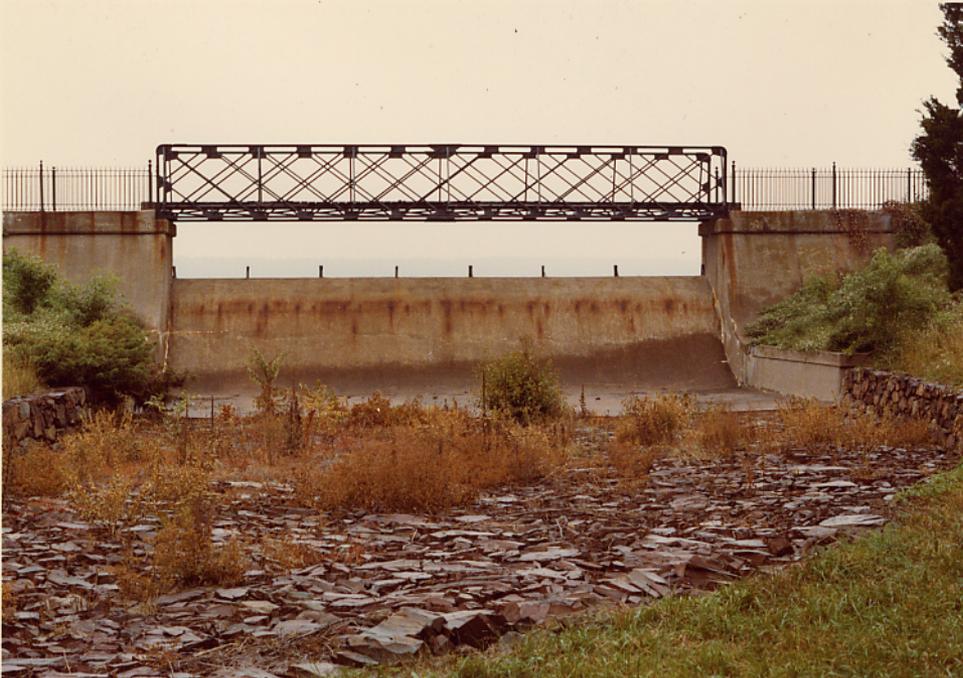
The spillway on the east dike is made of reinforced concrete and appears very sound. A steel truss pedestrian bridge with a wooden walkway spans the spillway width. The decking of the walkway has rotted and it is in need of repair.

PHOTO 2
DOWNSTREAM FACE OF SPILLWAY

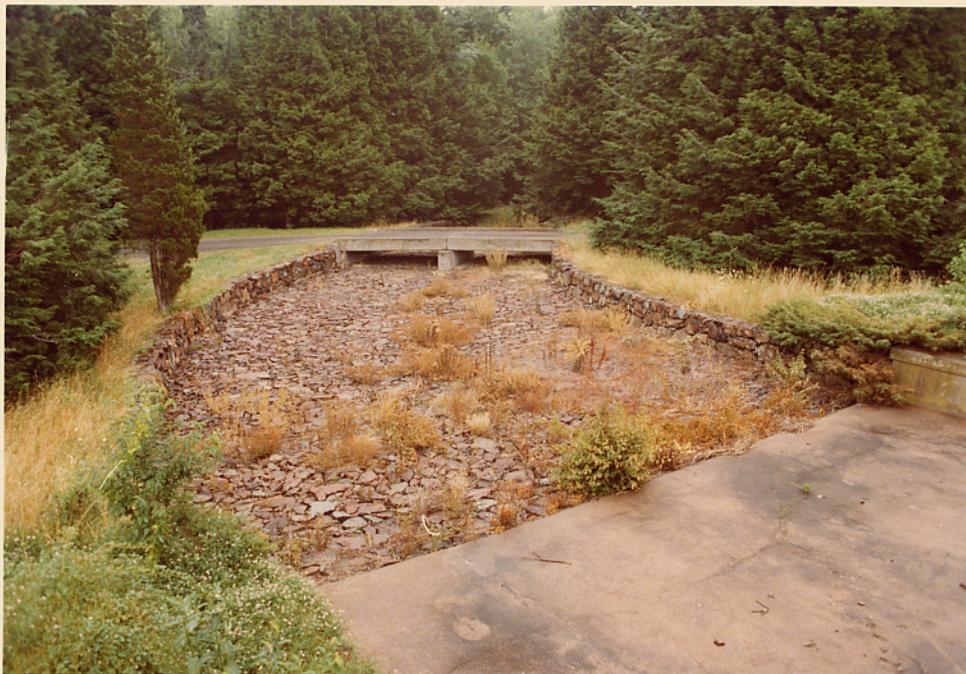
PHOTO 3
DOWNSTREAM SPILLWAY CHANNEL

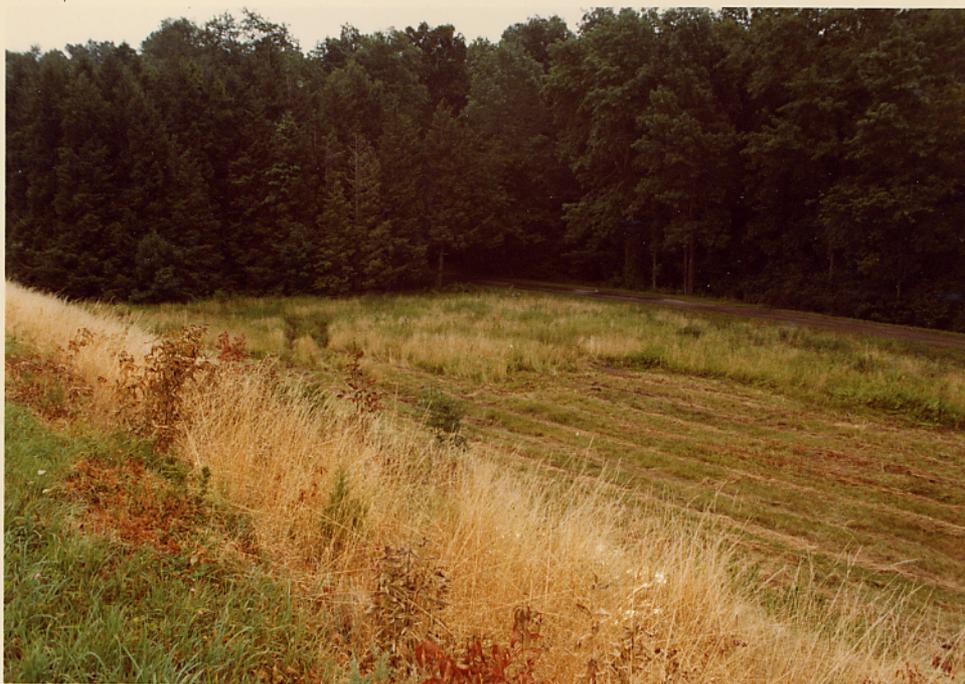
Seepage discharges in the vicinity of the lower valve chamber of the main dam and the downstream earth slopes of the east dike should be further investigated to determine their origin and monitored to determine any change.

PHOTO 4
WET SPOT AT TOE OF EAST DIKE
