HAMMONASSET RIVER BASIN  
MADISON/KILLINGWORTH, CONNECTICUT

HAMMONASSET RESERVOIR DAM  
CT. 00400

PHASE I INSPECTION REPORT  
NATIONAL DAM INSPECTION PROGRAM

SEPTEMBER 1978

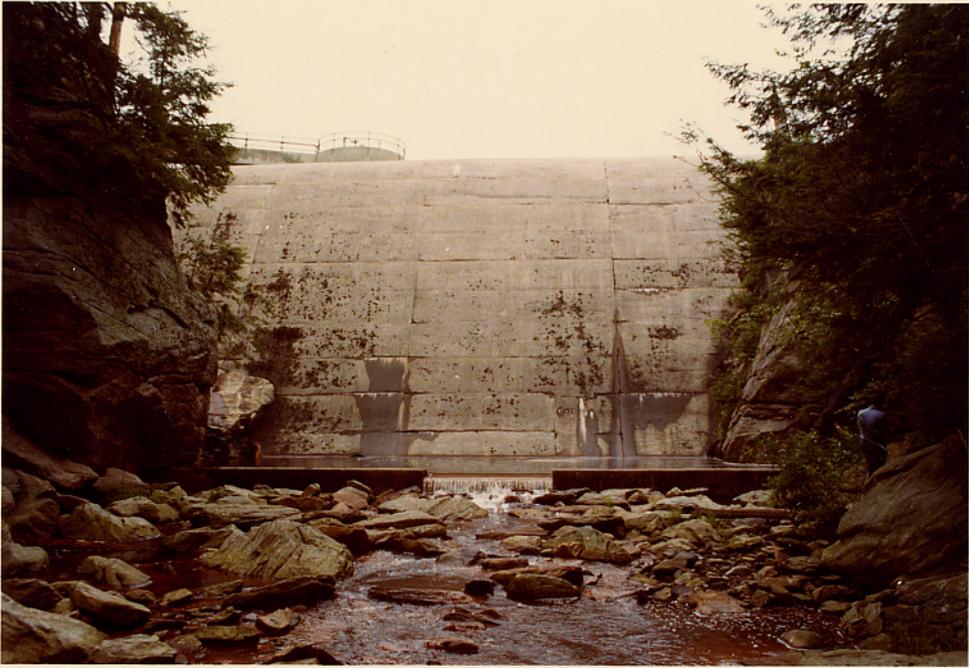
b. Dam - The crest and the downstream face of the spillway showed no visible cracks. A small amount of seepage was observed at two places on the downstream face (Appendix C, Photos 1, 7 and 8) as well as a steady flow from the interface of the dam and the ledge (Appendix C, Photo 6). The general condition of the body of the dam was good. On the apron at the toe of the dam is a metering weir with a gauge so that minimum flows can be controlled by means of the valves in the intake well.

PHOTO 1  
DOWNSTREAM FACE OF DAM

1. Instrument observations should be implemented at the leaking construction and expansion joints on the downstream face of the dam and at the junction of the rock ledge with its west wing. Seepage should be checked in dry weather after the apron of the spillway has been drained.

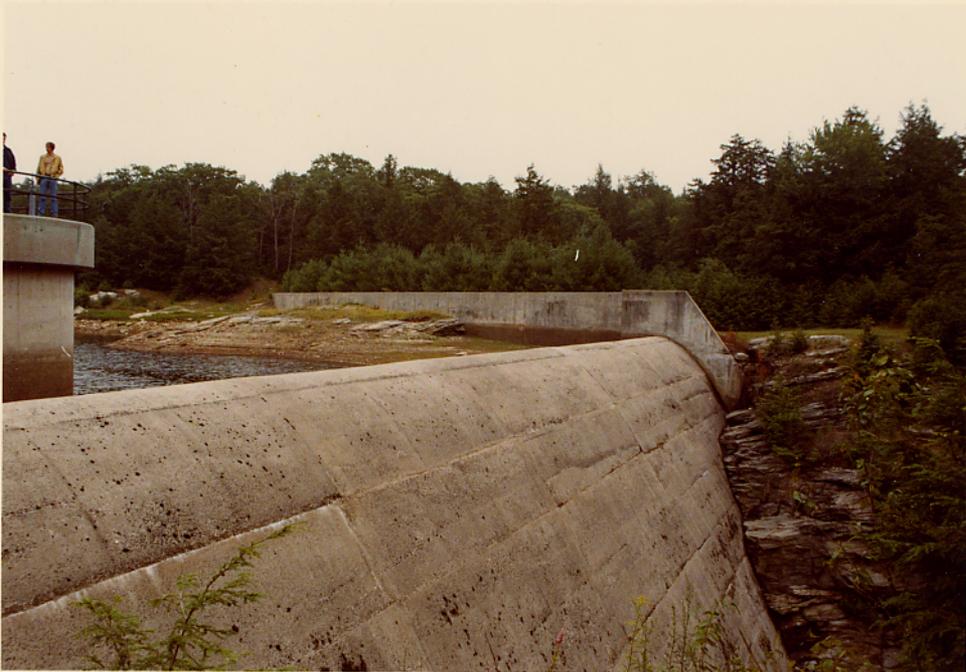
PHOTO 2  
CREST OF DAM

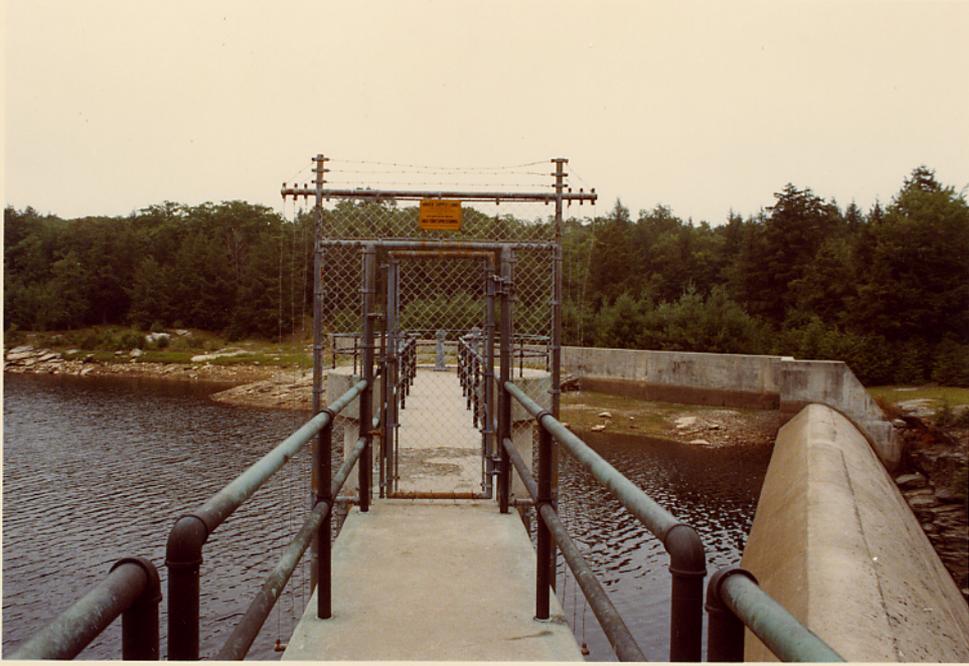
The access to the intake well and its attached equipment has been protected from vandals by the use of gates and chains (Appendix C, Photo 3). The purpose of the valve to the blowoff line is so the minimum flow downstream can be maintained. There is no written or formal operating procedure to control the reservoir for purposes of flood control. The water level is quite often several feet below the spillway crest, because of the demand to supplement water at Lake Gaillard.

PHOTO 3  
WALKWAY OF BRIDGE TO INTAKE WELL

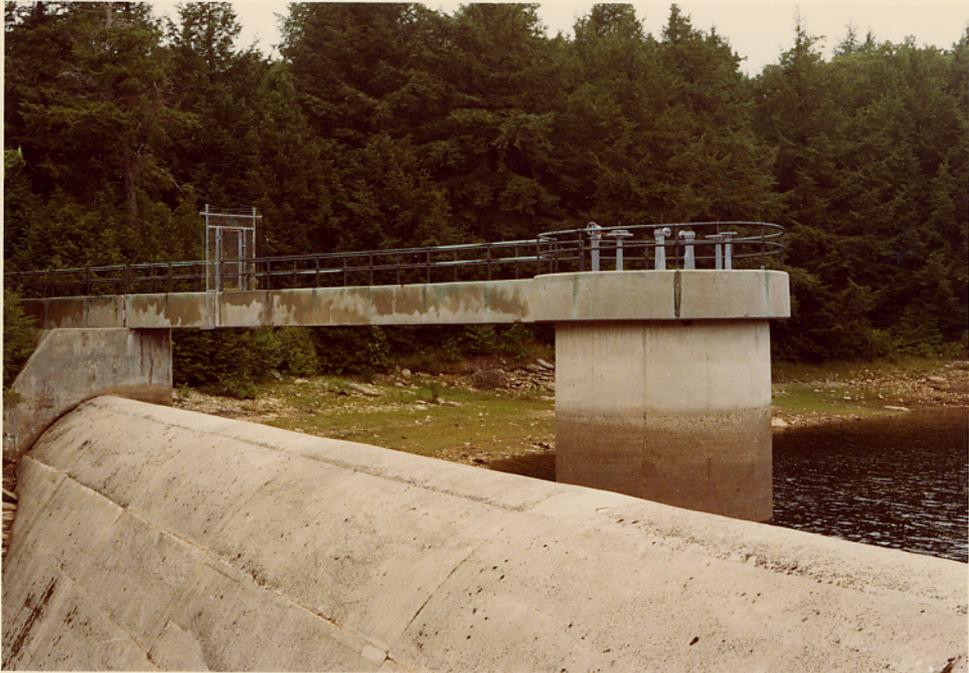
PHOTO 4  
CREST OF DAM LOOKING AT INTAKE WELL

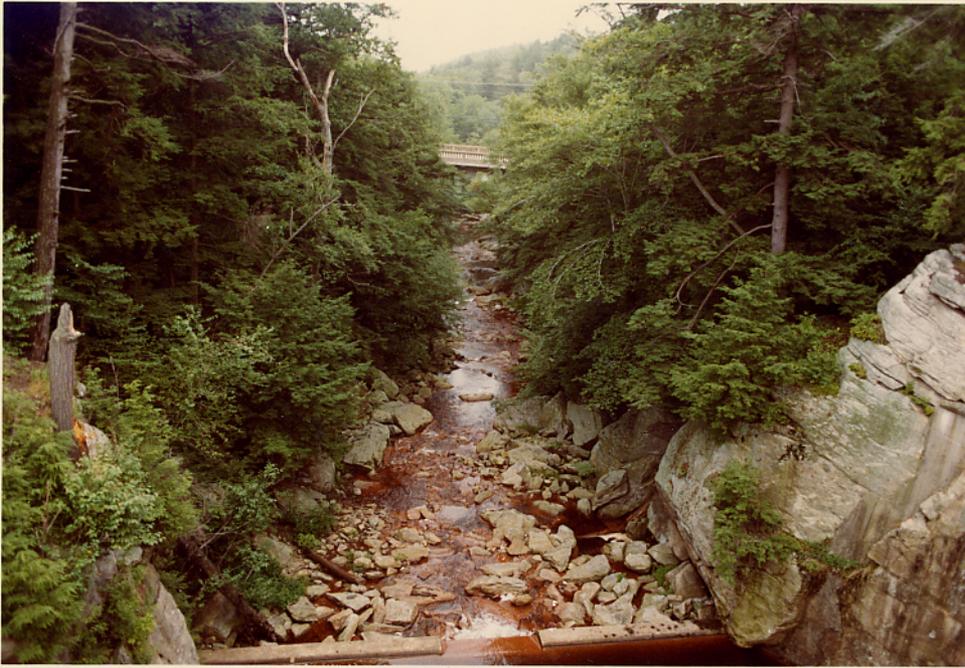
PHOTO 5  
LOOKING DOWNSTREAM FROM CREST OF DAM

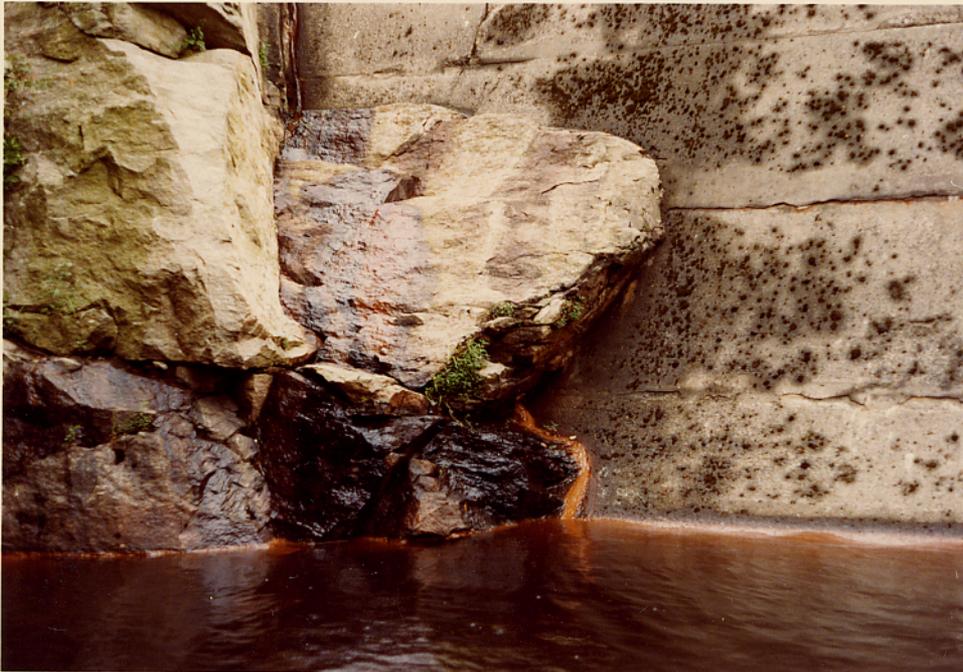
The visual inspection revealed no apparent areas of distress in the concrete. The observations did show some seepage between the rock-concrete interface and the construction joints, however, this is not detrimental to the safety of the dam. Overall, the general condition of the dam is good.

PHOTO 6  
SEEPAGE AT JUNCTION OF ROCK AND DAM

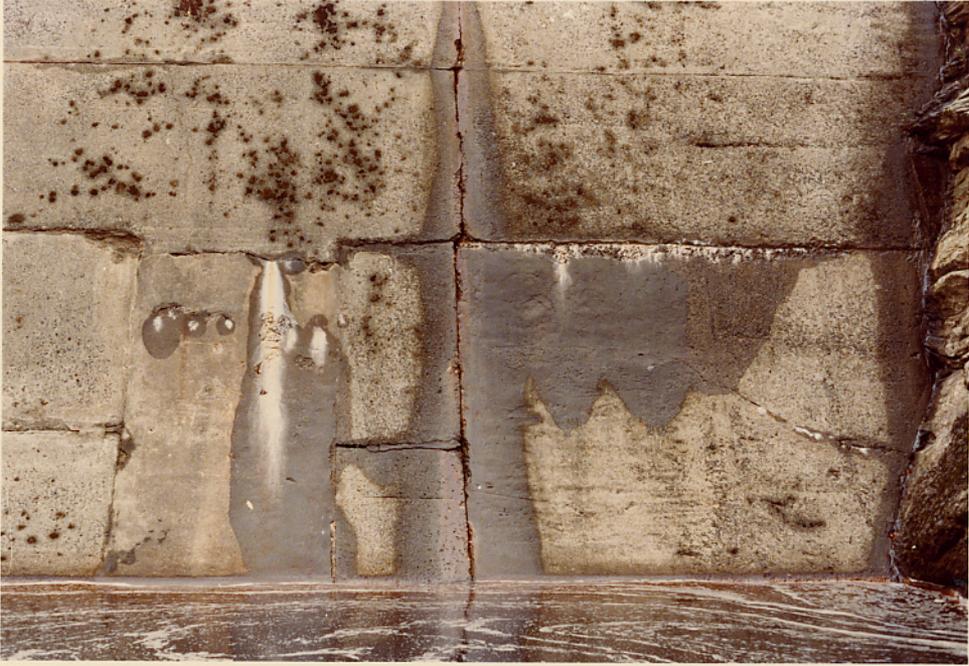
PHOTO 7  
SEEPAGE AT FACE OF DAM

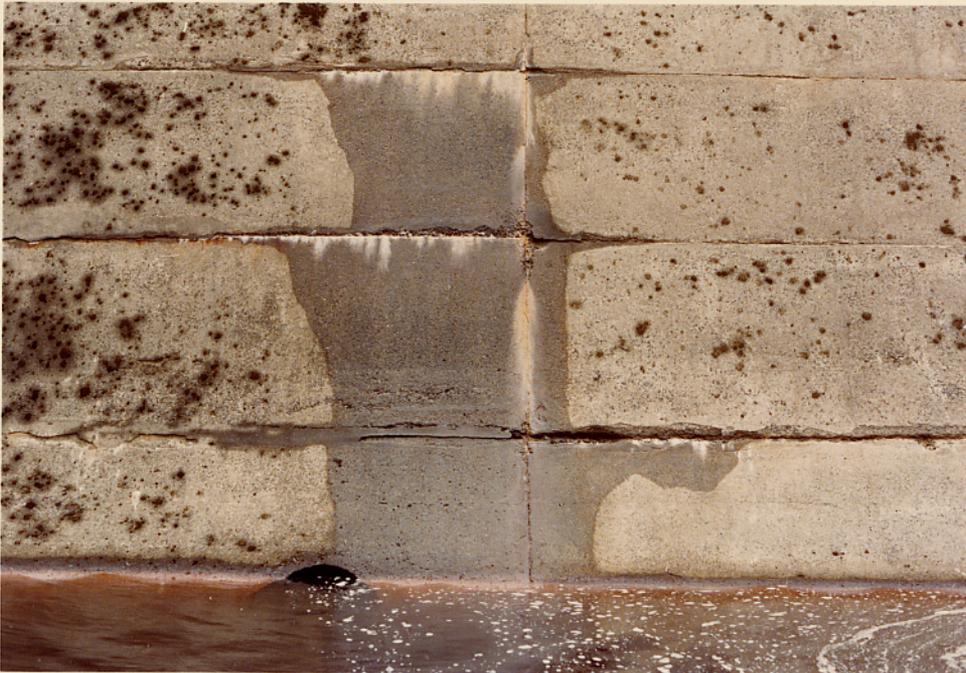
PHOTO 8  
SEEPAGE AT FACE OF DAM
