**CONNECTICUT RIVER BASIN
HADDAM, CONNECTICUT**

**HIGGANUM RESERVOIR DAM
CT 00430**

**PHASE 1 INSPECTION REPORT
NATIONAL DAM INSPECTION PROGRAM**

NOVEMBER 1978

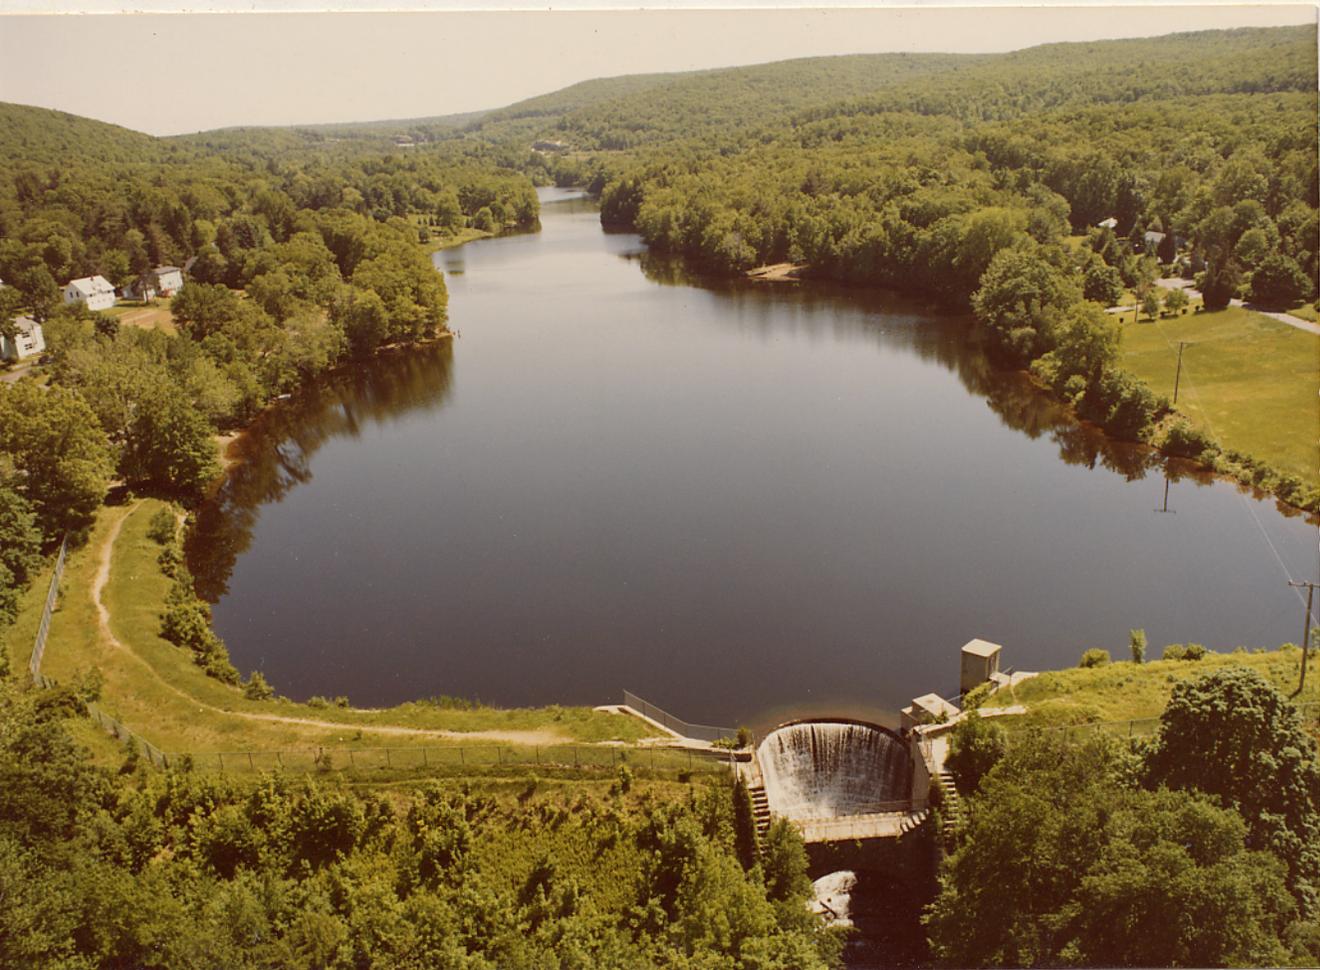
C-1 HIGGANUM RESERVOIR - LOOKING UPSTREAM

- b. Dam: The top surface of the embankment on both sides of the spillway is grassed with a worn footpath along the entire length, see Photo C-1. There is an apparent small 12 inch deep path along the top of the dam between Sta 5+0 and 7+0 (Refer to Appendix B-3 for stationing). Riprap appears to be absent at many locations along the upstream face. Many trees and brush are growing on the upstream face, as well. An example of this growth on the upstream face of the dam is shown in Photo C-4.

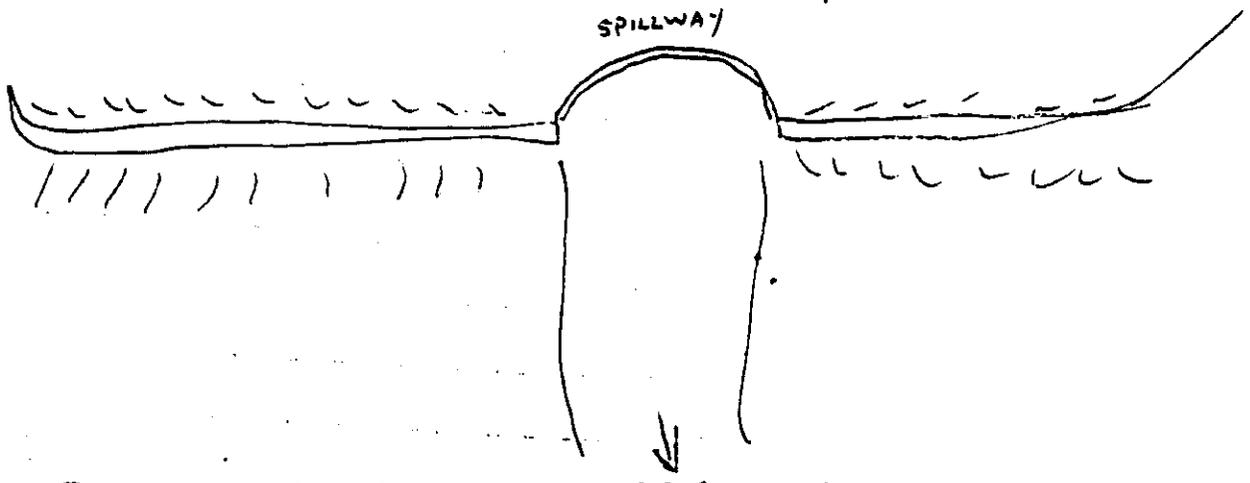
7-27-77 BRUSH ON SLOPES & SEEPAGE ALONG
 TOE E OF OUTLET & ABOUT HALF WAY
 UP SLOPE ON WEST SIDE SHOULD BE
 MONITORED ETC.

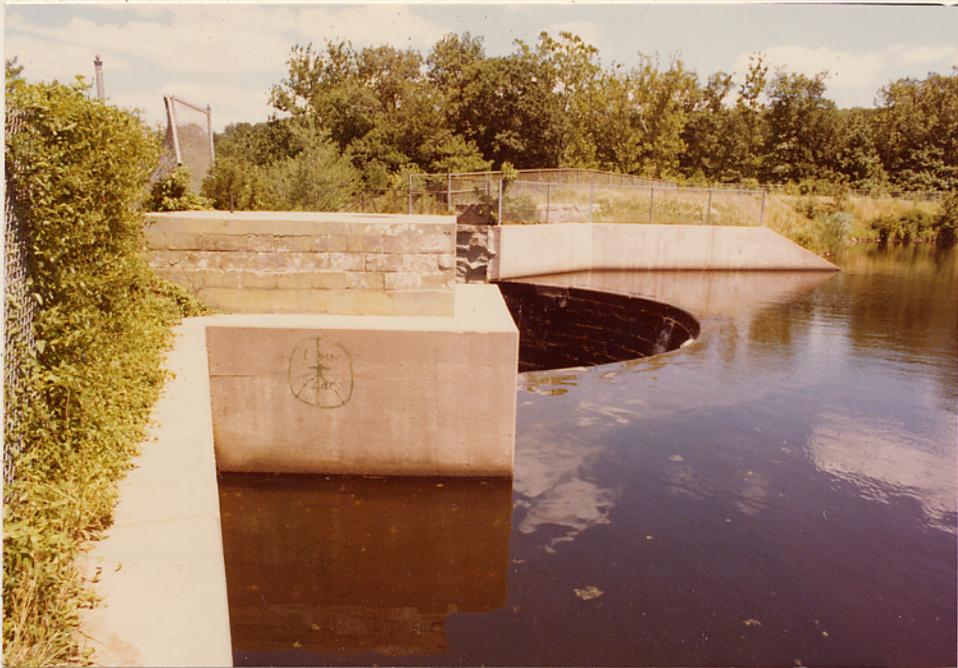
C-2 OVERALL VIEW OF SPILLWAY FROM LEFT EMBANKMENT

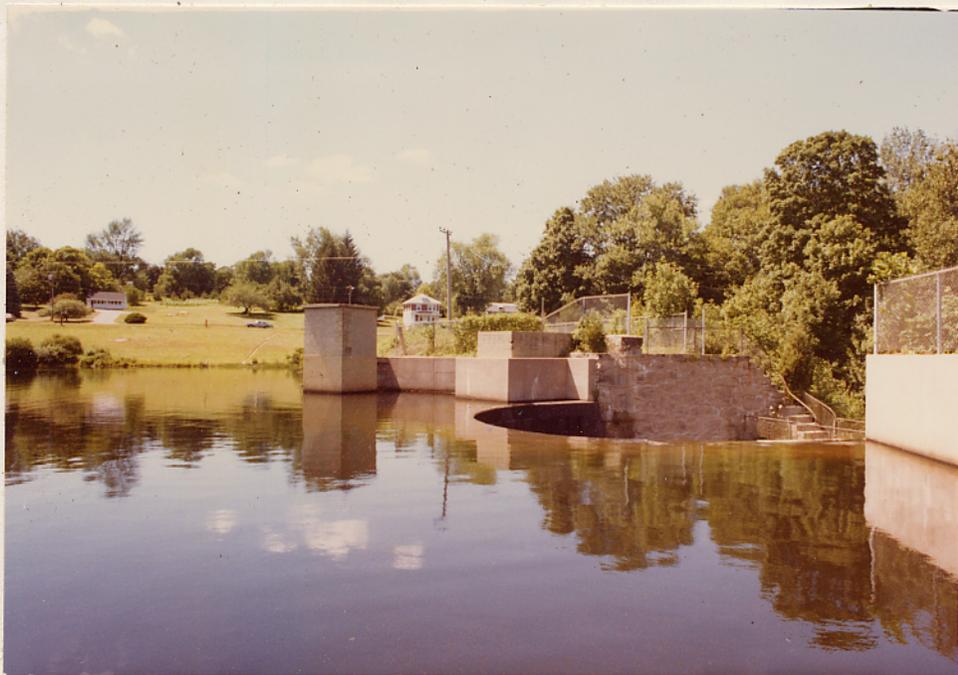
C-3 OVERALL VIEW OF SPILLWAY AND GATEHOUSE FROM RIGHT EMBANKMENT

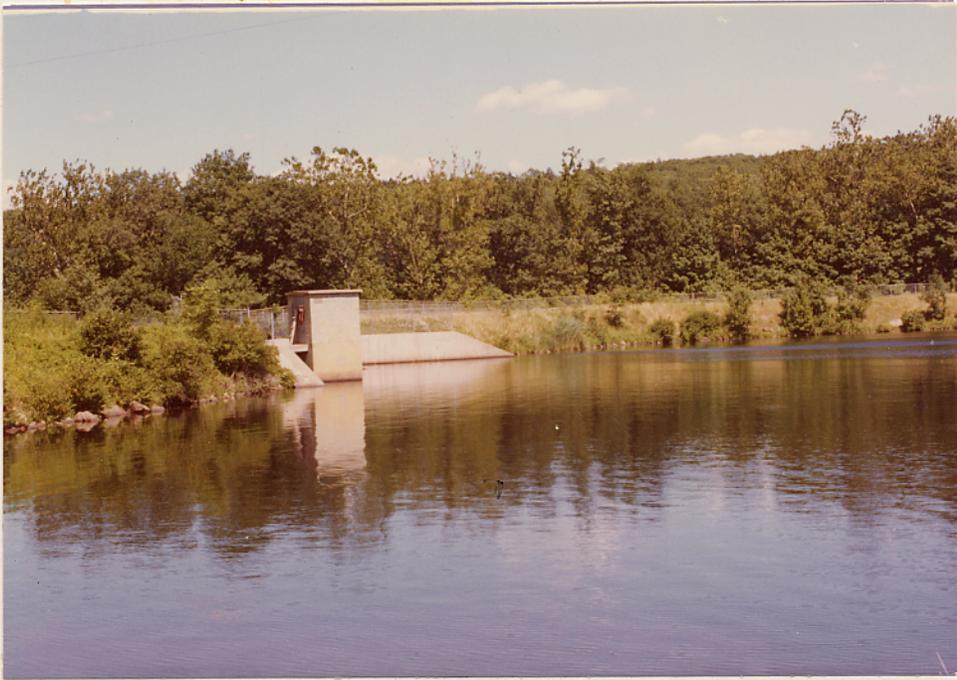
C-4 OVERALL VIEW OF DAM FROM RIGHT SIDE OF RESERVOIR SHOWING EARTH EMBANKMENTS AND GATEHOUSE.

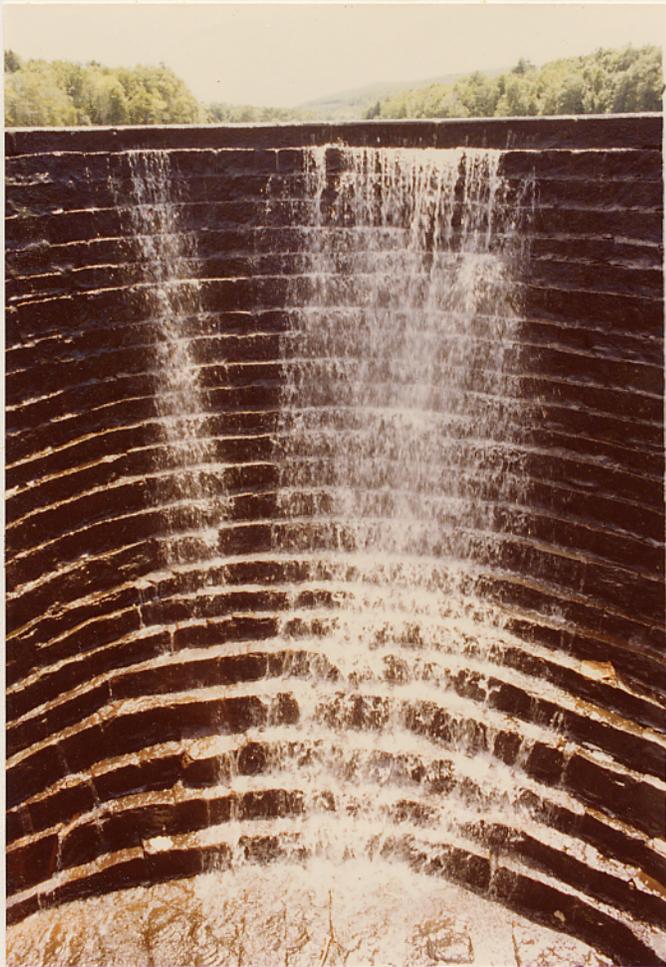
C-5 VIEW OF FACE OF SPILLWAY

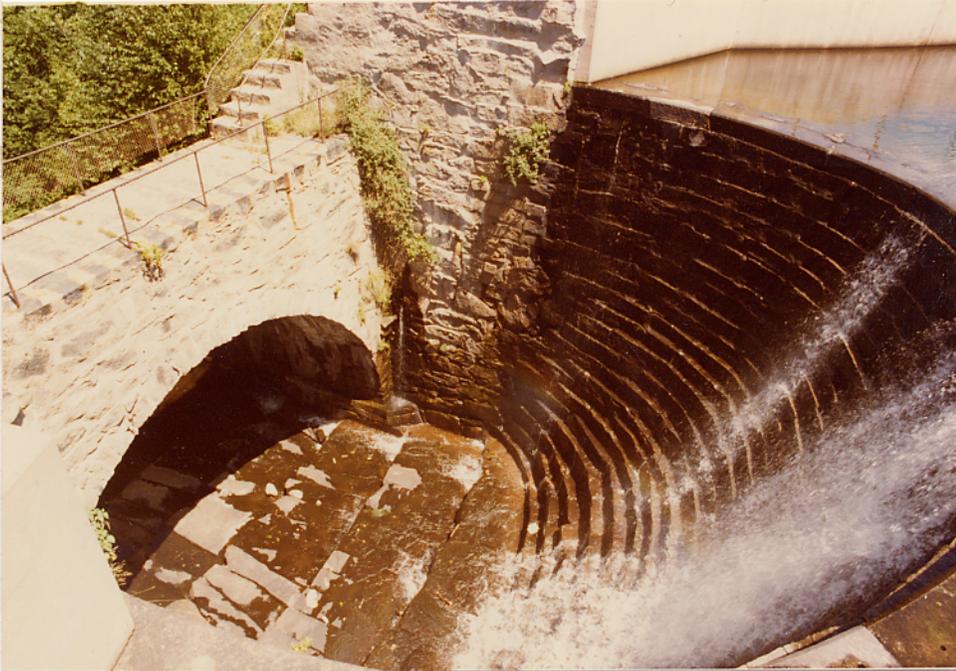
- c. Appurtenant Structures: Seepage was observed emanating from a joint in the right spillway abutment just upstream from the footbridge approximately 35 feet down from the dam crest. Seepage was also observed along the base of contact of the right and left spillway abutment with the channel floor. Extensive iron staining is evi-

C-6 VIEW SHOWING RELATIONSHIP OF SPILLWAY TO
STONE ARCH BRIDGE AND RIGHT TRAINING WALL.
(NOTE LEAK IN TRAINING WALL AT BRIDGE.)

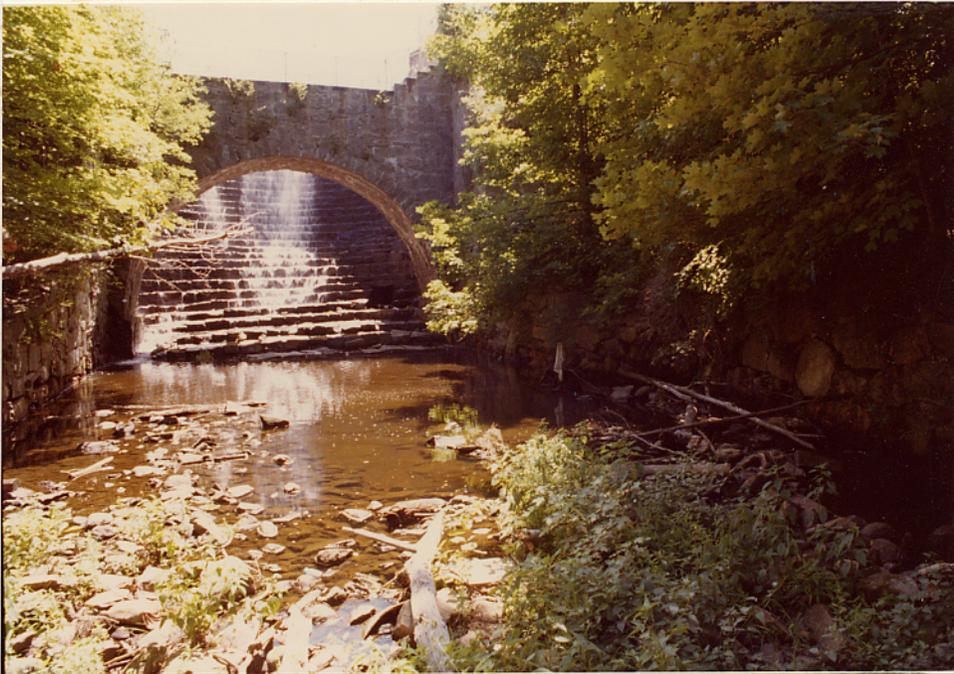
C-7 VIEW OF BRIDGE, SPILLWAY AND DISCHARGE CHANNEL

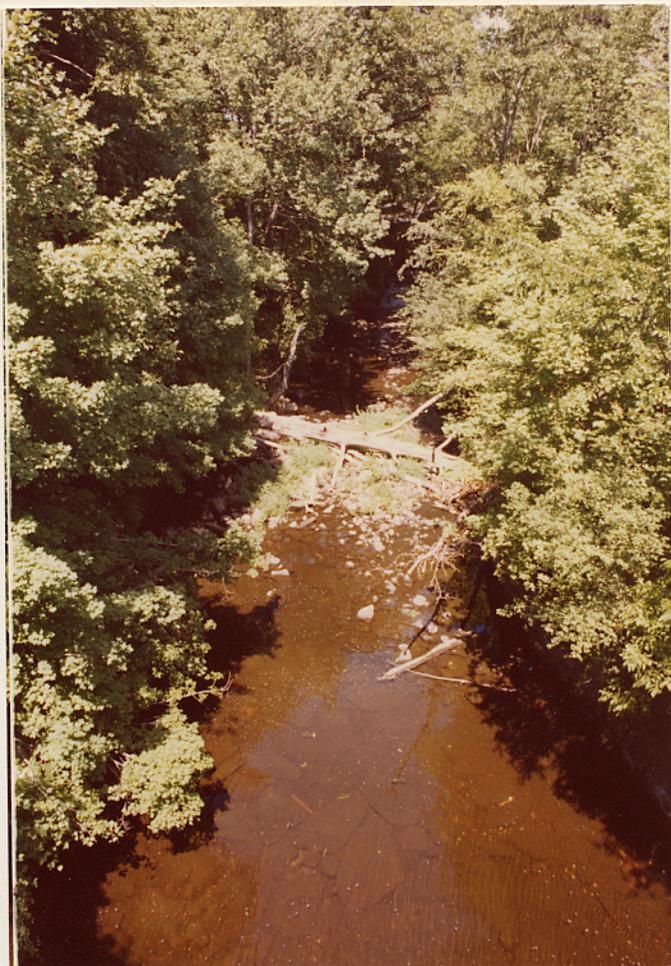
C-8 VIEW OF DISCHARGE CHANNEL TAKEN FROM ARCH BRIDGE. (NOTE OBSTRUCTIONS AND OVERHANGING TREE GROWTH.)

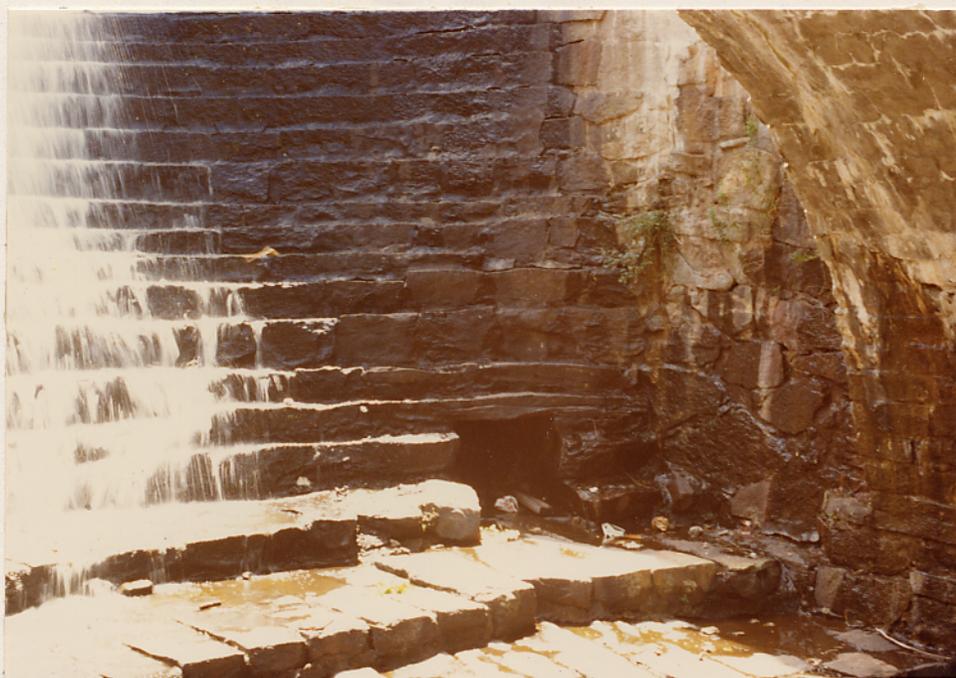
C-9 OUTLET CONDUIT

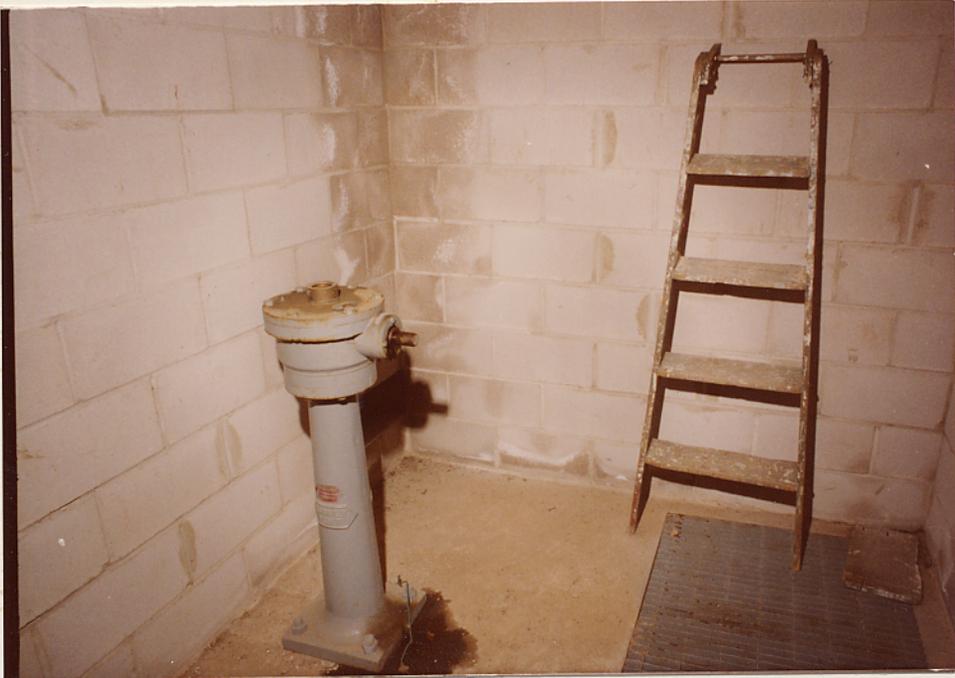
All gate operations at the dam are directed by the Hartford office of the Department of Environmental Protection (D.E.P.). The gate, reportedly, has not been operated since 1972. An operational check of the gate was performed at the time of the visual inspection and the mechanism and gate functioned satisfactorily. The gatehouse and lift mechanism appeared to be in good condition.

C-10 INTERIOR OF GATEHOUSE SHOWING GATE
OPERATING MECHANISM

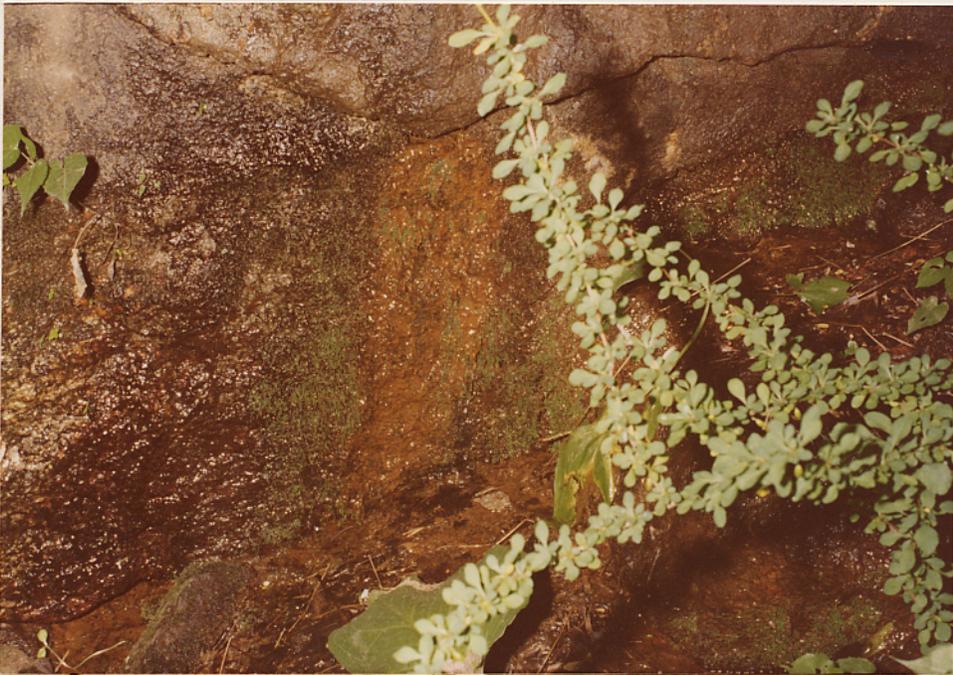
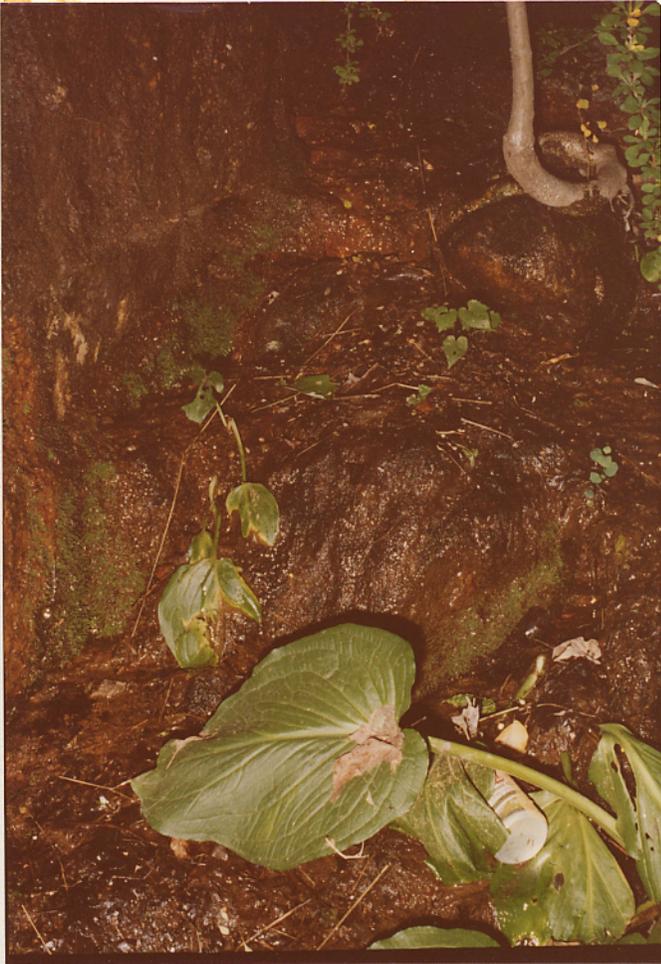
Seepage was also present along the contact of the abutments and the spillway channel. Although these seepage conditions may have been occurring for many years, continued seepage aggravated by any rise in the water level behind this dam may, over a period of time, lead to internal erosion in the dam.

C-11 SEEPAGE EMANATING FROM DOWNSTREAM FACE
OF WALL - LEFT EMBANKMENT

C-12 SEEPAGE EMANATING
FROM DOWNSTREAM FACE OF
WALL - LEFT EMBANKMENT

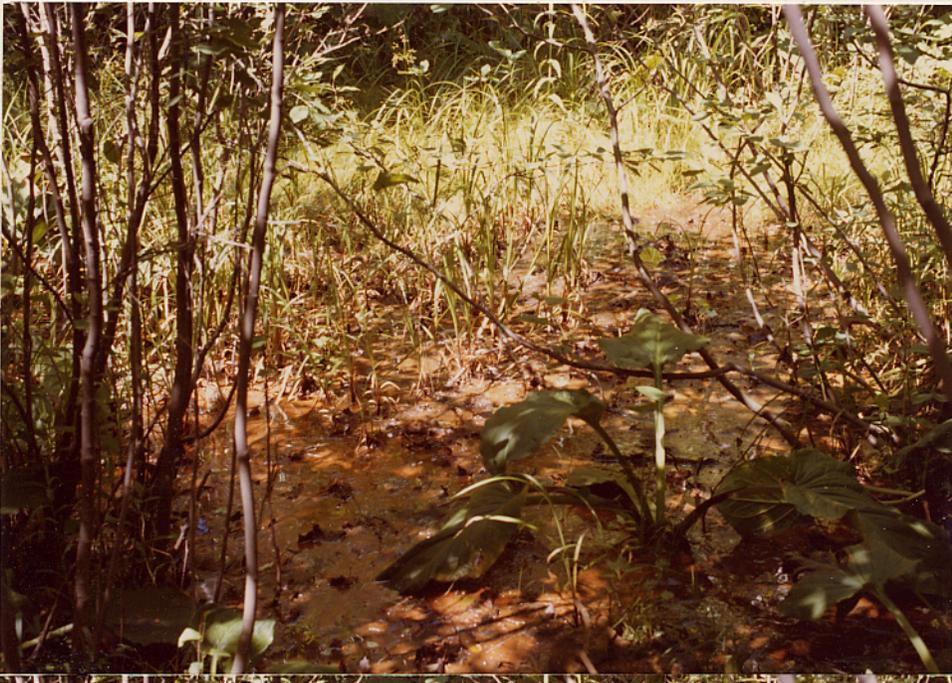
1. Significant seepage was observed exiting from several locations along the downstream toe of the dam and from the abutments in the areas outlined below.
 - (a) A large area of apparent seepage along the downstream toe of the right side of the dam.
 - (b) Two areas of seepage near the masonry retaining wall perpendicular to the spillway channel on the left side of the dam.
 - (c) Seepage flowing from the joints of the spillway abutments adjacent to the foot bridge about 25 feet from the crest.

C-13 EXTENSIVE AREA OF SEEPAGE - RIGHT EMBANKMENT

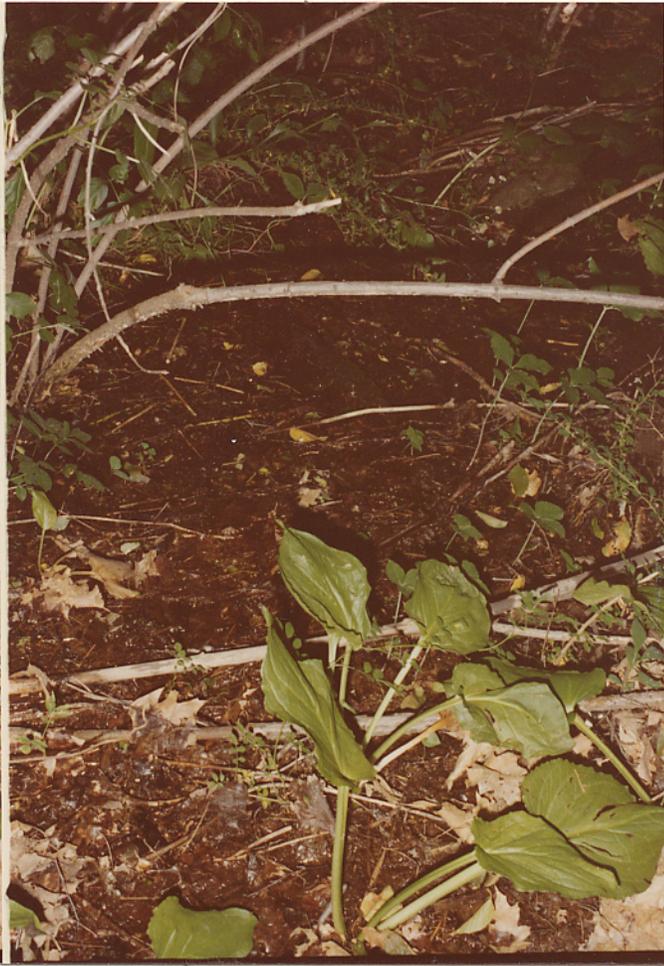
The chamber is approximately 8 feet west of the training wall. Approximately 15 feet north of the chamber, in a direction parallel to the downstream channel, a large wet zone approximately 10 feet long and 5 feet wide was observed. There was no apparent flow from this area.

C-14 SEEPAGE AREA DOWN-
STREAM FROM WALL
LEFT EMBANKMENT

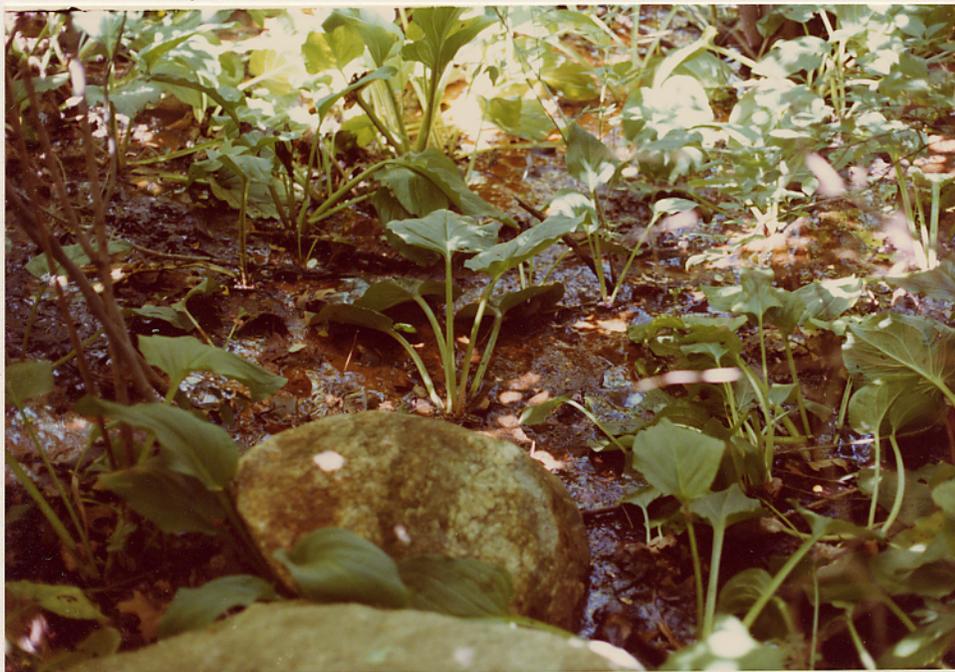
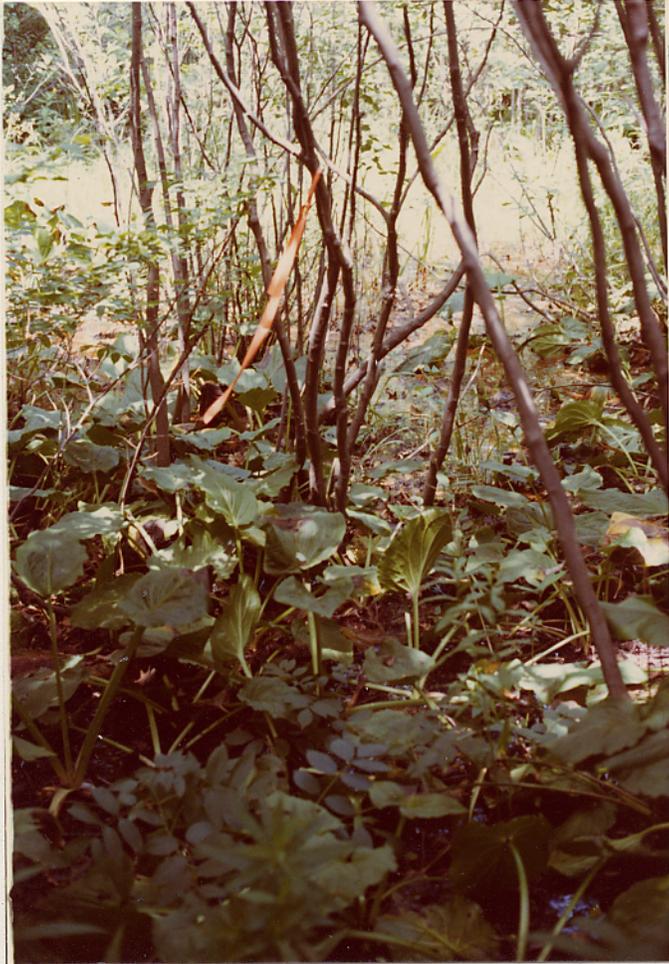
C-15 SEEPAGE AREA ALONG TOE OF RIGHT EMBANKMENT

C-16 SEEPAGE AREA ALONG TOE OF RIGHT
EMBANKMENT
