CASE POND UPPER DAM
CT 00560

PHASE I INSPECTION REPORT
NATIONAL DAM INSPECTION PROGRAM

MAY 1980

Identification No.:	CT 00560
Name of Dam:	Case Pond Upper Dam
City:	Manchester
County and State:	Hartford County, Connecticut
Stream:	Birch Mountain Brook
Date of Inspection:	November 14, 1979

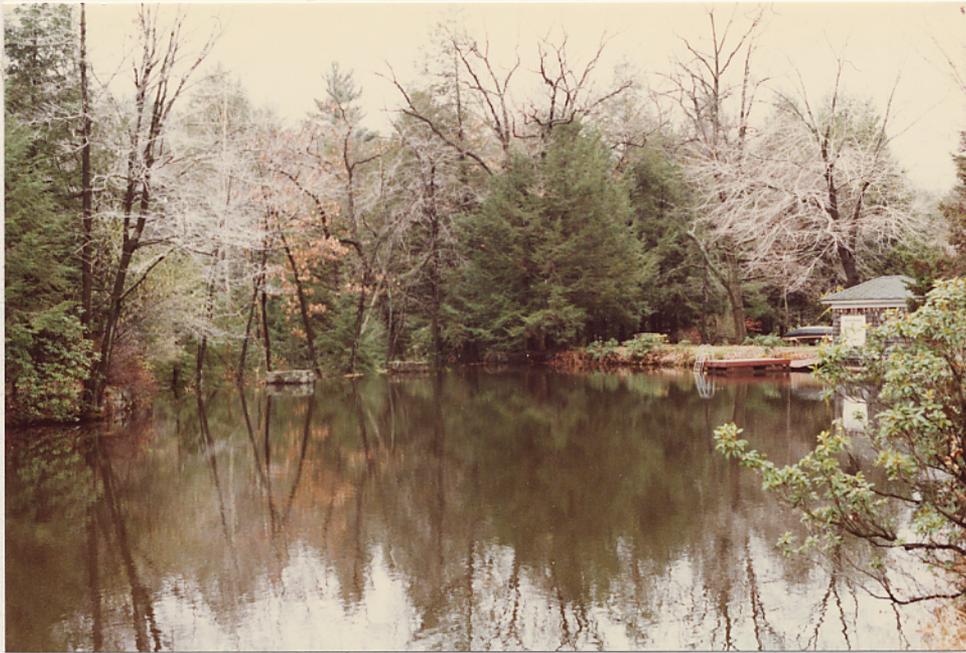
UPSTREAM OVERVIEW OF THE DAM WITH THE TREE COVERED EMBANKMENT TO THE LEFT. (11/14/79)

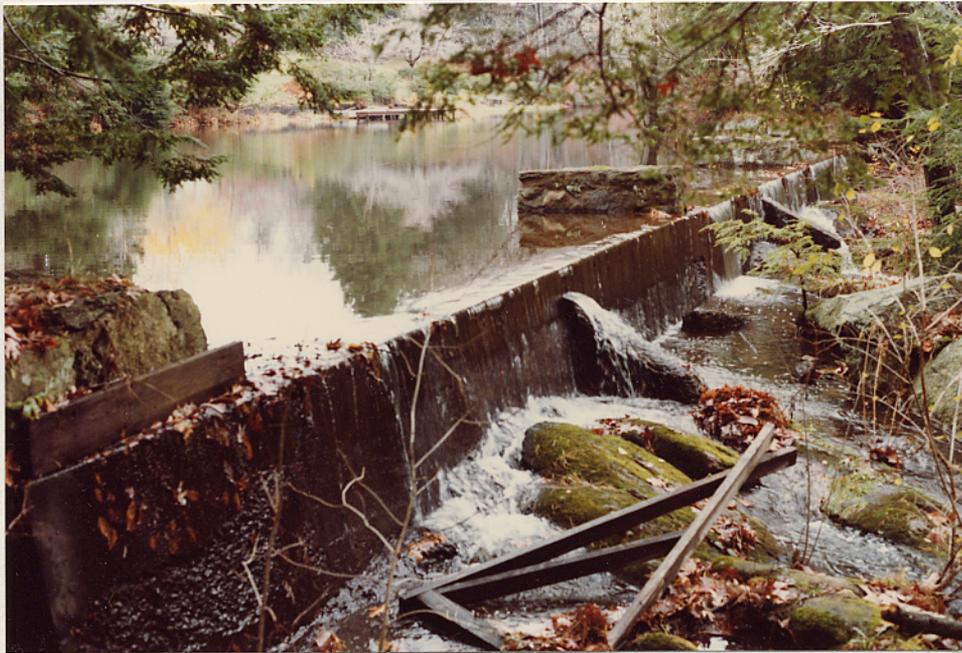
DOWNSTREAM OVERVIEW AS OBSERVED FROM THE RIGHT ABUTMENT. (11/14/79)

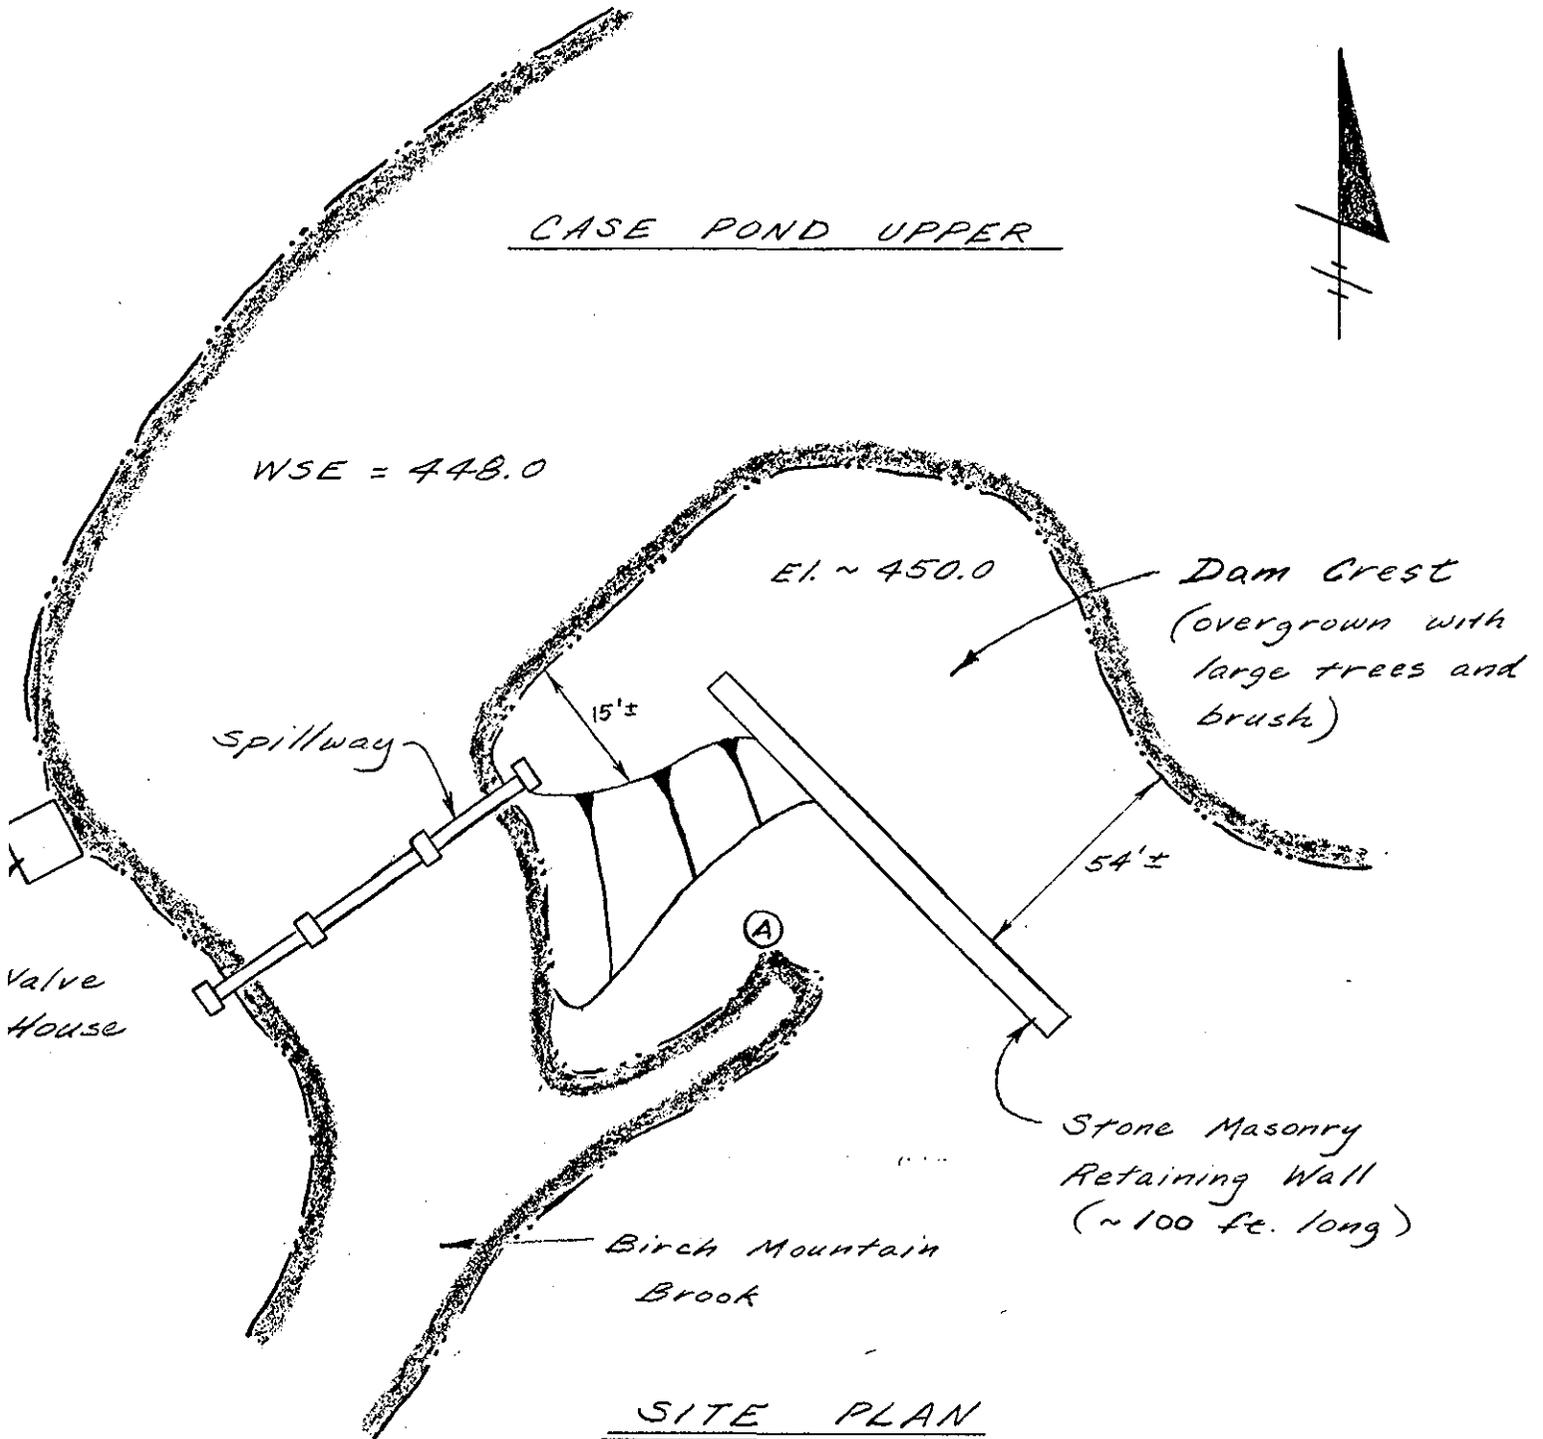
SUBJECT	CASE POND UPPER DAM	SHEET	B-1	BY	A. H.	DATE	3/60	JOB NO.	2060-001
---------	---------------------	-------	-----	----	-------	------	------	---------	----------

Ⓐ Approximate location of "boiling" seepage.

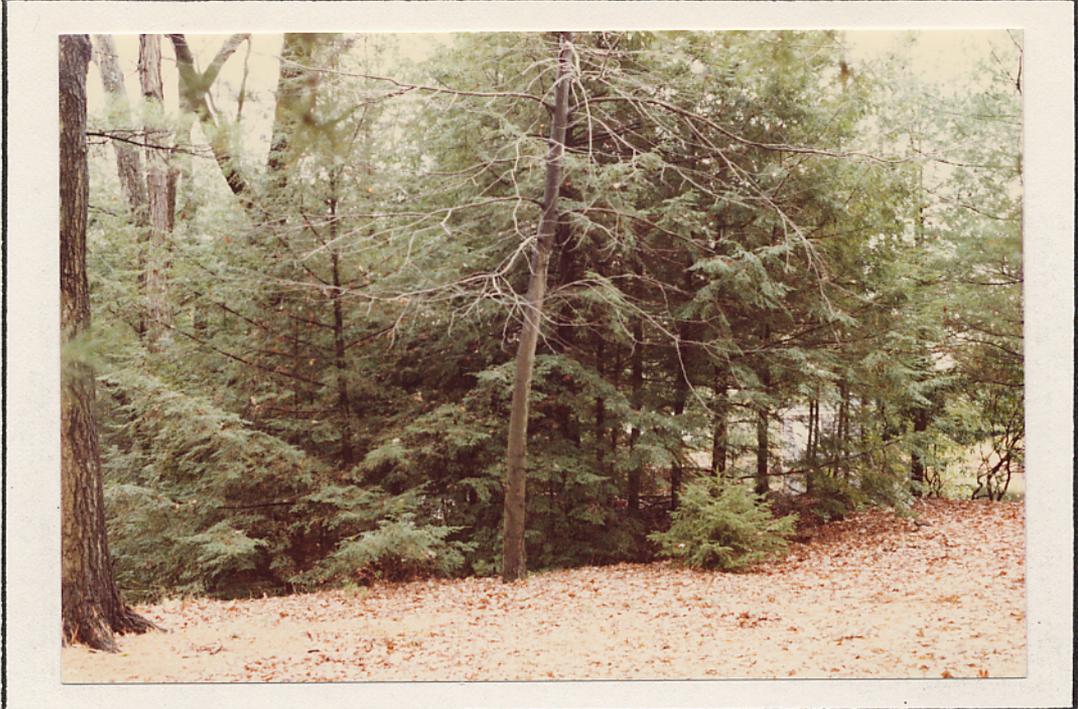
2. The dam crest to the left of the spillway is almost completely overgrown with large trees and brush. A few of the trees have trunk diameters of at least three feet. The larger trees range up to 50 feet in height. No evidence of settlement, cracks, or other indication of surface deficiency, was observed.

1. DENSE TREE COVER ON THE DOWNSTREAM FACE OF THE DAM. (11/14/79)

The dam is considered to be in poor condition. All of the trees and brush, especially the large trees, should be removed from the embankment crest and both the upstream and downstream faces. Erosion protection should be provided for the upstream face of the dam. The seepage condition and the necessity for a low-level outlet should be investigated.

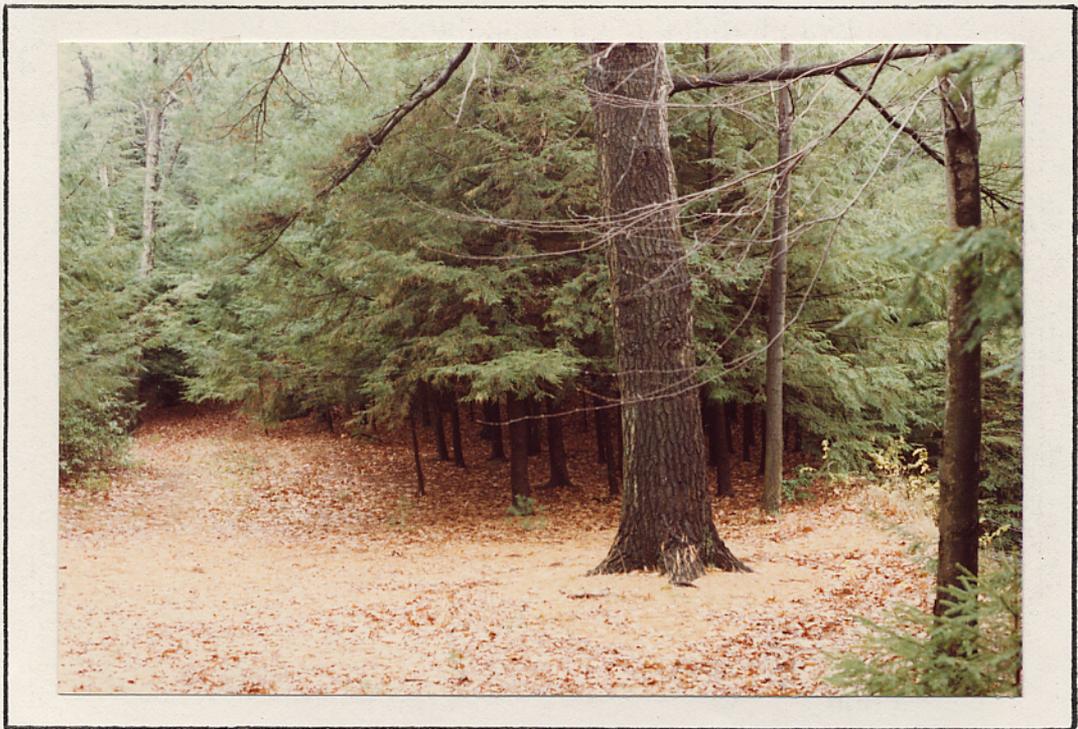
2. DENSE TREE COVER ON THE TOP OF THE DAM LOOKING TOWARDS THE LEFT ABUTMENT. (11/14/79)

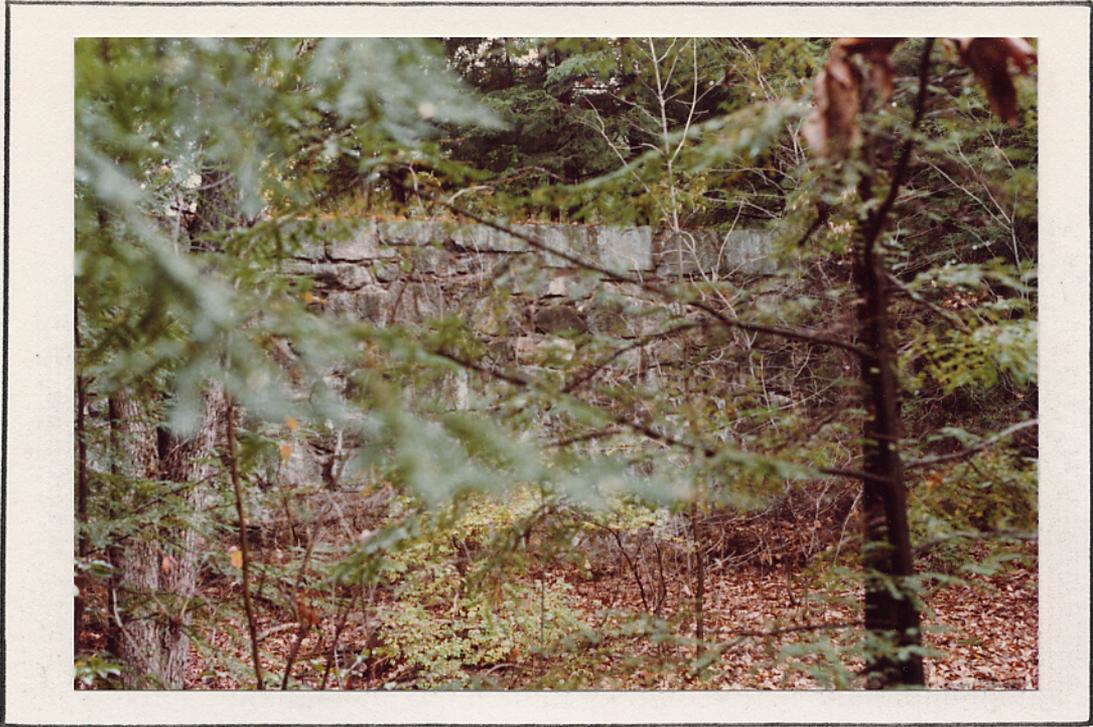
3. About 100 feet of the downstream face of the dam, towards the left abutment, is retained by a vertical 16-foot high stone masonry wall. The wall appears to be in fair condition with some loss of mortar, but no evidence of leakage through the wall or vertical or horizontal misalignments were observed. Rust-colored seepage, with a flow estimated to be about two gallons per minute, was observed in the old streambed about 10 feet downstream of the retaining wall (Page C-4). The soil in the area of the seepage is very soft. According to Mr. Dennison, this condition has remained unchanged for many years.

The roots of large trees growing on the embankment may be providing seepage paths through the dam and could be dislodging joint material from the downstream masonry retaining wall. High winds could uproot the trees causing removal of significant volumes of embankment material. The rust-colored seepage in the vicinity of the downstream toe of the embankment indicates that seepage paths may have developed through the embankment or foundation. Although the condition has remained constant for many years, according to Mr. Dennison, the potential remains for piping of fine-grained soil from the embankment.

6. Mortar between stones in the retaining wall is cracked or missing.

3. VERTICAL DOWNSTREAM MASONRY WALL NEAR THE LEFT ABUTMENT.
(11/14/79)

2. All deteriorated concrete and masonry surfaces should be repaired.

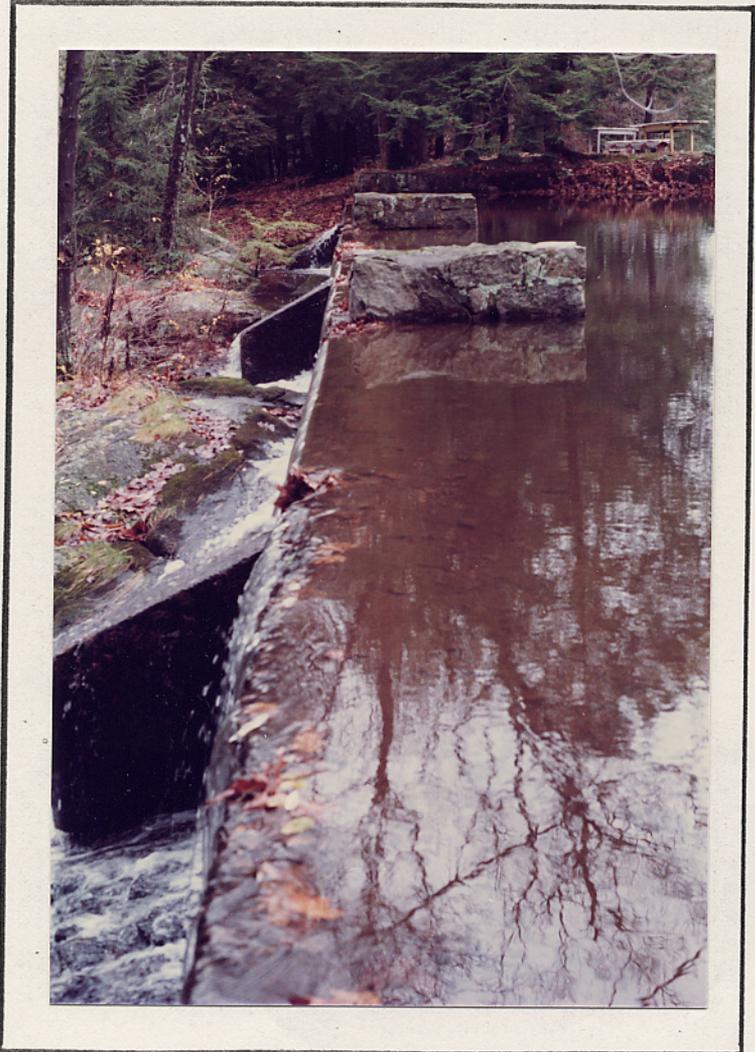
c. Appurtenant Structures. The spillway consists of a concrete wall, approximately three feet high and 87 feet long. The concrete generally appears to be in fair condition except for some spalling along the downstream face of the wall. In addition, some leakage was observed at the base of the wall near the right abutment.

4. VIEW ALONG THE SPILLWAY
CREST LOOKING TOWARDS THE
RIGHT ABUTMENT. (11/14/79)

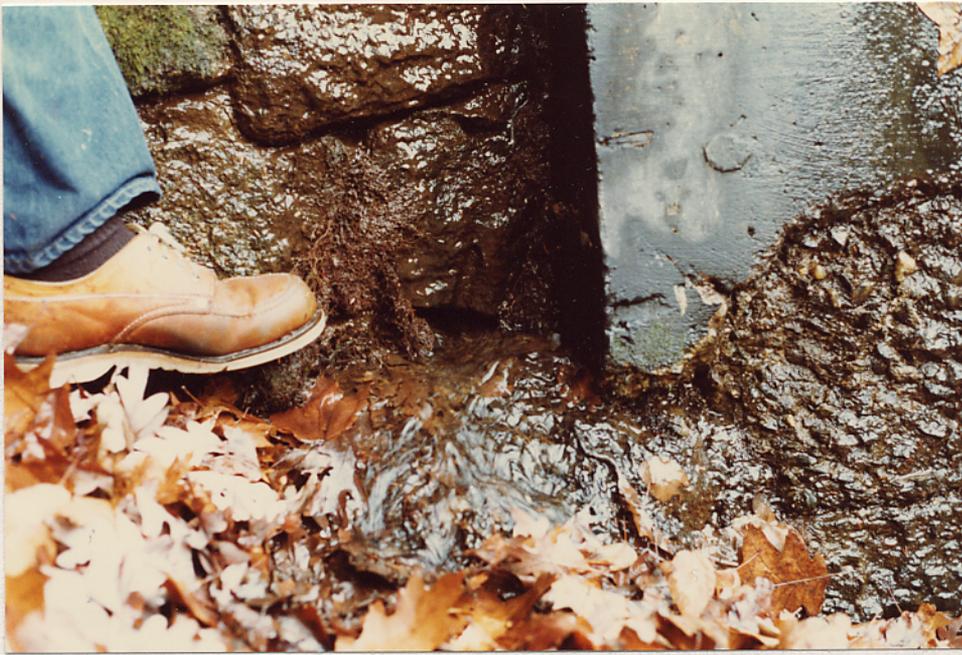
5. Leakage is occurring under the spillway wall near the right abutment.

5. SEEPAGE THROUGH THE SPILLWAY WALL. (11/14/79)

1. Investigate the causes of the seepage located in the vicinity of the downstream toe of the embankment (about 10 feet downstream of the retaining wall) and at the base of the spillway wall and assess the need for remedial action at each location.

3. Cracks between the spillway wall and the rock foundation should be repaired.

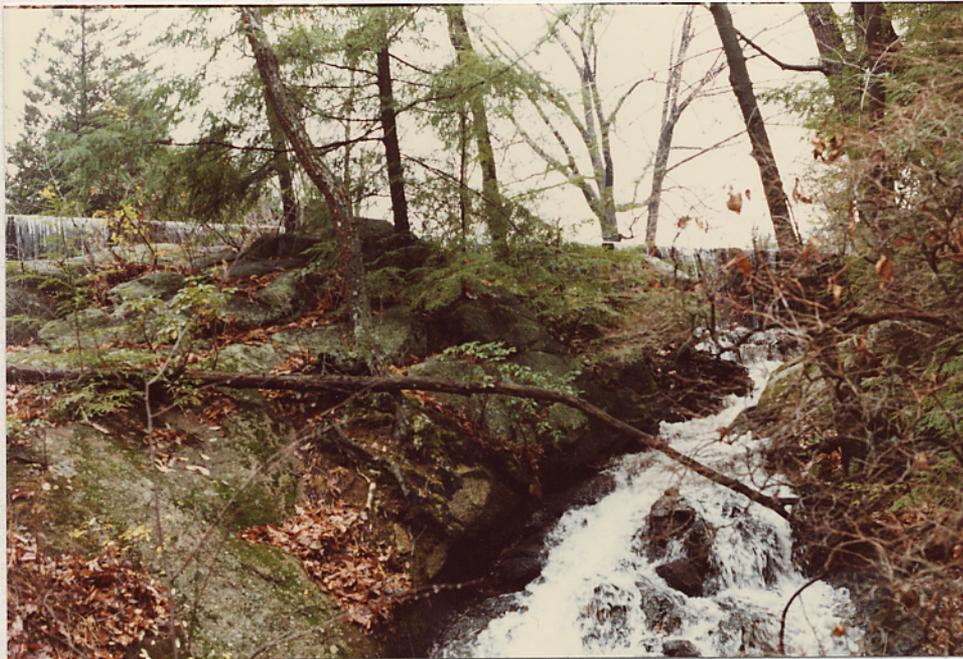
6. DISCHARGE IMMEDIATELY DOWNSTREAM OF THE SPILLWAY. (11/14/79)

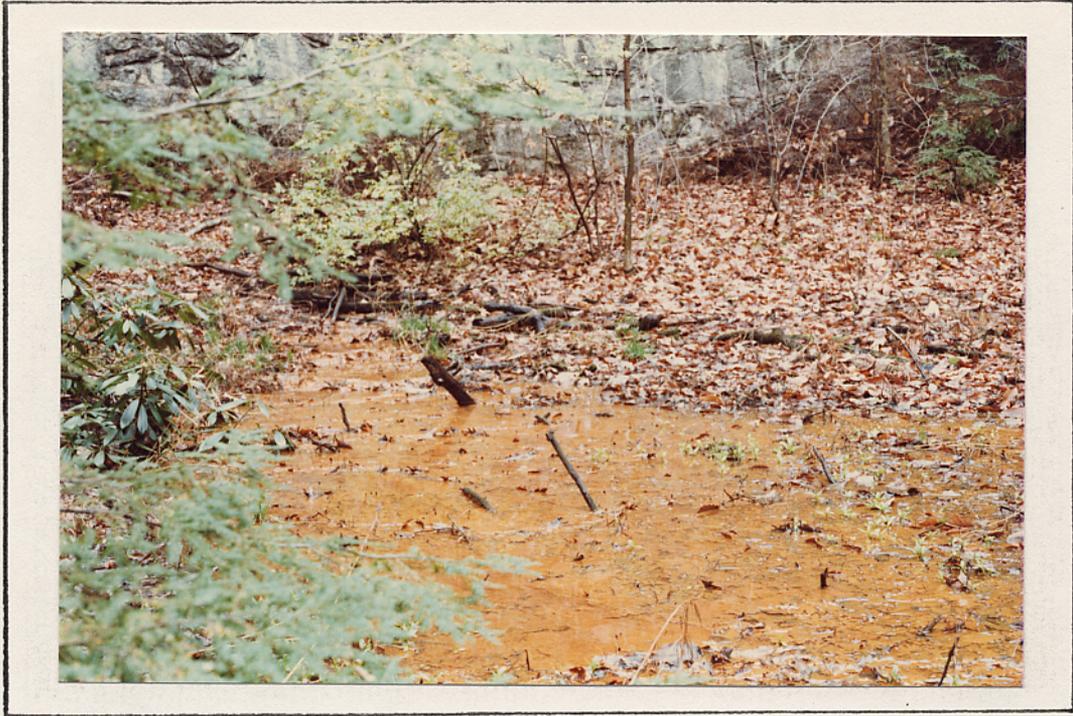
1. A significant amount of seepage (about 2 gpm) was observed in the vicinity of the downstream toe of the embankment about 10 feet from the downstream embankment retaining wall.

7. SEEPAGE WHICH BEGINS ABOUT 10 FEET DOWNSTREAM OF THE VERTICAL DOWNSTREAM MASONRY WALL OF THE DAM. (11/14/79)

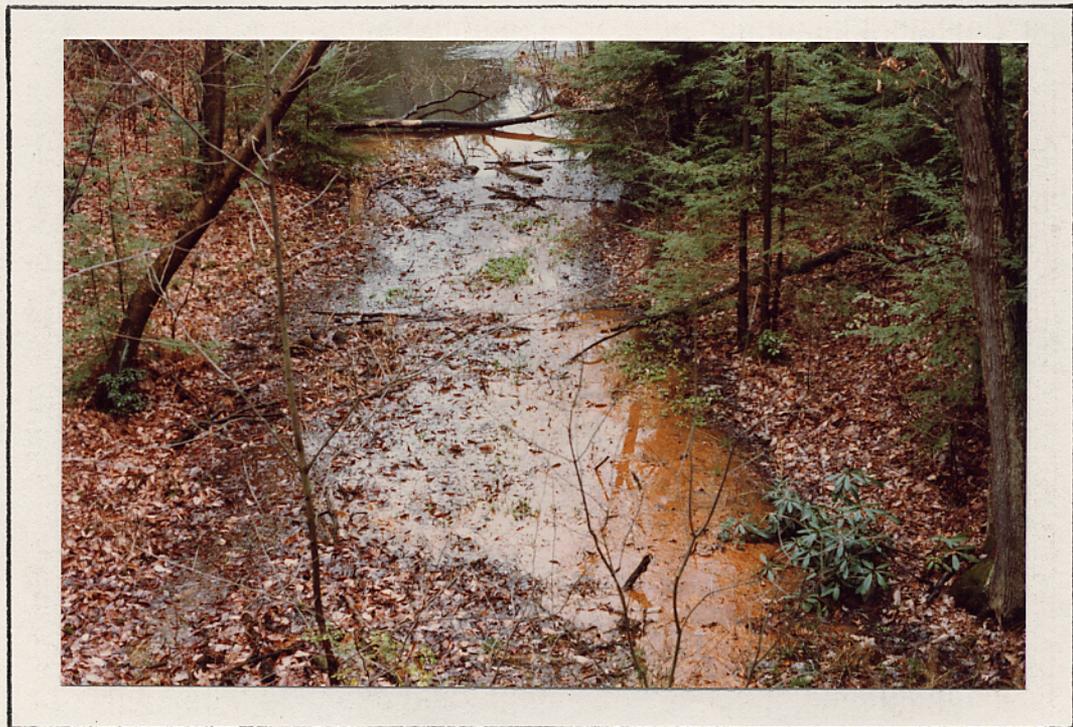
8. SEEPAGE FLOW AS VIEWED FROM THE CREST OF THE DOWNSTREAM VERTICAL MASONRY WALL OF THE DAM. (11/14/79)

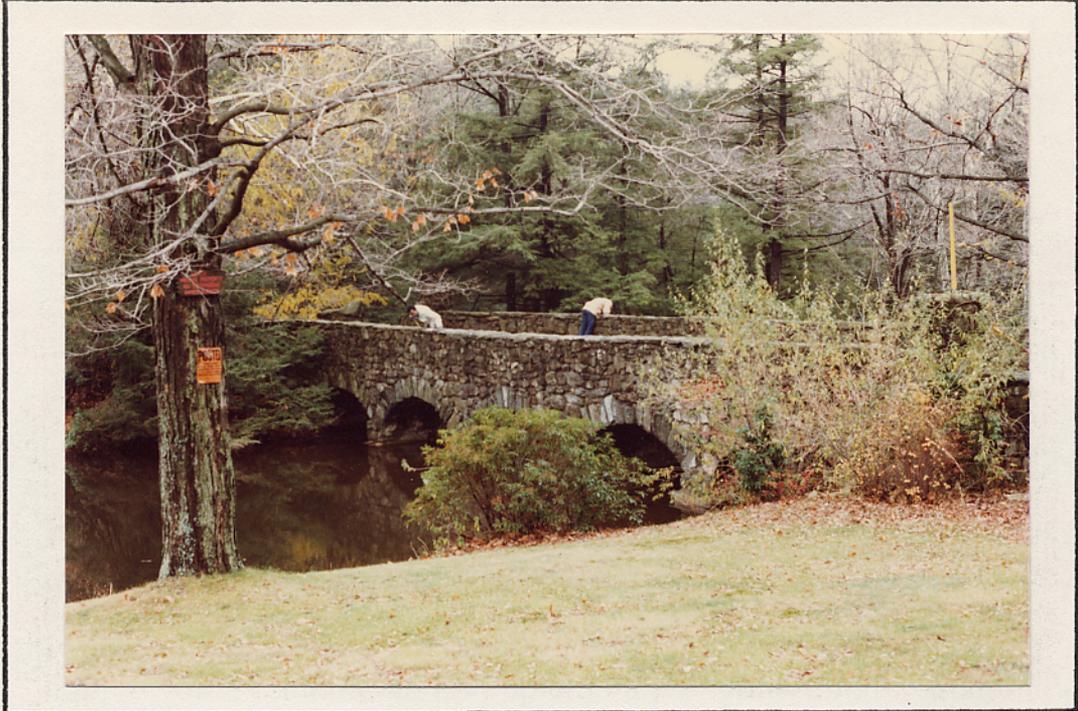
d. Hazard Classification. The potential damage area is considered to be a highway bridge (Spring St.) located approximately 600 feet downstream of the dam. Breach flows would travel through Case Pond Lower Dam then down a steep incline to the Spring Street Bridge. The first residential area is an apartment complex located about 4,400 feet downstream of the dam. The failure analysis indicated that breach floodwaters would be contained within the channel banks at this location. A failure of the dam could result in appreciable damage to the highway bridge, but it is unlikely that lives would be lost at any downstream location. Therefore, Case Pond Upper Dam is classified in the "Significant" hazard potential category.

9. MASONRY BRIDGE BUILT OVER THE CASE POND LOWER DAM APPROXIMATELY 600 FEET DOWNSTREAM OF THE CASE POND UPPER DAM. (11/14/79)

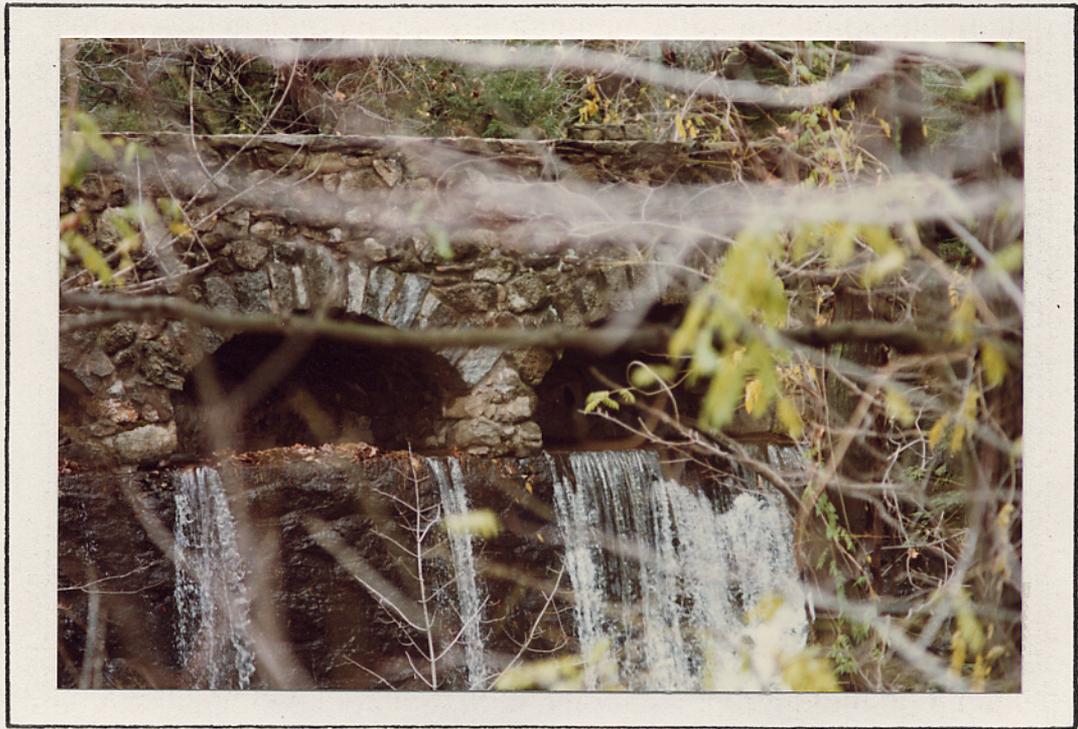
10. DISCHARGE OVER THE CASE POND LOWER DAM SPILLWAY. (11/14/79)

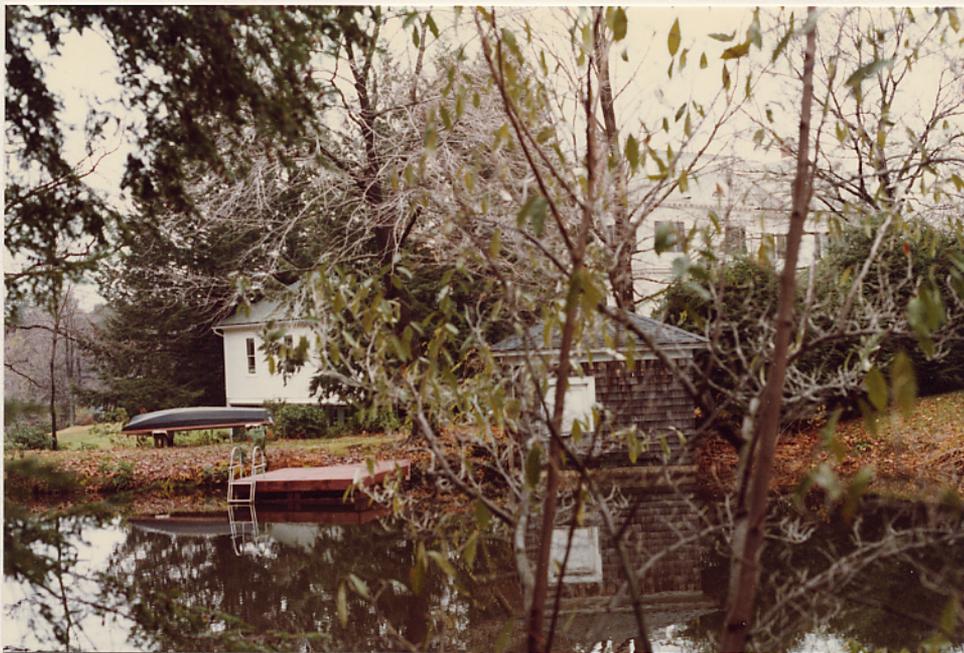
11. REGION APPROXIMATELY 100 FEET UPSTREAM OF THE SPILLWAY WHERE WATER HAS IN THE PAST OVERTOPPED THE RIGHT BANK OF THE POND. (11/14/79)

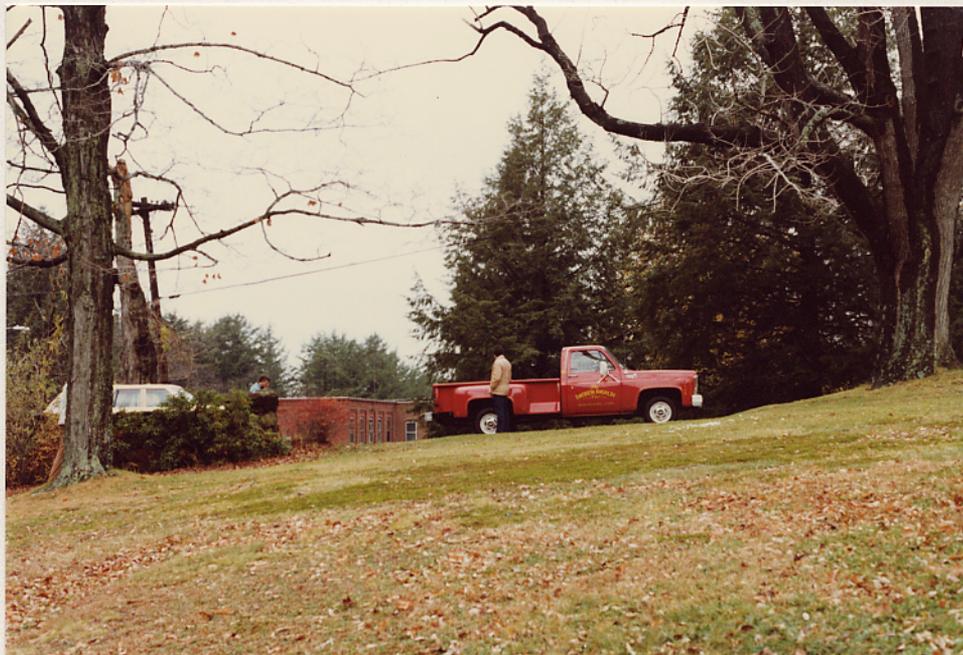
12. REGION TO THE RIGHT OF THE CASE POND LOWER DAM WHERE DISCHARGE WOULD BE CONCENTRATED DURING PERIODS OF EXCESSIVE FLOW. (11/14/79)

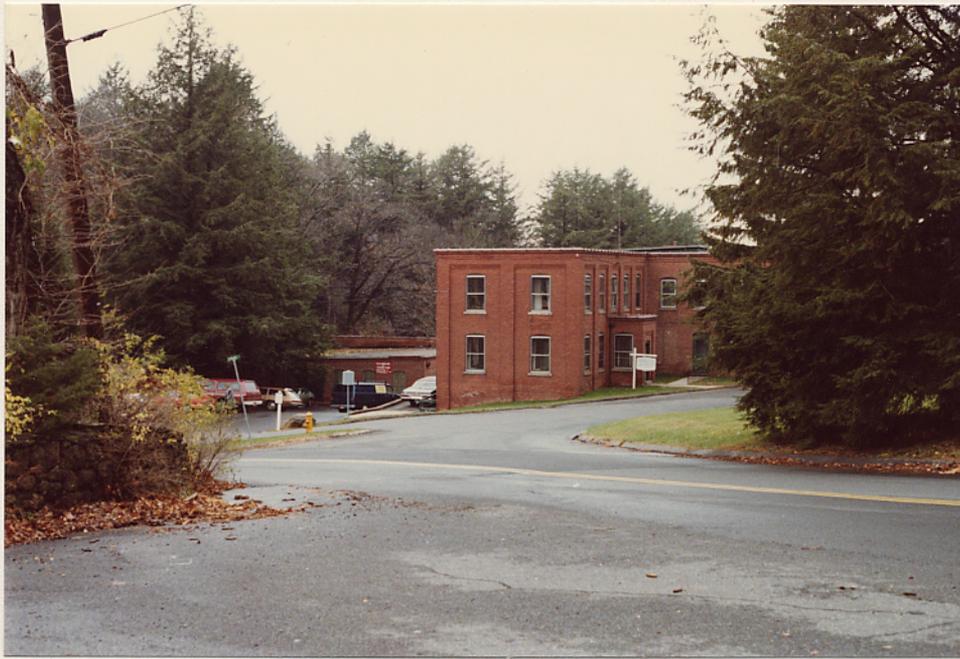
13. FACTORY COMPLEX ABOUT 900 FEET DOWNSTREAM OF CASE POND UPPER DAM. (11/14/79)

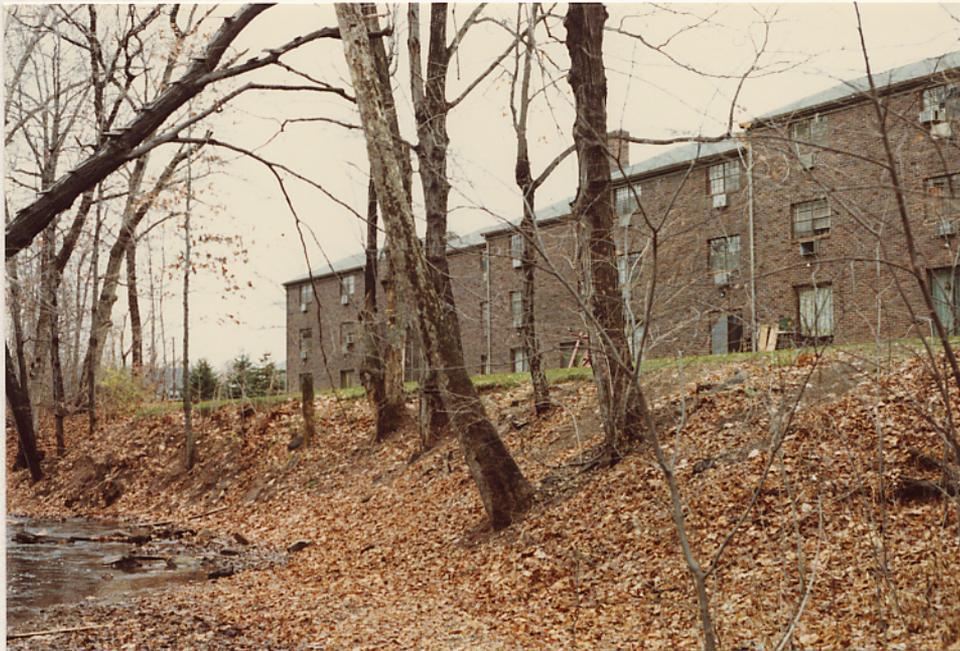
14. APARTMENT COMPLEX ABOUT ONE MILE DOWNSTREAM OF CASE POND UPPER DAM. (11/14/79)
