GLOBE HOLLOW RESERVOIR DAM

CT. 00012

PHASE I INSPECTION REPORT
NATIONAL DAM INSPECTION PROGRAM

JUNE 1979

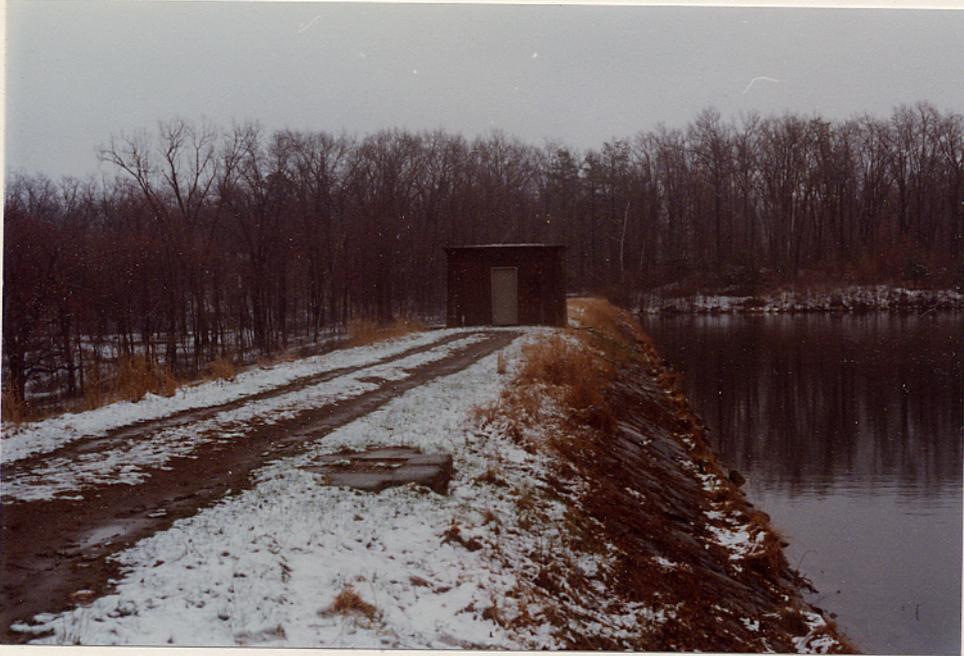
The upstream slope is faced with hand-placed rock riprap which extends to within 1.5 ft. of the dam crest. The riprap is in generally good condition with no evidence of sags or bulges. The downstream toe of the embankment contains a drainage zone of coarse riprap which also appears to be in good condition. At each end of this riprap there are 6 in. dia. cast iron drain pipes extending from the toe of the dam. It was estimated that the discharge from the left pipe was about 0.05 gpm, while the right pipe had essentially no discharge, with just a few drops coming out of it. There was some minor seepage along the toe of the embankment, about 30 ft. right of the right toe drain pipe, where the dam intersects natural ground, estimated to be less than 1 to 2 gpm. There was one small rodent hole about 4 in. dia. and 18 in. deep located approximately 50 ft. right of the right toe drain outlet pipe, at the intersection of the toe drain with natural ground. (See Photo Nos. 1 and 2, Appendix C).

1. Upstream slope of dam.

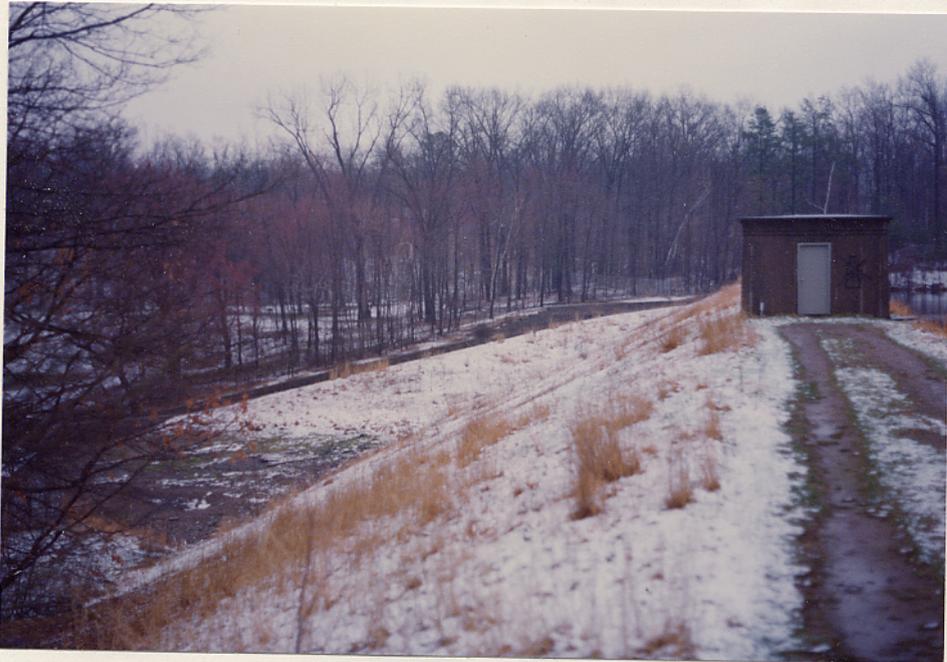
2. Downstream slope of dam.

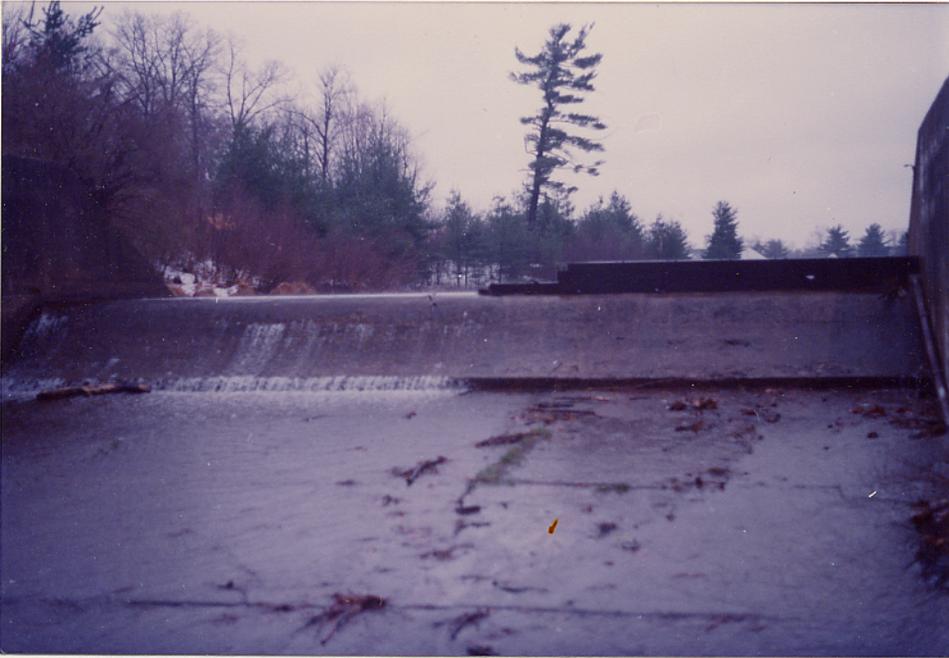
c. Appurtenant Structures. The spillway channel at the right abutment of the dam has a 35 ft. wide ogee crested weir with concrete training walls extending 6 ft. above the spillway crest to elevation 271 MSL. Old wooden flashboards were fixed to the left half of the weir. In general the spillway concrete is in fair condition. The discharge channel is about 190 ft. long and generally appears to be in fair condition. The channel training walls are about 2 ft. high, except in the vicinity of the bend, where the right wall has been raised locally at some time after original construction, presumably to forestall overtopping (See Photo Nos. 5 and 6, Appendix C). At the right training wall of the channel approximately 40 ft. downstream of the crest, some minor deterioration of the concrete has occurred. There are some settlement cracks in the floor of the discharge channel which generally follow the construction joints. (See Photo Nos. 3,4,5 and 6, Appendix C).

3. Spillway crest and deteriorated flashboards viewed from downstream chute.

- (1) Pending completion of the review of the use of flashboards recommended in Section 7.2, remove flashboards installed on half the spillway weir, because of apparent spillway inadequacy and the potential for overtopping of the dam, and leave them removed.
- (2) Repair cracks in the concrete outlet headwall.
- (3) Repair cracks in spillway discharge channel training walls and bottom slab.
- (4) Monitor seepage quantity and clarity from toe drains at least once a year.
- (5) Backfill rodent holes and monitor the embankment for new burrows.
- (6) Develop a formal surveillance and flood warning plan.
- (7) Institute procedures for a biennial periodic technical inspection of the dam and appurtenant works.

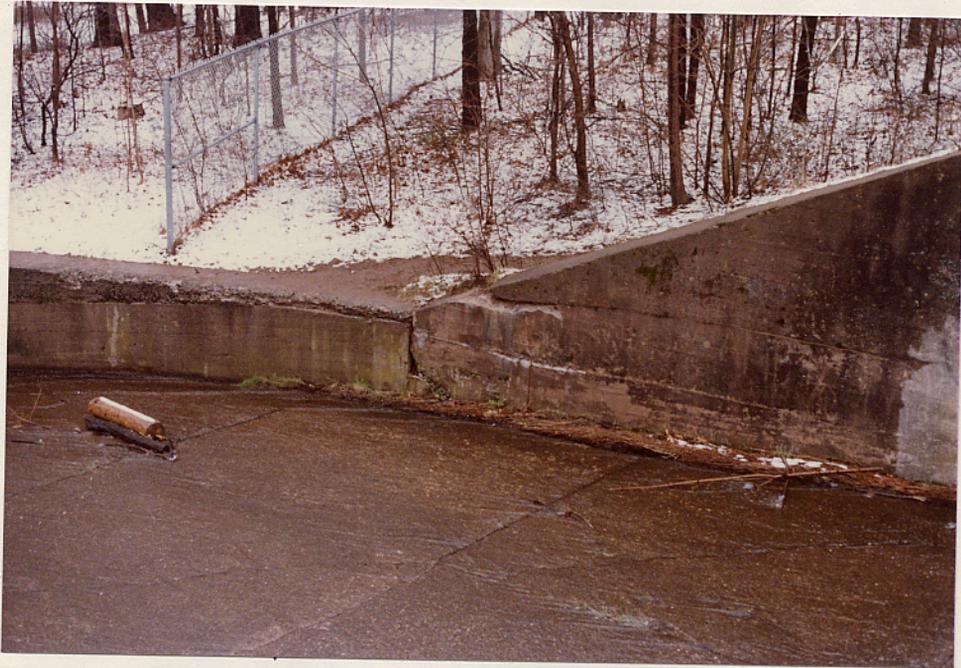
4. Deterioration of right downstream training wall.

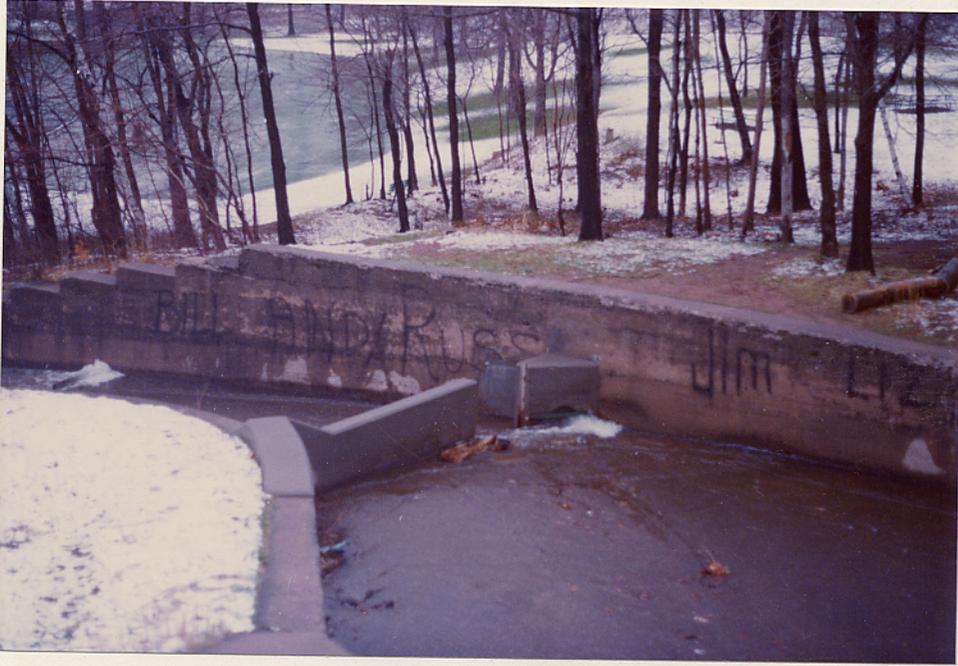
5. Diversion weir in downstream spillway chute.

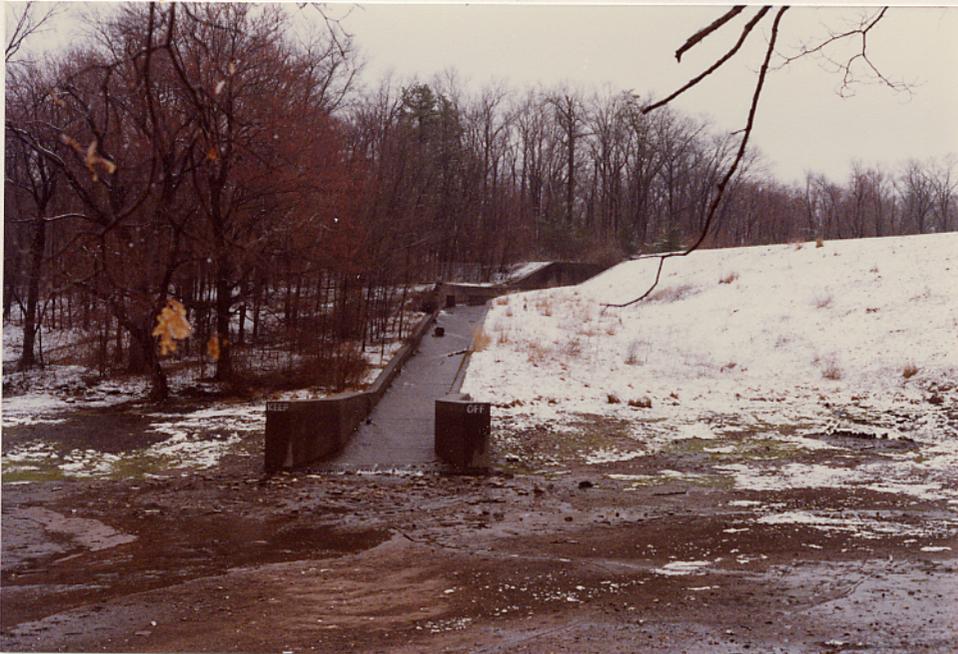
It should be noted that, while the spillway opening could theoretically handle about 36% of the routed test flood outflow, it is doubtful whether the discharge channel could handle such a flow. The 2 ft. high training walls lining the spillway chute would probably be overtopped during high flows, especially in the vicinity of the swimming pool diversion weir. Overtopping of these walls could result in erosion of the downstream toe of the dam, a washout of the spillway and chute, and possible undermining of the dam embankment.

6. Downstream end of spillway chute.

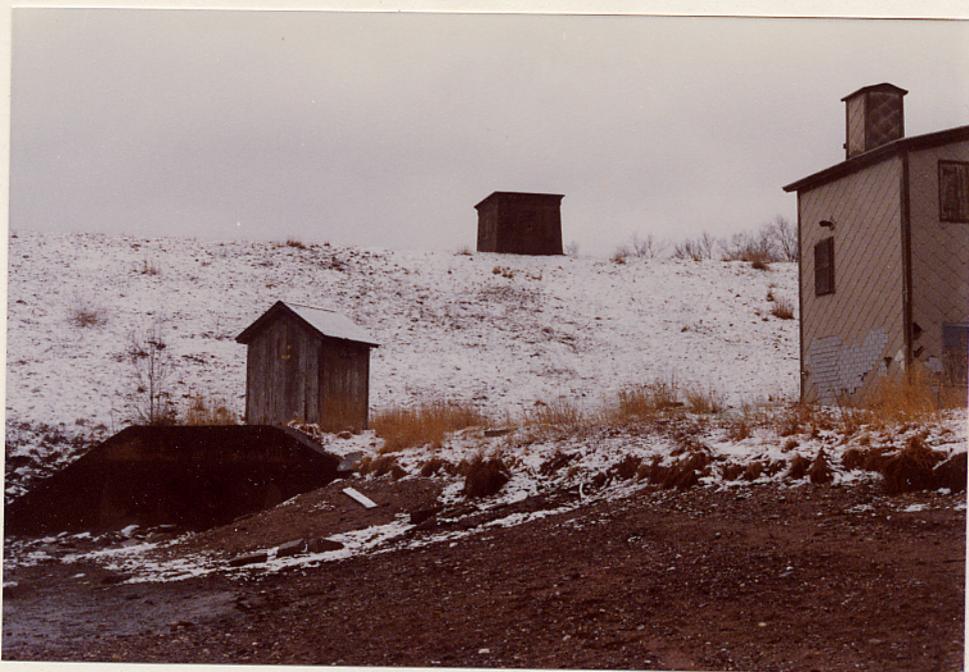
The gate house over a wet well in the center of the dam contains controls for regulating flows in four 24 in. dia. pipes (2 inlet and 2 outlet). Controls for four 24 in. valves and gates are located in the gate house. The gate house is in generally good condition with some minor deterioration of the concrete. Trashracks are provided in the wet well. Manchester City official indicated that all controls were operative and in good condition. (See Photo Nos. 7 and 8, Appendix C). One 24 in. dia. outlet pipe leads directly to the outlet headwall, the other outlet pipe can either distribute water to the treatment plant or to the outlet headwall. There is a crack in the outlet headwall concrete to the right of the right pipe. Seepage estimated at less than 0.1 gpm was issuing from the right cast iron pipe.

7. View of gate house on crest of dam and outlet headwall.

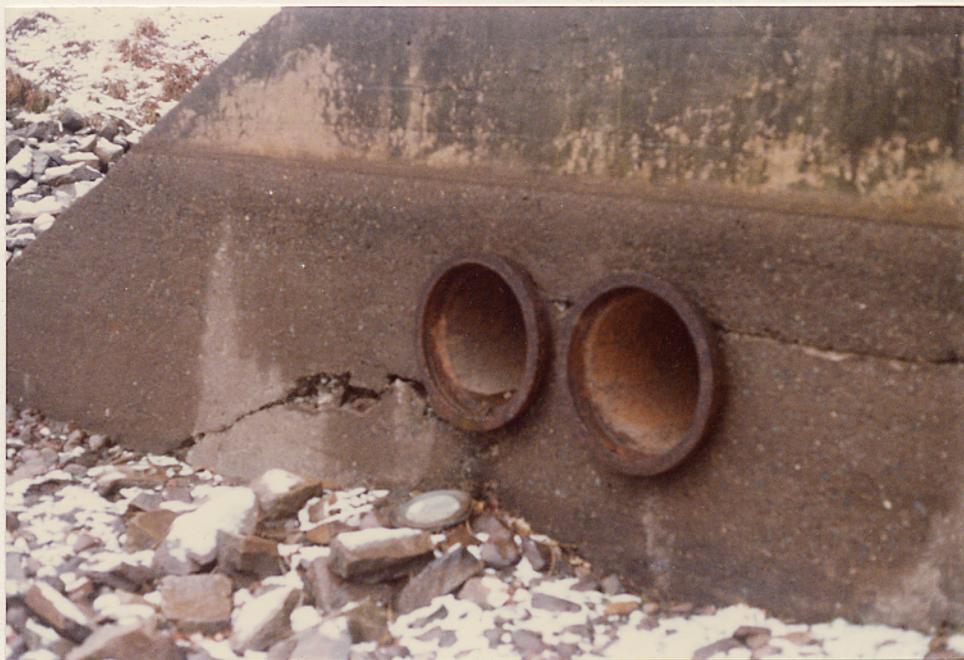
General Condition of Concrete	2 - Cast Iron Pipes
Rust or Staining on Concrete	N/A
Spalling	N/A
Erosion or Cavitation	N/A
Cracking	Cracking on Headwall only
Alignment of Monoliths	N/A
Alignment of Joints	N/A
Numbering of Monoliths	N/A

8. Outlet headwall at downstream toe of dam.

The owner should also implement the following operating and maintenance measures: (1) remove flashboards and discontinue their use until completion of studies in (1) above; (2) repair cracks in the concrete outlet headwall; (3) repair cracks in spillway discharge channel walls and bottom slab; (4) monitor seepage quantity and clarity from toe drains at least once a year; (5) develop a formal surveillance and flood warning plan; and (6) institute procedures for a biennial periodic technical inspection of the dam and apputeneant works.

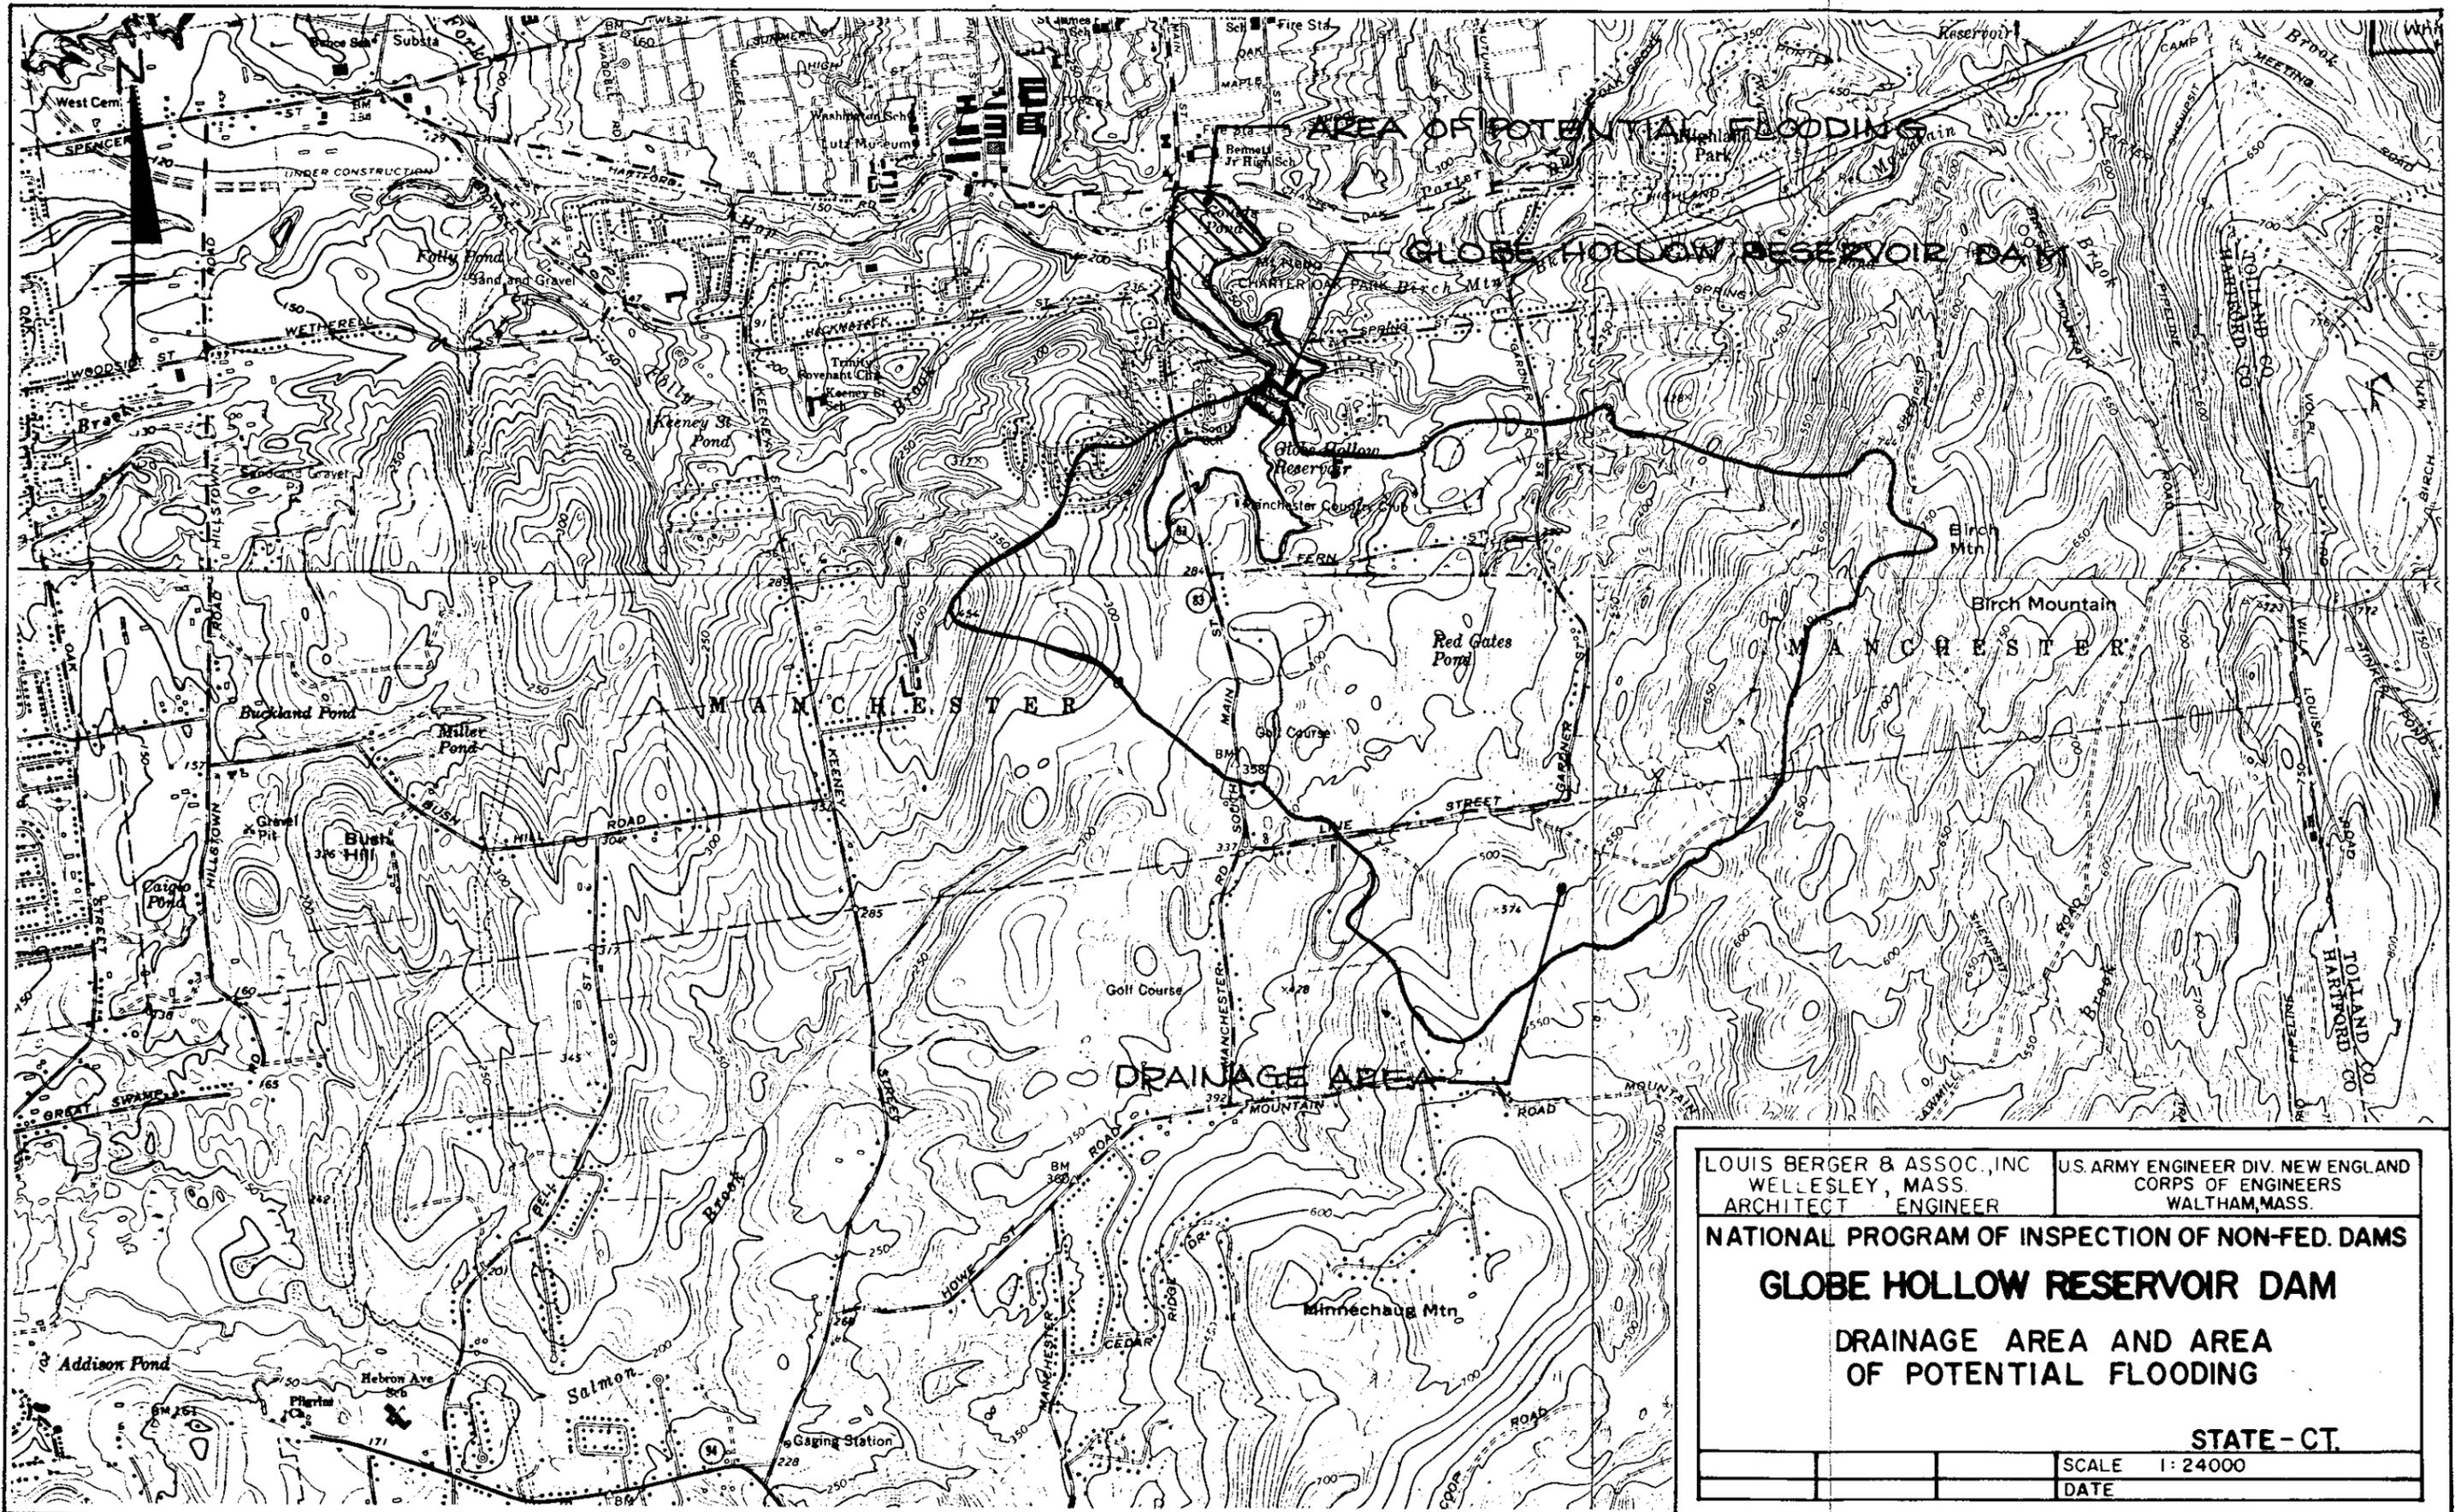
FIGURE 6 SHEET D-22

Further downstream or a point about 1,200 ft. from the Spring Street crossing, the Hop Brook intersects with the southeast cloverleaf of the U.S. Route 6/South Main Street interchange, where the brook is culverted through the interchange to the west side of South Main Street. Though considerable erosion and damage to the ramps and culvert may result, the interchange would serve to retain the flood outflow, protecting downstream roadways and structures from damage. (See Fig. 6, Sheet D-22, Appendix D).
