**BOURNE
HIGHWAY BRIDGE**

1976 Condition Report

CONTRACT NO. DACW 33-76-C-0005

AMMANN & WHITNEY
CONSULTING ENGINEERS
TWO WORLD TRADE CENTER
NEW YORK, N.Y.

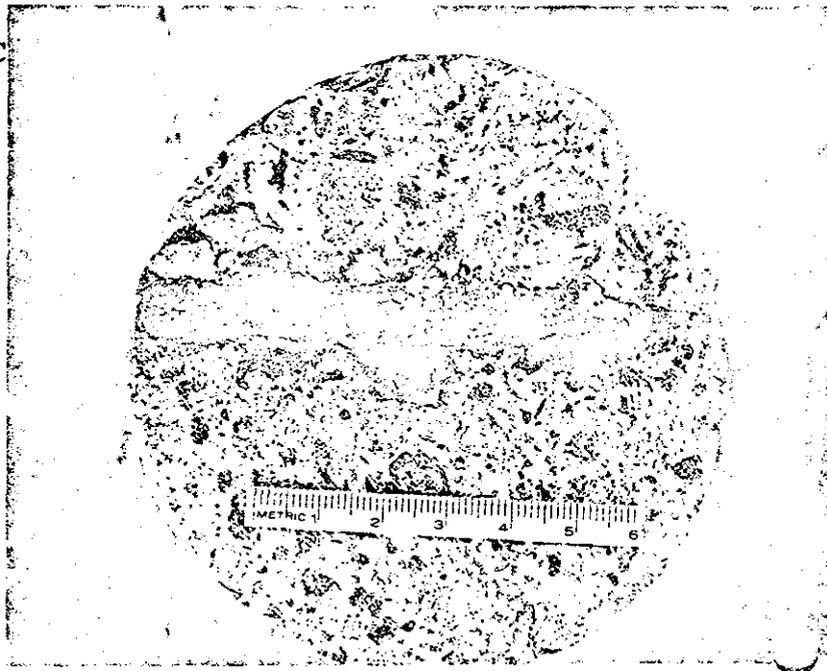
Fig.1 A--Core S-6 with honeycombed Haydite-aggregate concrete overlain by traprock-aggregate concrete. Six-centimeter scale. B--Core B-2 with abundant honeycombed Haydite-aggregate concrete. Compressive strength is 1320 psi. C--Core B-1 with intensely corroded rebar and adjacent corrosion products.

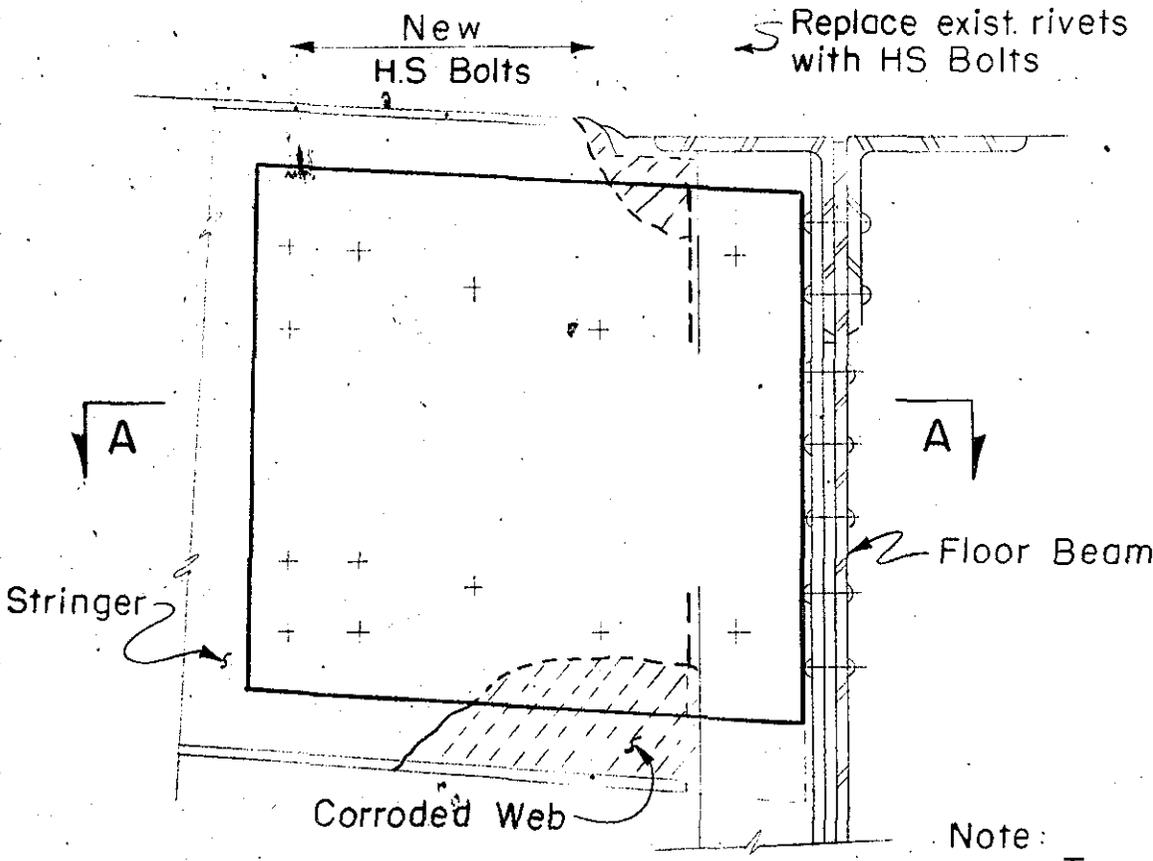
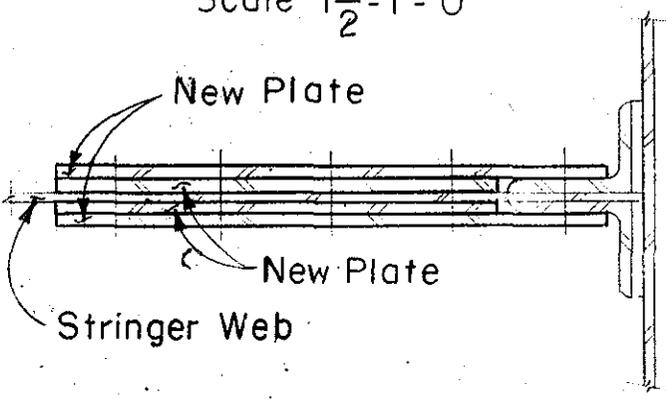
STRINGER REPAIR

The stringers, except for those in Span B4, were in good condition. Deterioration of the stringers was confined to the outside Stringers ST-1 and ST-9, usually at the floor beam connection. In Bay 3-4 of Span B4, Stringer ST-9 exhibited substantial metal loss as can be seen in Photo B-B4,3-4,E,4.

The same type of corrosion occurred to ST-9 in Bay 5-6 as can be seen in Photo B,B4,5-6,E,4 and ST-9 in Bay 7-8 as can be seen in Photo B,B4,7-8,E,9. Repair of these

stringers should have a high priority since the continuation of such deterioration could result in an unsafe condition in the future.

The method of rigging utilized for this inspection permitted full length observation of all stringers. The inspection showed that some stringers in Bays 3-4 and 7-8 of Span B4 were heavily deteriorated at the north connections. From the amount of metal loss, it is apparent that this corrosion has been occurring for a long period of time. The sidewalk channel support connections and the lateral bracing system of the approach spans are also badly corroded.

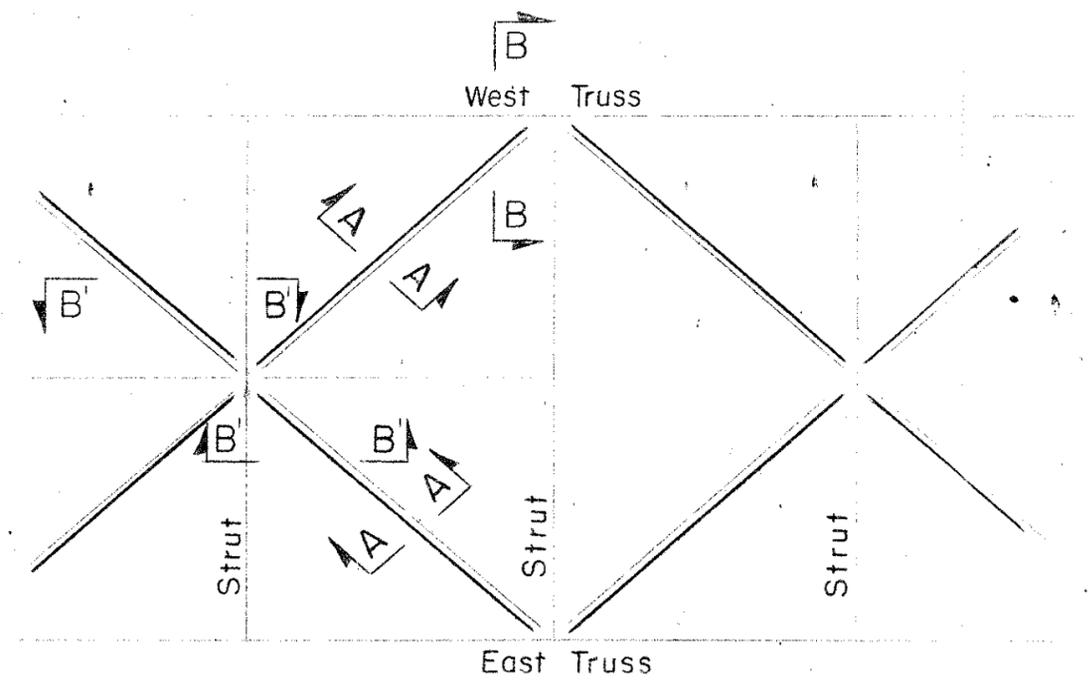
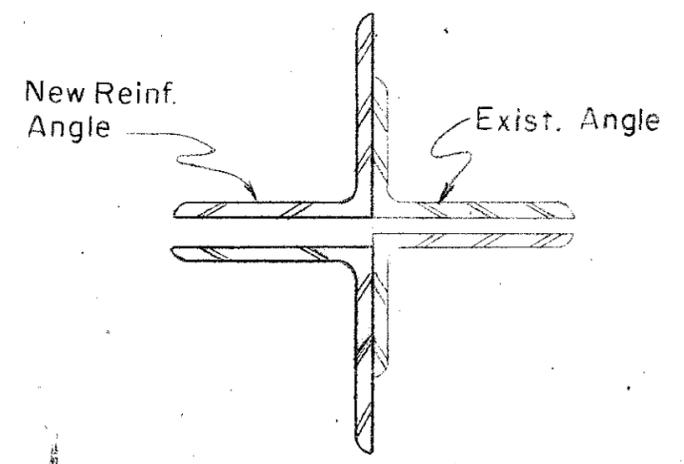
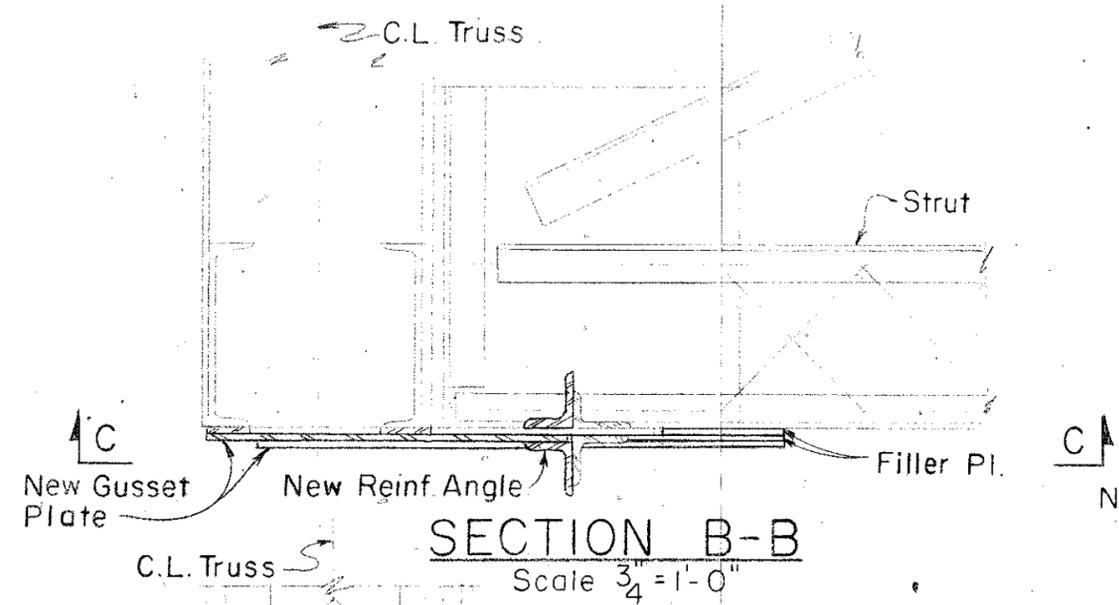
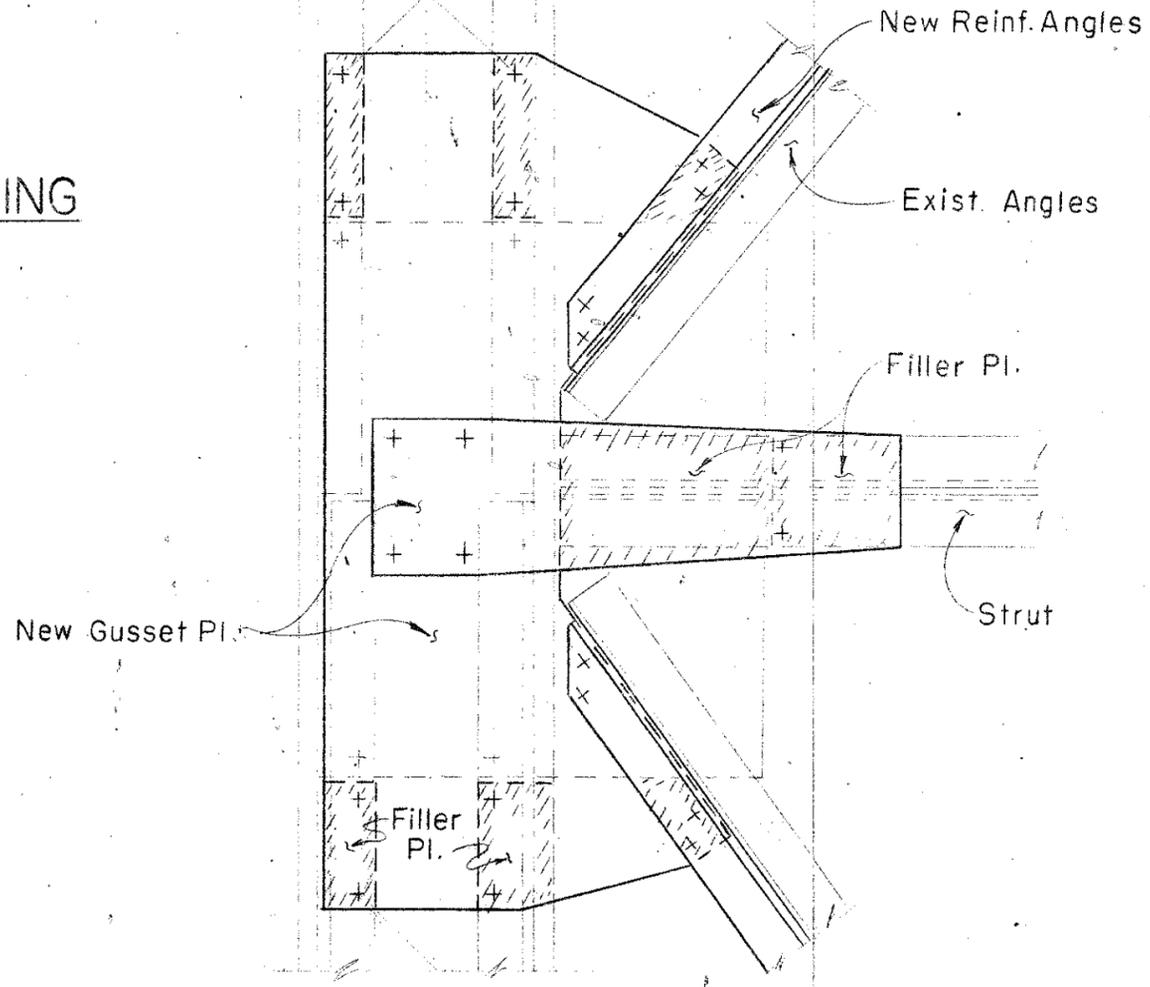
DEPARTMENT OF THE ARMY
 NEW ENGLAND DIVISION, CORPS OF ENGINEERS
 CAPE COD CANAL, MASSACHUSETTS
 BOURNE HIGHWAY BRIDGE
 1976 CONDITION REPORT
 BOTTOM LATERAL BRACING REPAIR
 AMMANN & WHITNEY, N.Y., N.Y.

The upper lateral bracing gussets and angles together with the lower lateral bracing system were probably the members with the greatest amount of deterioration. Many upper lateral gusset plates are knife-edged as can be seen in Photo D,B7,4-5,S,1 and, in some cases, completely deteriorated as can be seen in Photo D,B2,5'-4',E,1. Both upper and lower bracing angles were severely deteriorated between the back-to-back legs which tended to push the legs apart, as can be seen in upper bracing Photo D,B4,6-7,W,3. In other cases, the result of the corrosion was complete deterioration to the edge of the horizontal leg, as can be seen in Photo E,B4,6-7,N,1 showing lower bracing.
