Periodic Inspection Report No. 6
Hopkinton Lake
Hopkinton, New Hampshire

SUBJECT: Independent Technical Review (ITR) of Periodic Inspection Report
No. 6, Hopkinton Lake, Hopkinton, New Hampshire

PERIODIC INSPECTION NO. 6
HOPKINTON LAKE
HOPKINTON, NEW HAMPSHIRE

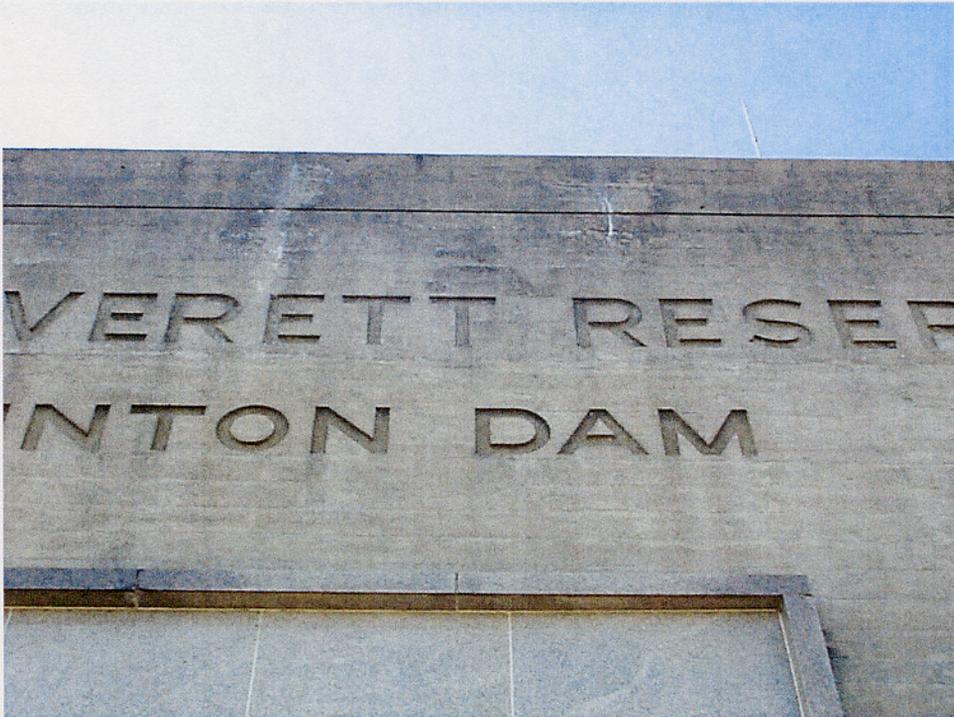
Photo A-1 – North face of control tower. Note hairline crack with light efflorescence at roof parapet.

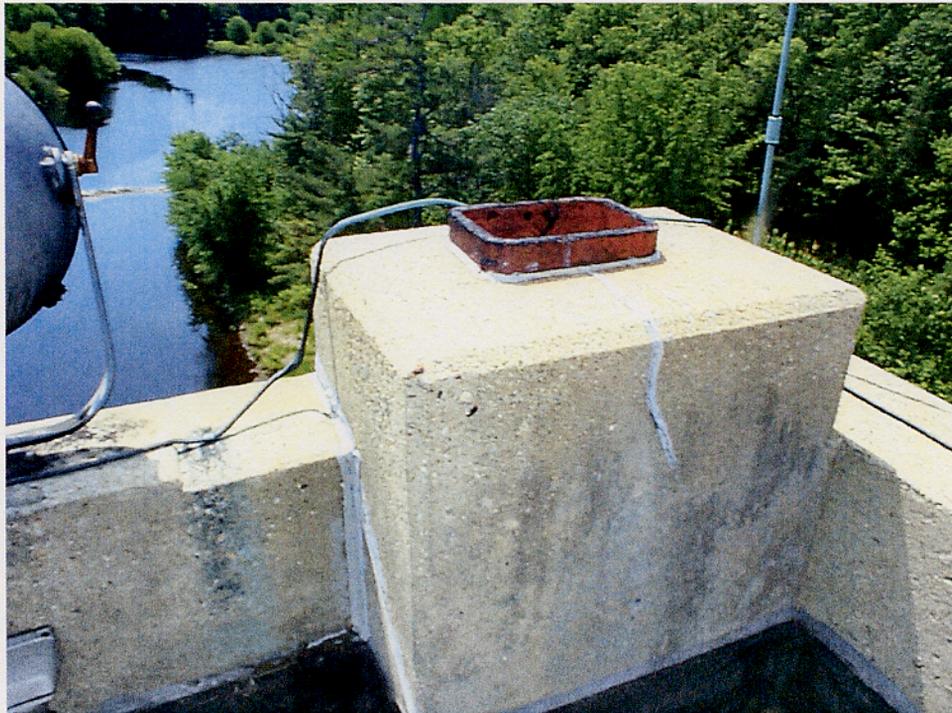
Photo A-2 – Southwest chimney. Note sealed cracks in chimney and crack in flue liner, typical at northeast chimney.

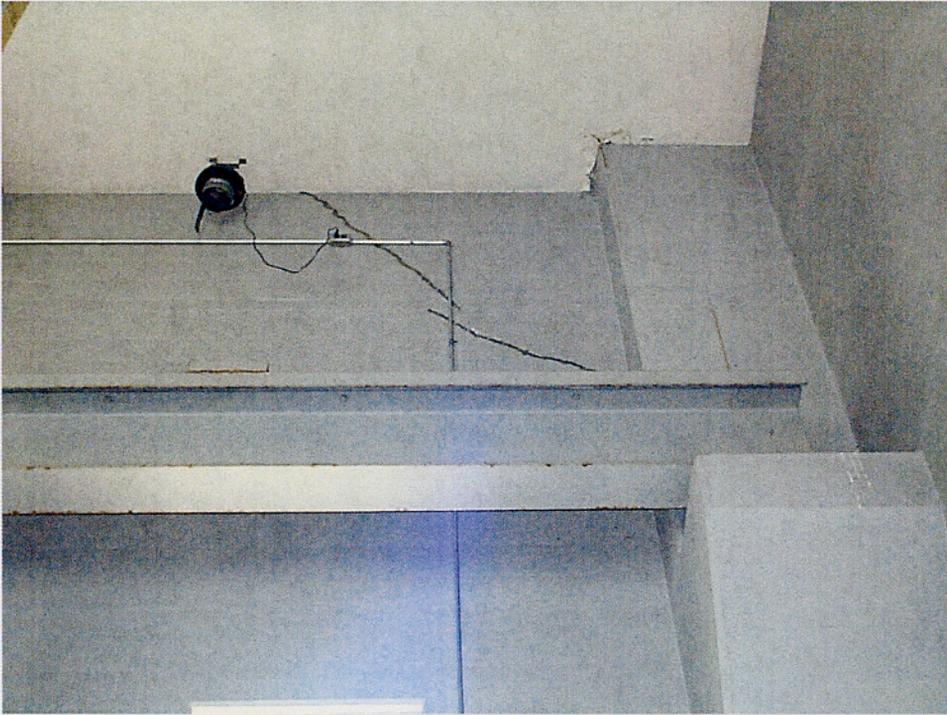
Photo A-3 – Interior of control tower, northeast corner. Note peeling paint on ceiling and sealed cracks.

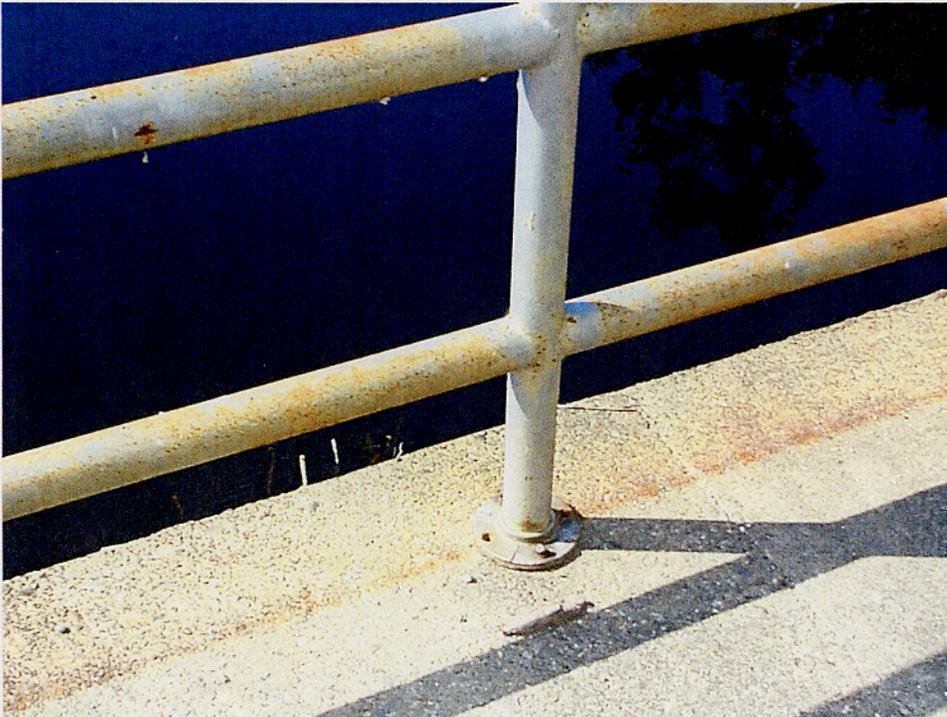
The railings are rusted and there are loose/missing bolts at various base plate connections and at the top railing-parapet connection on the west side (see Photo A-4). There is also debris and vegetation on the raking platform.

Photo A-4 – Inlet Raking Platform. Note rust and missing bolts at railing base on raking platform.

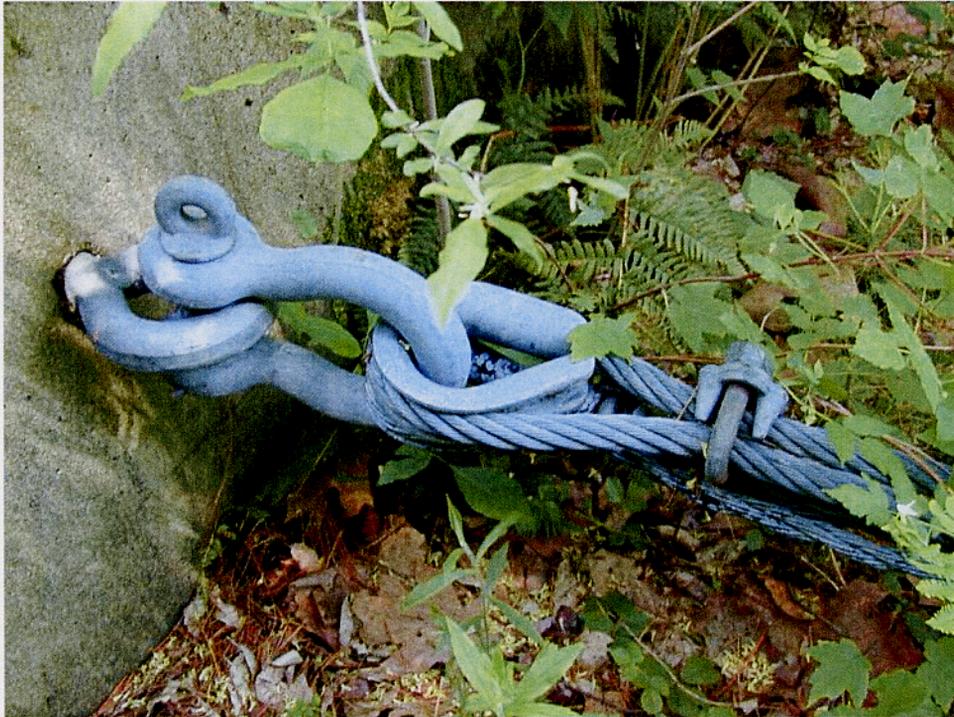
Photo A-5 – Left log boom anchor, typical of right side.

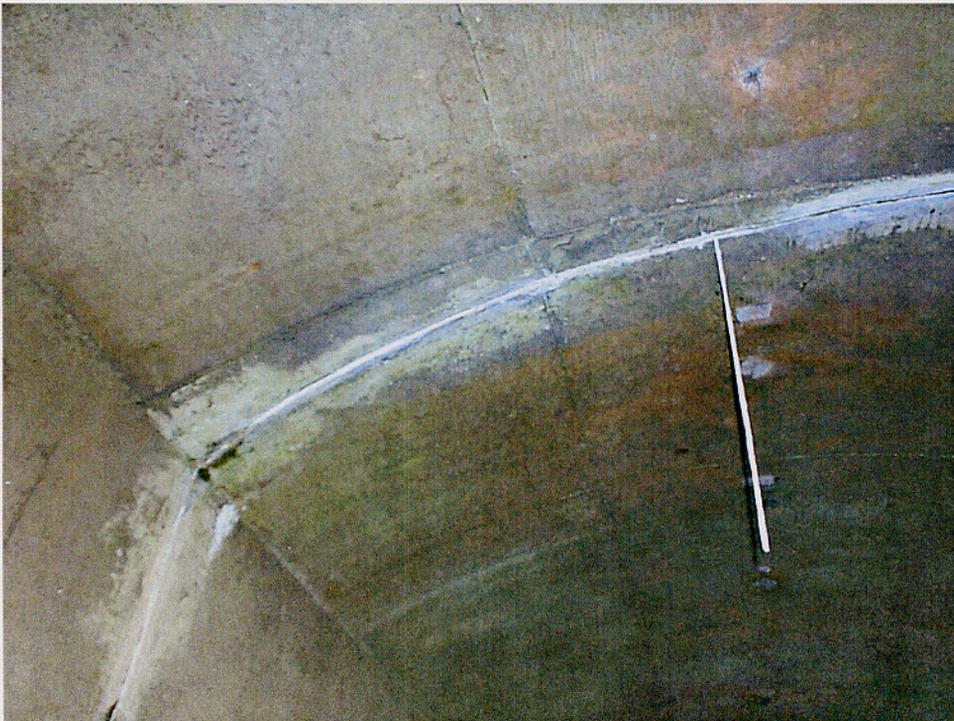
Photo A-6 – Typical monolith joint. Note loose sealant material. Typical of conditions in conduit 2.

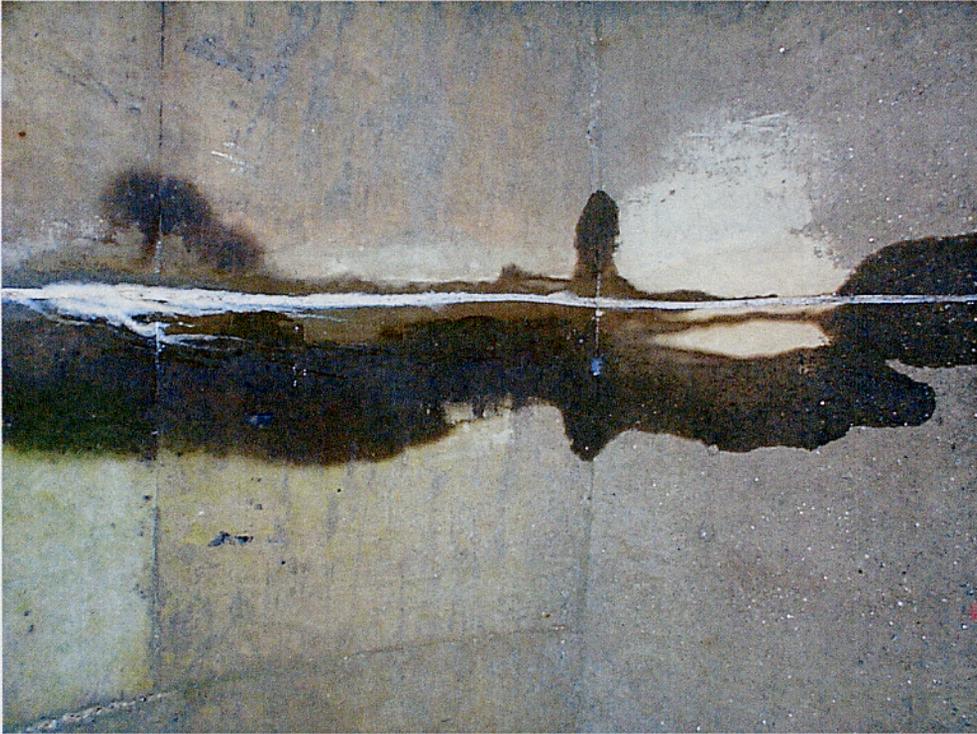
**Photo A-7 – Hairline cracks with efflorescence and active seepage at ceiling joint of conduit 1 between monoliths 5 and 6.
Typical of conditions in conduit 2.**

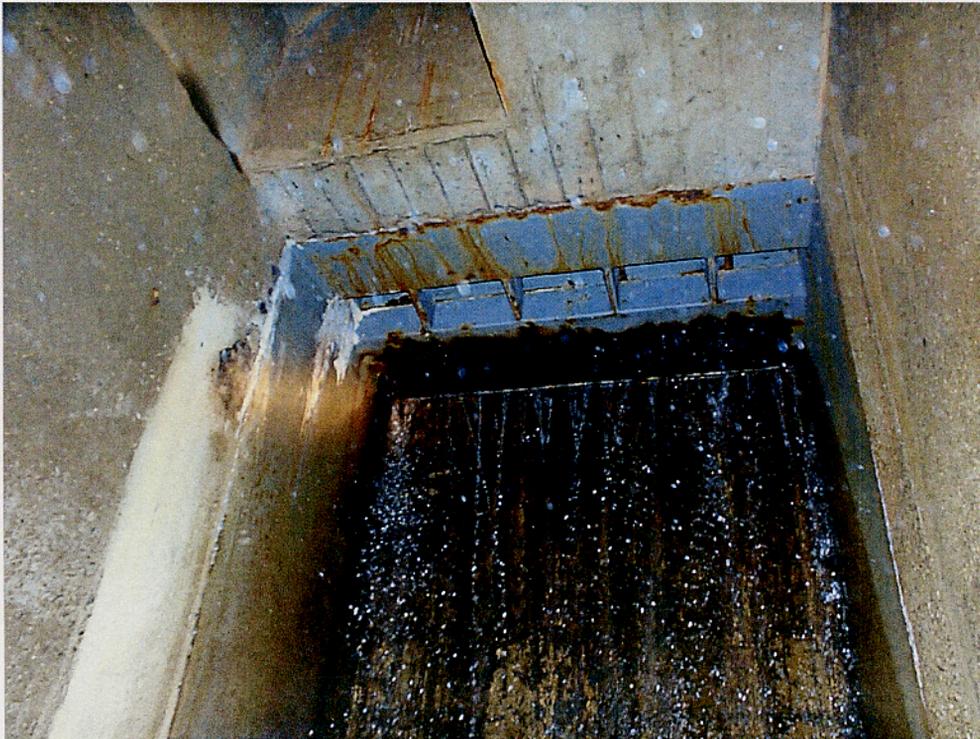
Photo A-8 - Note rust on gate chamber steel and air vents. This condition is typical at all gates.

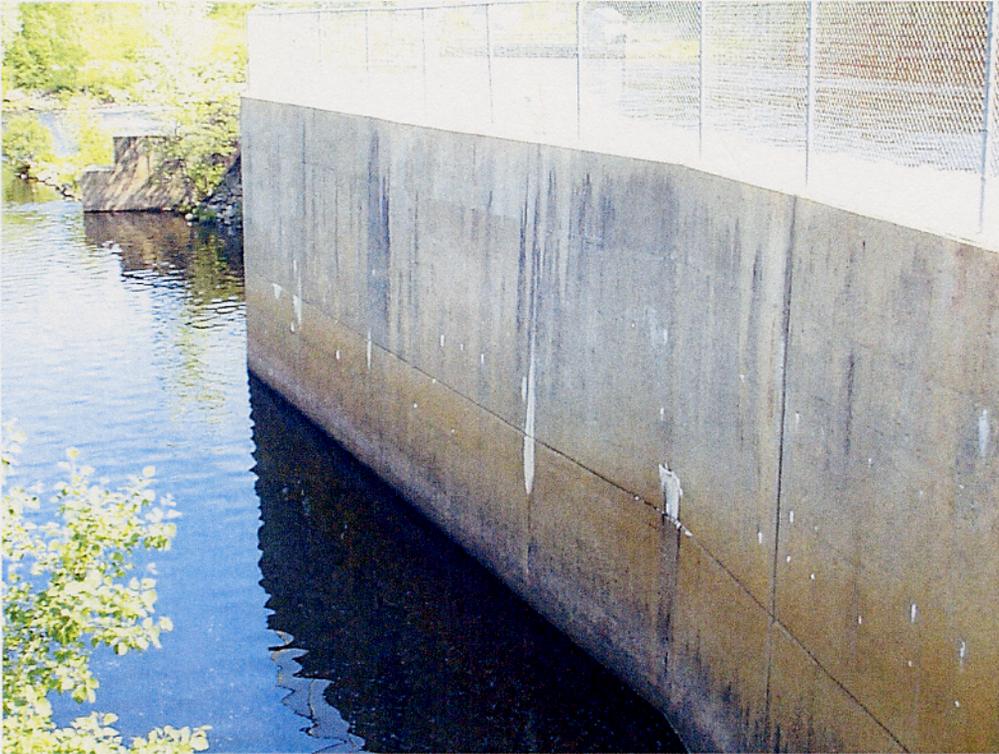
Photo A-9 - East retaining wall of outlet structure. Note isolated areas of efflorescence.

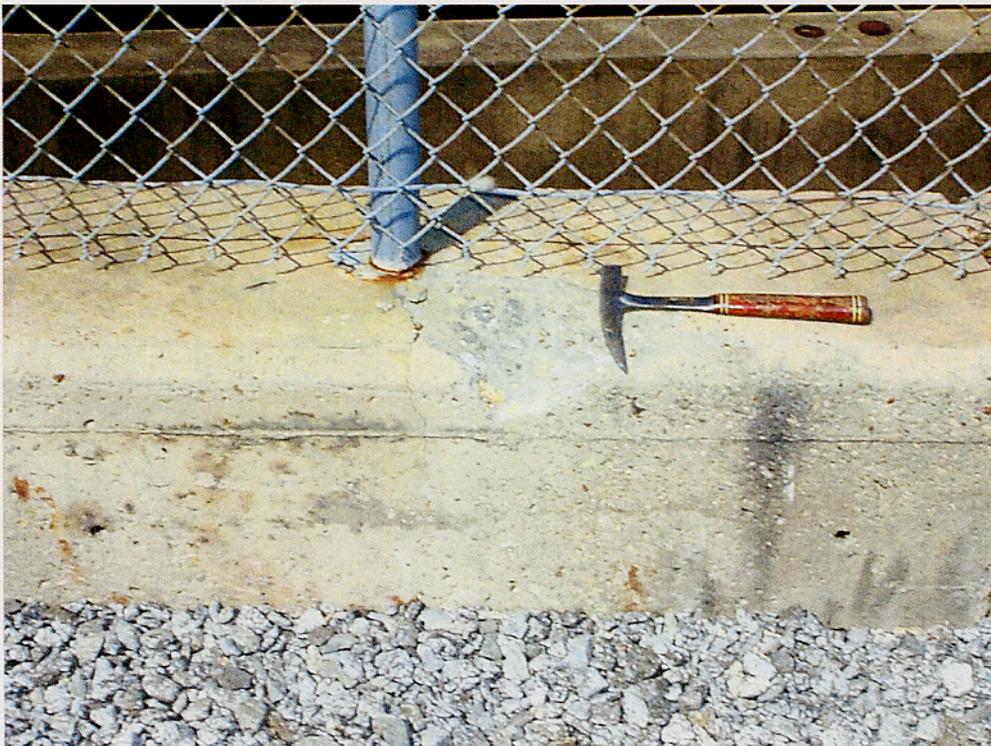
The east retaining wall has numerous areas of scaling on the top horizontal portion of the wall. There is also a 12" x 7" x 2" deep spall (see Photo A-10), a 15" x 8" x 2" deep spall, and hairline to 1/16" cracks where the fence posts are attached to the top

Photo A-10 - East retaining wall of outlet structure. Note spalled concrete and typical hairline cracks at fenceposts.

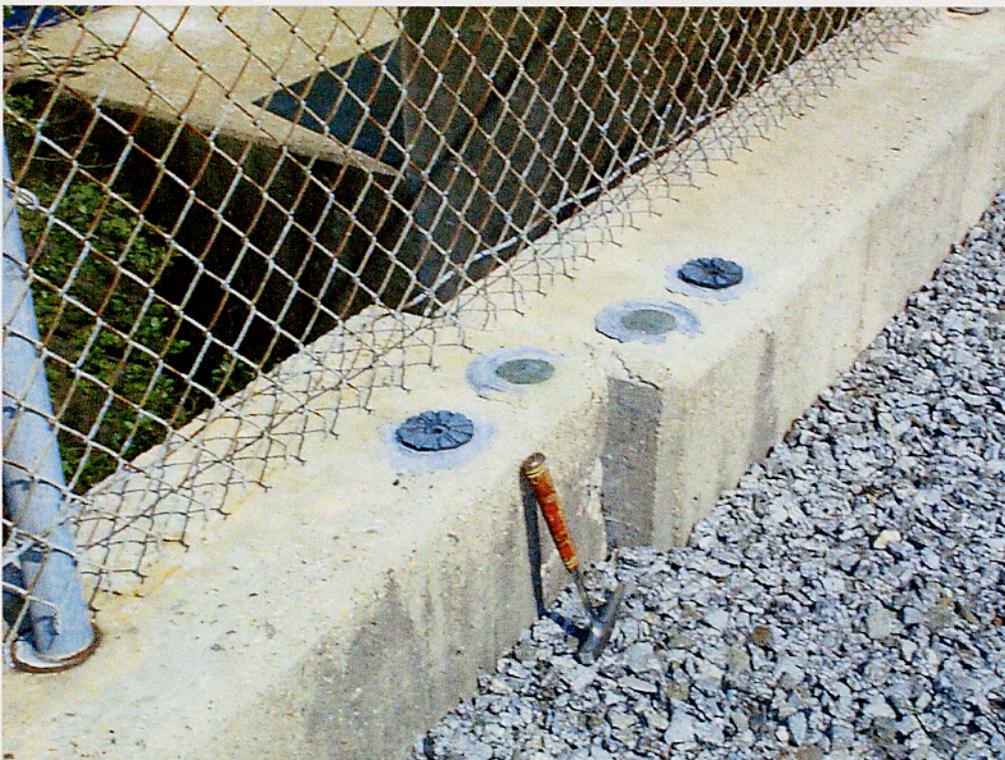
Photo A-11 - East retaining wall of outlet structure. Note 4" offset between wall sections.

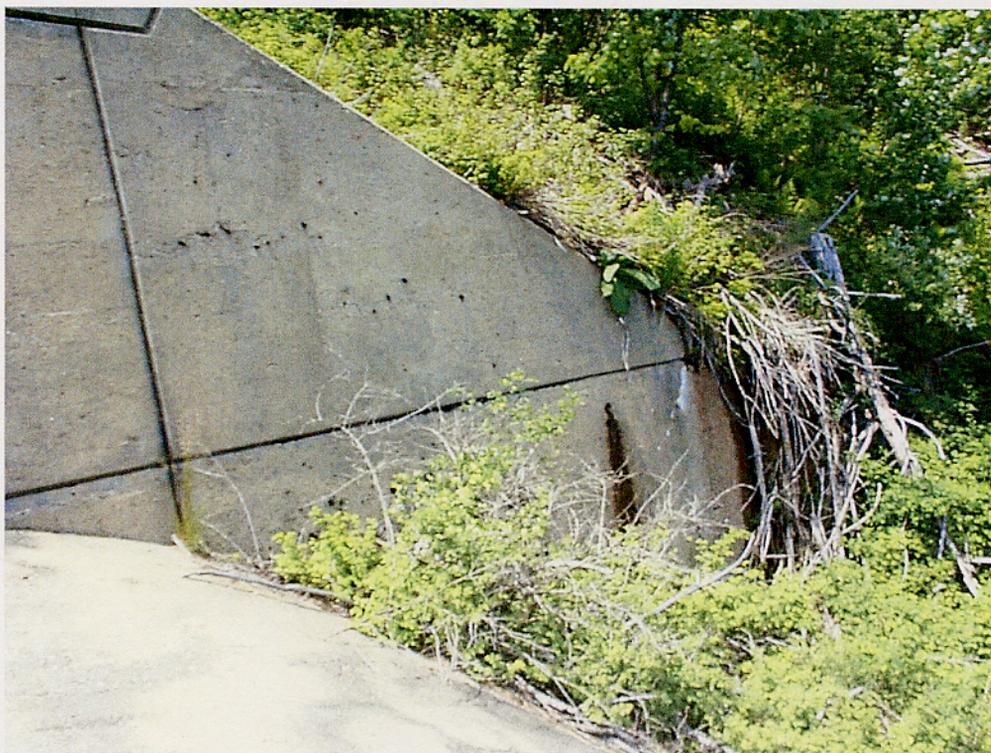
(2) Control. The overall condition of the concrete in the spillway is good. Minor joint deterioration was noted at various locations. There are isolated hairline cracks with efflorescence and there is vegetation at the joint between the spillway and the

west retaining wall (see Photo A-12). A spall (<1 s.f.) on the middle of the downstream face next to a weep-hole has not changed since the last inspection.

Photo A-12 - Spillway weir/West retaining wall. Vegetation growth same as in 1997. Note hairline crack with efflorescence below horizontal construction joint.

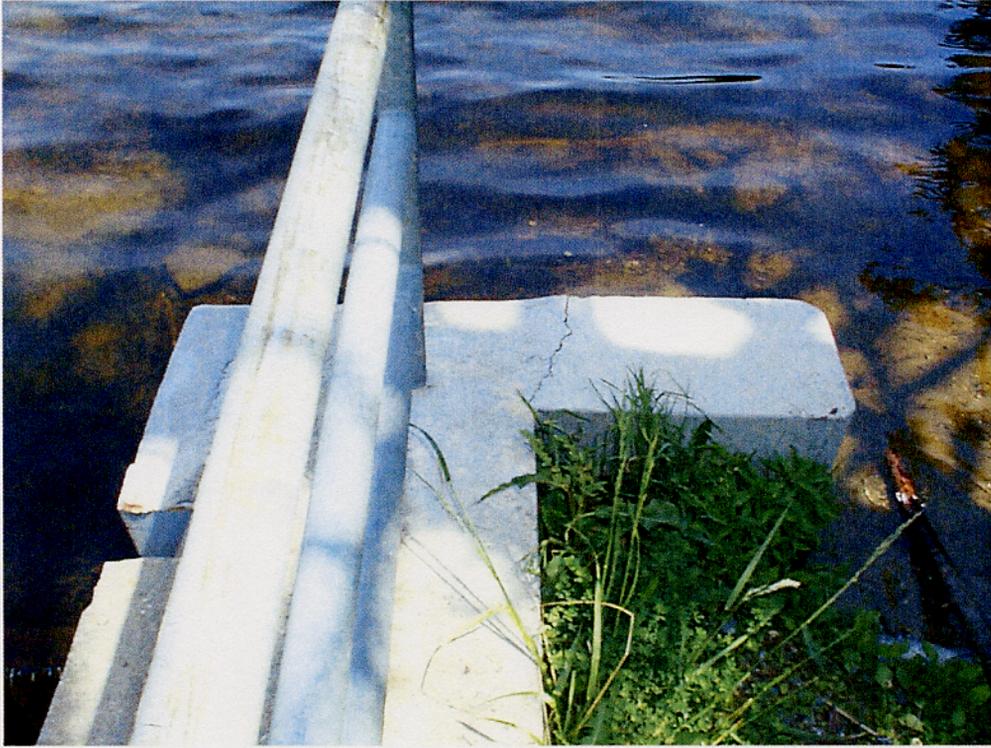
Photo A-13 – ¼" crack at North Weir inlet wall.

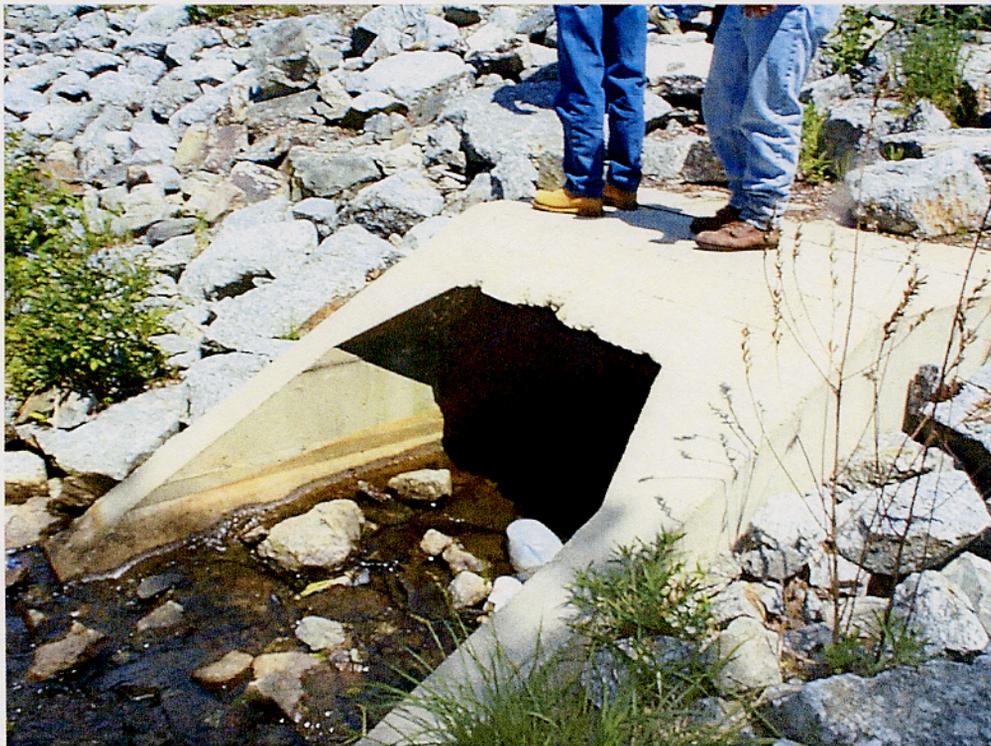
Photo A-14 – Outlet of North Weir. Note spalling on top edge.

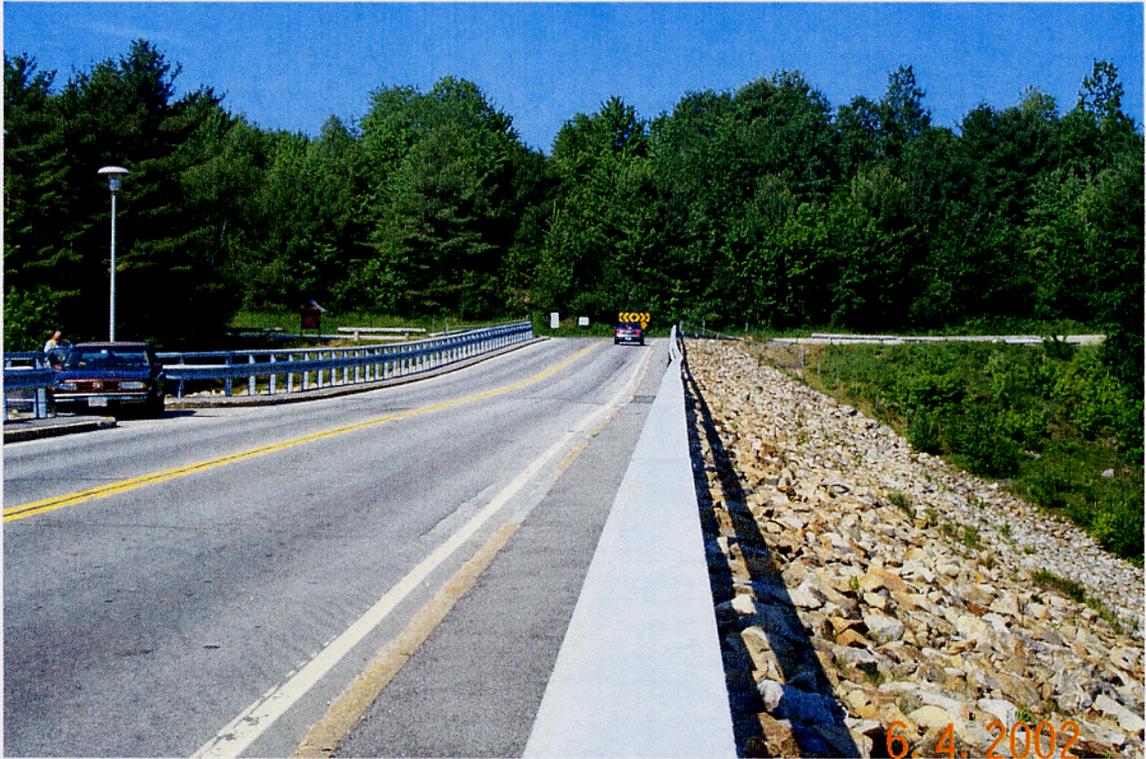
(c) Crest. The crest of the dam (State Route 127) is in good condition (Photo E-5). The guardrail along the upstream edge appears properly aligned. The guardrail adjacent to the west storm drain along the downstream edge was previously reported as showing signs of movement. GES personnel, found that the outlet pipe had separated from the catch basin and water was draining directly into the gravel layer below the stone protection. The outlet pipe and the overlying gravel and rock-fill were repaired. The downstream guardrail still appears to lean in the downstream direction in front of the west storm drain, but the rip rap from the crest to the storm drain outlet appears to have stabilized. Both the east and west catch basins are clean of debris. There is grass growing in the sand and gravel deposits on the slope formed by the runoff.

Photo E-5: Crest and downstream guard rail. Dip in guard rail remains after the west outlet rain was repaired.

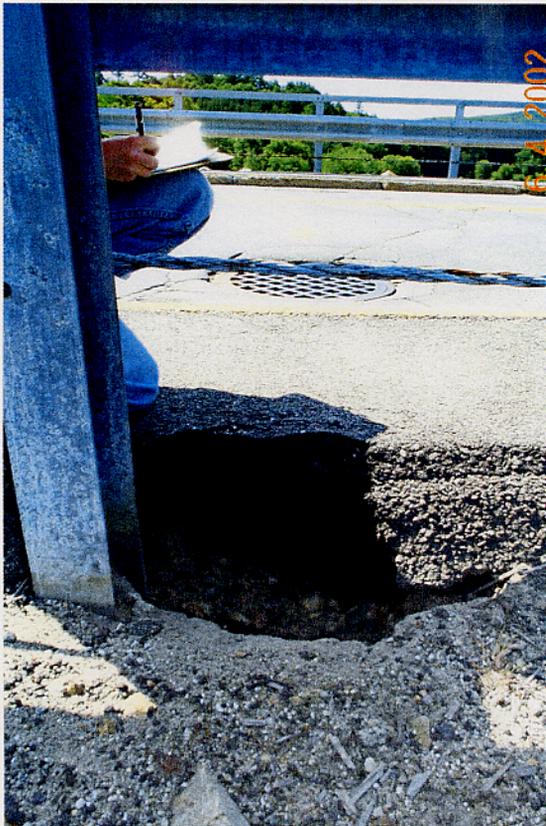
Photo E-6: Hole formed below the downstream sidewalk adjacent to the east catch basin.

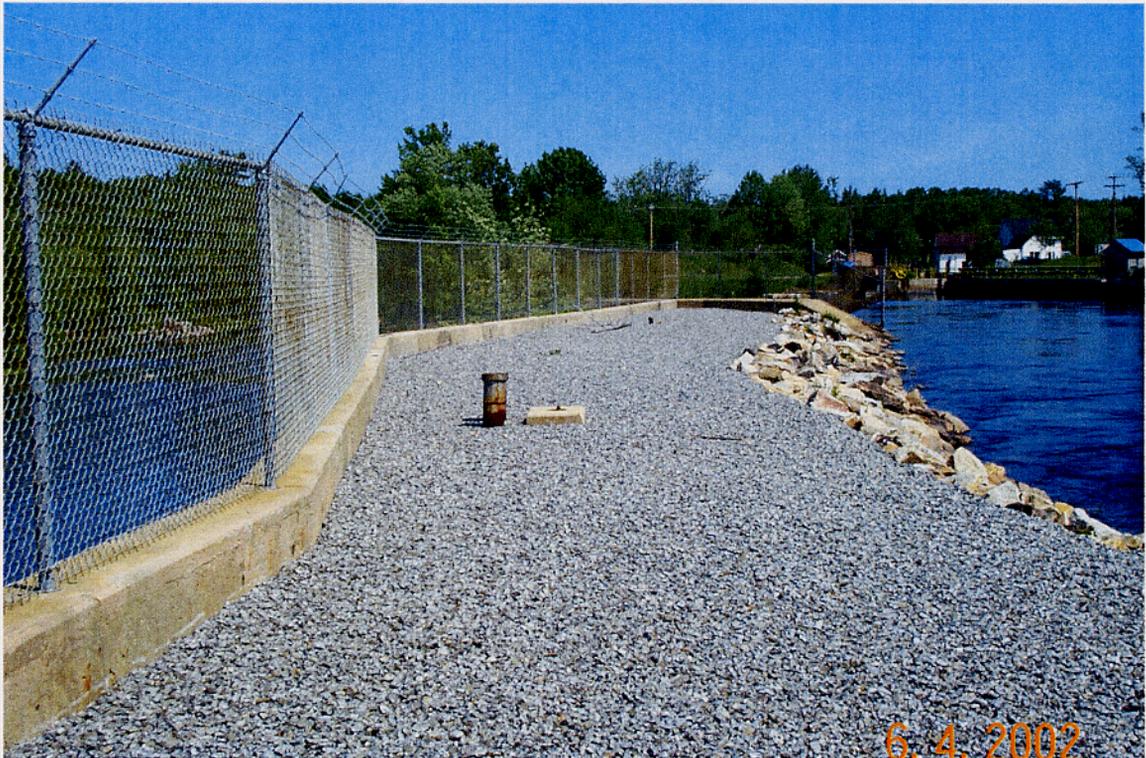
Photo E-7: Downstream forebay dike; 2.5 years after rehabilitation repairs for the east outlet wall.

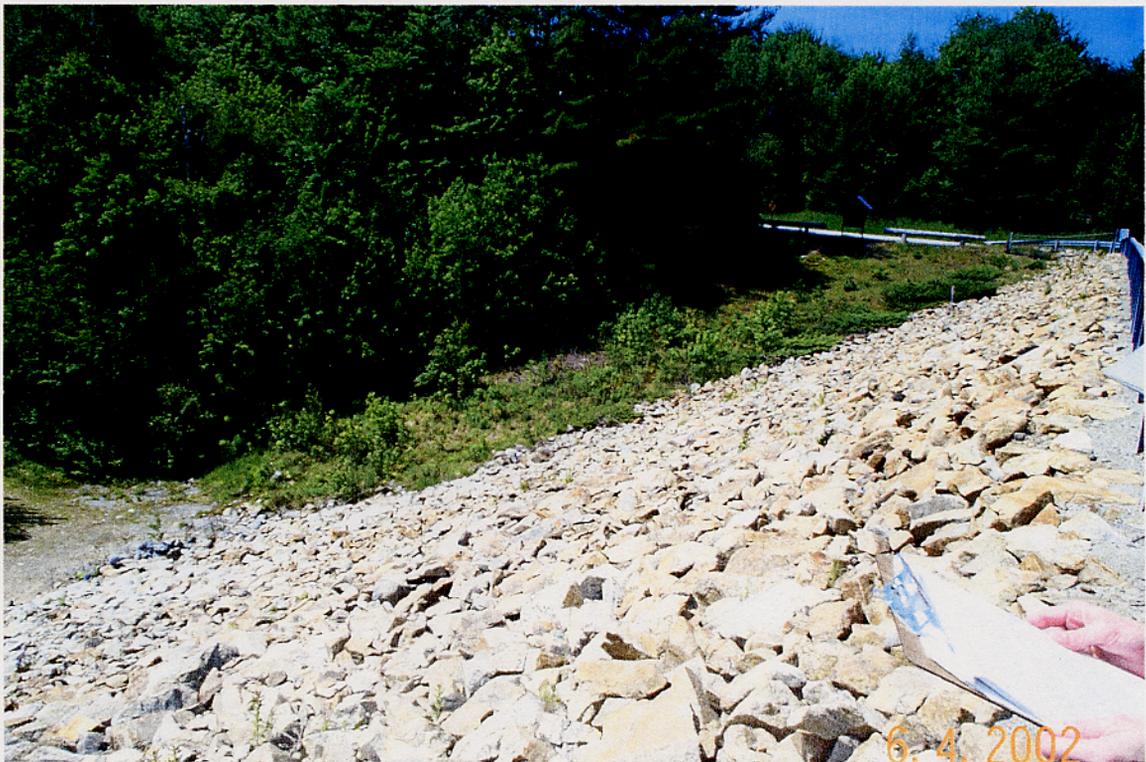
Photo E-8: Left upstream abutment. Trees have been cleared, but some brush has started to grow back.
