**CONNECTICUT RIVER BASIN
BANK EROSION STUDY**

(RECONNAISSANCE REPORT)

New England River Basins Commission

1 JUNE 1974

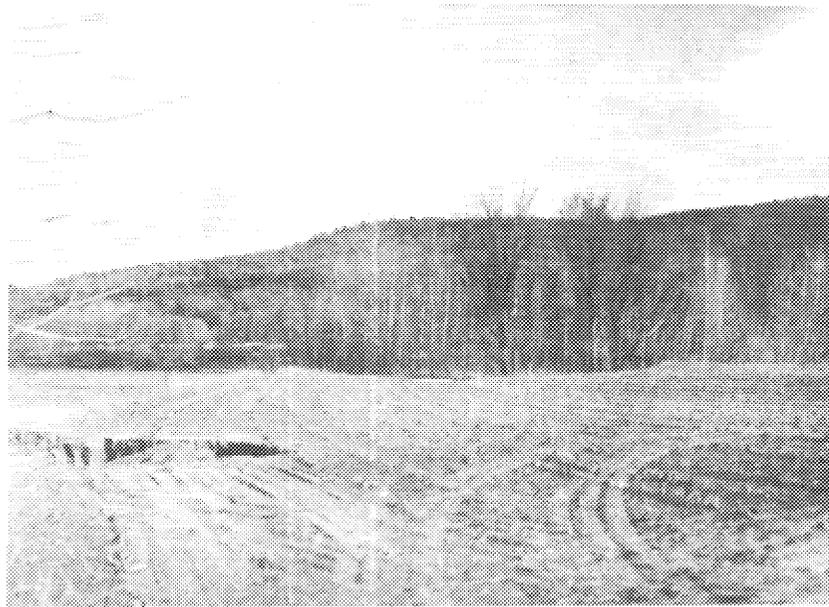
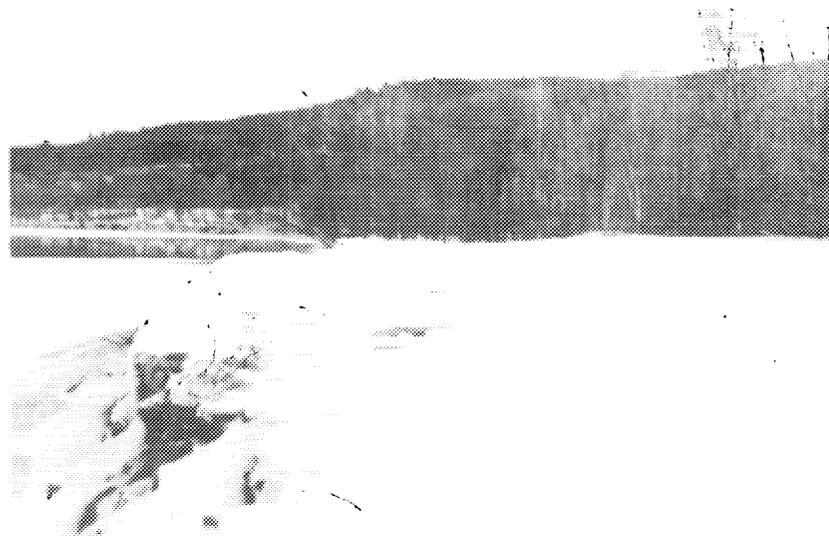
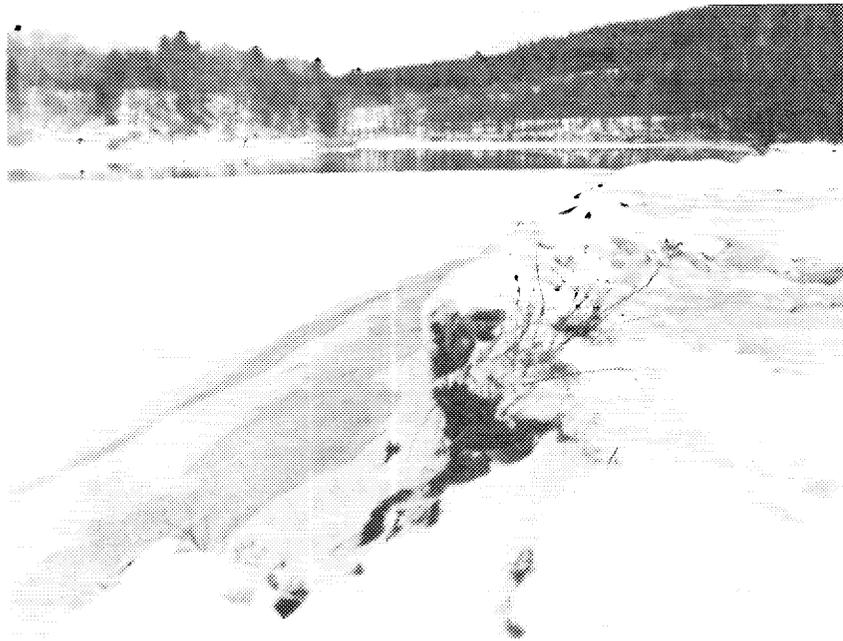
EXHIBIT 2-1

*LOCATION 12
CHESHIRE COUNTY FARM
WESTMORELAND, NEW HAMPSHIRE*

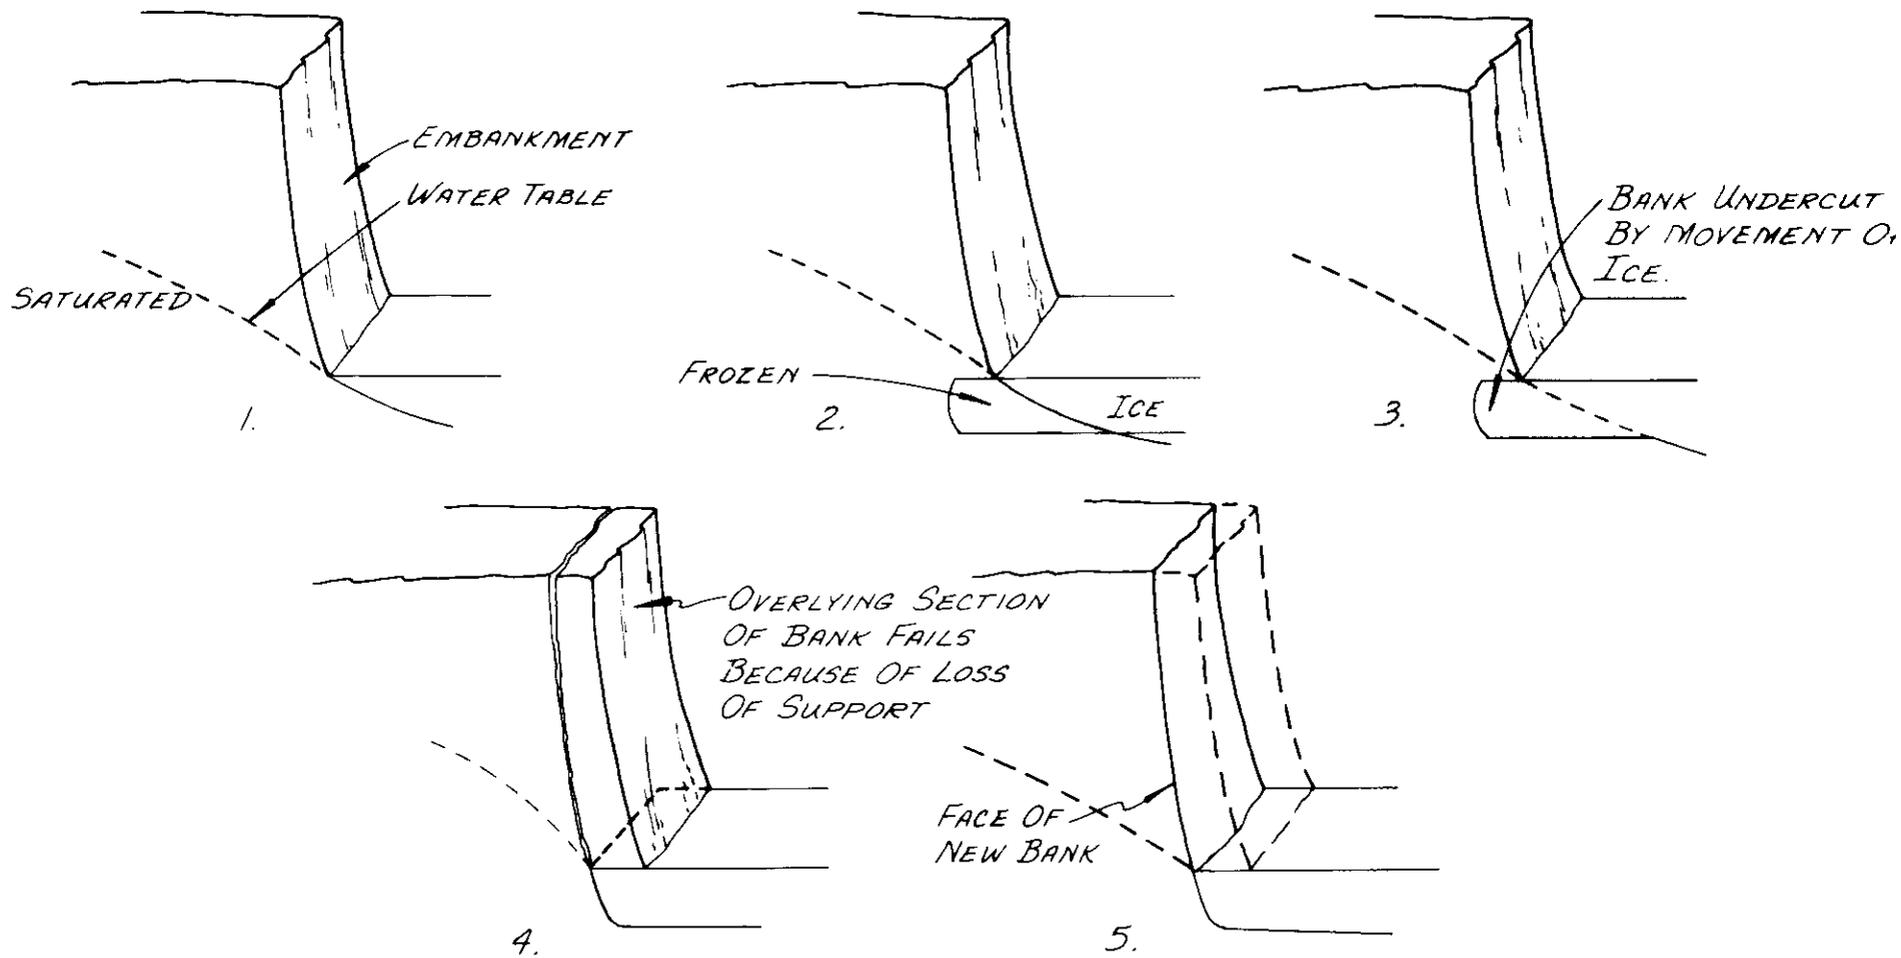
EXHIBIT 6-1

Each county reported numerous instances of gouging, of steeply sloping banks, by ice cakes. One county reported the personnel had observed ice cakes gouging up to 10 feet into the river banks. They also reported numerous instances of bank failure after large clods of frozen soil removed when cakes of anchor ice broke away from the banks, as illustrated in Exhibit 6.

REMOVAL OF SOIL MATERIAL BY ANCHOR ICE
