# FLOOD PLAIN INFORMATION

*PASSUMPSIC and STEVENS RIVERS  
AND SOUTH PEACHAM BROOK*

**BARNET, VERMONT**

APRIL 1978

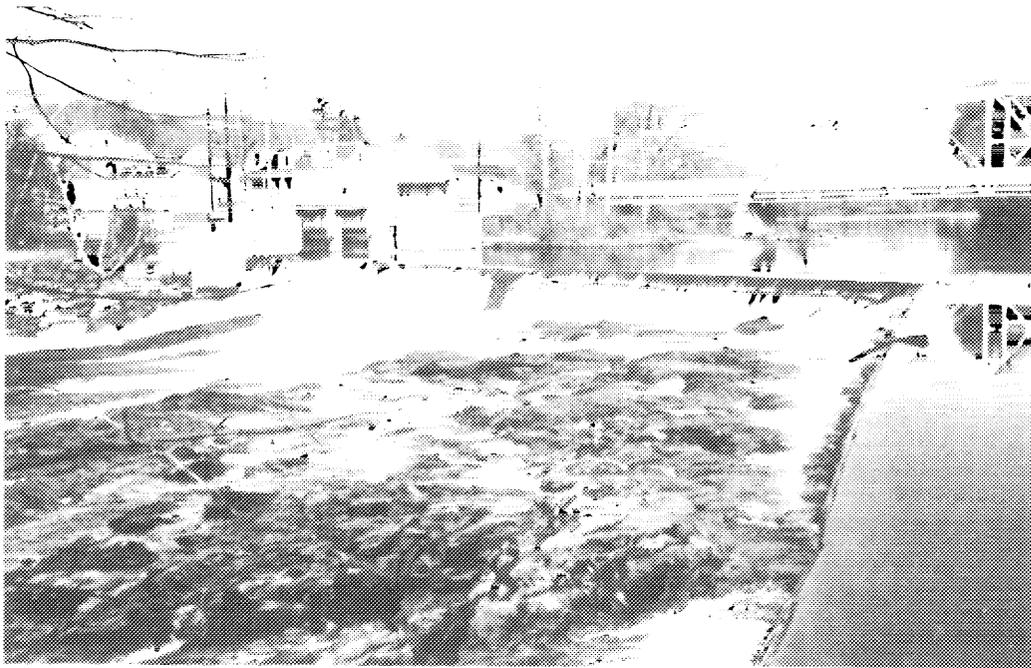
FIGURE 2 - Passumpsic Dam on Passumpsic River (Dam  
XS 53, River Mile 5.13)

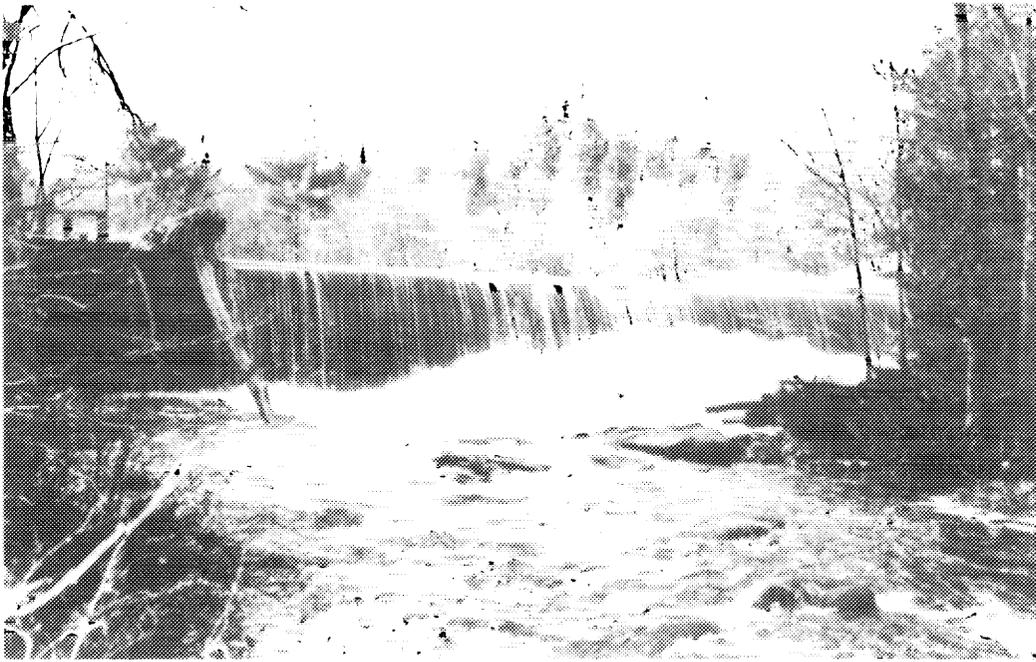
FIGURE 5 - Mill Dam on Stevens River (Dam XS 39,  
River Mile 3.93)

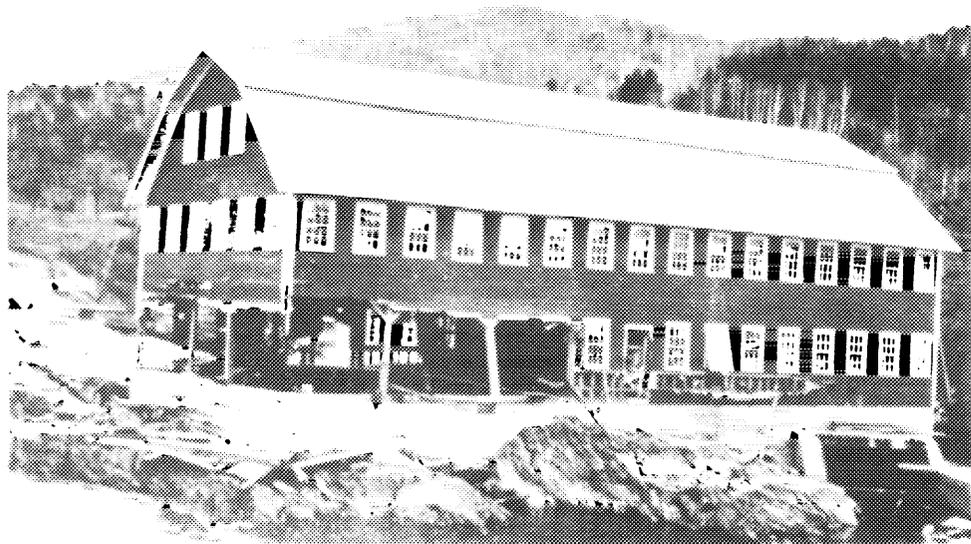
FIGURE 8 - Roy Brothers Mill after the floodwaters  
had subsided (1927).

Figures 7 through 10 depict the flooding in Barnet during the 1927 Flood. (Photos and quotes located on the following pages, courtesy of the Vermont Historical Society).

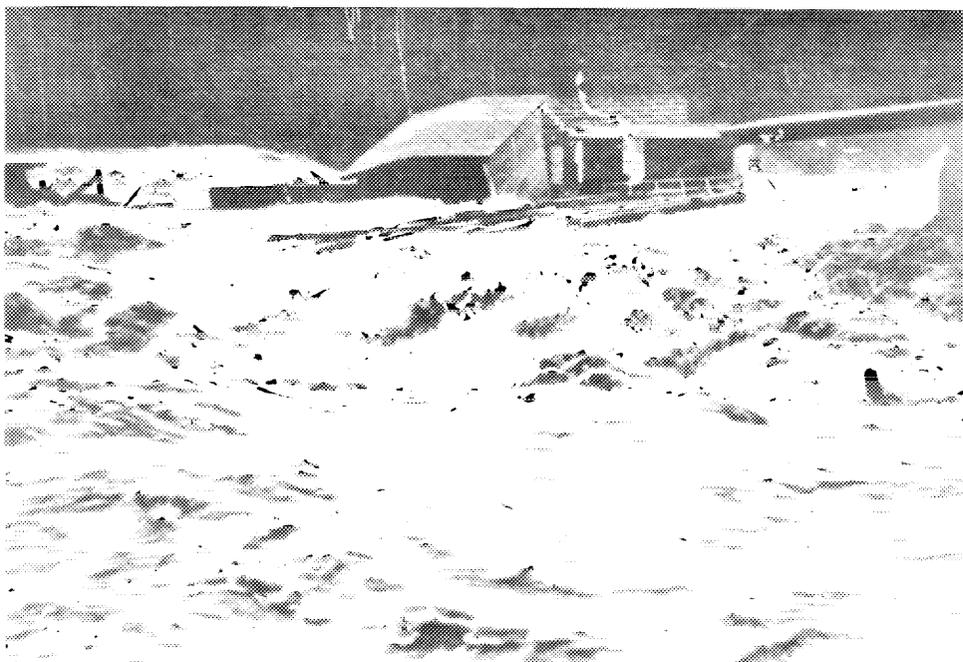
FIGURE 10 - Debris obstructing flow on Passumpsic River at Passumpsic (1927).

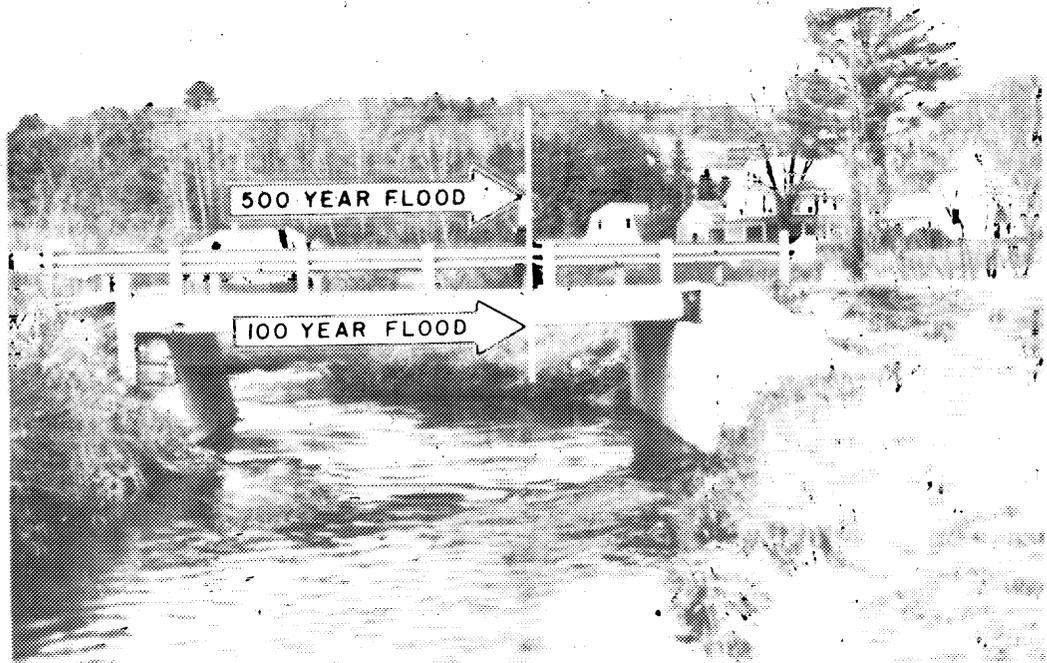
FIGURE 14 - Future flood heights at the Main Street Bridge crossing the South Peacham Brook in West Barnet.

Photographs, future flood heights.--The levels that the 100-Year and 500-Year Floods are expected to reach at various locations along the Barnet Study Area are indicated on the following photographs, Figures 11 through 14.
