Section 206- Flood Plain Management Services Program

**SOUTHEAST AREA DRAINAGE
DISTRICT STUDY,
EAST PROVIDENCE, RHODE ISLAND**

March 1996

**US Army Corps
of Engineers**
New England Division

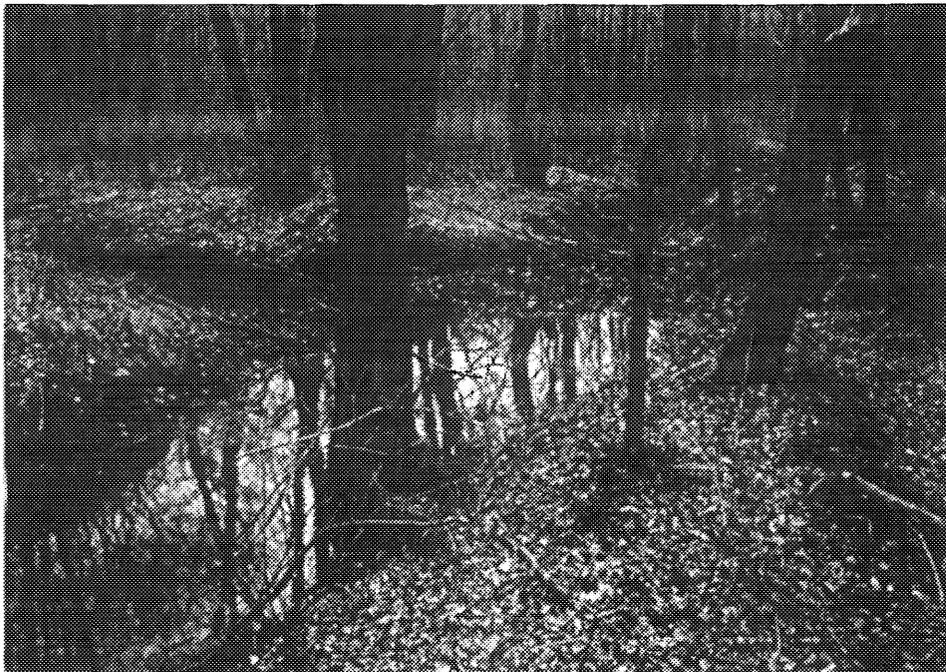
Photo 2 - Normal flow path turns to east in vicinity of Thurston Street. Secondary channel continues to the south.

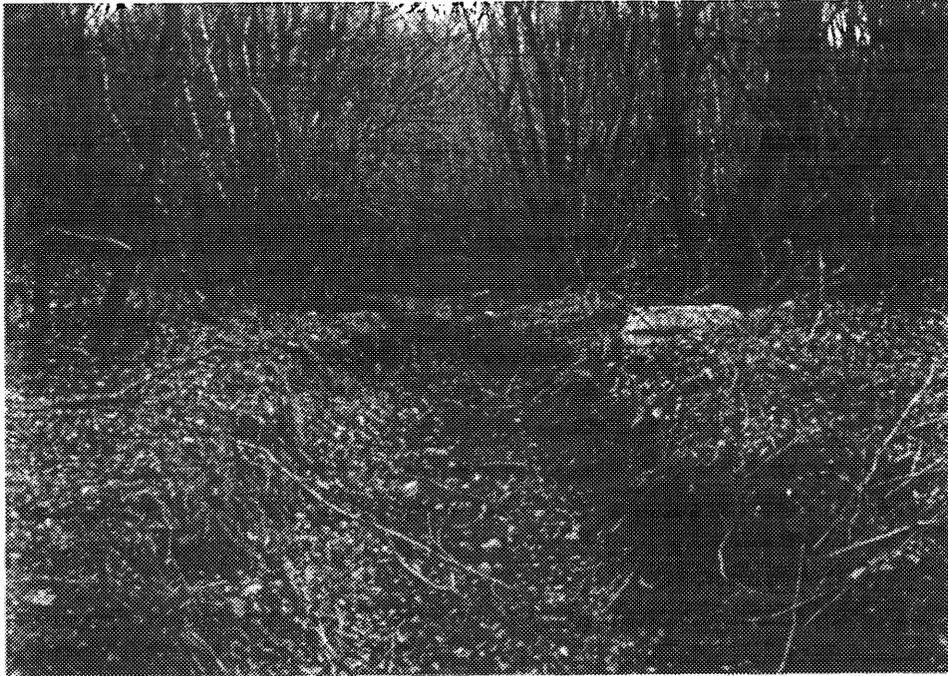
Photo 3 - Upstream of Rounds Ave. No flow in secondary channel.
Looking north from Rounds Avenue.

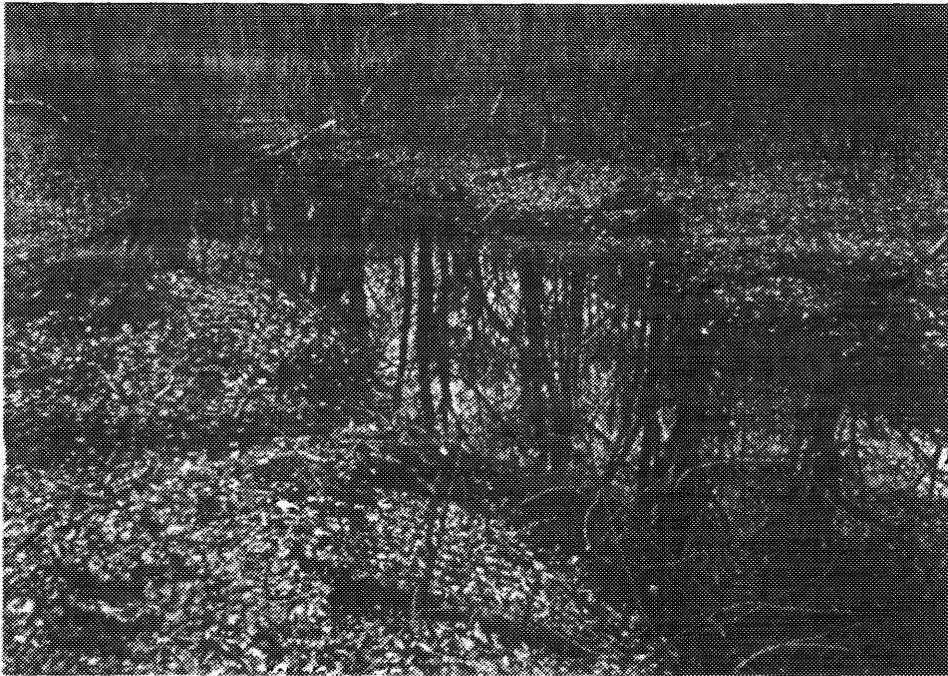
Photo 4 - Upstream of Rounds Ave. & Tanglewood Drive.
No flow in secondary channel, looking northeast.

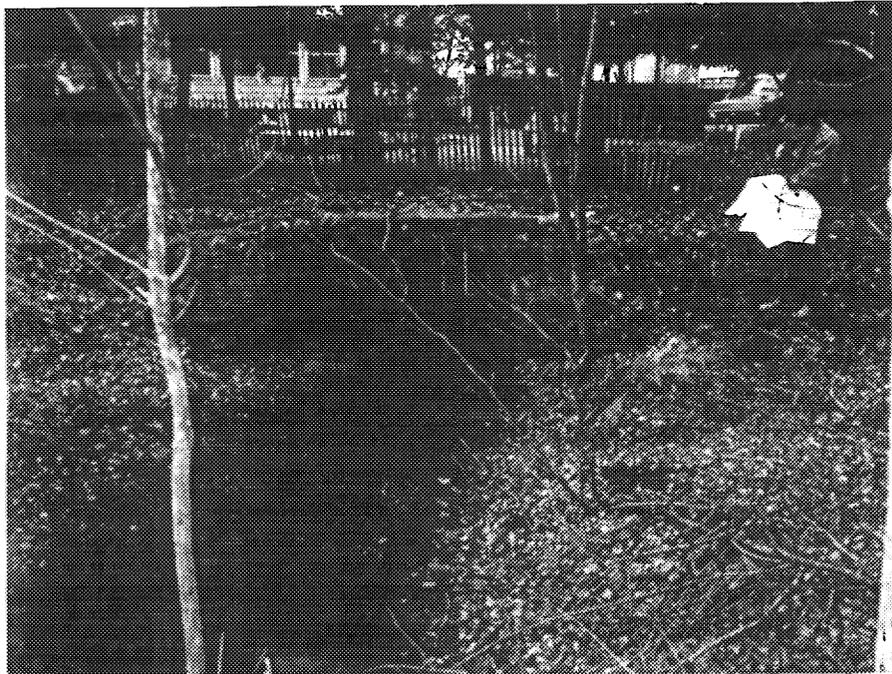
Photo 5 - Normal flow path enters 48" diameter pipe
@ Tanglewood Drive and Rounds Avenue.

Minor sediment buildup in pipe of about 1-2". Stone and mortar headwalls are in good condition with only some minor areas of missing mortar at the wingwall. A trash rack/grate is attached to the headwall. The pipes of the grate are corroded and bottom portions of the pipes are missing. (See Photo 5)

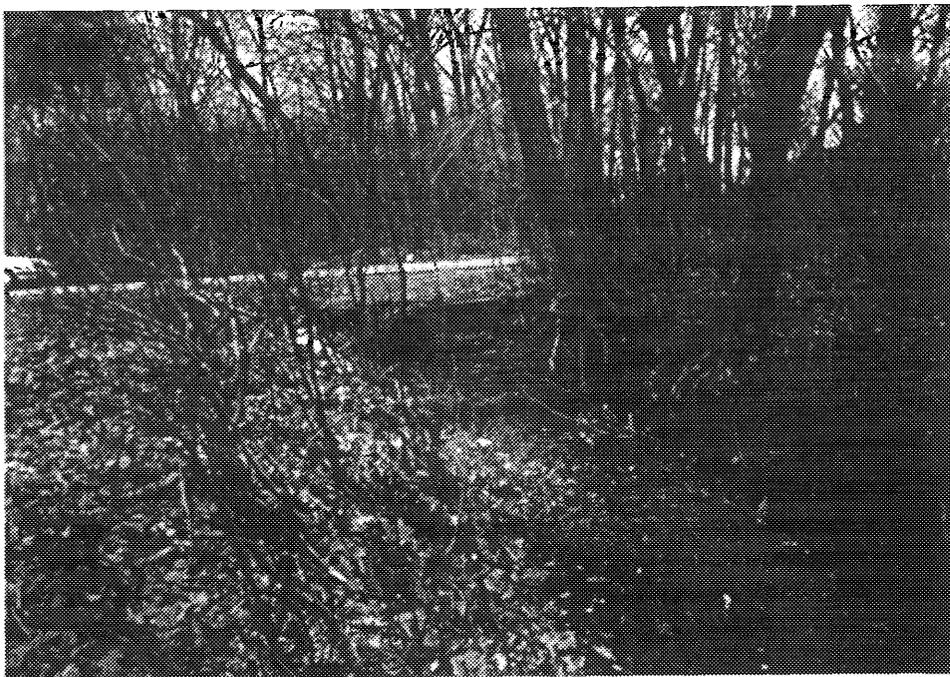
Photo 8 - Downstream of Glenrose Drive. 30" diameter pipe.

Stone/mortar headwall at upstream end has some loose stones and missing mortar. Concrete headwall at downstream end is in good condition. There are minor spalls and chipping of concrete pipe. There is no apparent settlement or deflection of the culvert. Approximately 70' downstream is the confluence of the main flow from Annawomscutt Brook which discharges from the drainage network. (See Photo 8)

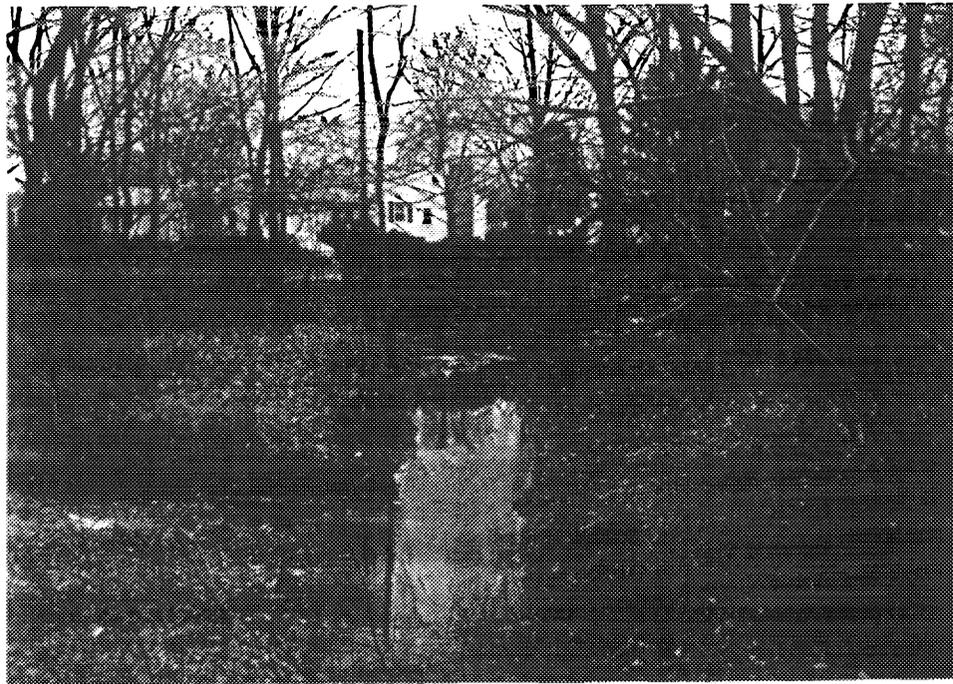
Photo 9 - Downstream of Glenrose Drive. Note two 36" diameter pipes is outfall for drainage network conveying normal flow path. Secondary channel enters at the left.

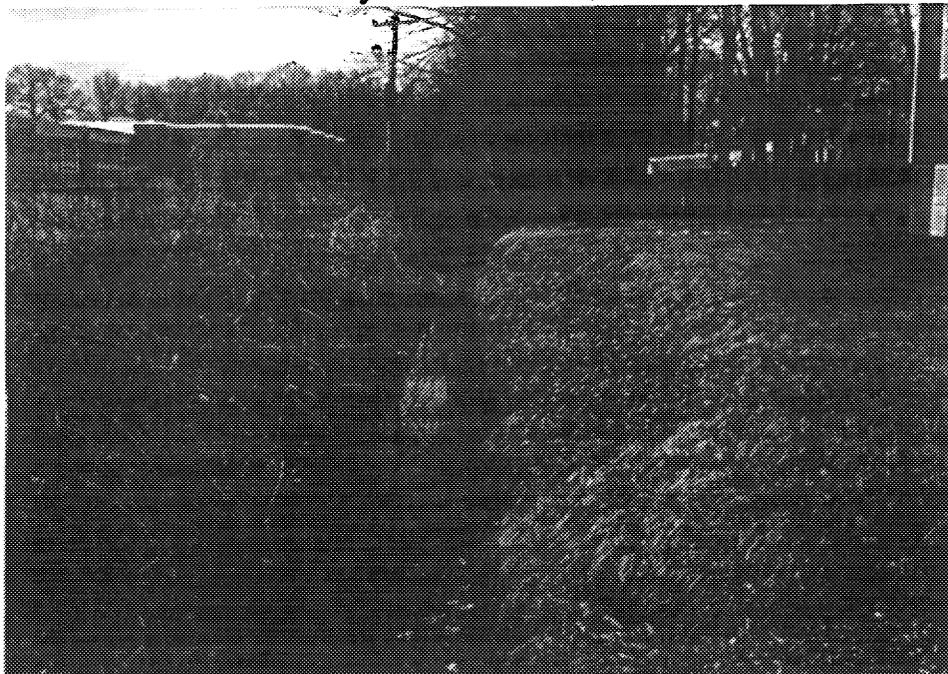
Photo 10 - Typical channel looking upstream (north) from Legion Way.

As previously mentioned, the normal flow path for Annawomscutt Brook enters a 48" diameter concrete pipe into the local storm drain pipe network. The underground network proceeds west along the south side of Rounds Avenue and then south behind the residences on Ferncrest Drive to Glenrose Drive. The drainage network eventually discharges through two 36" diameter concrete pipes at Glenrose Drive (see Photo 9). Approximately 70' south of Glenrose Drive the main Annawomscutt Brook channel exiting the stormwater pipe network and the secondary channel recombine. The channel is about 6' wide at this location and continues south between the houses on Ferncrest Drive and the Waddington Elementary School (see Photo 10) before passing through a 42" diameter concrete pipe culvert under Legion Way (see Photo 11).

Approximately 600 feet further downstream, the brook flows through a 42-inch diameter culvert at Legion Way (see photos 10 and 11 of main report). The brook continues about another 900 feet downstream, and crosses through a large strip mall parking area. Two access roads cross over the brook. Beneath the northern access road are twin 72-inch corrugated metal culverts (see photos 12 and 13 of main report), while two 36-inch corrugated metal culverts pass under the south access road (see photo 14 of main report). At the downstream end of the parking area, the brook flows through a 5- by 12-foot opening under Willett Avenue (see photo 15 of main report) and into the town of Barrington, Rhode Island.

Upstream: Good channel alignment; vegetated streambanks. (See Photo 10)

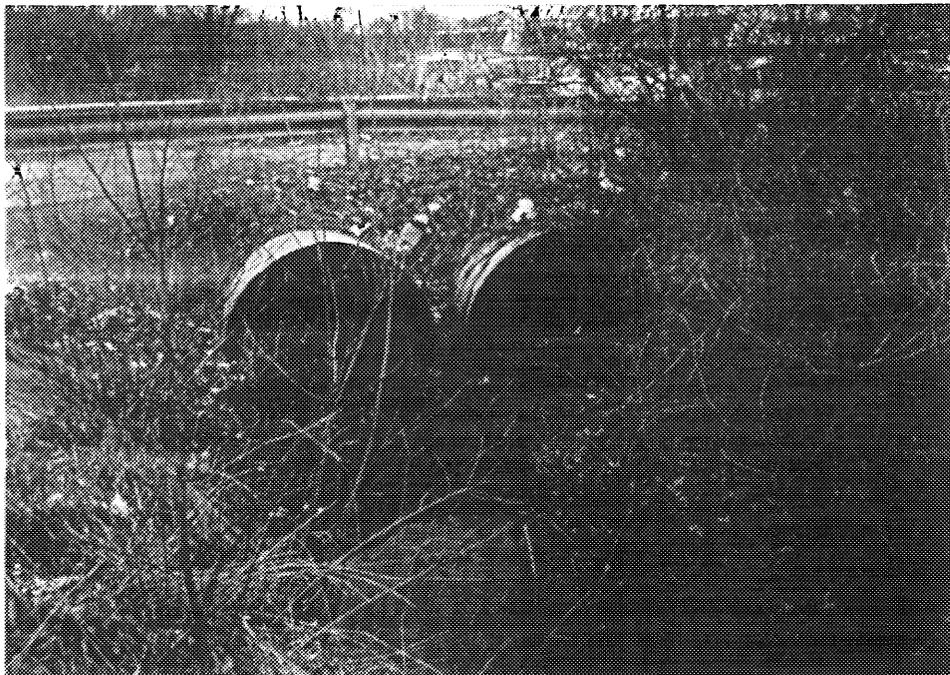
Photo 12 - Upstream end of north access road at plaza parking lot.

Annawomscutt Brook then flows south through a shopping plaza and commercial land use area. The brook runs directly through the plaza's parking lot with two access roads crossing the brook between both sides of the lot. The channel is about 10' wide in this area. At the northerly crossing the brook passes through two 72" corrugated metal pipe culverts. The west culvert is partially blocked by sediment and vegetation (see Photos 12 and 13). At the southerly access road crossing the brook passes through two 36" pipe culverts. The western 36" pipe appears to be constructed of different types of pipe. The upstream end is corrugated metal and the downstream end is reinforced concrete (see Photo 14). The brook then flows south through a 5' by 12' concrete box culvert under Route 103, Willett Avenue (see Photo 15) and continues into Barrington. It flows through the backyards of a primarily residential area with only one street crossing, a 42" diameter concrete pipe culvert at Promenade Street (see Photo 16).

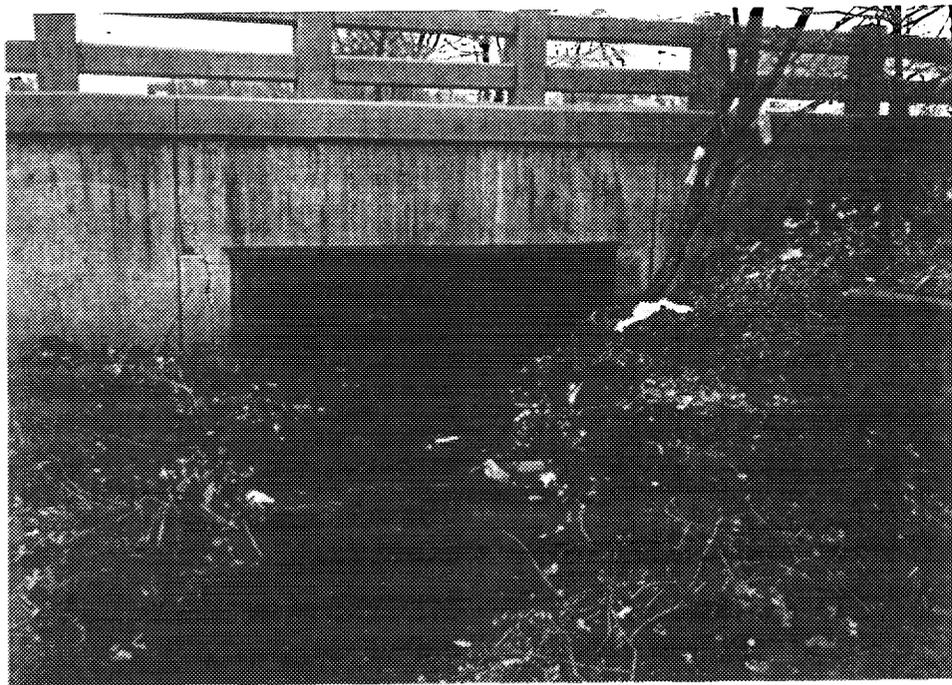
Photo 15 - Downstream @ Willett Avenue. Note headwall on right for 3.5' diameter drainage pipe.

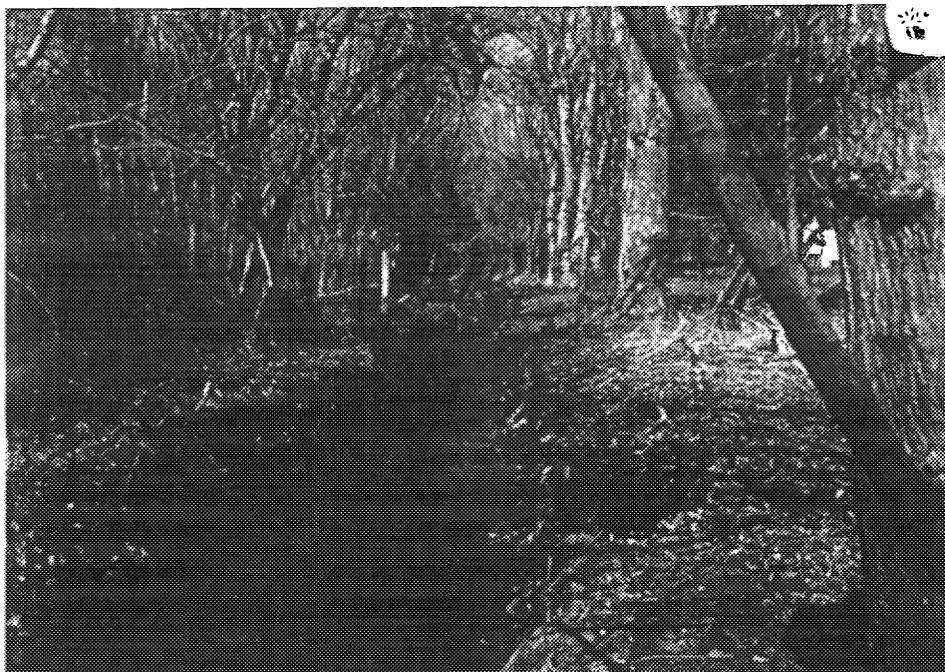
Photo 16 - Typical brook configuration. Looking upstream from Promenade Street.

Photo 16 - Upstream of Promenade Street.

f. Watershed Subarea BA1. Forty-two percent of this 403-acre subarea is residential. Annawomscutt Brook flows through culverts at Promenade Street and Haines Park Road (see photos 16 through 20 of main report). A large storage

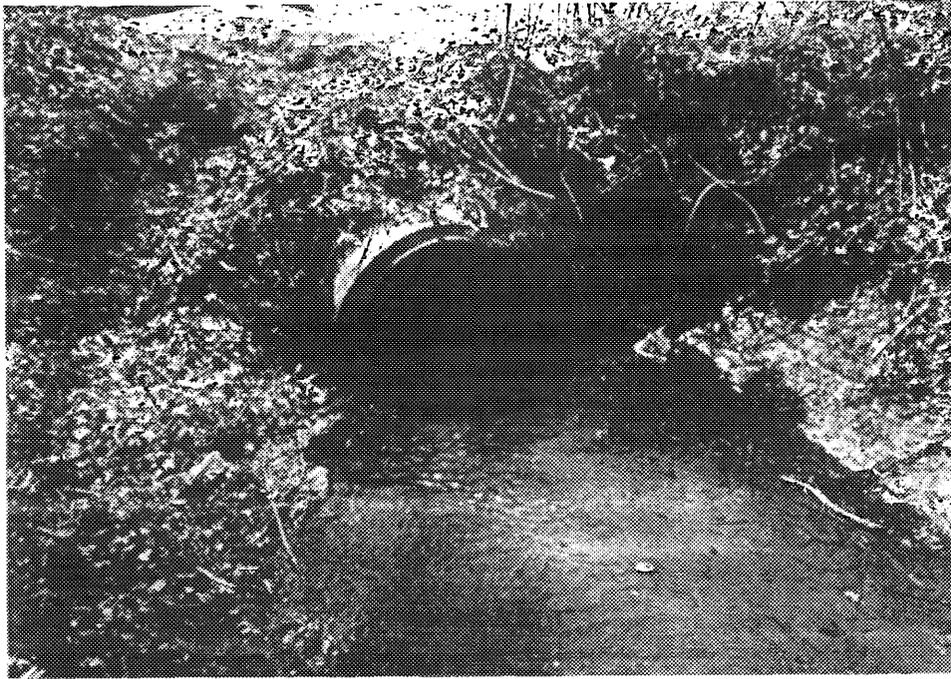
Photo 17 - Upstream end @ Promenade Street.

Photo 17 - Upstream of Promenade Street.

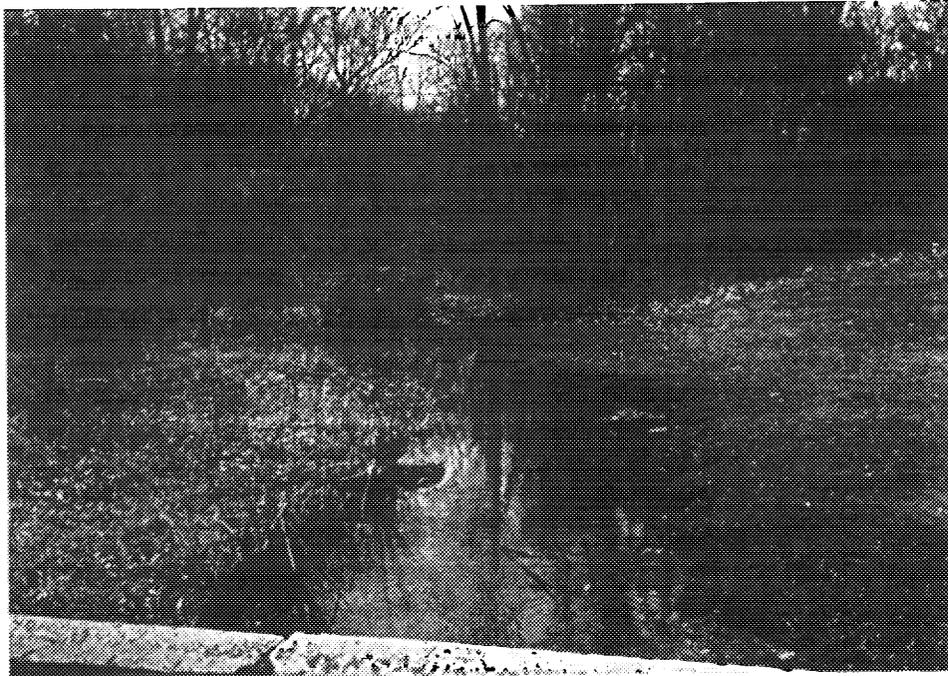
Photo 20 - Typical channel configuration. Looking downstream from Haines Park Road.

Photo 20 - Downstream of Haines Park Road.

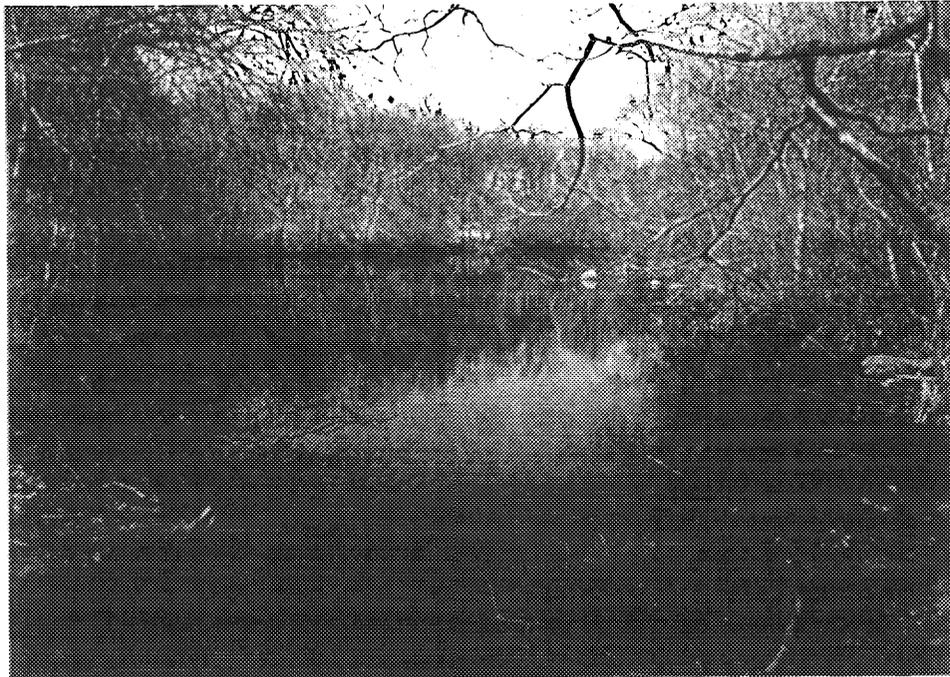
Photo 21 - Looking upstream north of bike path.

Photo 21 - Upstream of bike path.

area, with an estimated capacity of approximately 170 acre-feet, is located between Haines Park Road and a bike path (see photo 21 of main report). The flow out of the storage area, which consists of a swampy area and a pond, is restricted by a 4- by 2-foot stone masonry culvert (see photo 22 of main report). The culvert passes the brook under the bike path, which was, once a Conrail line. The flow then enters another small storage area, passes through an estimated 5-foot diameter culvert (see photo 23 of main report), and travels down a wide channel to a small dam (see photo 24 of main report), where it spills over into Drown Cove.

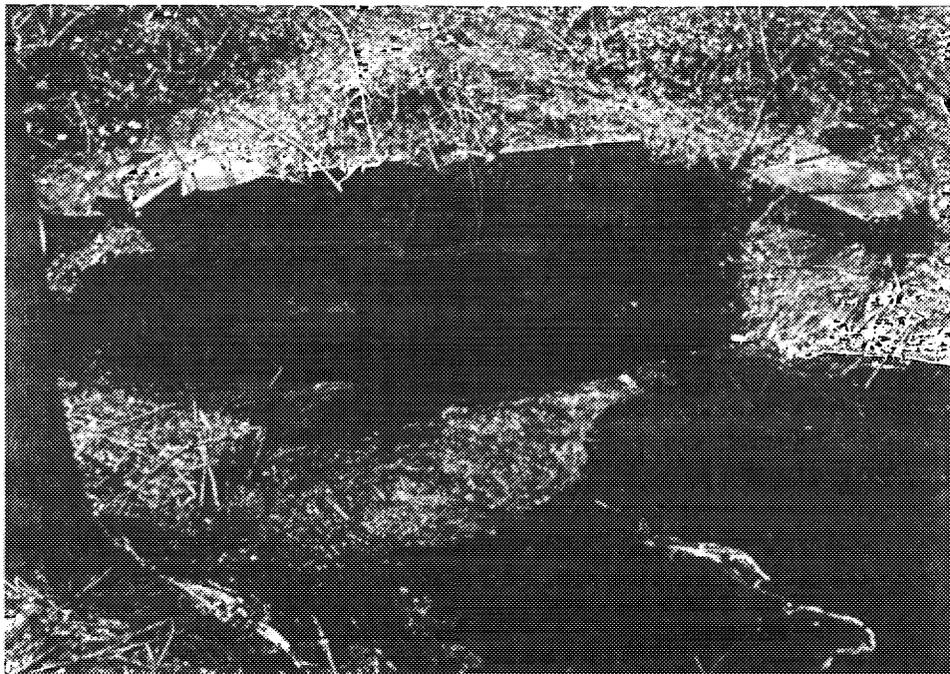
Photo 22 - Upstream end of stone culvert under bike path.

Photo 22 - Upstream end of bike path.

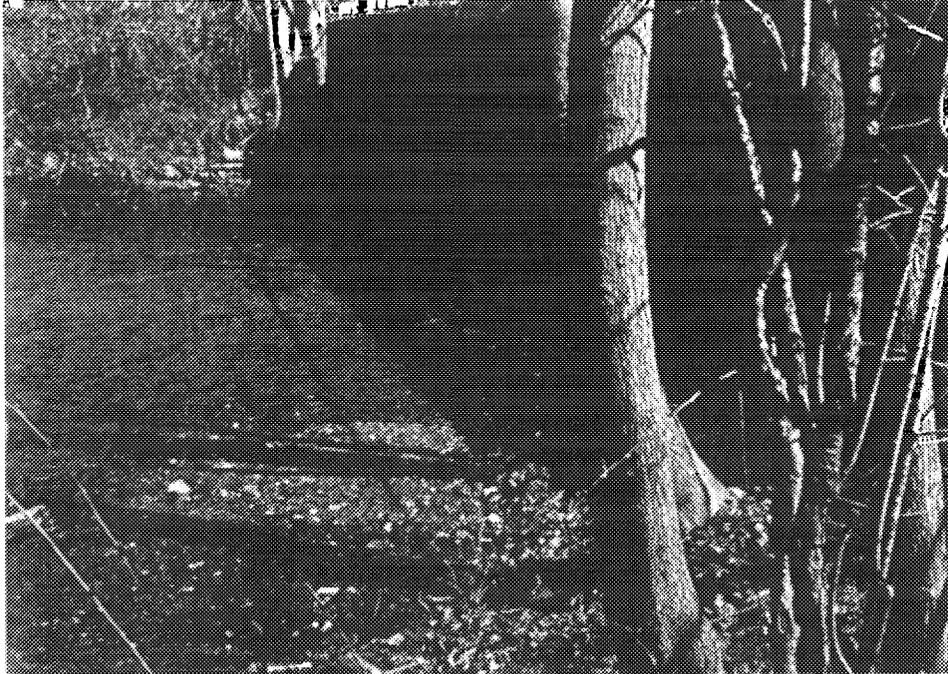
Photo 23 - Upstream at 60" diameter culvert
under Bay Spring Avenue.

Photo 23 - Upstream of Bay Spring Avenue.
