Monitoring Cruise at the Massachusetts Bay
Disposal Site
November 1988 - January 1989

Disposal Area Monitoring System DAMOS

Contribution 73
May 1990

**MONITORING CRUISE AT THE
MASSACHUSETTS BAY DISPOSAL SITE
NOVEMBER 1988 - JANUARY 1989**

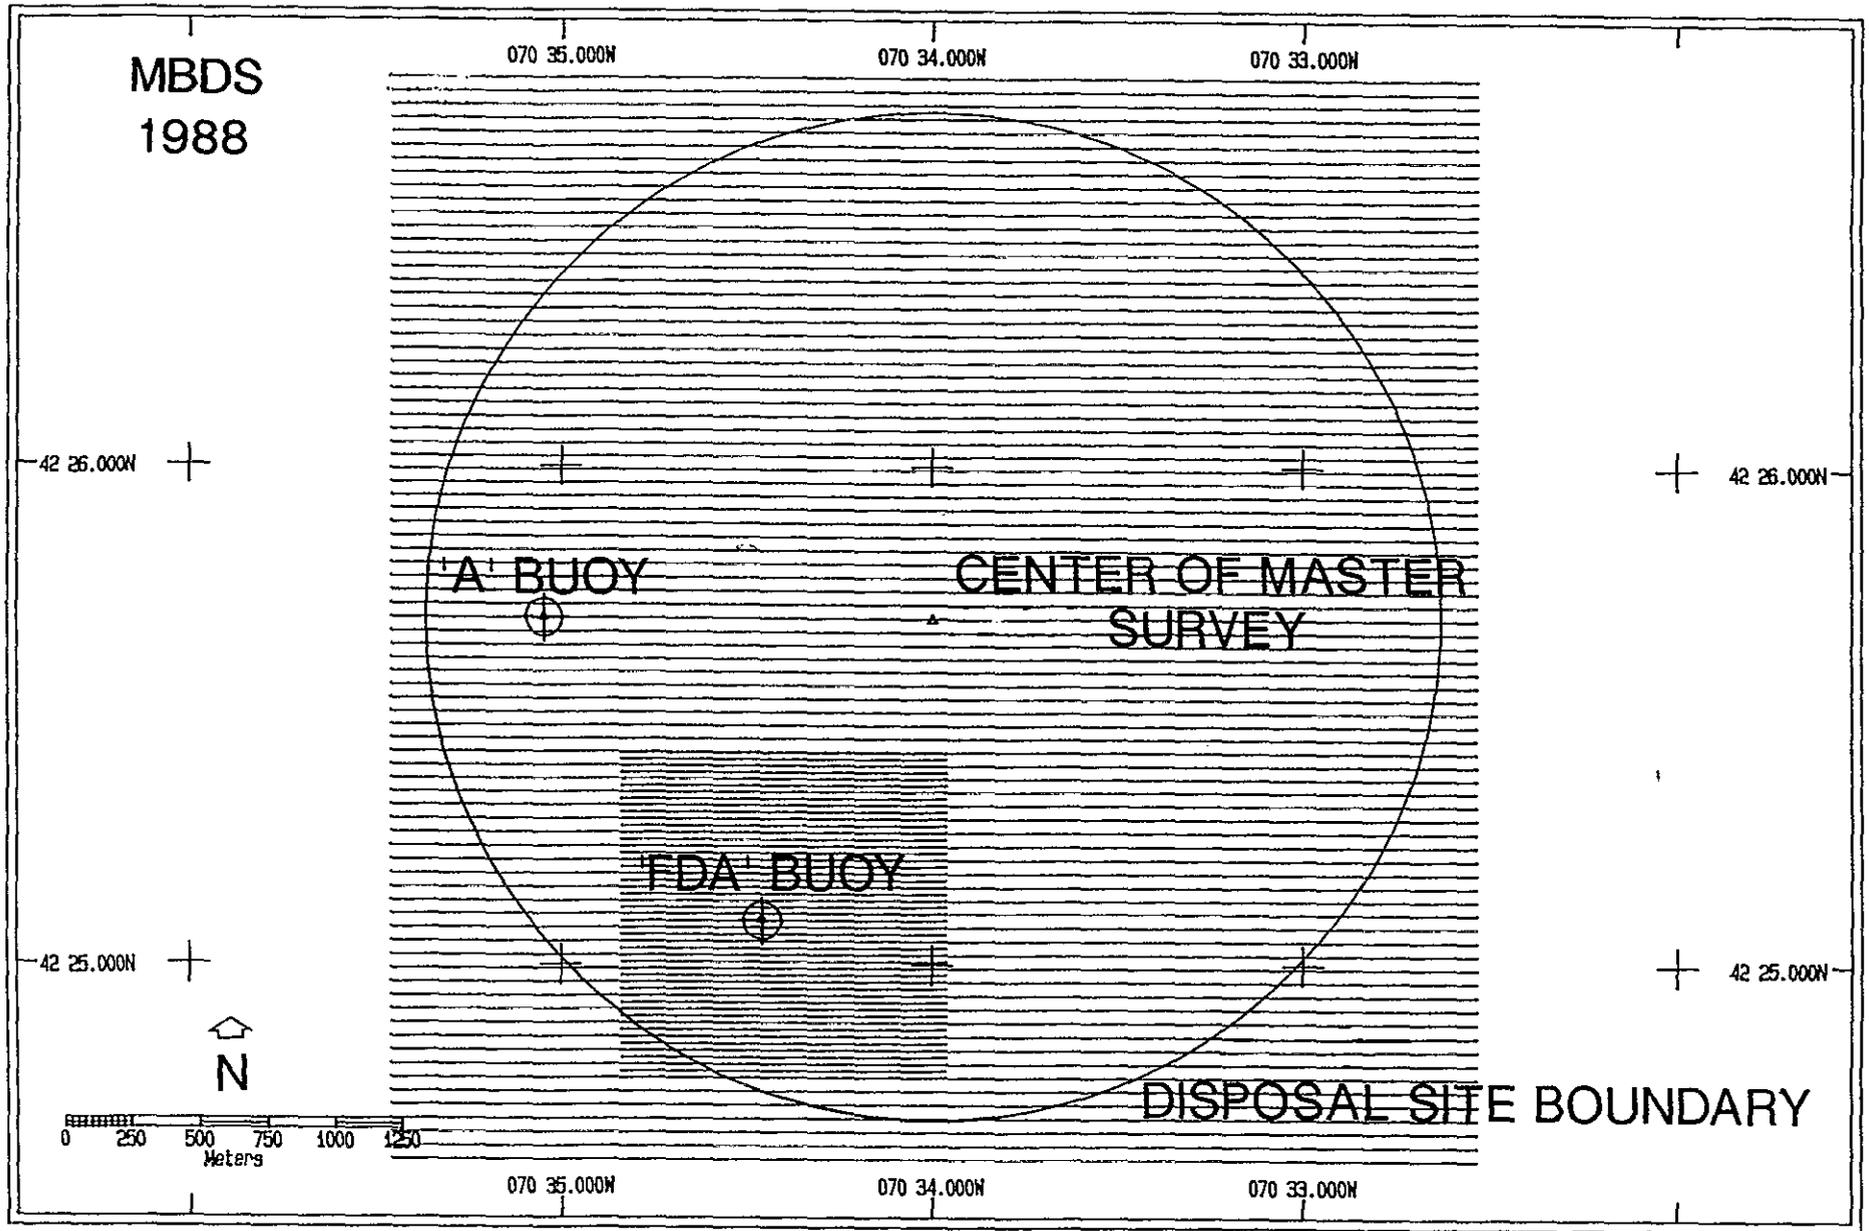
Figure 1-1. Map of bathymetric survey lanes used at MBDS, indicating the location of the "FDA" and "A" buoys, as well as the MASTER MBDS survey encompassing the entire area.

The bathymetric survey conducted at the MBDS "FDA" buoy on 4 November 1988 encompassed a 1200 x 1200 m grid with 25 m lane spacing, centered at coordinates 42° 25.095 N and 70° 34.423 W (Figure 1-1). This same grid was used in the previous bathymetric survey of this area in January 1987. Between 5 and 19 November 1988, the master bathymetric survey was conducted over a 4000 x 4000 m grid with 50 m lane spacing, centered at 42° 25.695 N and 70° 33.999 W (Figure 1-1).

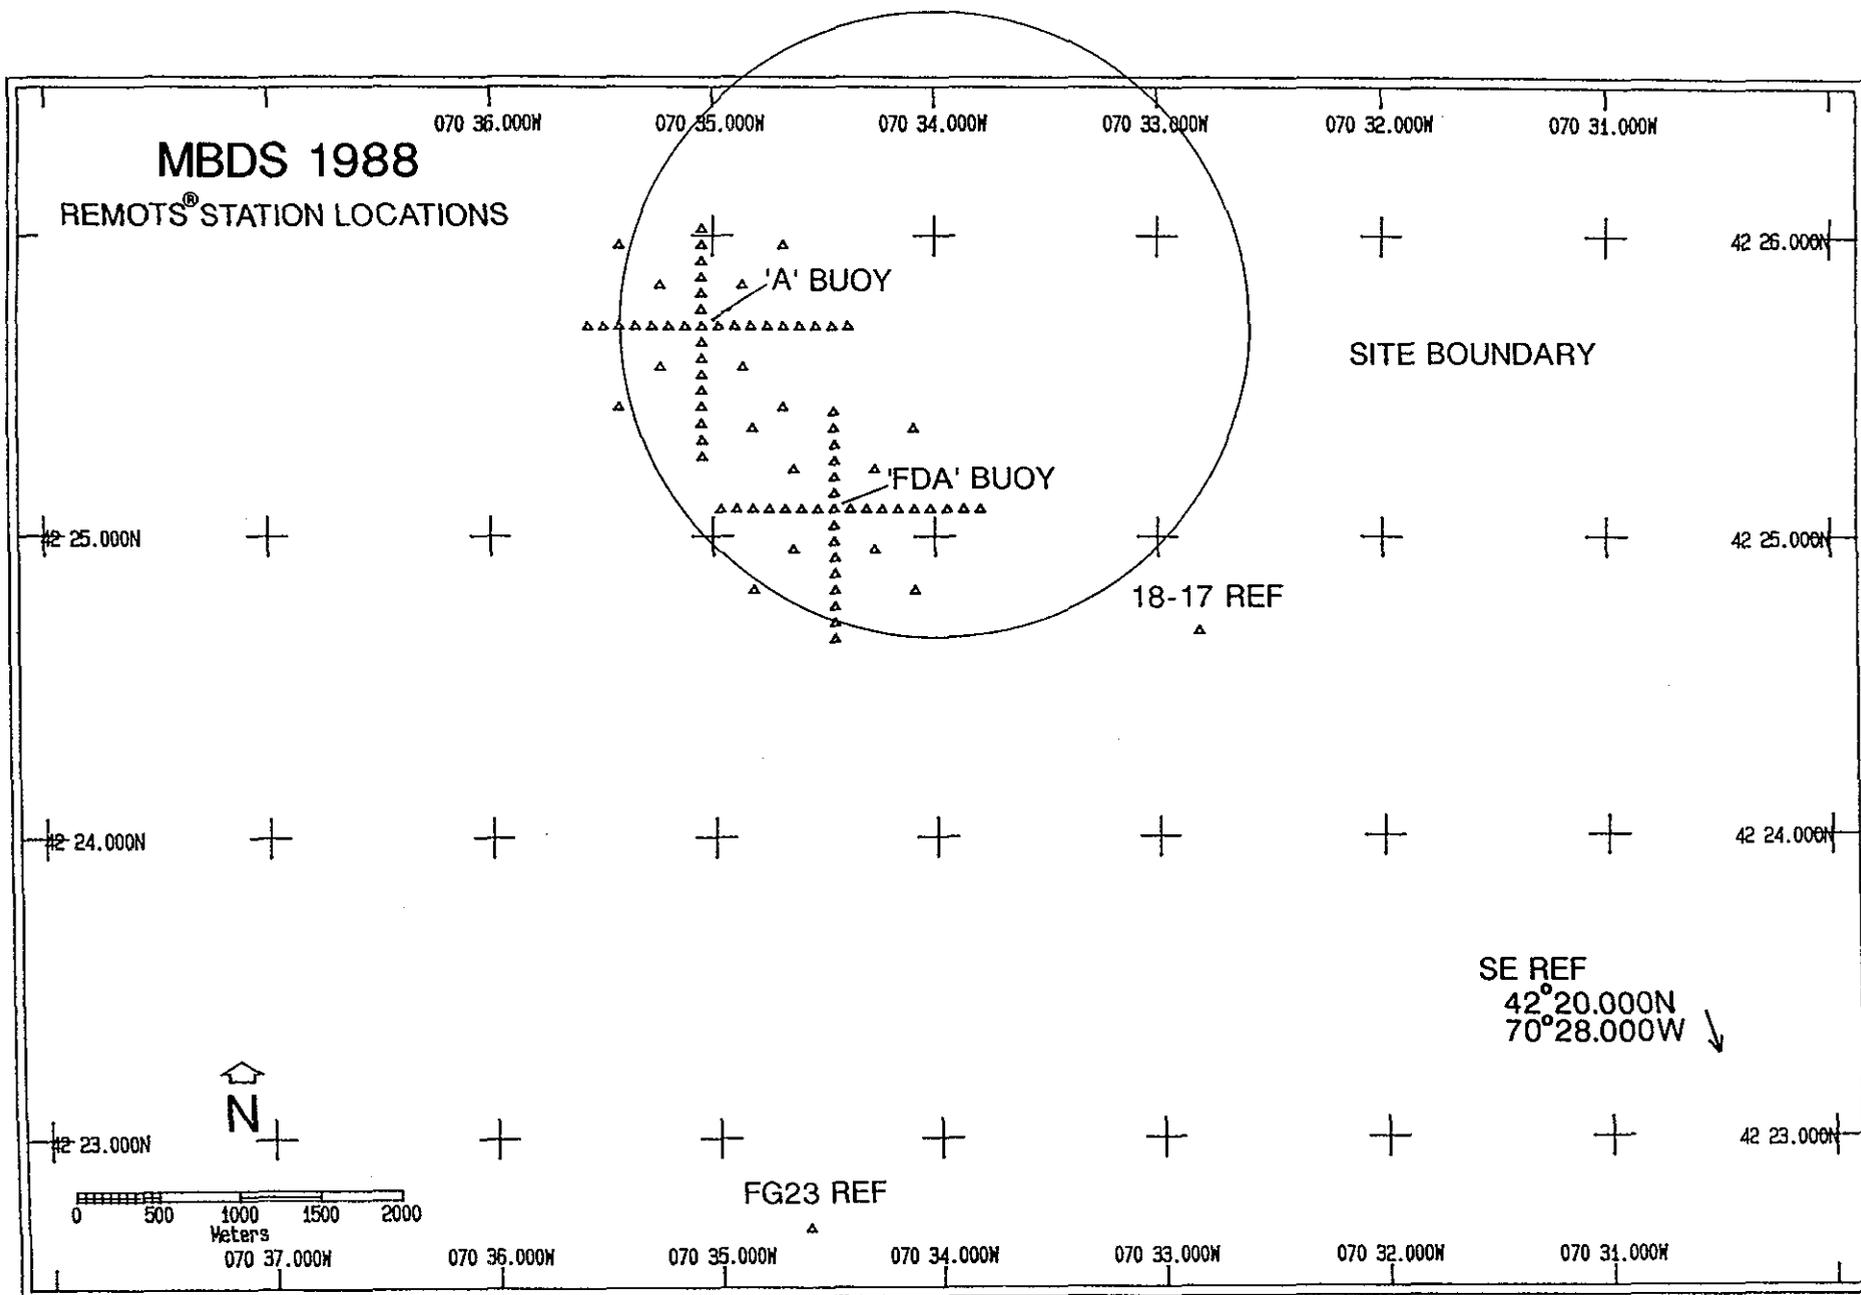
Figure 2-1. Location and designation of REMOTS[®] stations (triangles) at MBDS, January 1989. Cross-shaped grids with 100 m station spacing were used at the three outlying reference sites (FG23, SE-REF and 18-17).

of 39 stations situated around the disposal buoy in a cross-shaped pattern. Stations were spaced 100 m apart and extended 600 m to the north, 800 m to the south, 900 m to the east, and 700 m to the west of center (Figure 2-1). Stations were also located in each of the four quadrants at 250 and 500 meters NE, NW, SE, and SW. Additionally, thirteen REMOTS® stations arranged in a cross-shaped pattern and spaced 100 m apart were occupied at each of three reference locations to allow comparisons between ambient and on-site conditions. These reference stations were located at 42° 22.7 N, and 70° 34.6 W (station FG23); 42° 20.0 N, and 70° 28.0 W (station SE-REF); and 42° 24.686 N, and 70° 32.814 W (station 18-17; Figure 2-1).

The REMOTS® stations around the "A" buoy were occupied on 11 and 16 January 1989; the station grid was centered at 42° 25.7 N and 70° 35.04 W. Three replicate photographs were obtained at each of 39 stations arranged in a cross-shaped pattern, identical to the grid used for the REMOTS® survey at the "FDA" buoy (Figure 2-1).

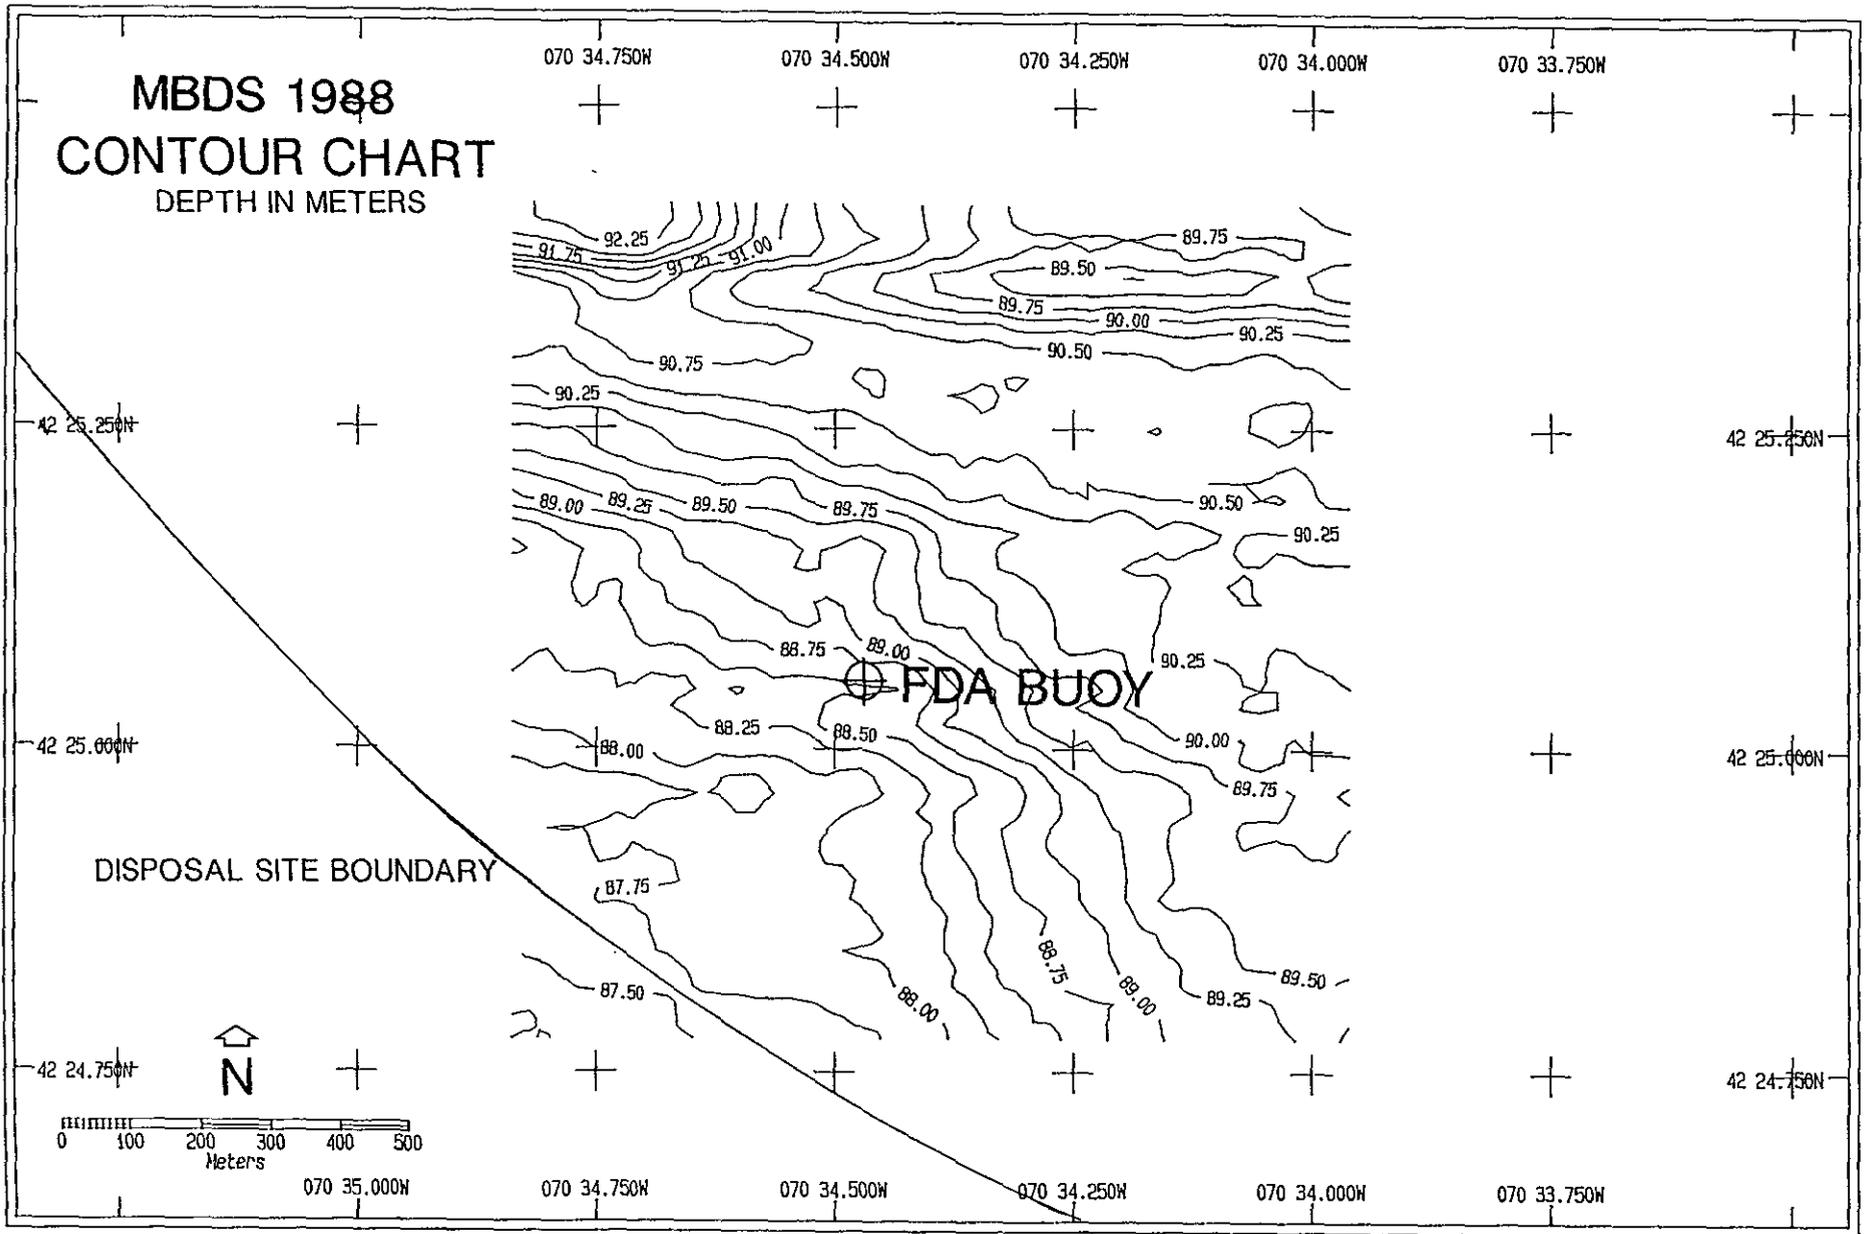
Figure 3-1. Bathymetric contour chart of the area surrounding the "FDA" buoy at MBDS, November 1988. The contour interval is 0.25 meters.

A comparison of the November 1988 and January 1987 precision bathymetric surveys (Figures 3-1 and 3-2, respectively) revealed that an acoustically-detectable layer of dredged material had been deposited at the "FDA" buoy in the time between the two surveys. In November 1988, the minimum depth at the disposal point was approximately 88.50 meters (Figure 3-1), compared to a depth of 88.75 meters in January 1987 (Figure 3-2). A depth difference contour chart (Figure 3-3) indicates that the deposit had a maximum thickness of 0.3 meters and was centered slightly east of the buoy. Depth differences on the order of 20 cm (i.e., approaching the limits of detection in this comparison of the 1988 and 1987 surveys) occurred within a 50 to 100 meter radius of the center of the deposit.

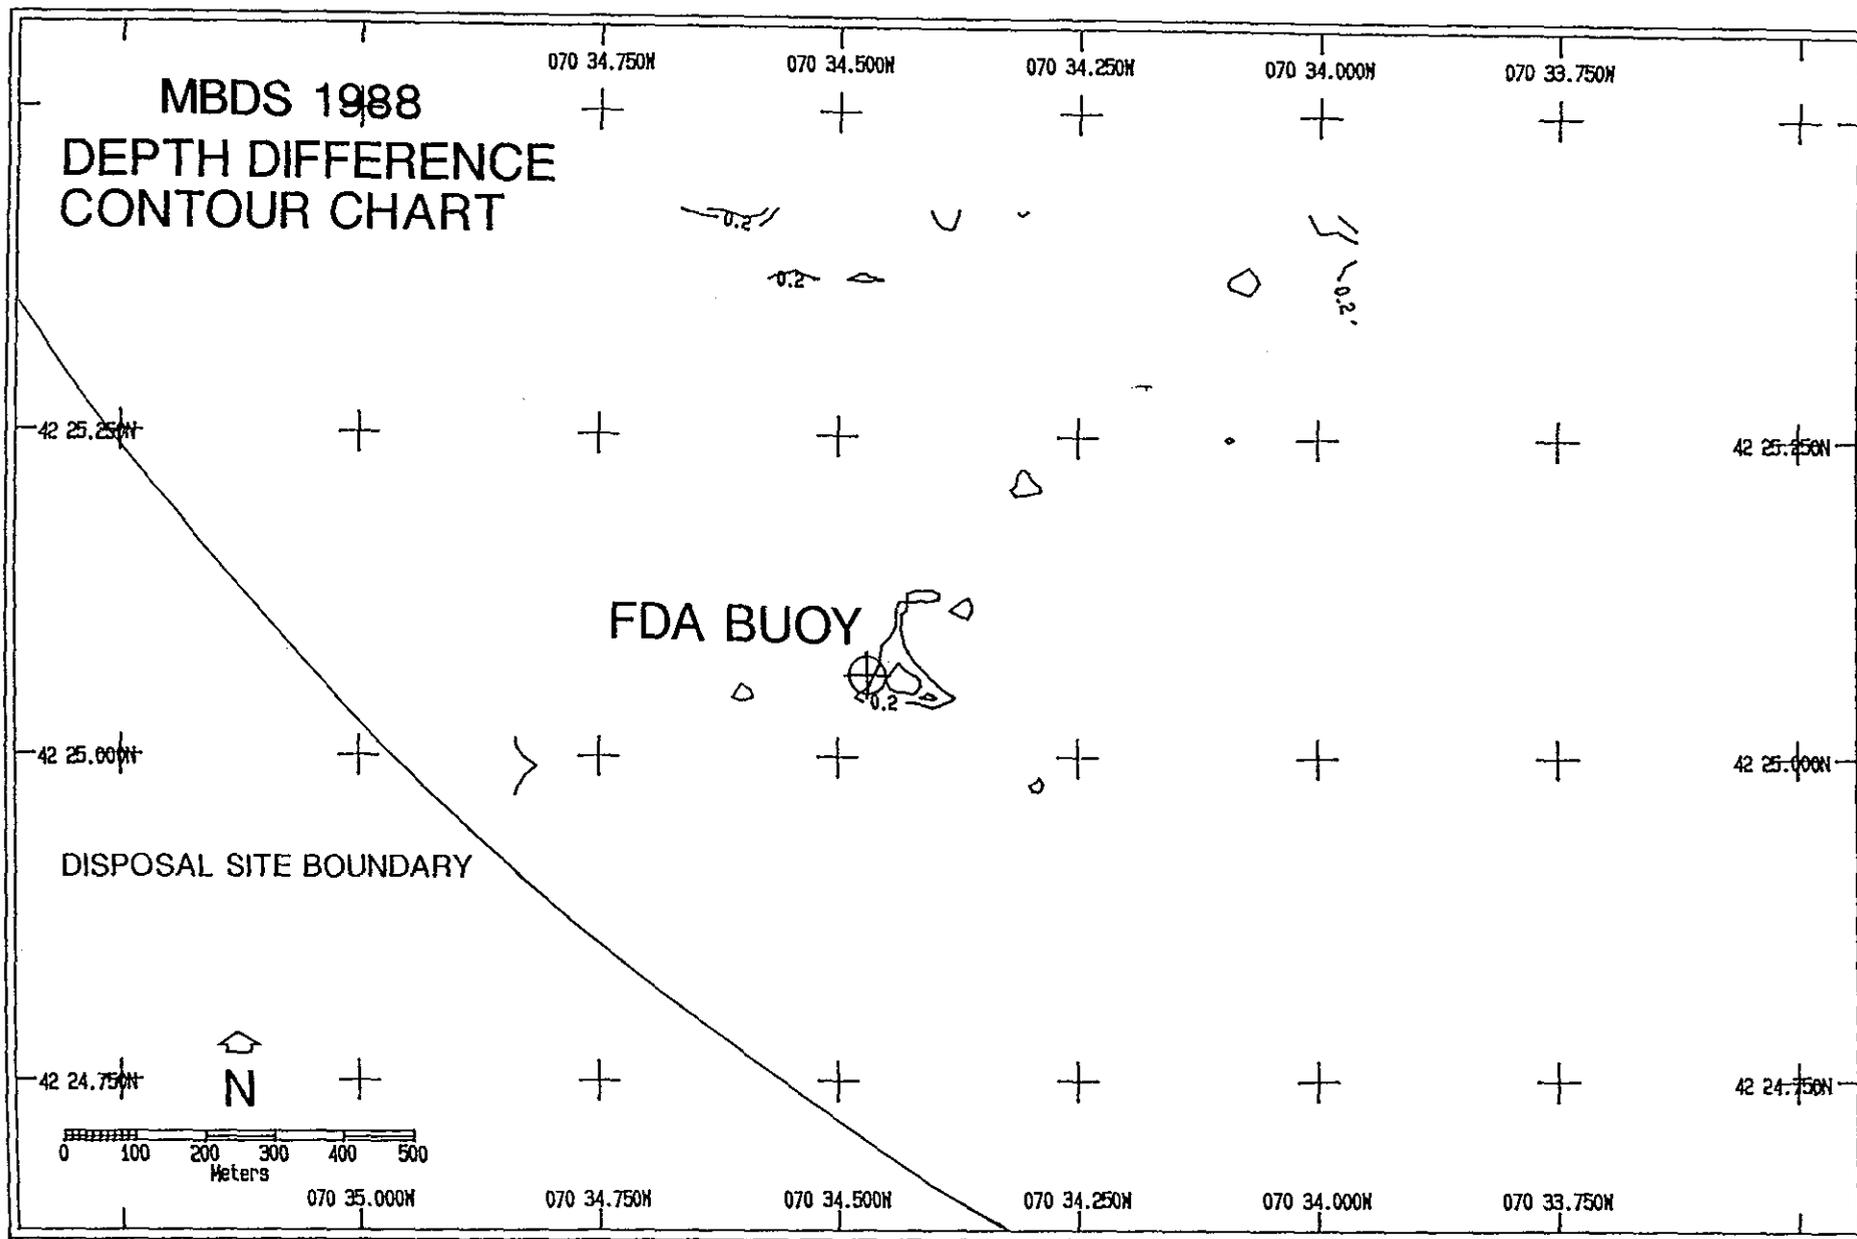
Figure 3-3. Depth difference (in meters) contour map based on comparison of the January 1987 and November 1988 precision bathymetric surveys at the "FDA" buoy.

For the 1200 x 1200 m survey area, comparison of the depth matrices from the 1987 and 1988 bathymetric surveys resulted in a volume difference calculation of 18,087 m³ of material deposited since the January 1987 survey. Examination of the disposal logs indicated that an estimated 140,000 m³ of material was deposited at this location between the January 1987 and November 1988 surveys.

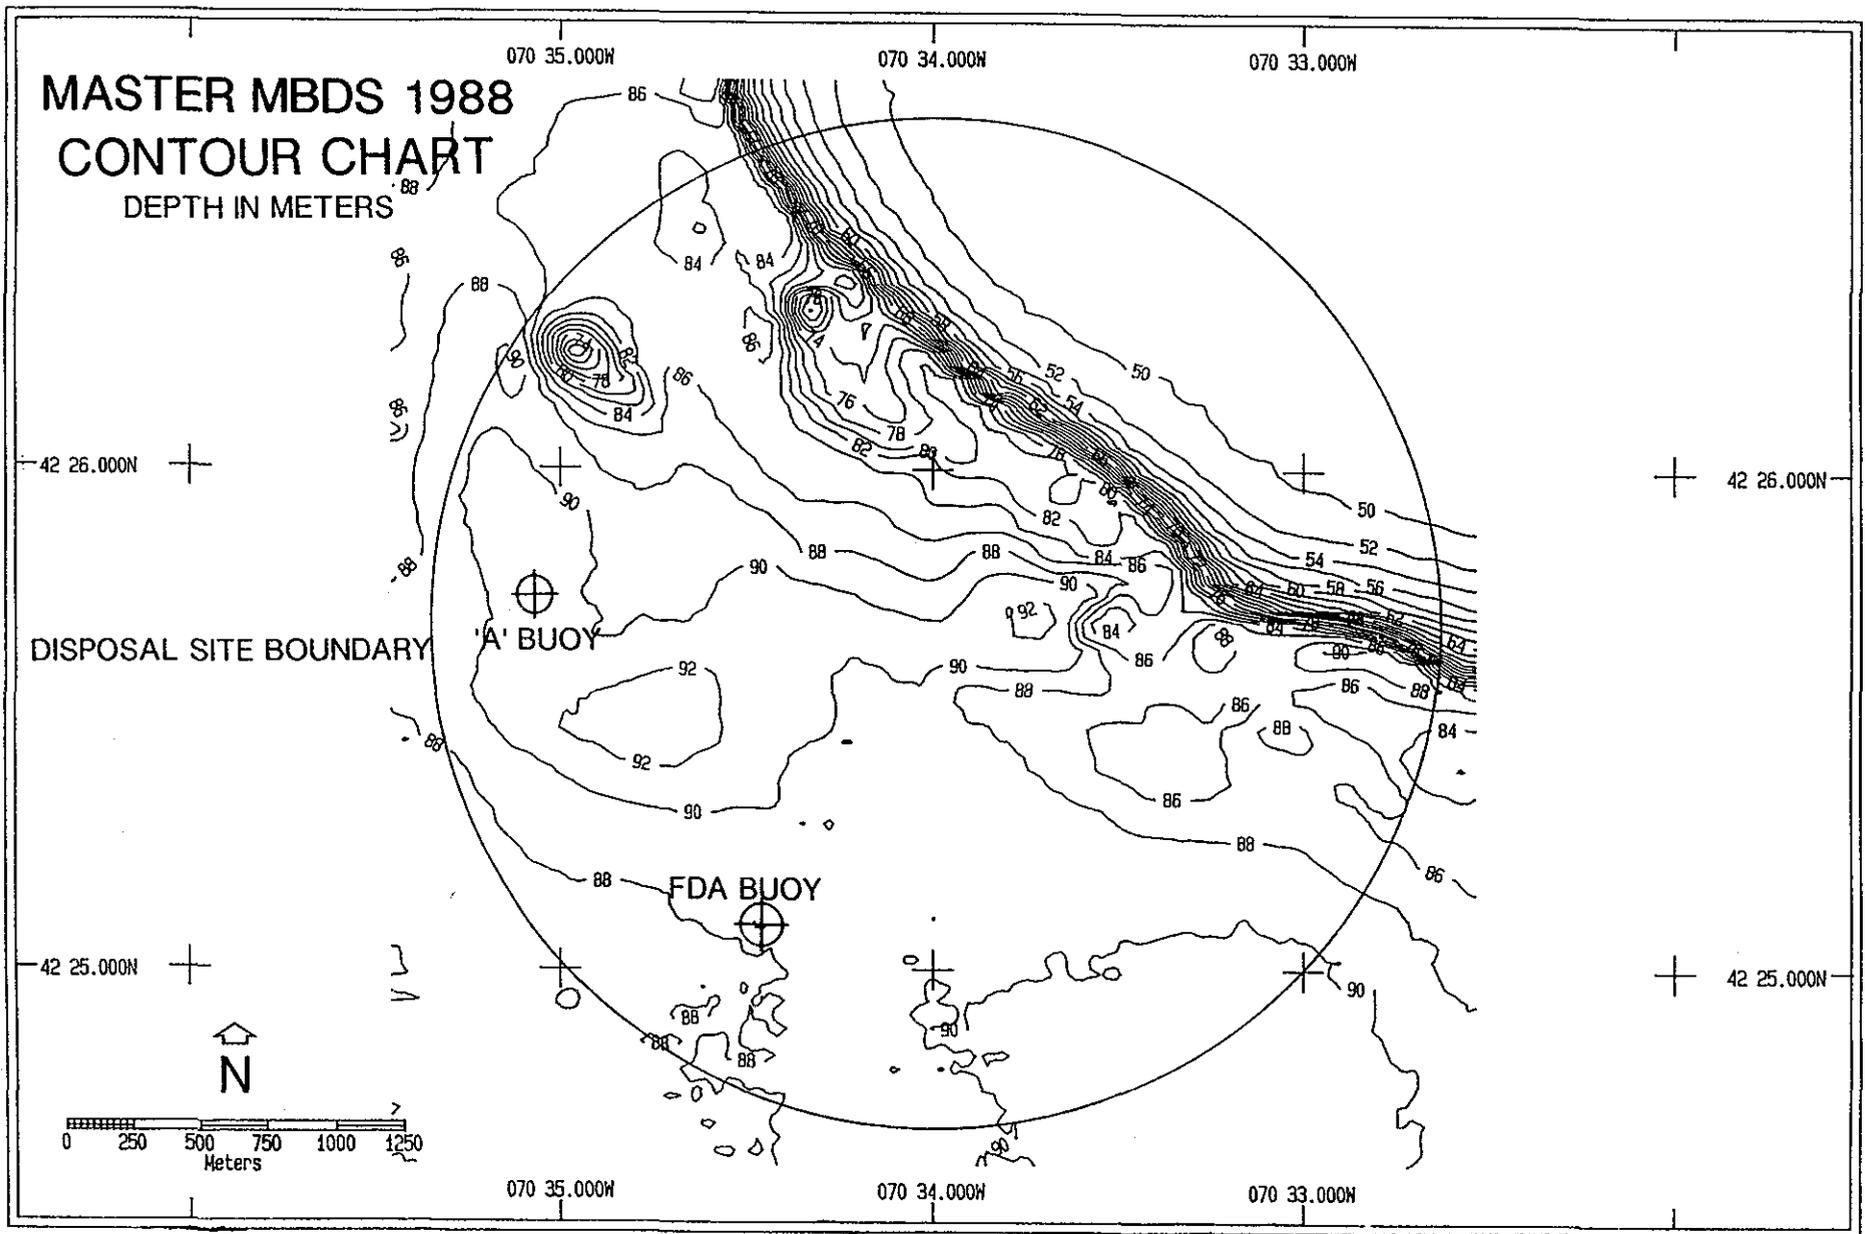
Figure 3-4. Bathymetric contour chart of the entire MBDS area, November 1988. Contour interval is 2.0 meters.

The second precision bathymetric survey performed at MBDS provided detailed bathymetric data for the entire disposal site and revealed the overall topographical features (Figure 3-4). The disposal site is located in a trough running northwest to southeast, just to the southwest of Stellwagen Bank. Extreme

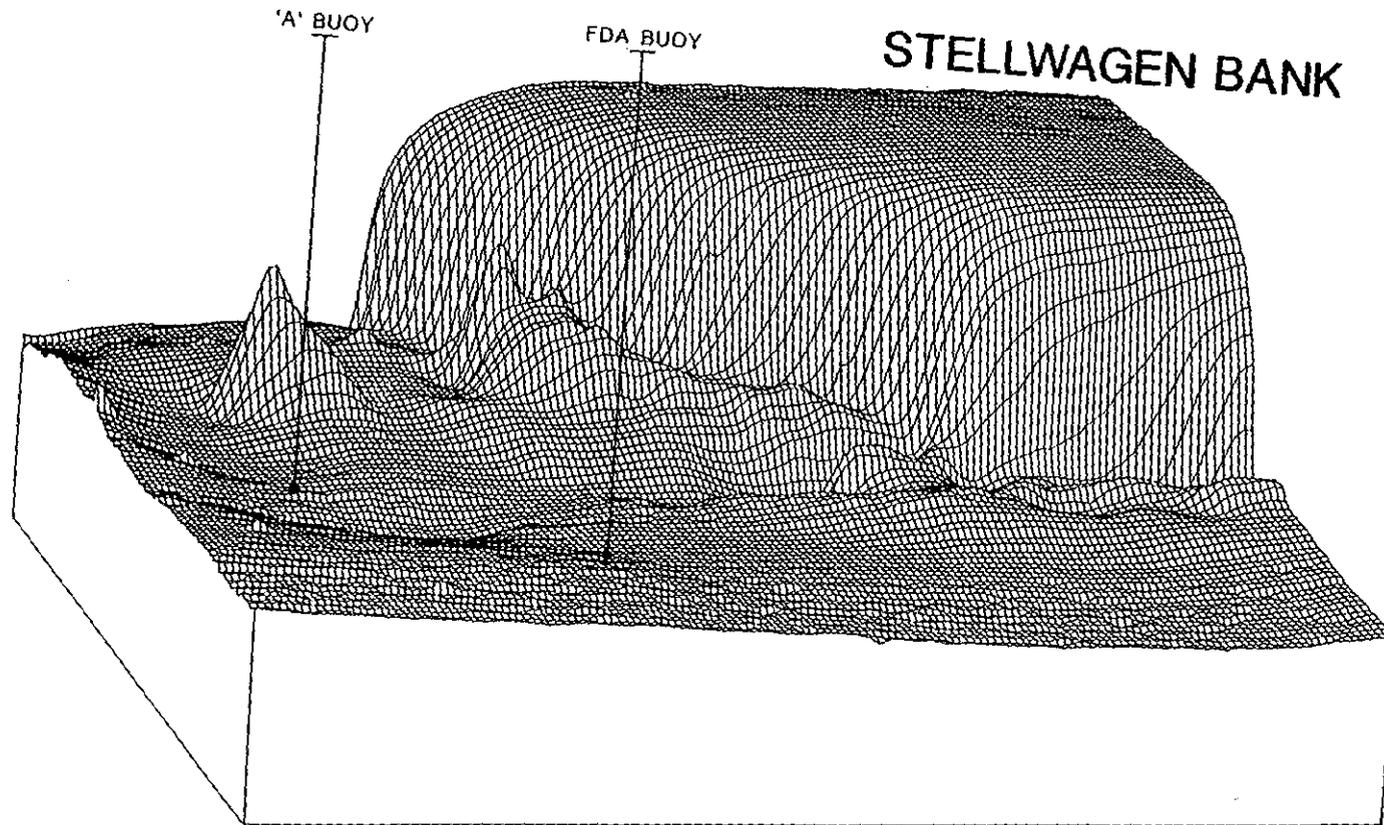
MBDS 1988
3-D CONTOUR PLOT

Figure 3-5. 3-D contour plot of the entire MBDS area, November 1988. The vertical exaggeration is 25X.

changes in depth of up to 20 meters over a 60 meter distance were found on the slopes of the bank (Figure 3-5).

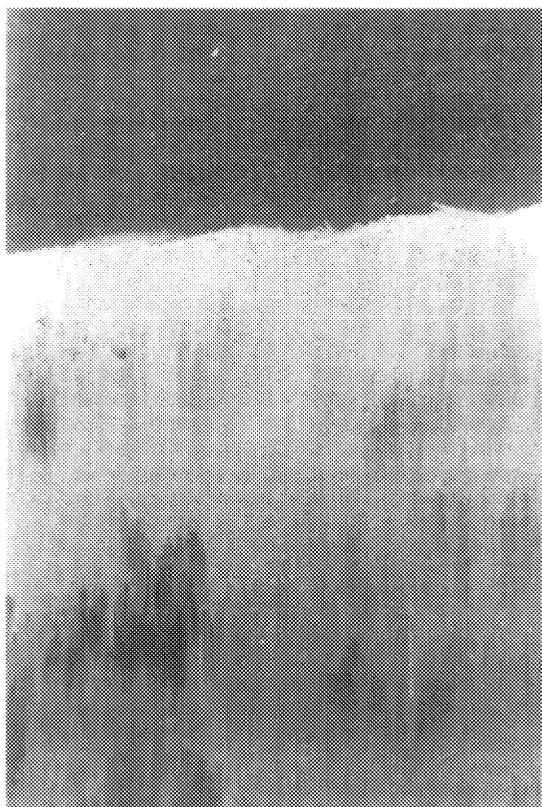
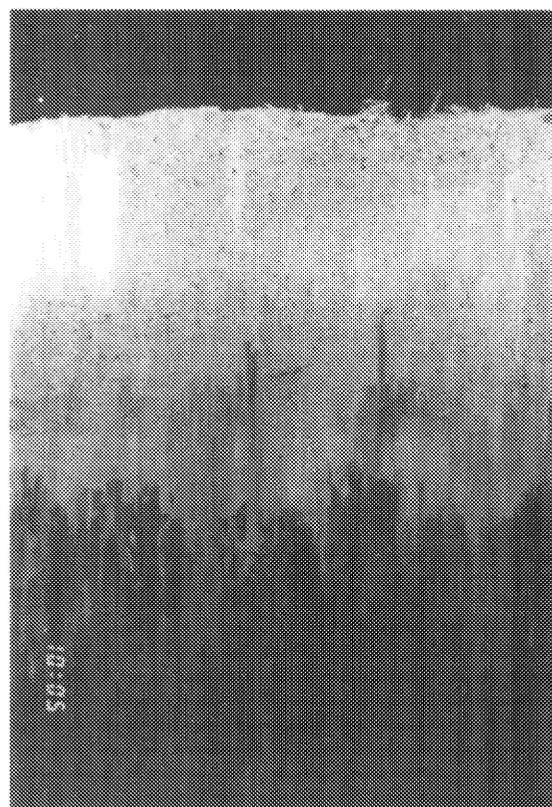
Figure 3-7. REMOTS® photographs from station 500E (A) and 300S (B) showing the presence of apparent relict dredged material on the flanks of the mound. Scale = 0.5X.

Dredged material layers presumed to be recently-deposited (i.e., since the January 1987 survey) were evident in the REMOTS® photographs from stations surrounding the disposal buoy (Figure 3-6). The precise boundaries of the "new" mound were difficult to determine due to the presence of relict dredged material at most of these same stations (Figure 3-7). This relict material was the result of disposal operations which have been ongoing at this location since November 1985.

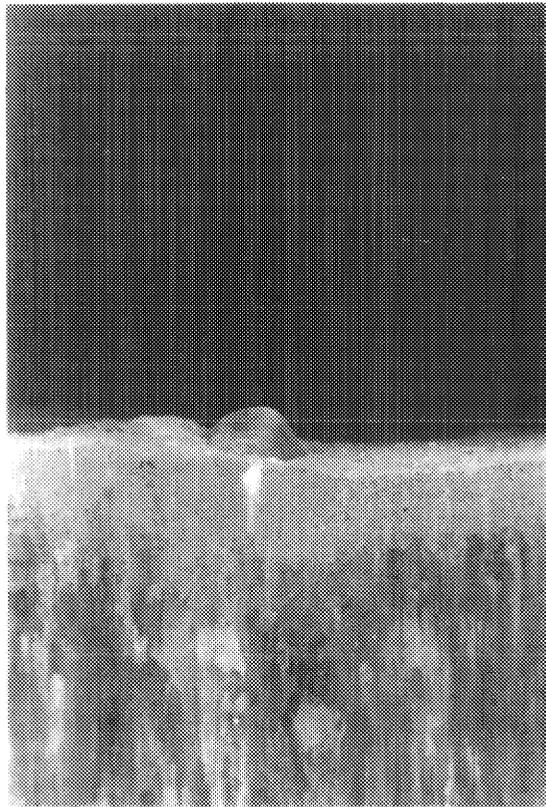
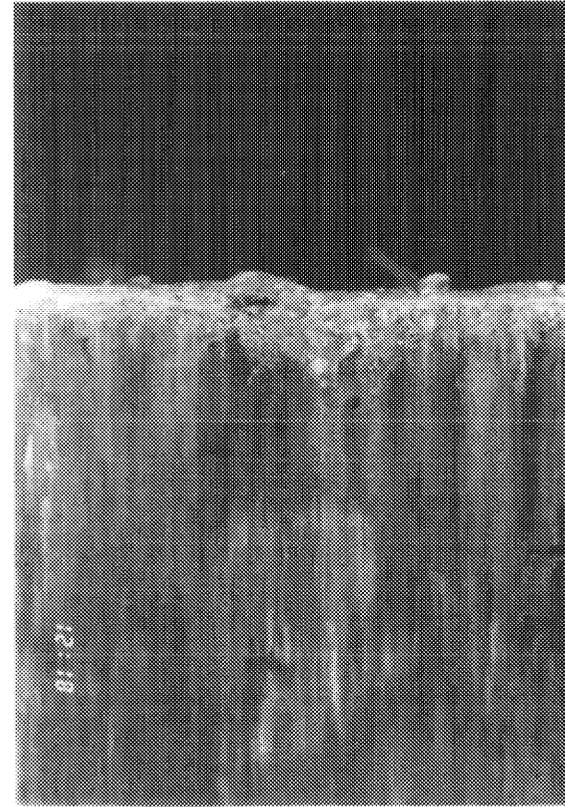
Figure 3-8. REMOTS® photographs from station 100E (A) and 200W (B) showing a "chaotic" mixture of silts, fine sands and sands intermixed with clay in the recently deposited dredged material. Scale = 0.5X

The apparent "fresh" dredged material consisted of a chaotic mixture of silts, fine sands and sands intermixed with clay (Figure 3-8). The REMOTS® photographs from the stations located closest to the point of disposal (CTR, 100S, 100N, out to 200E, and out to 300W) showed over-consolidated clay clasts and occasional rock rubble at the surface which limited camera penetration (Figure 3-9). At other stations, the dredged material appeared to be less consolidated, exhibiting more stratification and allowing deeper camera penetration (Figure 3-10). At these stations, the mixture of silts, fine silts, and sands was less chaotic with only an occasional buried clay clast, reflecting heterogeneity in the composition of the disposed material. Again, the thickness of the recently-deposited layers often could not be measured accurately because of the lack of a clear marker between the "fresh" dredged material and underlying relict material.

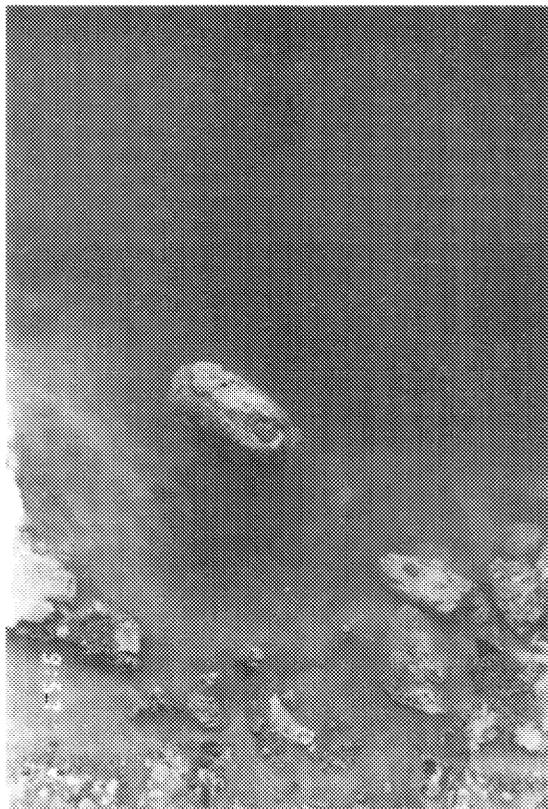
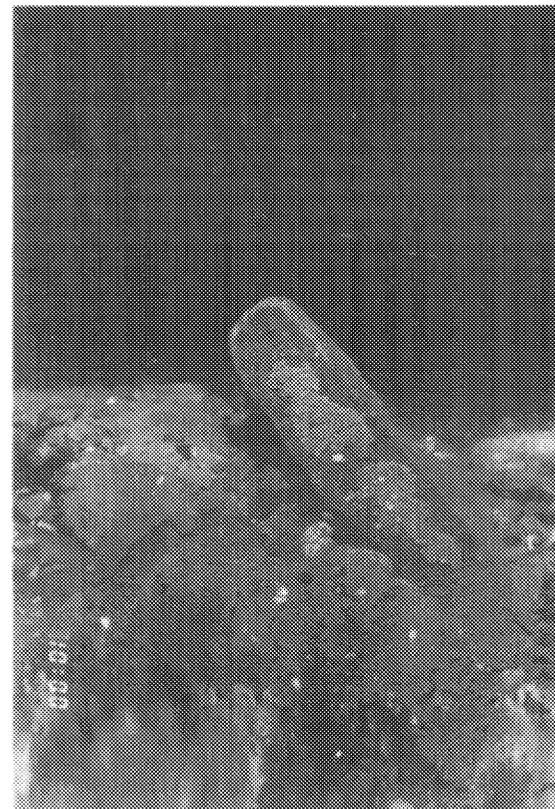
Figure 3-9. REMOTS® photographs from station CTR (A) and 100S (B) showing overconsolidated clay clasts and rubble at the surface and limited camera penetration. Scale = 0.5X.

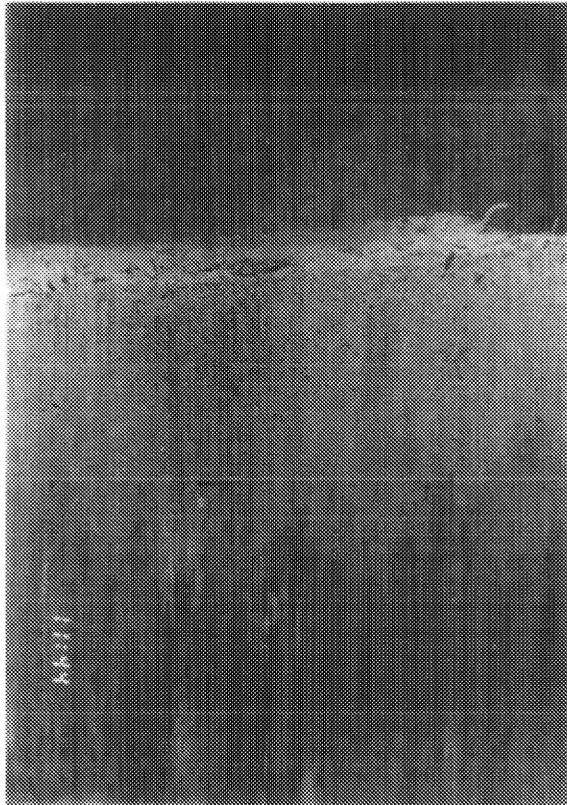
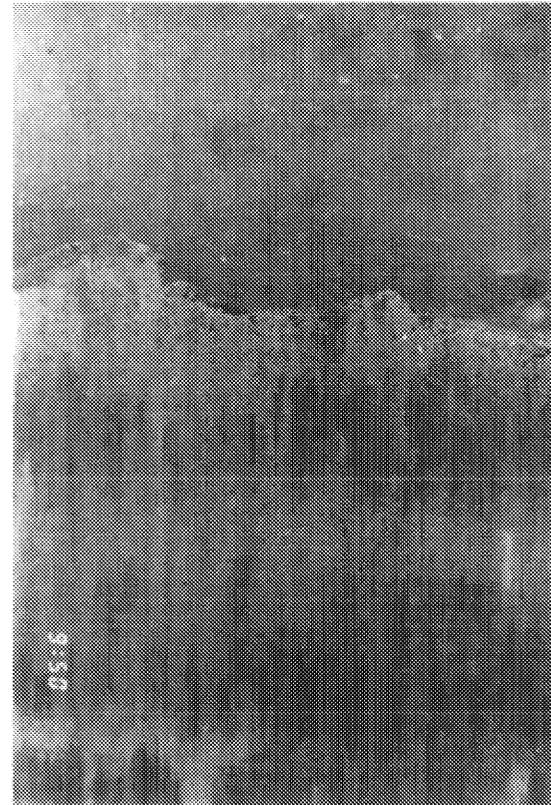
Figure 3-10. REMOTS® photographs from station 250SW (A) and 200N (B) showing less consolidation and deeper camera penetration with more stratification. Scale = 0.5X.

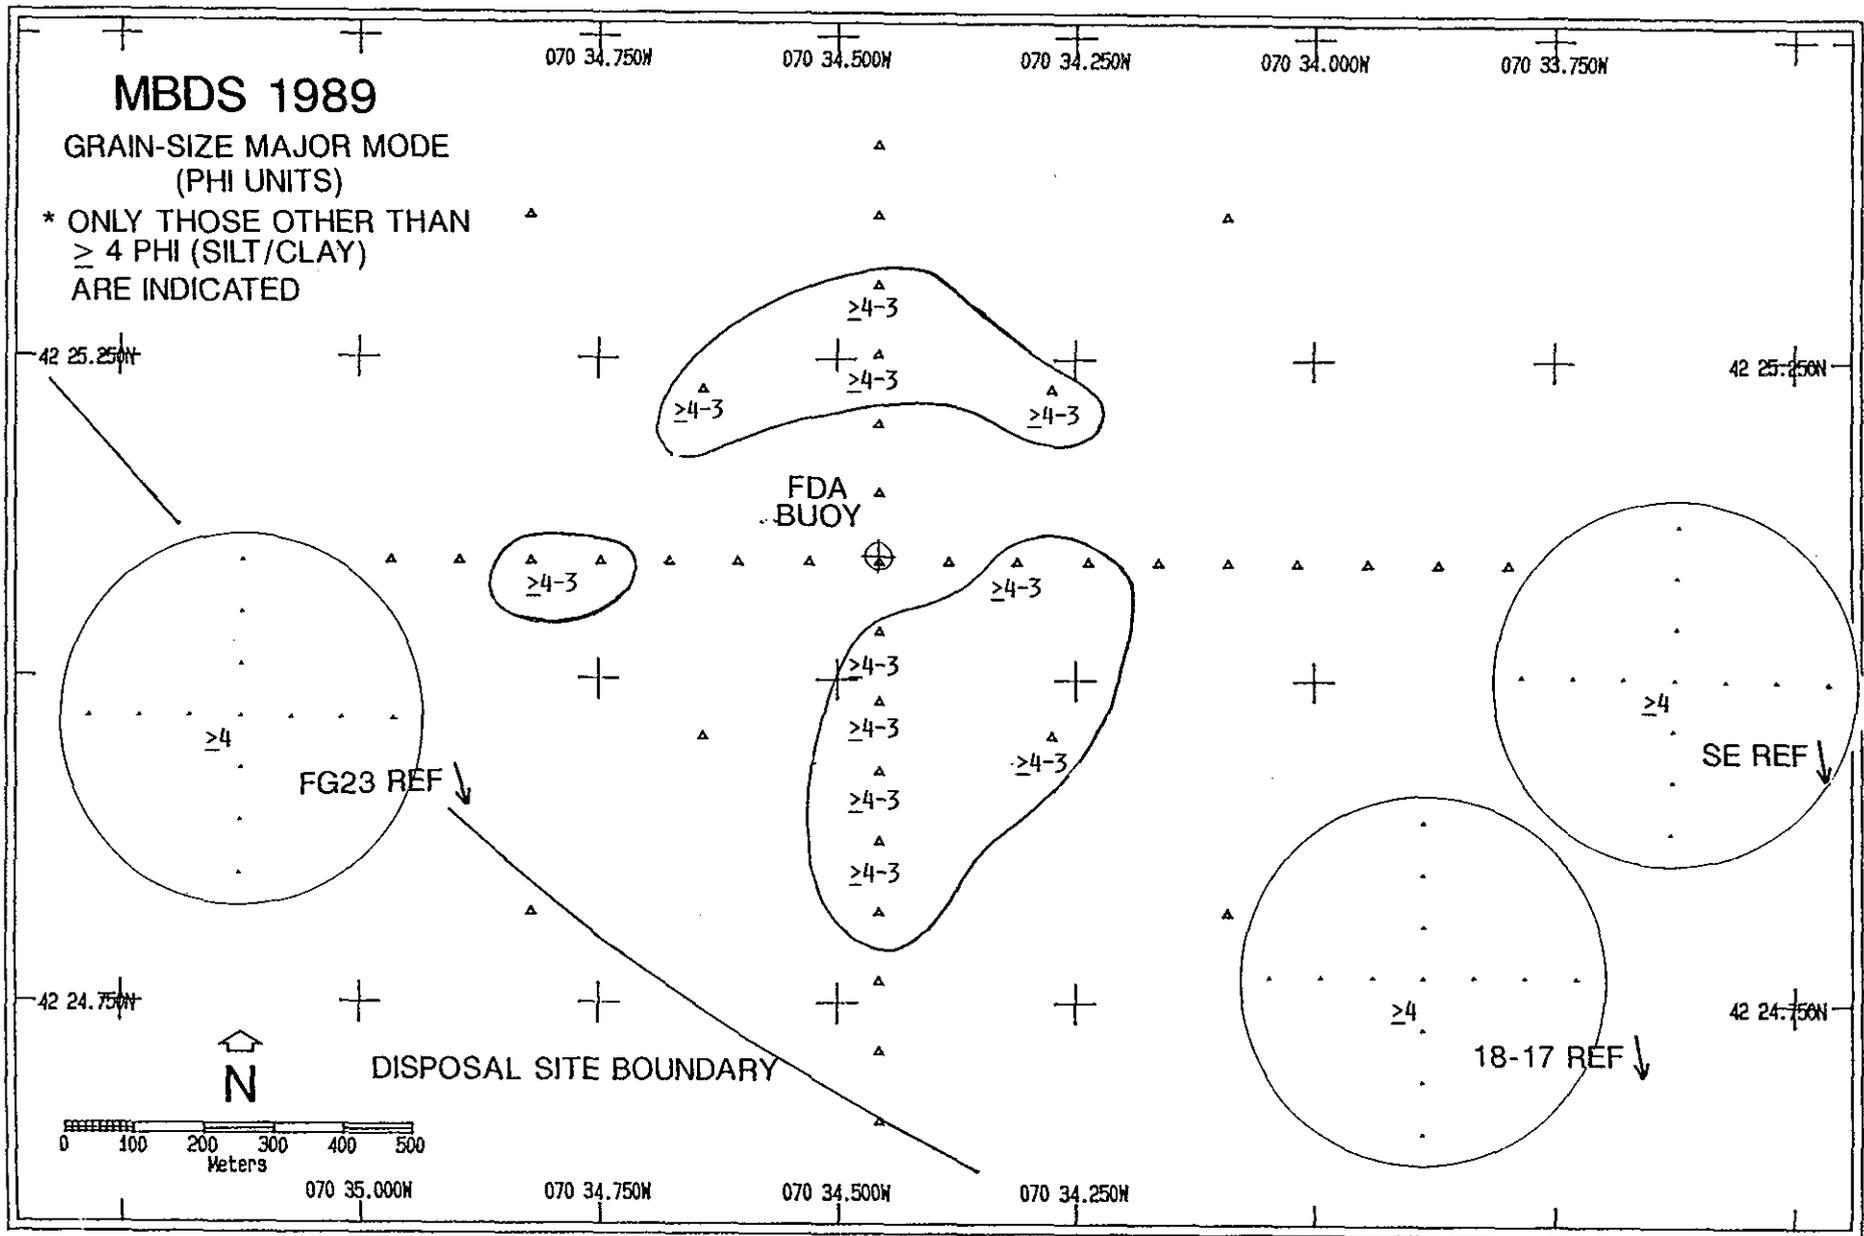
Figure 3-11.

Map of sediment grain size major mode (in phi units) at FADS, January 1989.

The majority of REMOTS® grid and reference stations consisted of silt-clay sediments (≥ 4 phi, Figure 3-11). Many of the stations having either relict or fresh dredged material exhibited grain size major modes from fine sand (4-3 phi) to silt-clay (≥ 4 phi). The majority of small-scale surface boundary roughness values at the stations around the "FDA" buoy where dredged material was present ranged between 0.6 to 1.8 cm, while the majority of values at the reference stations ranged from 0.0 to 0.6 cm (Figure 3-12). Boundary roughness values at the "FDA" buoy stations having dredged material were significantly greater than those at the reference stations (Mann-Whitney U-test, $p < 0.001$). Not surprisingly, this greater surface boundary roughness reflected the physical bottom disturbance related to disposal operations.

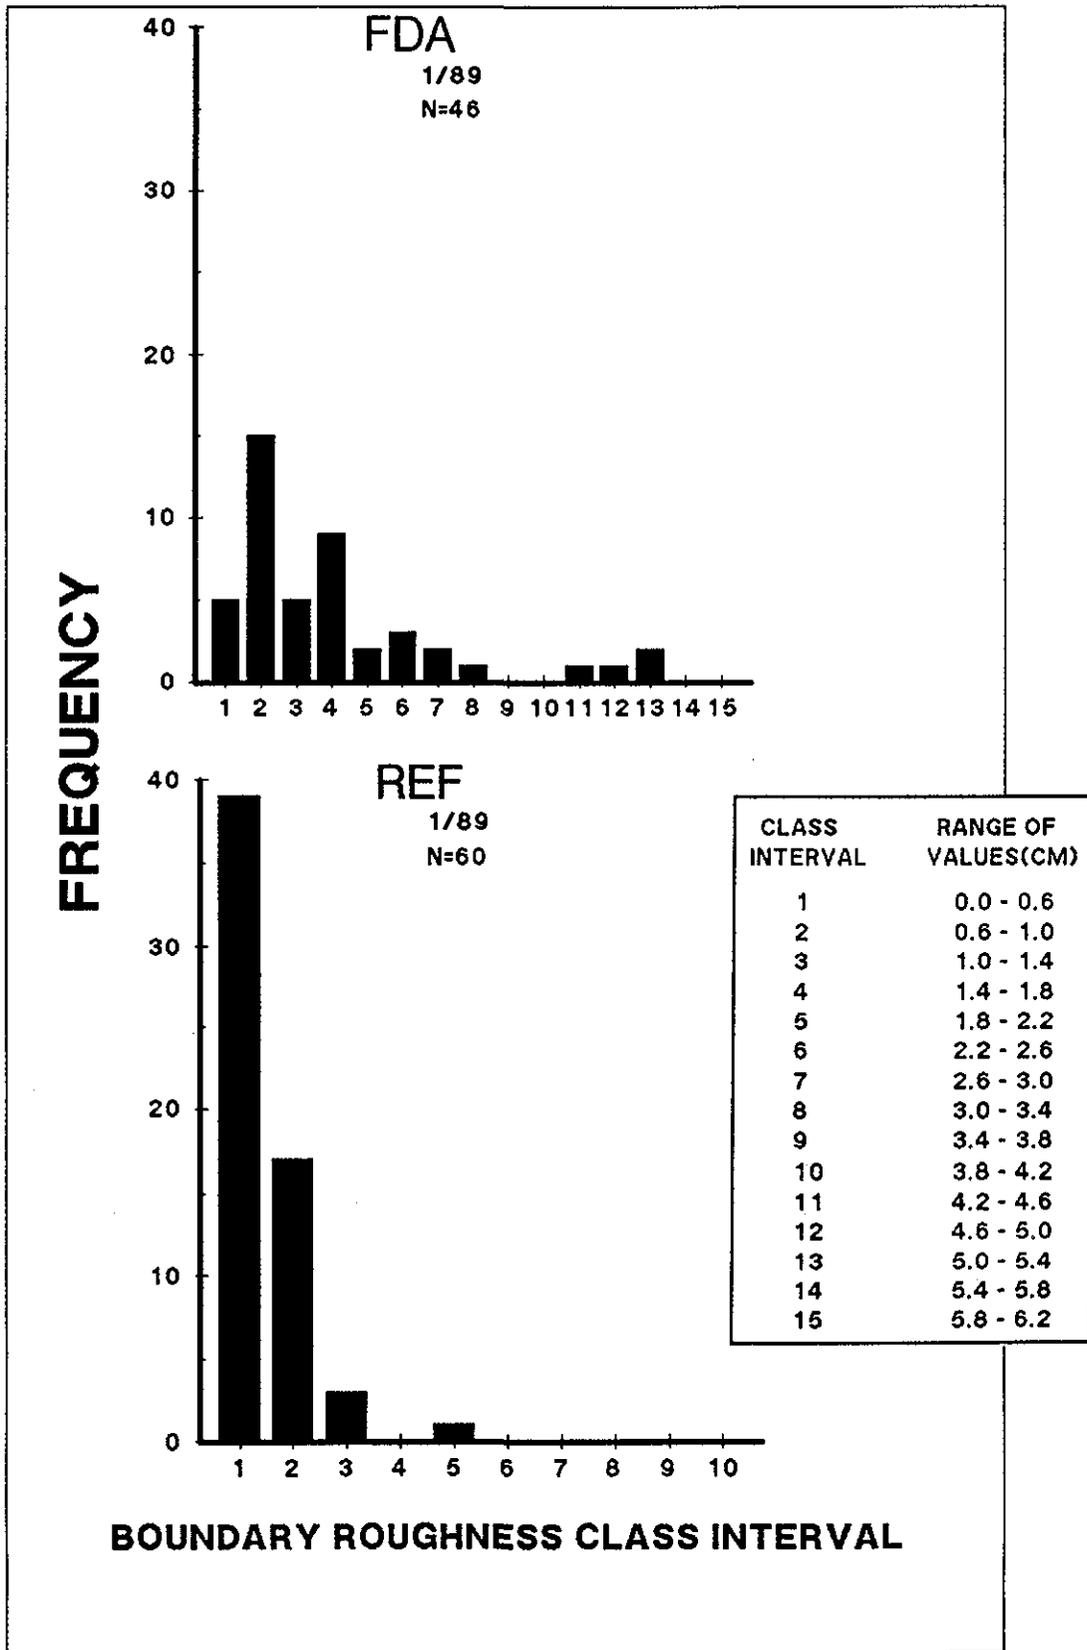
Figure 3-12. Frequency distribution of small-scale surface boundary roughness values for all replicates at the reference stations and at the FDA buoy stations where fresh dredged material was present, January 1989 (n = number of replicates).
