Monitoring Cruise at the Massachusetts Bay
Disposal Site
November 1988 - January 1989

Disposal Area Monitoring System DAMOS

Contribution 73
May 1990

**MONITORING CRUISE AT THE
MASSACHUSETTS BAY DISPOSAL SITE
NOVEMBER 1988 - JANUARY 1989**

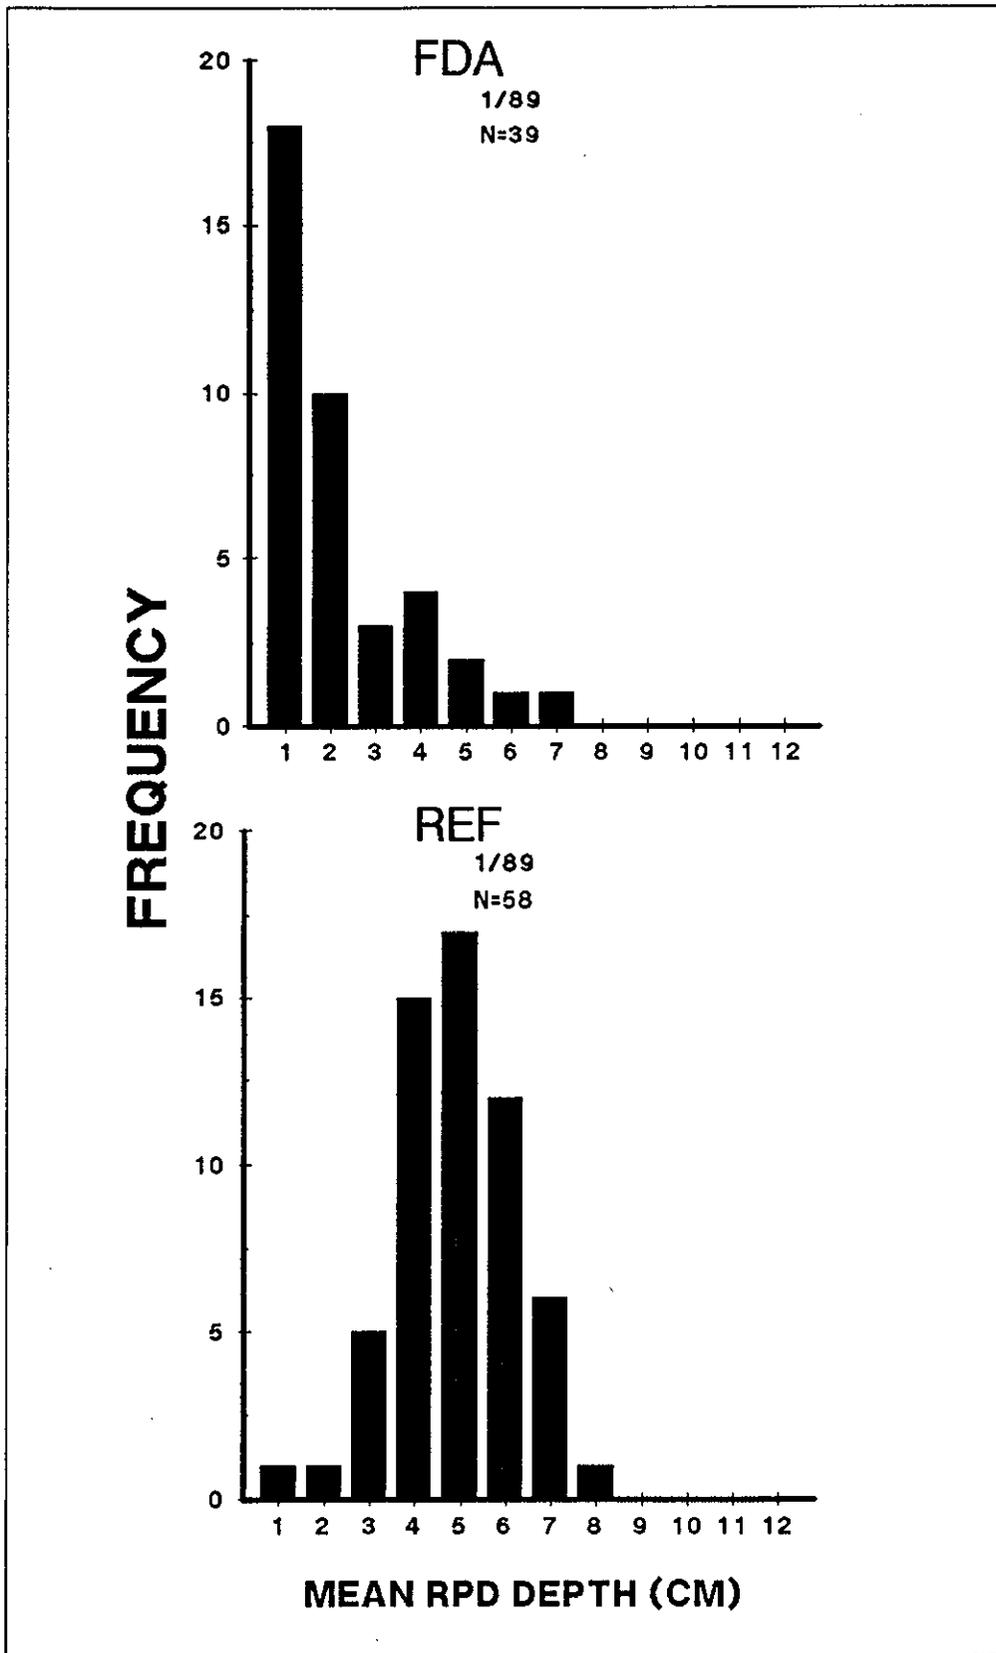
Figure 3-13. Frequency distributions of apparent RPD depths for all replicates at the reference stations and the FDA buoy stations where dredged material was present, January 1989.

The frequency distribution of mean apparent RPD depths for the "FDA" buoy stations where dredged material was present was right-skewed with a major mode at the 1.0 cm class interval, while the distribution of RPD depths for the reference stations showed a normal distribution with a major mode at the 5.0 cm class interval (Figure 3-13). The reference station RPD values were

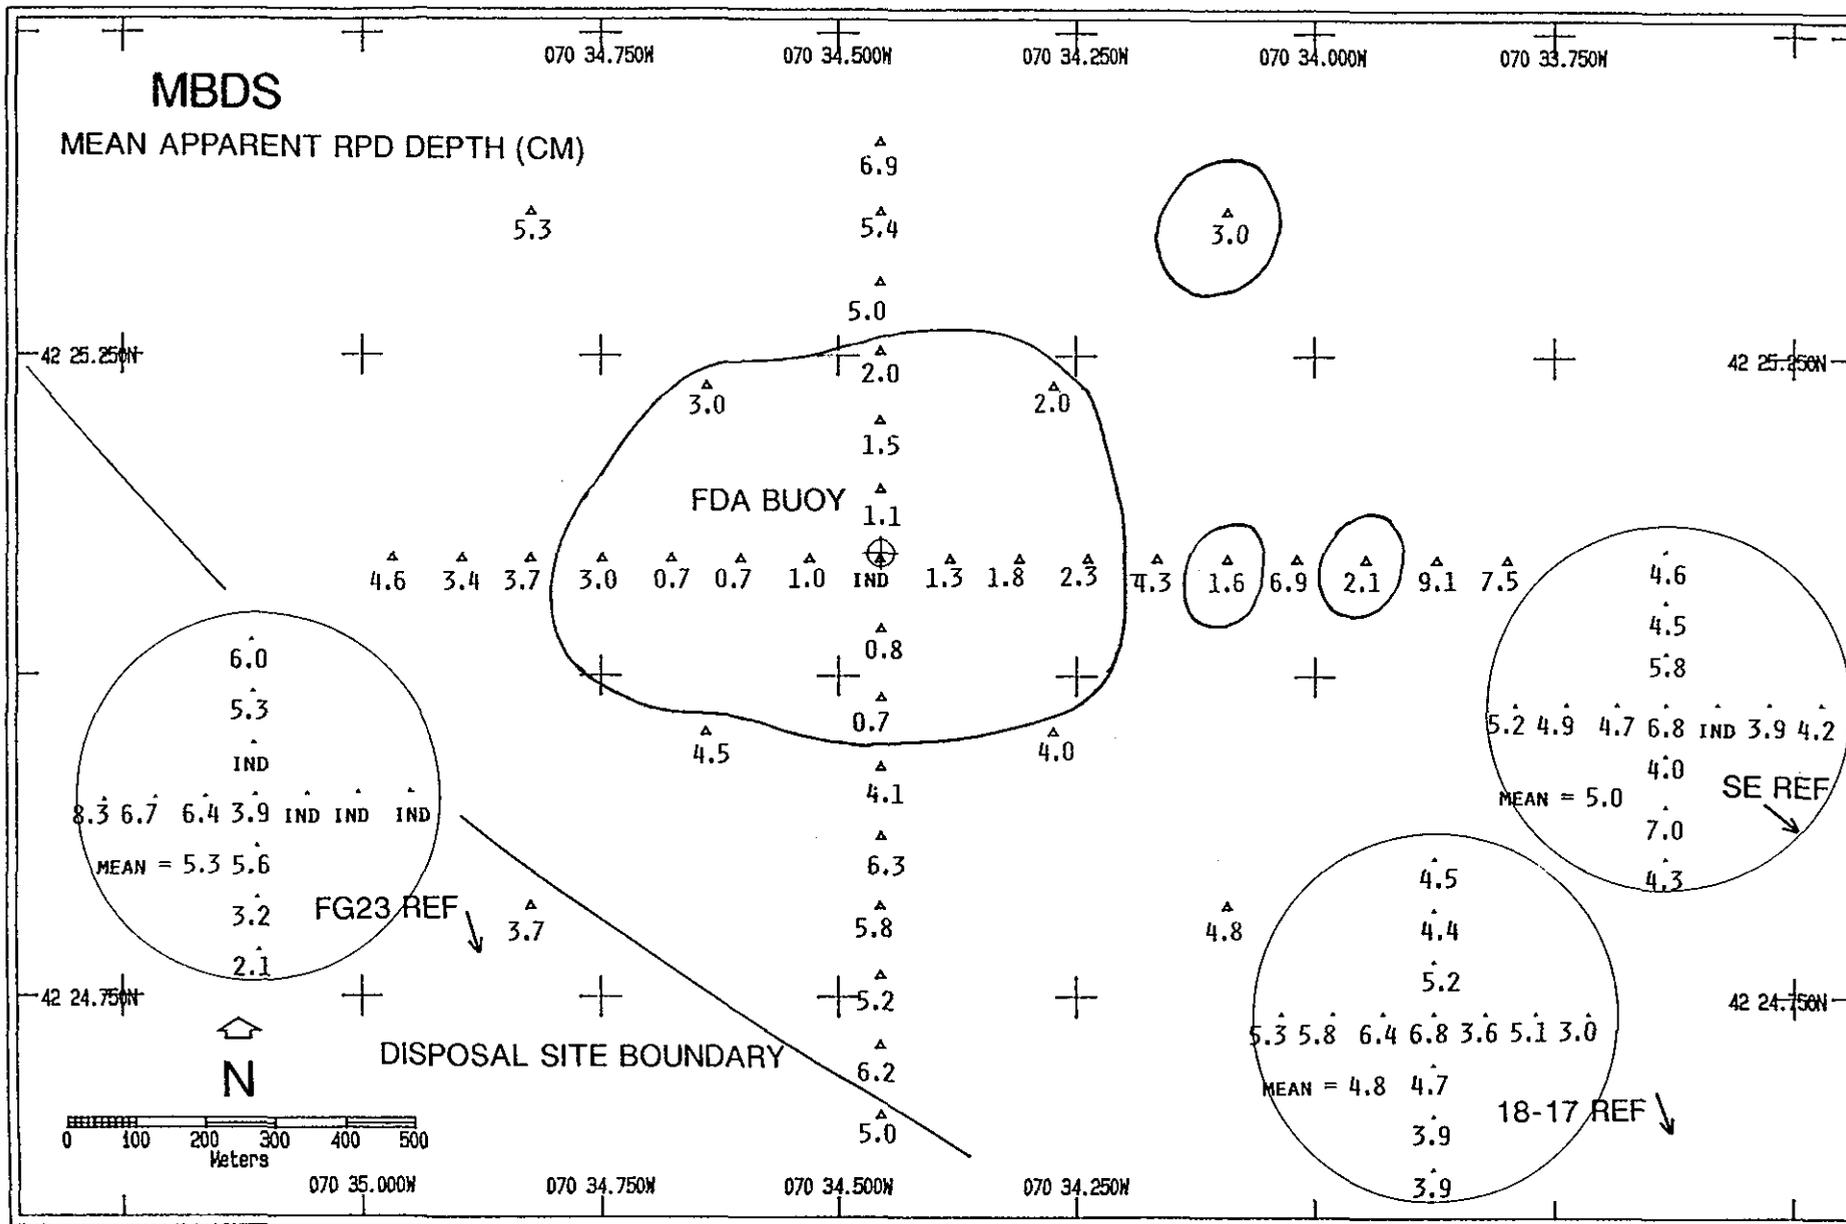
Figure 3-14. The mapped distribution of apparent RPD depths (cm), averaged by station, at the FDA buoy in January 1989. The contours delimit stations having mean apparent RPD depths ≤ 3 cm.

significantly deeper (Mann-Whitney U-test, $p < 0.001$). RPD depths less than 2.0 cm occurred at stations immediately around the buoy, generally corresponding to that area of the disposal site having recently-deposited dredged material (Figure 3-14).

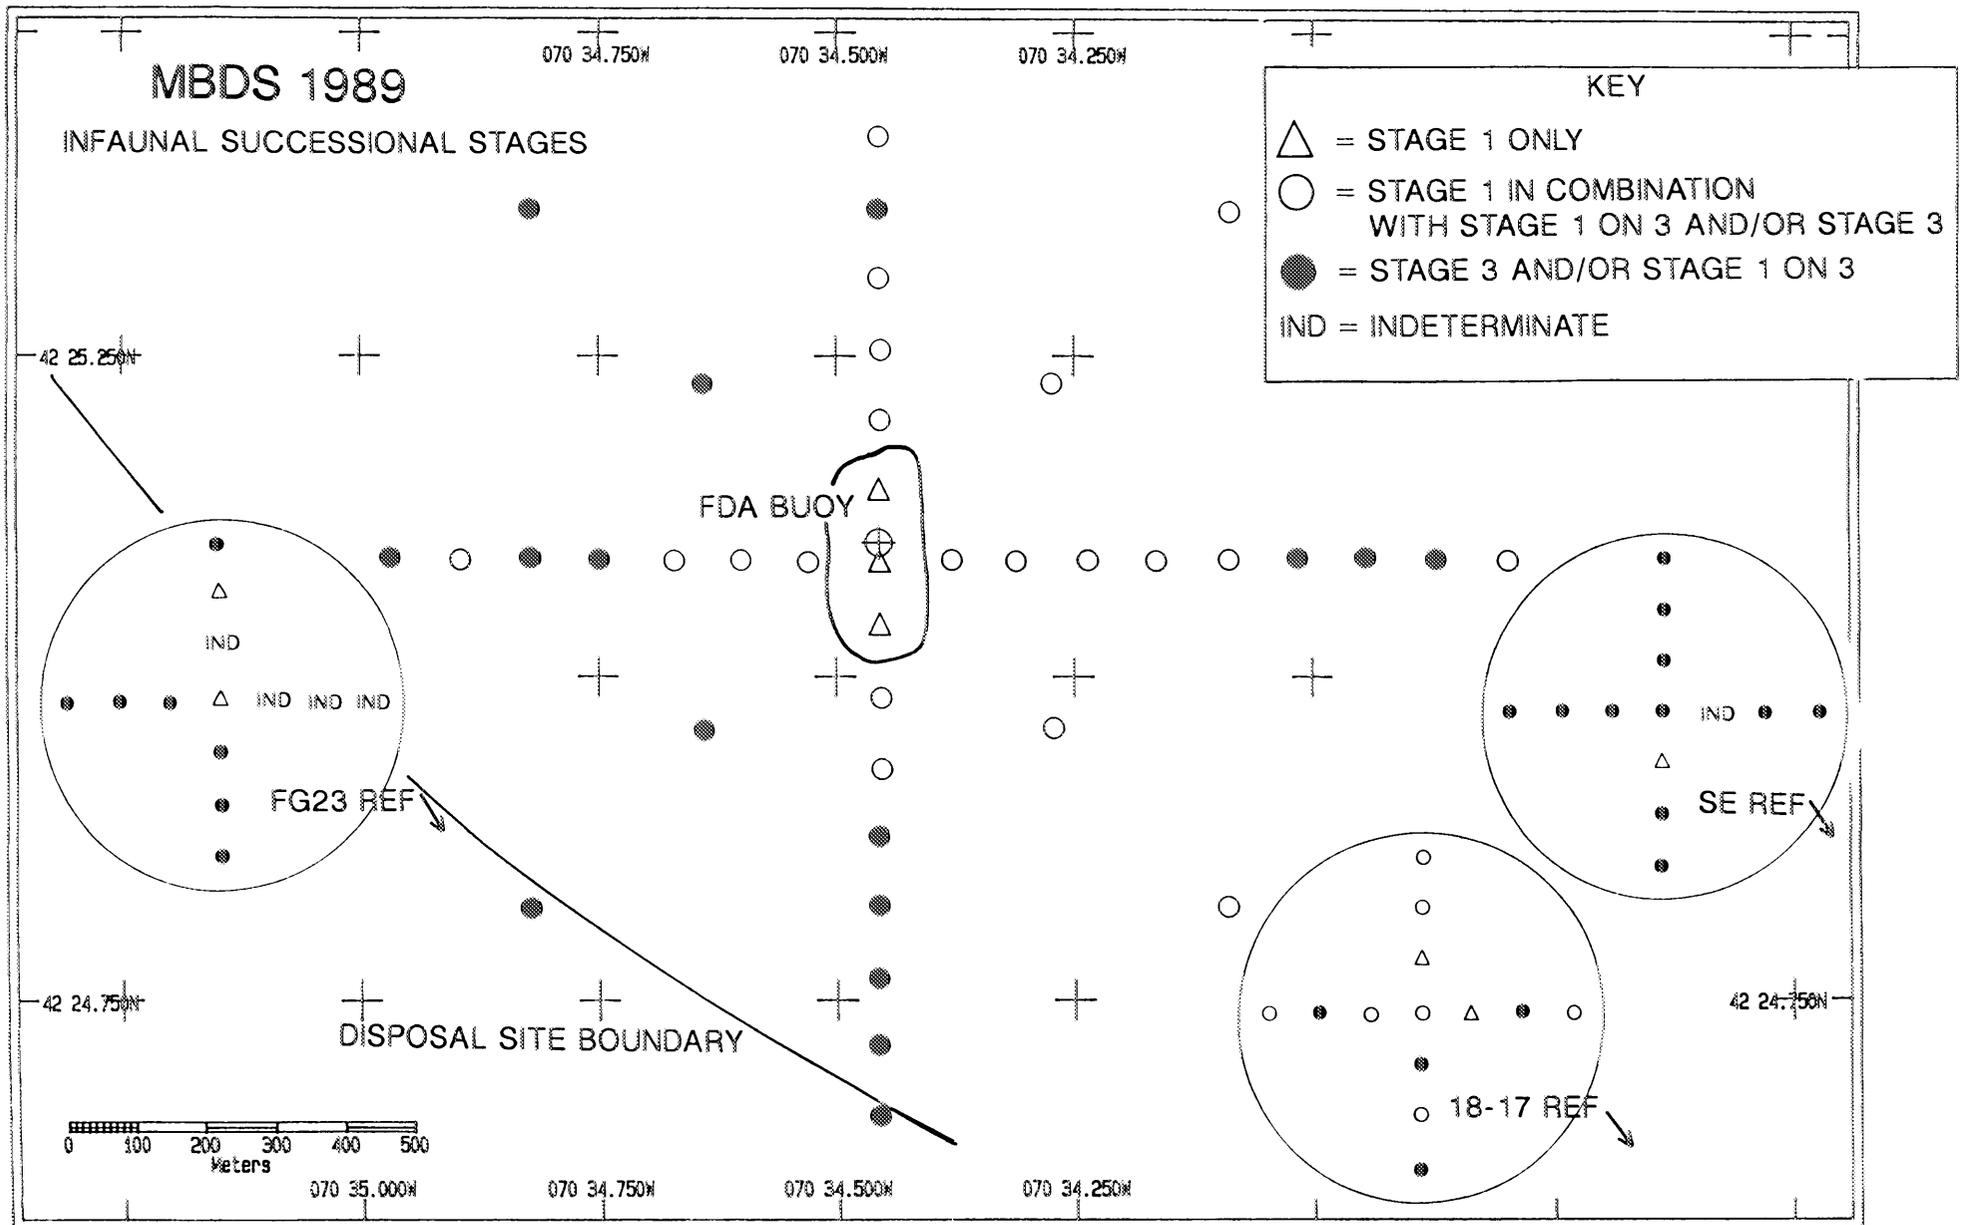
Figure 3-15. The mapped distribution of infaunal successional stages at the FDA buoy, January 1989. The contour delimits the disposal site stations where only Stage I seres were seen in the replicate REMOTS® photos.

Only three stations located at or near the point of disposal had evidence of only Stage I organisms (100N, CTR, 100S); Stage III taxa were evident at all but five of the reference stations (Figure 3-15). At the remainder of the disposal site stations, there was evidence of Stage III taxa (i.e., head-down deposit-feeding infauna) in at least one of the replicate photographs (Figure 3-16). In January 1987, 66% of the replicate photographs ($N = 92$) at the "FDA" buoy REMOTS® stations showed evidence of Stage III taxa, compared to 75% ($N = 108$) in the present survey. These proportions of Stage III taxa present in 1987 and 1989 were not found to be significantly different (Chi-squared Test, $p > 0.1$). However, at the reference stations, 68% of the 1989 replicates ($N = 57$) showed evidence of Stage III taxa, compared to 94% ($N = 32$) in January 1987. These proportions of Stage III taxa present were found to be significantly different (Chi-squared Test, $p < 0.01$).

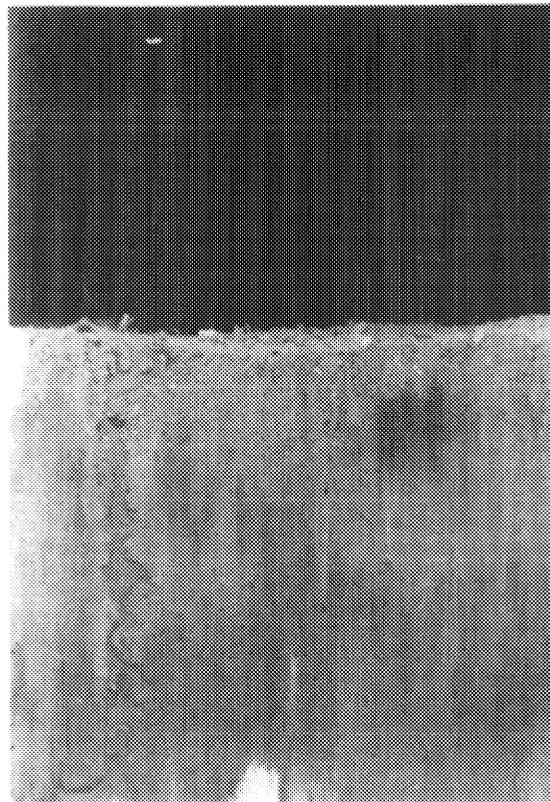
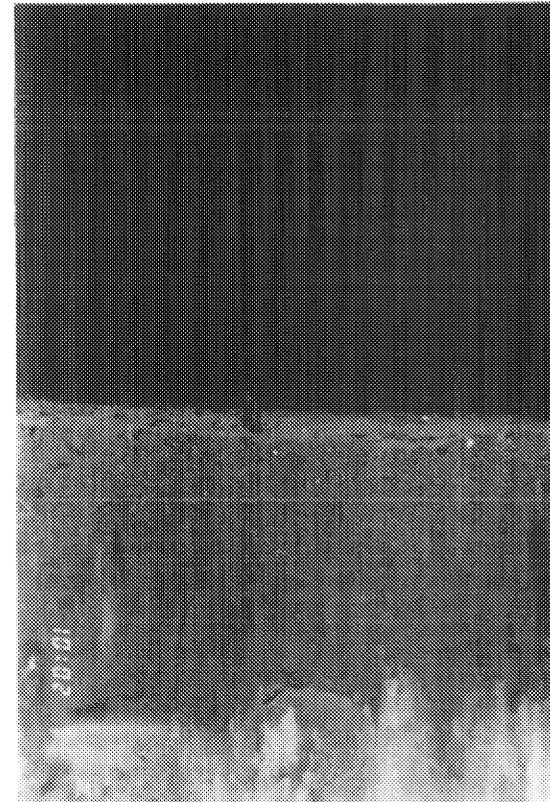
Figure 3-16. A large feeding void at depth indicates the presence of Stage III organisms at station 500N (A), while the REMOTS® photographs from station 300E (B) and 200S (C) show Stage I on III organisms at the disposal site. Scale = 0.5X.

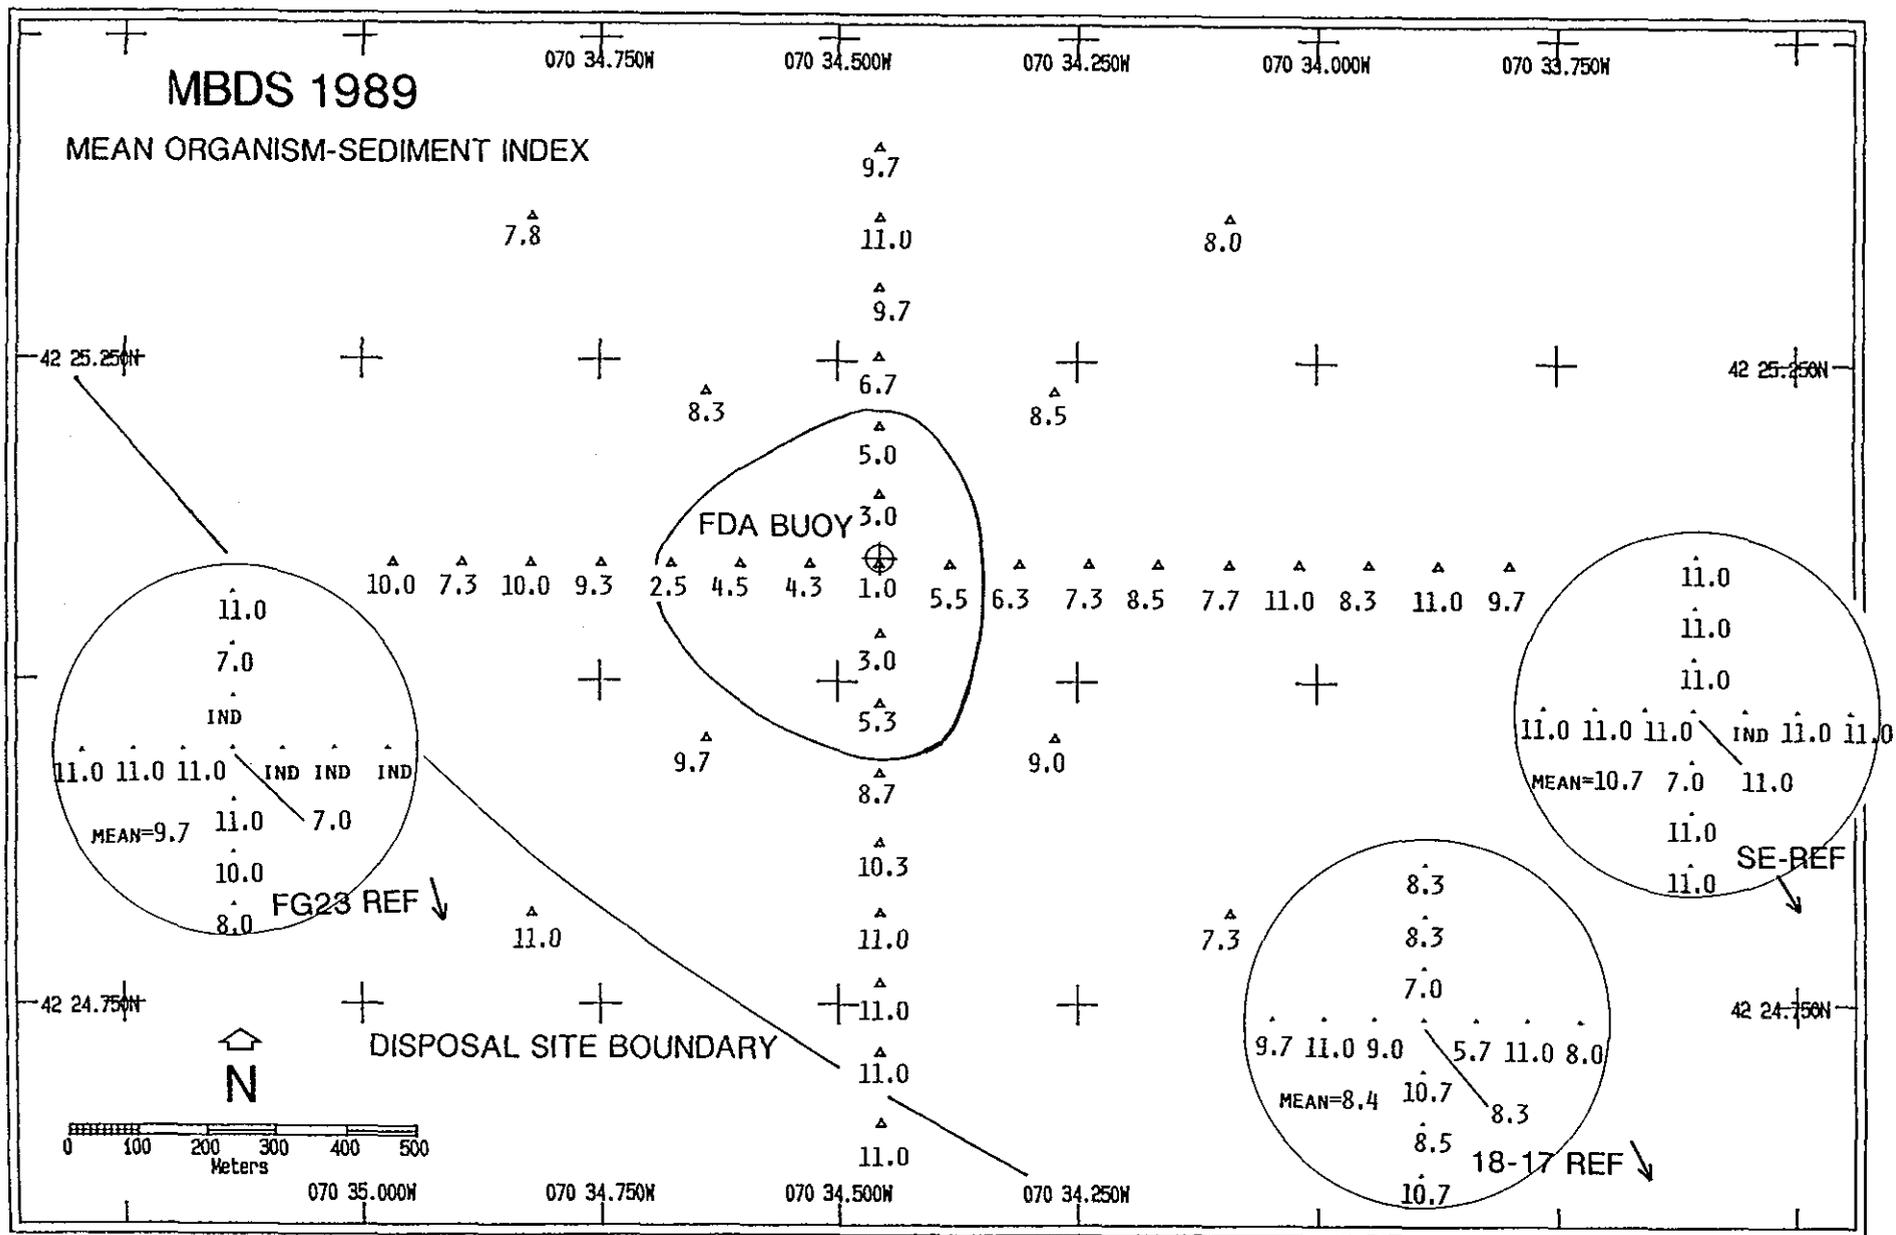
Figure 3-17. The distribution of Organism-Sediment Indices, averaged by station, at the FDA buoy in January 1989. The contour delimits stations having mean OSI values $\leq +6$.

The pooled reference station OSI values were significantly higher than those at the "FDA" buoy stations where dredged material was present (Mann-Whitney U-test, $p < 0.001$). The mapped distribution of OSI values confirms this statistic: OSI values less than or equal to +6 occurred at stations in the immediate vicinity of the disposal buoy (Figure 3-17). Frequency distributions also showed higher values at the reference stations (Figure 3-18). However, the OSI values for all stations at the disposal site and for the reference stations had not changed significantly since the January 1987 REMOTS® survey (Mann-Whitney U-test, $p = .0527$ for the disposal site and $p = .0608$ for the reference stations).

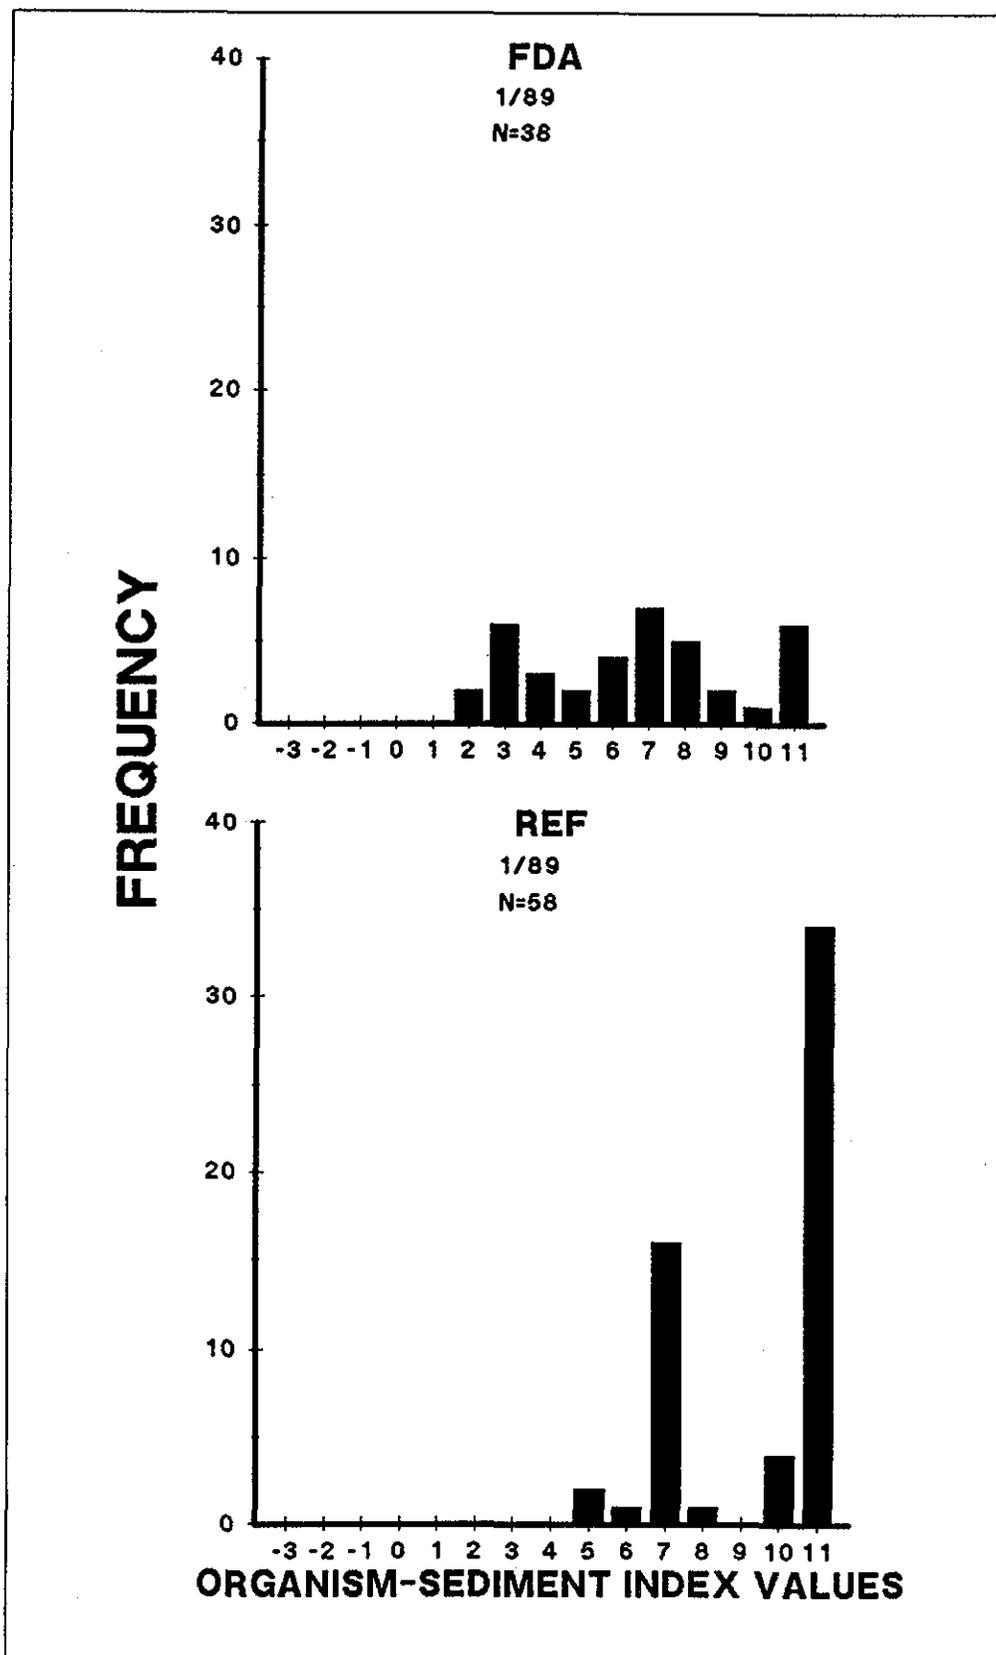
Figure 3-18. Frequency distributions of Organism-Sediment Indices for all replicates at the reference stations and at the disposal site stations where dredged material was present, January 1989.

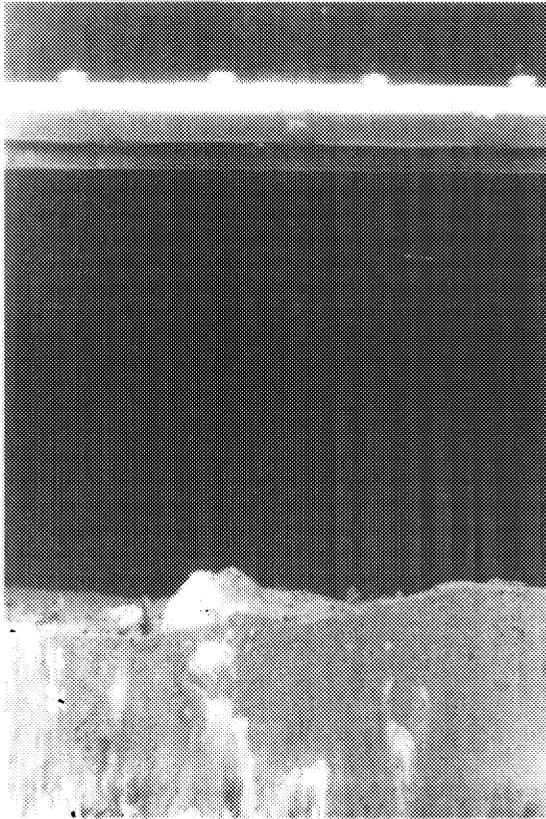
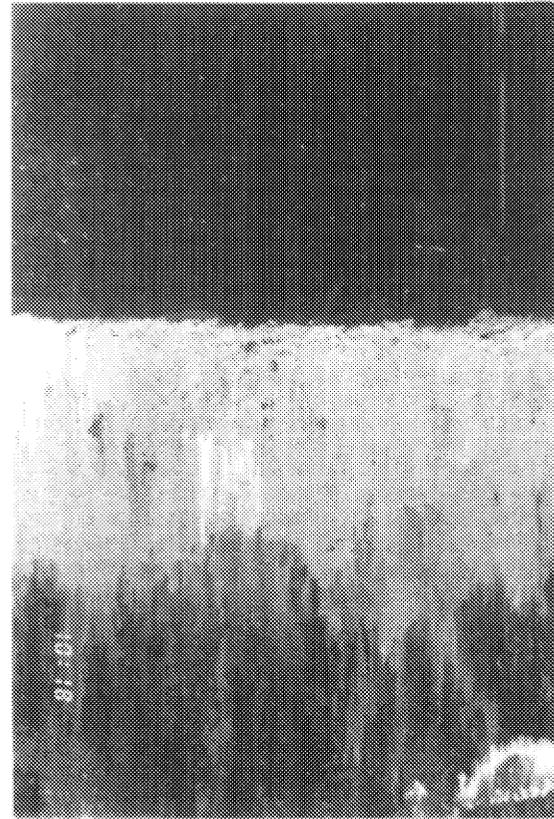
Figure 3-19. REMOTS® photographs from station 200E (A) and 100E (B) showing the presence of dredged material with clay clasts evident at the surface and at depth. It is difficult to estimate how recently this light-colored, highly-consolidated material was deposited. Scale = 0.5X.

It was estimated that 6,700 m³ of dredged material were deposited at the "A" buoy since the January 1987 survey at MBDS. In most of the January 1989 REMOTS® photographs, it was difficult to determine whether the observed dredged material was fresh or relict (Figure 3-19). The photographs from eight of the stations showed no evidence of dredged material. Given the small volume of disposed sediment, most of the dredged material evident at the remainder of the stations was assumed to be relict.

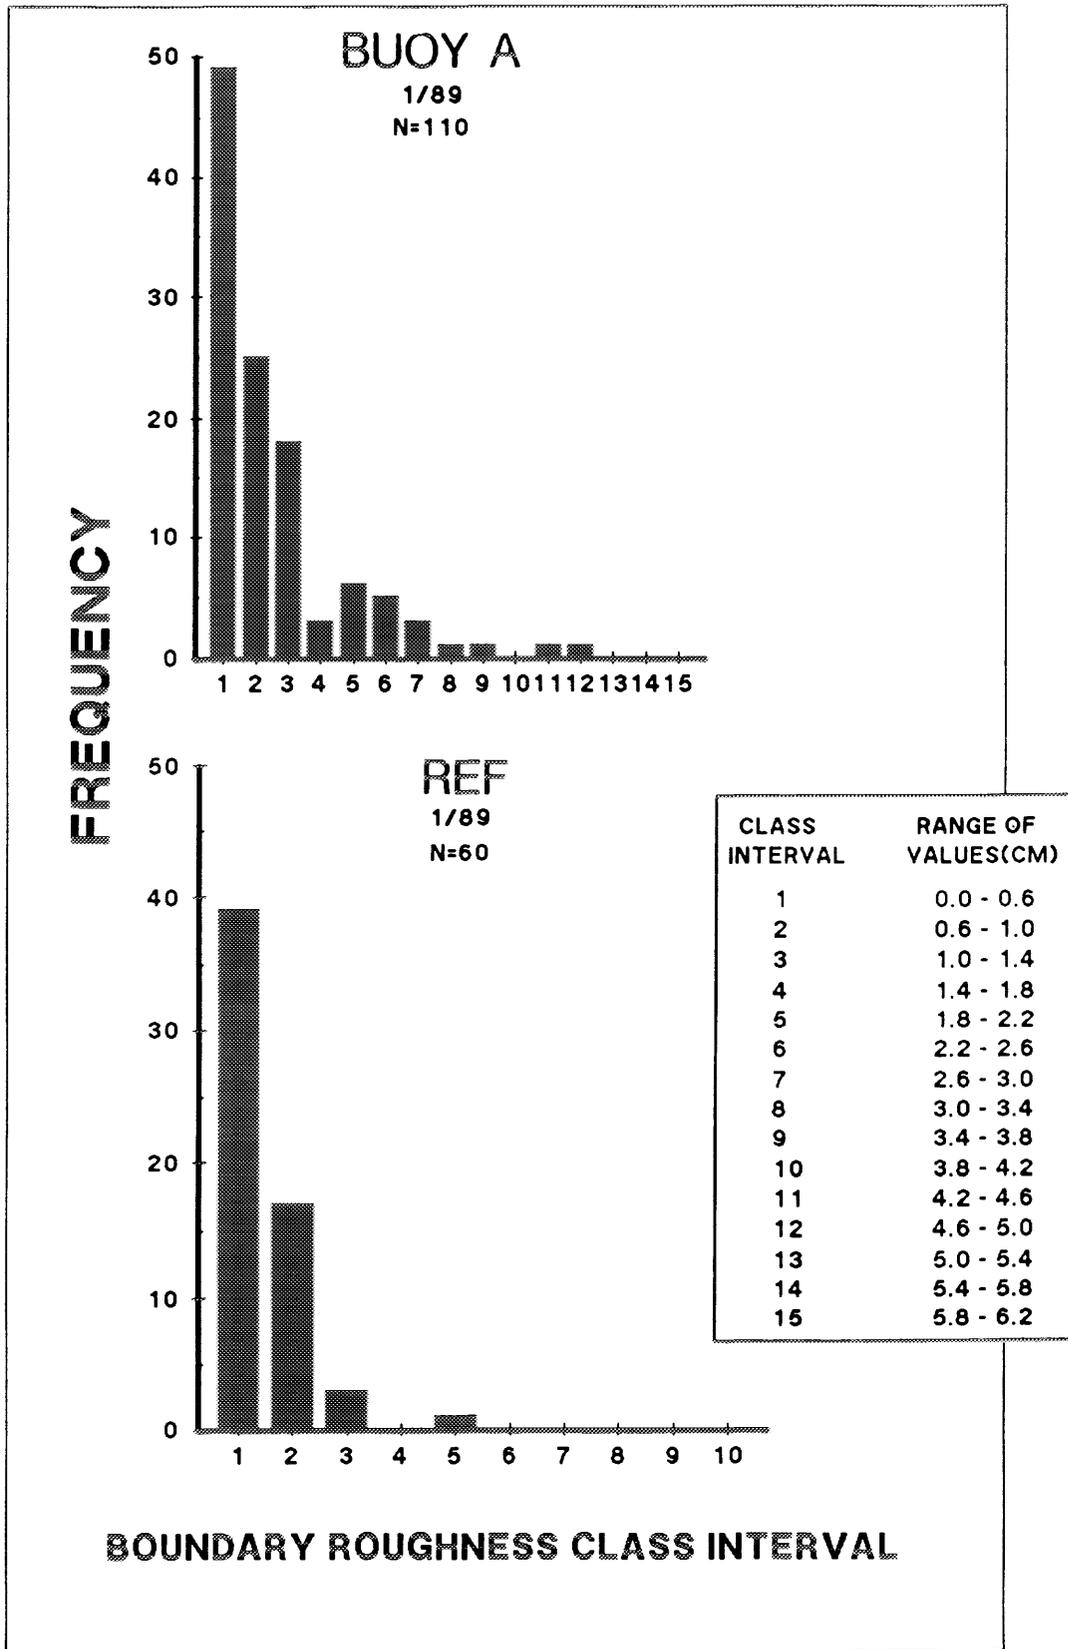
Figure 3-20. Frequency distributions of small-scale surface boundary roughness values for all replicates at both the "A" buoy and reference site stations at MBDS, January 1989.

All of the REMOTS® stations consisted of silt-clay sediments (≥ 4 phi). Boundary roughness values at the "A" buoy stations were significantly greater than those at the reference stations (Mann-Whitney U-test, $p < 0.001$); more values at the "A"

buoy stations fell within the higher class intervals (Figure 3-20).

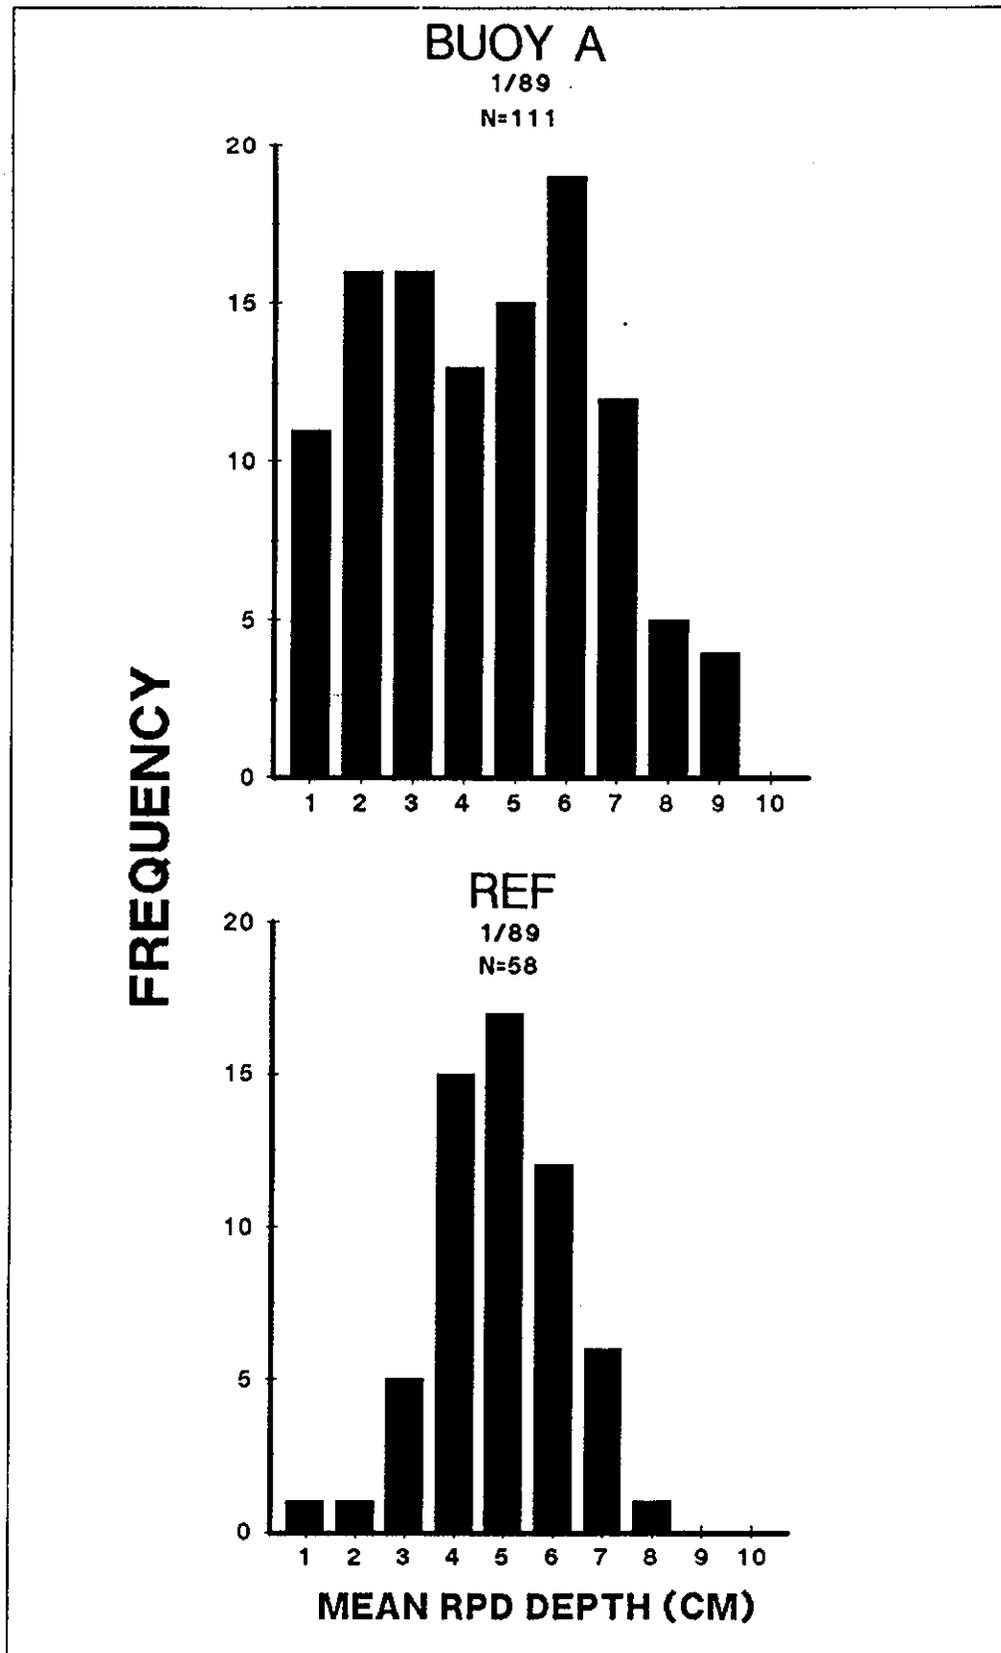
Figure 3-21. Frequency distribution of apparent RPD depths for all replicates at both the "A" buoy and reference site stations at MBDS, January 1989.

Mean apparent RPD depths at the "A" buoy stations were not significantly different from the reference stations (Mann-Whitney U-test, $p = 0.162$; Figure 3-21). Mean RPD depths less than 3.0 cm occurred at stations close to the buoy, corresponding to that area which most likely was affected by disposal operations during the past year (Figure 3-22).

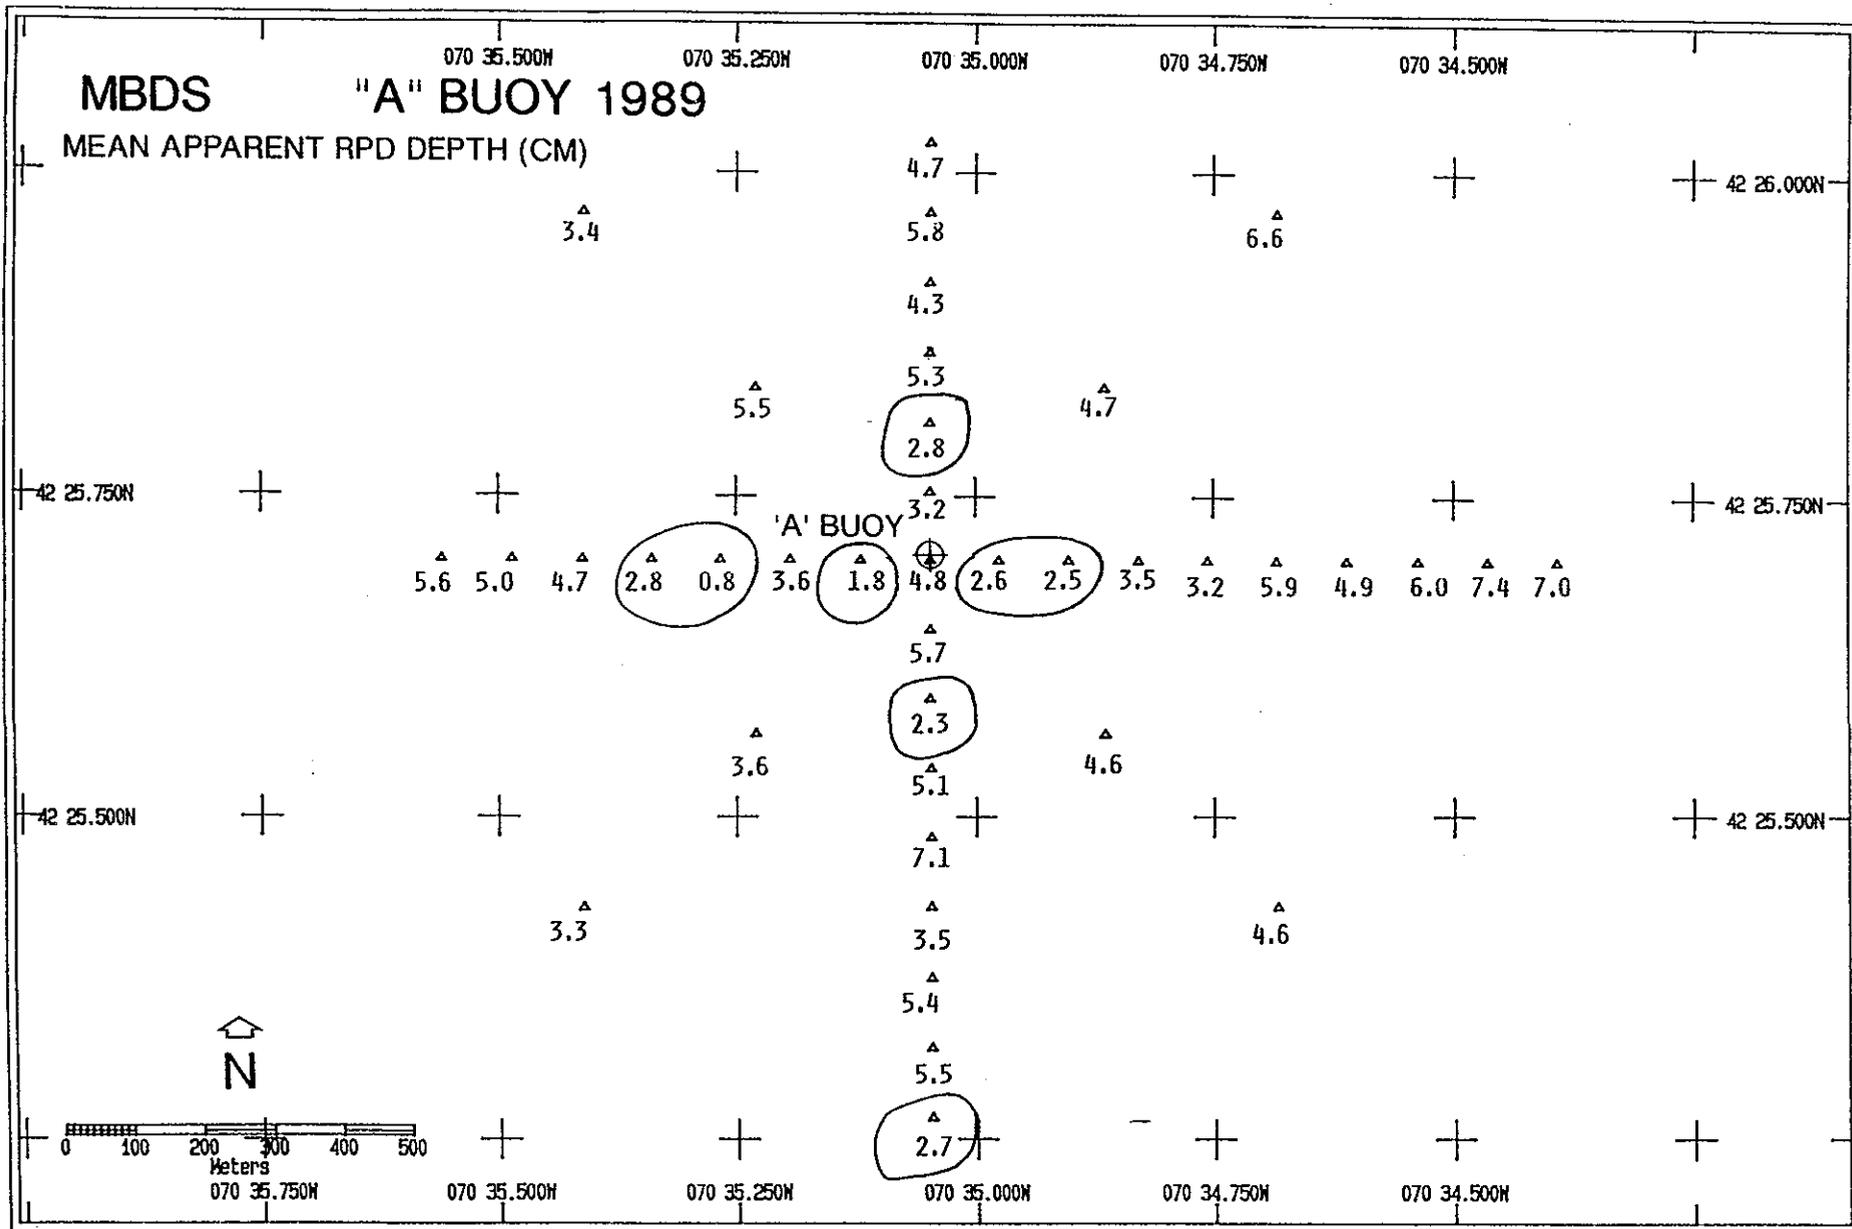
Figure 3-22. The mapped distribution of apparent RPD depths (cm), averaged by station, at the "A" buoy at MBDS, January 1989. The contours delimit stations having mean apparent RPD depths ≤ 3 cm.

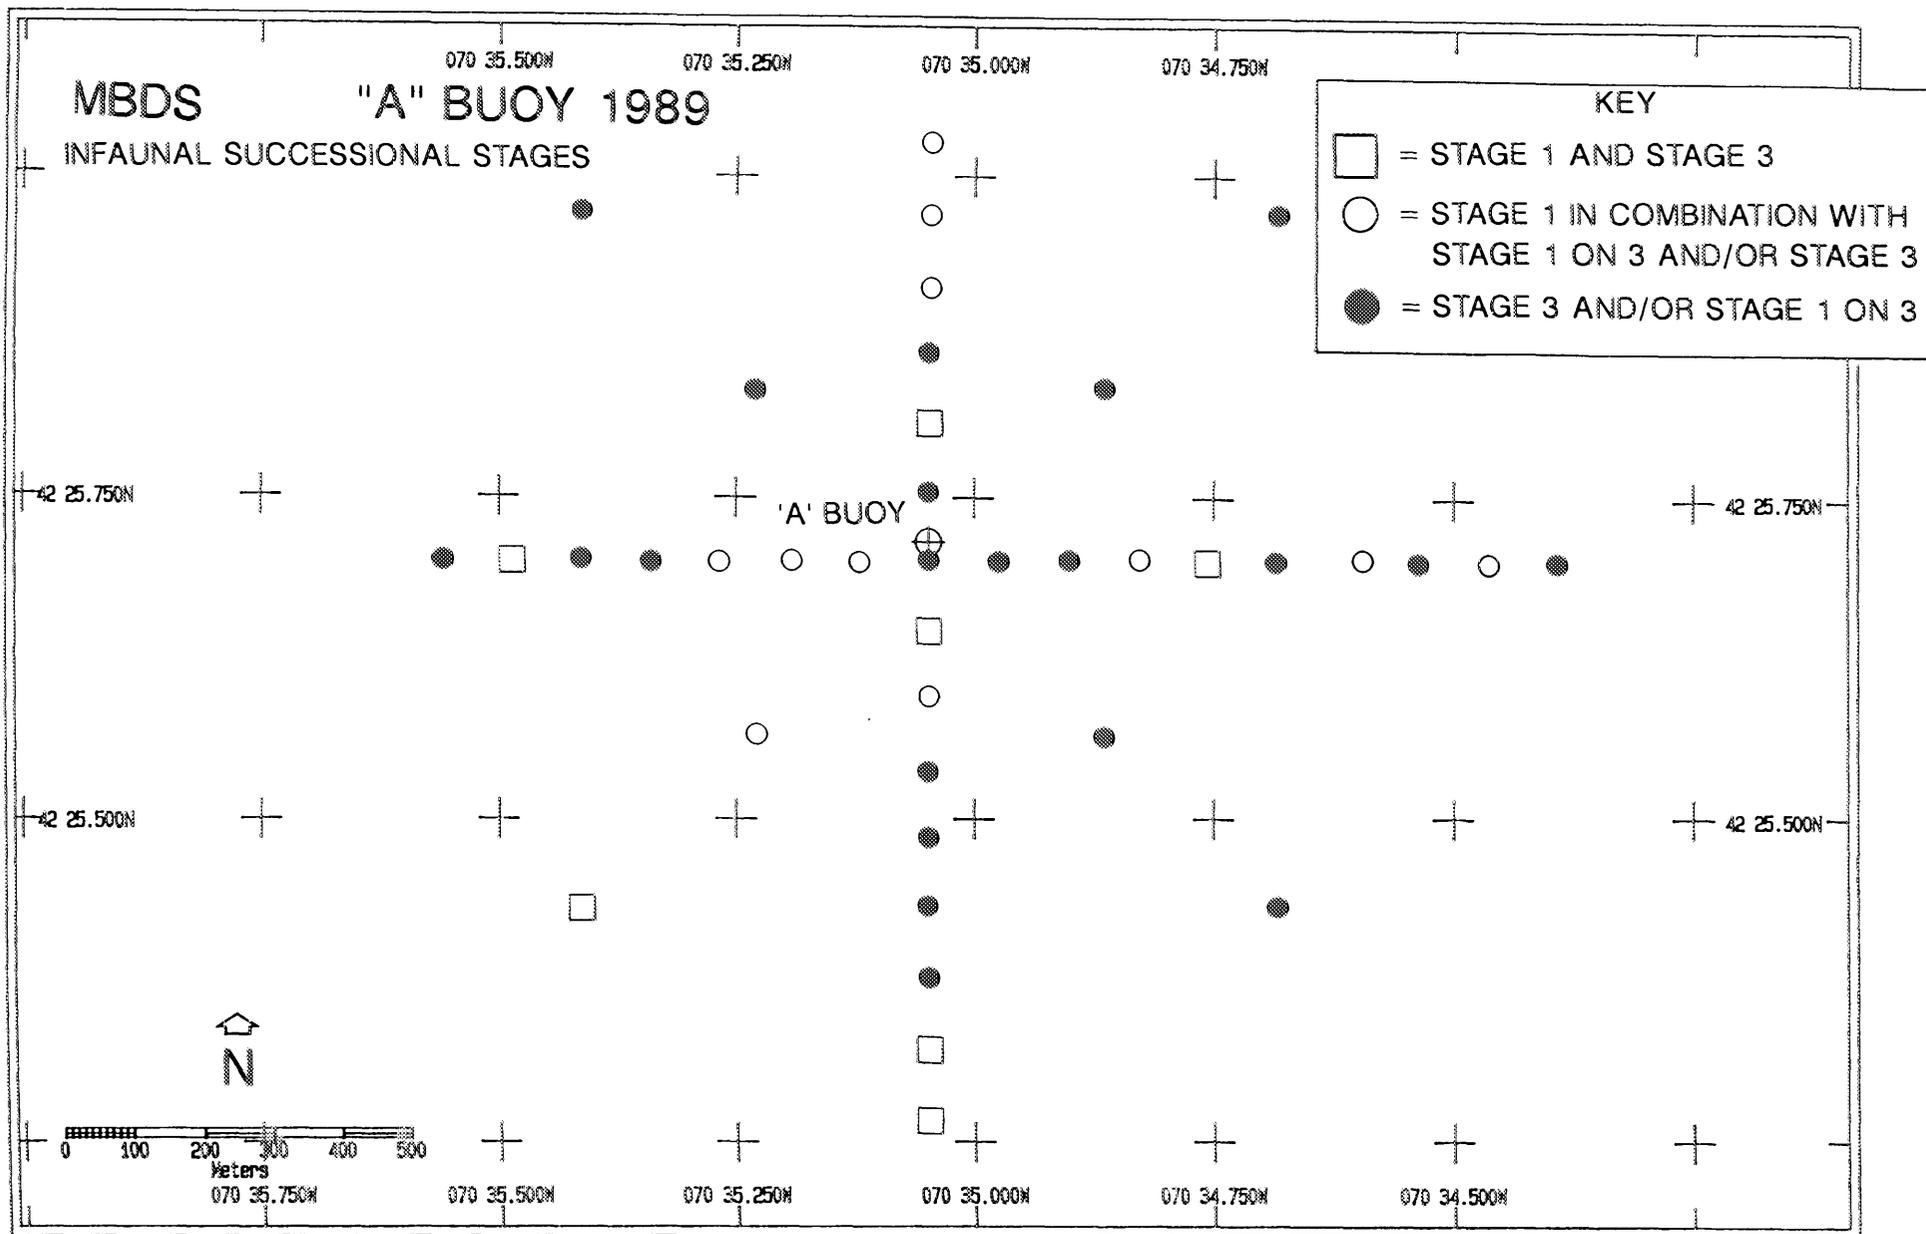
Figure 3-23. The mapped distribution of infaunal successional stages at the "A" buoy at MBDS, January 1989.

None of the stations within the "A" buoy grid had only Stage I taxa present; all showed evidence of Stage III taxa in at least one of the replicate photographs (Figures 3-23). The Stage III taxa included head-down deposit-feeding infauna, as evidenced by feeding voids at depth, as well as relatively large, tube-dwelling polychaetes visible at the sediment surface (Figure 3-24). At the "A" buoy stations, 82% of the replicates showed evidence of Stage III taxa, compared to 68% at the reference stations.

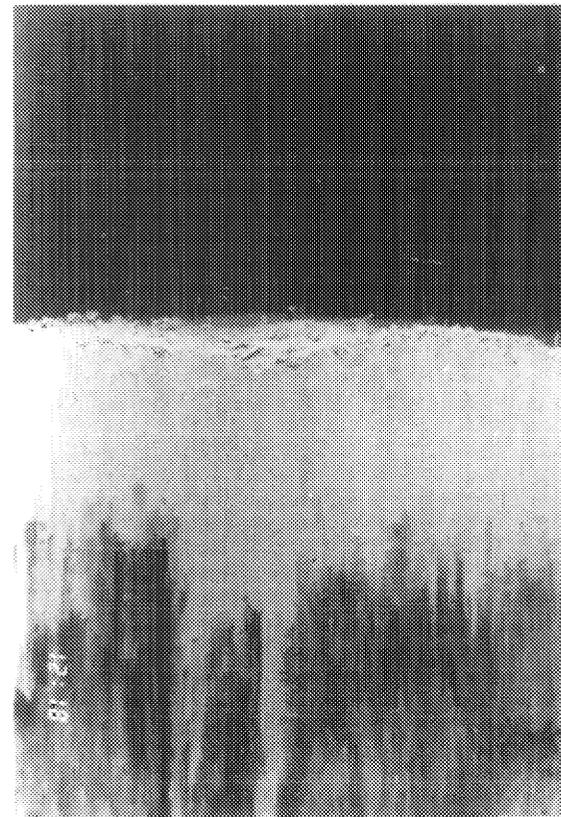
Figure 3-24. REMOTS® photographs from the vicinity of the "A" buoy showing dense Stage III tubes at the surface (photo A from station 800S) and surface tubes along with a feeding void at depth (lower right hand corner of photo B from station 250NW). Scale = 0.5X.
