Monitoring Cruise at the Massachusetts Bay
Disposal Site
November 1988 - January 1989

Disposal Area Monitoring System DAMOS

Contribution 73
May 1990

**MONITORING CRUISE AT THE
MASSACHUSETTS BAY DISPOSAL SITE
NOVEMBER 1988 - JANUARY 1989**

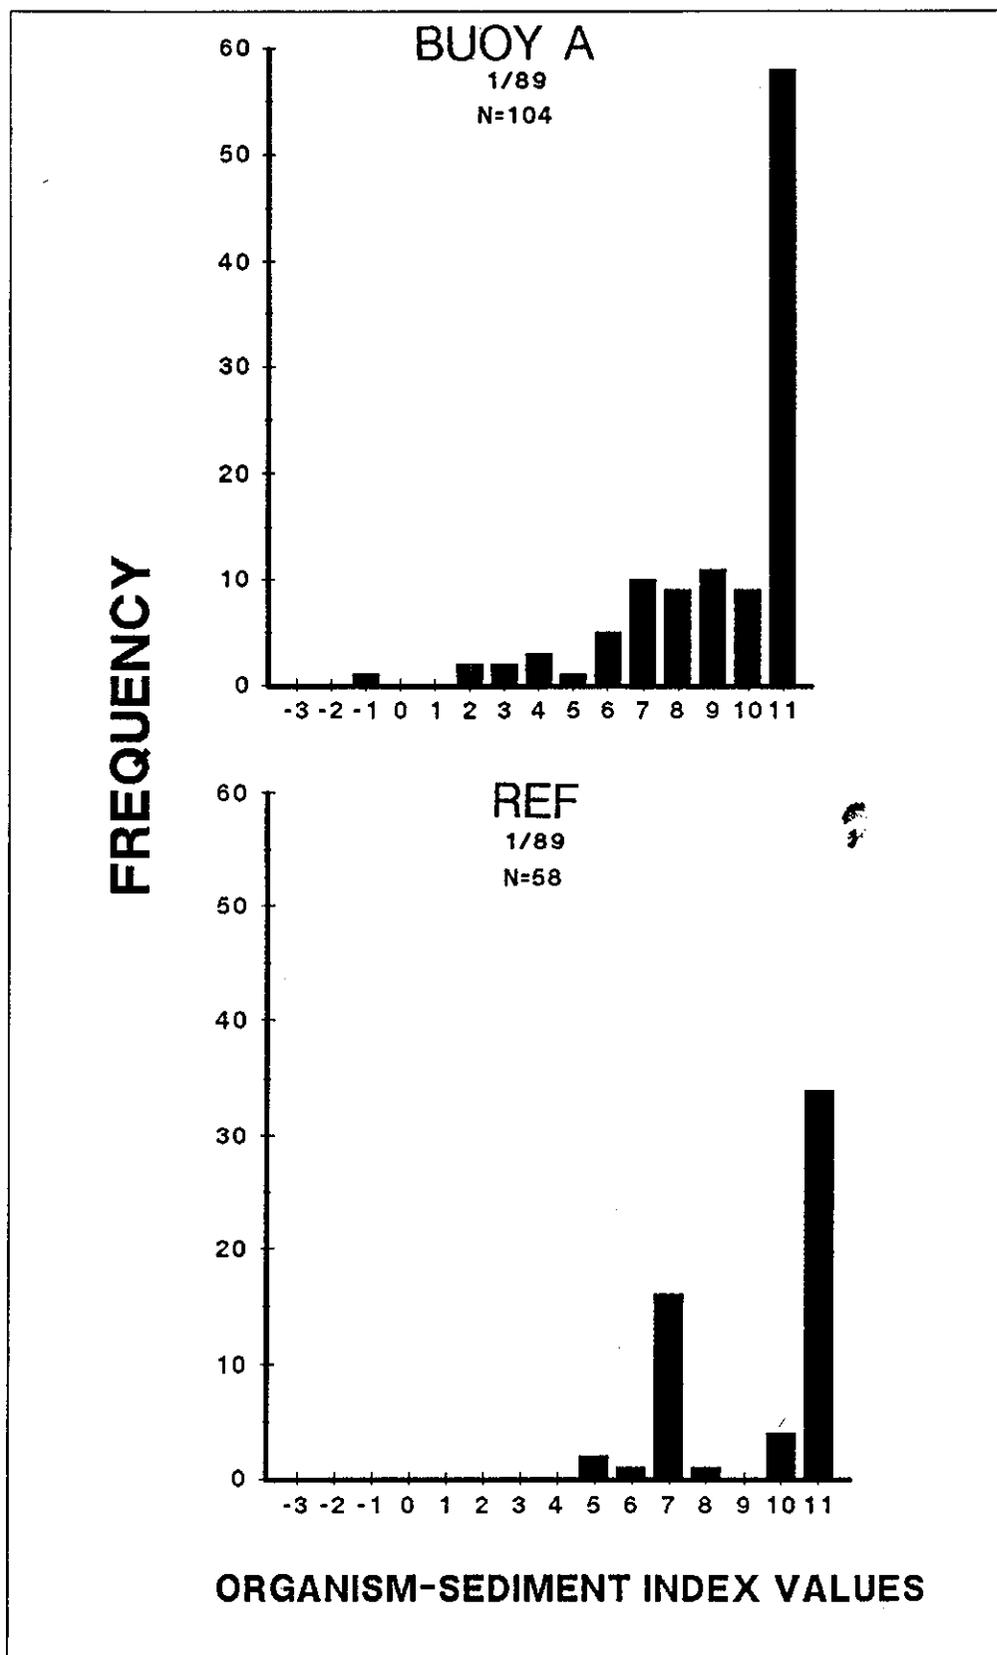
Figure 3-25. Frequency distributions of Organism-Sediment Indices for all replicates at both the reference and "A" buoy stations, January 1989.

The frequency distributions of OSI values at the "A" buoy and at the reference stations both had major modes at +11 (Figure 3-25); there was no significant difference between these two groups (Mann-Whitney U-test, $p = 0.686$). With the exception of station 300W, all the "A" buoy stations had OSI values greater than +6 (Figure 3-26).

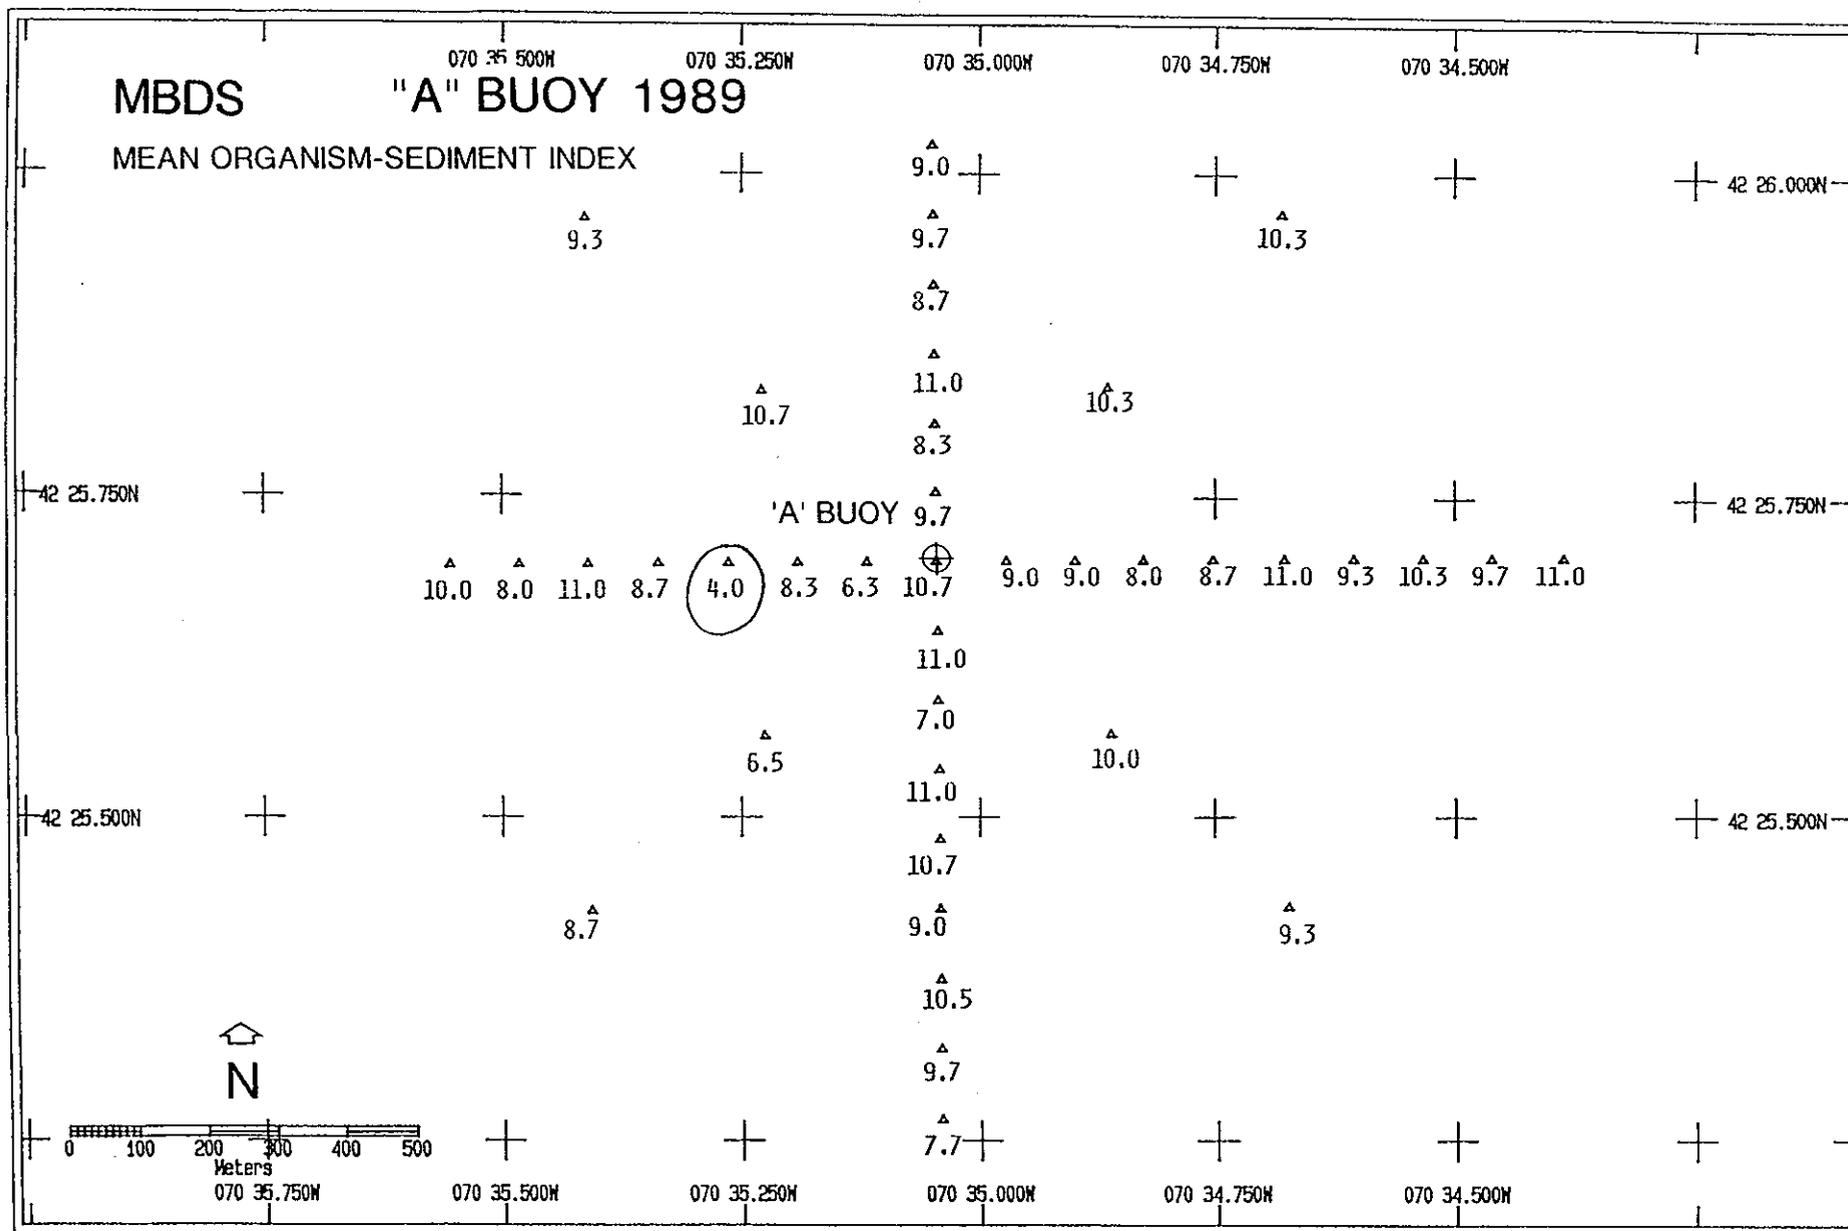
Figure 3-26. The distribution of Organism-Sediment Indices, averaged by station, at the "A" buoy at MBDS, January 1989. The contour delimits the single station (300W) having a mean OSI value $\leq +6$.

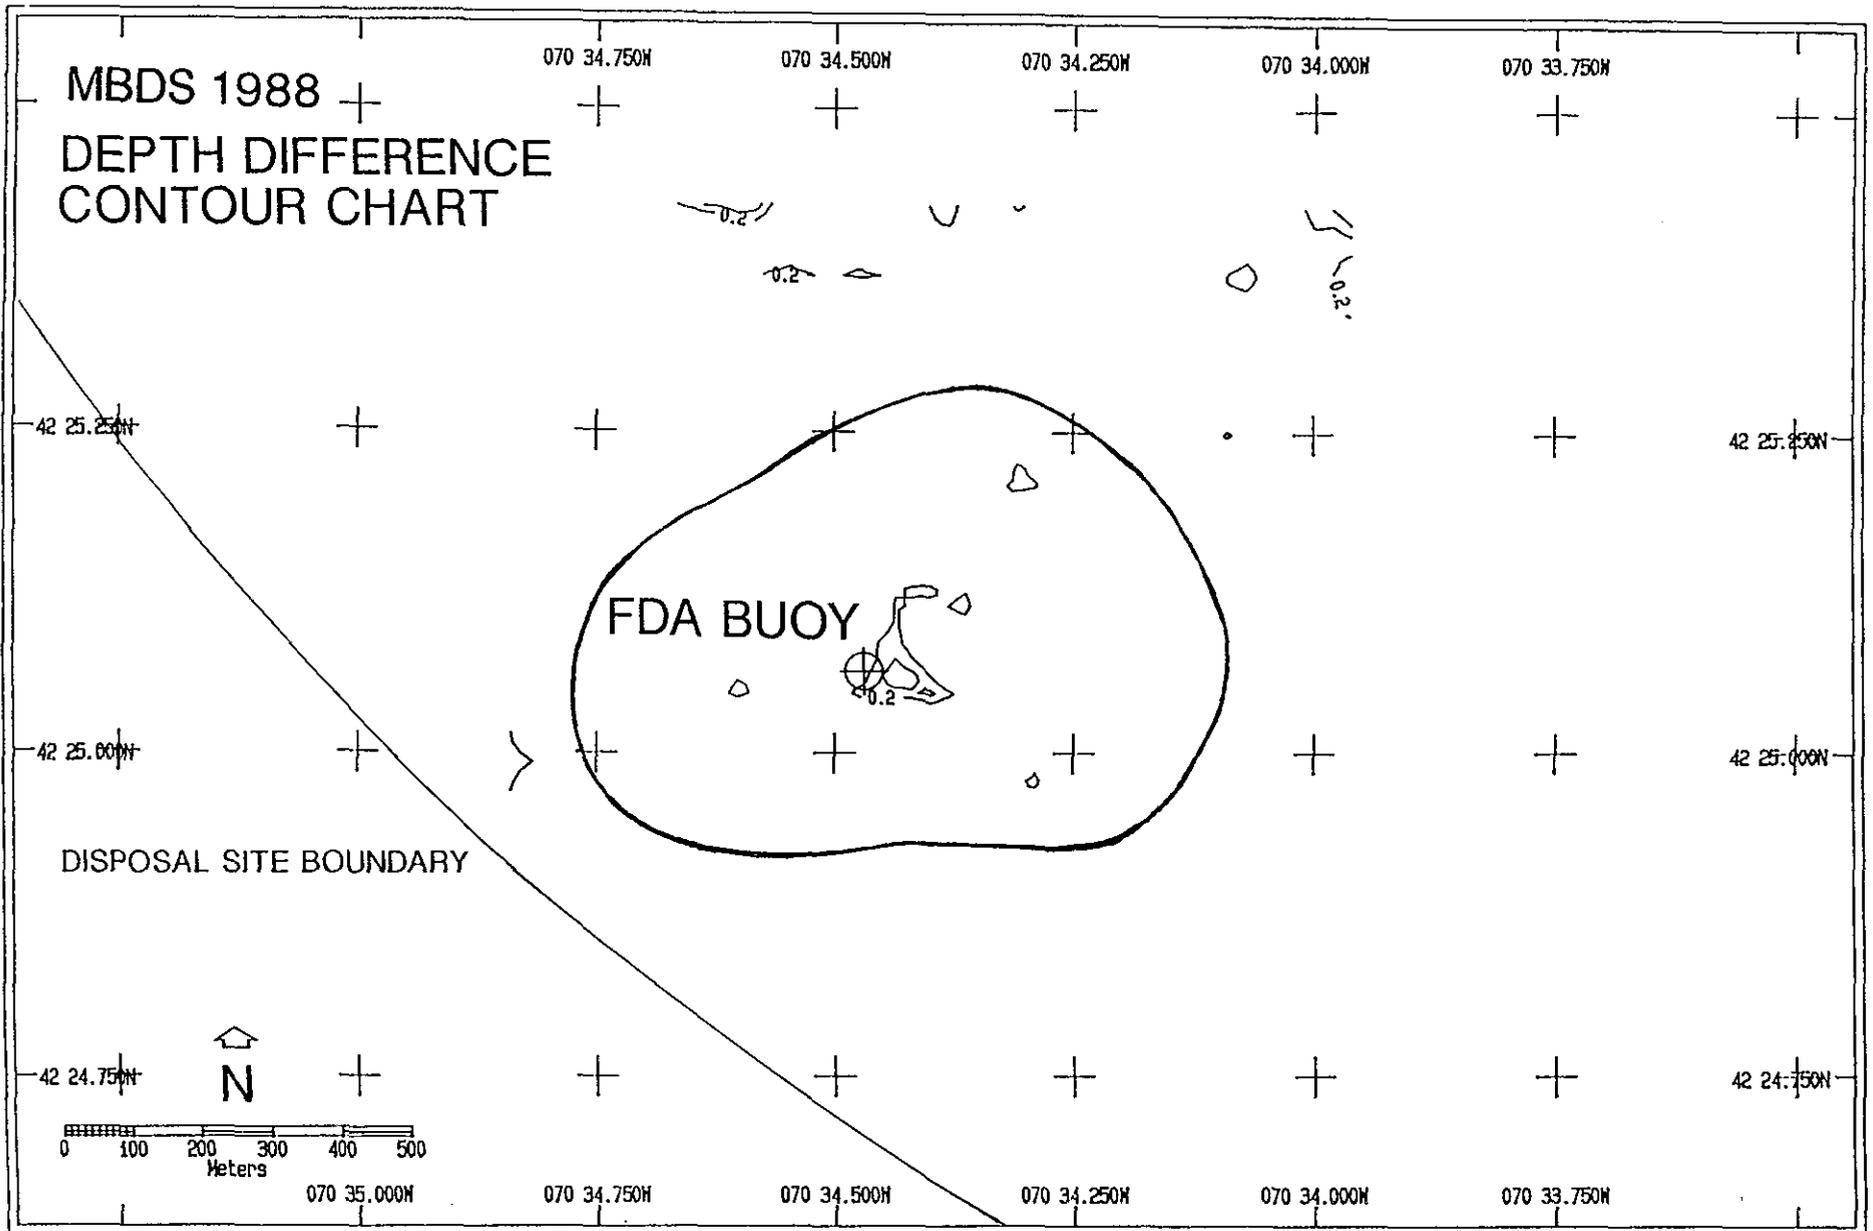
Figure 4-1. Depth difference contour chart with the thick contour line indicating the extent of recently-deposited dredged material around the "FDA" buoy as determined by REMOTS® photography (see Figure 3-6).

The REMOTS® results showed the new mound had a larger radius than indicated by the bathymetry results mainly because of the camera's ability to detect thin layers on the flanks of the deposit. Such layers were below the limits of detection by precision bathymetry and were therefore unaccounted for in the volume difference calculation. When the area representing the flanks of the mound was digitized and measured, it was found to occupy 306,908 m². A reasonable estimate for the average thickness of the fresh dredged material layers in this area was 14 cm, based on the actual thickness of such layers at several flank REMOTS® stations (see Figure 3-6). This results in an estimated volume of 42,967 m³ of material on the mound flanks not accounted for in the bathymetric depth difference calculation. Adding this to the depth difference volume estimate of 18,087 m³ results in a final total of 61,054 m³ of dredged material detected on the bottom using the two techniques.
