Monitoring Cruise at the Portland Disposal Site  
January 1989

# Disposal Area Monitoring System DAMOS

Contribution 78  
September 1990

US Army Corps  
of Engineers  
New England Division

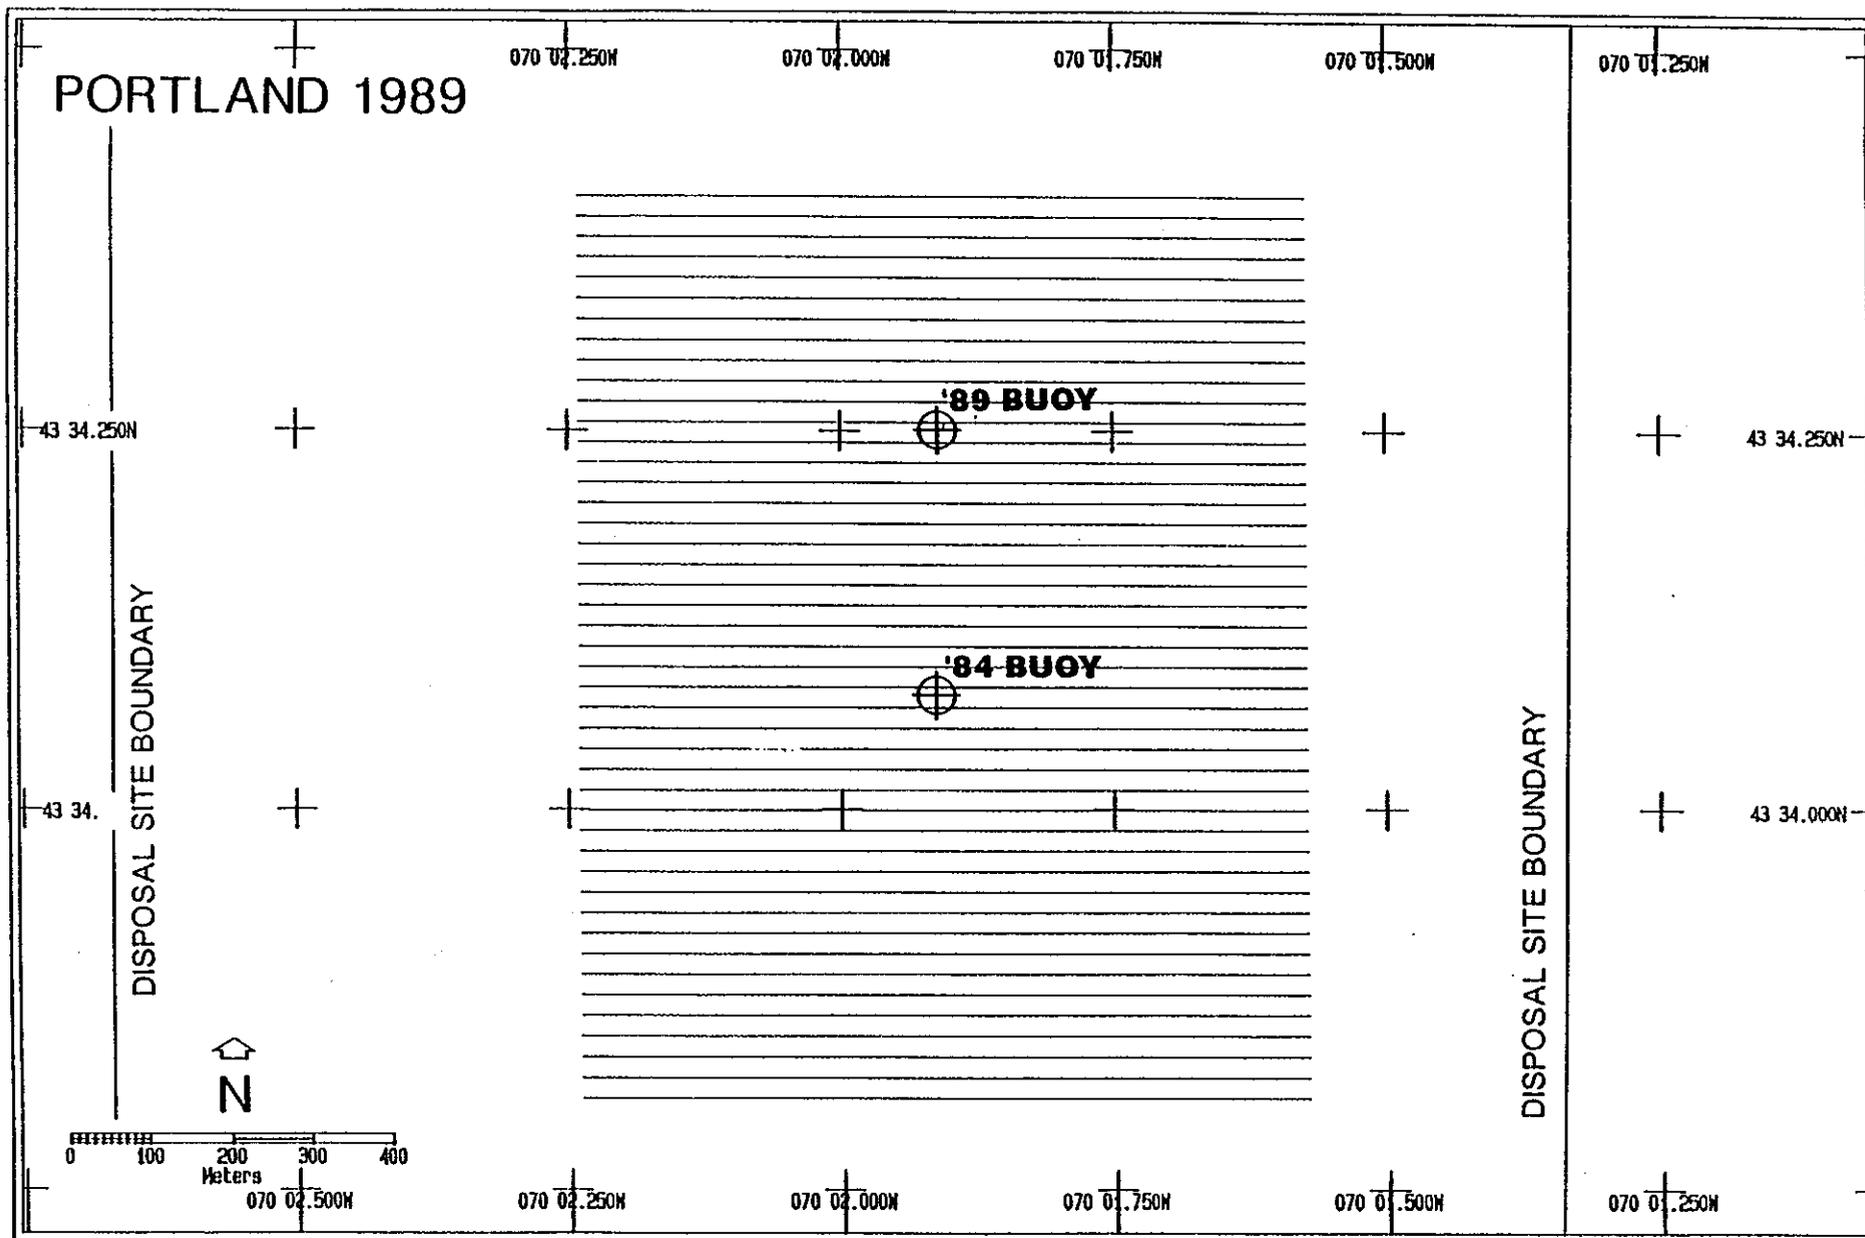
Figure 2-1. Bathymetric survey lanes at Portland, January 1989.

The original survey grid of 900 m x 900 m used in the 1984 survey was enlarged to 900 m x 1100 m to encompass potential dredged material north of the present buoy location (Figure 2-1). Forty-five lanes were surveyed, oriented east and west with 25 m lane spacing, overlaying the 1984 survey track and continuing an additional 200 m north. The survey grid covered the positions of both the 1984 and present buoy locations.

Dredged material disposal began at the Portland site in 1979. Initial disposal occurred at a taut-wire moored buoy located at 43° 34.11' N, 70° 01.91' W. This buoy was the location for specific disposal operations until its removal in 1984. For the last five years, disposal has taken place at a conventionally moored buoy presently located 350 meters north of the taut-wire buoy location (Figure 2-1).

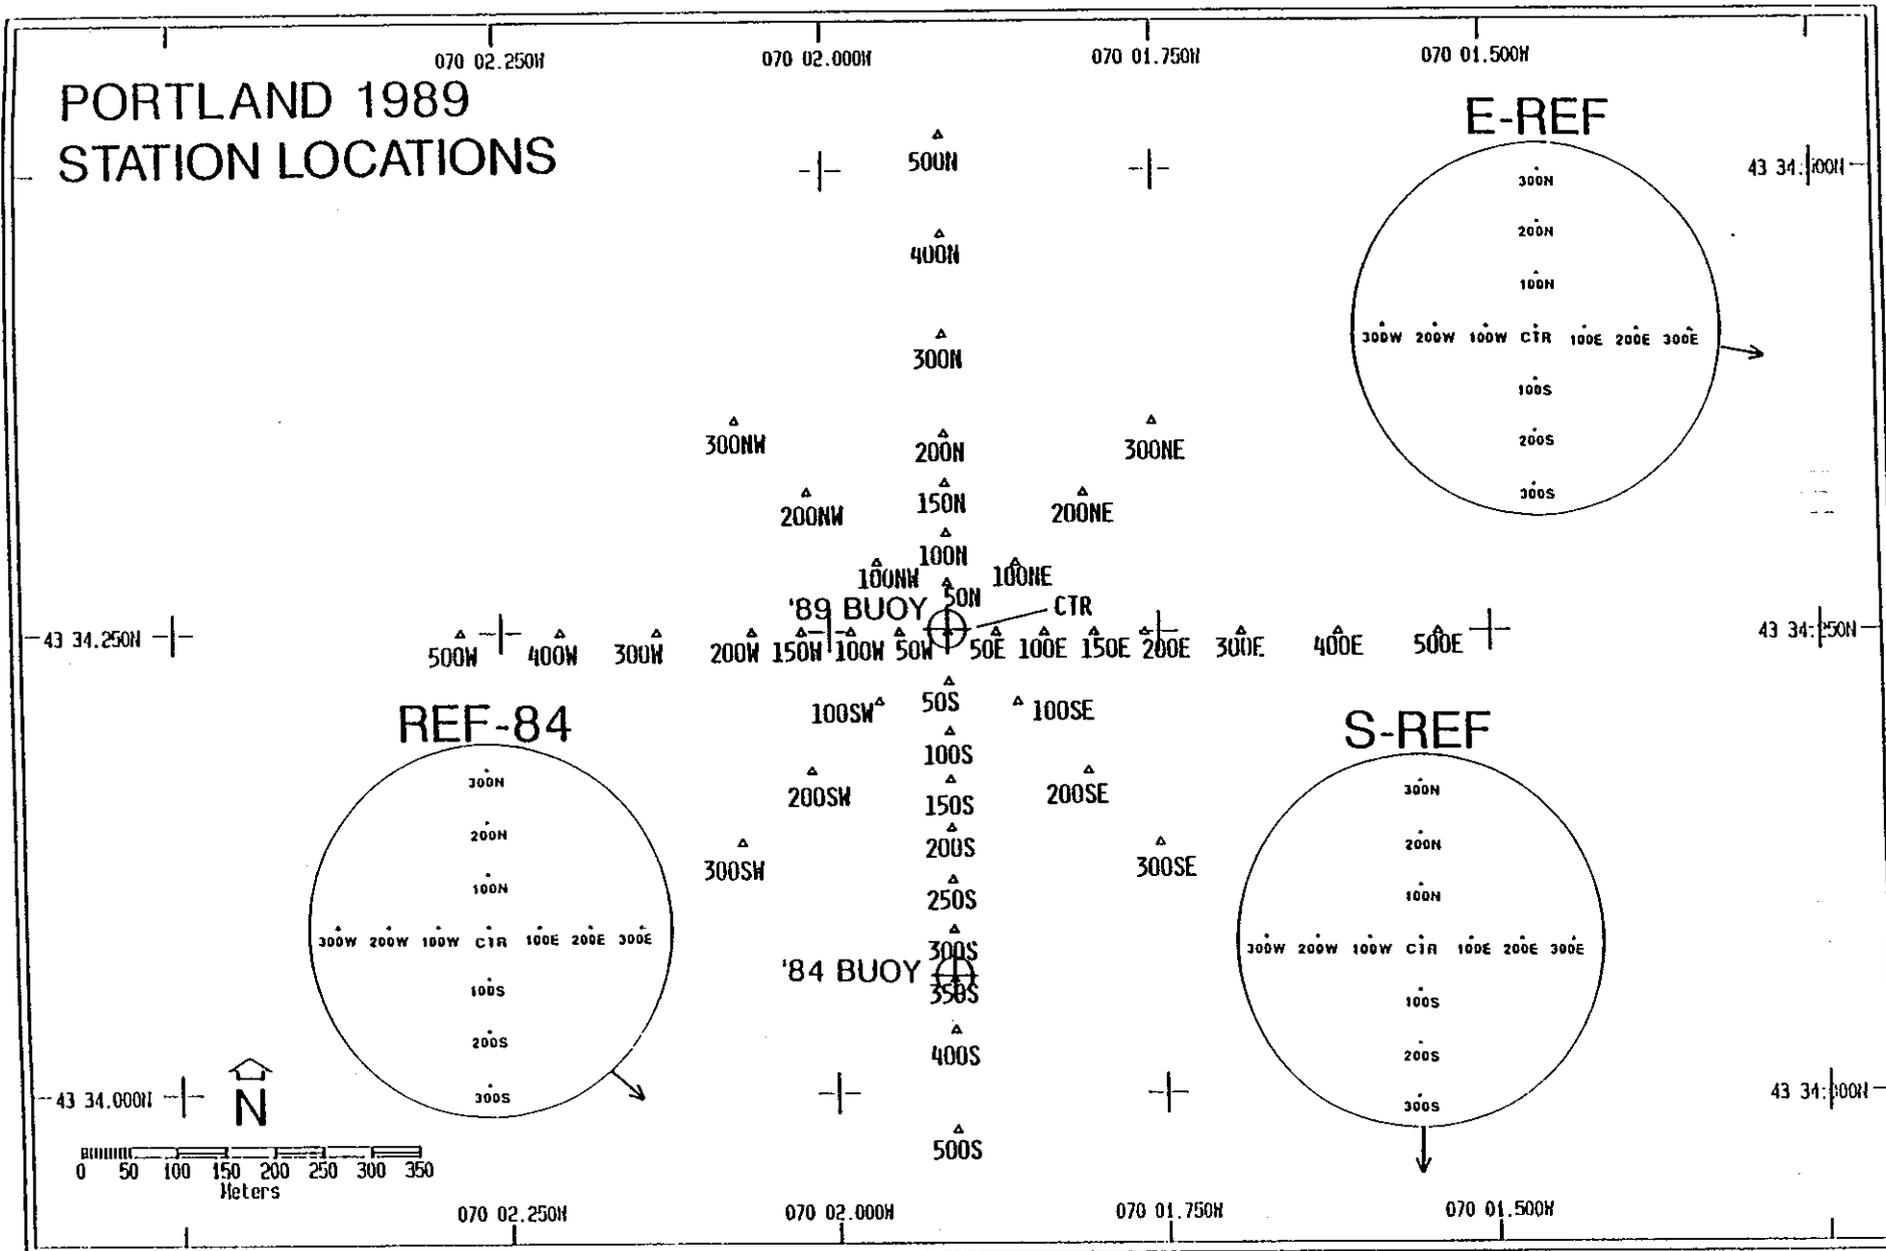
Figure 2-2. Locations and designations of REMOTS® stations occupied at Portland, January 1989.

The REMOTS® survey grid was centered at the present disposal buoy. A cross-shaped sampling pattern was established with stations at 50 m, 100 m, 150 m, 200 m, 300 m, 400 m, and 500 m north, east, south, and west from the center, with additional stations in each quadrant at 100 m, 200 m, and 300 m, northeast, southeast, southwest, and northwest of center. After identification of the old disposal mound with bathymetry, two additional stations at 250 m and 350 m south were added (Figure 2-2). At each of the 43 stations, an attempt was made to acquire three replicate sediment-profile photographs.

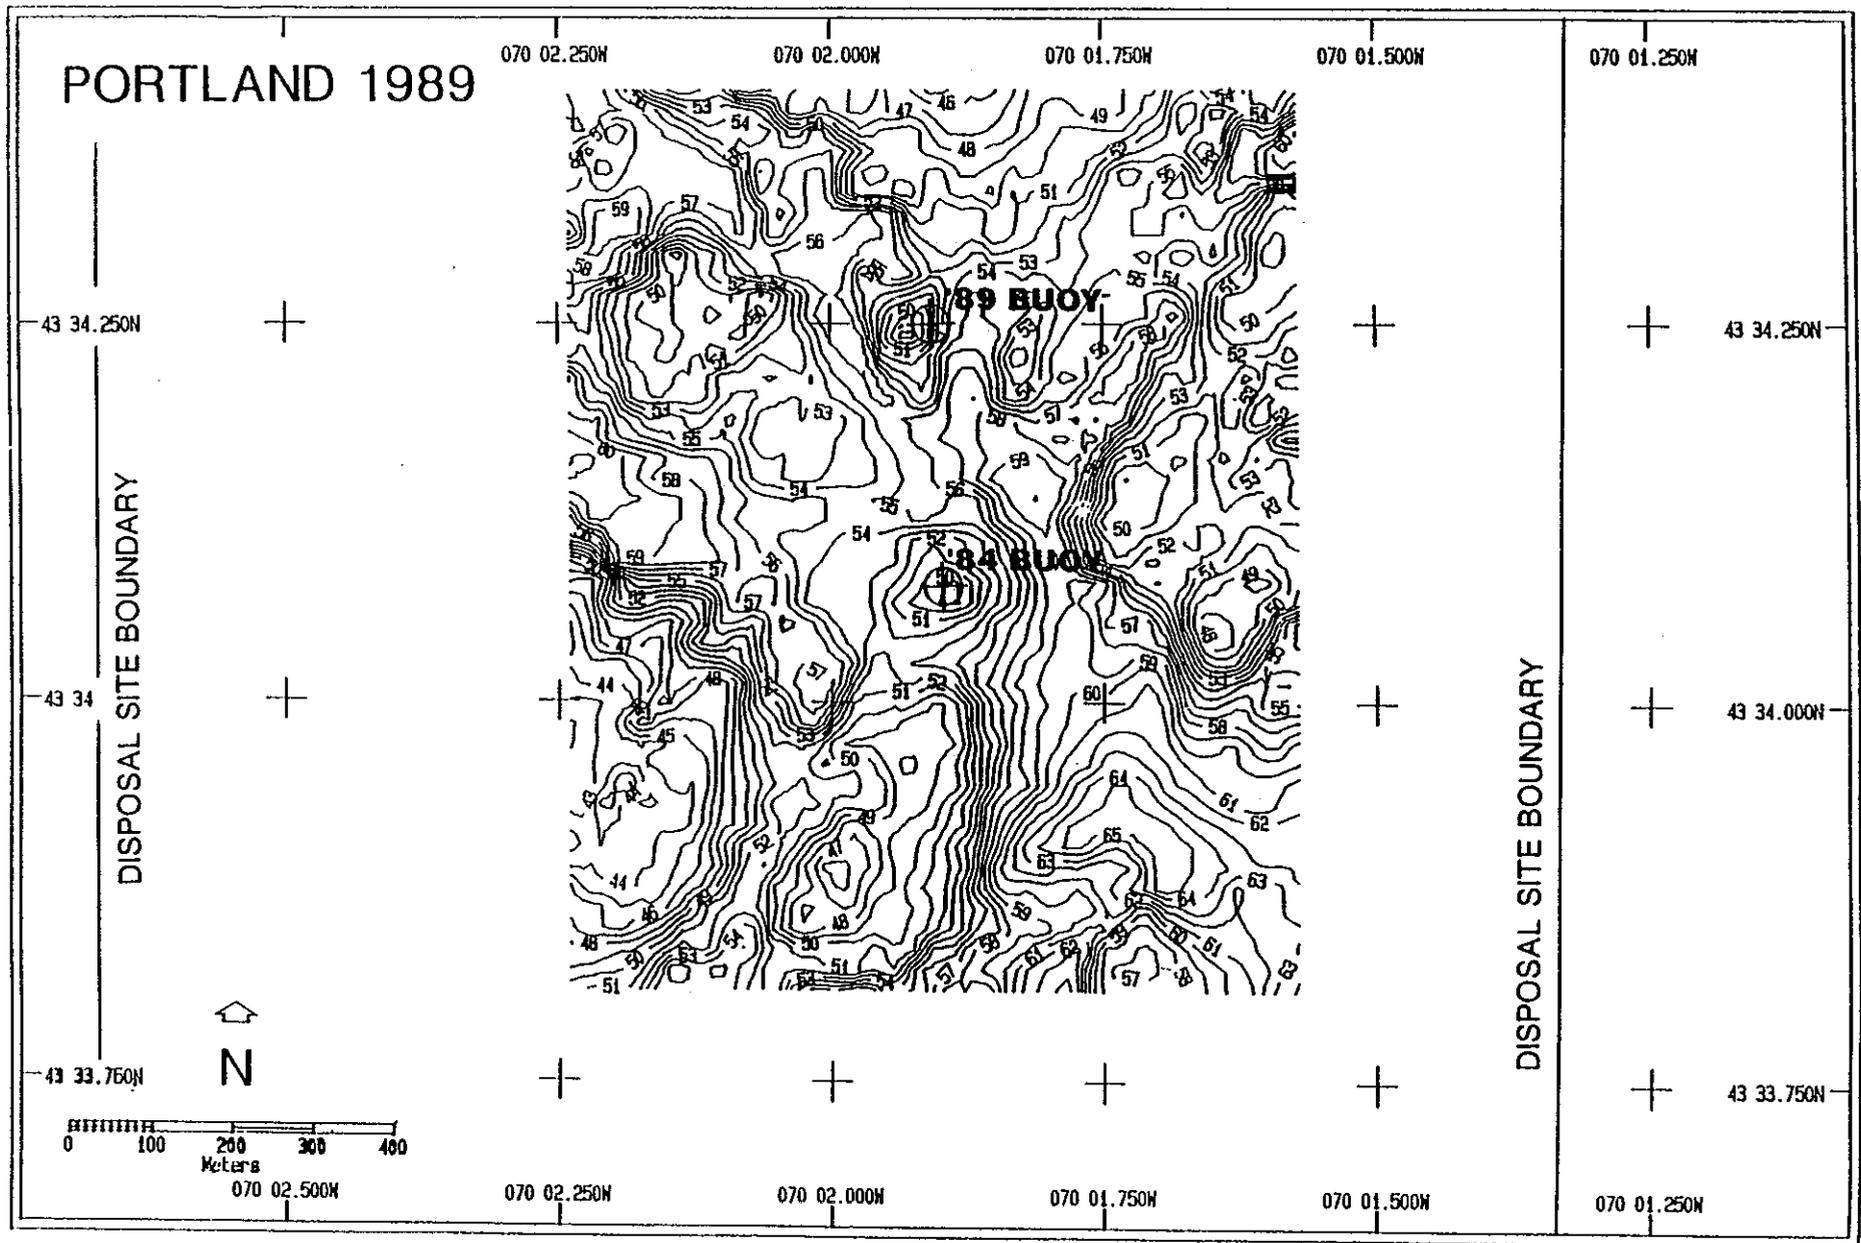
Figure 3-1. Contoured bathymetric chart of Portland Disposal Site, January 1989.

The bathymetric survey identified the existing mound at the former taut-wire buoy location, and a mound-like structure at the current disposal buoy location (Figure 3-1). Previous bathymetric surveys conducted in 1979, 1980, and 1984 had ended with their northern boundary at the current disposal point; however, they all have shown shallower depths in this area. Depth difference calculations revealed no change in bottom topography at the former taut wire buoy location and no visible differences from the 1984 survey elsewhere in the disposal area (Figure 3-2).

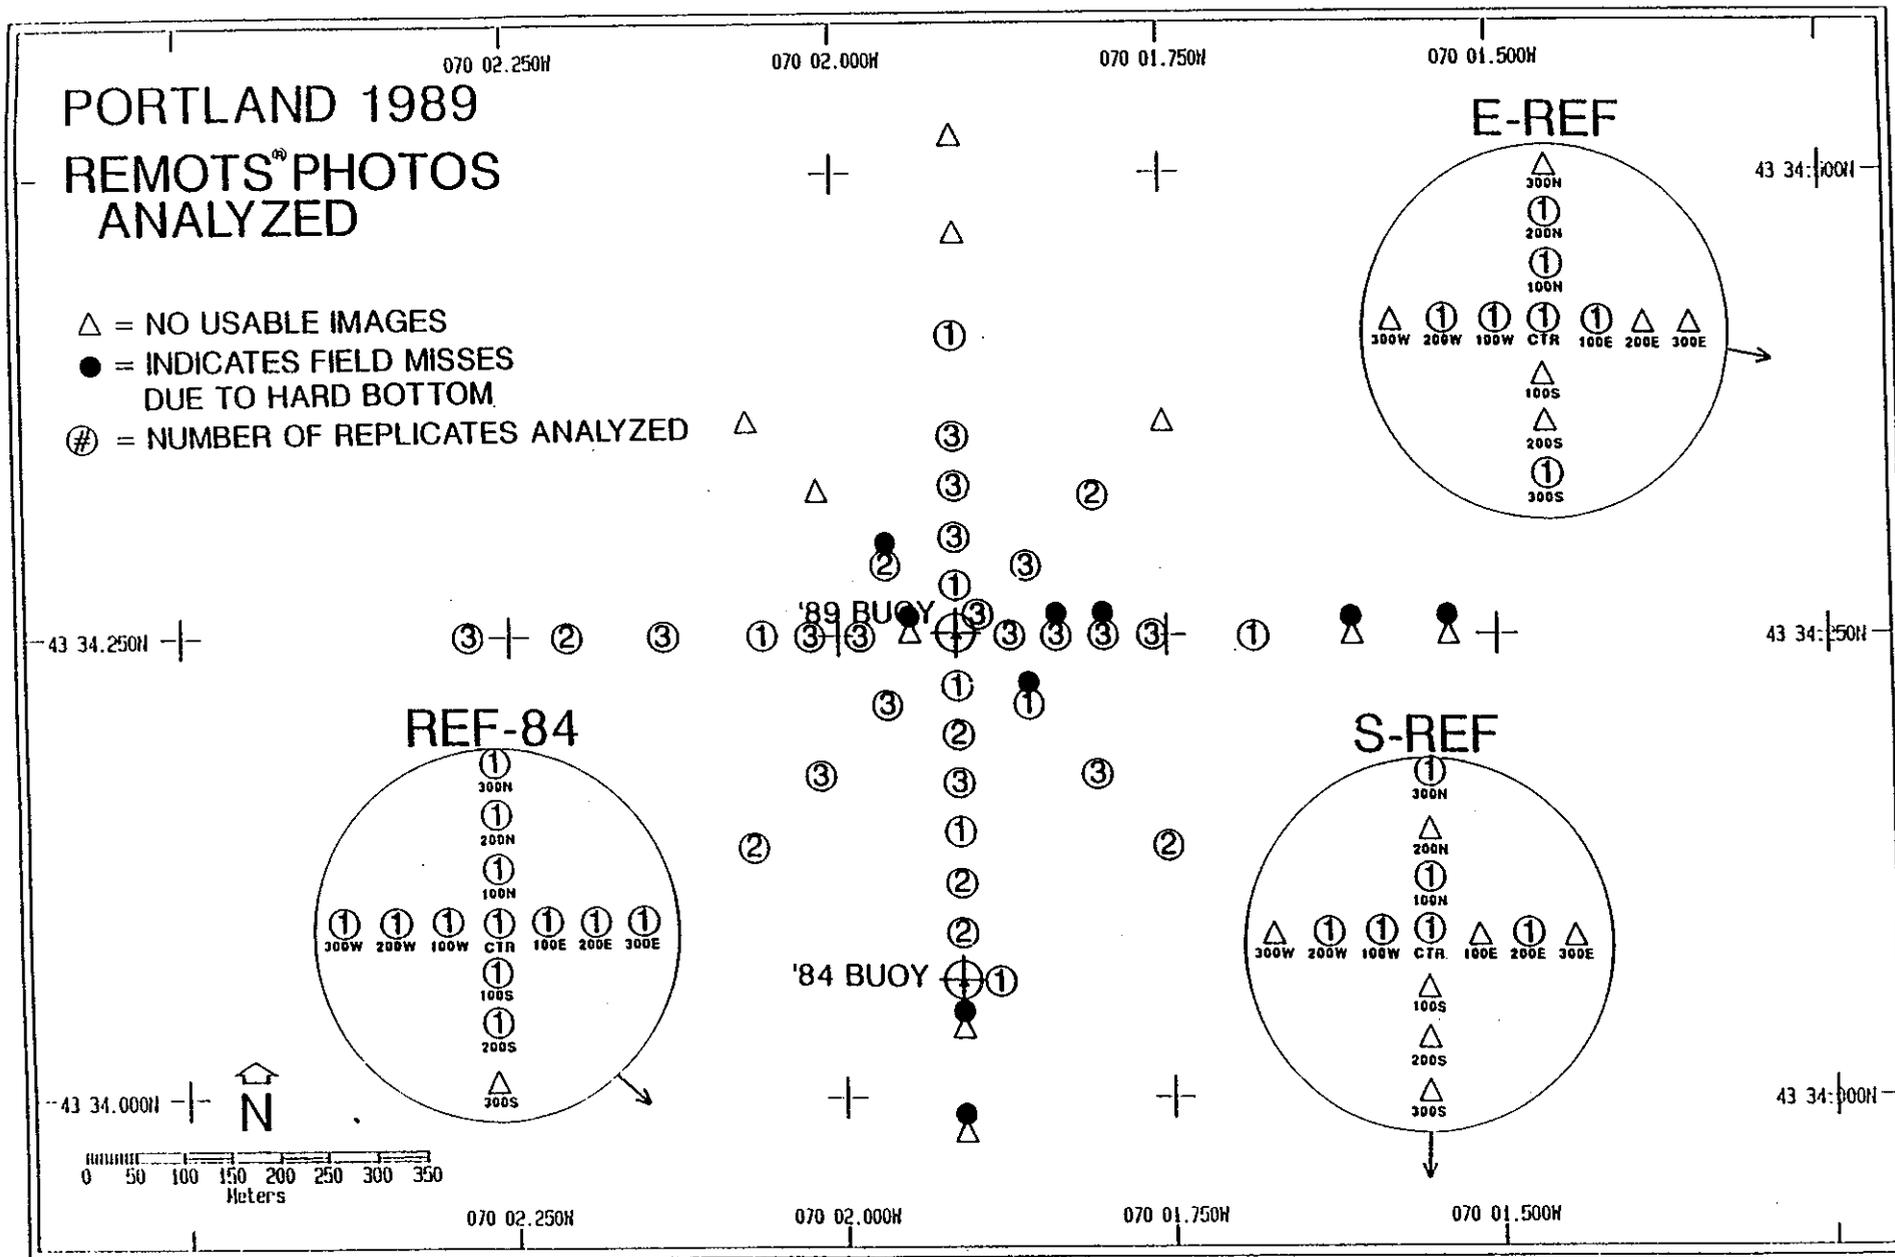
Figure 3-3. Location and number of usable REMOTS® photographs obtained at the Portland site.

It was impossible to obtain REMOTS® photographs at several stations because they had such irregular, hard bottom which prevented camera prism penetration (Figure 3-3). The REMOTS® camera is activated when the prism is lowered below the base frame; any bottom projections (such as rocks) that come up through the frame and block prism travel will prevent the camera from firing. At other stations, three to five camera lowerings produced one or more photographs, but they did not show sediment penetration, again indicating hard or irregular bottom.

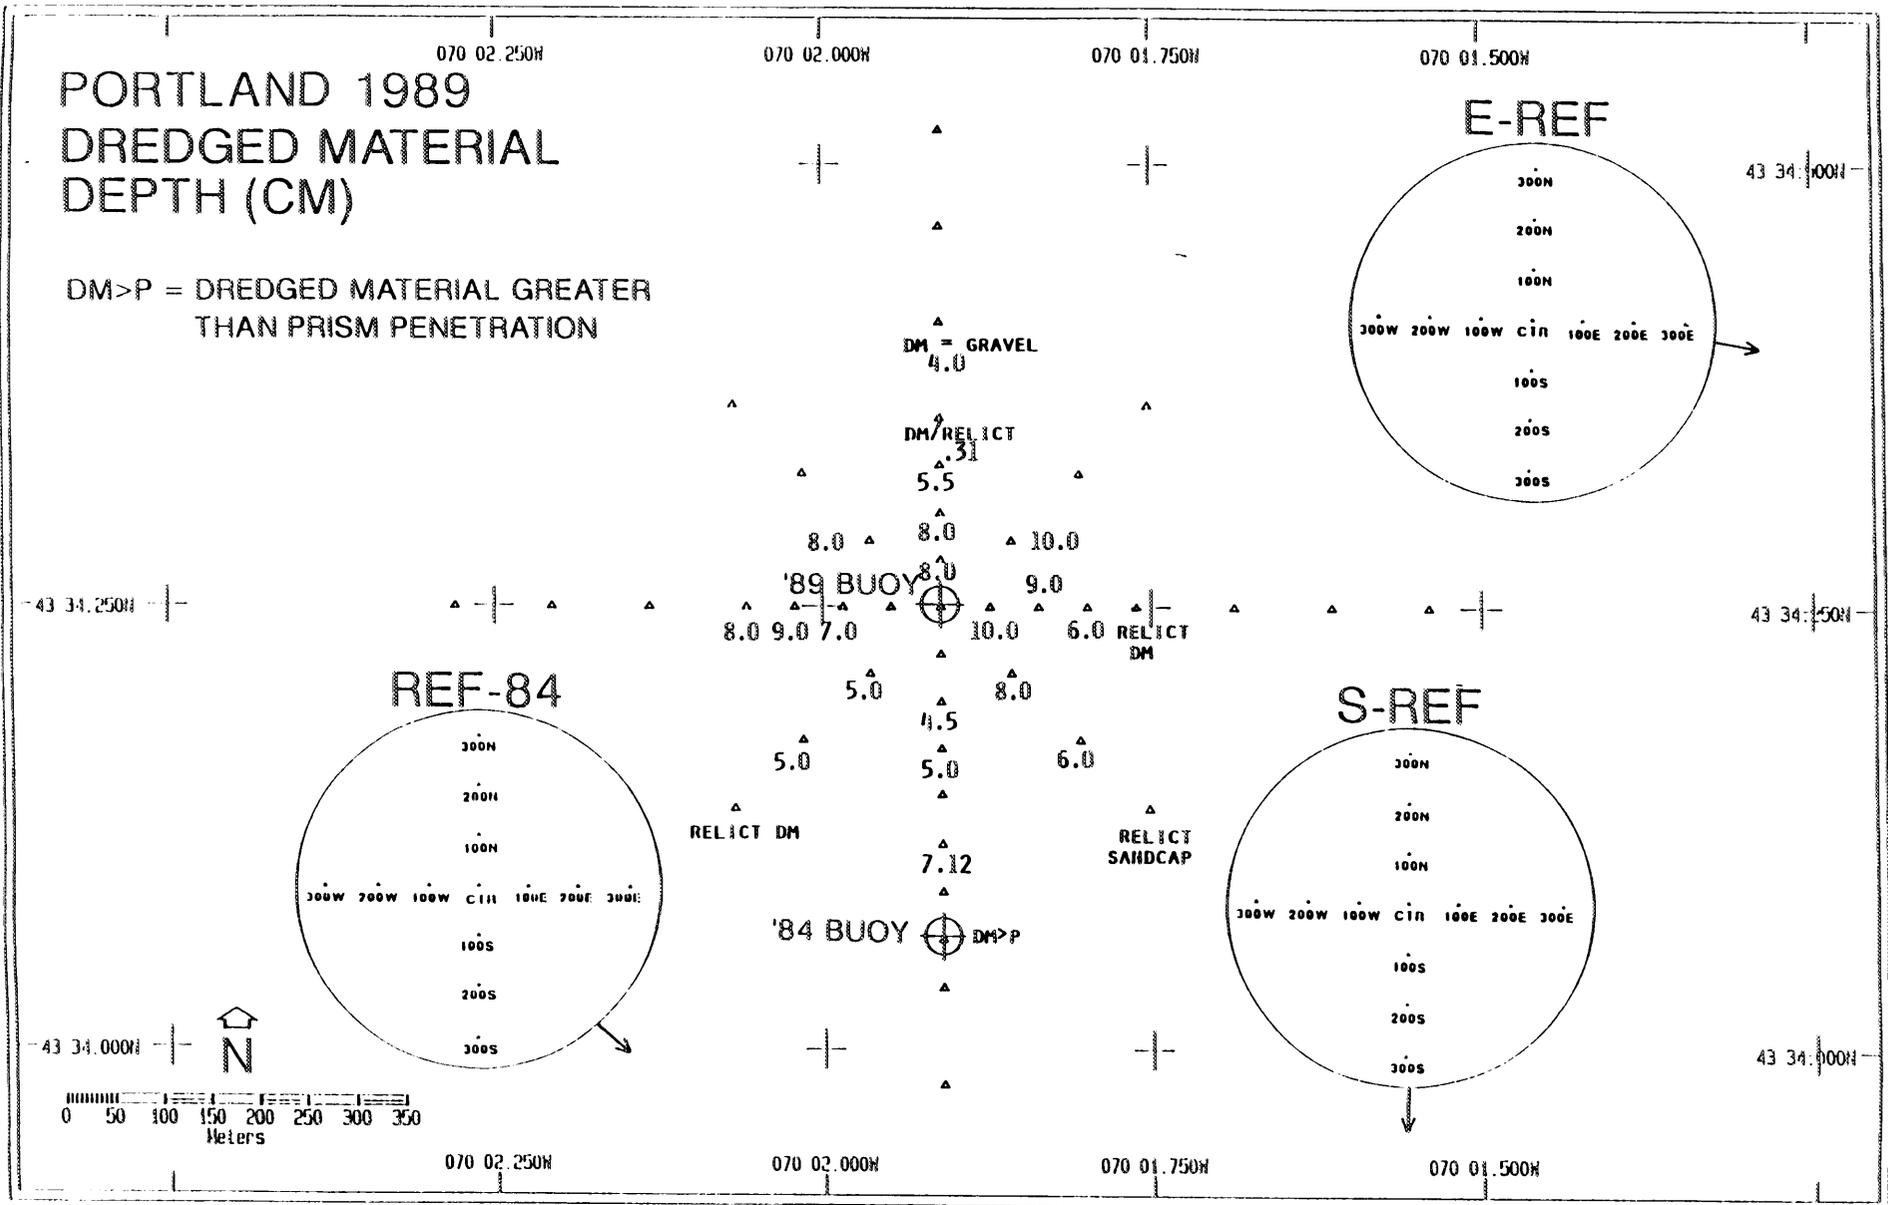
Figure 3-4. Distribution and thickness of dredged material layers at Portland Disposal Site, January 1989.

Recently deposited dredged material covered a circular area centered at the present buoy location and having a diameter of roughly 500 - 600 meters (Figures 3-4 and 3-5). Relict dredged material was evident beyond this area to the east, south, and west (Figure 3-6). Relict dredged material with overlying "fresh" material was visible at several stations scattered throughout the mound. Only a few stations at the outer edges of the REMOTS® sampling grid had no dredged material (Figure 3-7).

The main objectives of the survey were to determine the areal extent of dredged material and assess the benthic recolonization of the disposed material. Dredged material ("relict" and "fresh") was identified at 83% (25/30) of the REMOTS® stations, covering a circular area with a diameter of approximately 700m.

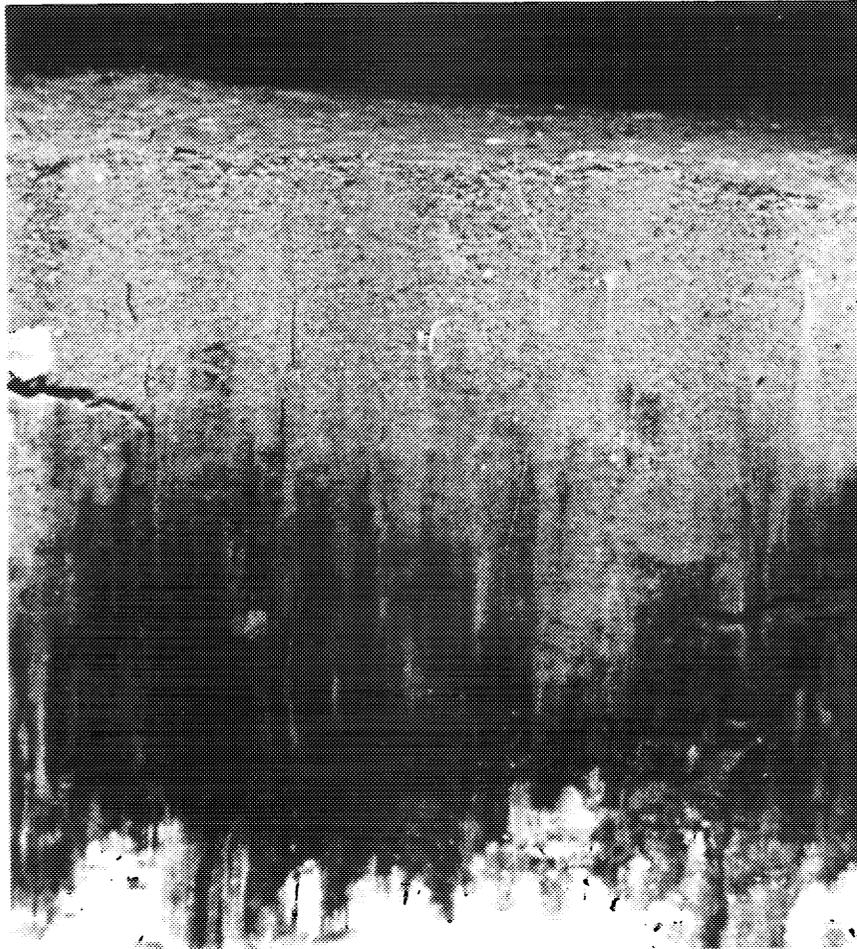
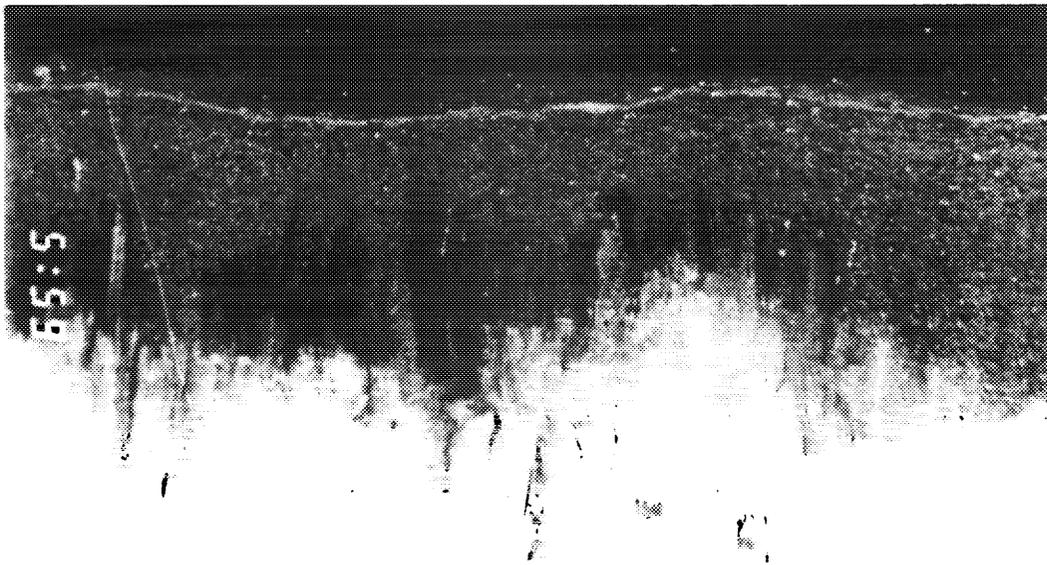
Figure 3-6. Two REMOTS® photos illustrating relict (photo A from station 200SW) and recently deposited (photo B from station 100SW) dredged material at the Portland Disposal Site.

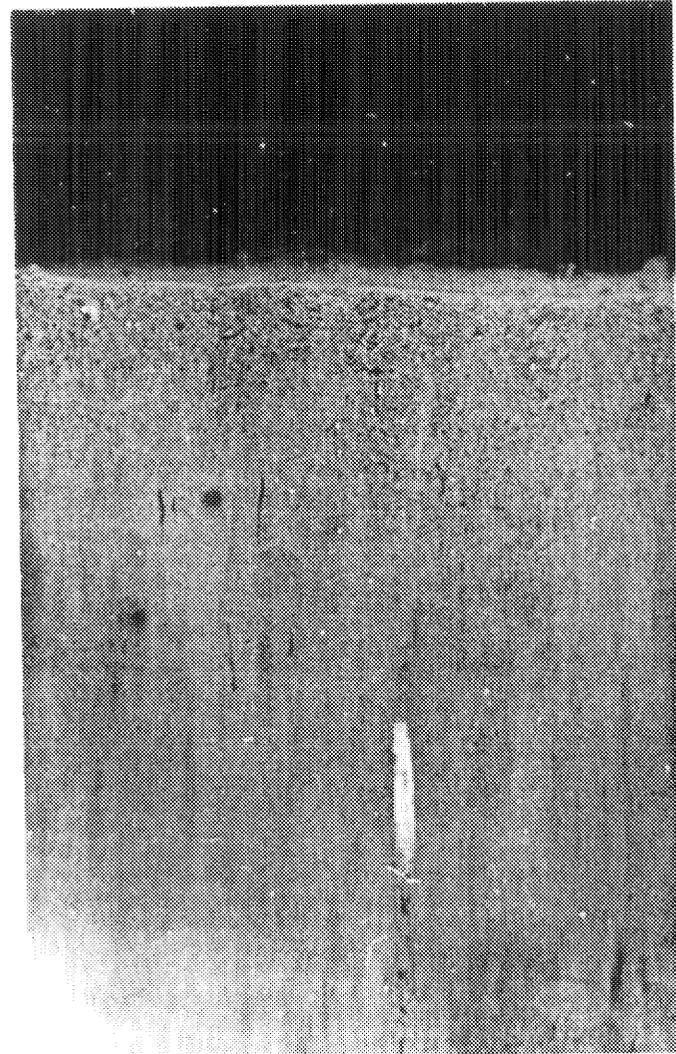
Figure 3-7. Two REMOTS® photos illustrating ambient sediment at Portland Disposal Site. Photo A is from station 300E photo B is from reference station E-REF 100W.

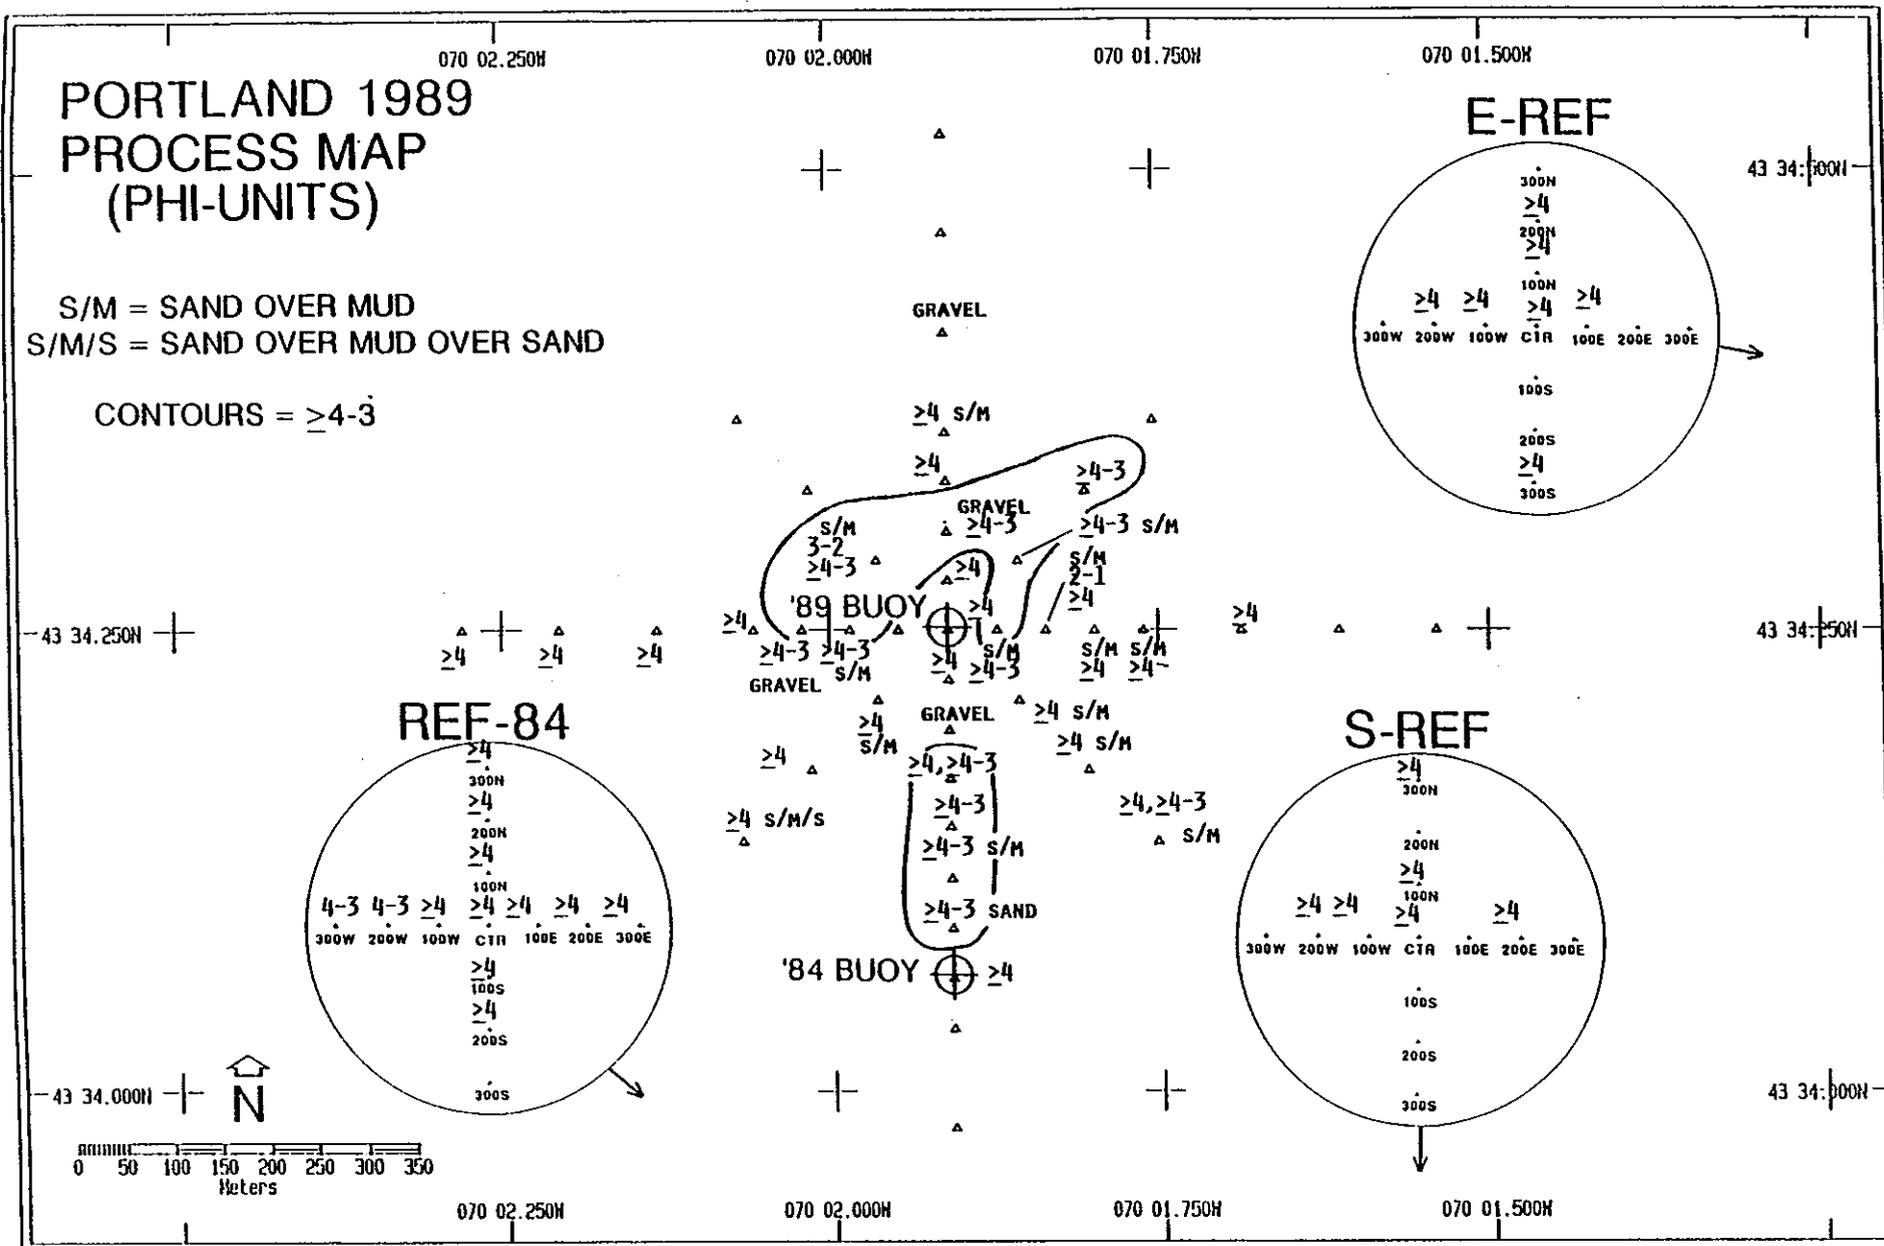
Figure 3-8. Distribution of sediment types at Portland Disposal Site and reference sites, January 1989.

Silt-clay (4 phi) was the most prevalent sediment grain size at the disposal site and at all three reference stations. Stations 150, 200, 250, and 300 south all had very fine sand to silt clay (4 - 3 phi) as the major mode. These stations bracket and extend slightly north of the 1984 disposal buoy area. Similar material was found at the center and north of the present disposal point (Figure 3-8). Sand over mud, and sand/mud/sand stratigraphy existed at many stations scattered across the REMOTS® grid, with gravel visible at four stations (150W, 150N, 300N, and 100S).

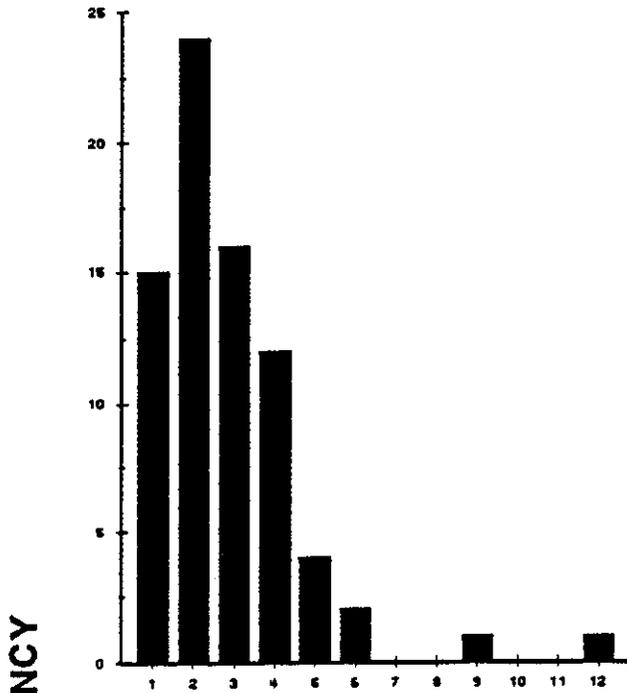
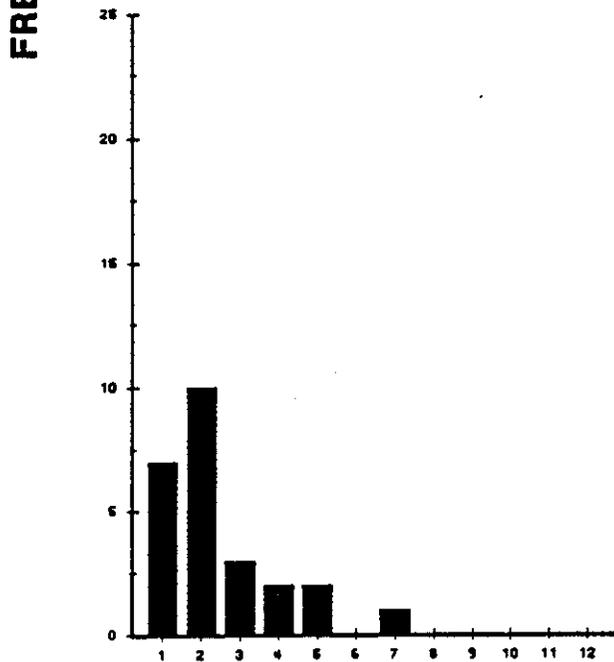
Figure 3-9. Boundary roughness frequency distributions at Portland Disposal Site and reference stations.

There was no discernable difference in the frequency distributions of boundary roughness values at the disposal site and the reference stations (Figure 3-9).

CLASS INTERVAL	RANGE OF VALUES (CM)
1	0.0 - 0.6
2	0.6 - 1.0
3	1.0 - 1.4
4	1.4 - 1.8
5	1.8 - 2.2
6	2.2 - 2.6
7	2.6 - 3.0
8	3.0 - 3.4
9	3.4 - 3.8
10	3.8 - 4.2
11	4.2 - 4.6
12	4.6 - 5.0
13	5.0 - 5.4

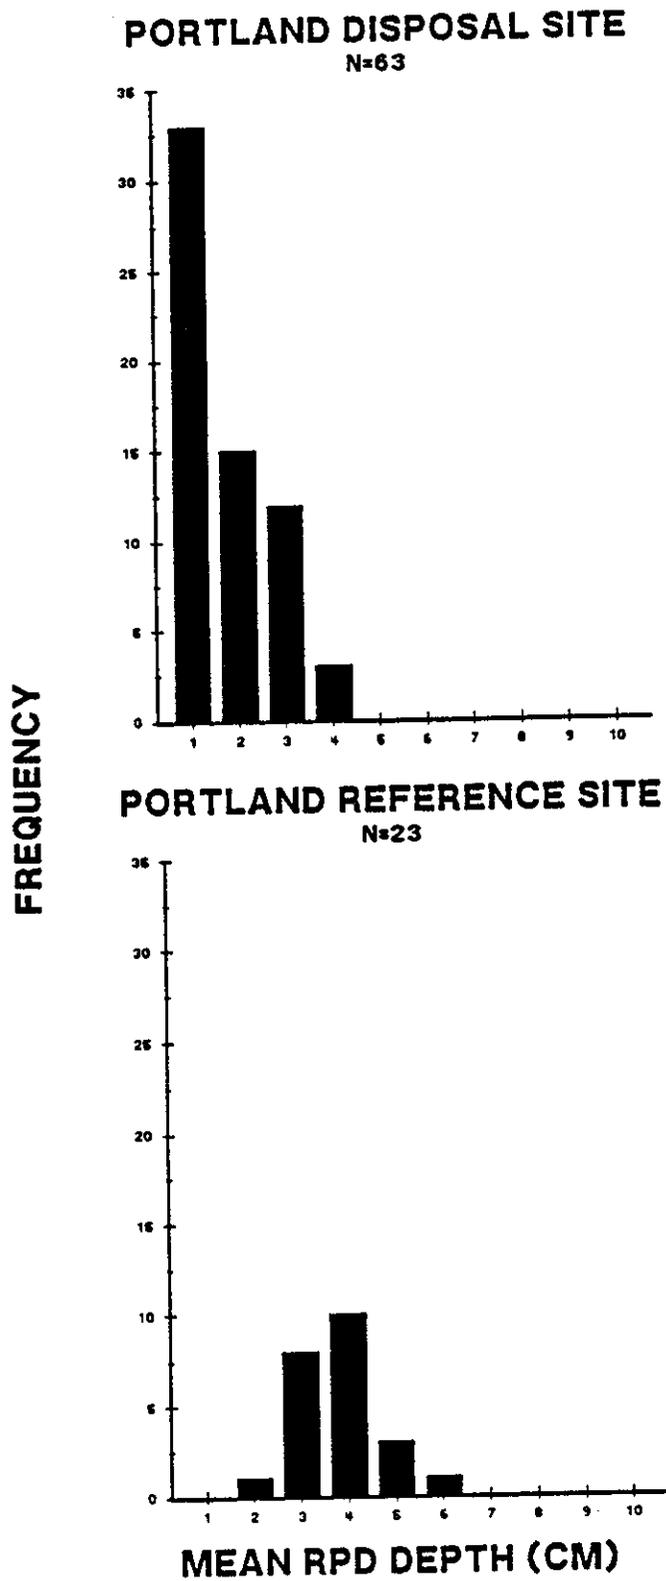
Figure 3-10. Frequency distributions for apparent RPD depths at Portland Disposal Site and reference stations.

Mean apparent Redox Potential Discontinuity (RPD) depths range from zero to 4.3 cm at the disposal site stations where dredged material was present with the average at 1.5 cm (Figure 3-10). Stations with relatively low RPD values (< 2.25 cm) occurred around the center of the disposal area (Figure 3-11). In contrast, the reference stations had significantly greater RPD depths.

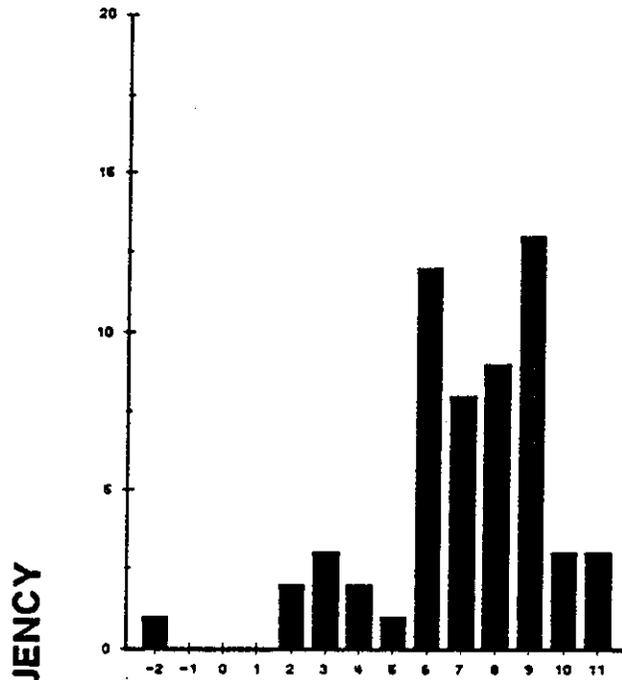
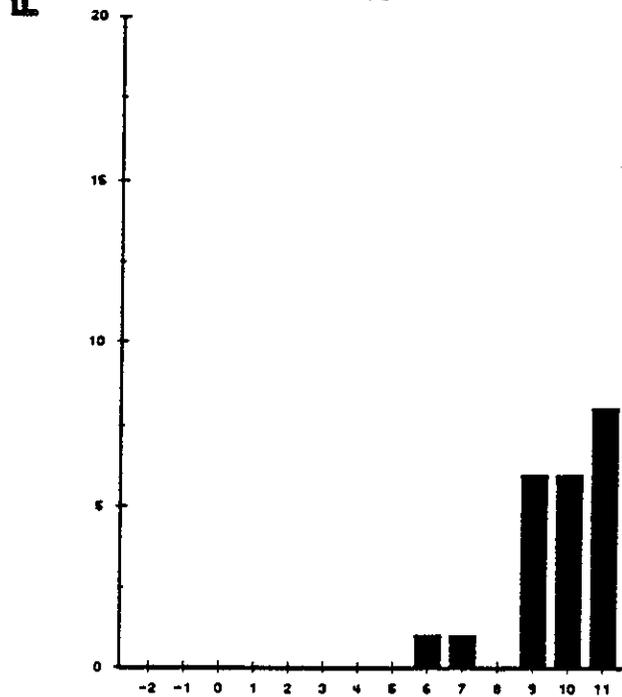
Figure 3-13. Frequency distributions of Organism-Sediment Index values at Portland Disposal Site and reference stations.

The Organism-Sediment Index (OSI) values for the disposal stations were significantly lower than the values for the reference sites, mean = 7.1 vs. 9.8 (Figure 3-13). This difference was due primarily to the deeper RPD values at the reference areas. Four stations clustered at the center of the disposal site had relatively low mean OSI values (<+6), presumably representing the area most recently disturbed by disposal operations (Figure 3-14).
