Monitoring Cruise at the
Cornfield Shoals Disposal Site
August 1992

Disposal Area Monitoring System DAMOS

Contribution 106
January 1996

**US Army Corps
of Engineers**
New England Division

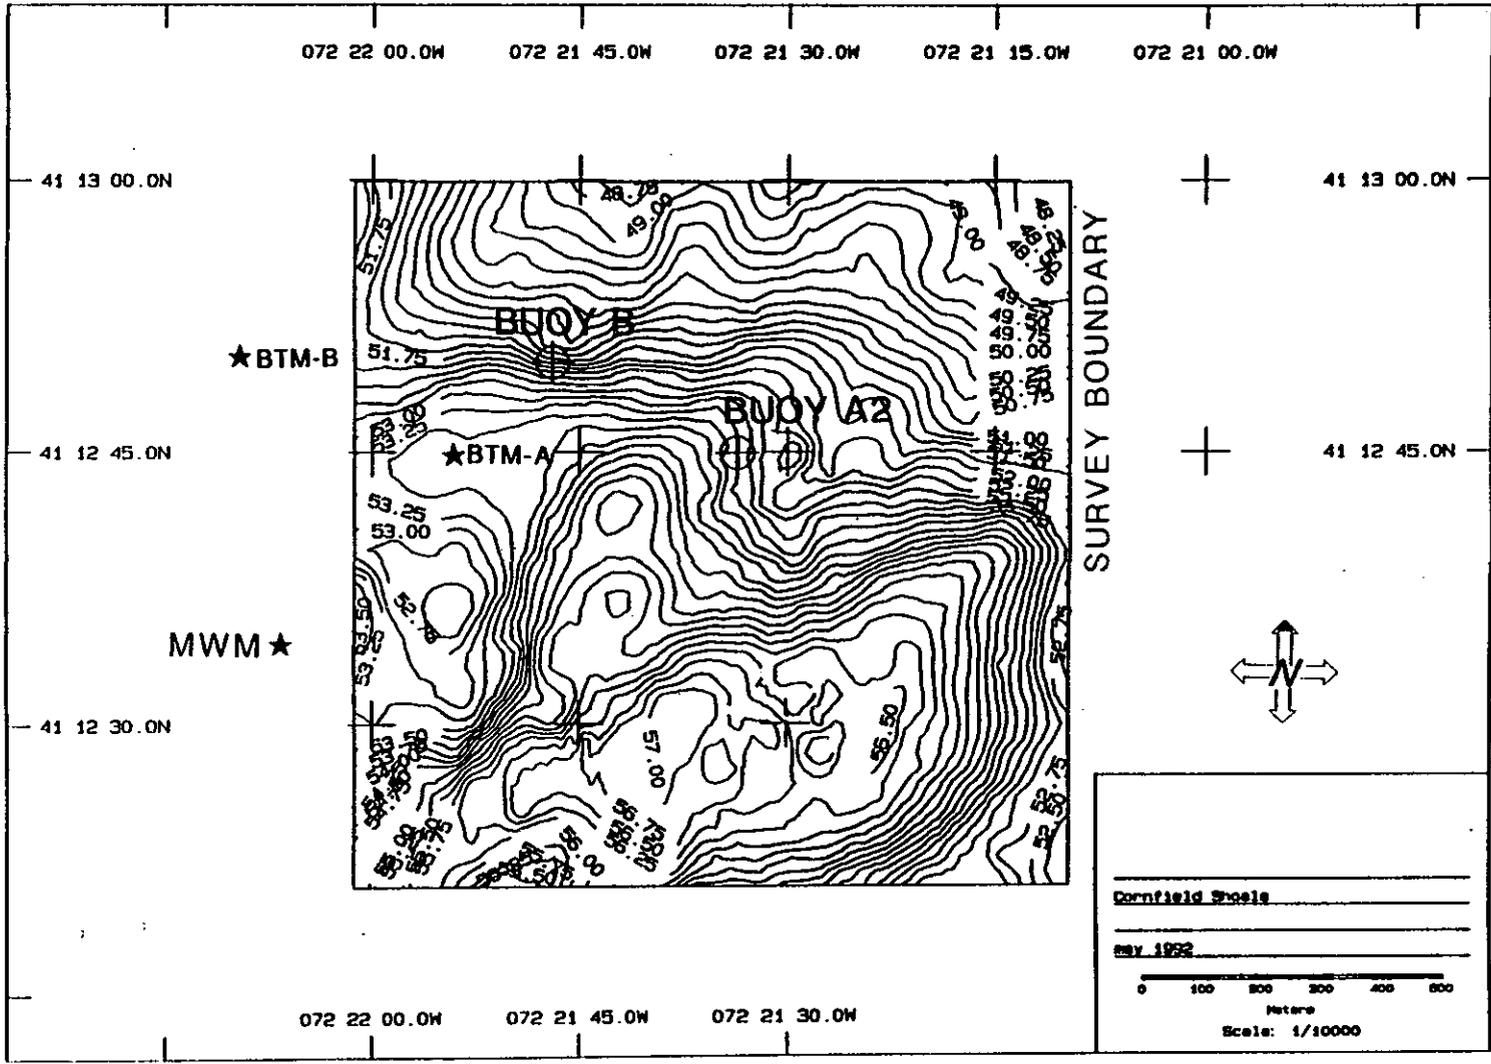
Figure 1-2. Location of disposal buoy and current meters at the Cornfield Shoals Disposal Site, 1991-1992

As part of a joint study between the University of Connecticut and the Newport, RI, office of Science Applications International Corporation (SAIC), a taut-wire moored buoy was deployed at two locations within CSDS in 1991. Between 12 September and 9 October 1991, 50,803 m³ of sandy dredged material was released at buoy location A2 (Figure 1-2). Between November 13, 1991 and April 14, 1992, 105,479 m³ of fine-grained dredged material from North Cove was released at buoy location B. Coincident with these disposal operations, a near-bottom current meter was deployed at BTM-A (near A2) on August 8, prior to disposal, and moved to BTM-B (near B) on October 21. A midwater current meter (MWM) was deployed southwest of BTM-A on August 1 (Figure 1-2). A series of studies at CSDS from July 1991 (predisposal) to May 1992 (postdisposal) documented the accumulation of dredged material at these buoy locations and provided circumstantial evidence for active bed transport in the area (Wiley 1994). The current meter data showed the east-west tidal component as the dominant current direction. Maximum velocities for the midwater meter were 120 cm·s⁻¹ on the spring tide and 60 cm·s⁻¹ on the neap. For the nearbottom meter, maximum velocities were 80 cm·s⁻¹ on the spring and 40 cm·s⁻¹ on the neap. All of these current velocities are sufficient to erode medium to fine sands (Bohlen et al. 1992)

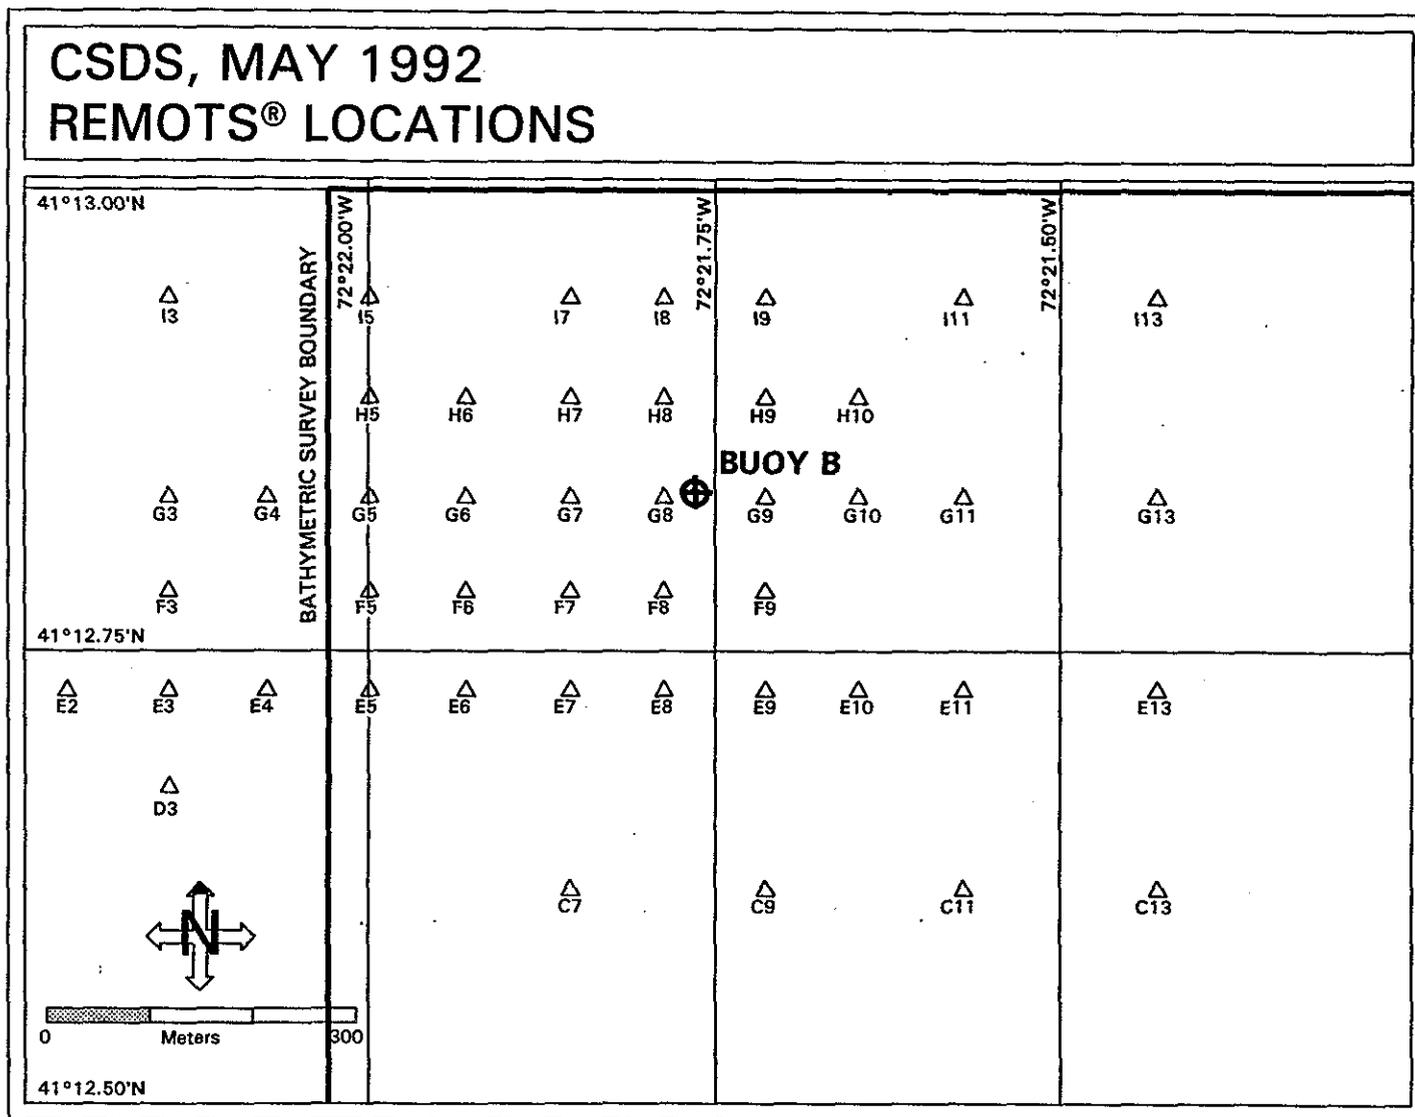
Figure 2-1. REMOTS® station locations at the Cornfield Shoals Disposal Site, May 1992

A REMOTS® survey was conducted at CSDS on August 6, 1992 to define the limits of dredged material distribution. In May 1992, a 45-station orthogonal REMOTS® grid had been surveyed to define the dredged material boundary (Figure 2-1). In August 1992,

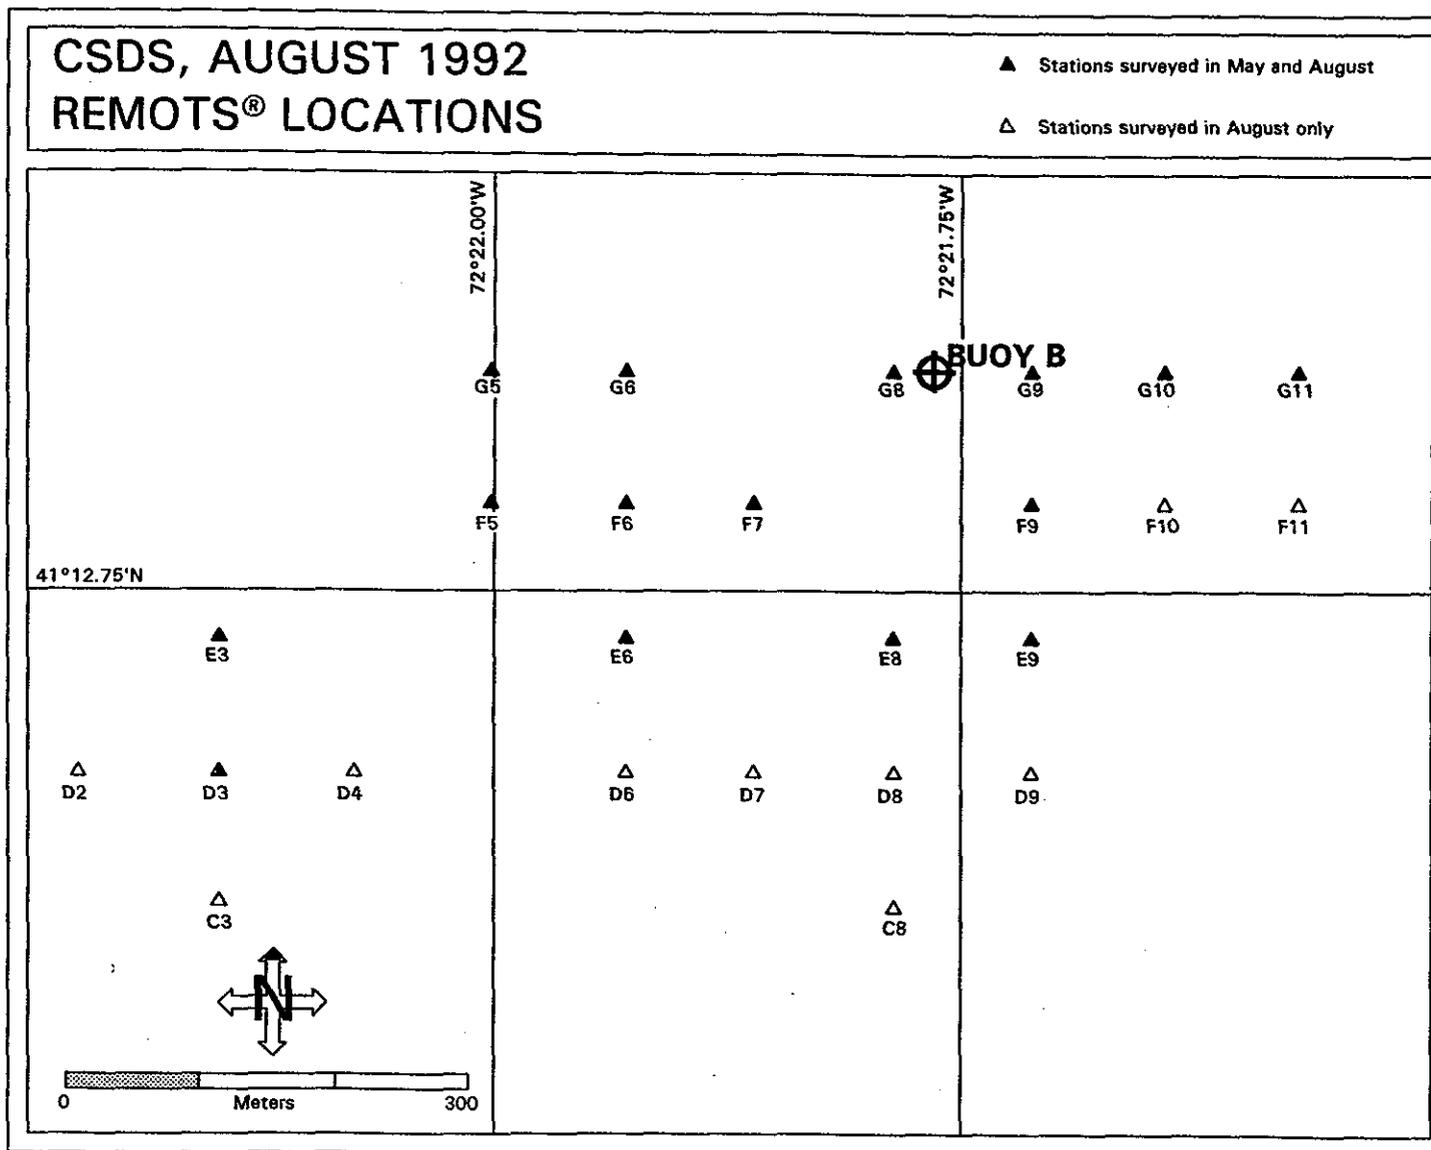
Figure 2-2. REMOTS® station locations at the Cornfield Shoals Disposal Site, August 1992

15 stations were resurveyed. Ten additional stations along the southern boundary of the dredged material deposit were surveyed at this time to map further the extent of the fine-grained dredged material documented in the May survey (Figure 2-2). Three replicates were taken at all stations. Analysis of the REMOTS[®] sediment-profile photographs was limited to grain size measurement, average penetration, and documentation of the presence of dredged material.

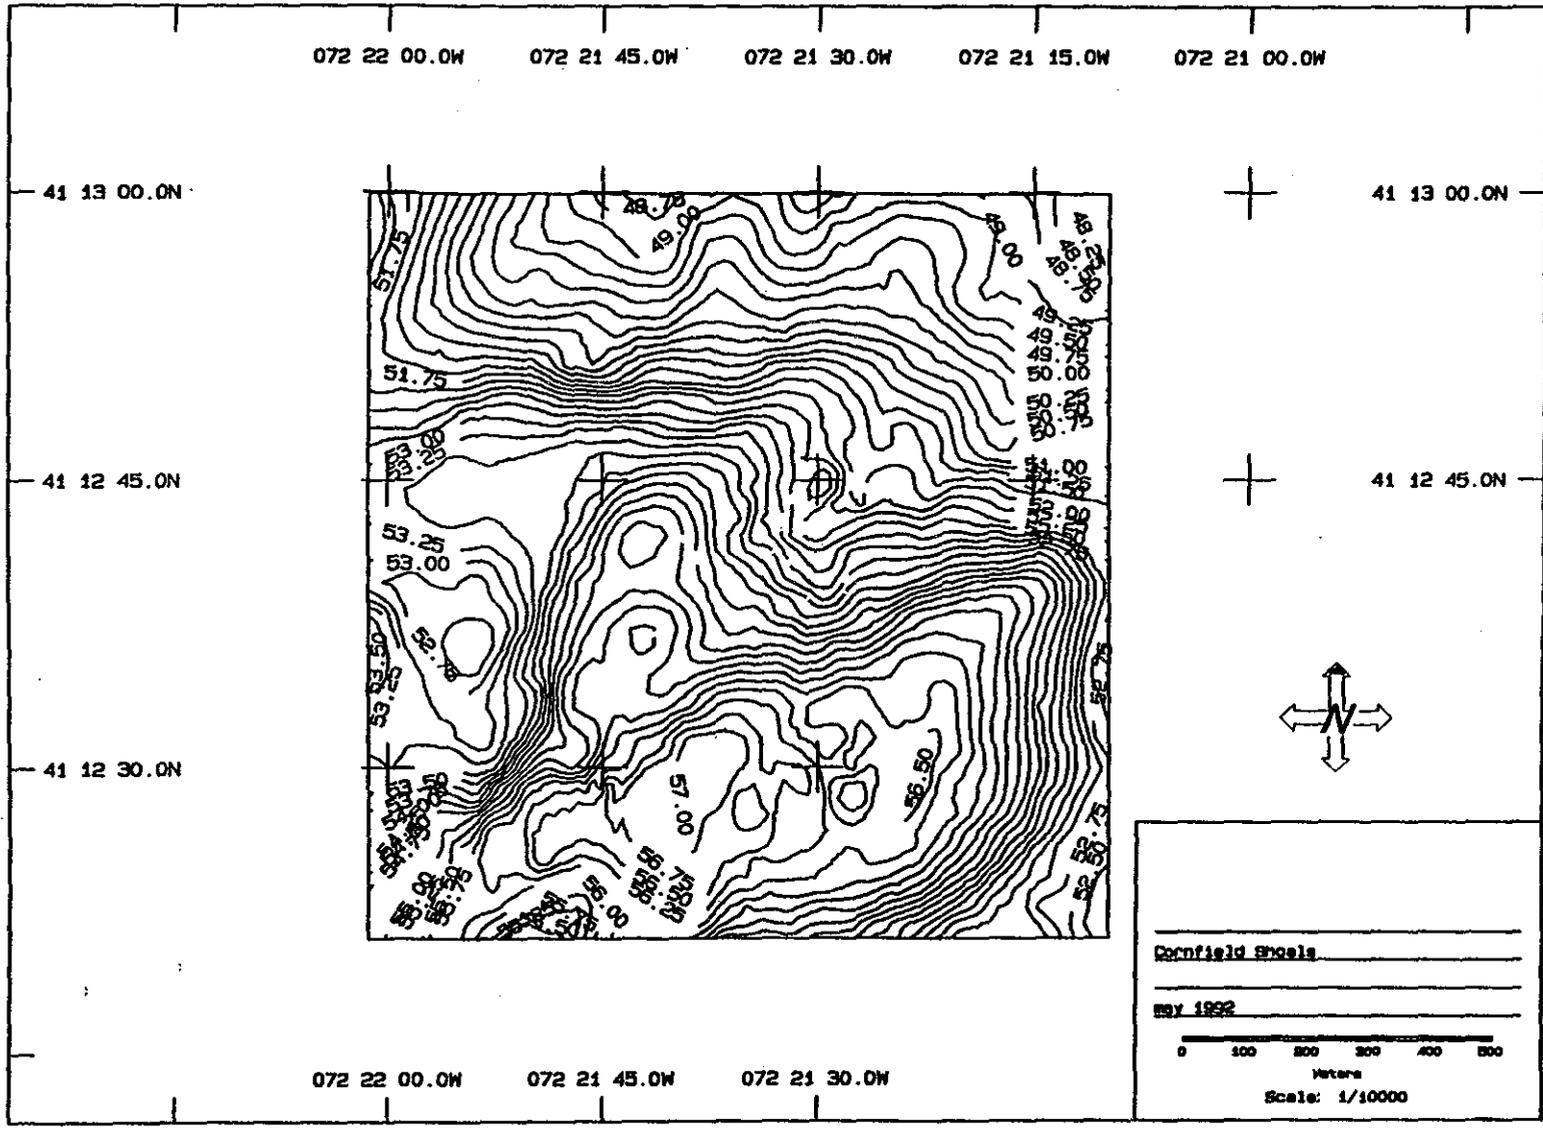
Figure 3-1. Bathymetric contour plot at the Cornfield Shoals Disposal Site, May 1992 (depth in meters)

The bathymetry at CSDS changed very little between May 1992 (Figure 3-1) and August 1992 (Figure 3-2). At approximately 72°21.75' W and 41°12.85' N, the mound formed by the disposal of fine-grained sediment from North Cove caused the contour lines to bend to the south in both surveys. South of 41°12.50' N, the contours in the August survey were slightly deeper and more convoluted than in May. This is the area where sand waves were recorded in the fathometer trace in May (Wiley 1994). Comparing depths in the two bathymetric surveys showed very little loss from May to August (Figure 3-3). Five areas of -20 cm depth difference exist, each a maximum of 75 m in diameter. Up to 40 cm of material had accumulated at 16 locations in the southern portion of the survey area from May to August (Figure 3-4). Each of these areas was less than 100 m in diameter.

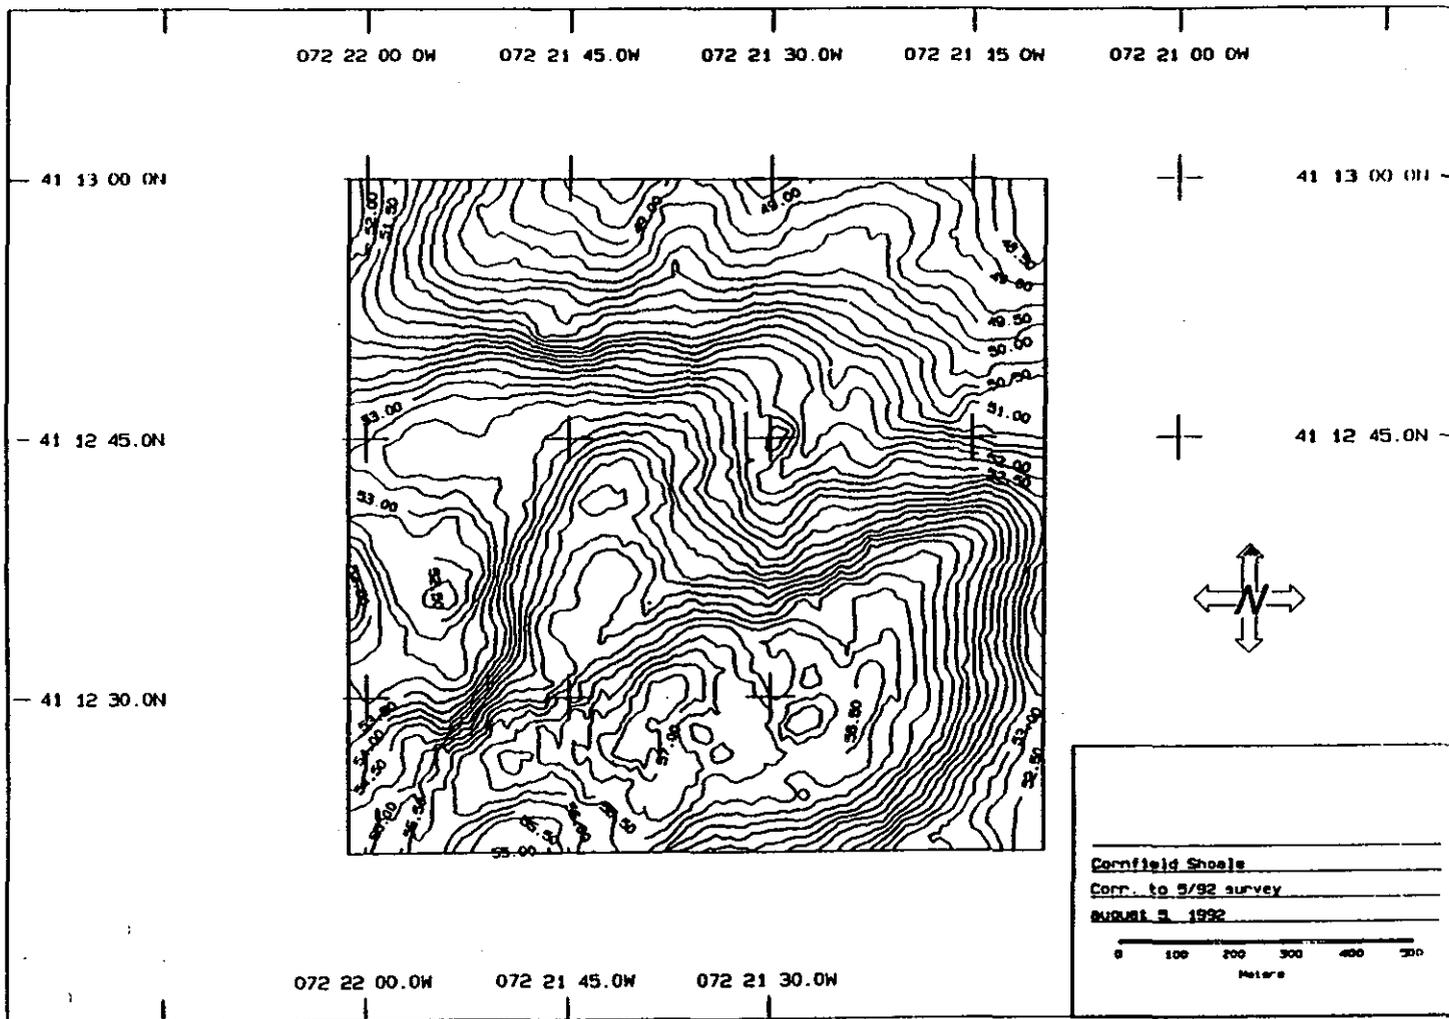
Figure 3-2. Bathymetric contour plot at the Cornfield Shoals Disposal Site, August 1992 (depth in meters)

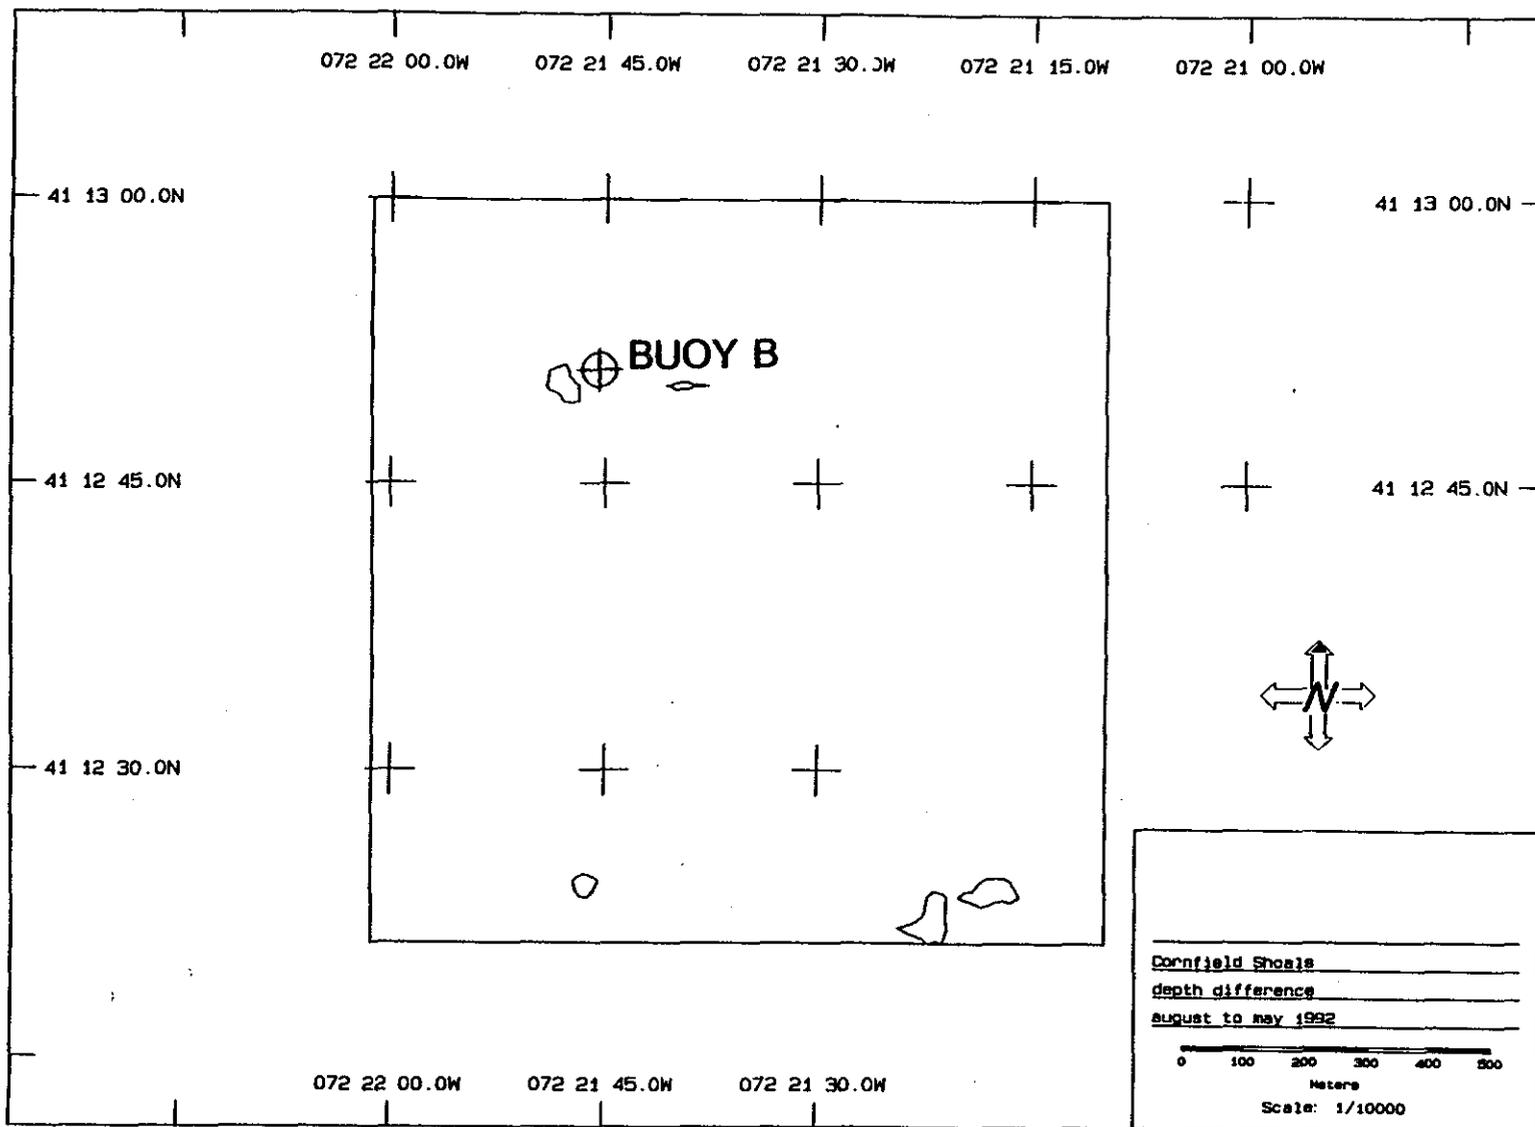
Figure 3-3. Negative depth difference contour plot between May 1992 and August 1992 (contours at 0.2 m)

At the North Cove buoy location, up to 50 cm of dredged material had accumulated between December 1991 and May 1992 (Wiley 1994). The two areas of 20 cm loss in August were to the east and west of this area of accumulation. Based on the bathymetric measurements, there was no change in the water depth at the center of the disposal mound between May and August, again supporting the relative stability of the fine-grained deposit.

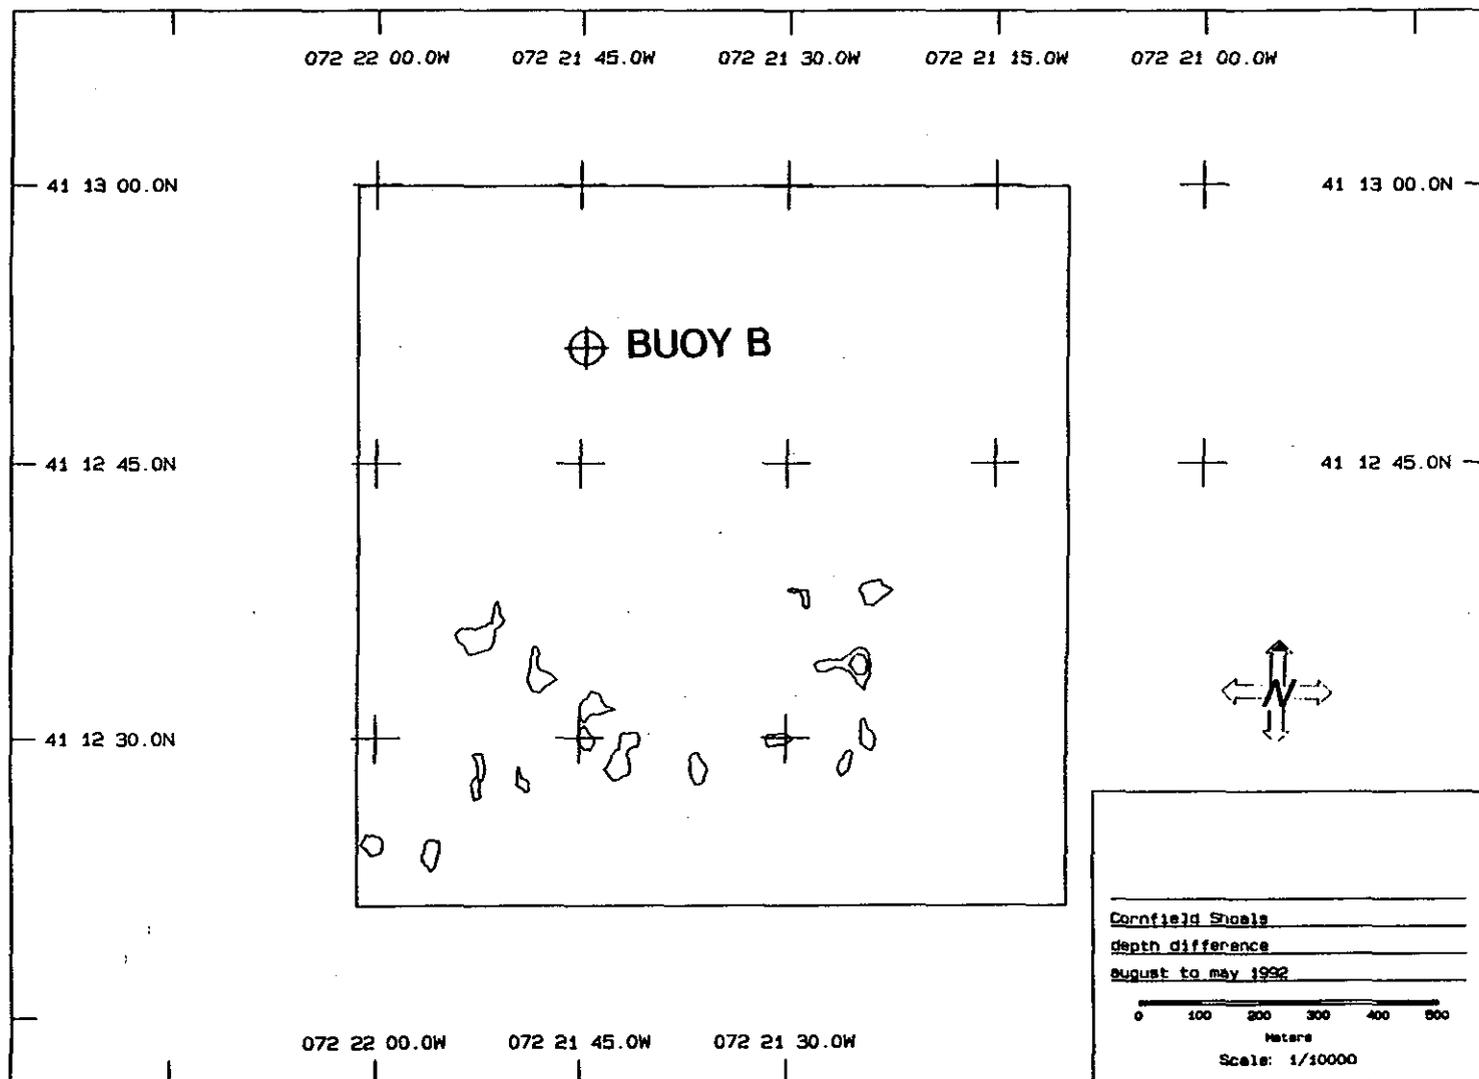
Figure 3-4. Positive depth difference contour plot between May 1992 and August 1992 (contours at 0.2 and 0.4 m)

Comparing the May to August bathymetric surveys showed a clustering of positive depth differences in the southern portion of the survey area. This coincides with the known location of a sand wave field. Migration of sand waves (part of the east-west transport supported by previous studies [Wiley 1994]) could have caused the accumulations noted between May and August 1992. The north-south alignment of the areas of accumulation are also parallel to the wave crests.

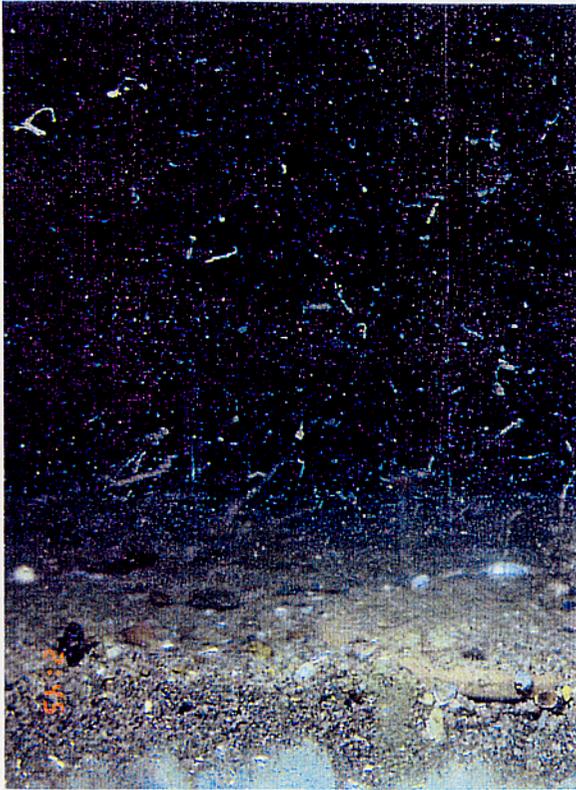
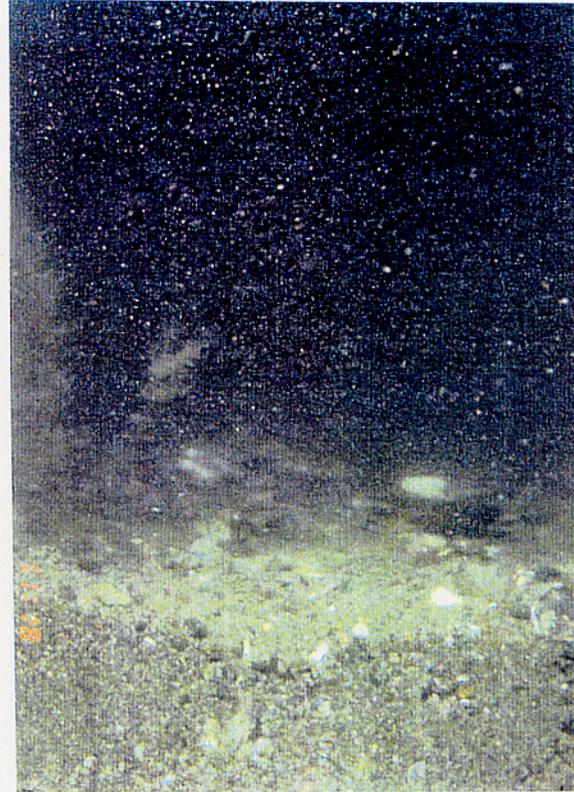
Figure 3-6. Station E3 showing sand/mud in May 1992 (A) and sand in August 1992 (B)

Of the 25 REMOTS® stations surveyed at CSDS in August 1992, two were fine-grained dredged material, and four were sand over mud. The remaining stations were sand (Figure 3-5). The two stations with fine-grained dredged material (G8 and G9) were located closest to the specified disposal point. Of the REMOTS® stations that were surveyed both in May and August 1992, E3, F6, F7, G5, G10, D3, F8, and E9 were sand over mud in May, but only sand was visible in August (Figure 3-6). Station F9 was ambient sandy sediment in May, but in August it was sand over dredged material (Figures 3-7 and 3-8). Stations G6, G8, and G9 remained unchanged. Sand is very difficult for the REMOTS® camera to penetrate; as a result, REMOTS® photographs taken at a sandy station usually have very low penetration and often do not show the subbottom structure. Ten new stations were surveyed in August to determine if there was any other fine-grained material at the site that had not been detected in May. Eight of these stations detected only sand, but D6 and D7 showed sand over fine-grained dredged material.

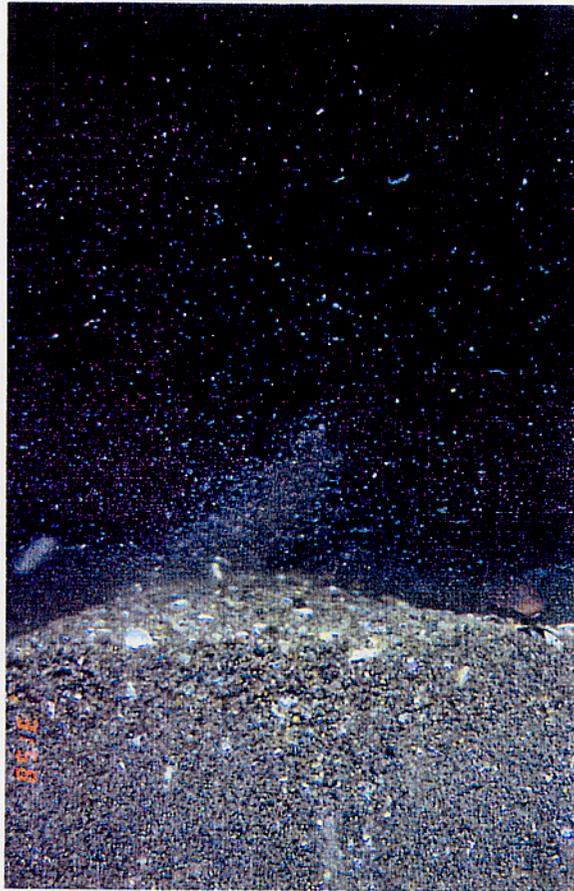
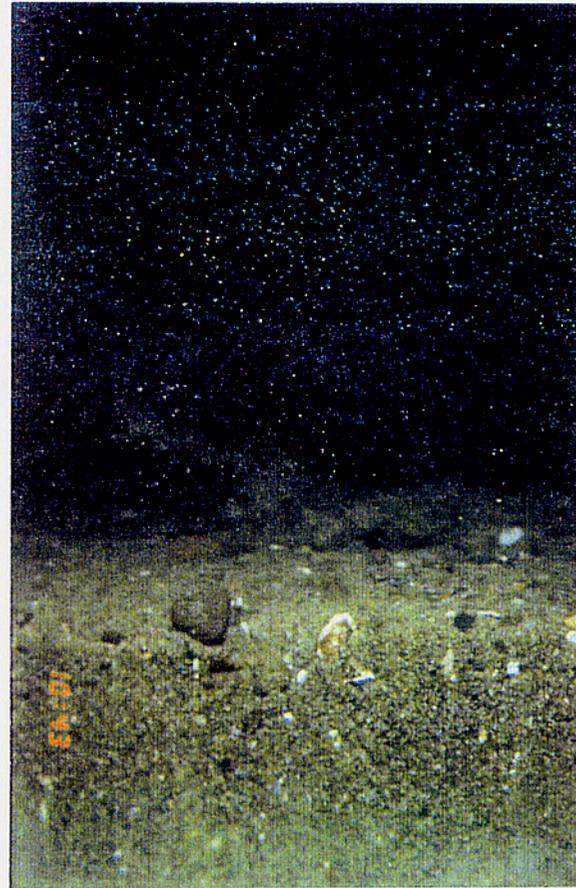
Figure 3-7. Station F9 in May 1992 (A) and August 1992 (B), showing change from ambient sandy sediment to sand over mud

The absence of any detectable accumulations where the sand had moved over the mud may be a result of compaction of the mud under the sand. The change at F9 from sand in May to sand over mud in August 1992 may have been due to a loss of sand, allowing the REMOTS® camera to penetrate through to the dredged material. The new stations surveyed in August detected mud under the sand at stations D6 and D7. This extended the previous estimation of the location of the fine-grained dredged material boundary to the south.

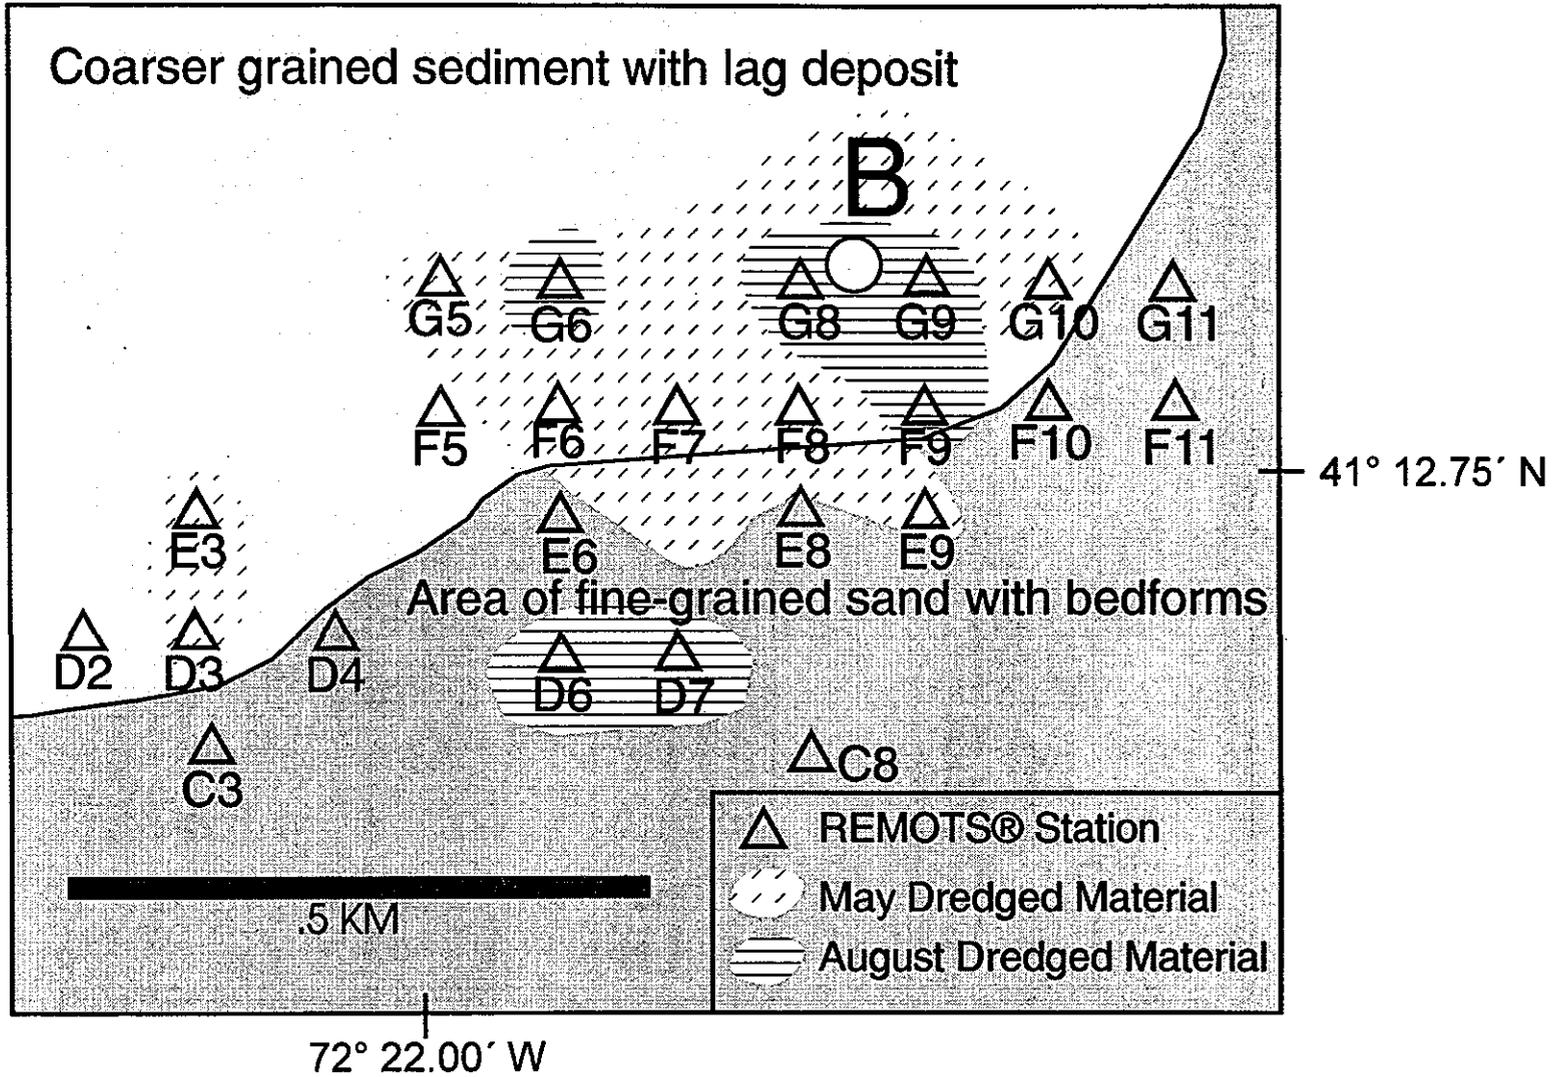
Figure 3-8. Sand and dredged material distribution at the Cornfield Shoals Disposal Site, May and August 1992

In addition to documenting the presence of ambient sand or fine-grained dredged material, the REMOTS® sediment-profile photographs showed variations in the sand grain size between stations and mapped the locations of sand waves or lag deposits. In both May and August, coarser grained sand with lag deposits of pebbles or shells was found north of 41°12.75' N, and finer grained sand with bed forms was found to the south (Figure 3-8).

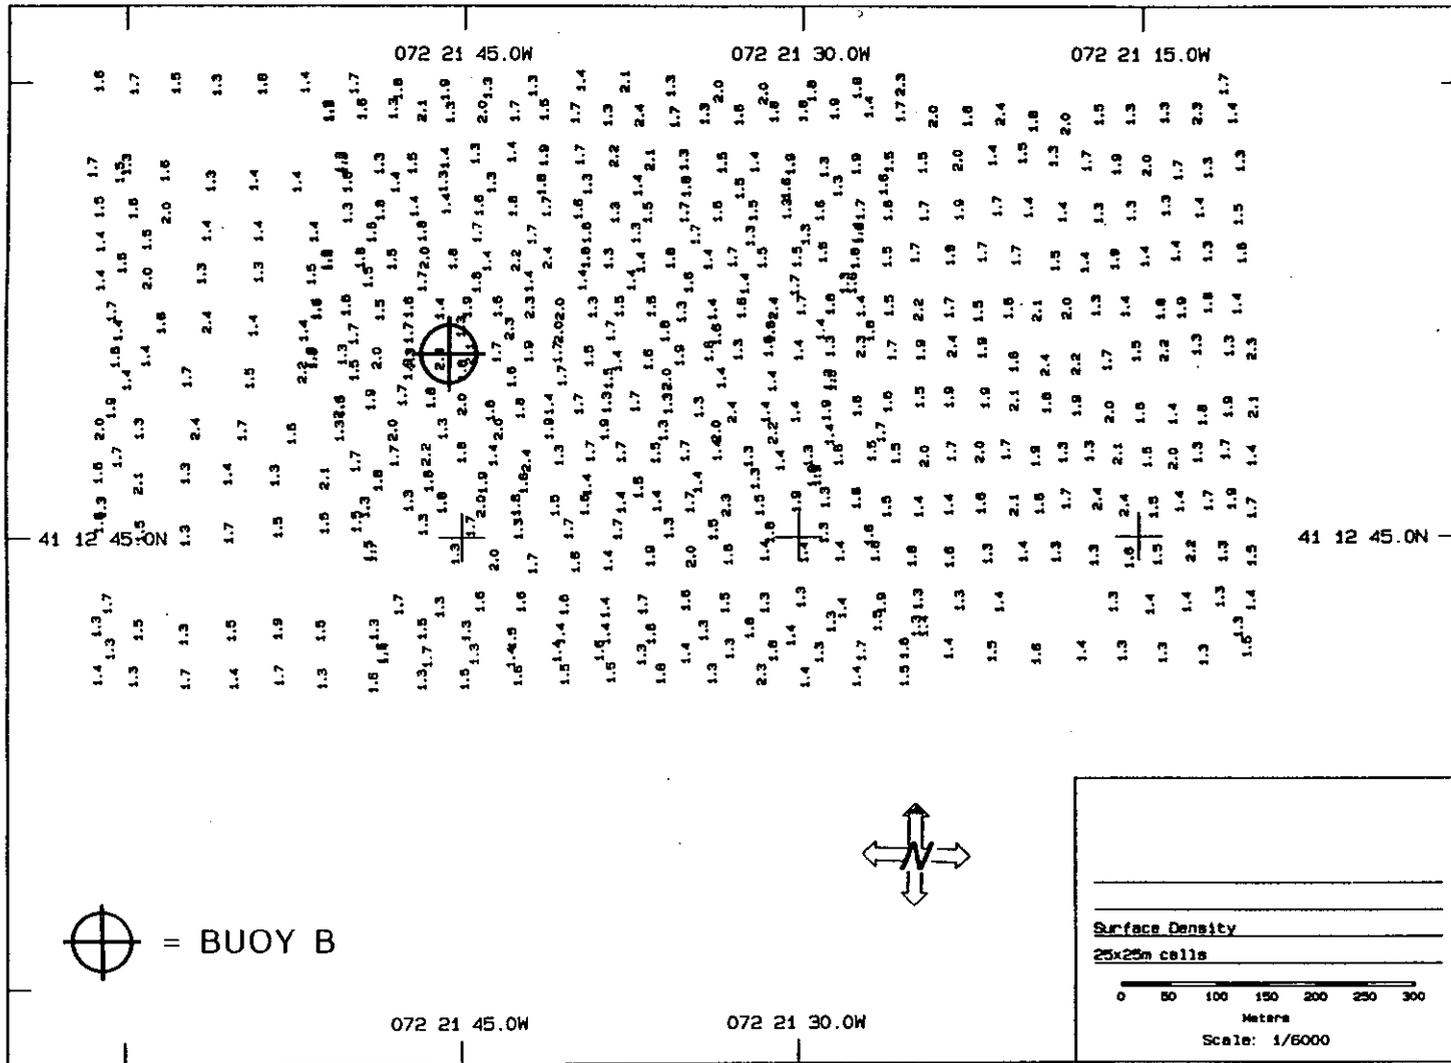
Figure 3-9. Smooth sheet of surface sediment density ($\text{g}\cdot\text{cc}^{-1}$) at the Cornfield Shoals Disposal Site, August 1992

Surface density data ranged from $1.3 \text{ g}\cdot\text{cc}^{-1}$ to $2.3 \text{ g}\cdot\text{cc}^{-1}$. The surface sediment density data show high variability between data points (Figure 3-9). At REMOTS® stations G8 and G9, where the median grain size mode was greater than 4 phi (silt/clay), the density values range from 1.5 to $1.8 \text{ g}\cdot\text{cc}^{-1}$. The remaining REMOTS® stations surveyed in August all had grain sizes of one to two phi (medium to fine sand) which should correspond to densities of more than $1.9 \text{ g}\cdot\text{cc}^{-1}$. The density data show values of $1.3 \text{ g}\cdot\text{cc}^{-1}$ and greater at all the REMOTS® locations. The contour plot of the density data (Figure 3-10) shows areas of relatively uniform density between 1.3 and $1.6 \text{ g}\cdot\text{cc}^{-1}$. Values greater than $1.6 \text{ g}\cdot\text{cc}^{-1}$ (Figure 3-11) are concentrated north of $41^{\circ}12.75' \text{ N}$.

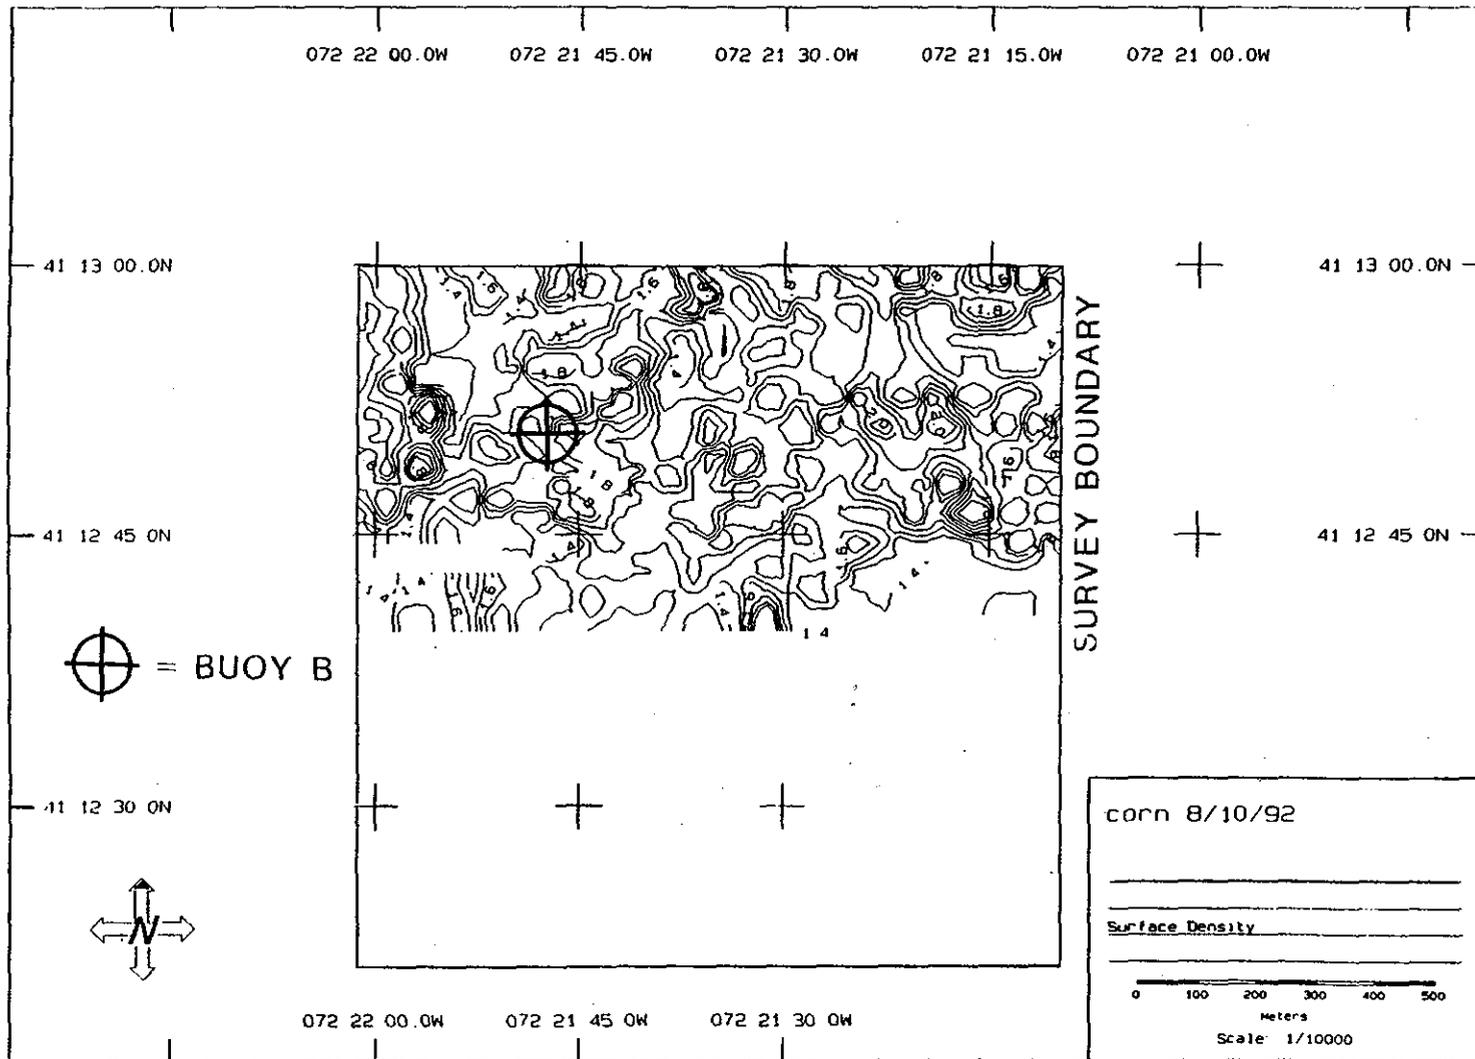
Figure 3-10. Contour plot of surface sediment density ($\text{g}\cdot\text{cc}^{-1}$) at the Cornfield Shoals Disposal Site, August 1992.

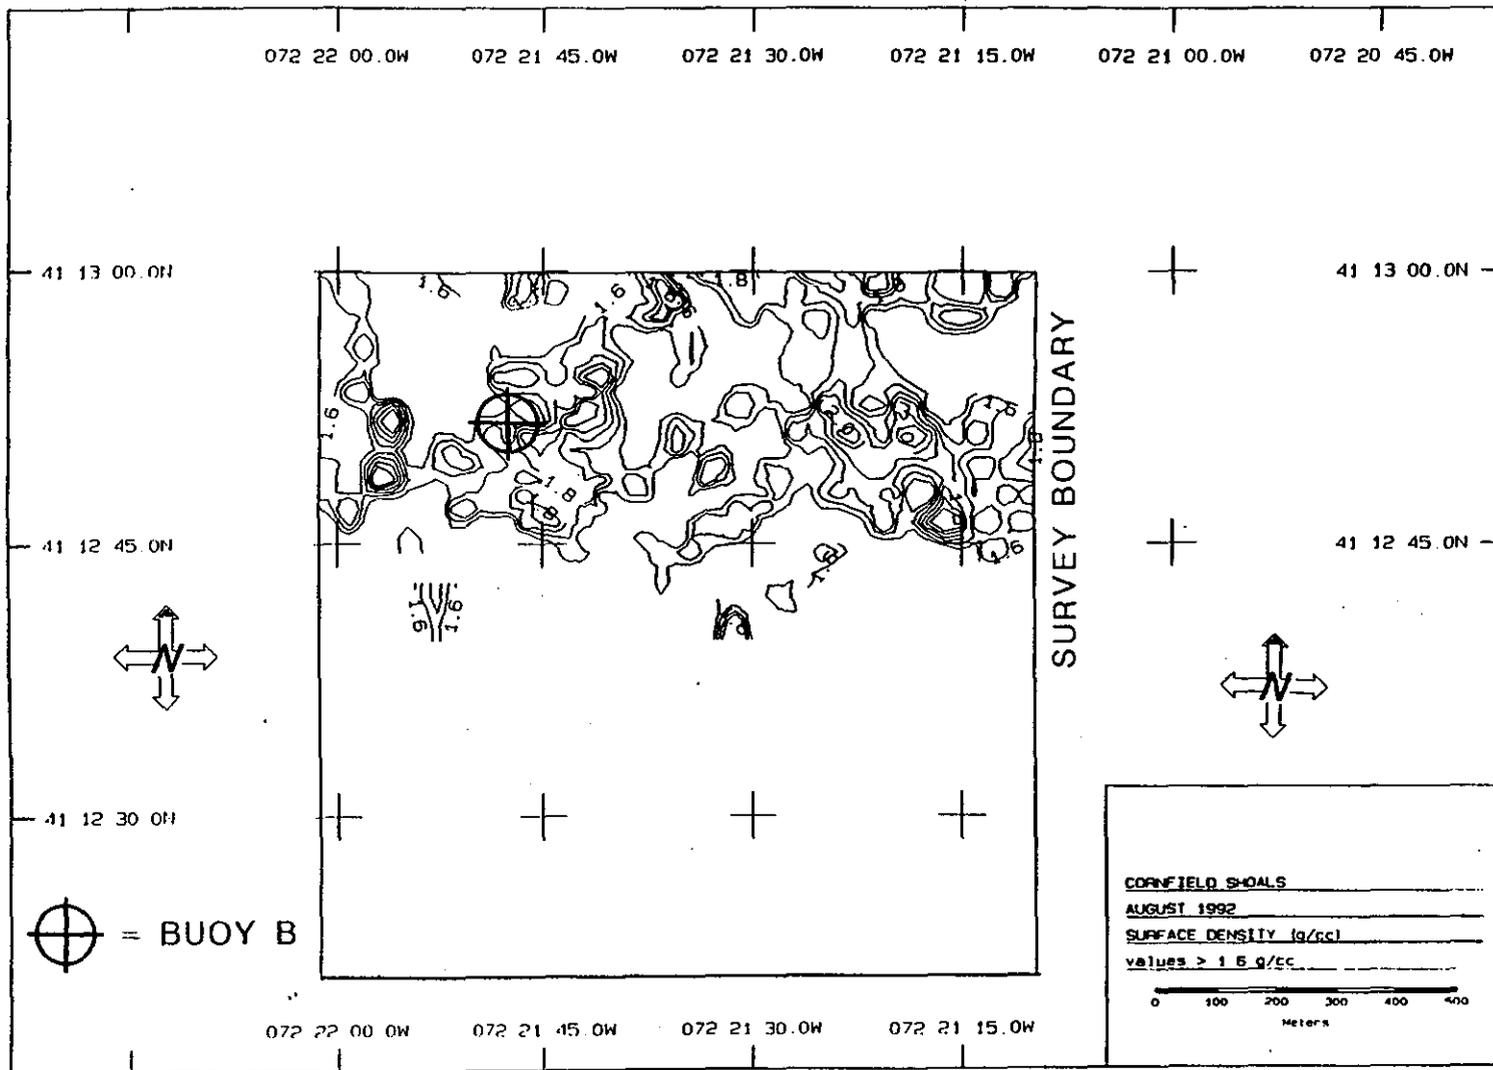
Figure 3-11. Surface sediment density values $> 1.6 \text{ g}\cdot\text{cc}^{-1}$
