Monitoring Cruise at the
Cornfield Shoals Disposal Site
August 1992

Disposal Area Monitoring System DAMOS

Contribution 106
January 1996

**US Army Corps
of Engineers**
New England Division

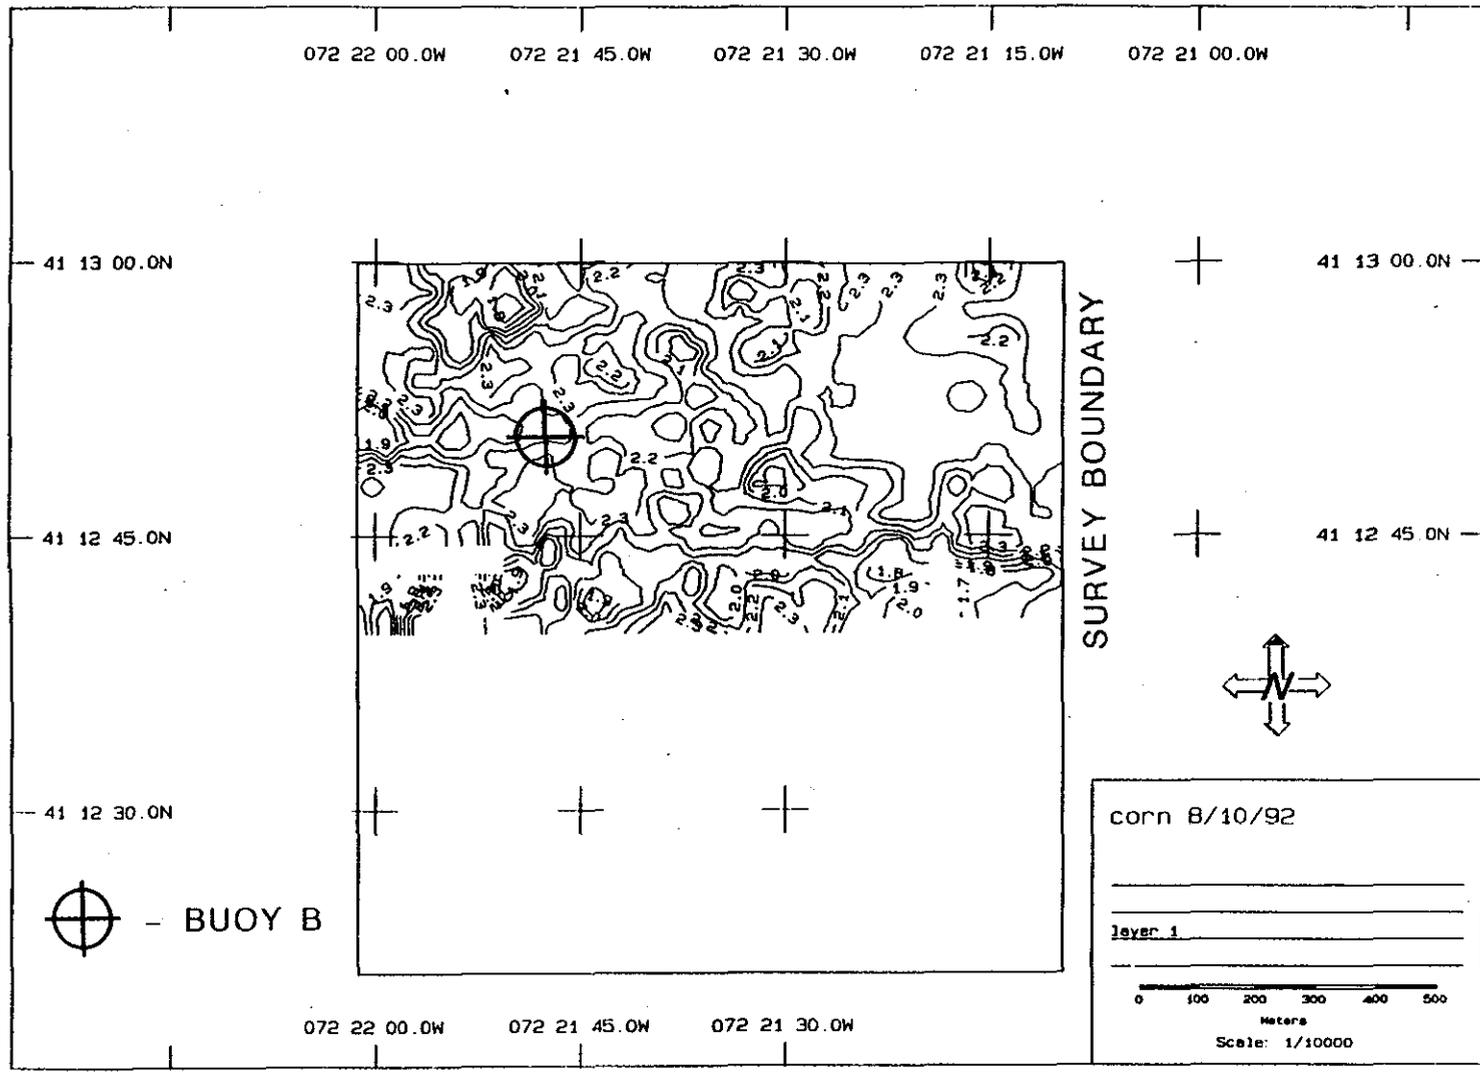
Figure 3-12. Sediment density (g·cc⁻¹) at the Cornfield Shoals Disposal Site, approximately 15 cm below the sediment surface

Subsurface sediment density at CSDS was collected at 15 cm intervals below the surface. Data was collected for multiple intervals although attenuation and data degradation prevented any realistic analysis on all but the initial layer. The contour plot of the density values of the first layer (15 cm below the sediment water interface) shows an increase in density at all points of the survey (Figure 3-12).

Subsurface density values were collected by the 24 kHz acoustic survey at 15 cm intervals below the seafloor. If the fine-grained material had been detected by this system (i.e., the mud was located at 15 or 30 cm below the surface), there would have been a corresponding drop in density values. The density results around the mound (at 15 cm below the seafloor) all exceed $2.0 \text{ g}\cdot\text{cc}^{-1}$. In the REMOTS® photographs, the top of the fine-grained deposit was detected within 8 cm from the seafloor. Only if the deposit exceeded 7 cm thick would it have been discernible by the subbottom system. Based on depth differences before and after the deposit of the North Cove material, the mound formed was 50 cm high at its apex. This is reason to believe that there should have been fine-grained material detected in the 24 kHz acoustic survey.
