An Investigation of the Dispersion  
of Sediments Resuspended by  
Dredging Operations in New Haven Harbor

# **Disposal Area Monitoring System DAMOS**

Contribution 112  
November 1996

**US Army Corps  
of Engineers**  
New England Division

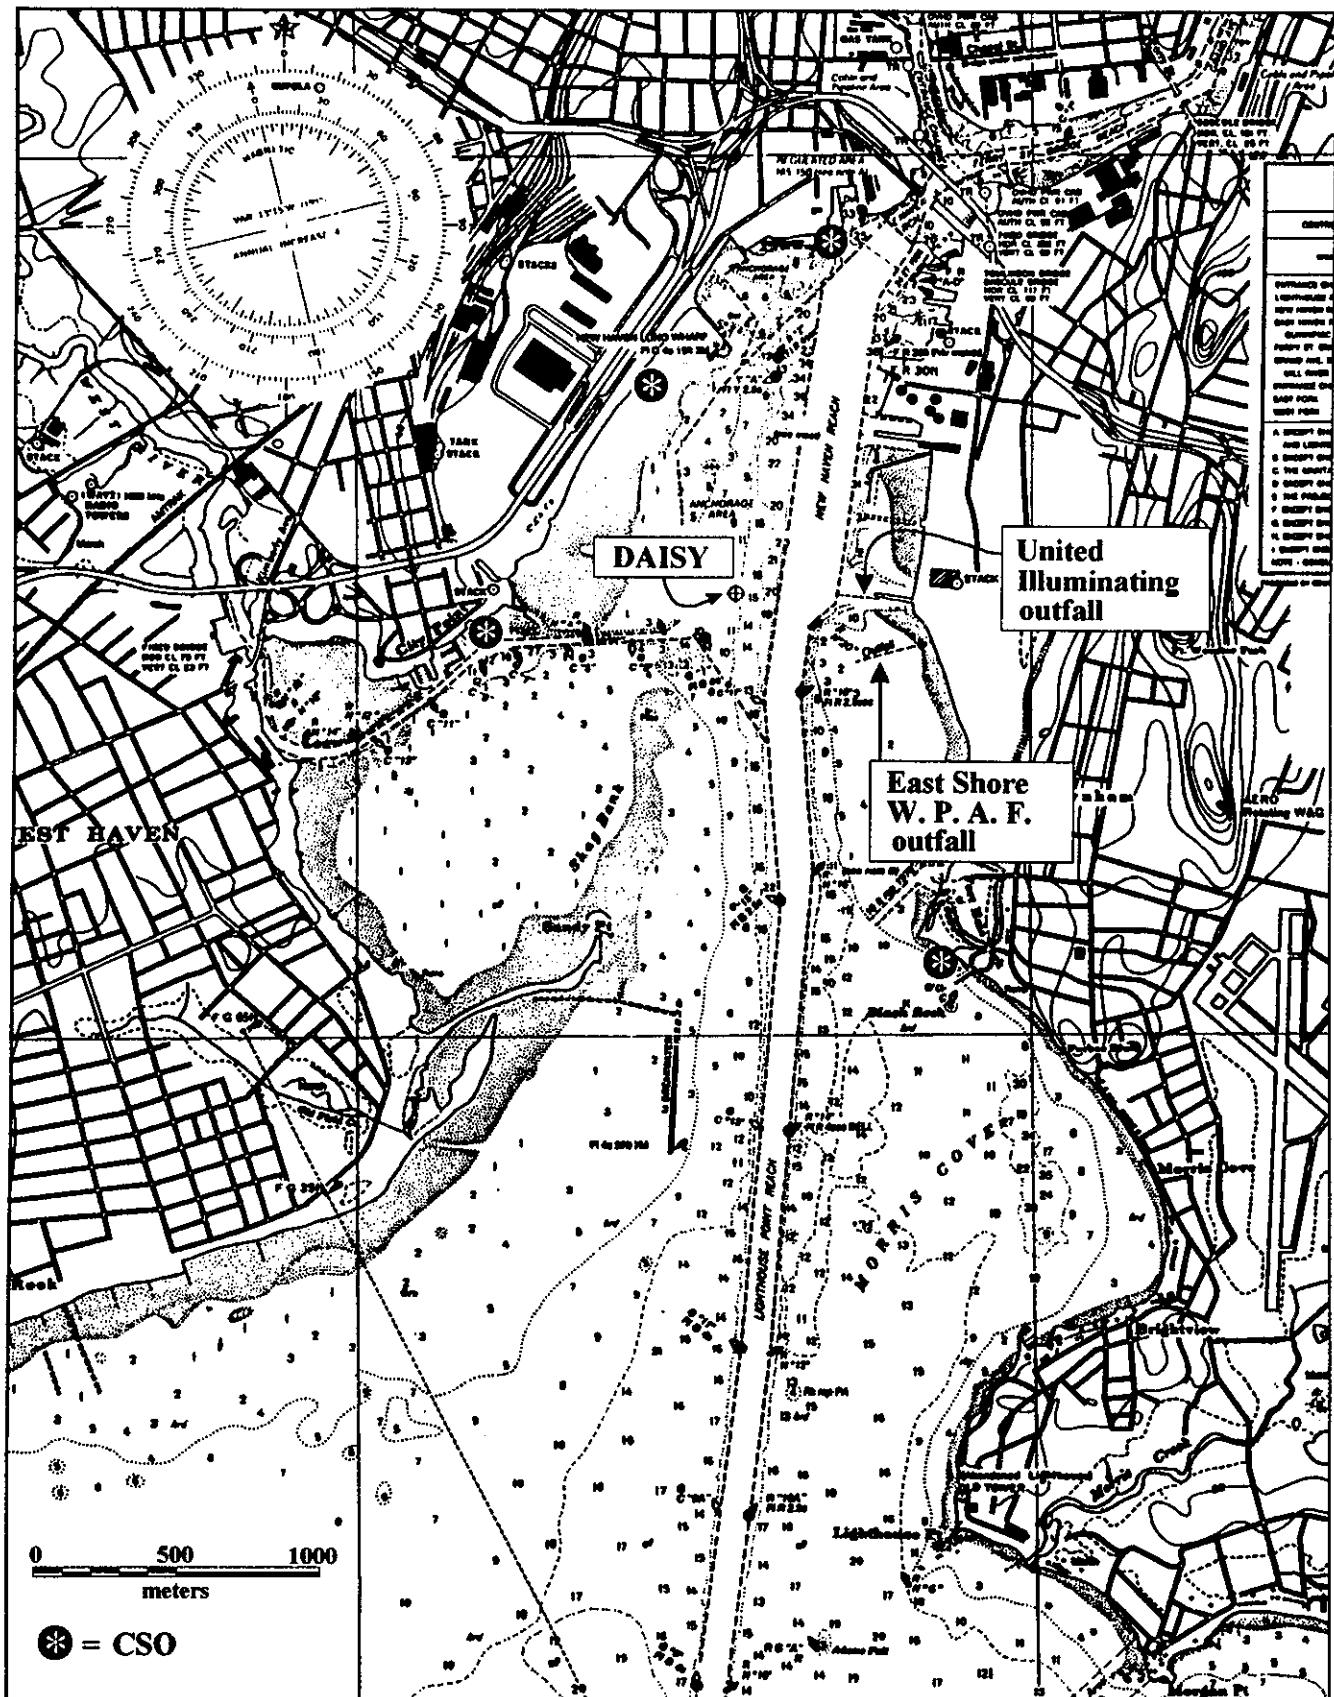
**Figure 1-1.** Bathymetric chart of the study area, New Haven Harbor, CT (from NOAA Nautical Chart #12371 - Scale 1:12, 800)

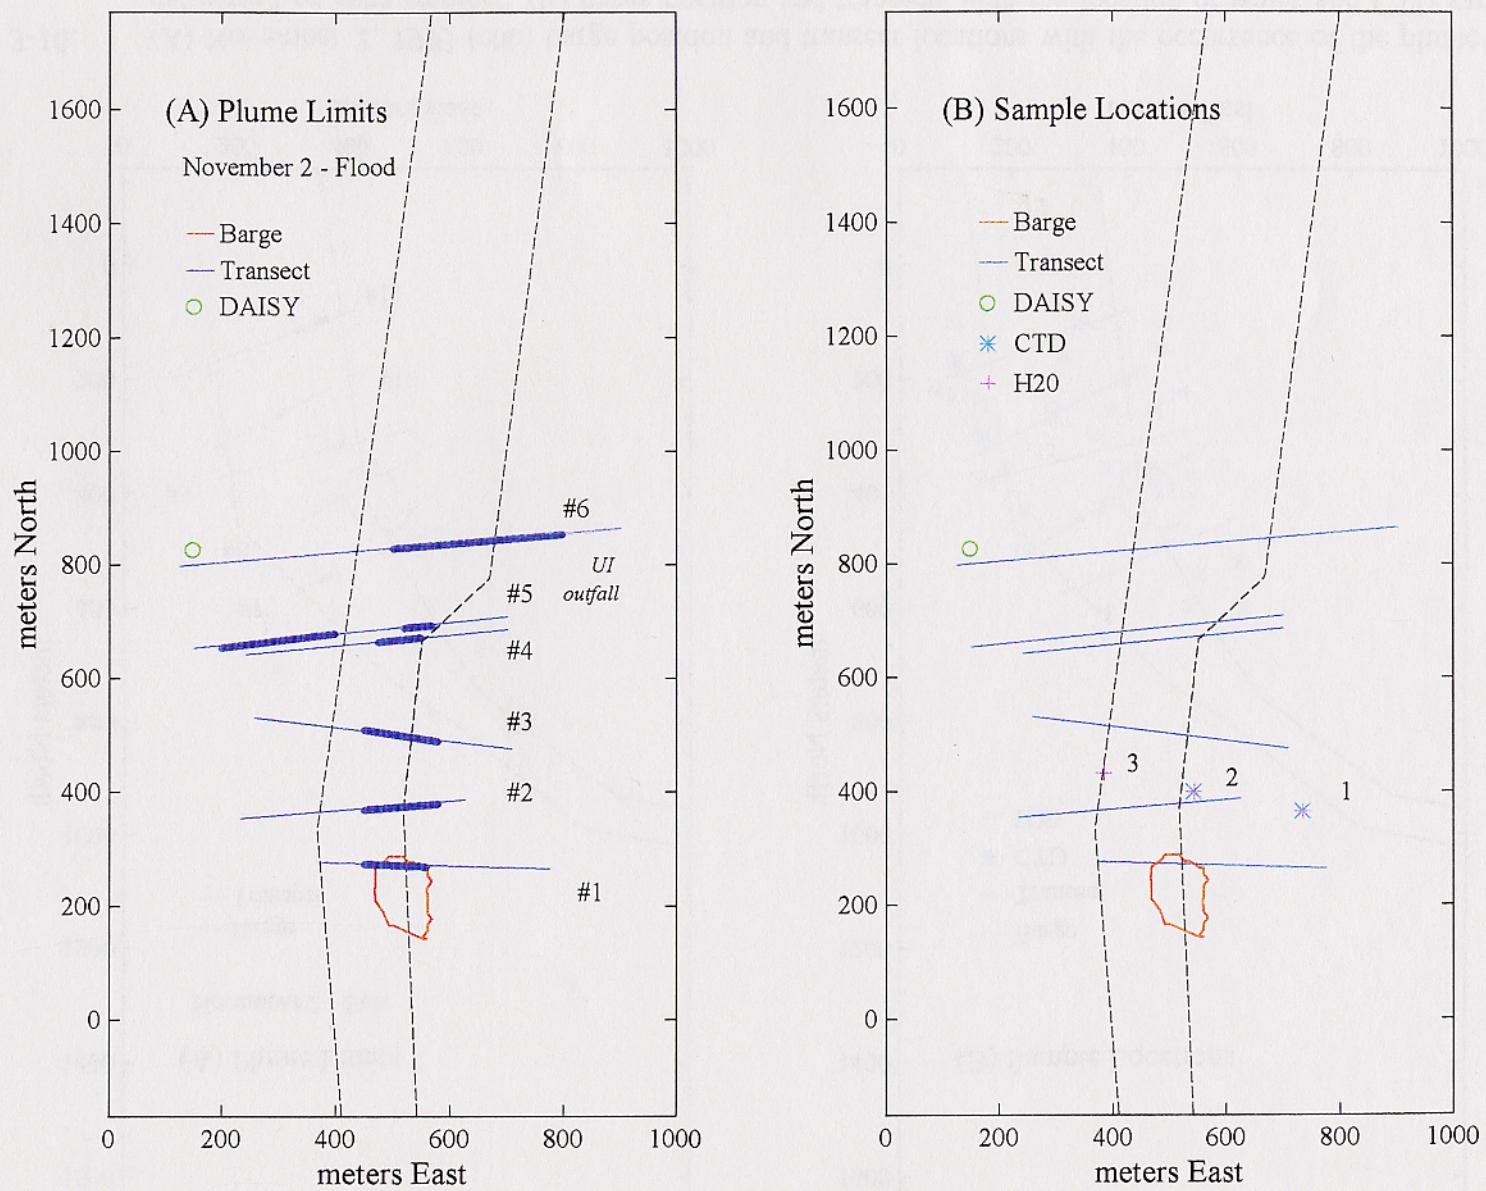
**Figure 3-9.** (A) November 2, 1993 (flood) barge position and transect locations with the occurrence of the plume delineated on each transect; (B) barge position and transects with the location of water and CTD samples

Two surveys were completed on November 2. A survey was run during maximum flood while the dredge was stationed south of the Gateway Marine Terminal (Figure 3-9) and another survey was conducted during the early ebb, after the barge moved north of the terminal (Figure 3-10). The flood survey indicated that the plume extended northward for approximately 400 meters. The United Illuminating outfall, located approximately 600 meters north of the barge, obscured the plume signal, and plume tracking in this region was terminated. A small patch of the plume was observed to the west of the main channel, in 6 meters of water, 400 meters north of the barge (Figure 3-11). The survey run during the beginning of the ebb shows that considerably smaller patches of the plume were advected along the channel for a distance of approximately 250 meters south of the barge (Figure 3-12). A small patch was observed 150 meters north of the barge, possibly a relict from the previous flood. Dredge operations stopped and started throughout the survey, which may explain the smaller, more variable nature of the patches. The CTD data, collected during the early ebb, shows only slight density stratification (2-3 psu) within the top 2 meters, due mainly to the proximity to upstream sources of fresher water, i.e., the Mill and Quinnipiac Rivers. Surface to bottom temperature differences were less than a degree.

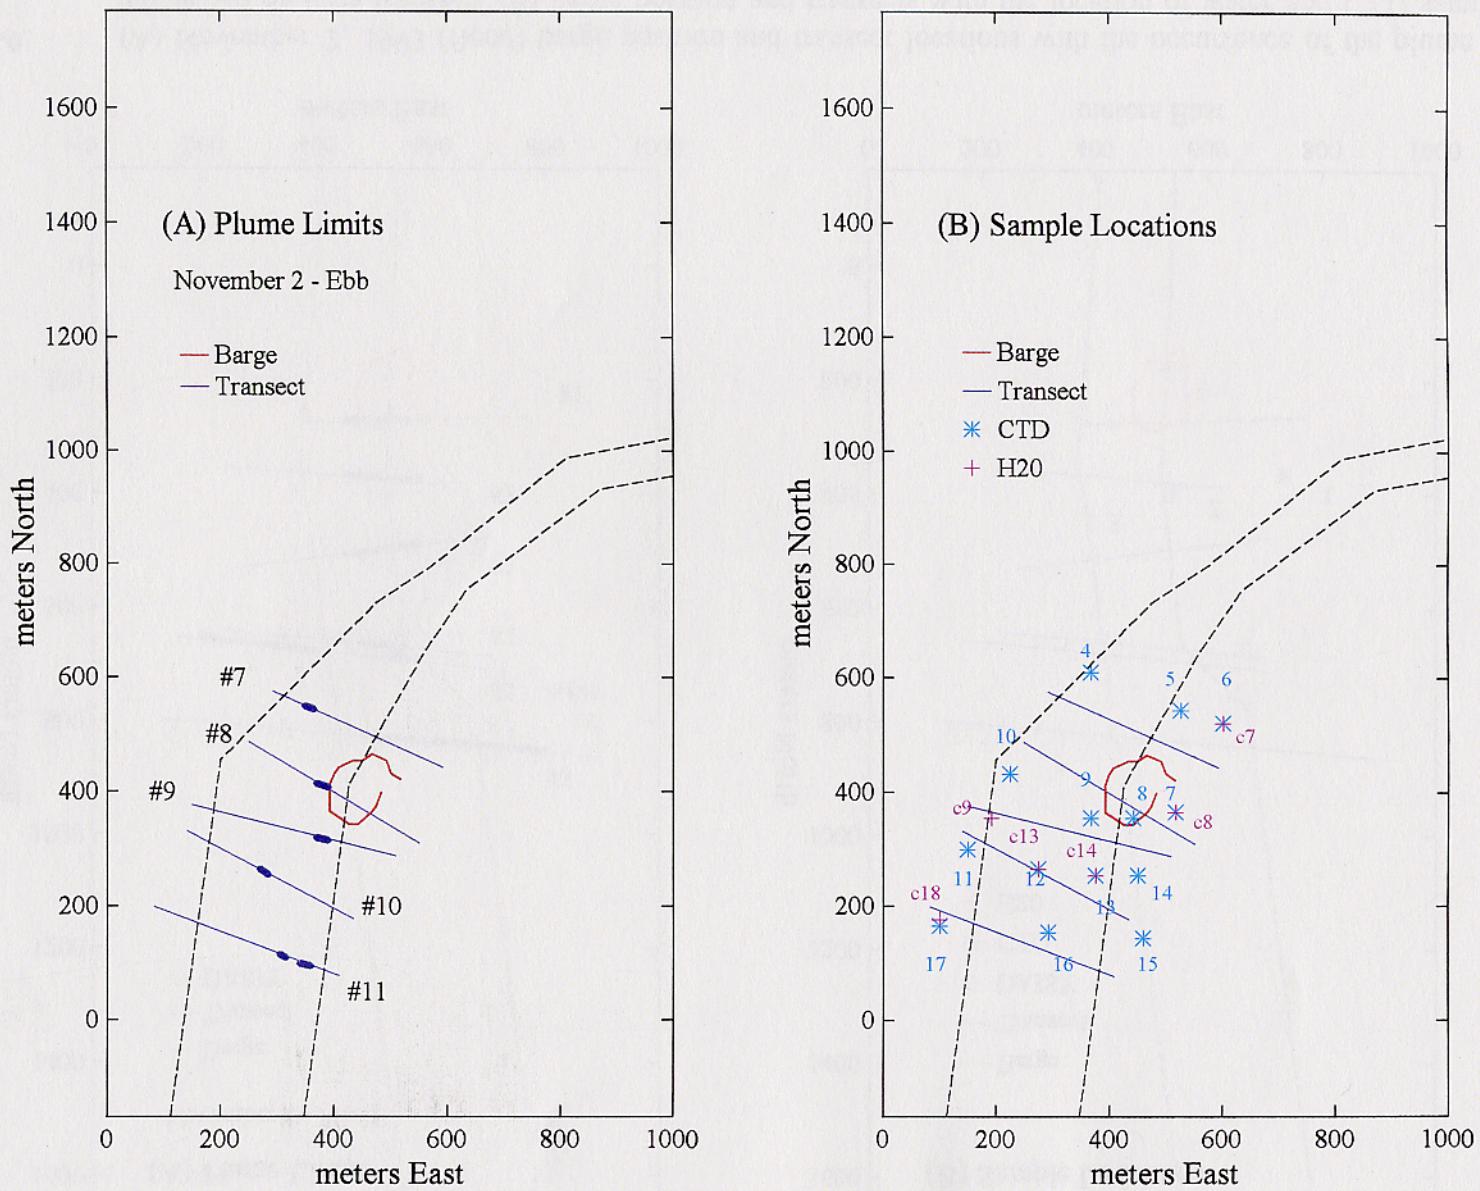
**Figure 3-10.** (A) November 2, 1993 (ebb) barge position and transect locations with the occurrence of the plume delineated on each transect; (B) barge position and transects with the location of water and CTD samples

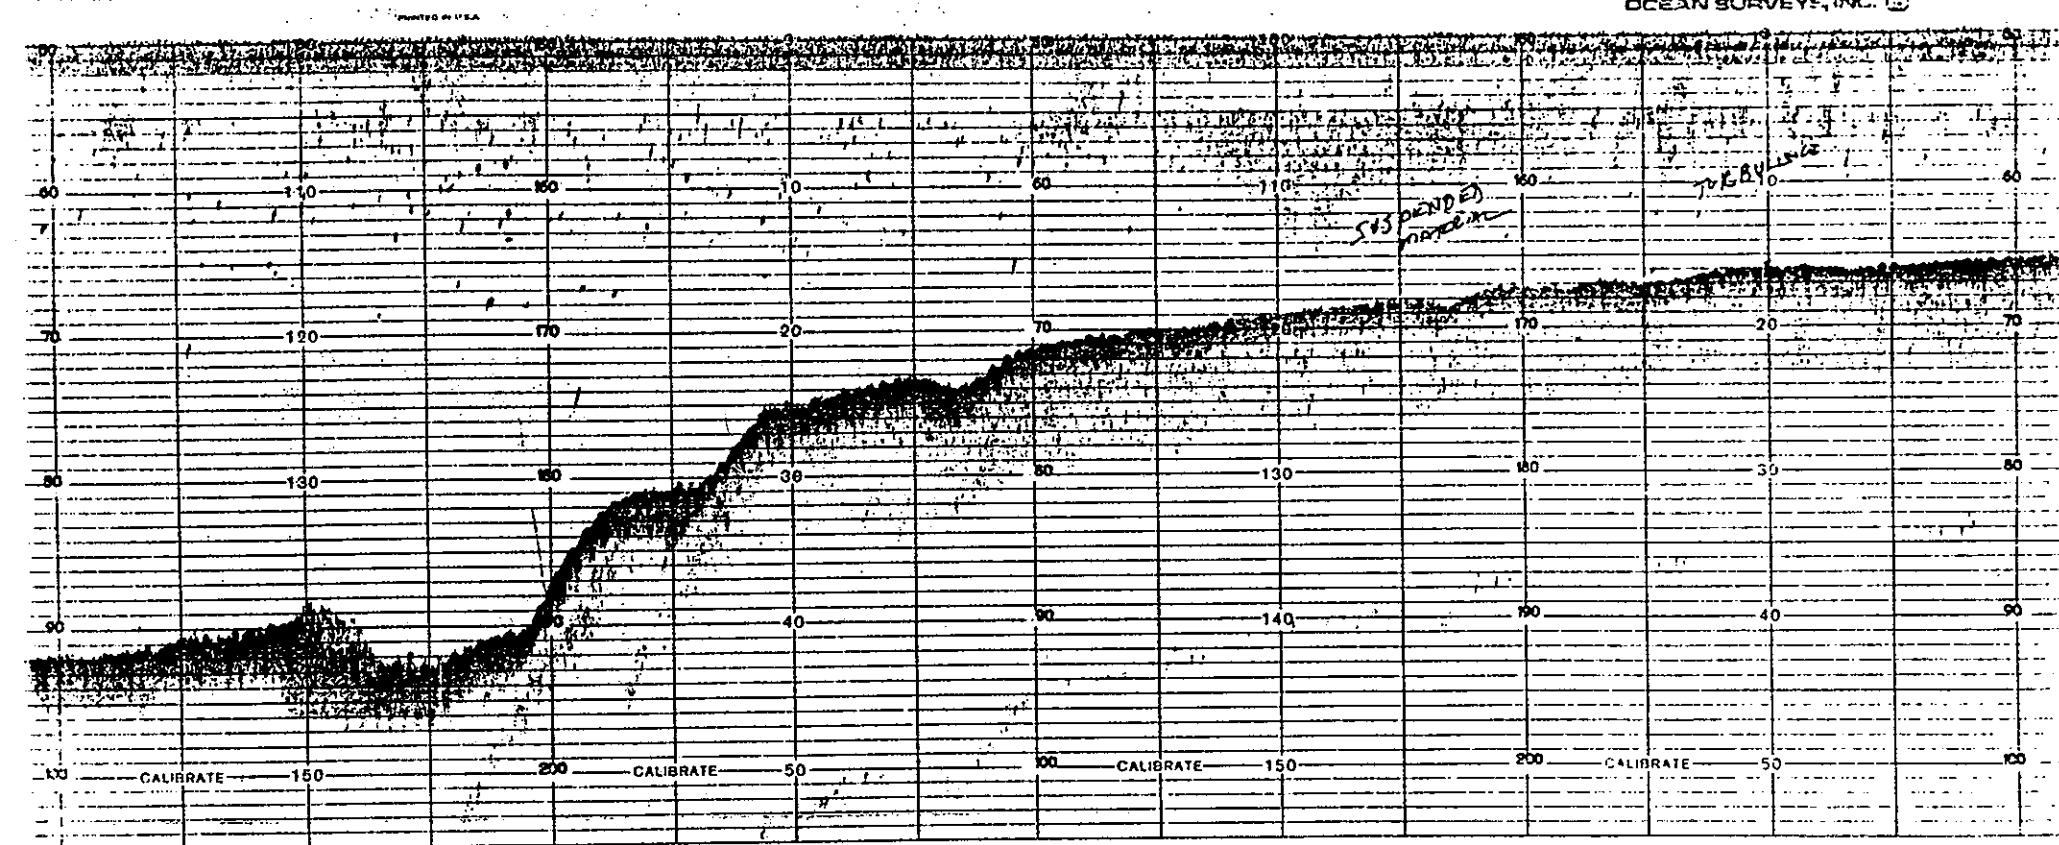
**Figure 3-11.** Patch of the plume observed while running Transect #5, 400 meters downcurrent and out of navigation channel, November 2. Profile runs east to west.

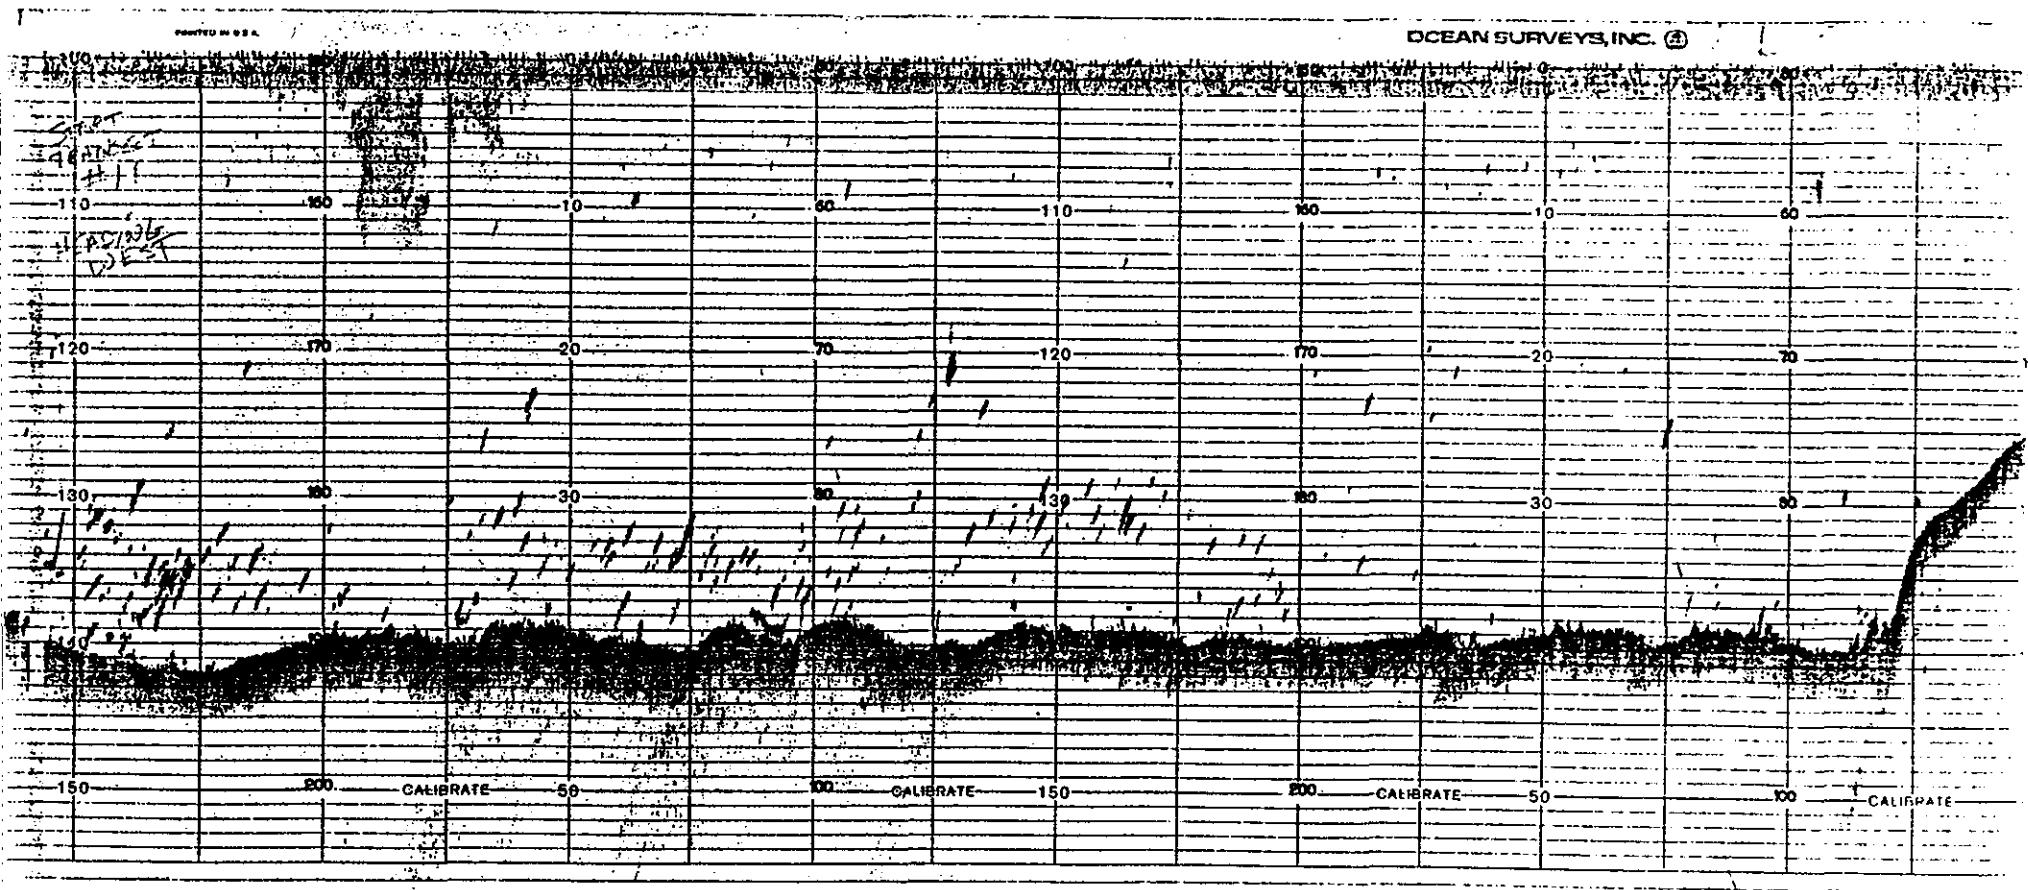
**Figure 3-12.** Transect #11, showing a plume patch that has been advected 250 meters downcurrent along the eastern side of the navigation channel. Profile runs east to west.

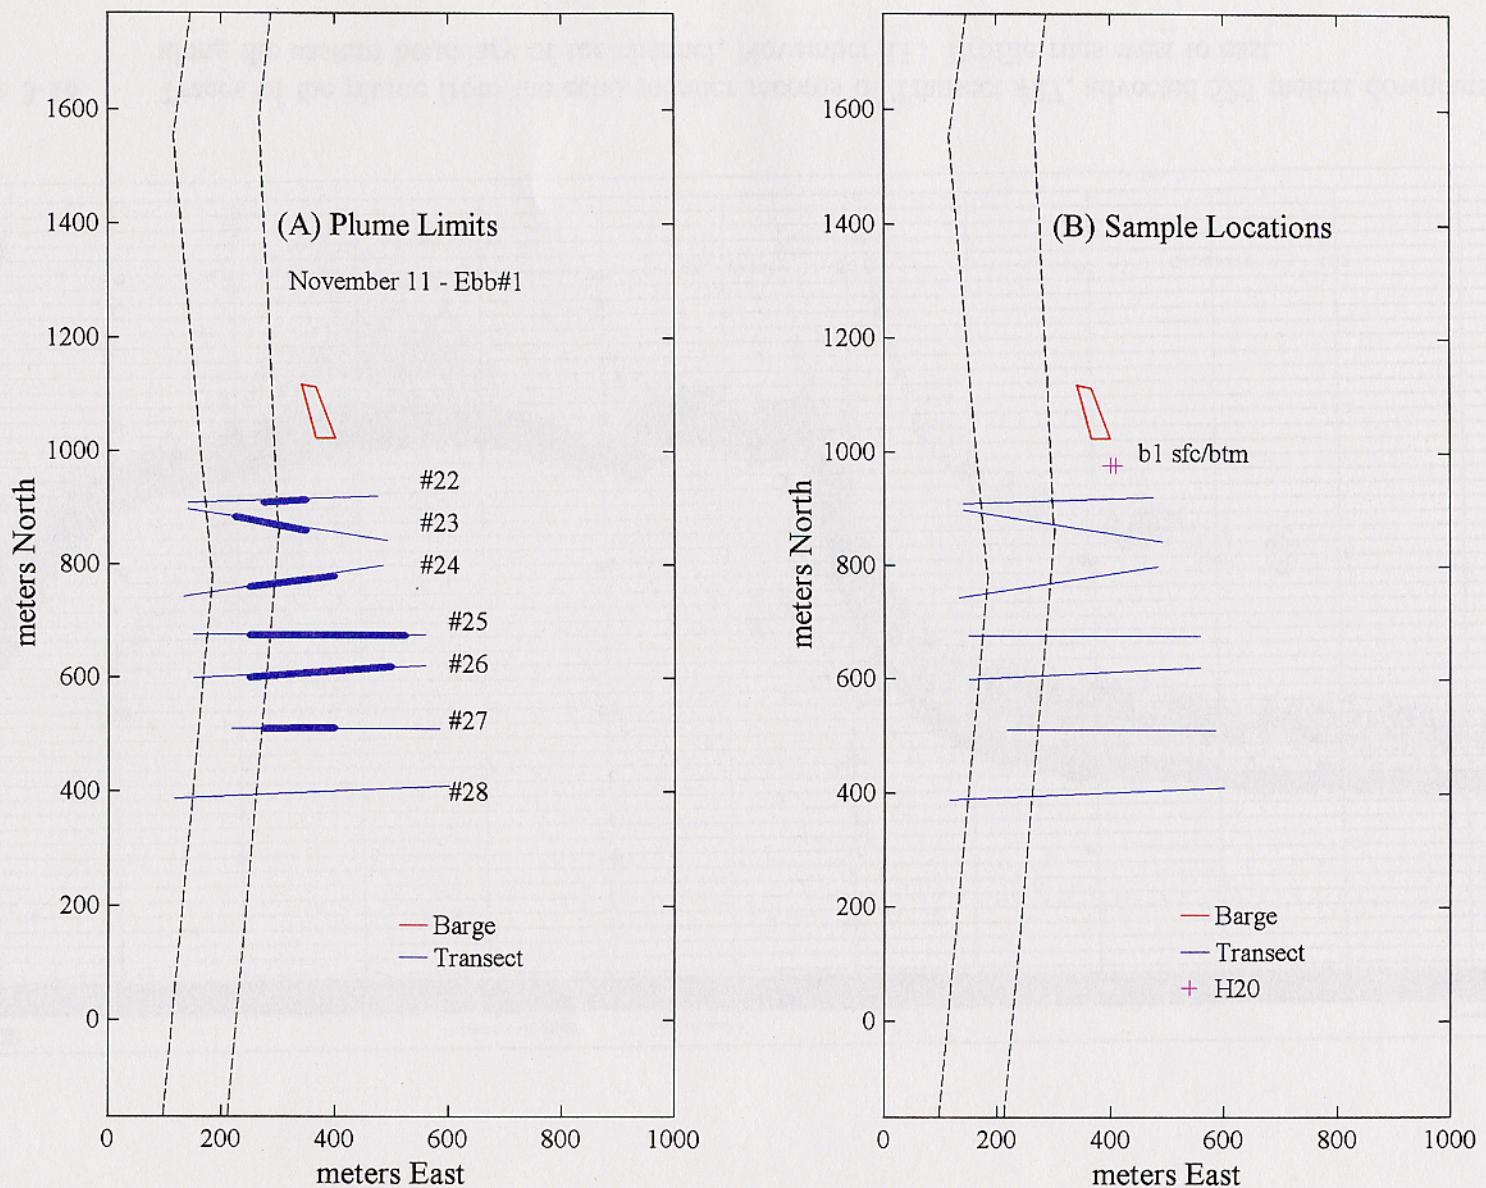
**Figure 3-15.** (A) November 11, 1993 (first ebb survey) barge position and transect locations with the occurrence of the plume delineated on each transect; (B) barge position and transects with the location of water samples

The dredge was located near buoy "16" (Figure 3-15) during two ebb surveys conducted on November 11. Results of the first ebb survey, run during maximum ebb currents, indicated that the plume traveled approximately 525 meters downstream along the east bank of the channel (Figure 3-16) with excursions of 200 meters eastward onto the adjacent shoals. The second survey (Figure 3-17), during the latter half of the ebb, shows the plume again hugging the east bank for a distance of only 200 meters (Figures 3-18). Currents were slack by the end of the last transect. The majority of the plume observed during this second survey resides in deeper water with only minimal excursions (within 50 meters) over the adjoining shallows. Plume distributions in this area display some of the characteristics of a density current, i.e., a gravitationally induced density contrast between the sediment-laden plume and ambient waters (Figure 3-19). CTD casts, taken between the two surveys, indicate a well mixed water column with negligible stratification.

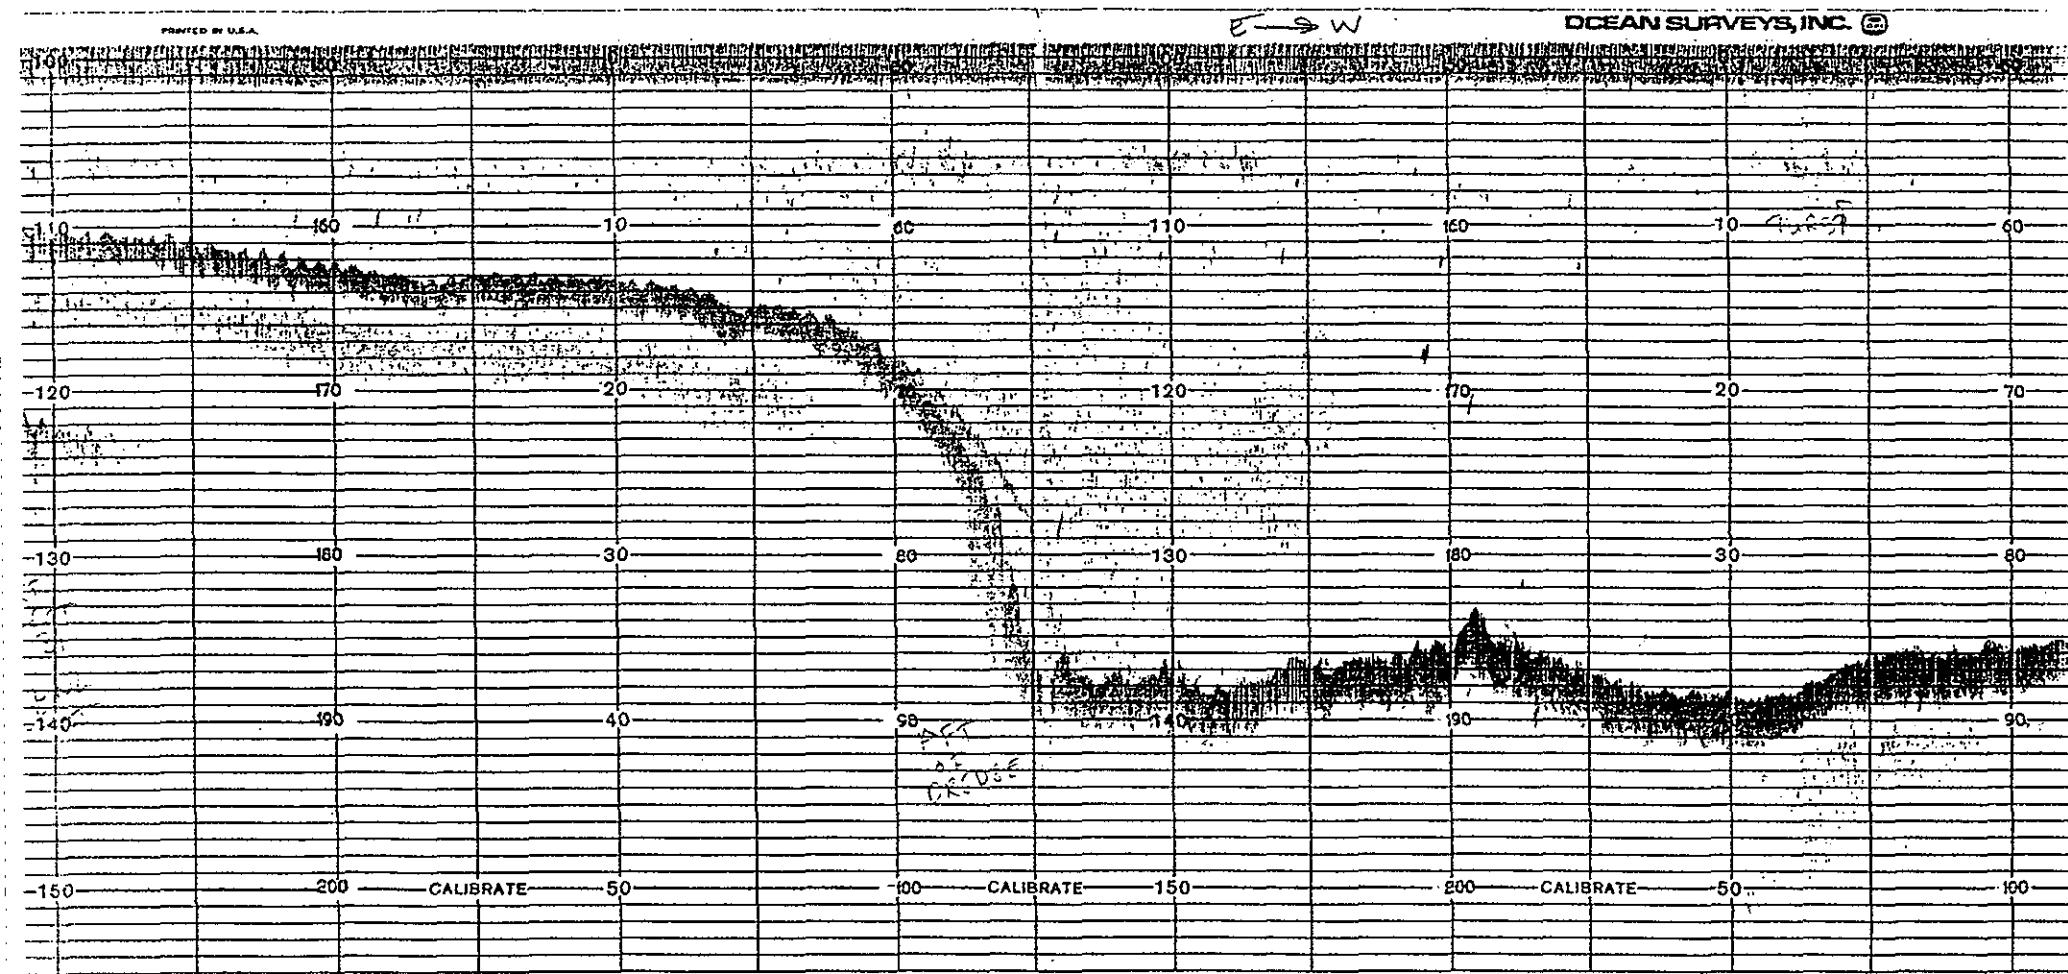
Figure 3-18. Echo sounder record from Transect #31; portions of the plume have been advected 200 meters downstream along the eastern flanks of the channel, November 11. Profile runs east to west.

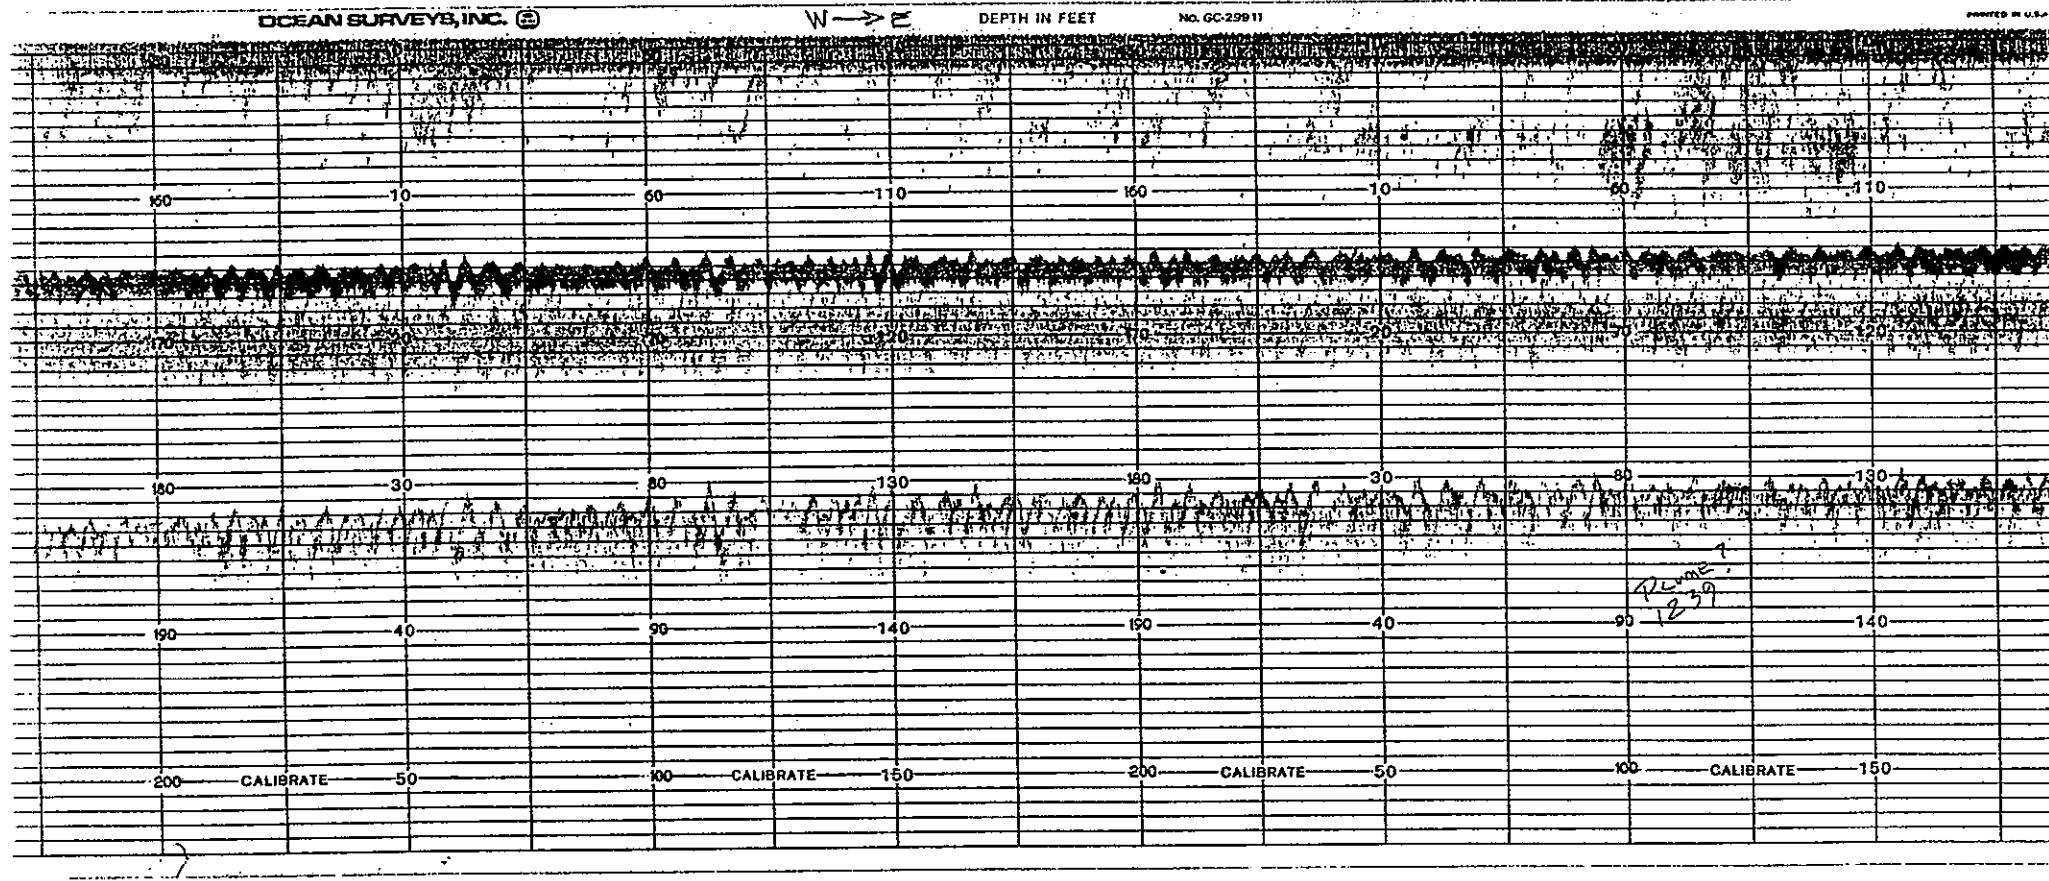
**Figure 3-21.** Patches of the plume observed in the shoal areas of Morris Cove, 650 meters northeast of barge operations. Profile is from Transect #39 recorded on November 15, and runs west to east.

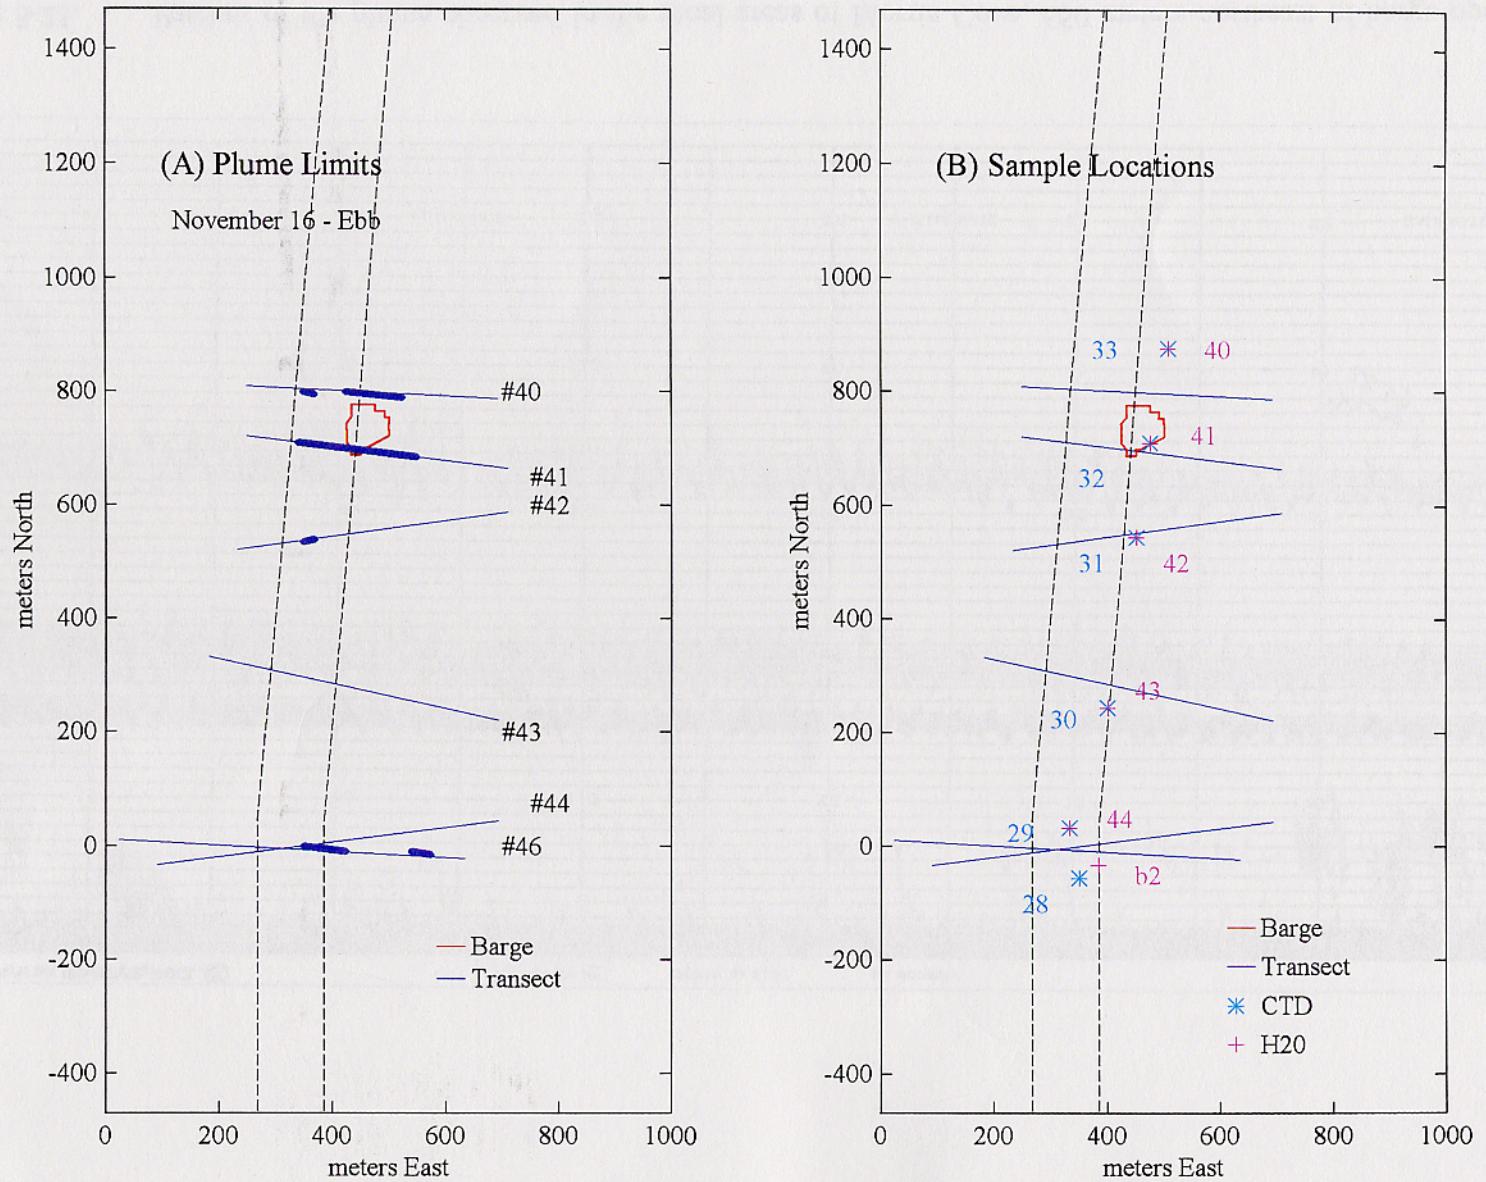
**Figure 3-22.** (A) November 16, 1993 barge position and transect locations with the occurrence of the plume delineated on each transect; (B) barge position and transects with the location of water samples

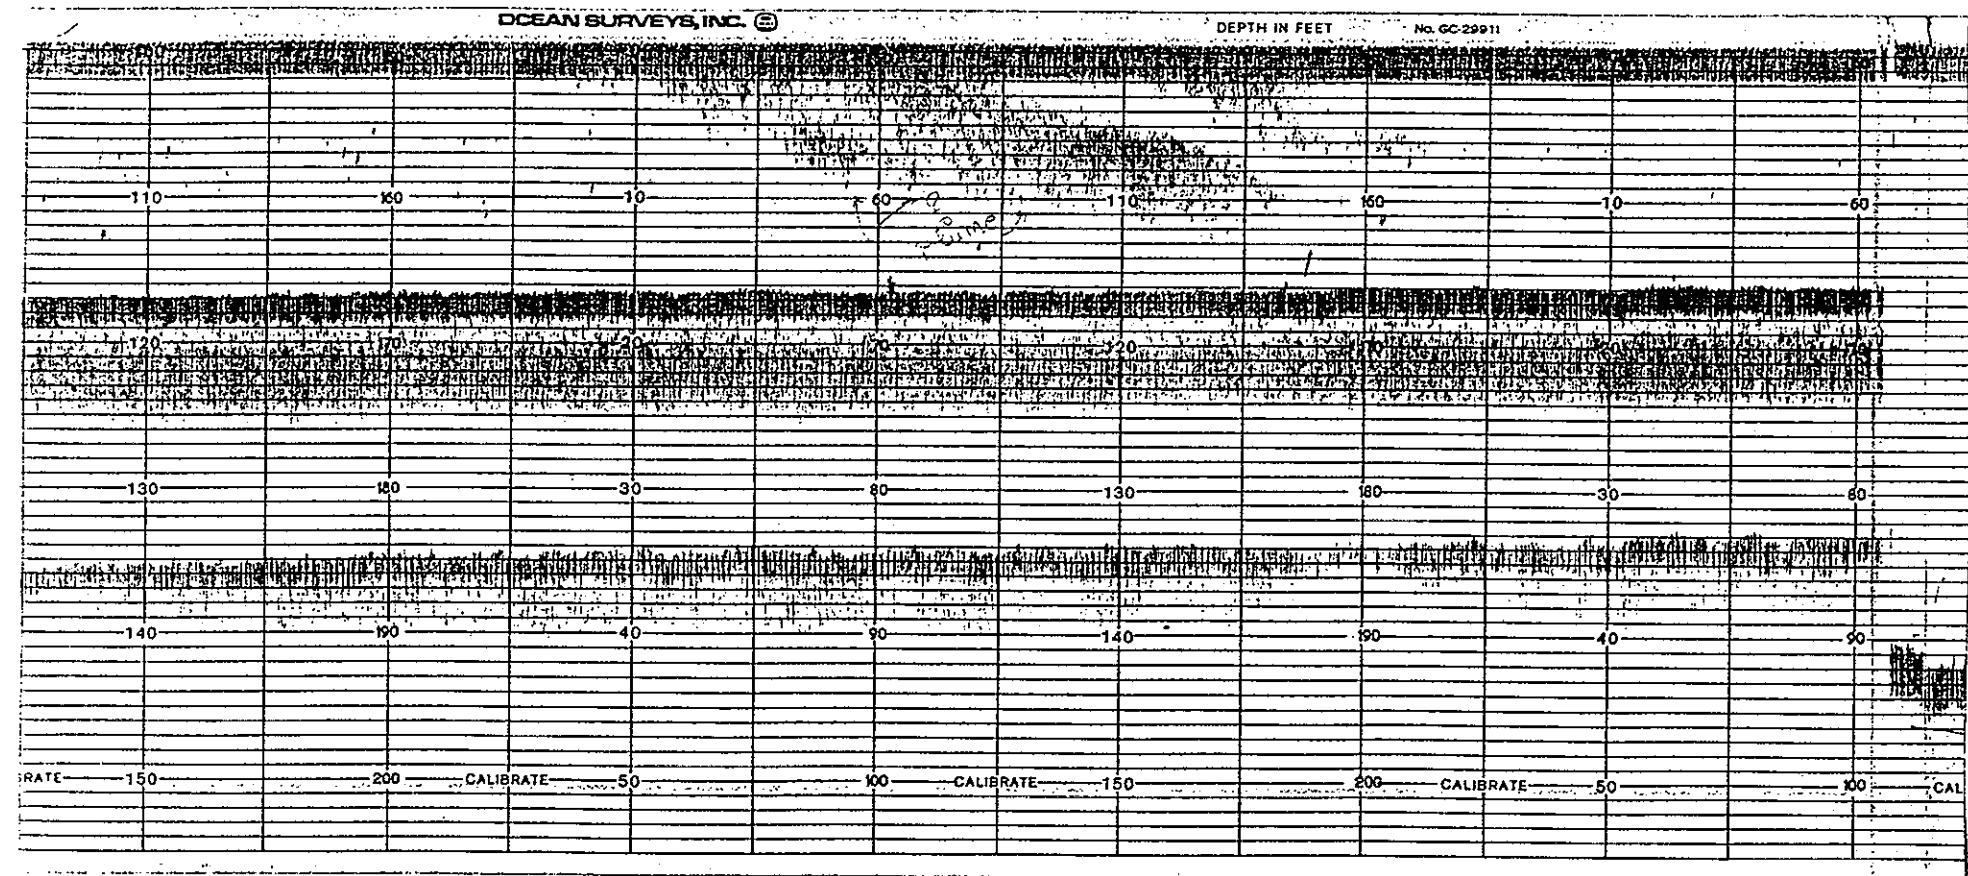
Figure 3-23. Patches of the plume observed outside of the navigation channel, in Morris Cove, 700 meters downcurrent of the barge. Profile is from Transect #46 recorded on November 16, and runs west to east.

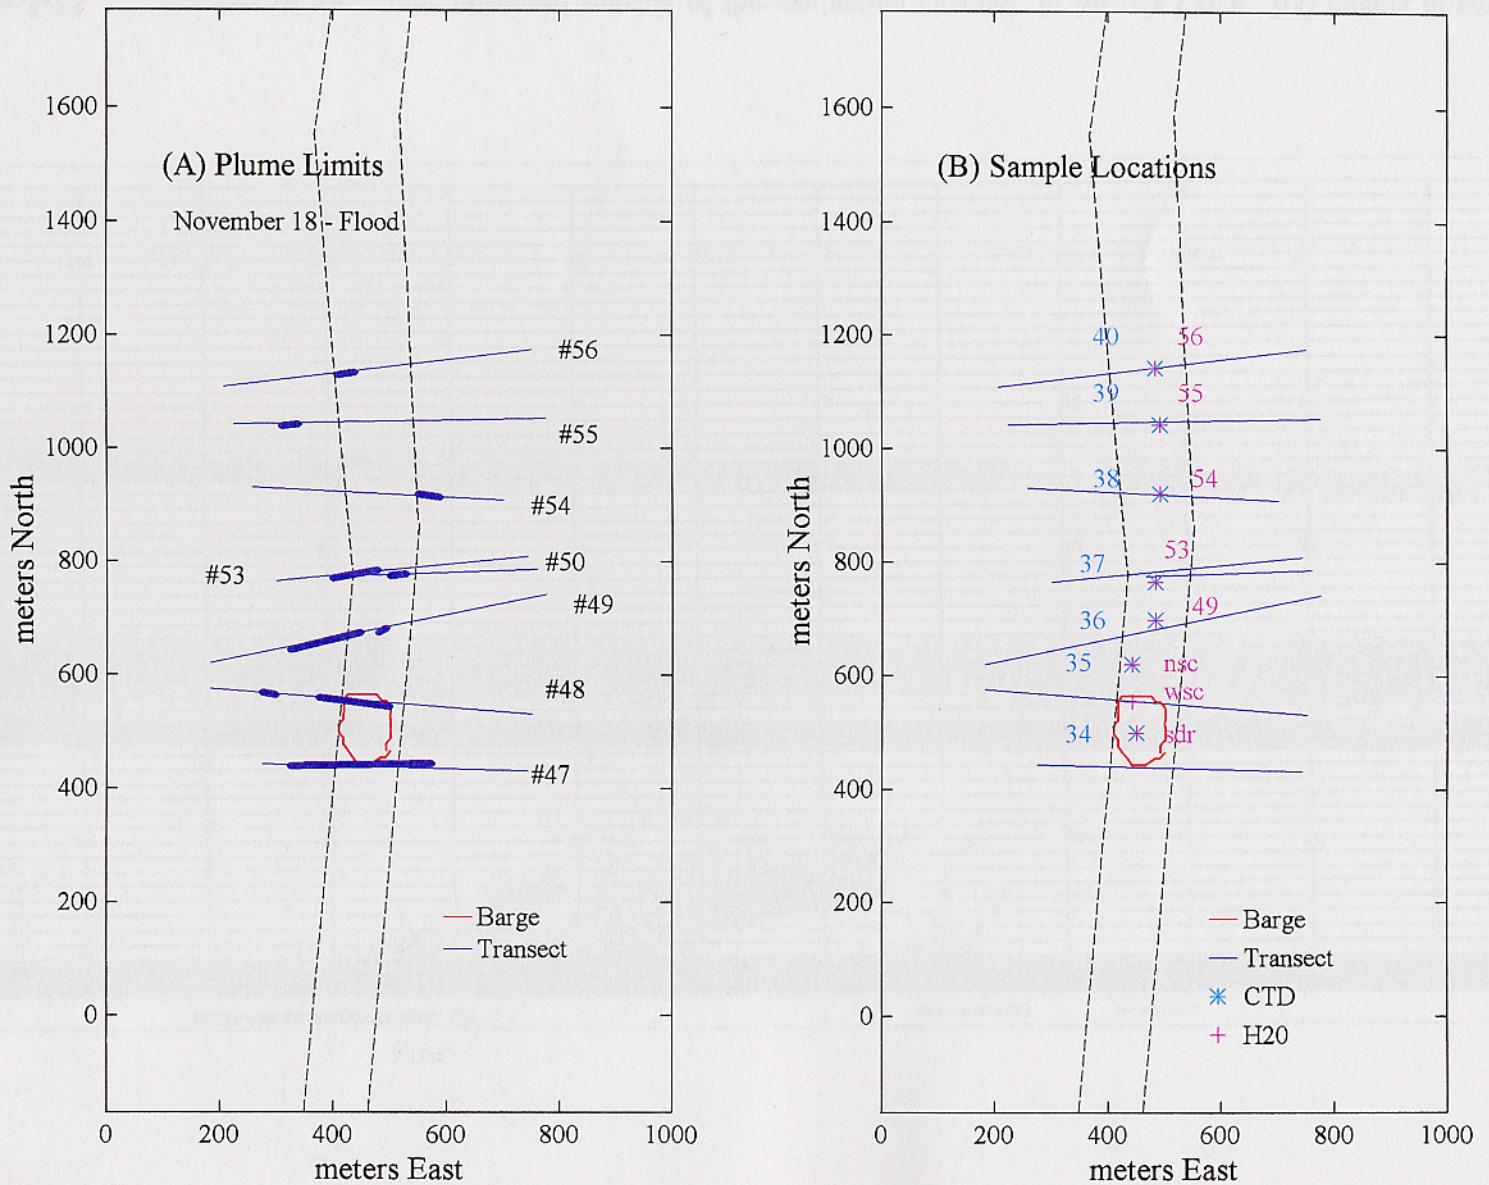
**Figure 3-24.** (A) November 18, 1993 barge position and transect locations with the occurrence of the plume delineated on each transect; (B) barge position and transects with the location of water samples

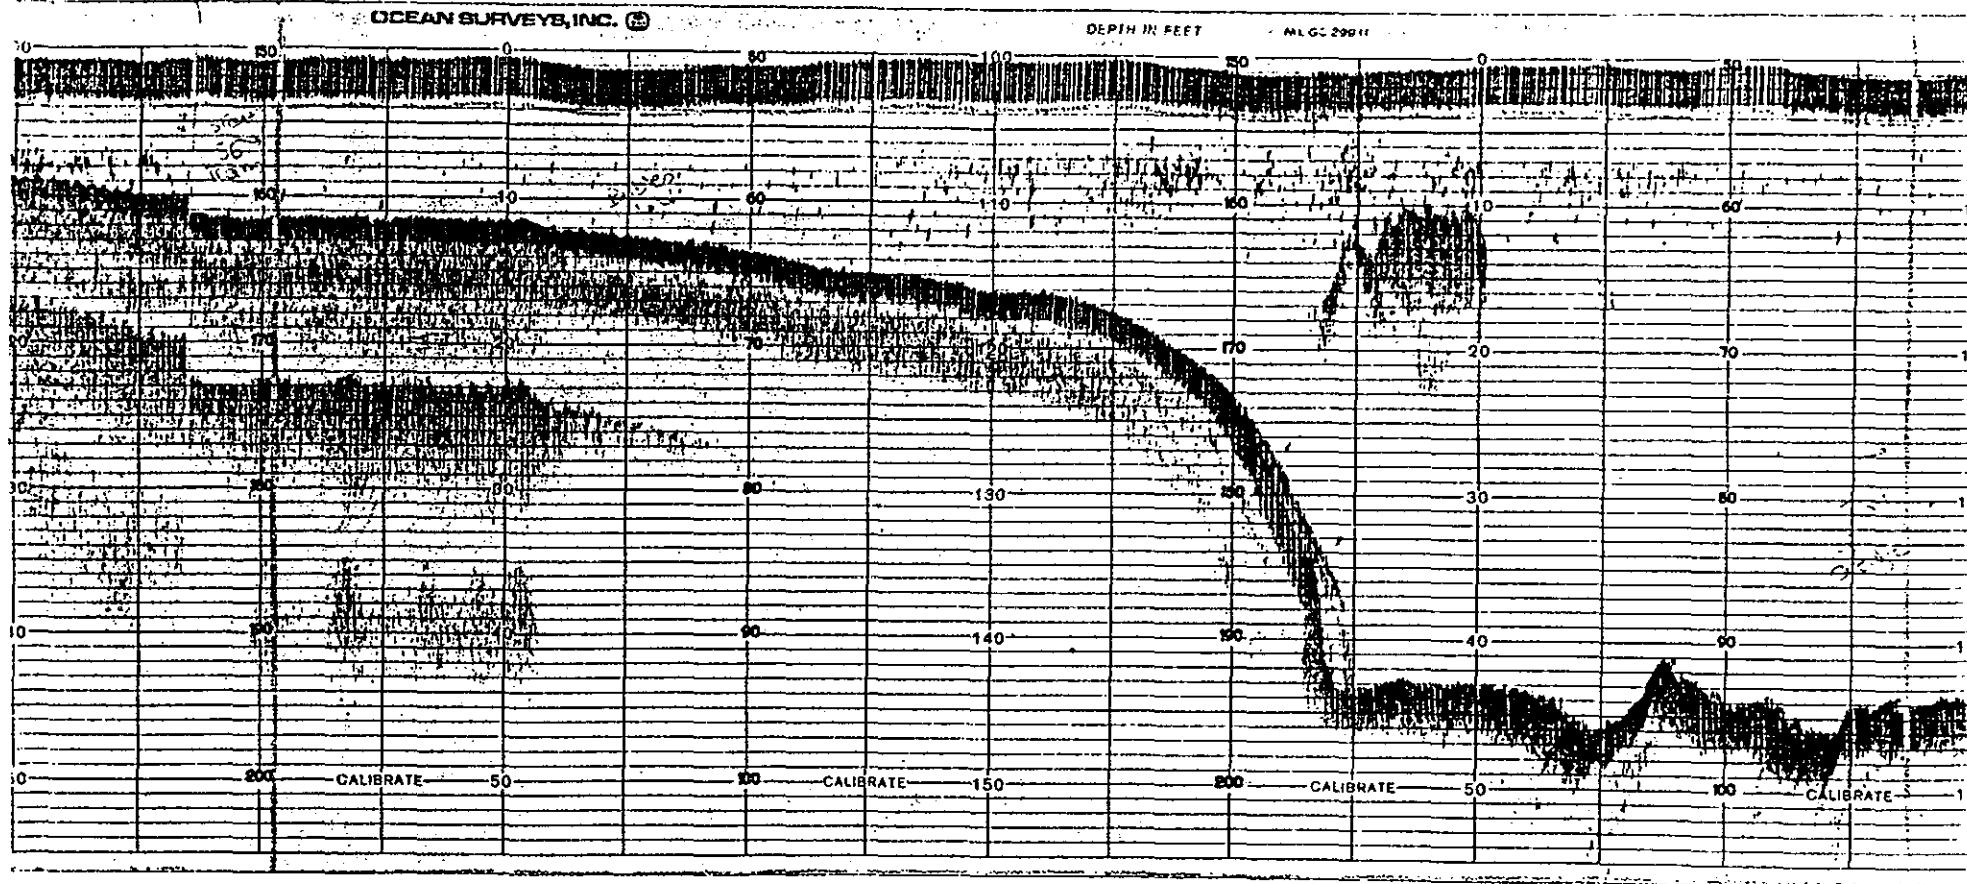
**Figure 3-25.** Traces of the plume observed 575 meters downcurrent, on the eastern side of the channel. Records are from traces obtained on November 18, Transect #56. Profile runs east to west.
