An Investigation of the Dispersion  
of Sediments Resuspended by  
Dredging Operations in New Haven Harbor

# **Disposal Area Monitoring System DAMOS**

Contribution 112  
November 1996

**US Army Corps  
of Engineers**  
New England Division

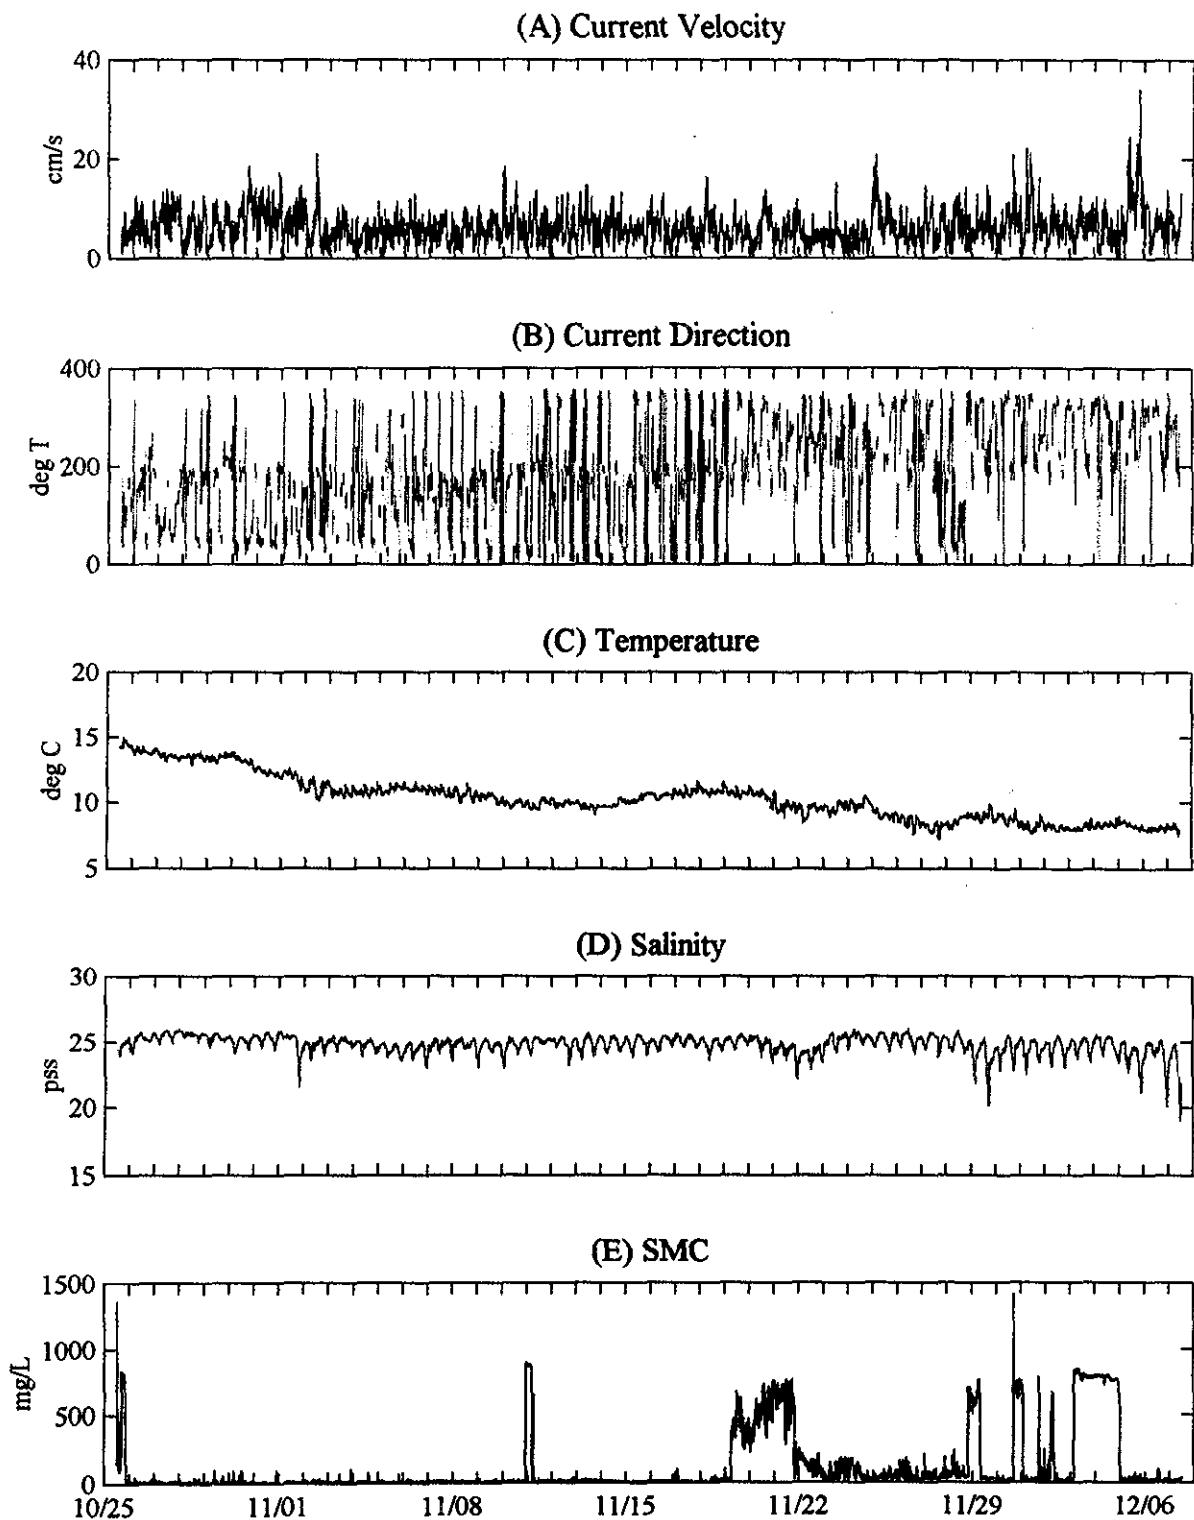
**Figure 3-26.** Time series plots for the complete DAISY deployment period, October 25 to December 7, 1993

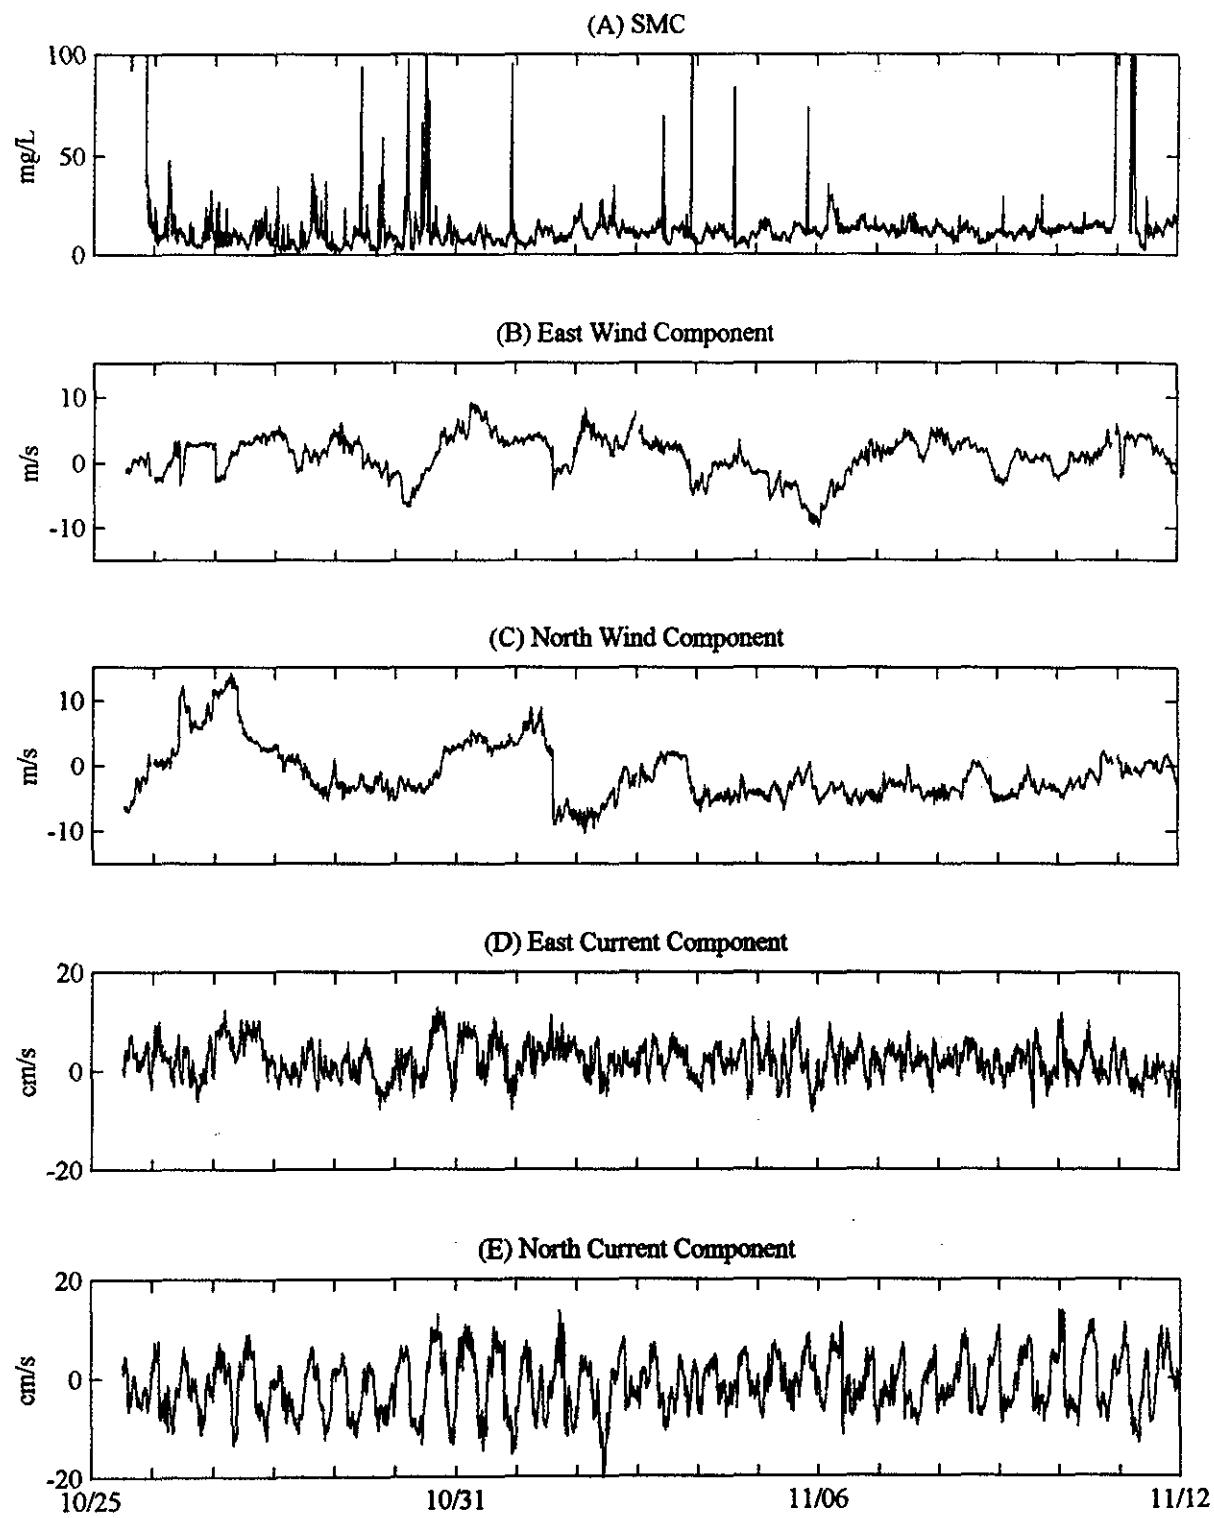
**Figure 3-30.** The suspended material concentration data compared with wind and current data for the first half of the deployment, October 25 to November 11, 1993

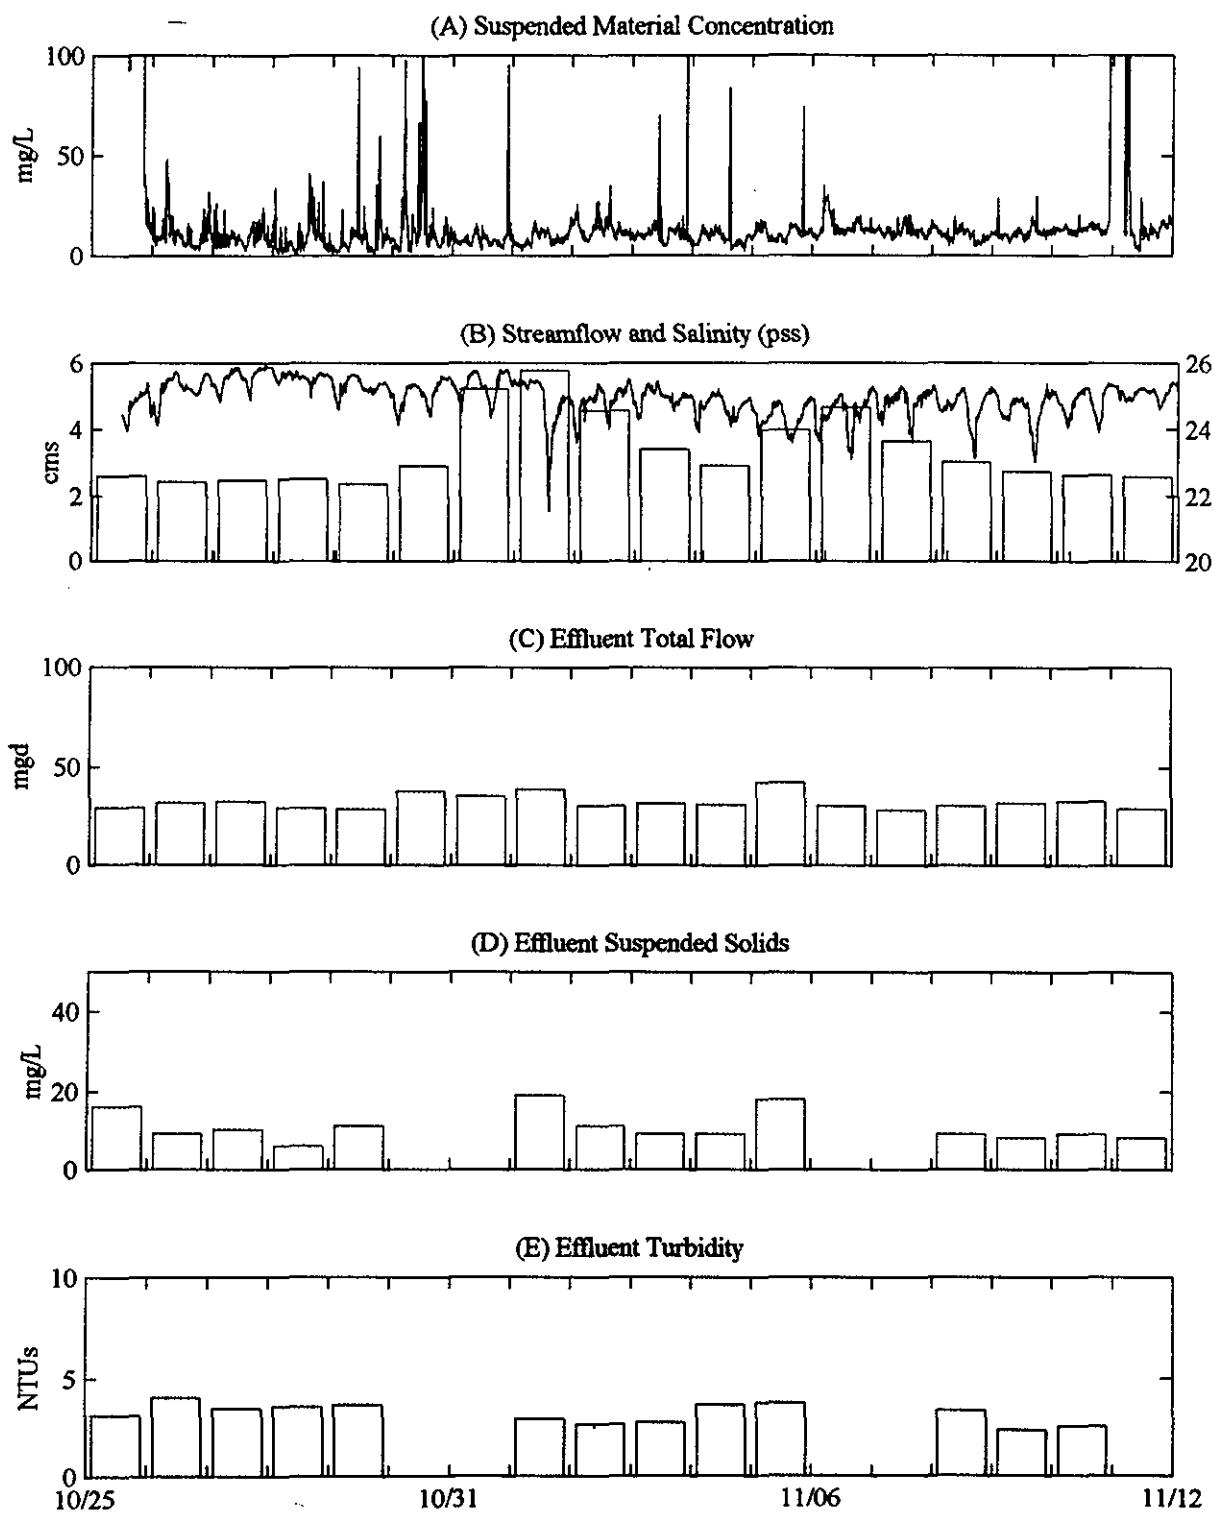
**Figure 3-31.** The suspended material concentration data compared with stream flow and effluent from the East Haven Pollution Abatement Facility for the first half of the deployment, October 25 to November 11, 1993

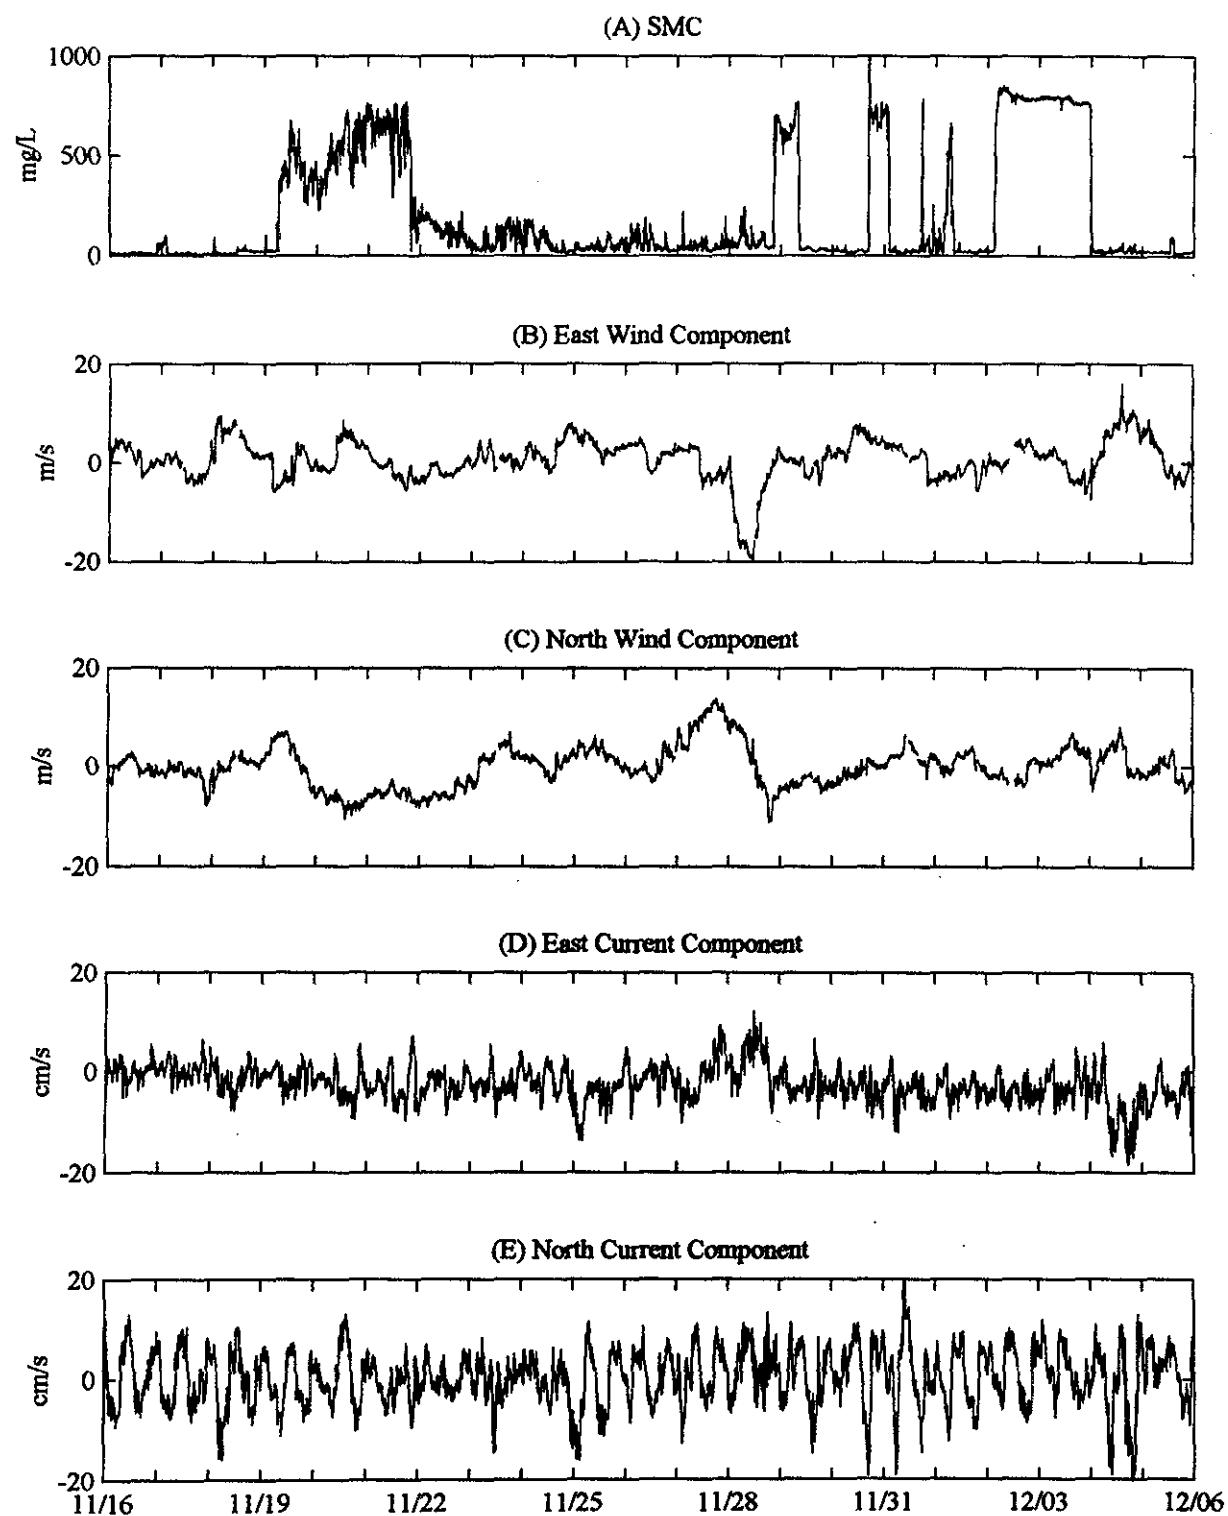
**Figure 3-32.** Enlargement of the period during which the largest SMC perturbations were observed, November 16 to December 6, 1993. Concentration data are compared with wind and current data.

During the latter half of the DAISY deployment period (November 11 to December 7, 1993) several major events are recorded in the suspended material concentration data. These disturbances differ substantially in character from those that were observed during the first part of the deployment. In contrast to the short duration, spiky perturbations of the first deployment, the perturbations of the second deployment were longer lived and significantly larger in amplitude. These events also had a residual effect in that the average background concentrations increased to near  $20 \text{ mg}\cdot\text{l}^{-1}$  (Figure 3-32; A).

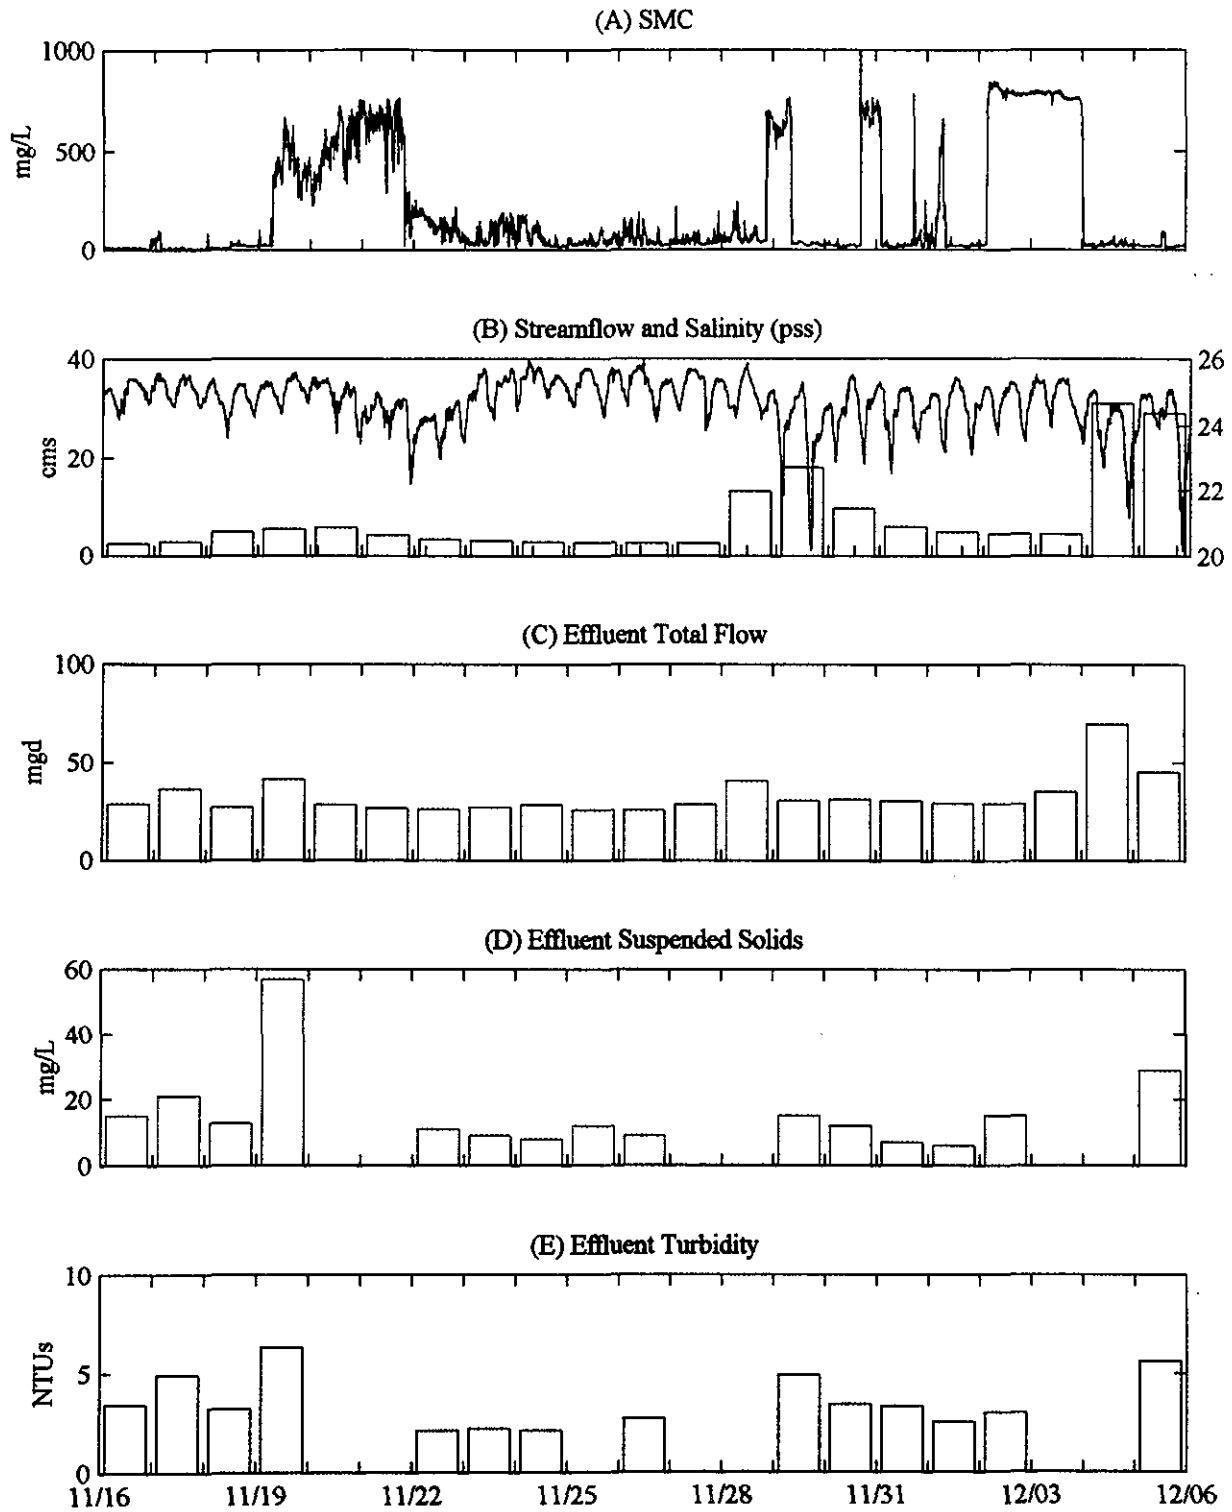
**Figure 3-33.** The suspended material concentration data compared with stream flow and effluent data obtained from the East Haven Pollution Abatement Facility for the period November 16 to December 6, 1993

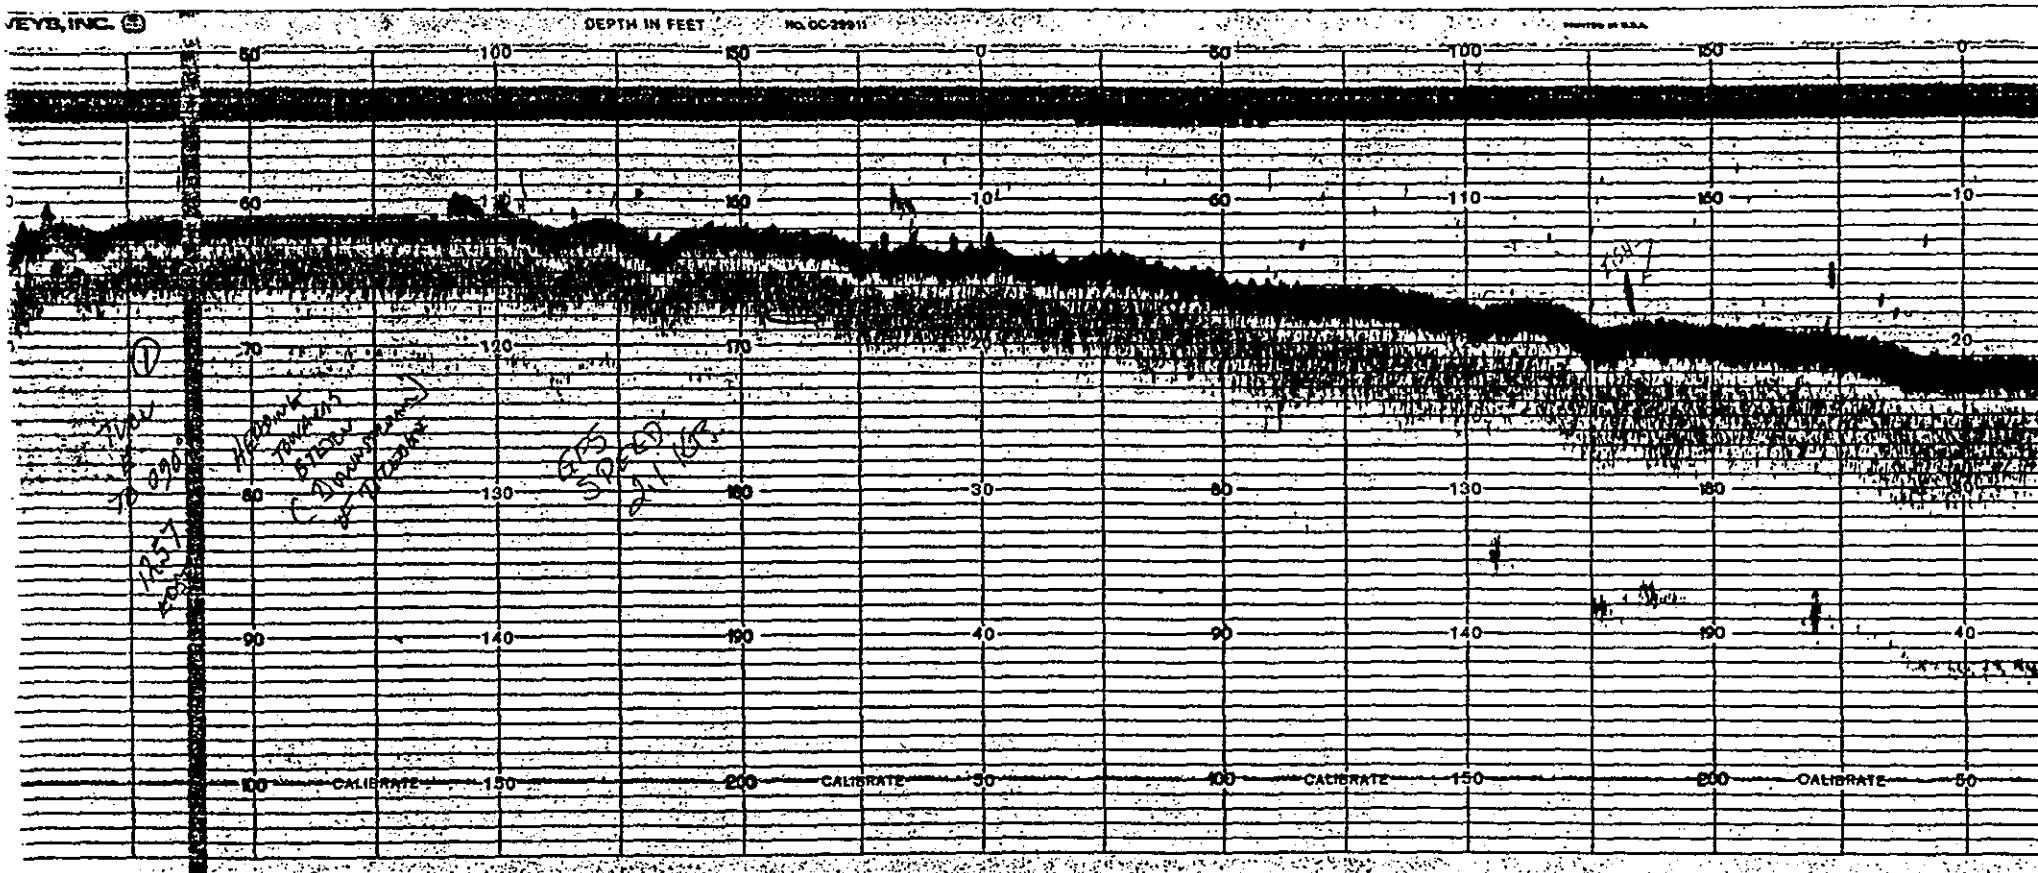
Beginning segment of Transect A acoustic profile surveyed on 25 October 1993; profile runs west to east

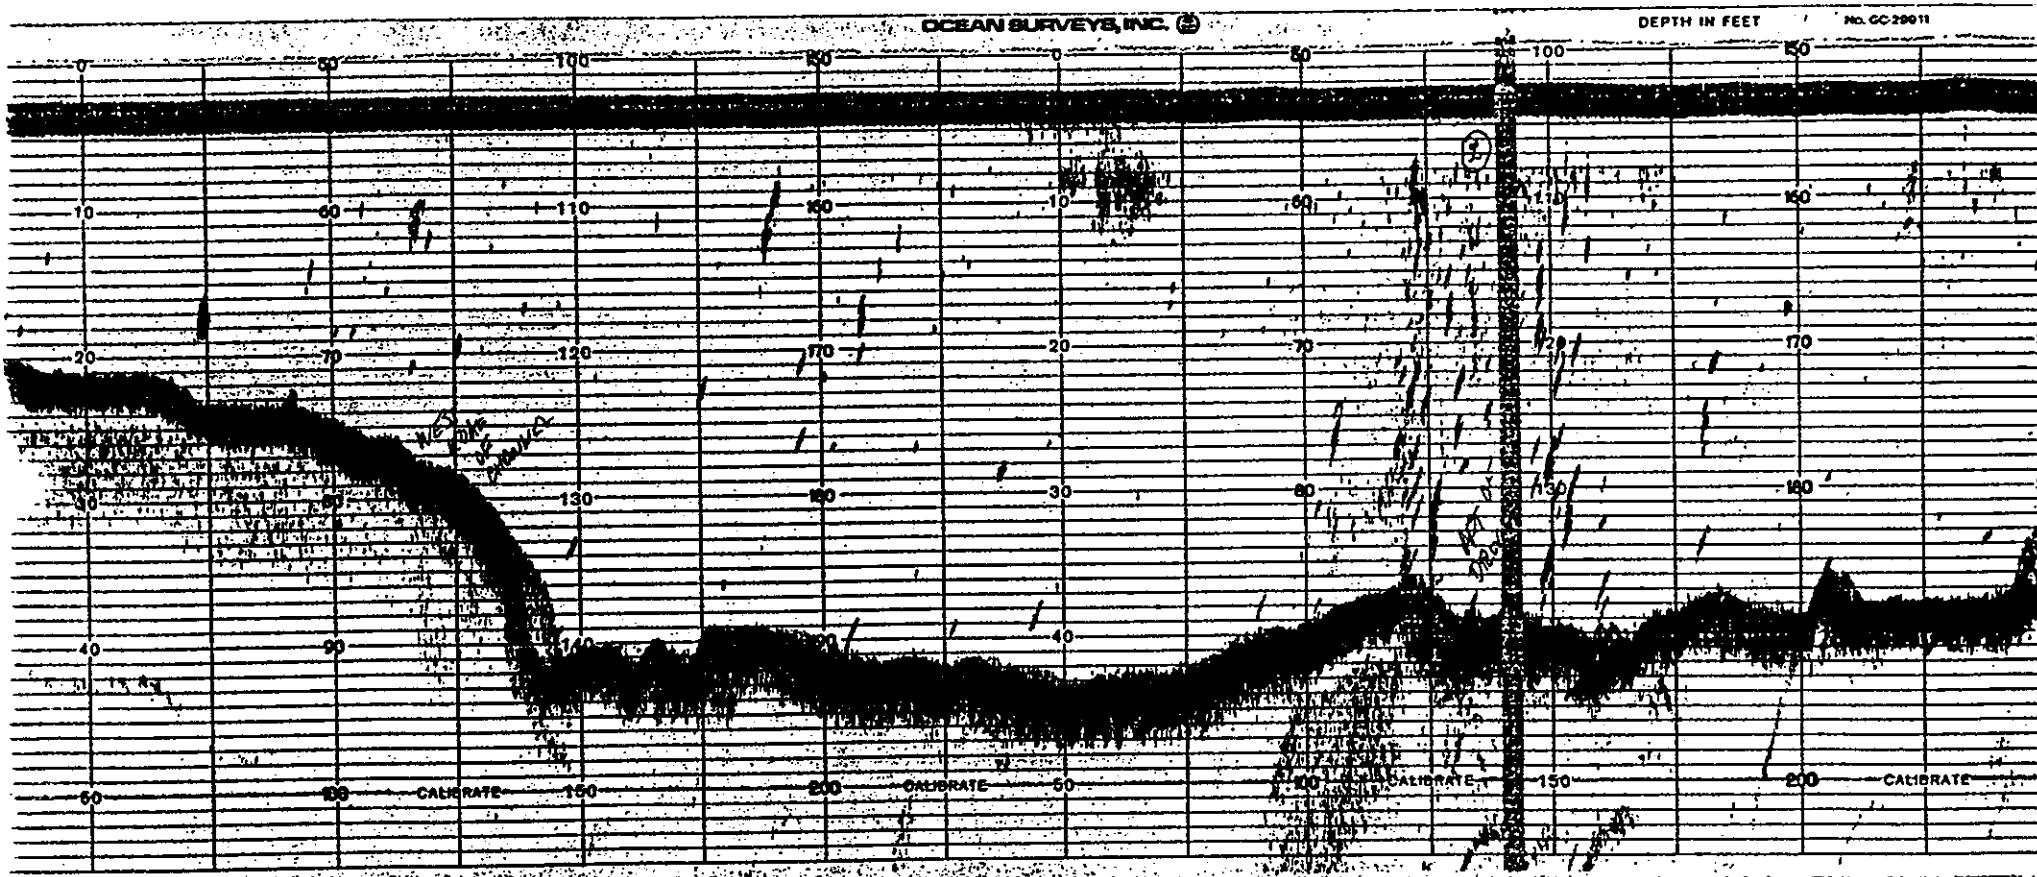
Middle segment of Transect A acoustic profile surveyed on 25 October 1993; profile runs west to east

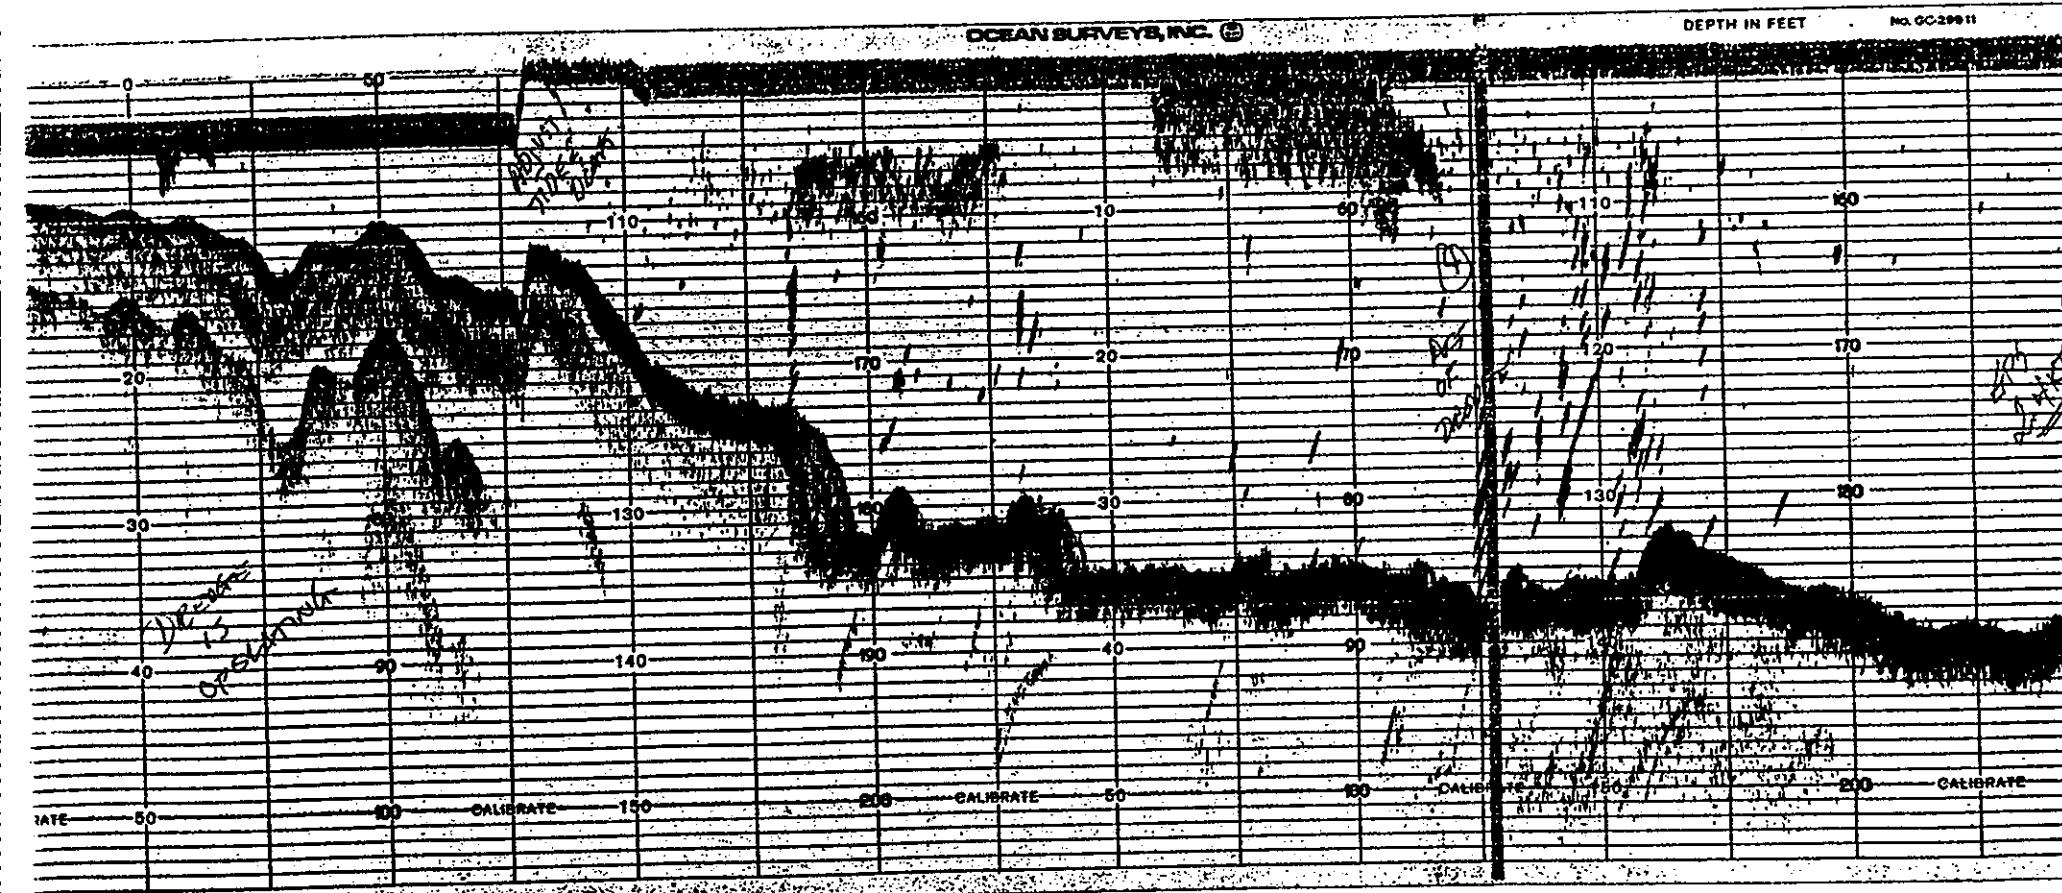
Beginning segment of Transect B acoustic profile surveyed on 25 October 1993; profile runs east to west

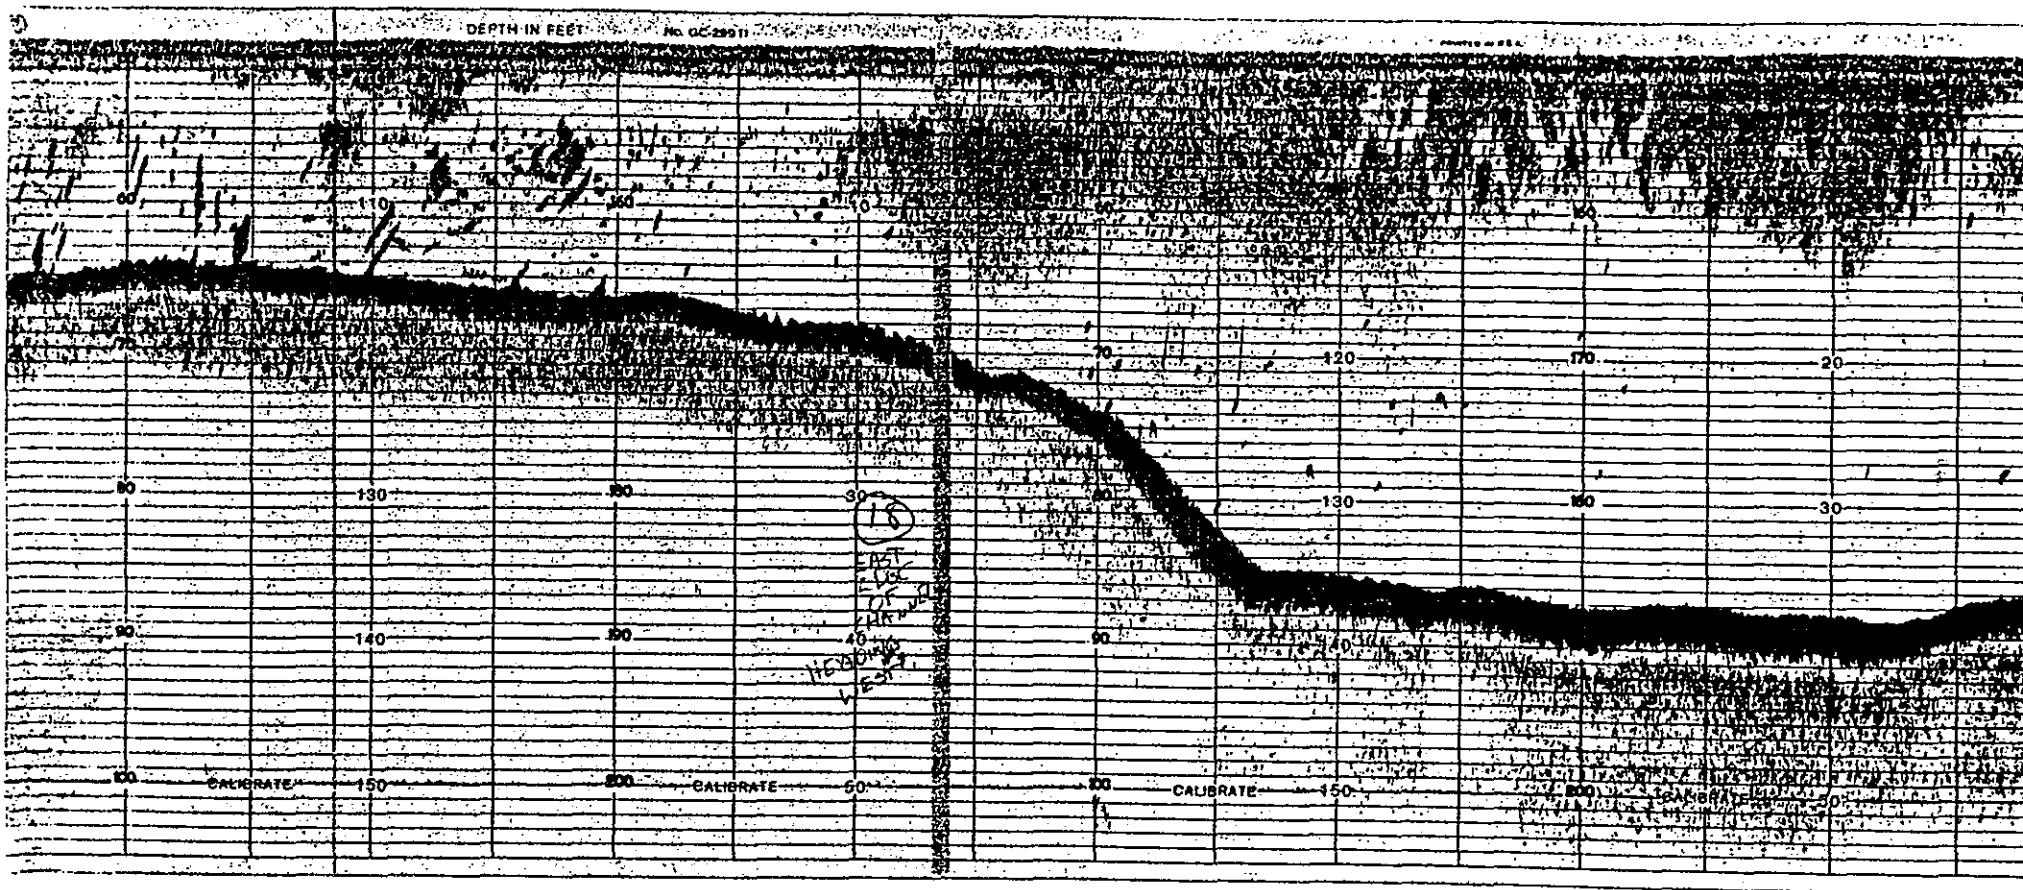
Beginning segment of Transect H acoustic profile surveyed on 25 October 1993; profile runs west to east

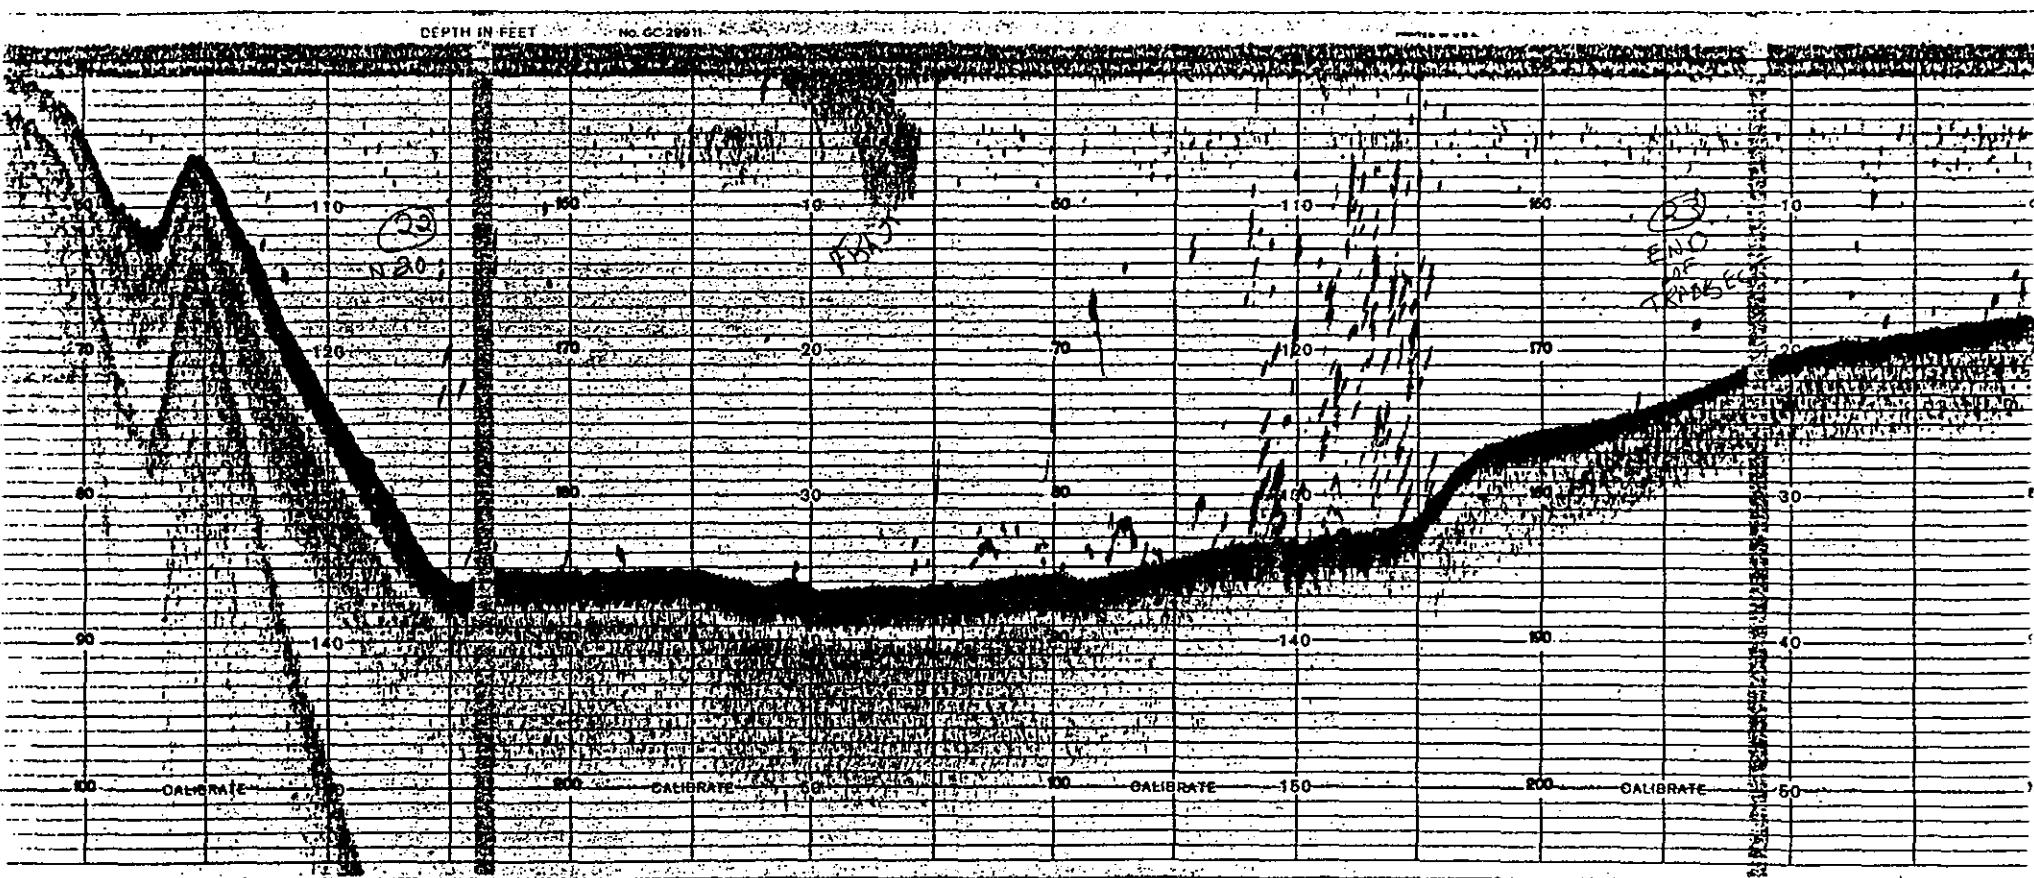
Transect I acoustic profile surveyed on 25 October 1993; profile runs east to west

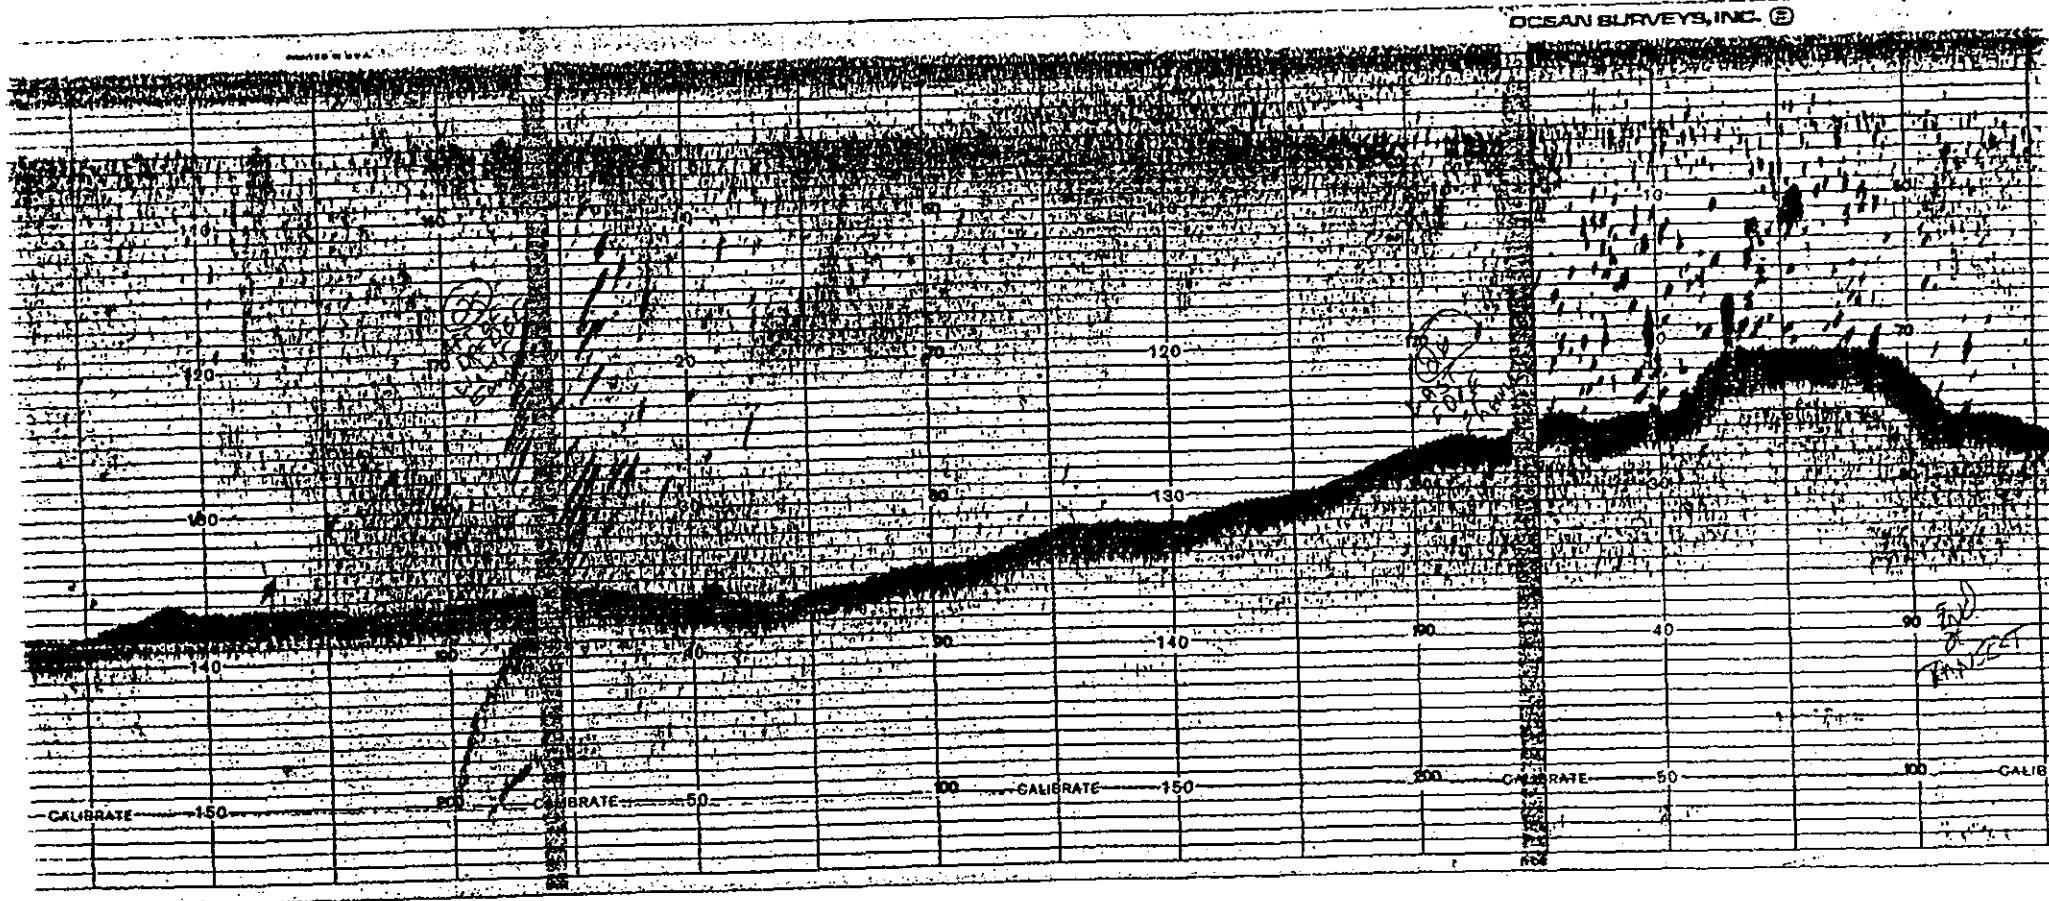
End segment of Transect J acoustic profile surveyed on 25 October 1993; profile runs west to east

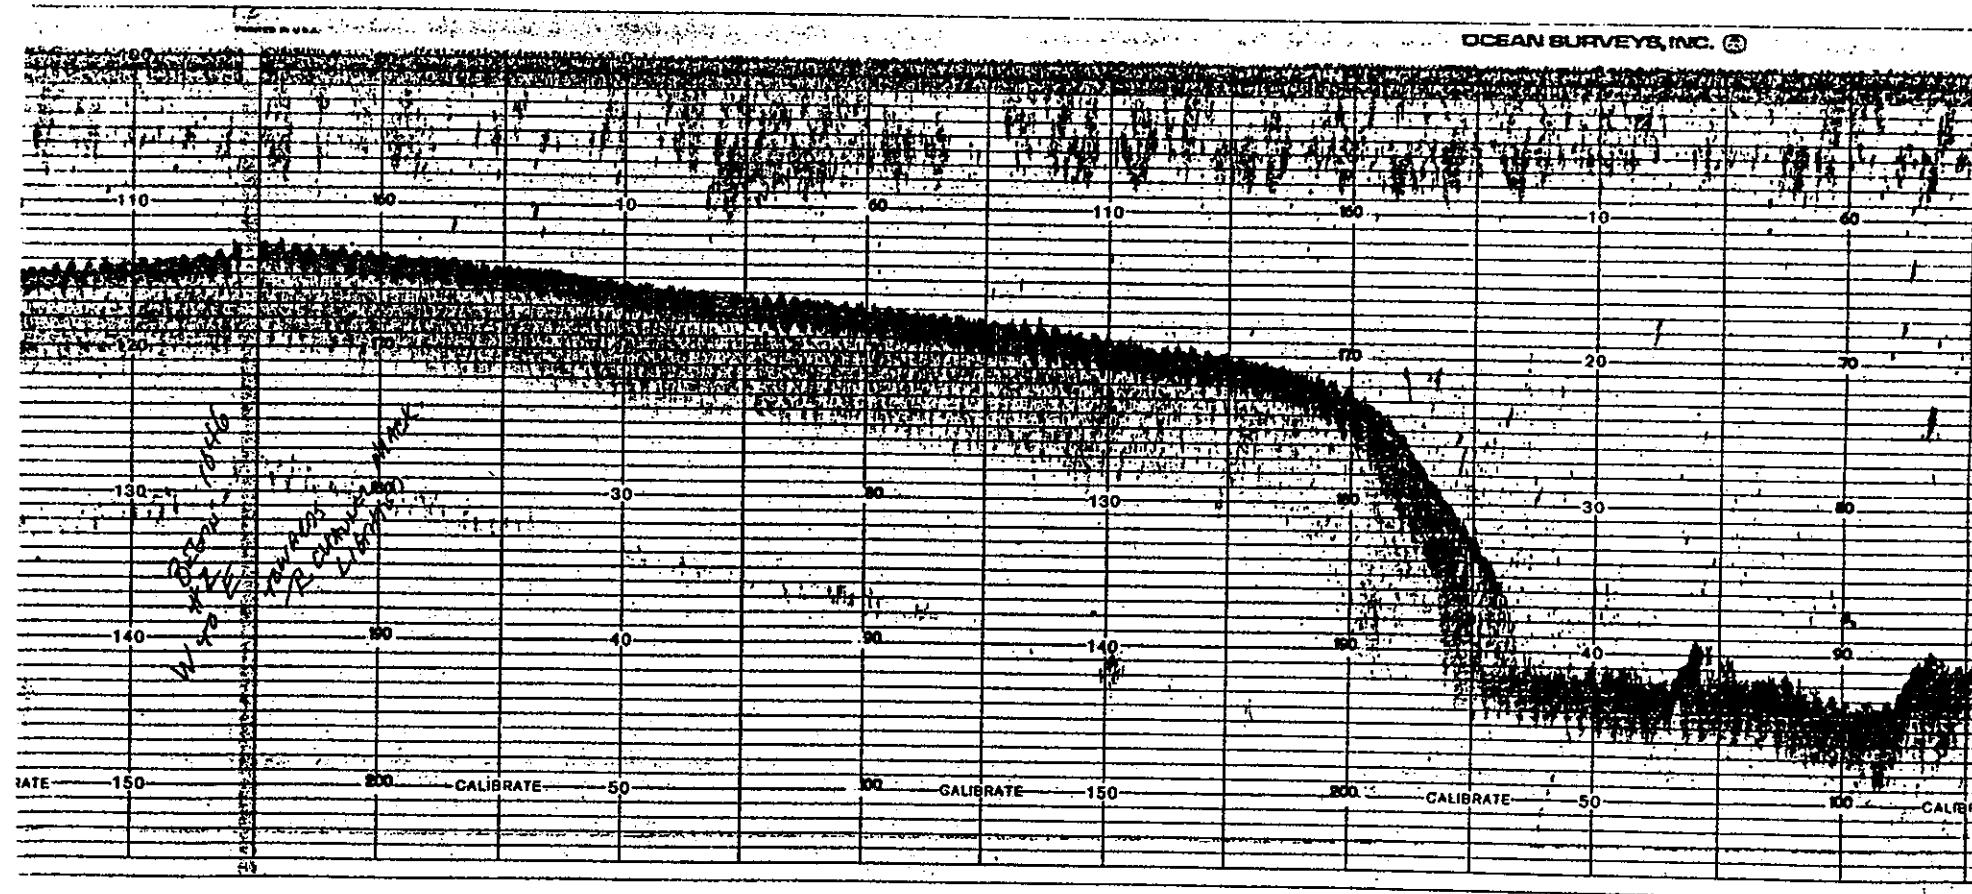
Beginning segment of Transect #2 acoustic survey of 2 November 1993; profile runs west to east
