An Investigation of the Dispersion  
of Sediments Resuspended by  
Dredging Operations in New Haven Harbor

# **Disposal Area Monitoring System DAMOS**

Contribution 112  
November 1996

**US Army Corps  
of Engineers**  
New England Division

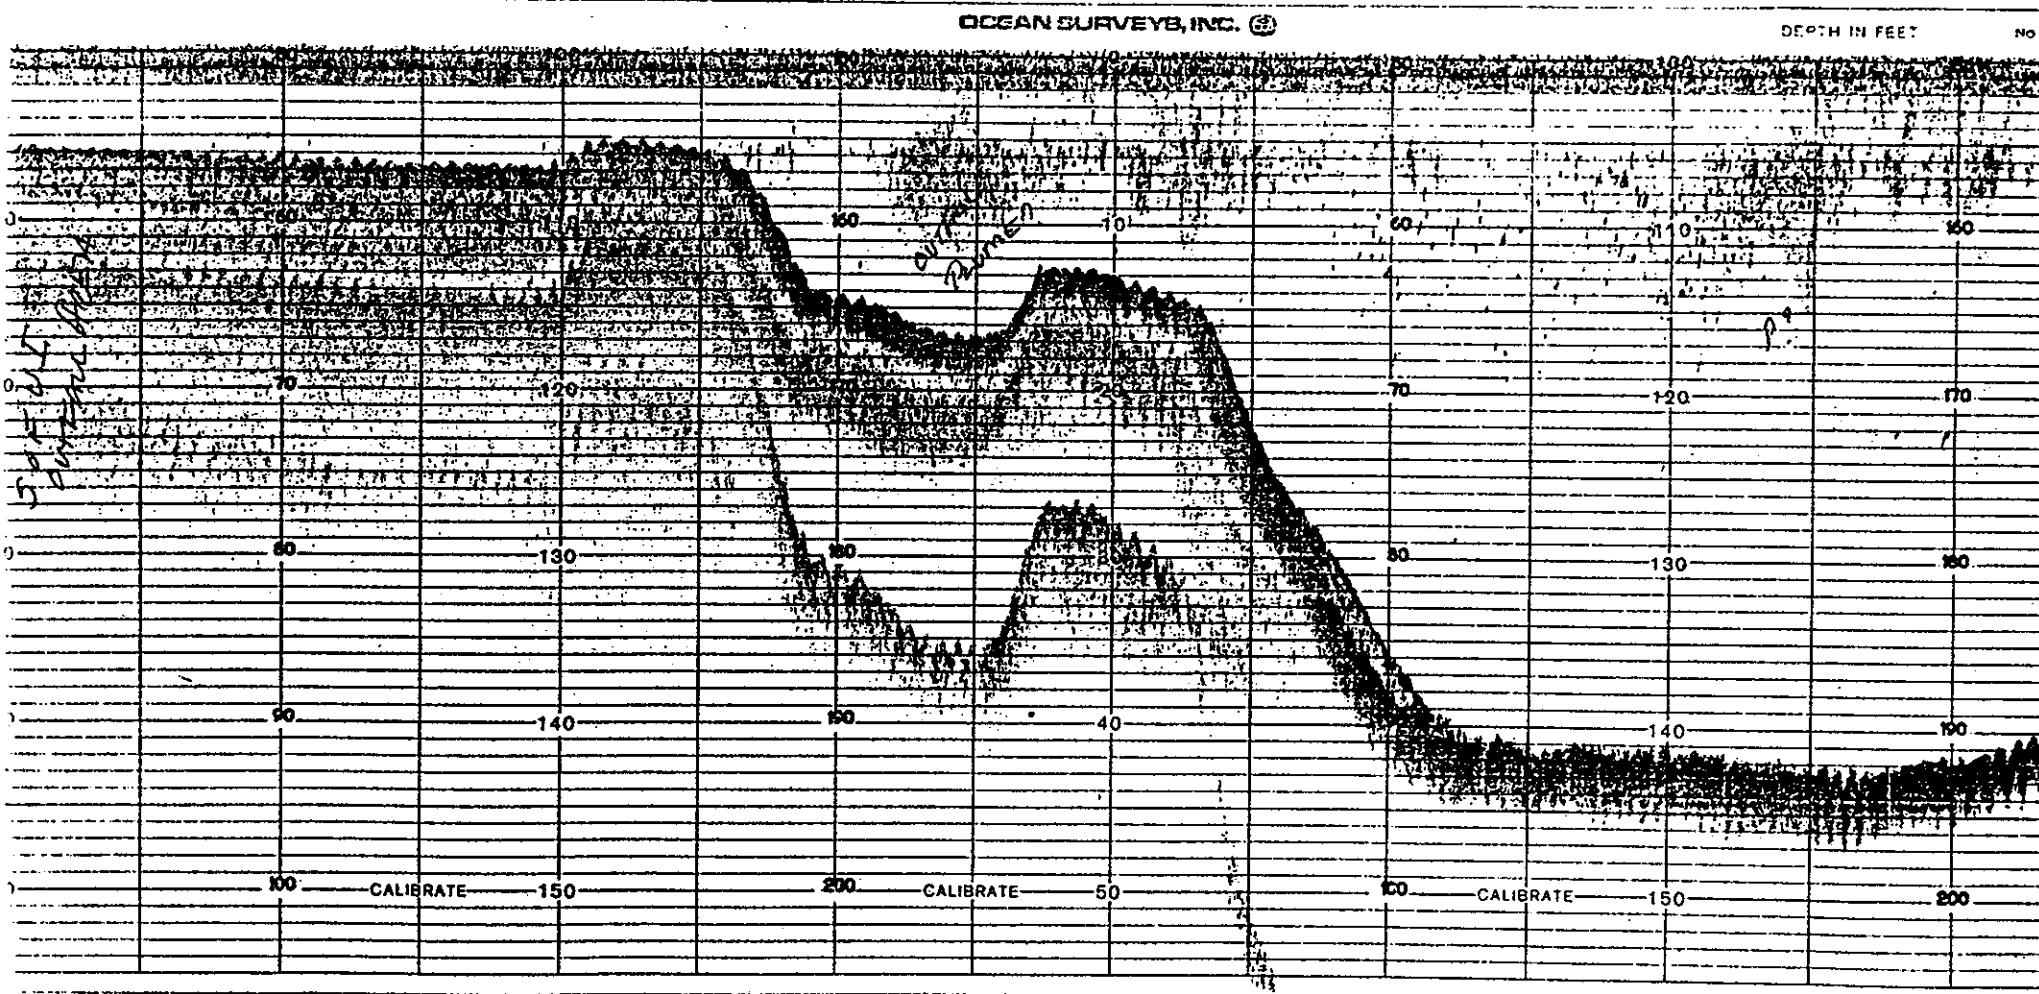
Beginning segment of Transect #3 acoustic survey of 2 November 1993; profile runs east to west

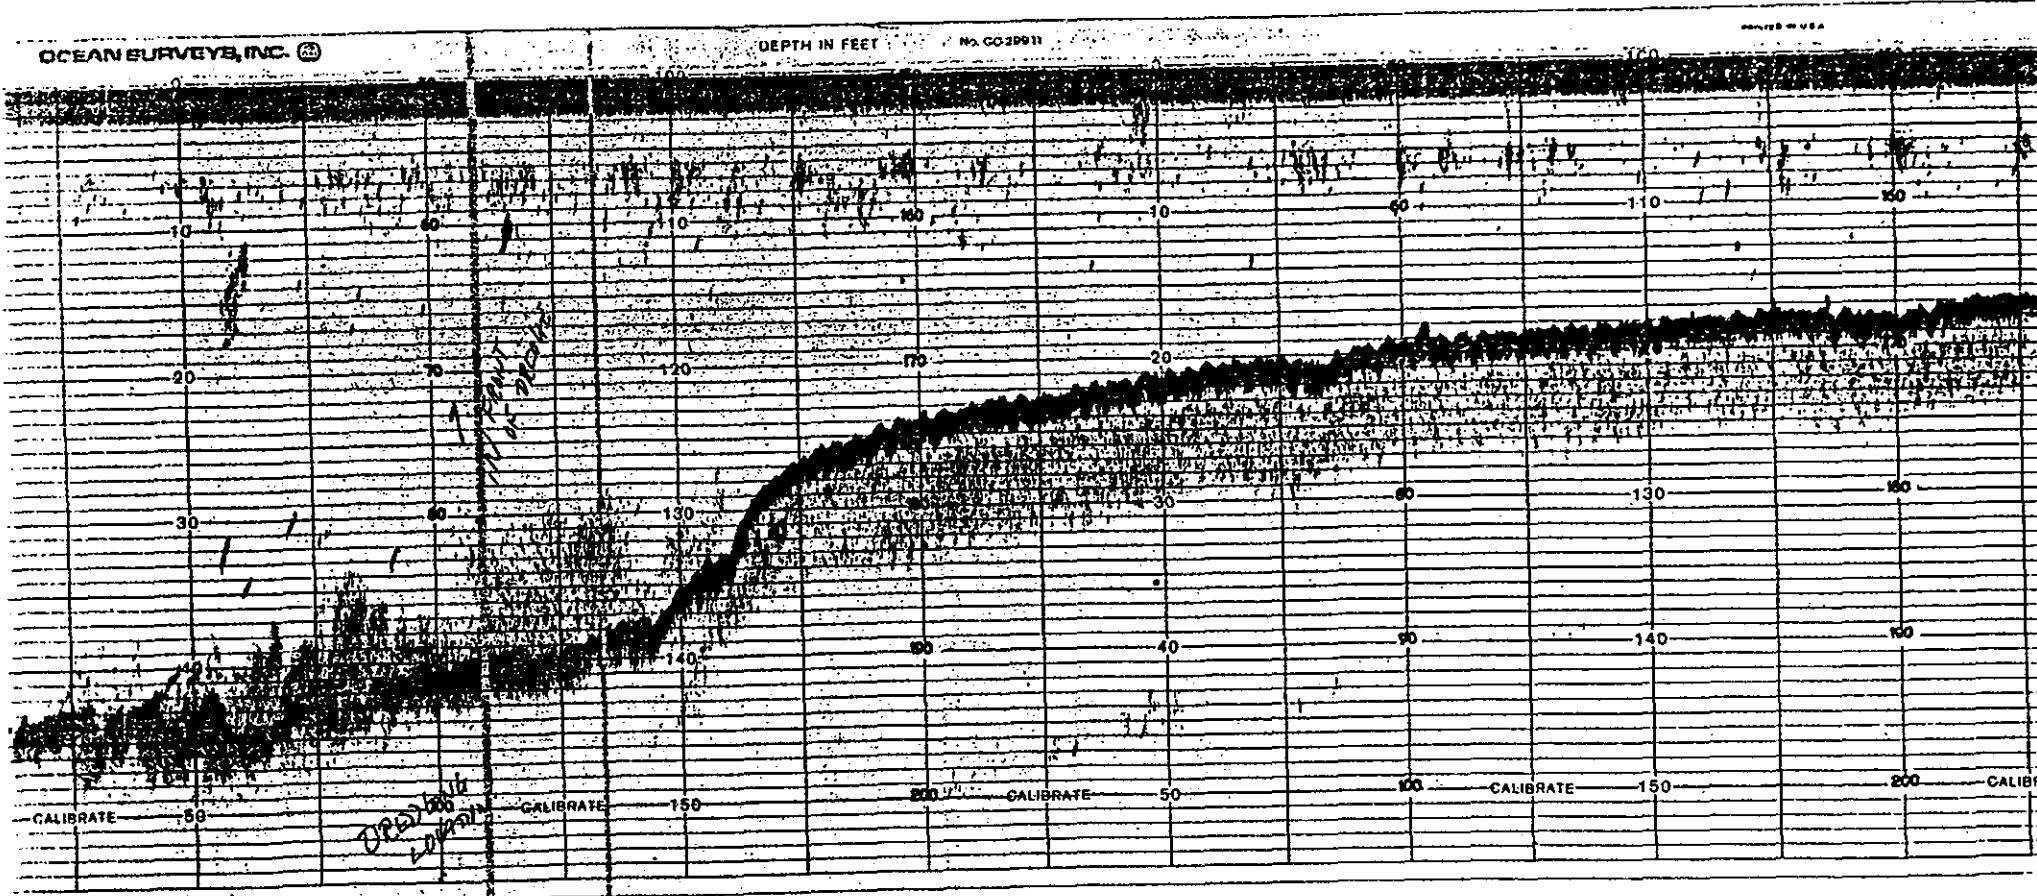
End segment of Transect #13 acoustic survey of 3 November 1993; profile runs east to west

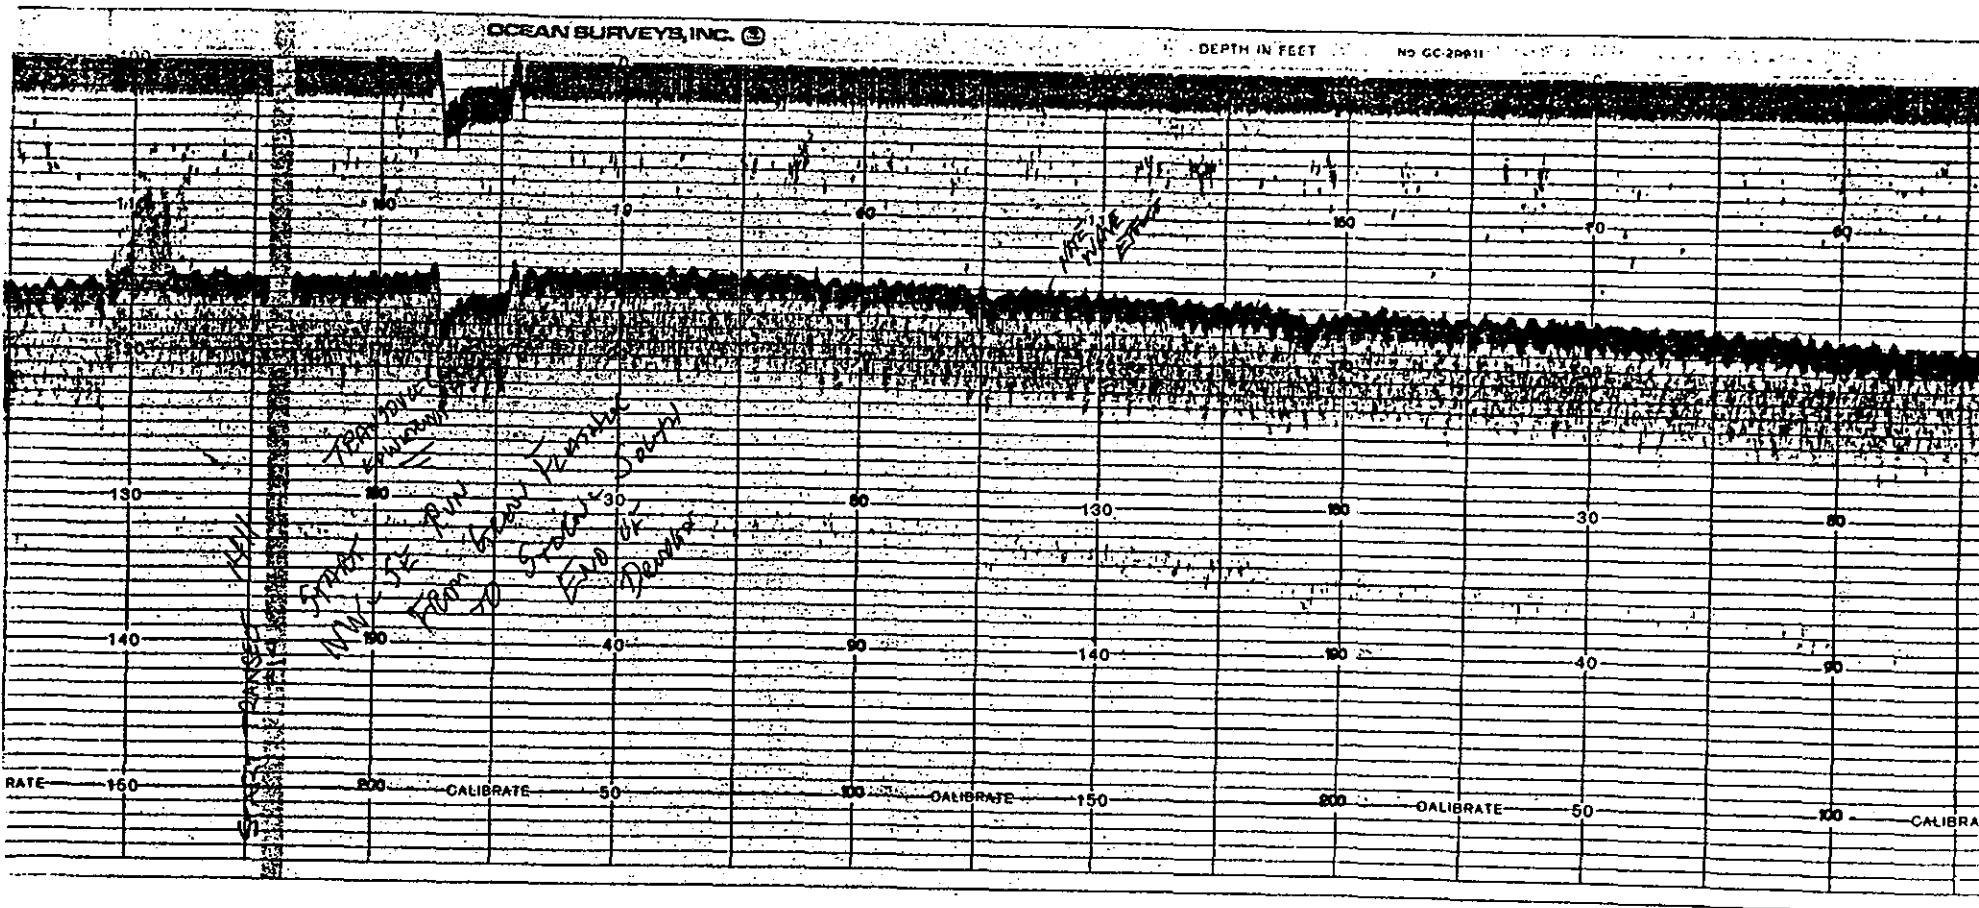
Beginning segment of Transect #14 acoustic survey of 3 November 1993; profile runs northwest to southeast

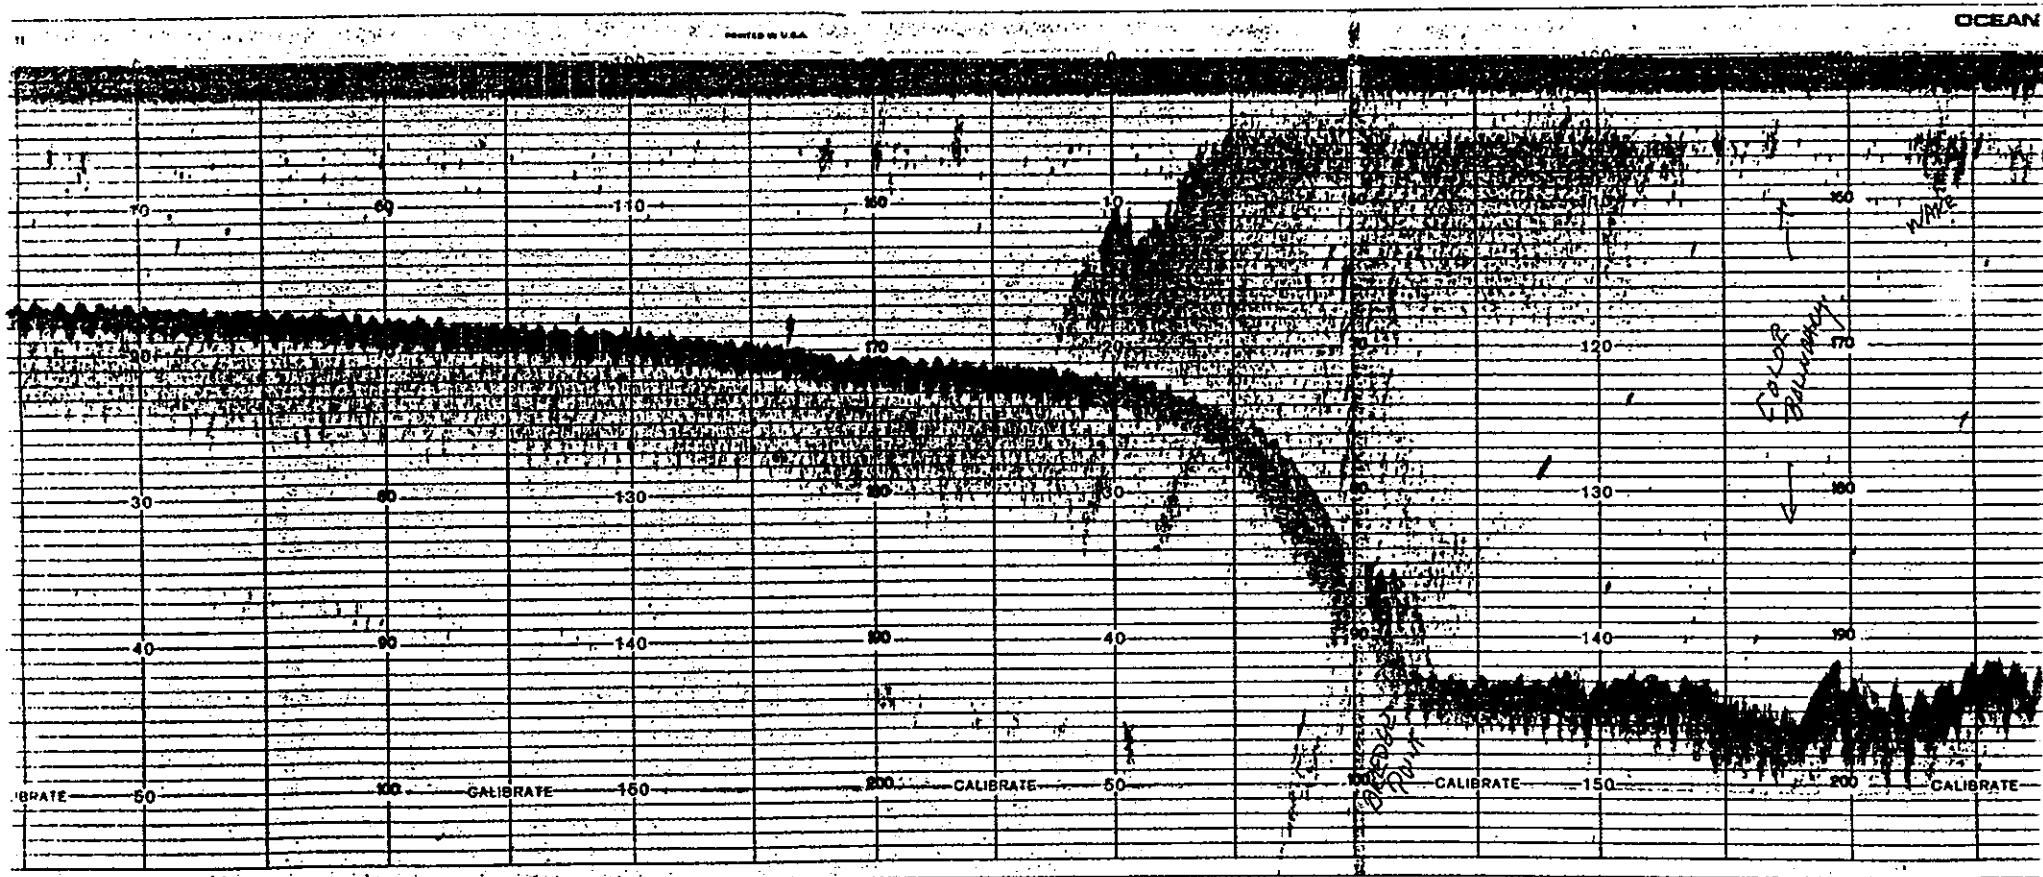
Middle segment of Transect #14 acoustic survey of 3 November 1993; profile runs northwest to southeast

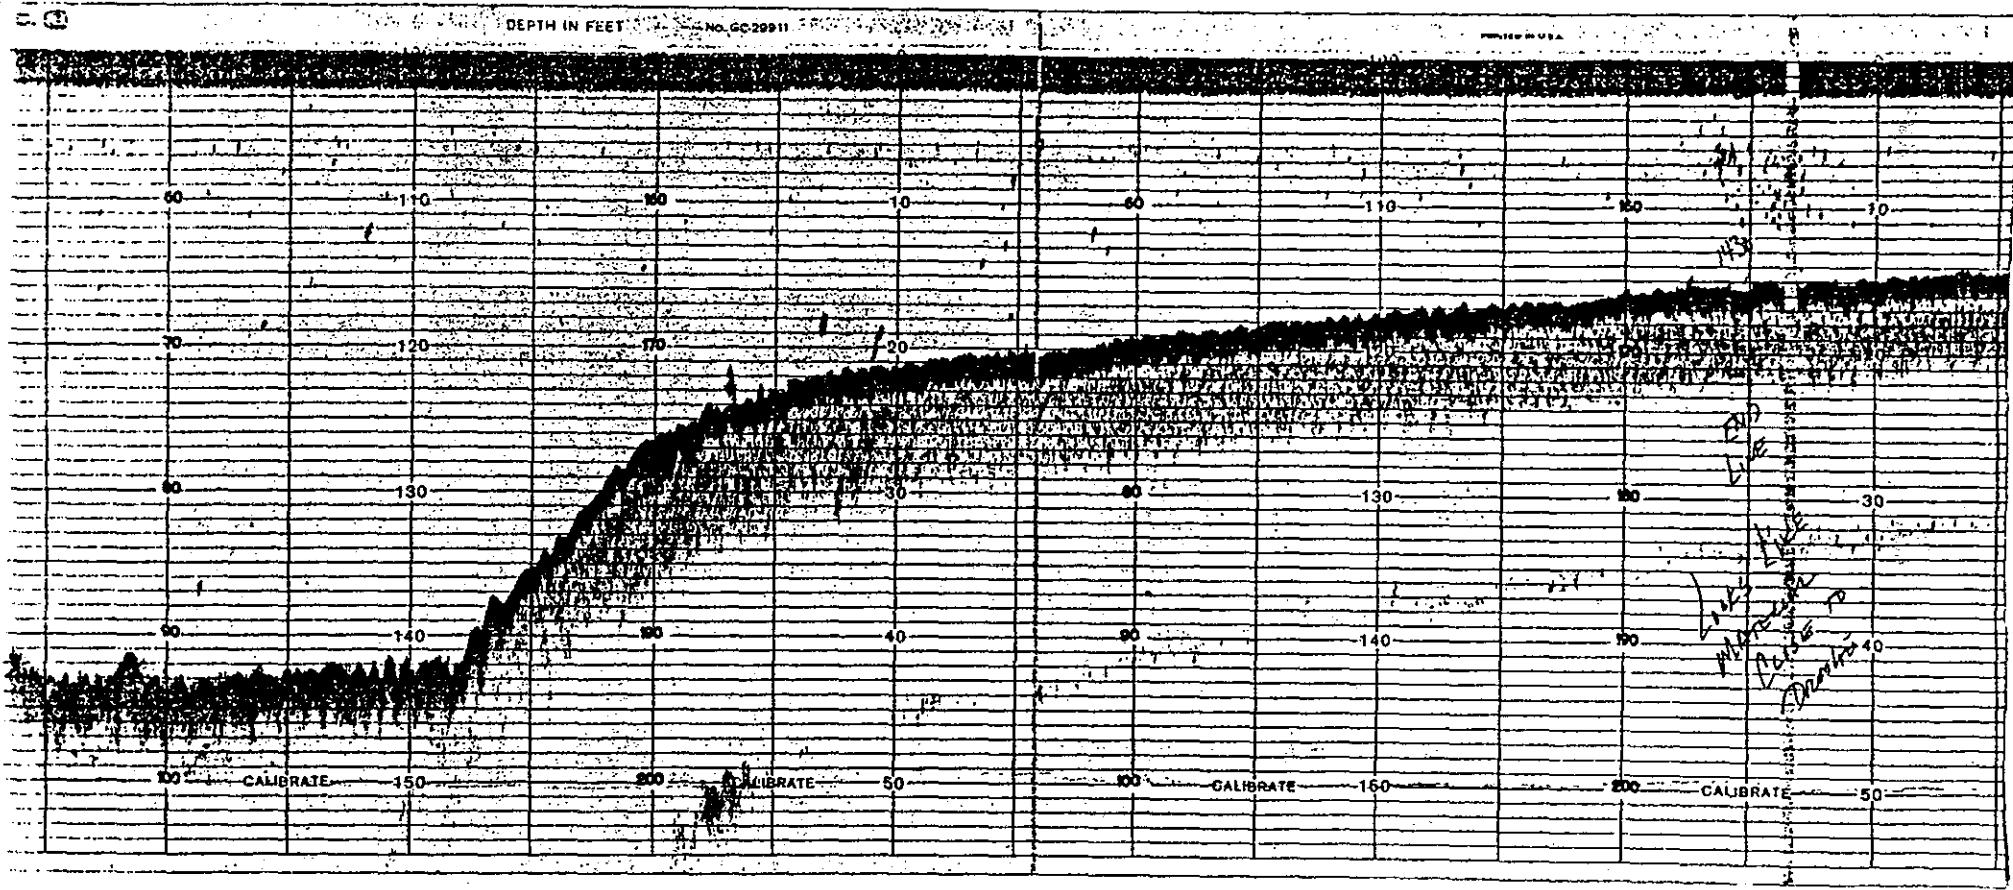
End segment of Transect #15 acoustic survey of 3 November 1993; profile runs east to west

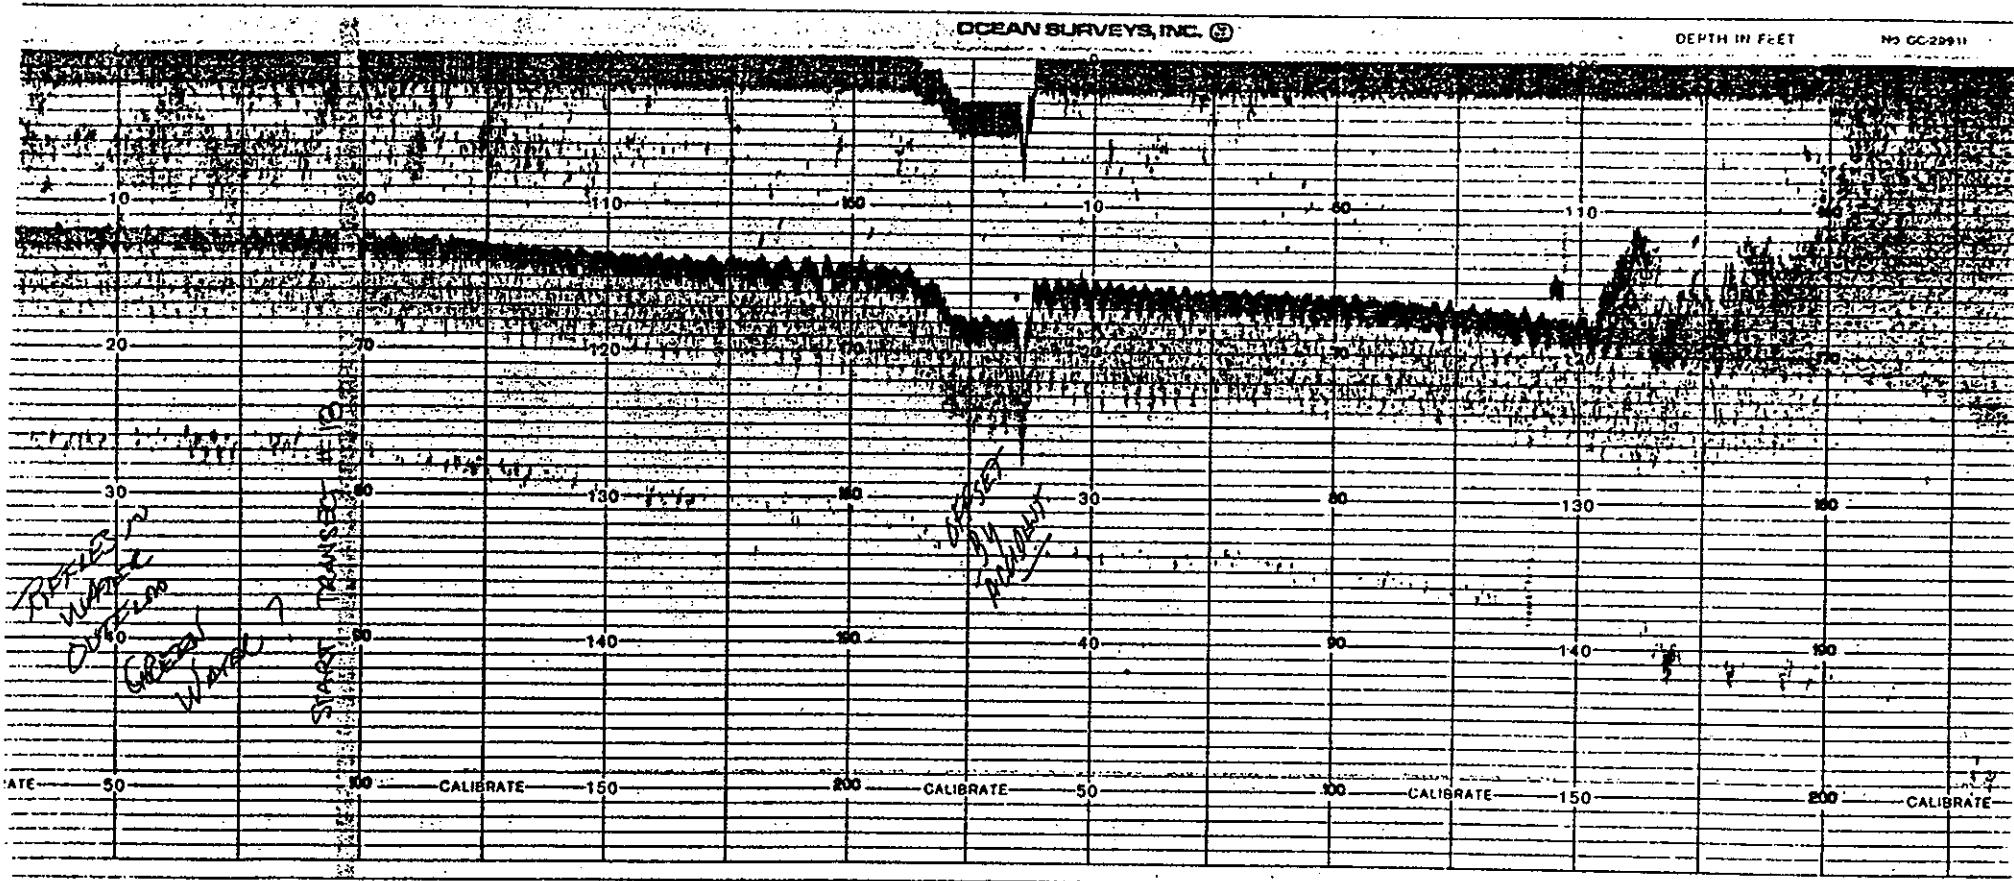
Beginning segment of Transect #18 acoustic survey of 3 November 1993; profile runs west to east

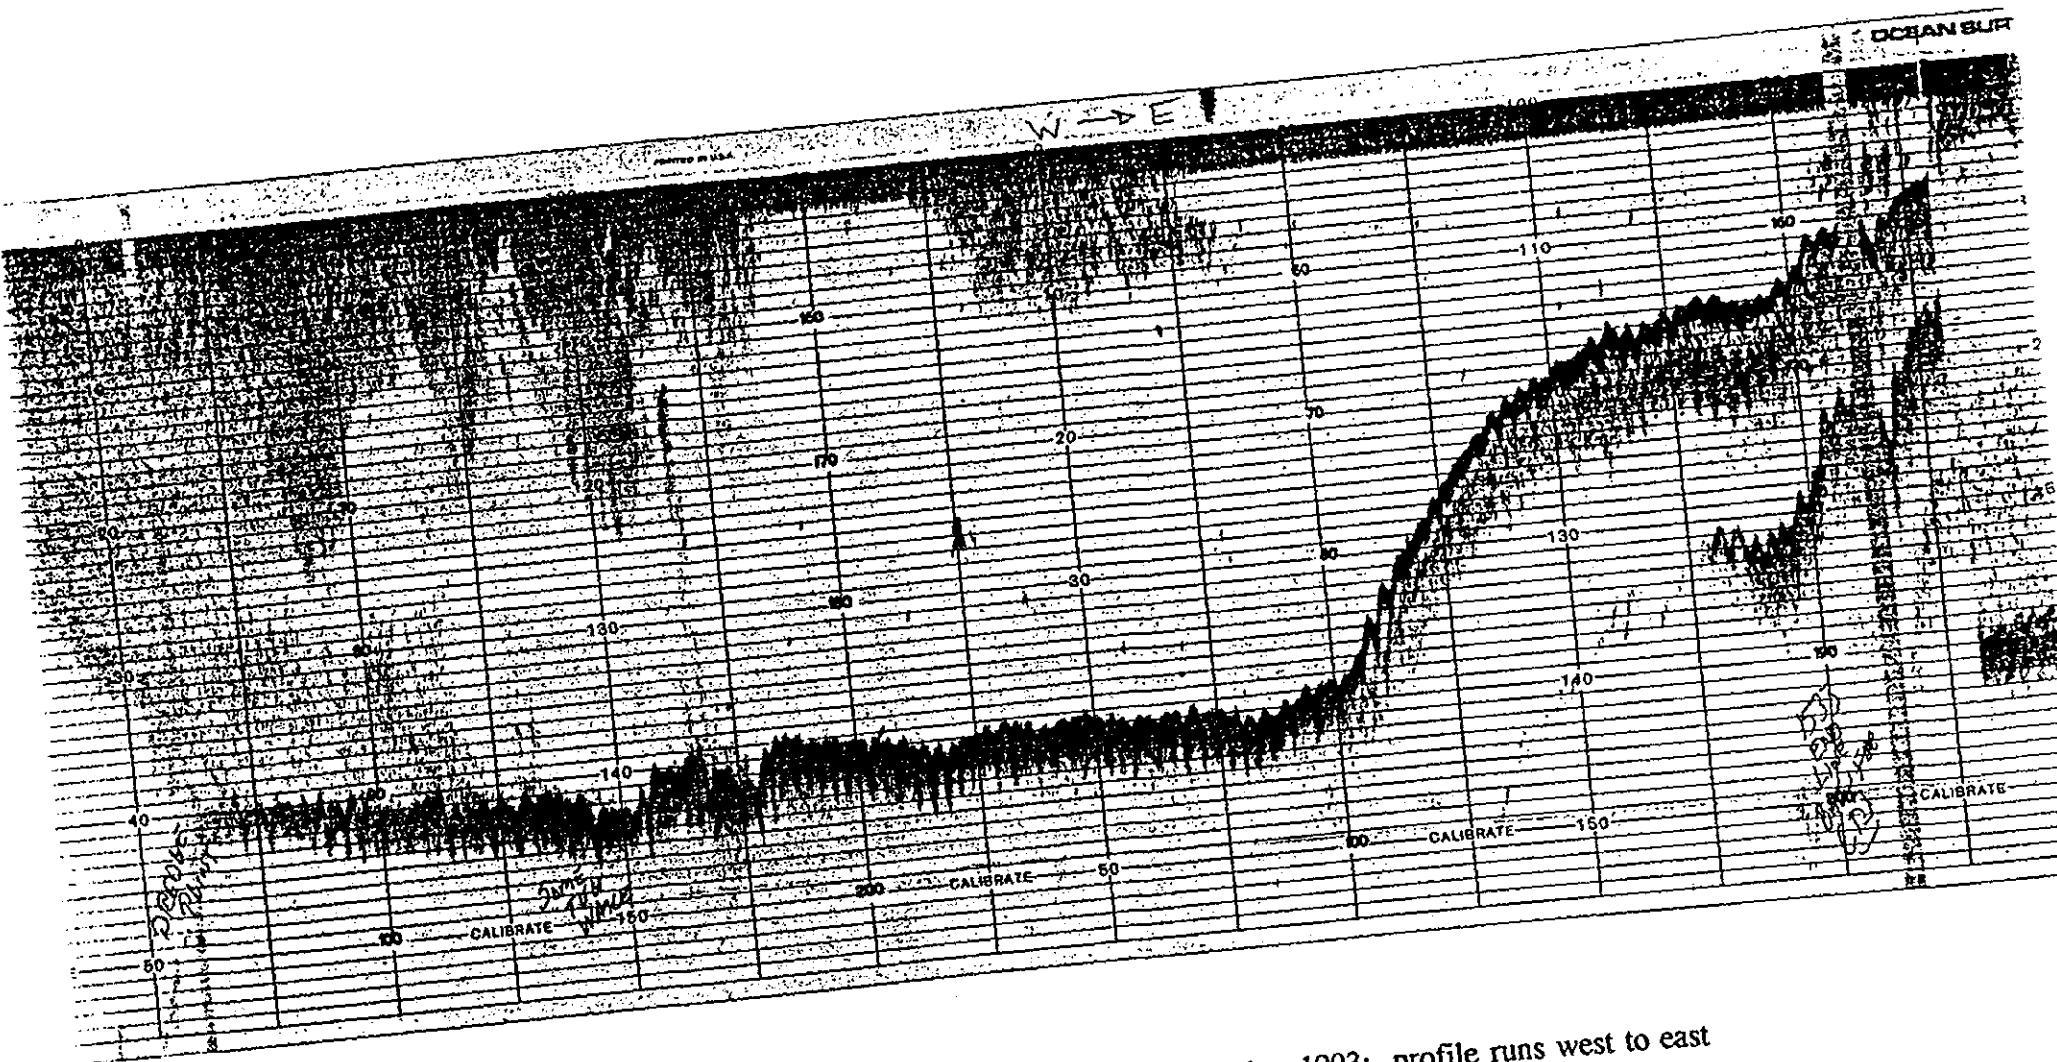
End segment of Transect #18 acoustic survey of 3 November 1993; profile runs west to east

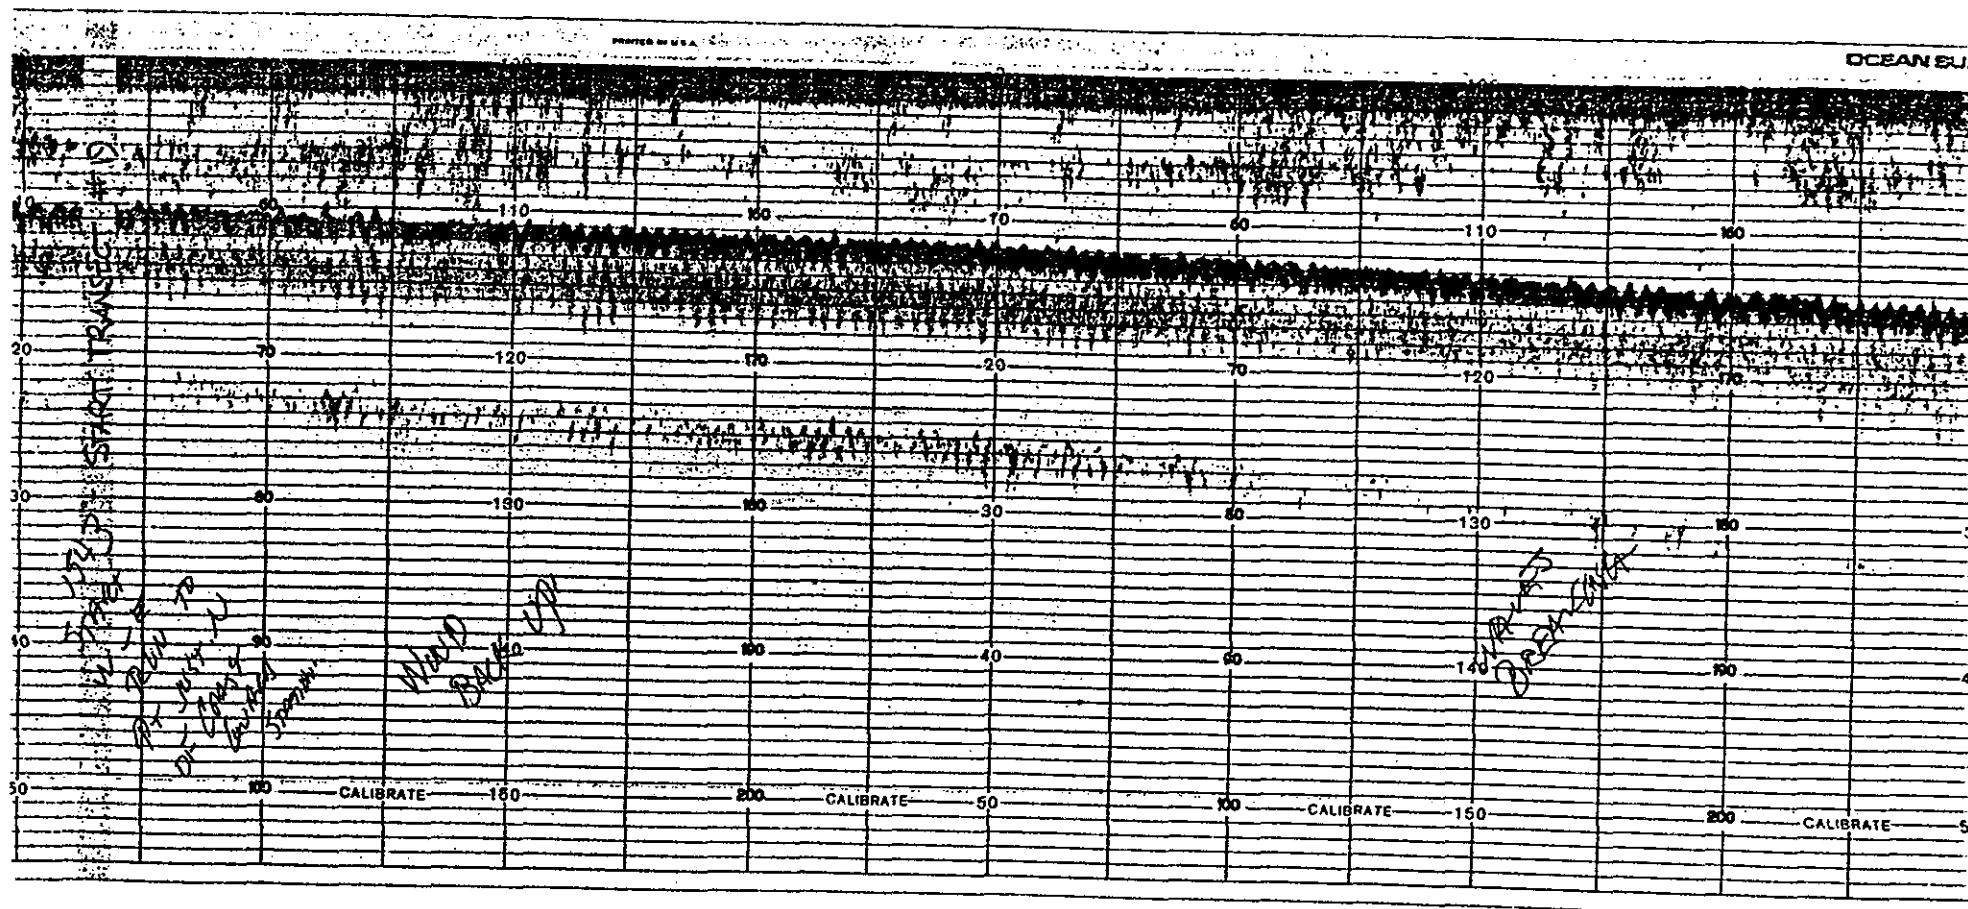
Beginning segment of Transect #19 acoustic survey of 3 November 1993; profile runs west to east

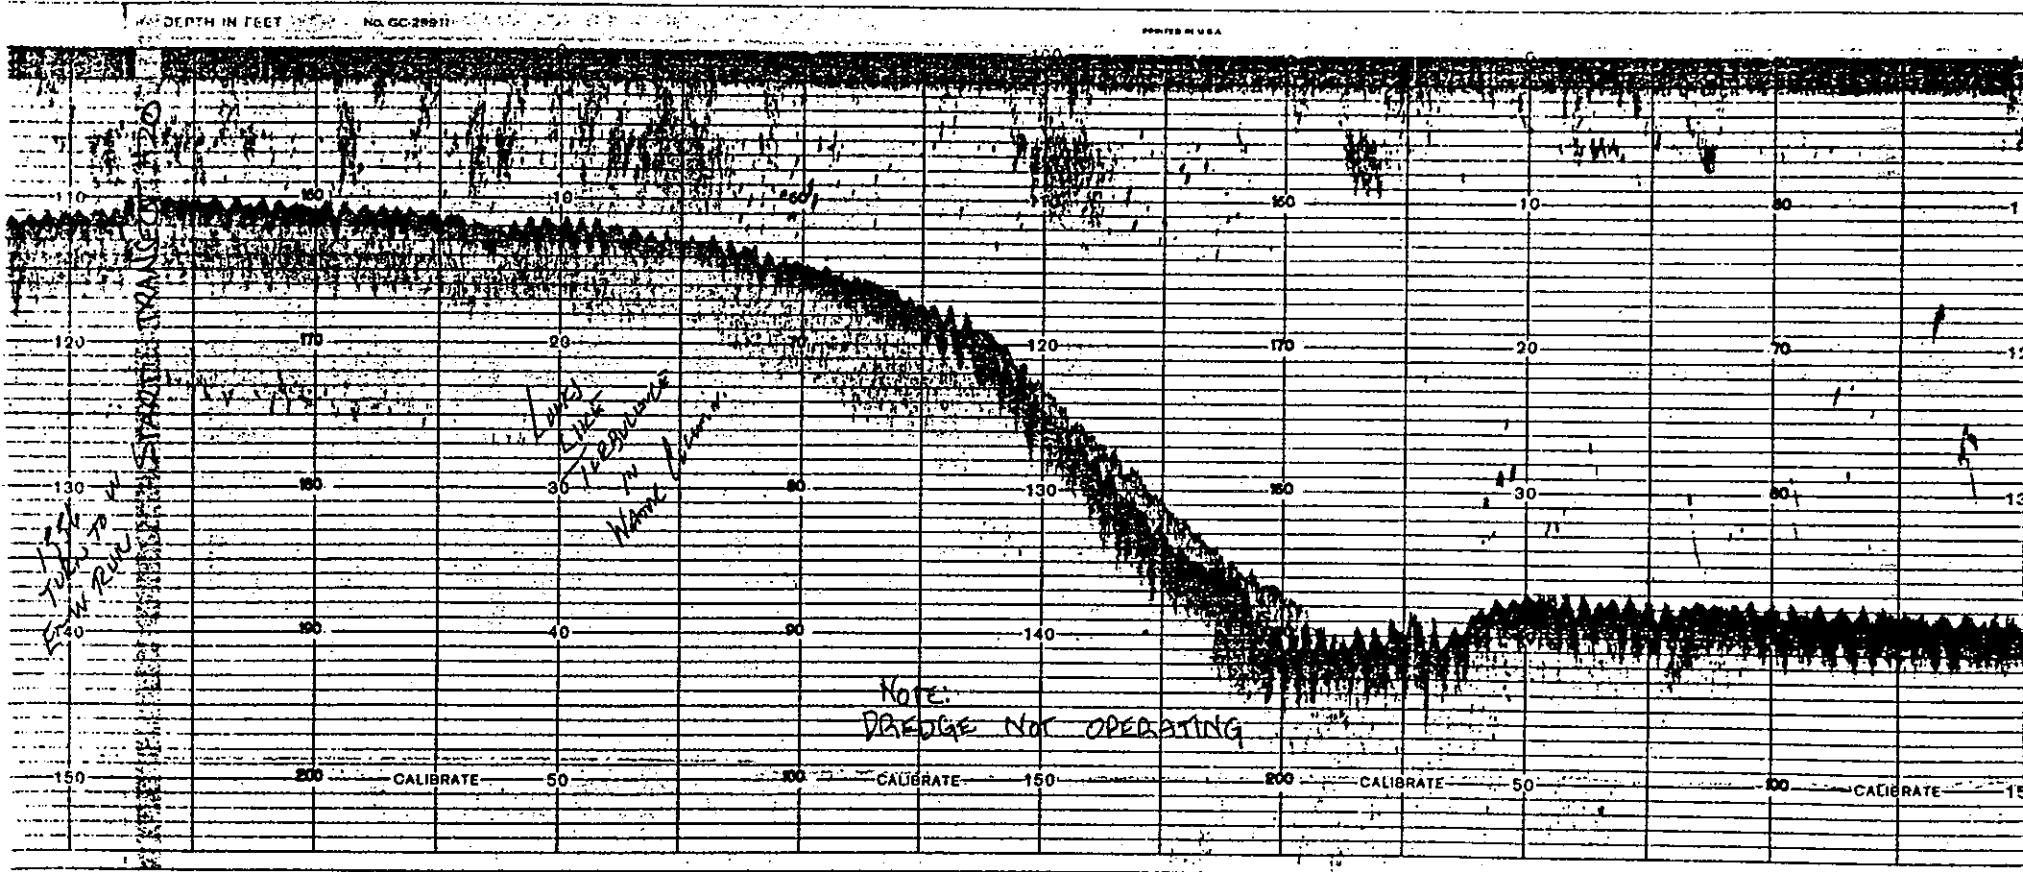
Beginning segment of Transect #20 acoustic survey of 3 November 1993; profile runs east to west

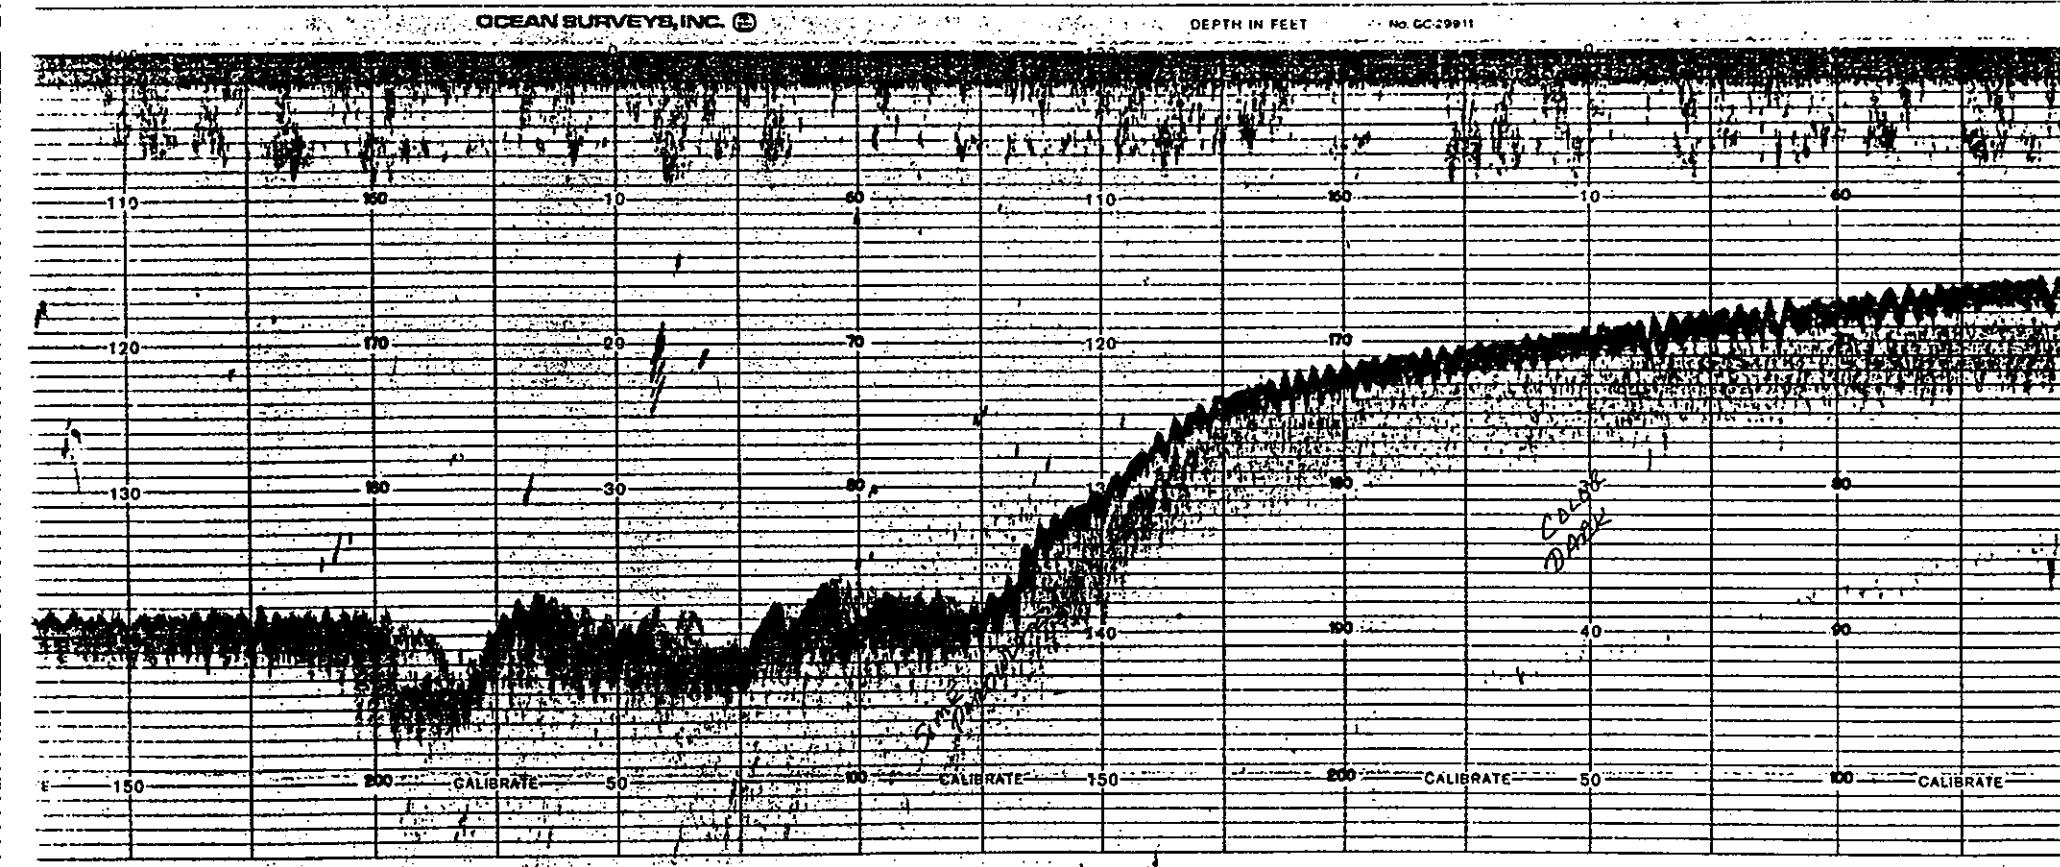
End segment of Transect #20 acoustic survey of 3 November 1993; profile runs east to west

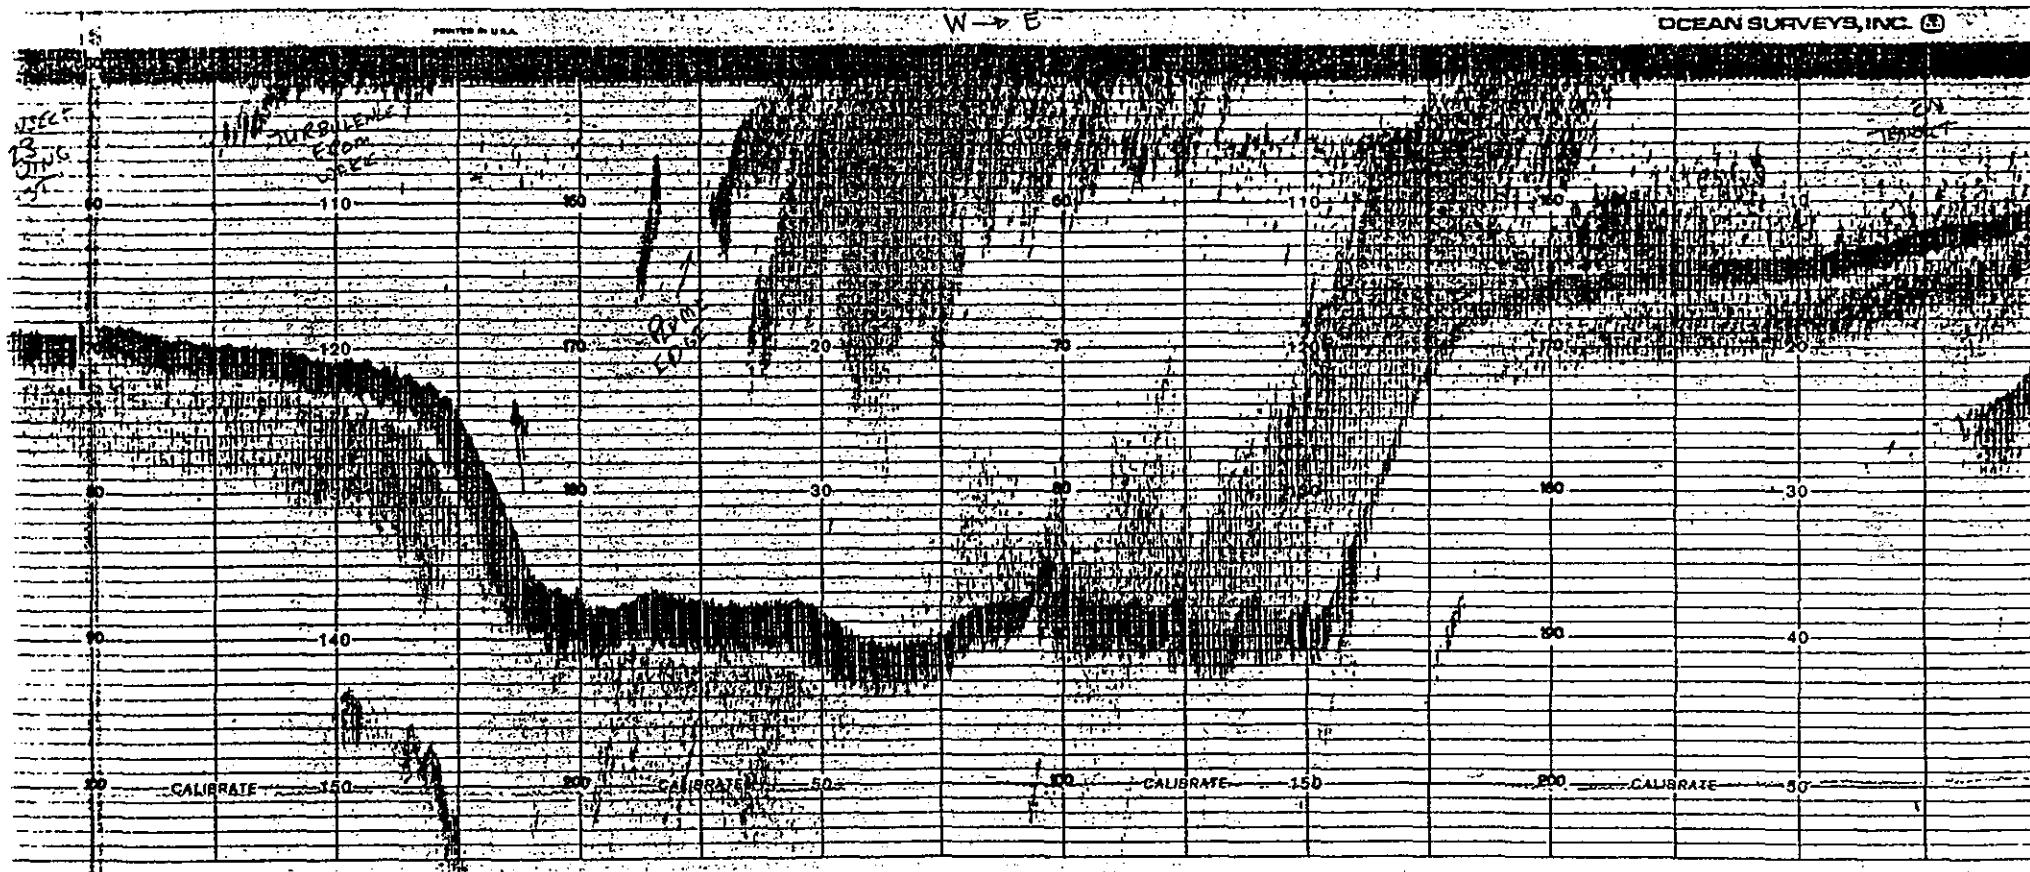
Transect #23 acoustic survey of 11 November 1993; profile runs west to east

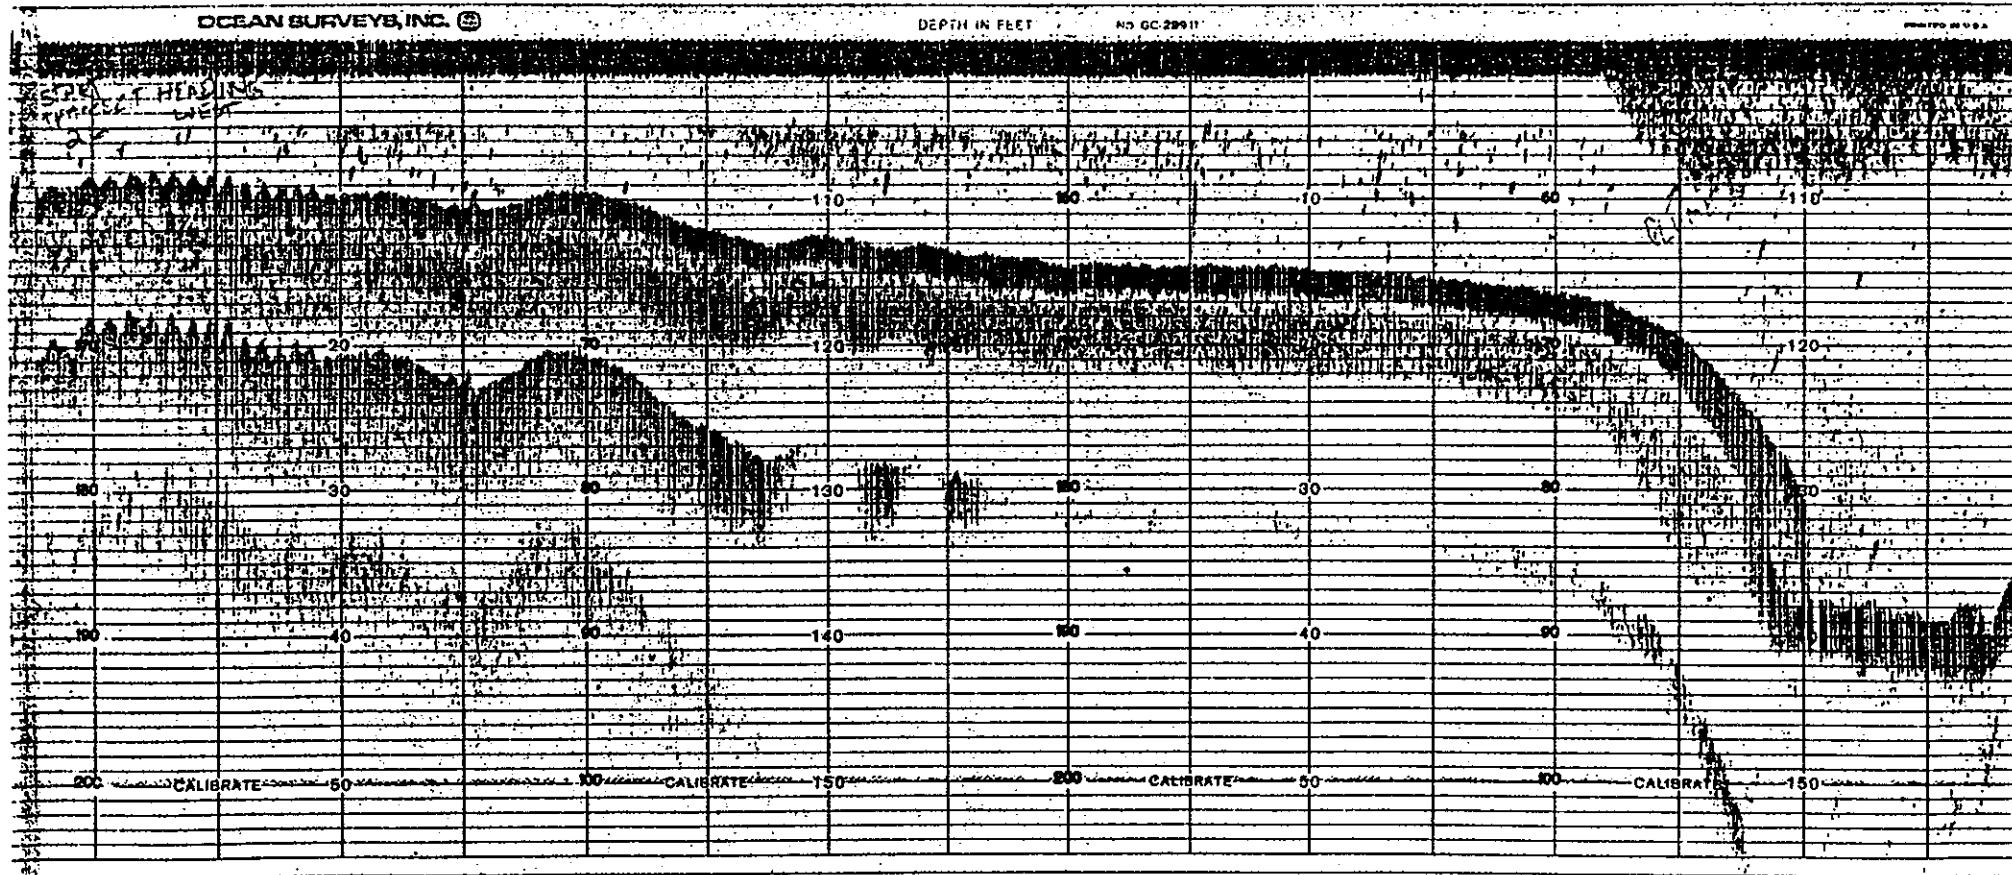
Beginning segment of Transect #26 acoustic survey of 11 November 1993; profile runs east to west
