An Investigation of the Dispersion  
of Sediments Resuspended by  
Dredging Operations in New Haven Harbor

# **Disposal Area Monitoring System DAMOS**

Contribution 112  
November 1996

**US Army Corps  
of Engineers**  
New England Division

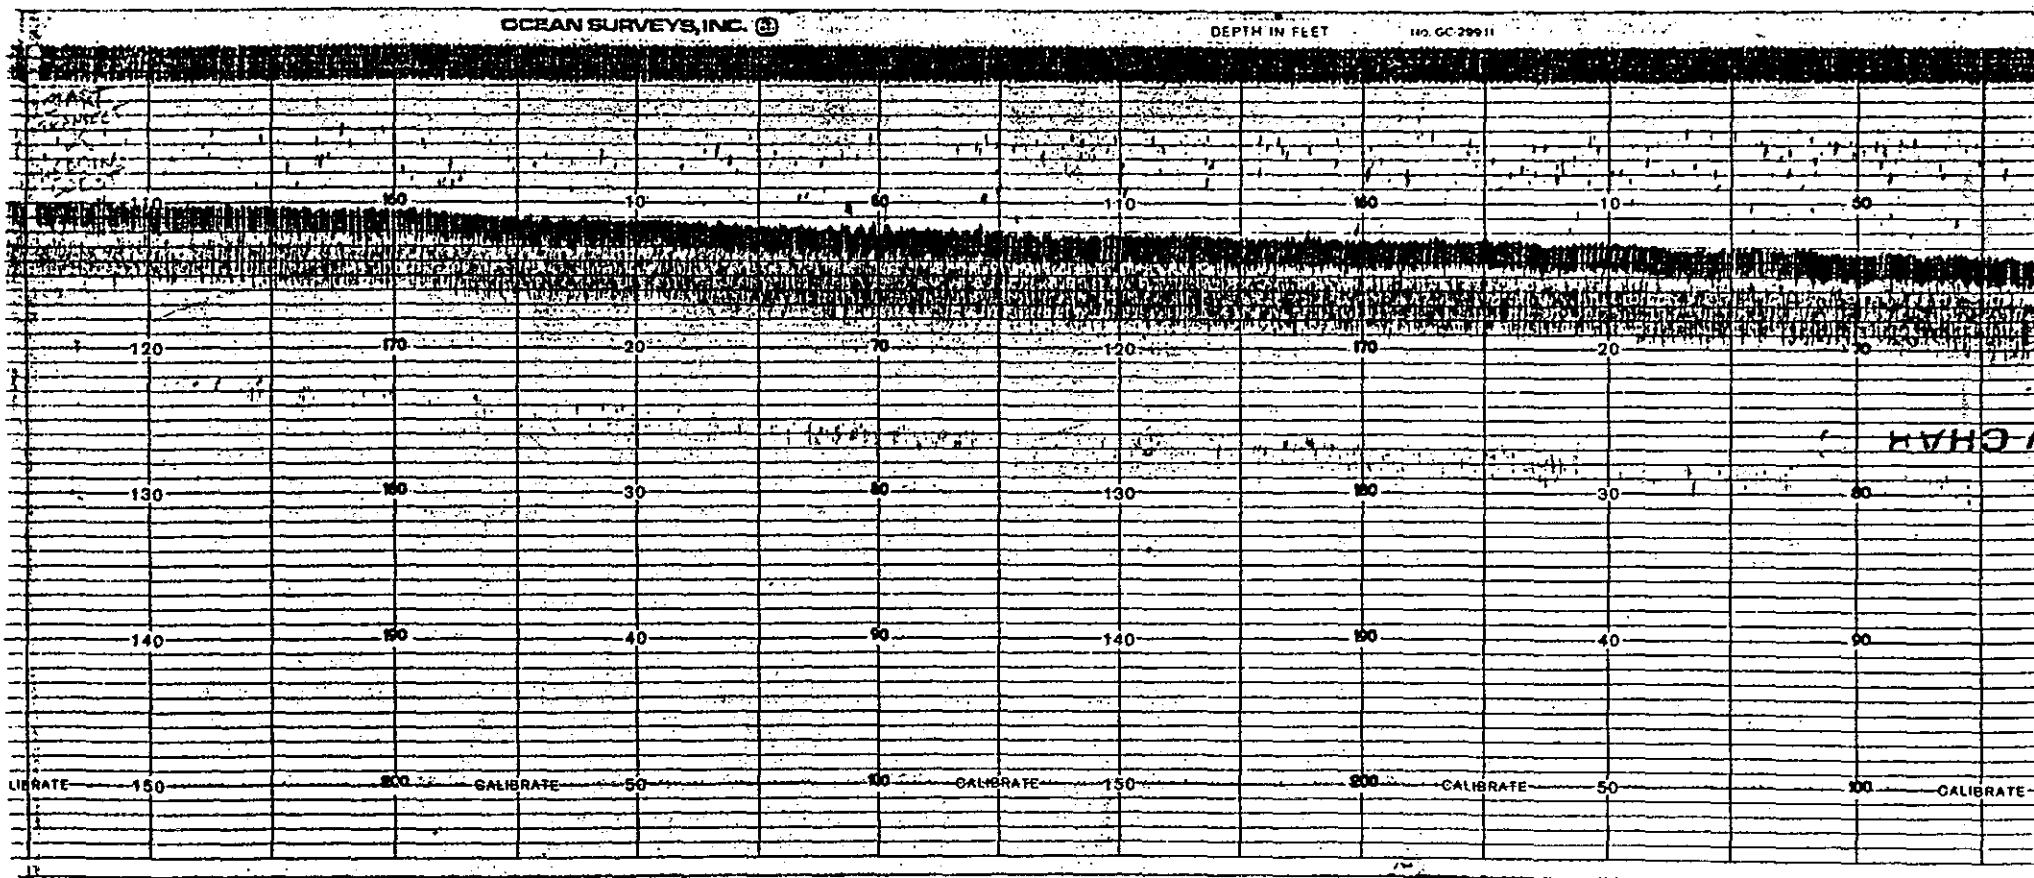
Beginning segment of Transect #28 acoustic survey of 11 November 1993; profile runs east to west

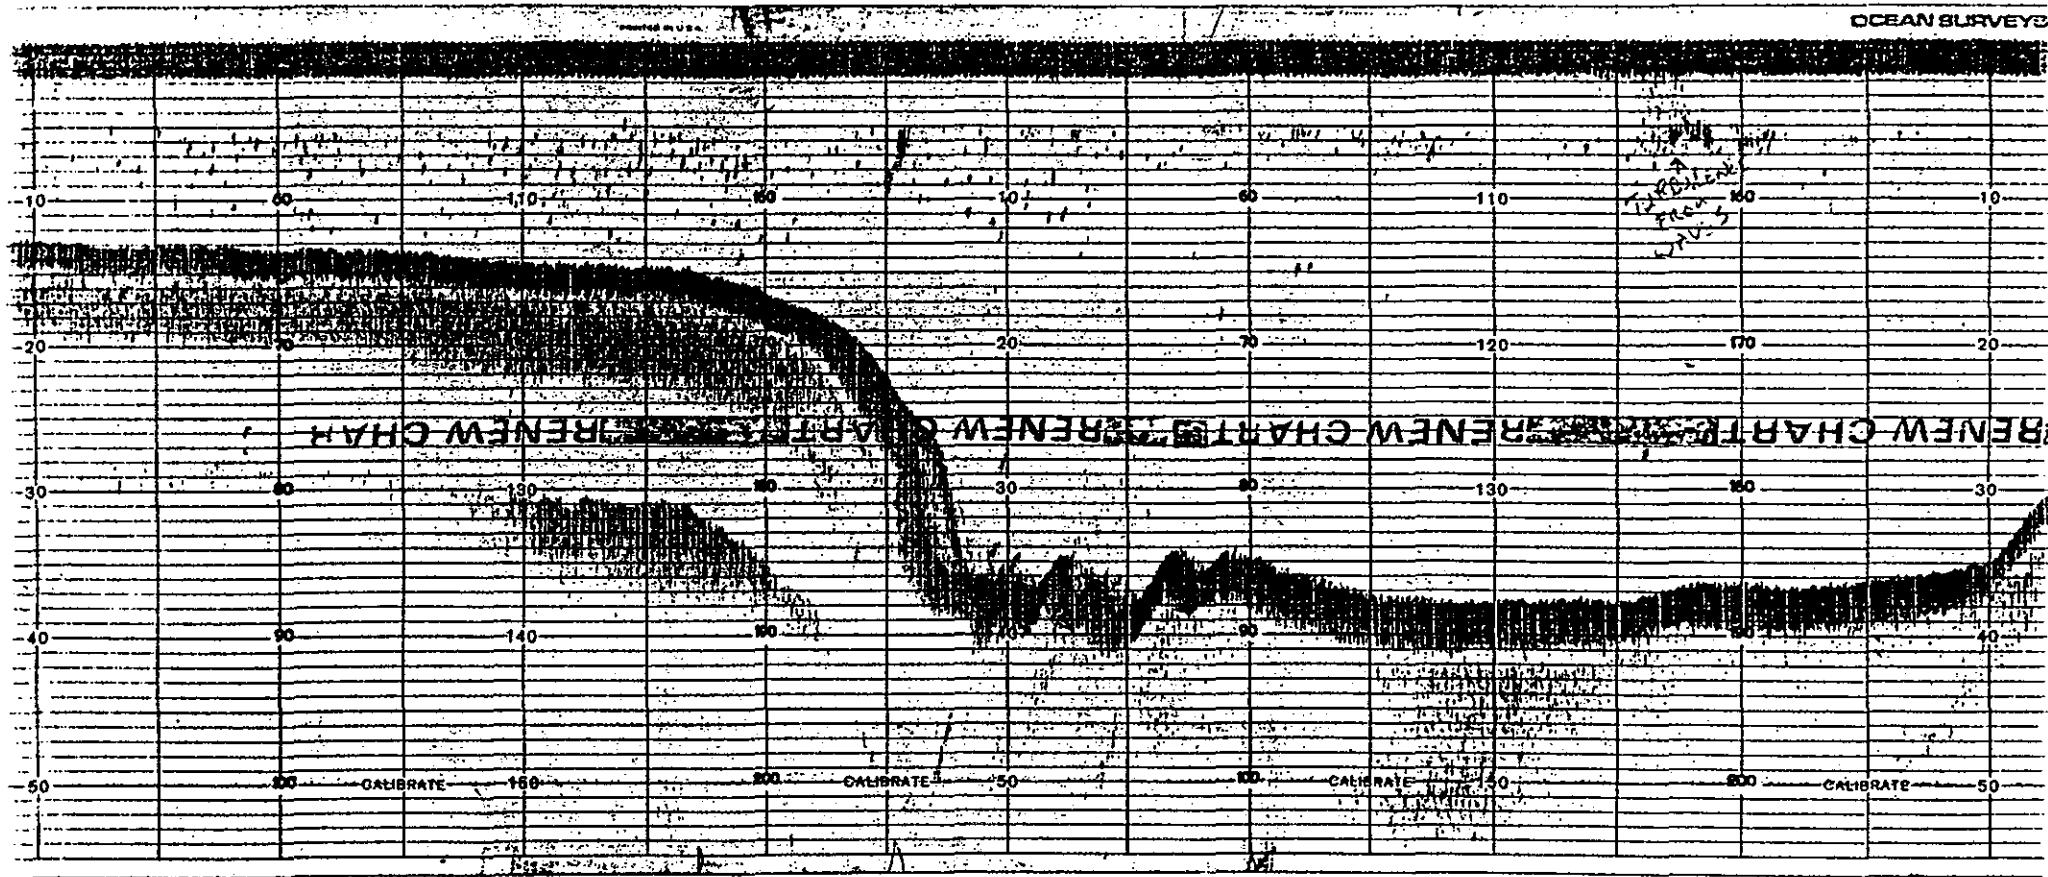
Middle segment of Transect #28 acoustic survey of 11 November 1993; profile runs east to west

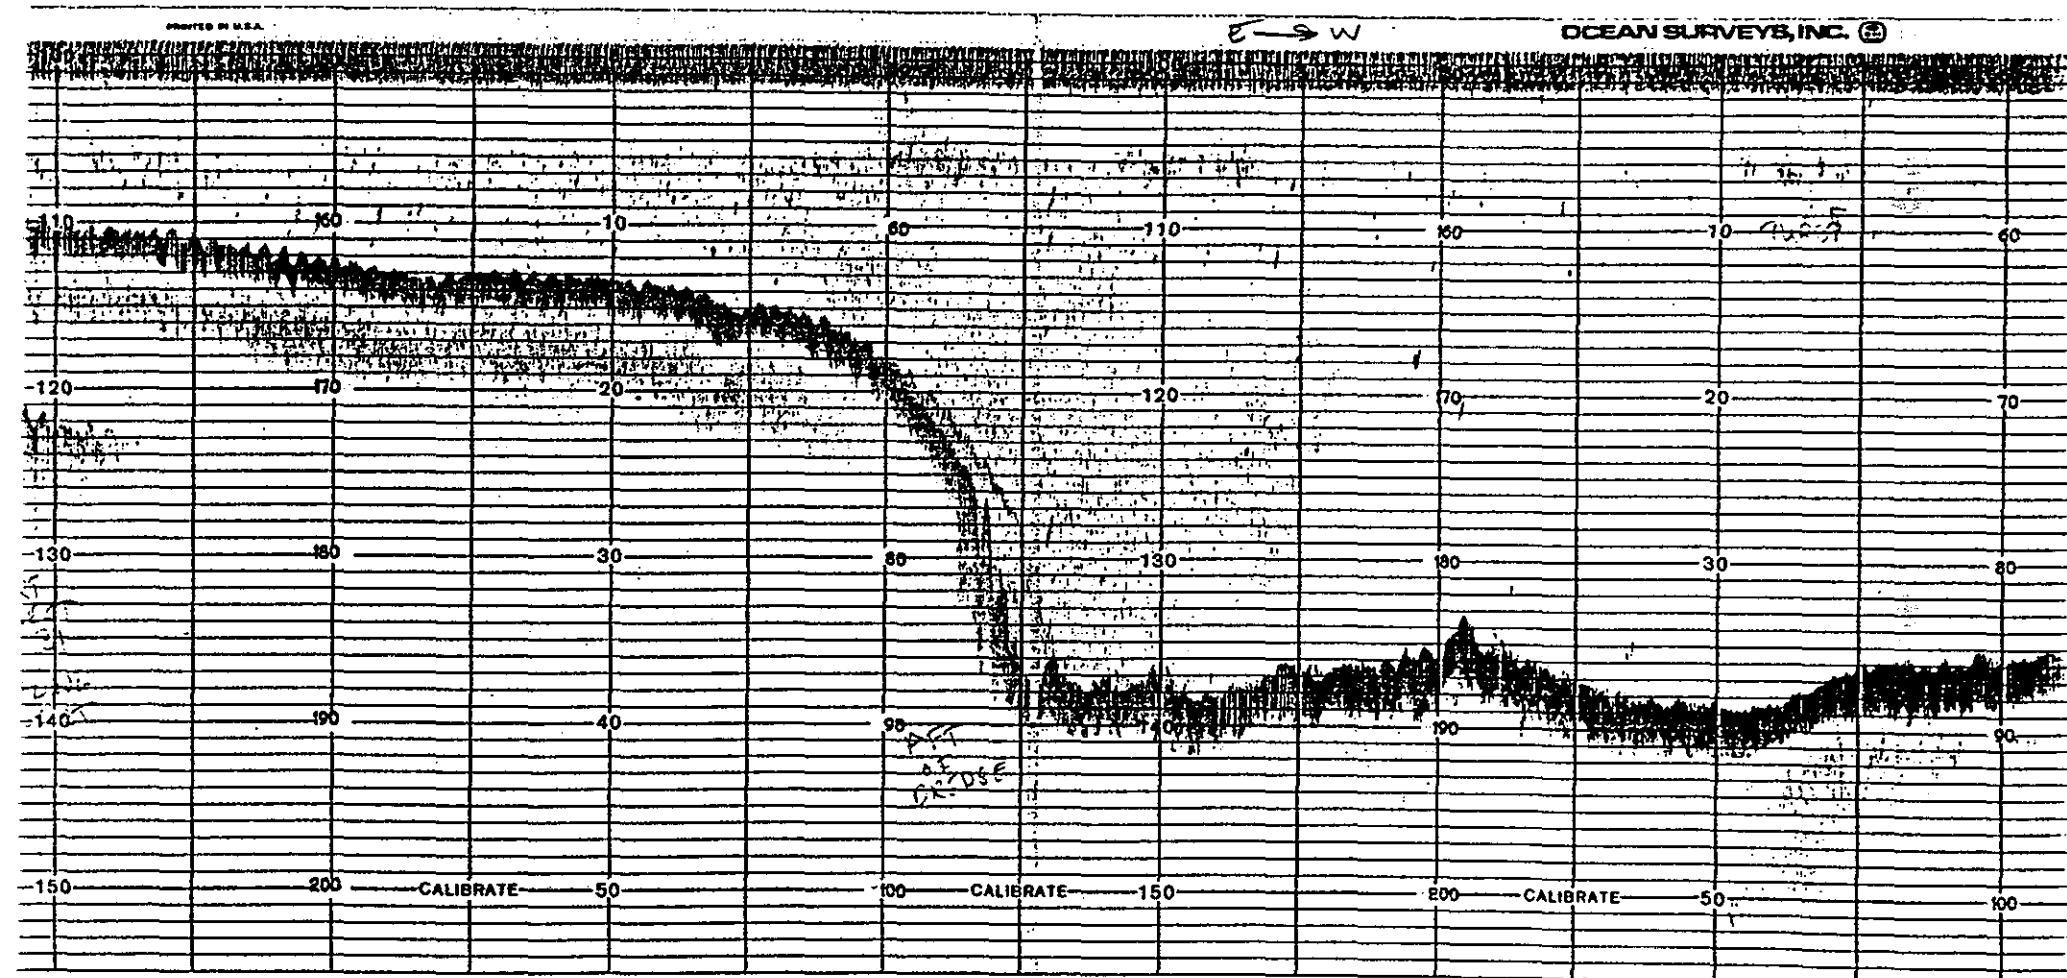
Beginning segment of Transect #31 acoustic survey of 11 November 1993; profile runs east to west

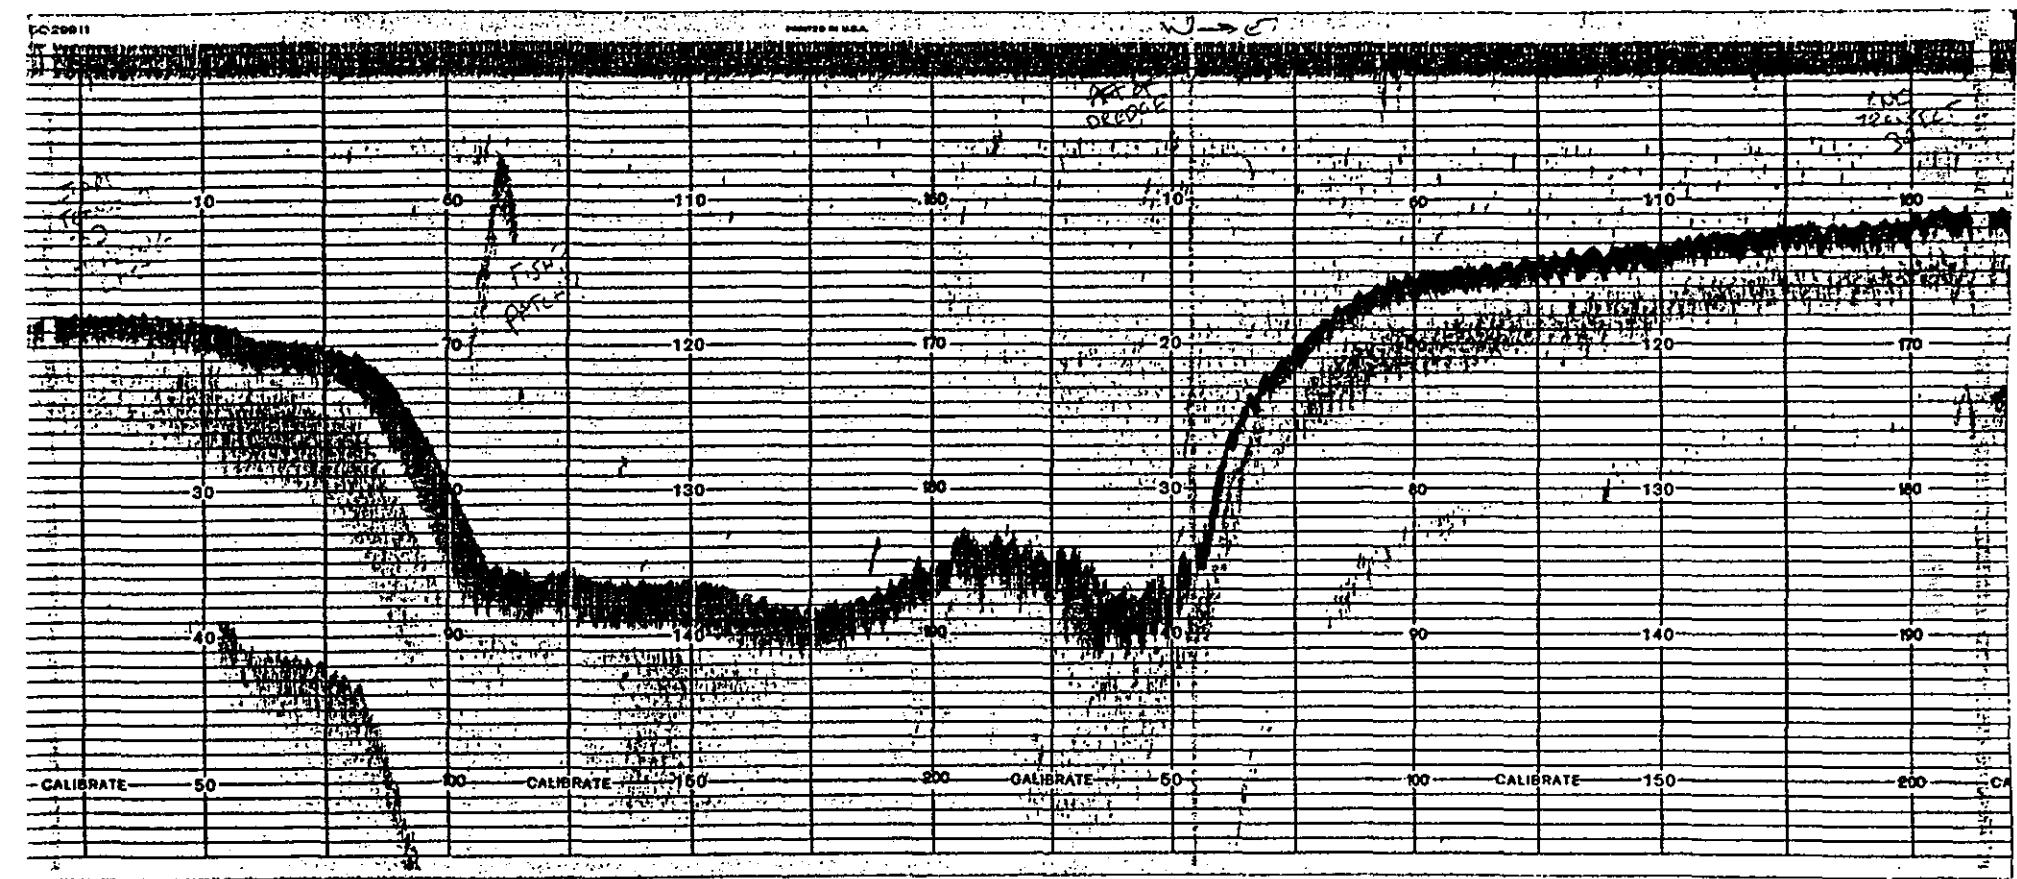
Transect #32 acoustic survey of 11 November 1993; profile runs west to east

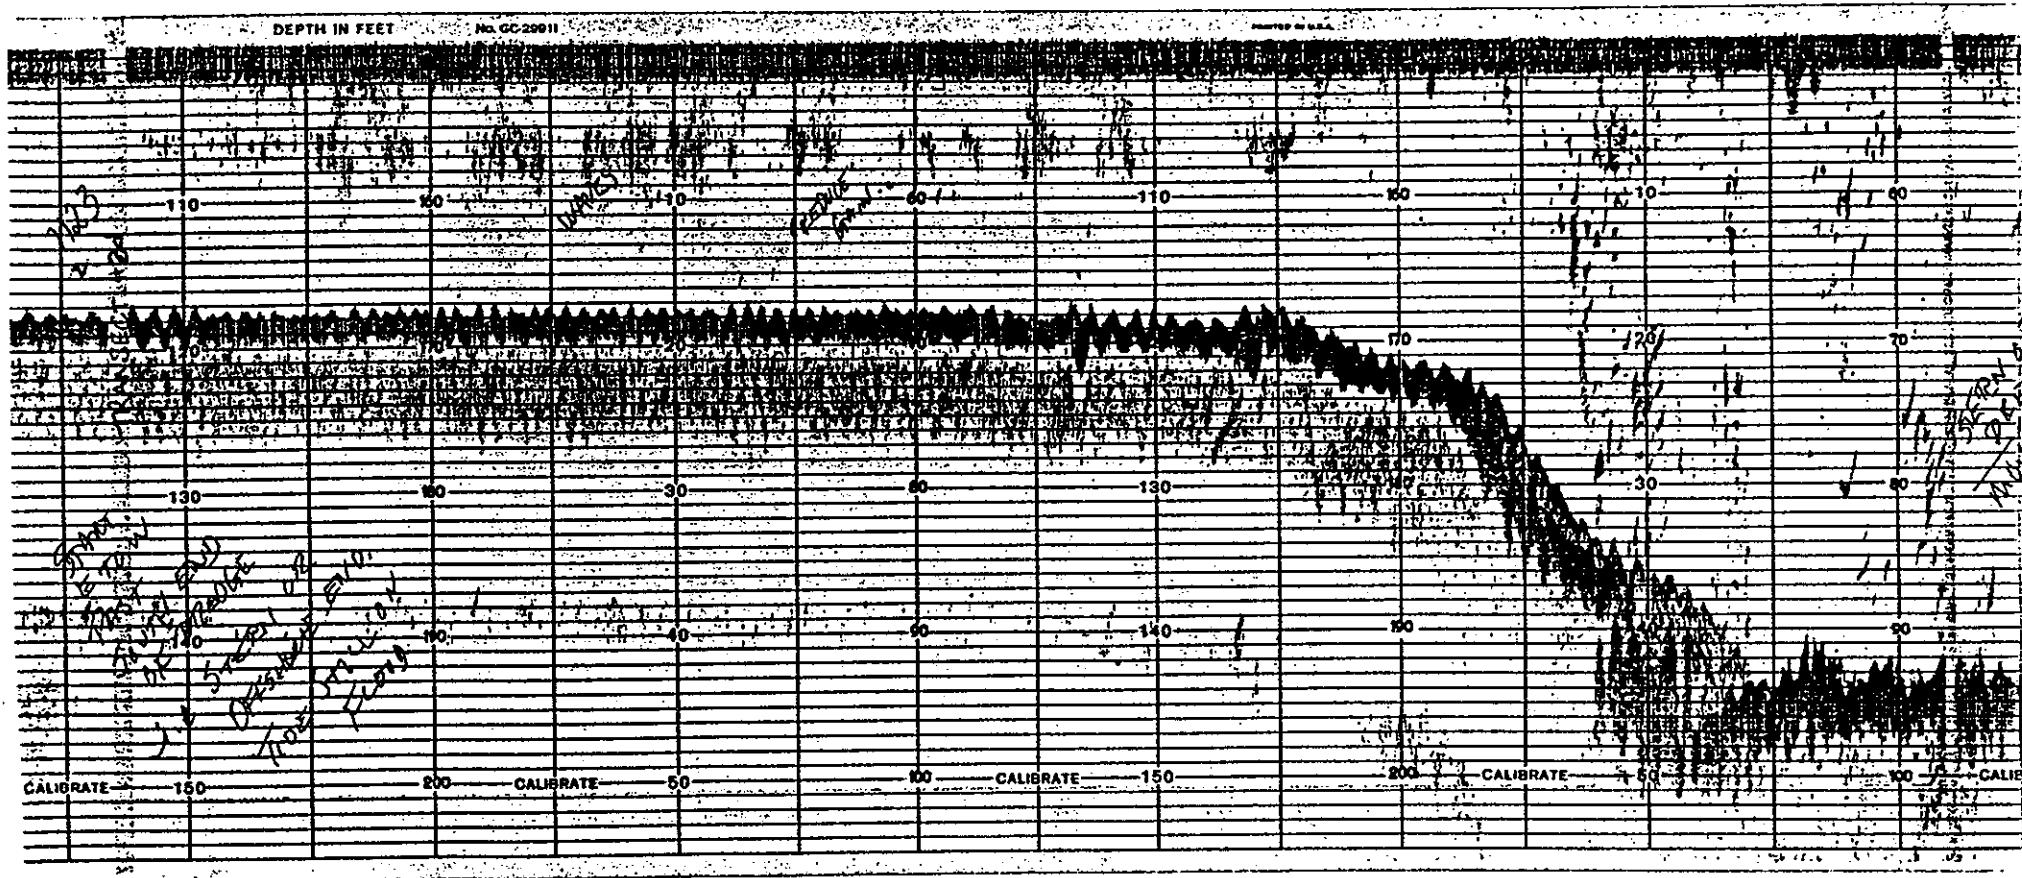
Beginning segment of Transect #34 acoustic survey of 15 November 1993; profile runs east to west

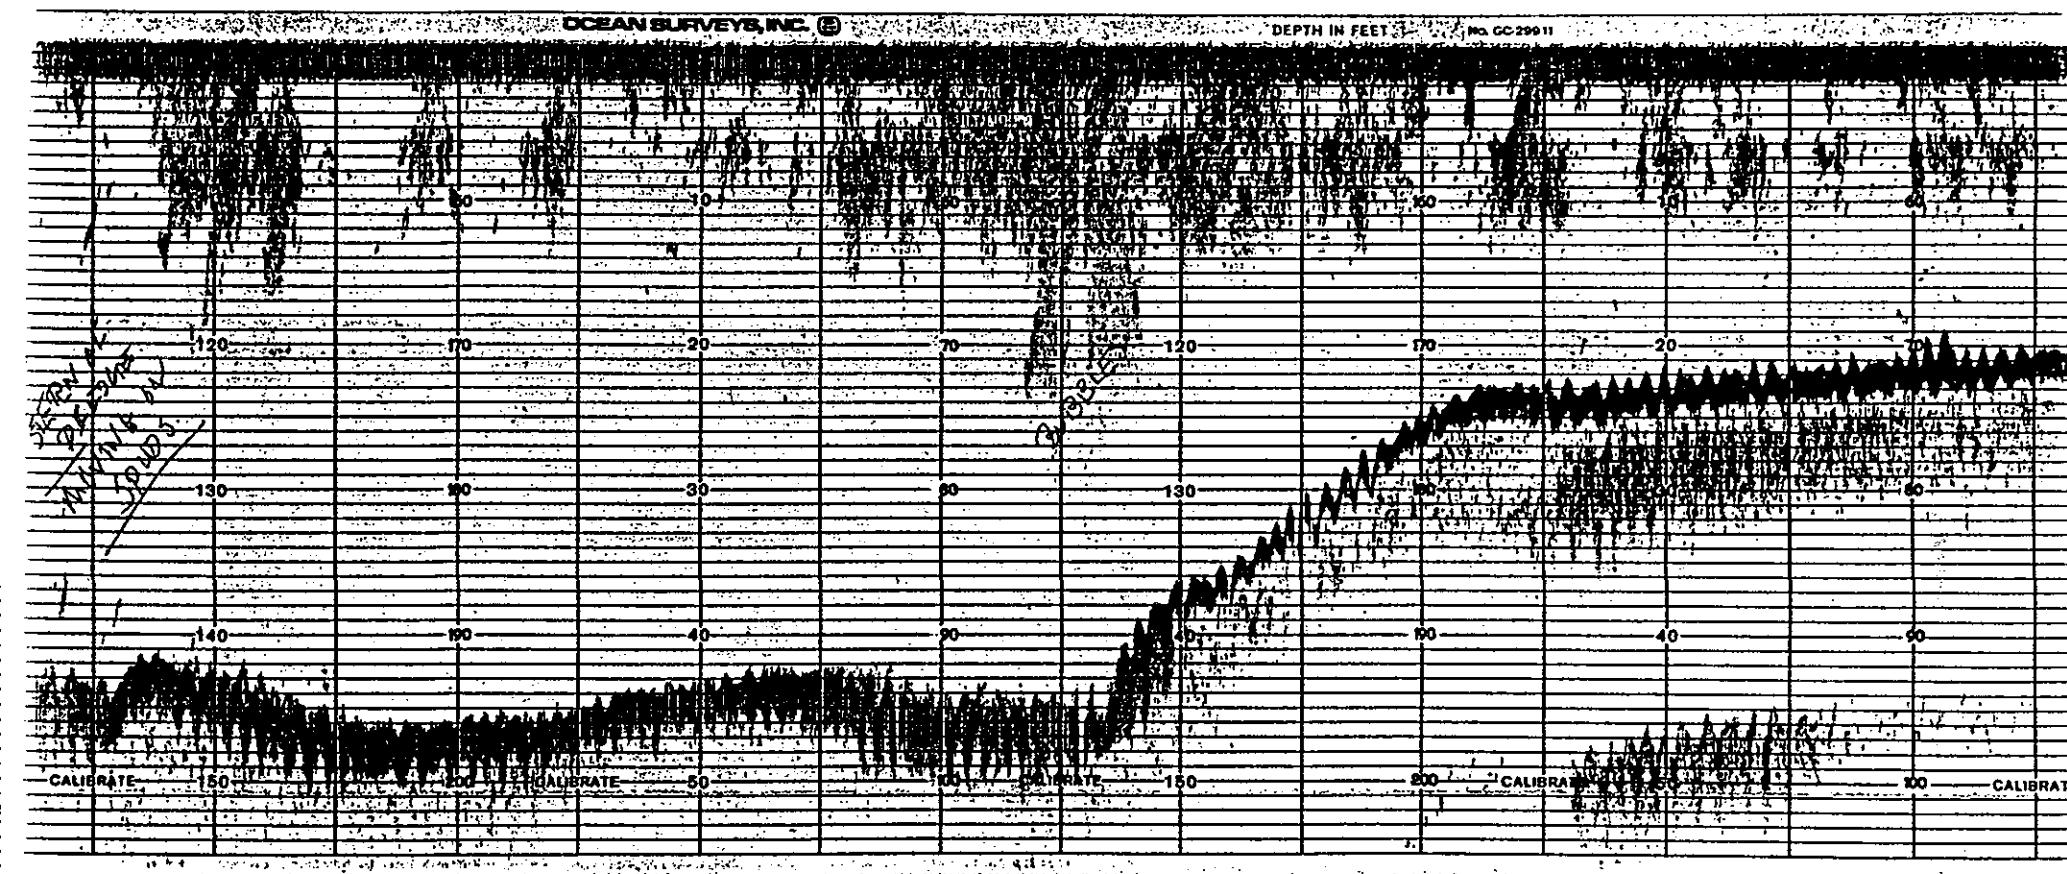
End segment of Transect #34 acoustic survey of 15 November 1993; profile runs east to west

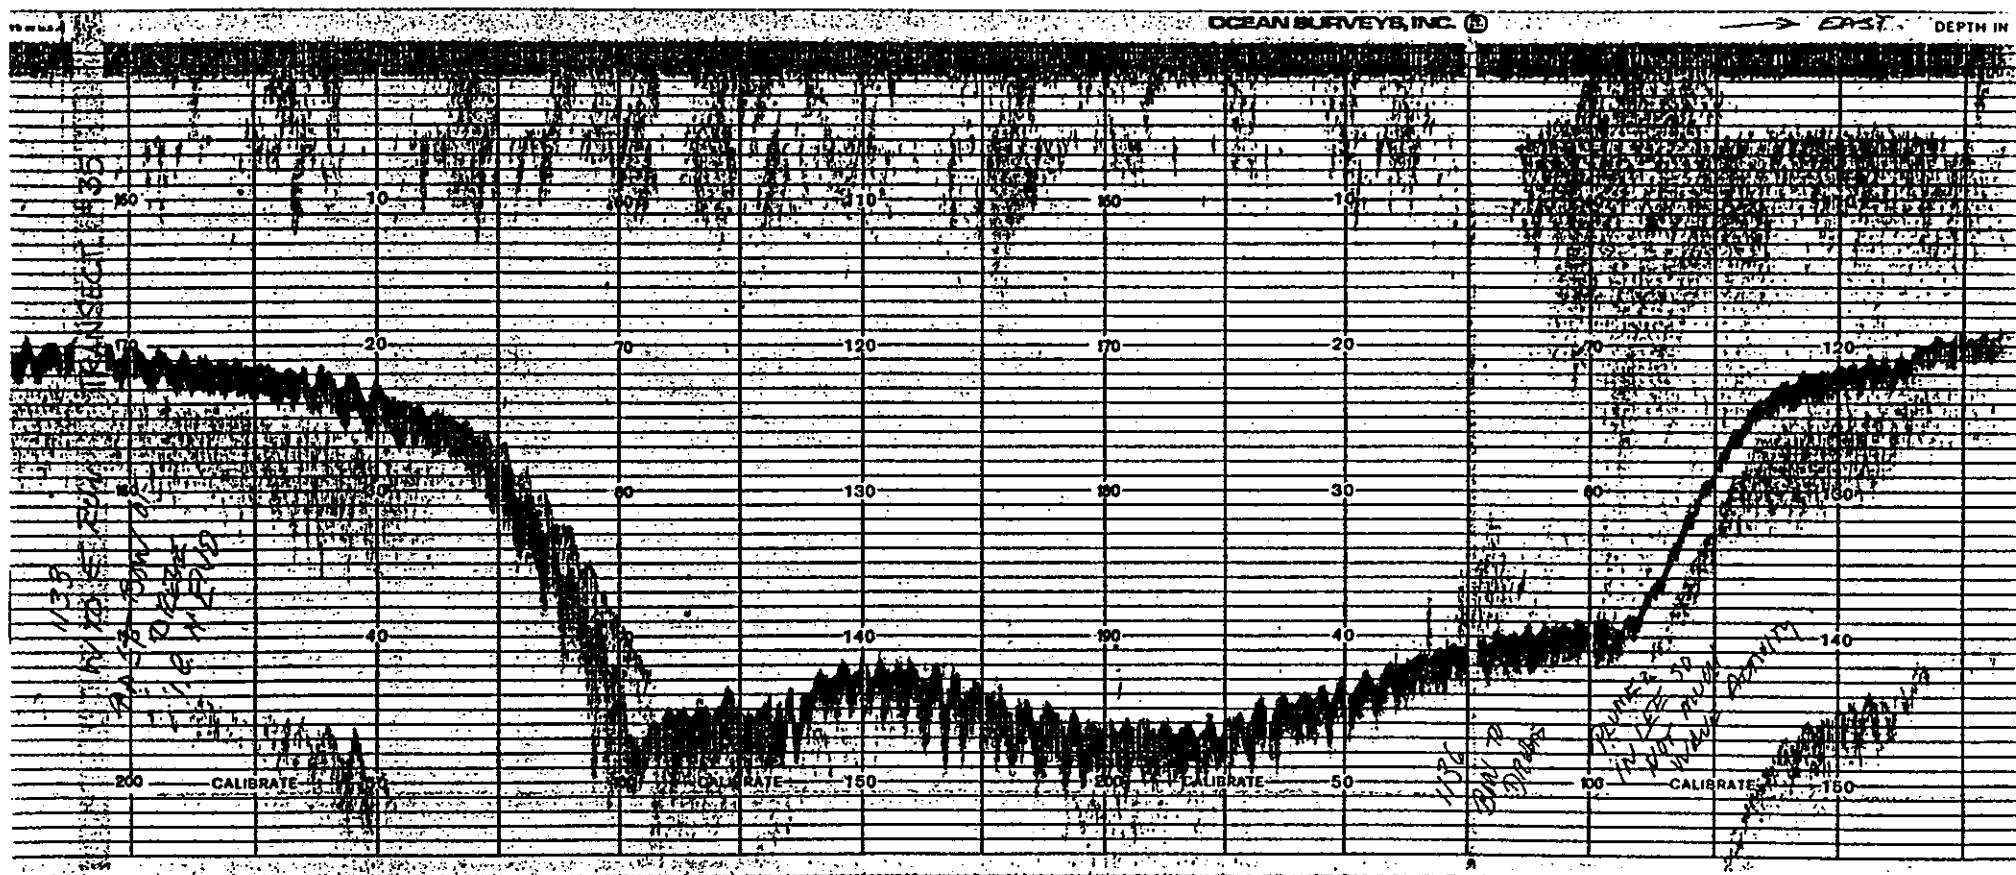
Beginning segment of Transect #35 acoustic survey of 15 November 1993; profile runs west to east

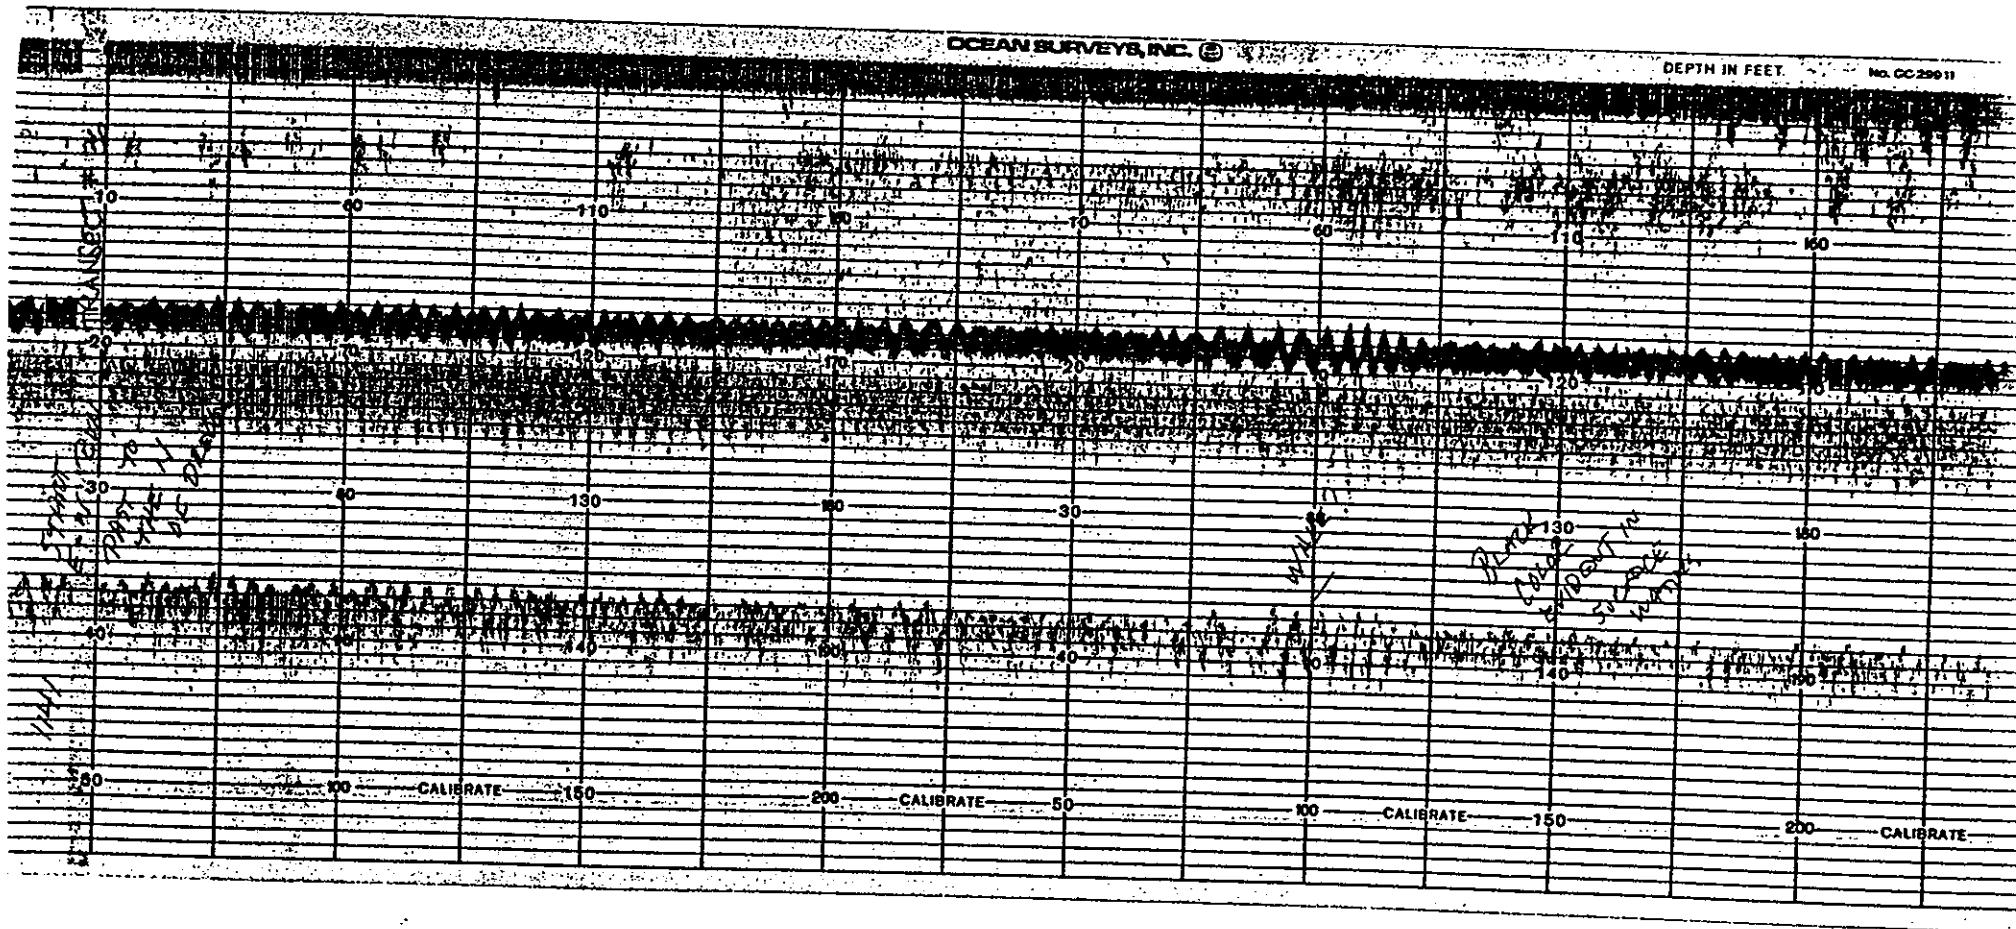
First of 4 segments for Transect #36 acoustic survey of 15 November 1993; profile runs east to west

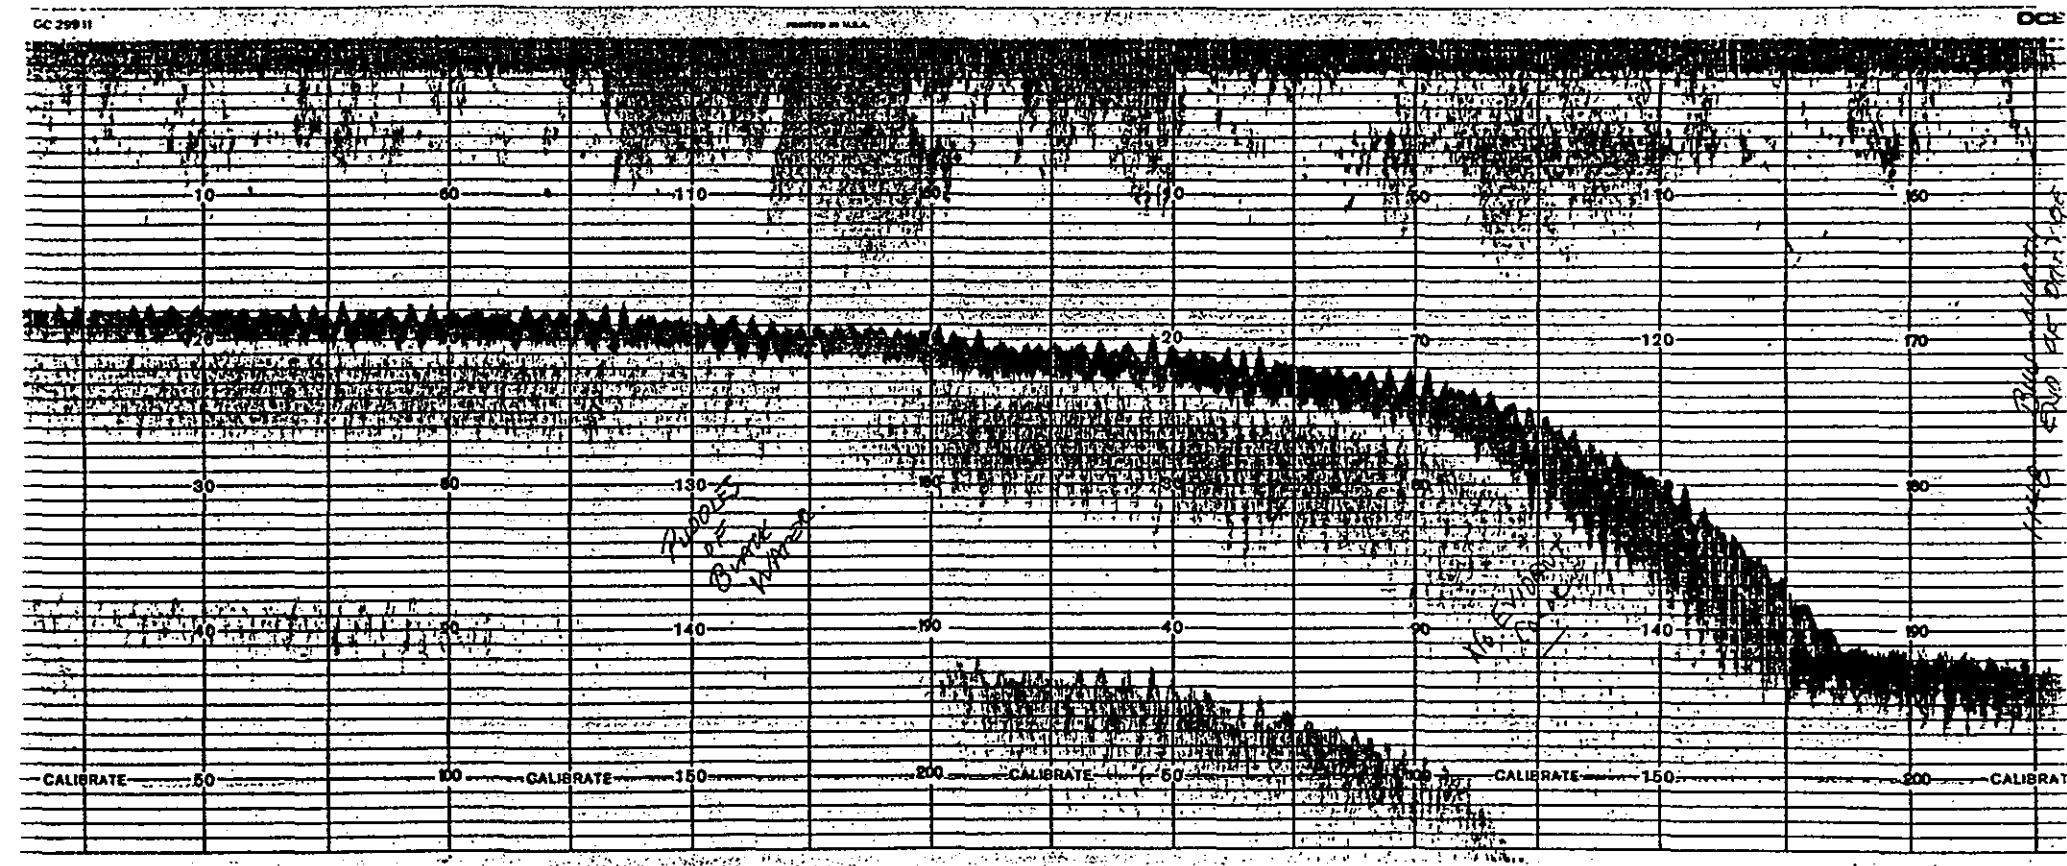
Second of 4 segments for Transect #36 acoustic survey of 15 November 1993; profile runs east to west

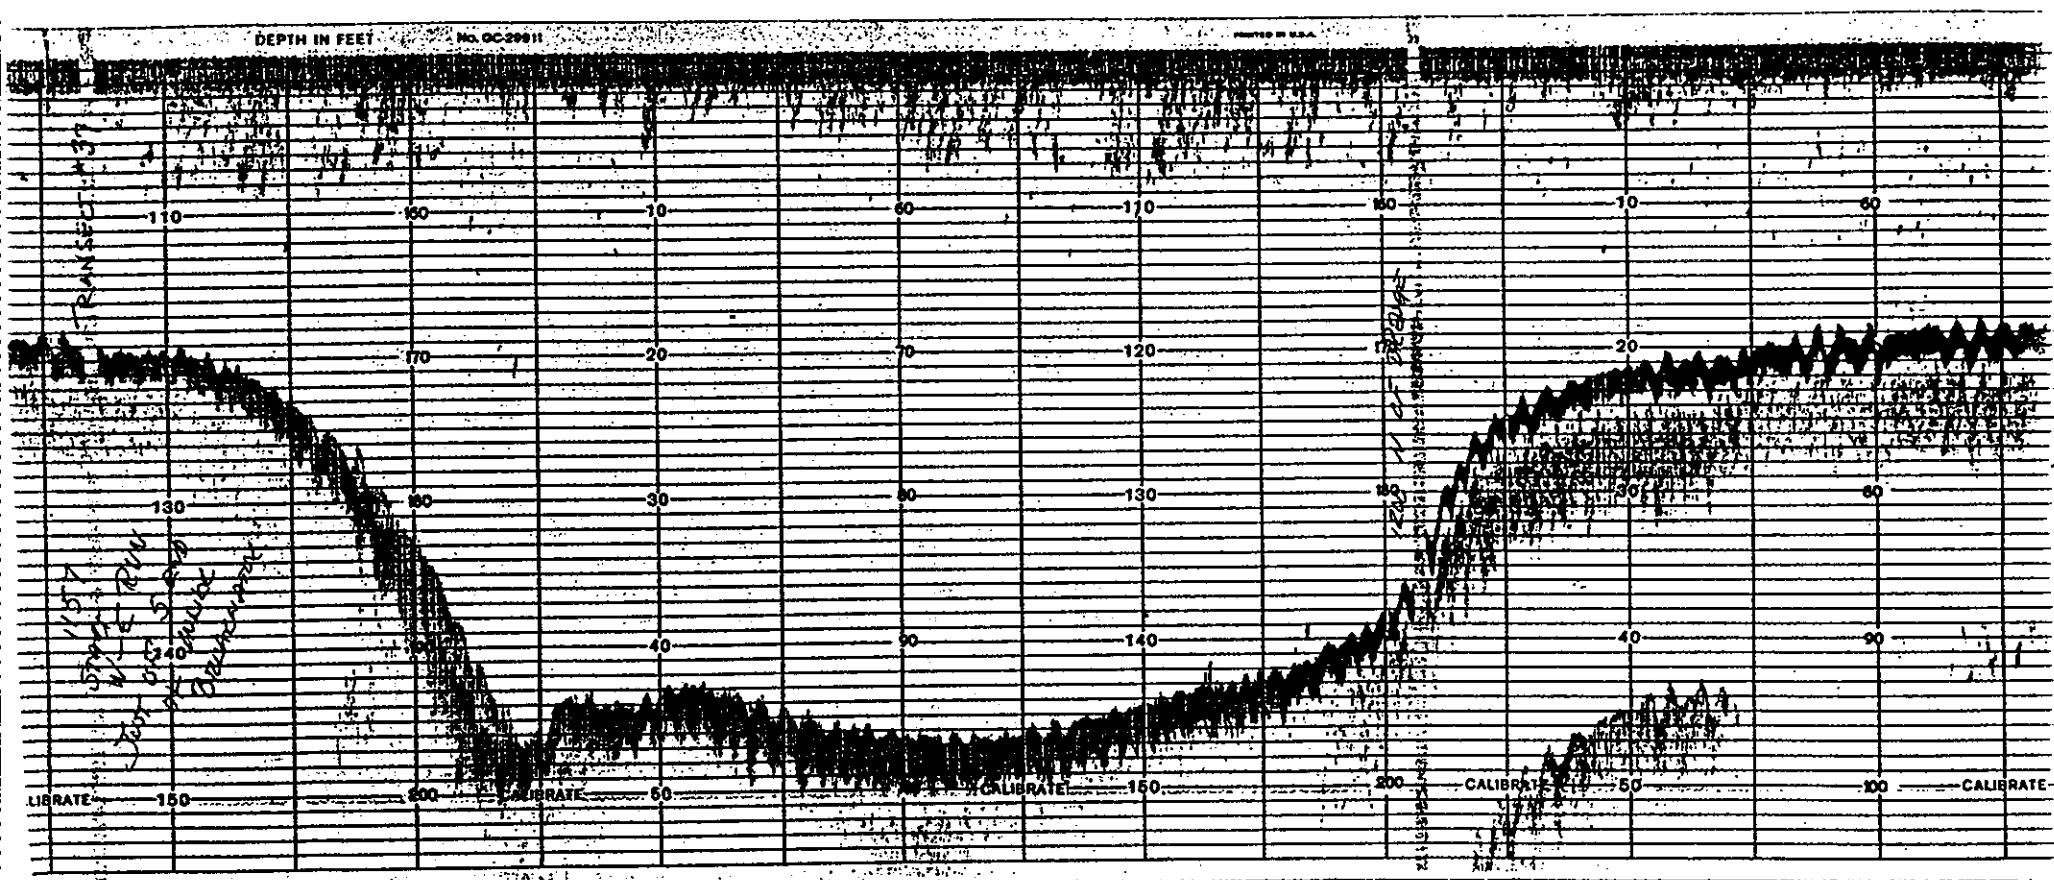
Beginning segment of Transect #37 acoustic survey of 15 November 1993; profile runs west to east

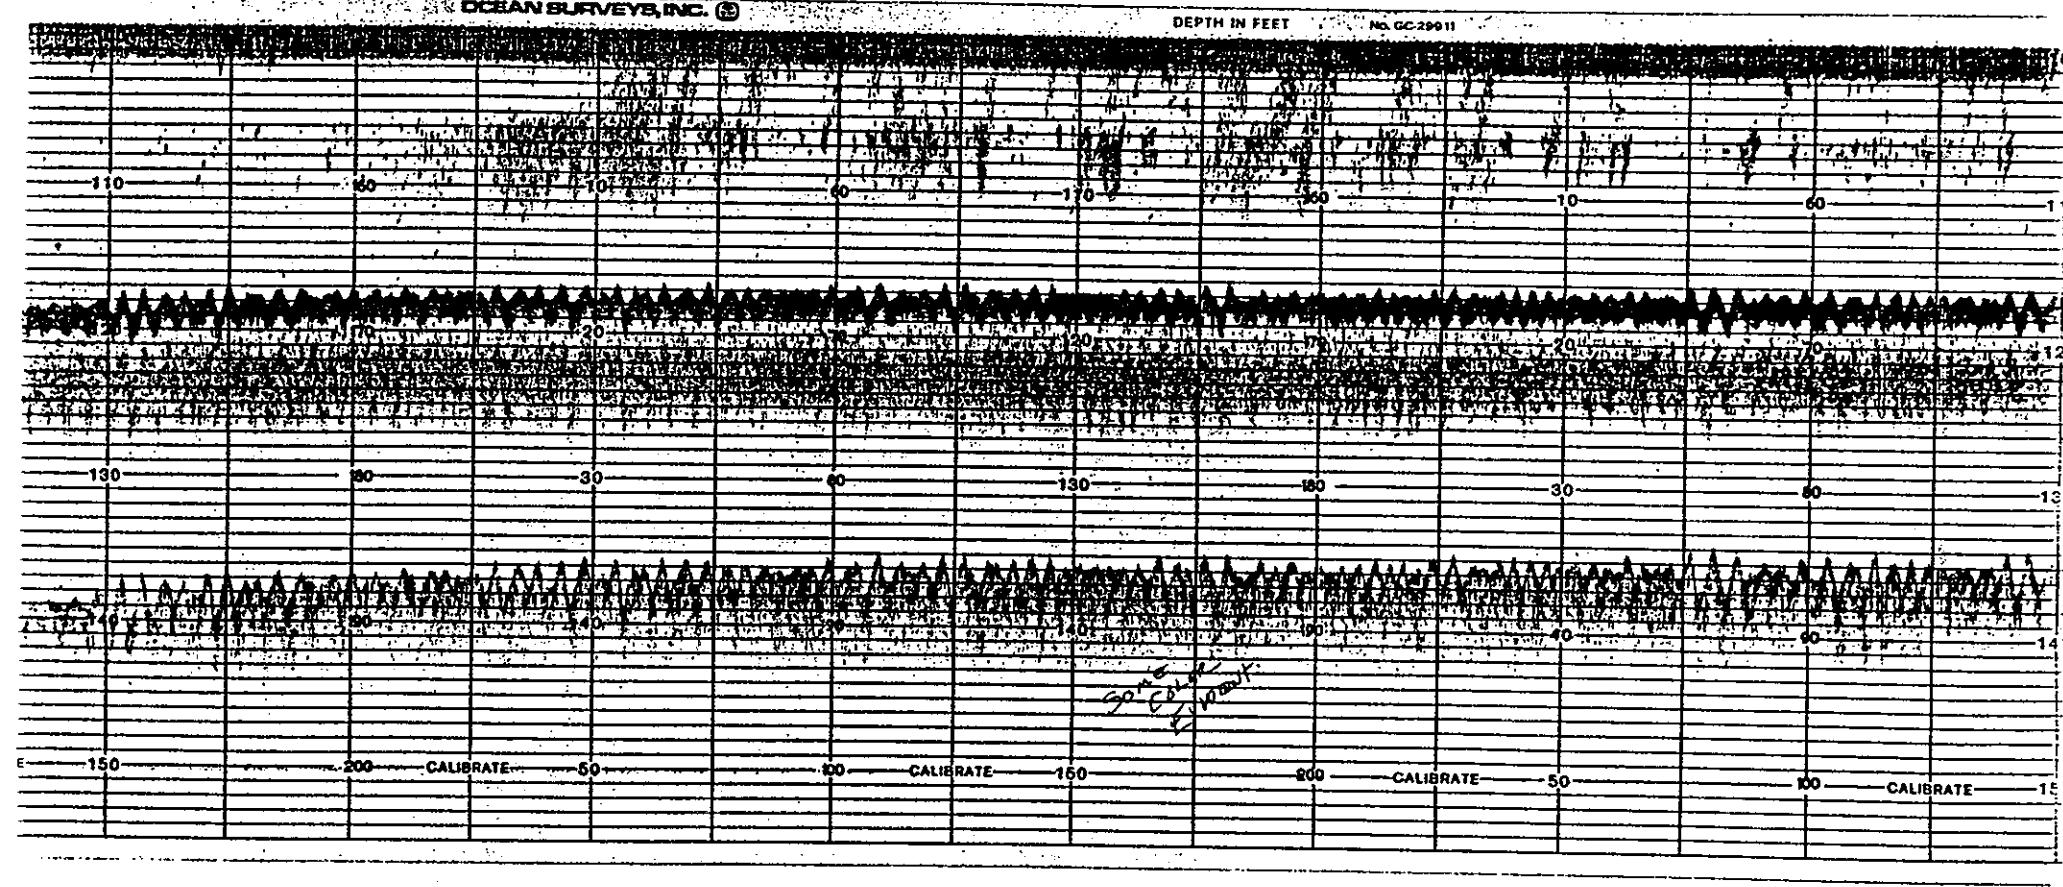
Middle segment of Transect #37 acoustic survey of 15 November 1993; profile runs west to east

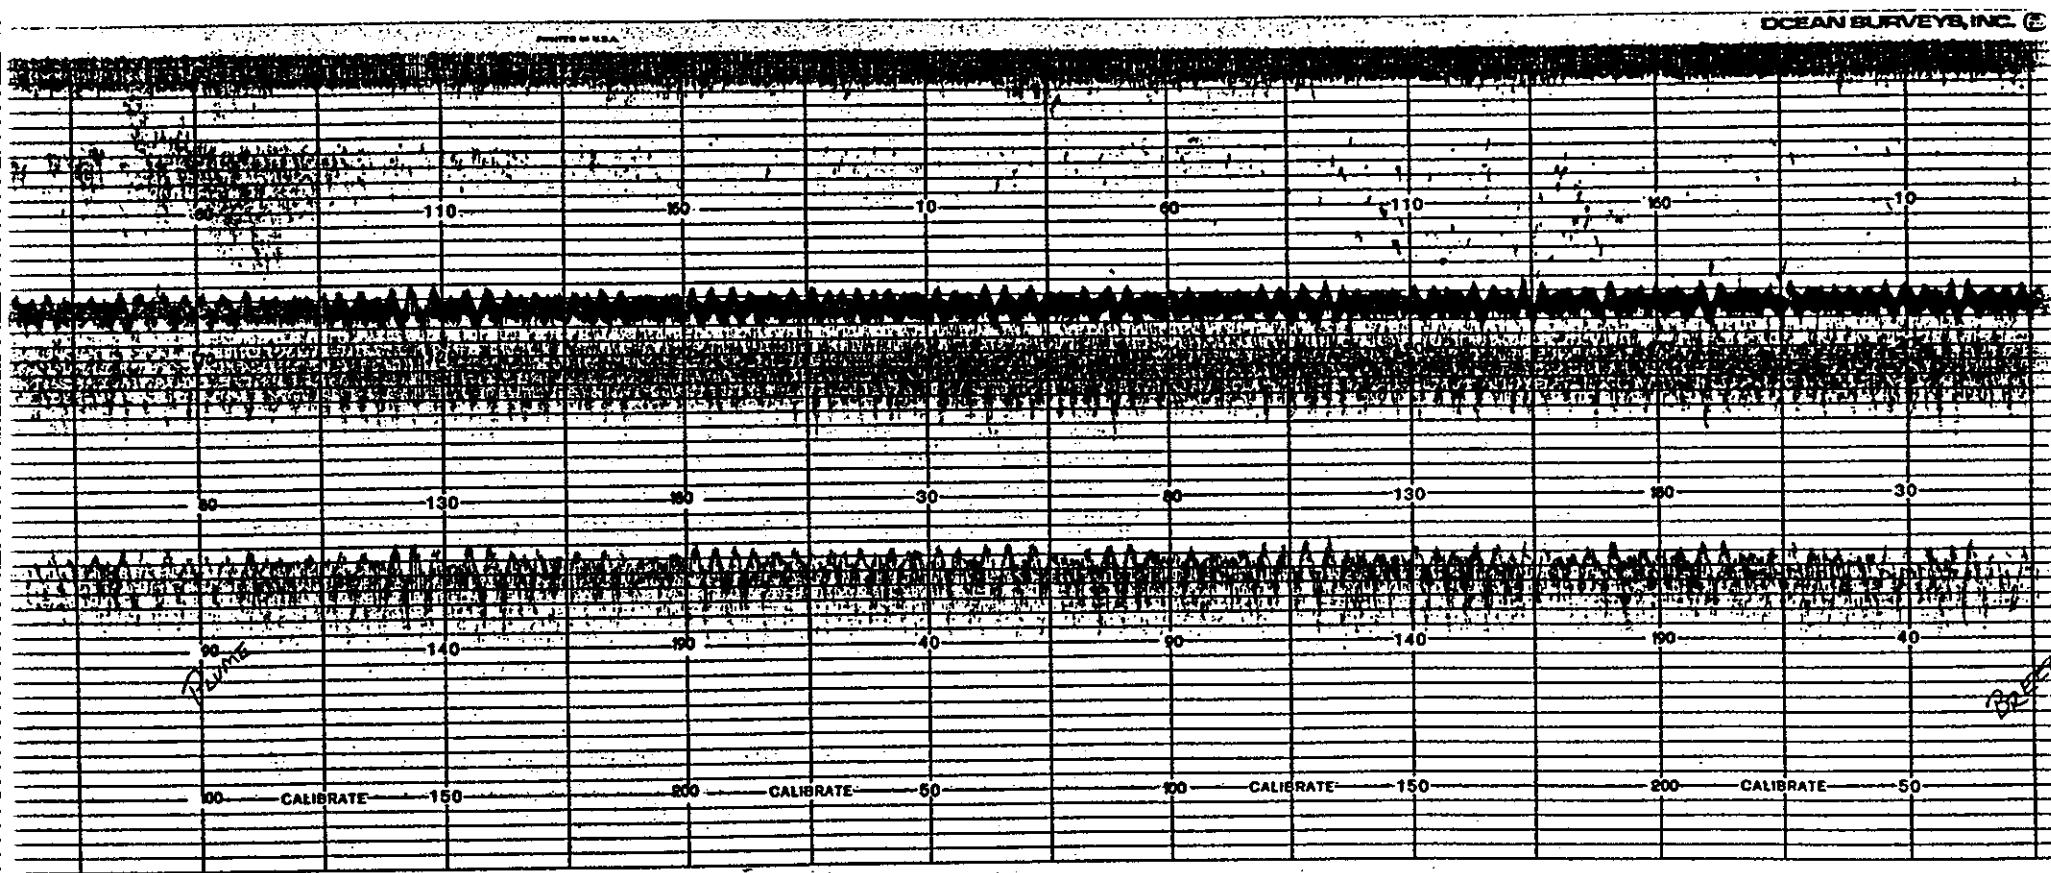
Second of 4 segments for Transect #38 acoustic survey of 15 November 1993; profile runs east to west
