An Investigation of the Dispersion  
of Sediments Resuspended by  
Dredging Operations in New Haven Harbor

# **Disposal Area Monitoring System DAMOS**

Contribution 112  
November 1996

**US Army Corps  
of Engineers**  
New England Division

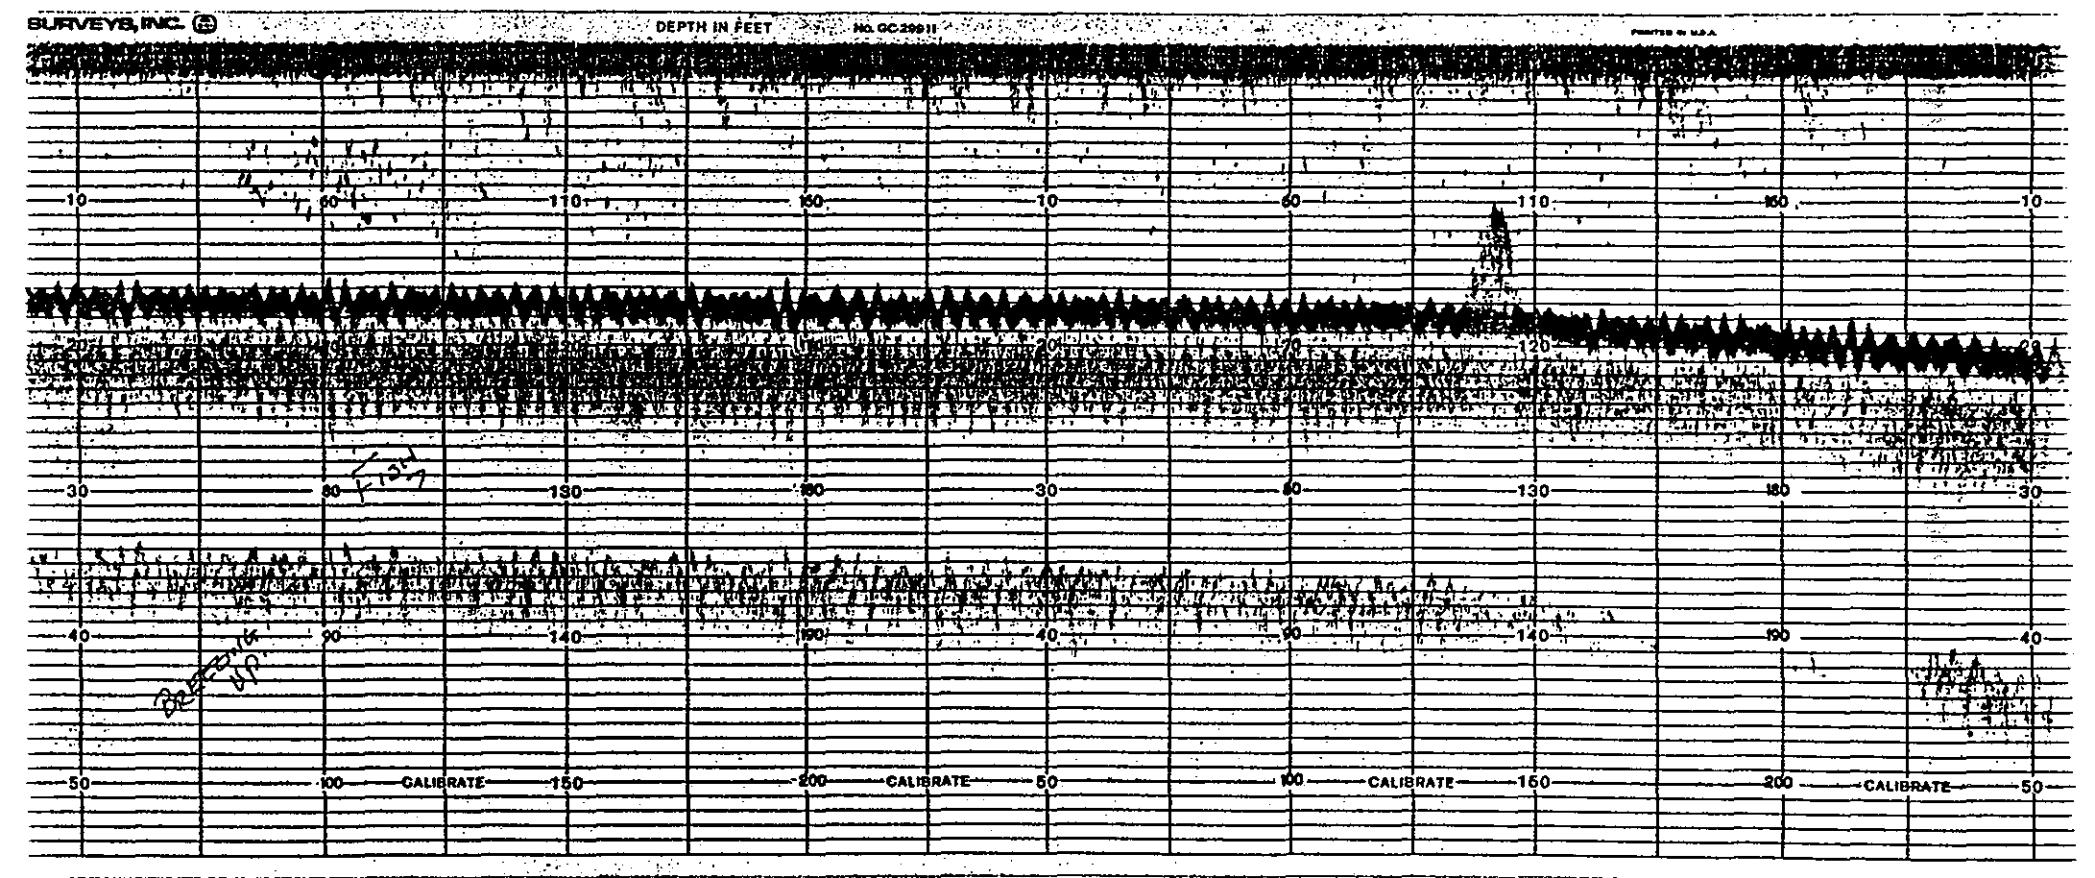
Third of 4 segments for Transect #38 acoustic survey of 15 November 1993; profile runs east to west

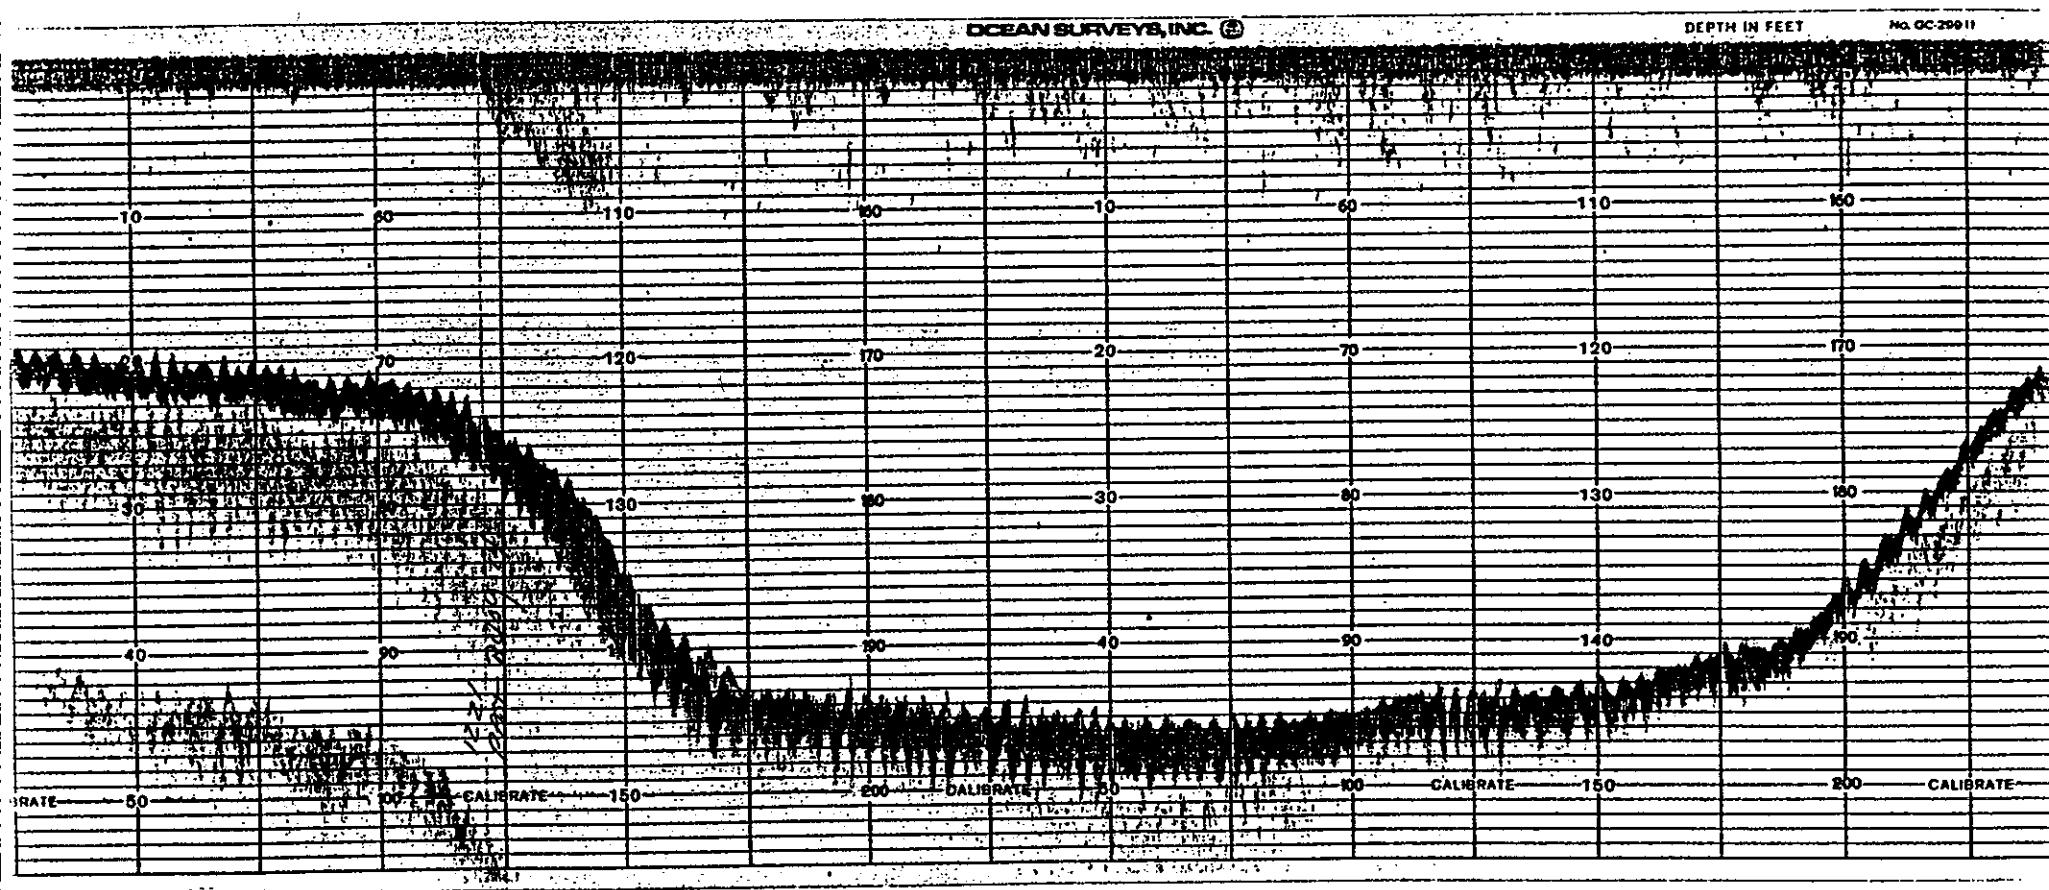
Fourth of 4 segments for Transect #38 acoustic survey of 15 November 1993; profile runs east to west

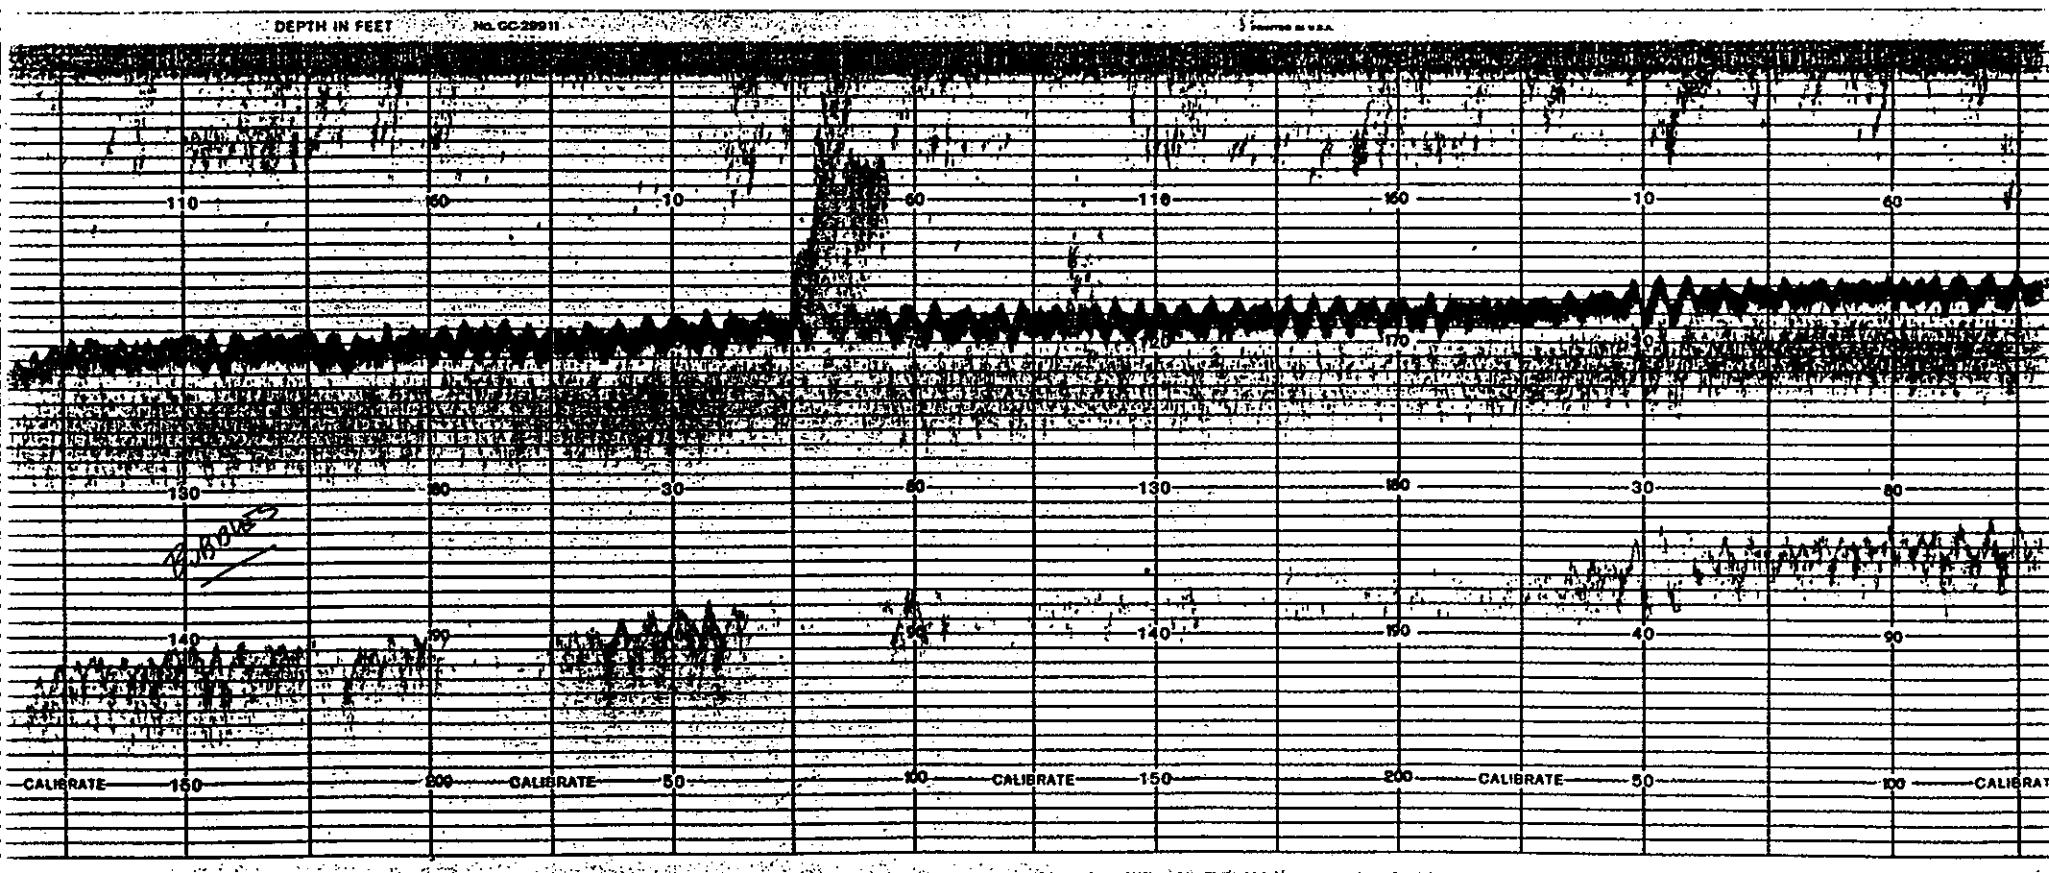
Second of 5 segments for Transect #39 acoustic survey of 15 November 1993; profile runs west to east

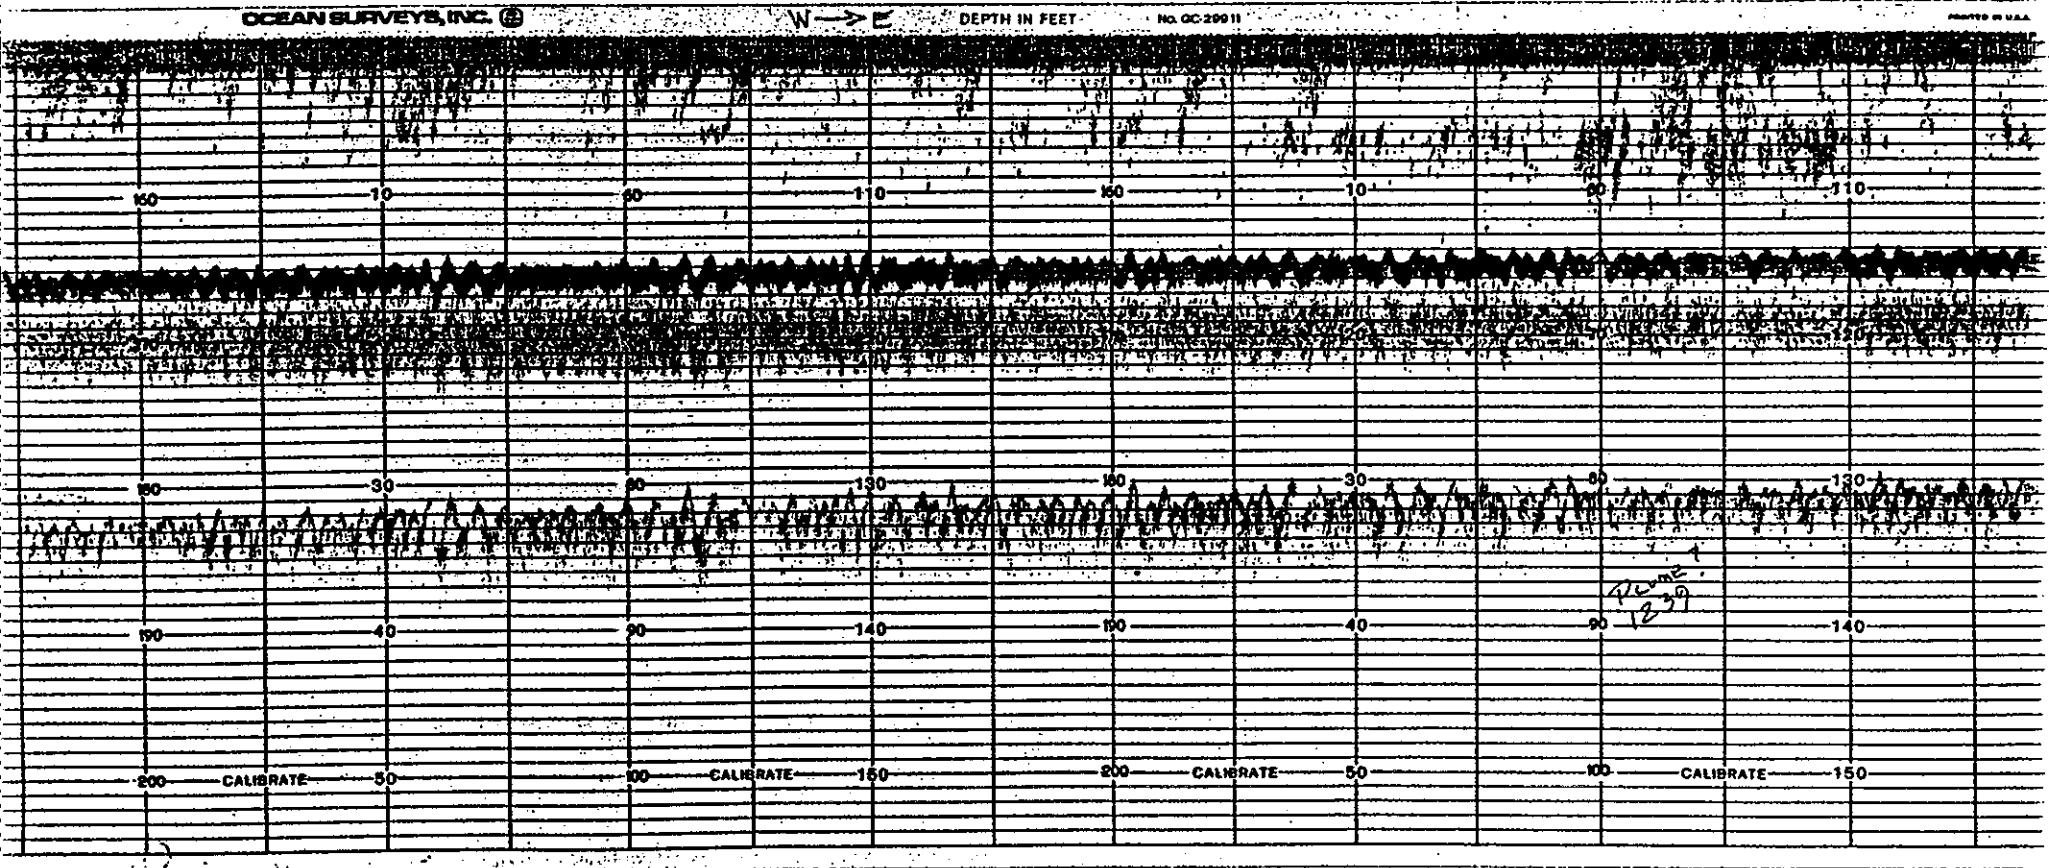
Fourth of 5 segments for Transect #39 acoustic survey of 15 November 1993; profile runs west to east

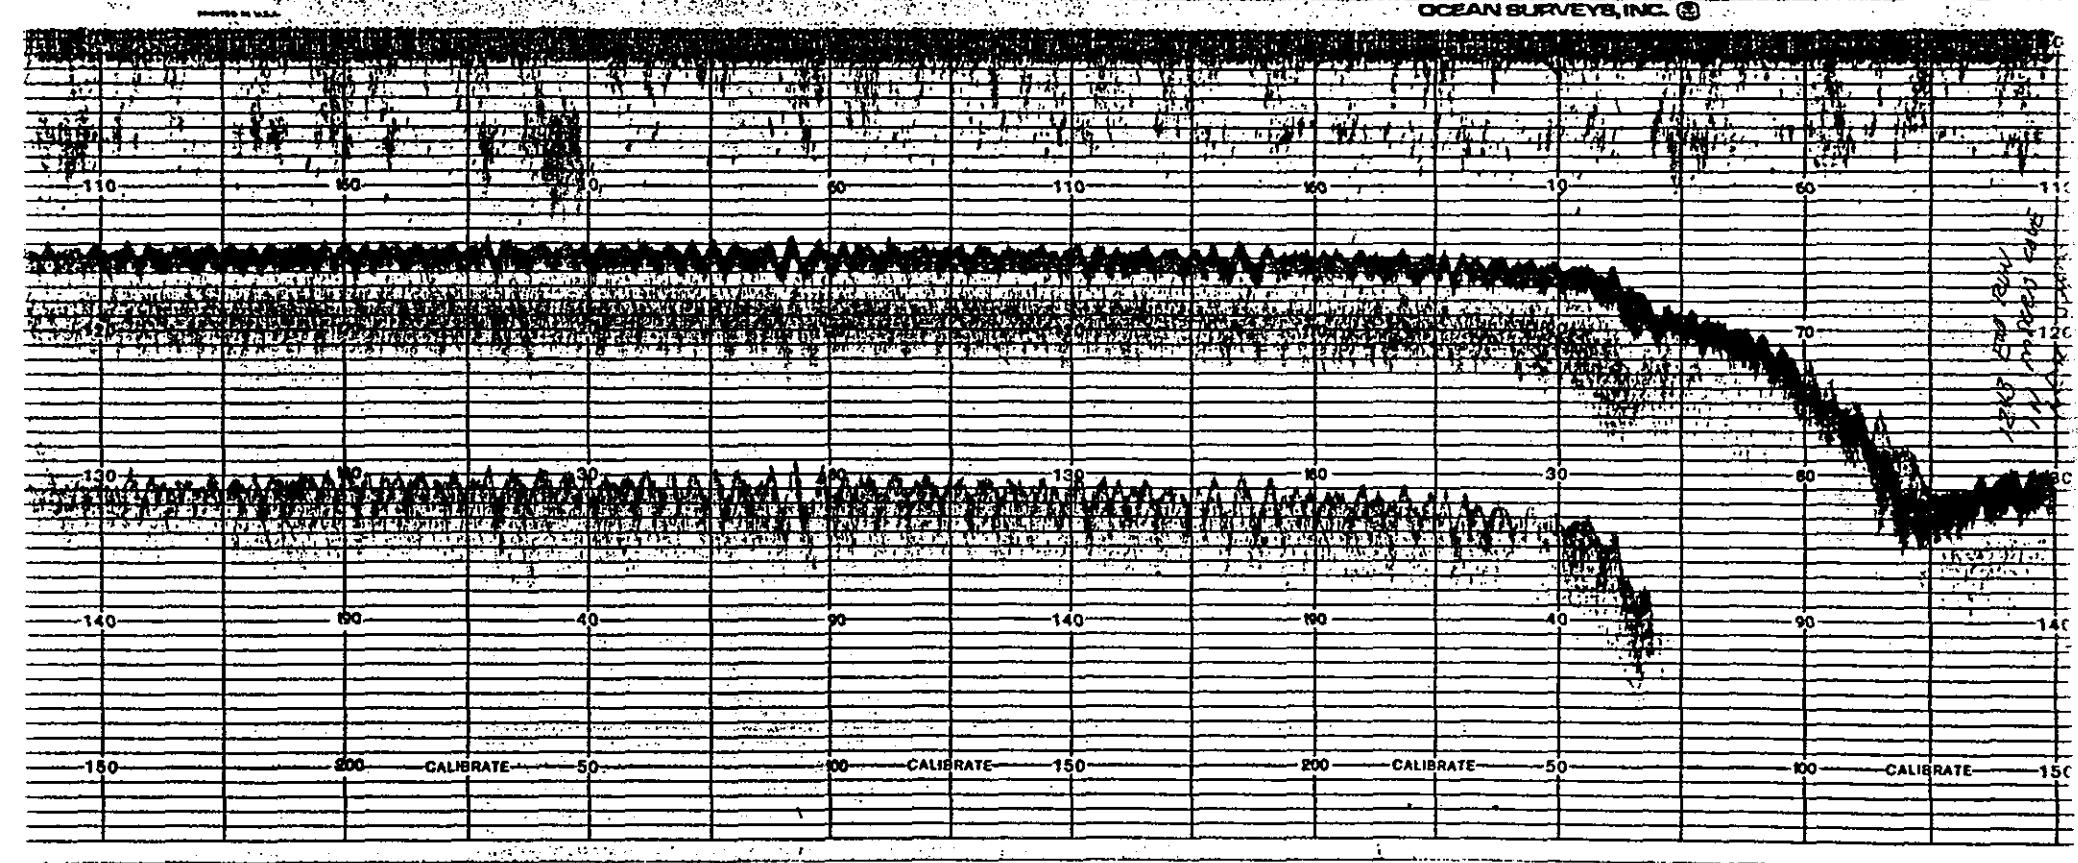
Fifth of 5 segments for Transect #39 acoustic survey of 15 November 1993; profile runs west to east

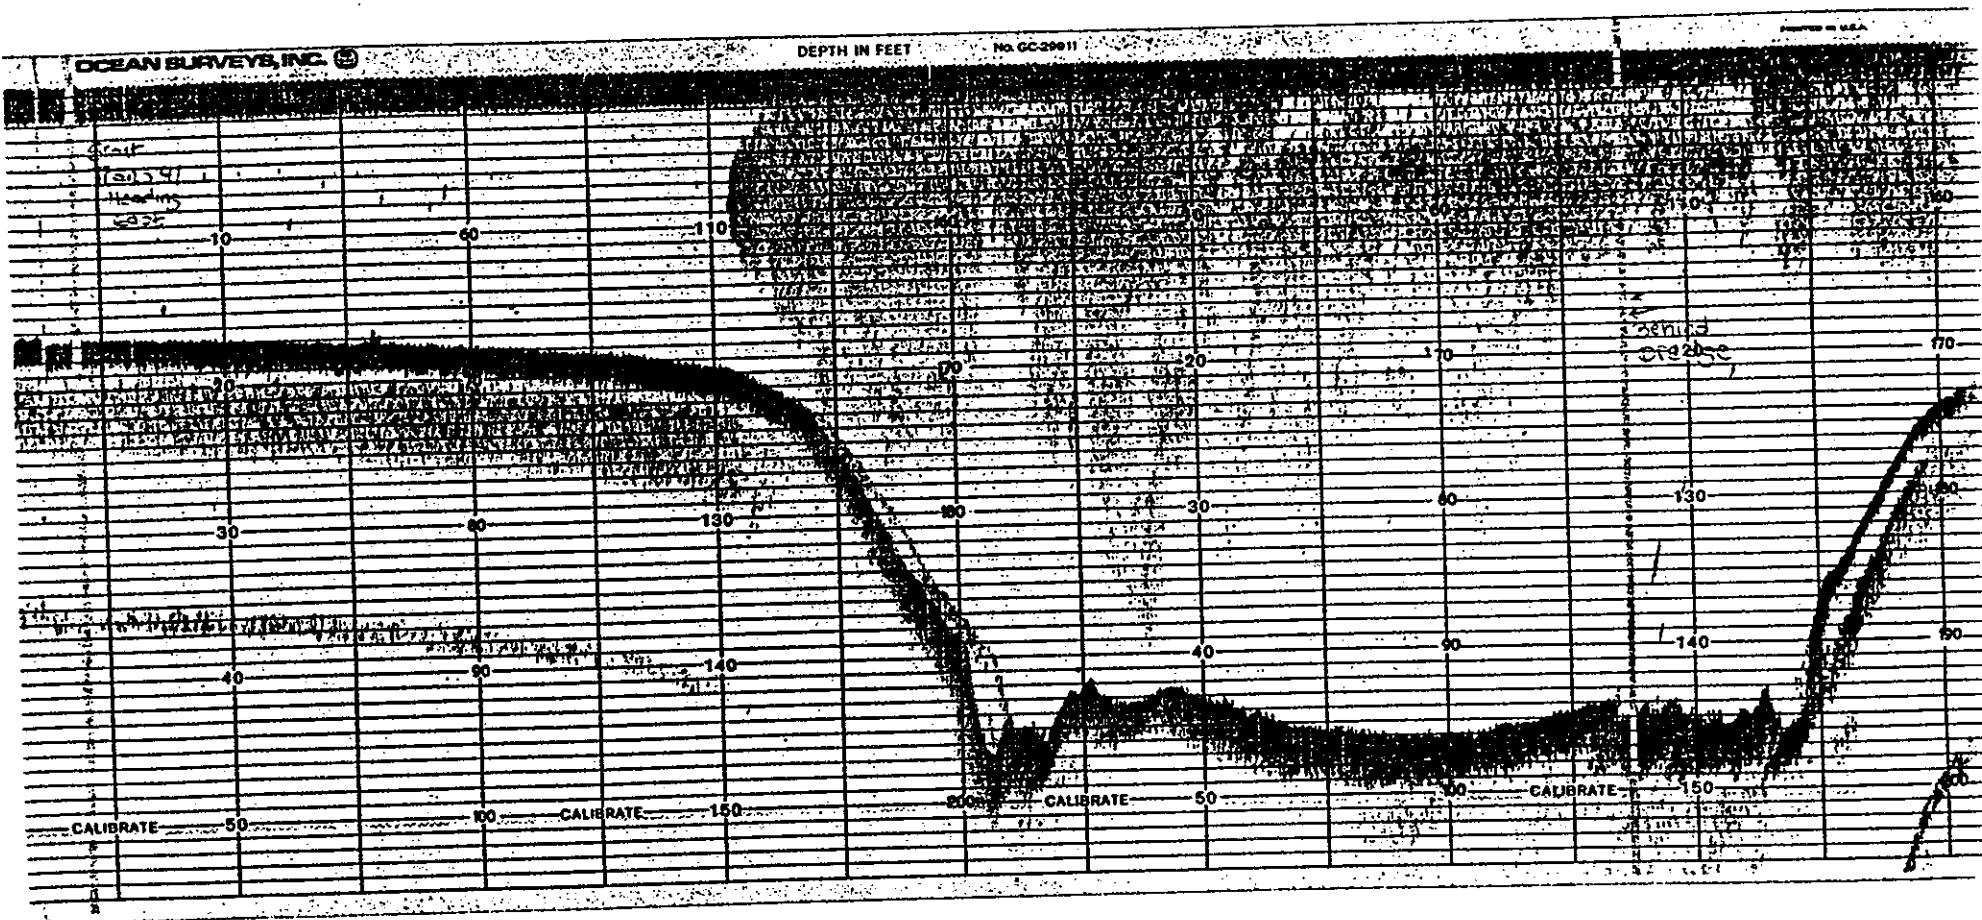
Beginning segment of Transect #41 acoustic survey of 16 November 1993; profile runs west to east

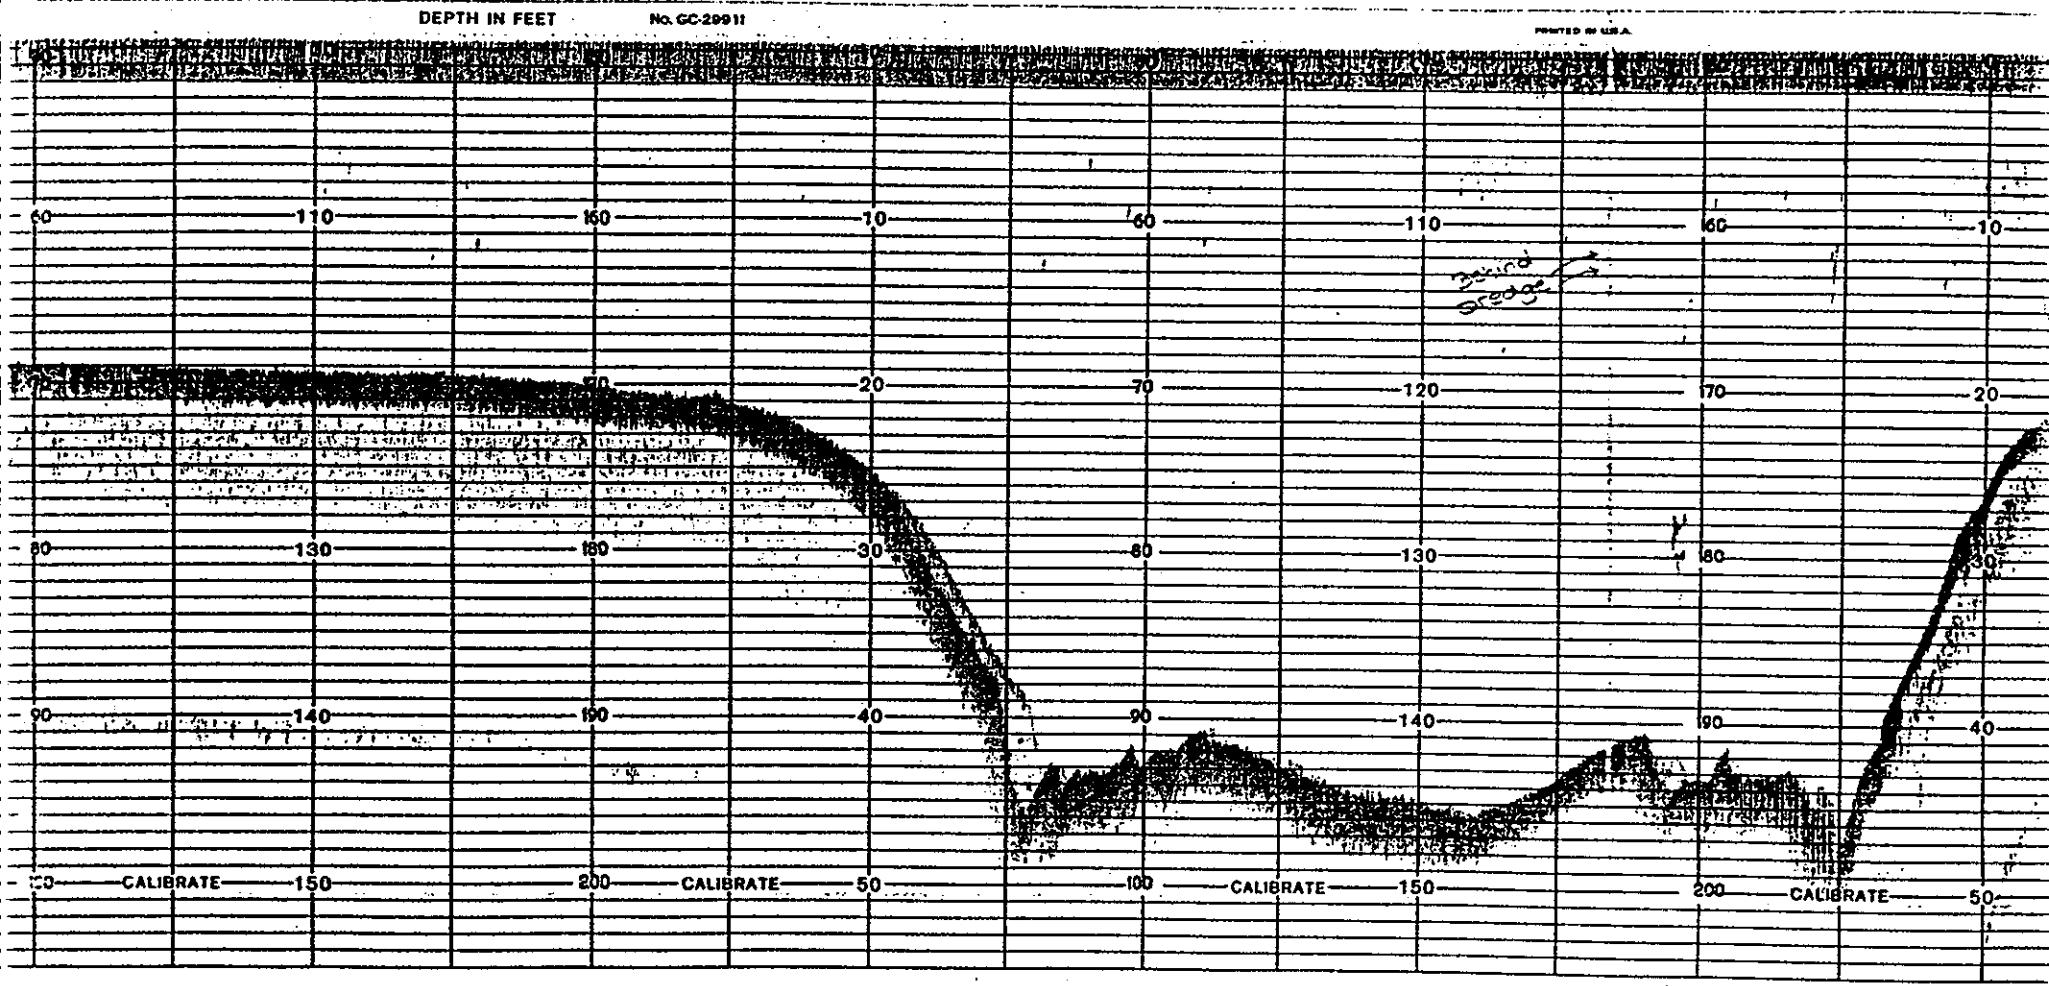
Beginning segment of Transect #43 acoustic survey of 16 November 1993; profile runs west to east

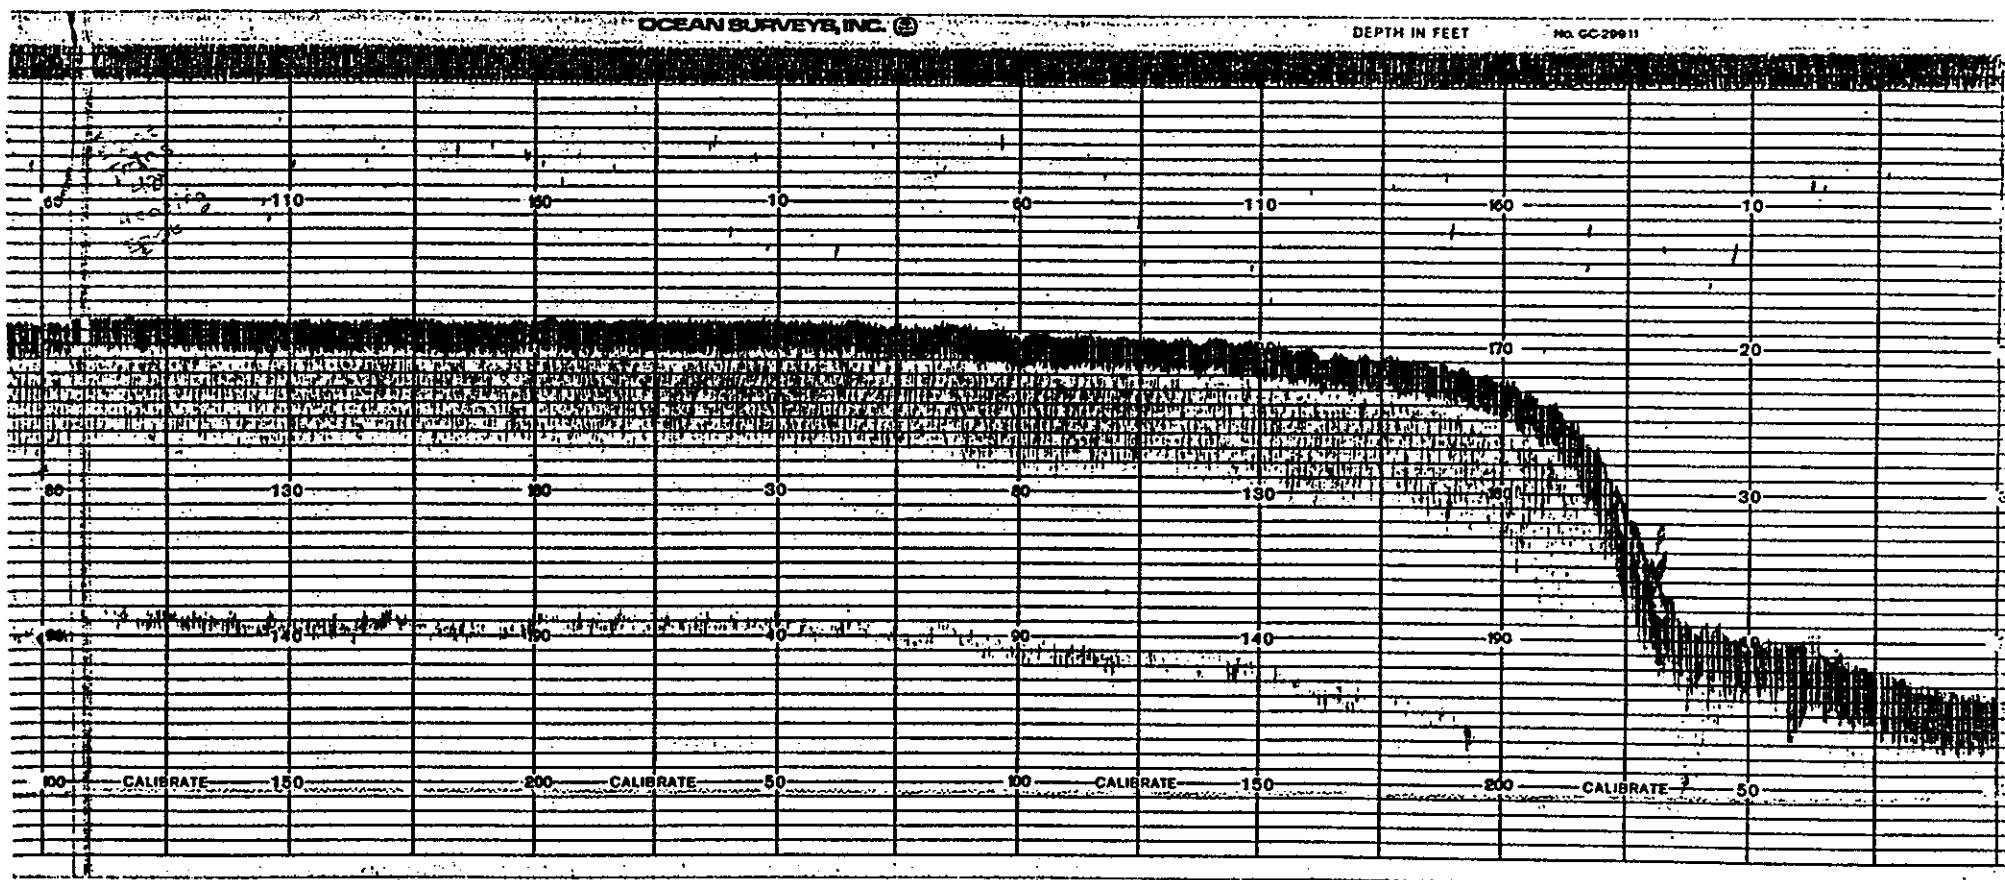
Beginning segment of Transect #46 acoustic survey of 16 November 1993; profile runs west to east

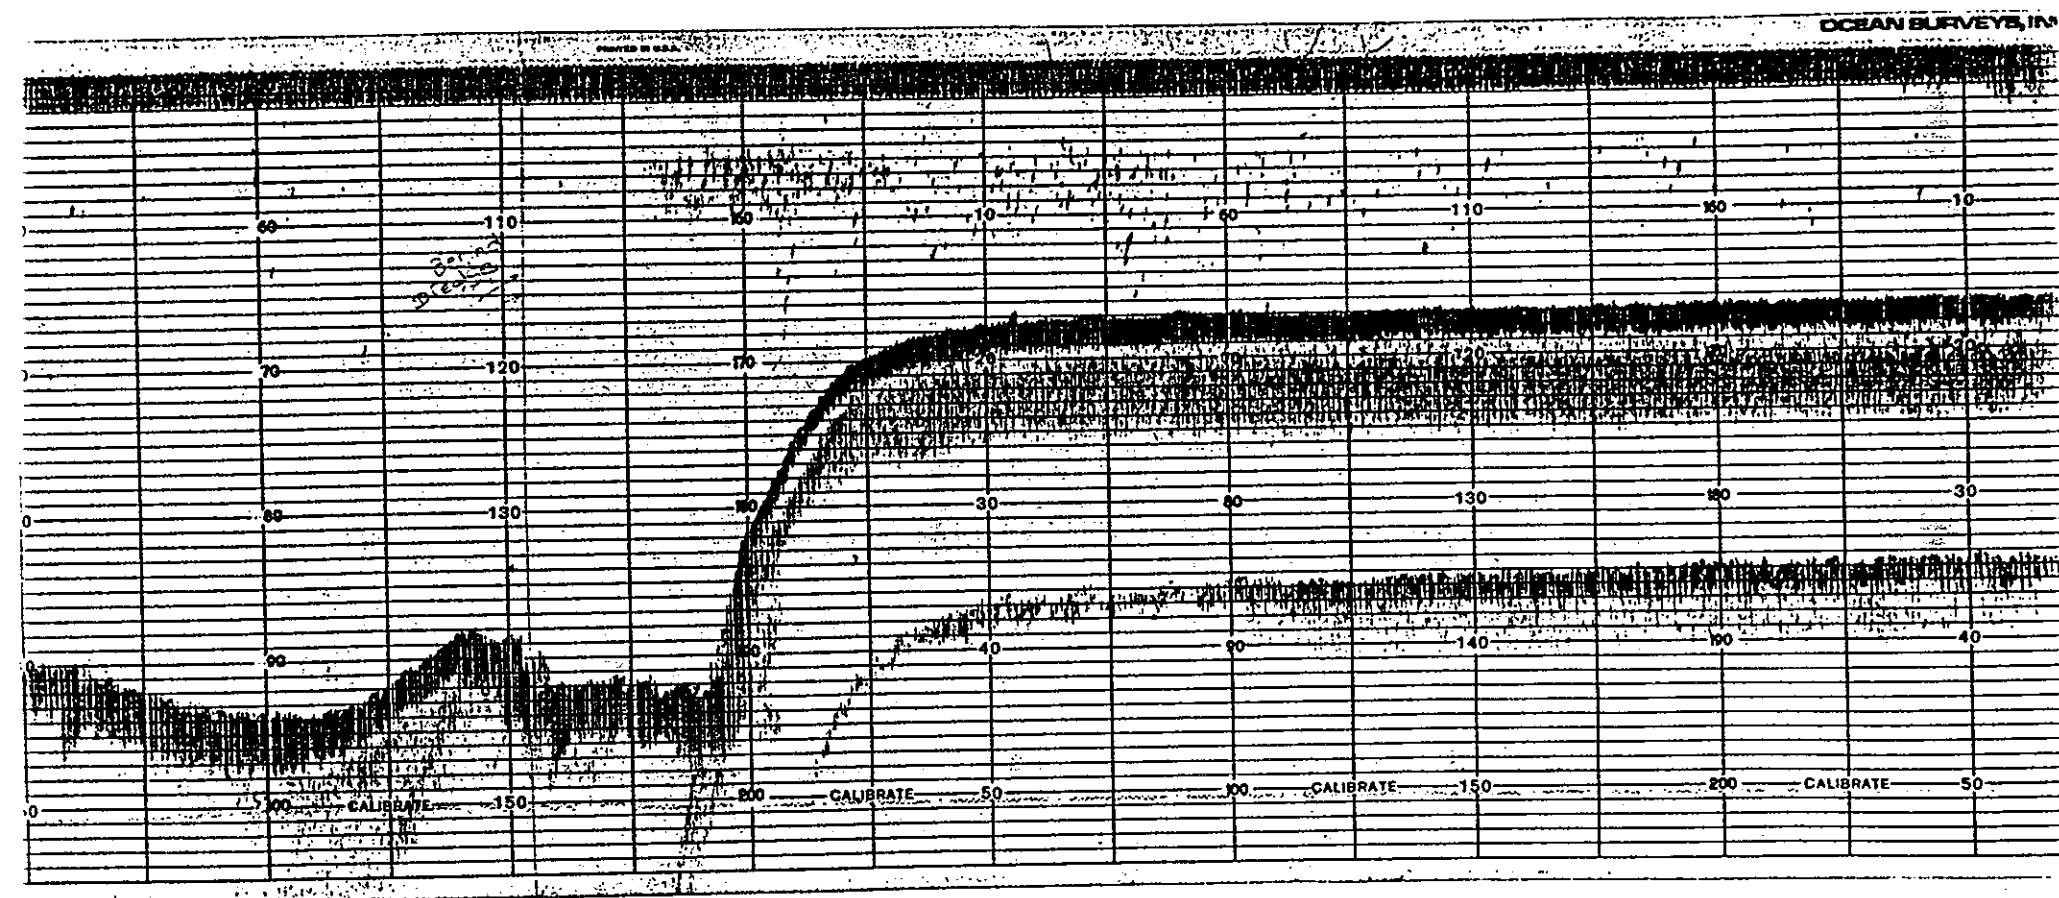
Middle segment of Transect #46 acoustic survey of 16 November 1993; profile runs west to east

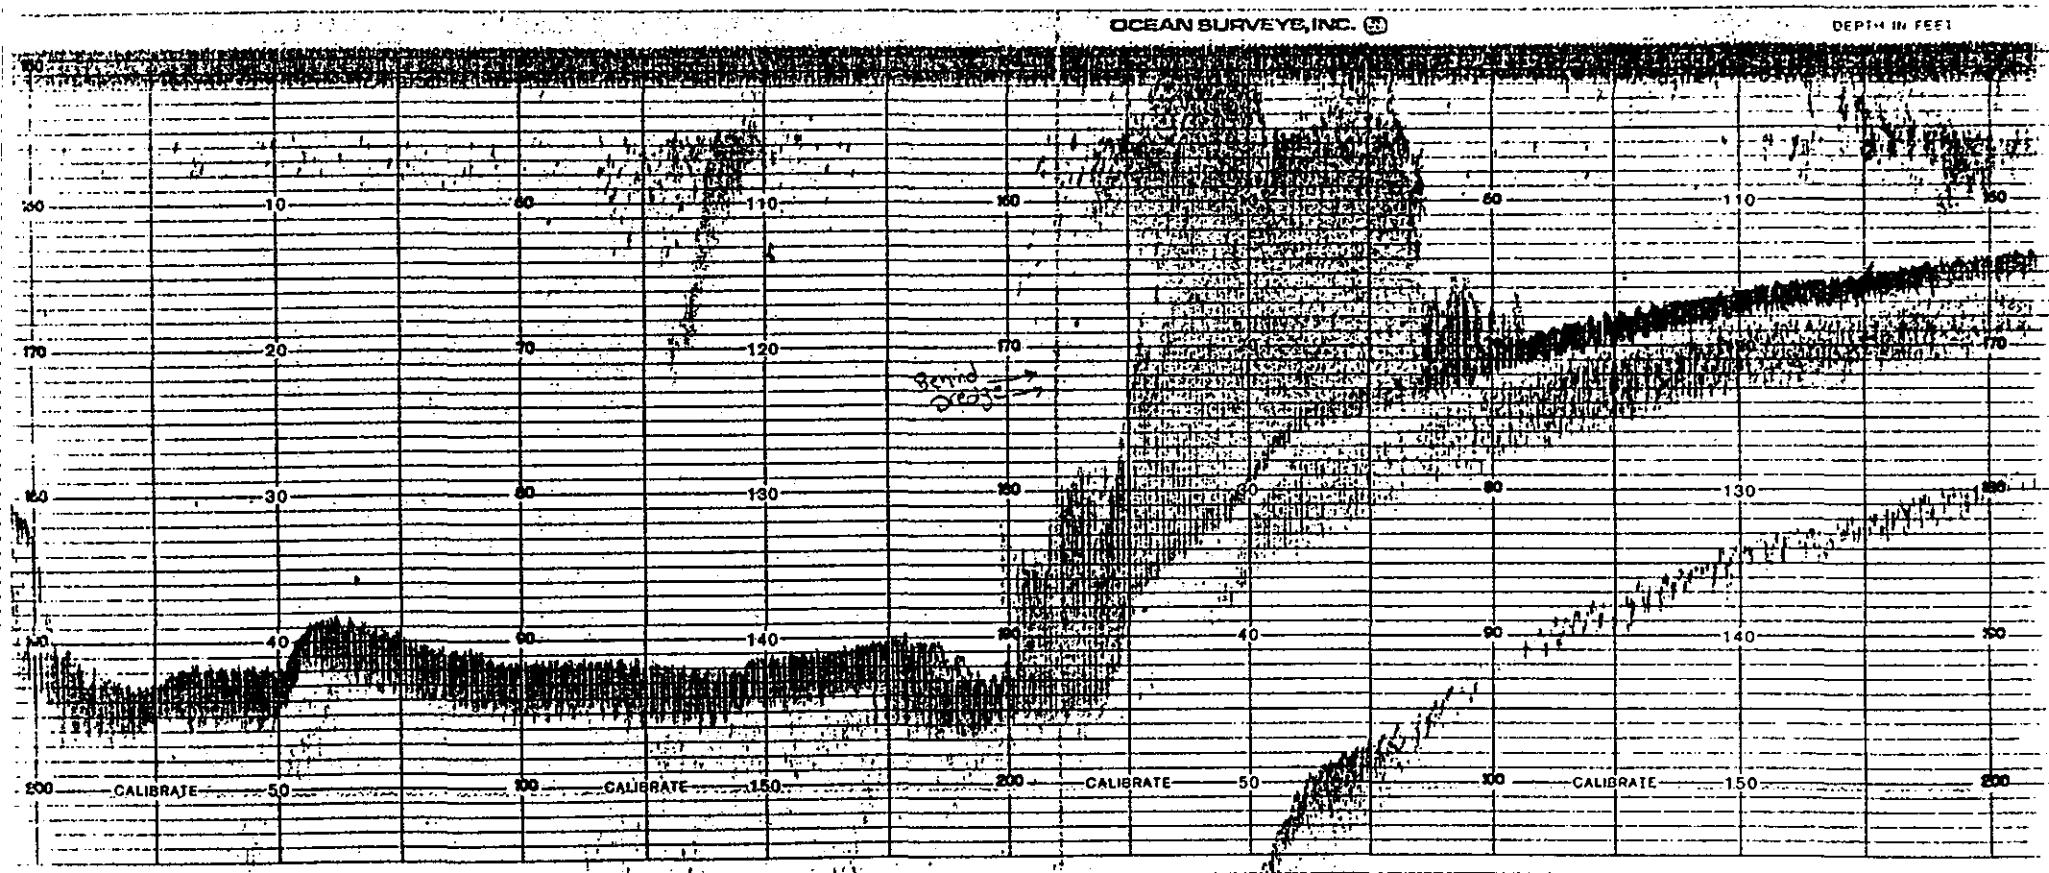
Middle segment of Transect #48 acoustic survey of 18 November 1993; profile runs east to west

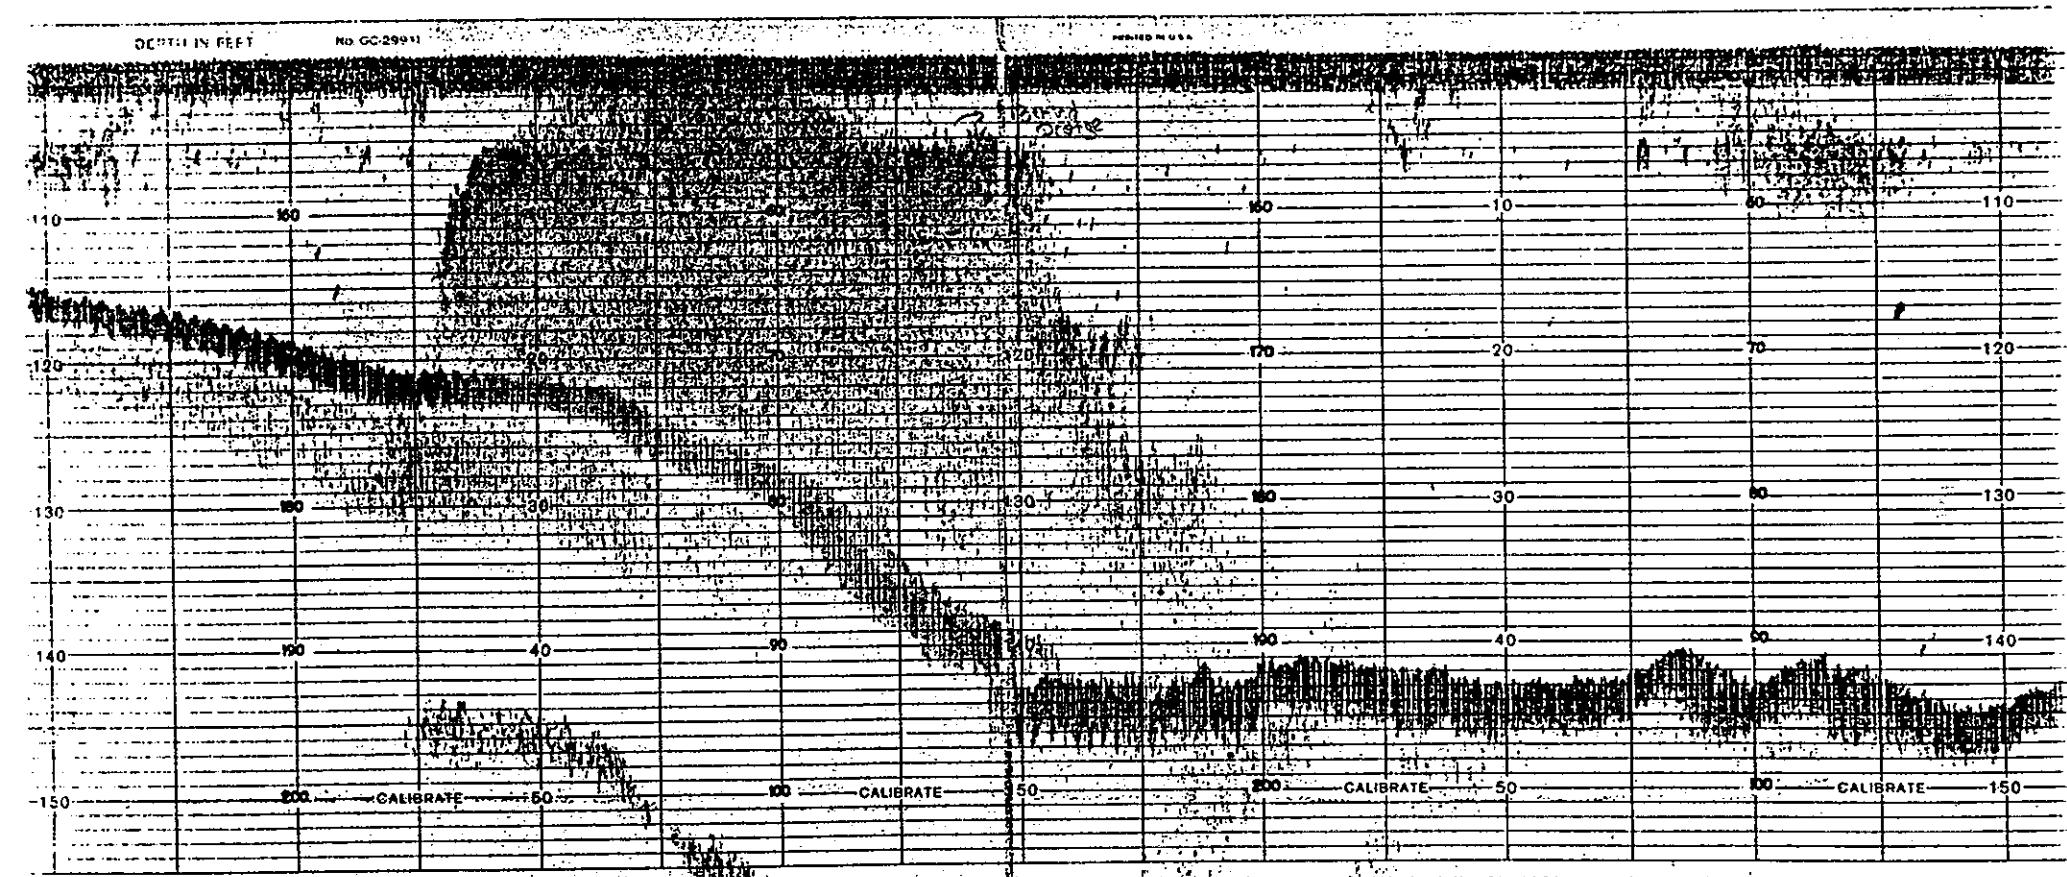
Middle segment of Transect #49 acoustic survey of 18 November 1993; profile runs west to east

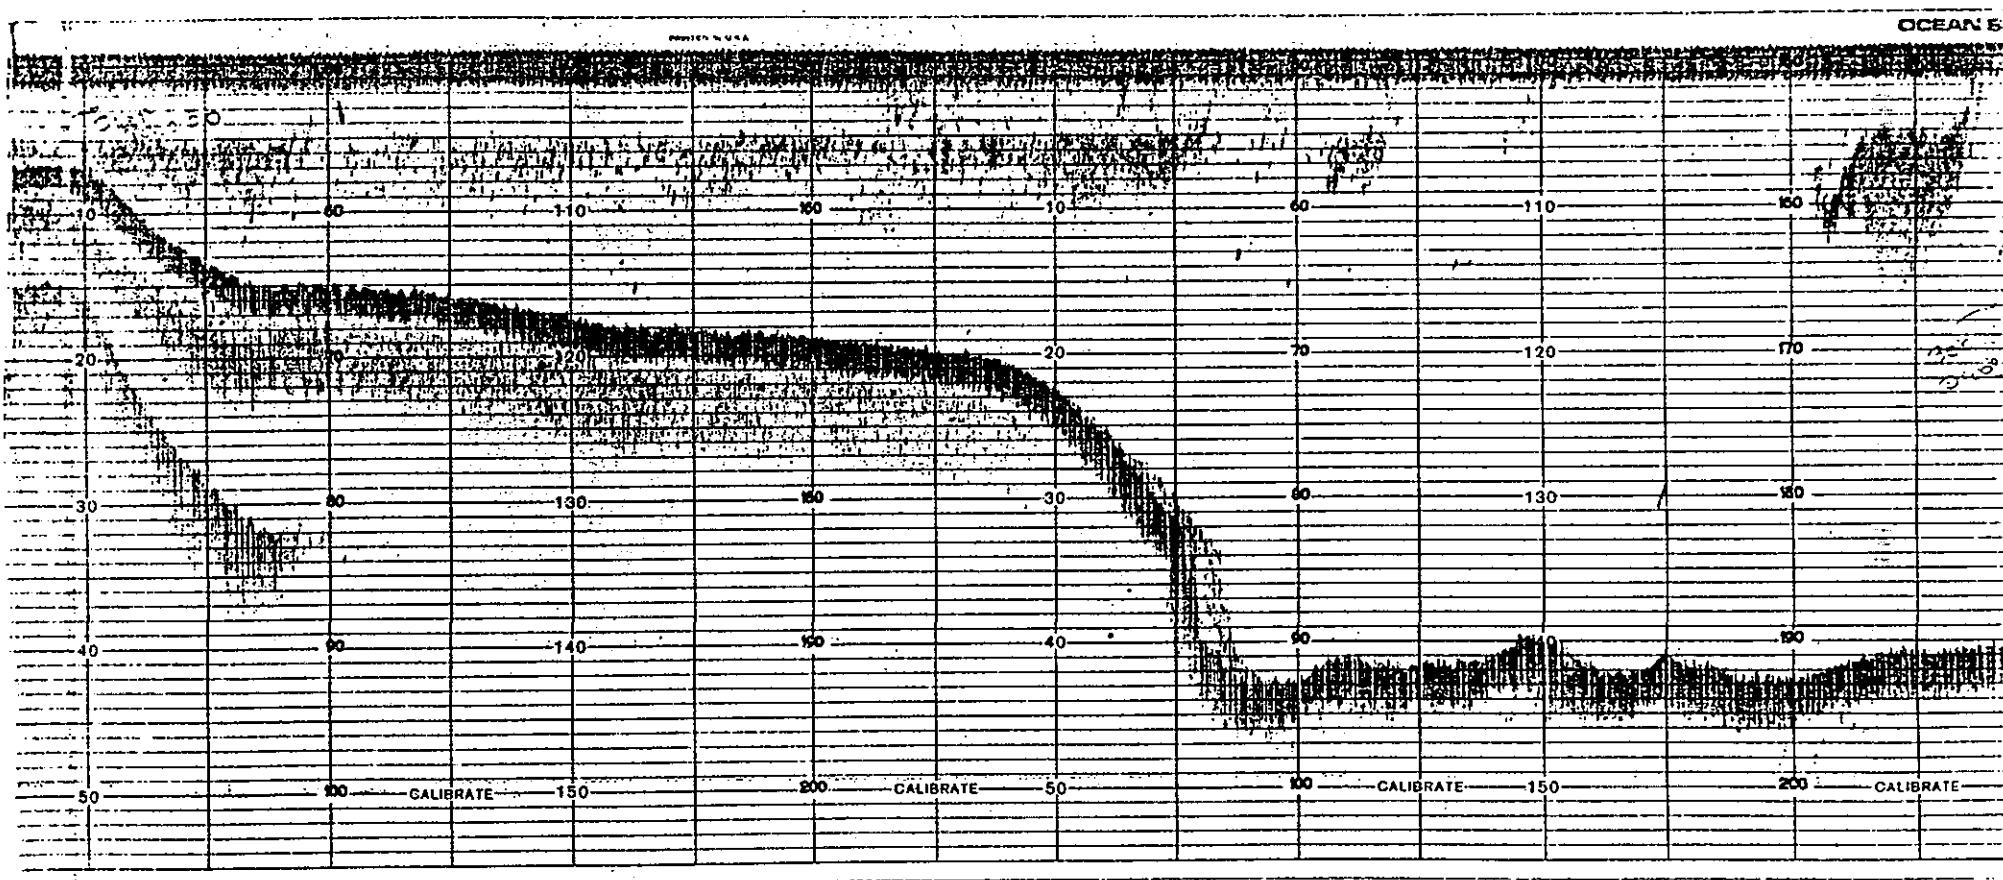
Beginning segment of Transect #50 acoustic survey of 18 November 1993; profile runs east to west
