BUZZARDS BAY RAILROAD LIFT BRIDGE OVER CAPE COD CANAL

INSPECTION AND CONDITION REPORT

OCTOBER, 1984

RE: CONTRACT NO. DACW33-84-C-0022
Inspection and Condition Report
Vertical Lift Railroad Bridge
Cape Cod Canal
Buzzards Bay, Massachusetts

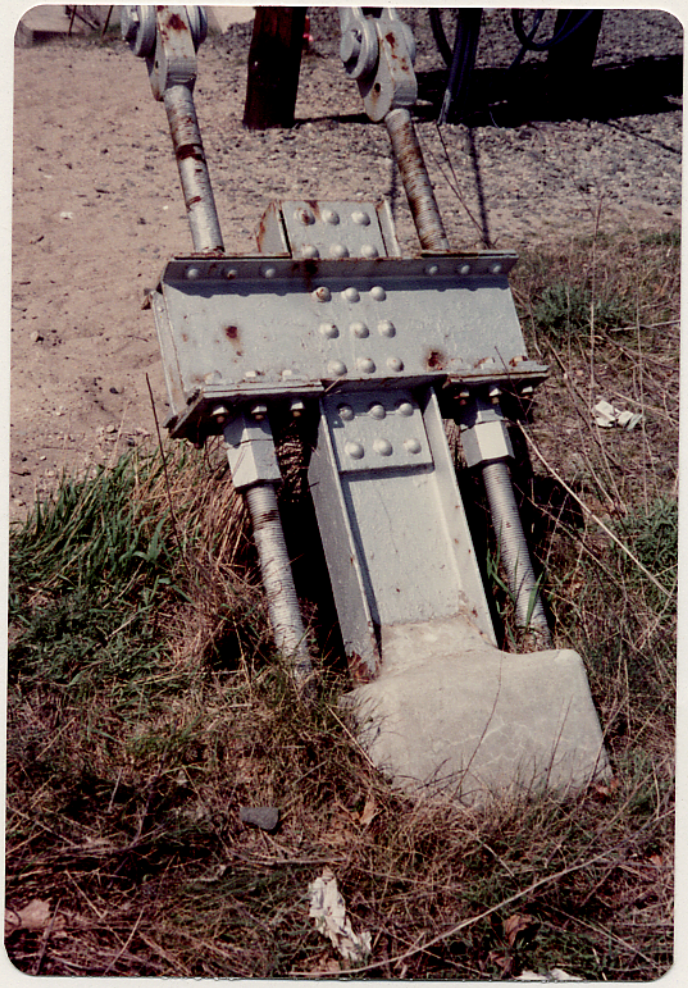
The visible elements of the anchorage metalwork are structurally sound. Surface corrosion exists on the metalwork of all four units (see Photograph I-2). Pitting, a maximum 1/16 to 3/32 inch deep, was noted in the webs of the longitudinal support beams of the north anchorages adjacent to the concrete embedment. Two 3/4 inch bolts, with beveled washers, are missing in the bottom flange of the lower transverse channel of the northeast anchorage and one other bolt is loose. A similar bolt and washer is missing at the southeast anchorage unit. Photographs II-28, 29 and 30 illustrate the other backstay anchorage units.

Photograph I-2 - Southwest backstay anchorage metalwork. Note typical corrosion.

1. Replace two bolts and tighten a third fastener in the northeast anchorage metalwork. Replace a similar fastener at the southeast anchorage.

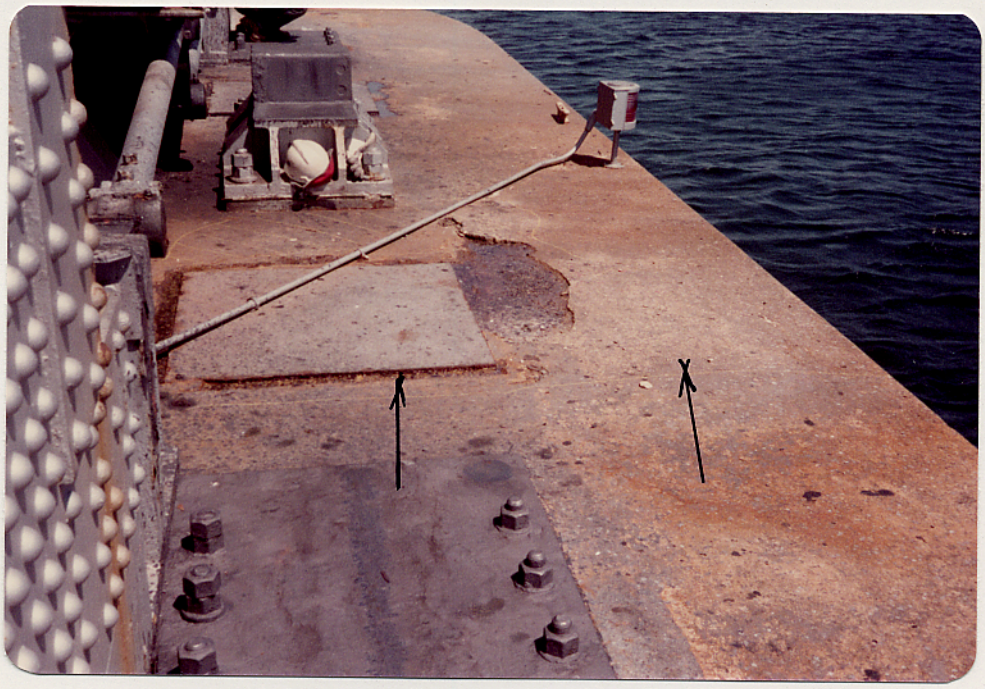
The concrete coping of both piers was visually examined and sounded with hammers to determine deteriorated or unsound concrete areas. The horizontal concrete surfaces of both piers are spalled (1/2 to 1 inch deep), generally around bearing plates where moisture collects. A major spalled area exists in the northwest quadrant of the Pier B coping. No reinforcing is presently exposed at the spalled areas. Pier B has approximately 160 square feet and Pier C has about 96 square feet of deteriorating and unsound concrete. Transverse hairline cracks of minor significance exist in the upper surfaces of both piers. Figure 1-5 and Photographs I-3 and II-36, 40 and 41 show the spalled and unsound concrete areas on the pier tops.

Photograph I-3 - View of spalled and unsound areas on Pier C near west jacking plate.

7. Repair spalled and unsound concrete areas on the horizontal and vertical surfaces of the pier copings.

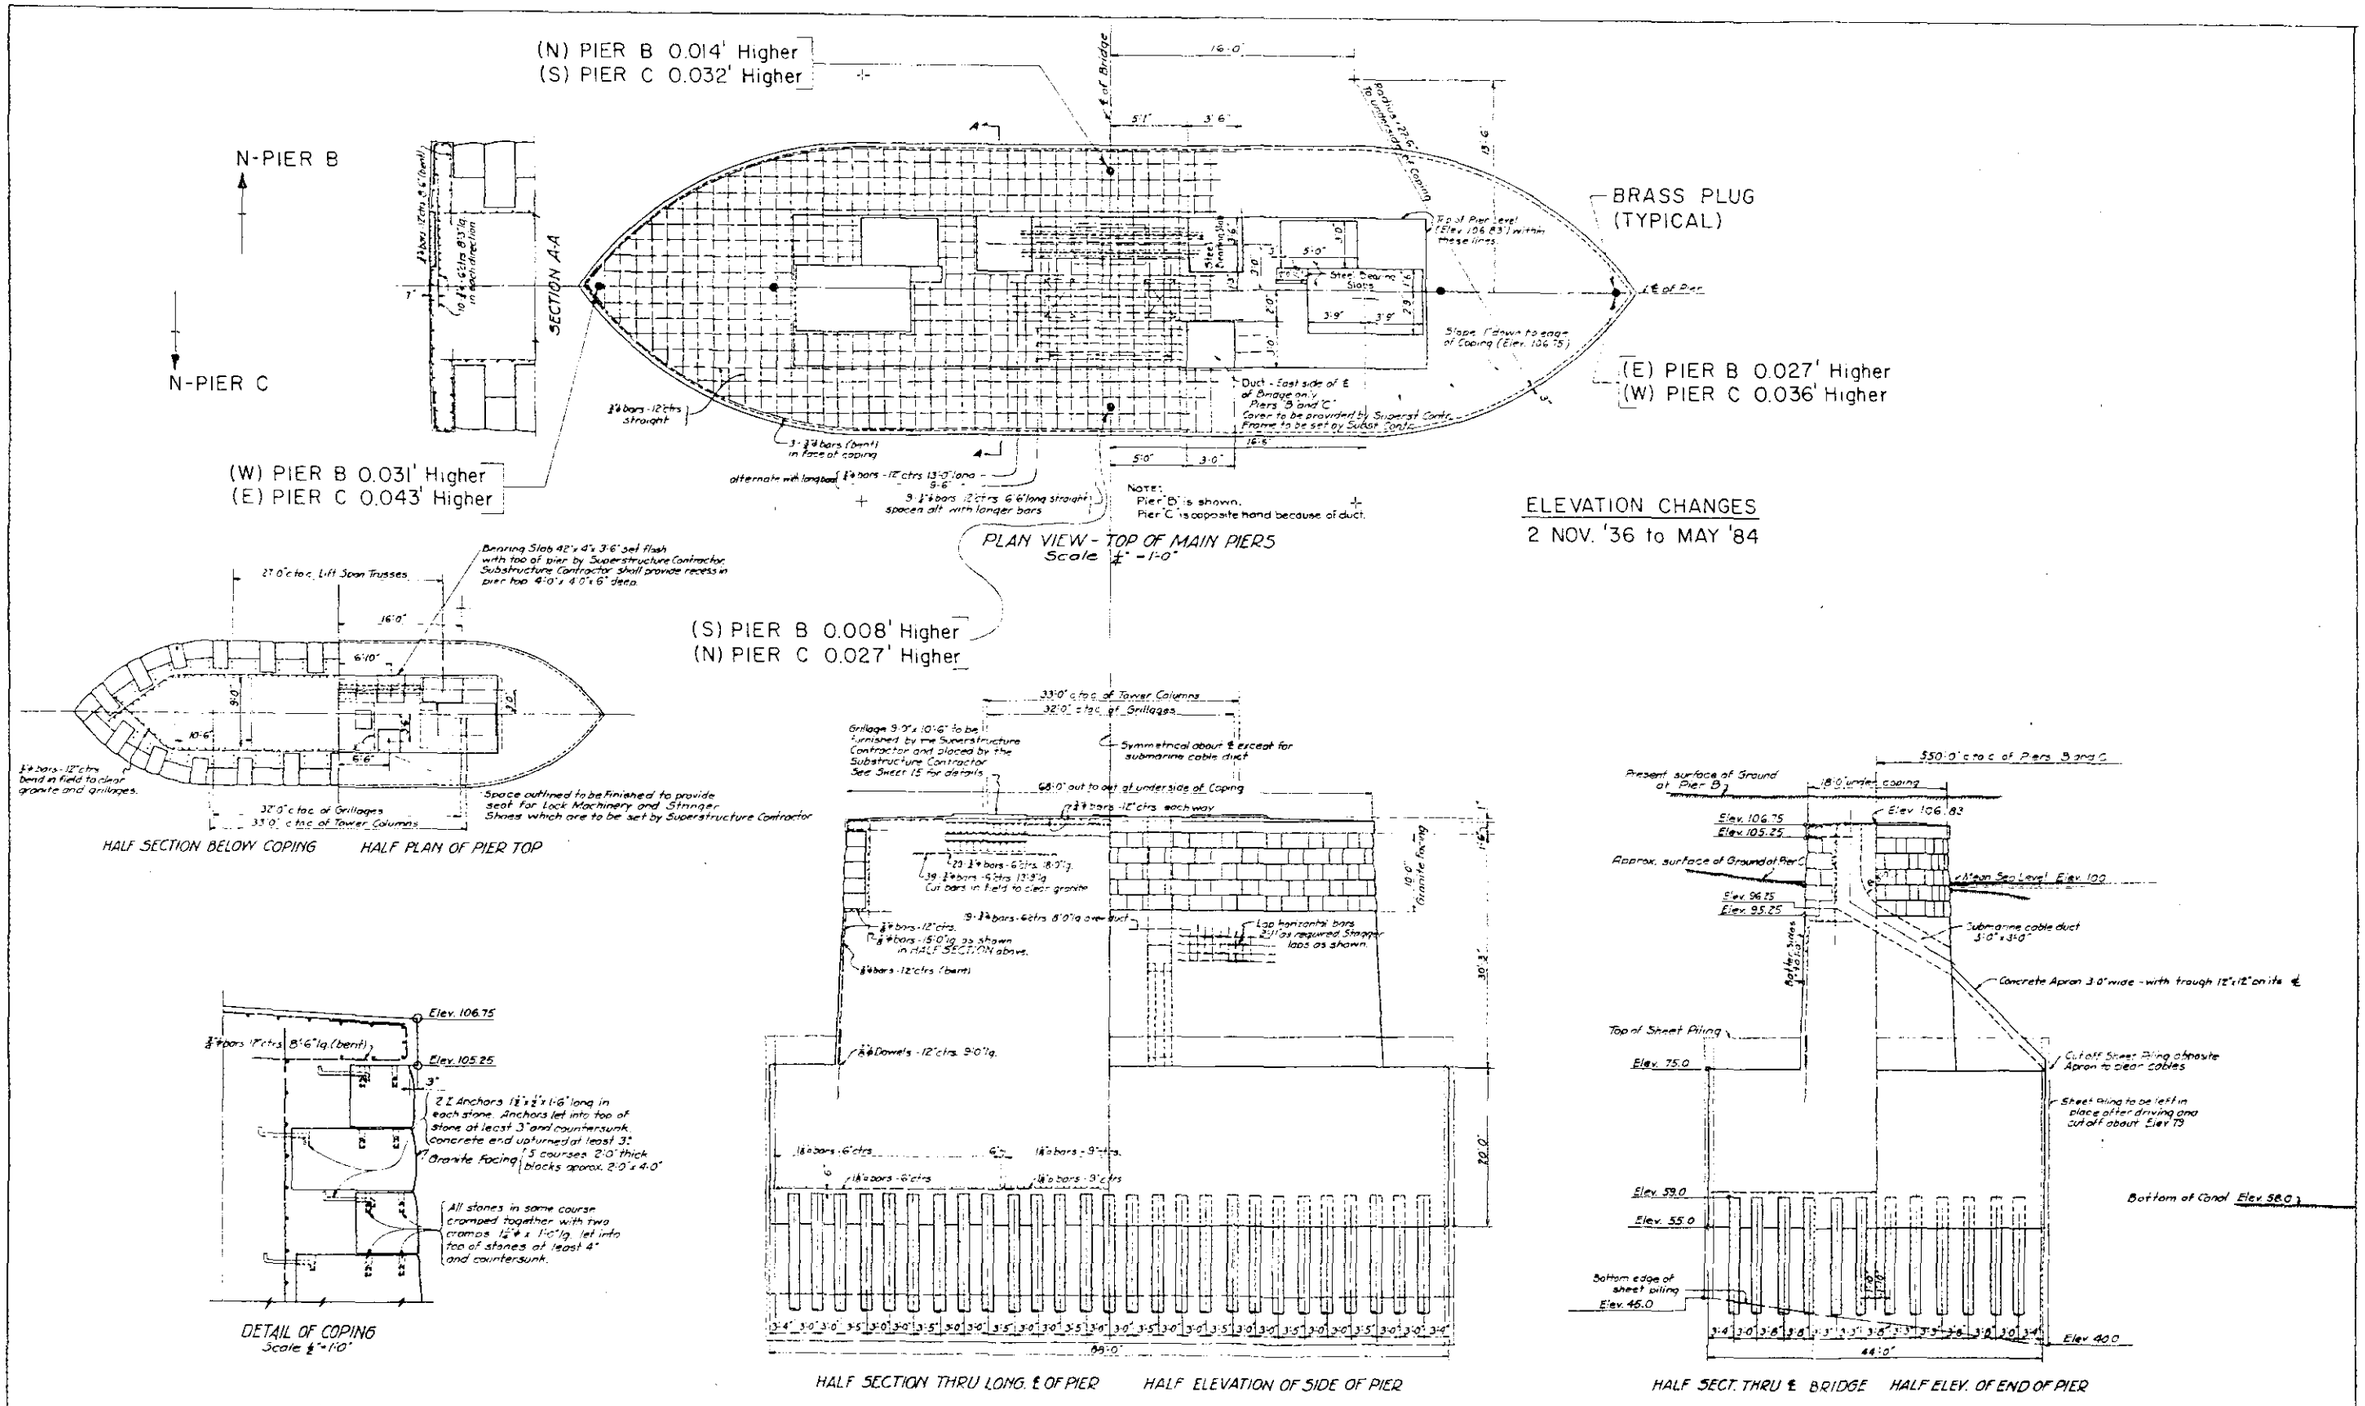
FIGURE 1-2

The changes in the elevations recorded for the piers and abutments between 1936 and 1984 are shown on Figures 1-2 and 1-3. The substructure units appear to have risen an insignificant amount. The average of the change in elevations at each unit indicate a 1/8, 1/4, 3/8 and 5/16 inch rise of the respective substructure units A through D. No adverse affects on the superstructure should be realized by substructure movements of this magnitude.

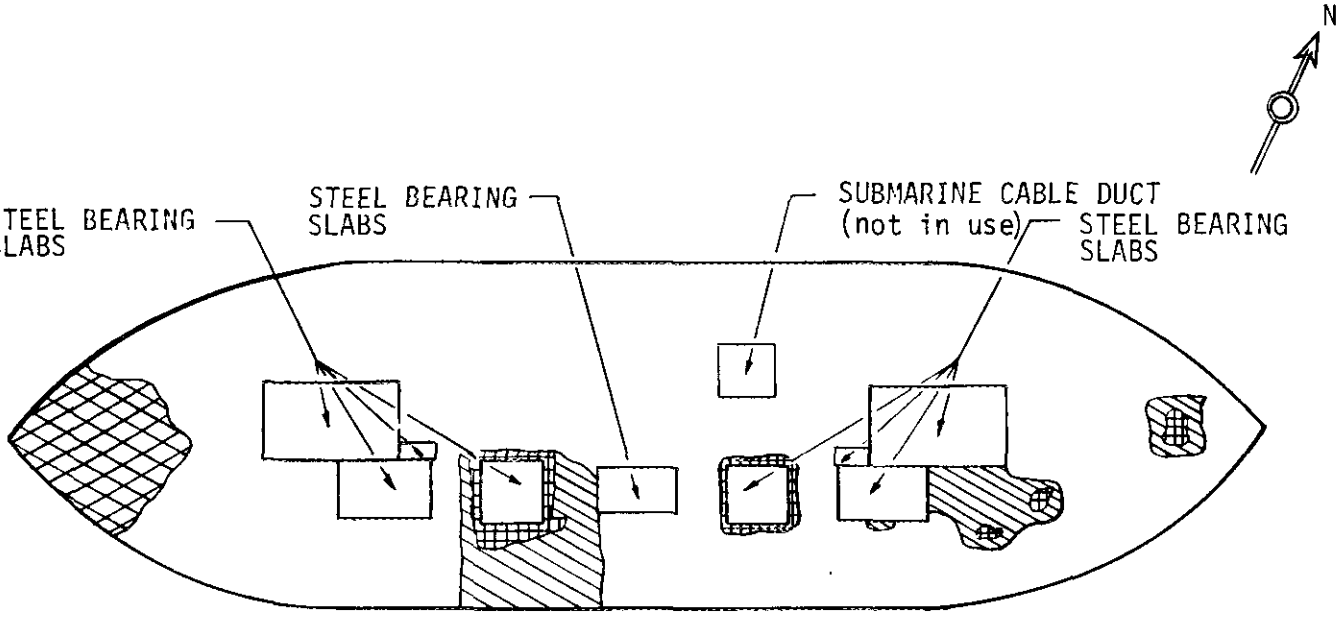
PLAN VIEW TOP OF PIER C

SPALLED CONCRETE

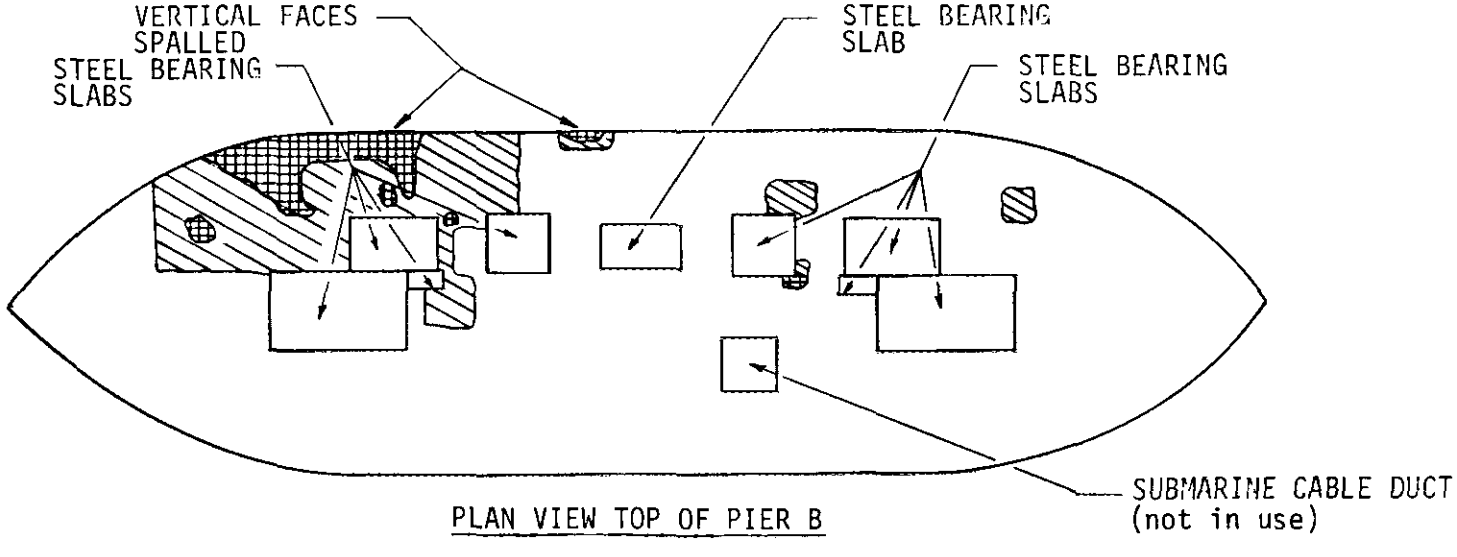
FIGURE 1-5

PLAN VIEW TOP OF PIER B

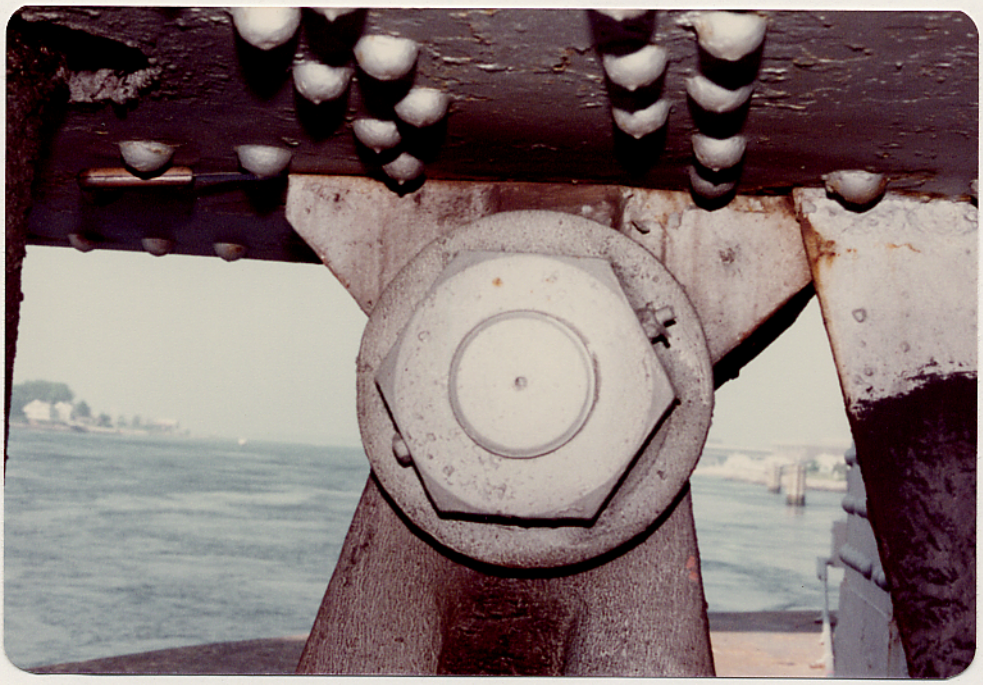
A small gap and rust stains, indicating minor relative movement, was observed between the expansion bearing upper shoes and the truss horizontal connection plates on the inboard end of both devices. A scraper blade can be inserted in the gap at the west bearing (see Photograph I-5). This condition may be caused by elongated connection bolts.

Photograph I-5 - Note rust stains and gap between west expansion bearing upper shoe and horizontal connection plate.

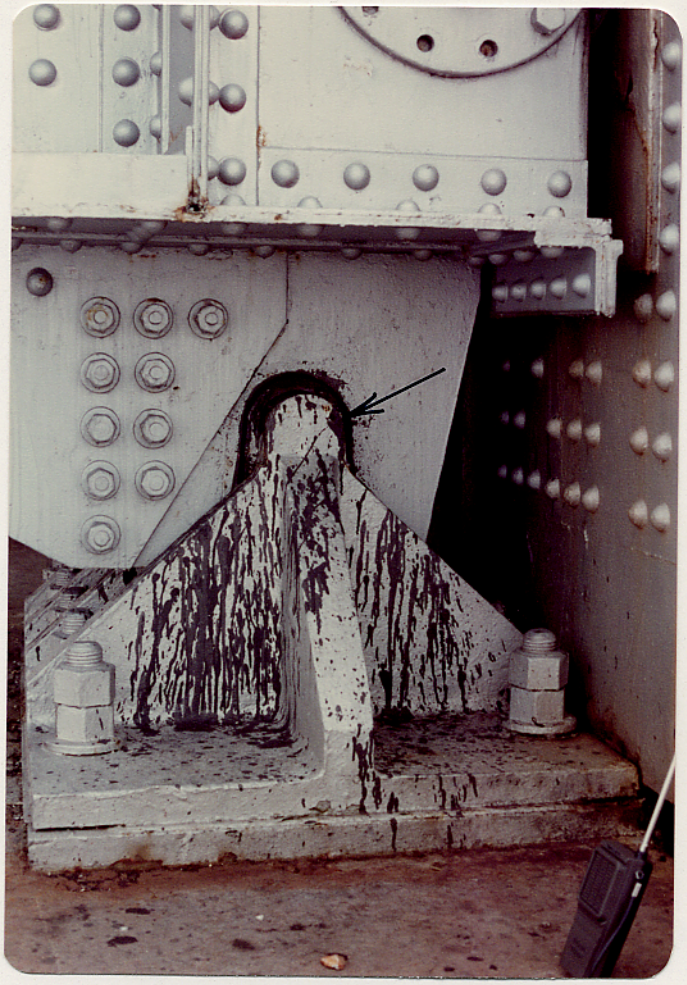
During and after seating of the lift span, contact exists on the south portion of the circular wear plates for the west fixed bearing upper and lower shoes. A 1/8 inch gap exists on the top and the north side between the wear plates of the west shoes (see Photograph I-6). Normal wear exists at the point of contact. Contact between the circular surfaces of the upper and lower shoes at the east fixed bearing is at the crown. Moisture and debris is being trapped in the pockets of the fixed bearing lower shoes (see Photograph II-56).

Photograph I-6 - Arrow indicates point of contact between shoes at west fixed bearing.

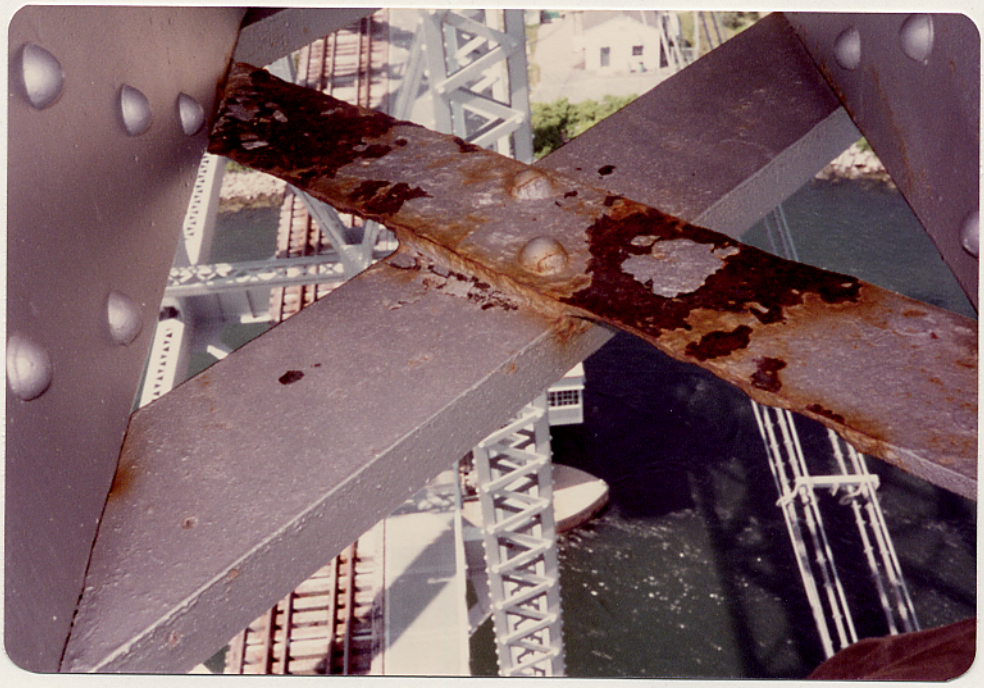
channel and bar sections. Major section loss has occurred in the bar sections, generally between Panel Points 4 and 6 and between Panel Points 4' and 6' on both trusses (see Photographs I-7 and II-61 and 64). The channels have packed rust and section loss at their connections to the chords.

Photograph I-7 - Deteriorated lacing bar in east top chord between Panel Points 5' and 6'.

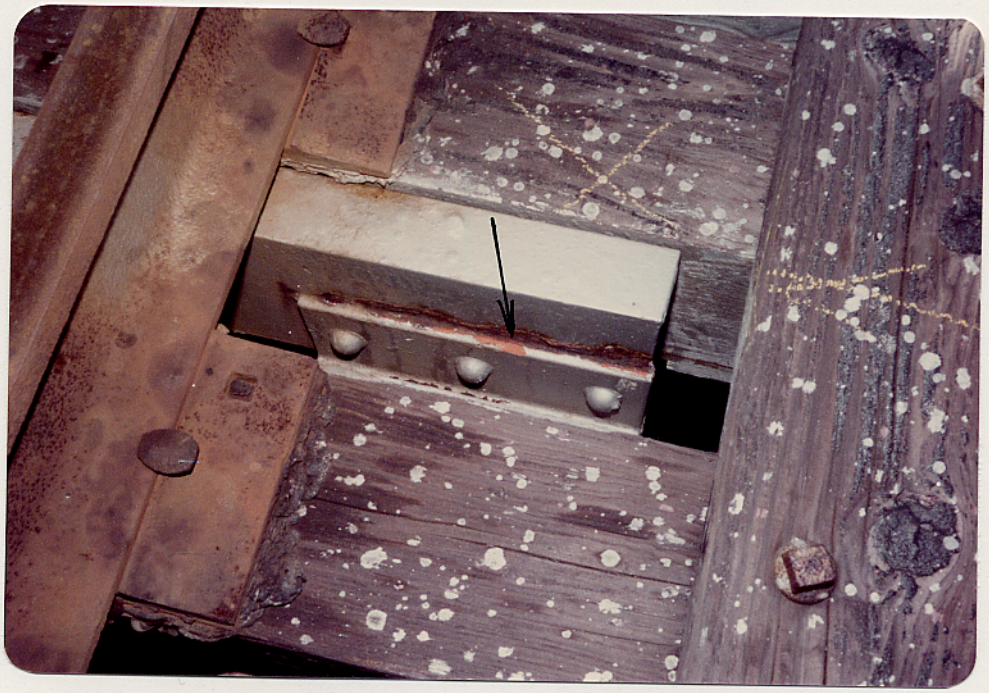
The webs of many walkway transverse support channels are corroded with up to 1/8 inch of section loss at the top of the connection angles on the stringer top flanges (see Photograph I-11). In addition, the heads of the rivets through the channel bottom flanges at the stringers have loss of section. At each channel a timber tie abuts the open side of the member, preventing access for cleaning and painting. The open sides of the channel should be thoroughly cleaned and painted and deteriorated rivets replaced when ties are replaced. Additional rivets on the back side of the channels pass through the connection angles mentioned above to add redundancy.

Photograph I-11 - Typical area of corrosion and section loss in walkway support channels.

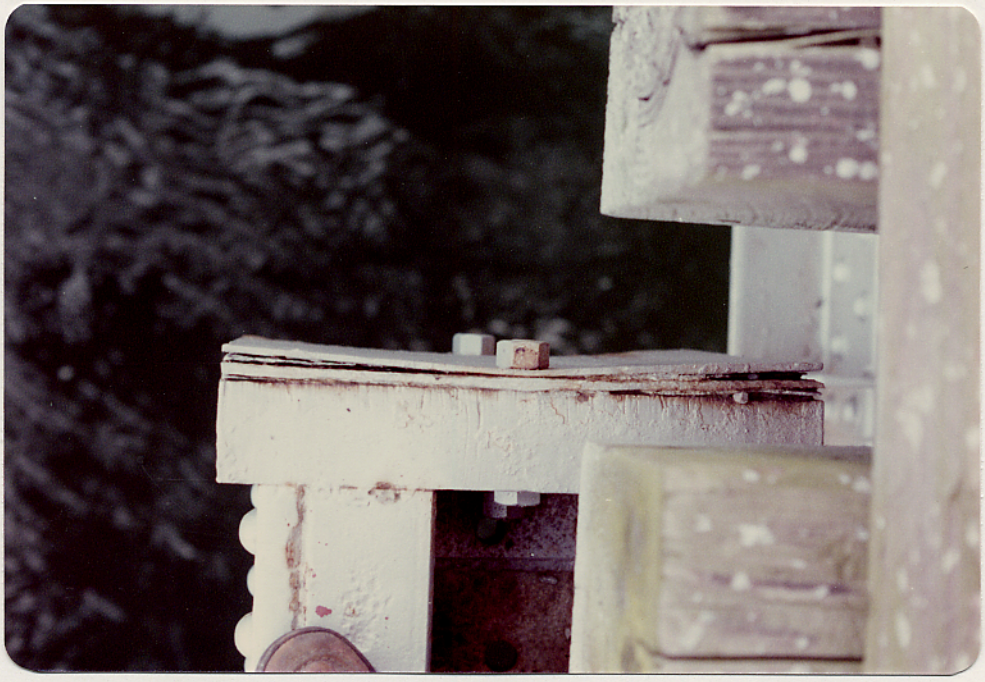
Two jacking struts are provided for placement between the lift span end floorbeam and lifting girder when the counterweight ropes are replaced. One strut is stored in the north span and one in the south span along the west stringer between Panel Points 1 and 2. The repairs recommended for the struts in the 1971 Inspection Report were completed. Drain holes were provided in the web; however, corrosion of the strut metalwork is continuing. Packed rust has formed between the shim plates on the north end, causing section loss and displacement of the plates (see Photograph I-14).

Photograph I-14 - Displaced shim plates and packed rust at lower end of north span jacking strut.

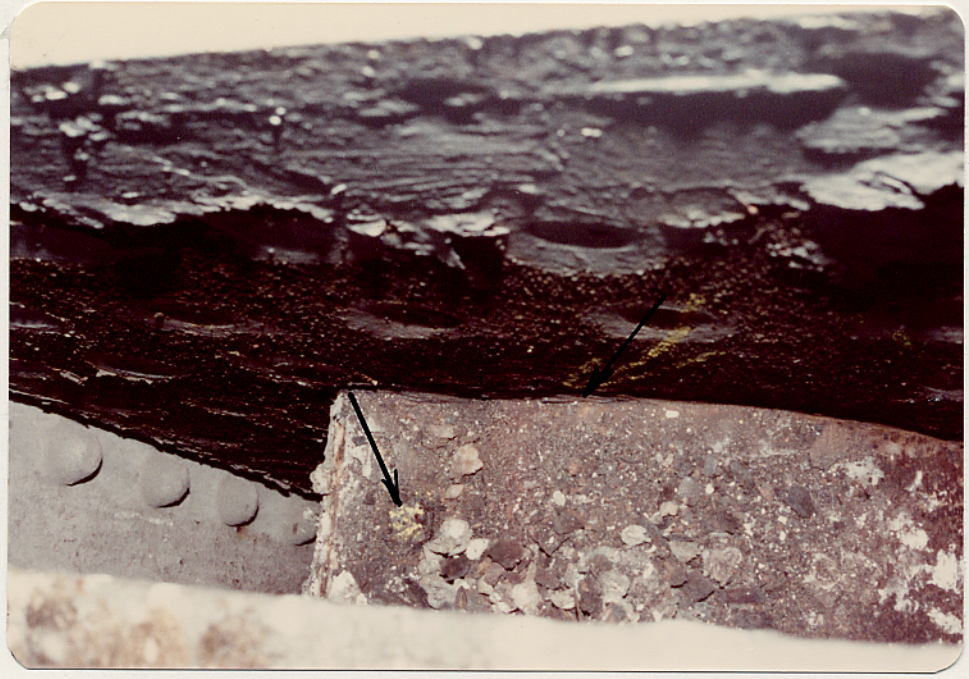
The interior sides of the counterweight hangers and adjacent support metalwork and the pin collars have not been recently painted. Corrosion has caused a maximum of 1/8 inch depth of pitting in the hangers and adjacent support plates at the pin collars. The heads of fasteners for the pin collars are severely deteriorated (see Photograph I-18). The pin collars should be removed and the metalwork sandblast cleaned and painted.

Photograph I-18 - Typical corrosion and minor section loss on pin collars and fasteners and interior surfaces of counterweight hanger plates and support metalwork.

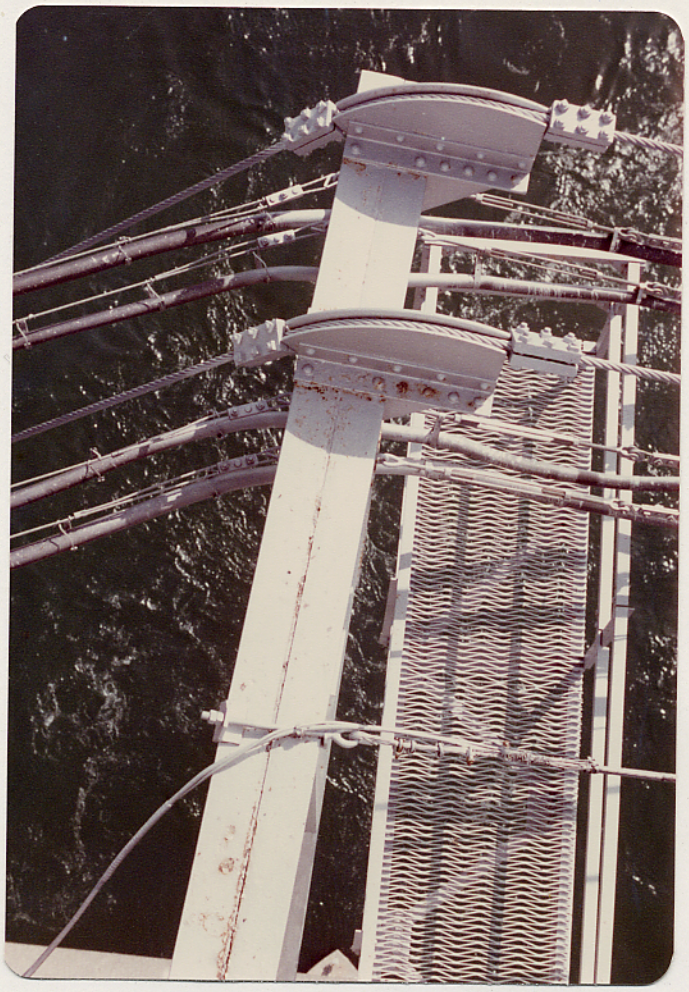
The catenary brackets supporting the messenger cables on the east and west sides of the tower are pivoted toward the channel and the outboard ends rotated toward the channel (see Photograph I-21). The bracket rotation has apparently developed since the new messenger cables were installed in 1976-77, as no deformation was reported in the 1971 Inspection Report. Each bracket was plumbed at three locations and the amount of offset between the top and bottom flanges and the degree of rotation is tabulated on Figure 2-8. No structural cracks were observed in the bracket metalwork. The brackets should be analyzed to determine if remedial measures are required.

Photograph I-21 - Plan view of northeast catenary bracket.

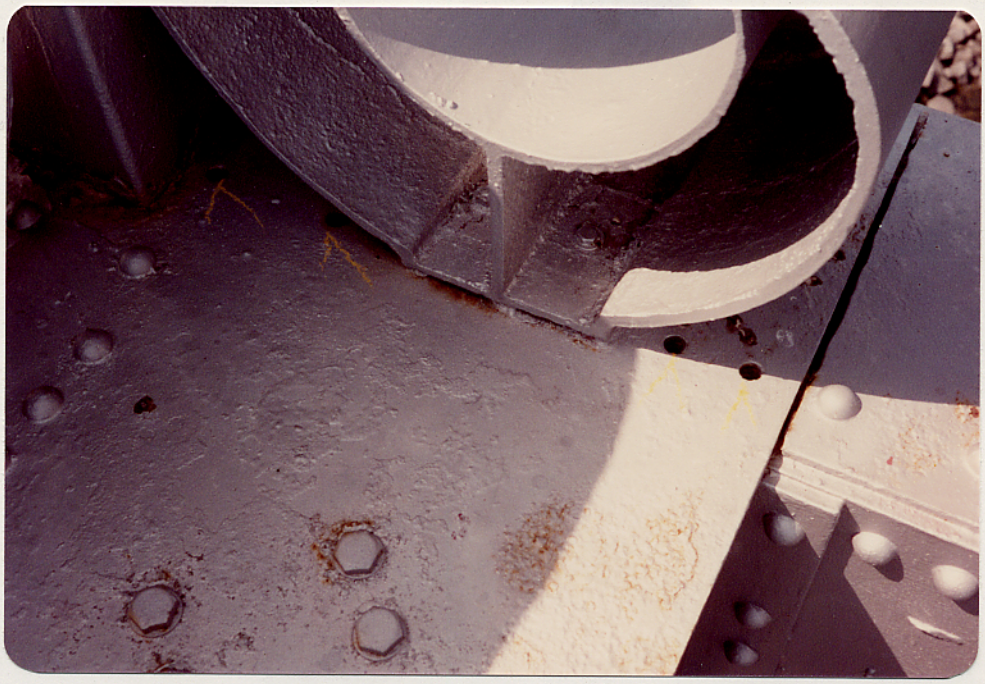
Five fasteners are missing in the upper lateral connection plate on the top chord at Panel Point 4, west truss (see Photograph I-23). Three fasteners are missing in the connection of a support bracket angle for the ornamental ironwork on the portal strut near bridge centerline at Panel Point 4. The west decorative ball at Panel Point 4 is dented (see Photographs II-118 and 119).

Photograph I-23 - Missing fasteners at Panel Point 4, west top truss.

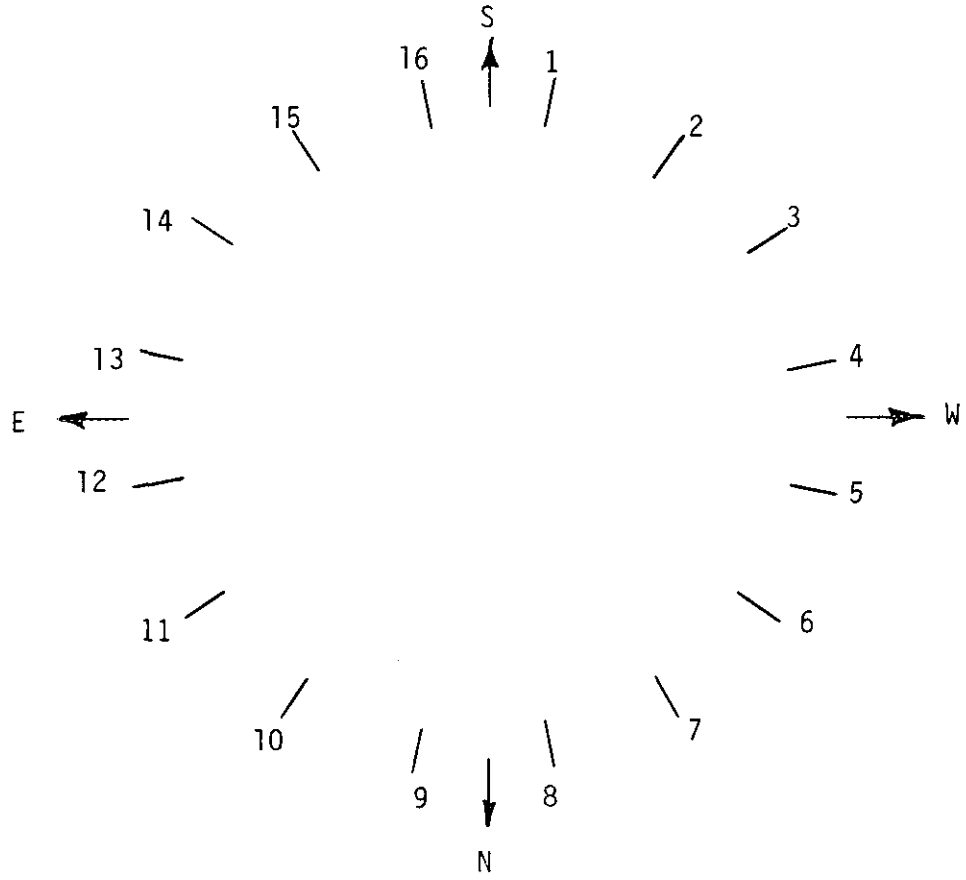
FIGURE 2-7

The decorative spire atop the machinery house enclosure consists of a welded lattice of angles. Packed rust and moderate section loss exist on these members adjacent to the connection plates (see Photographs I-19 and I-20). Many of the welds are broken, usually at the horizontal angle connections. A listing of broken weld locations is provided on Figure 2-7.

h) Moderate section loss in spire lattice angles adjacent to connection plates and broken welds at many connections. Locations of separated welds are listed in Figure 2-7.

22. Remove corrosion deposits and refasten the separated bracing members in the spire lattice at locations indicated on Figure 2-7. Bracing members with excessive section loss should be replaced.

21. Remove corrosion deposits and refasten the broken connections of the spire lattice angles at locations listed in Figure 2-7. Replace severely deteriorated angles as necessary.

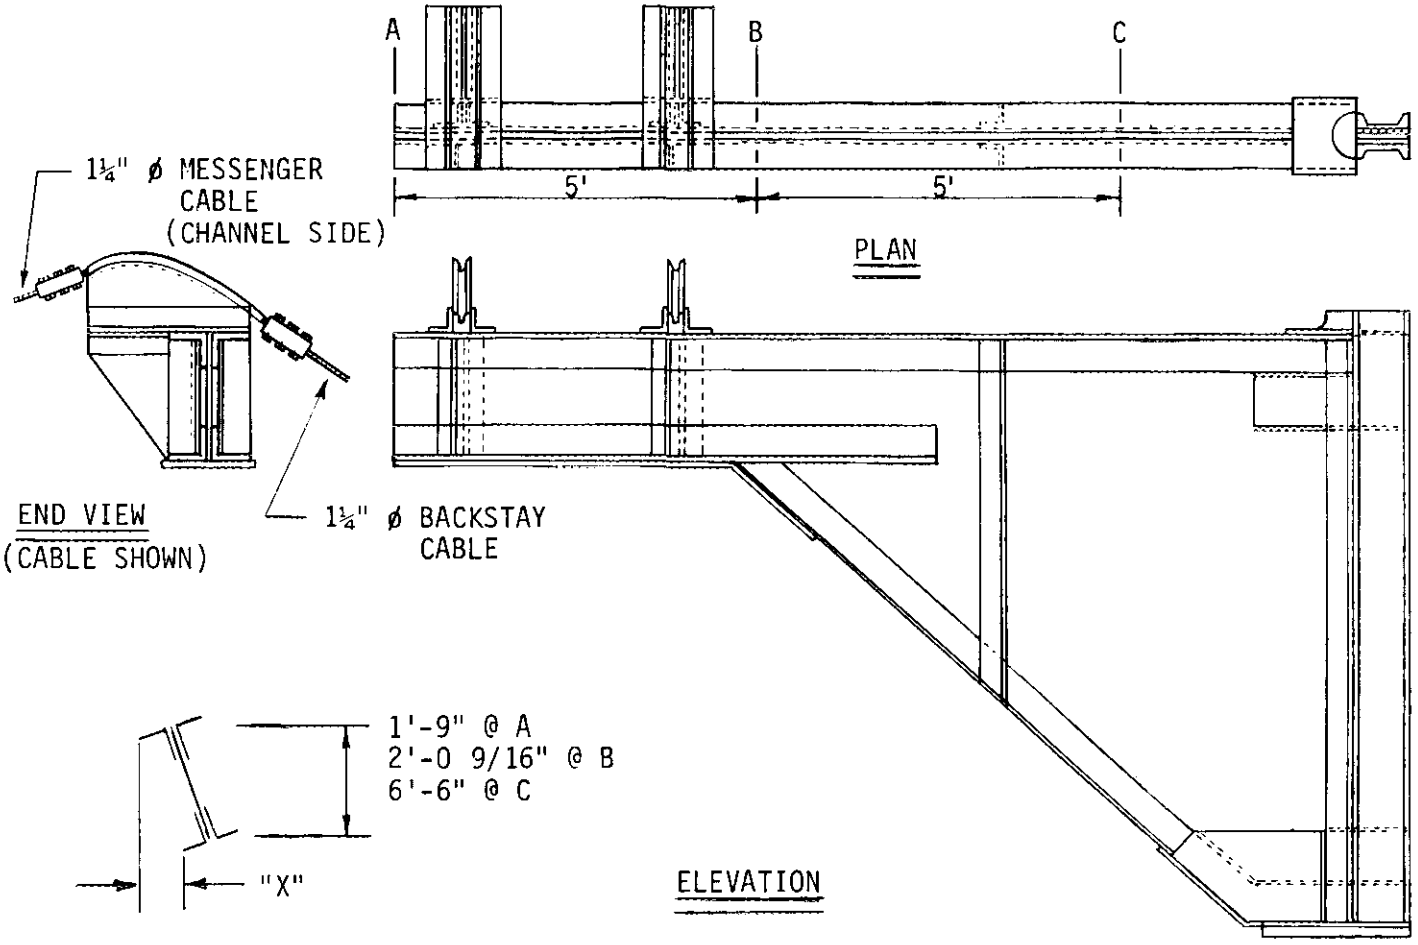
FIGURE 2-8

i) The catenary brackets supporting the messenger cables are pivoted northward and the outboard ends are rotated in the same direction (see Figure 2-8).

BRACKET	ROTATION DIRECTION	LOCATION	DIMENSION "X"	DEGREE OF ROTATION
NORTHEAST	SOUTH	A	1-3/4"	4.8 deg.
		B	3/4"	1.7 deg.
		C	1/2"	0.4 deg.
NORTHWEST	SOUTH	A	2-7/8"	7.8 deg.
		B	1-1/8"	2.6 deg.
		C	3/4"	0.5 deg.
SOUTHEAST	NORTH	A	1-7/8"	5.1 deg.
		B	7/8"	2.0 deg.
		C	3/4"	0.5 deg.
SOUTHWEST	NORTH	A	2-7/8"	7.8 deg.
		B	1-1/4"	2.9 deg.
		C	1/8"	0.1 deg.

NOTES: 1. ROTATION IS TOWARDS THE CHANNEL IN ALL CASES.

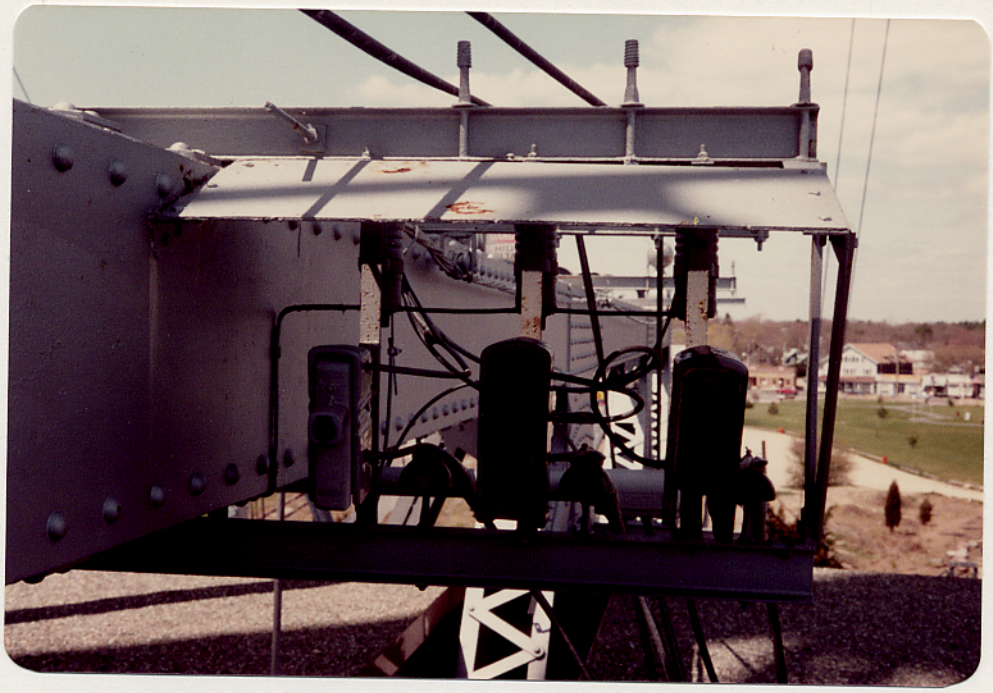
Photograph I-28 - High voltage fuse assemblies on control house roof. Note broken unit, far right.

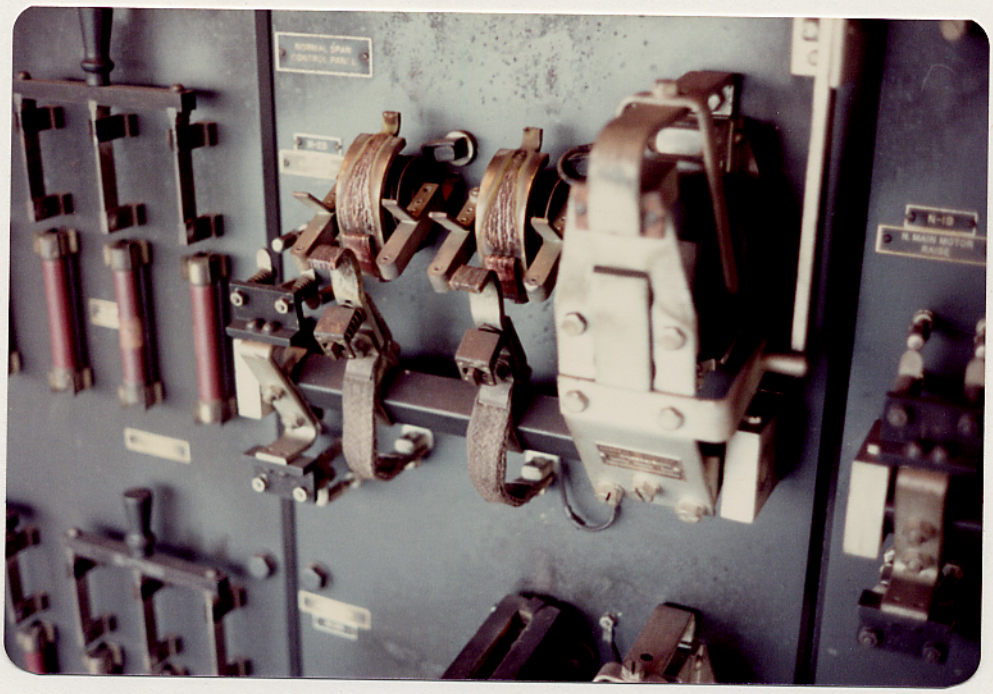
auxiliary contact linkages on some contactors is excessively worn, and have reportedly interfered with bridge operation on occasion. Replacement parts for these contactors will probably have to be custom manufactured, since this type of equipment has been obsolete for quite some time. All contactor and relay coils were meggered and appeared in satisfactory condition.

Photograph I-29 - Selsyn excitation contactor with arc chutes removed to show pitting and scorching of the contacts and arcing horns.

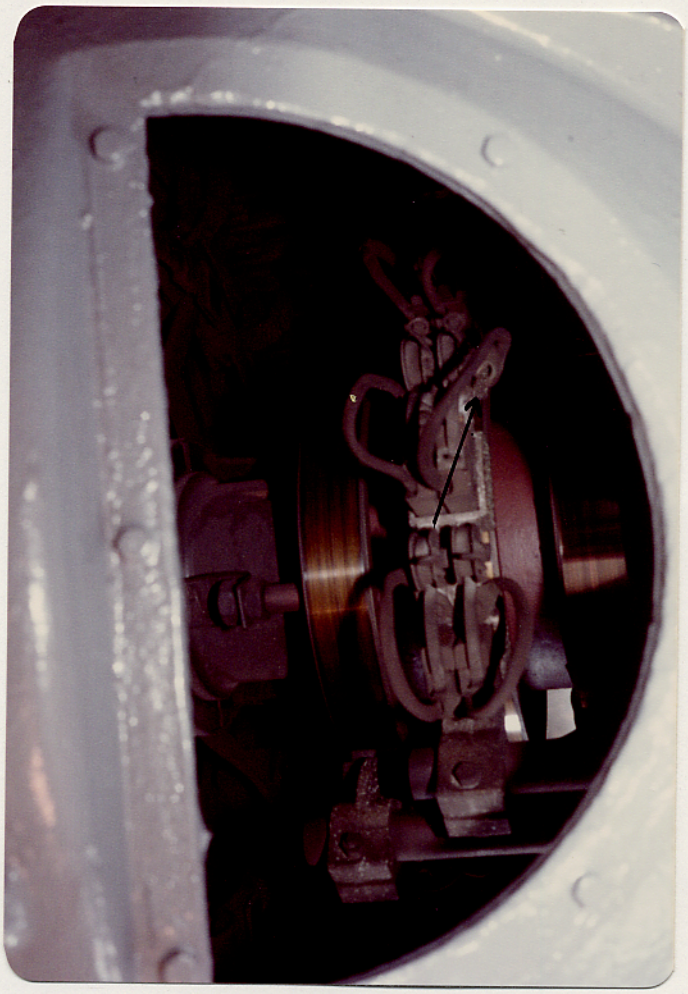
Photograph I-30 - Loose wire terminal on drive motor brush holder assembly, resulting from sheared terminal screw.

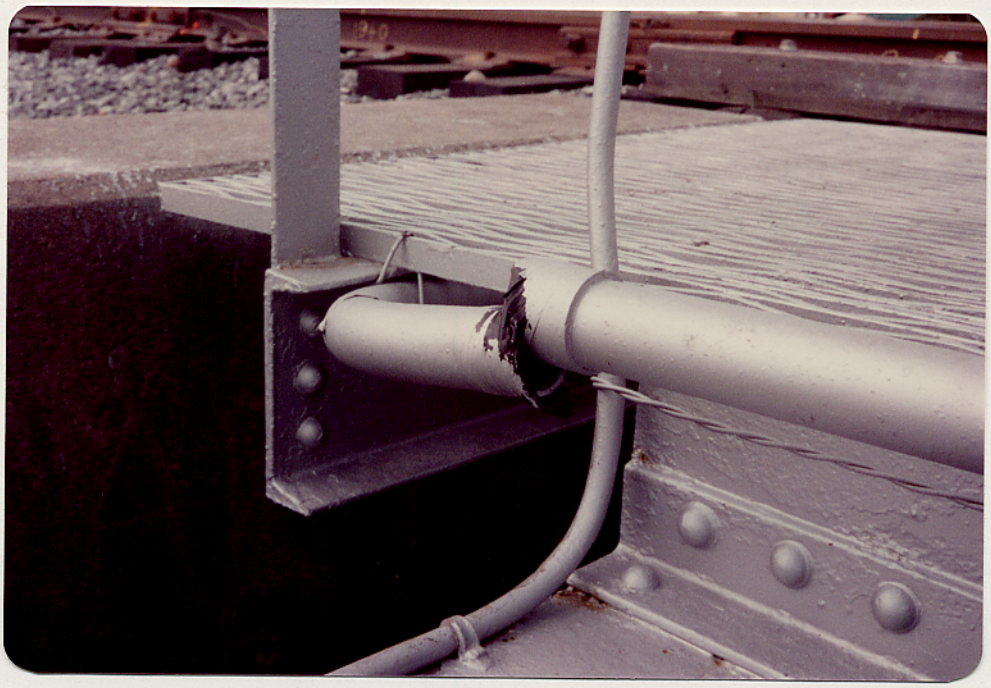
Conduits on the south tower and pier were generally in satisfactory condition, with a few exceptions. The plastic conduit on the tower span was broken in several places (see Photograph I-33). This conduit was improperly supported, using plastic cable ties. Also, a conduit body cover was missing. In some places, conduit clamps were rusted. The two large junction boxes at the bottom of the south tower were in good condition, except for some missing cover bolts.

Photograph I-33 - Broken and improperly supported plastic conduit on south tower span.

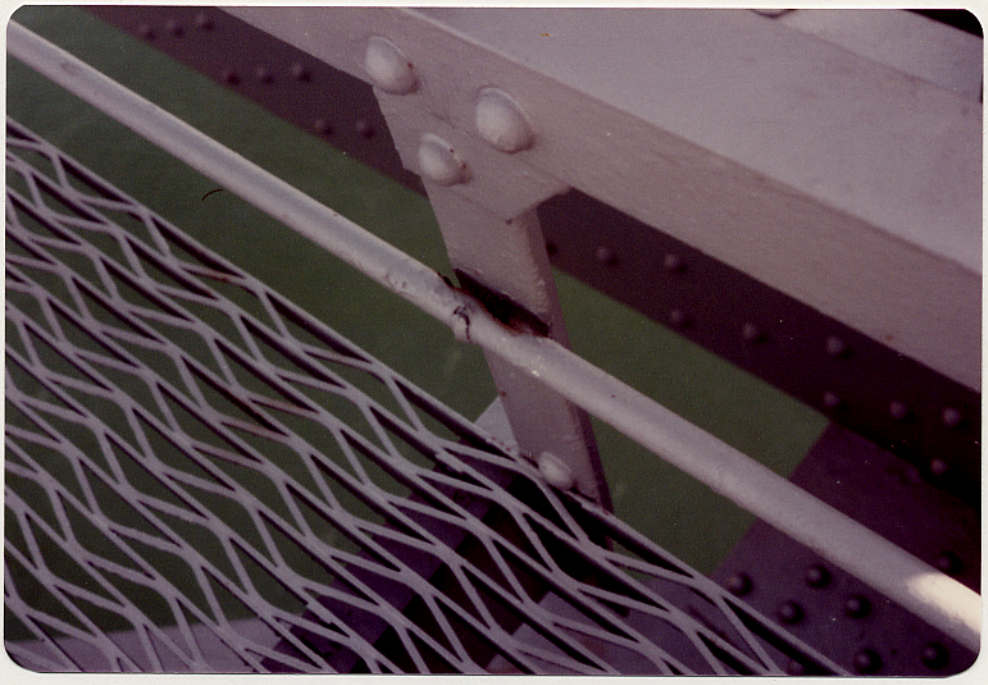
Conduits on the top chord of the lift span were in satisfactory condition. However, conduits at stair and walkway levels were suffering from severe rusting at and of the support clamps (see Photograph I-34).

Photograph I-34 - Corroded conduit along the lift span walkway.

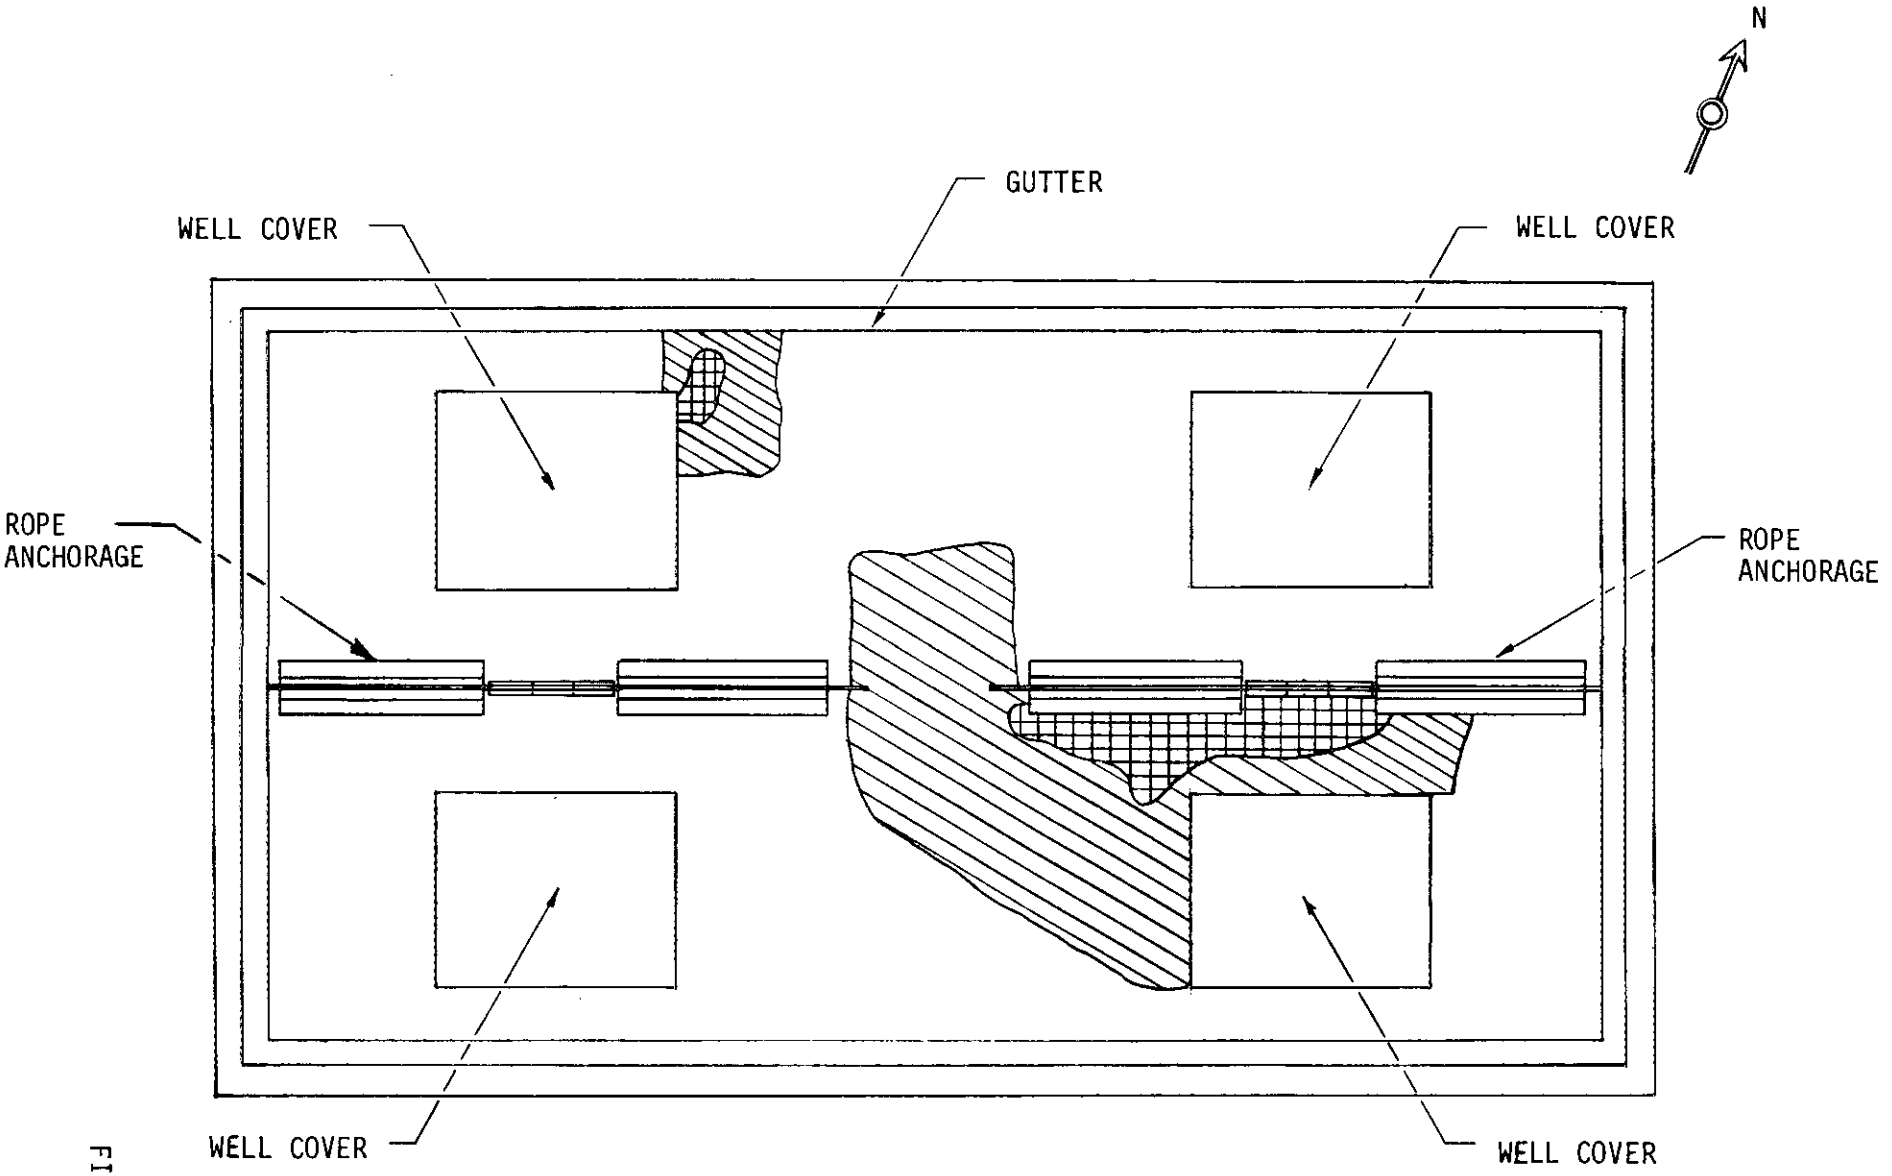
PLAN VIEW TOP OF SOUTH MAIN COUNTERWEIGHT

Project VERTICAL LIFT RAILWAY BRIDGE
Subject SOUTH COUNTERWEIGHT
CONCRETE DETERIORATION
