BUZZARDS BAY RAILROAD LIFT BRIDGE OVER CAPE COD CANAL

INSPECTION AND CONDITION REPORT

OCTOBER, 1984

RE: CONTRACT NO. DACW33-84-C-0022
Inspection and Condition Report
Vertical Lift Railroad Bridge
Cape Cod Canal
Buzzards Bay, Massachusetts

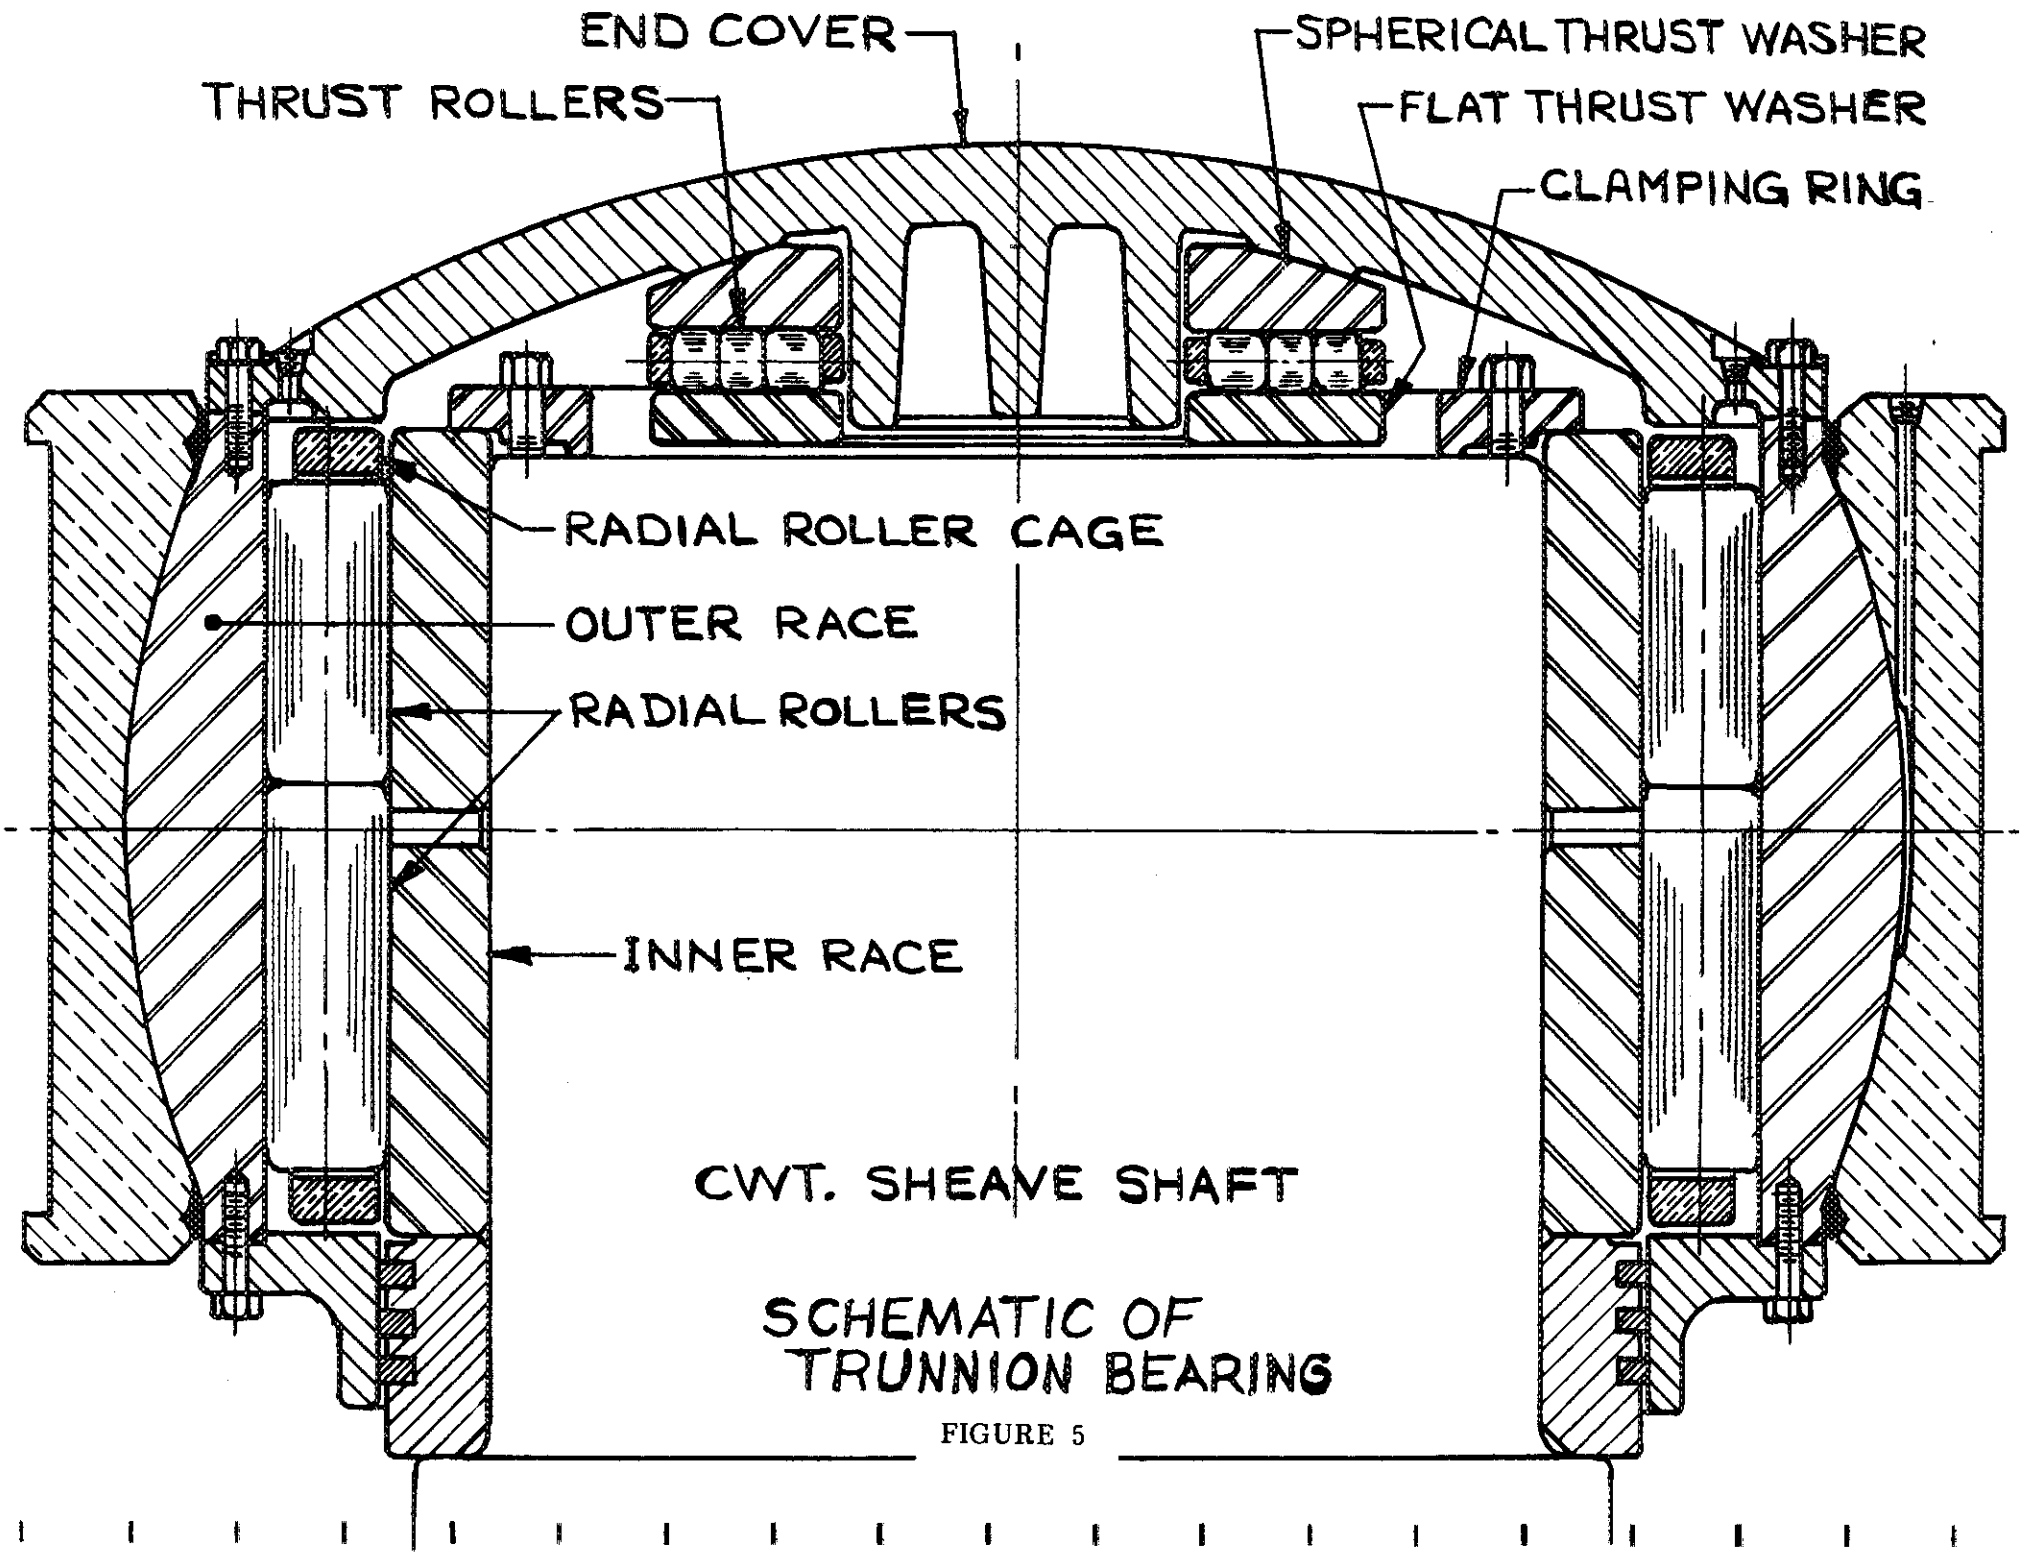
FIGURE 5

Three elements of the thrust washer are supported by the boss, as seen in the schematic in Figure 5. The flat thrust washer rides on the end of the boss. The flat washer had worn a sizeable groove in the top of the boss, as seen in the photograph.

Several serious flaws in design of the trunnion bearing were found. First of all, the radial roller assembly is a group of cylindrical rollers mounted in a bronze cage that is free to float axially. The rotating assembly can float until the bronze cage comes into contact with the stationary end cover on either end of the bearing housing. The end covers are made of soft steel, ASTM A27-24. The machined surfaces that the bronze comes into contact with have a very rough finish, approximately 250 microinches. When the rotating soft bronze comes into contact with the stationary rough steel surfaces, the bronze abrades very quickly.

The usual procedure to restrict end float of cylindrical roller bearing assemblies is to provide shoulders on the inner and/or outer races. The ends of the hard polished rollers contacting hard polished shoulders does not create a problem. The bearings on the Buzzards Bay Bridge do not have shoulders on either the inner or outer race. The outside diameter of the inner race and the inside diameter of the outer race are both pure cylinders, as shown in Figure 5.

The thrust bearing has several serious design deficiencies. The outside diameter of the boss supporting the three thrust bearing components is the same soft steel with the same rough surfaces mentioned above. The flat thrust washer theoretically rotates at the speed of the counterweight sheave shaft. The thrust roller assembly in its bronze cage rotates at half the speed of the same shaft. The flat washer and bronze cage both rotate on the soft steel boss with a poor surface finish. Again, the bronze and the steel boss will both wear.

The thrust rollers are cylindrical. The thrust roller assembly includes fifteen sets of three rollers held in radial pockets in the bronze cage, as seen in Figure 5 and Photograph 88.

With three rollers of the same diameter in each radial pocket, the three rollers must rotate at different speeds. The flat ends of the abutting rollers must slide rotationally with respect to one another. No provision was made to lubricate the abutting ends of the rollers. The sliding of the rollers on the two thrust washers and the unlubricated abutting ends of the rollers rotating against one another all create heat quickly when operating under load. It is this heat that is generated that caused the heat discoloration of the thrust rollers and thrust washers.

The access to internal parts of the radial bearing is very poor, even with the end cover removed. Note in the schematic in Figure 5 that the space between the inner and outer races at the ends of the rollers is almost completely covered by the bronze roller cage. Visual access to areas beyond the ring of the bronze cage is virtually non-existent.

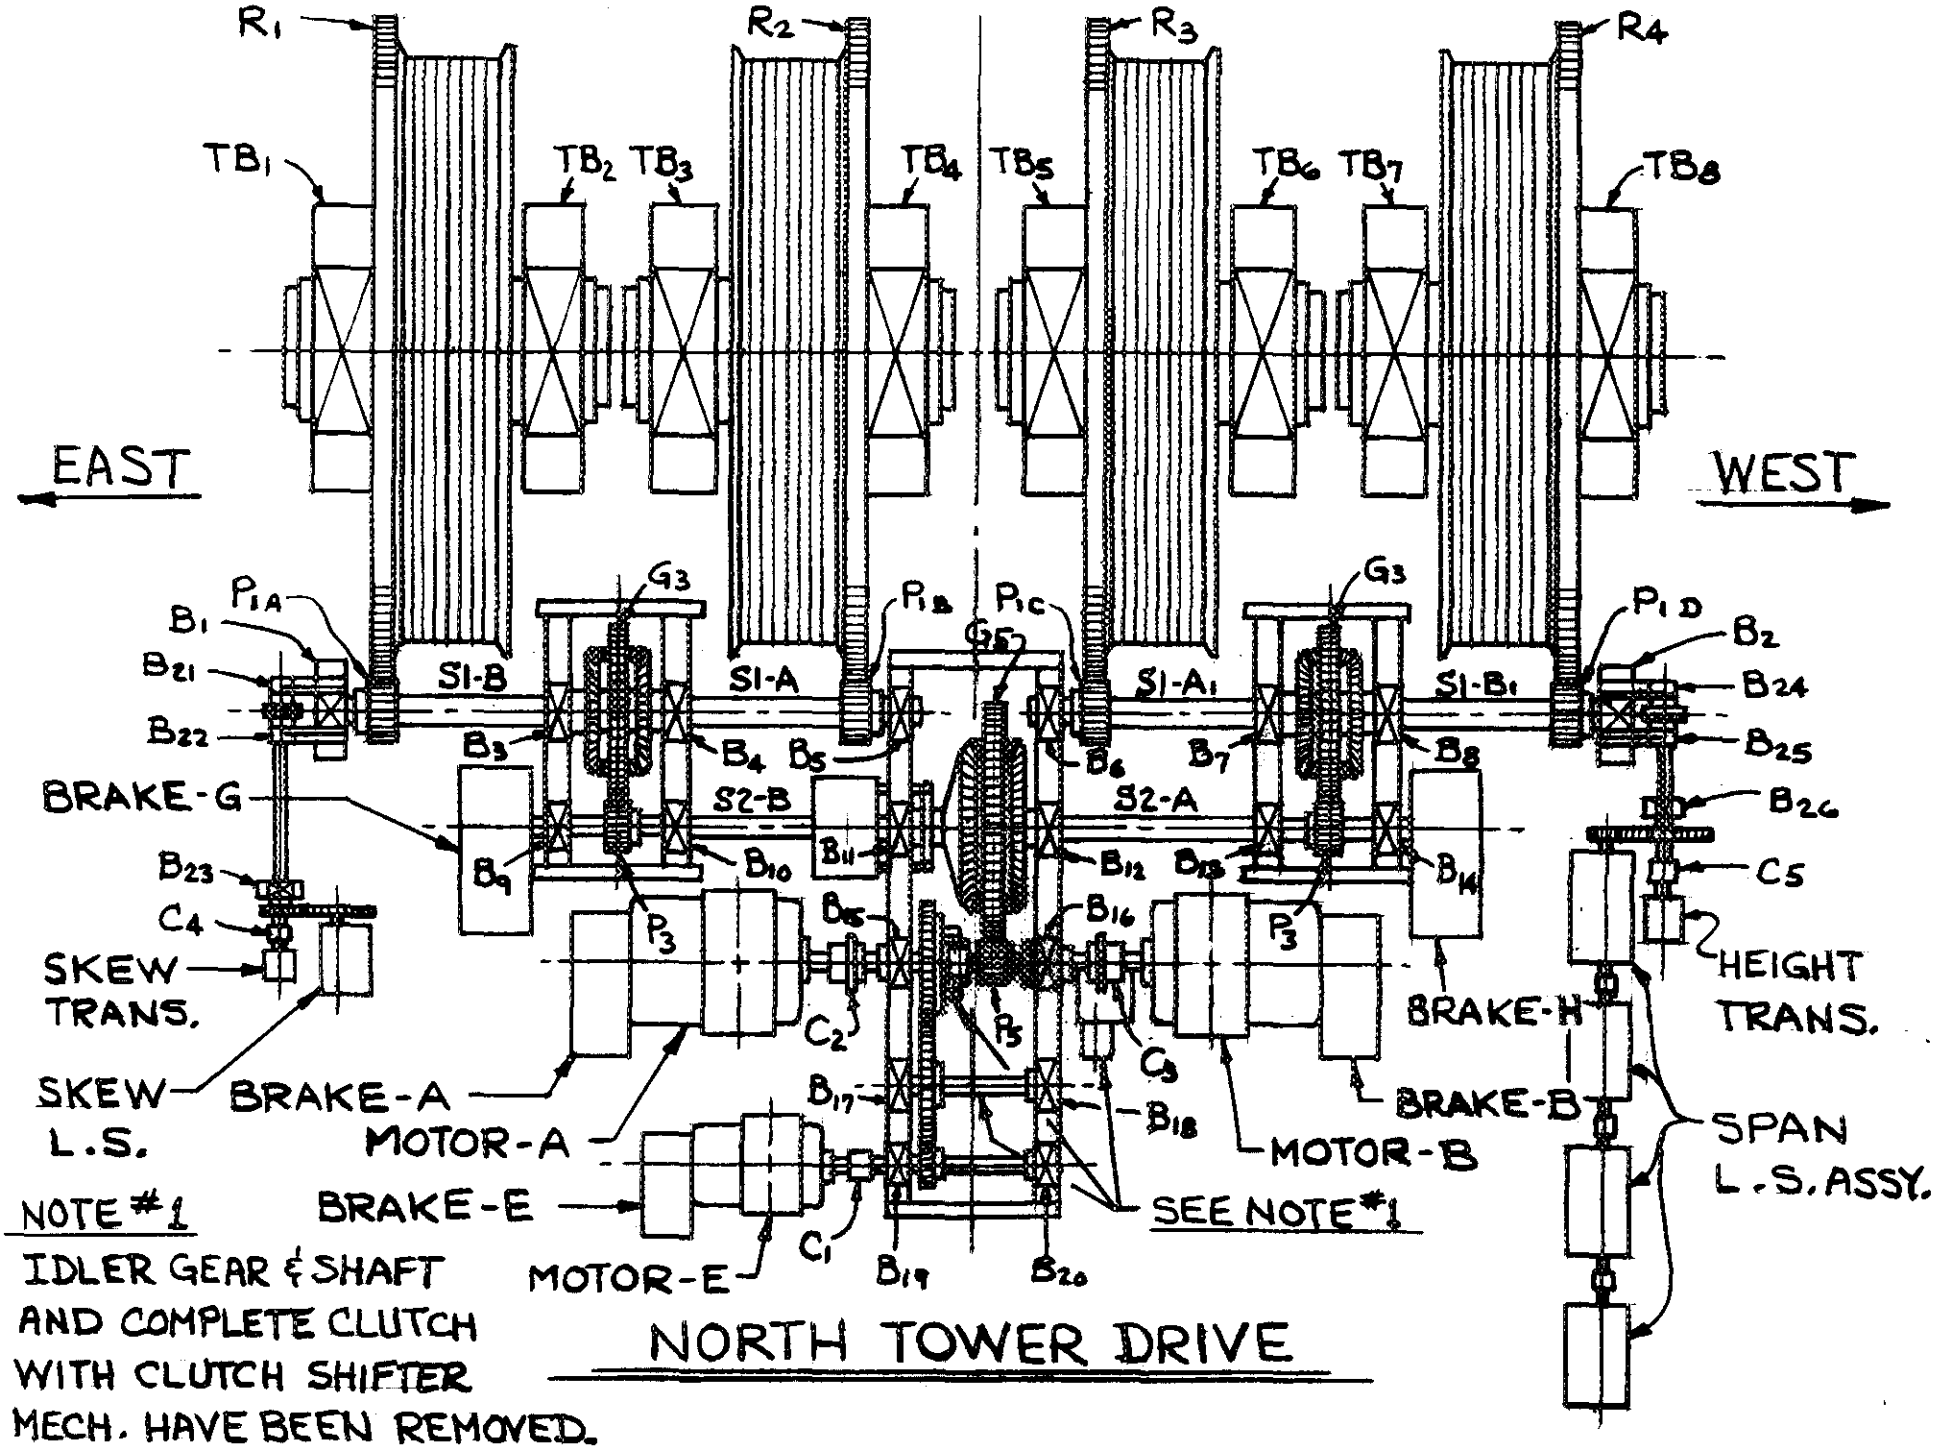
TABLE 1

BEARING	CLEARANCE		WEAR	REMARKS
	ORIGINAL	CURRENT		
B_9	.005"	.012"	.007"	Opened - Good condition.
B_{10}	.005	.001	NIL	
B_{11}	.005	.011	.006	
B_{12}	.005	.018	.013	
B_{13}	.005	.002	NIL	Opened - Light scratching on journal, not well polished, deep scoring in cap, old dry grease
B_{14}	.005	.011	.006	
B_{15}	.005	.019	.014	Opened - Good condition.
B_{16}	.005	.007	.002	Opened - Good condition.

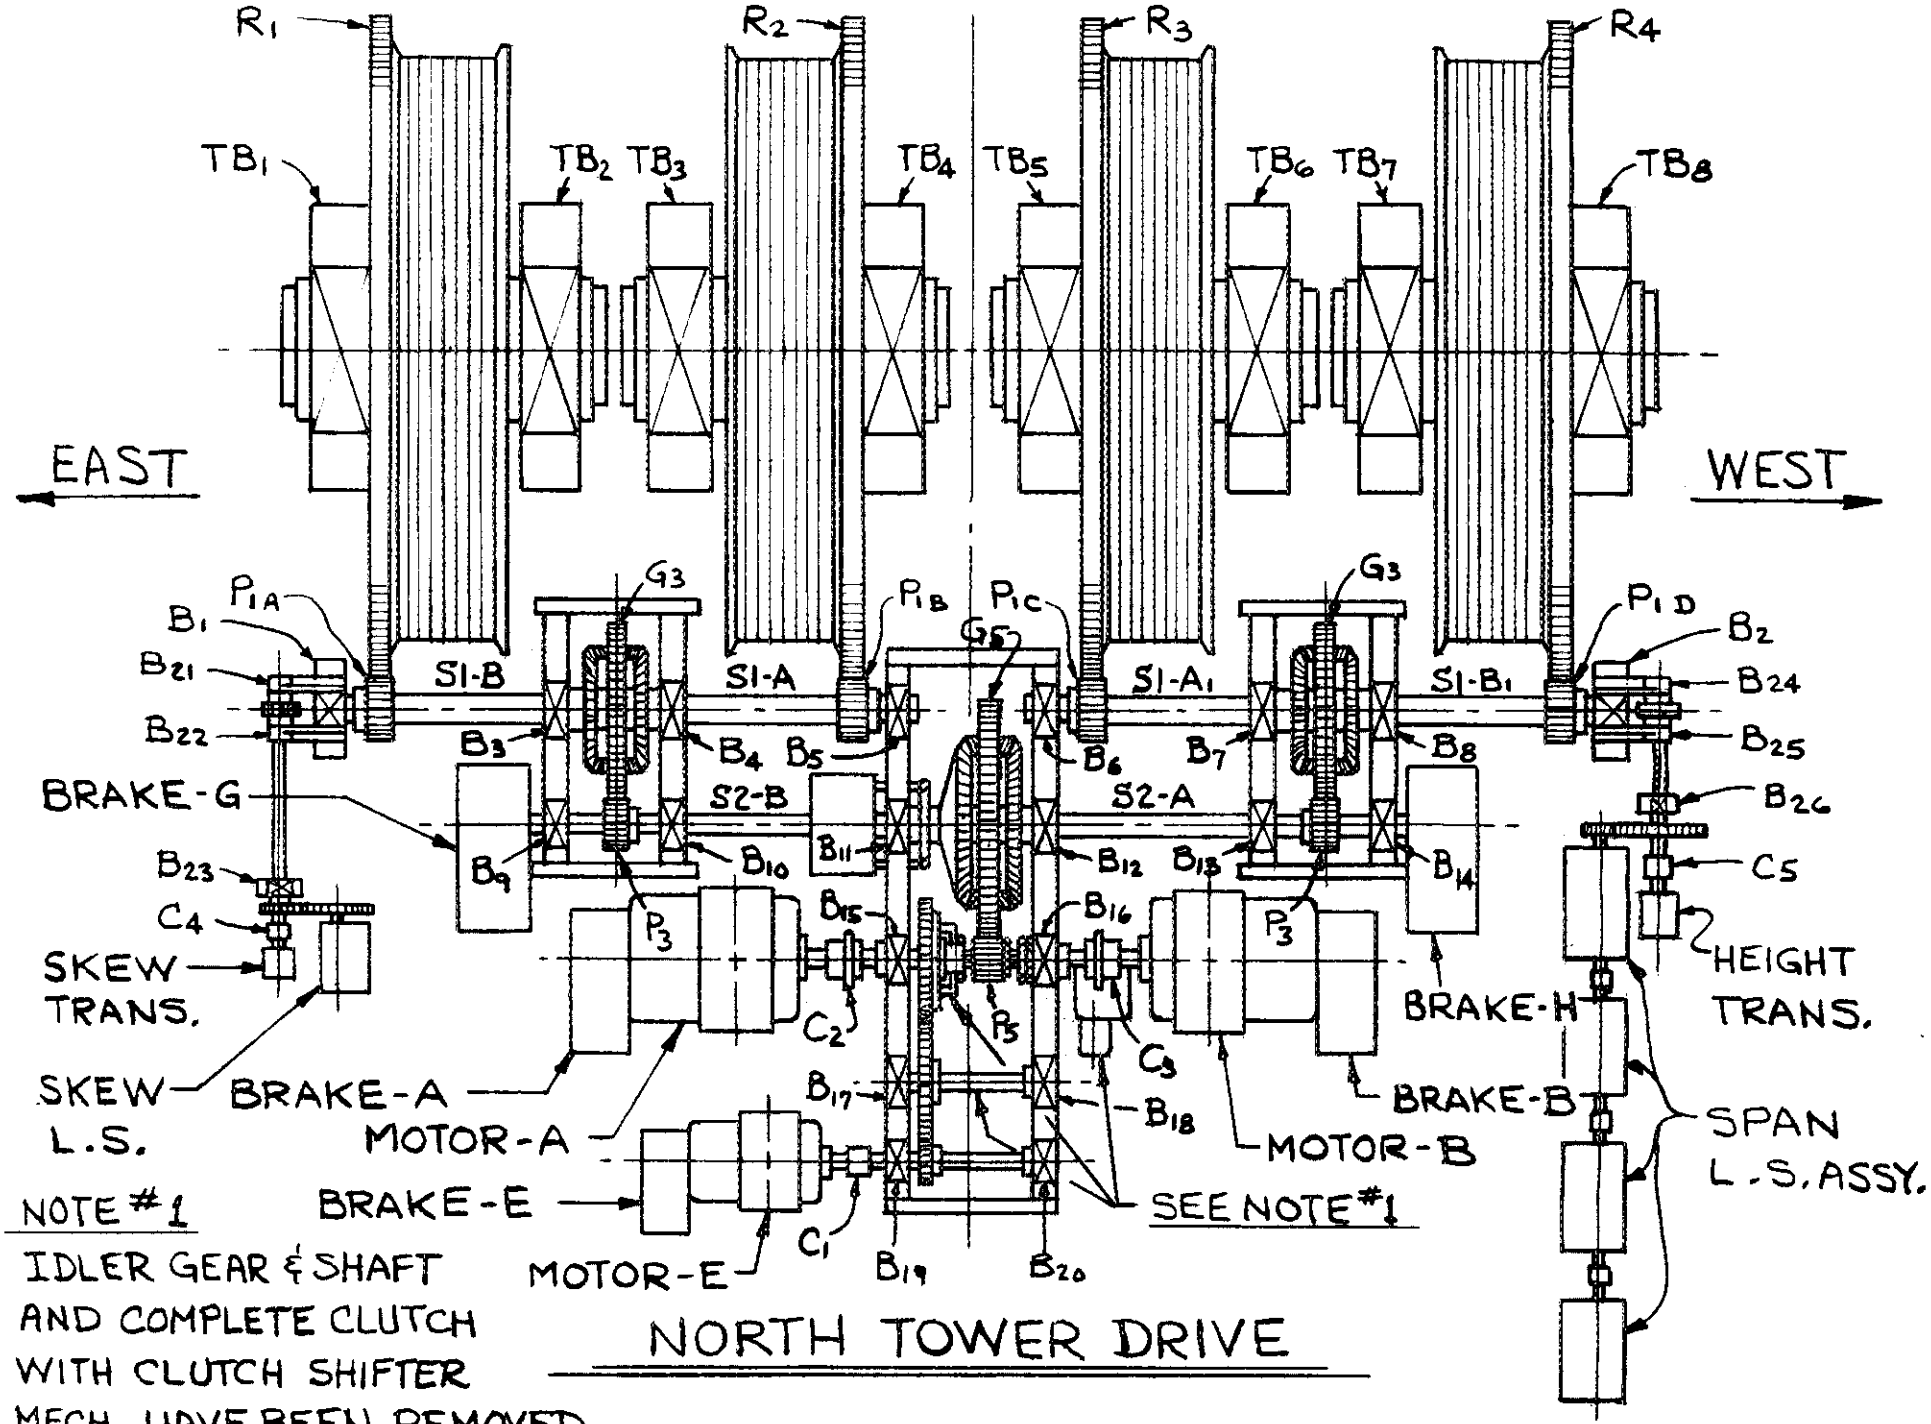
GEAR IN QUESTION				GEAR TOOTH MEASUREMENTS						WEAR		BACKLASH	
Gear	Circular Pitch (CP) ~~or Diametral Pitch (DP)~~	Number of Teeth in Gear	Pressure Angle in Degrees	Type of Measurement Span or Chordal Tooth Thickness	For Span - Number of Teeth Span Taken Over	"As Built" Measurement	Present Measurements: Position on Tooth Measurement Taken			Inches	Percent of Original Tooth Thickness	Original	Present
							EAST	MIDDLE	WEST				
G_5	1.50	120	20	Span	17	24.073	-	24.014	-	.059	7.9	- NOT SHOWN ON SHOP DRAWINGS -	
P_5	1.50	19		Span	3	3.653	3.639	41	41	.014	1.9		
G_3-West	1.75	80		Span	11	17.891	17.837	17.838	17.839	.054	6.2		
P_3-West	1.75	21		Span	3	4.275	4.252	56	49	.026	3.0		
G_3-East	1.75	80		Span	11	17.891	17.838	37	37	.053	6.1		
P_3-East	1.75	21		Span	3	4.275	4.251	54	51	.024	2.7		
R_4	2.25	280		Chordal		1.125	1.109	12	15	.016	1.4		
P_1D	2.25	19		Span	3	5.476	20	25	30	.056	5.0		
R_3	2.25	280		Chordal		1.125	1.113	16	24	.012	1.1

P_1C	2.25	19		Span	3	5.476	24	26	25	.052	4.6		
R_2	2.25	280		Chordal		1.125	1.108	15	11	.017	1.5		
P_1B	2.25	19		Span	3	5.476	29	31	28	.048	4.3		
R_1	2.25	280		Chordal		1.125	1.114	24	24	.011	1.0		
P_1A	2.25	19		Span	3	5.476	5.425	26	23	.053	4.7

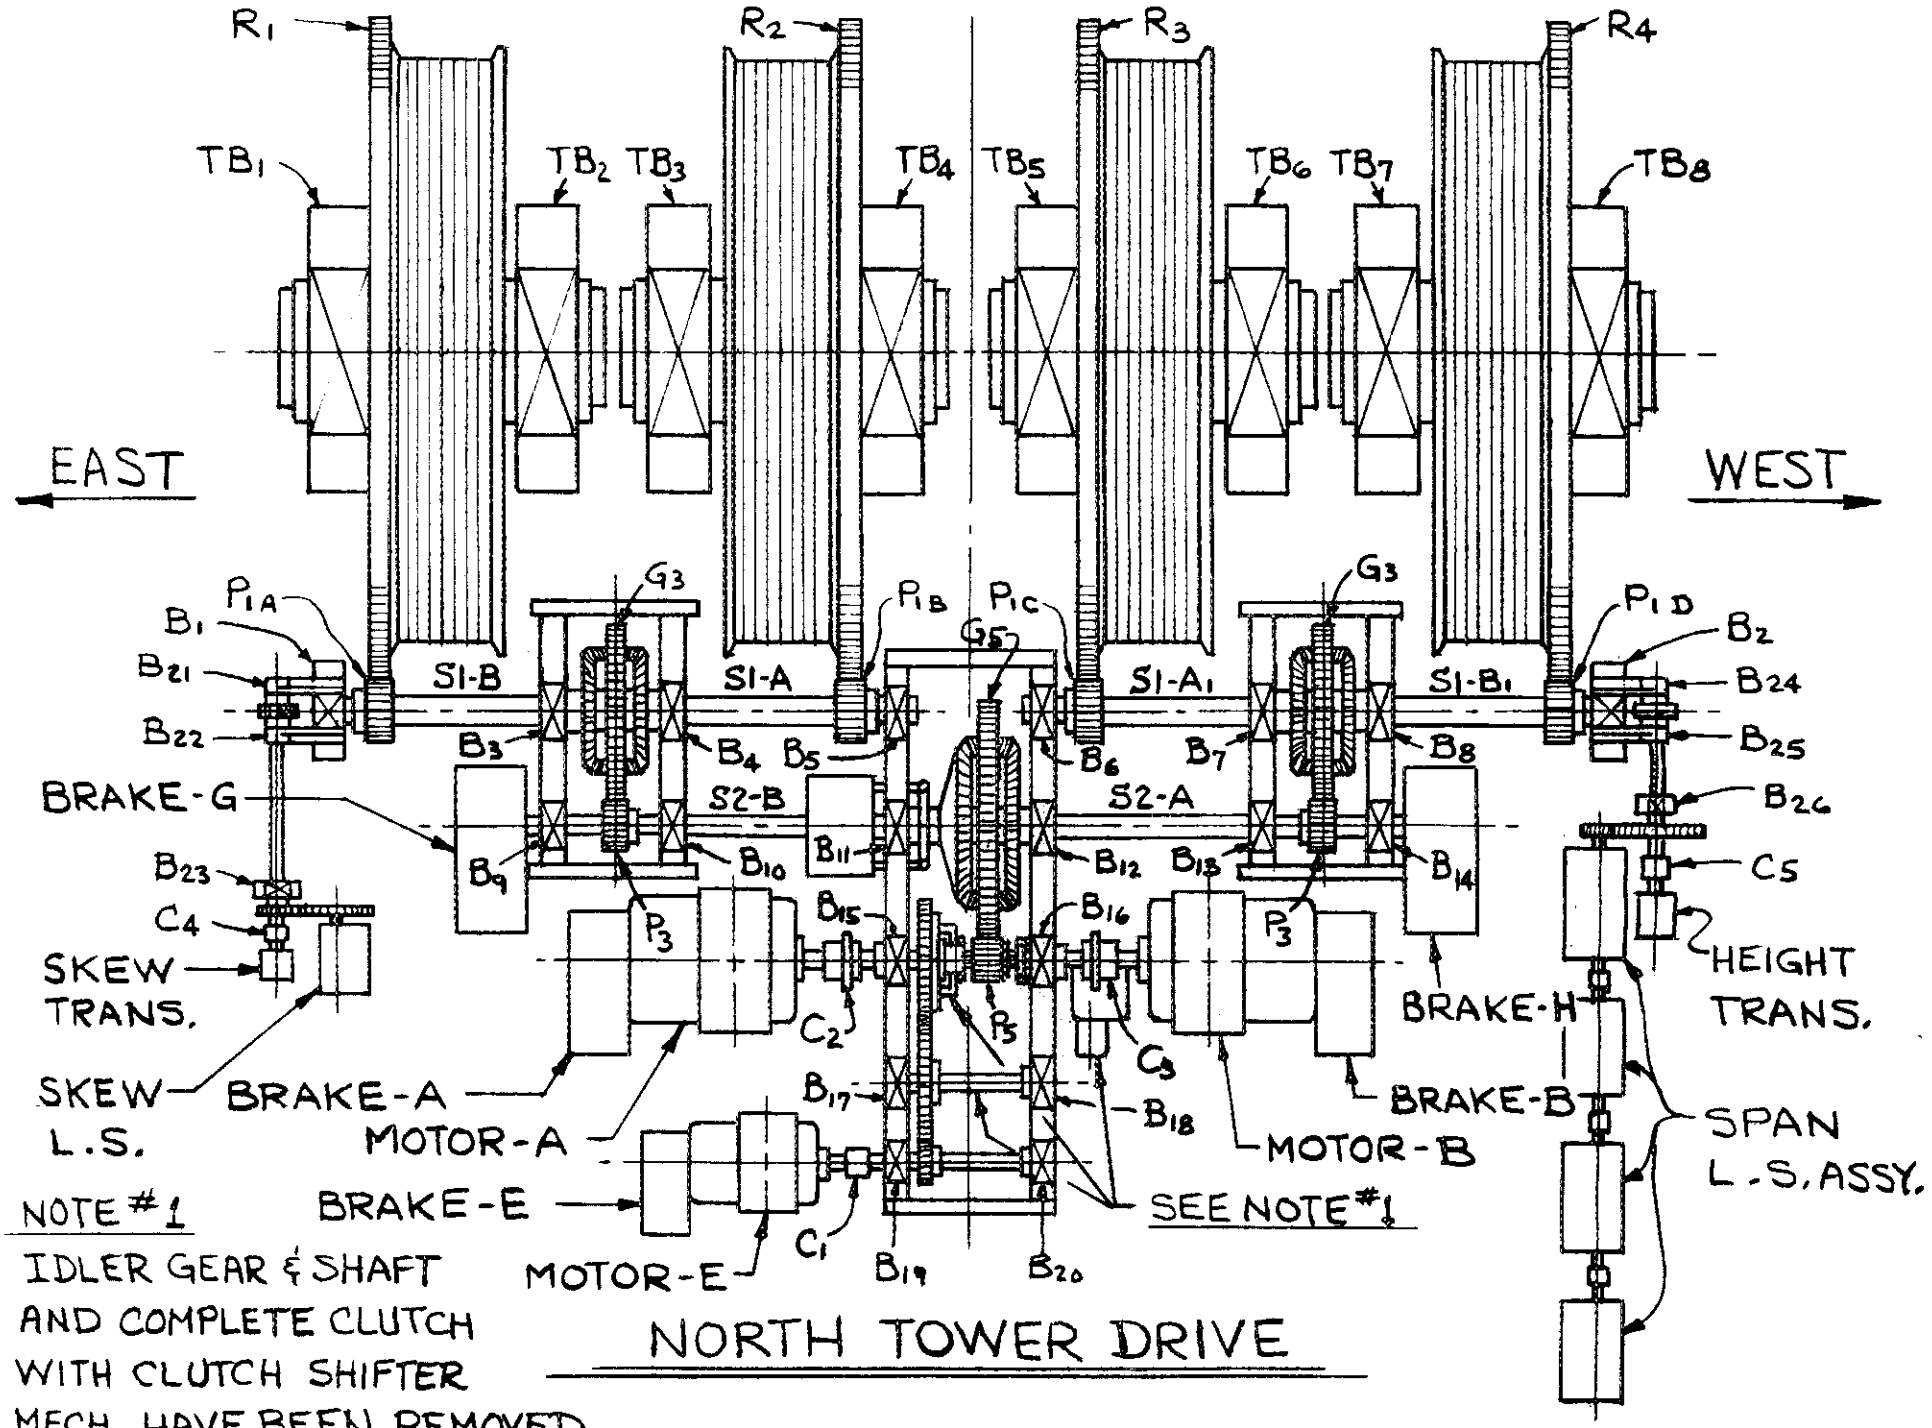
SPAN DRIVE COMPONENTS
NORTH TOWER

PART NAME	PART #	REMARKS
BRAKE	A	Limit switch doesn't actuate. Lining 3/8". OD of brake wheel not polished. Gap = 1 3/16".
BRAKE	B	Lining 3/8". Brake wheel nicely polished. Limit switch sluggish. Gap = 7/8".
BRAKE	E	Lining 3/8". OD of brake wheel rusty. Big spaces, shoes to drum when released. Gap = 3/4".
BRAKE	G	Lock nut on brake shoe adjustment backed off. Lining 1/2". Old moderate scoring on brake wheel. Gap=2 1/4"
BRAKE	H	OD brake wheel - one old groove. Limit switch doesn't actuate. Lining 1/2" & 7/16". Gap = 2 5/16".
COUPLING	C_1	Opened - Inadequate lubrication. No other deficiencies found.
COUPLING	C_2	Opened - Lubricant OK. No other deficiencies found.
COUPLING	C_3	Opened - Lubricant OK. No other deficiencies found.

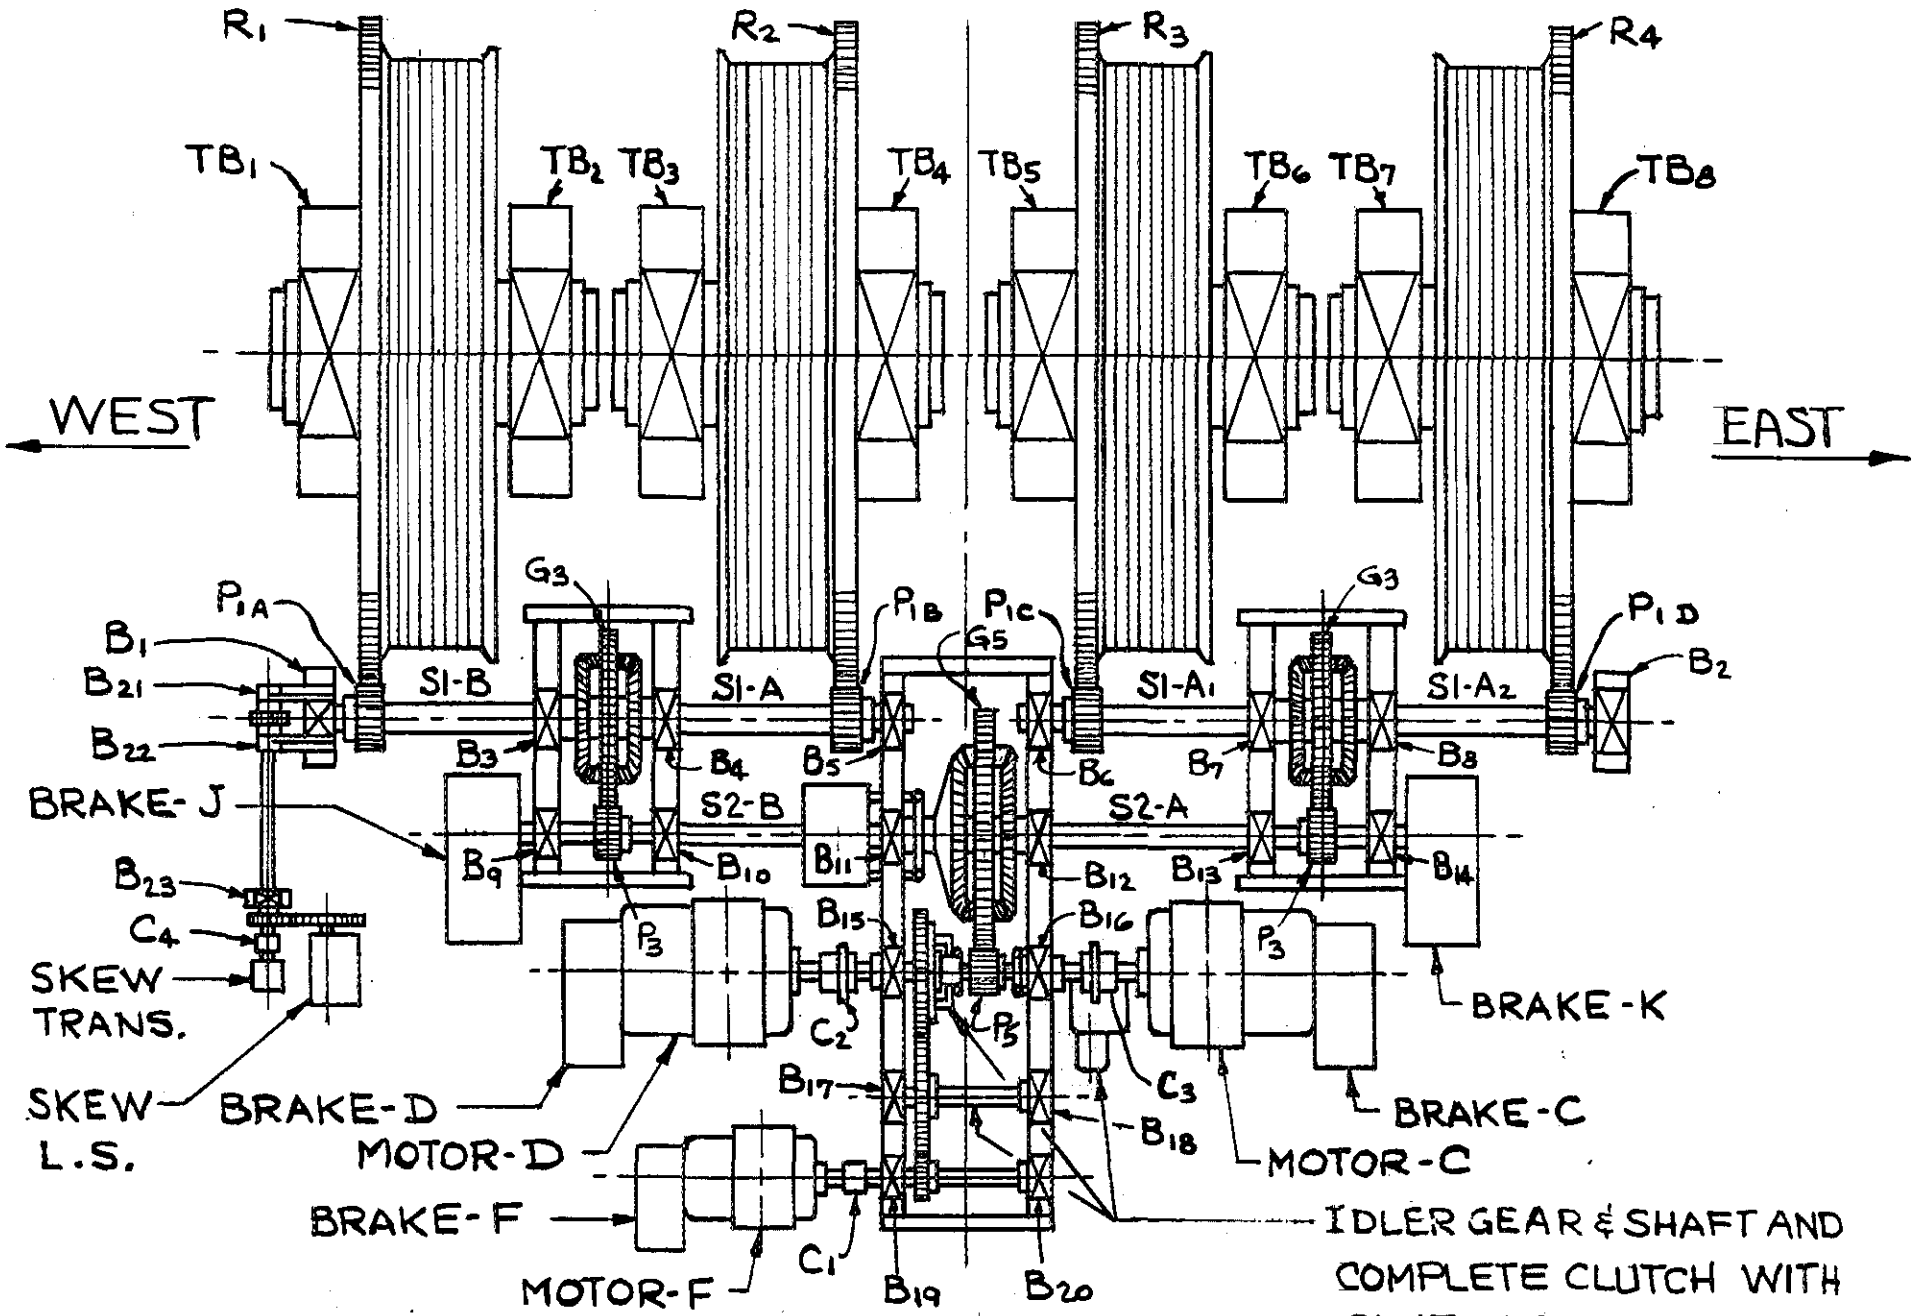
TABLE 4

BEARING	CLEARANCE ORIGINAL	CLEARANCE CURRENT	WEAR	REMARKS
B_2	.006	.016	.010	Clearance is in bottom. Gear tooth load may be holding shaft up.
B_9	.005	.012	.007	Opened - Only 35% contact.
B_{10}	.005	NIL *	NIL	Opened - Journal has minor scoring. 60% contact.
B_{11}	.005	.014	.009	
B_{12}	.005	.011	.006	
B_{13}	.005	.005 *	NIL	Opened - Good condition. Good alignment. 100% contact.
B_{14}	.005	.010	.005	Opened - Shaft poorly aligned with bearing. Minor scoring on journal. Only 10% contact
B_{15}	.005	.012 *	.007	Opened - Minor scratching on journal. Poor alignment. 10% contact.
B_{16}	.005	.015 *	.010	Opened - Minor scratching on journal and in cap. Poor alignment. 25% contact.
B_{23}	.004	NIL *	NIL	No significant wear.

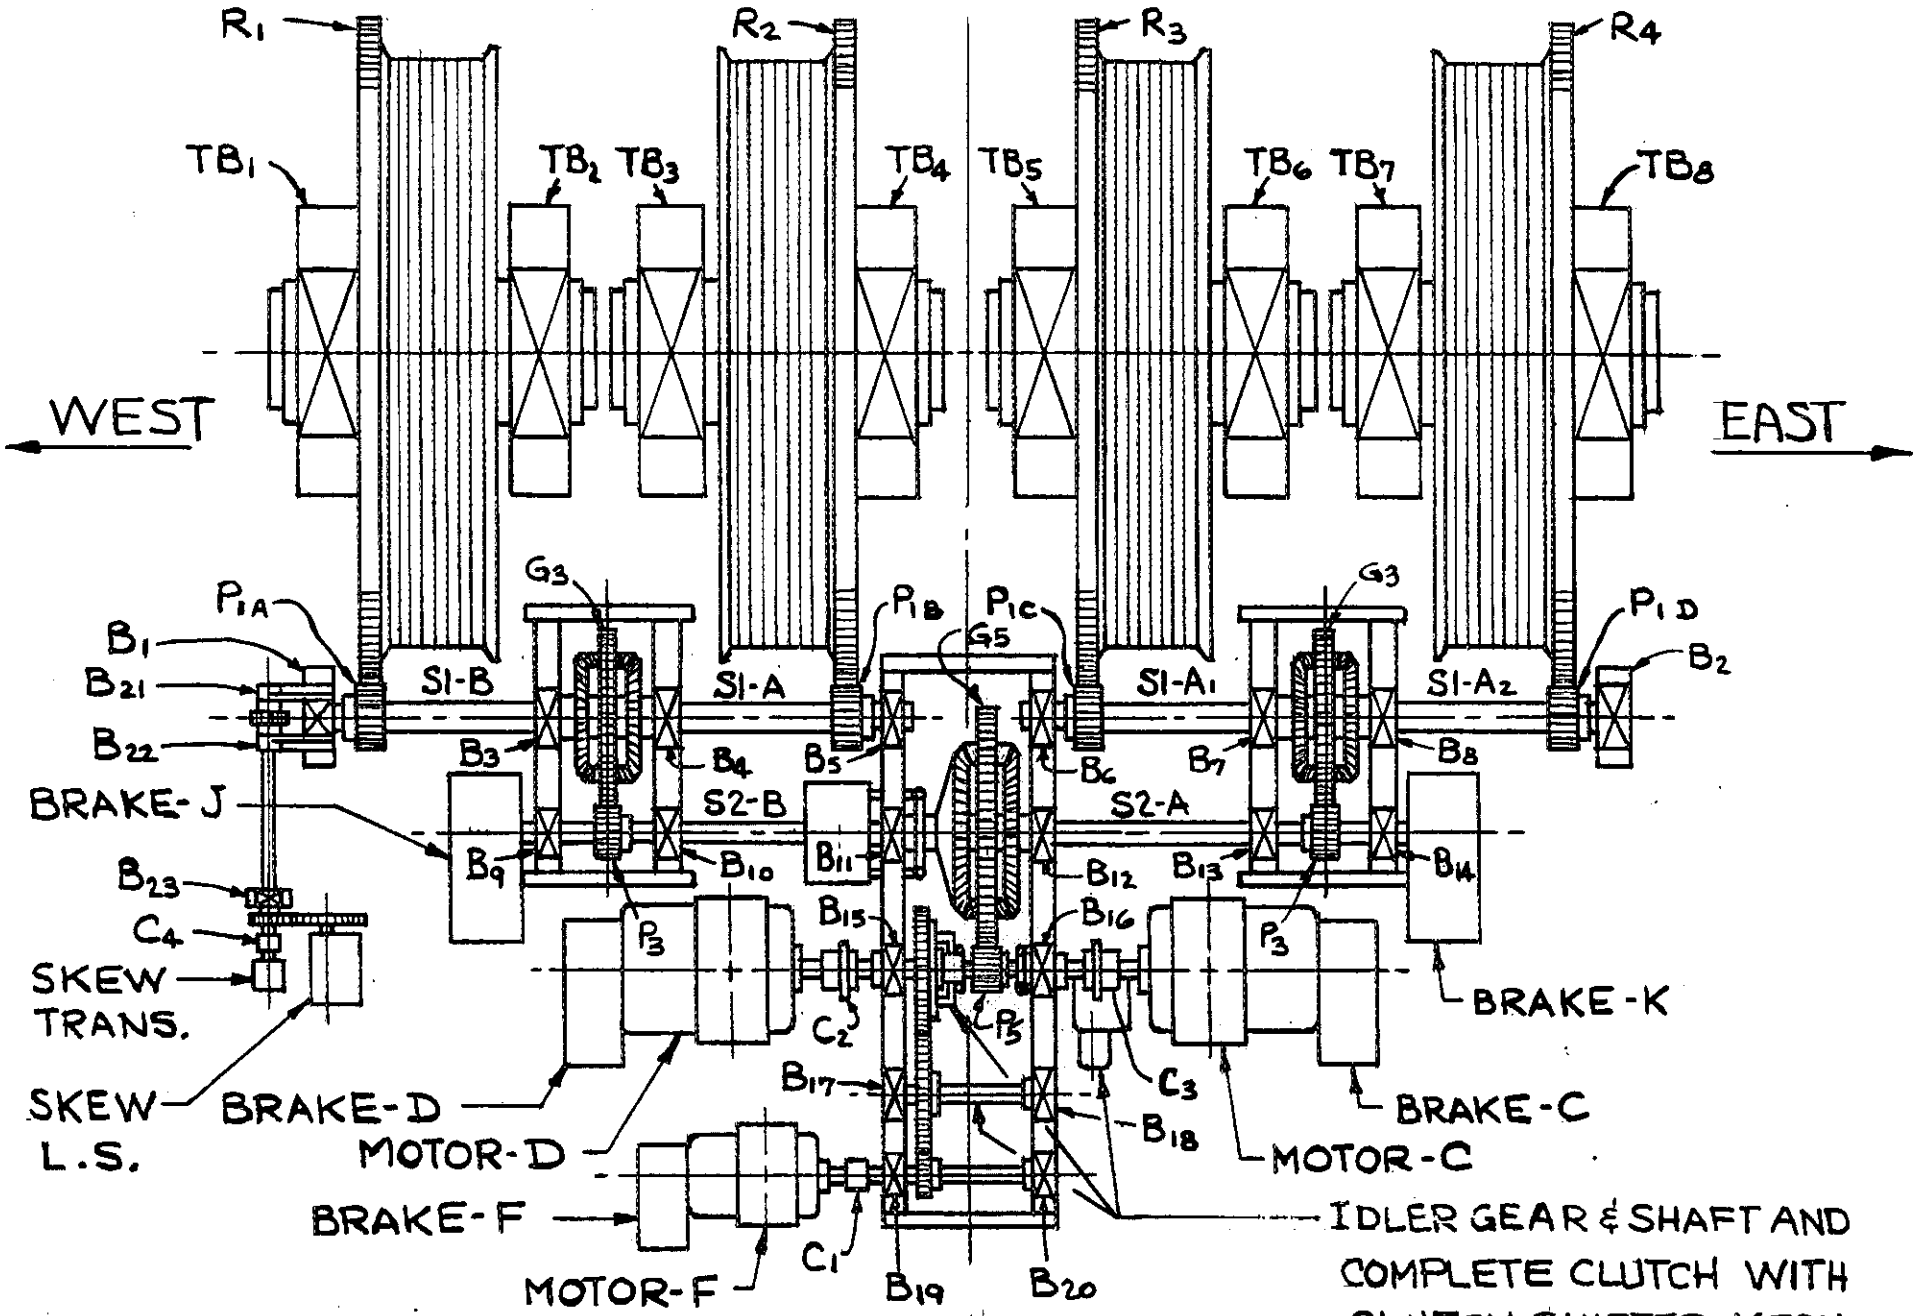
TABLE 5

GEAR IN QUESTION				GEAR TOOTH MEASUREMENTS						WEAR		BACKLASH	
Gear	Circular Pitch (CP) or ~~-Diametral Pitch (DP)~~	Number of Teeth in Gear	Pressure Angle in Degrees	Type of Measurement Span or Chordal Tooth Thickness	For Span - Number of Teeth Span Taken Over	"As Built" Measurement	Present Measurements: Position on Tooth Measurement Taken			Inches	Percent of Original Tooth Thickness	Present	Original
							EAST	MIDDLE	WEST				
G_5	1.50	120	20	Span	17	24.073		24.073		.062	8.3	1/32	
P_5	1.50	19		Span	3	3.653	3.642	3.640	3.369	.014	1.9		
G_3-West	1.75	80		Span	11	17.891	17.824	24	21	.070	8.0	1/32	
P_3-West	1.75	21		Span	3	4.275	4.261	56	55	.020	0.6		
G_3-East	1.75	80		Span	11	17.891	17.837	39	40	.054	6.2	3/64	
P_3-East	1.75	21		Span	3	4.275	4.255	54	52	.023	1.3		
R_4	2.25	280		Chordal		1.125	1.105	11	12	.020	0.2	3/64	
P_1D	2.25	19		Span	3	5.476	5.419	5.419	5.419	.057	5.1		
R_3	2.25	280		Chordal		1.125	1.108	12	09	.016	1.4	3/64

P_1C	2.25	19		Span	3	5.476	5.416	5.419	5.421	.060	5.3		
R_2	2.25	280		Chordal		1.125	1.132	34	29	NIL		1/32	
P_1B	2.25	19		Span	3	5.476	5.425	5.425	5.423	.053	4.7		
R_1	2.25	280		Chordal		1.125	1.111	12	12	.014	1.2	3/64	
P_1A	2.25	19		Span	3	5.476	5.420	5.424	5.428	.056	5.0

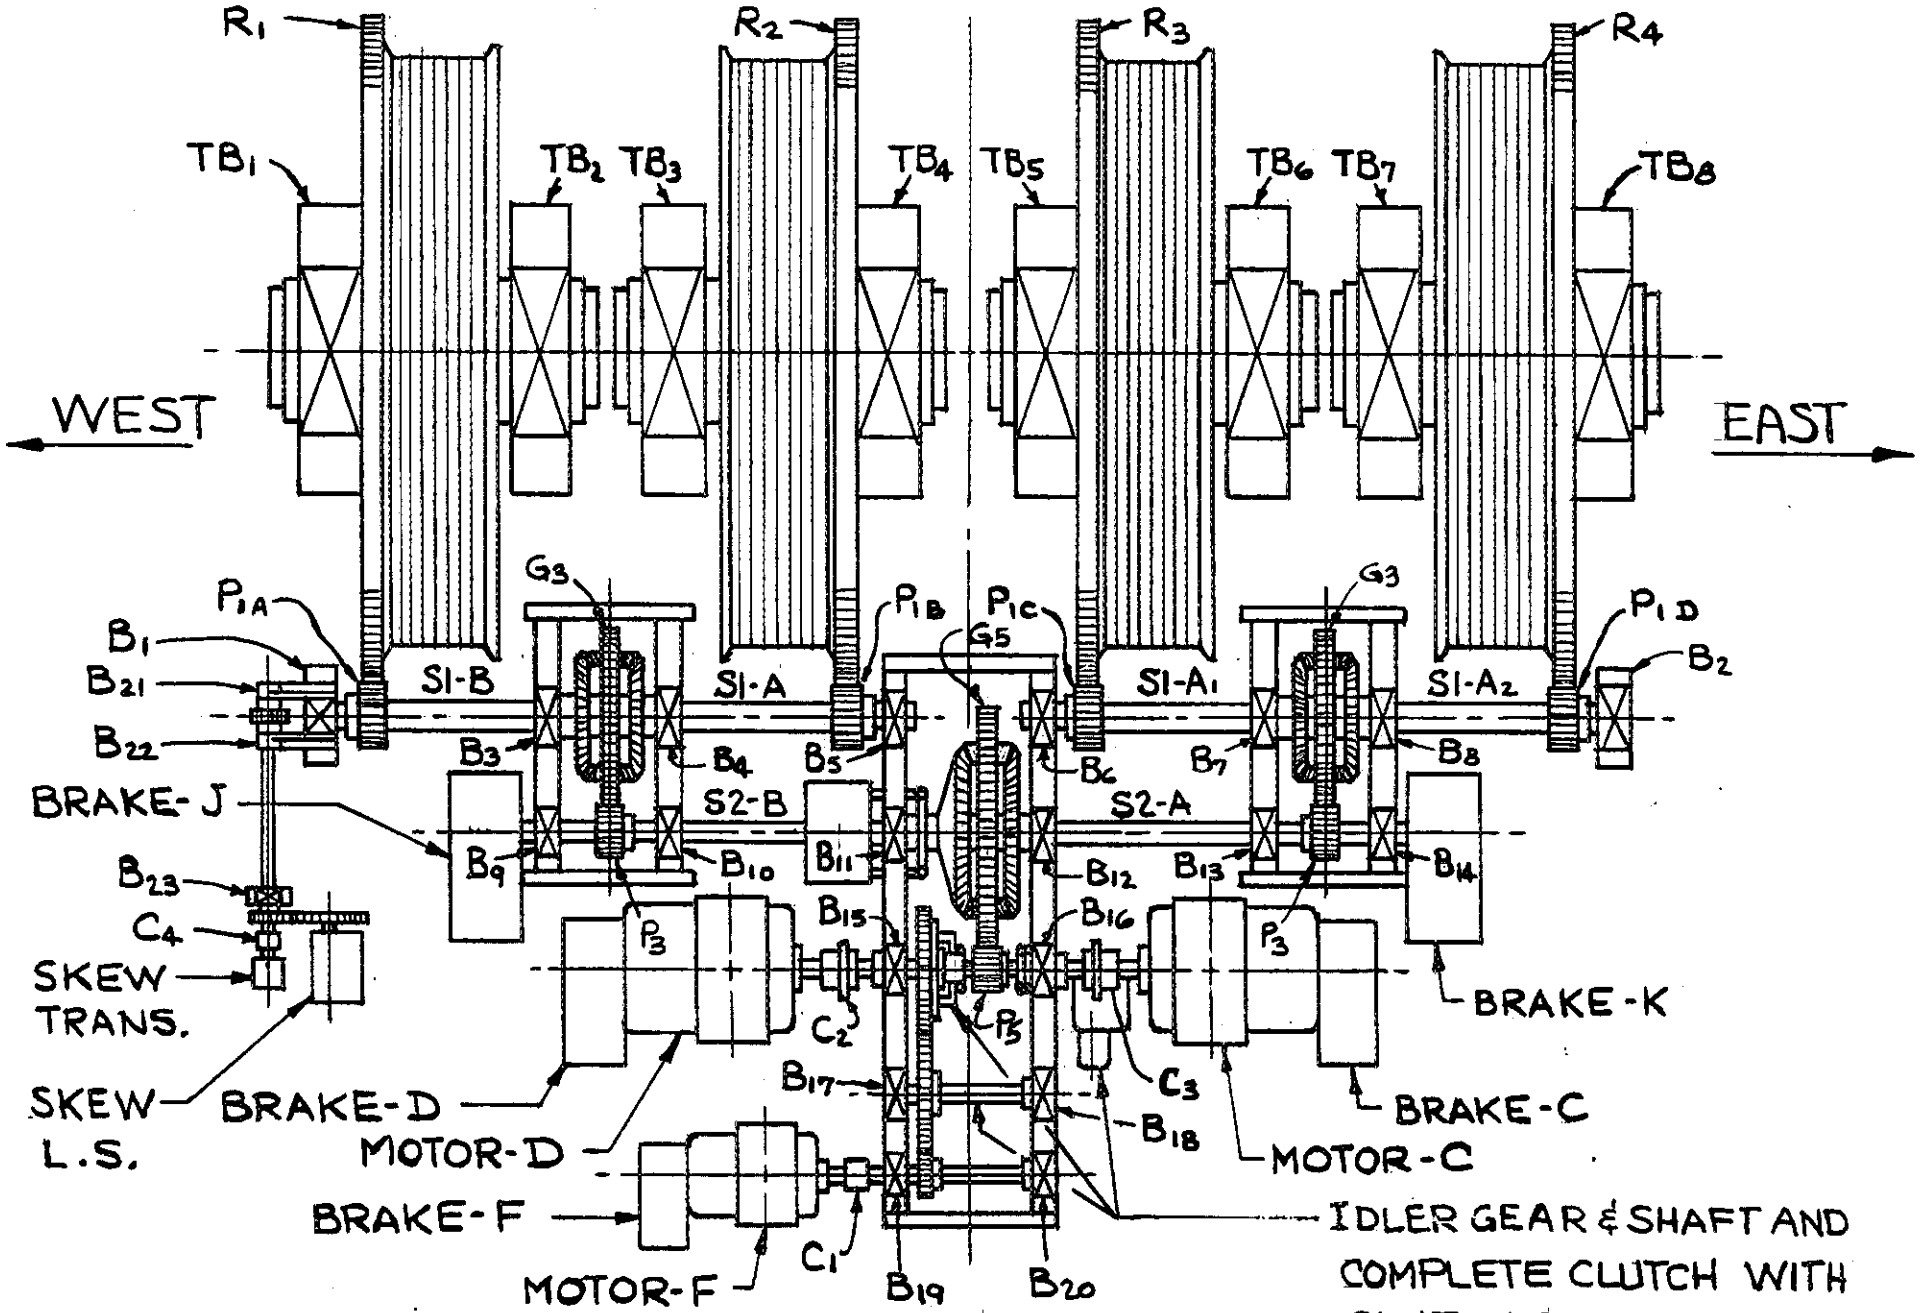
TABLE 6

PART NAME	PART #	REMARKS
BRAKE	C	Shoes are in firm contact. Limit switch inoperable. Thruster fluid OK. Gap = 1 5/8".
BRAKE	D	Limit switch inoperable. Thruster fluid level OK. Drum not well polished, but smooth. No signs of distress. Gap = 1 1/2".
BRAKE	F	(For emergency motor not currently in operation.) Fluid level OK. Drum rusty, paint on it. South shoe not in good contact with drum. Brake shoes are out of adjustment. Has no limit switch. Gap = 15/16".
BRAKE	J	Brake shoes in firm contact with drum. Drum well polished. Limit switch for hand release doesn't trip when brake released manually. (Limit switch inoperable.) Thruster overfilled with fluid. Gap = 2 1/4".
BRAKE	K	Limit switch moves, but operation questionable. Drum nicely polished. Fluid level overfull. Gap = 2 5/16".
COUPLING	C_1	Opened - Inadequate lubricant. No other deficiencies found.
COUPLING	C_2	Opened - Lubricant OK. No other deficiencies found.

COUPLING	C_3	Opened - Lubricant OK. No other deficiencies found.
