BUZZARDS BAY RAILROAD LIFT BRIDGE OVER CAPE COD CANAL

INSPECTION AND CONDITION REPORT

OCTOBER, 1984

RE: CONTRACT NO. DACW33-84-C-0022
Inspection and Condition Report
Vertical Lift Railroad Bridge
Cape Cod Canal
Buzzards Bay, Massachusetts

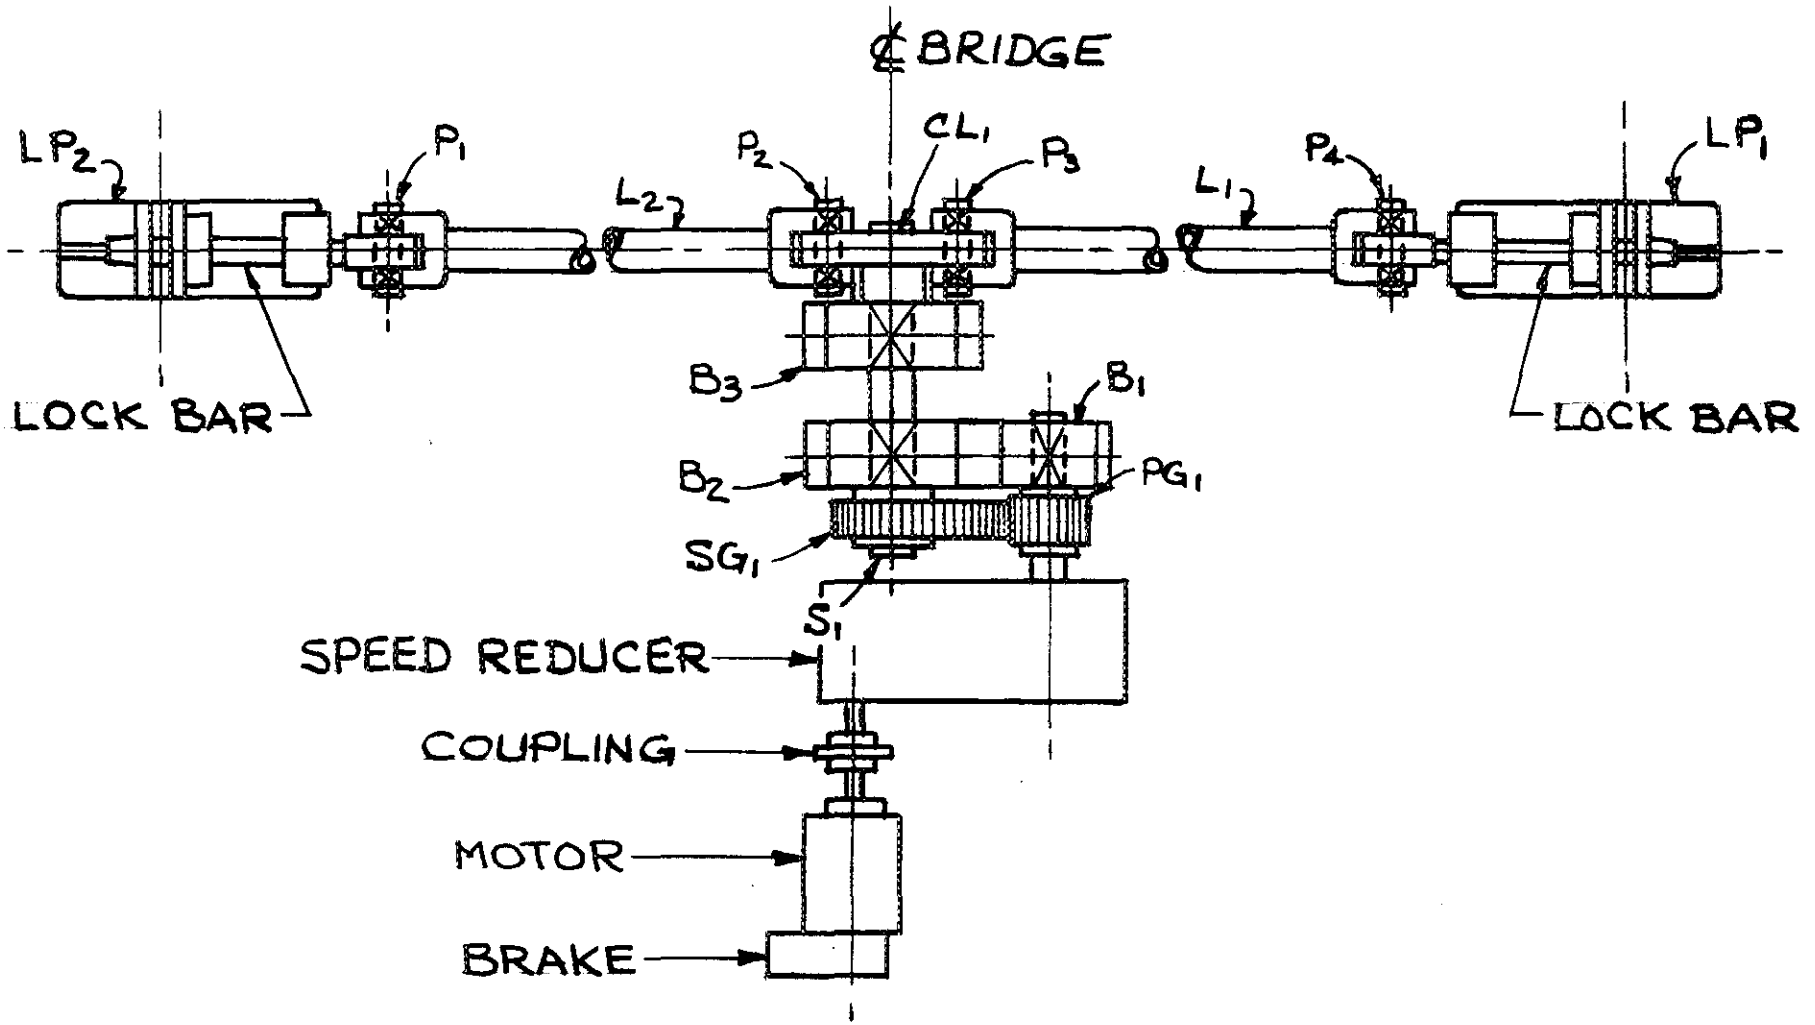
LOWER SPAN LOCK

PART NAME	#	REMARKS
BRAKE		Mounting bracket severely corroded.
MOTOR		
COUPLING		Opened - All internal parts heavily corroded. No lubricant present. Grid fractured.
SPEED REDUCER		Opened - Oil in housing heavily contaminated. Much foreign matter and sludge in bottom of housing and in oil passages. Seal leaks on input shaft.
PINION	PG_1	Teeth on both gears have experienced severe loss of metal due to corrosion.
GEAR	SG_1	Was not being lubricated until recently.
BEARING	B_1	Clearance .008".
BEARING	B_2	Clearance .012". Nuts on cap bolts heavily corroded.
BEARING	B_3	Clearance .012".
CONNECT ROD	L_1	Bolts and nuts used to attach clevis at each end heavily corroded.
CONNECT ROD	L_2	Bolts and nuts used to attach clevis at each end heavily corroded.
PIN	P_1	Clearance .009".
PIN	P_2	Clearance .007".
PIN	P_3	Clearance .010".
PIN	P_4	Clearance .010".

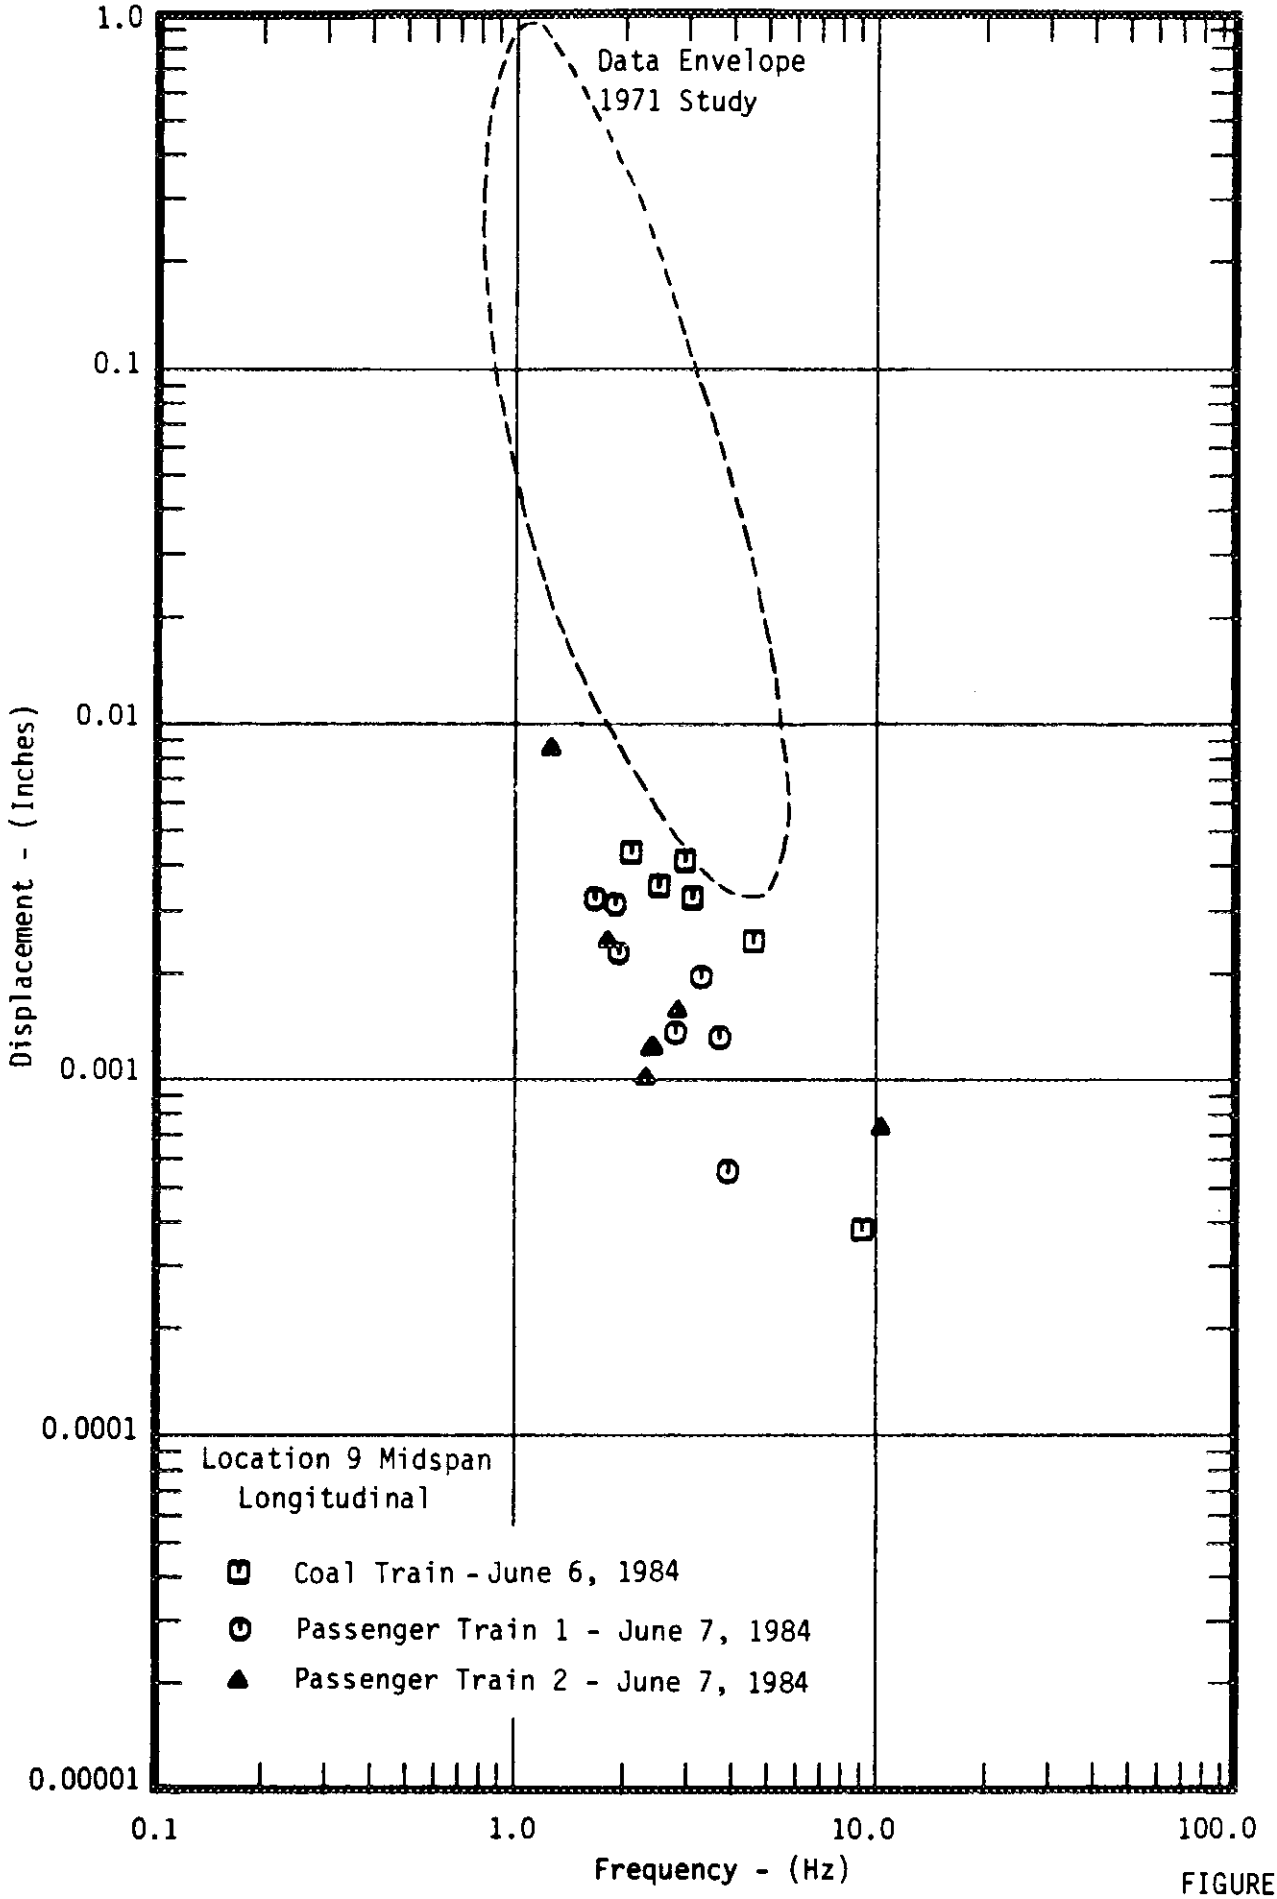
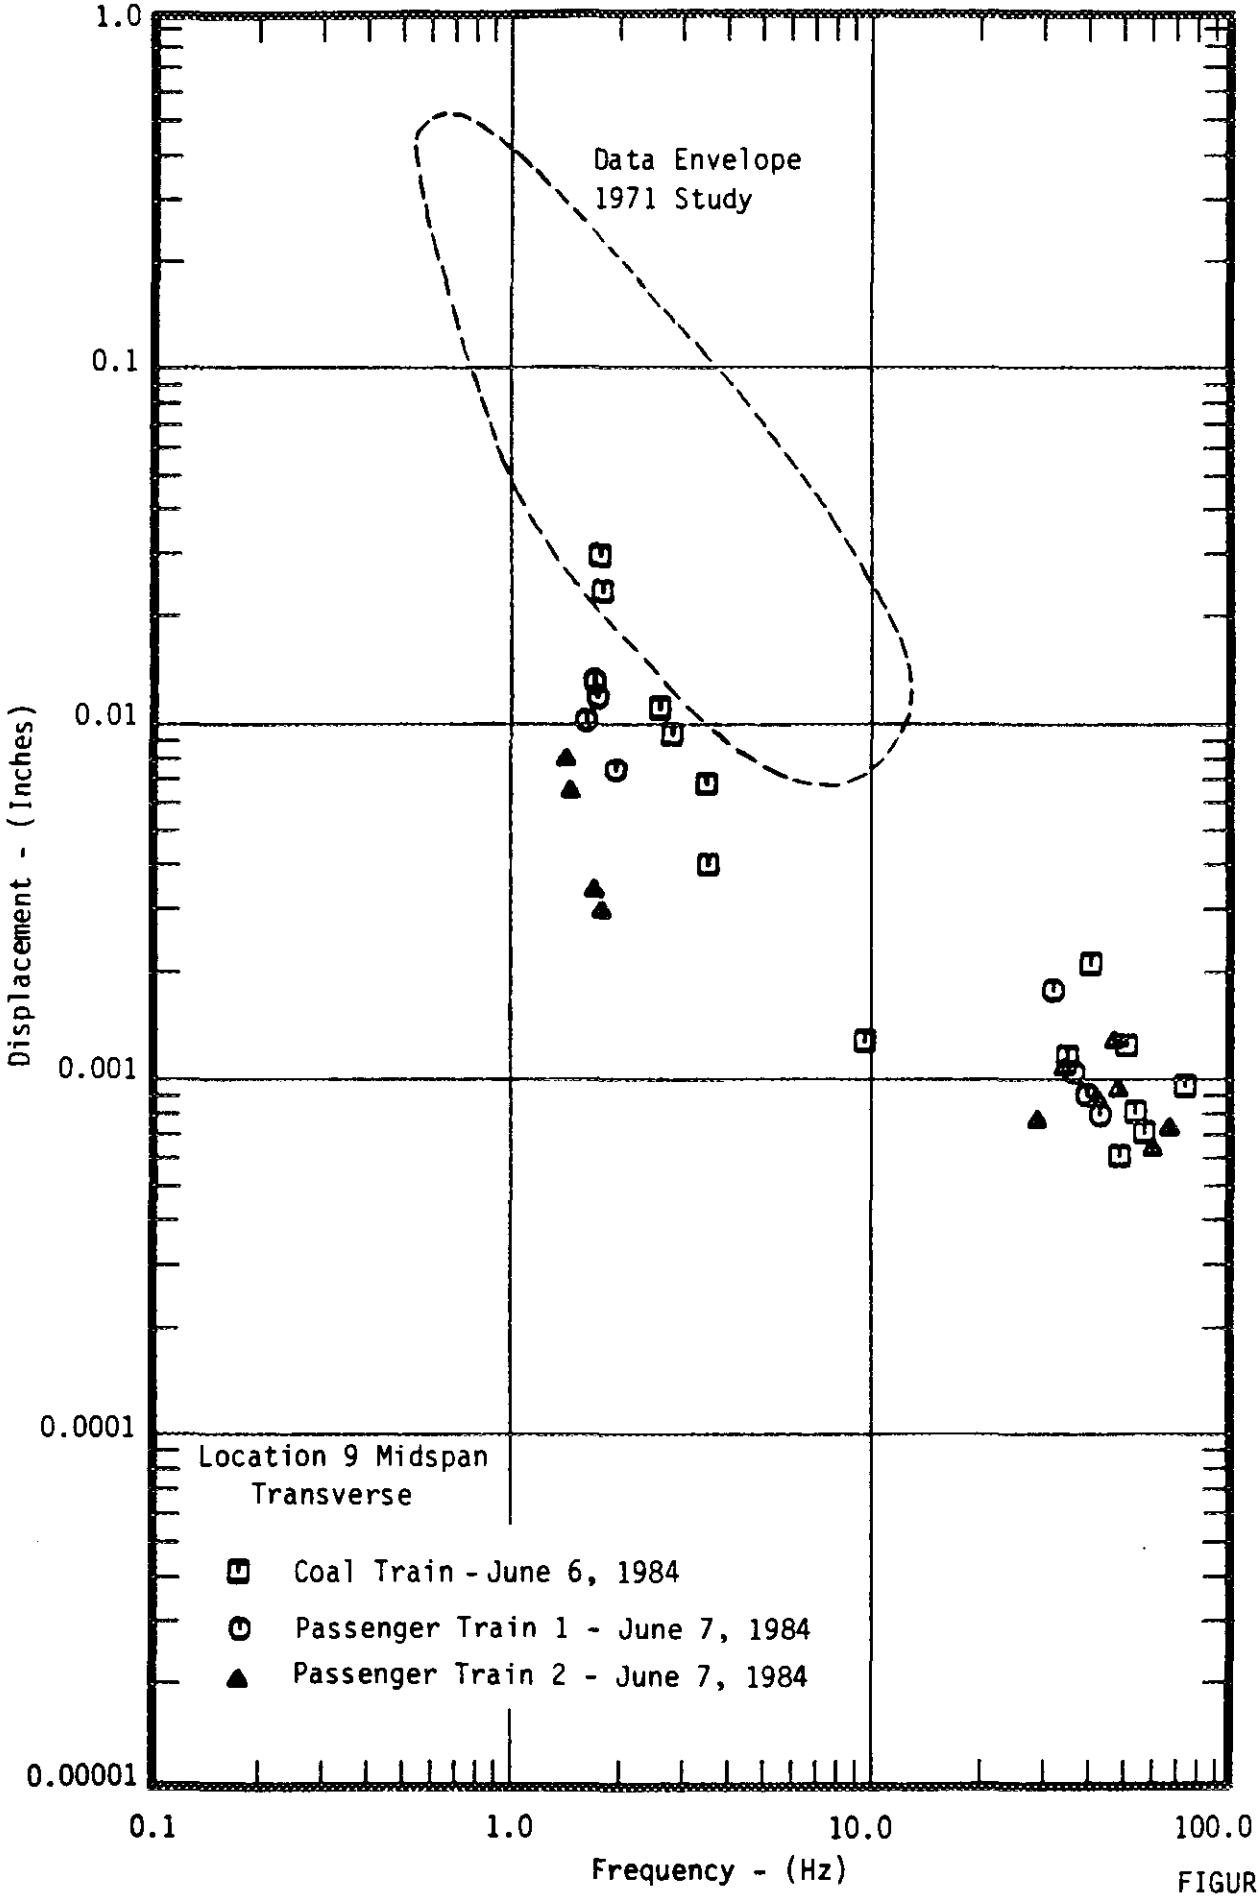
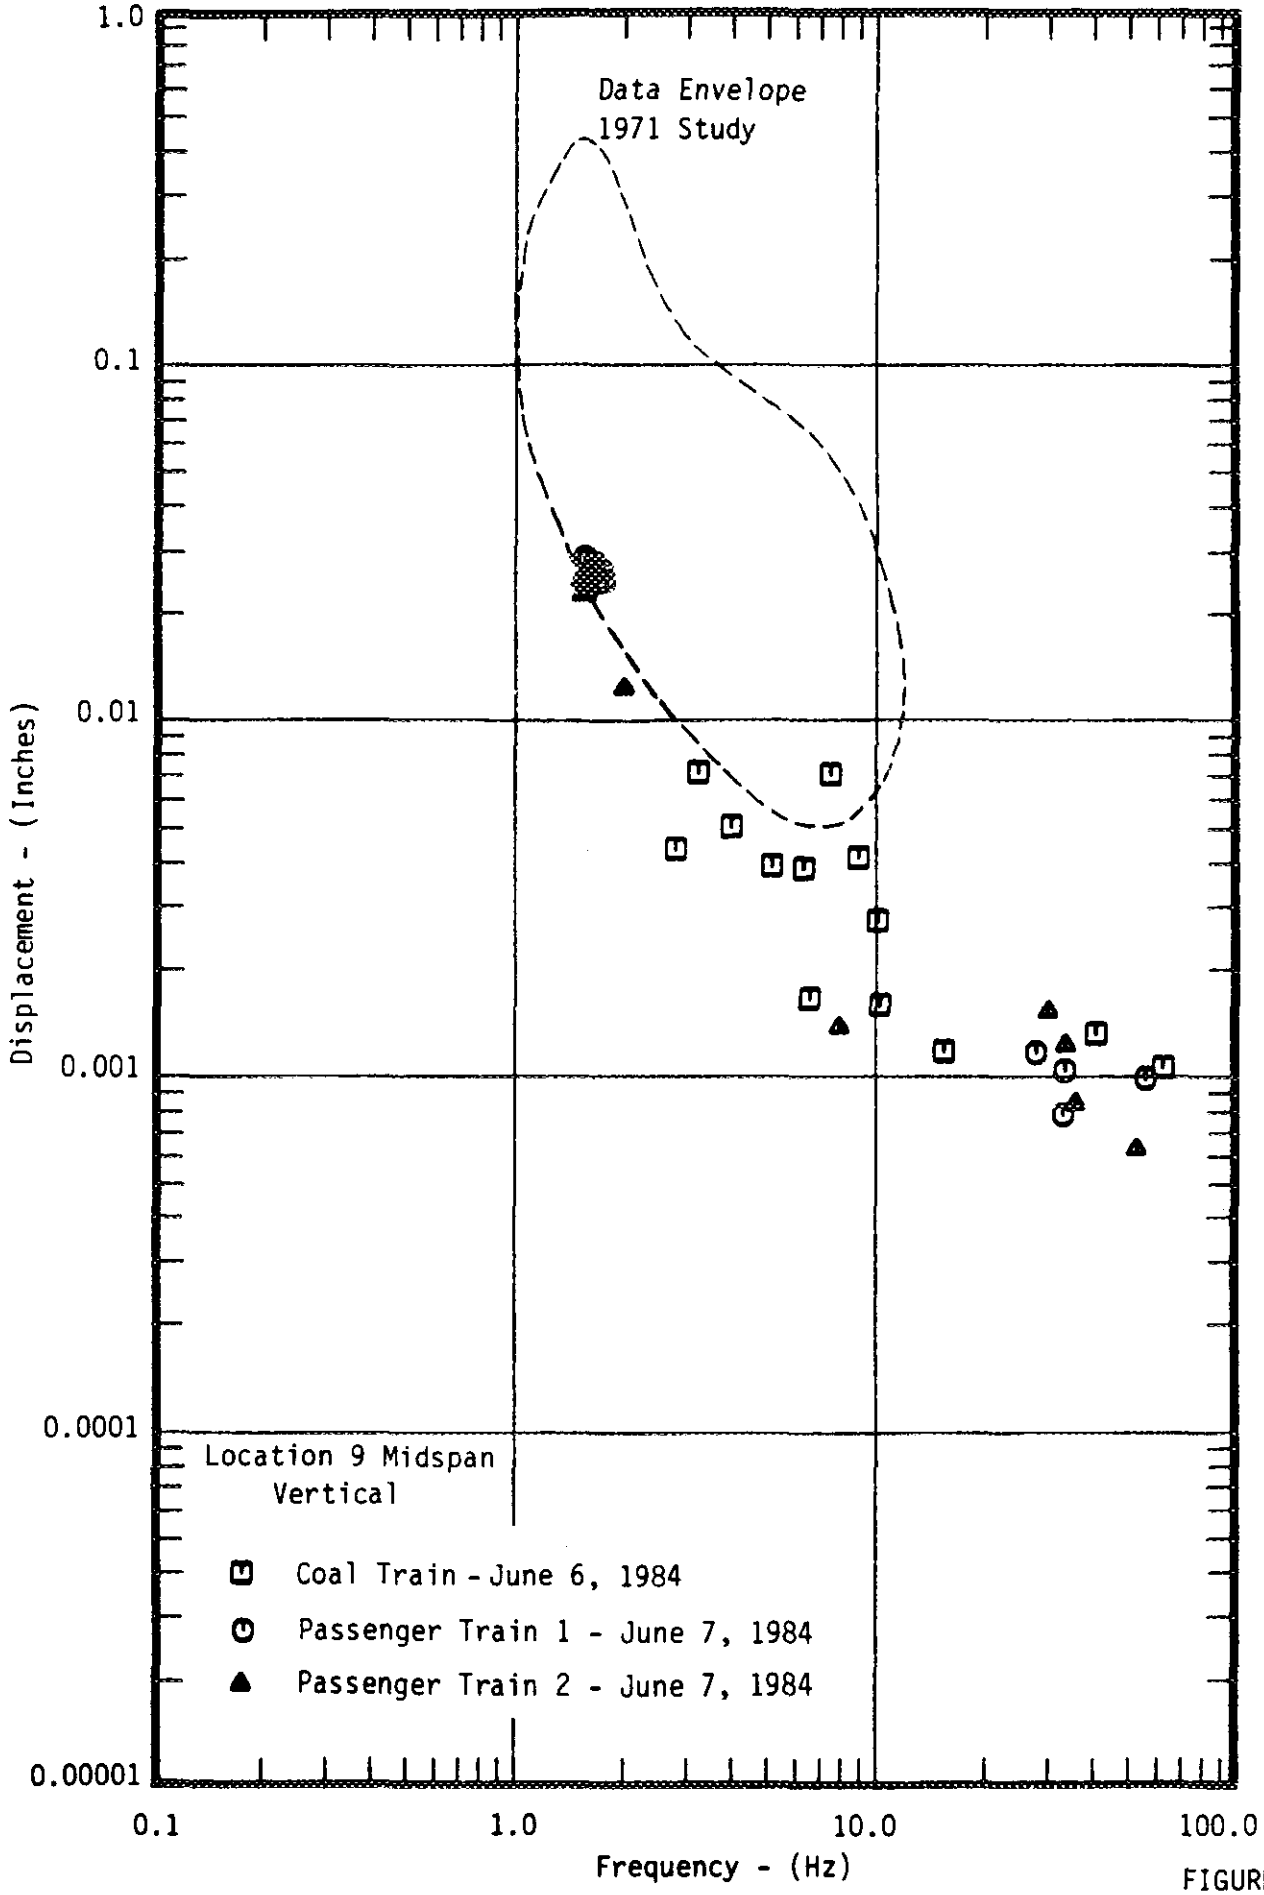
Displacements at mid-span are plotted on Figures 5→7. Results at this mid-span location are similar in amplitude to those observed at location 3N but are significantly lower than those reported in 1971 for this location, L9. In addition, the peak value of approximately 1.0 inch displacement [2.0 inch peak to peak] at a frequency of 1 Hz., reported in 1971, seems relatively high for train induced vibrations. Values given for mid-span in the 1971 study were re-examined in this study by re-interpreting the records collected in 1971. The re-interpreted vibration amplitudes at L9 are shown on Figures A-1 to A-3 in Appendix A. The re-examined records provide results that fall below or within the lower range of displacements quoted in the 1971 study. Also, the re-examined records illustrate that displacements observed in 1971 at mid-span could have been larger than those observed during the present study. Higher displacements could be related to heavier loads or to higher speeds allowed for train crossings in 1971.

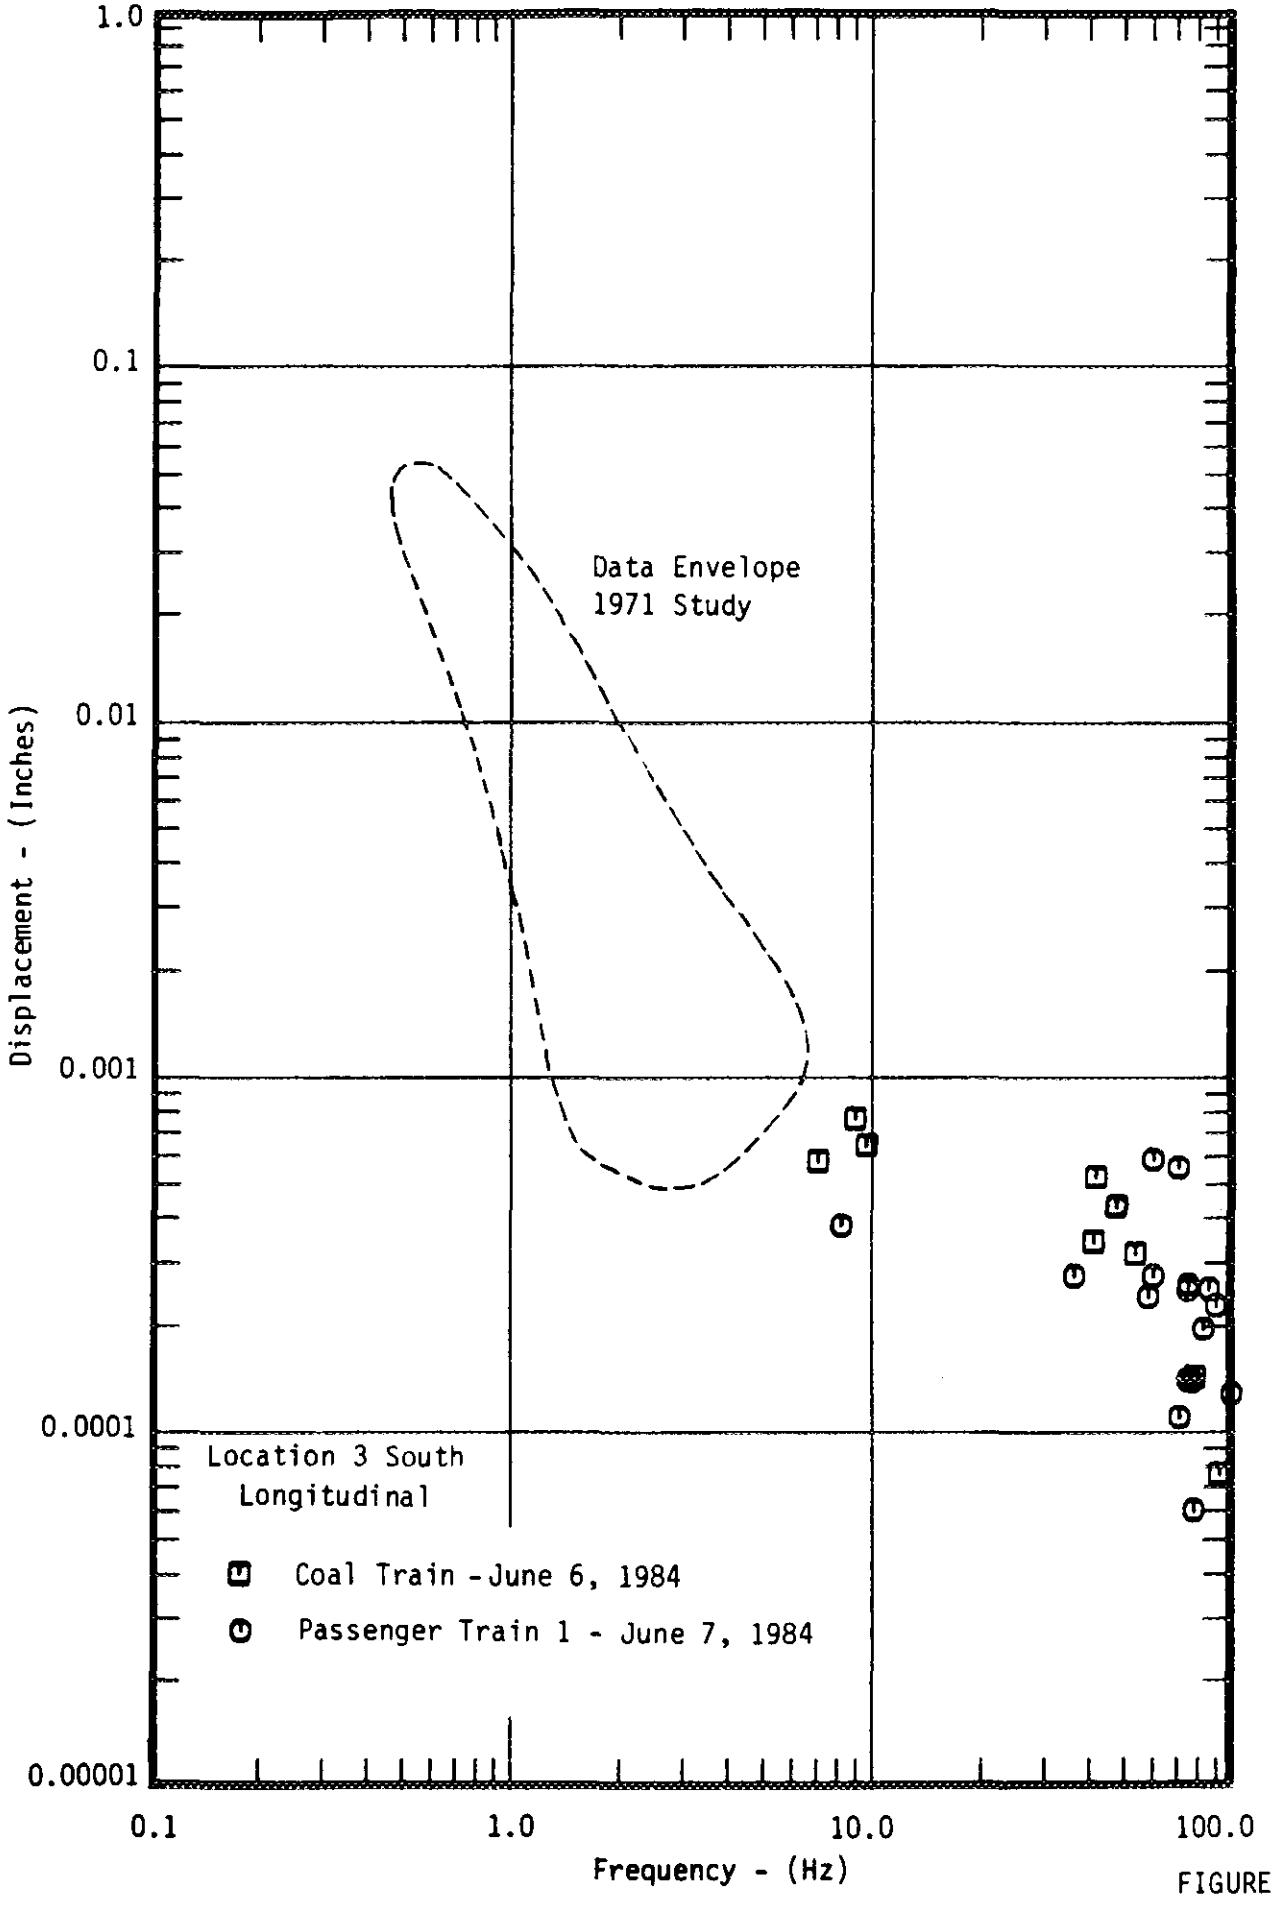
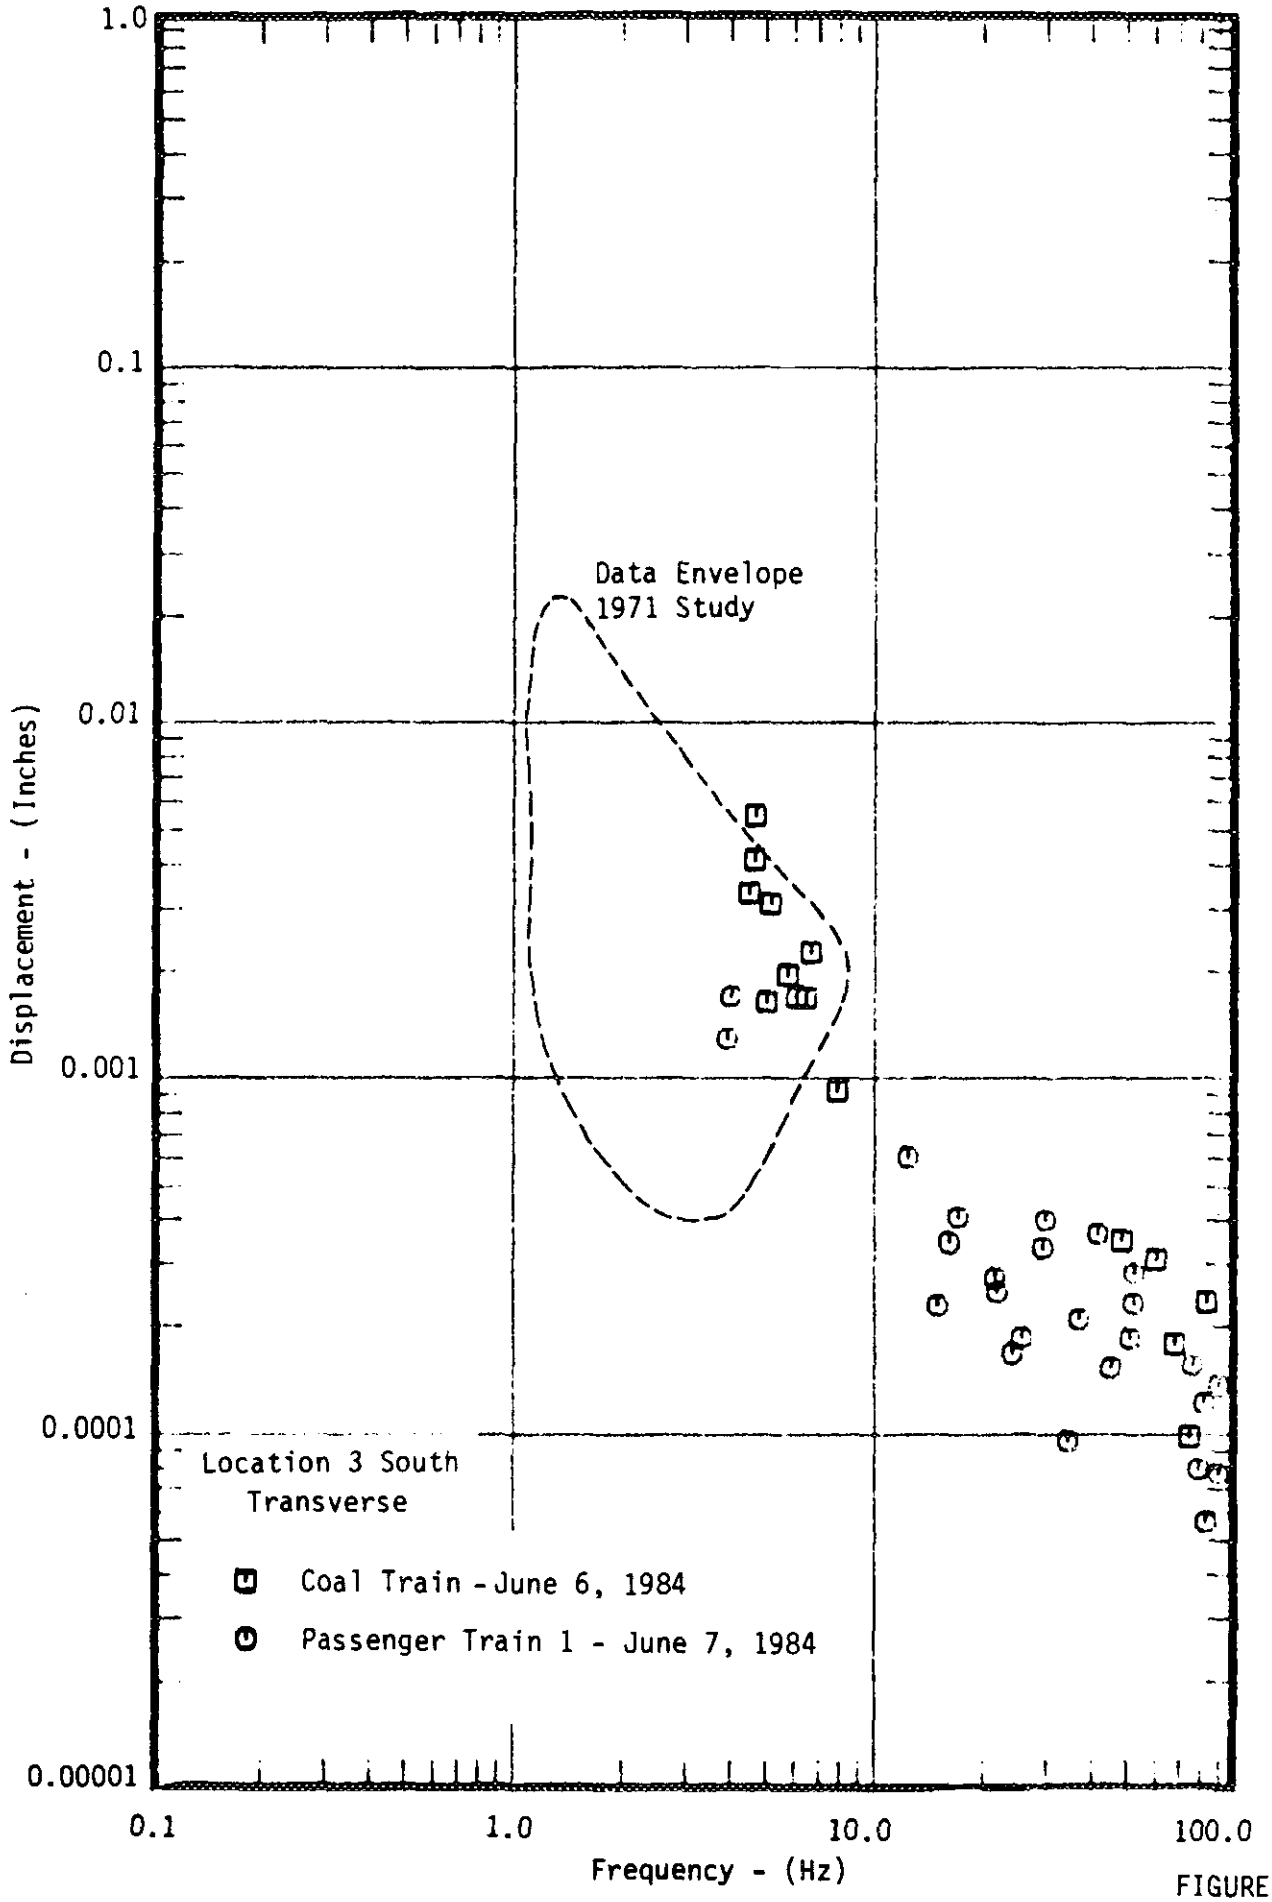
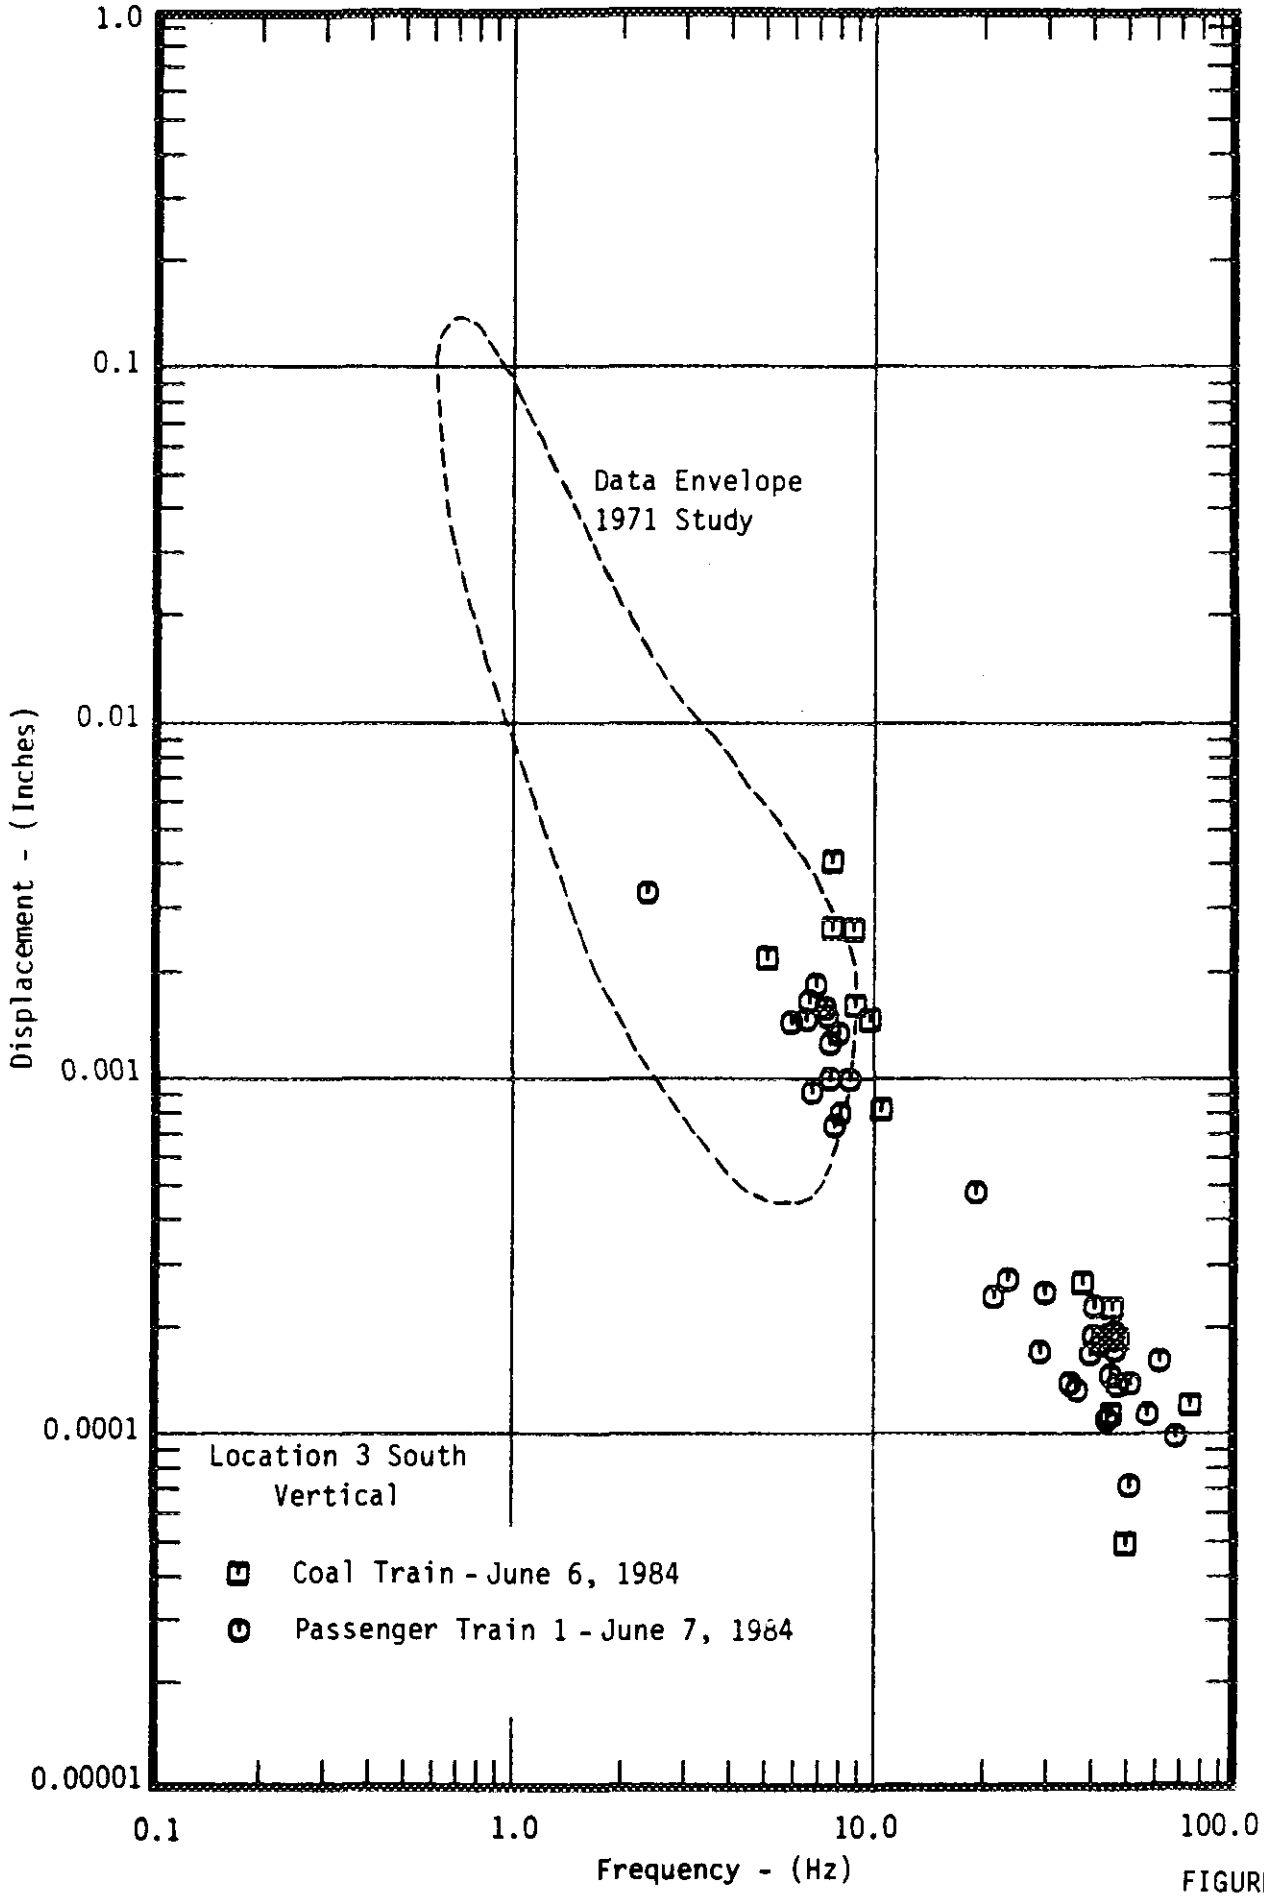
Displacements at Location L3S are plotted on Figures 8→10. Vibrations at this location are similar in amplitude and frequency distribution to those observed at Locations L9 and L3N and are consistent with those reported for this location in the 1971 study.
