BUZZARDS BAY RAILROAD LIFT BRIDGE OVER CAPE COD CANAL

INSPECTION AND CONDITION REPORT

OCTOBER, 1984

RE: CONTRACT NO. DACW33-84-C-0022
Inspection and Condition Report
Vertical Lift Railroad Bridge
Cape Cod Canal
Buzzards Bay, Massachusetts

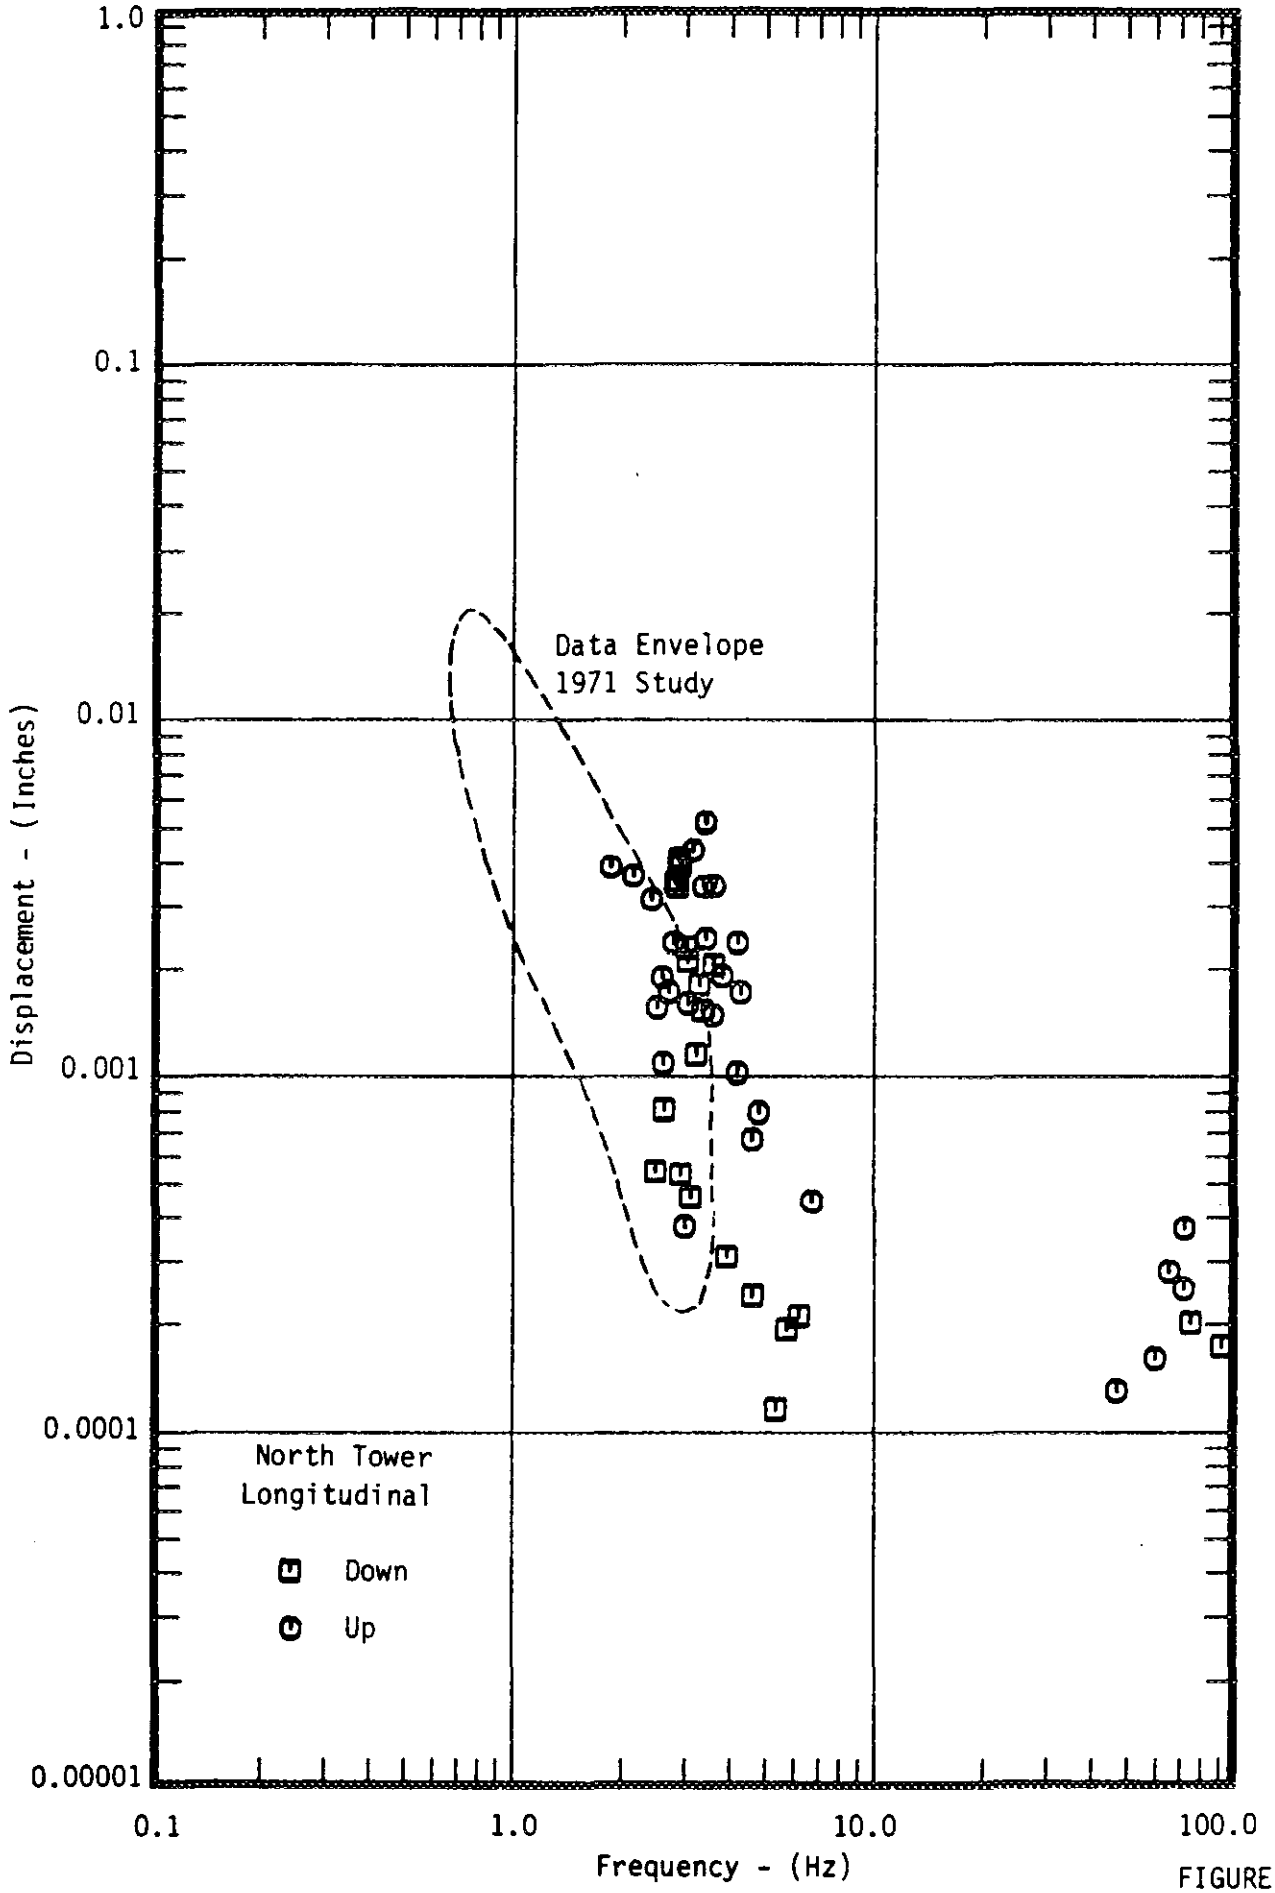
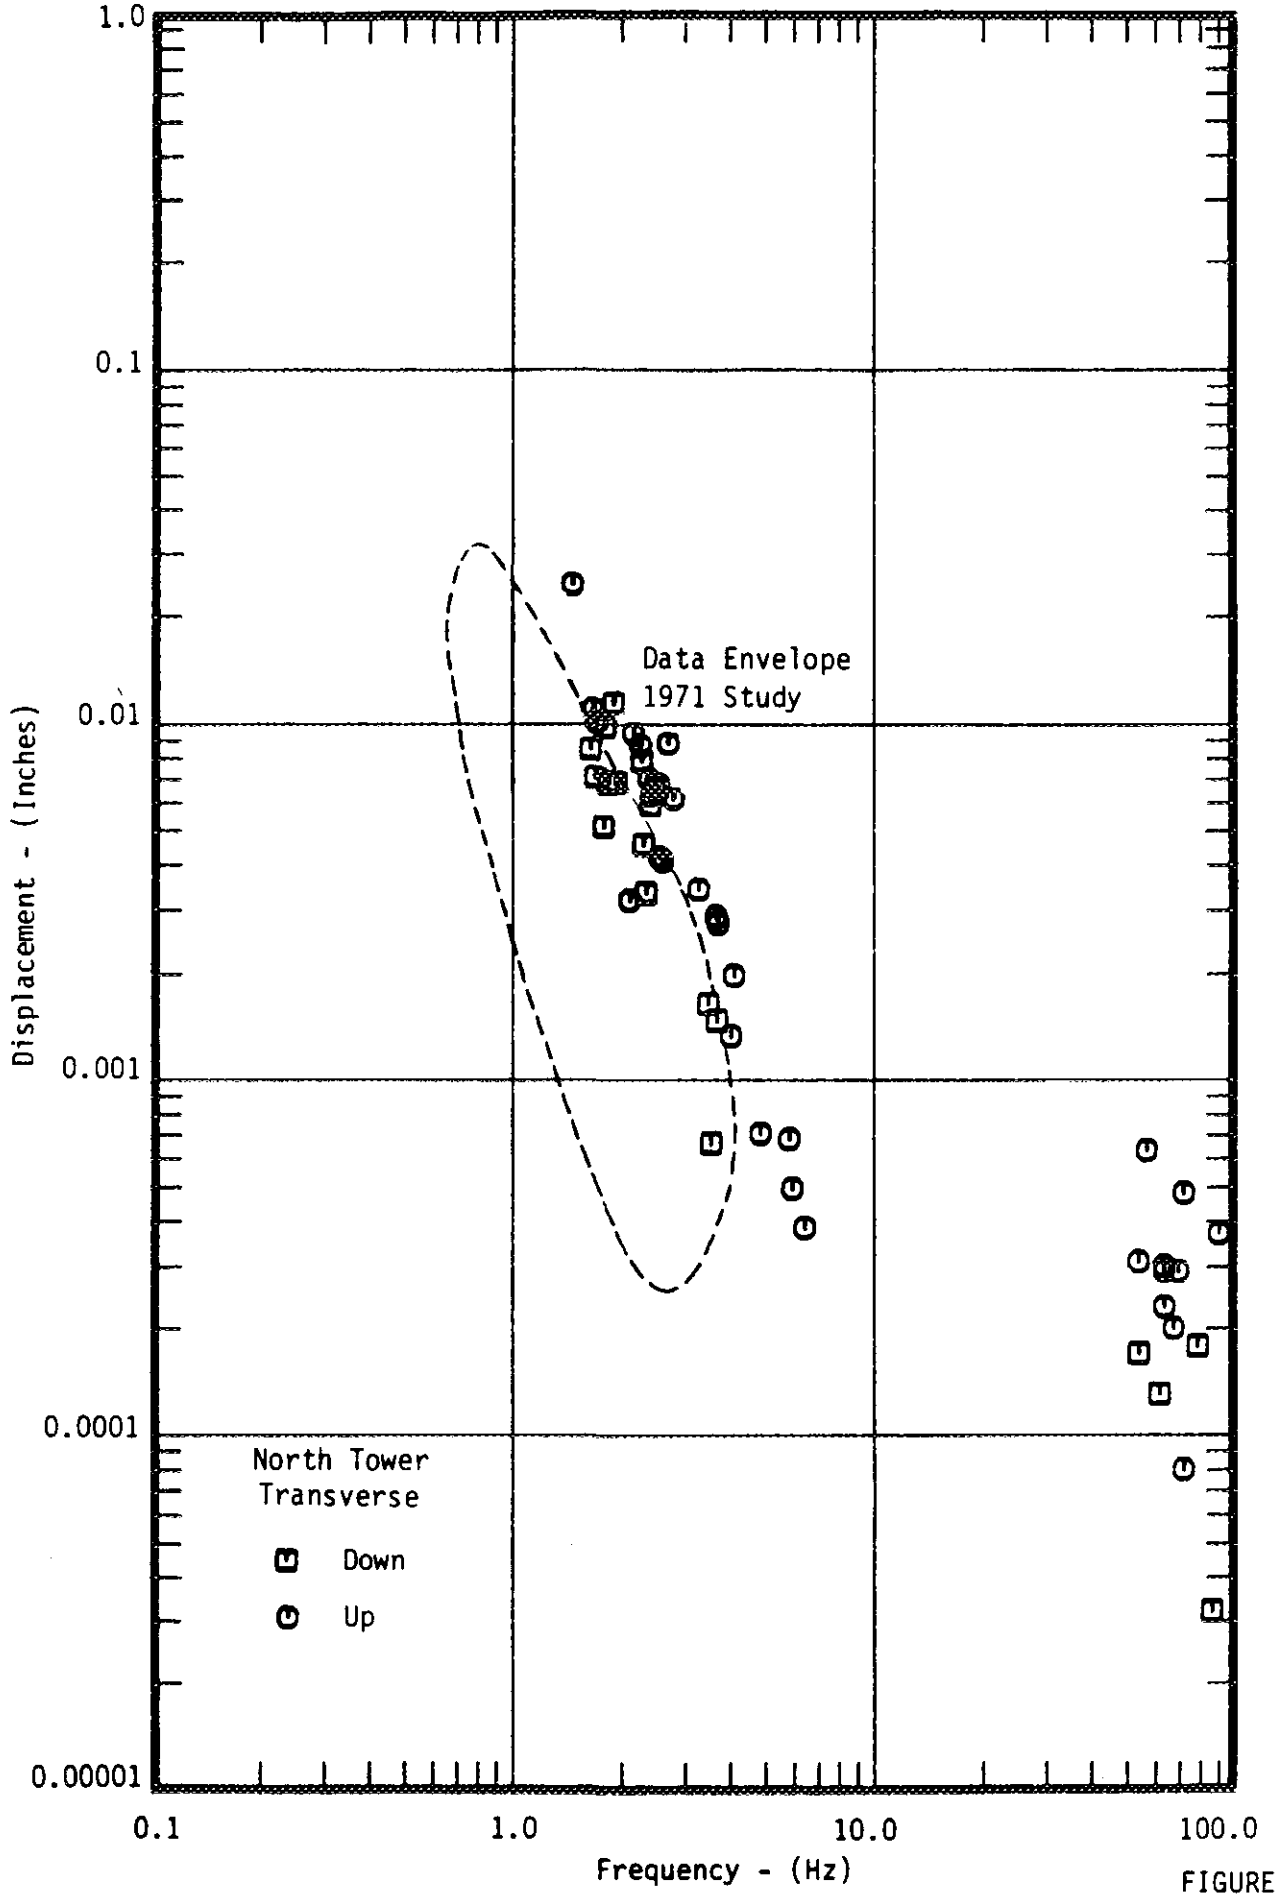
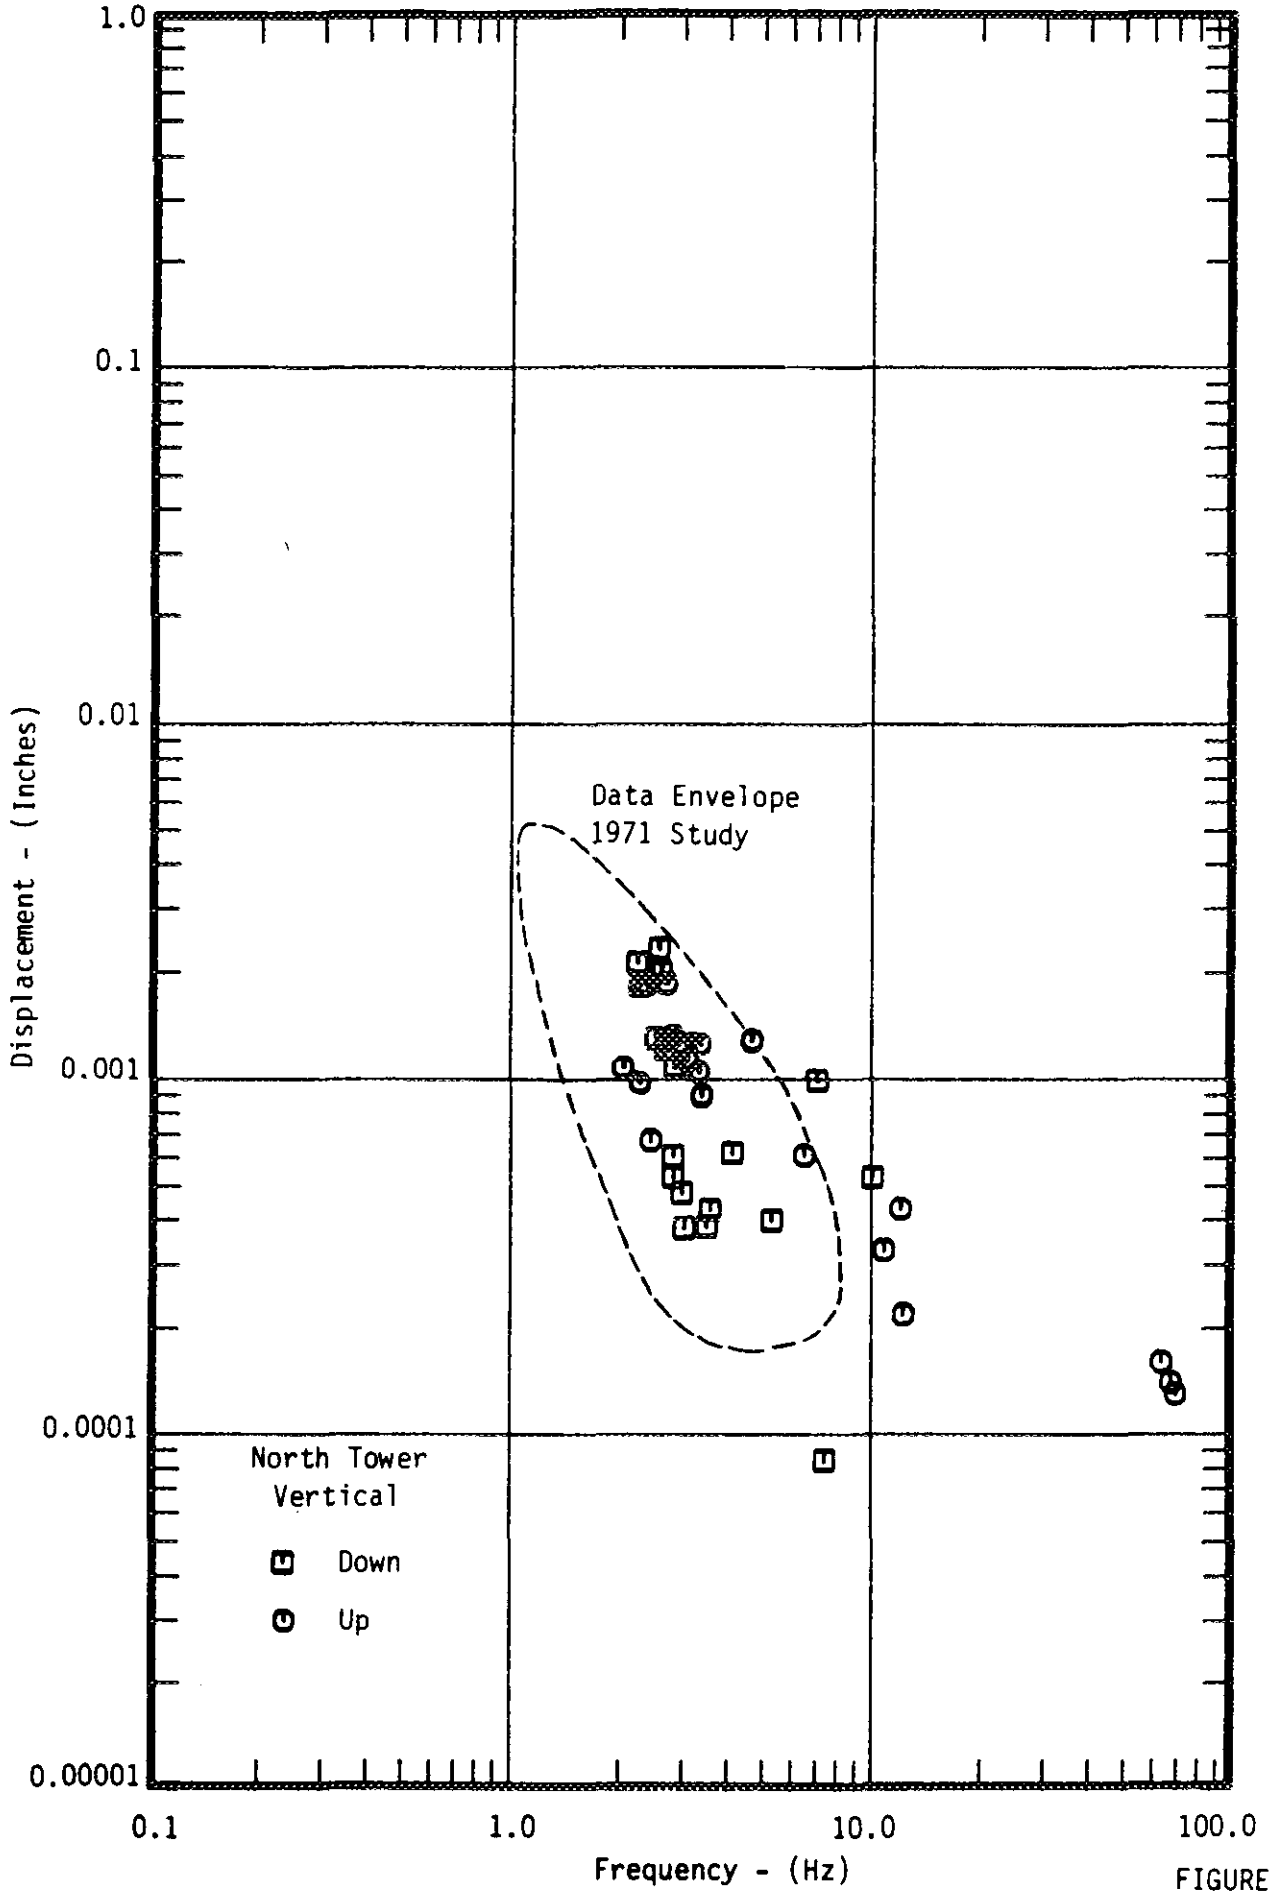
Displacements induced in the North Tower by upward and downward movement of the lift span are shown on Figures 11→13. The results of this present study are consistent with those reported in 1971.

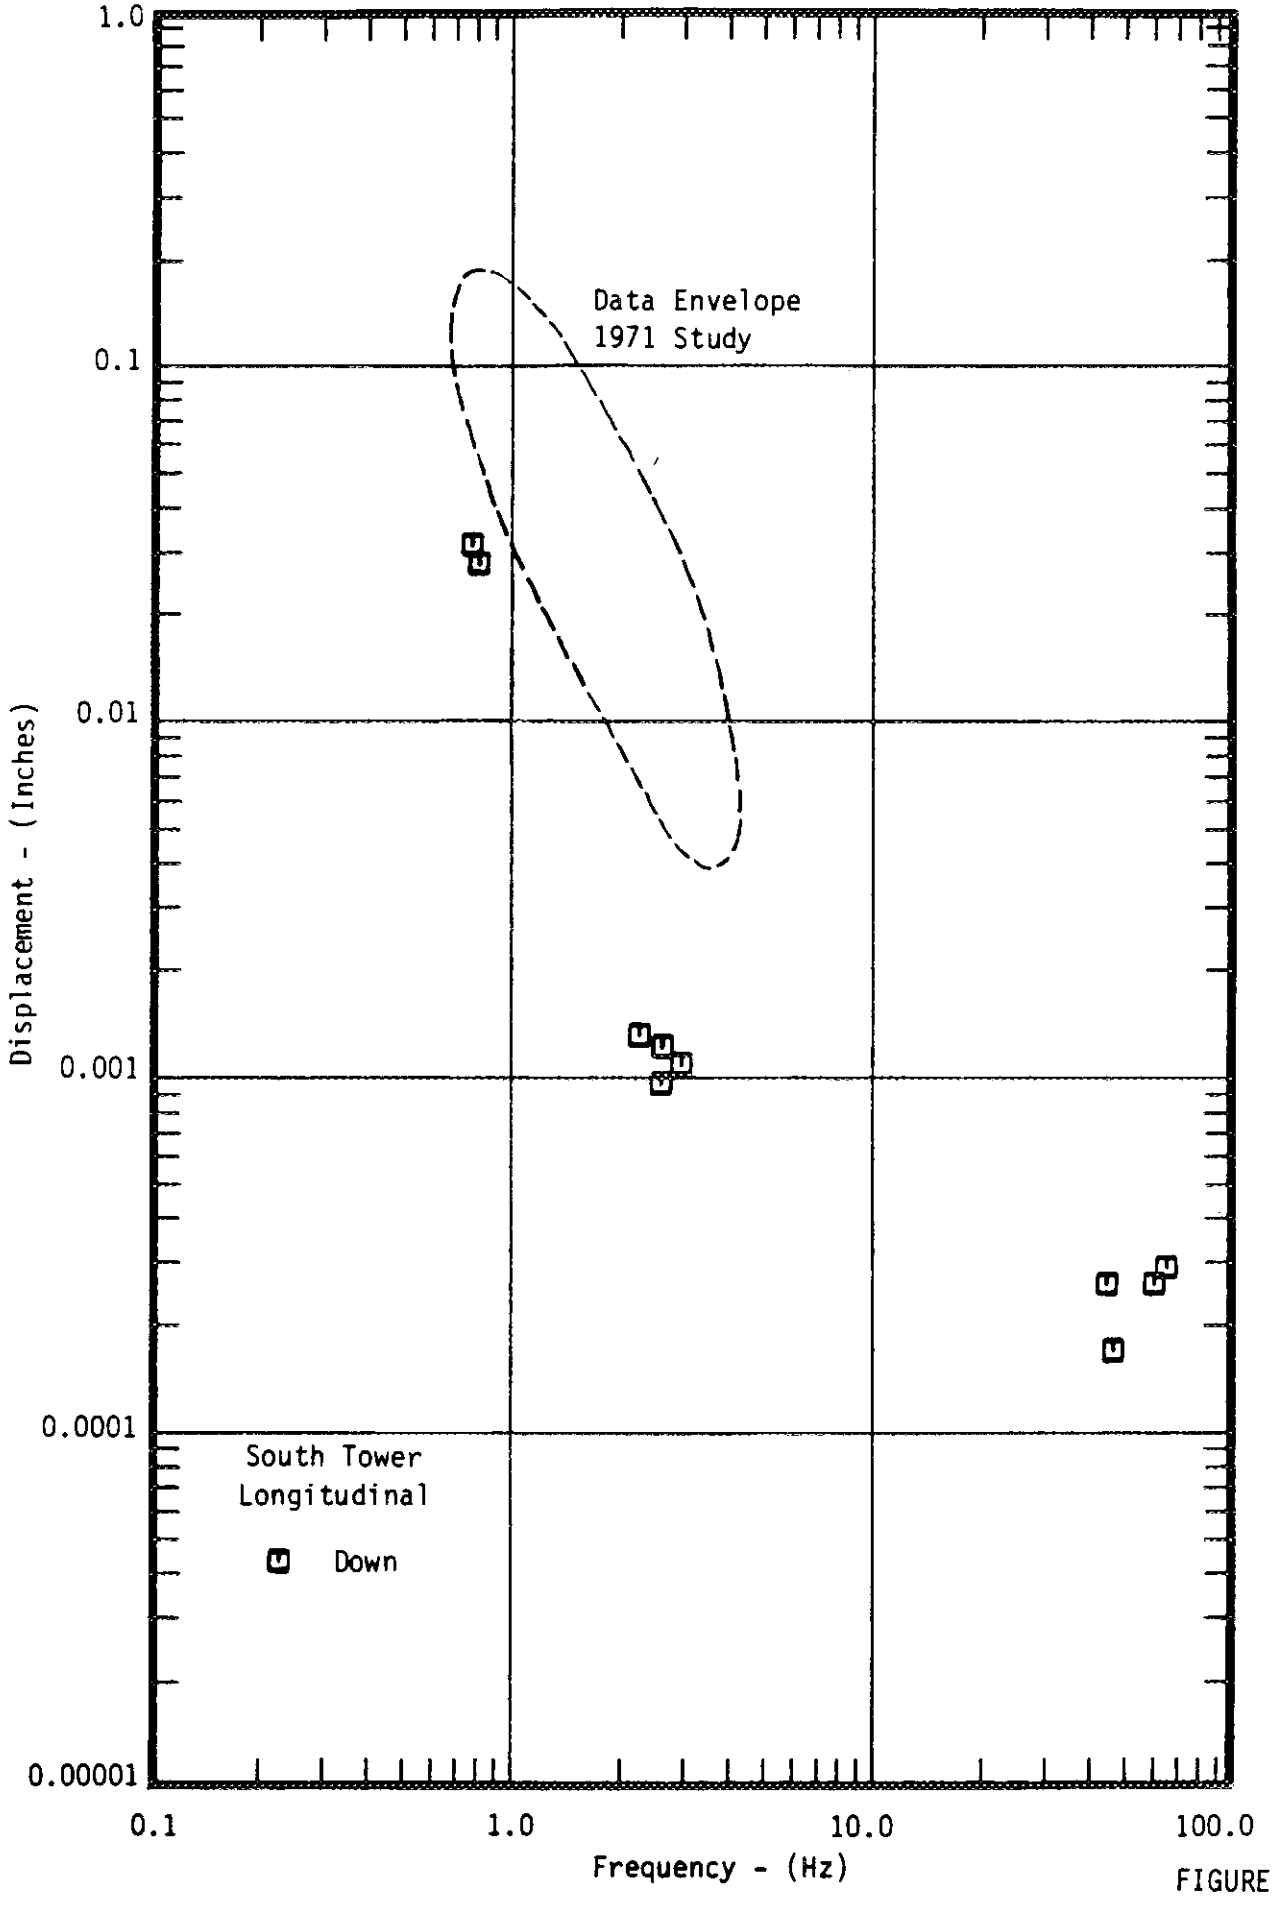
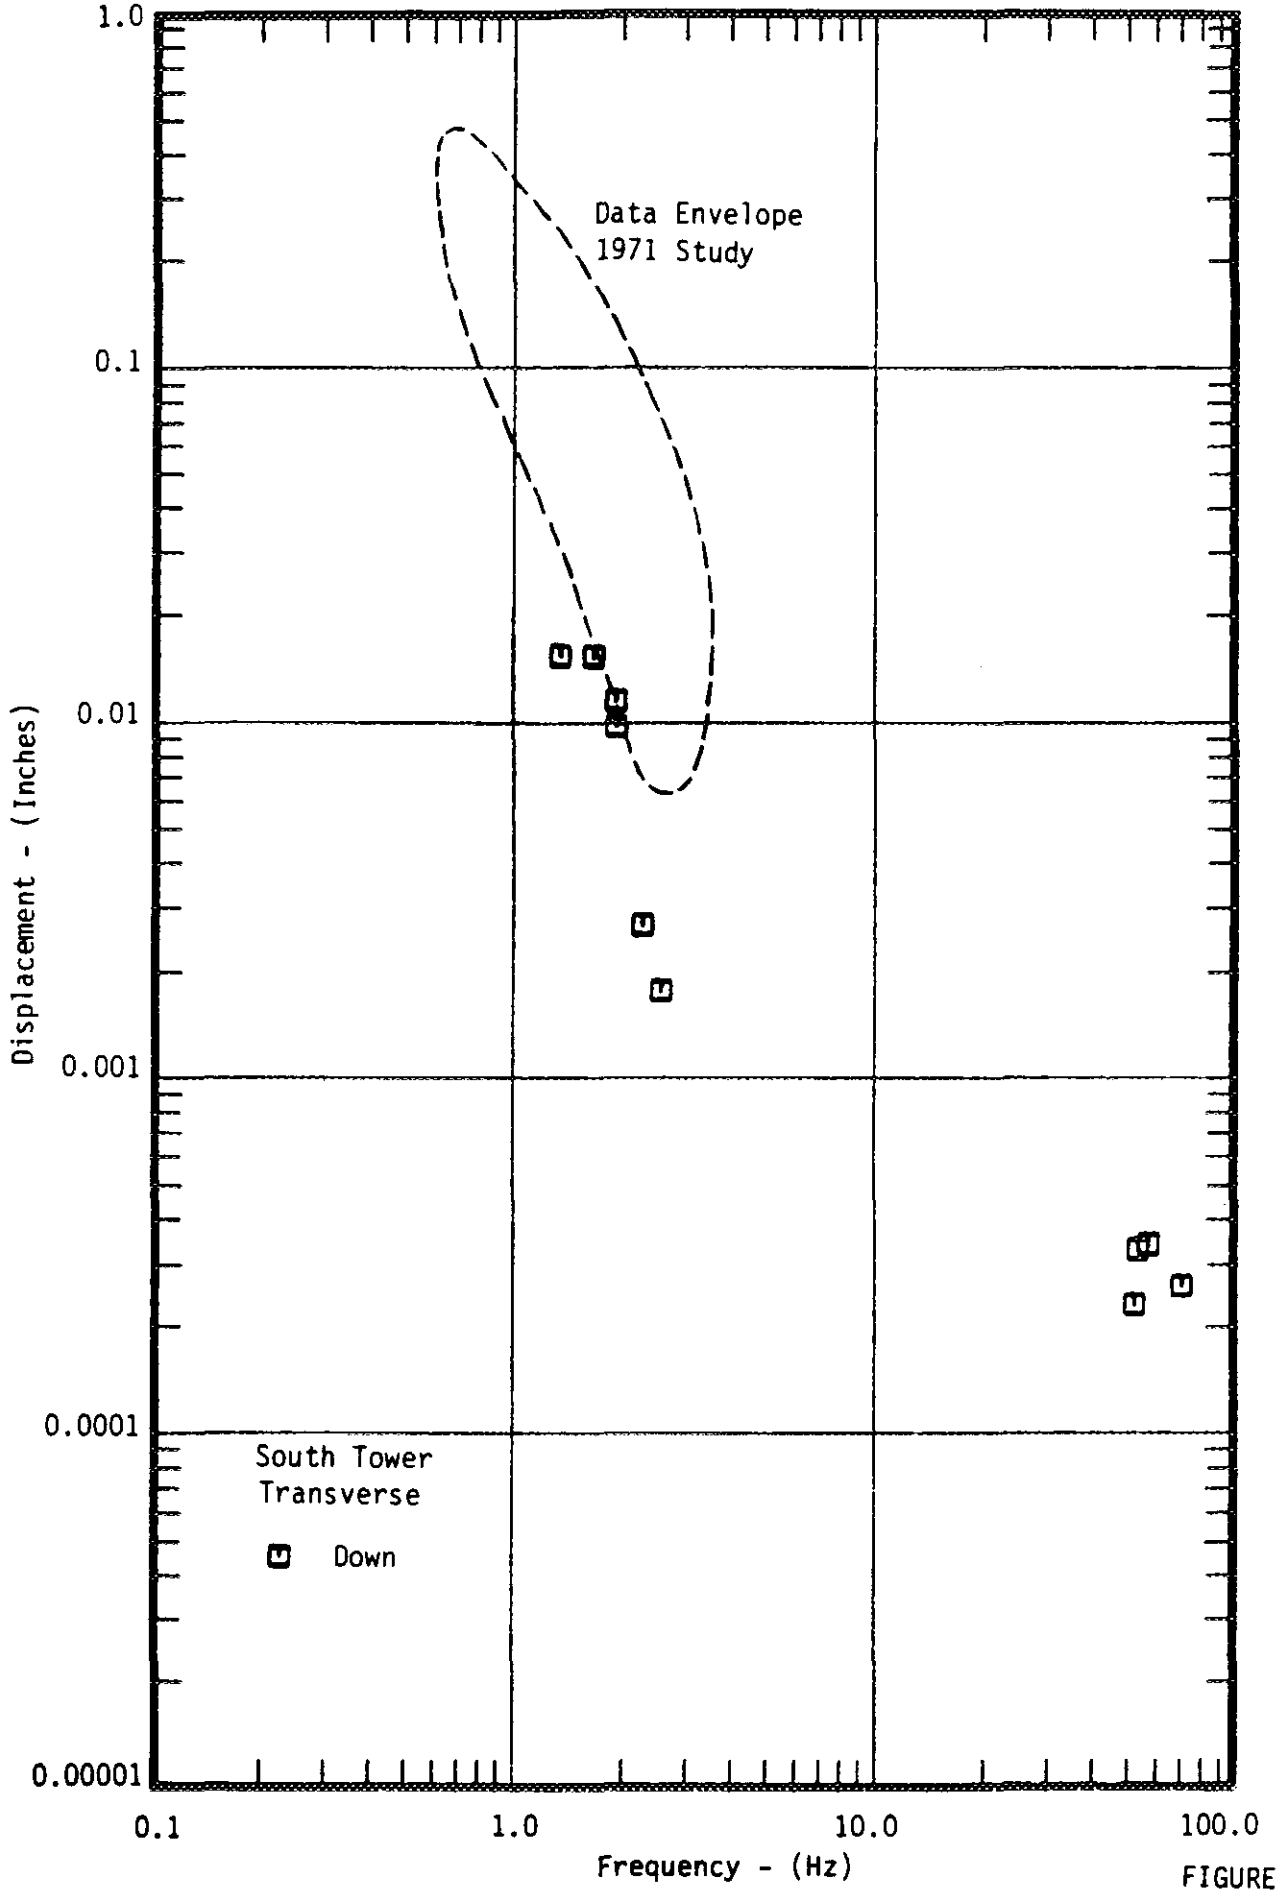
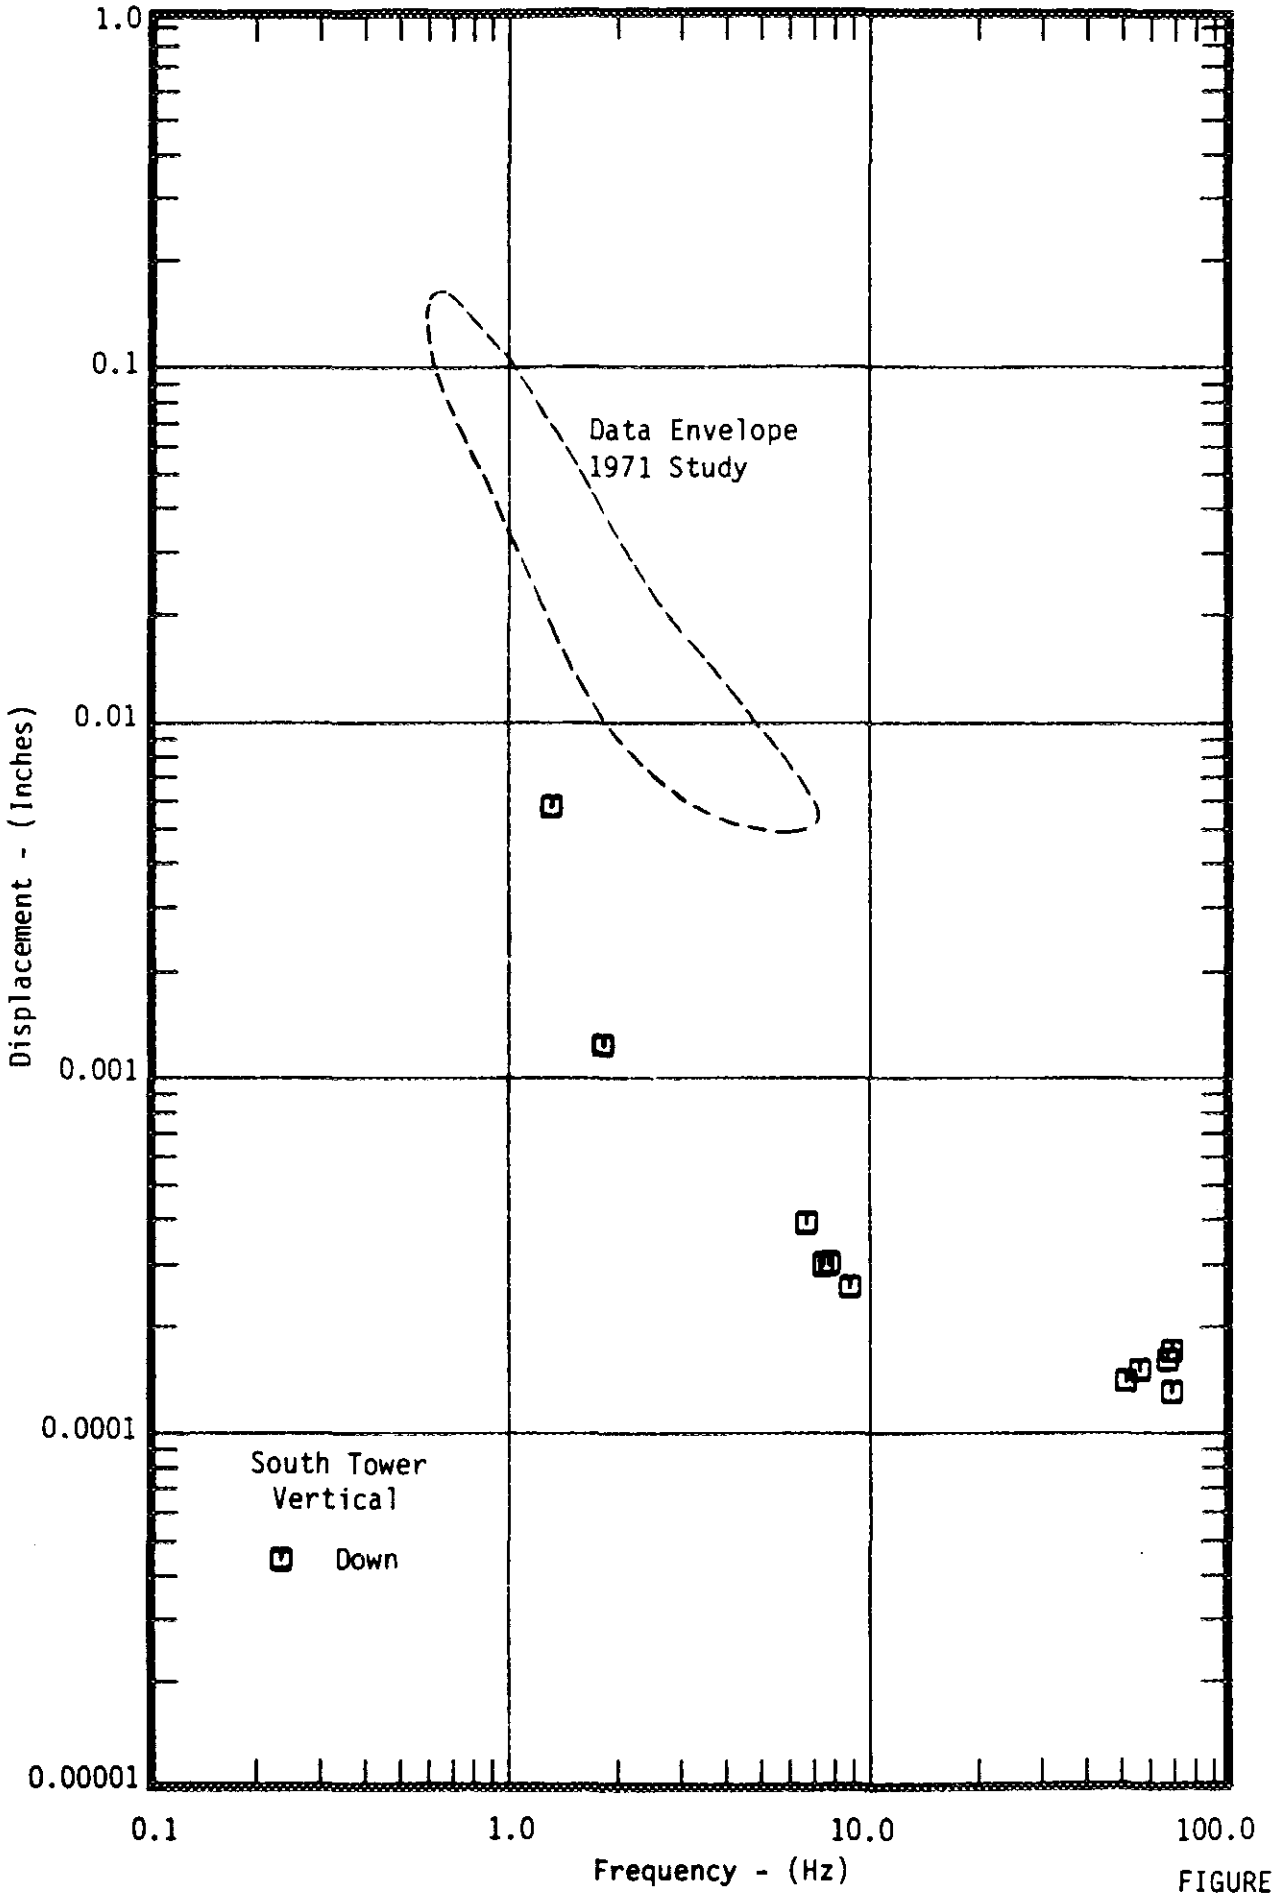
Displacements in the South Tower for downward movement of the lift span are compared to the 1971 results on Figures 14→16. As for the case of train vibrations reported at mid-span in the 1971 study, vibrations reported in that study for the South Tower seem high. Records obtained in 1971 for the South Tower have been re-interpreted; the re-examined displacements are plotted on Figures A-4 through A-6 in Appendix A. The re-examined records provide results that fall below or within the lower range of displacements quoted in the 1971 study.

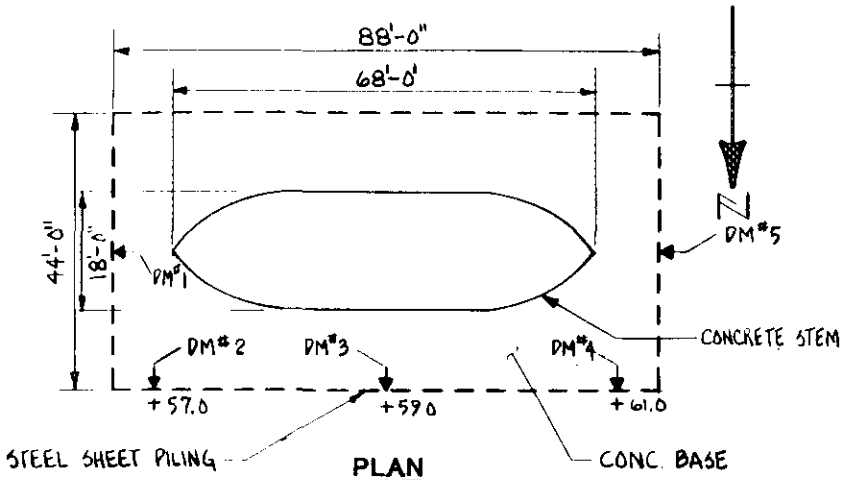
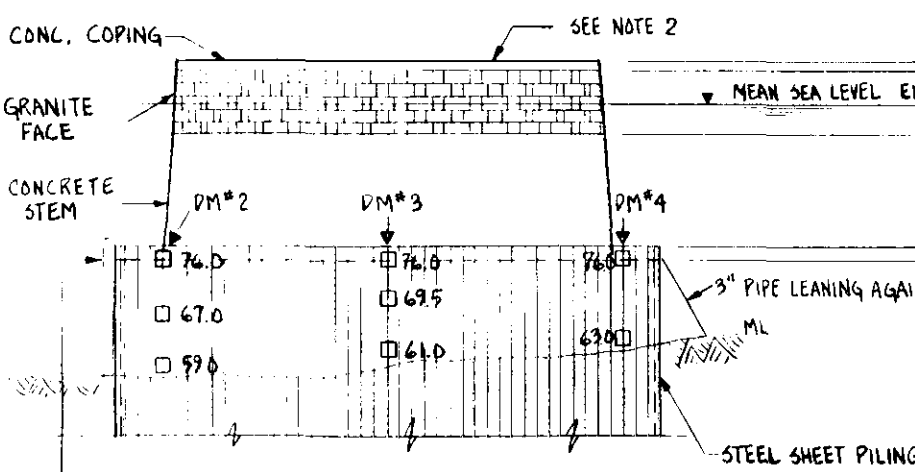
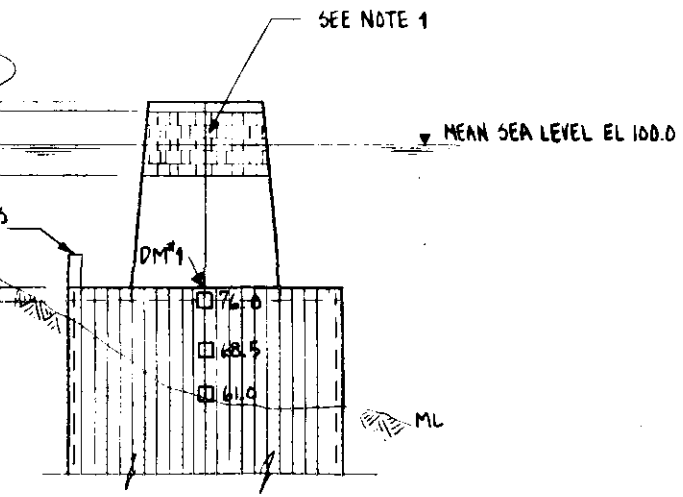
FIG 597-84-2

The steel sheet piles are generally in good condition. Ultrasonic steel thickness readings indicate a minimum steel thickness of .215" (flange), however, average readings were considerably higher (.330" web; .400" flange), see Figure 597-84-2 for thickness readings, locations and elevations. The cleaned surface of the steel is slightly pitted with a maximum depth of less than 1/16" (see Photo #9). Corrosion by-product which covers the steel is 3/8" to 1/2" thick with an outer layer of hard, crusty material. Below the outer

1. APROX 42 LINEAR FEET OF DETERIORATED JOINT GROUT IS NOTED @ THE EAST END OF PIER B @ EL 103.25 AND EL 101.25 TO A MAX. DEPTH OF 6"
2. HAIRLINE CRACKING IS NOTED ON FACE OF COPING AND IS ASSOCIATED WITH SPALLING ON THE DECK
3. CONCRETE STEM DIMENSIONS TAKEN @ EL 105.25

Along the northeast corner of the concrete base there is an 8-foot section of the steel sheet pile wall which has been damaged. The damage begins at the northeast corner and runs to the west at the top of the sheet pile (El. 75.0 to El. 65.0). In this area the steel sheeting has been flattened and folded over the concrete edge (El. 75.0) to the southerly direction (see Photo #10). Due to the deflection and deformation, there is one hole (1"x5") in the flange of the fifth sheet as counted from the corner to the west at El.74.0 (see Figure 597-84-3). There is some local crushing of the concrete in this area, however, this damage appears to be minor.

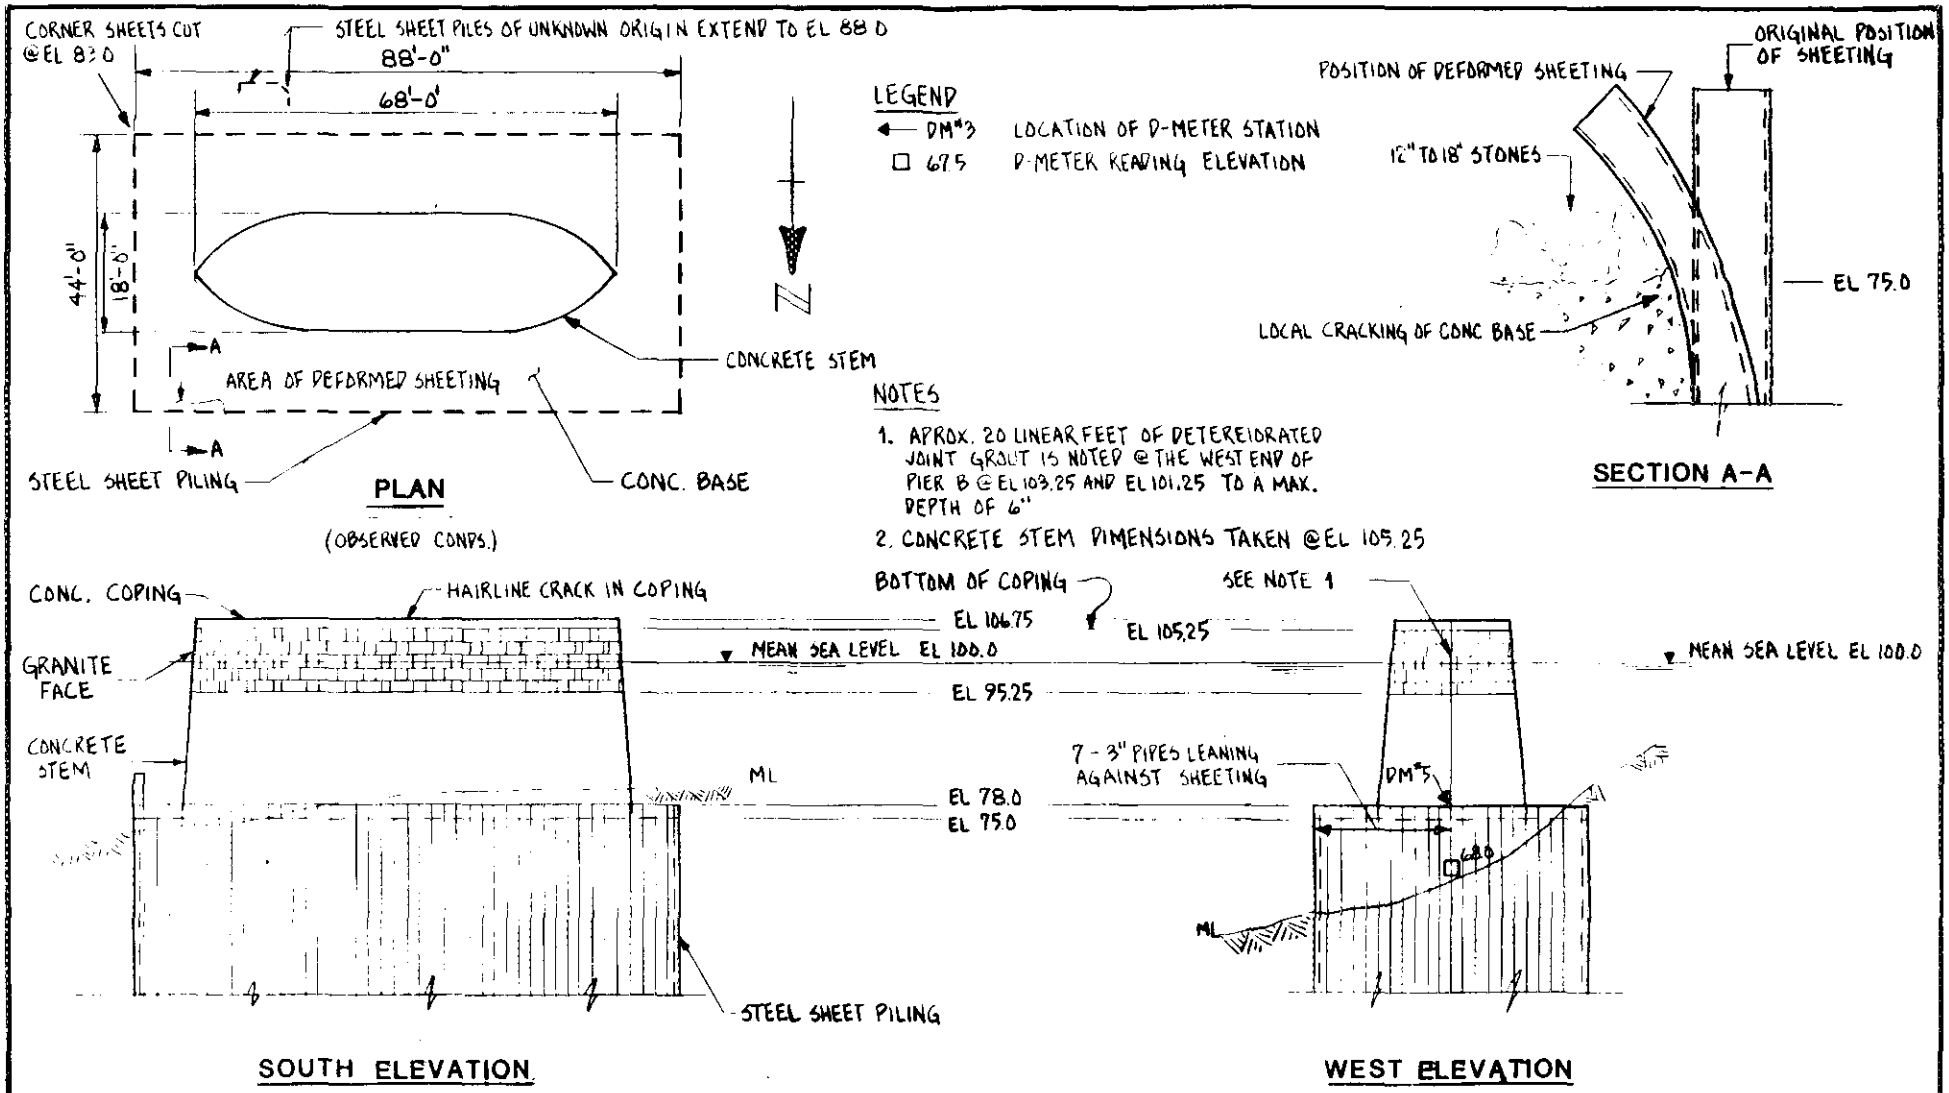
67.5 D-METER READING ELEVATION
NOTES
1. APROX. 20 LINEAR FEET OF DETERIORATED JOINT GROUT IS NOTED @ THE WEST END OF PIER B @ EL 103.25 AND EL 101.25 TO A MAX. DEPTH OF 6"

At the southeast corner of the concrete base the steel sheeting has not been cut to grade (El. 77.0). The top of the corner sheets were left at El. 83.0. Also three sections of sheeting were found 10 feet to the south of the concrete base and approximately 25 feet to the west of the southeast corner of the concrete base. The tops of these sections of sheeting were left at El. 88.0.

Joints between granite blocks are generally found to be in excellent condition (see Photos #12, #13, #14, #15). At the east and west ends there are some joints with grout deteriorated at El. 103.25 and El.101.25 (second and third joints below concrete coping) to a maximum depth of 10". Pier B has a total of 62 linear feet of deteriorated joint grout.

The two locations where an apparent impact has occurred to the concrete base, (Pier B, northeast corner; Pier C, northwest corner), exhibit only local damage to the structure. However, it should be determined through established survey points that the impact did not shift the structure's foundation.

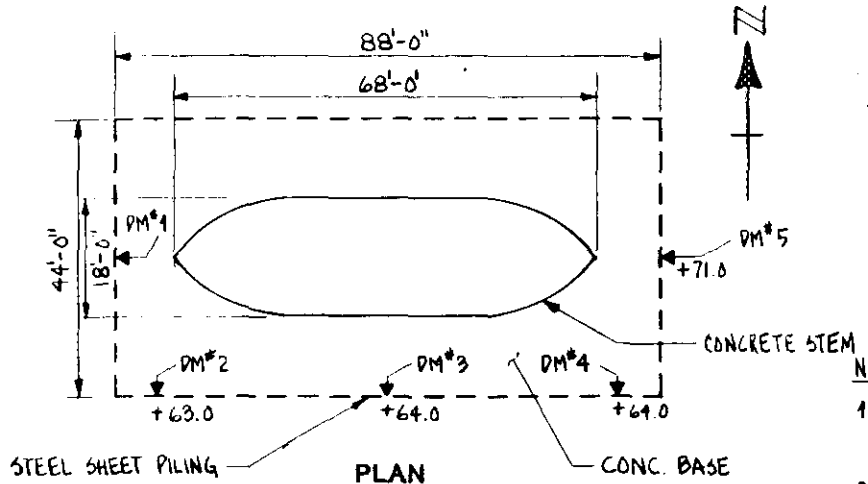
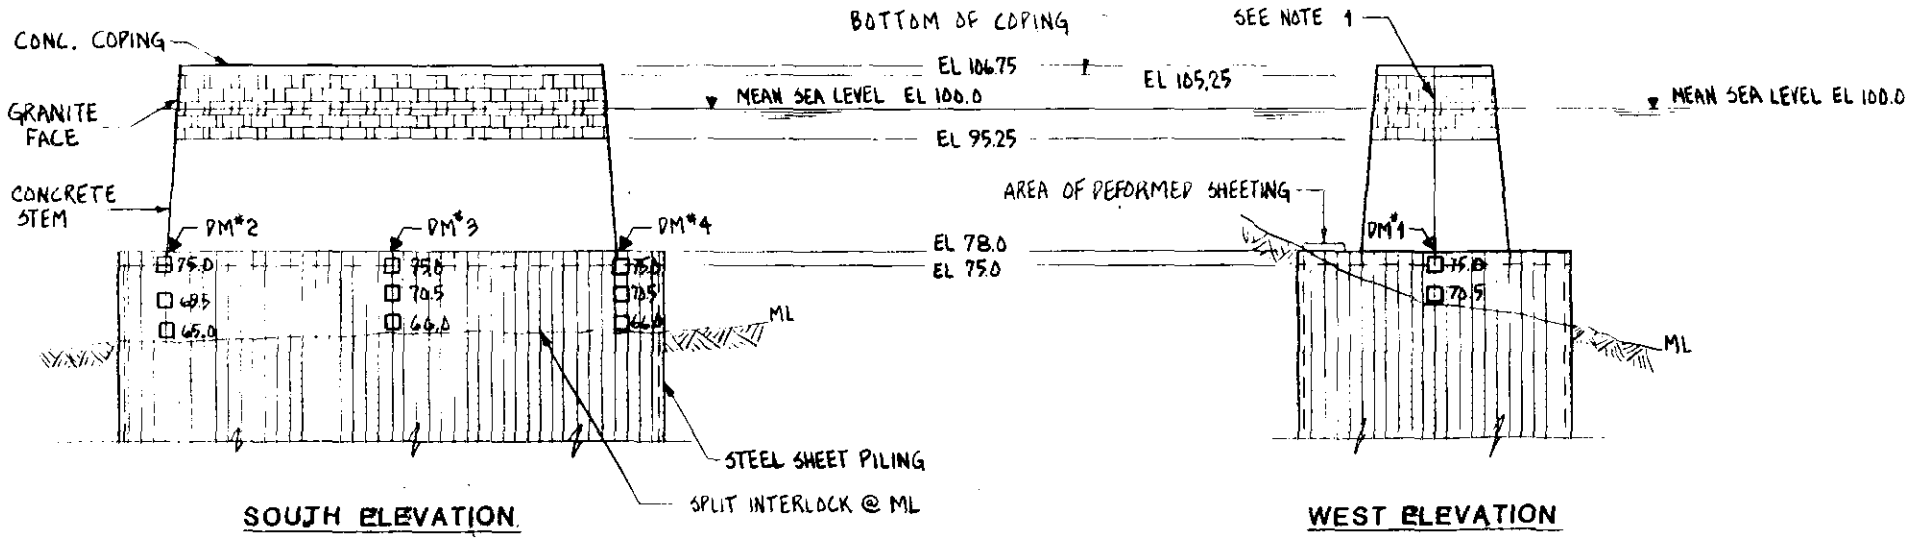
FIG 597-84-4

The steel sheet piles are in good condition. After cleaning the surface of the steel, slight pitting was observed on the steel surface with the pits being less than 1/16" deep (see Photo #17). A corrosion profile of the steel is similar to Pier B with an outer layer of hard, crusty material. Behind the outer layer are trapped pockets of gas and a soft black layer of corrosion by-product (see Photo #18). Ultrasonic steel thickness readings indicate a minimal steel thickness of .205" (flange); however, average readings were considerably higher (.390, flange; .315, web) see Figure 597-84-4 for thickness readings, locations and elevations.

There is one split interlock along the channel face approximately 20' to the west of the southeast corner. The split originates approximately 4' above the ML. At the ML the sheet separation is approximately 3". Concrete, which is exposed at the separation, appears to be in sound condition.

1. APROX. 20 LF OF DETERIORATED JOINT GROUT IS NOTED @ THE WEST END OF PIER C AT EL 103.25 AND 101.25 TO A MAX. DEPTH OF 6"
2. CONCRETE STEM DIMENSIONS TAKEN @ EL 105.25
