BUZZARDS BAY RAILROAD LIFT BRIDGE OVER CAPE COD CANAL

INSPECTION AND CONDITION REPORT

OCTOBER, 1984

RE: CONTRACT NO. DACW33-84-C-0022
Inspection and Condition Report
Vertical Lift Railroad Bridge
Cape Cod Canal
Buzzards Bay, Massachusetts

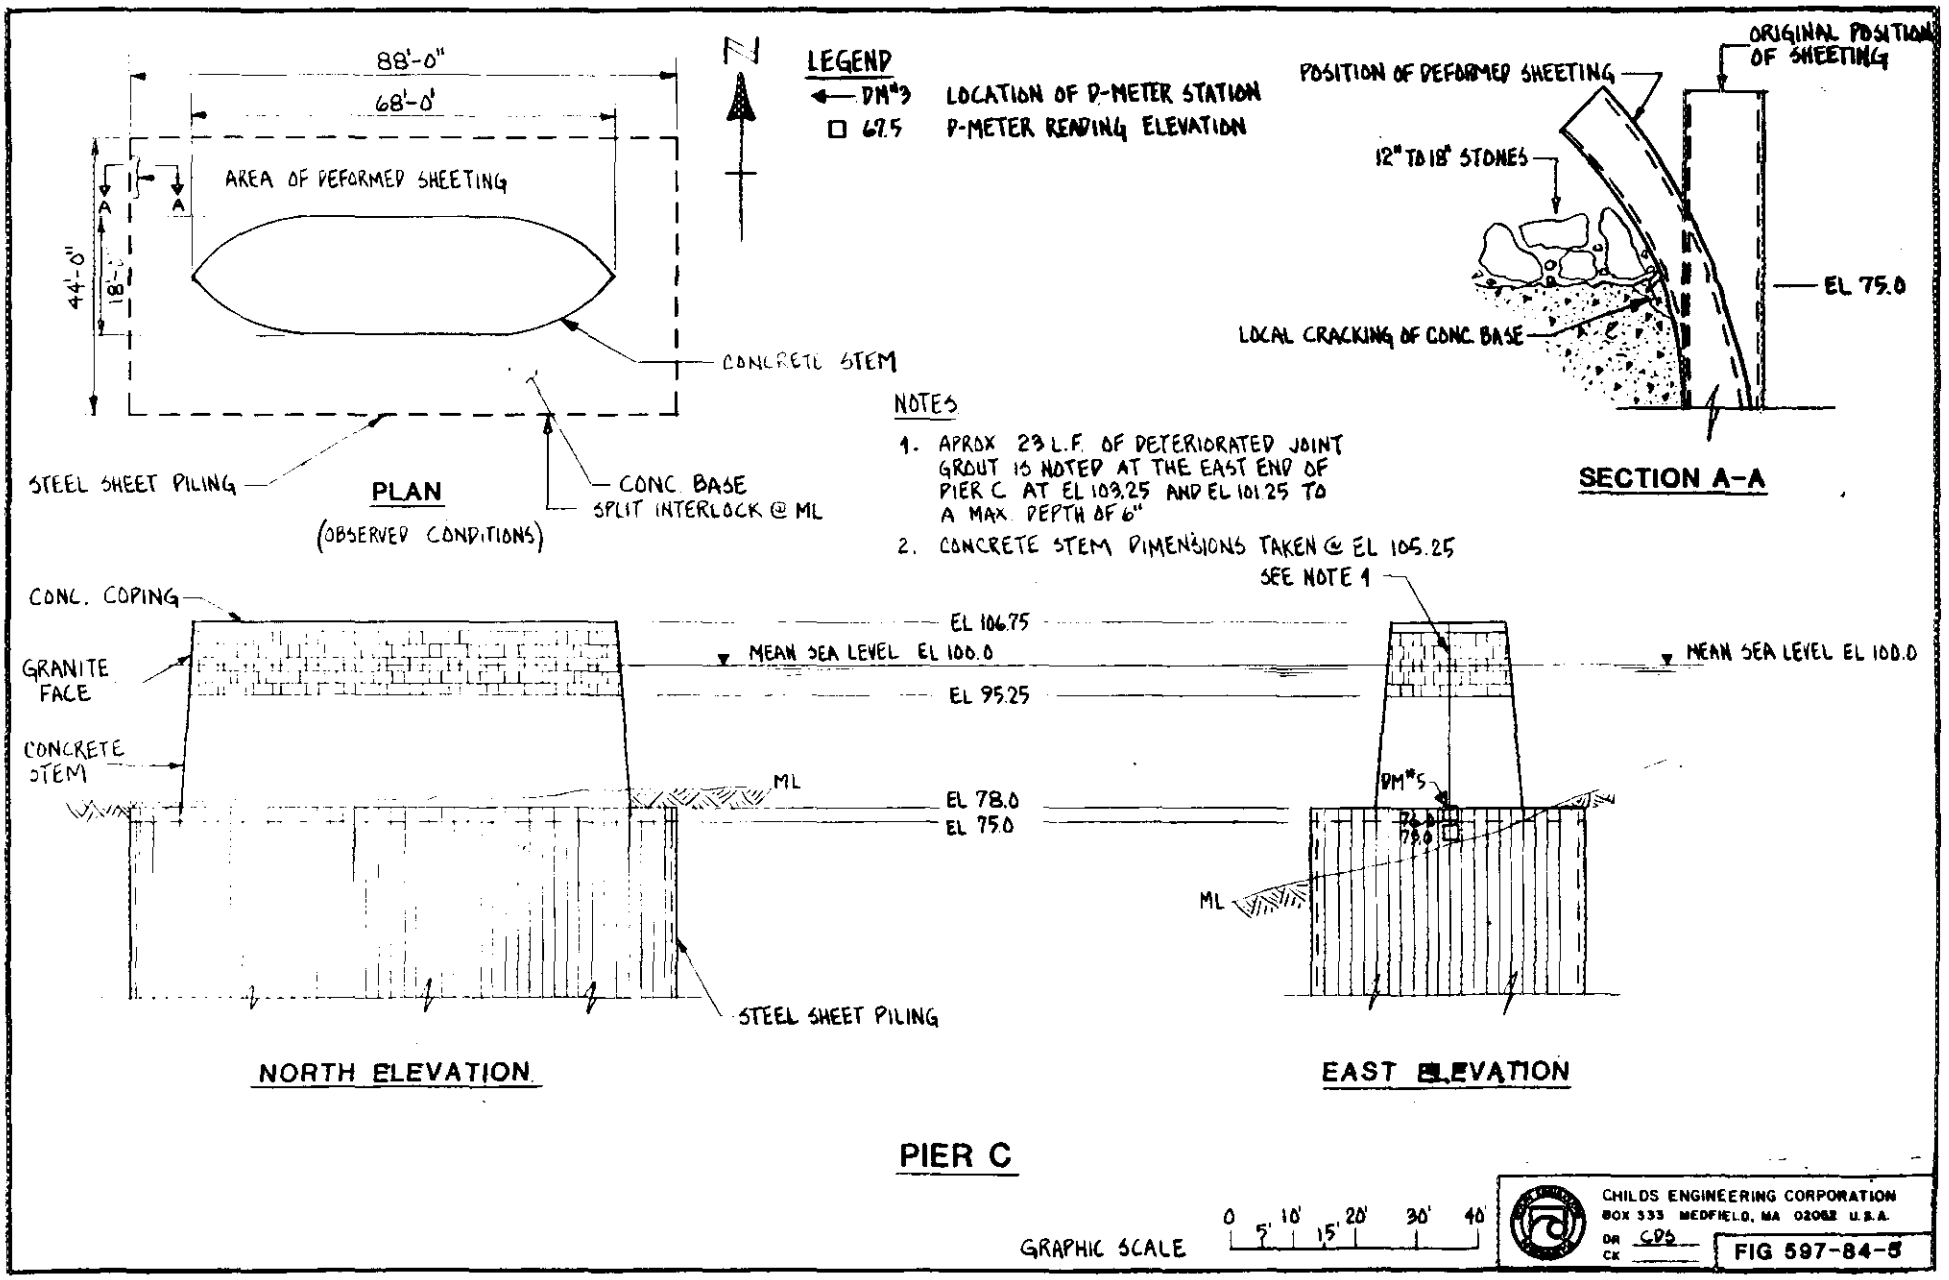
At the northwest corner of the concrete base the exposed sheet piles have been folded over the top of the concrete edge (El. 75.0) to the easterly direction (see Figure 597-84-5). The full extent of this damage could not be determined due to the elevation of the mudline (El. 74.0) in that area. The damage appears to be minor with no structural significance.

A split interlock was noted on Pier C along the channel face. This condition is stable and does not appear to be structurally significant at this time.

The two locations where an apparent impact has occurred to the concrete base, (Pier B, northeast corner; Pier C, northwest corner), exhibit only local damage to the structure. However, it should be determined through established survey points that the impact did not shift the structure's foundation.

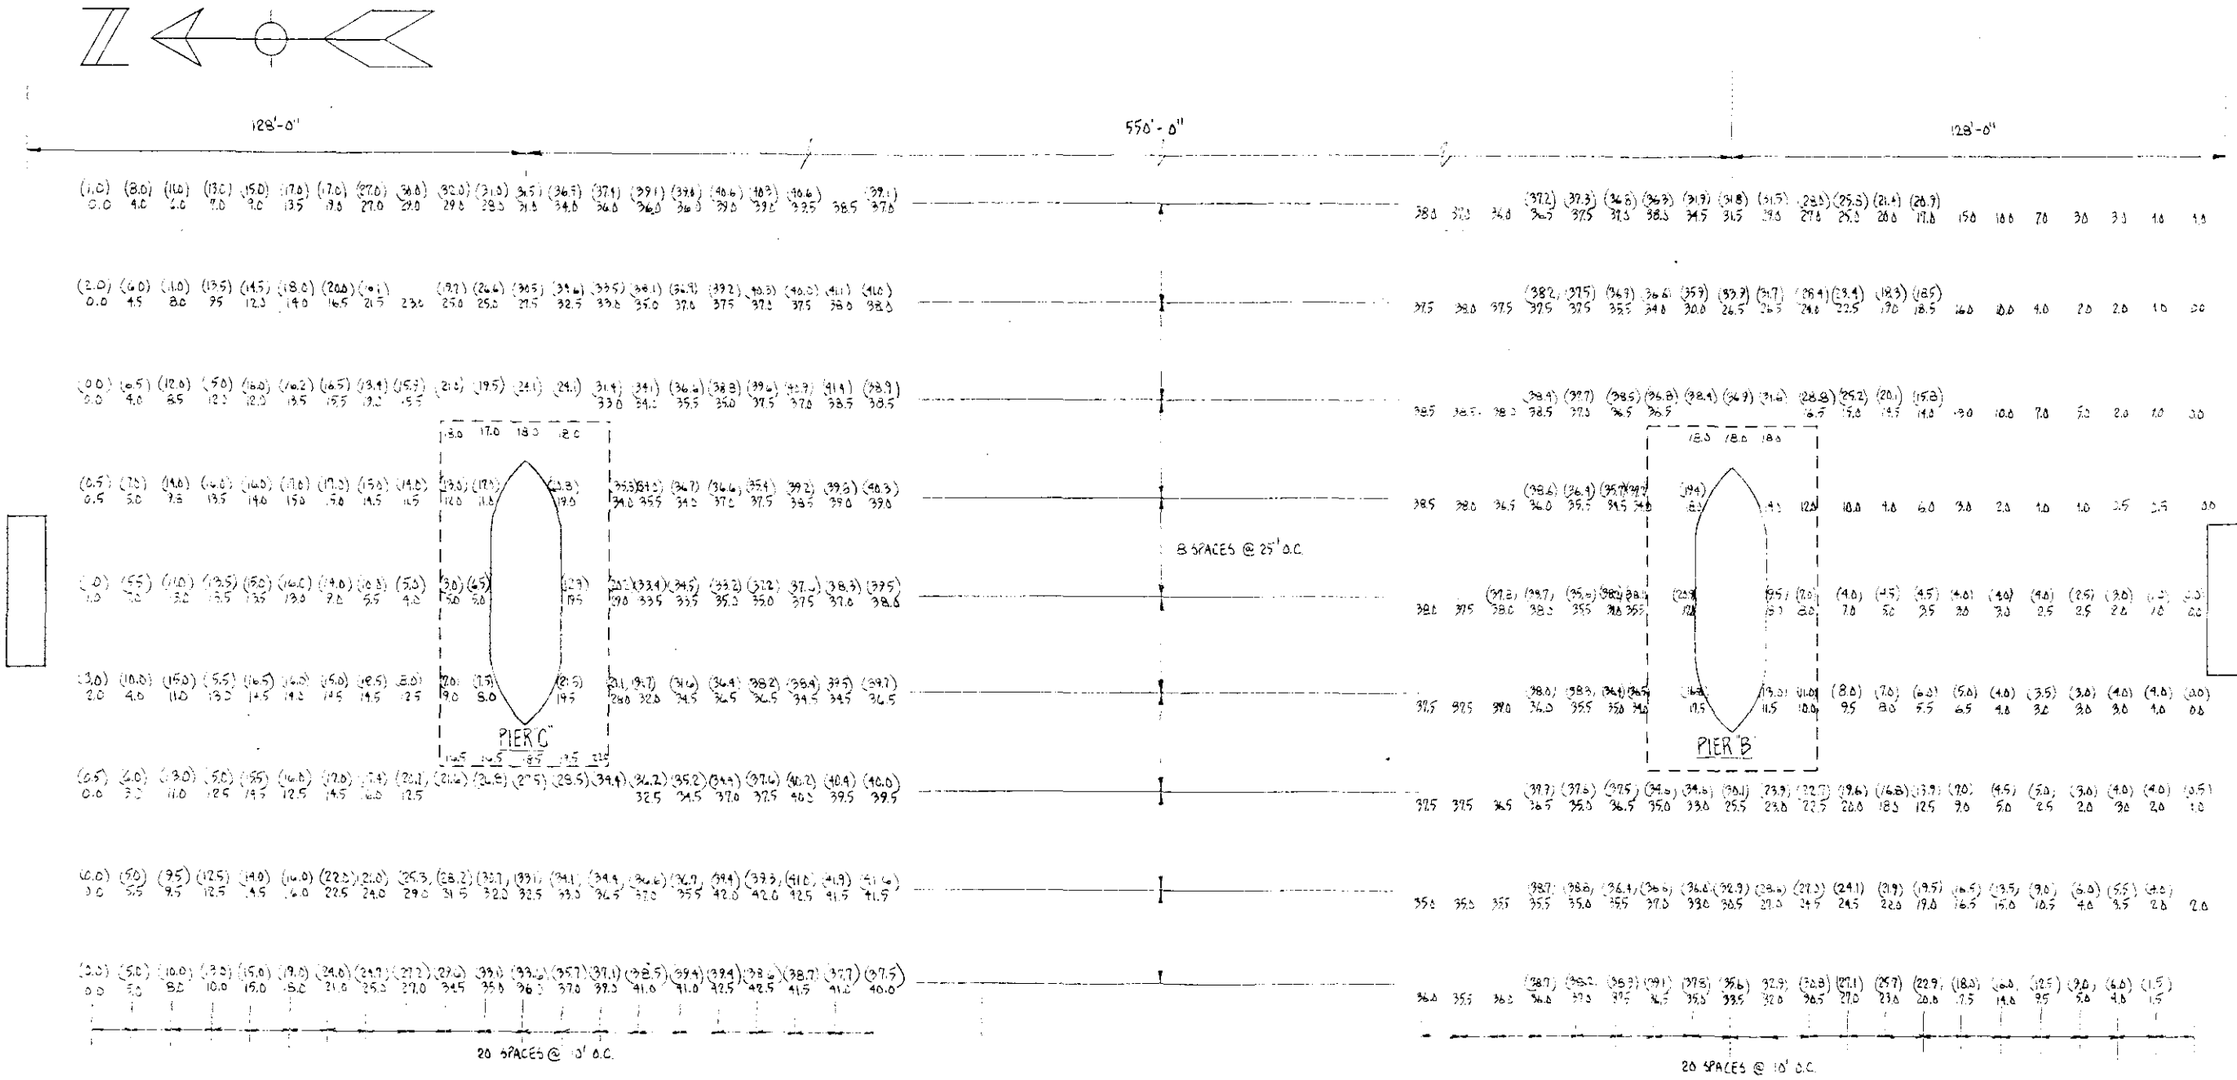
Fathometer runs were made about the pier foundations of the railroad lift bridge (see Figure 597-84-6) with a white line recorder. Established elevations were used to gauge the water level at the time of each run. Adjustments were then made with the data being referenced to mean low water.

1. SOUNDINGS ARE IN FEET BELOW M.L.W.
