APPRAISAL REPORT
Lancaster, Massachusetts
North Nashua River

Streambank Protection Project

April 1990

US Army Corps
of Engineers
New England Division

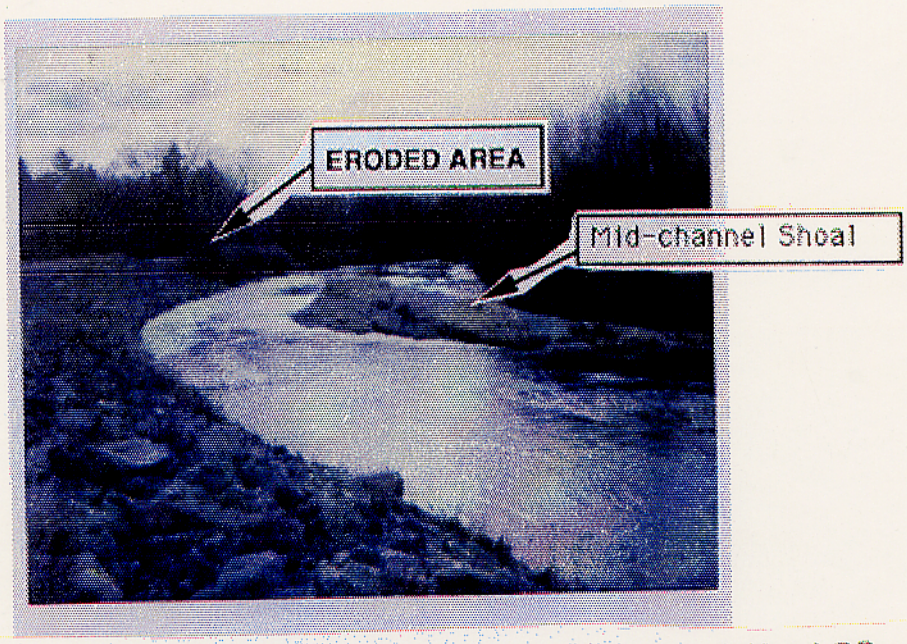
Plate 5

Figure 1. N. Nashua River, looking downstream of the LPP at the mid-channel shoal.

Figure 2. N. Nashua River, looking upstream at the LPP.

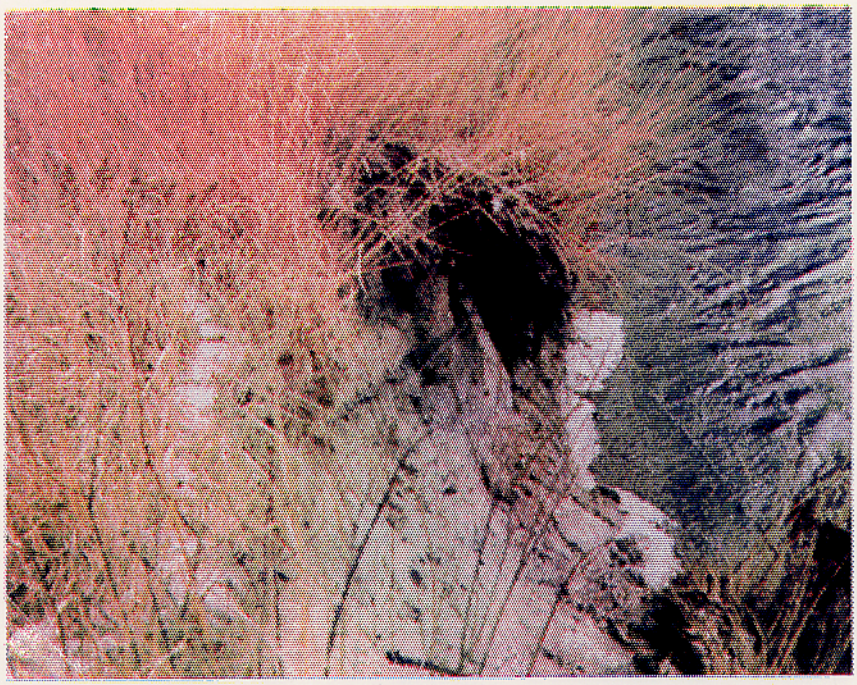
December 8, 1989
Photo 3 - Closeup view of streambank erosion on left channel bank downstream of project.

December 8, 1989
Photo 4 - Wide view of left bank erosion downstream of project.
