STATUS REPORT DISPOSAL OPERATIONS
AT THE CENTRAL LONG ISLAND SOUND
DISPOSAL SITE

DISPOSAL AREA MONITORING SYSTEM (DAMOS)

GEOPHYSICAL ASPECTS OF CAPPING OPERATIONS

MAY 1983

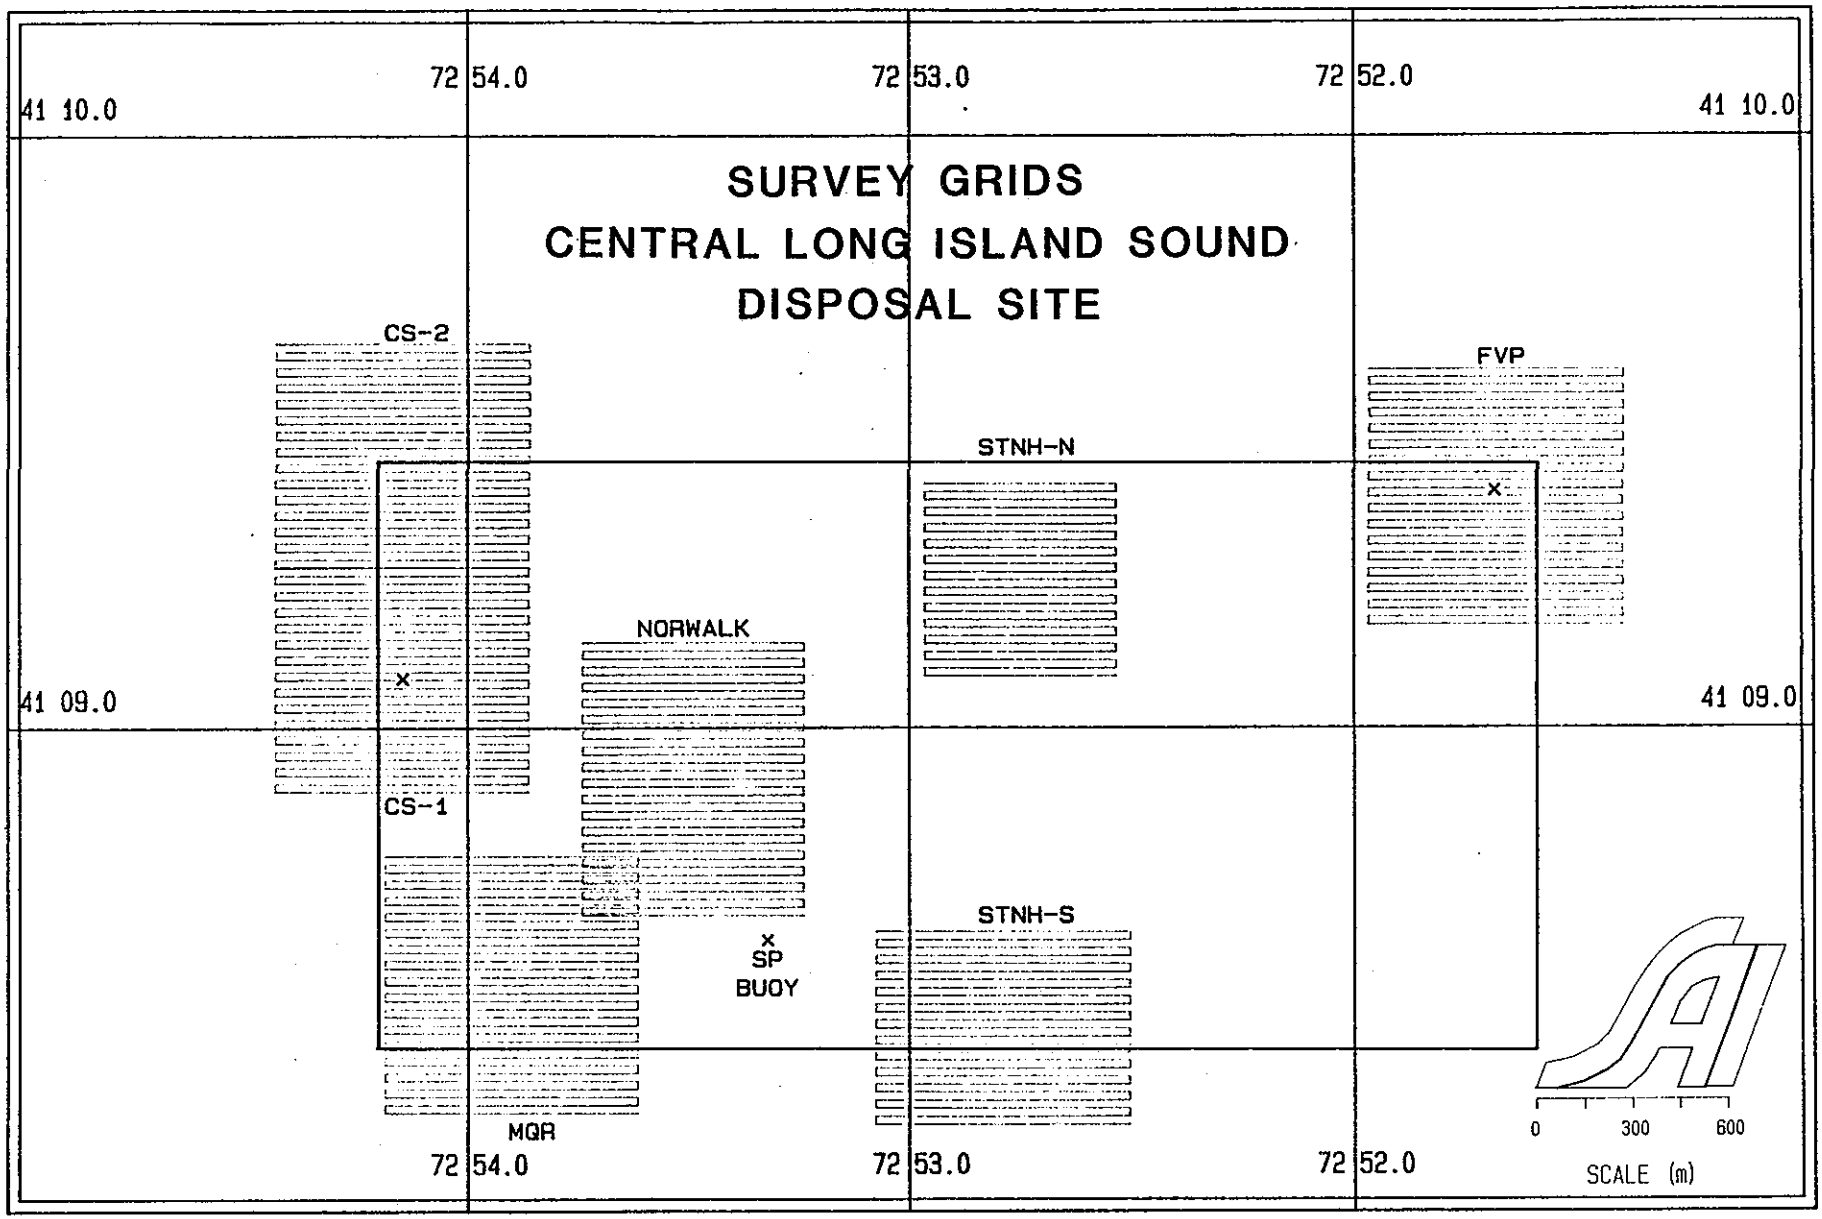
Figure 1-1

An overview of the CLIS disposal site showing the relative positions of the disposal points and the extent of survey coverage is presented in Figure 1-1. All of these sites have been studied in detail using replicate precision bathymetric surveys, side scan sonar, precision grab sampling and diver observations as well as additional, more specialized observations in some cases.

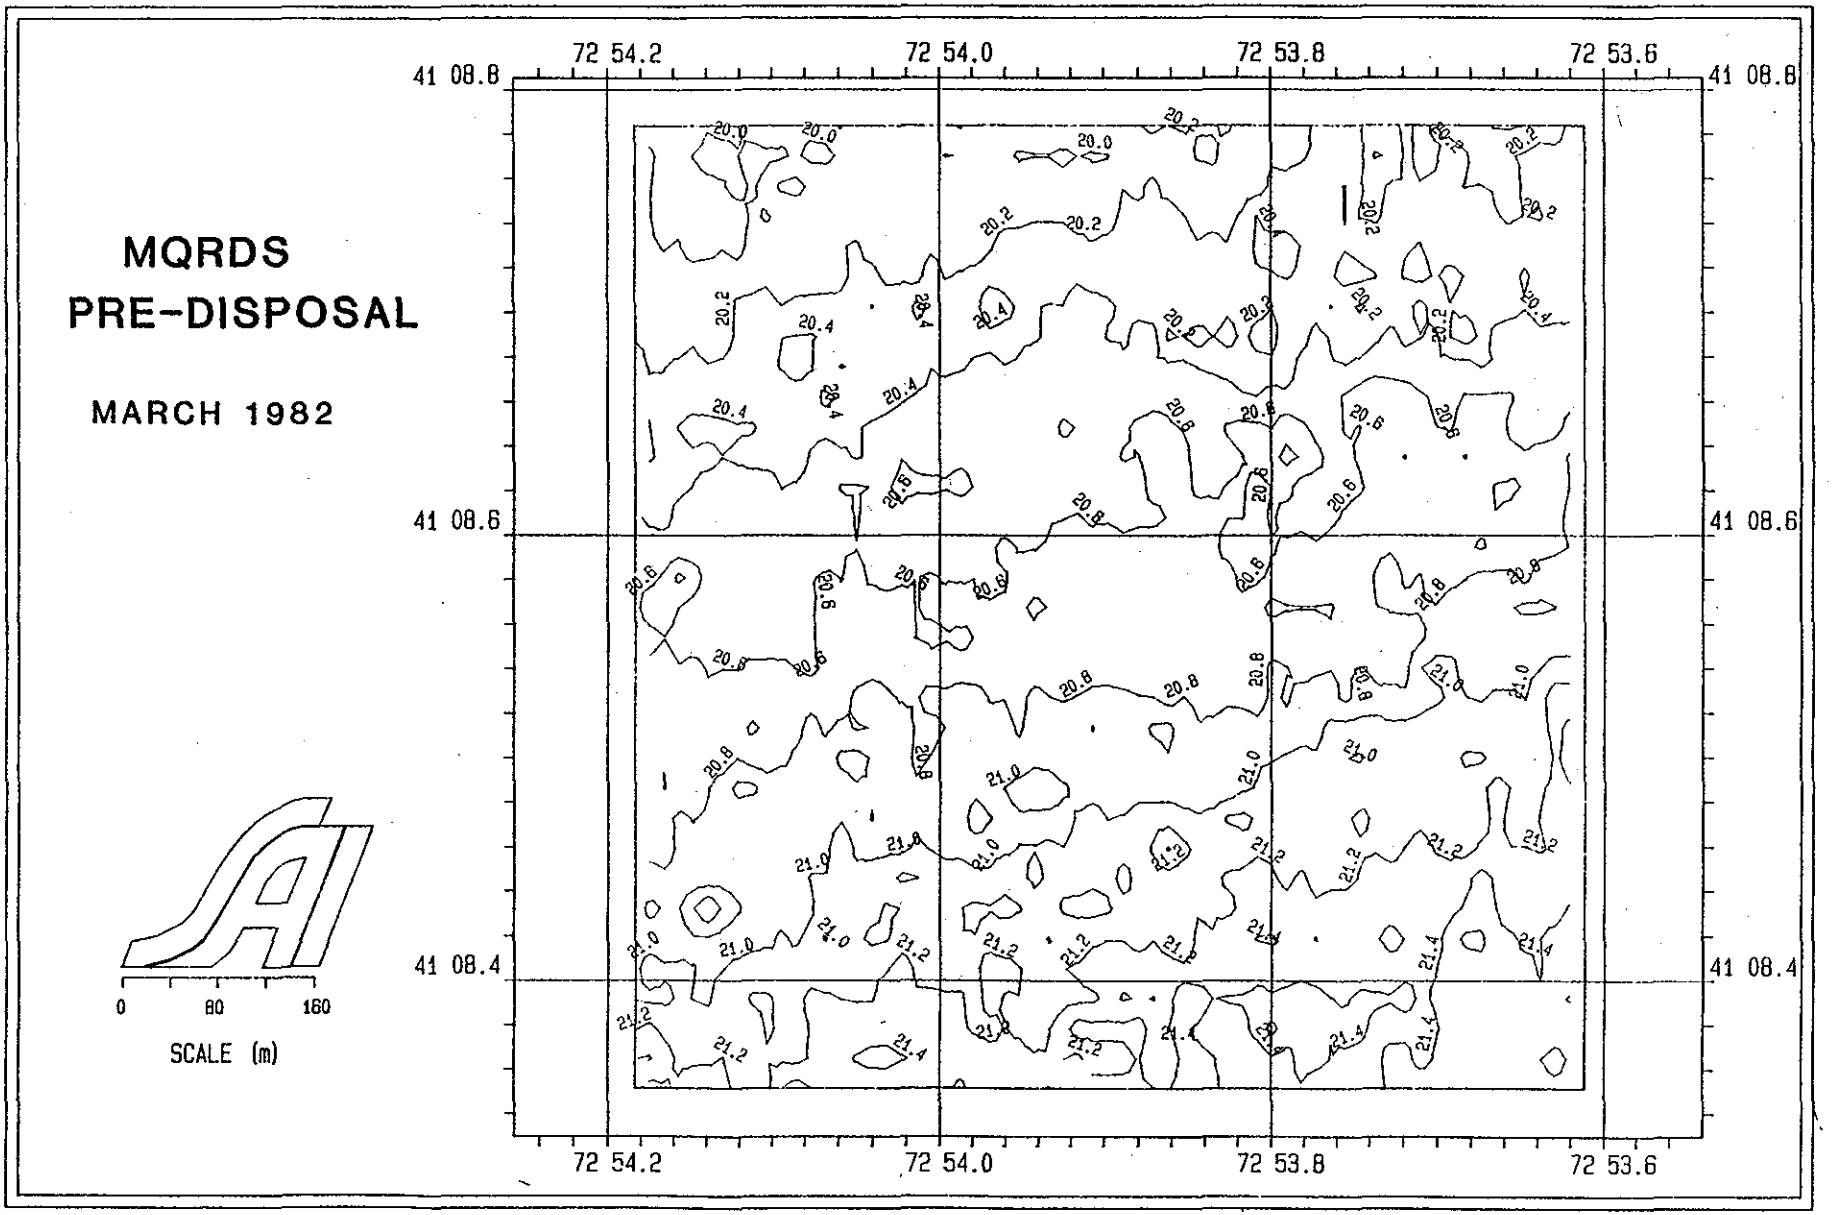
Figure 2-1

During the spring of 1982, sediment from the Mill River in New Haven was capped with additional material from the Quinnipiac River. Figures 2-1 and 2-2 present bathymetric charts before and after that operation. The mound created by the capping operation is readily apparent in Figure 2-2 as an elliptical shaped elevation with axes of 300 m and 180 m and a maximum elevation of approximately 1.5 m. Figure 2-3 shows the same site 9 months after disposal and immediately prior to initiation of the present New Haven project. Very little change had occurred over this period indicating a stable containment situation.

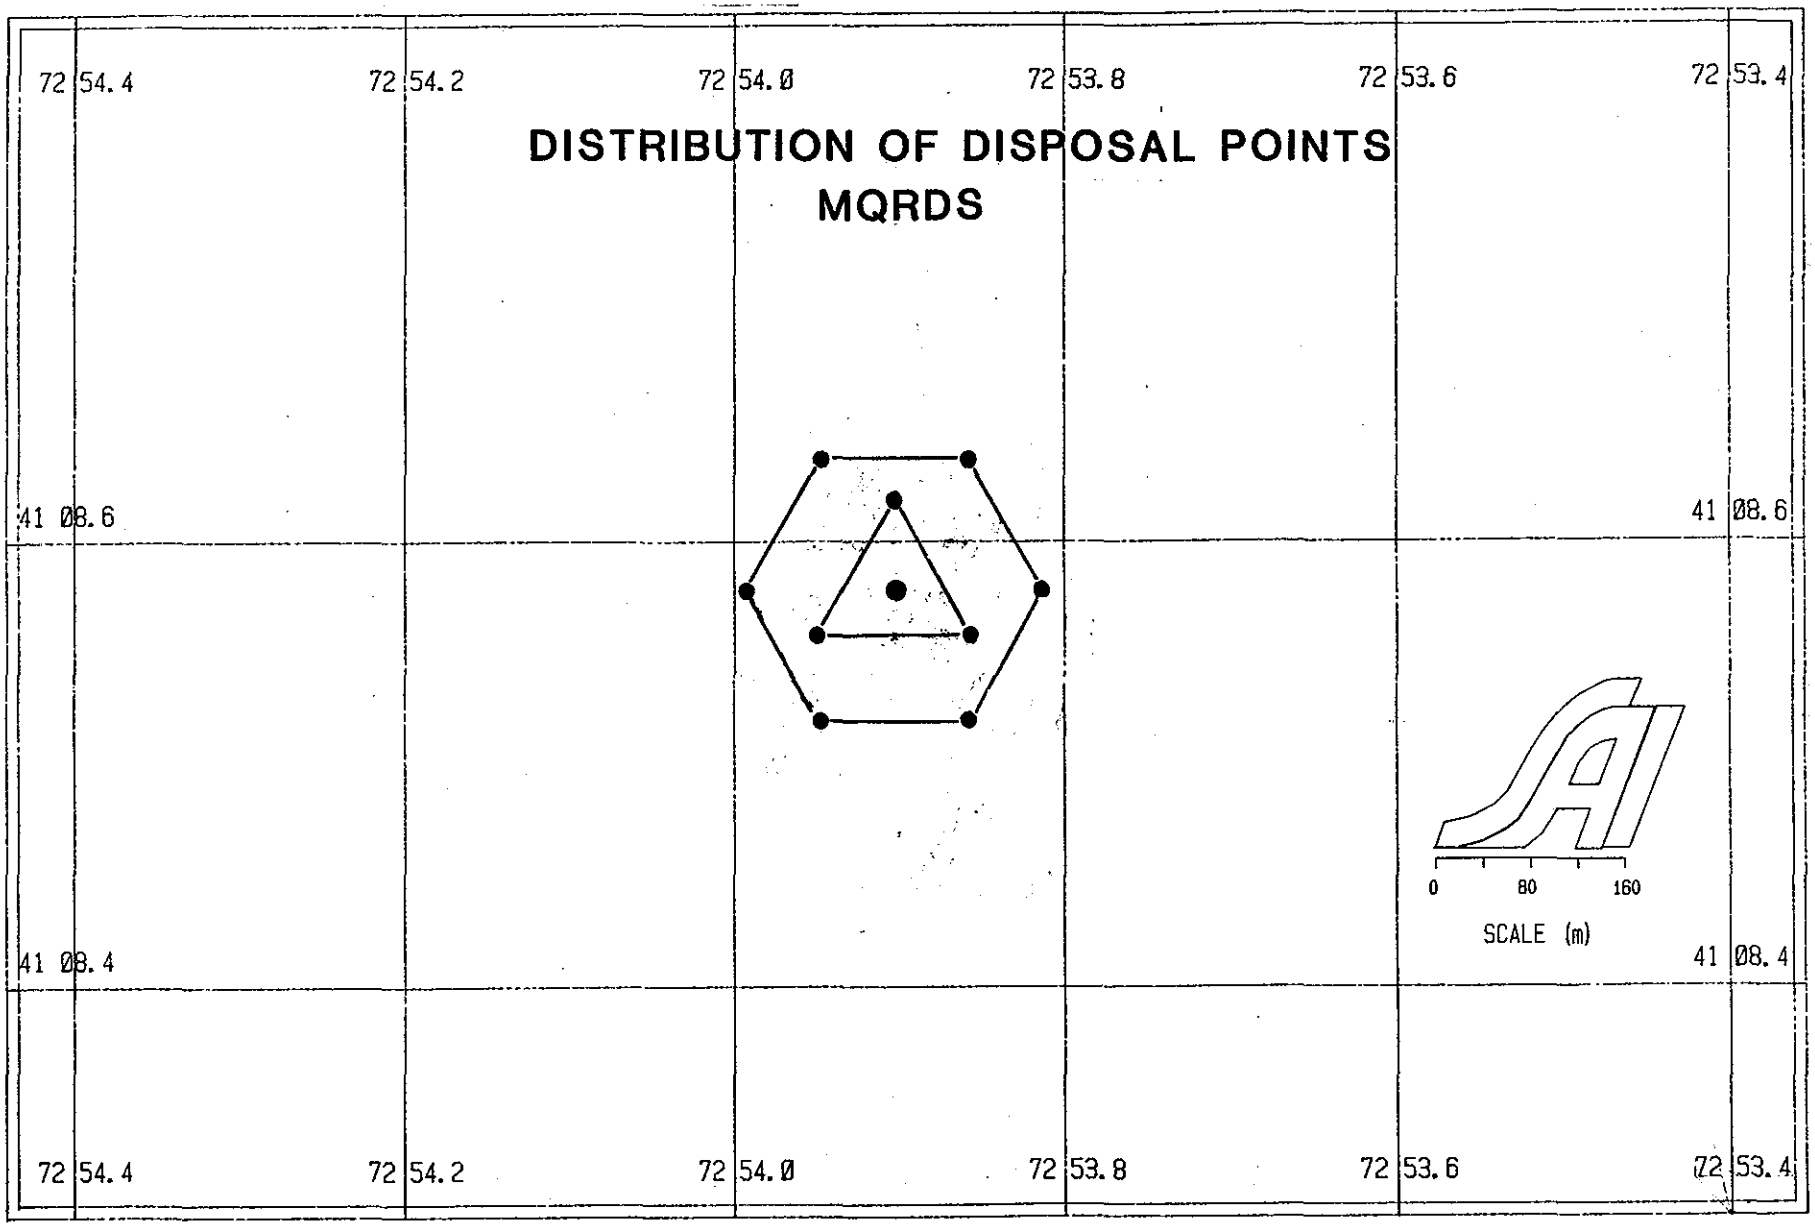
Figure 2-4

A total of ten different disposal points were specified as shown in Figure 2-4. The computer then sequenced through these points and directed the helmsman to the correct location. The system also provided a record of the ship's track to and from the disposal site and the exact location of dumping for each scow load.

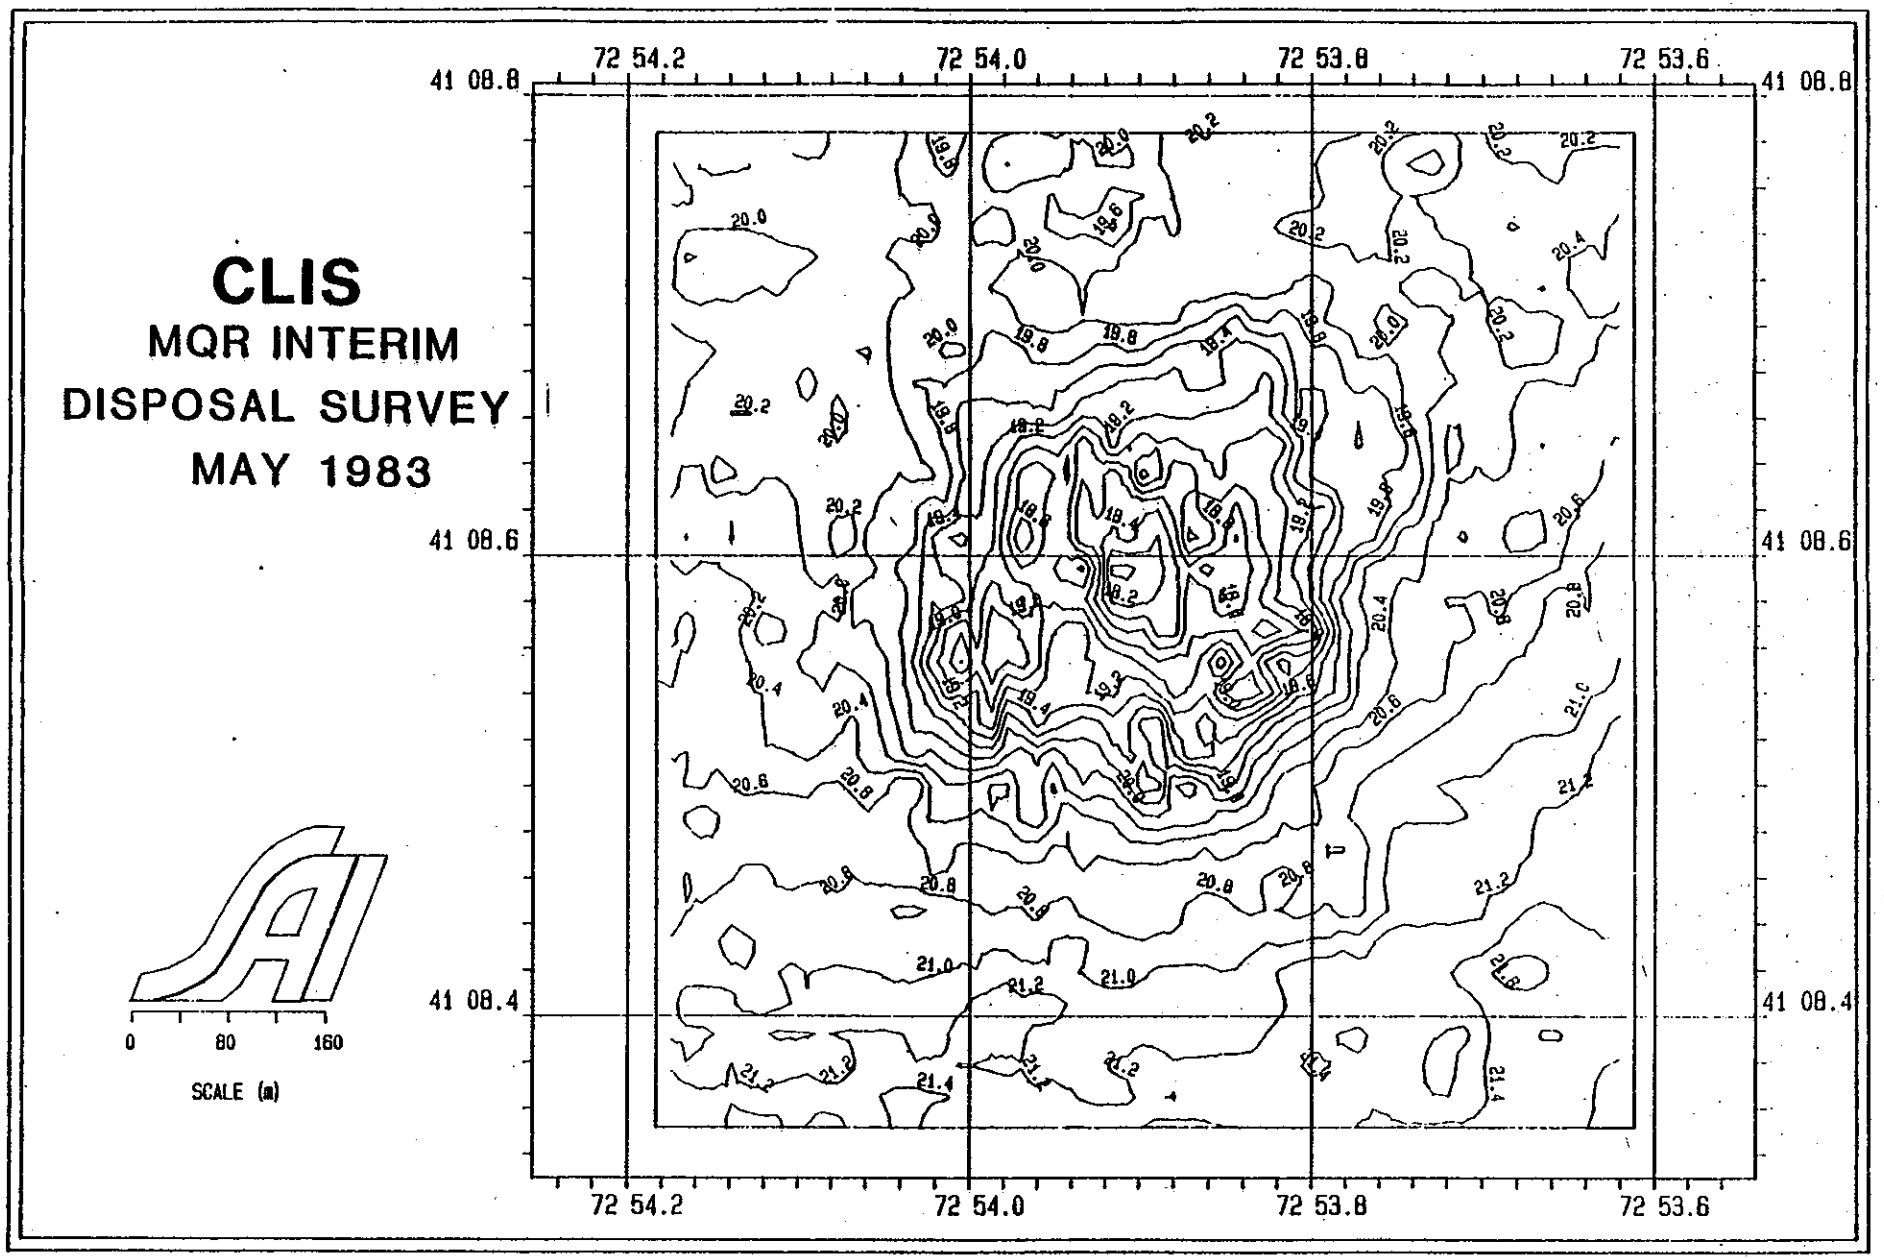
Although some problems were experienced due to loss of Loran-C signals, the system was successful in distributing the dredged material over the designated area. Figure 2-5 is a contour chart of an interim bathymetric survey conducted on May 6, 1983. At this time, approximately 70% of the dredging had been completed and the mound at the MQR site had expanded to a roughly circular configuration with a diameter of 400 m and an average thickness of approximately two meters.

across the mound. As in previous capping operations, the thickness of dredged material decreases rapidly beyond the flanks of the mound to 1-2 cm at distances of 400 m from the center of the site. Traces of material were present, however, at distances of up to 1000 meters, particularly on the west transect.

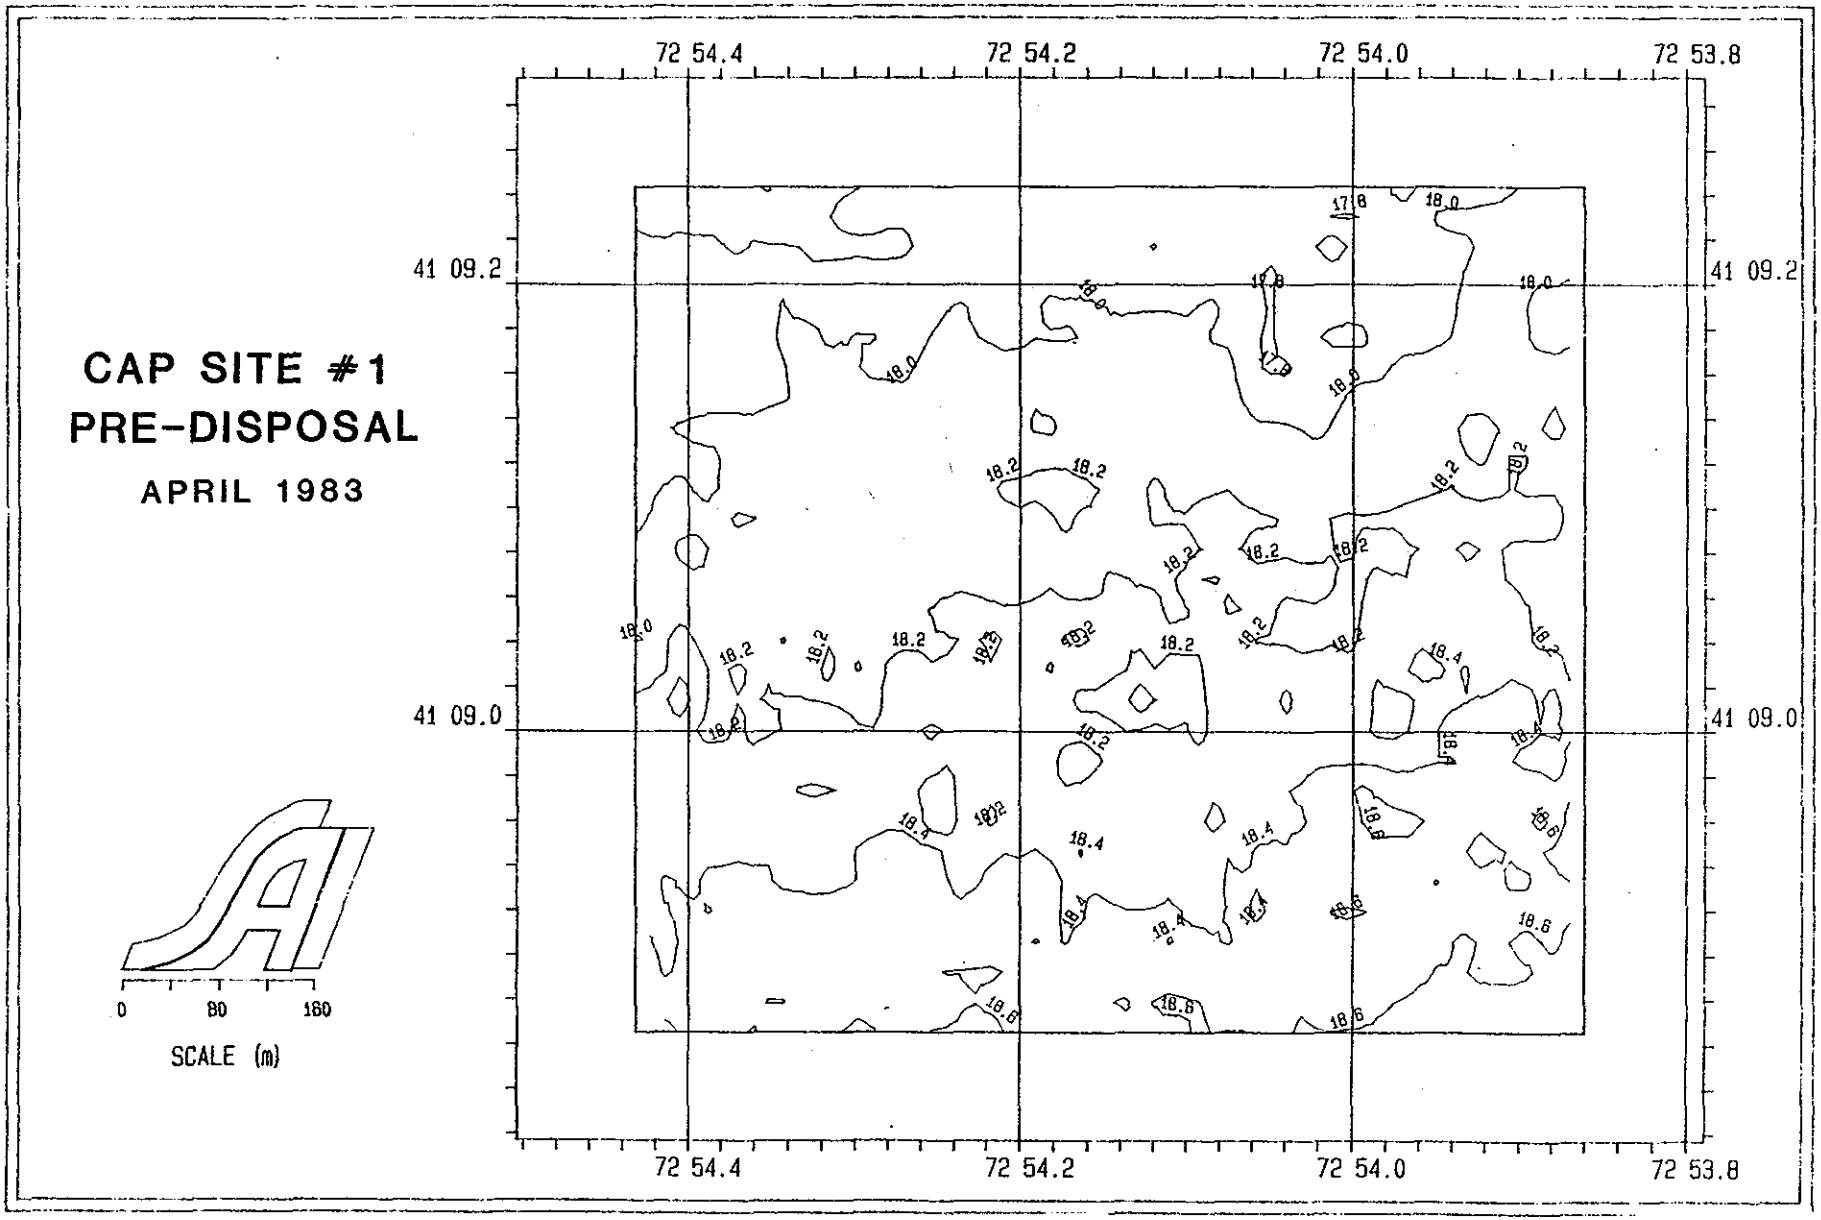
Figure 3-1

A baseline bathymetric survey (Fig. 3-1) of Cap Site 1 on 7 April, 1983 indicated a relatively flat bottom sloping only .5 m from north to south over the survey area. This survey was made a few days after disposal operations began and a slight elevation is apparent in the south center of the survey.

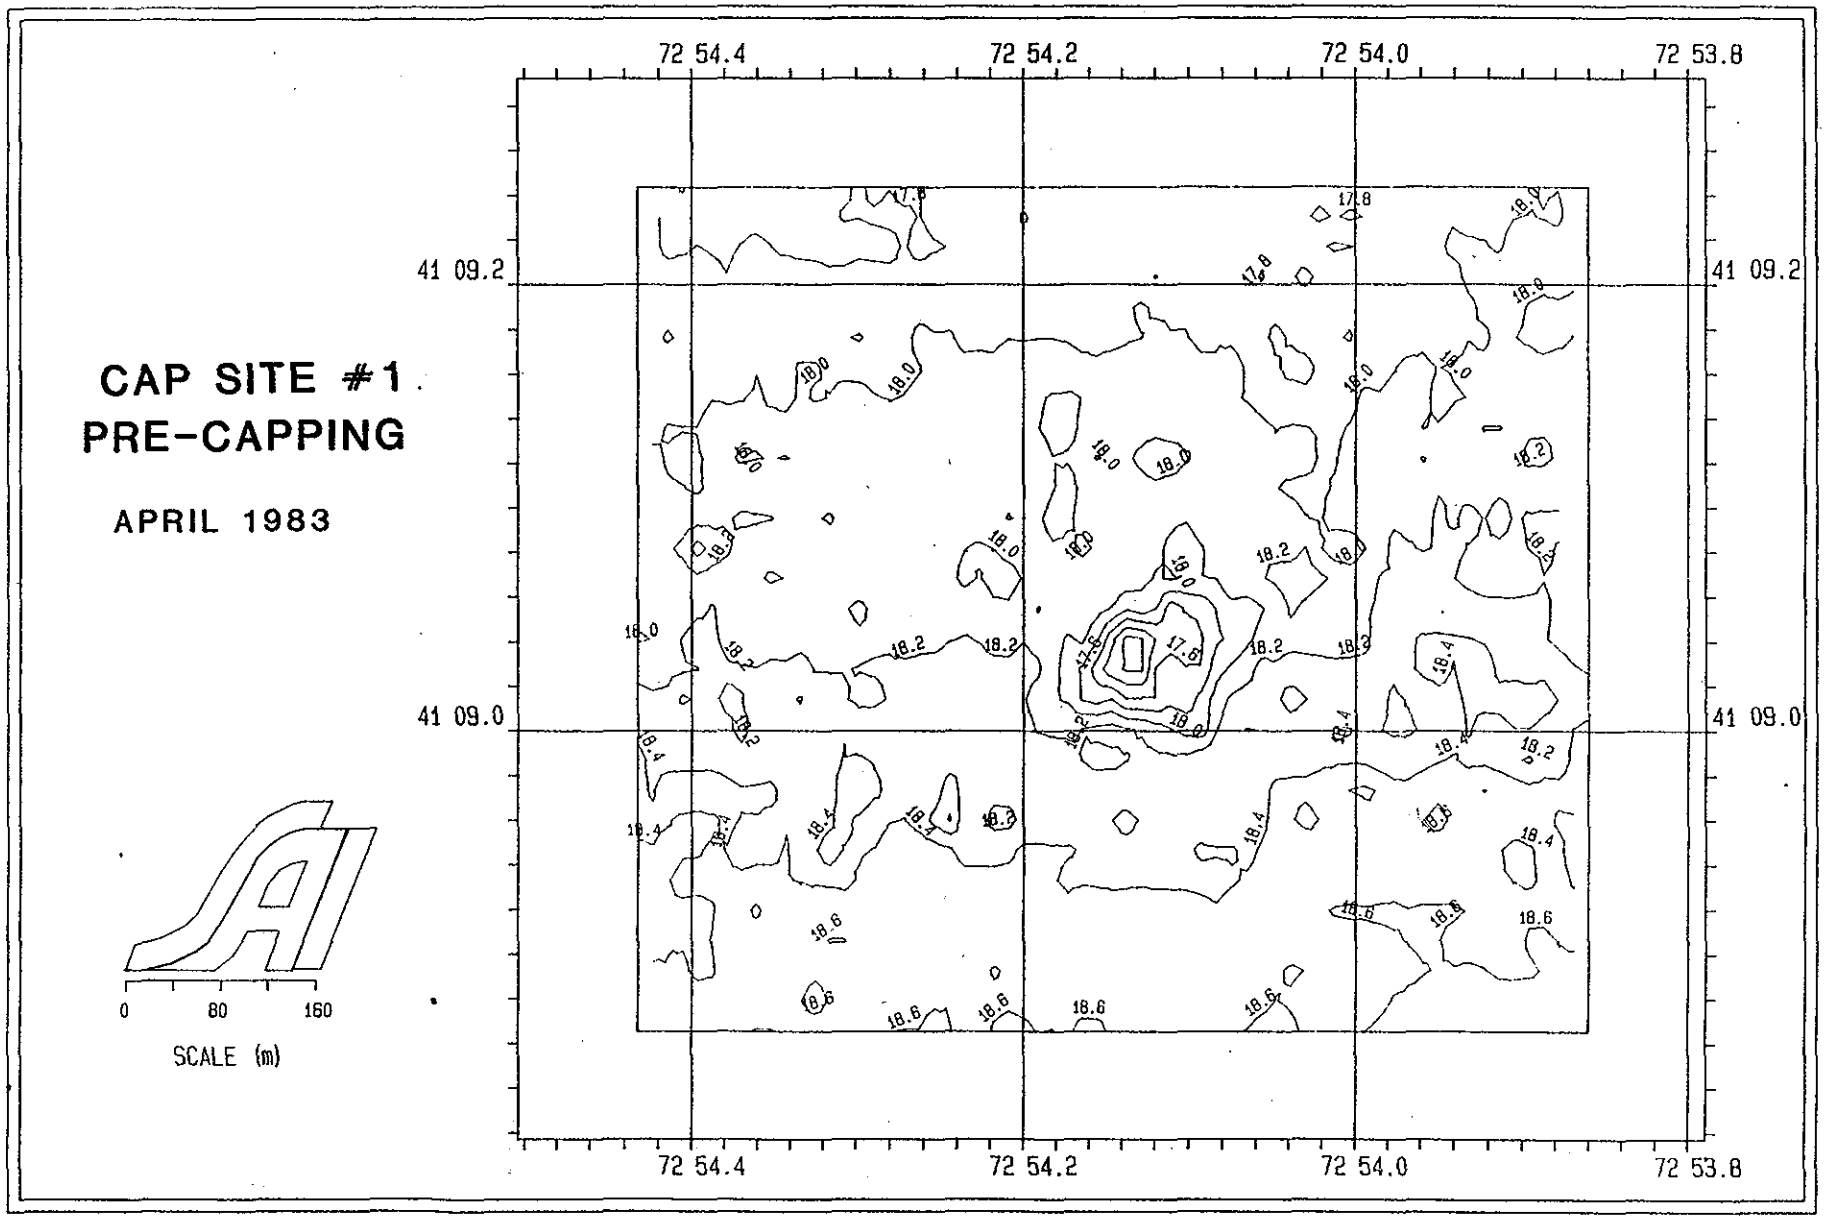
Figure 3-5

The combination of bathymetric and side scan data obtained at the site support the observation that initial disposal operations were not tightly controlled through dumping with the buoy immediately north of the scow. After emphasis was placed on the importance of point dumping, the subsequent operations were conducted close to the buoy and the Post-Black Rock disposal survey (Fig. 3-5) indicates a small mound less than 200 meters in diameter and approximately one meter thick was formed south of the buoy.

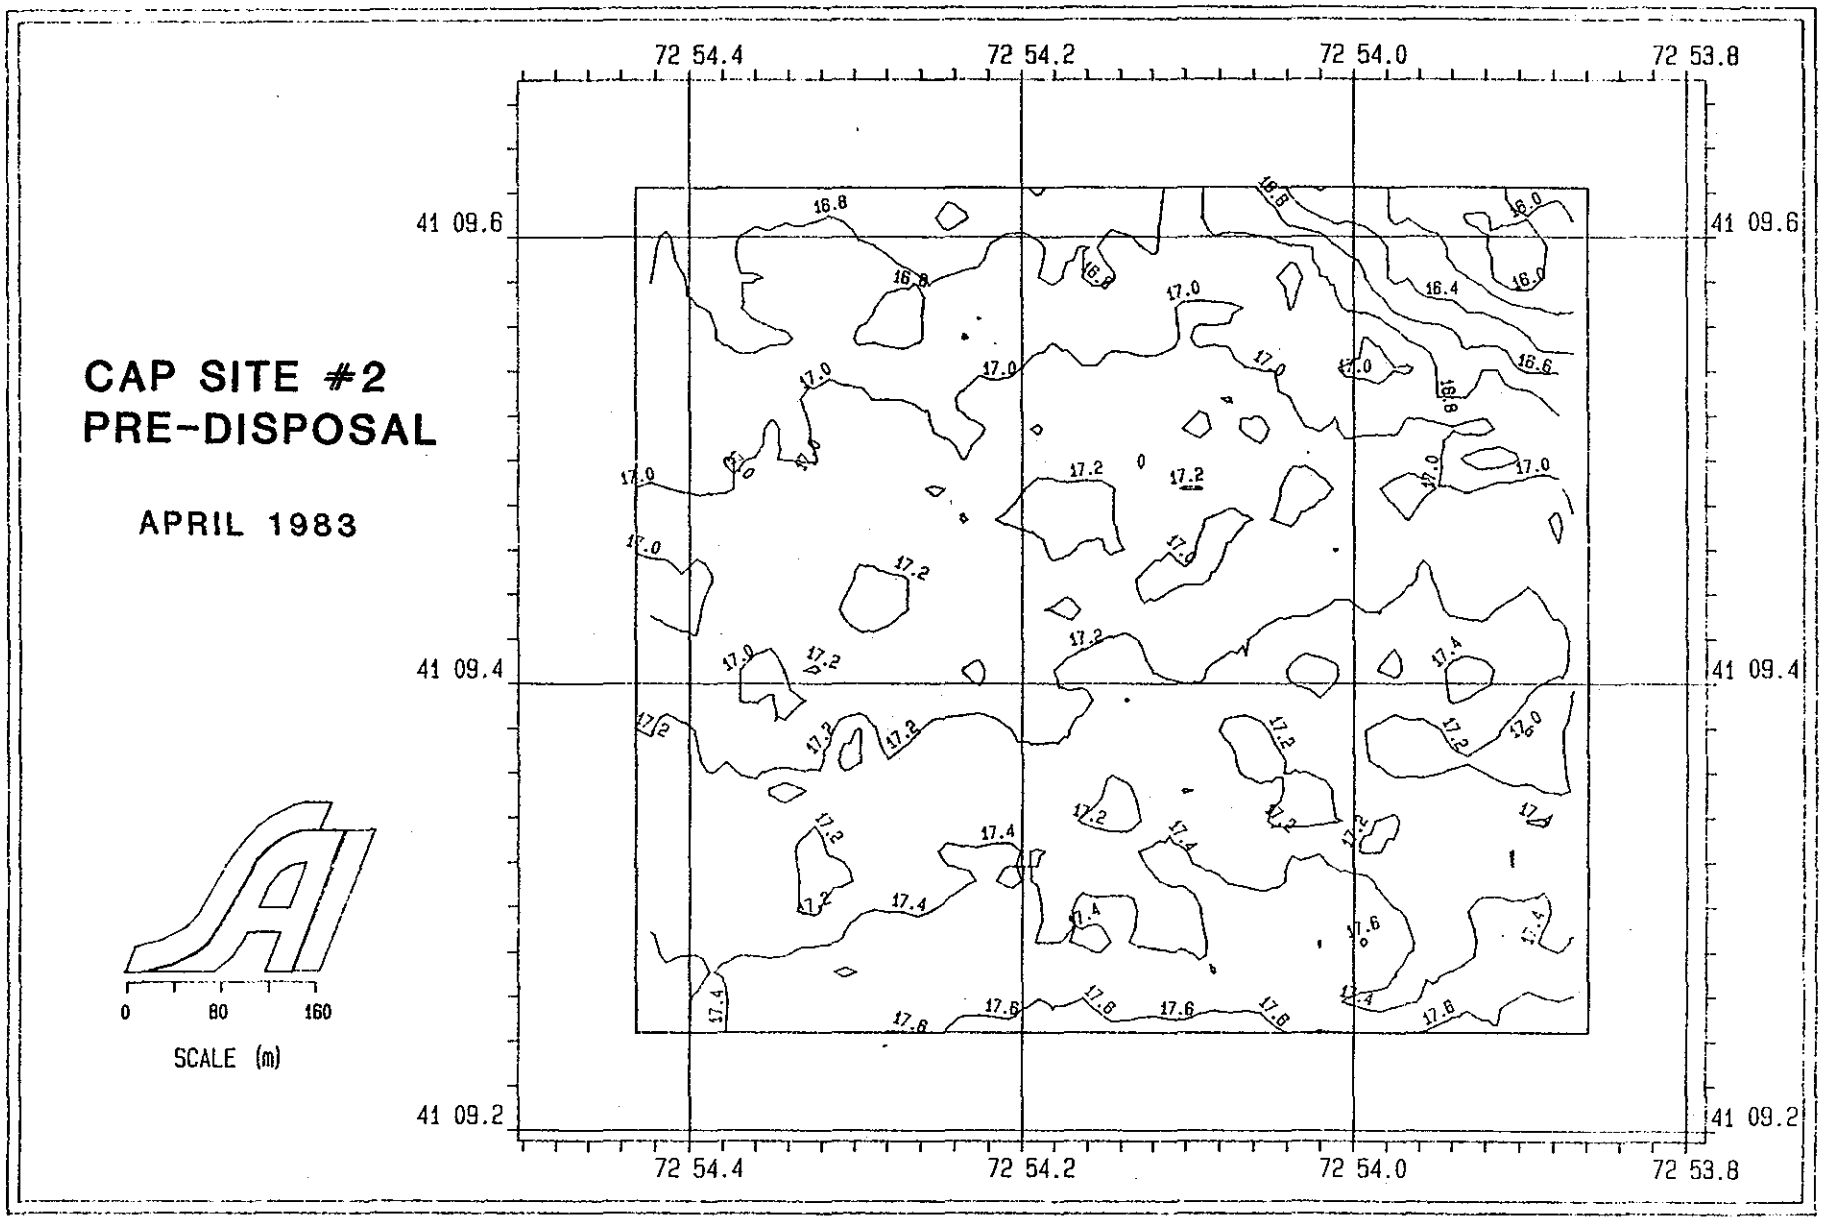
Figure 4-1

Cap Site 2 was established 700 m north of Cap site 1 to provide a site for capping with sand material. The baseline survey (Fig. 4-1) indicates a more complex topography than the CS1 site, but still maintains a slope with a depth difference of one meter from north to south across the site. A shoal area with a topographic relief of one meter is also present in the northeast corner of the site. Sediment samples in that area were a coarse sand, indicating the possible presence of previous disposal in the area.

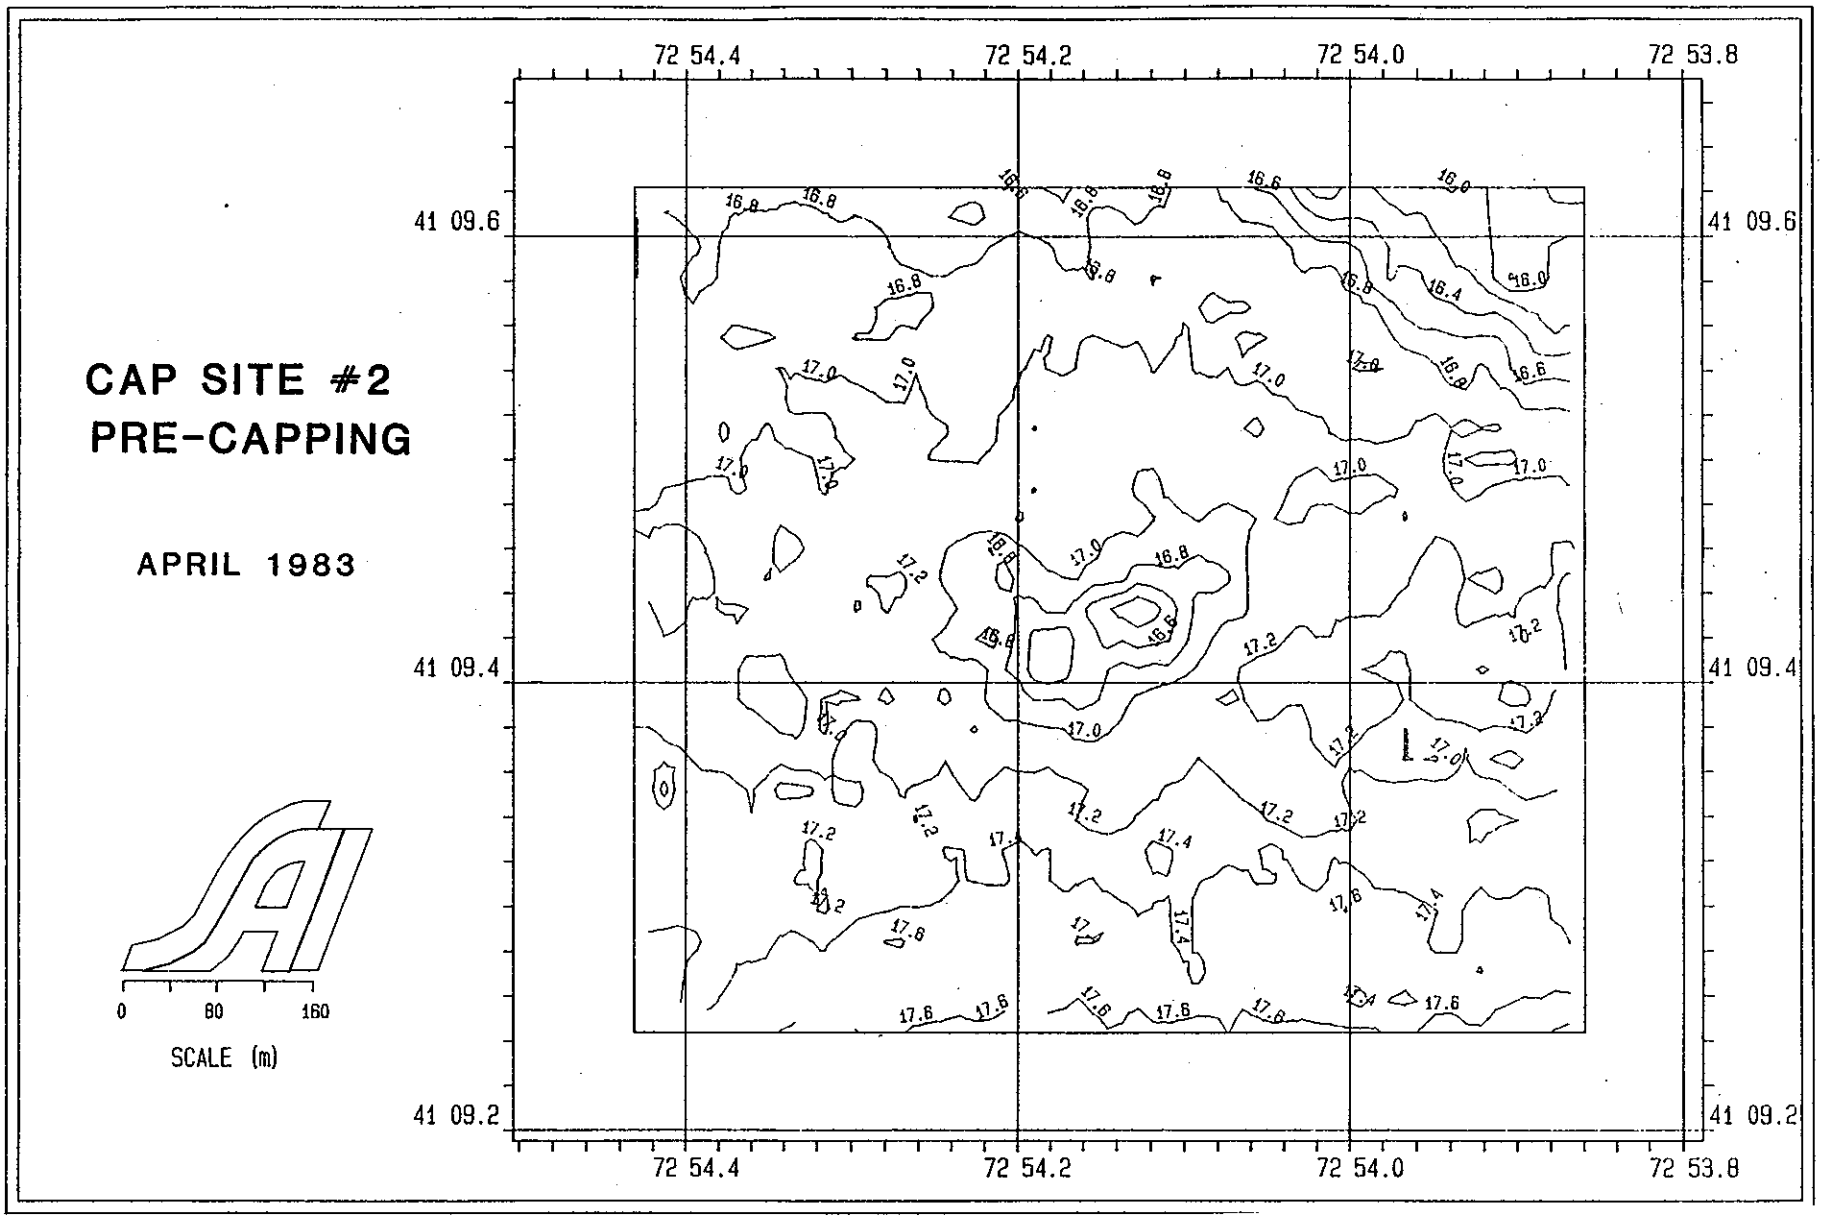
Figure 4-2

An interim survey of the CS2 site (Fig. 4-2) was conducted on 28 April, 1983 and indicated the presence of an elliptical mound approximately 200 meters long in the east-west direction and 100 meters across in the north-south direction. Total elevation of the mound was generally less than one meter, and may reflect a lack of cohesion in sediments from the upper Black Rock Harbor area.

In summary, Cap Site 2, while similar to the Cap Site 1 area on the baseline survey, may require special care in placement of the cap, since the material dumped at the buoy appears to have spread out over a larger portion of the bottom. A significant amount of material has been dumped since the interim survey was completed, and a Post-Disposal survey is planned for the near future to assess the results of the entire operation.

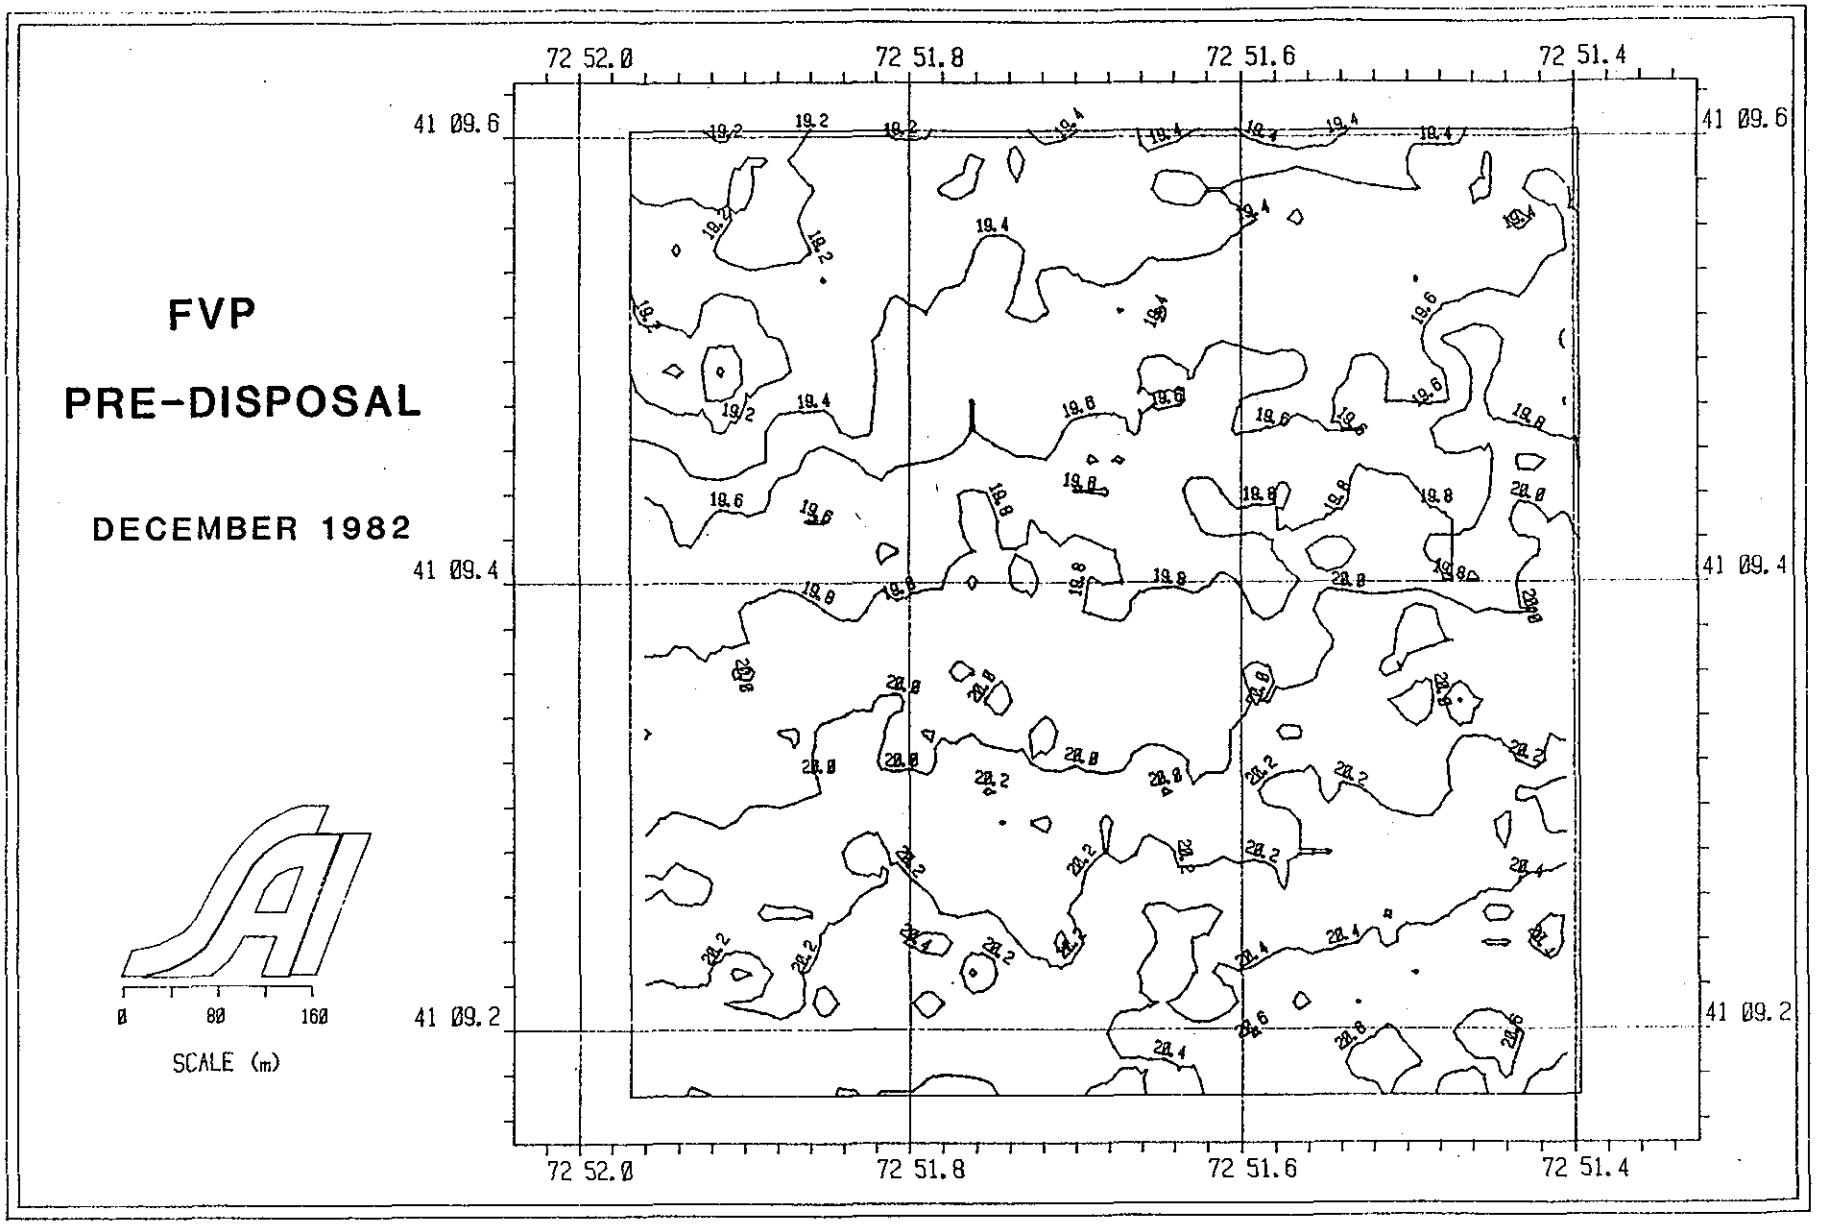
Figure 5-1

Several baseline surveys have been conducted at the FVP site and results have previously been reported in DAMOS Contribution #23, describing the Site Selection of the FVP Site. The last survey conducted prior to initial disposal operations took place on 10 December, 1980 and is shown in Figure 5-1. As discussed previously, the bottom at the site has a gentle slope
