STATUS REPORT DISPOSAL OPERATIONS
AT THE CENTRAL LONG ISLAND SOUND
DISPOSAL SITE

DISPOSAL AREA MONITORING SYSTEM (DAMOS)

GEOPHYSICAL ASPECTS OF CAPPING OPERATIONS

MAY 1983

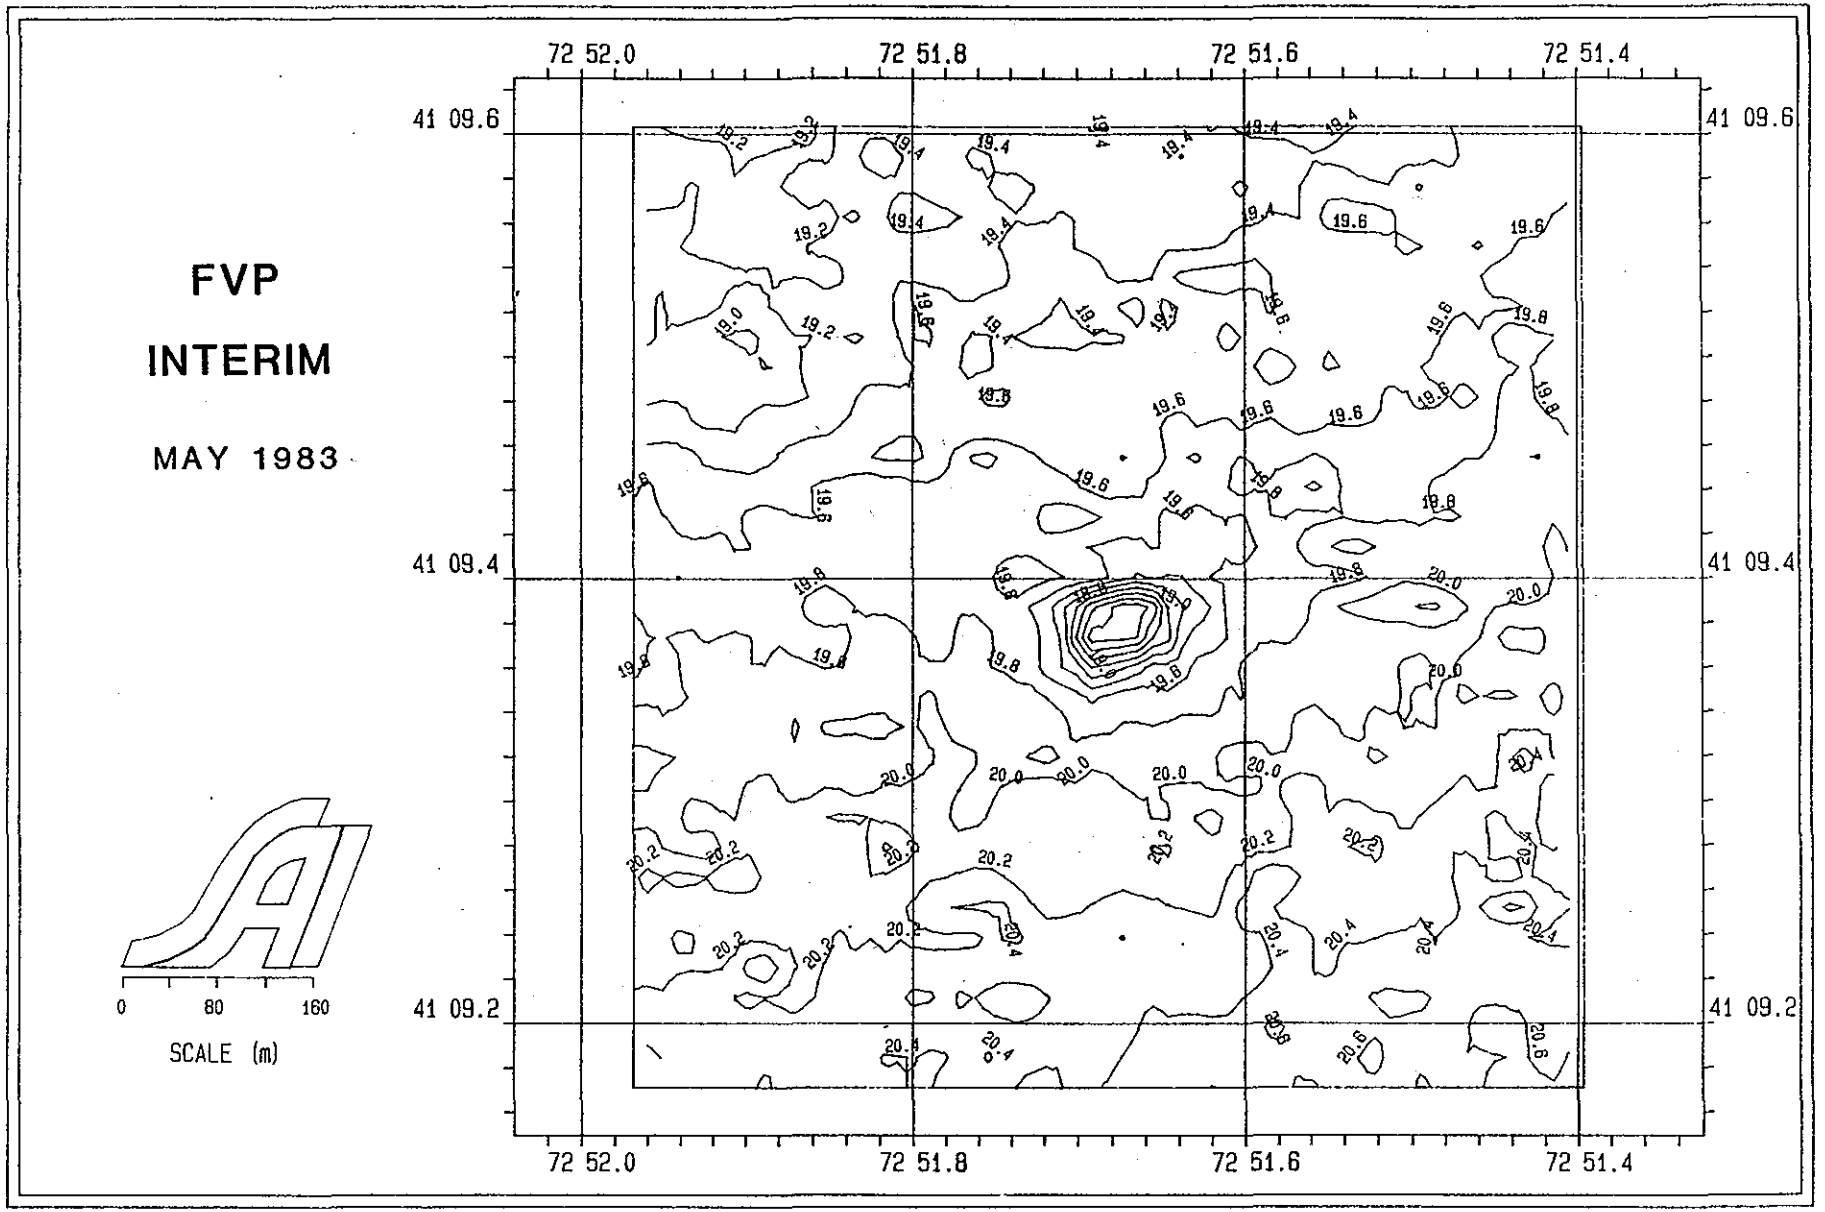
Figure 5-4

A second interim bathymetric survey and associated side scan survey were conducted on 5 May, 1983, after disposal of approximately 35000 m^3 of dredged material had been completed. The results of this survey (Fig. 5-4) were also satisfactory as a small mound approximately 150 m in diameter had formed at the buoy with a topographic relief of more than one meter. Sediment samples taken at the same time revealed a covering of several centimeters thickness extending out to a range of 200 m on the east and slightly farther on the west side of the mound. This covering consisted of fine black organic silt with a high water content and low cohesiveness, which appeared to be quite fluid

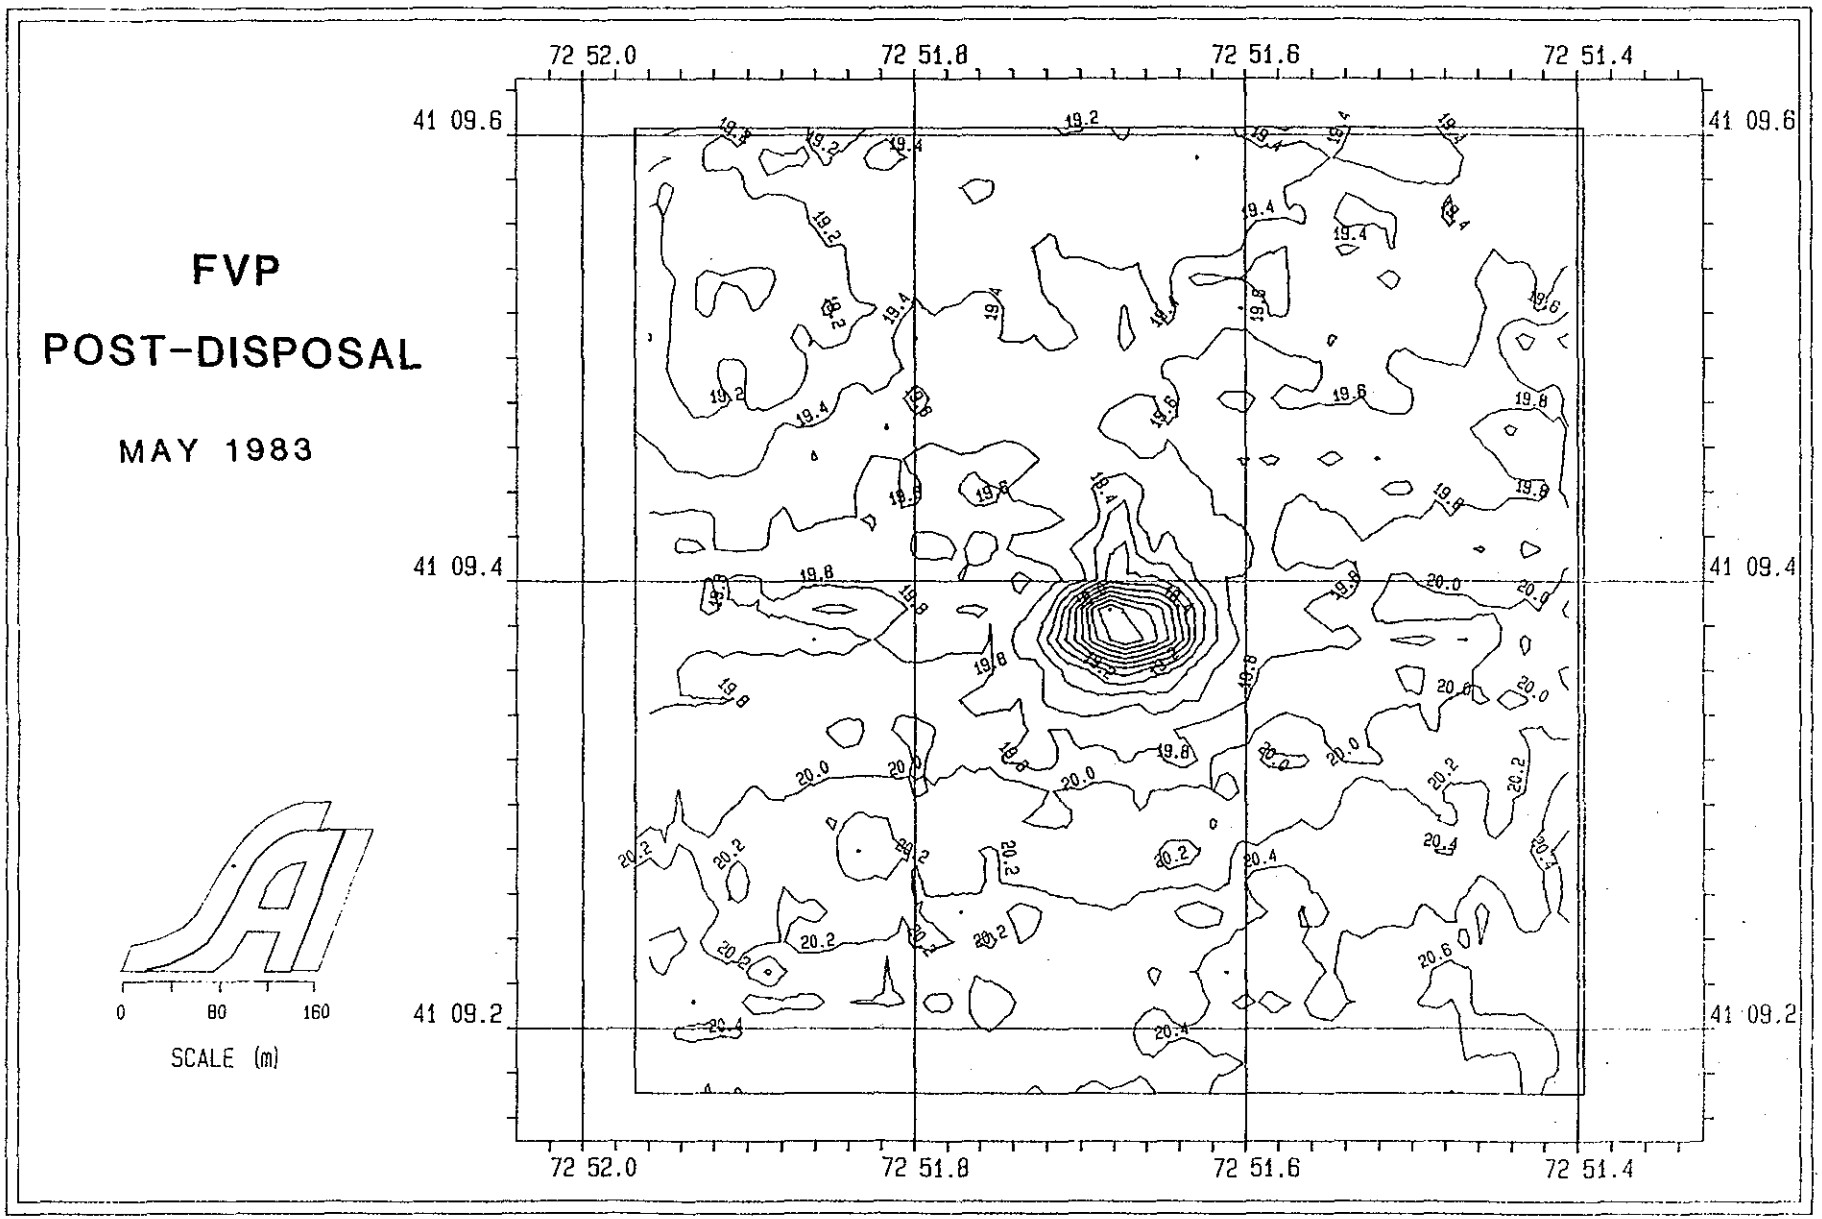
Figure 5-8

Following completion of the FVP portion of Black Rock Harbor dredging, a Post Disposal Baseline survey was conducted on 19 May, 1983. This survey (Fig. 5-8) indicated that approximately 55,000 m^3 of material, measured by scow displacement, had formed a small elliptical mound slightly less than 200 meters in diameter and slightly more than two meters thick. Vertical profiles through the center of the mound (Fig. 5-9) support this observation. Problems with tracking the fathometer record by the on-board digitizer make the values on lane 18 invalid, however, post survey analysis of the analog record will provide correct data for future profiles and volume calculations.

In summary, the disposal operation at the FVP appears successful; however, the potential for movement of sediment does exist because of the high water content, fluid muds on the margins of the mound. Careful monitoring during the immediate post-disposal period is essential to assess the potential impact should this movement occur.
